Archaeological Observation

English Heritage Trust

Cleeve Abbey Phase 2

BA1520CAW

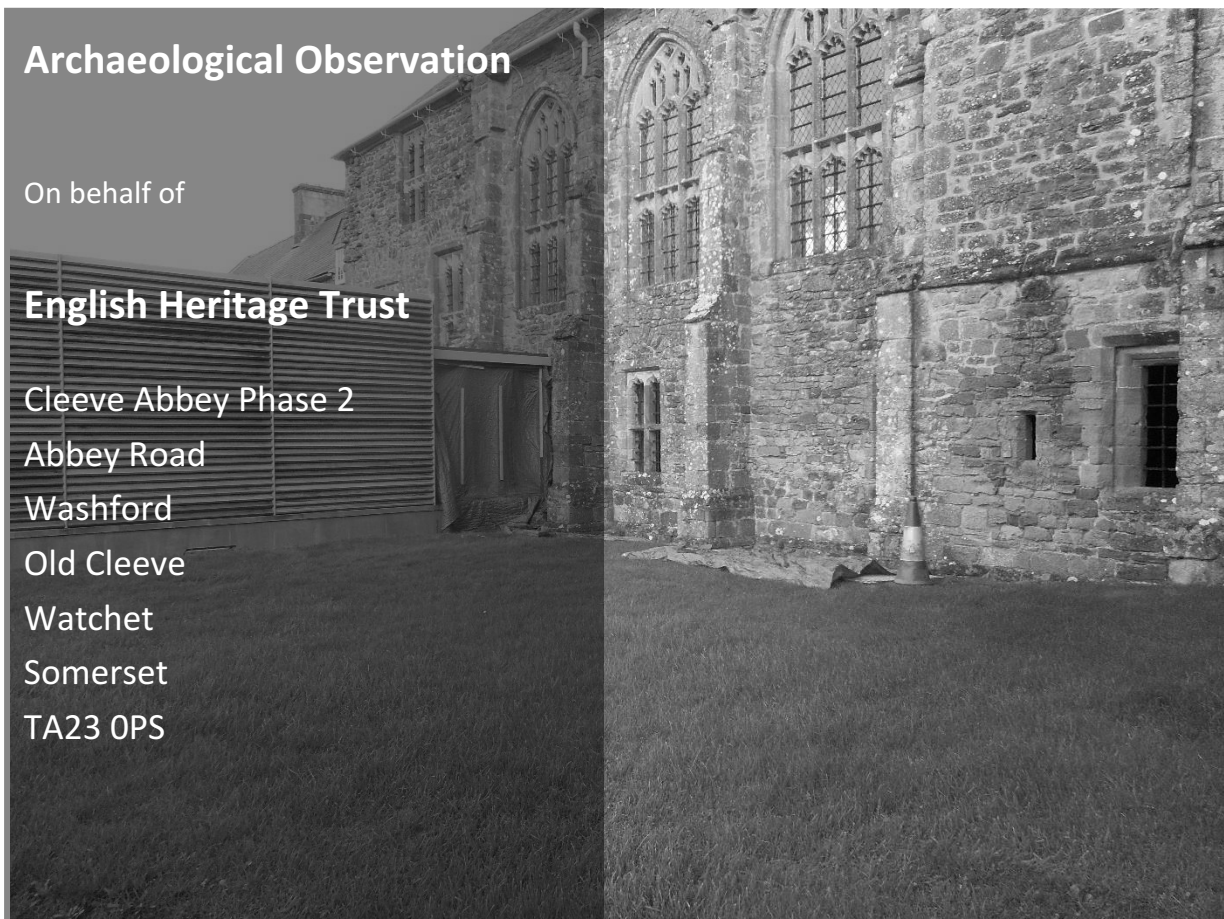
Cover: View northwest of South Cloister of Cleeve Abbey showing new pavilion structure and location of Pit 2

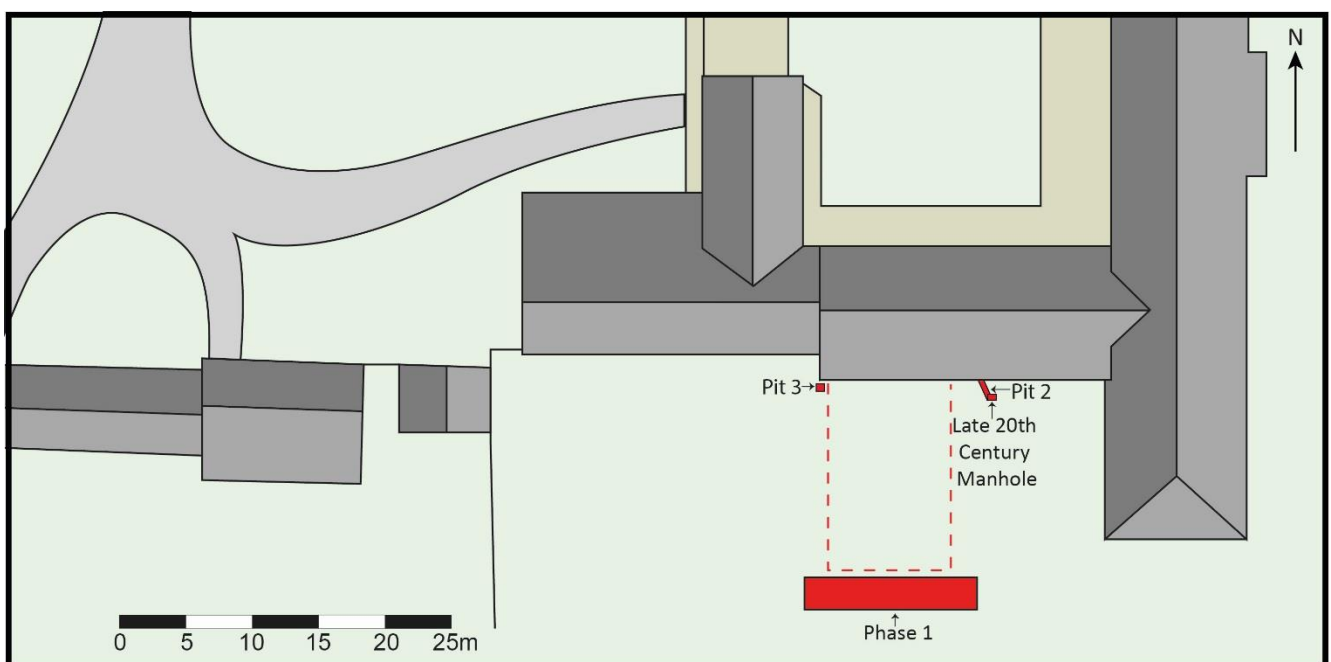
Fig. 2: Plan showing location of Phase 1 and Phase 2 groundworks

The groundworks forming Phase 2 (*figs. 2 & 3*) comprised two pits located to the E and W of the new pavilion structure (Pit 2 and Pit 3, respectively). To avoid duplication of context numbers, the Phase 1 trench previously opened was referred to as Trench 1 whilst the numbering system for this current Phase 2 report commenced with Pit 2.

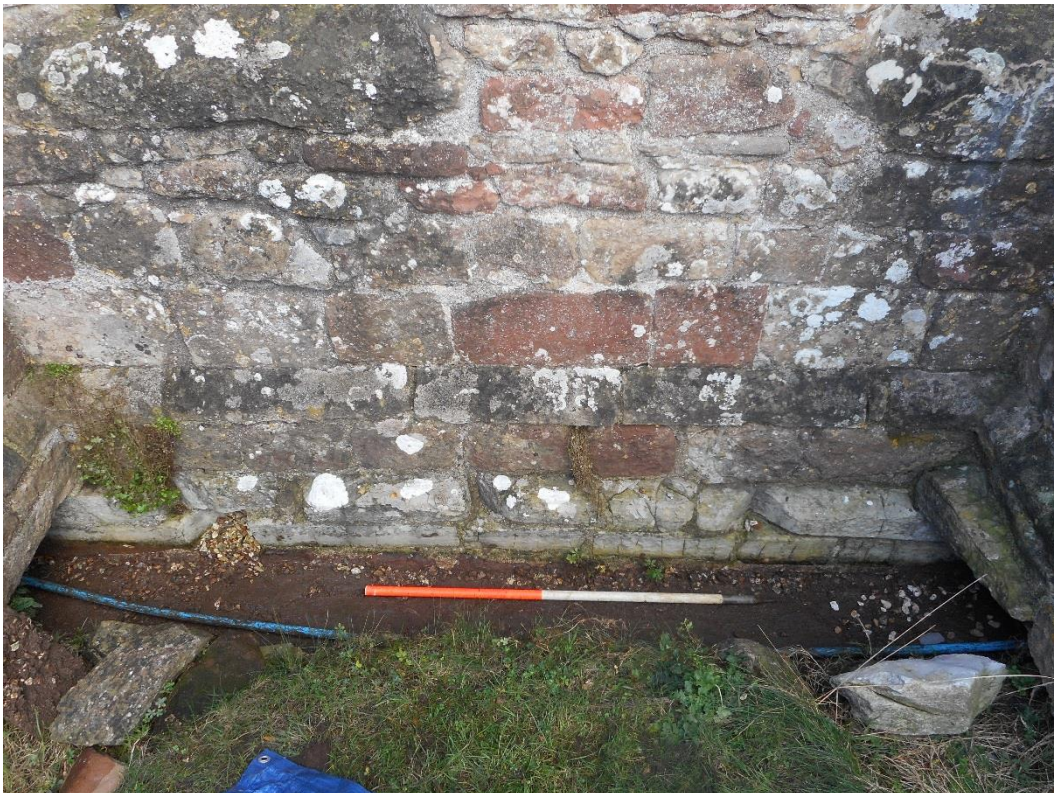
Pit 2 was located approximately 2.5m to the E of the eastern edge of the pavilion structure (*cover image*), joining new drainage into the line of the existing drain, via an inspection chamber (205); inspection chamber (205) was previously identified during Phase 1 of the groundworks. The route of the new drain utilized the course of a drainage channel (202), which ran beneath the buttresses of the South Cloister of the Abbey (*Plate 1*). Although the date of this channel is unknown, it appears to be post-medieval. The S side (202) was constructed of brick and concrete, although excavation of the pit revealed that the slate base, (203) extended slightly further southwards than the modern edging (202) (*Plate 2*). This may suggest that the post-medieval structure utilised an earlier, existing drain.

Plate 1: View N of South Cloister wall and slate drainage channel (203)

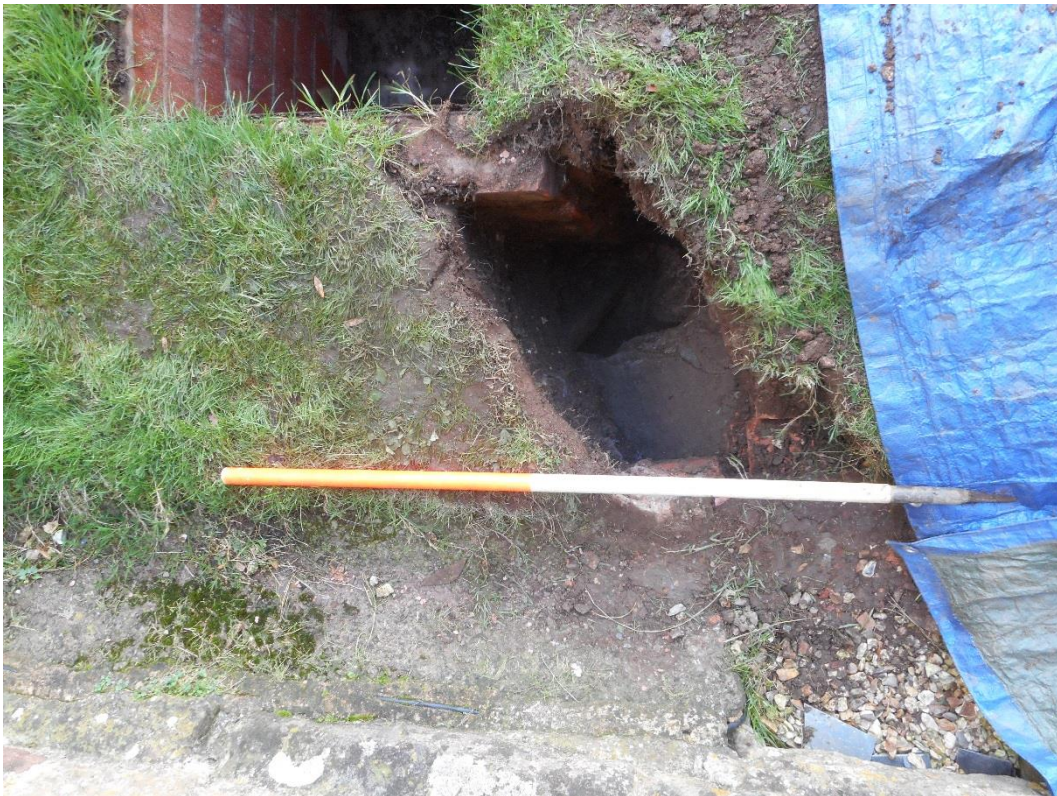
There was no backfill present in the drain. It was necessary to remove the section of brick edging that was present within the Pit to allow access for the new water pipe, which was laid directly above the slate (203).

Plate 2: View S of Pit 2 during excavation showing exposed slate layer (203)

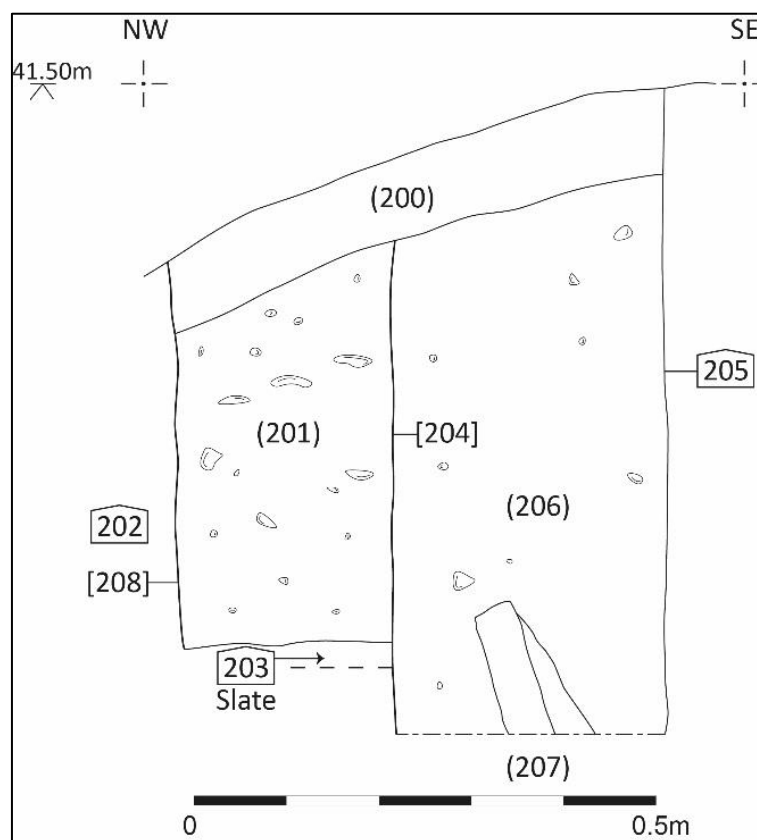
This material had been truncated by construction cut [208] for the modern concrete-and-brick edging material (202) of the drain and in turn had been truncated by cut [204] for the drain inspection chamber (205). Whilst the construction of (202) retained the slate layer (203) as its base, (205) was much deeper and so construction cut [204] truncated the slate (203) as well as the made ground (201) (*fig. 4*).

Within cut [204], were two backfill deposits, the upper deposit (206) evidently having formed from disturbed and re-deposited made ground material (201). Present within this backfill was a single large flat stone that was likely to have been part of the original edging of the drainage channel (203). Underlying (206) and present at the impact depth, was a loose light reddish-pink, slightly silty sand with frequent small and medium sub-rounded stones. This material appeared to be similar in terms of composition to the earliest stratigraphic context revealed during Phase 1 of the groundworks, although the limited area exposed within Pit 2 means it is unclear if (207) originally formed part of a similar deposit or if it was imported from elsewhere to be used as backfill.

Fig. 4: SW-facing section of Pit 2

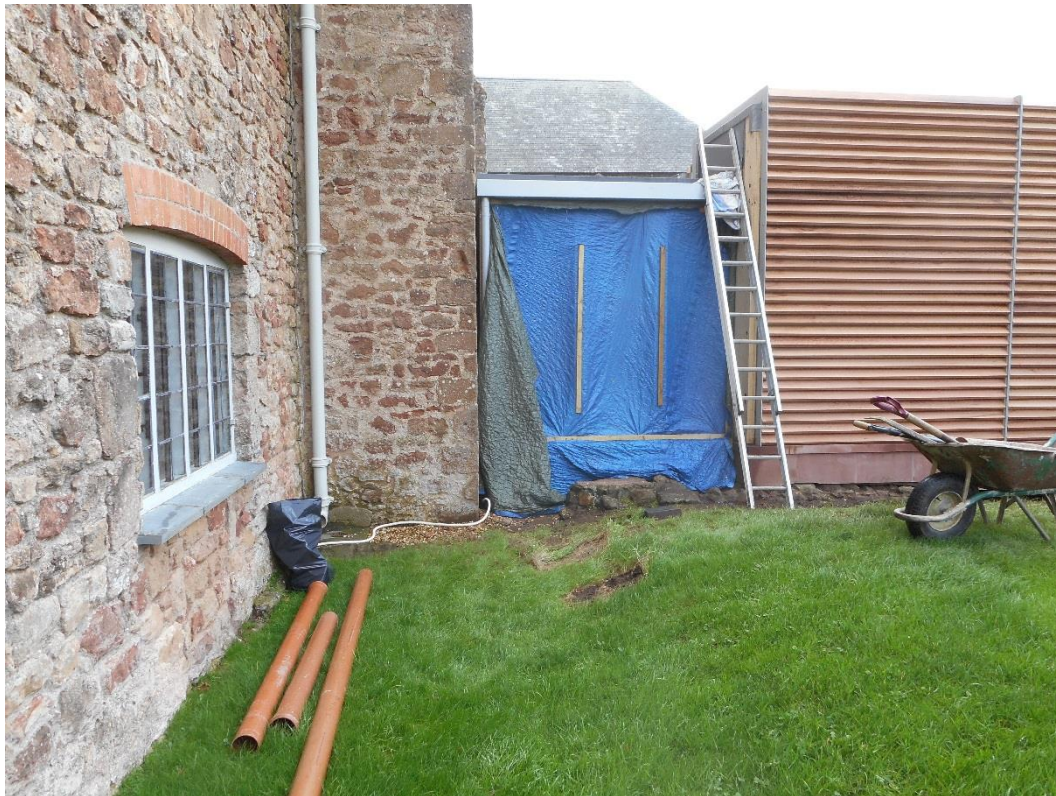
Pit 3 was located adjacent to the corner of the western edge of the pavilion structure and the South Range of the Abbey (*Plate 3*) in order to connect the new drain into the existing drainage, which was laid around 2001 and which had necessitated the removal and relaying of several stones at the northern end of the western wall of the Old Refectory.

Plate 3: View E showing location of Pit 3

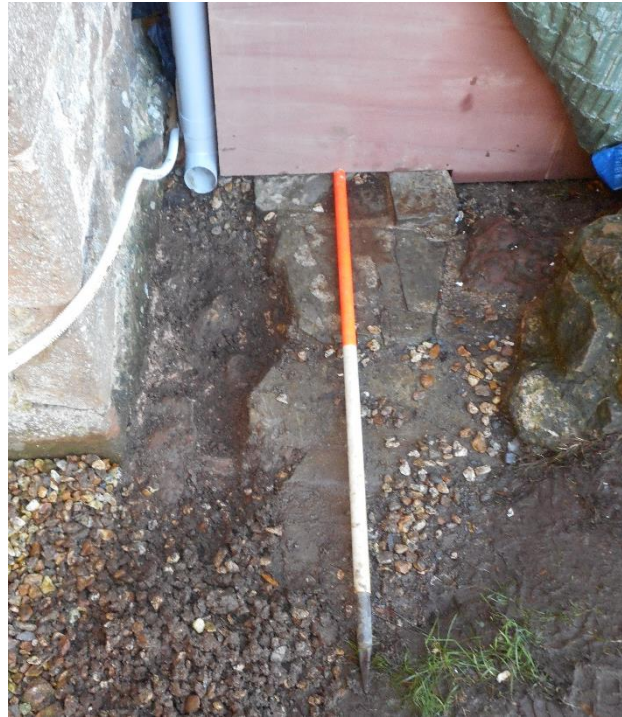
To avoid any undue disturbance to the extant fabric of the Abbey building, one of the previously removed stones (300) measuring 0.4m × 0.36m × 0.05m was lifted to allow access to the existing drainage (*Plate 4*).

Directly underlying the stone was a shallow layer of modern pink lime mortar (301) that was used during the relaying of the stone and which overlay the modern drainage pipe. To the immediate N of the pipe and partially overlain by (300), part of the extant fabric of the wall footings of the South Range of the Abbey was exposed (302). This was revealed further at ground level prior to excavation by the removal of a thin layer of gravel adjacent to the edge of the building.

Plate 4: Pre-excitation view E of Pit 3

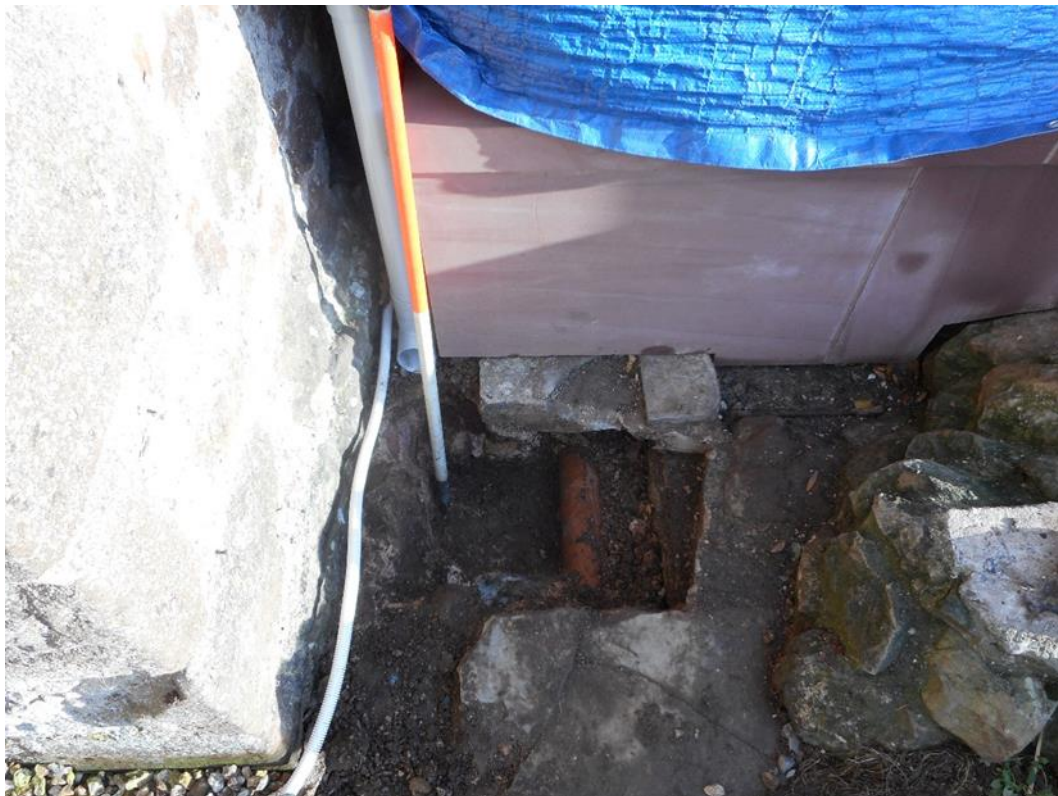
The E-W wall footings (302) were of light pinkish-red medium sub-angular and sub-rounded unworked sandstone construction with a light pink mortar bond. A small area measuring 0.3m × 0.3m × 0.25m was removed to allow sufficient space for the connection (*Plate 5, fig. 6*).

Plate 4: Post-excitation view E showing partially removed wall footing (302)
