## Archaeological Observation

**The National Trust**

Croome Court

BA1539 CCPR

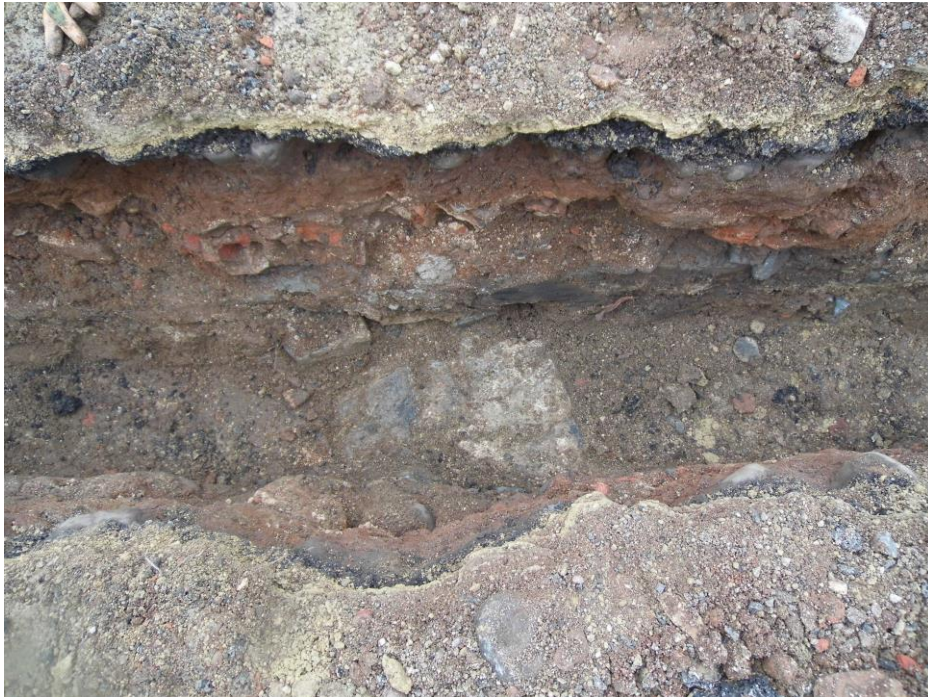
Wall (511) (*Plate 1; fig. 2*) was encountered during excavation of the LPG trench close to the Stable Block (Stable Court). This rested on a blue lias masonry foundation and was aligned NE/SW, compared to the more N/S alignment of the existing building. A further wall (528) (*Plate 2*) was encountered in the yard between the Red Wing and the Stable Block. Once again, this ran on a more NW/SE alignment than the present buildings suggesting an earlier phase of construction.

The plan of any building represented by these structures could not be ascertained, as the narrow trench limited the area available for investigation; additionally, the structure had been damaged during construction of the Laundry Range in the 18<sup>th</sup> century. However, the substantial width of the masonry uncovered might suggest a NW/SE aligned wall and a return to the NE.

*Plate 1: Wall (511) in the base of the trench; view N*

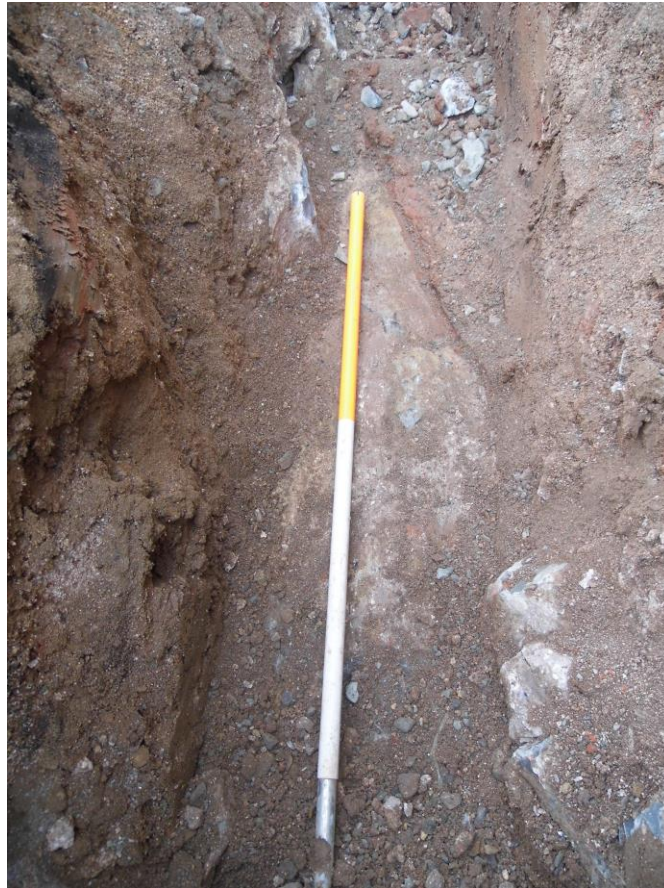
Wall (528) (*Plate 2*) appeared to be cut by walls (527) and (532), which related to the former Laundry Range between the Red Wing and the Stable Block and which would thus confirm an earlier date. As the Laundry Range is indicated on plans as early as those of Snape (1796) and Hopcroft (1810), this would suggest that wall (528) certainly could be of some antiquity.

Interestingly, all buildings in the vicinity shown on Doherty's plan of c.1751 and Beighton's 1714 drawing reflect the alignment as the present property. It is possible that these drawings are schematic but it is also possible that (511) and (528) predate the buildings shown on 18<sup>th</sup> -century plans. A 1750 drawing (Kay 2012, 73) shows a structure on a similar alignment to the two walls revealed in the trenching. It is thus possible to suggest that this wall represents the survival of an earlier structural component associated with the 17<sup>th</sup> -century complex of manorial buildings at Croome, which appears to have been built on slightly different orientation to the ancillary ranges shown in this location on late 18<sup>th</sup> -and early 19<sup>th</sup> -century mapping.

*Plate 2: View N of wall (528)*

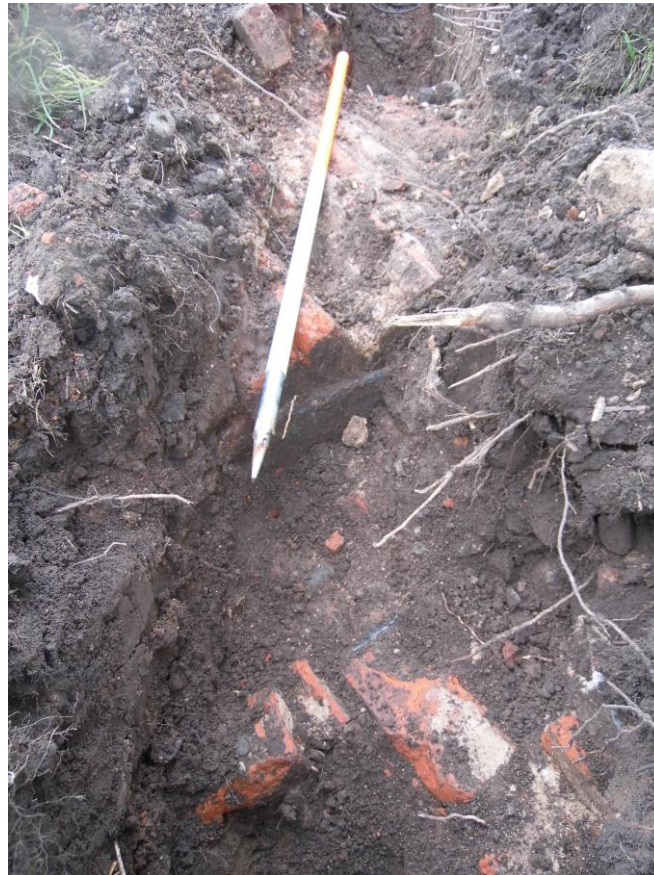
On the N side of the house, the trenches revealed three substantial brick culverts, (513) (*Plate 3*) (524) and (535), associated with the system of drains and culverts installed in the mid-18<sup>th</sup> century and first encountered with the discovery of a NW/SE -aligned brick culvert (1008/(1005)/(1011) during the previous LPG tank excavation (BAL 2015). The position and alignment of a smaller stone drain (512) suggests that it fed into (535) (*fig. 2*). Interestingly, the service trench revealed that culvert (513), which appeared to represent a continuation of the previously discovered culvert (1008/(1005)/(1011), had been blocked using a substantial slab of stone. Following a gap of c. 0.5m the culvert appeared to continue to the SE (*Plate 3*). The reason for the break in the structure is not known. A number of loose bricks suggested that the culvert had collapsed at this point. No evidence was seen for any later feature cutting it.

*Plate 3: View N of culvert (513) showing stone slab blocking close to scale and loose bricks in foreground*

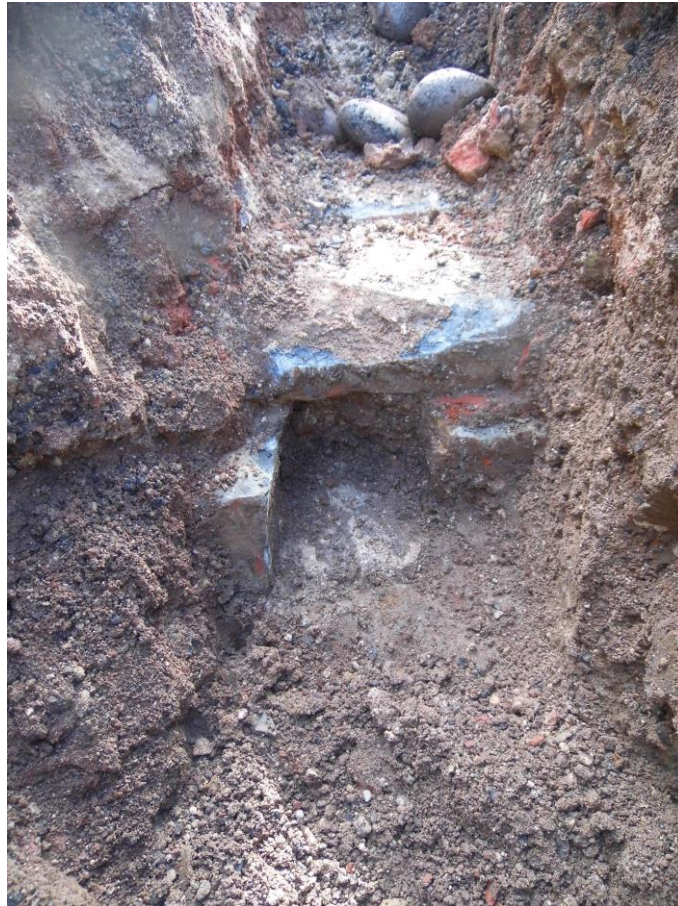
The smaller N/S drain (512) was constructed mainly of roughly squared blocks of blue lias, although occasional ceramic tiles were also used, presumably representing recycled material from the remodelling of the house. The roof was formed of blue lias slabs and the structure was bonded with cream mortar. Its position and alignment suggest it fed into culvert (535) and probably formed part of the drainage network installed during the mid-18<sup>th</sup> - century. Its floor appeared to be formed of cream mortar with black flecks (*Plate 4*).

*Plate 4: Stone drain (512) view S*

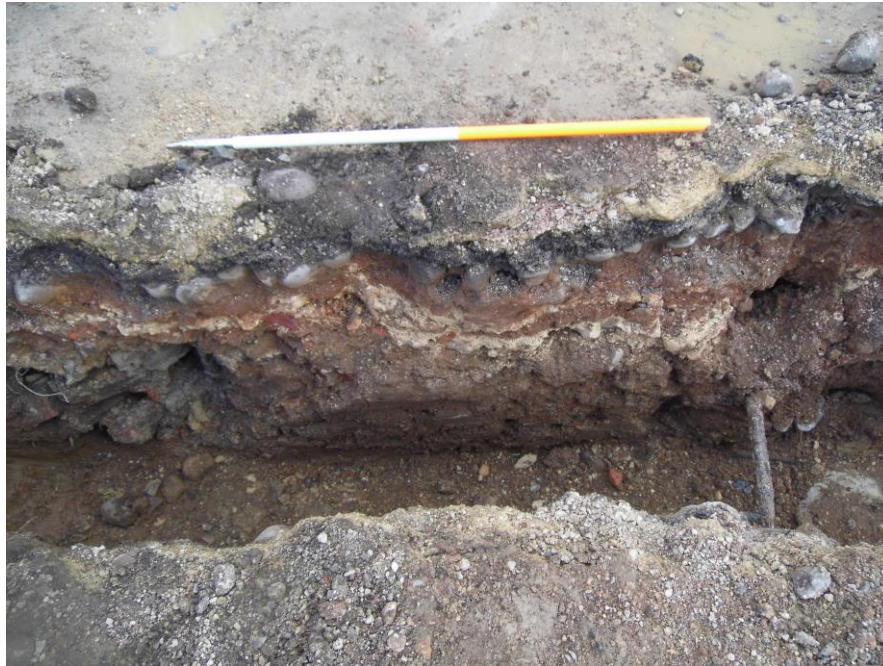
Cobbled surface (506) (*Plate 5*) commenced at the same point as the existing driveway (516). This surface is likely to be that shown on a late 19<sup>th</sup> -century photograph of the 9<sup>th</sup> Earl of Coventry and his daughters on horseback (Kay 2012, 122) and of the 10<sup>th</sup> Earl and his family in the 1930s (*Ibid.*, 135). The bedding layer (507) for the cobbles consisted of mortar and other building debris; as there was no sign of any earlier surface beneath layer (507), which lay either above natural subsoil (502) or a less compact mixed layer of building rubble (508), it seems likely that these cobbles formed the original surface of the North Courtyard.

*Plate 5: View W showing cobbles (506) and bedding layer (507)*

While no finds were available to confirm their date, a payment for river cobbles from Bewdley is recorded in the accounts for 1755 (Kay 2012, 105-6). A surface of substantial cobbles would be long-lived and easy to repair when necessary. Areas of cobbles were previously uncovered during limited excavations in 2009. The fact that the N edge of this surface coincided with the present limit of the lawn confirms the cartographic evidence and that this area of the grounds has undergone little change in terms of landscaping. The building debris consolidation (507) and looser debris (508) would, in this case, derive from the remodelling of the house in the mid-18<sup>th</sup> century. The cobbles had been covered by tarmac prior to the deposition of (516), the existing gravel surface. The cobbled surface does not seem to have extended into the service yard, although a considerable amount of disturbance has undoubtedly taken place in this area.
