1. Executive Summary

This report gives the results of the programme of excavation and observation undertaken at No 3 Well Street Exeter EX4 6QR by Border Archaeology Ltd on behalf of Grahame and Rebecca Dudley of Culmvale Stoke Canon Exeter in 2014. The report also includes the results of geoarchaeological and geological borehole investigations conducted on July 1st 2014 by ARCA University of Winchester.

An octagonal structure of local Heavitree masonry was discovered and is believed to represent the late medieval phase of the original well structure. The well had been disturbed by a brick conduit on the W side.

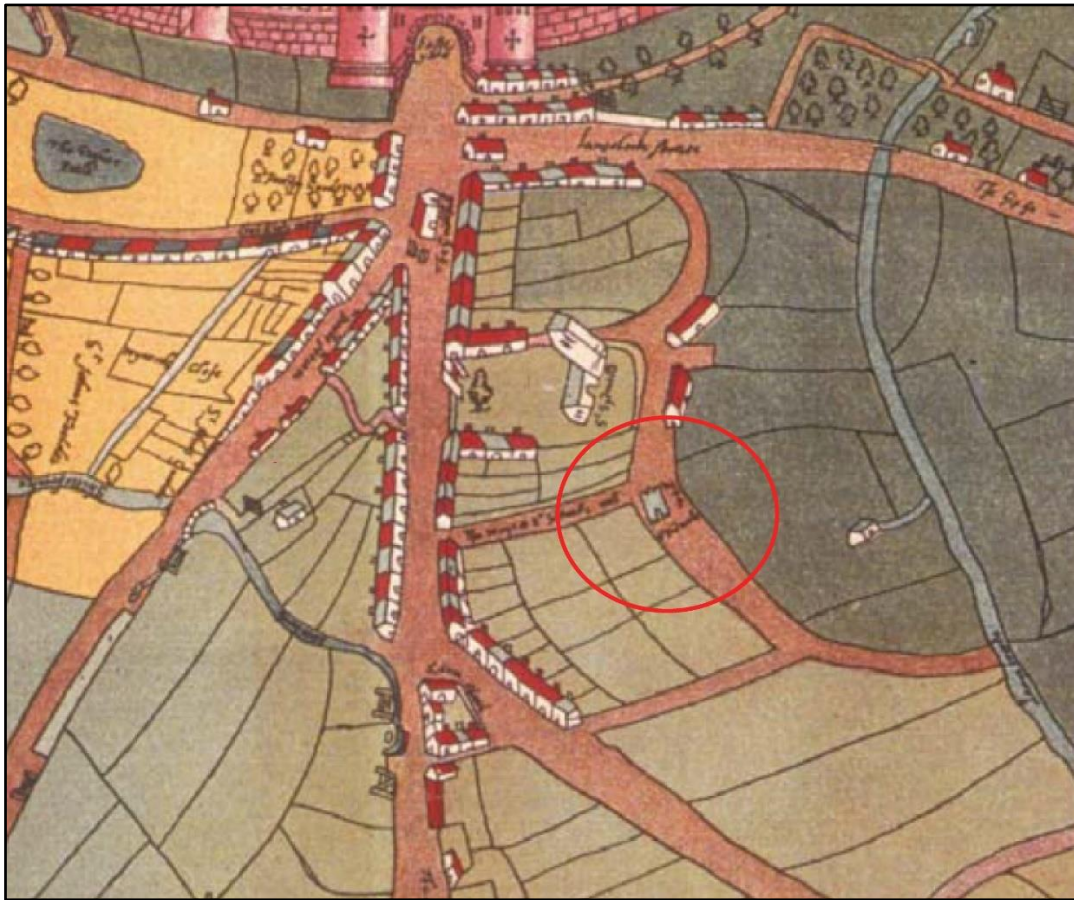
Fig. 2: Extract from Hooker's Plan of St Sidwell's Fee (1587) (Reproduced courtesy of Devon Record Office)

The earliest cartographic source to show the well is Hooker's 'Plan of St Sidwell's Fee' dated 1587 (*Fig. 2*), which shows the structure as a castellated polygonal structure situated in the middle of Well Street (which appears somewhat broader compared to its present width). The well is depicted immediately to the NE of the junction with present day York Road, described as 'the way to St Sidwell's Well'. The well structure is shown as having an entrance facing NE into Well Street and an enclosure is shown bounding the well to the N and W.

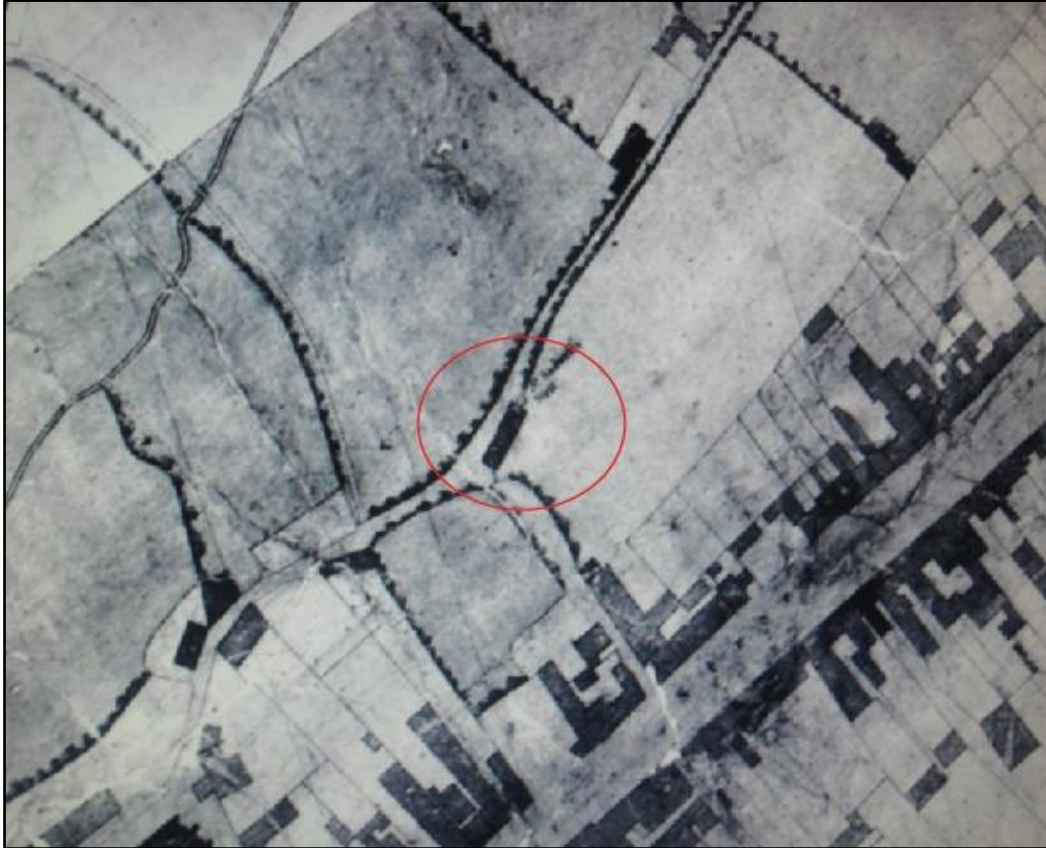
Fig. 6: Extract from Coldridge's map of Exeter (1819) St Sidwell's Well immediately adjacent and NE of York Cottages; (Reproduced by courtesy of Devon Record Office)

J. Coldridge's map of Exeter dated 1819 (Fig. 6) shows that a pair of cottages (known from c.1828 onwards as Nos. 1 & 2 York Cottages) had been erected at the corner of Well Street and York Road, within the central and western part of the recessed area marked on Tothill's map. The well is depicted as a polygonal structure projecting out from the NE end of the cottages. The accuracy of this depiction is confirmed in a later Dean and Chapter Plan by Robert Cornish, dated September 1824, which also shows the well structure NE of the two cottages.

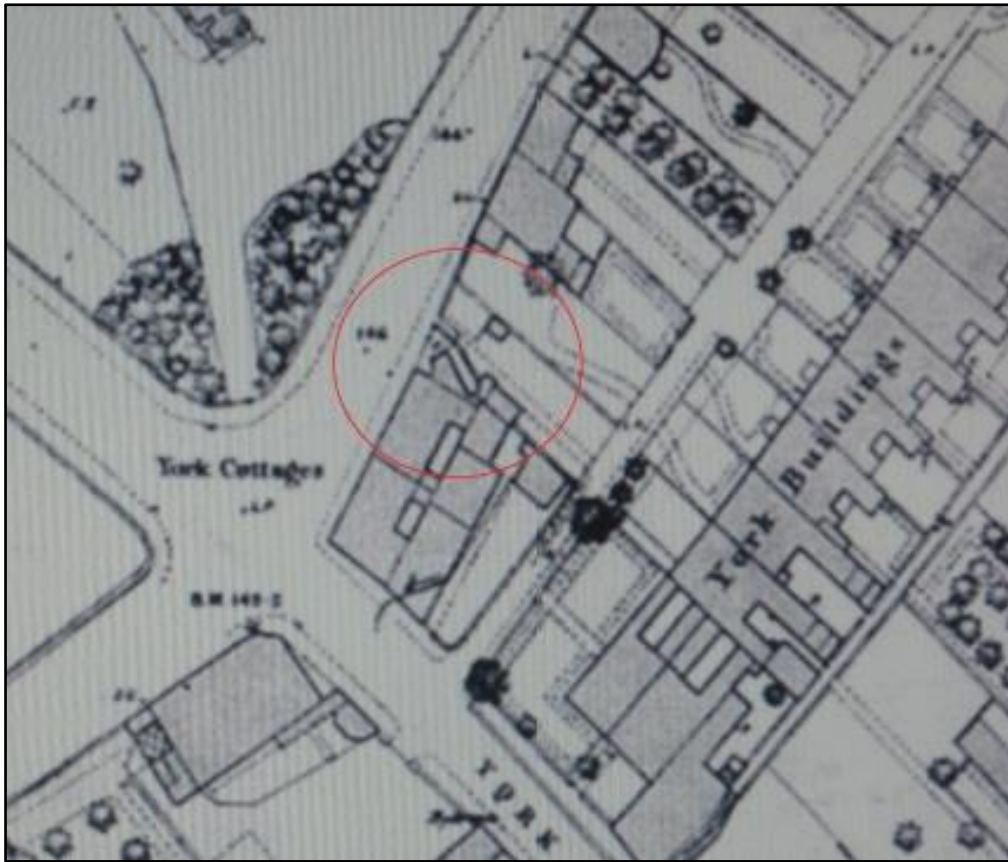
Fig. 7: Extract from the OS 1st edition 1:500 map of 1876

It would appear that the well had probably fallen out of use by the mid-1870s, as it is not specifically marked on the OS 1st-edition 1:500 map of 1876 (Fig. 7), although an irregularly shaped structure is marked immediately to the NE of Nos. 1-2 York Cottages, which may represent the structure containing the well.

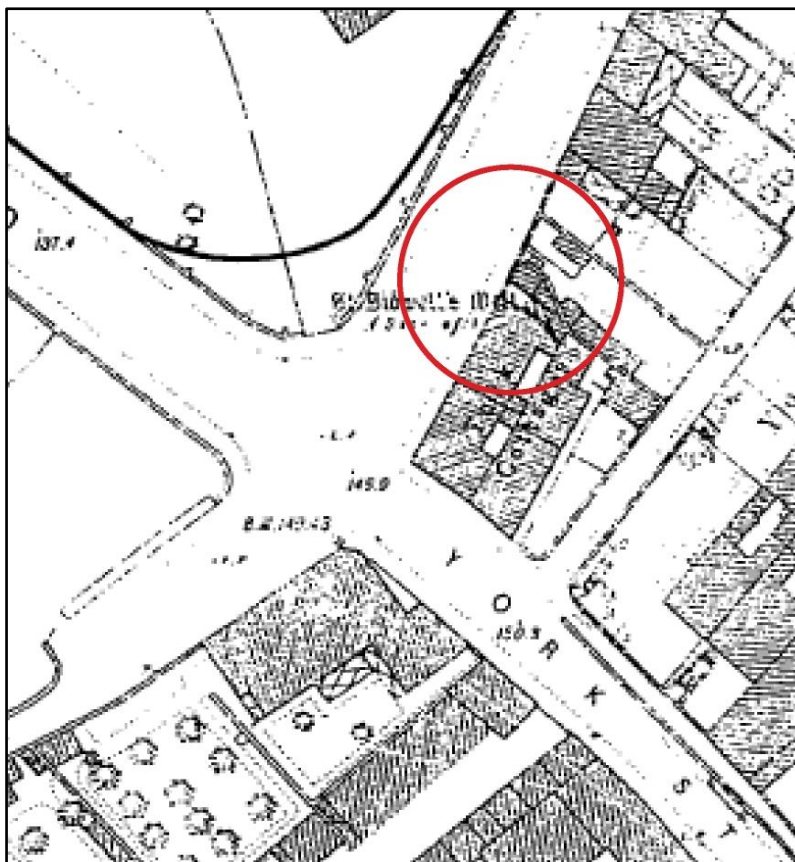
Fig. 8: Extract from the OS 1:500 map (1888) showing the site of St Sidwell's Well to the NE of York Cottages;
(Reproduced by courtesy of Devon Record Office)

A later OS 1:500 map surveyed in 1888 marks the irregularly shaped building as 'St Sidwell's well (site of)' which would appear to confirm that the well had ceased to be used by that date.

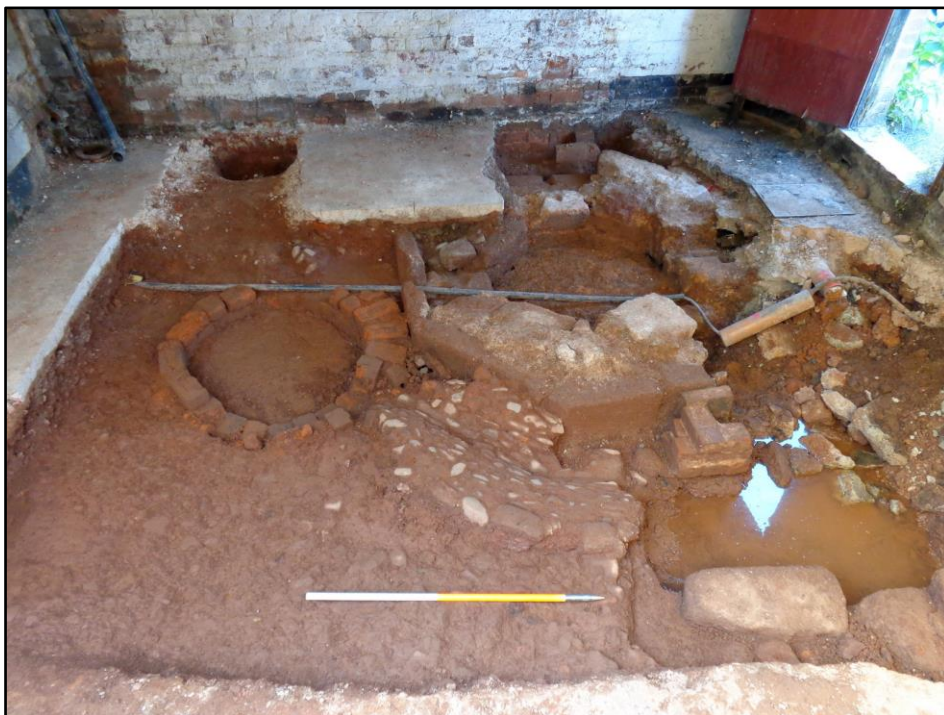
Plate 1: View S of the well (1002) later shaft (1006) to the left and wall (1011) front right

Well (1002) was an octagonal masonry structure constructed of Heavitree stone blocks set on edge forming a wall with an internal rubble core that featured Heavitree, other stones and mortar. The observable part of well (1002) was the superstructure that was constructed of very finely cut Heavitree blocks, however lower courses of less well dressed Heavitree were also observed where the superstructure had been disturbed. The Heavitree blocks averaged 0.5m in length, 0.4m in width and 0.4m in depth with an almost ashlar finish leading to very limited pink/grey bonding mortar between the blocks. The well structure (1002) measured 2.15m in external diameter with an internal aperture of 1.05m. The NW side had been converted to a brick arched conduit (1010) and the N side was truncated by the modern silt trap tank [1008], additionally there was damage from the NW/SE electric cable installation.

It was clear that the courses of Heavitree present do not represent the upper courses of the well as the exposed top blocks had mortar on the surface and therefore weren't the finished capping stones. It is possible, due to the rubble core, that only one further course of Heavitree existed above that revealed and that this would have represented the final capping course and would have been of very finely dressed stone that was desirable for reuse elsewhere.

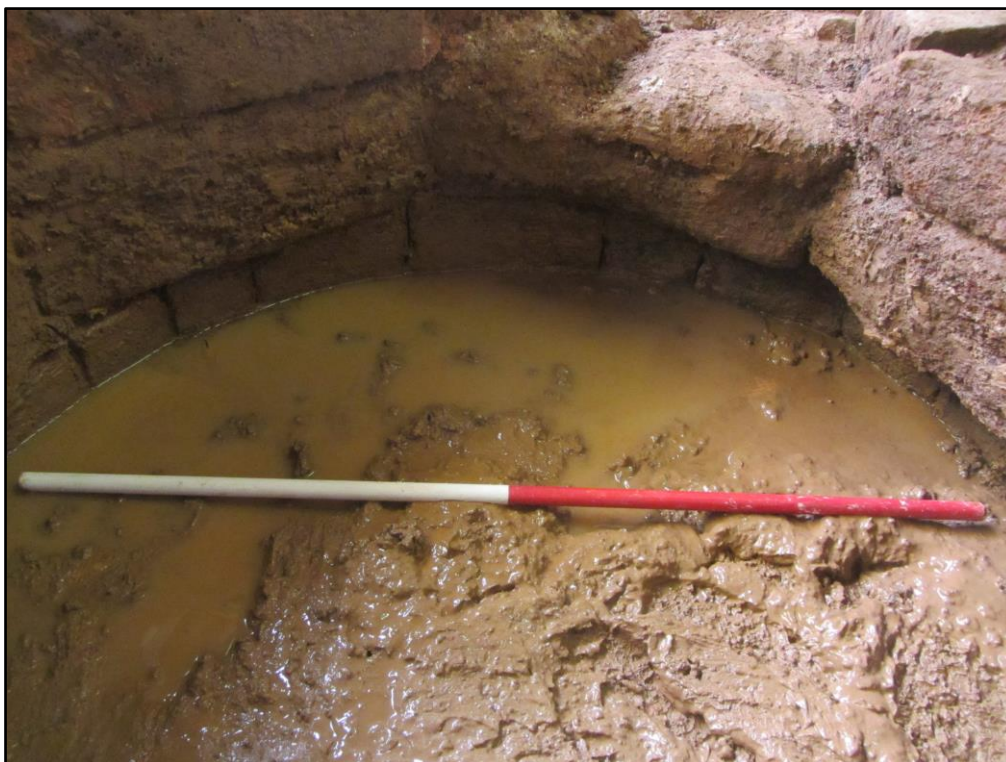
The lining (showing at 44.11m OD) and lower levels of the well were constructed of smaller, cut stone (*Plate 2*) that lay at the water table.

Plate 2: View SE showing Heavitree masonry upper courses (1002) with smaller-sized stones lining the shaft

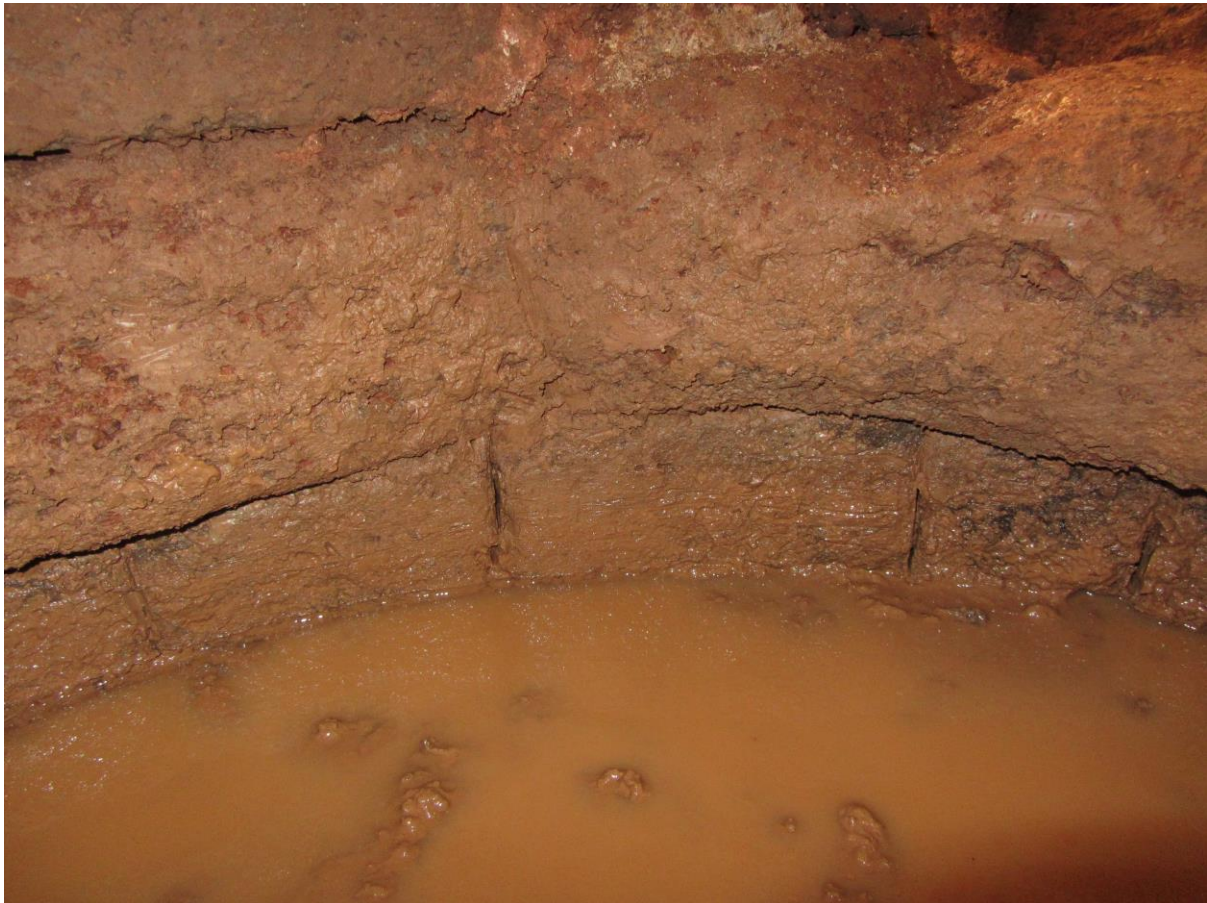
Due to the restrictions of the excavation and observation, it was not possible to extract or examine lower levels of the stone courses in close detail but in the excavators opinion the stone though different in size was the same type of geology, i.e. Heavitree, and with no observable mortar.

Plate 3 View of lower stone course (1002)

Three courses of the medieval well were discovered in good condition. The well appears to have undergone a number of rebuilds and the masonry of the upper part of the structure was of a different form from that of the lower coursing (*Plate 3*).

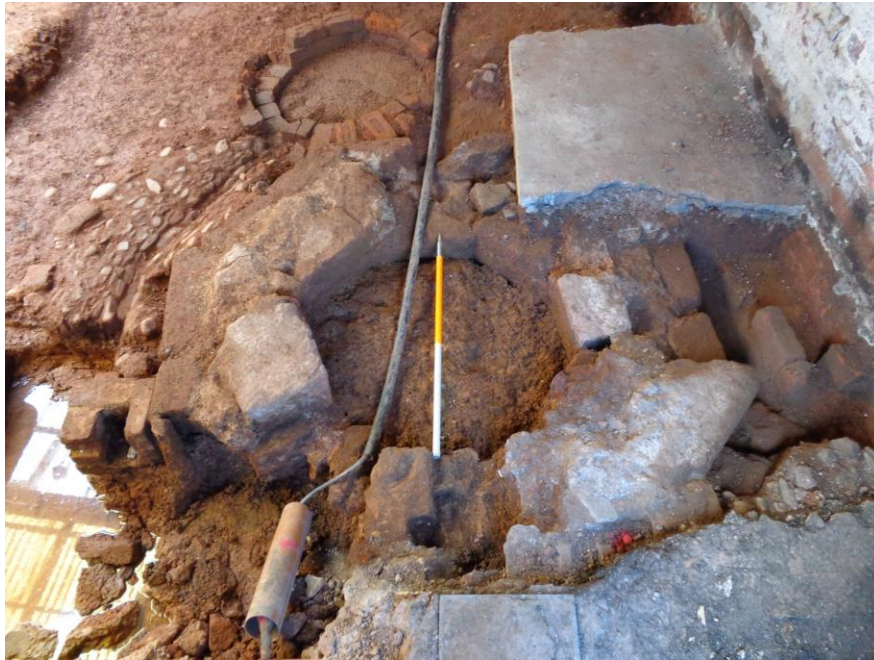
An octagonal shape was present in the upper courses, but not in the lower. This may be due to the large size of the upper stones necessitating the shape, or by design, i.e. larger stones were chosen in order to effect the octagonal shape. A castellated well is shown on Hooker's 1587 plan (Fig 2) and a round or possibly octagonal building on a 1590 Dean and Chapter map (Stoyle 2014, 20) and a stylised small building on the Hogenberg 1618 map (Stoyle 2014, 6 and 83). Exeter medieval octagonal well shapes were recorded by William Dawson in 1838 prior to renovations, at Headwell and Cake Lane not St Sidwells. (Stoyle 2014).

Plate 4; General shot of octagonal shape of well (1002).

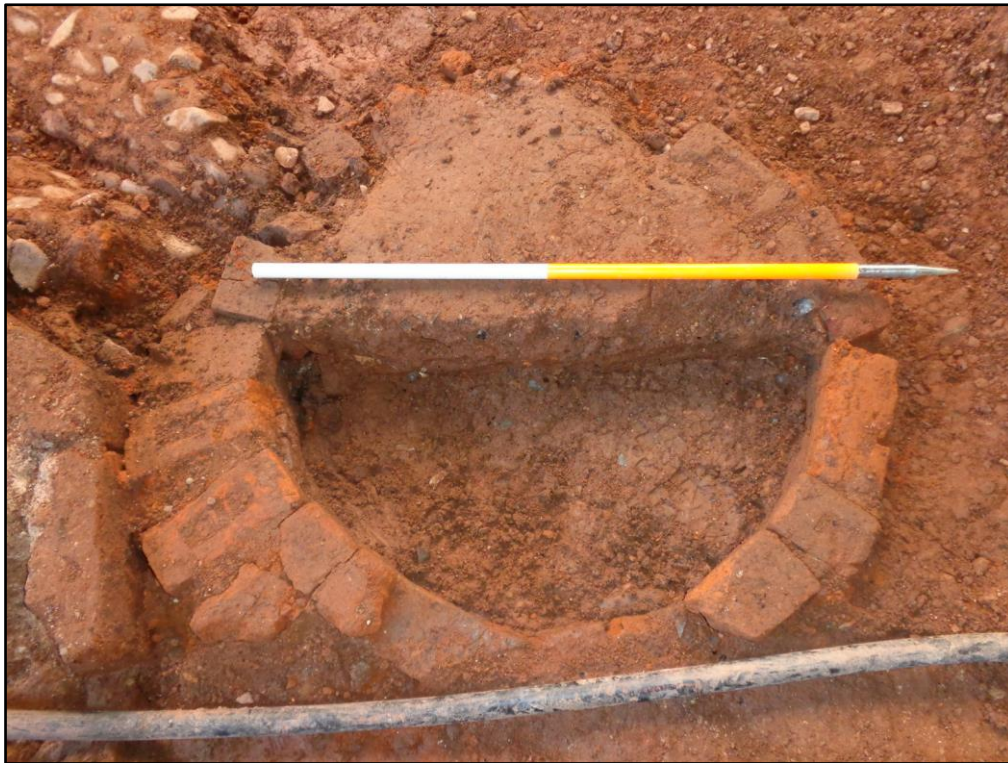
Plate 5: View N of the later well (1006) showing several bricks stamped 'HF'

The well (1006) (*Plate 5*) was smaller and built of hand-made brick stamped with HF. Three courses were exposed of one or two brick width only with no definite coursing style, the lowest level being header on and stretcher occasionally used to cross gaps. The structure had been backfilled with compacted clay (1007) with 19th century finds. The bedrock here was encountered at 1.1m below the surface.

A borehole drilled in the centre of the brick well structure (1006) that was adjacent on the E side of the stone well (1002) encountered bedrock of the Whipton Formation at a depth of 3.26m, 1m of peat clay overlay this. The peat was overlain by 0.25m of sandy clay, and above this was a backfill deposit of about 1.5m with 19th century artefacts (Appendix 2).

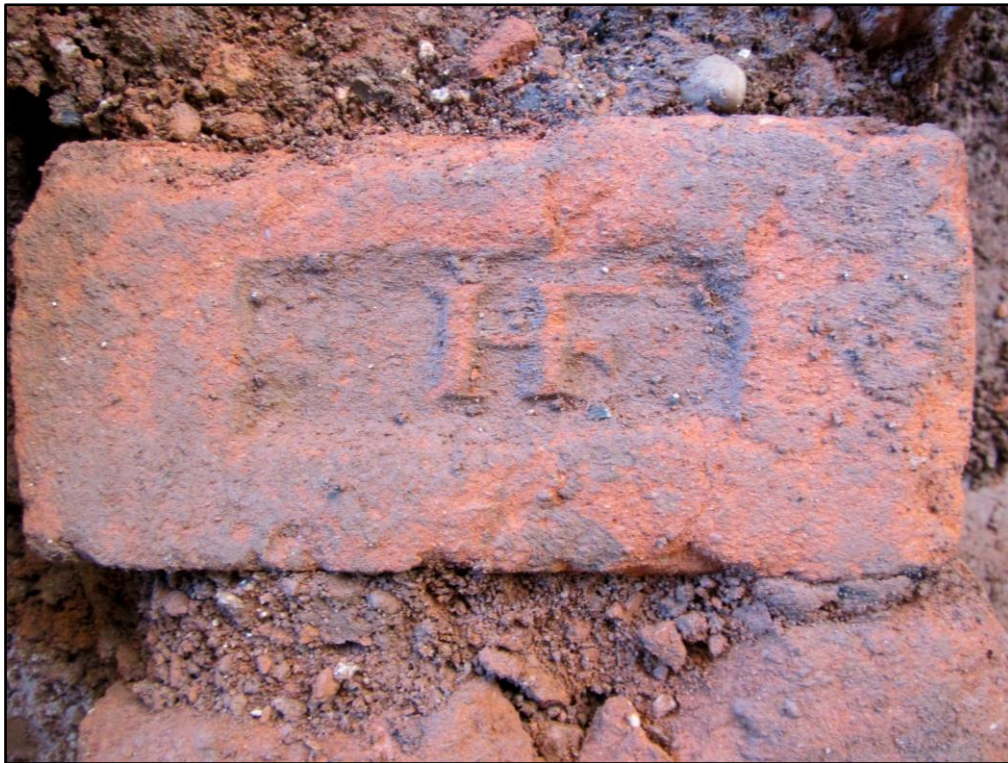
Plate 6: Brick stamped with initials 'HF'

The cutting of the levelling deposit (1000) by the 19th century brick well strongly suggests it was cut a short time after the construction of the 19th century housing. This is further supported by the use of bricks marked HF that may have been left over from the housing construction. A clear cut [1005] was observed around the brick well and was circular in plan with vertical sides and an extremely sharp break of slope at the top, it was lined by brick structure (1006). The brick structure (1006) had been built against the cut [1005] walls and, in places, had left voids where the bricks had not butted against the cut [1005] walls. Brick structure (1006) was comprised of frogged bricks laid mostly stretcher style with an external structure diameter of 1.25m and internal structure diameter of 0.9m. The bricks used were 240mm x 120mm and occasionally imprinted HF suggesting their redundancy following the housing construction. The fill of the brick well (1007) is of uncertain date but probably represents a deliberate backfill and marks the point at which a domestic water supply was no longer required as the site became semi-industrial or the point at which the construction of brick well (1006) was found not to draw sufficient water. The fill (1007) was a compact red brown clayey silt with occasional to moderate slate inclusions, occasional brick fragments and occasional medium sized rounded pebbles.

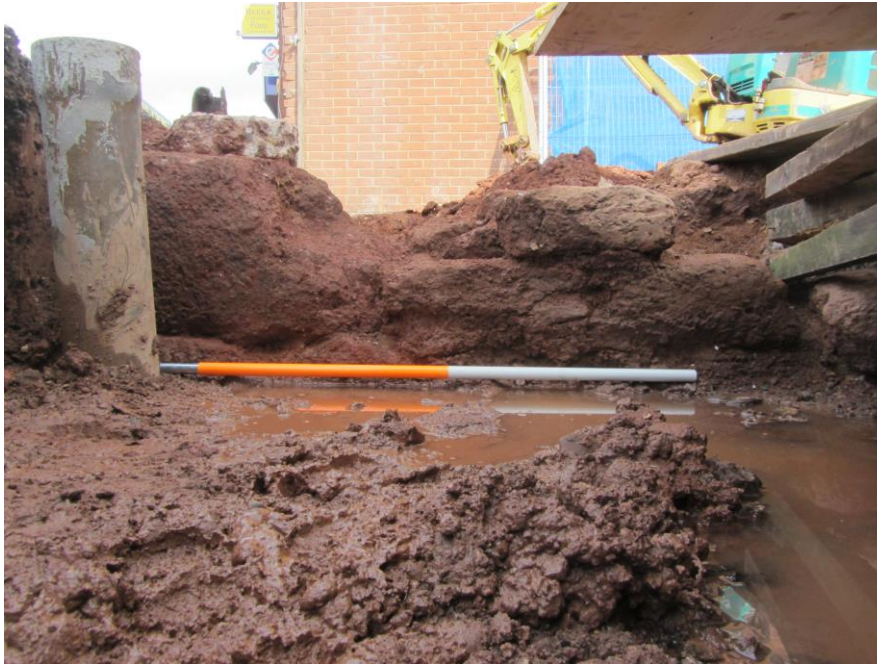
Wall structure (1011) about 0.5m N of stone well (1002) was formed of Heavitree blocks of varying sub-rectangular sizes with a reasonably regular width averaging 0.3m and varying in length from 0.3m to 0.6m with 0.24m depth. There was no bonding material although the blocks were significantly less well dressed than those comprising the well (1002) and had merely been roughly hewn and squared. The blocks of (1011) formed an L shape measuring 1.8m NW/SE and 2.9m NE/SW although this may have originally extended further. At least three courses were visible on the SE/NW elevation. The wall (1011) abutted (1004). Unfortunately, due to modern disturbance on the E side of the wall (1011) it was not possible to ascertain if (1011) directly overlay the cobbles (1004) or if the cobbles abutted it (Fig 11, Plate 7).

Plate 7: View of wall (1011) with modern disturbance on its E side

No dating evidence was recovered from the wall (1011) except one piece of South Somerset ware of probable 18th century date (Appendix 1).

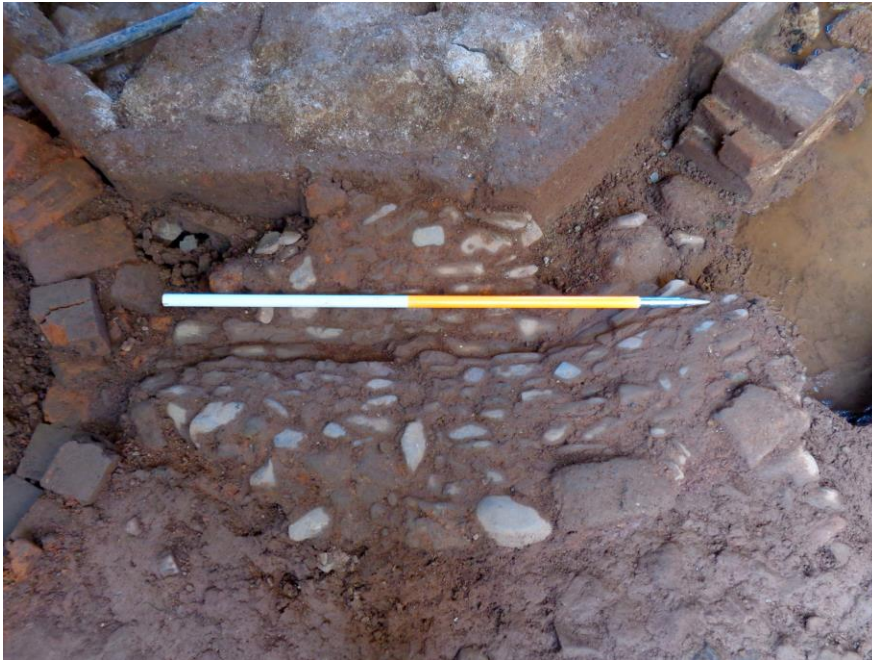
The cobbled surface (1001) around the wells was made of stones 0.2m to 0.6m in diameter, water rounded and set in the levelling deposit (1003). The surface was laid in a spiralling direction around the octagonal well in a way that would enhance drainage, it was therefore contemporary with or later than the well. Pottery from the 14th to 18th century was found in this deposit. The underlying deposit (1003, 1004) had pottery of the 13th to 14th centuries, showing medieval occupation (though it could of course have been brought onto the site as a levelling layer). However, 16th and 17th century pottery was also present in underlying (1004) meaning this layer was 17th C at the earliest.

The cobbled surface (1001) abutted and was later than or possibly contemporary with the octagonal well (1002).

Plate 8 Cobbled surface (1001) abutting well (1002)
