Archaeological Standing Building Recording

The Former Norville Factory
Tarrington Road
Tredworth
Gloucester
GL1 4PF

April 2017

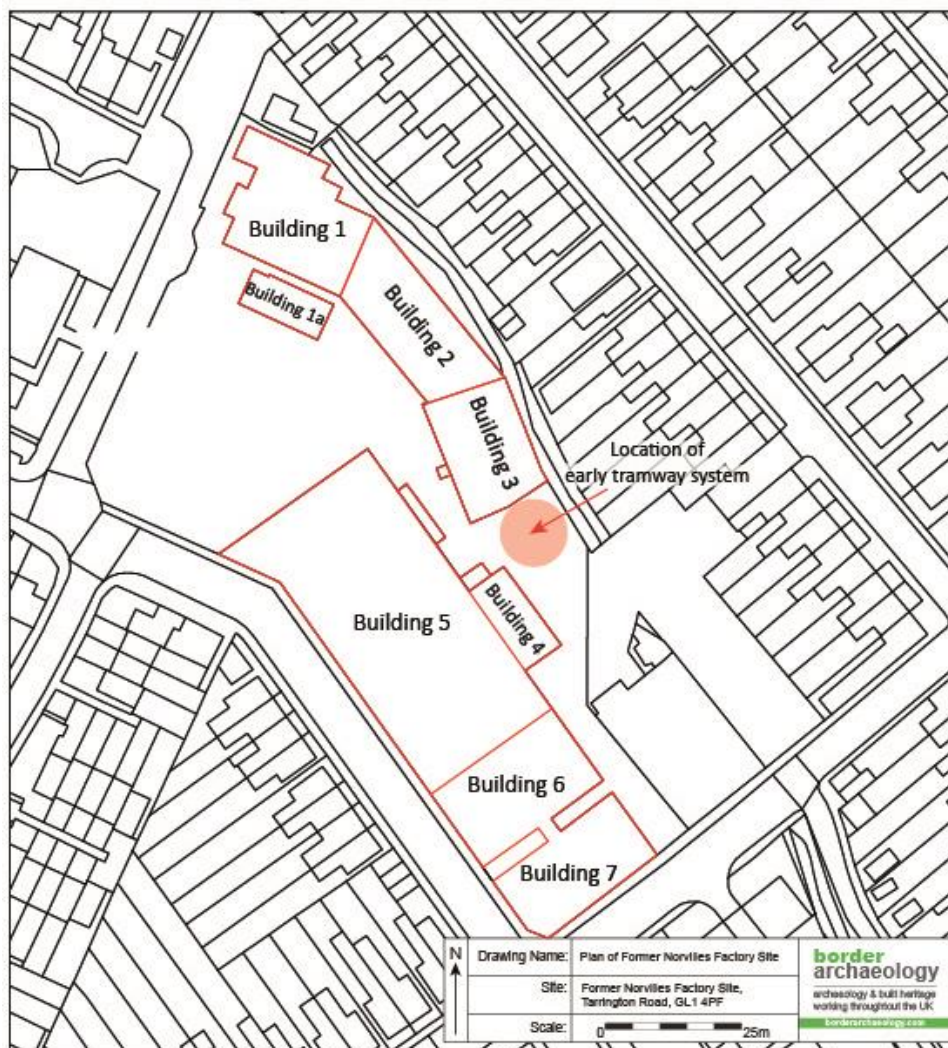
Fig 2: Plan showing location of buildings as seen in April 2017

The site lies at approximately 19.70m AOD and is within the Barton and Tredworth ward. It comprises a disused industrial complex containing a range of former factory building spanning the late 19th and 20th centuries. A fire in 2012 destroyed much of the fabric existing at that time and a number of fire-damaged buildings were demolished. It is considered that only a single structure, identified herein as Building 3, has survived largely intact from the late 19th century. Much of the remainder of the complex has been subject to alteration or reconstruction due to change of use whilst Building 2, a modern infill block linking Buildings 1 and 3, and Building 1a both date from the late

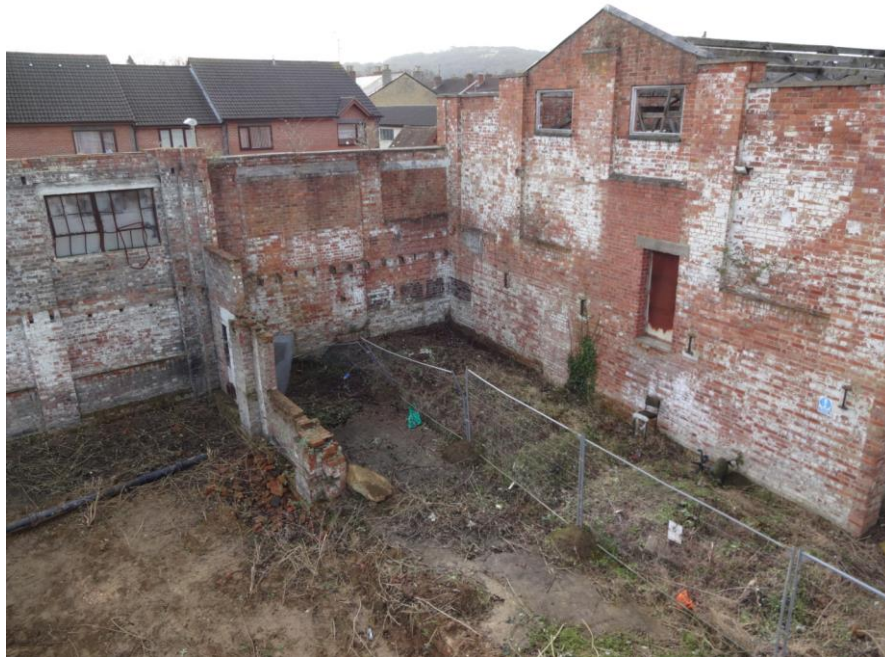
Plate 1: View SW showing Building 7 and other structural remains at the southern extent of site, with fire-damaged building to left

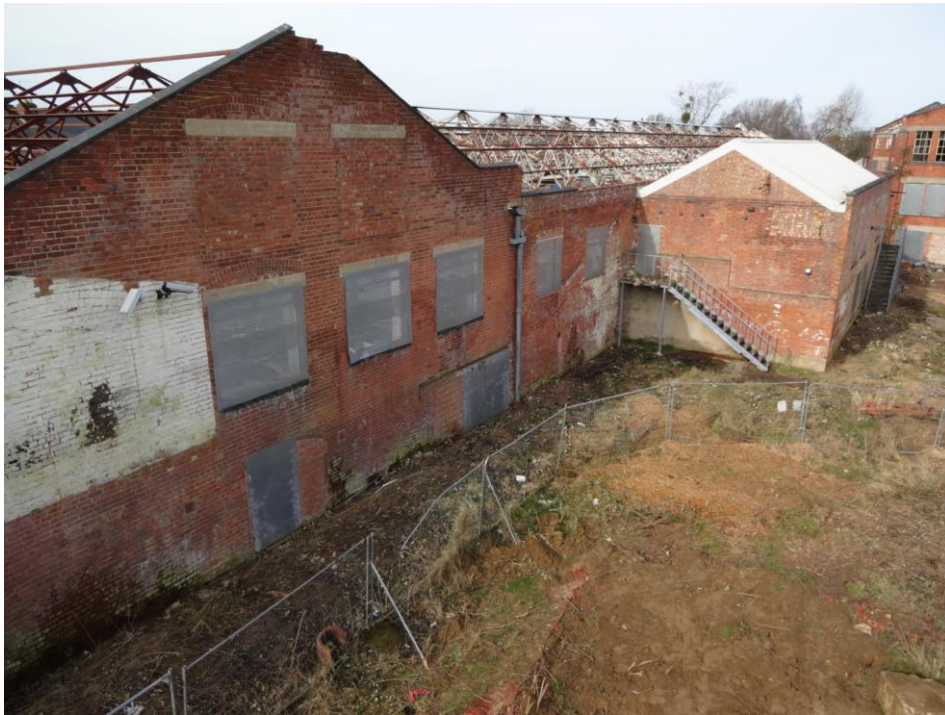
Plate 2: View NW showing Buildings 5, 6, 4 & 3 (extreme right of picture)

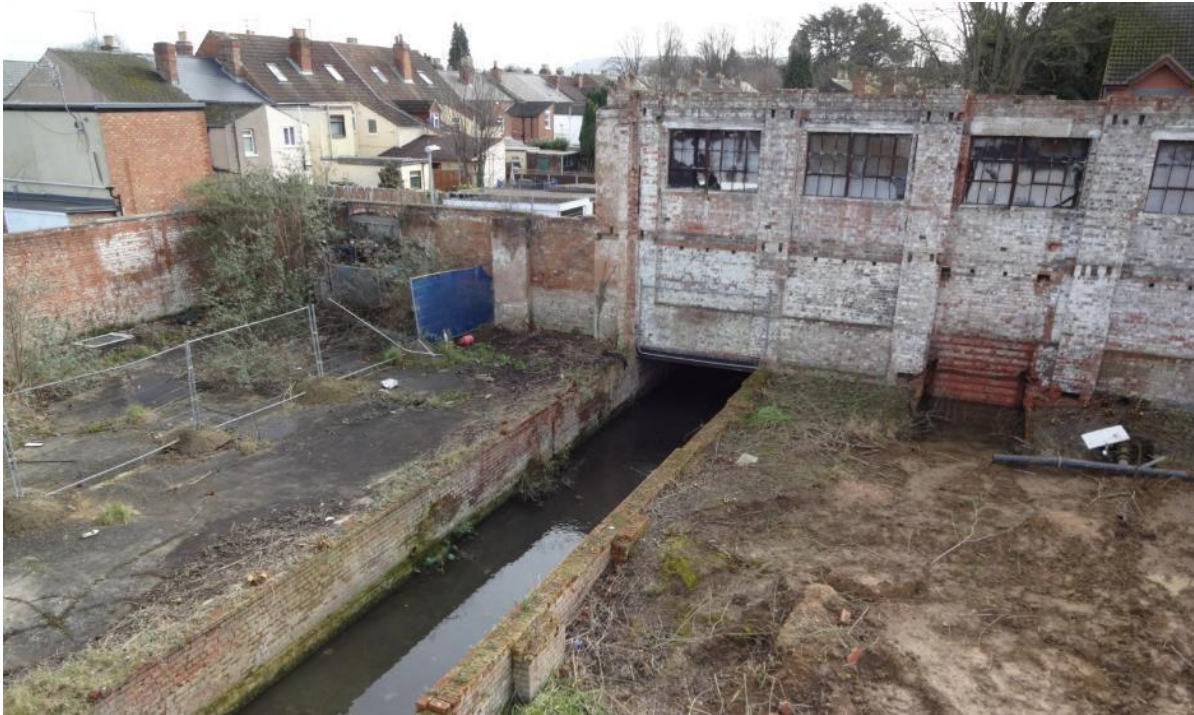
Plate 4: View SE showing remains of buildings on N side of the Sud Brook, some of which may be of late 19th century date

None of these buildings survived the fire of 2012 and only the partial remains of an external wall remain upstanding along the Hatherley Road frontage (*Plate 4*).

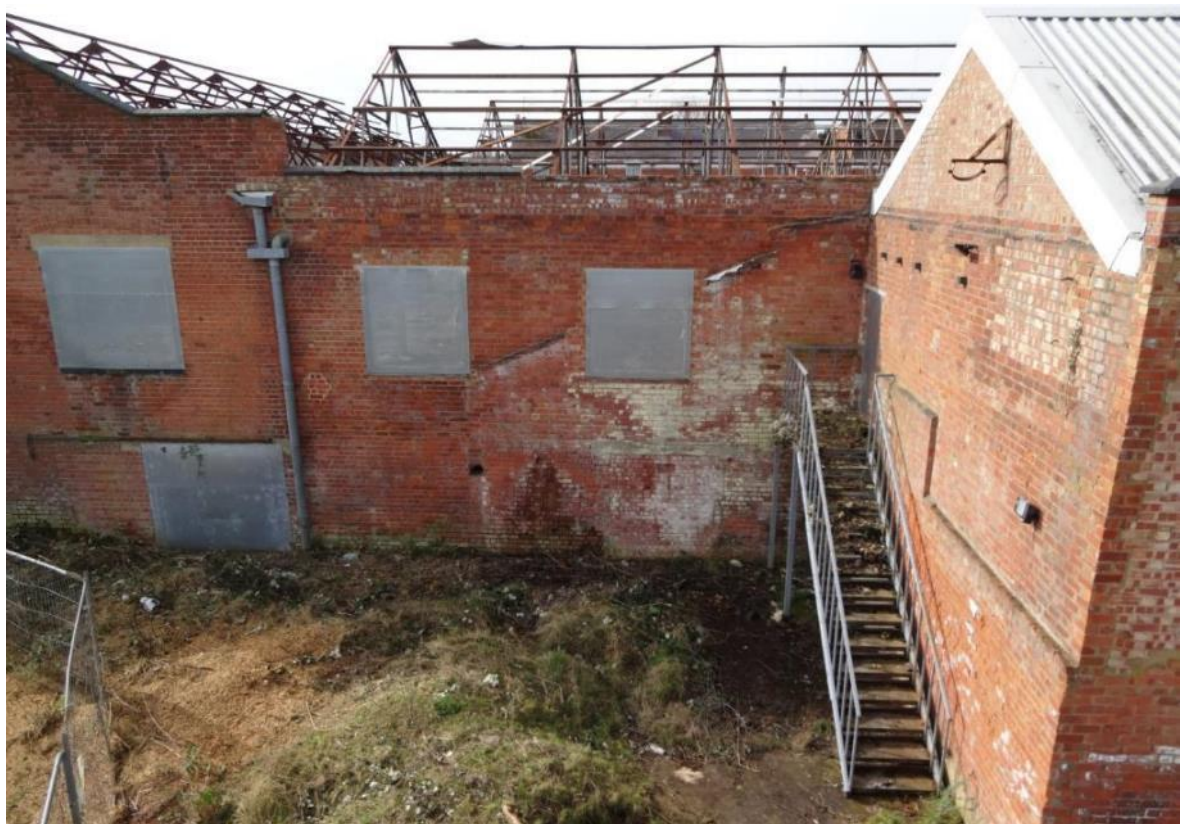
Few of these buildings appear to survive in their original form and a number have subsequently been swept away entirely, largely as result of the fire of 2012. There are, for example, no buildings present on the western side of the site previously occupied by the timber drying sheds. Whilst the block plans of 1897 and 1907 show a building reflecting both the form and location of Building 4, it is clear that this building has been much altered, with modern brickwork visible in all three elevations. The block plan of 1897 shows a small oblong structure attached to the SE elevation of this building which is also shown on the plan accompanying the sale of the Hatherley Works to Slumberland Ltd in 1966 but which has since been demolished. However, a clear outline remains visible, punctured by two modern window openings, where this building abutted the NE elevation of Building 5. Its profile suggests a lean-to structure with a stepped mono-pitch roof and a doorway at ground-floor level providing access through into Building 5 (*Plate 7*).

Plate 7: View SW showing stepped mono-pitch profile of building formerly attached to Buildings 4 and 5

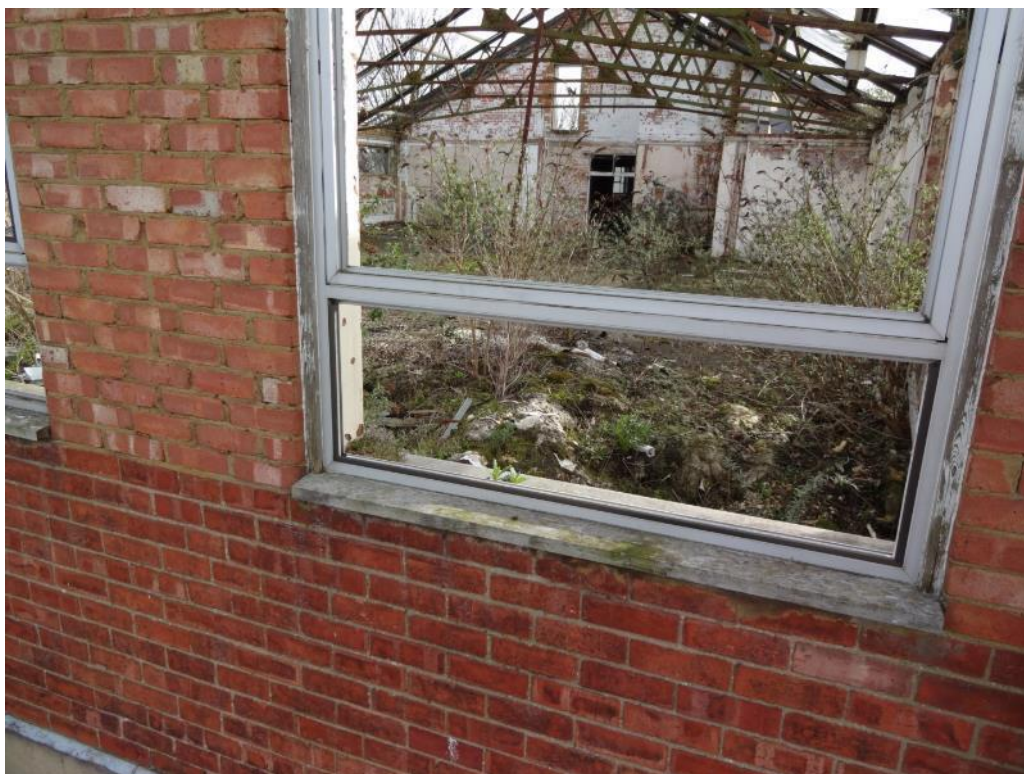
Plate 9: View through upper storey window of Building 1 showing internal floor space and gable end with access through to Building 2 with stairwell and elevator shaft to rear right. Note door threshold positioned at ceiling height.

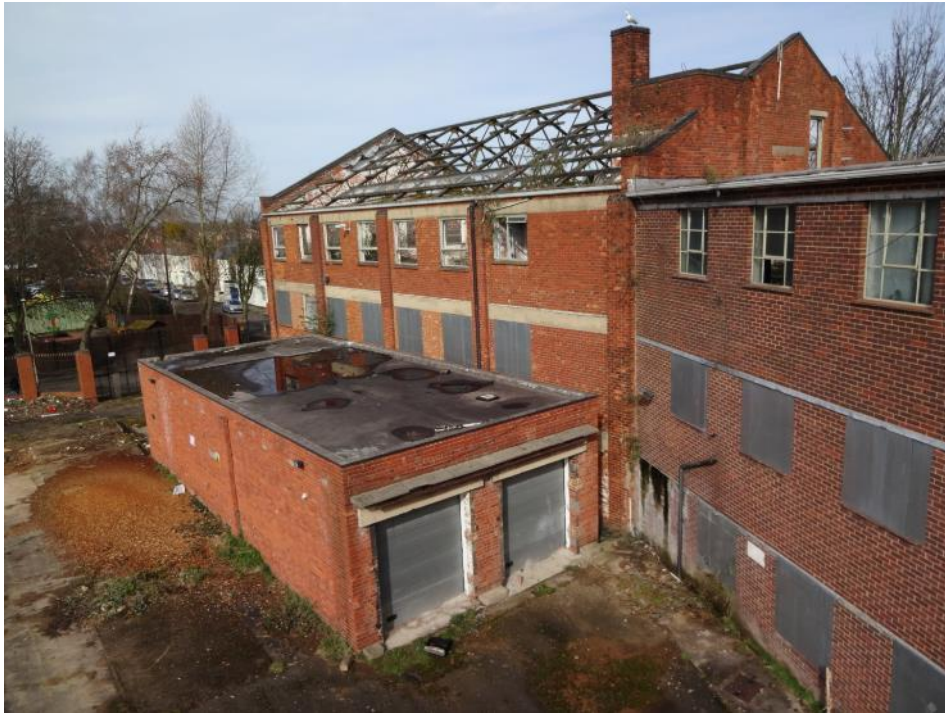
The SE elevation comprises a stepped gable of brick construction with a single course of Staffordshire blue brick coping. Much of the gable is now obscured by Building 2, with only the upper storey visible protruding above its roofline. This comprises a pair of brick pilasters extending to the full height of the gable set either side of a blocked window, with a redundant door opening at upper storey level suggesting external access to the loft space served by means of lifting gear or winch to raise goods directly from ground-floor to upper storey level (*Plate 14*).

Plate 14: View N of SE elevation of Building 1 abutted and largely obscured by Building 2. Building 1a is situated to left

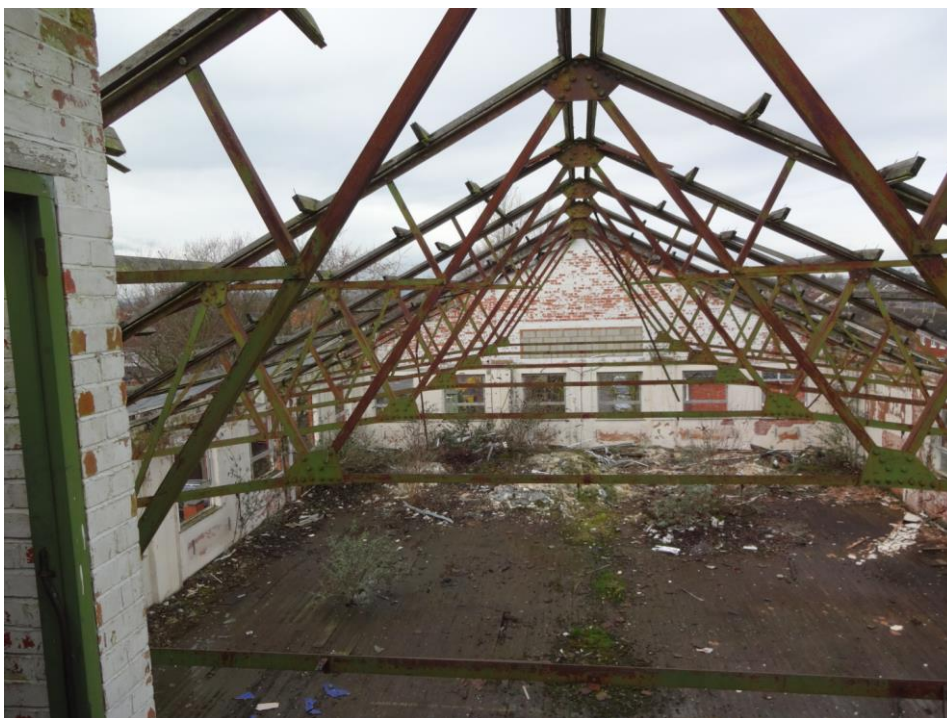
Plate 15: View NW of upper storey Building 1 showing double fink roof truss construction

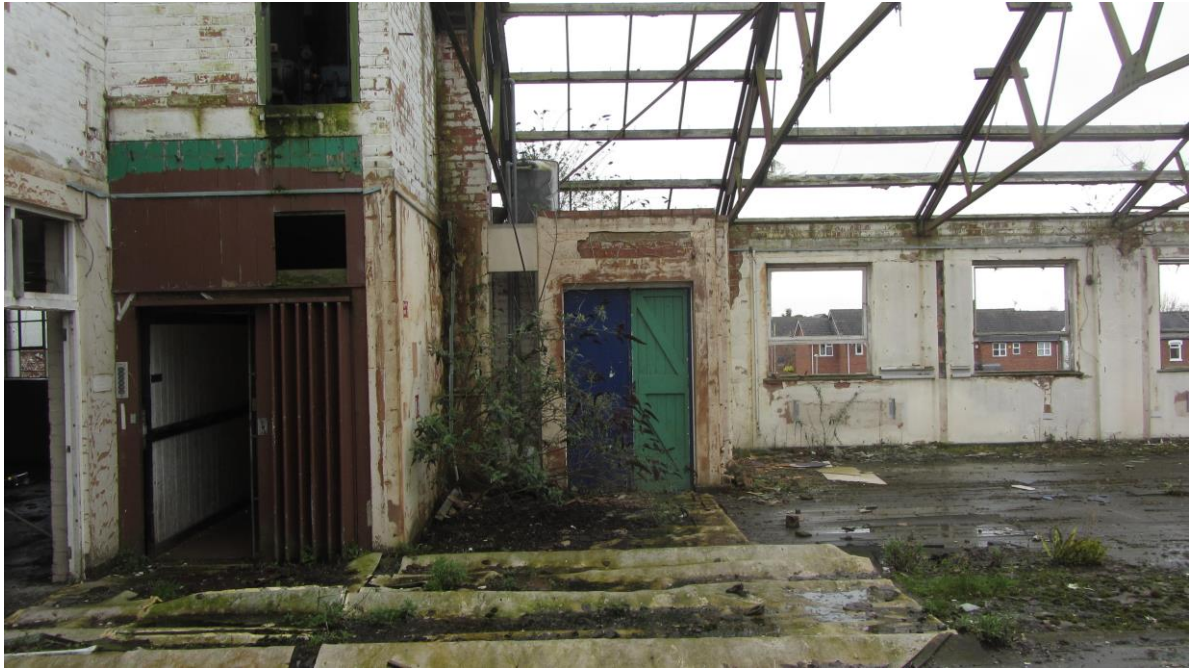
Plate 16: View NW showing goods elevator shaft and adjoining stairwell at upper storey level Building 1

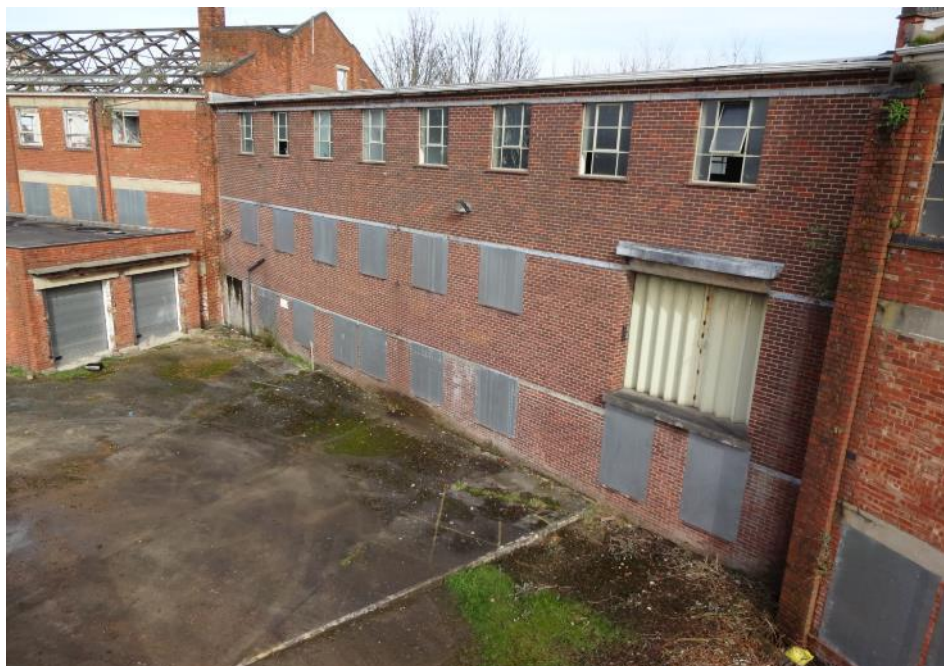
Building 1a is a small modern rectangular single-storey brick structure constructed adjacent to the SW elevation of Building 1 (*Plates 14 & 17*). It contains a single blocked window opening beneath a concrete lintel in the NW elevation and two overhead roller shutter doors in the SE elevation which appear to have replaced a sliding door, the metal rail and housing for which remains in situ.

Plate 17: View N of SW elevation of Building 2. Building 1a shown centre left

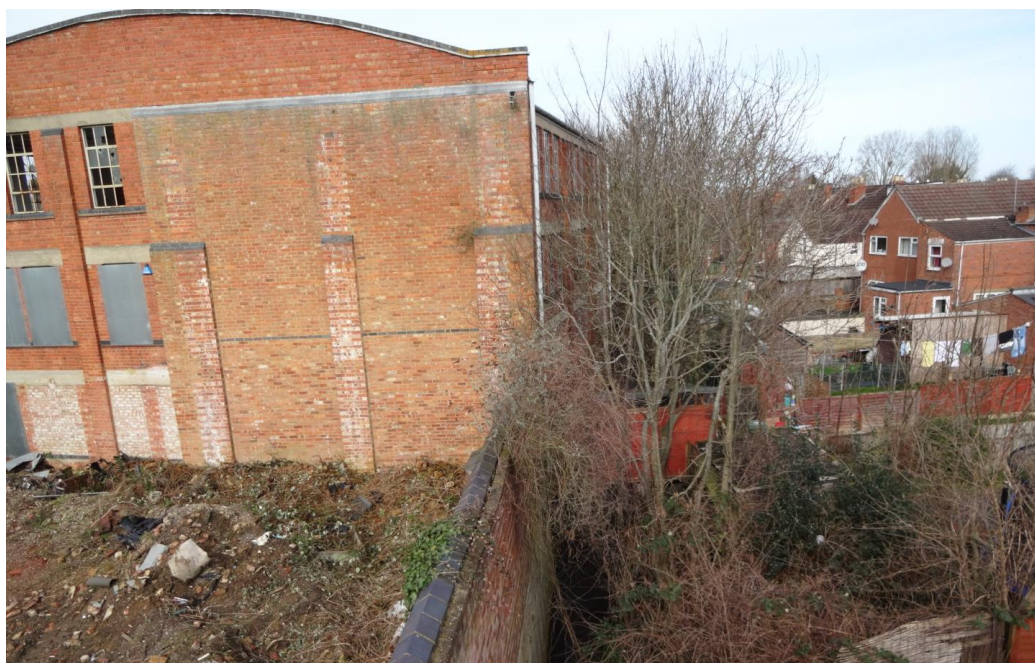
The S gable elevation reflects the curvature of the roof structure (*Plate 22*). A slight dogleg, or 'kink', roughly midway along the façade divides the elevation in terms of fenestration and marks the point at which the building was abutted by a now demolished structure shown on the plan of 1942 as 'space occupied by Hatherley Works' (*Plate 21*). This section of the elevation thus contains no door or window openings. A blocked opening in the SW corner of the elevation at ground-floor level marks the location of a former 'Drying Room' shown on the 1942 plan. The building adjoins a later infill block (Building 2) at its N extent and the E elevation abuts the Sud Brook, the presence of the watercourse and adjacent rear garden plots preventing clear access. However, the limited views available showed a similar pattern of fenestration, with fewer blocked window openings.

Plate 22: View NW showing S elevation of Building 3 and culverted watercourse (Sud Brook), with NE-facing elevation just visible adjacent to the watercourse and rear gardens of neighbouring properties. The photograph shows a thickening of the brickwork marking the point at which a former ironmonger's store built in 1909 abutted the elevation.

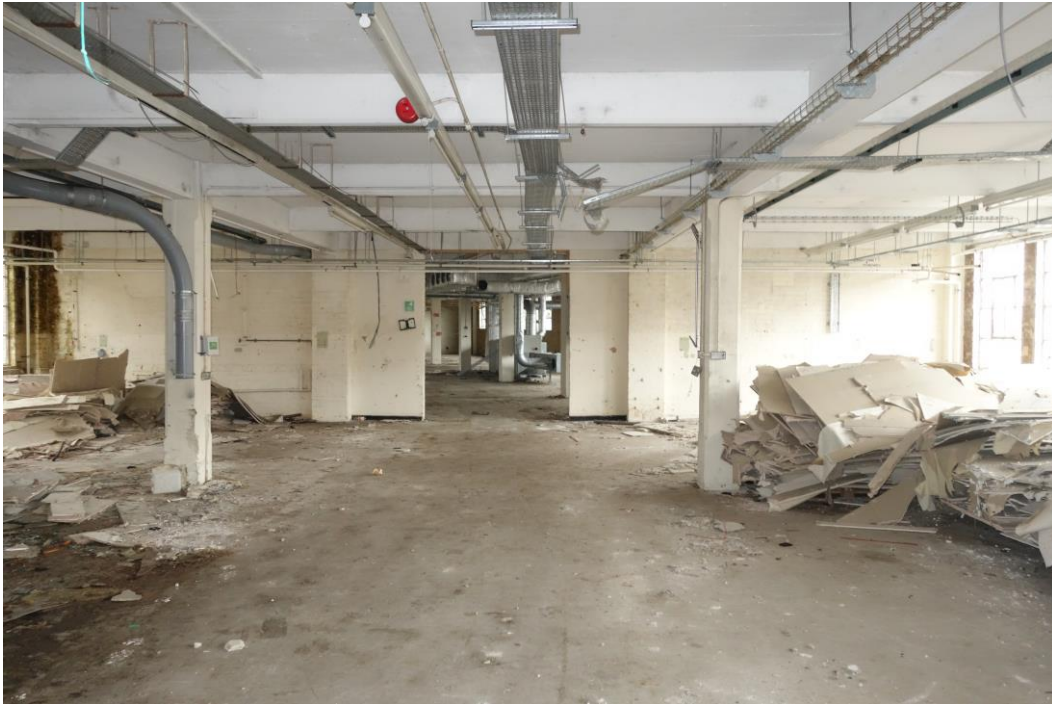
Plate 24: View NW showing internal cross-section consistent with Section B-B shown on 1942 plan (fig. 5)

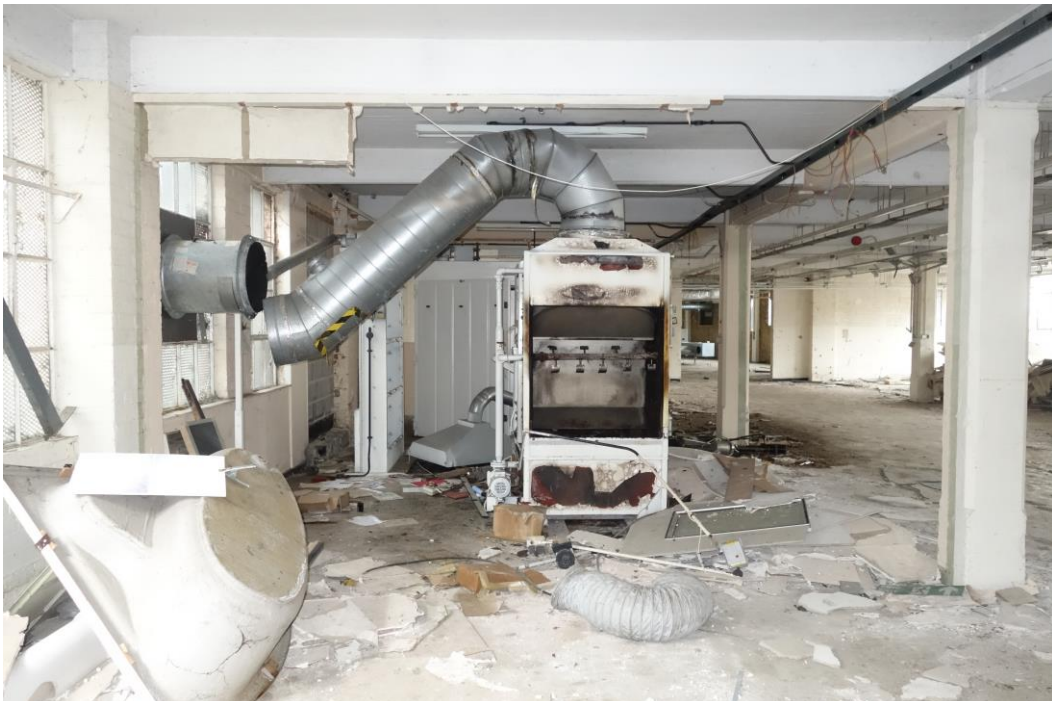
Plate 25: View of ground floor showing area of former drying kiln shown on 1942 plan (fig. 5)

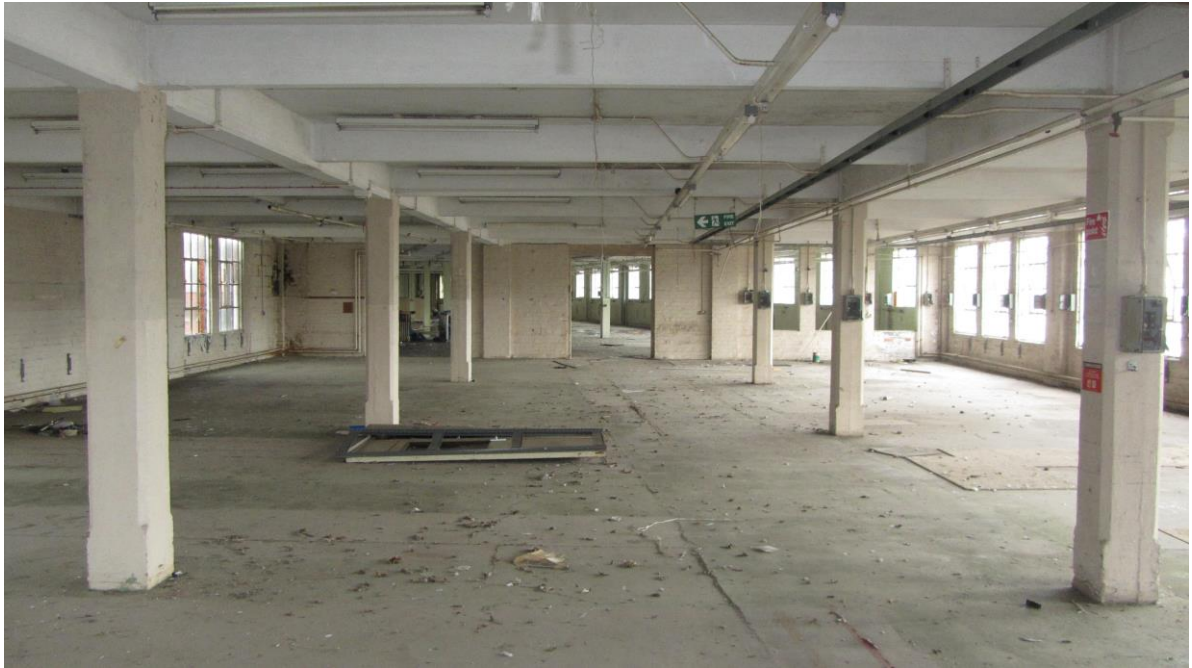
Plate 26: View NW of first floor Building 3 looking through into Building 2 and showing moulded pillars and reinforced concrete beams

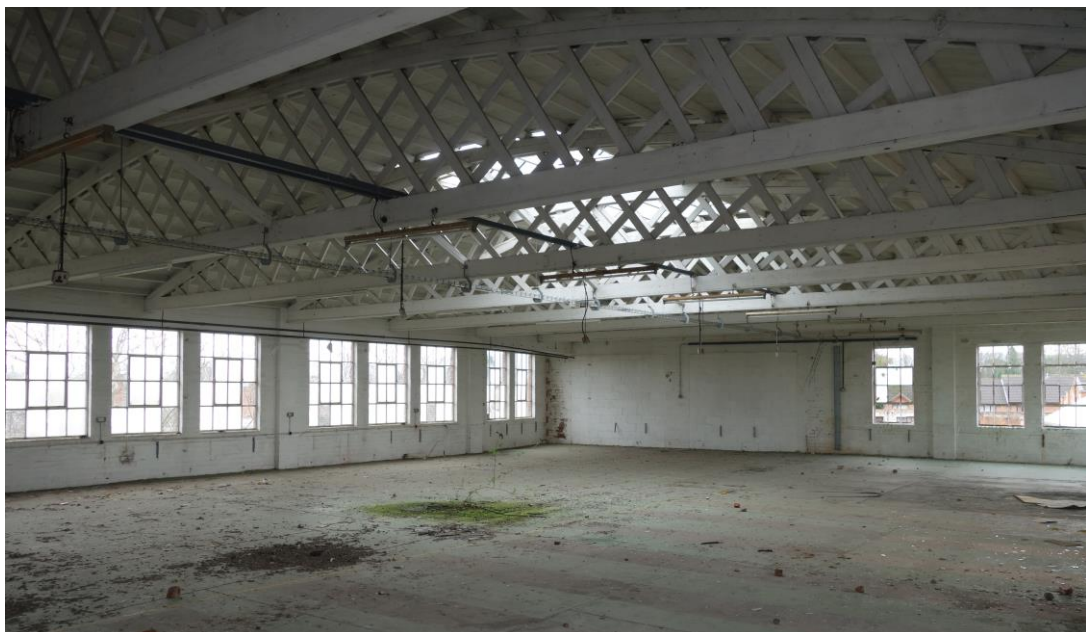
*Plate 27: Internal view SE of upper storey of Building 3 showing lattice trusses supporting roof structure.
Note: Open plan with no moulded beams.*

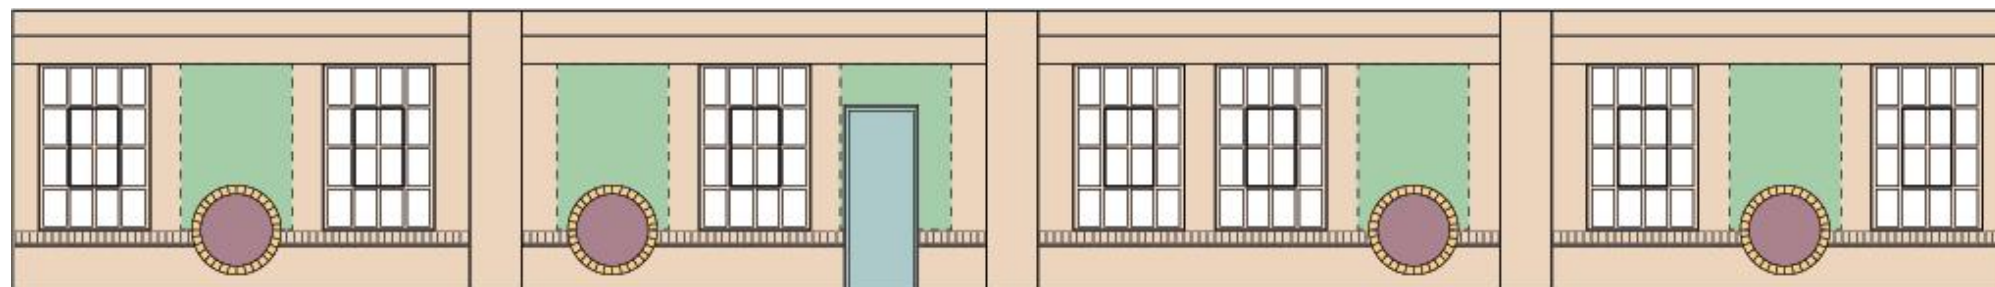
Fig. 6: Elevation drawing of W internal elevation at upper story level

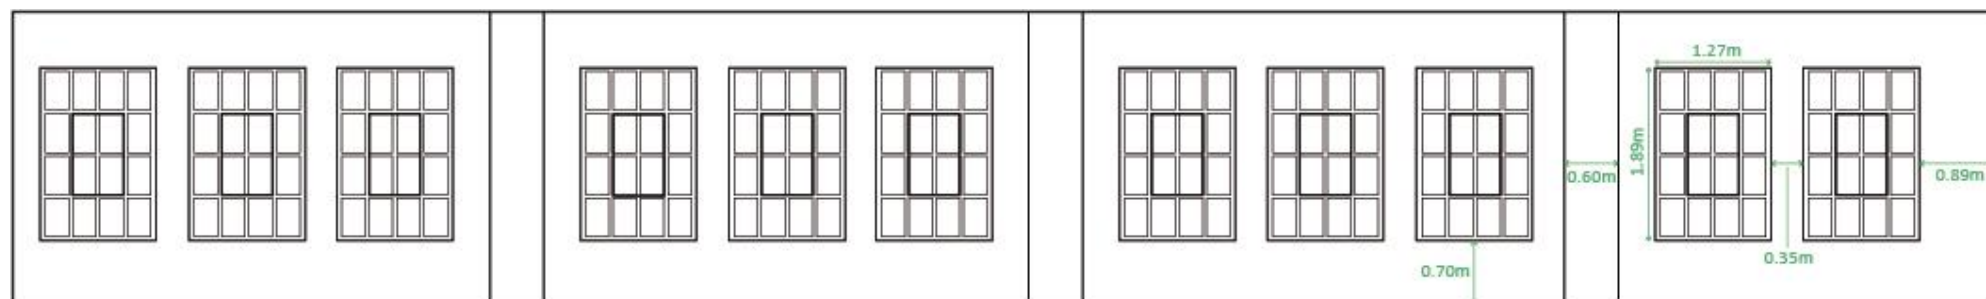
Fig. 7: Elevation drawing of E internal elevation at upper story level

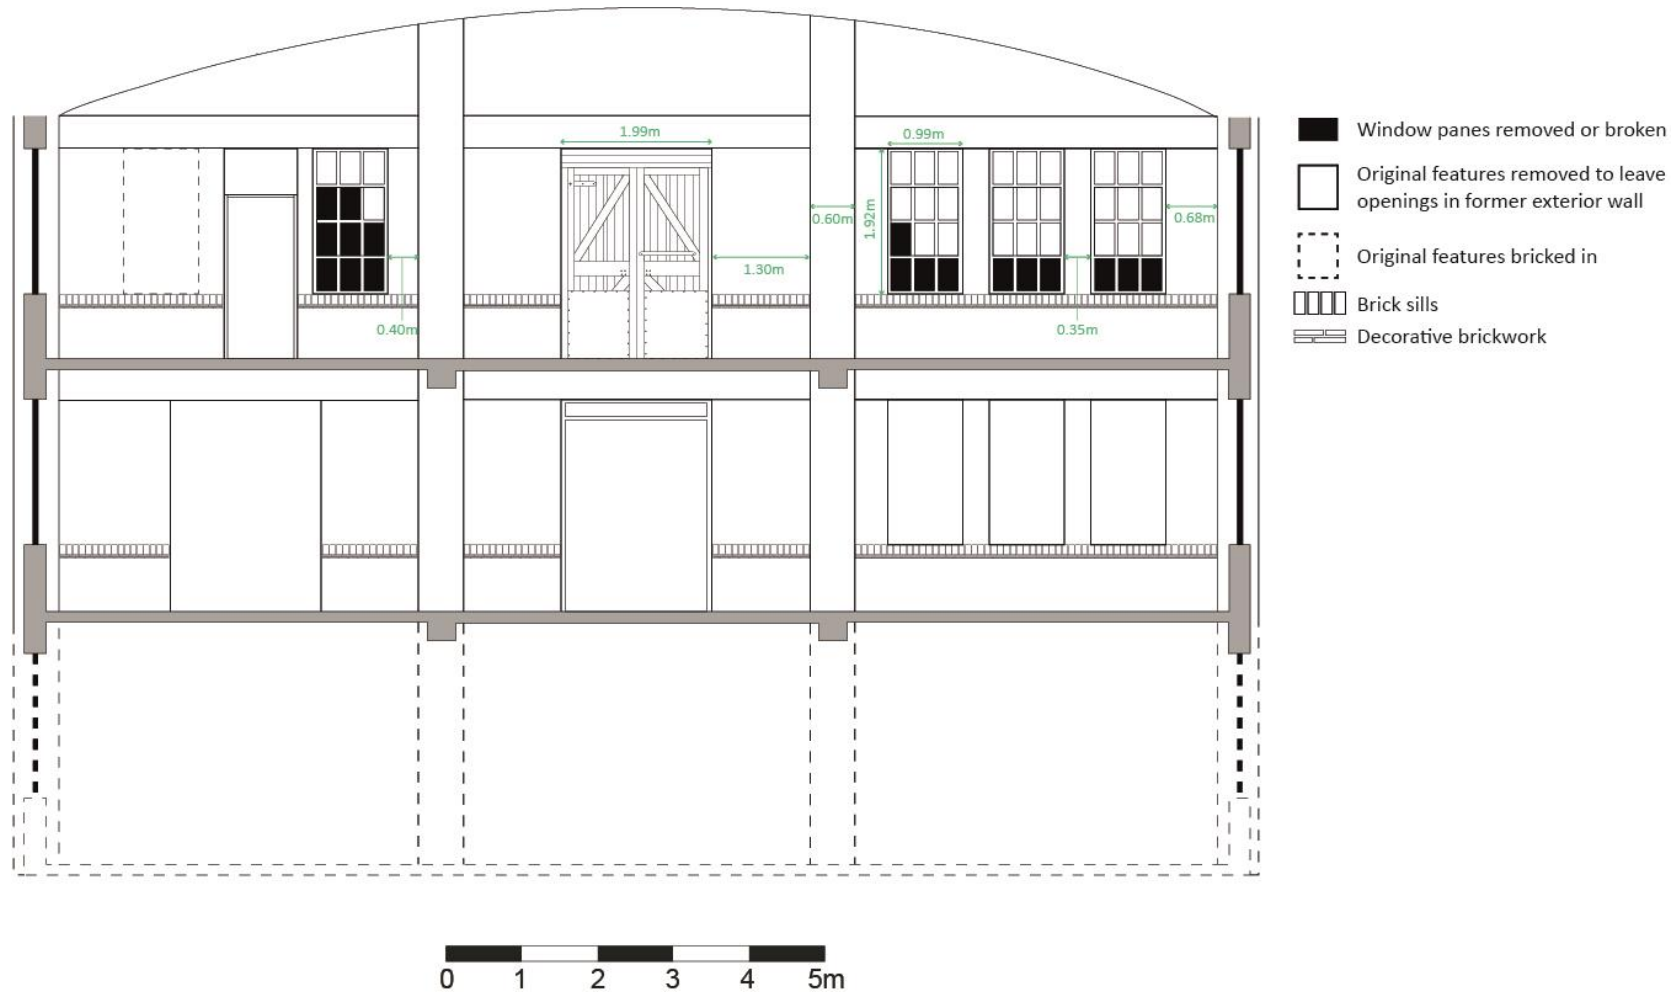
Fig. 10: Plan of upper storey - Building 3

Similarly, the uppermost floor was subject to detailed recording. The roof construction was clearly visible and detailed measurements were taken of its curvature. The curved roof deck consists of timber planking on narrow purlins, these being carried on a series of lattice trusses resting on the external walls, with no column supports present in the upper storey span. The roof trusses are braced longitudinally by pairs of crossed timbers (*Plate 35; fig. 8*). Placed centrally within the roof structure is a lantern feature providing an additional source of light at upper storey level (*Plates 32-34; fig. 10*).

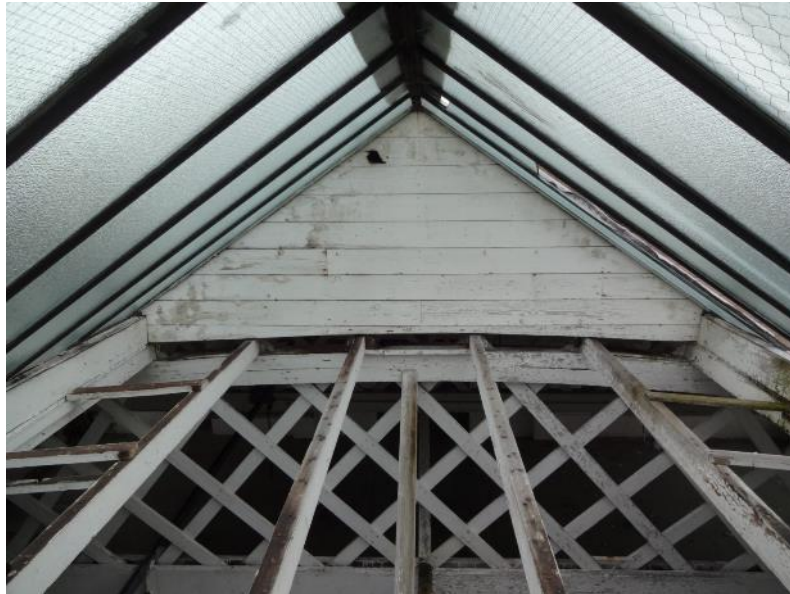
Plate 32: Internal detail of central lantern

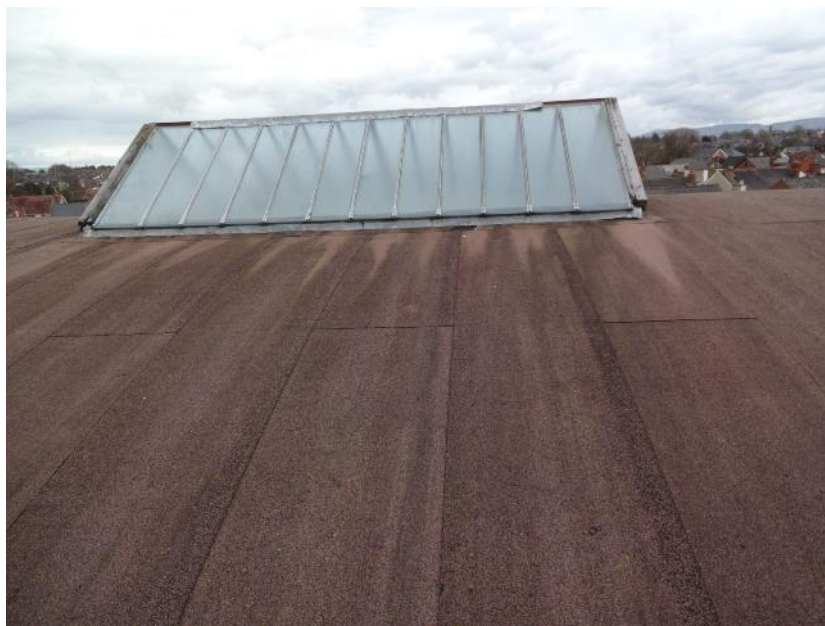
Plate 33: Detail of external roof structure of Building 3 showing lantern

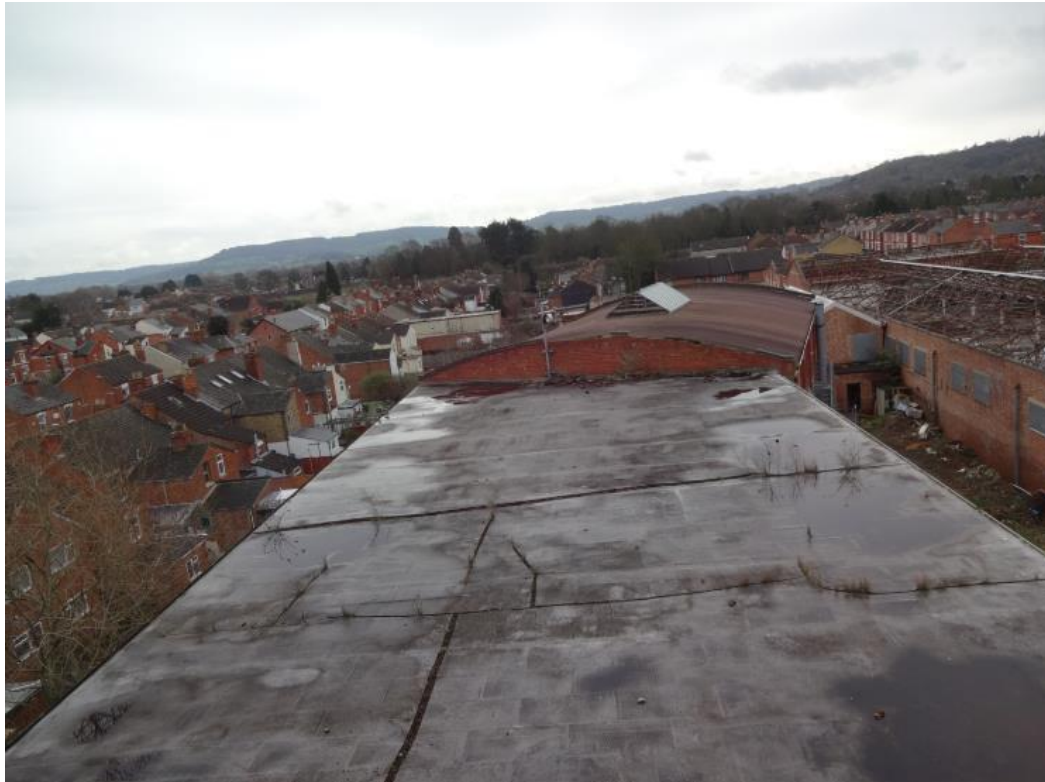
Plate 34: Detail of external roof structure showing flat roof of Building 2 (foreground) and curved profile of Building 3

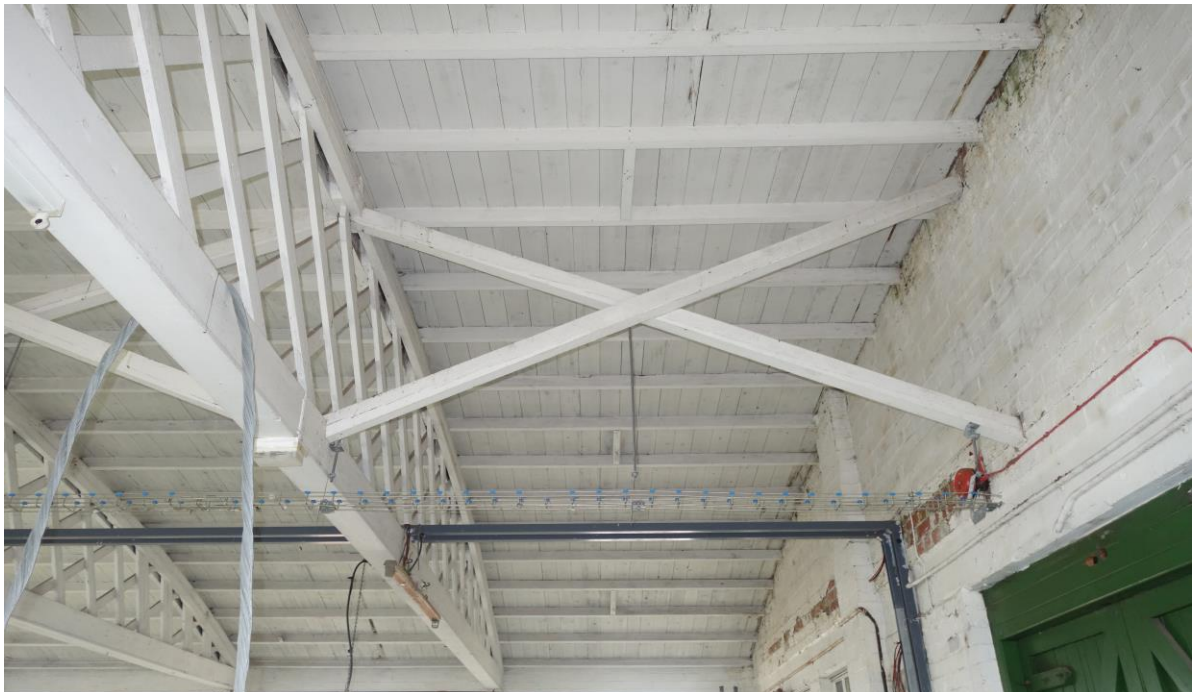
Plate 35: Detail of roof structure showing cross-braces separating trusses

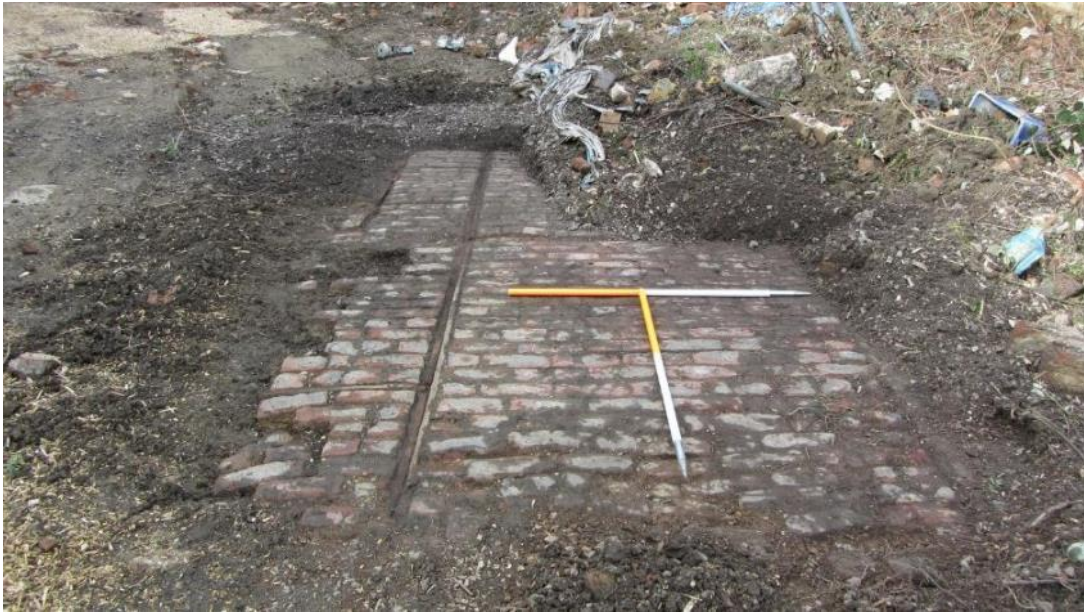
An area of brick paving incorporating wooden tracks/rails for carts/trolleys was identified as being of significant historical importance and was thus subject to detailed recording (*Plates 37 & 38; fig. 11*). It was noted that this feature appeared to continue NW towards Building 3 and is highly likely to be the remains of a tramway system, all elements of which had been designed and built on site, connecting the main mill complex to all of the surrounding buildings and which is described in a 1904 account of the Hatherley Works as ‘an elaborate and unique tramway system by which the product is carried on trucks through every department from the timber yard to all floors of the warehouse without lifts’. At its hub was a capstan, which drew the tramways up to the mill floors.

Plate 37: View NW showing extant remains of 'tramway' showing wooden rails and associated brick yardage

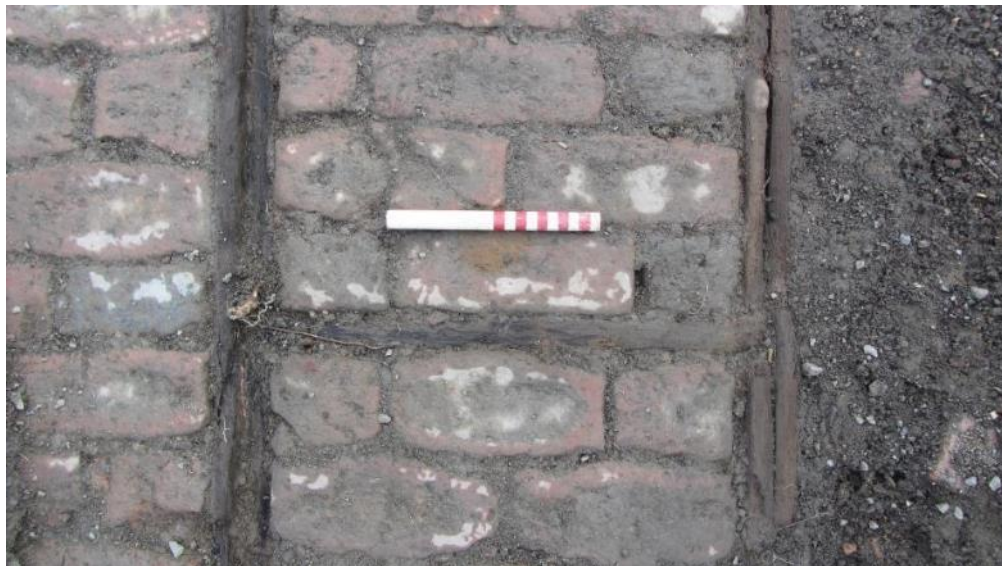
Plate 38: Plan view of tram rails showing detail of construction

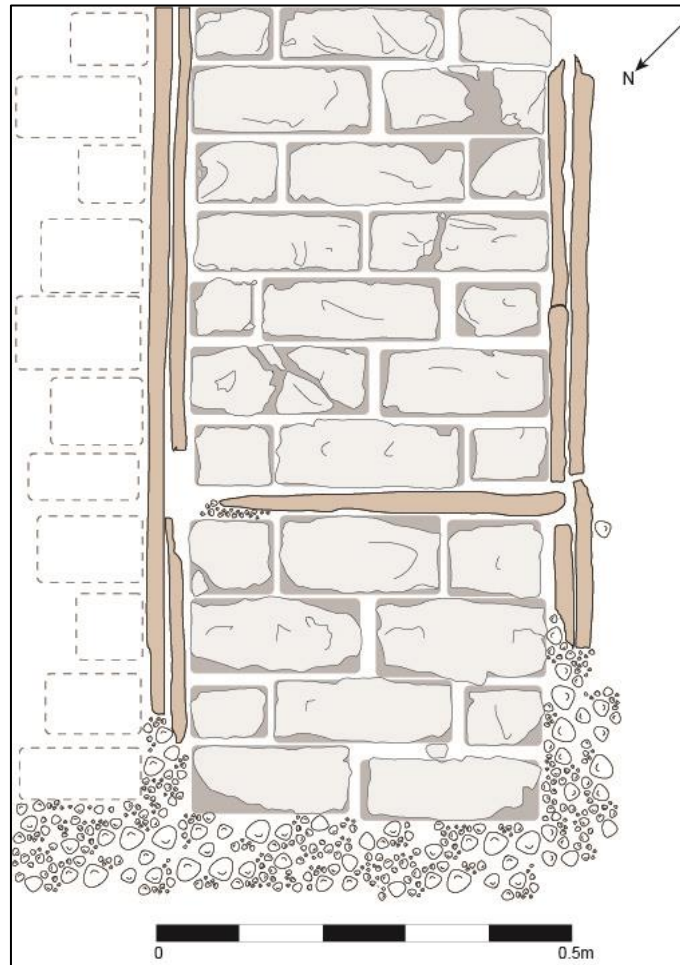
Documentary evidence shows this feature is integral to one of the earliest phases of activity on the site and was probably associated with the original late 19th century ladder works. A smaller area of similar brick paved construction was located slightly to the W.

Fig. 11: Plan of former tram rails

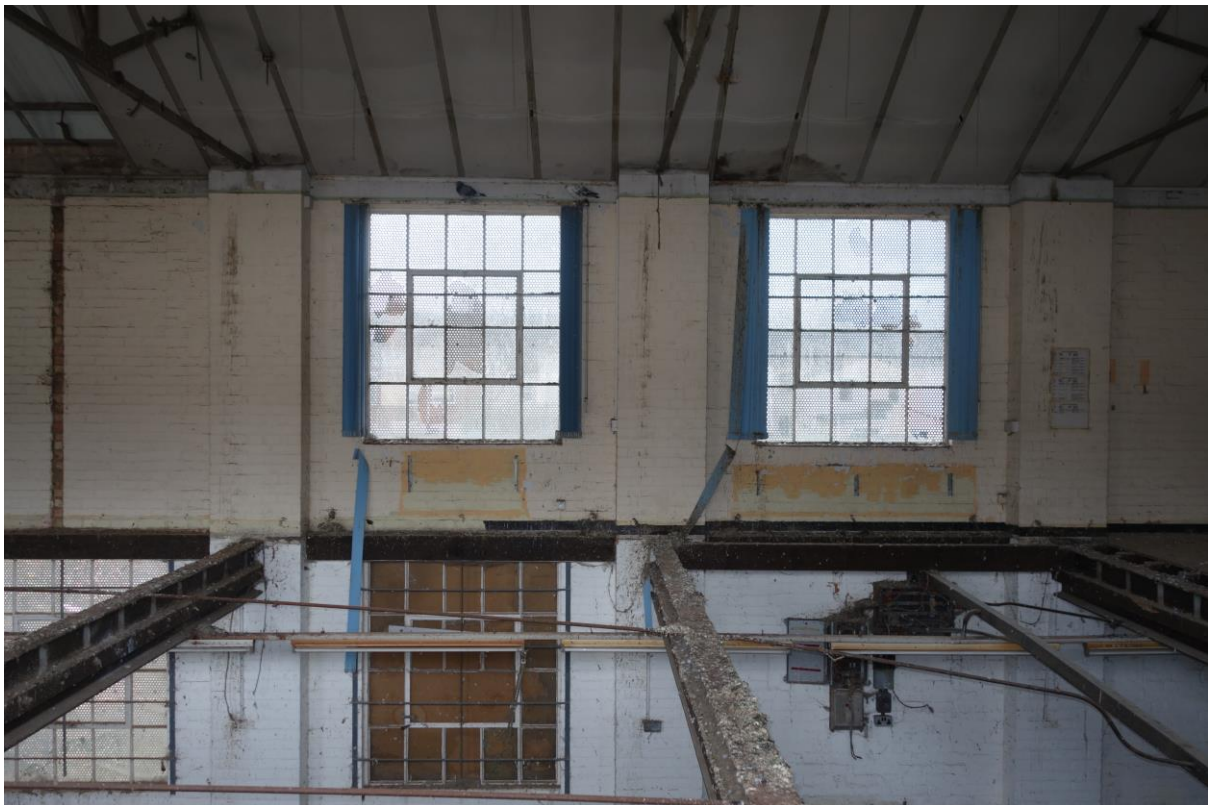
The roof construction comprises steel trusses resting on brick piers. The upper floor is supported on steel box frame joists; very little of the original flooring remains *in situ* and the building is largely open to the roof. The fenestration is clearly visible internally, comprising a row of 25-pane steel casement windows with central opening on each floor. The interior walls are whitewashed throughout.

Plate 39: View NE of Building 4 showing internal structural detail

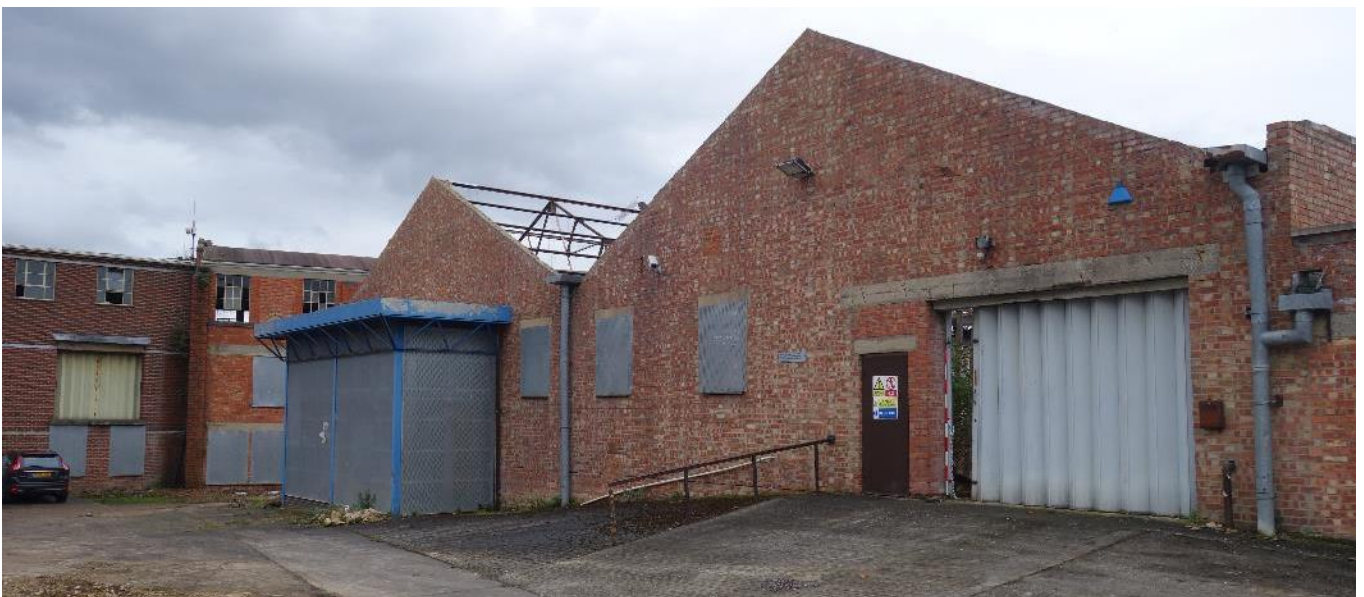
Plate 40 View E of NW elevation of Building 5 showing modern frontage with horizontal concertina folding door and concrete loading ramp
