Archaeological Standing Building Recording

The Former Norville Factory
Tarrington Road
Tredworth
Gloucester
GL1 4PF

April 2017

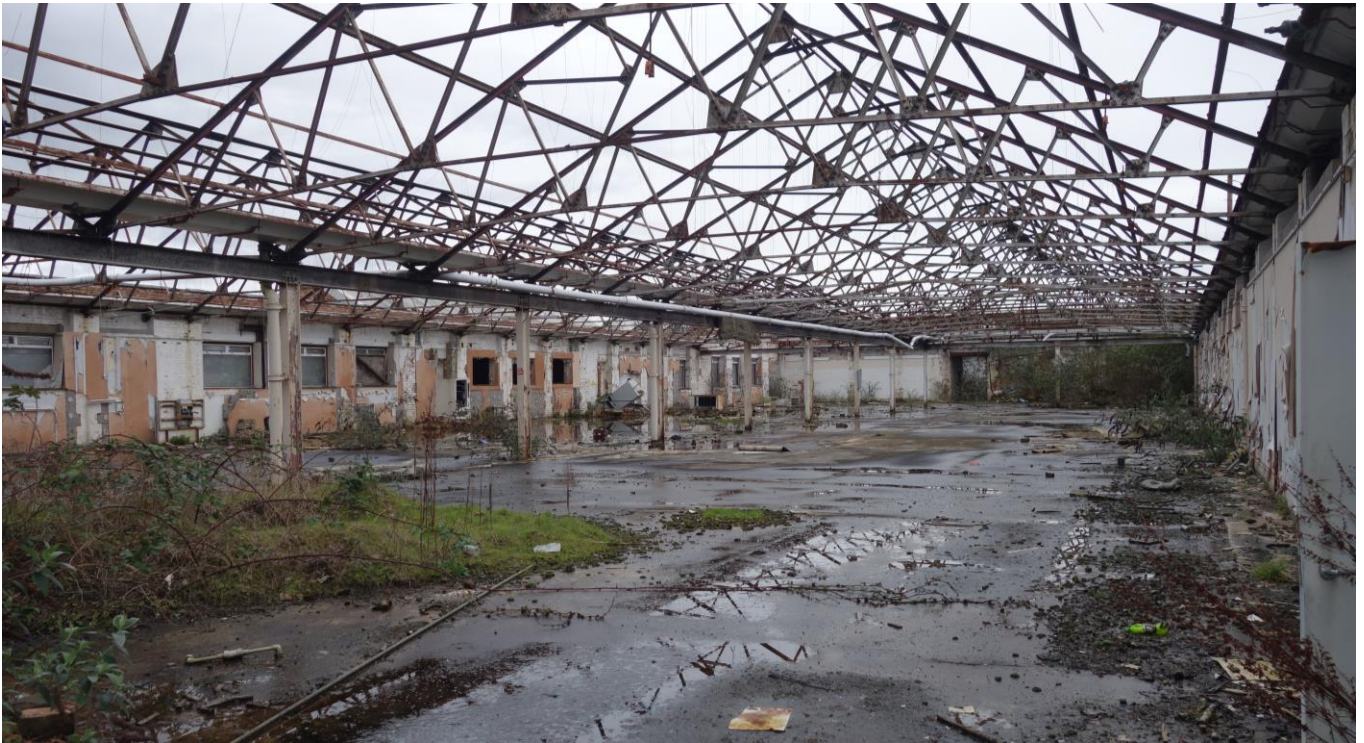
Plate 41: Internal view of Building 5 looking through into Building 6 at far end. Note: Laminated PVC-style floor covering.

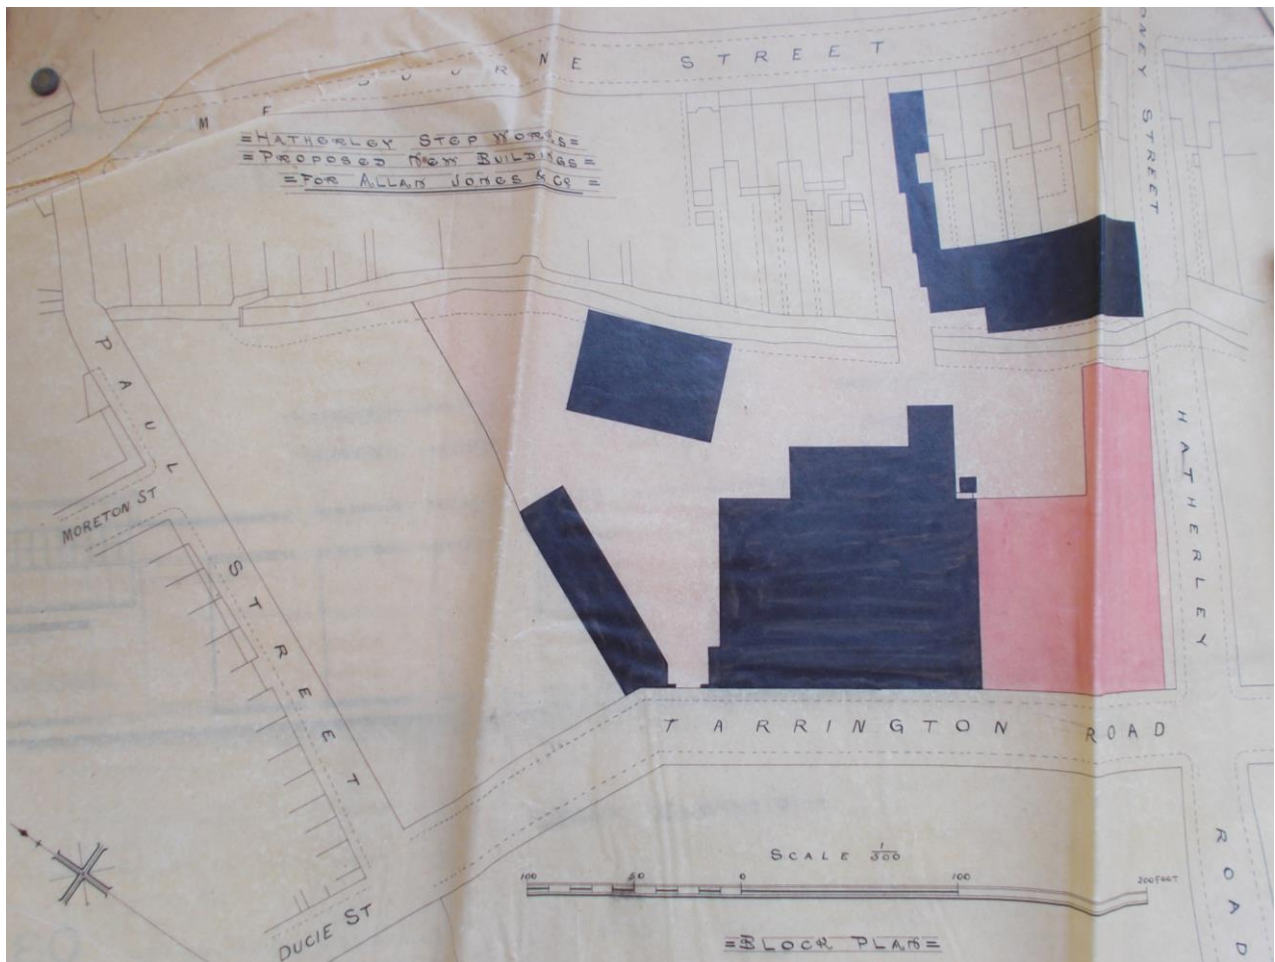
Fig. 12: Plans showing proposed layout of Buildings 6 & 7 dated 1897

A block plan submitted as part of a planning application dated 1897 (*fig. 12*) shows the first substantial phase of development to the S of Melbourne Street (with proposed development shown in red) following the grant of a 14-year lease on the property in 1888 to Charles Allan Jones, the founder and sole proprietor of the Hatherley Step Works. A range of industrial buildings now occupied the northern and southern flanks of the brook and the plot to the rear of No. 116 Melbourne Street West had been fully integrated into the works complex. These formed 'the valuable trade premises and extensive yards situate in Melbourne Street known as 'The Hatherley Works' referred to in an advertisement in the Gloucester Citizen dated 30 August 1892. The site is shown as bounded on its NW and NE sides by the newly-laid out streets of Tarrington Road and Hatherley Road, respectively.

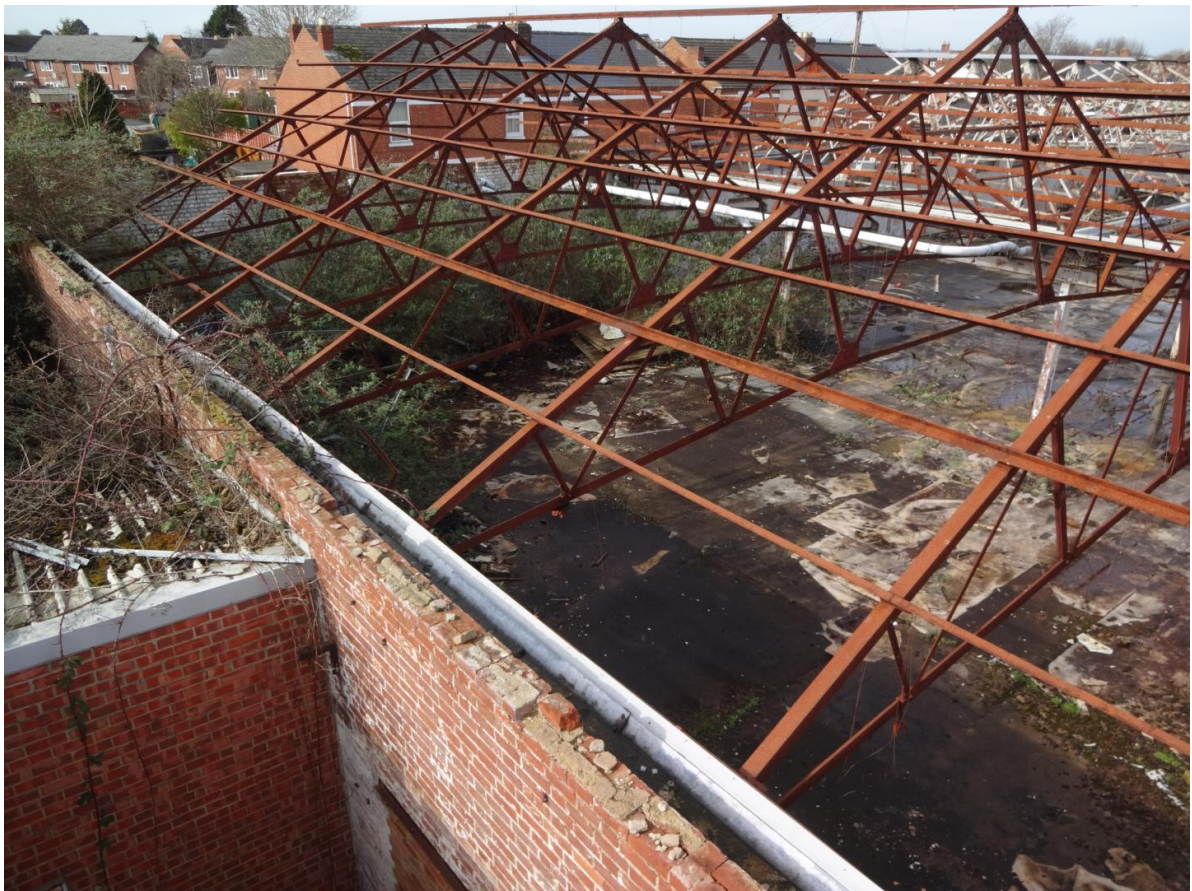
Plate 44: View W of Building 6 showing roof structure

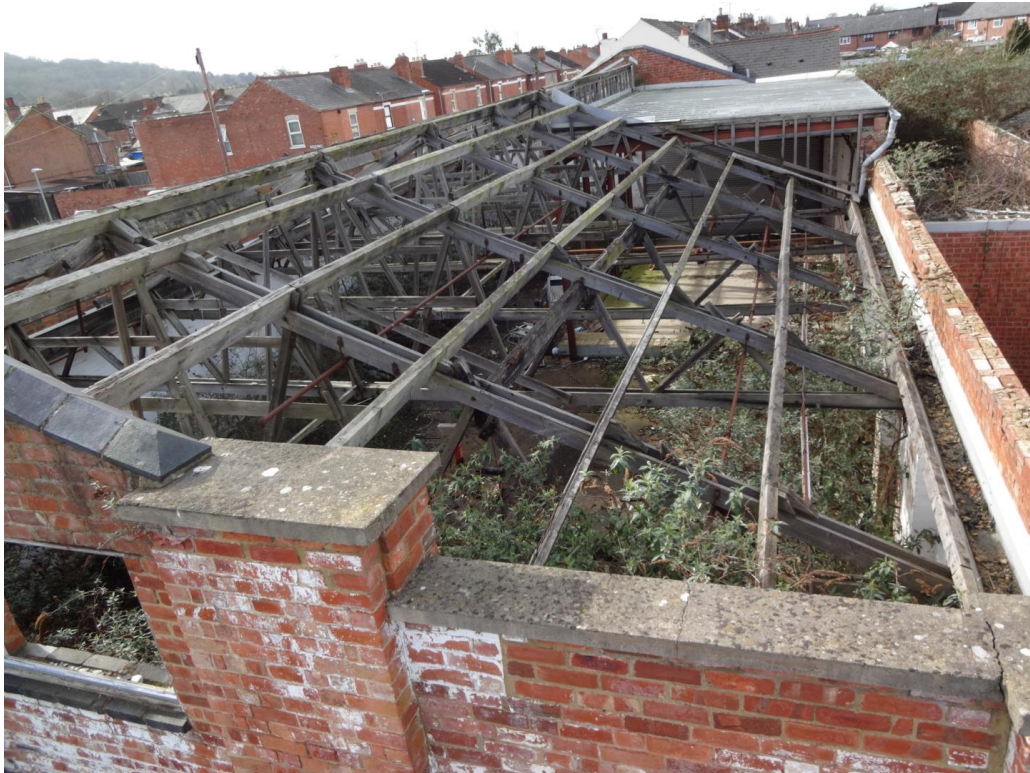
Plate 45: View SW of Building 7 showing roof structure

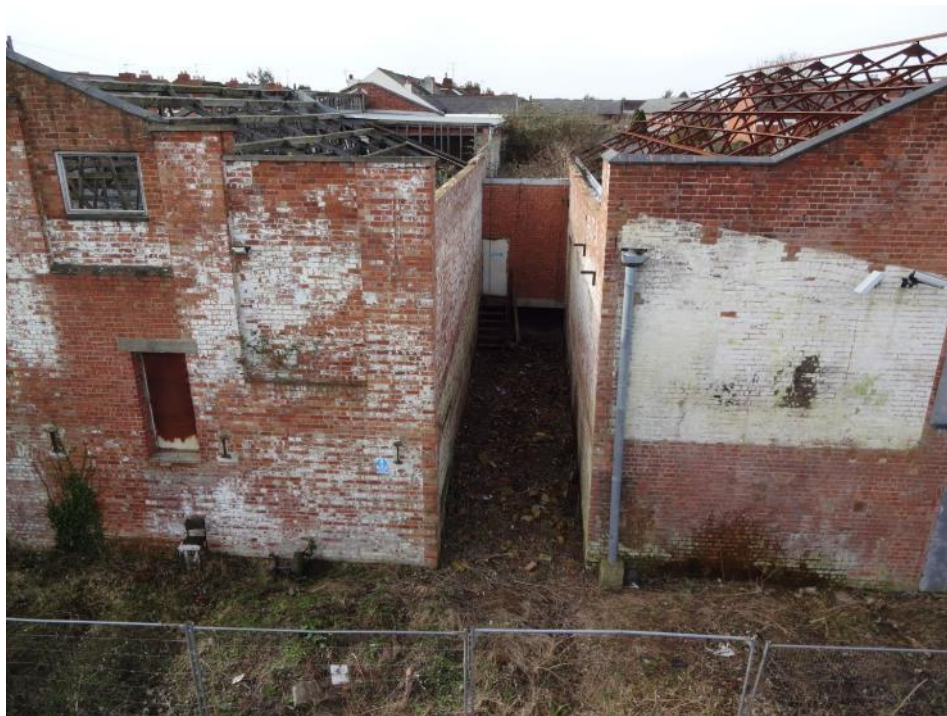
Plate 46: View W showing E elevations of Buildings 6 (right) and 7 (left) with connecting link block (centre). Note evidence of lean-to structure formerly attached to Building 6 and traces of whitewash adhering to the Building 7 elevation

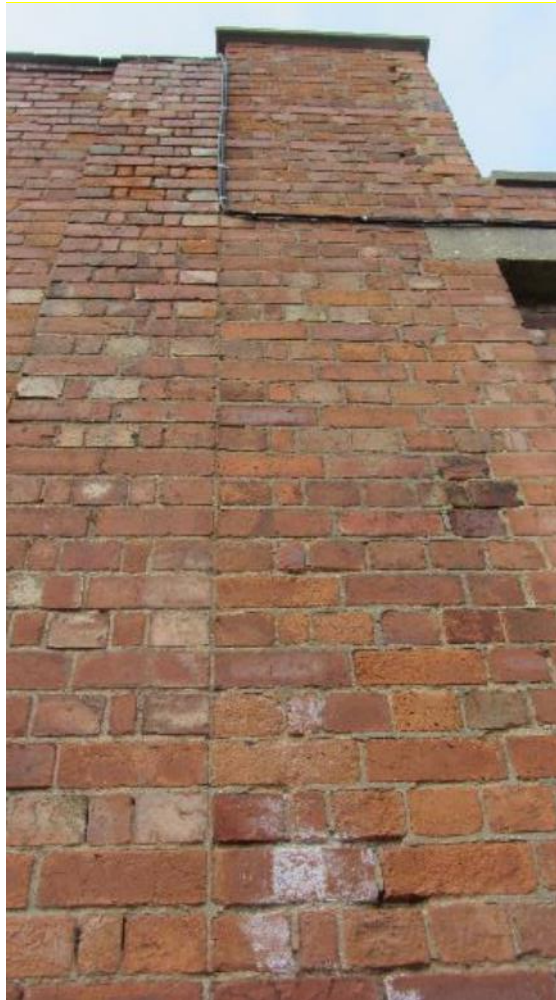
The dating of the elevations is somewhat problematic, although the character of the masonry would appear largely consistent with an earlier 20th century date. This however creates a difficulty in explaining the clear difference in form between the existing elevation and that shown in the architect's drawings of 1897. However, with respect to Building 7, a construction break in the Hatherley Road elevation shows where the brickwork of the now-destroyed range extending up to the Sud Brook abuts earlier fabric (*Plate 47*) suggesting the E elevation has been reconstructed at some point.

Plate 47: View from Hatherley Road showing construction break

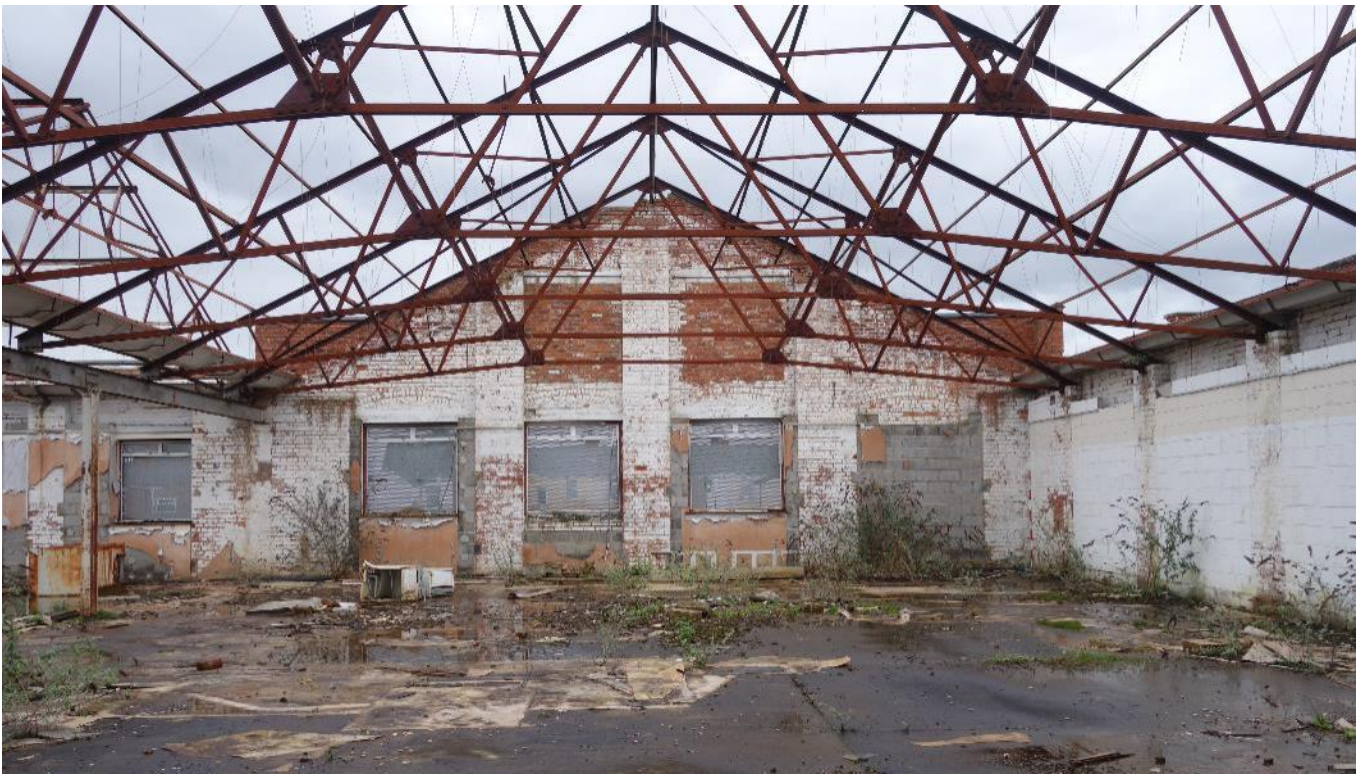
Internally, Buildings 6 and 7 are heavily overgrown with ruderal species such as elder and buddleia and are in a generally poor condition (*Plate 48 & 49*). The timber roof structure has of Building 7 been cut away in the W corner to accommodate the modern steel-framed loading bay with raised concrete floor which opens onto Tarrington Road (*Plate 50*).

Plate 48: Interior of Building 6. View E showing roof structure and internal gable.

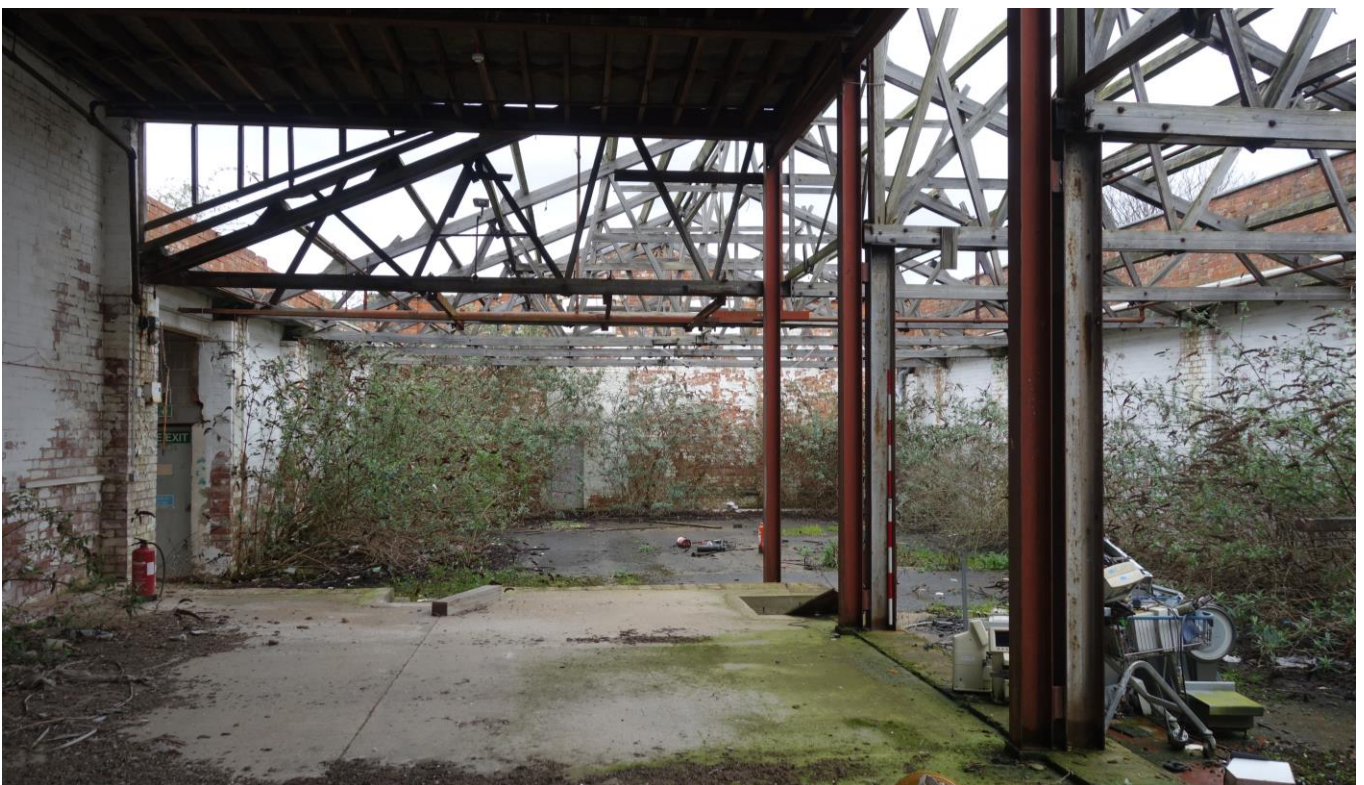
Plate 49: Interior of Building 7. View E from modern loading bay with original roof trusses to right and rear.

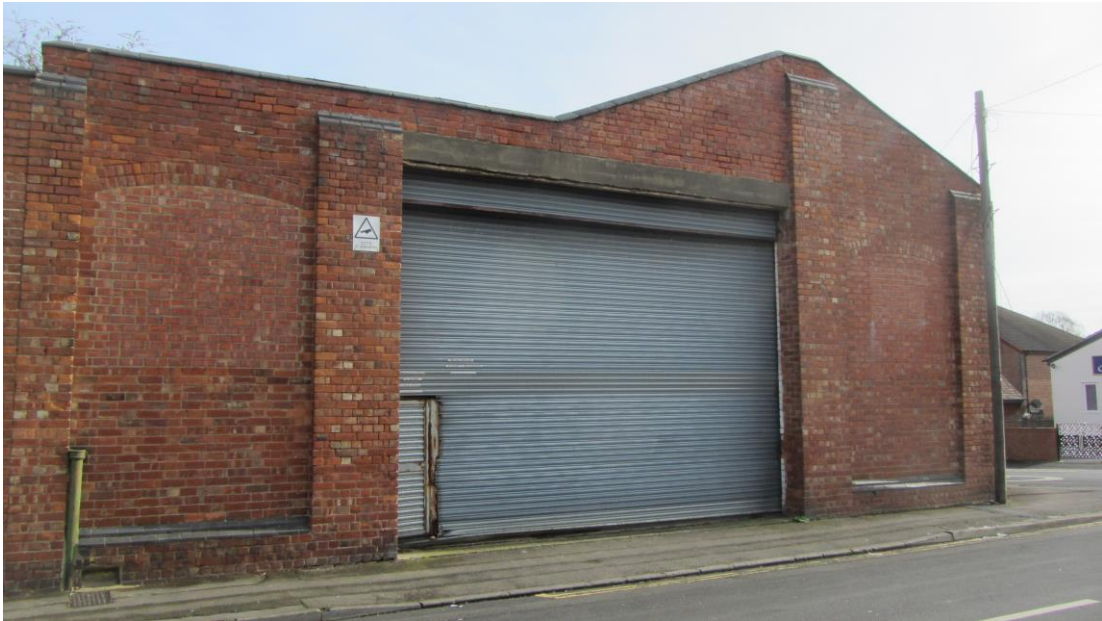
Plate 50: View ESE from Tarrington Road towards Hatherley Road showing existing west elevation of Buildings 6 & 7 with earlier openings to the left and right infilled with later brickwork.

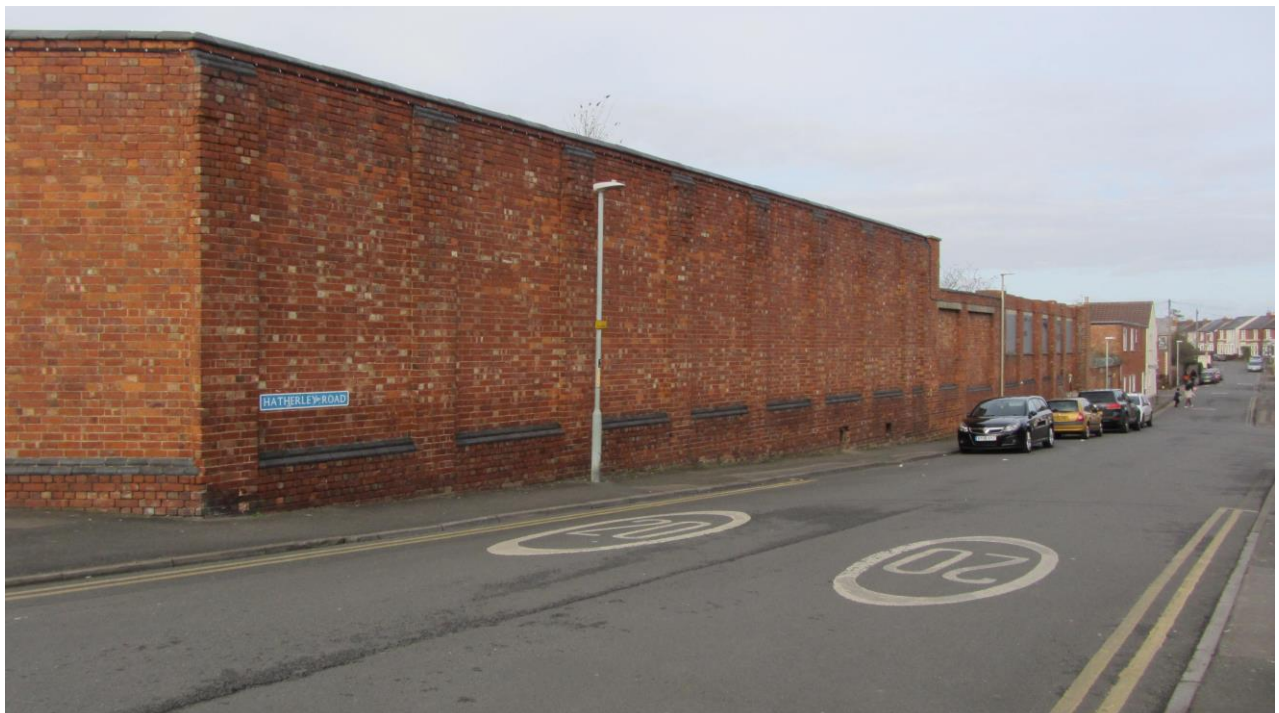
Plate 51: View along Hatherley Road showing present condition of S elevation of Building 7. Note blocked window openings

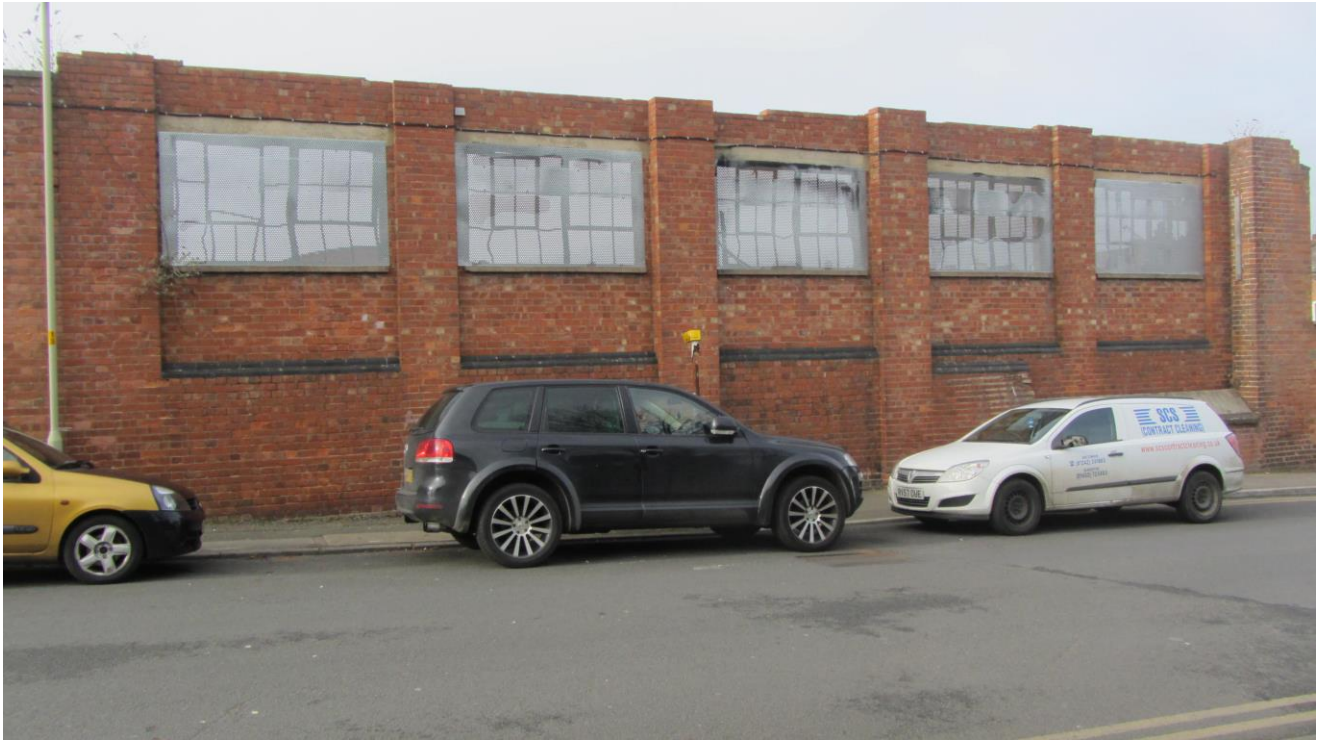
Plate 52: View from Hatherley Road showing detail of existing fenestration. The stepped abutment (to the right) shows the location of the Sud Brook bridging point
