Archaeological Observation

**Ledbury Trunk Main (Town)
Ledbury
Herefordshire**

Dŵr Cymru Welsh Water /
Laing O'Rourke

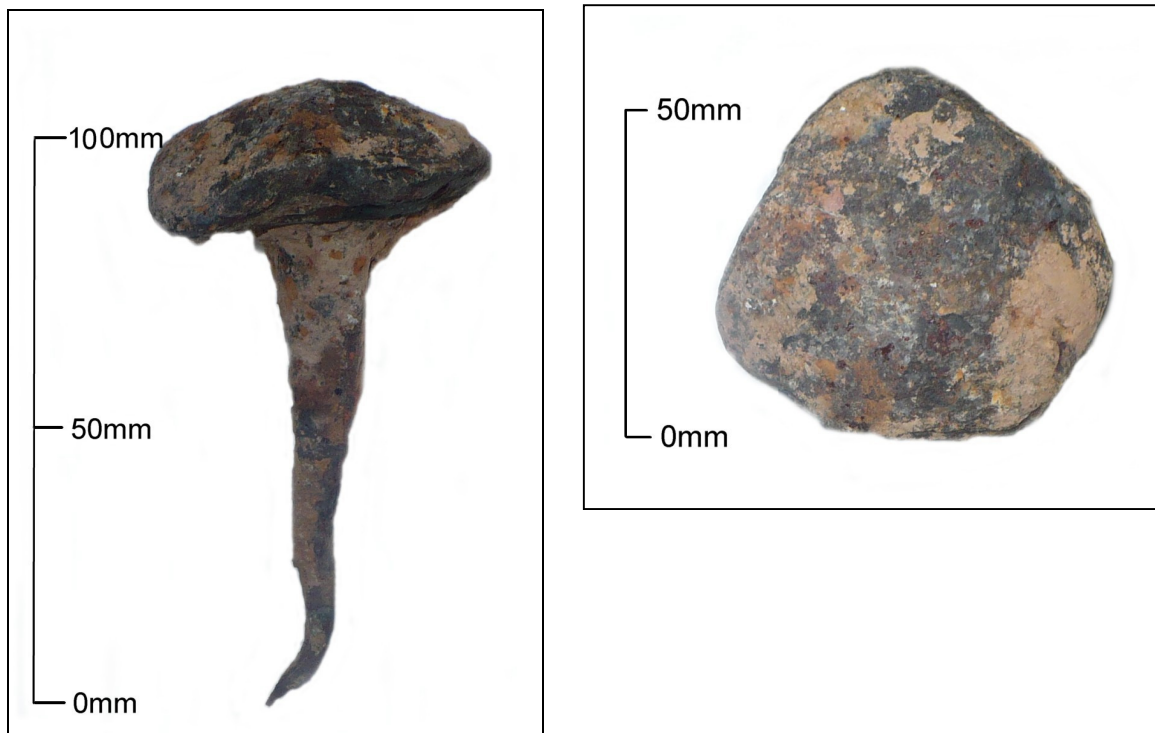
Plates 3 & 4: Medieval or early post-medieval iron spike

An iron (Fe) spike, was excavated from an access pit in the road outside No 76 The Homend / High Street from a moderately compacted red sand silt clay containing occasional small stones & degraded stone inclusions. The deposit was >1.20m in thickness & measured >3.80m (N-S) by >3.20m (E-W) and had been heavily disturbed or redeposited by the installation of a modern water pipe.

The spike has a large flattish or slightly domed squared head, measuring 50mm x 55mm across, and a squared stem measuring 90mm in length (**Plates 3 & 4**). It is probably medieval or early post-medieval in date & may have been used for structural or decorative purposes.
