## Archaeological Observation

**National Trust**

Attingham Park Shrewsbury SY4 4TP

Area 3 (Car Parking)

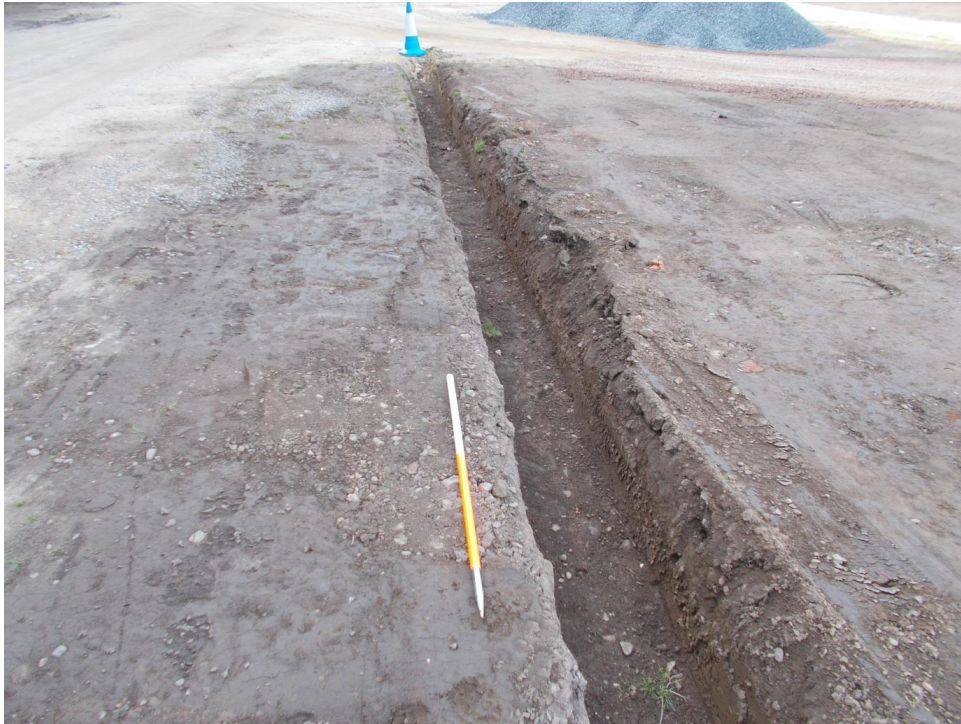
*Plate 1: View looking SSE showing Trench 1*

Within the first 4m from the NNW end of the trench, the stratigraphy consisted of (101=201), a friable mid-brown silty clay topsoil with occasional small to medium rounded and sub-angular stones, occasional charcoal and CBM flecking, 0.10m thick, which in turn overlaid (102=202) a moderately dark reddish brown silty clay topsoil with small to medium rounded stones and occasional charcoal flecking, extending to a depth of 0.25m (max). Crossing both trenches was the near vertical cut [107=207] for a modern linear metallised trackway with a sharp break of slope at the top and a flat base (Plate 2), extending ENE-WSW between Trenches 1 and 2 and measuring approximately 17m long, 6.5m wide and 0.30m deep. It was filled by (103=203) a friable light orange brown sand with occasional small stones, 0.10m thick, which overlaid (104), a moderate to well compacted blackish grey tarmac deposit with terram fragments 0.20m deep, underlying which was subsoil deposit (102=202), 0.05m thick.

Two long parallel trenches (Trenches 1 & 2) oriented NNW-SSE were excavated within Area 3. Trench 1 measured 90m long by 0.40m wide and 0.35m deep and Trench 2 measured 86m long by 0.40m wide by 0.35m deep. The stratigraphy within both trenches was identical and may be summarised as follows:

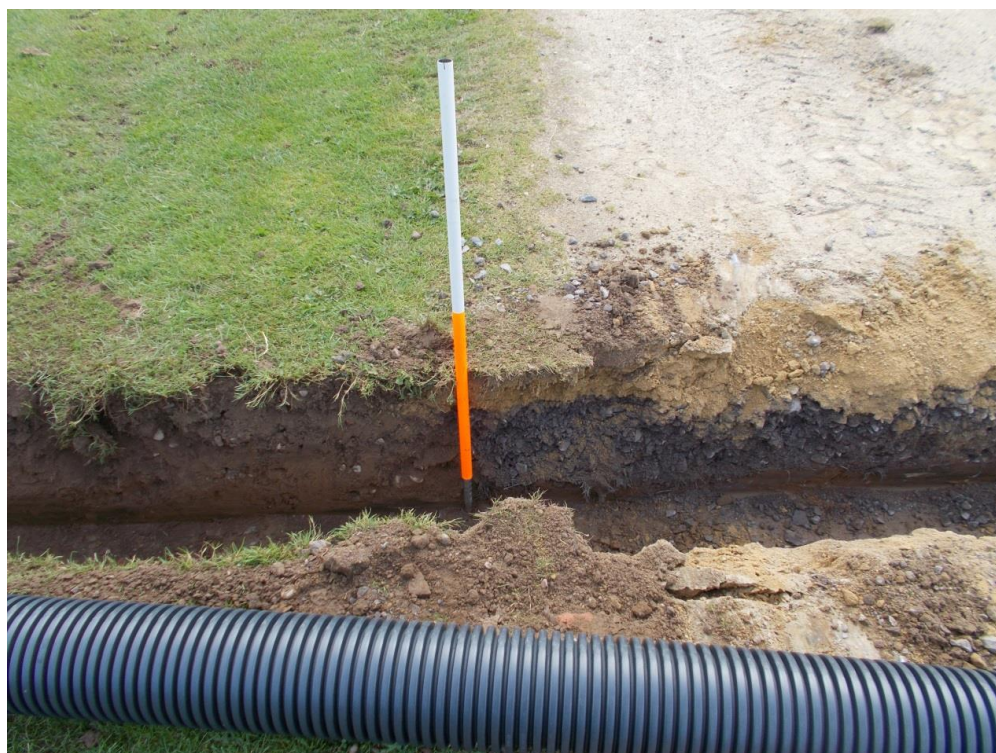
*Plate 2: View looking ENE showing trackway feature [207] within WSW facing section of Trench 2*

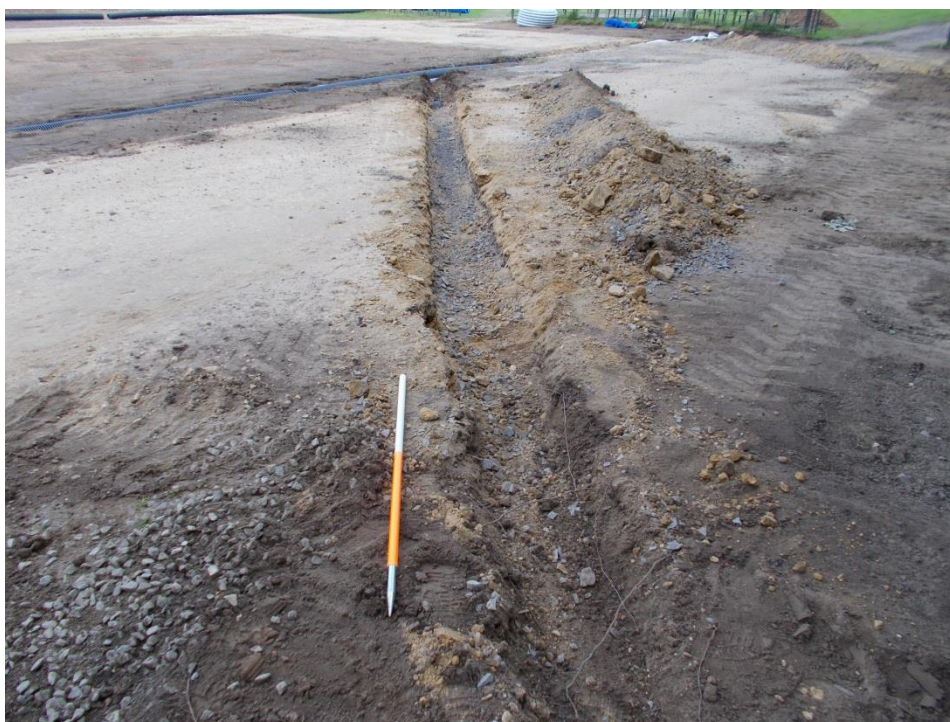
*Plate 3: View looking NW showing Trench 3 bisected by modern linear metal trackway feature oriented NNW-SSE*

Within each of these trenches, a modern linear metal trackway feature (recorded as [303]=[403]=[503] [603]=[703]=[803]) was observed running on a NNW-SSE alignment across Area 3 (*Plate 3*). The trackway was visible in section as a near vertical cut with a sharp break of slope at the top, its visible dimensions measured 5m wide (ENE-WSW) by 0.20m deep and it was filled by a friable light orange brown sand (304=404=504=604=704=804) 0.10m deep which in turn overlaid a moderate to well compacted blackish grey tarmac and gravel deposit (305=405=505=605=705=805) again 0.10m deep.

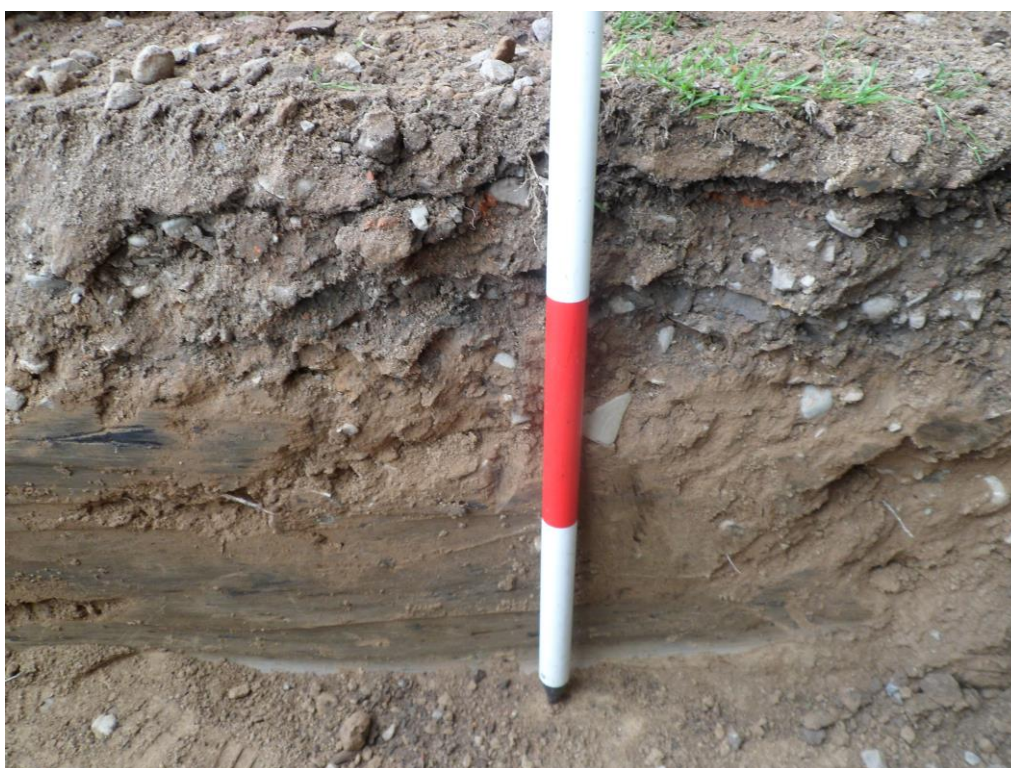
The section of trenching extending from the car park at NGR: SJ54728 10156 to NGR: SJ54703 10157 revealed two contexts. The uppermost of these (301) was a friable mid greyish-brown silty clay, with frequent small sub-rounded and sub-angular stones. Beneath this was (302), a friable mid brown clayey silt, containing very occasional sub-rounded stones (*Plate 4*).

*Plate 4: View N of trenching adjacent to car park*

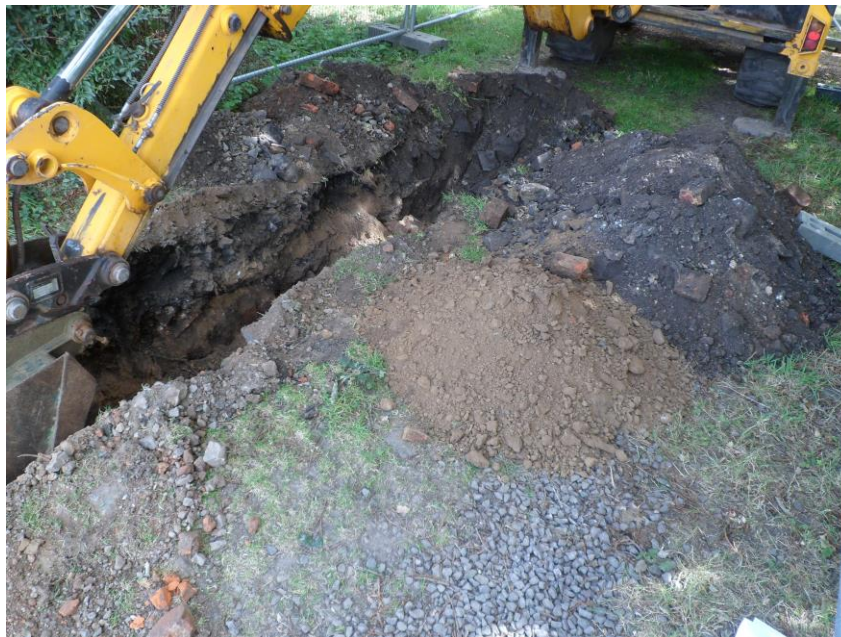
Between NGR SJ54703 10157 and NGR: SJ54756 10167, the uppermost deposit was (303), a rubble deposit within a friable dark brown silty clay extending E from the gateway into the woodland consisting of moderate to large angular stones, with occasional fragmentary unfrosted brick and frequent medium angular and small sub-angular stones. This overlay a continuation of context (302) (*Plate 5*).

*Plate 5: View NE showing rubble deposit in gateway*

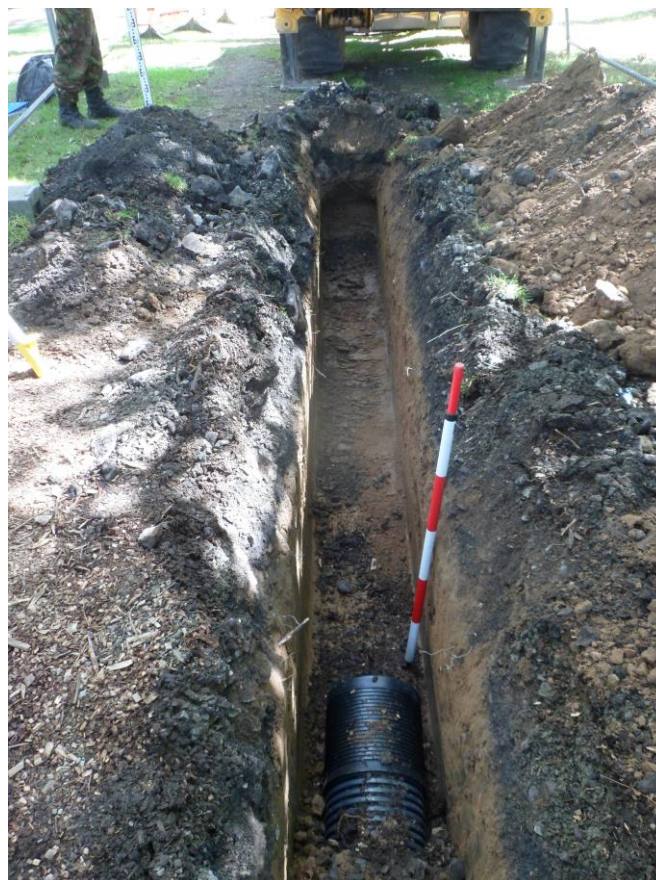
*Plate 6: View E showing continuation of trenching*

From NGR: SJ54756 10167, the upper deposit consisted of friable dark greyish-brown silty clay, which was similar in composition to (301) but markedly less stony (*Plate 6*).
