Archaeological Field Evaluation

Gloucester City Homes

Land adjacent to Edward

June 2017

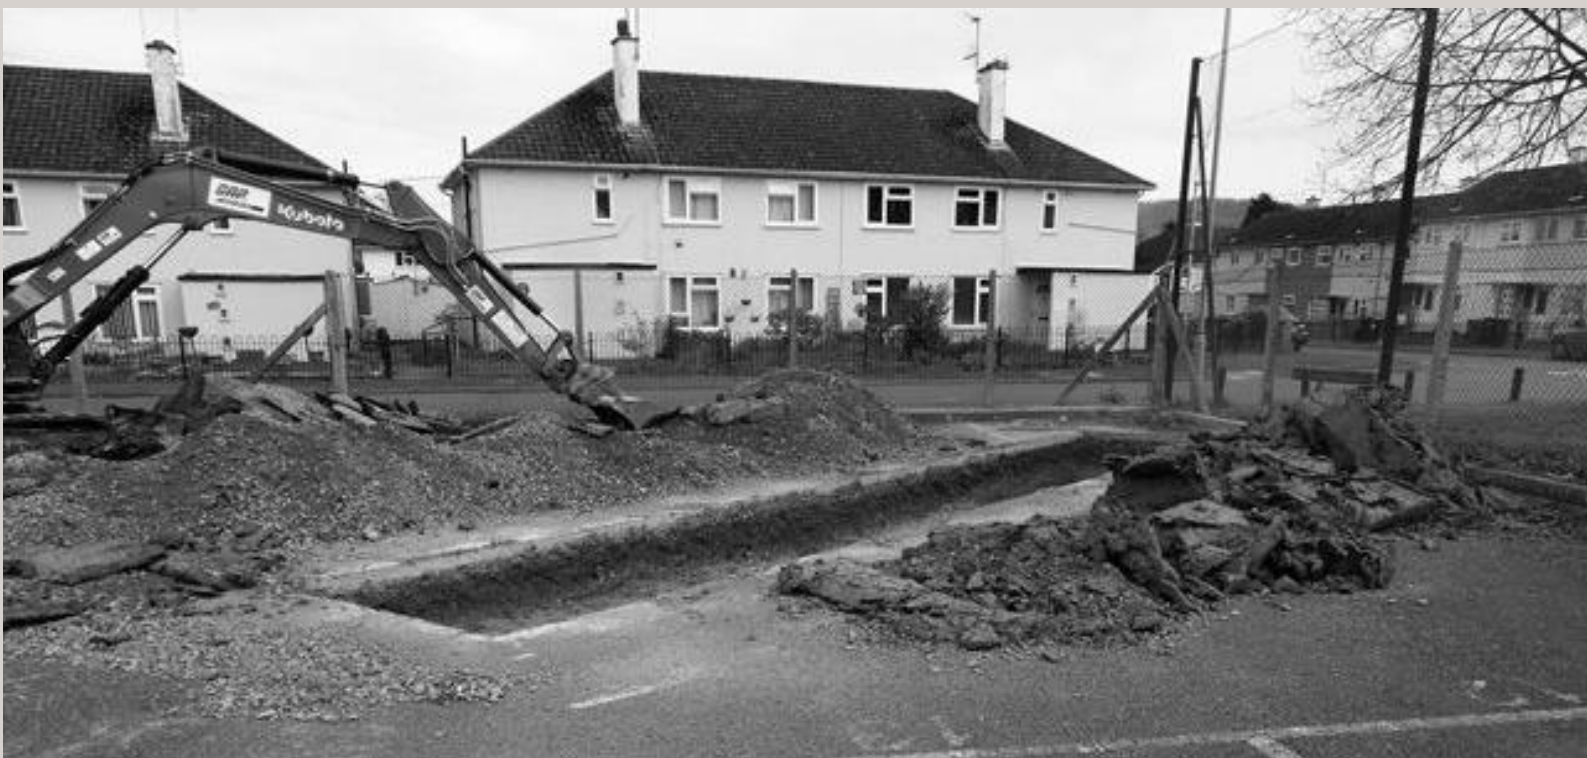
Cover: View southeast showing Trench 1 under excavation

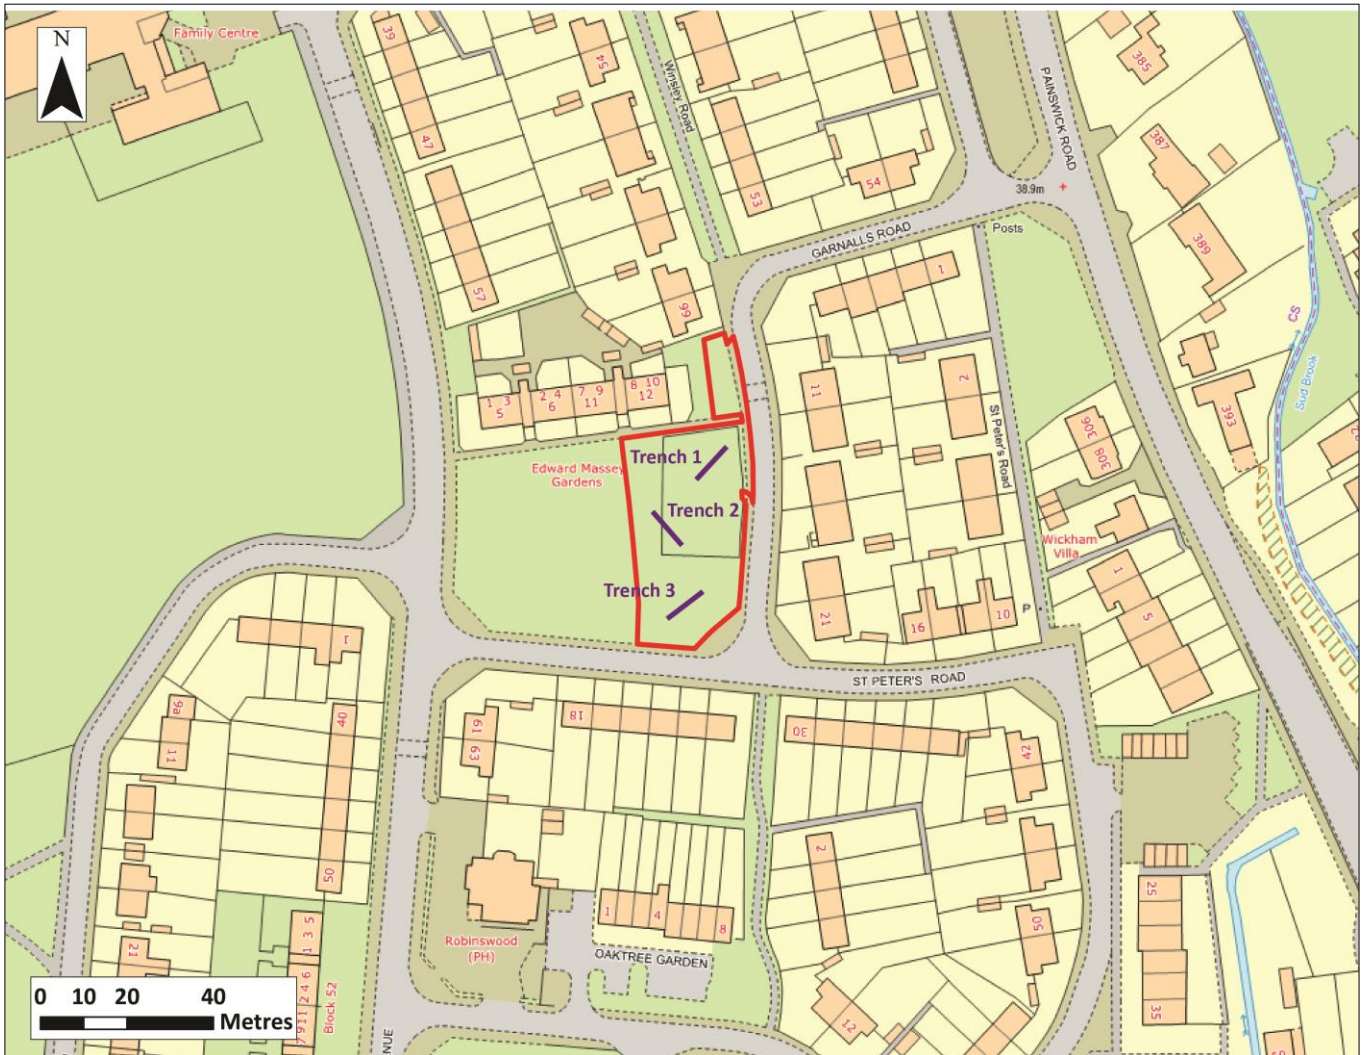
Fig. 2: Trench location plan

Three trenches measuring 10m × 1.8m were opened by machine using a wide-blade toothless ditching bucket within the main part of the site. Trench 1 was aligned NE/SW, Trench 2 NW/SE and Trench 3 ENE/WSW (*fig. 2*).

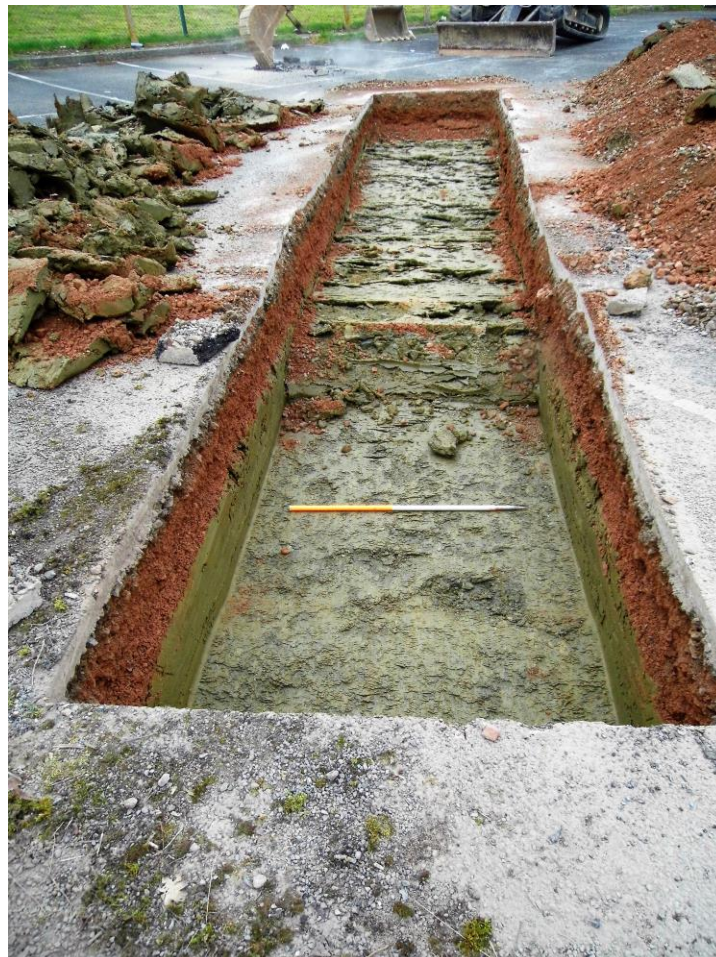
No archaeological features or deposits were present on the site. The topography suggested that the carpark area may have been lowered, presumably during the construction of the estate in the 20th century. This would seem to have removed topsoil and also subsoil deposits, with the natural clay (investigated by *sondage*) (*Plate 1*) lying immediately beneath the tarmac surface and consolidation.

Plate 1: Trench 1 view NE showing sondage into natural clay
