Archaeological Observation

**AMP6 2nd Batch Mains Renewal
Langley to Broome
Near Acton Burnell
Shropshire**

June 2017

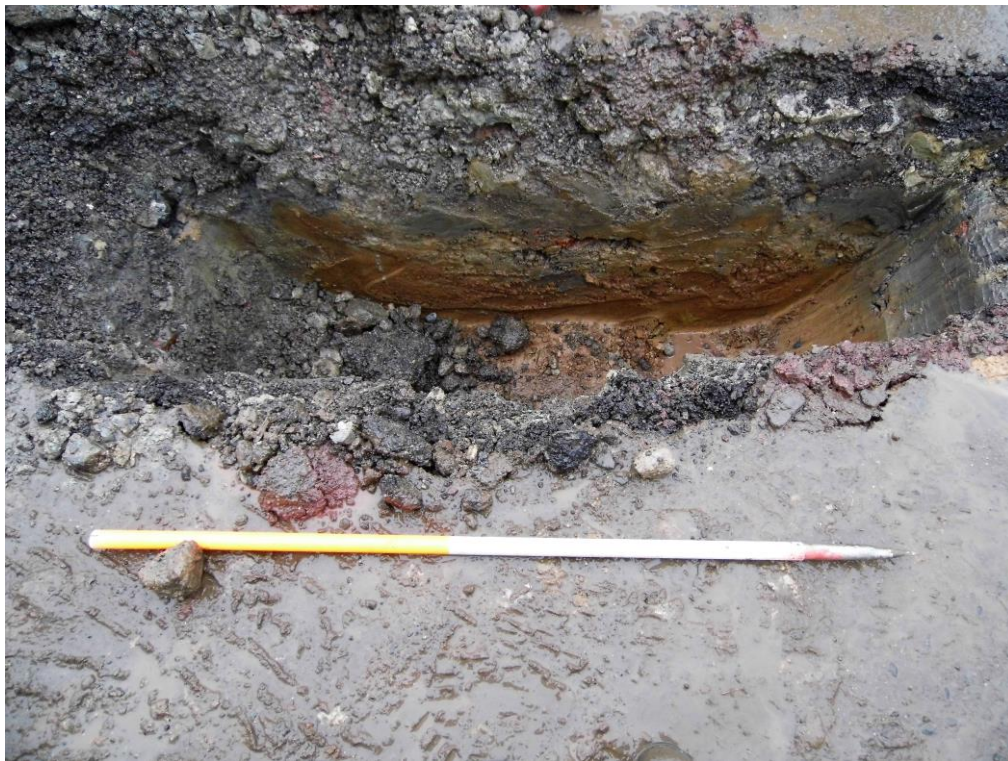
Plate 1: Access Pit 3 under excavation within the Scheduled Area; view N

The two Access Pits within the Scheduled Area revealed no evidence of archaeological finds, features or deposits. These excavations were limited in extent and thus may not have encountered any deposits or features present in these areas. Disturbance caused during insertion of the existing service could be clearly seen in AP 2. However, in both AP 2 and AP 3 the lack of topsoil or subsoil deposits demonstrated that these were removed during road construction; it is possible, therefore, that archaeological deposits were truncated during this process. It could be seen that no cut features were present.

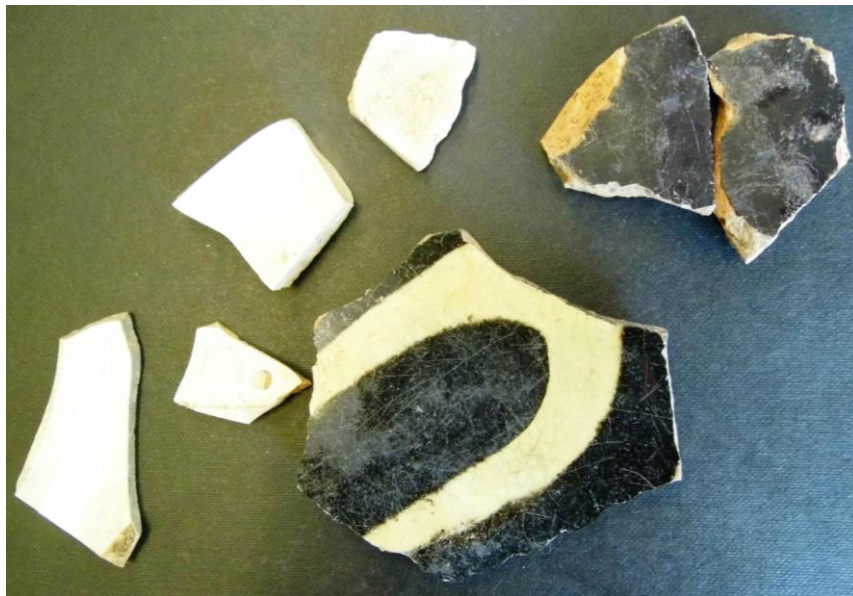
A sample, totaling seven sherds, of the later post-medieval and modern pottery was retained from material recovered from the topsoil during open-cut trenching to the N of the Scheduled Monument. All sherds postdate the construction of Langley Hall and are contemporary with or postdate the 18th century farmhouse. They may have been deposited during attempts to cultivate the field to the N of the monument, although deposition with material used for ground consolidation at gateways cannot be ruled out for some of the sherds.

Plate 2: Sample of pottery from the site

The pottery would appear to derive from standard domestic waste. The fragments of coarse-ware and the single sherd of slipware were almost certainly from Staffordshire. Creamware was at its most popular between c.1770

and the early part of the 19th century, although production continued beyond that date. No pottery of earlier date, such as might have been associated with the medieval-to-early post-medieval hall was seen during the course of the archaeological observation.

None of the pottery was recovered from secure contexts and all postdated the Scheduled Monument. It is not recommended that it be retained.
