## Archaeological Observation

**St Laurence's Church  
Church Stretton  
Shropshire**

NGR: SO 4524 9367

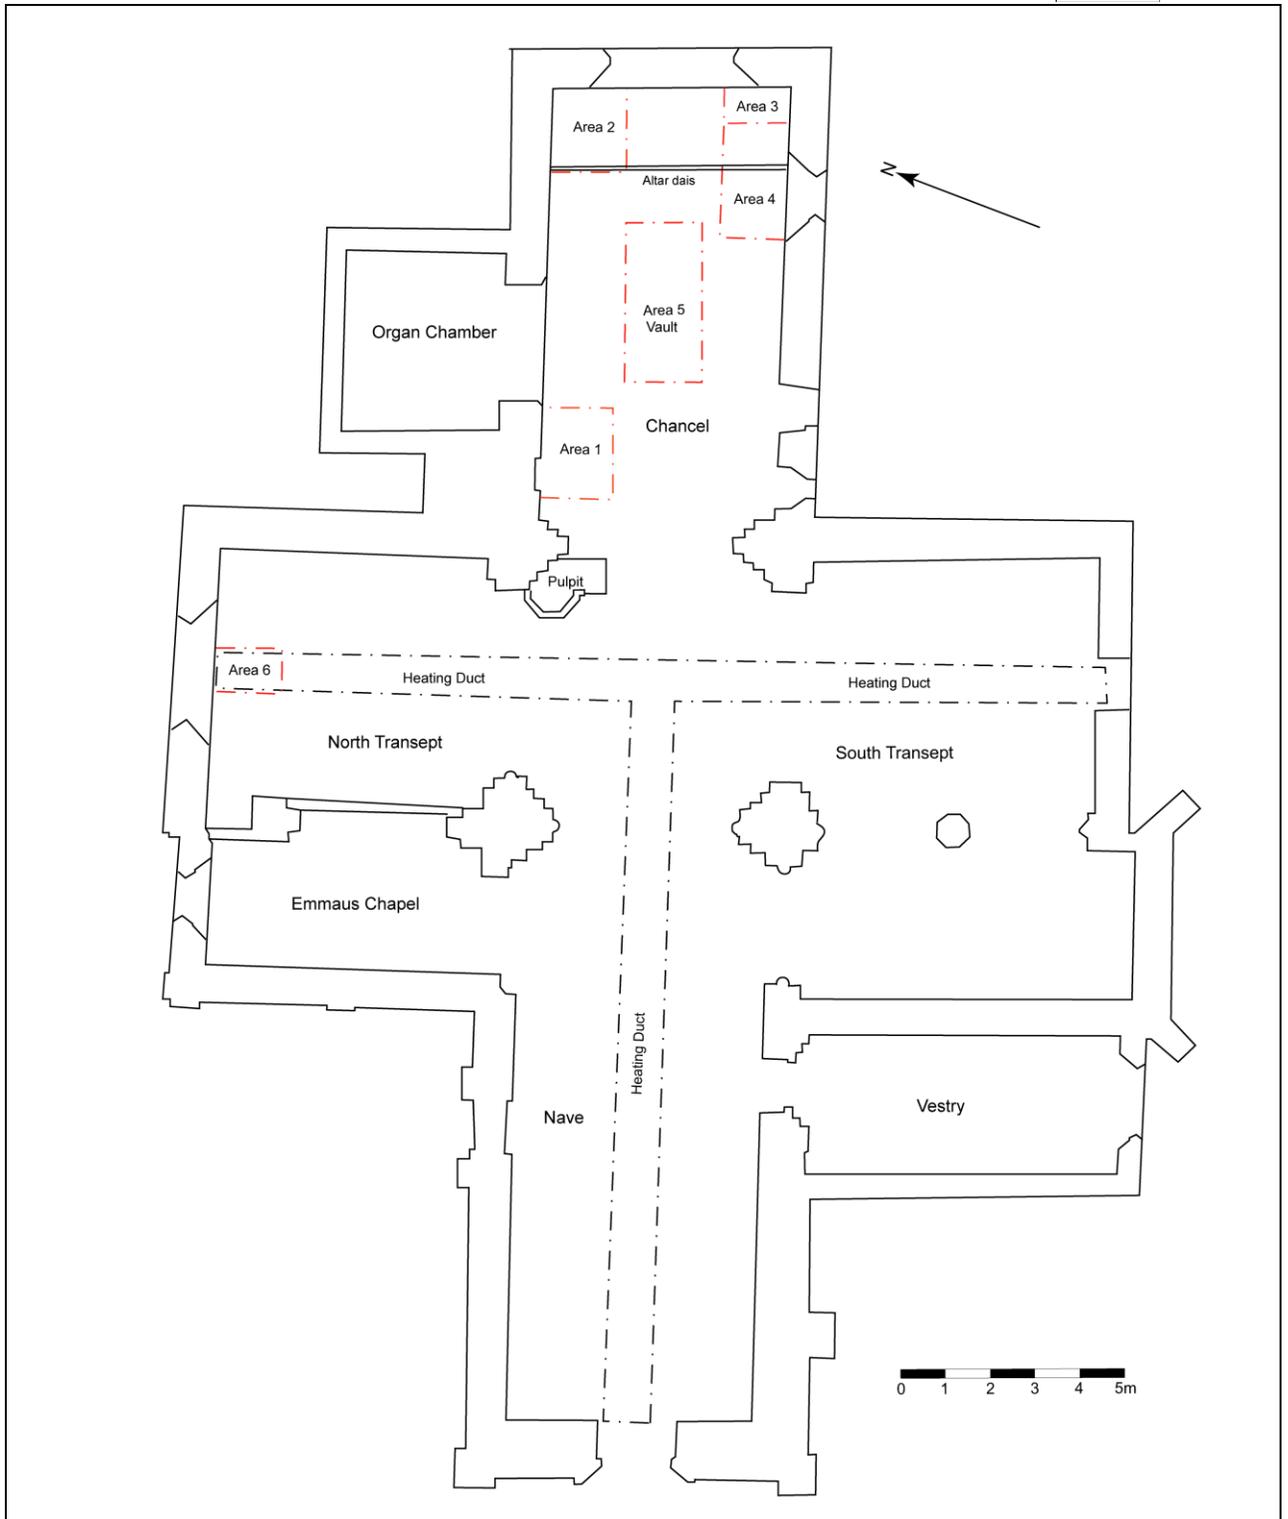
Fig. 2: Plan (Scale 1:100) showing location of concentrations of disarticulated human remains identified during ground reduction works within the church of St Lawrence, Church Stretton

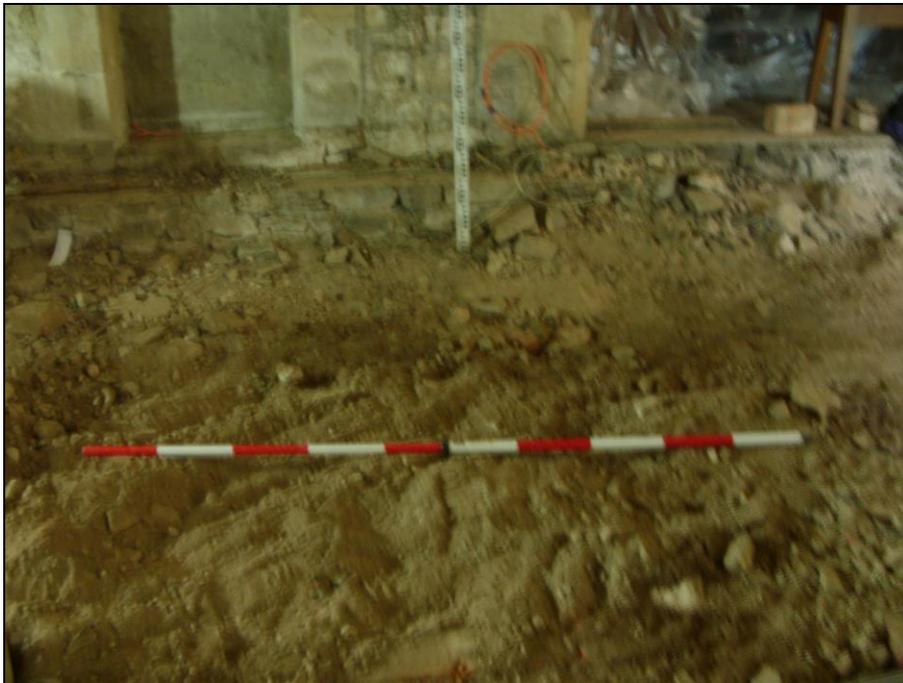
The first area of the Chancel to be reduced, measuring 2m (E-W) × 1.5 m (N-S) × 0.30m was located immediately S of the N wall of the Chancel adjacent to the Pulpit, previously occupied by choir stalls. A total of three contexts were identified within this area, the uppermost consisting of (101), a strongly indurated concrete slab sub-floor surface, measuring 0.05m thick. Underlying this was a layer of greyish mortar (102), about 0.02m thick, with frequent inclusions of gravel, which in turn overlaid a friable light greyish brown gravelly silt (103), approximately 0.20m thick, with frequent mortar inclusions, small to large sized angular, sub-angular and rounded stones and encaustic tile and brick fragments. Contained within this deposit was a moderate scatter of disarticulated human skeletal remains, which included one partially complete skull and 15 smaller skull fragments.

Plate 2: View looking N showing reduction of floor level in area of former choir stalls, adjacent to the N wall of the Chancel

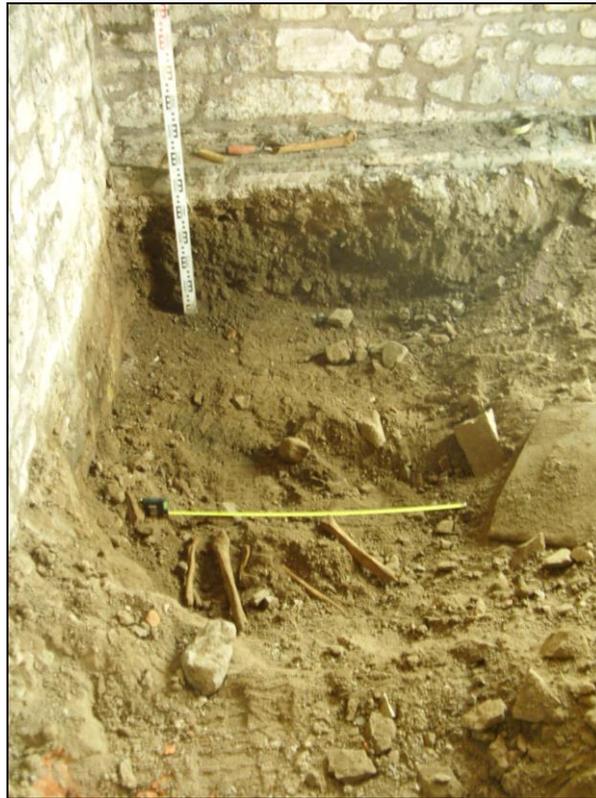
At the W end of Area 2, immediately underlying the mortar sub-base for the concrete floor surface, a low brick wall (105) was identified, consisting of two courses of unfrosted red bricks (105) bonded with a coarse greyish white mortar, extending N-S across the Chancel, which appeared to represent a raised dais upon which the altar was situated. Also contained within this deposit were a significant quantity of disarticulated human skeletal remains, consisting of two partially complete skulls and numerous other fragments, including a partially intact pelvis and several tibia and femur fragments. No evidence of a grave cut was identified; however the grouping of the remains suggested deliberate deposition rather than a random scatter.

Plate 3: View looking E showing disarticulated human remains as found in the NE corner of the Chancel following reduction of ground levels.

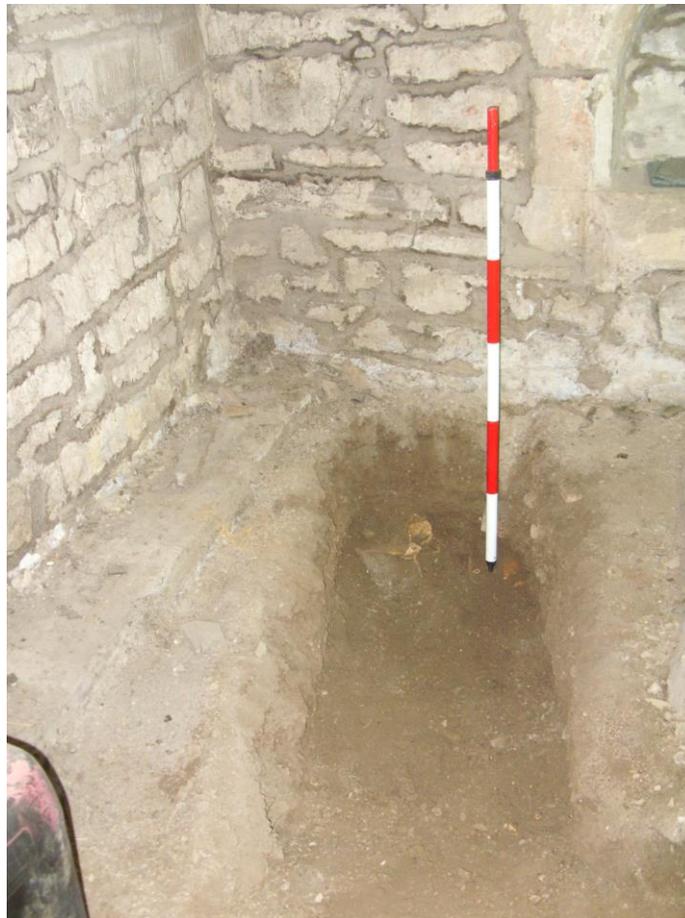
Underlying (103) was a firmly compacted dark greyish brown sandy silt deposit (104) with frequent mortar inclusions, fragments of tile and small to large sub angular stones, extending to a depth of 0.25m, together with a concentration of disarticulated human skeletal remains, including several pelvis and rib fragments and an intact tibia and fibia. The remains of what appeared to be a partially disarticulated skeleton were revealed in the N facing section of the trench at a depth of 0.35m, however no discernable grave cut was identified.

Plate 4: View looking S showing partially disarticulated skeletal remains identified in section extending beneath S wall of Chancel

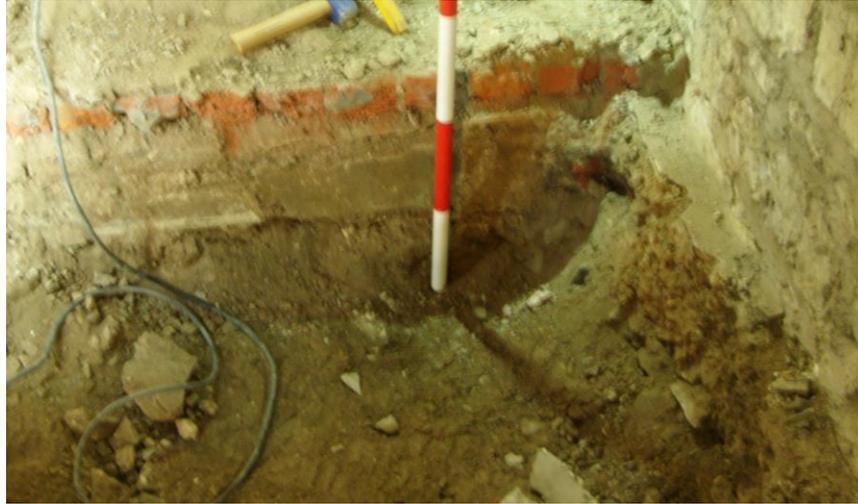
Plate 5: View looking E showing dais wall (105) overlying gravel make-up deposit (103) and sandy silt deposit (104)

Within this area, measuring 2.5m (E-W) × 1.8m (N-S) and located against the S wall of the Chancel the ground level was reduced by approximately 0.50m. Immediately beneath mortar deposit (102) underlying the existing concrete sub-floor (101), a low brick wall was identified (105) identical to that encountered in Area 2, its visible dimensions measuring 1.8m (N-S) × 0.20m (E-W) × 0.15m depth, comprising two courses of unfrosted red bricks extending N-S across the Chancel, which appeared to represent a raised dais upon which the altar was situated.

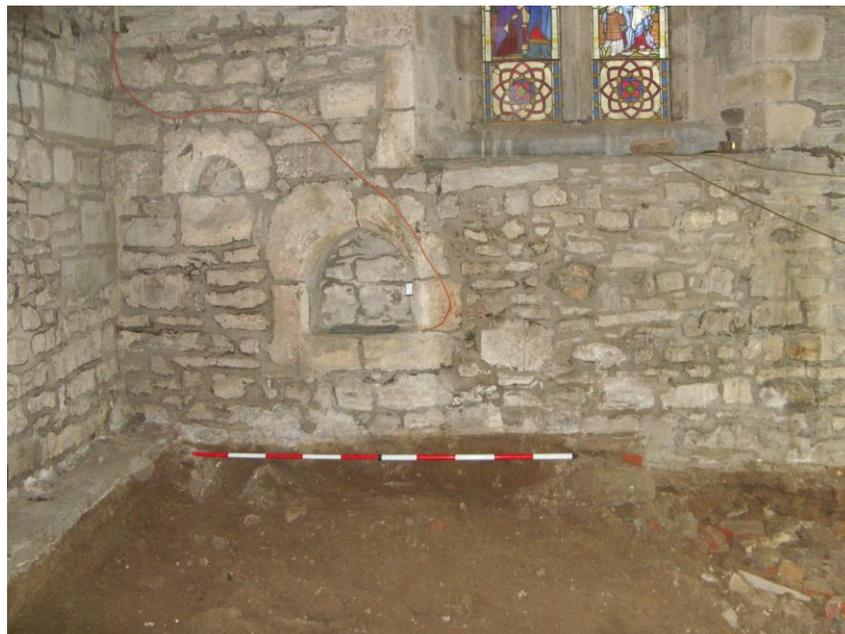
Plate 6: View looking S showing S wall of Chancel and reduction of ground level following demolition of dais wall (105) visible to right of scale

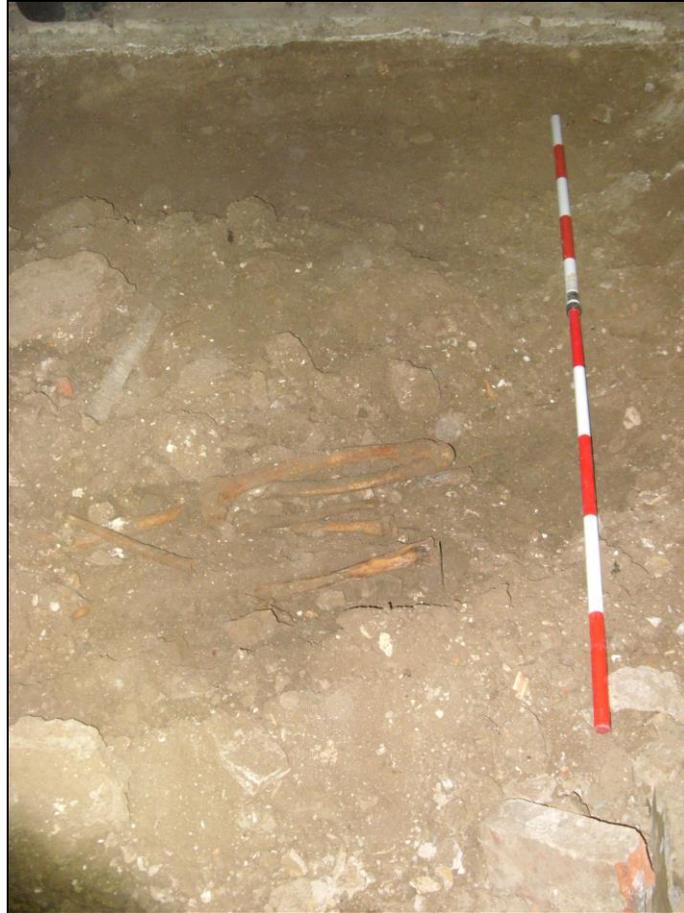
Plate 7: View looking E towards the E end of the Chancel showing a significant concentration of disarticulated skeletal fragments adjacent to the S wall (visible in foreground)

Underlying the brick wall was a friable light greyish brown gravel make-up deposit (103) with frequent mortar inclusions, small to large sized angular, sub-angular and rounded stones and tile and brick fragments, approximately 0.10m thick which in turn overlaid (104) a well compacted dark greyish brown sandy silt deposit with frequent mortar inclusions, fragments of tile and small to large sub angular stones. Following the removal of brick wall (105) and reduction of the ground level immediately to the W, along the S side of the Chancel, two significant concentrations of disarticulated human skeletal remains were identified, contained within (104) at a depth of between 0.30-0.50m.

These appeared to represent the remains of several individuals and included a partially intact skull, several intact ulna, fibula and tibia bones, femur fragments and a large pelvis fragment. Although the remains were disarticulated they appeared to have been deliberately deposited in two groups, one roughly located beneath the raised step or dais, while the other was located approximately 0.50m W of the first group, immediately adjacent to the S wall of the Chancel. Other pieces of coffin furniture were also identified in association with these remains, specifically heavily corroded Fe coffin nails.

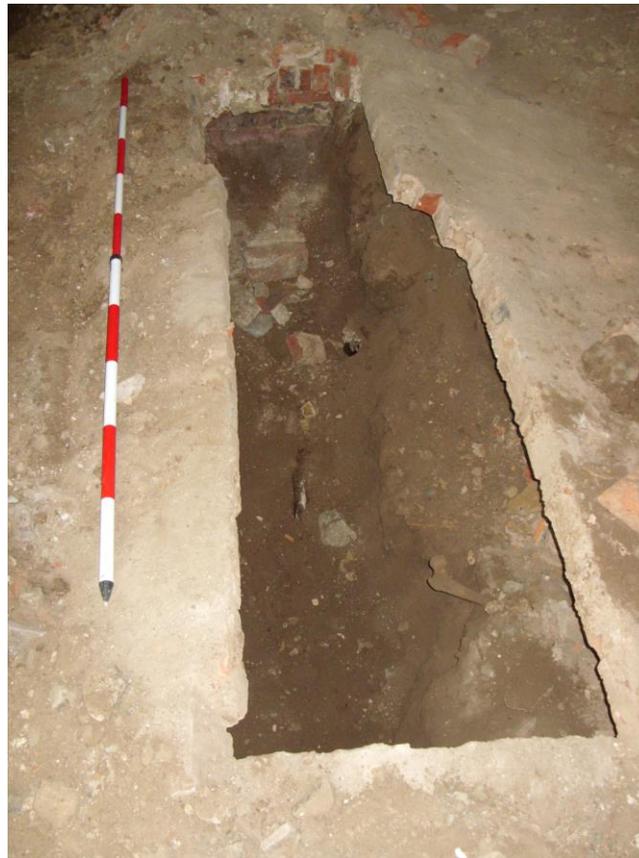
In the course of reducing the ground levels in the centre of the Chancel, the remains of a substantial red brick, barrel vaulted chamber were uncovered, immediately beneath the mortar sub-base (1002) underlying the existing concrete slab sub-floor (1001). The bricks were unfrogged (average measurement 0.25m × 0.12m × 0.10m), laid in an irregular Flemish bond and bonded with a coarse greyish white mortar. The visible dimensions of the vault (1003) measured 3.5m (E-W) × 1.7m (N-S) × 0.70m (at least eight courses of brick were visible); with evidence of a segmental arched opening at the W end of the chamber.

The full extent of the vault could not be ascertained due to the fact that it had been partially filled in; the backfill deposit (1005) consisted of a firmly compacted dark greyish brown sandy silt (similar to (104) encountered in Areas 2-4) with frequent CBM and mortar flecking, occasional, heavily corroded Fe coffin nails and Cu alloy handles and very occasional blue and yellow glazed pottery sherds (which appeared to be mid to late 19<sup>th</sup> century in date). Remains of lead sheeting (presumably representing lining for the coffins) were identified towards the base of the excavation but not removed. Towards the W end of the vault, there appeared to be a void beneath the backfill material however the maximum depth of the vault was not ascertained.

Plate 8: View looking W showing brick barrel vault revealed following removal of concrete flooring in centre of Chancel

A significant quantity of disarticulated human remains was identified within this backfill material, which appeared to represent the remains of several individuals. Two separate concentrations of human remains were also identified on the N and S sides of the vault, which may have constituted the remains of two distinct individuals although the remains were again heavily disarticulated. It was evident that the vault had been heavily disturbed and had been subsequently backfilled, probably during the Victorian restoration of the church (due to the occurrence of mid to late 19<sup>th</sup> century pottery within the backfill material).

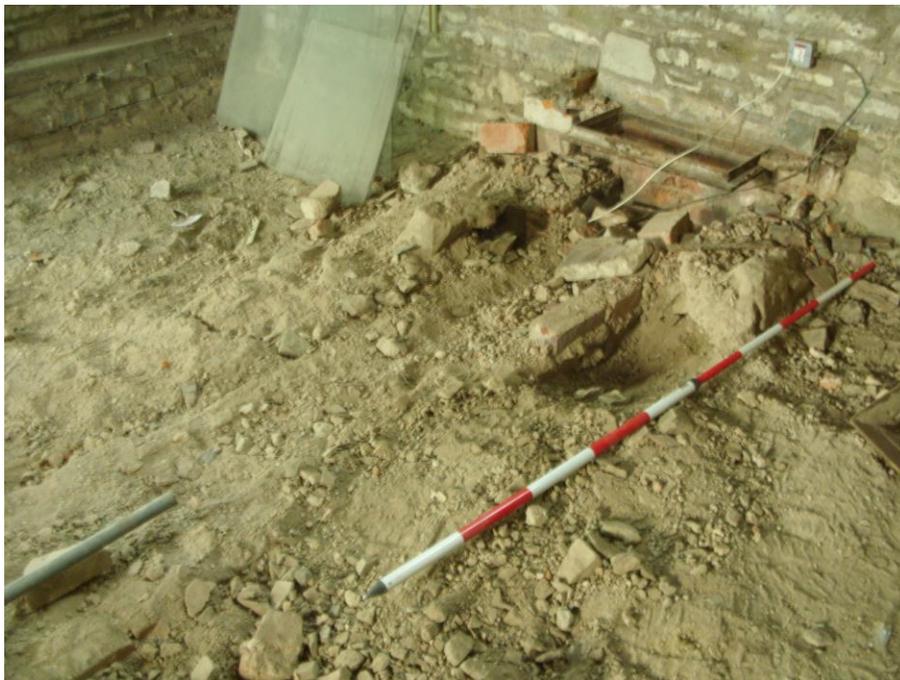
Plate 9: View looking NW showing location of skeletal remains adjacent to N wall of the North Transept, disturbed by 19<sup>th</sup> century brick heating duct

Contained within (003) at a depth of approximately 0.22m and partially disturbed by the cut for the heating duct [004] was a concentration of disarticulated human remains, located centrally against the N wall of the North Transept, within an area roughly measuring 1.5m (N-S) × 1.0m (E-W). The remains found appeared to belong to more than one individual; although there was no visible evidence of a grave cut, the grouping of the remains suggested that they had been deliberately deposited in that location. A small number of heavily corroded Fe coffin nails were found in association with these remains.

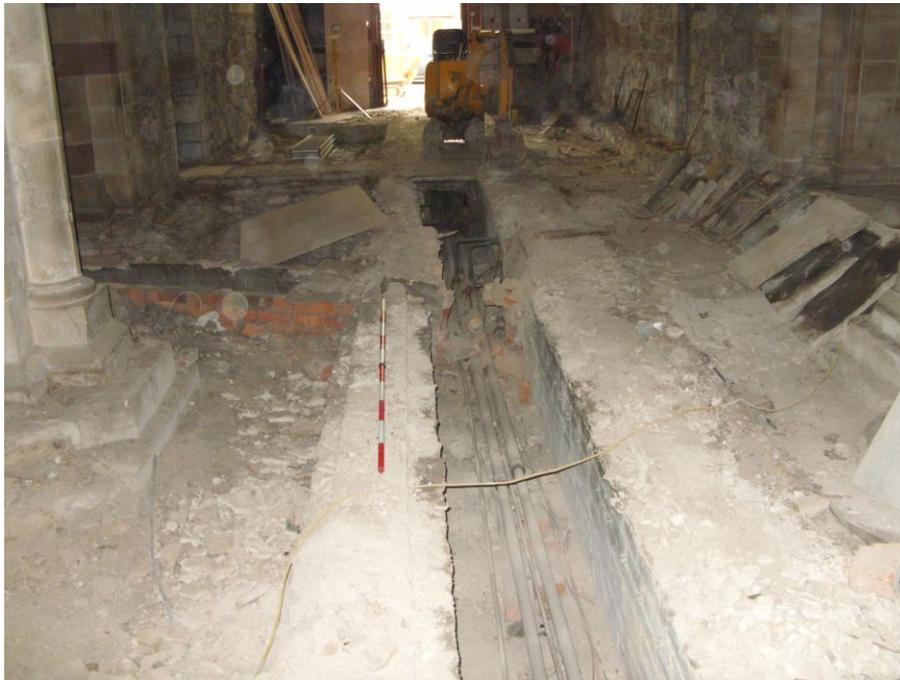
The final phase of groundworks, undertaken on 28<sup>th</sup>-29<sup>th</sup> January, comprised the removal of the low brick walling of the heating duct running axially E-W through the centre of the Nave. No evidence was revealed of human skeletal remains or other deposits, finds or features of archaeological importance during this phase of activity.

Plate 10: View looking W showing 19<sup>th</sup> century heating ducts in Nave following removal of concrete flooring
