Archaeological Observation

Muchelney Abbey

April 2015

BA1510MAS

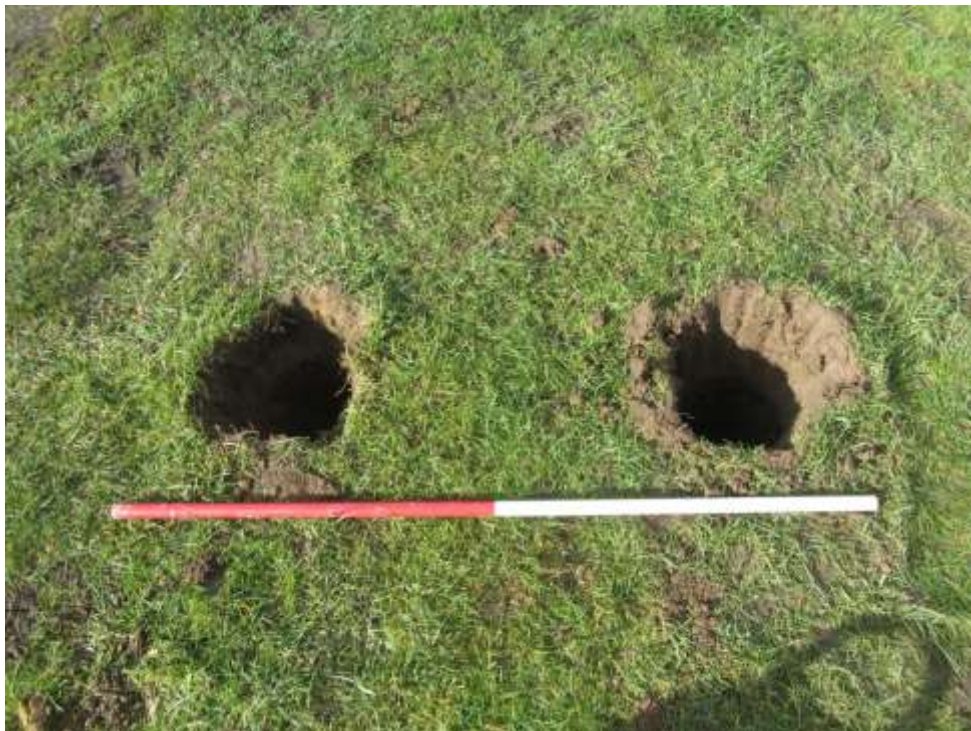
Plate 1: View NW showing postholes for signage

Topsoil 0.15m sandy-silt subsoil 0.10m overlying steel wire foundation grid, which in turn overlay sandy-silt containing frequent gravel/small stone inclusions (modern manmade ground – car park foundation)

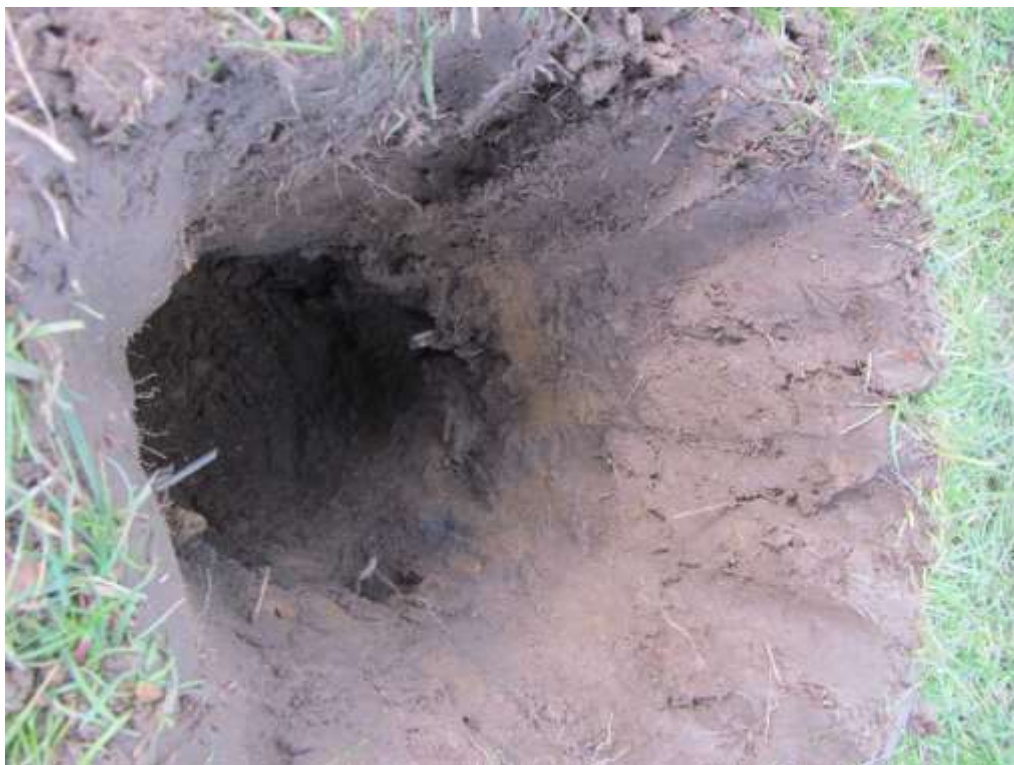
Plate 2: View showing hole fully excavated

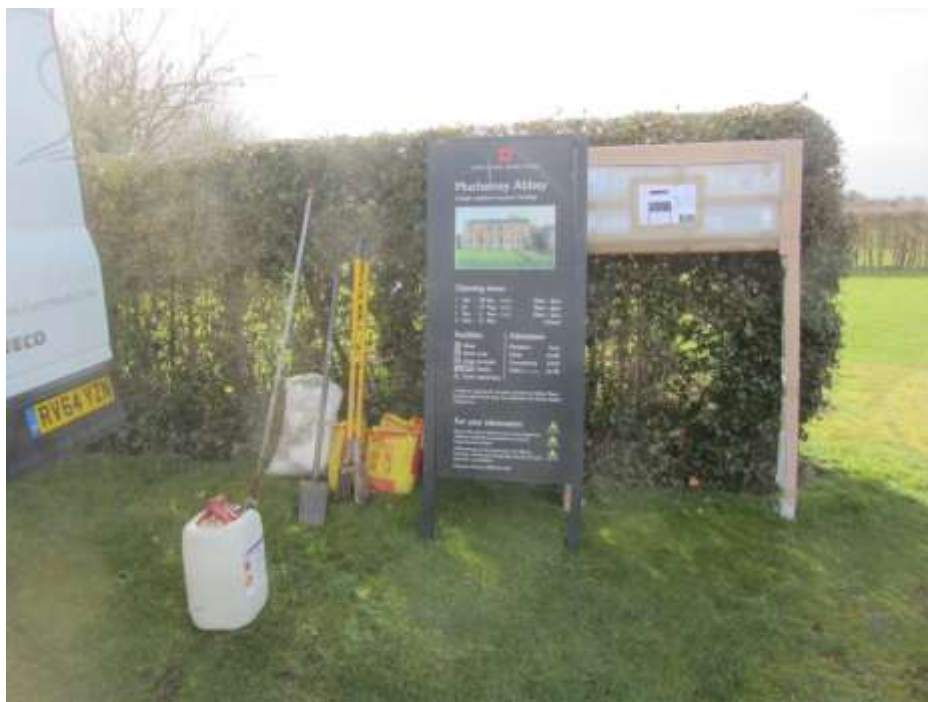
The existing 'Guardianship' panel was to the left of the opening in the hedge: the new panel was relocated to the right of the opening.

Plate 3: View S showing original signage prior to removal

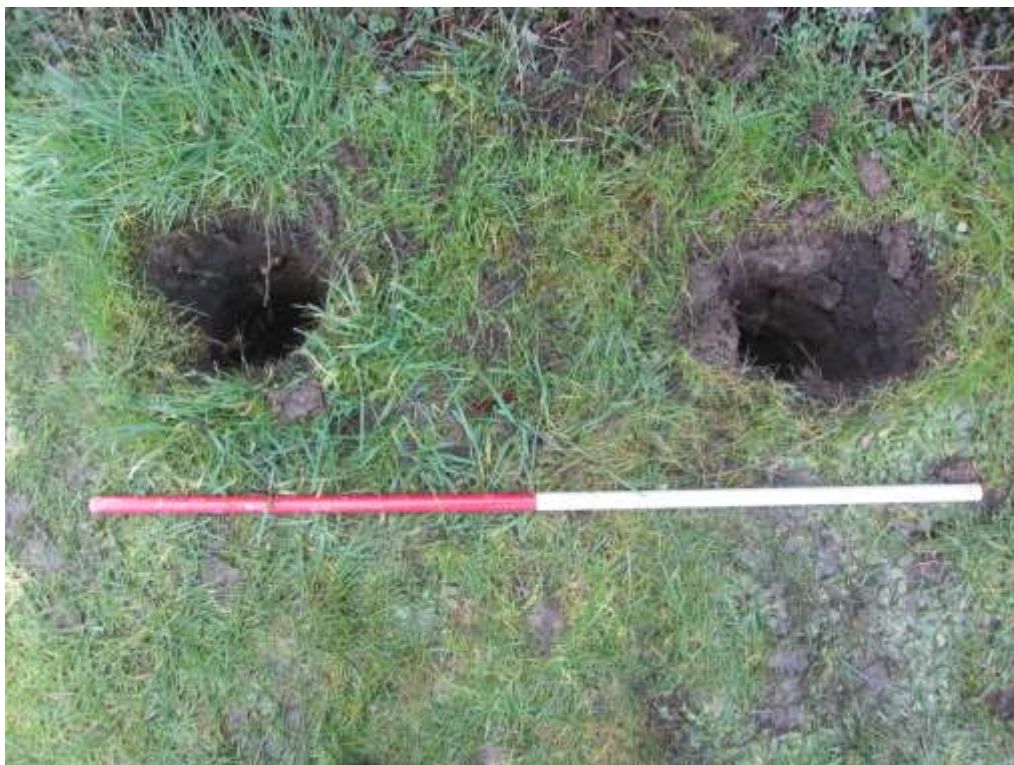
Plate 4: View S showing old sign removed

The holes for these posts (*Plates 4 & 5*) were 220mm (width) × 440mm (depth) (left) and 230mm (width) × 420mm (depth) (right). The first of these (left) revealed topsoil to a depth of 100mm, below which was mid brown clayey silt subsoil containing sand and small stones. The second hole (right) similarly revealed topsoil to a depth of 120mm with subsoil beneath, the composition of which was as that described above but with rare fragments of natural stone.

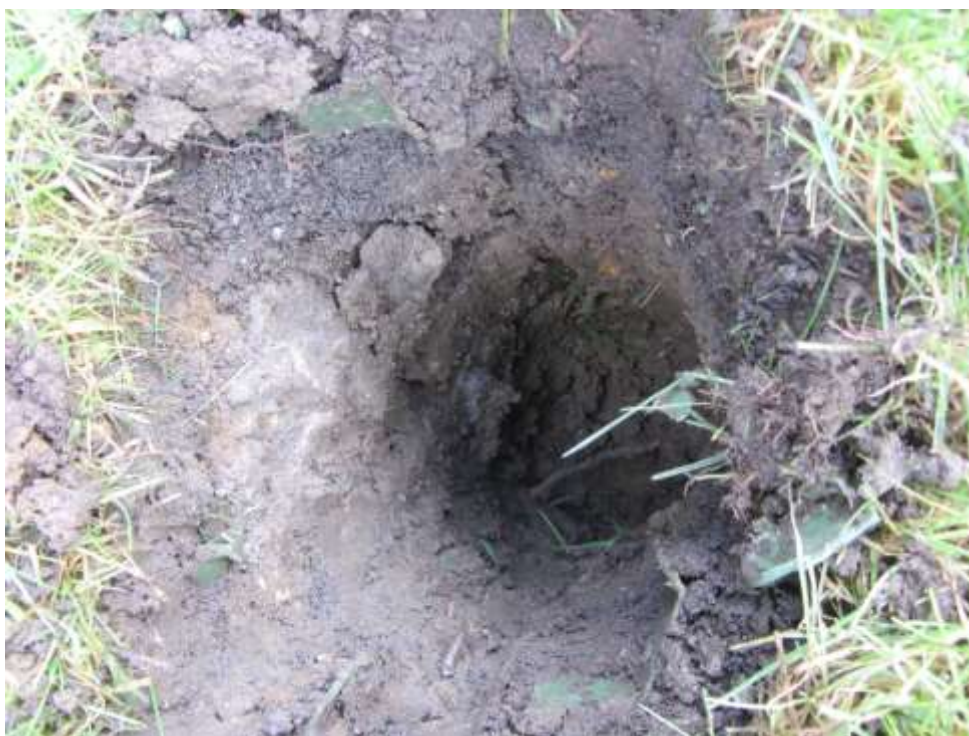
Plate 5: View S showing posthole (right)

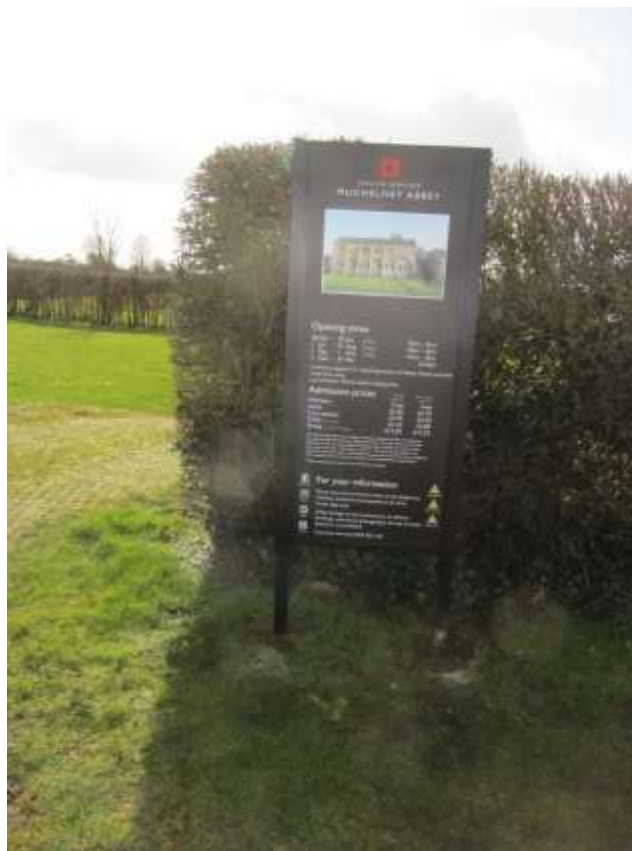
Plate 6: New signage in place

The new panel measured 1800mm (height) × 600mm (width). The existing sign was removed manually.

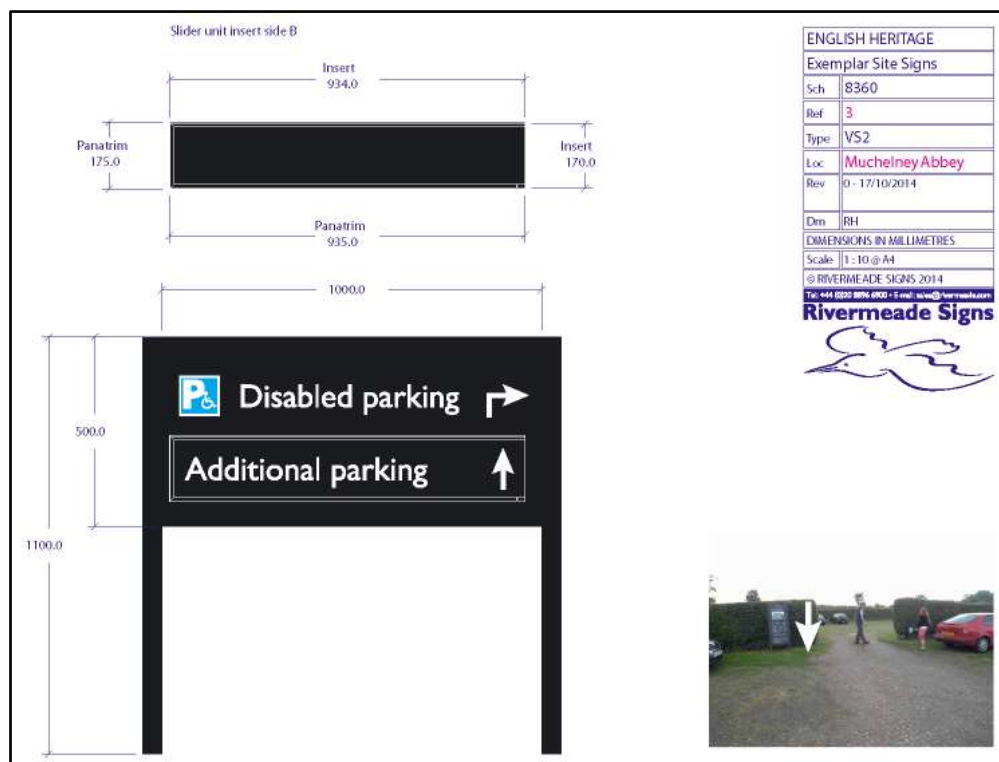
Fig.3: Illustration showing dimensions & location of signage

The existing 'Guardianship' panel was removed and replaced with a directional parking sign.

The new directional parking panel measured 1100mm (height) × 1000mm (width). The existing signage was removed manually and new sign inserted.

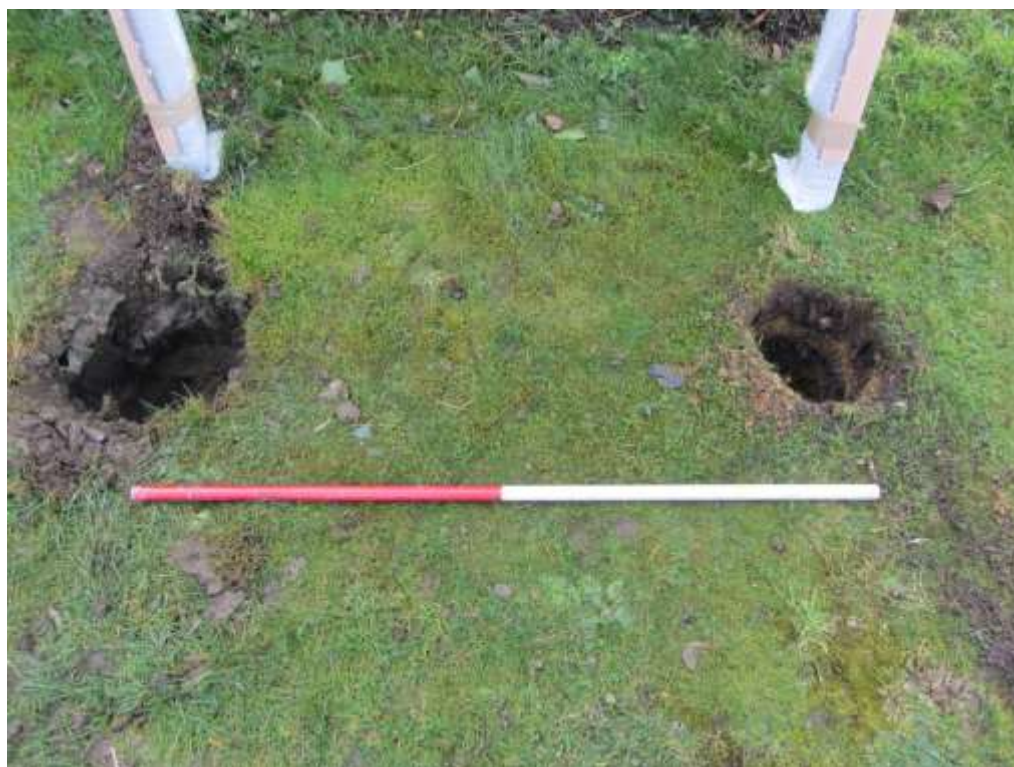
Plate 7: View S showing excavated holes

The holes for these posts (*Plates 7-9*) were 230mm (width) × 440mm (depth) (left) and 200mm (width) × 410mm (depth) (right). The first of these (left) revealed only made ground; the second hole (right) revealed topsoil to a depth of 100mm and 40mm of sand overlying 'terram', beneath which was a subsoil deposit some 270mm in thickness extending to the base of the cut.

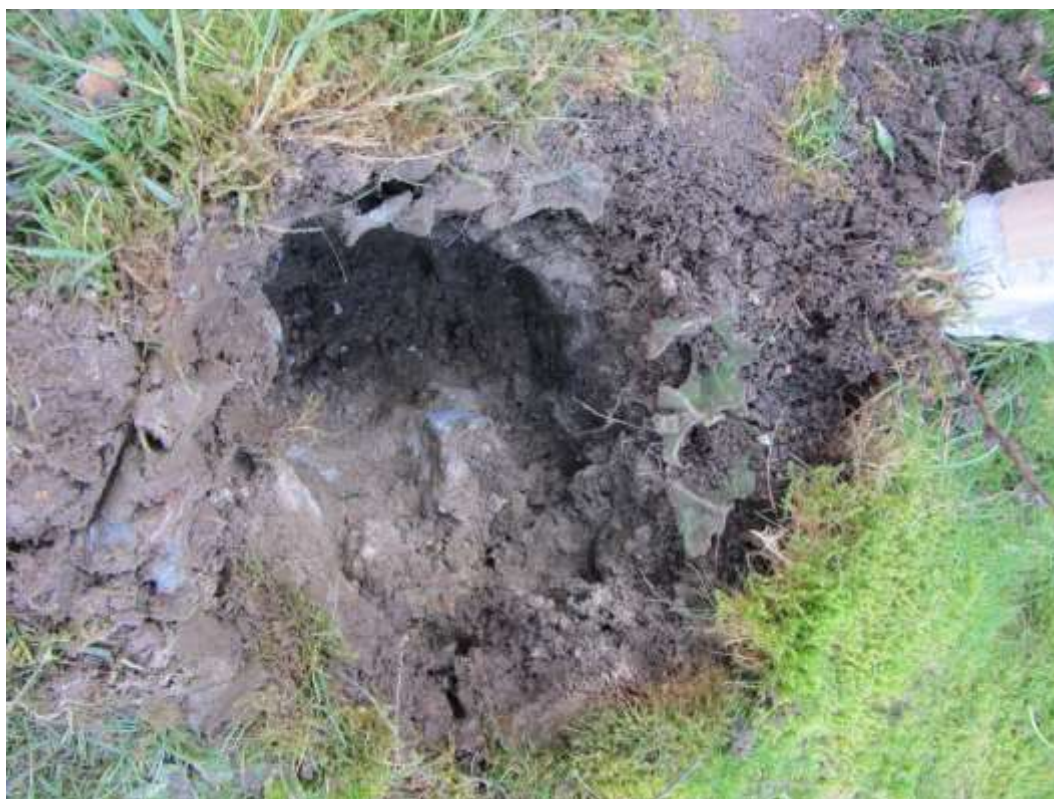
Plate 8: Left hole shown cut into made ground

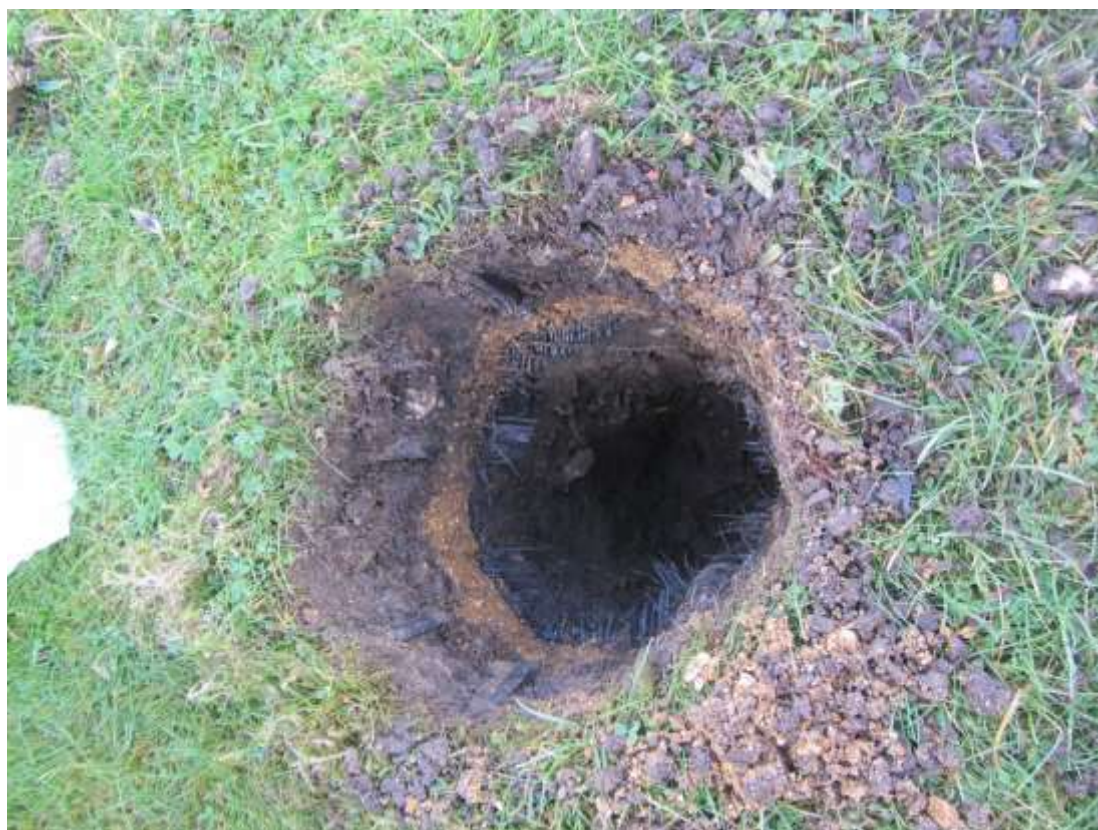
Plate 9: Right hole shown dug into made ground

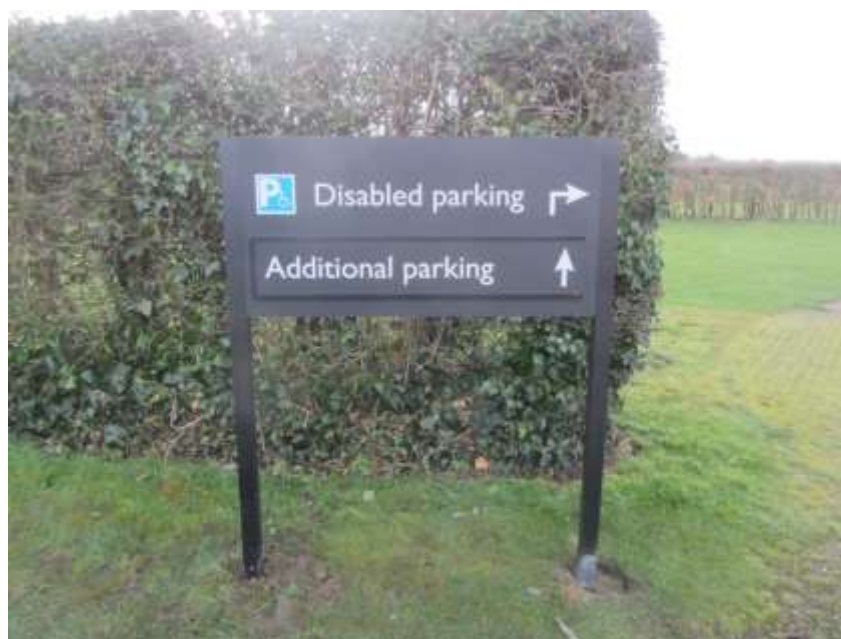
Plate 10: View S showing new signage in situ

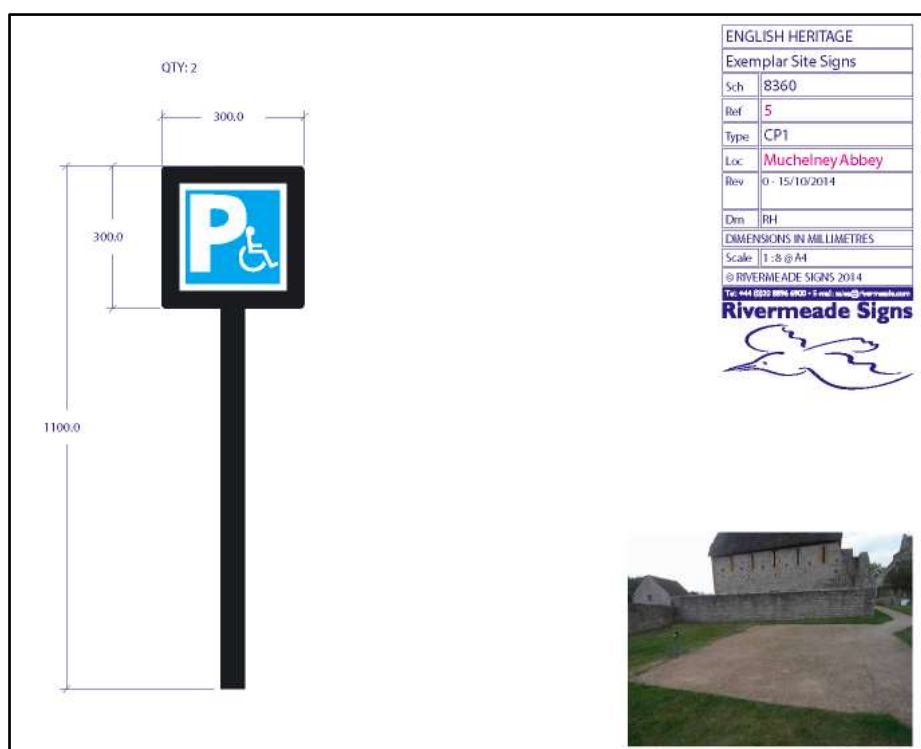
Fig. 4: Illustration showing dimensions & location of signage

Existing posts relating to the disabled parking signs were removed and new posts installed.

The new disabled parking panel measured 1100mm (height) × 300mm (width). Existing signs were removed manually and the new signs set into the same holes.

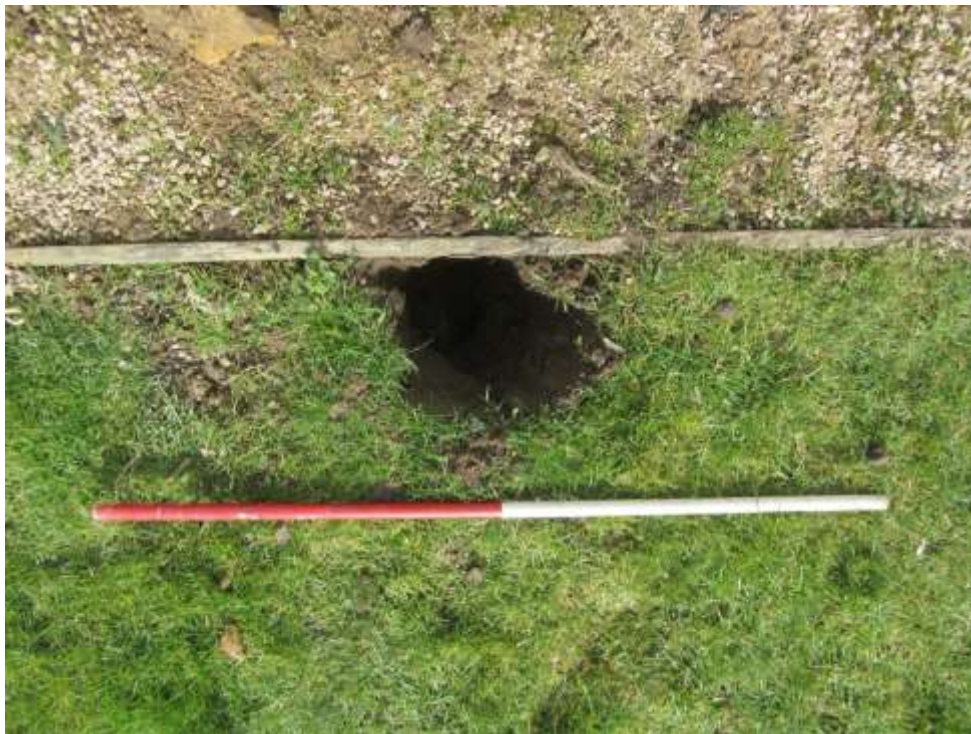
Plate 11: View N showing E sign removed

The holes for these posts (*Plates 11-13*) were 180mm (width) × 440mm (depth) (left) and 200mm (width) × 510mm (depth) (right). The first of these (left) revealed topsoil to a depth of 100mm underlying which to the base of the cut was a silty clay subsoil containing five small to medium -sized fragments of blue lias. The second hole (right) revealed topsoil to a depth of 100mm beneath which was a silty clay subsoil with occasional fragments of natural Ham stone and blue lias extending to a depth of 410mm.

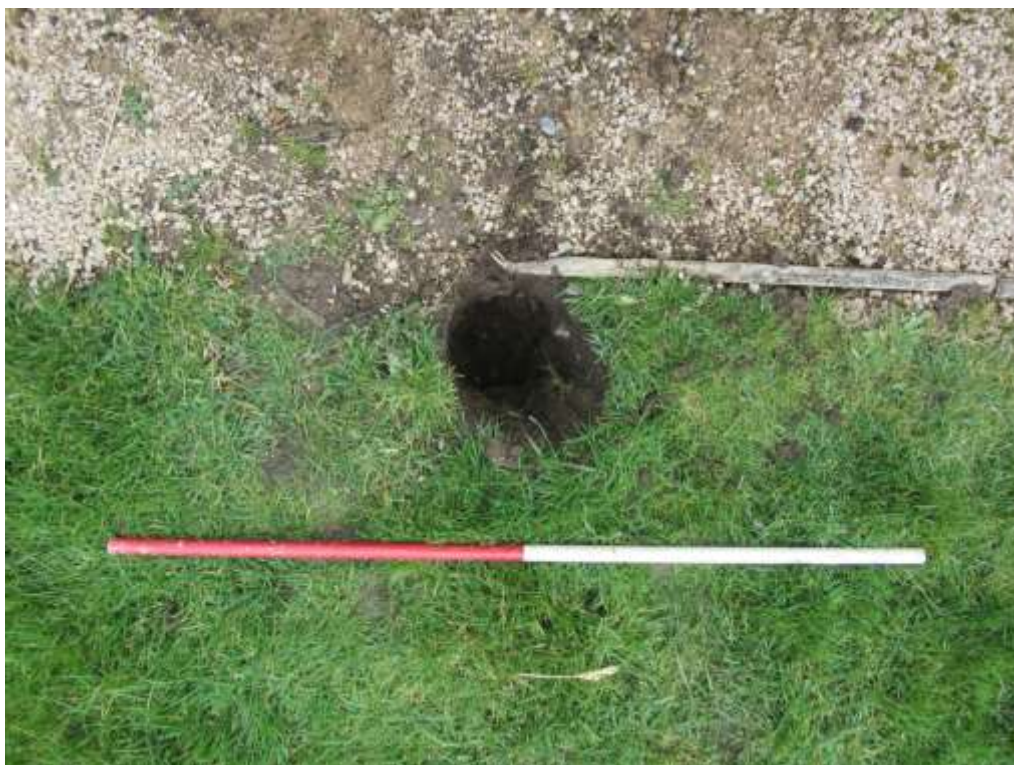
Plate 12: View S showing W sign removed

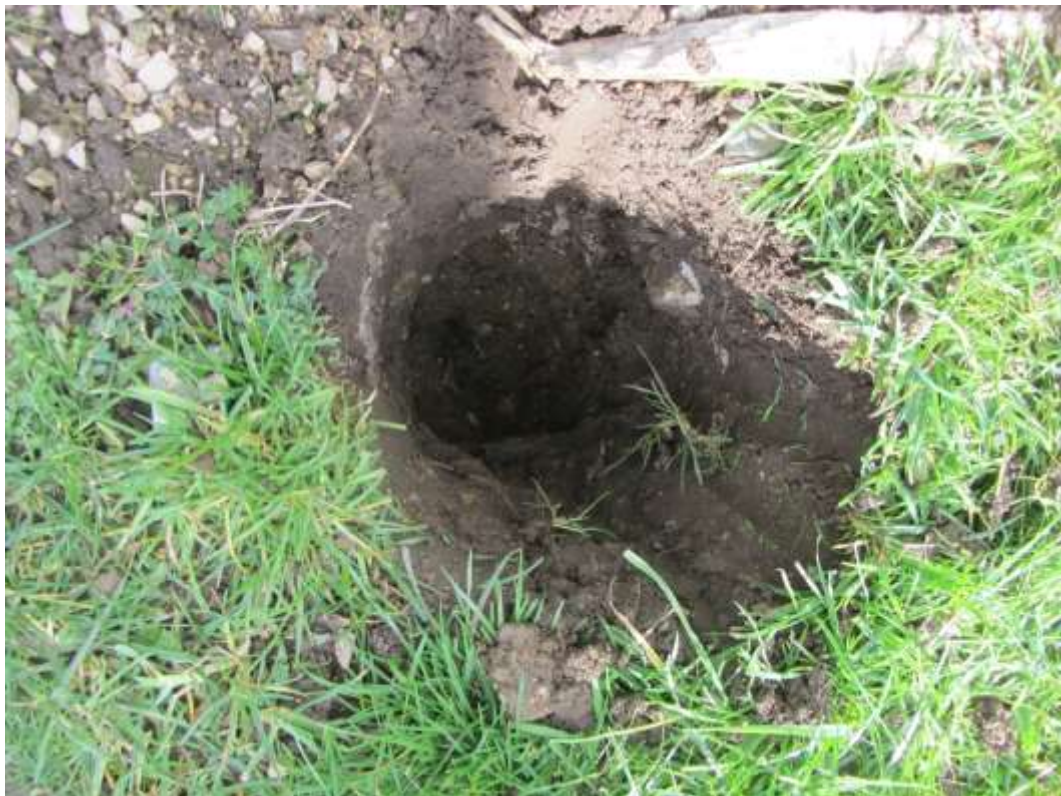
Plate 13: View showing deposits revealed

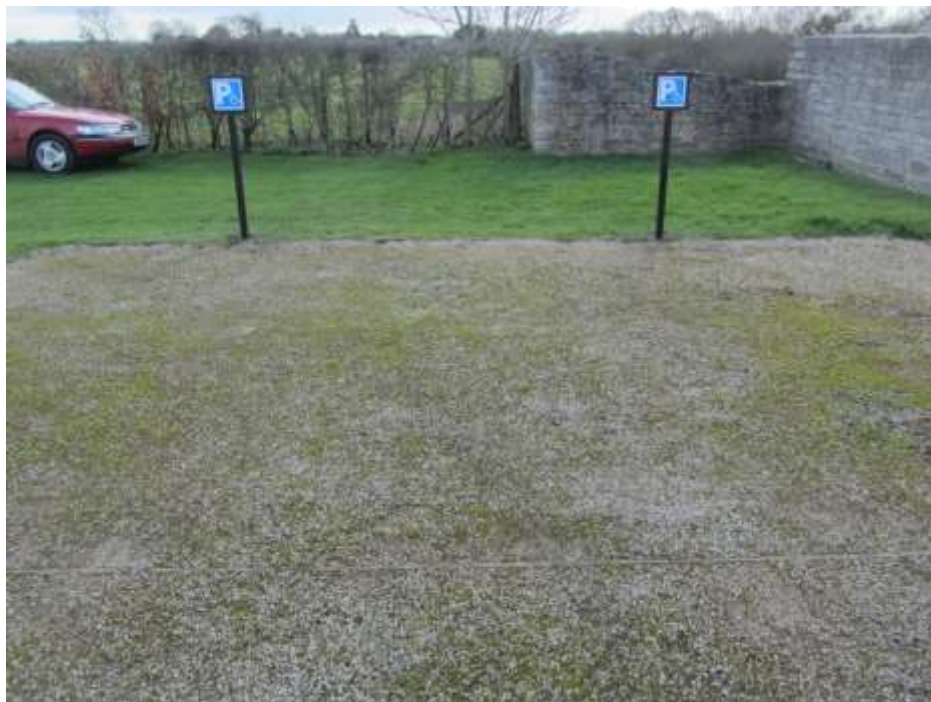
Plate 14: View S showing new signage in place – W sign on right, E sign on left of picture

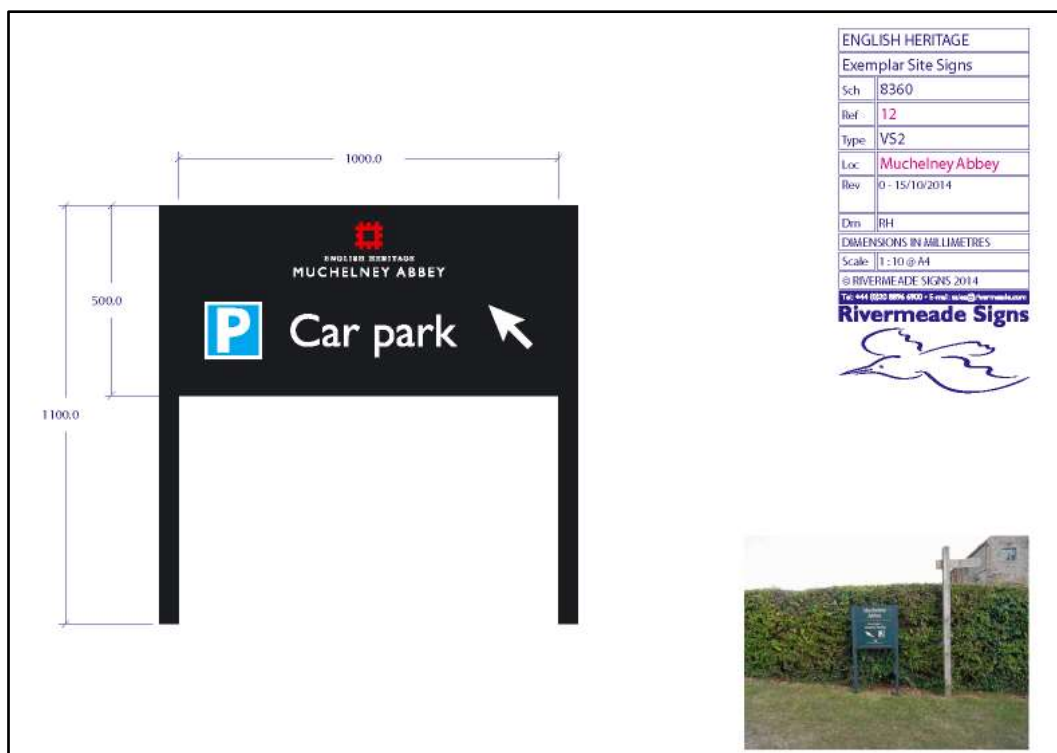
Fig. 6: Illustration showing dimensions & location of signage

The existing panel was removed and replaced with the new branded panel.

The new car park directional panel measured 1100mm (height) × 1000mm (width). The existing sign was removed manually and the new sign set into one of the same holes.

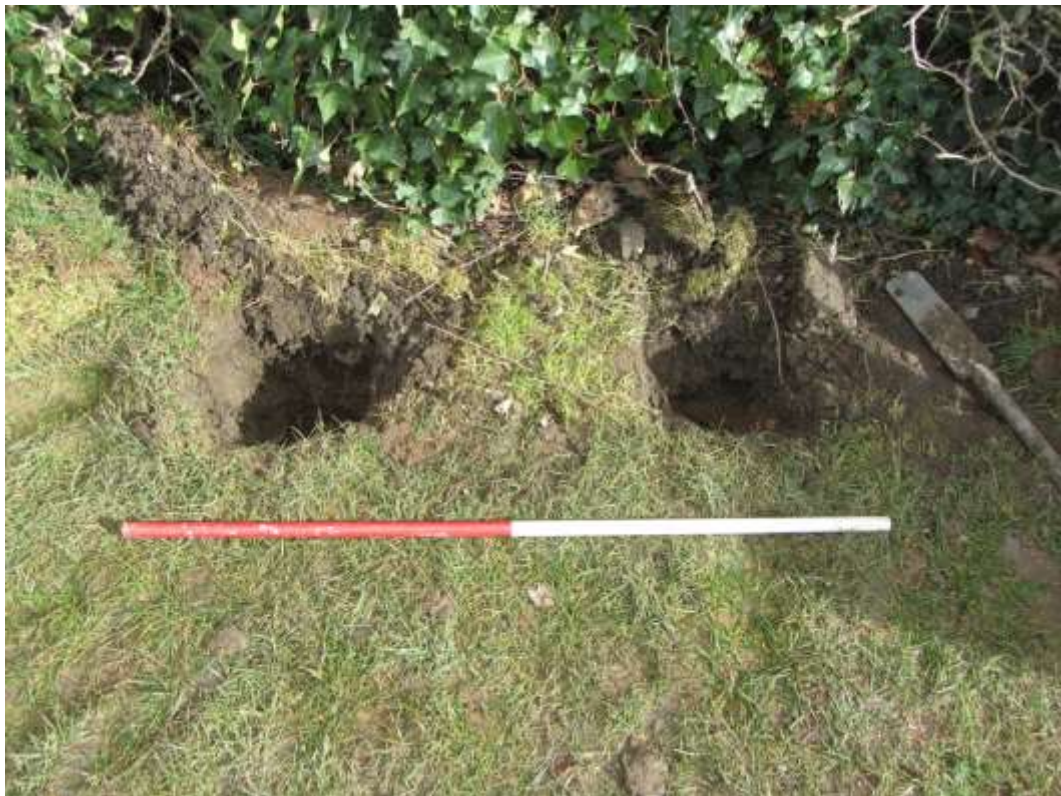
Plate 16: View E of sign removed

The holes for these posts (*Plate 16*) were 210mm (width) × 440mm (depth) (left) and 250mm (width) × 450mm (depth) (right). The first of these (left) revealed made ground (the result of 2014-15 flood reparation works) to a thickness of 150mm above a 100mm –thick topsoil, which in turn overlay concrete to a thickness of 190mm. The second hole revealed made ground to the base of the holes with 0.40m of modern topsoil.

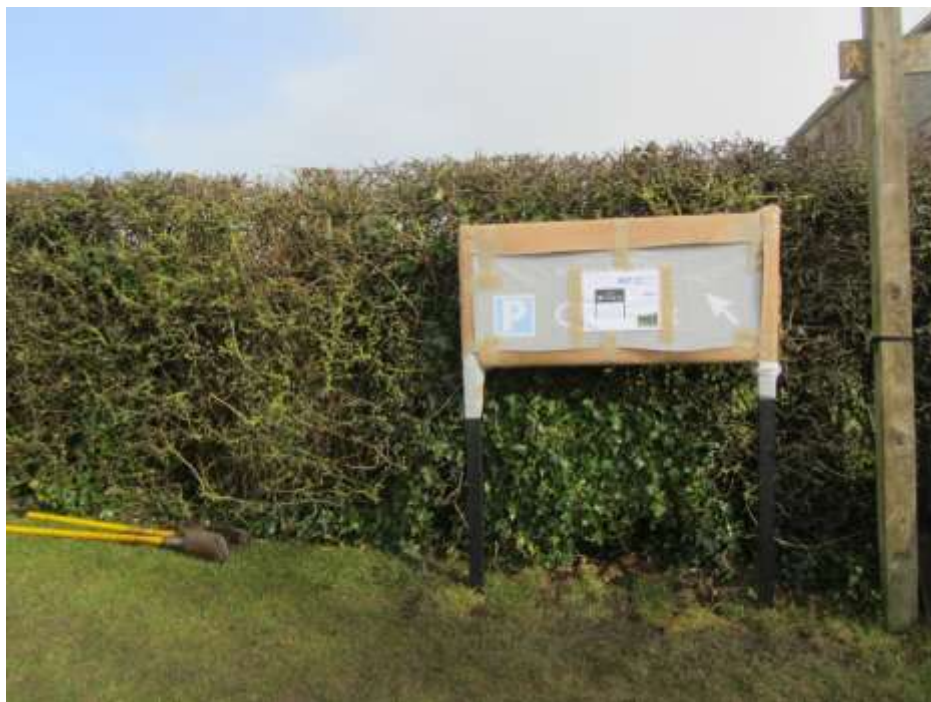
Plate 17: View E of new sign

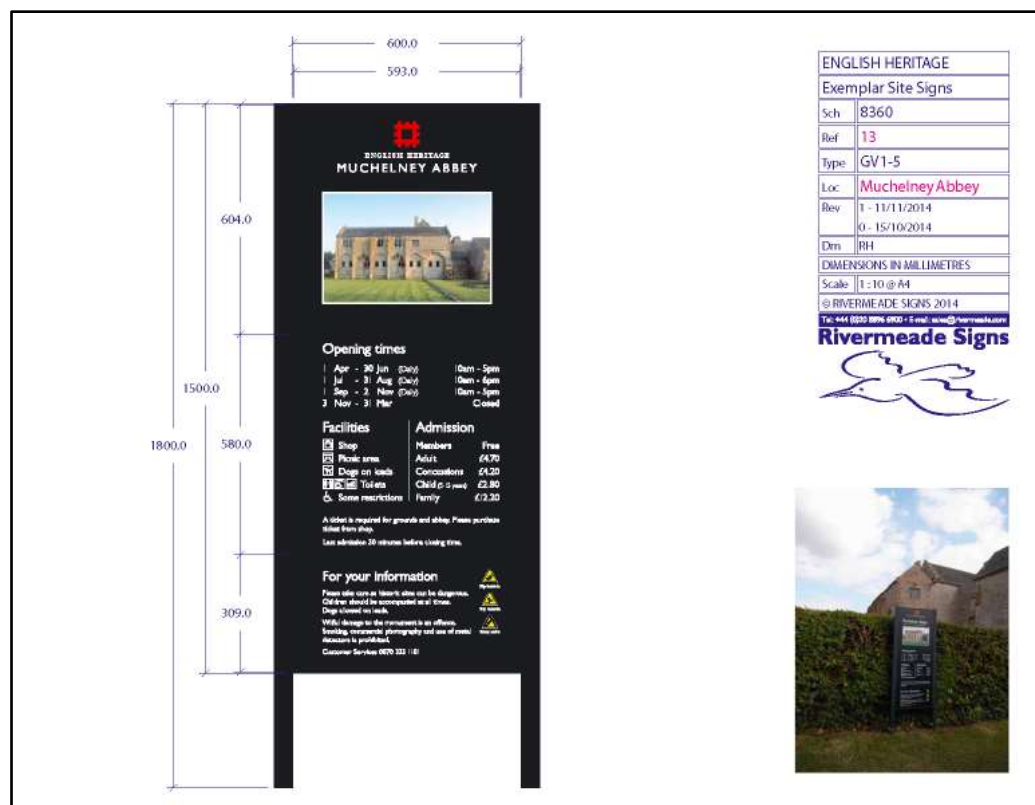
Fig. 7: Illustration showing dimensions & location of signage

The existing 'Guardianship' panel was removed and replaced with the new branded panel.

The new 'Guardianship' panel measured 1800mm (height) × 600mm (width).

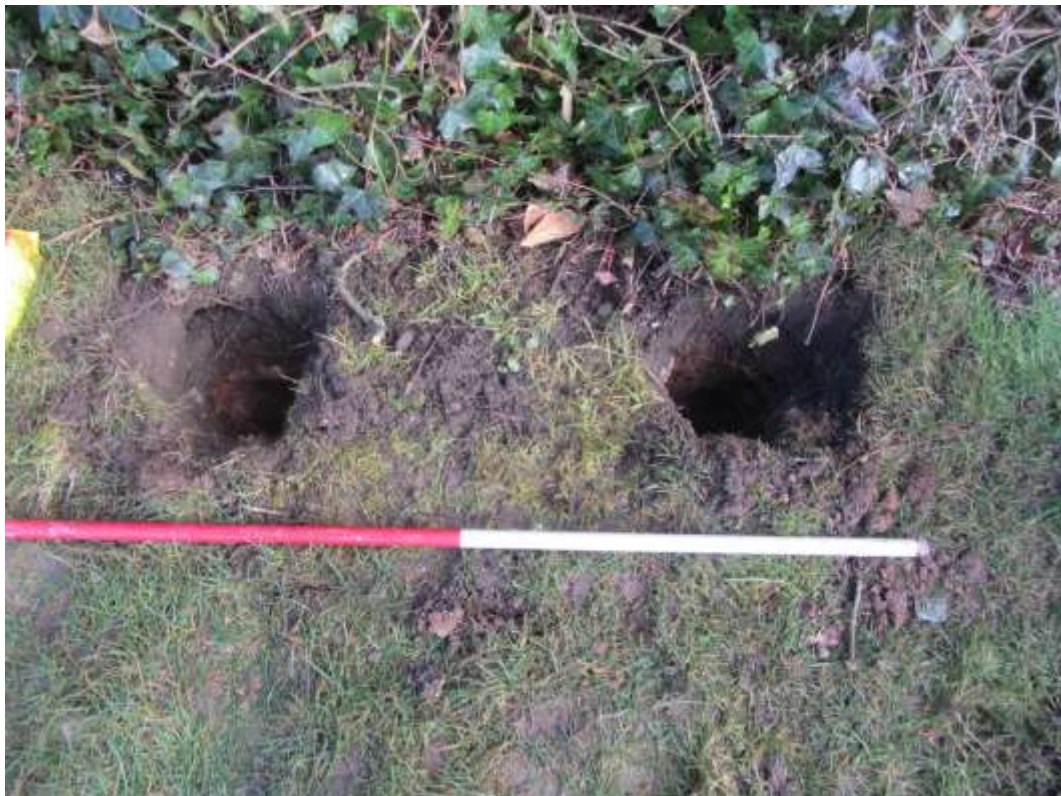
Plate 18: View E showing old sign removed

The holes for these posts (*Plate 18*) were 310mm (width) × 440mm (depth) (left) and 250mm (width) × 440mm (depth) (right). Recent made ground (the result of 2014-15 flood reparation works) was revealed to the full depth of the holes.

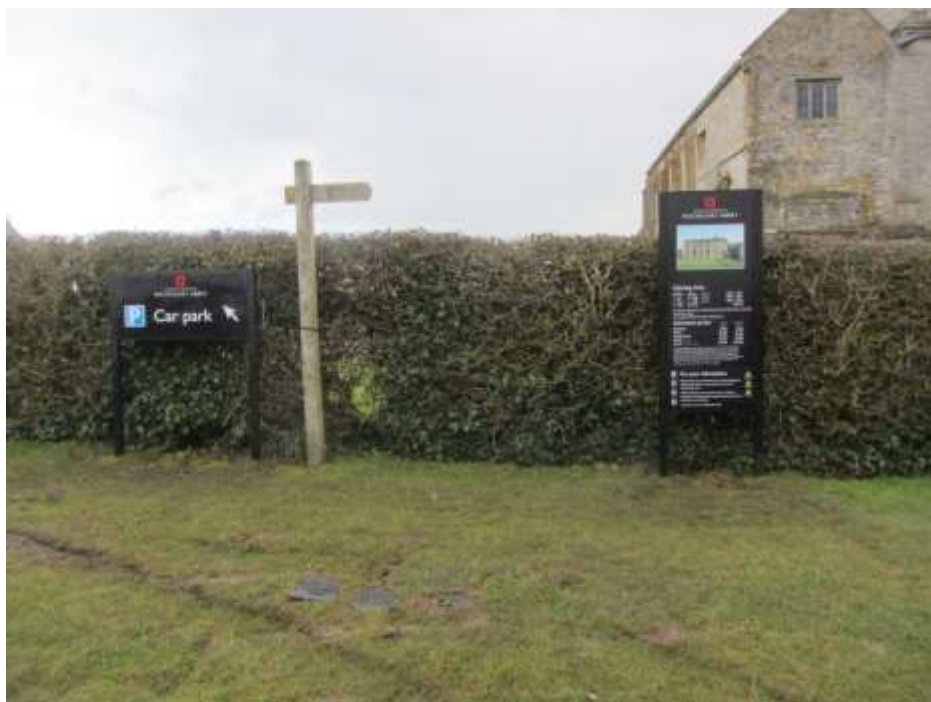
Plate 19: View E new signs in situ
