Archaeological Observation

**Water Pipeline Replacement
Works
Rainbow Hill
Worcester**

July 2016

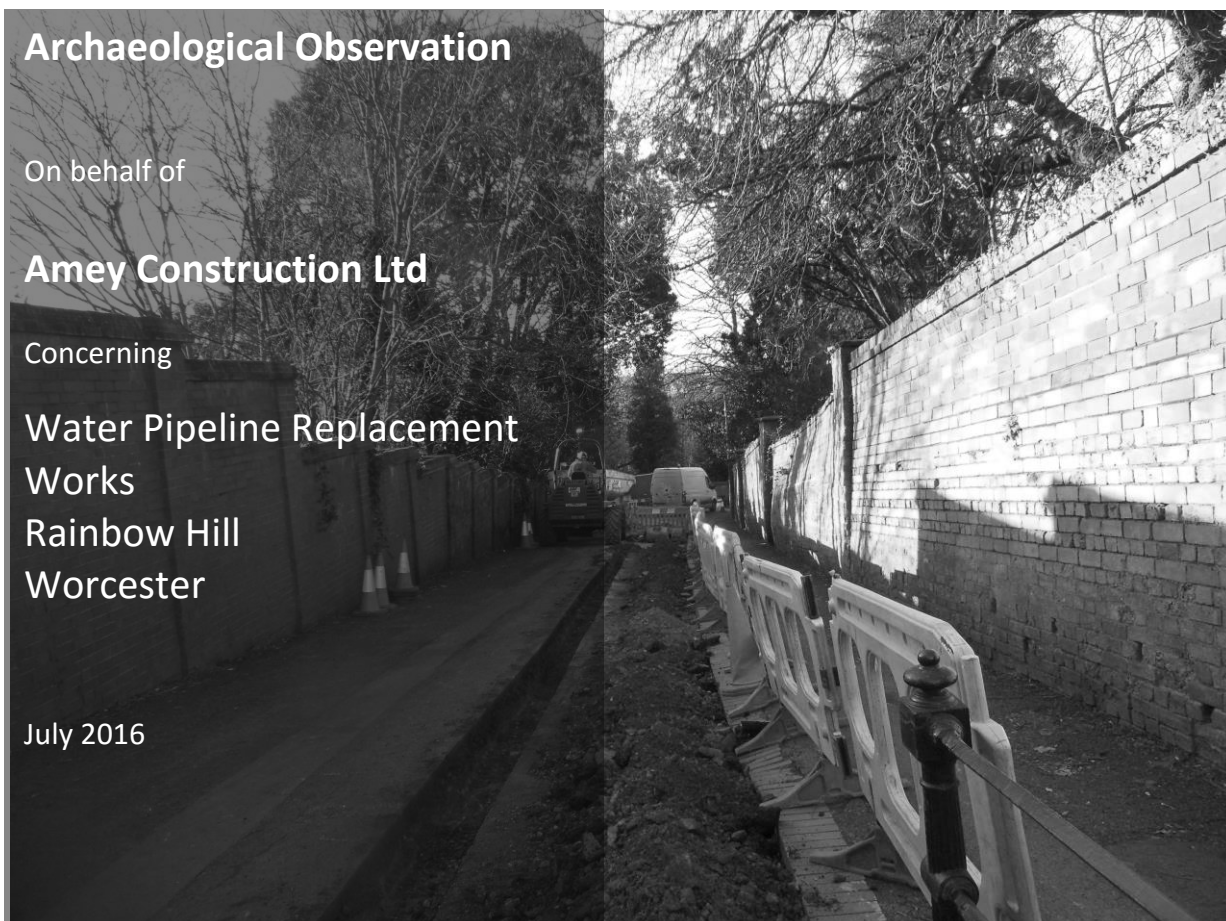
Cover: View southwest showing work in progress in Lansdowne Walk

From the junction with Lansdowne Crescent Lane to that with Lansdowne Crescent, work took place by means of open-cut trenching, maximising the potential for the discovery of archaeological features (*Cover & fig. 1*).

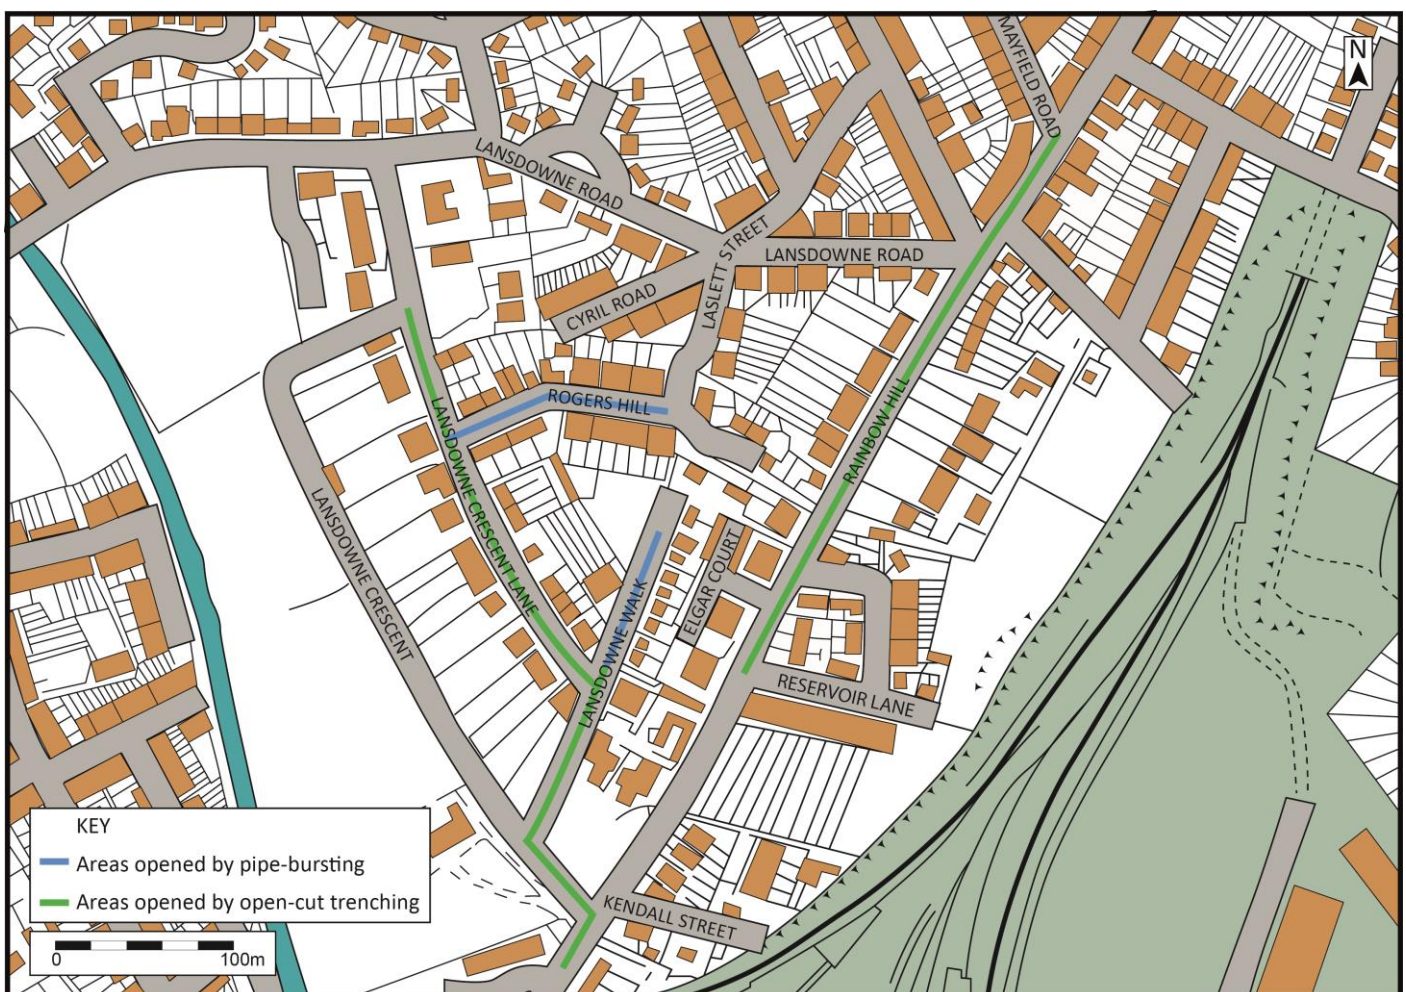
Fig 1: Plan showing location of water pipeline replacement ground works

Groundworks were either excavated by machine and toothless bucket or were hand-excavated by contractors under archaeological supervision. Open-cut trenching was opened along much of the pipeline route, with some sections employing pipe-bursting, involving the excavation of access pits (*fig. 1*). Areas of pipe-bursting included Roger's Hill and the NE part of Lansdowne Walk, to the junction with Lansdowne Crescent Lane. Trenching was opened in the remaining areas. In addition, a number of initial trial-pits were excavated to locate services and mains.

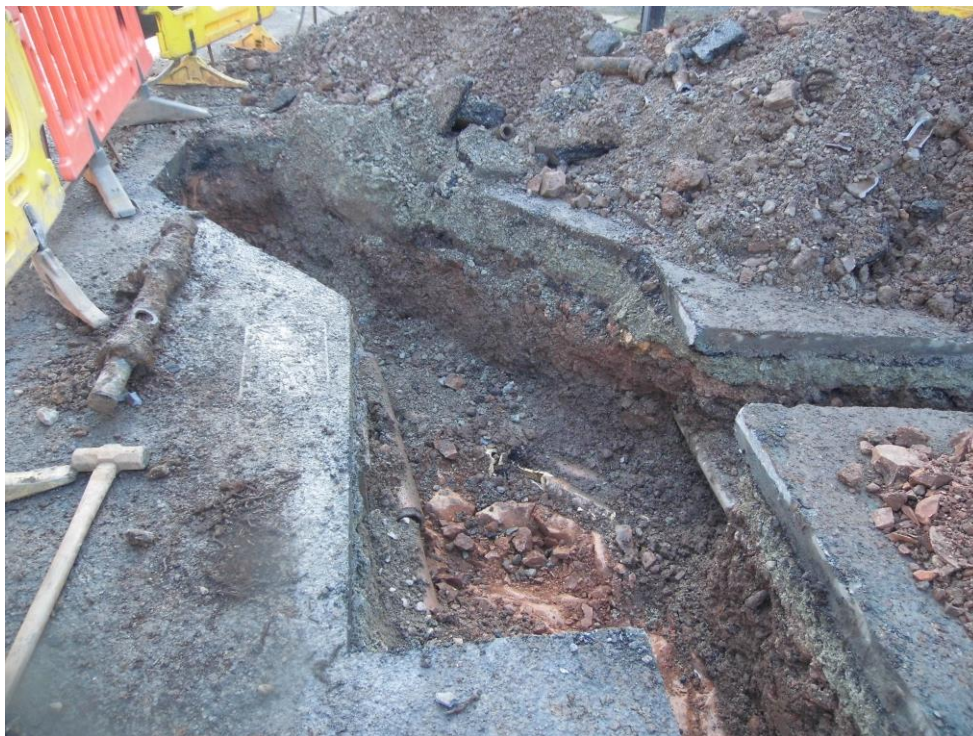
Plate 1: View NE at the junction of Lansdowne Crescent Lane and Lansdowne Walk showing existing ducts and natural bedrock

Trenching followed the line of a disused cast-iron main and the majority of deposits were thus heavily disturbed. However, at the junction of Lansdowne Walk with Lansdowne Crescent Lane undisturbed natural deposits were observed. These demonstrated the presence of bedrock at a shallow depth on the S slope of the hill.

Trenching excavations and access pits followed the line of existing services and this may account to a large extent for the absence of archaeological features and deposits. Natural deposits were seen in limited areas, particularly at the junction of Lansdowne Crescent Lane and Lansdowne Walk, and intermittently at the NE end of Rainbow Hill itself; however, these lay immediately beneath modern deposits.

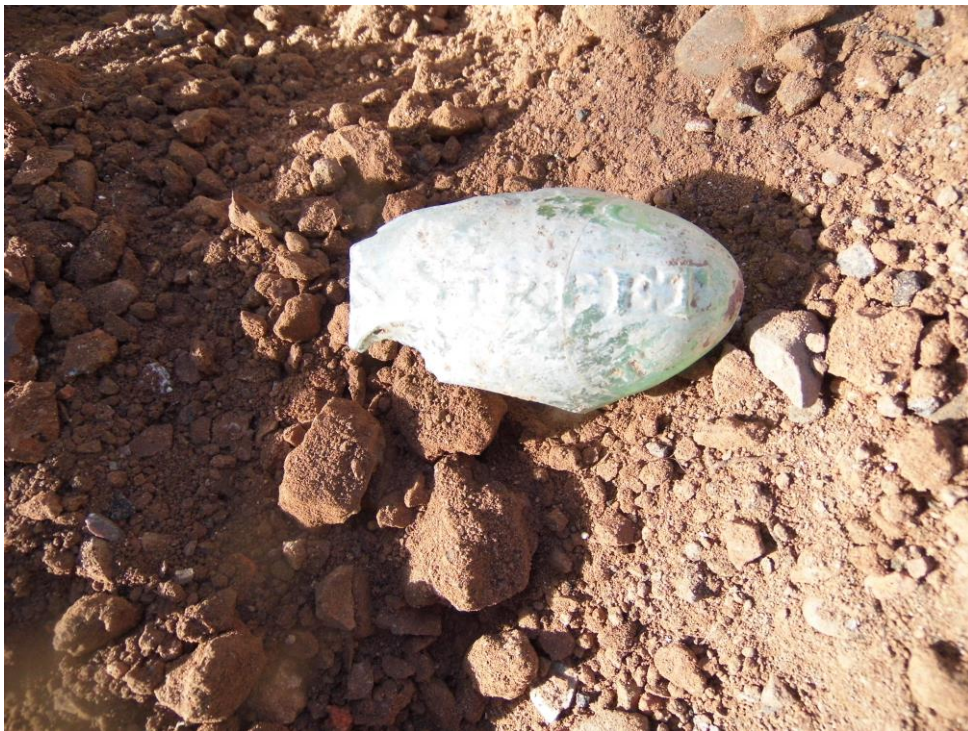
Plate 2: Base of a Schweppes 'torpedo' soda bottle, dating from between 1831 and 1895

A single find, not retained, (*Plate 2*) comprised the lower part of a 'torpedo' soda bottle, probably manufactured for Schweppes and dating to the 19th century, when these bottles were manufactured in large numbers. The word 'STREET' was visible and may refer to Schweppes' Margaret Street premises in London. Small fragments of modern (white) ceramics were also seen in the trench backfill.

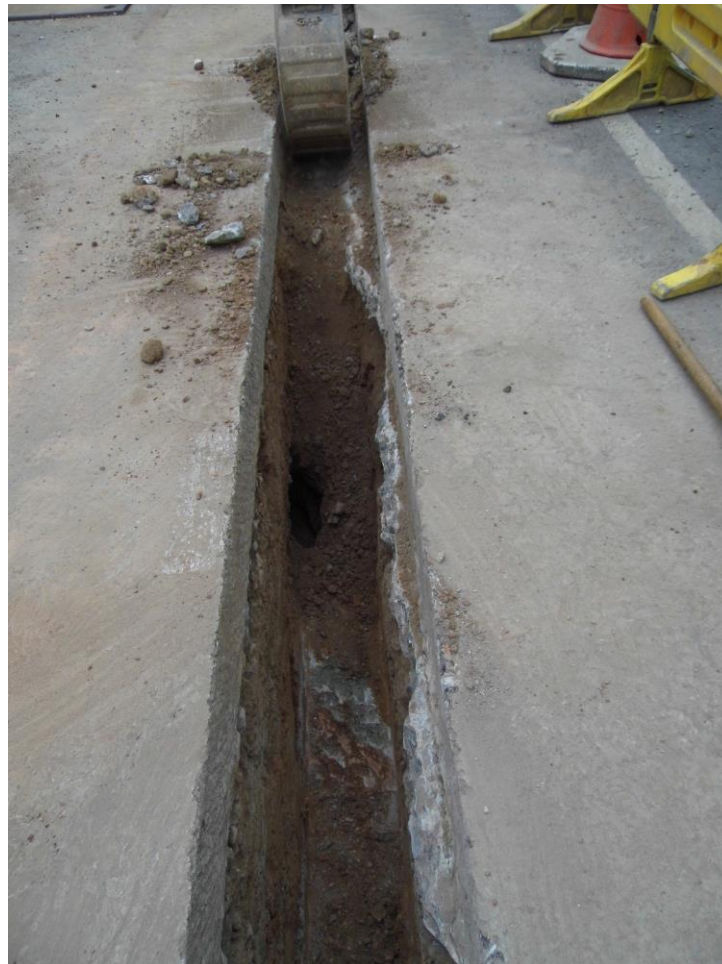
Plate 3: Concrete beneath existing road surface and bedrock in base of trench on Rainbow Hill; view SW

No archaeological features were present on Rainbow Hill. It is possible that earlier road surfaces and any other archaeological deposits which may have been present were removed during the installation and subsequent removal of lines for the electric tramway which ran along Rainbow Hill to Astwood Cemetery. The lines were installed in 1903/4 and were in use only until 1928 when the first motor buses came into use in the city. It is certain that in the centre of Worcester work to lay down the lines for the electric trams involved tearing up the existing roads meaning that it is possible that any surviving archaeological features, including previous road surfaces, may have been destroyed at about this time. One possible interpretation of the substantial layer of concrete (*Plate 3*) which was present intermittently along the trench is that it may have been associated with the tramway.
