Standing Building Recording

Markey Construction

Former Electricity Sub-Station
169 Southgate Street
Gloucester
GL1 1XE

November 2014

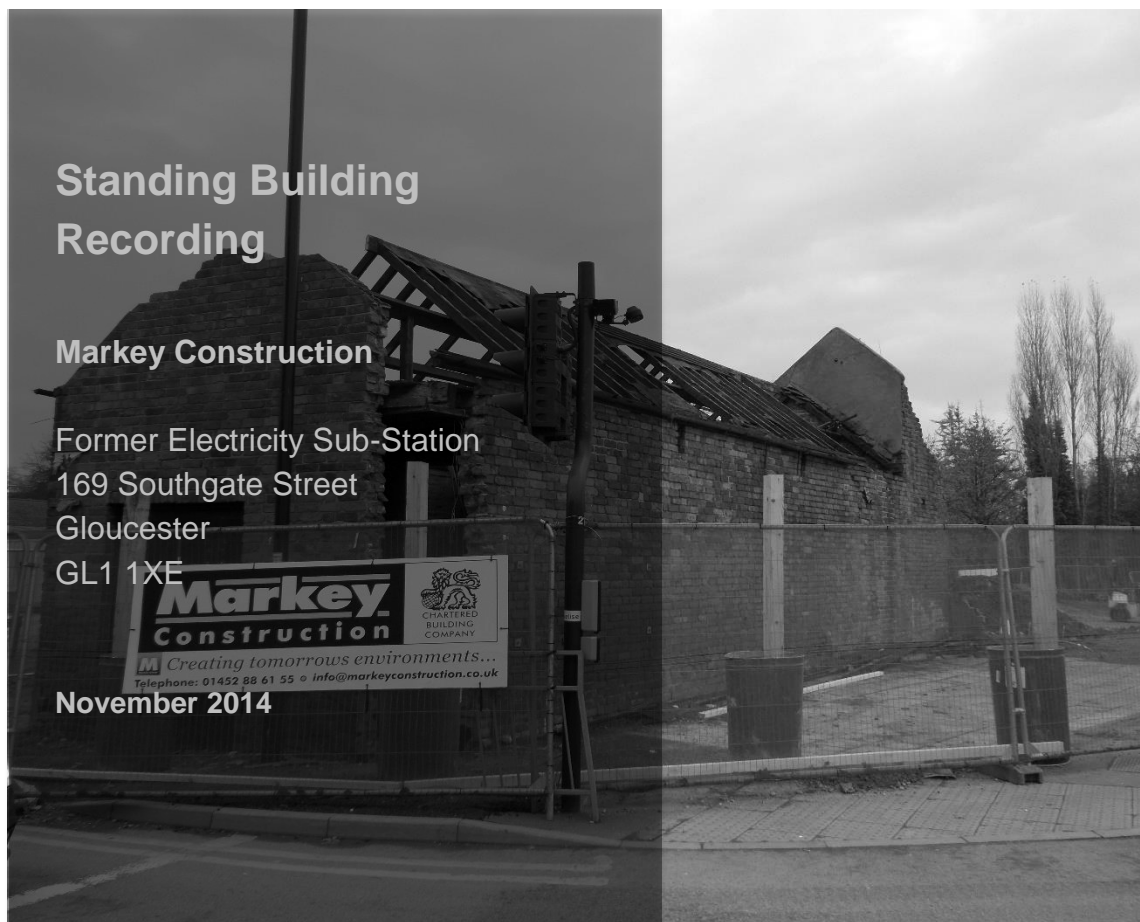
Cover: View looking southwest showing the north-facing principal elevation of the former sub-station building at 169 Southgate Street Gloucester

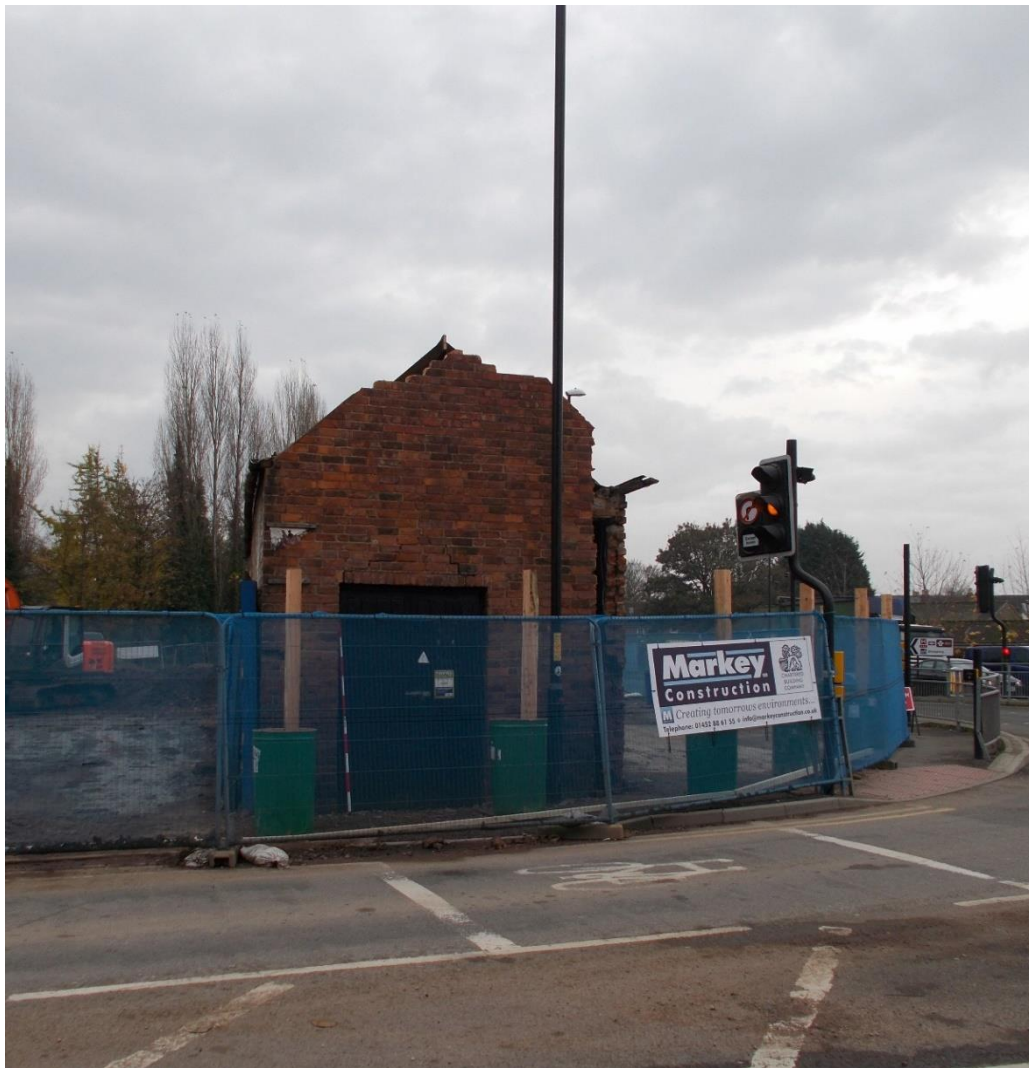
Plate 1: View looking E showing W-facing gable end of former sub-station fronting onto Southgate Street at junction with Trier Way

The former electricity sub-station (Building A) is a gabled red-brick structure exhibiting two principal phases of construction. The W-facing gable elevation (*Plate 1*), fronting onto Southgate Street, appears to have been substantially rebuilt, judging from the brickwork laid in stretcher bond which differs markedly from the bonding of the brickwork used in the N -and S-facing elevations (which is laid in a slightly irregular Flemish Bond). Evidence of a construction break is visible towards the W end of the N -and S-facing elevations (*Plate 2*). Inserted in the corner of the W-facing elevation is a flat headed doorway with a pair of double doors; it is likely that the reconstruction of this elevation occurred when the sub-station was installed in the mid-1960s.

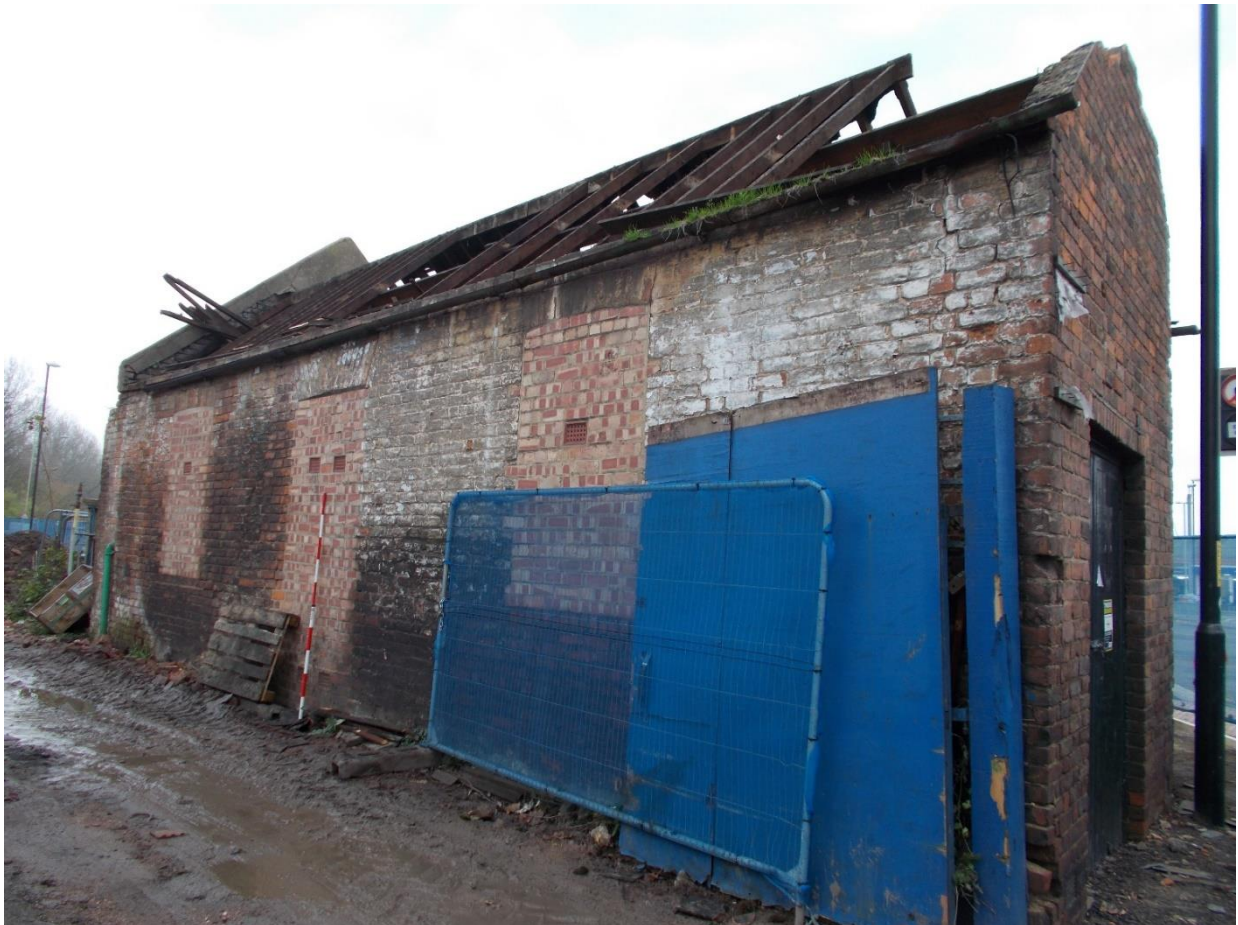
The principal N-facing elevation, which gave access to a yard immediately to the S of No. 169 Southgate Street, appears to have been partially reconstructed at some point, judging from the more irregularly coursed brickwork in the upper stages of the central and western bays of the elevation, which are coated with whitewash (*Plates 2 & 3*). Much of the brickwork is blackened, which may be explained by its close proximity to the former railway line. Inserted in the centre of the elevation is a tall flat-headed doorway (2.75m high × 1.40m wide) with gauged brick *voussoirs*, which is in turn flanked on either side by windows with segmental gauged brick arches (2m high × 1.30m wide). The doorway and windows were blocked up with later brickwork and ventilation grilles inserted (presumably when the sub-station was installed in the mid-1960s).

Plate 2: View looking SE showing N and W facing elevations of the former electricity sub-station (Building A) and the more steeply pitched roofline of the range attached to the E end (Building B)

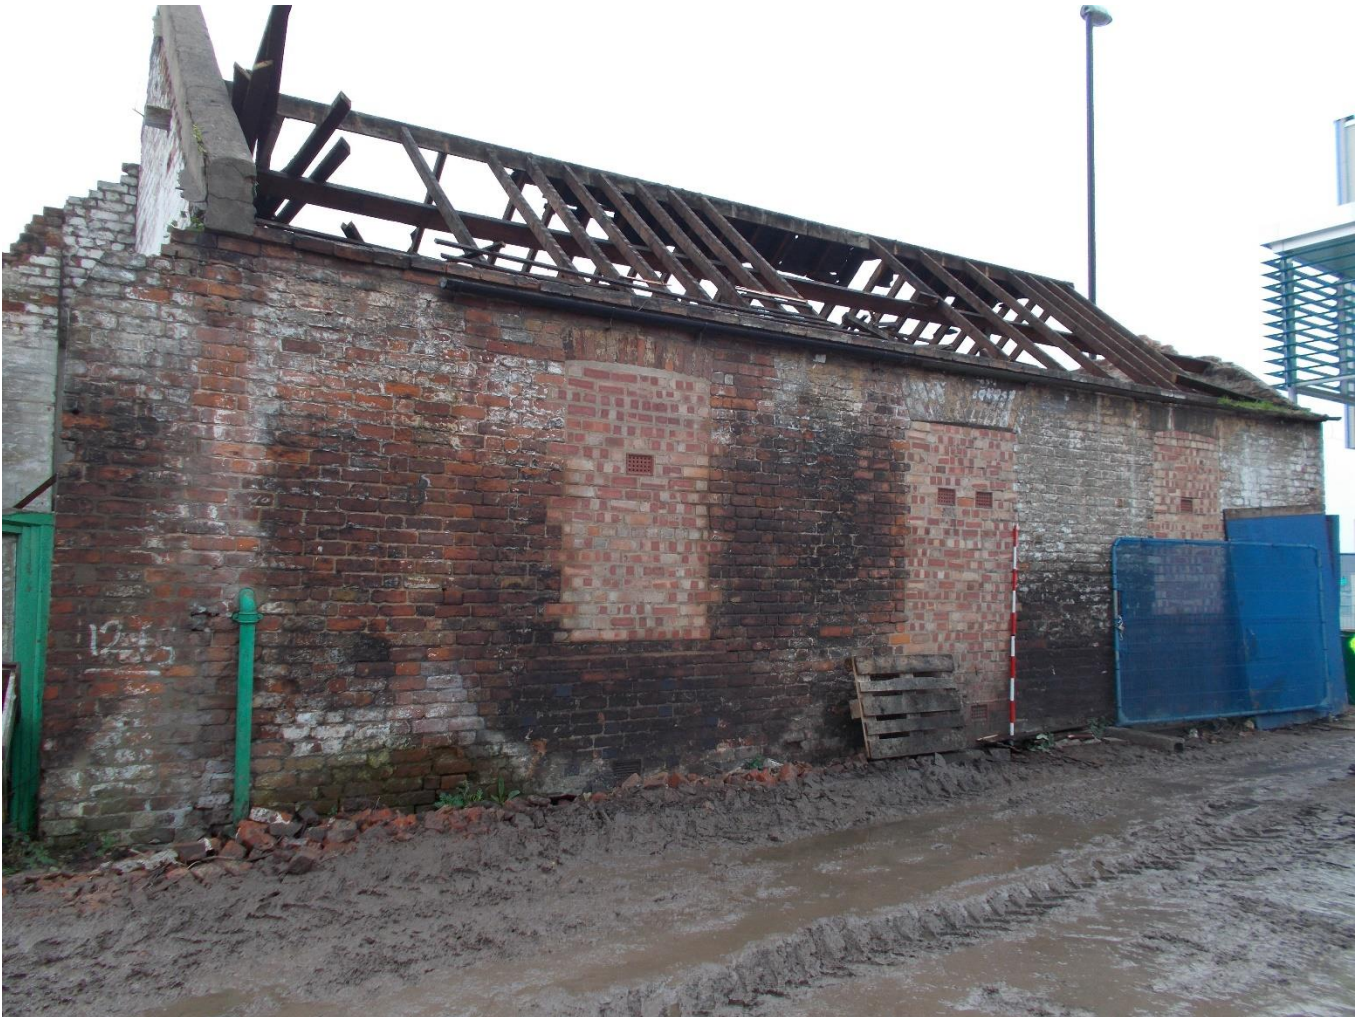
Plate 3: View looking SE showing N-facing elevation of Building A with doorway with gauged brick voussoirs flanked by two segmental arched windows, all bricked-up

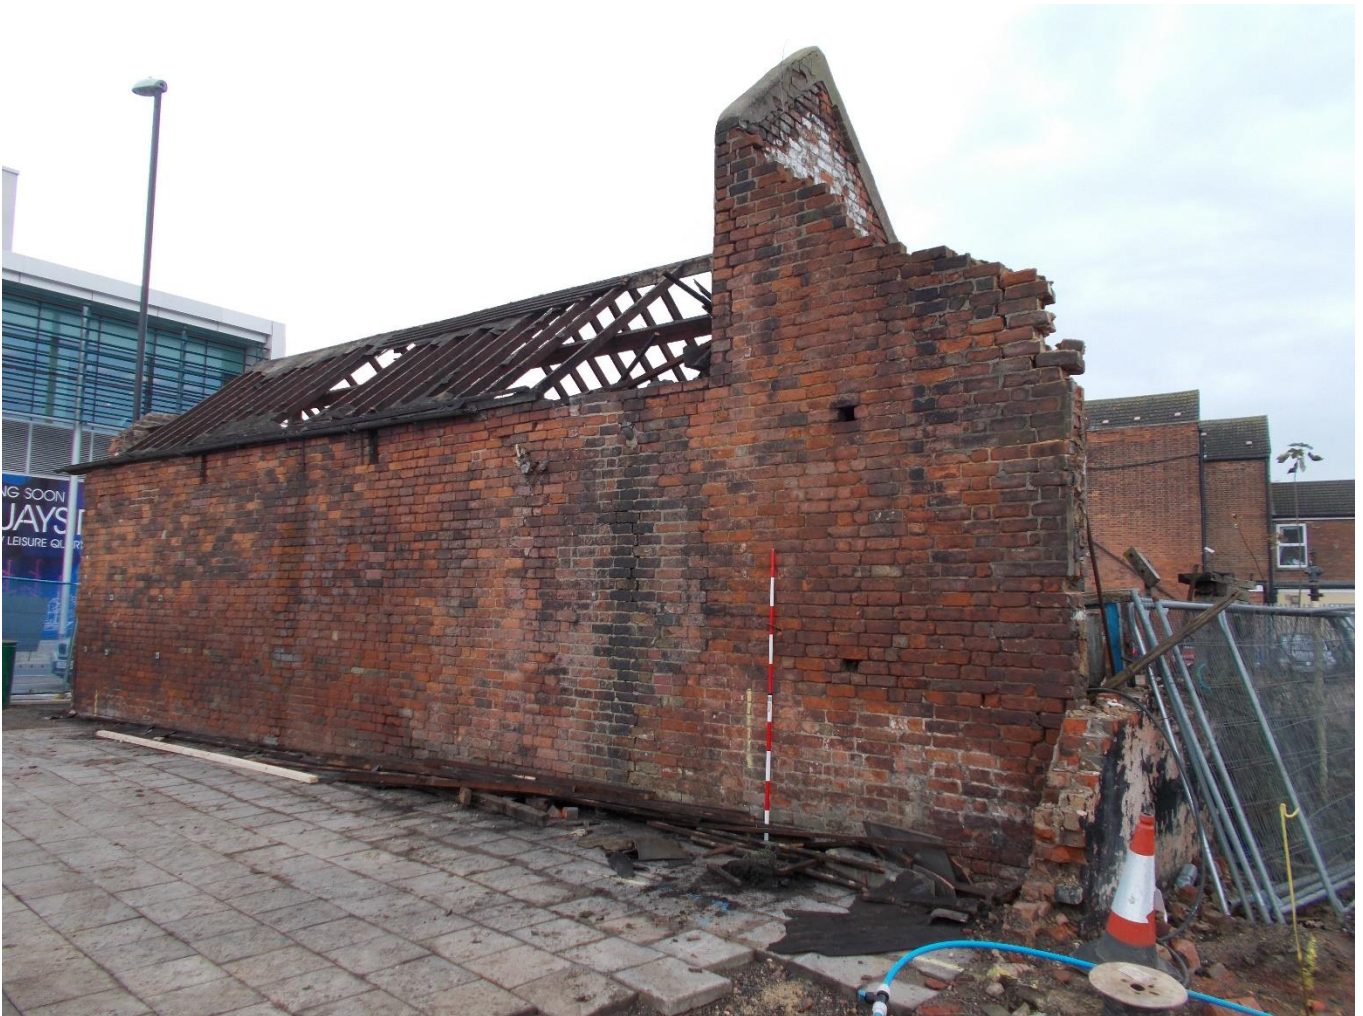
The S-facing elevation of Building A is devoid of architectural detailing and fenestration. In contrast to the N-facing elevation, this wall does not appear to have been whitewashed. The brickwork, which was laid in an irregular Flemish bond, is again heavily blackened, presumably reflecting its close proximity to the railway line (*Plate 4*). Evidence of cracking in the brickwork was noted in several places and a series of steel ties had been inserted in the W-end of the wall, presumably to prevent further weakening of the structure.

Plate 4: View looking NW showing S-facing elevation of Building A and the remains of Building B with projecting wall stub (at right end of picture)

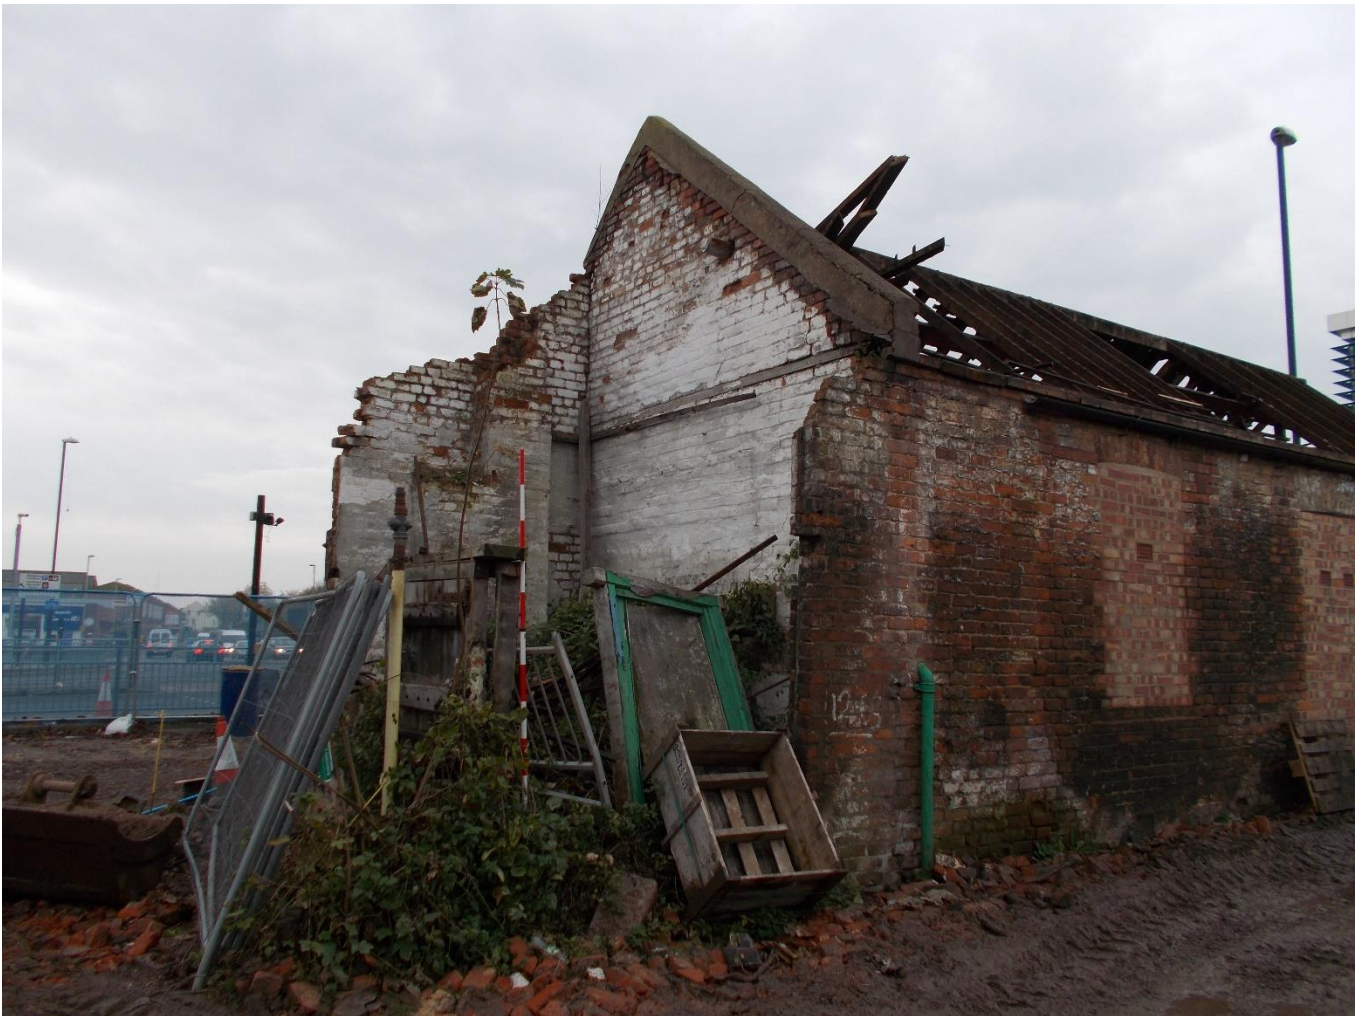
Adjoining the E end of the former sub-station are the heavily truncated remains of a much taller range (Building B), the gable of which was noticeably different in form and steeper in pitch compared to its western counterpart. The upper stages of the gable had been partially roughcast, although this appeared to be a later alteration.

No evidence of a construction break was noted between the two ranges, which suggests that they were probably contemporary with each other, which further appeared to be confirmed by the similarity of the brick bonding (laid in an irregular Flemish bond).

Plate 5: View looking SW showing largely demolished remains of gabled range (Building B) at E end of former sub-station building

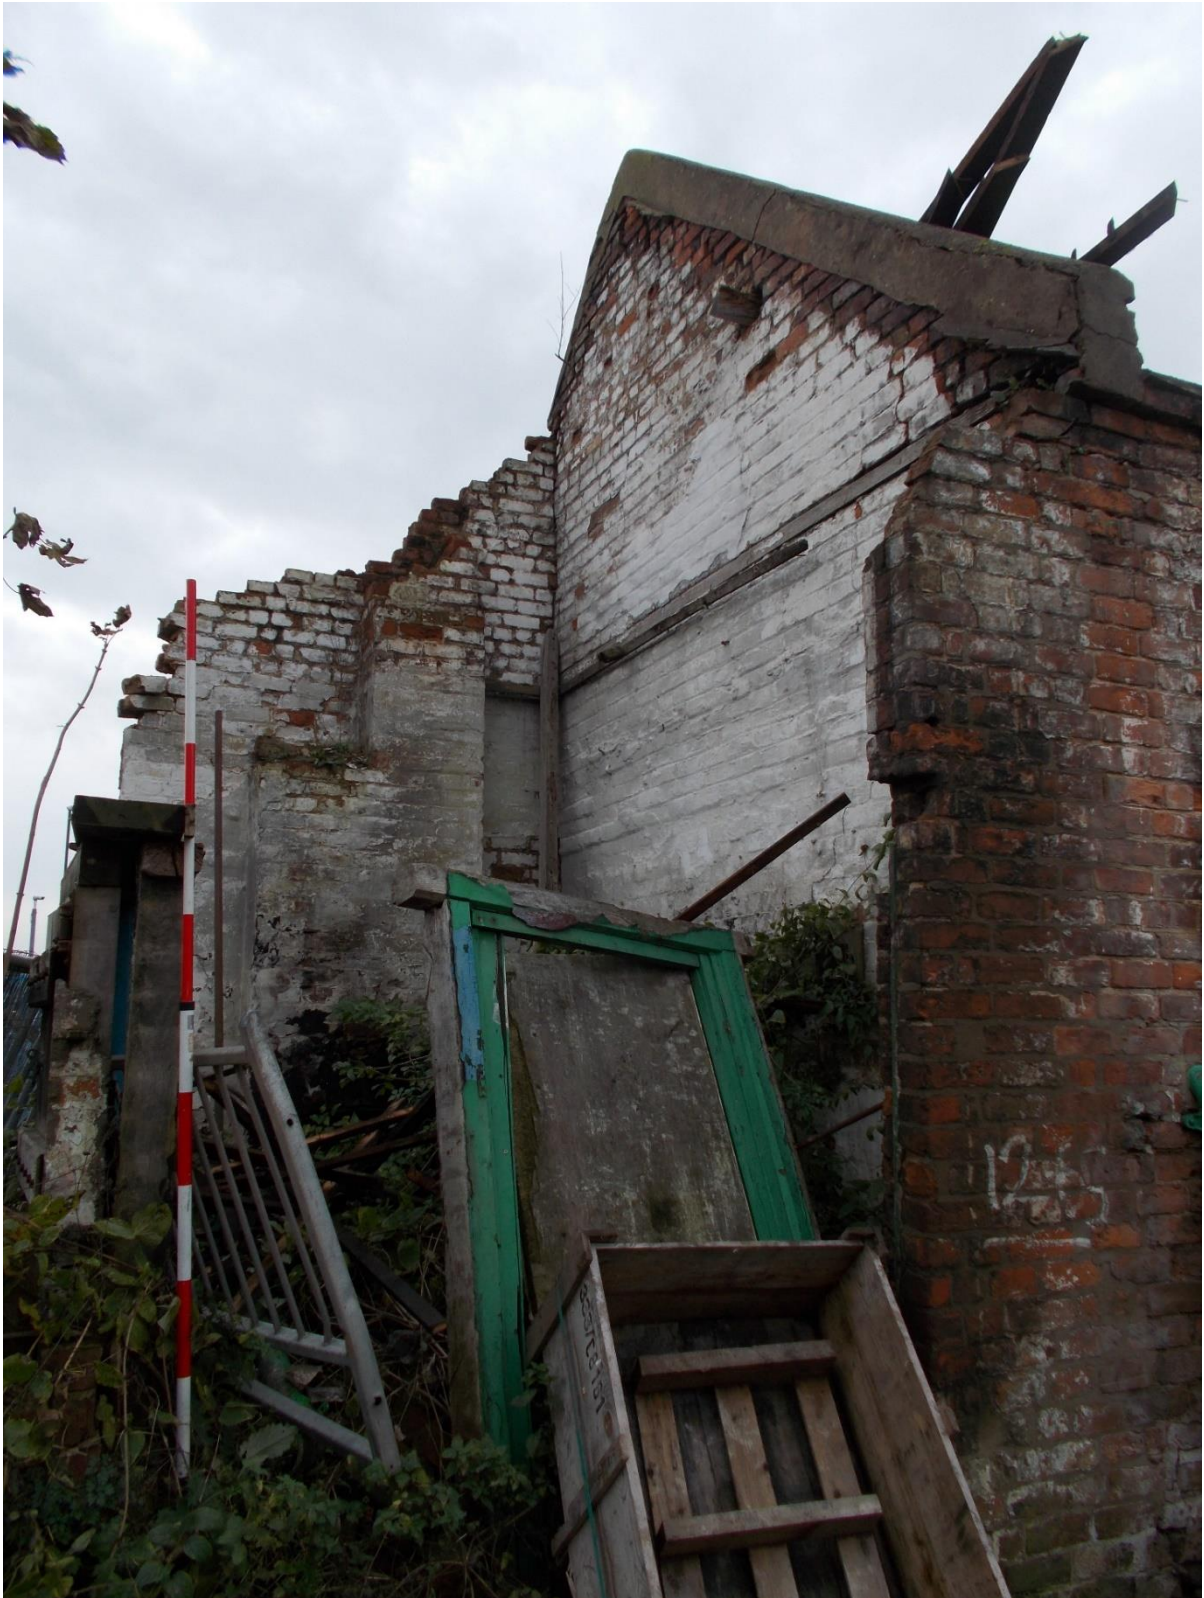
Attached to the E end of the N-facing elevation of the former sub-station (Building A) was a wall stub, two courses (0.25m) thick, which represented the heavily truncated remnant of the N wall of the taller gabled range (Building B). The jamb of a flat-headed doorway (2m high) was noted at the E end of the extant section of walling, together with the collapsed remains of the wooden frame of the door associated with it (*Plate 5 & 6*).

Plate 6: View looking SW showing detail of door jamb and door frame in N-elevation of Building B and stepped chimney flue in thickness of S-wall

The majority of the N -and E-facing walls of the taller gabled structure had already been demolished, revealing the interior, which was completely whitewashed. Evidence was noted for a sub-division between the ground floor and loft space; no other internal flooring was noted (*Plate 7*). Due to safety considerations, it was not possible to investigate this part of the structure further; however, evidence for what appeared to be a stepped chimney flue was visible in the thickness of the S wall (*Plates 6 & 7*).

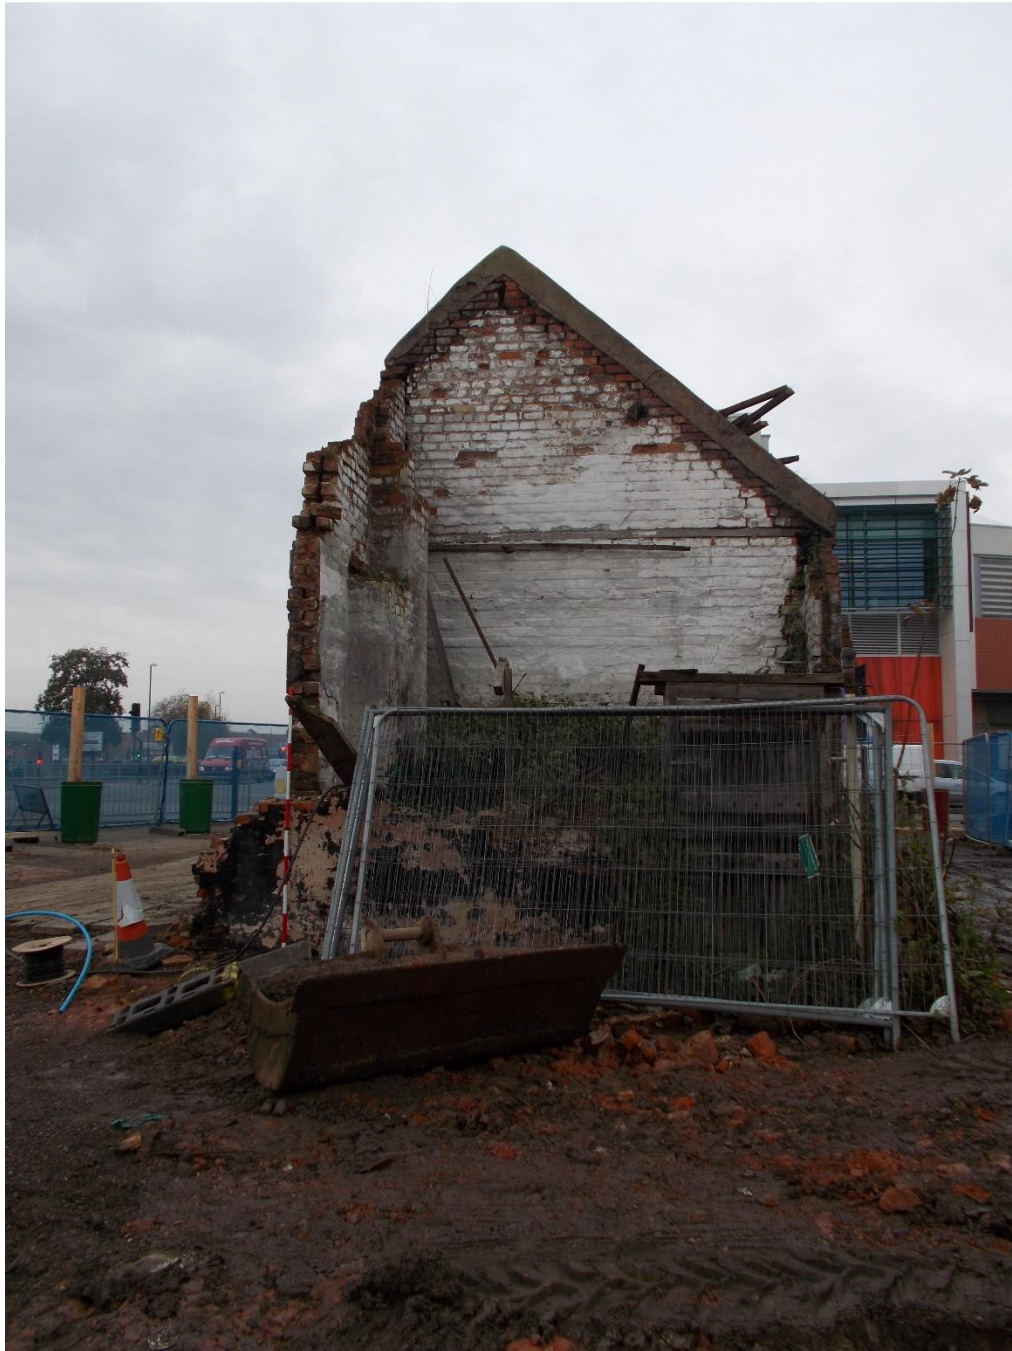
Plate 7: View looking W showing interior of Building B at E end of former sub-station with remains of chimney flue in thickness of S-wall

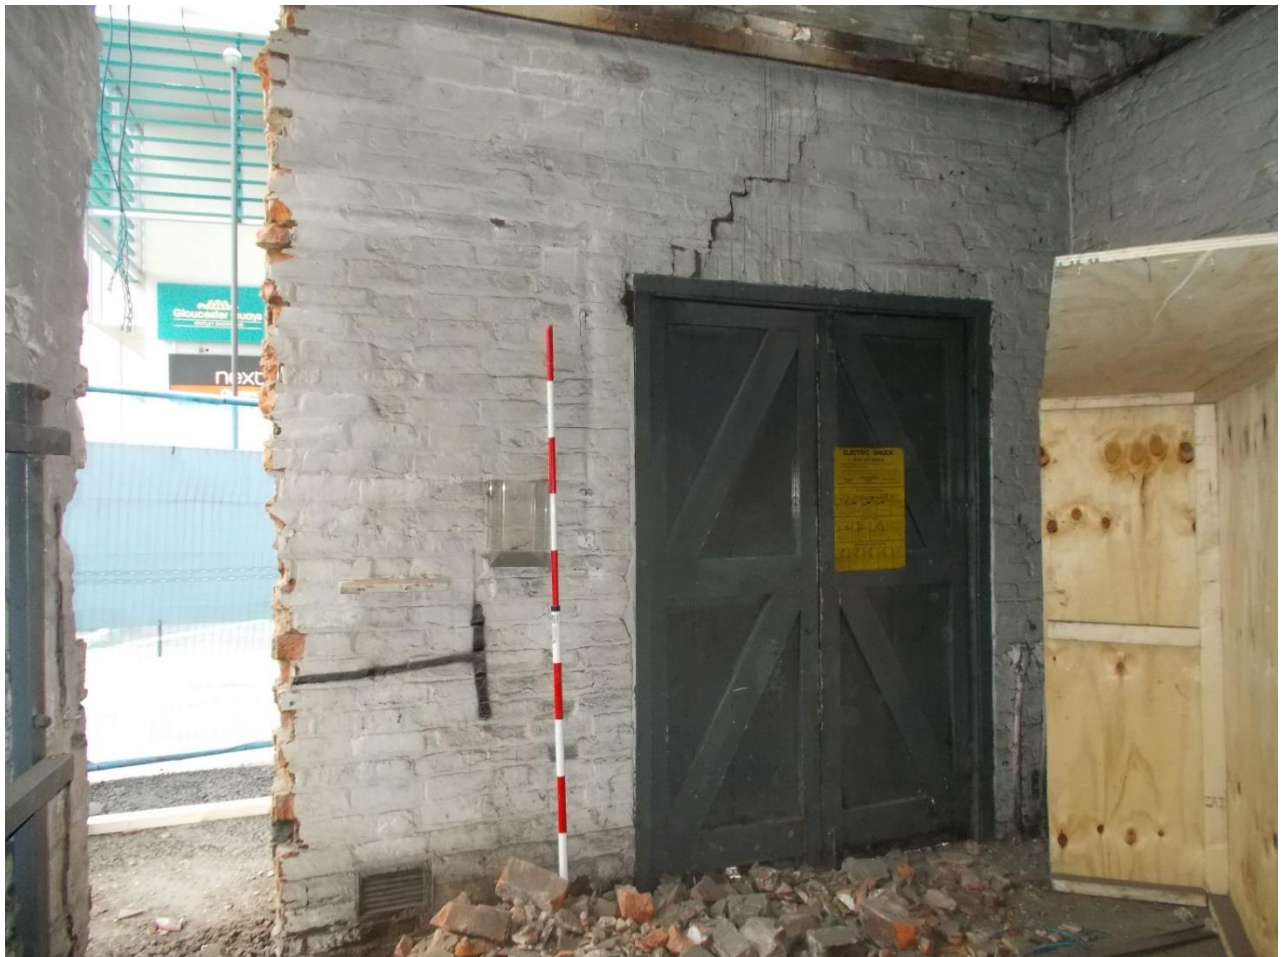
The interior of the former sub-station building (Building A) exhibited few features of interest and had been entirely coated in whitewash (*Plate 8*). The floor level of the building had been raised with concrete breeze blocks up to a height of 0.8m when the sub-station was installed in the mid-1960s and trenches laid out, presumably for electricity cabling. A substantial quantity of fixtures and fittings associated with the former sub-station (including the transformer and various wall switches) was still extant (*Plate 9*).

Plate 8: Internal view looking W showing flat headed doorway with pair of wooden double doors in W gable wall

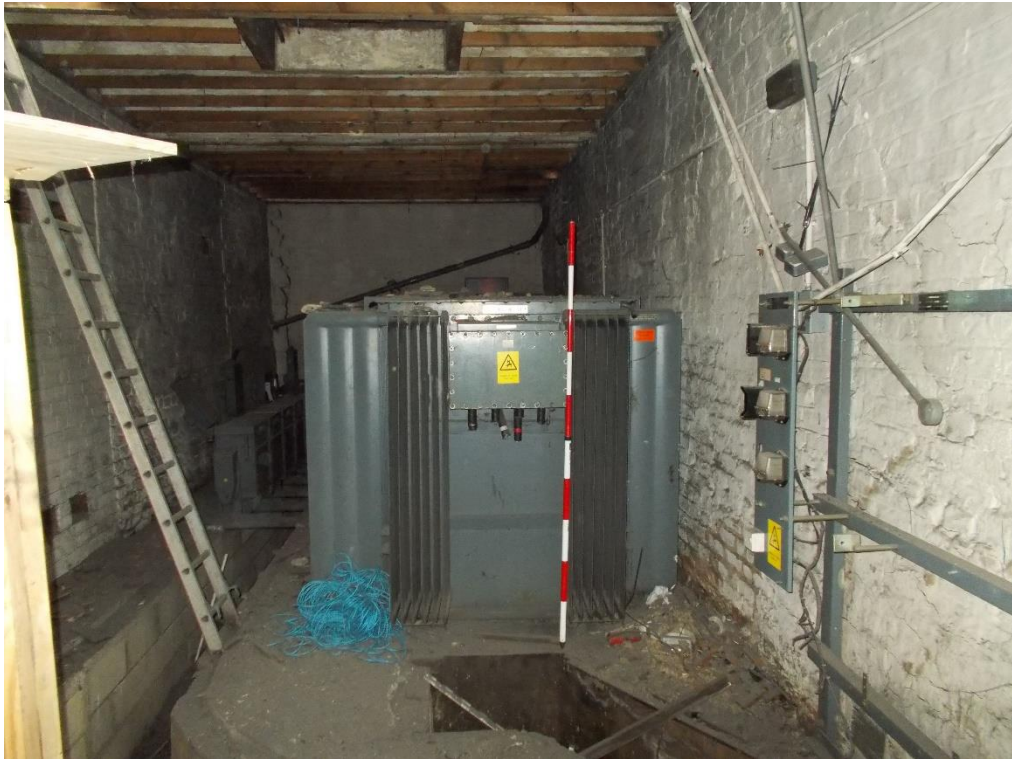
Plate 9: View looking E showing interior of Building A with raised concrete flooring with cable trenches leading to transformer. A hatch is visible in the ceiling just above the transformer

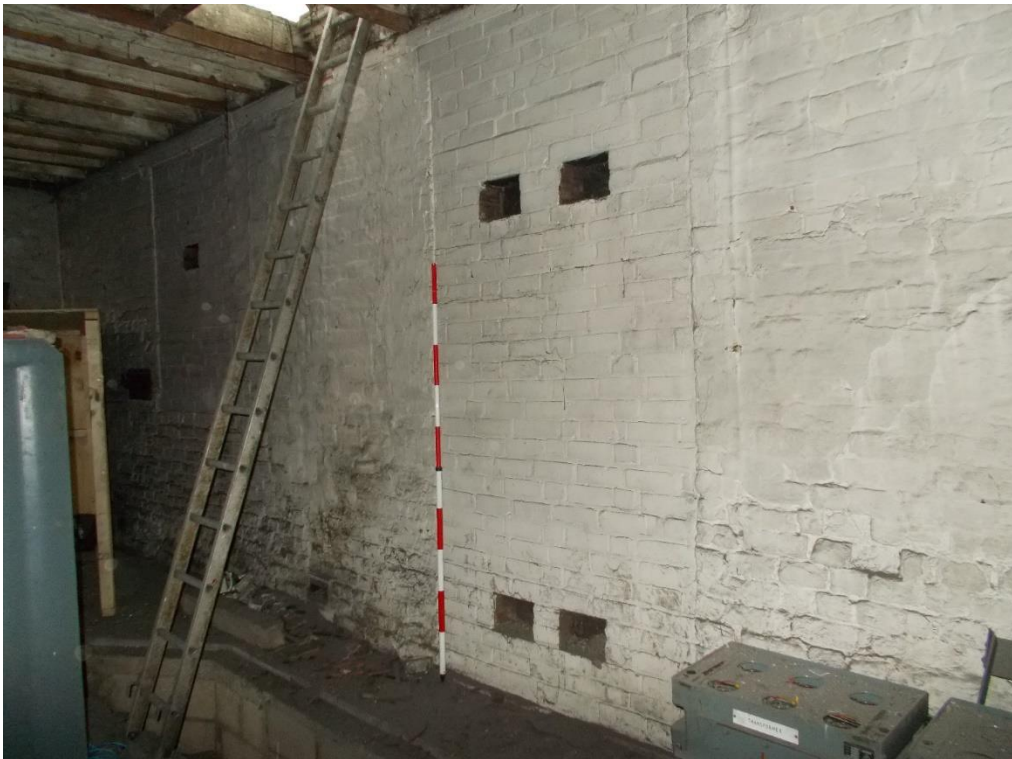
Plate 10: Internal view looking NW showing blocked doorway in N wall of Building A with hatch above and to left of doorway

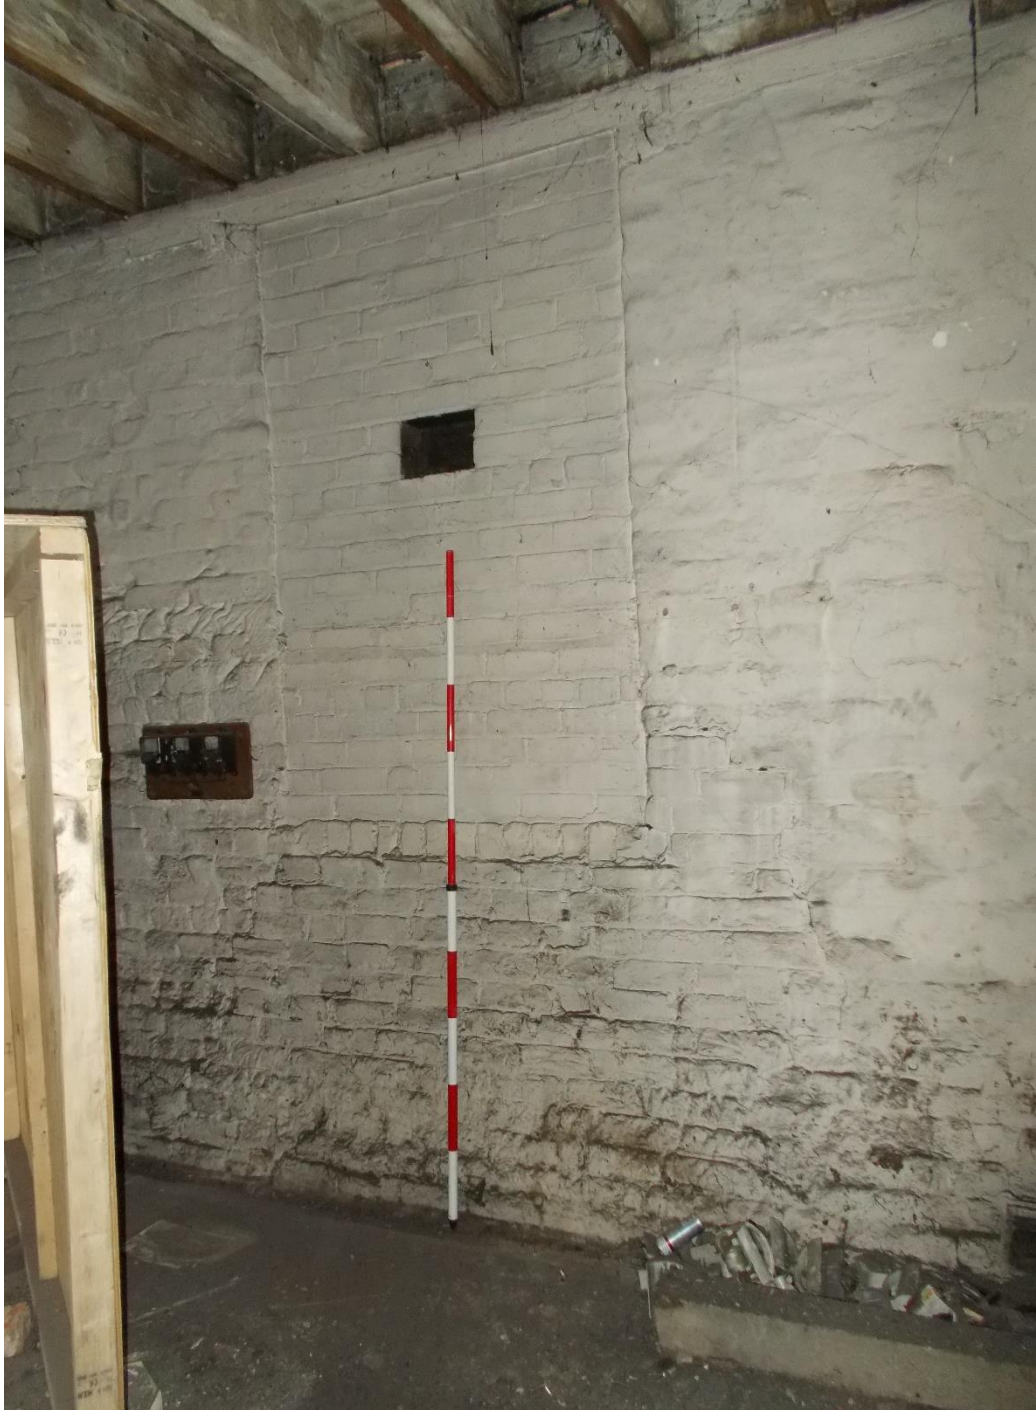
Plate 11: Internal view looking NW showing blocked up window with modern ventilation grille at W end of N wall, with indentation for possible partition wall visible to right of window

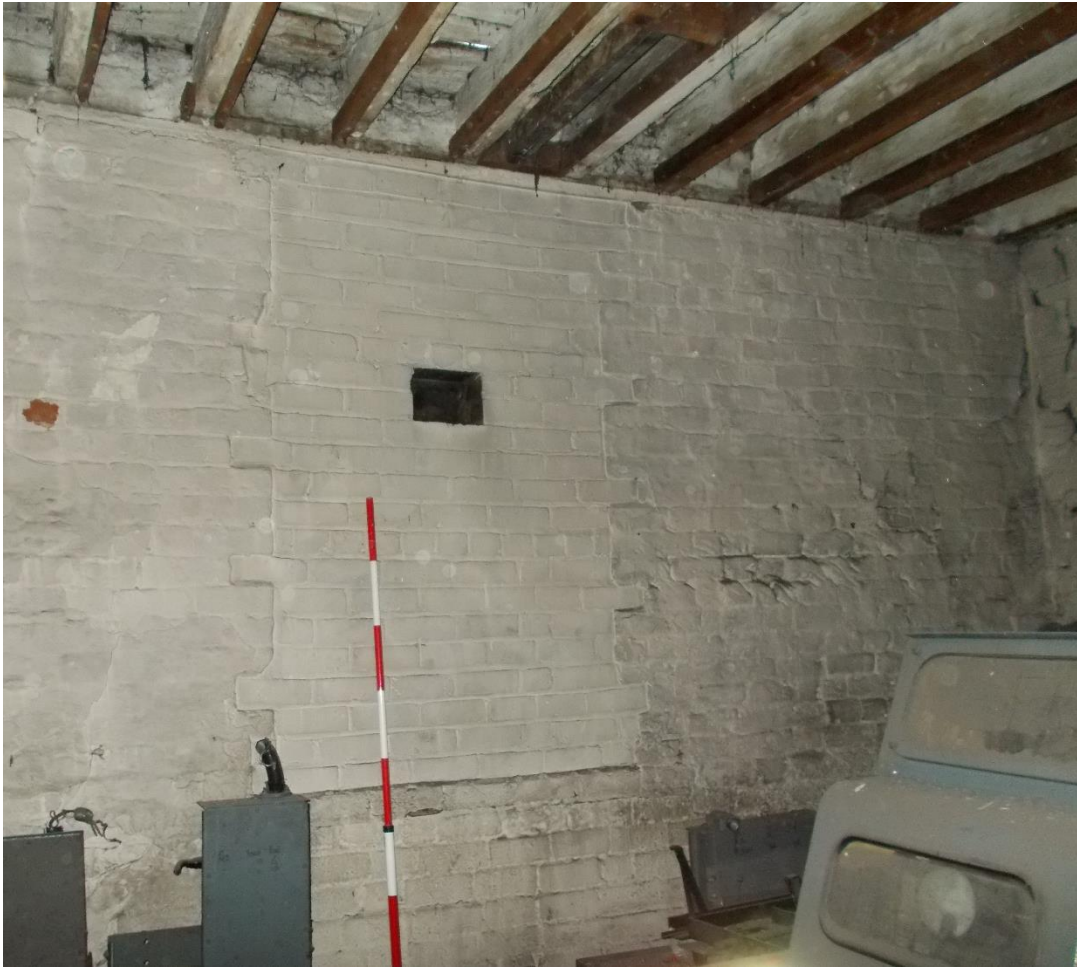
Plate 12: Internal view looking NNE showing blocked window with modern ventilation grille inserted in eastern bay of Building A
