## Standing Building Recording Survey

**BGD Property Ltd**

Former Rosswyn Hotel  
16-19 High Street  
Ross-on-Wye  
Herefordshire HR9 5BZ

**October 2016**

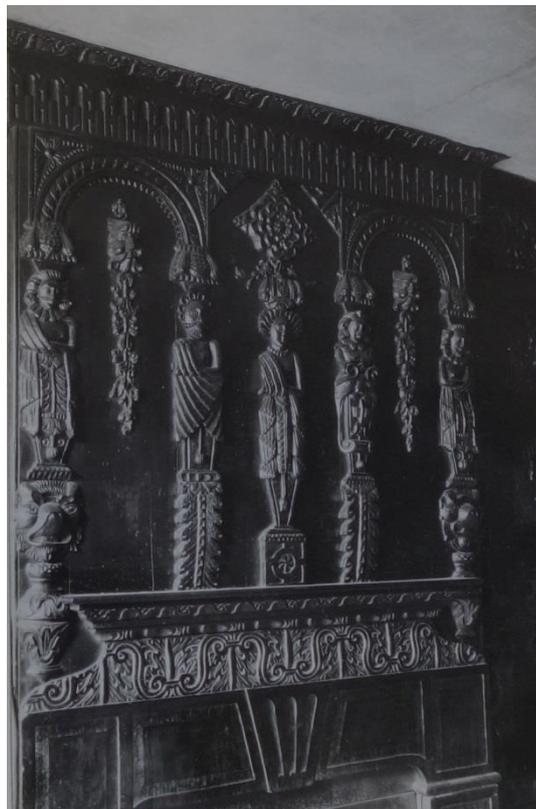
*Plate C: Photograph of 1930 showing the carved overmantel and frieze of early 17<sup>th</sup> century date formerly at Chepstow House (Reproduced by courtesy of the Historic England Archive)*

The RCHME survey of 1930 is of considerable value as it shows the layout of No. 17 prior to the extensive alterations made to the building after the Second World War, when it was converted from being a private residence into a hotel. It is described as 'a rectangular building of c.1700 built round a central chimneystack, part of the S and E walls are built in stone which may have formed part of an earlier building'. The W front is described as being 'refaced with modern brick' while 'the E front retains some mullioned window frames of c.1700'. The survey mentions that 'in the S wall within the passage (between Nos. 17 & 17A) a window has been inserted in the site of a former doorway'. The description of the staircase assigns it a date of c.1700 but mentions that it 'has a moulded rail and newels with acorn pendants reused from a mid-17<sup>th</sup> century stair'. Of particular interest is the description of the 'considerable amount of early 17<sup>th</sup> century woodwork' in the ground floor room in the SE corner of the house, including moulded panelling, a carved frieze and overmantel. It is likely that this can be identified with the carved panelling referred to in the 1907 sale catalogue for Chepstow House.

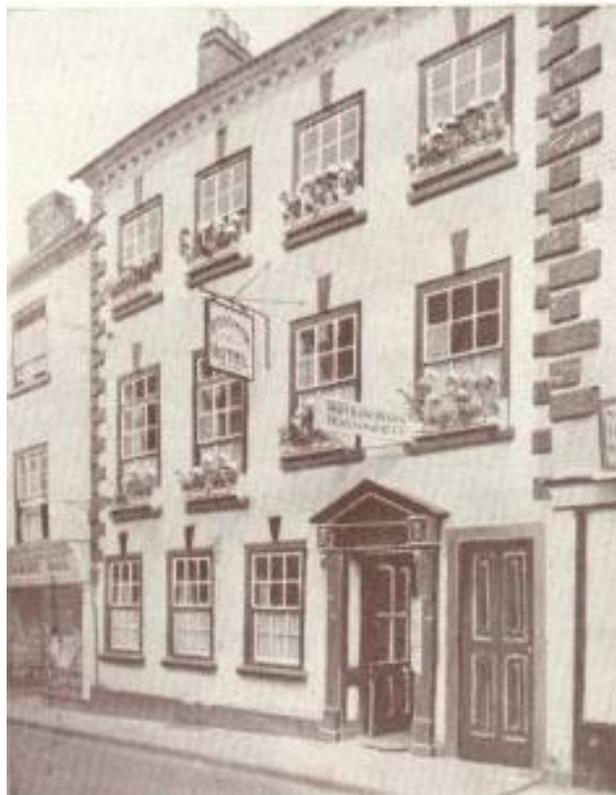
*Plate E: Photograph taken from advertisement of c.1948 showing the exterior of the Rosswyn Hotel  
(Reproduced by courtesy of Herefordshire Archives and Record Centre)*

Shortly after the Second World War, it appears that Chepstow House was purchased by Mr R.L. Skinner and converted into the Rosswyn Hotel. The earliest documented reference found to the hotel is in the Ross Town Guide of c.1946 and newspaper entries dated 1947 mention the provision of furniture for the hotel. Significantly a photograph of the exterior building contained in an advertisement of c.1948 shows that the door to the right of the pedimented doorcase, providing access to the passageway which originally ran between Nos. 17 and 17A, had not yet been removed and replaced with the present sash window (*Plate E*).

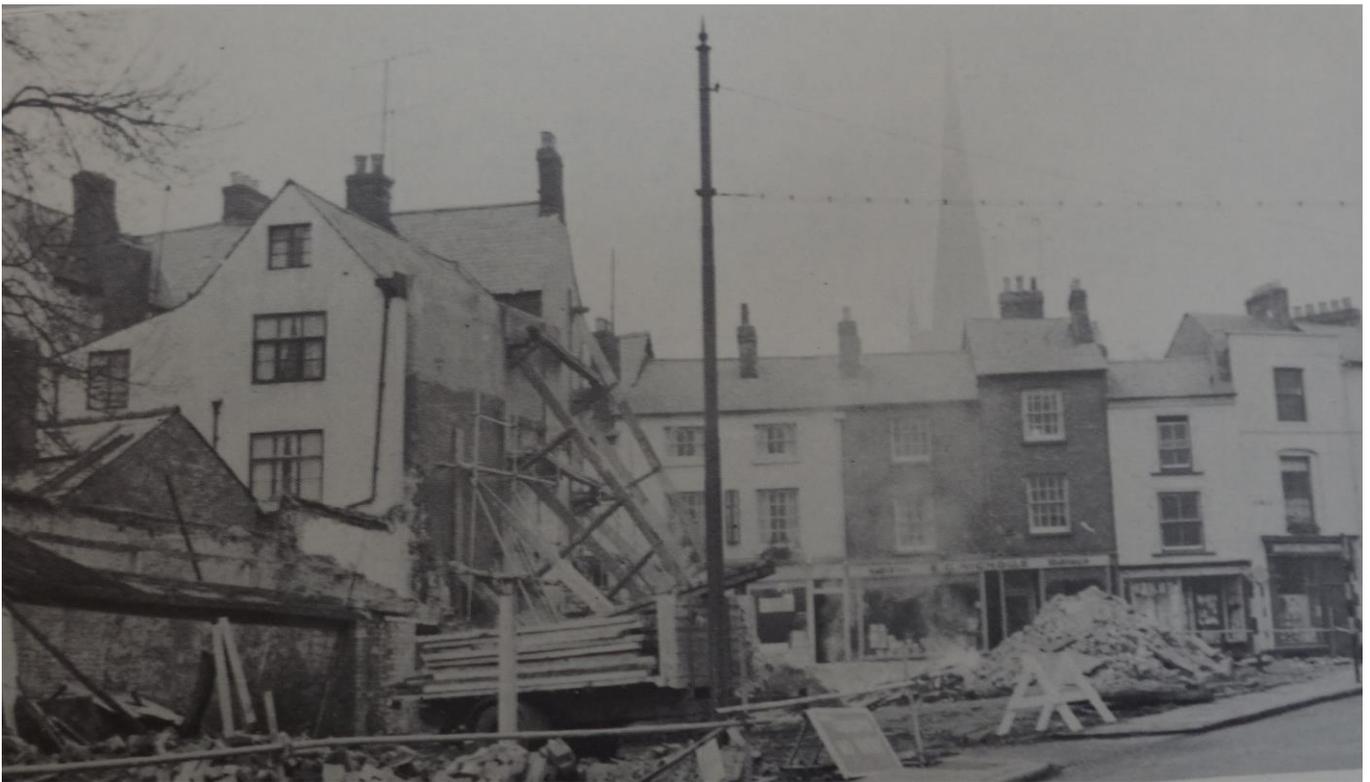
*Plate F: Extract from a photograph taken in 1960 showing the rear of the Rosswyn Hotel following the demolition of the George Hotel and Nos. 14 & 15 High Street*

This building appears to have replaced an earlier gabled outbuilding range which is still visible on a photograph taken in 1960 around the time of the demolition of the George Inn. Originally there was a passageway running E-W between Nos. 17 & 17A, however part of this passageway was removed when the doorway to the right of the principal entrance was blocked up at some time between 1950 and 1960.

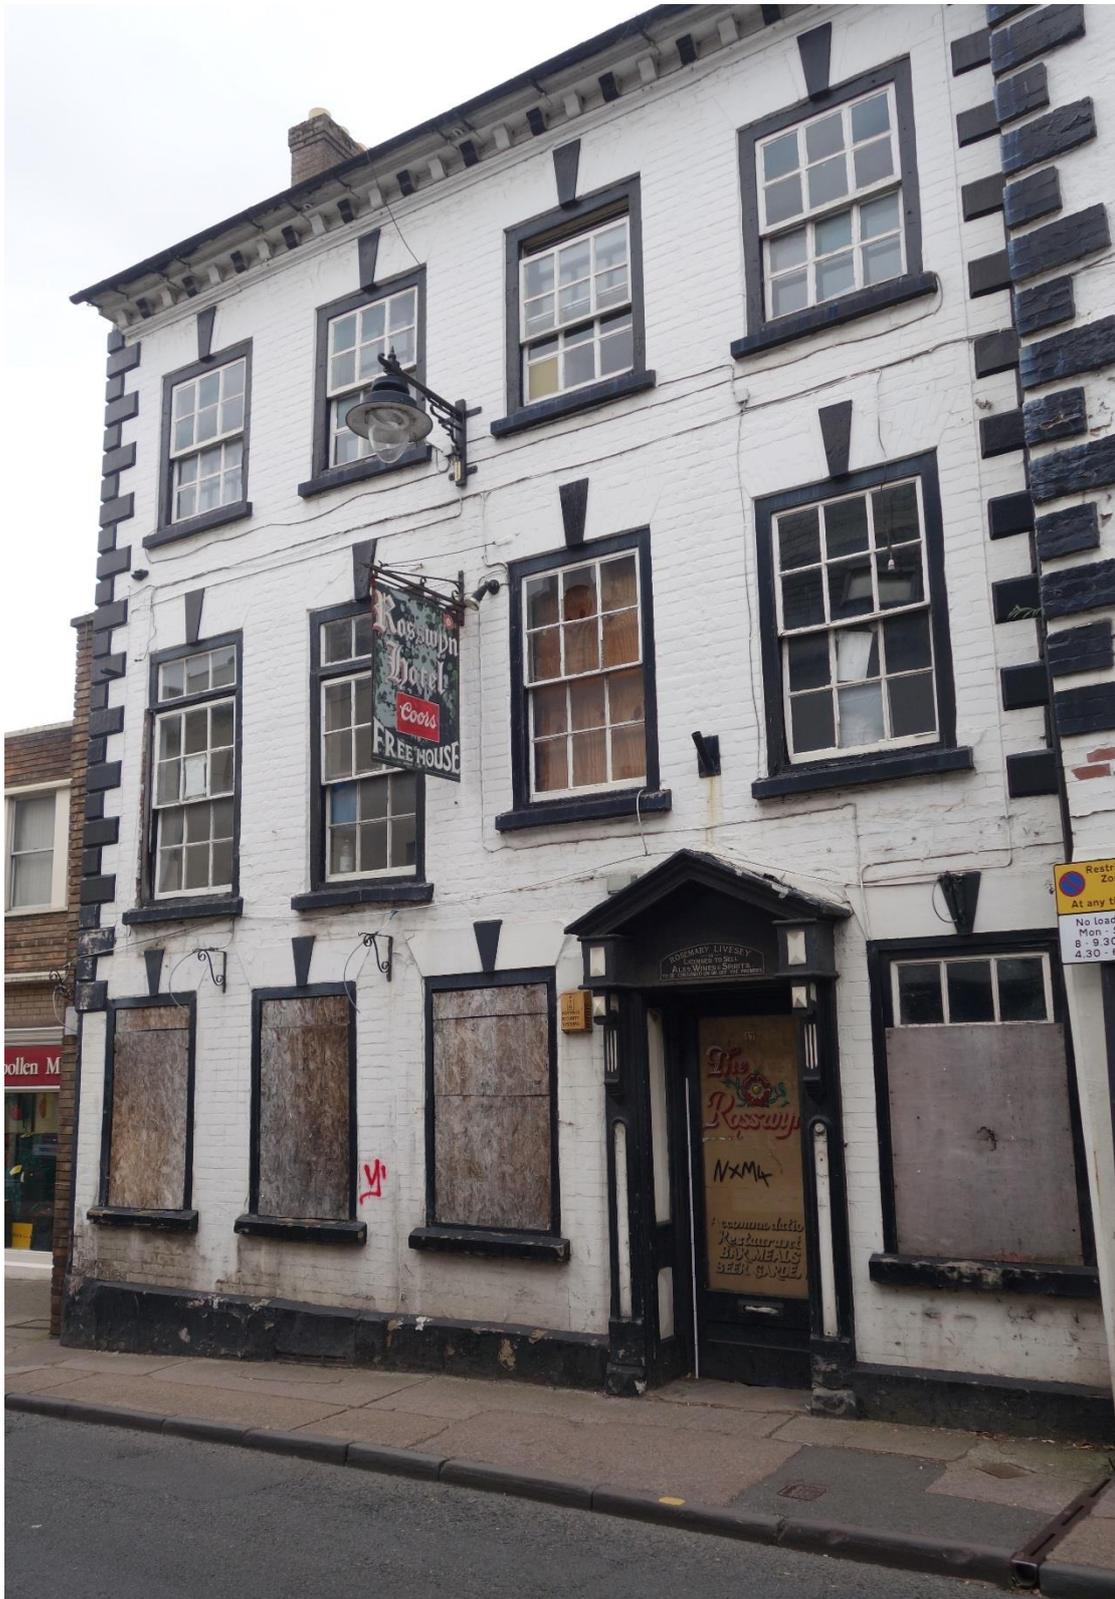
Plate 1: View looking NE showing the principal W-facing elevation of No. 17 High Street

The principal front (W-facing) street frontage of 17 High Street is three storeys high and is four bays wide, of brick construction painted in white except for the rusticated quoins, window architraves and the doorcase at ground level which are painted black (*Plate 1*). The principal entrance to the house at ground level is situated to centre-right of the façade and consists of a doorcase with an open pediment with flanking pilasters, entablature blocks and consoles (*Plate 2*).

To the left of the entrance are three 12-paned glazed sash windows with flush moulded box frames and thin glazing bars (now boarded-up) under gauged brick flat arches, the architraves, sills and keyblocks are painted black. To the right of the entrance is a single 12-pane sash window which appears similar in form to the other windows but in fact is a late 20<sup>th</sup> century insertion which replaced an earlier flat headed doorway in this location which is visible on a photograph of the Rosswyn Hotel taken in the late 1940s. This doorway originally led to a passageway which ran between Nos. 17 & 17A and which was blocked up when the two buildings were substantially altered in the 1970s.

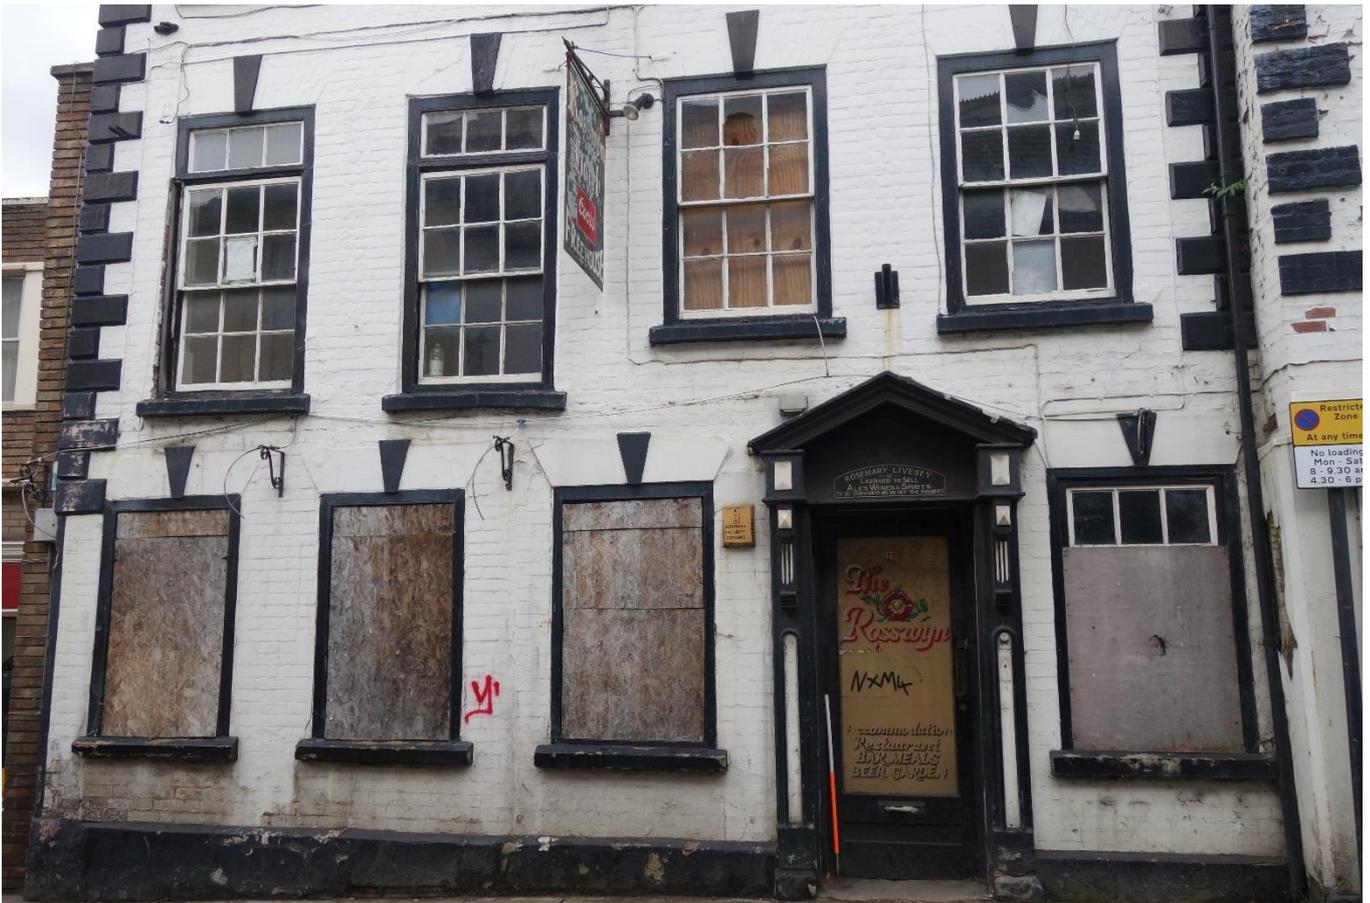
*Plate 2: View looking E showing detail of lower portion of front (W-facing) elevation of No. 17 High Street with open pedimented doorcase and flush box frame sash windows (the window to the right of the doorway is a modern replacement)*

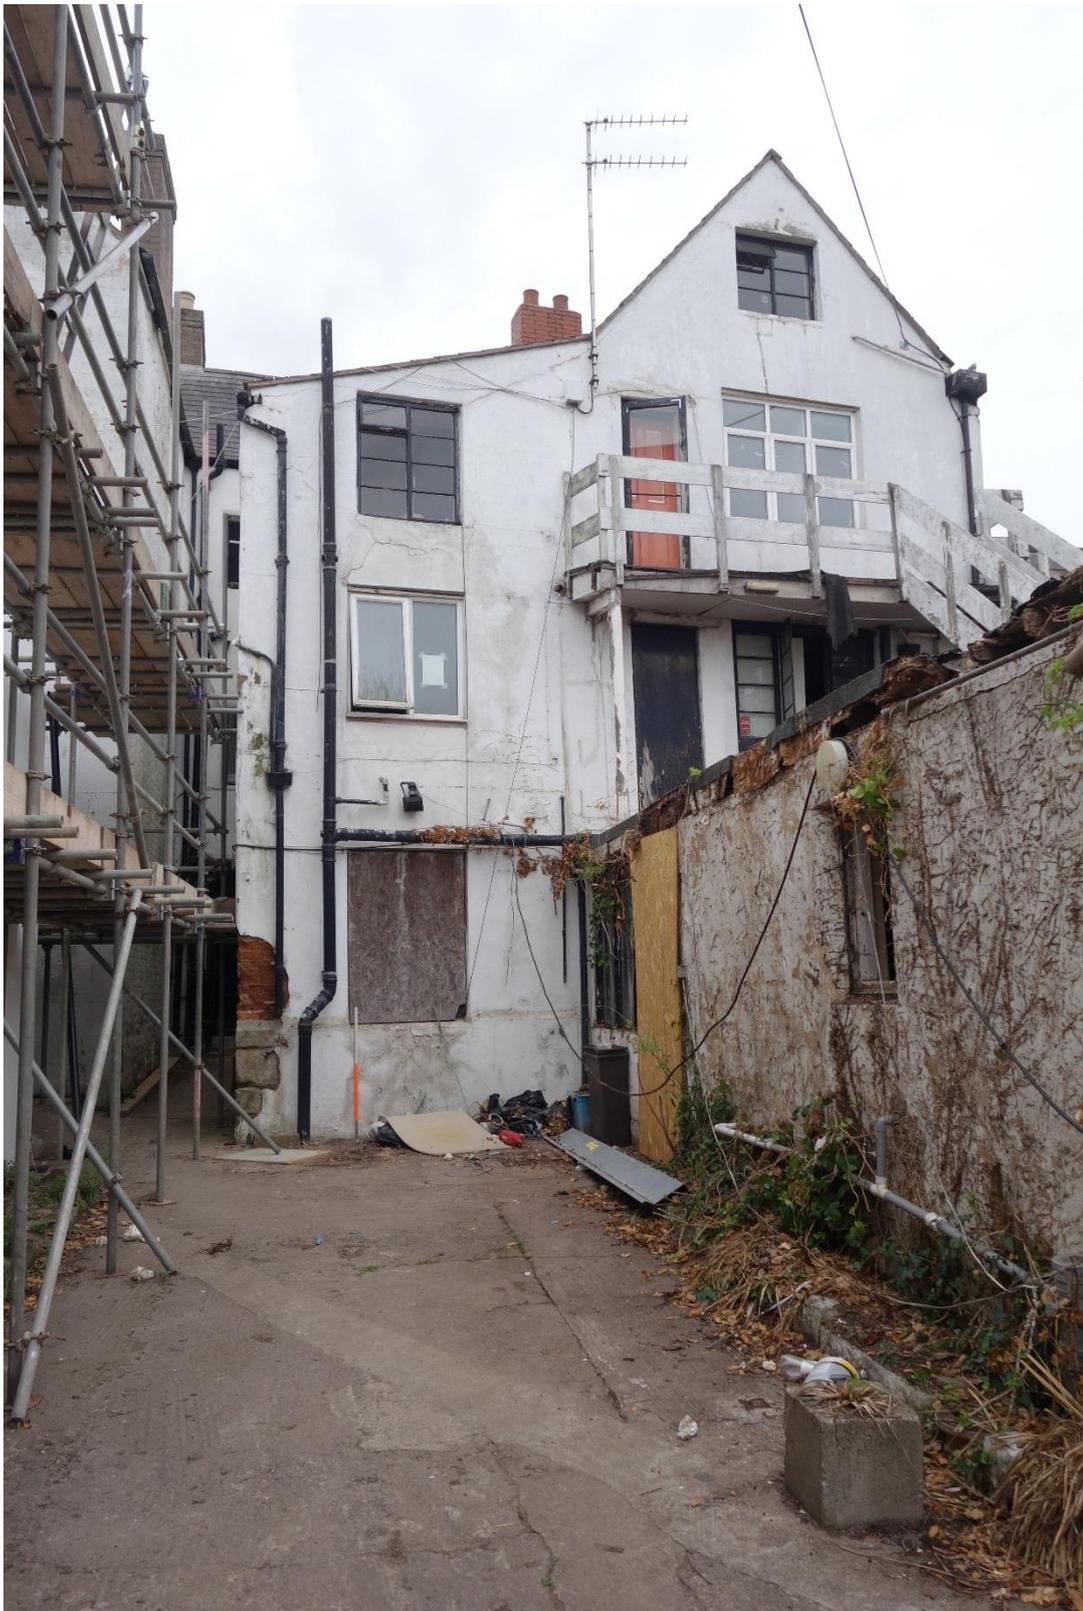
*Plate 3: View looking W showing rear elevation of No. 17 High Street with single storey modern outbuilding to right of picture*

The ground floor is largely concealed by a single storey rectangular building of brick construction and whitewashed externally, with a flat roof (covered with bitumen over plyboard) housing toilets and storerooms which appears to be entirely of late 20<sup>th</sup> century date.

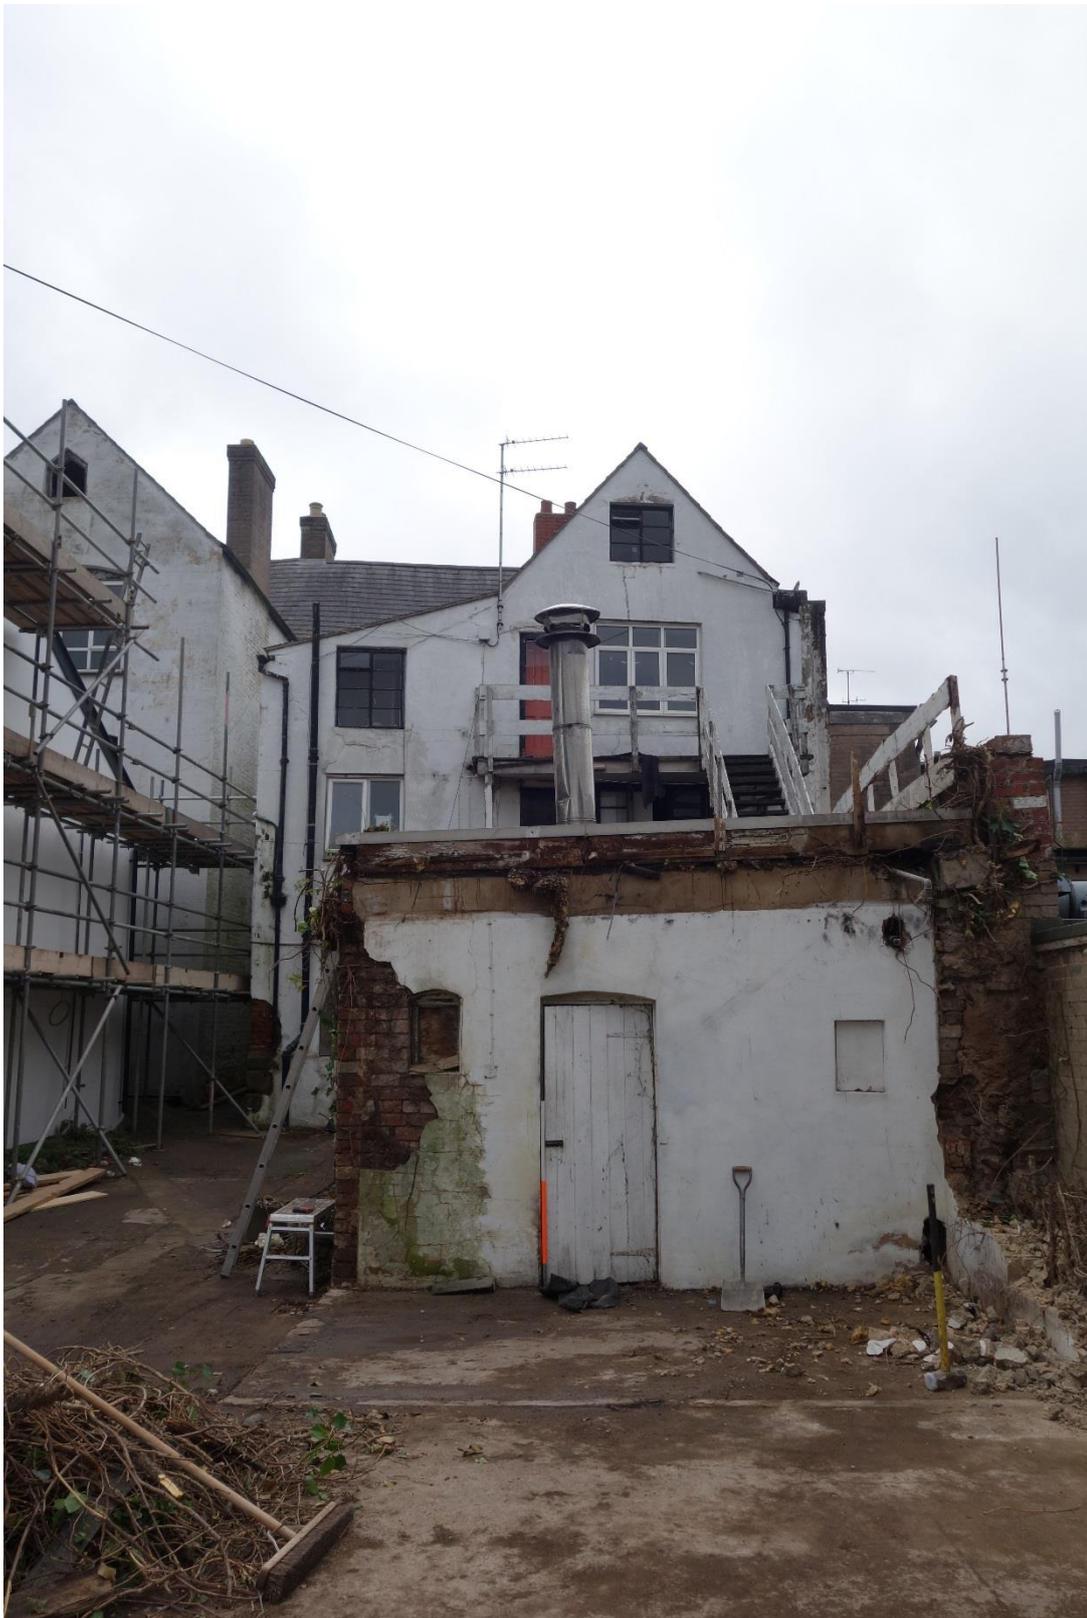
*Plate 4: View looking W showing rear elevation of Nos. 17 & 17 A High Street with outbuilding to rear of No. 17 in foreground*

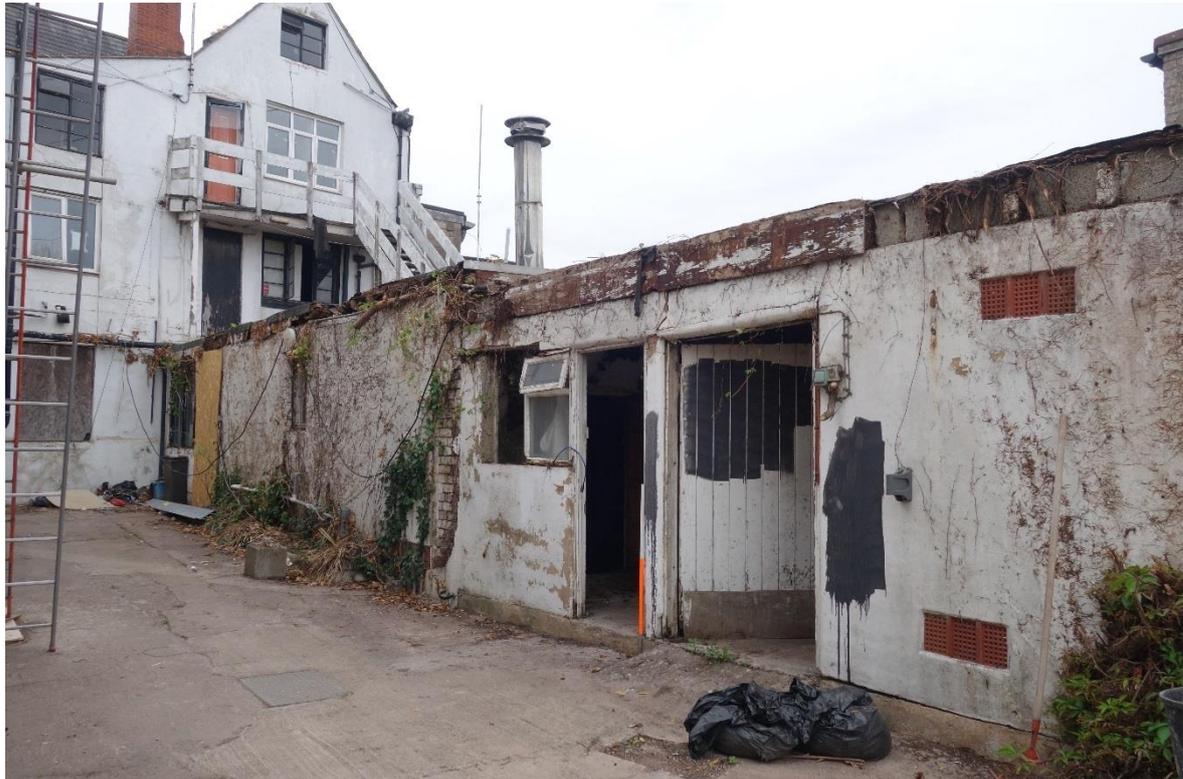
*Plate 5: View looking WNW showing S-facing elevation of modern single storey brick outbuilding to rear of No. 17*

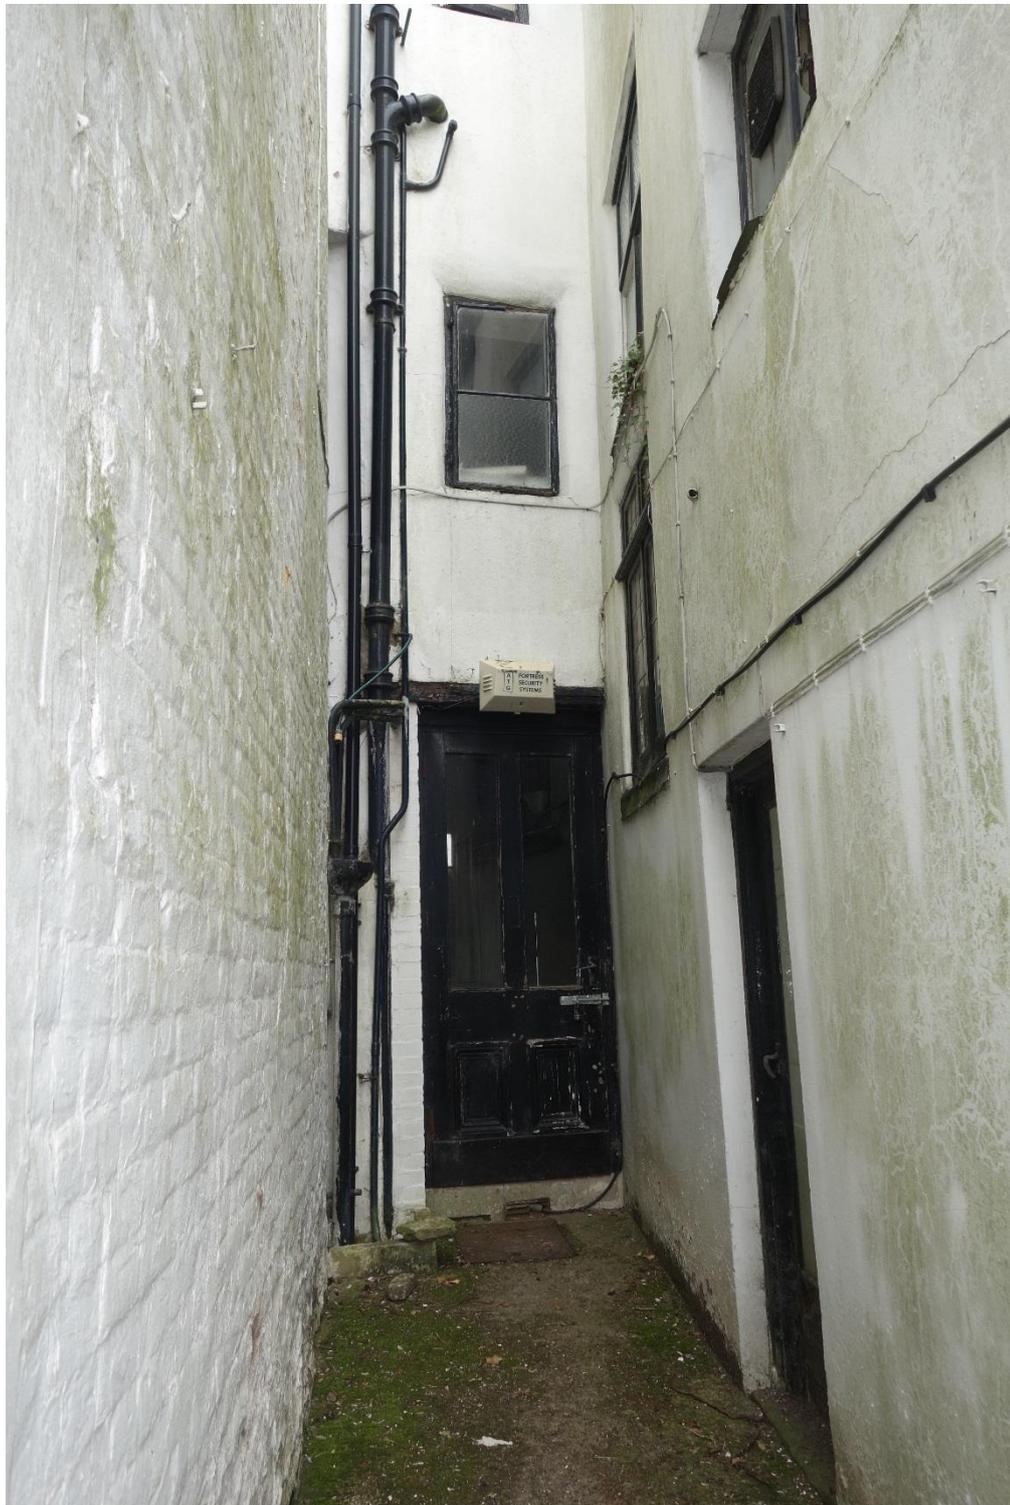
*Plate 6: View looking W showing modern rear entrance to No. 17 with earlier doorway and mullioned and transomed casement window in S elevation (to right of picture)*

The S-facing elevation is partially visible from the rear of Nos. 17 and 17A. A plan of the building surveyed by the RCHME in 1930 indicates that there was originally a covered passageway which originally ran E from the street frontage to the rear of the property, separating Nos. 17 & 17A. This passageway appears to have been removed at some point between 1950 and 1960 when the internal arrangements of both properties at ground floor level were significantly reorganized (presumably associated with its conversion into a hotel). The elevation is heavily rendered although portions of render have been removed to reveal roughly coursed rubble masonry at ground level. A single flat headed doorway with a moulded wooden door frame is located roughly midway along the elevation, the glazed door itself appears to be a modern replacement (*Plate 6*).

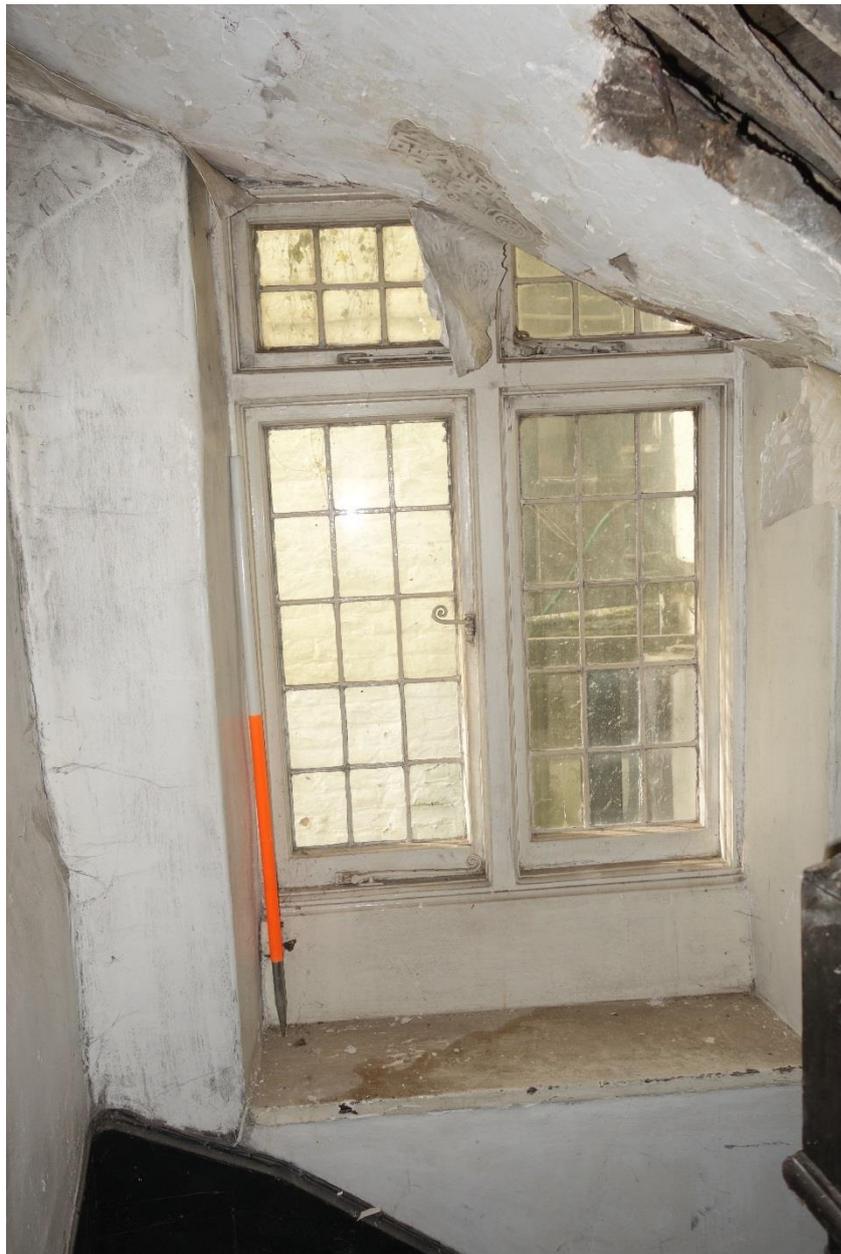
*Plate 7: Internal view showing detail of mullioned and transomed window in S wall, lighting the staircase between ground and first floor level*

Above and to the left of this doorway is a mullioned and transomed casement window with leaded lights and a wooden sill which lights the staircase leading from ground to first floor level (*Plates 6 & 7*). Above this window is another mullioned and transomed window lighting the staircase landing at first floor level; however, this window is glazed with frosted glass and the glazing bars are evidently of modern date. To the right of this window, a two light glazed window of modern date has been inserted at first floor level.

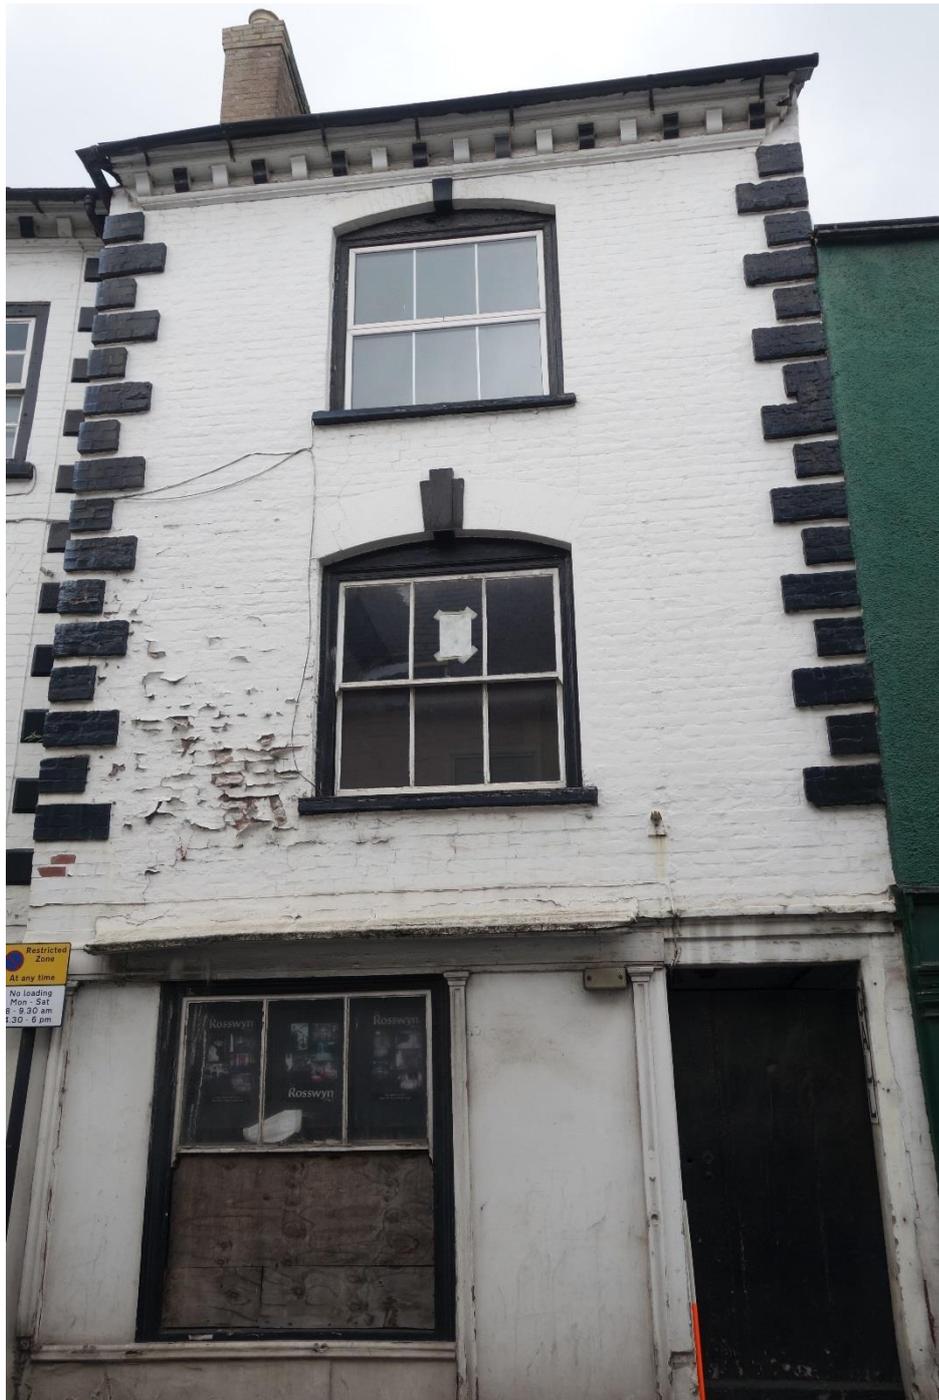
*Plate 8: View looking E showing front (W-facing) elevation of No. 17A High Street*

At ground floor level is a plain-flat headed doorway with a plank and batten door which leads to a covered passageway extending to the rear of the property, between No. 17A and Nos. 18-19. To the right of this doorway is a wide flat-headed six paned sash window set within a flush moulded case, above which is a moulded fascia board carried on three thin fluted pilasters (*Plate 8*).

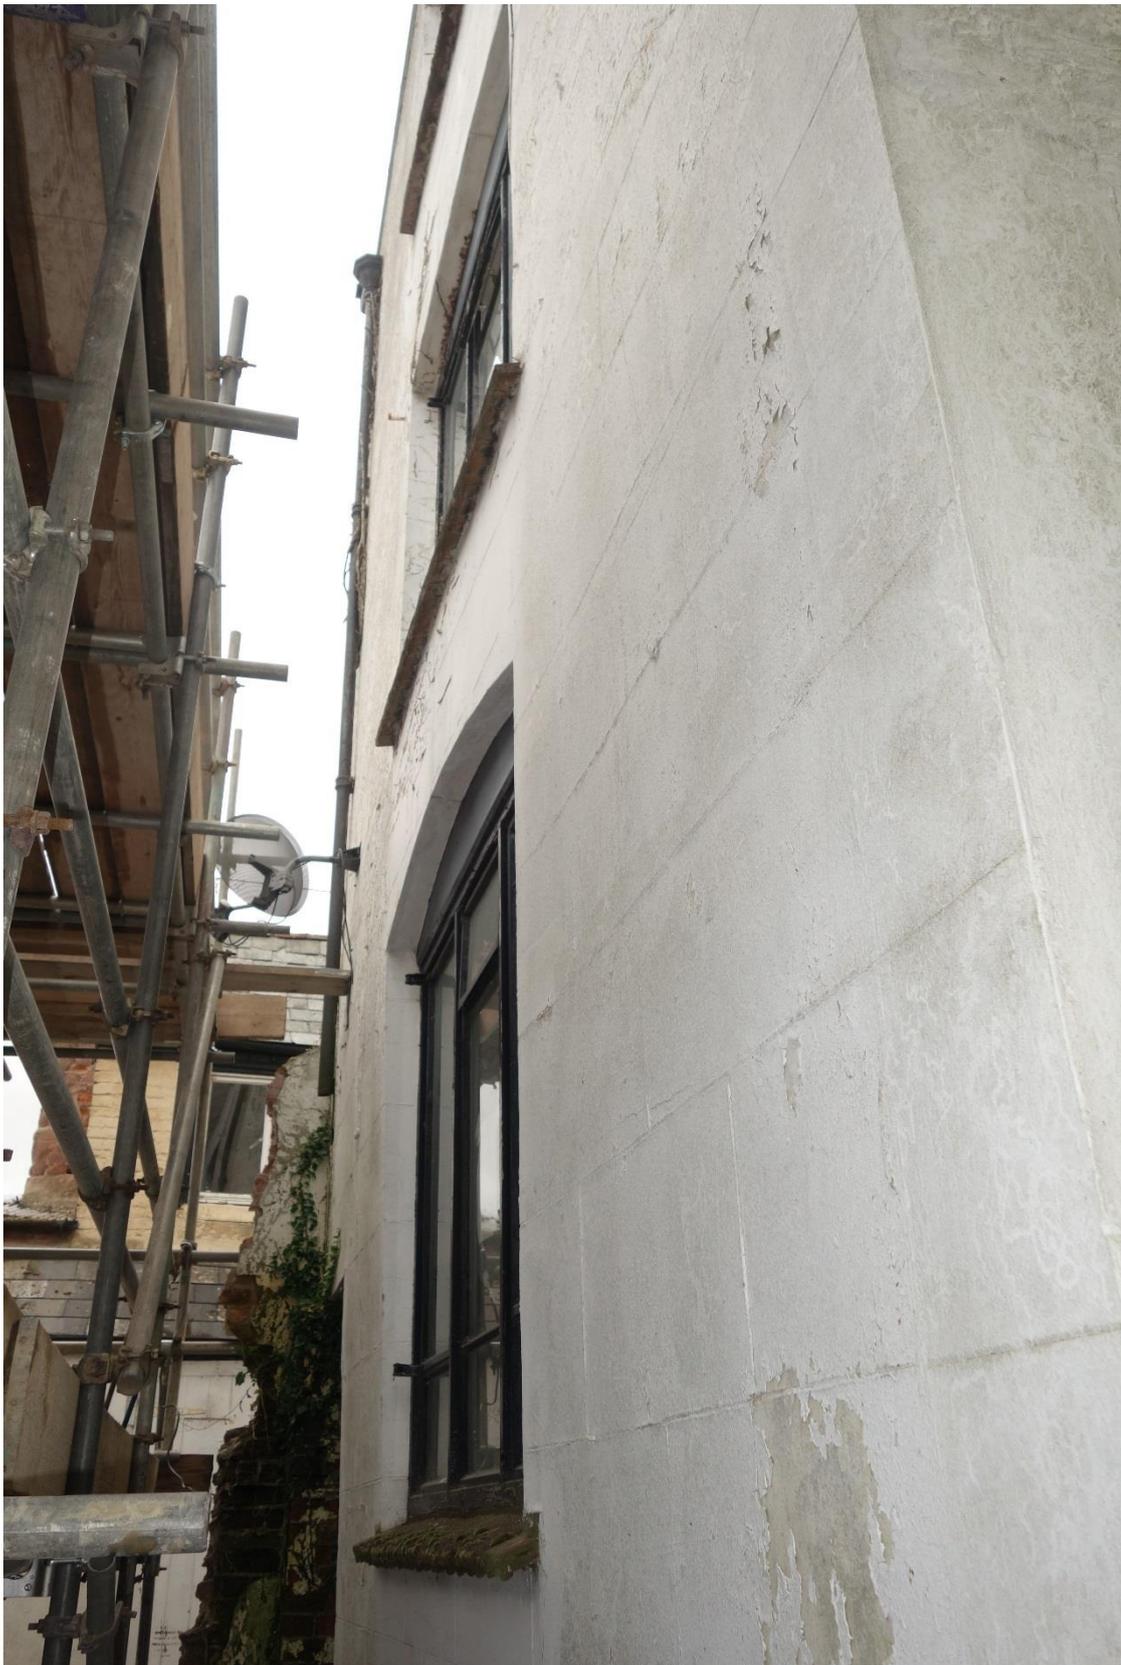
*Plate 9: View showing fenestration of rear (E-facing) elevation of No. 17A High Street, partially concealed by scaffolding*

The rear (E-facing) elevation of No. 17A is gabled and rendered externally. The fenestration consists of wide segmental arched windows on the ground, first and second floors, lit by tripartite casements at ground and first floor level (*Plate 9*), while the original window frame of the second floor window has been replaced by a 6-paned PVC casement. Inserted in the apex of the gable is a single-light pentagonal window; the glazing has been removed although the internal wooden frame of the window remains intact.

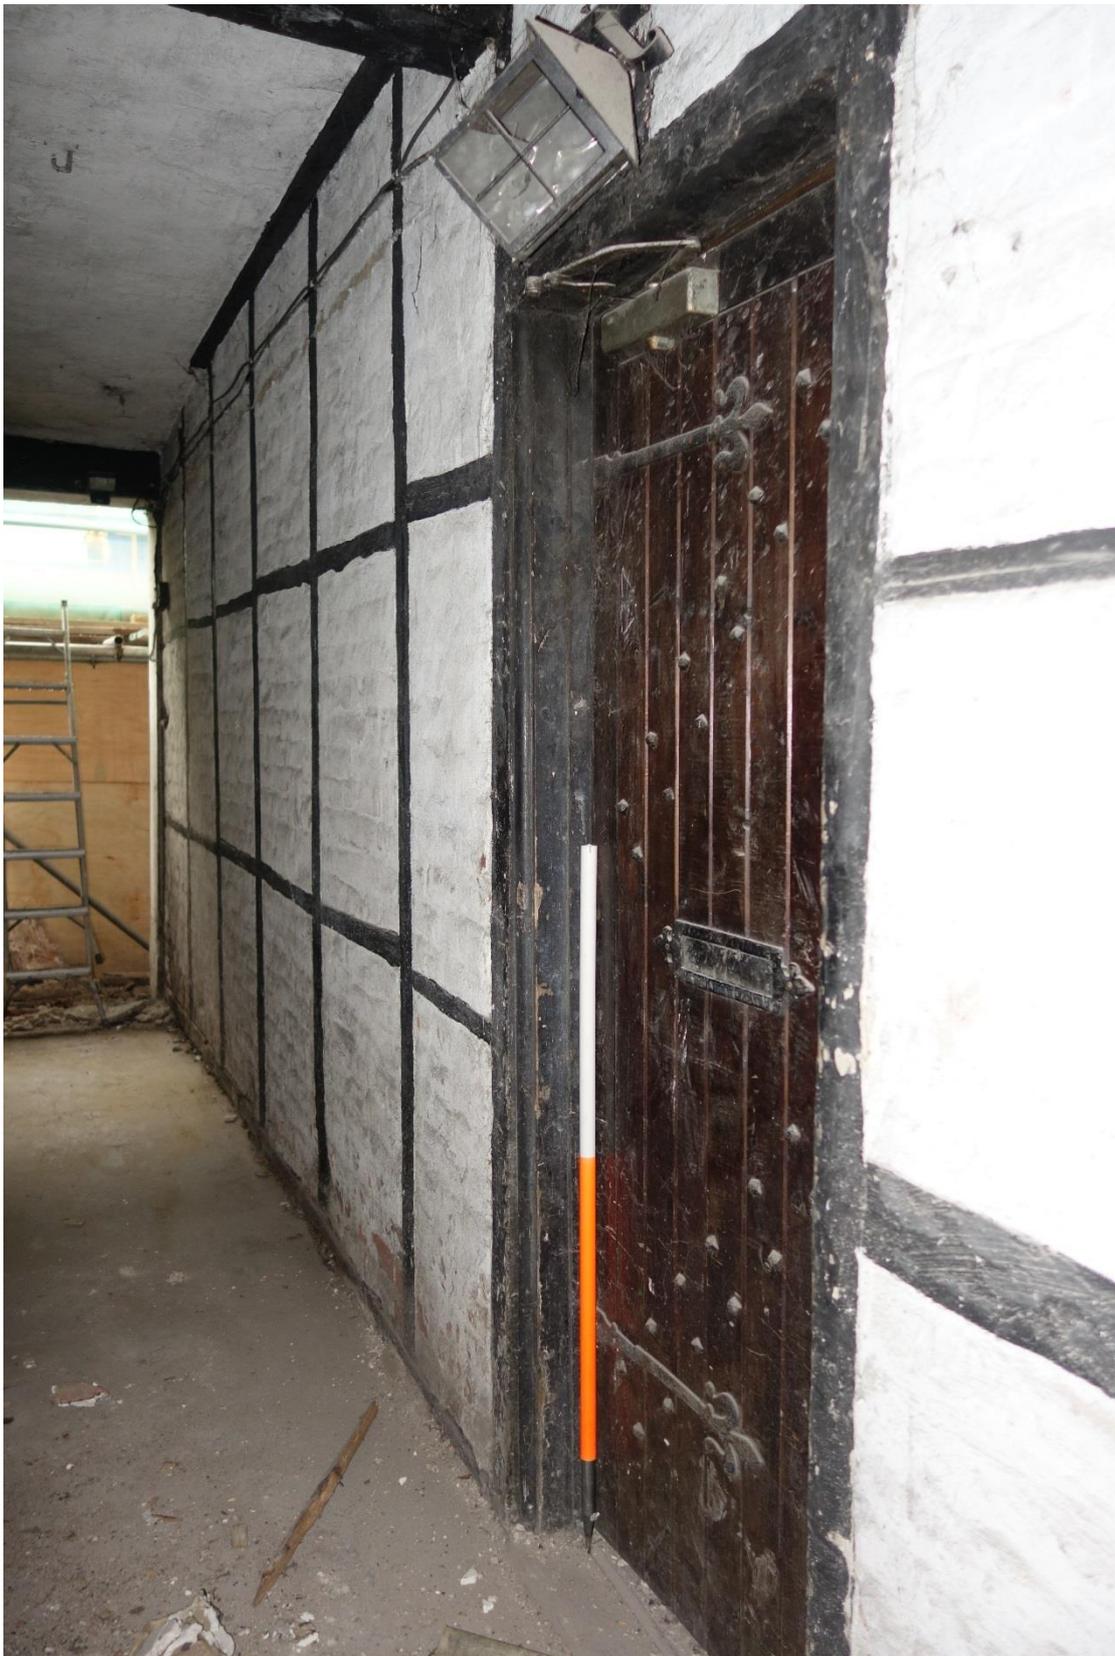
*Plate 11: View looking WNW showing moulded doorway set in S wall of covered passageway between No. 17A & No. 18*

The N-facing elevation is rendered and wholly devoid of fenestration. The S-facing elevation has a single light, flat headed glazed window inserted in the apex of the gable. At ground floor level (within the covered passageway separating No. 17A from Nos. 18-19 to the S), there are exposed rectangular timber framed panels with brick infill, coated in whitewash (*Plate 10*). Located roughly midway along the elevation is a plank and batten door with cast iron door straps and studs, set within a flat-headed, moulded wooden architrave (*Plate 11*).

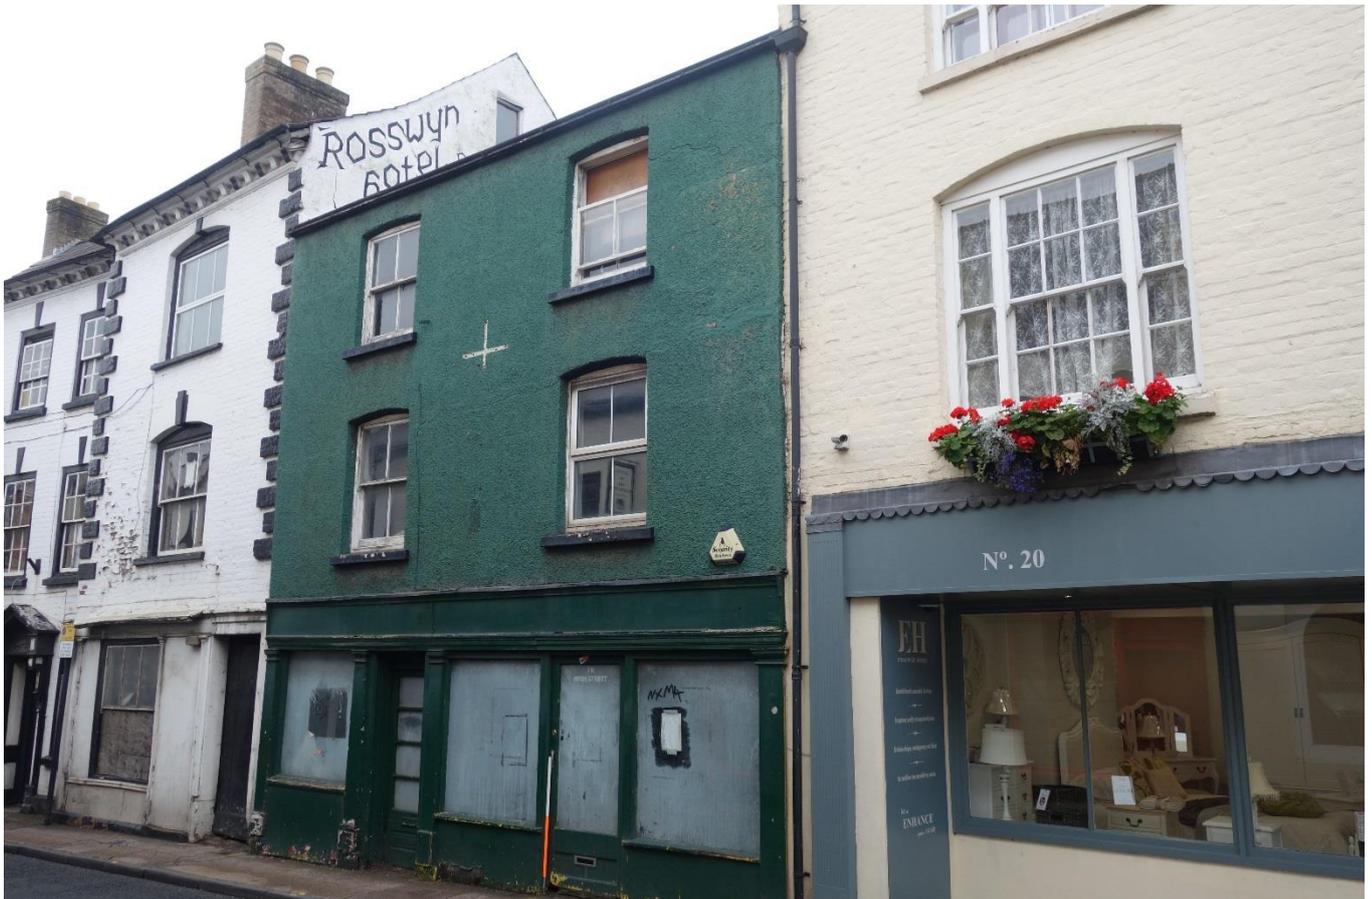
The front (W-facing) elevation of Nos. 18 & 19 High Street is three storeys in height and two bays wide, of brick construction, the upper storeys rendered with a glazed double-shop frontage at ground floor level. The upper part of the elevation is coated in a dull green render (*Plate 12*).

*Plate 12: View looking NE showing front (W-facing) elevation of former shop premises at Nos. 18 & 19 High Street*

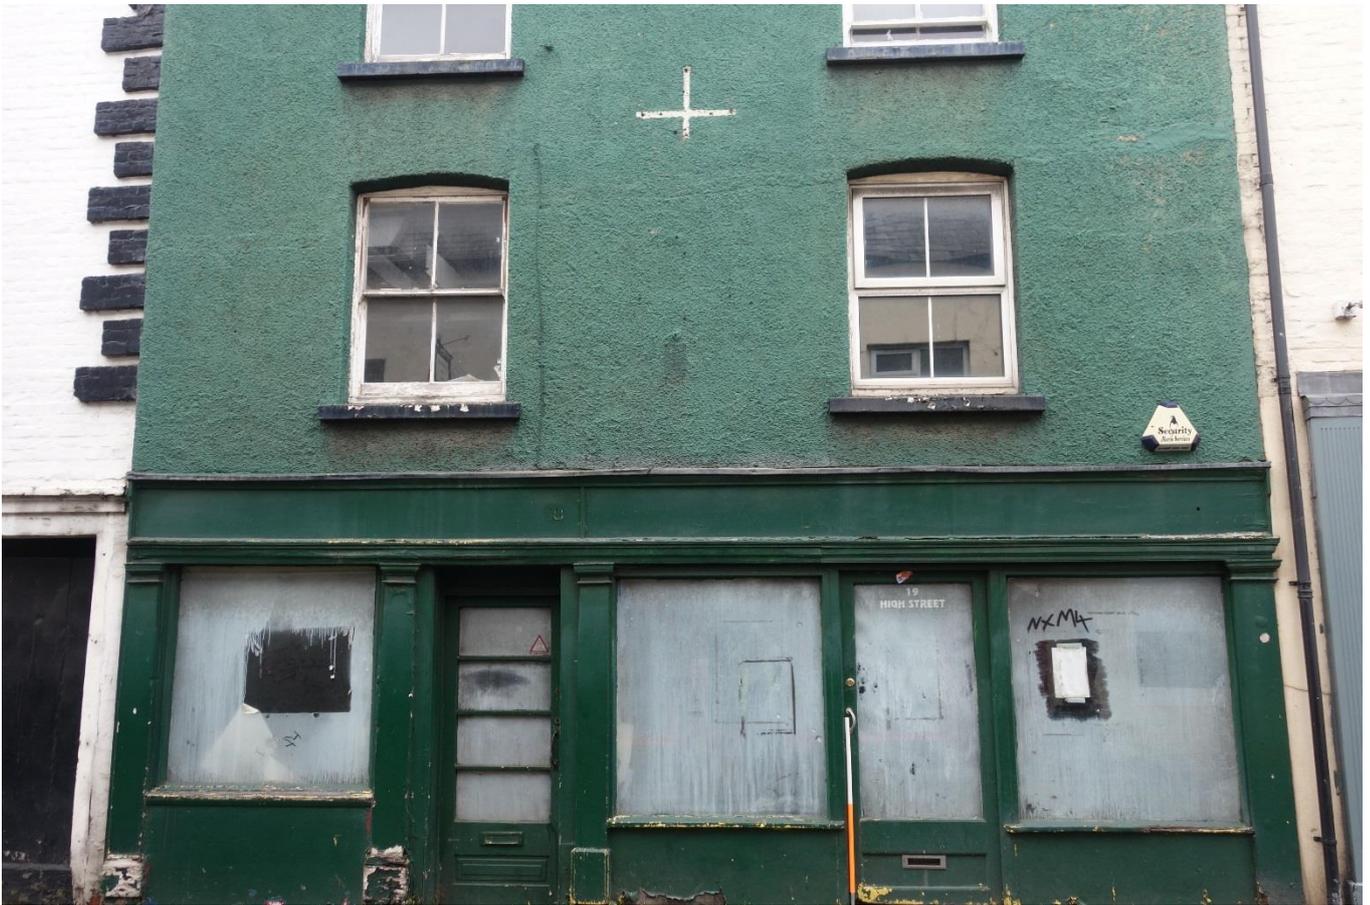
The shop frontage consists of three plate glass windows set within wide flat-headed openings with wooden sills, between which are two flat-headed doorways. It appears from early 20<sup>th</sup> century photographs that the plate glass windows originally had vertical glazing bars and that there were originally six intervening Tuscan pilasters along the full width of the elevation; of these only four have survived, the pilasters flanking the doorway to No. 19 having been removed.

*Plate 13: View looking E showing detail of glazed shop frontage at Nos. 18 & 19 High Street with segmental arched windows above*

Early 20<sup>th</sup> century photographs appear to show that there was originally only one doorway to the shop frontage, namely the door to No. 19, the present doorway to No. 18 represents a modern insertion, replacing a window which is shown on photos of c.1910 and 1930. Above the shop front is a moulded fascia board which runs the full width of the elevation (*Plate 13*). The fenestration at first and second floor level consists of two four paned windows set within segmental arched openings with wooden sills. Three of the windows are sashes but the sash frame for the right hand window at first floor level has been replaced with a modern casement.
