## Standing Building Recording Survey

**BGD Property Ltd**

Former Rosswyn Hotel  
16-19 High Street  
Ross-on-Wye  
Herefordshire HR9 5BZ

**October 2016**

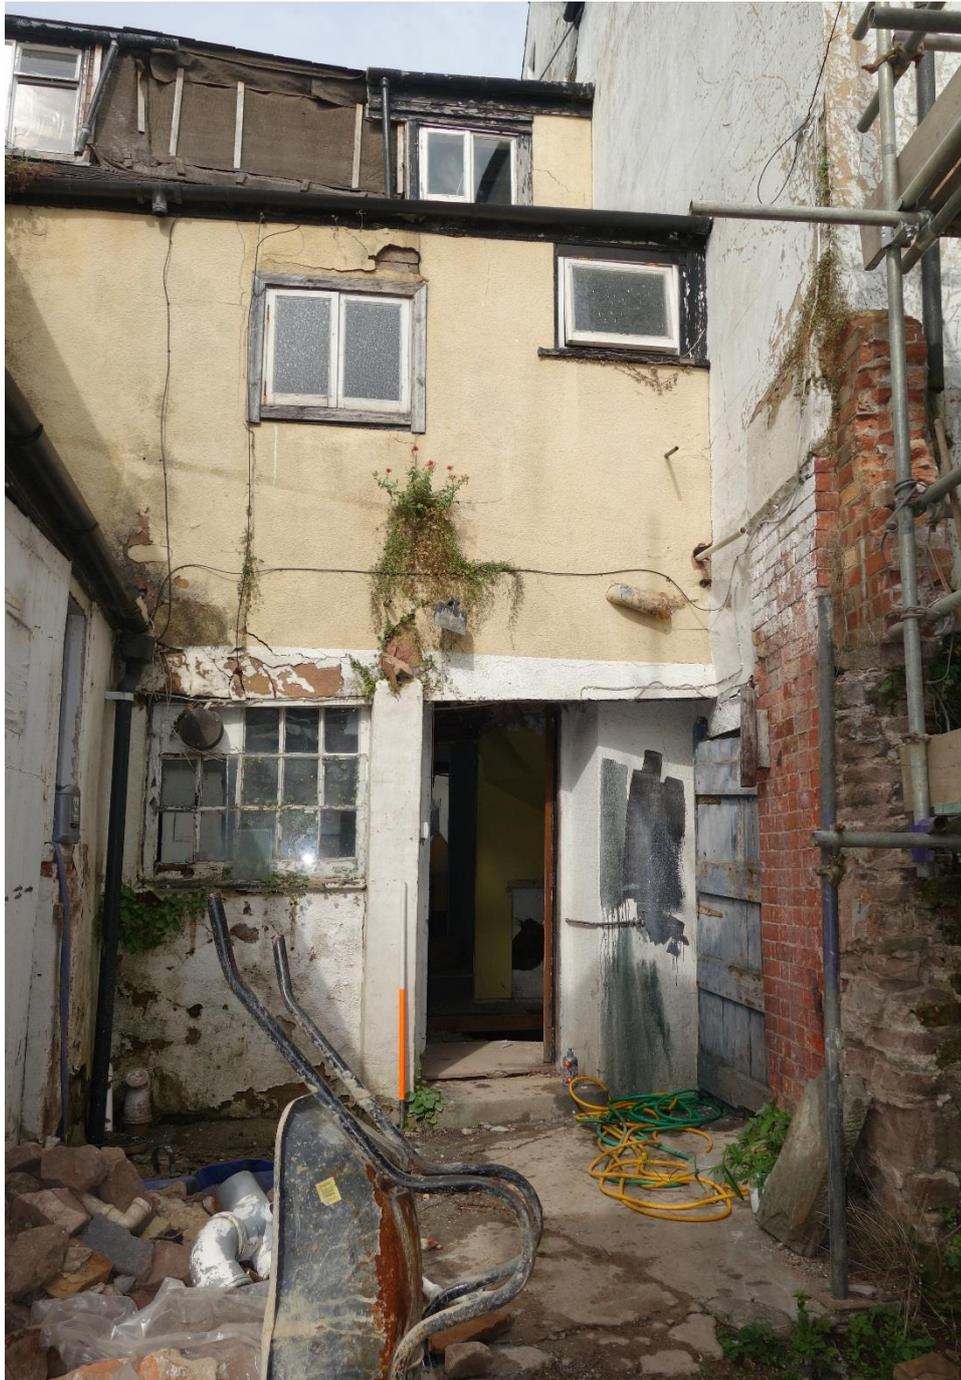
*Plate 14: View looking W showing rear elevation of No. 18 High Street*

The rear elevation of Nos. 18 & 19, which is in a very dilapidated condition, is of tiered construction with a slightly recessed uppermost storey. The exterior is heavily rendered but appears to be of timber framed construction with sections of brick and lath and plaster infill. The fenestration at ground and upper storey level appears to be of modern date (*Plate 14*).

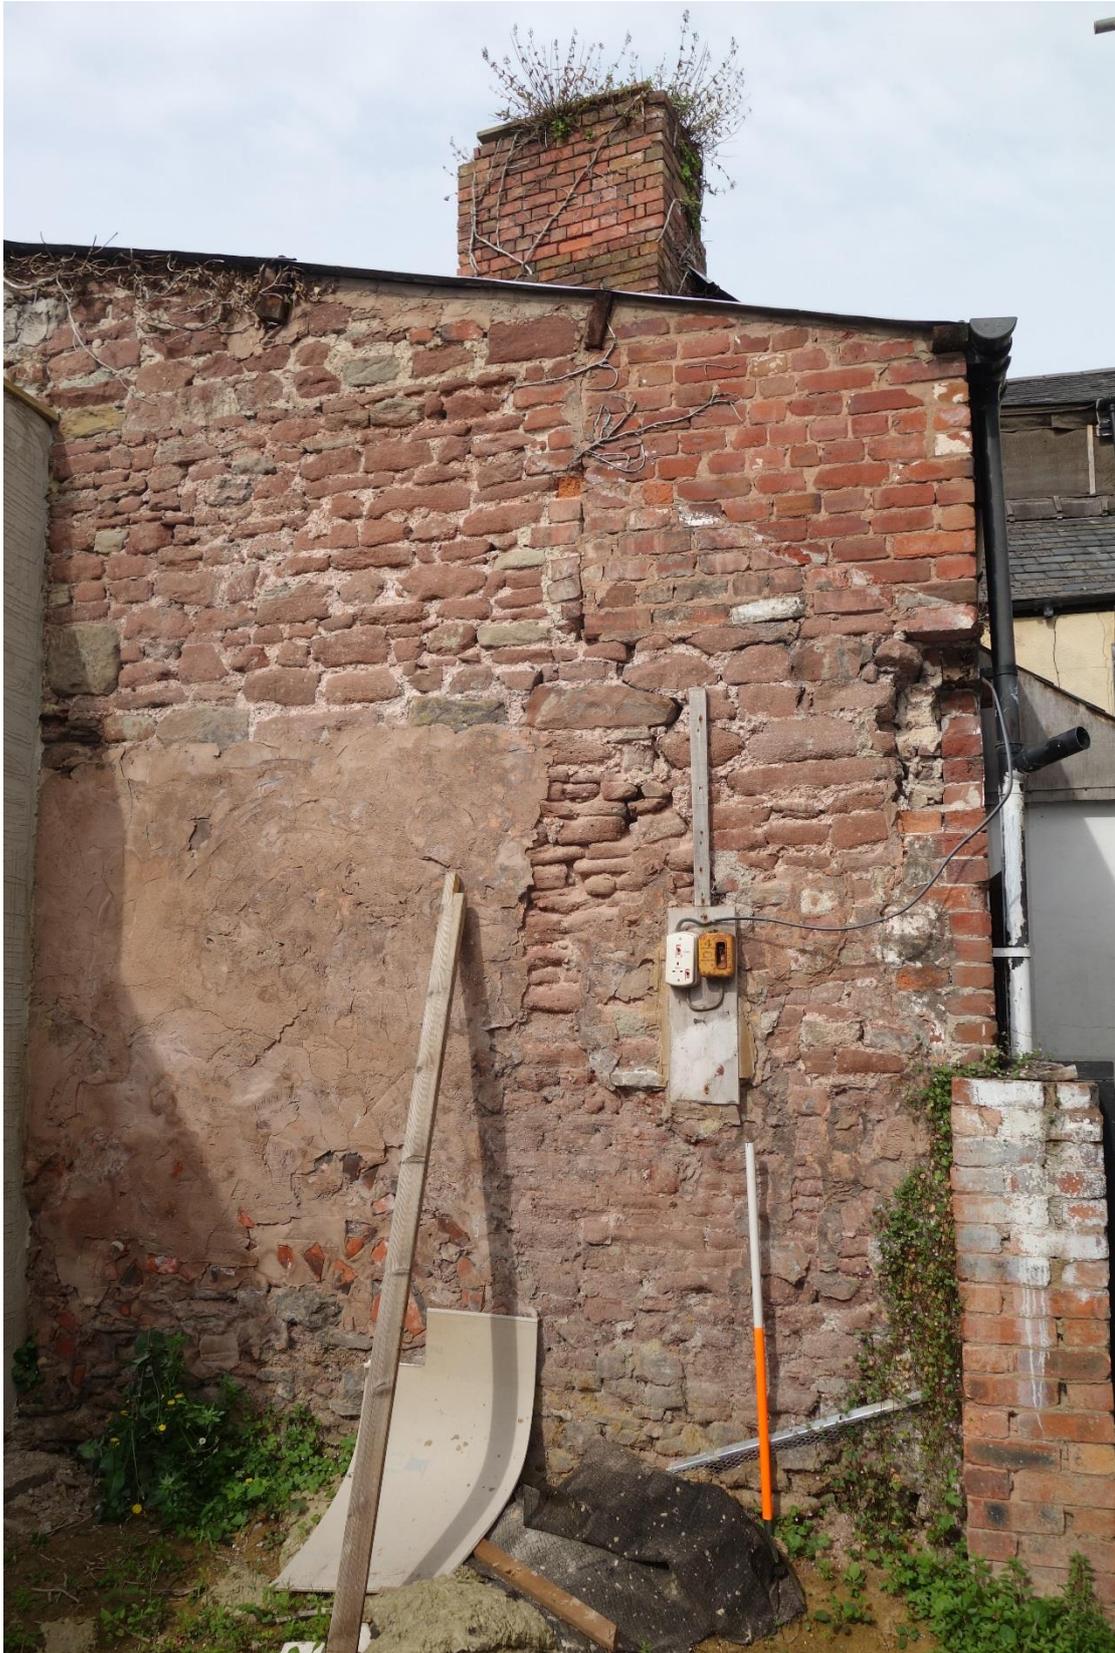
have been largely rebuilt in brick at some point during the 19<sup>th</sup> century. Attached to the E end of the gabled block is a small rectangular outbuilding with a catslide roof of probable 19<sup>th</sup> century date (*Plate 15*). The N and S walls are of brick construction, laid in English Garden Bond, and appear to have been extensively renewed at some point during the 20<sup>th</sup> century, while the E gable end wall is constructed of roughly coursed rubble masonry with brick infill.

*Plate 15: View looking W showing rear (E-facing) elevation of outbuilding to rear of No. 19 High Street*

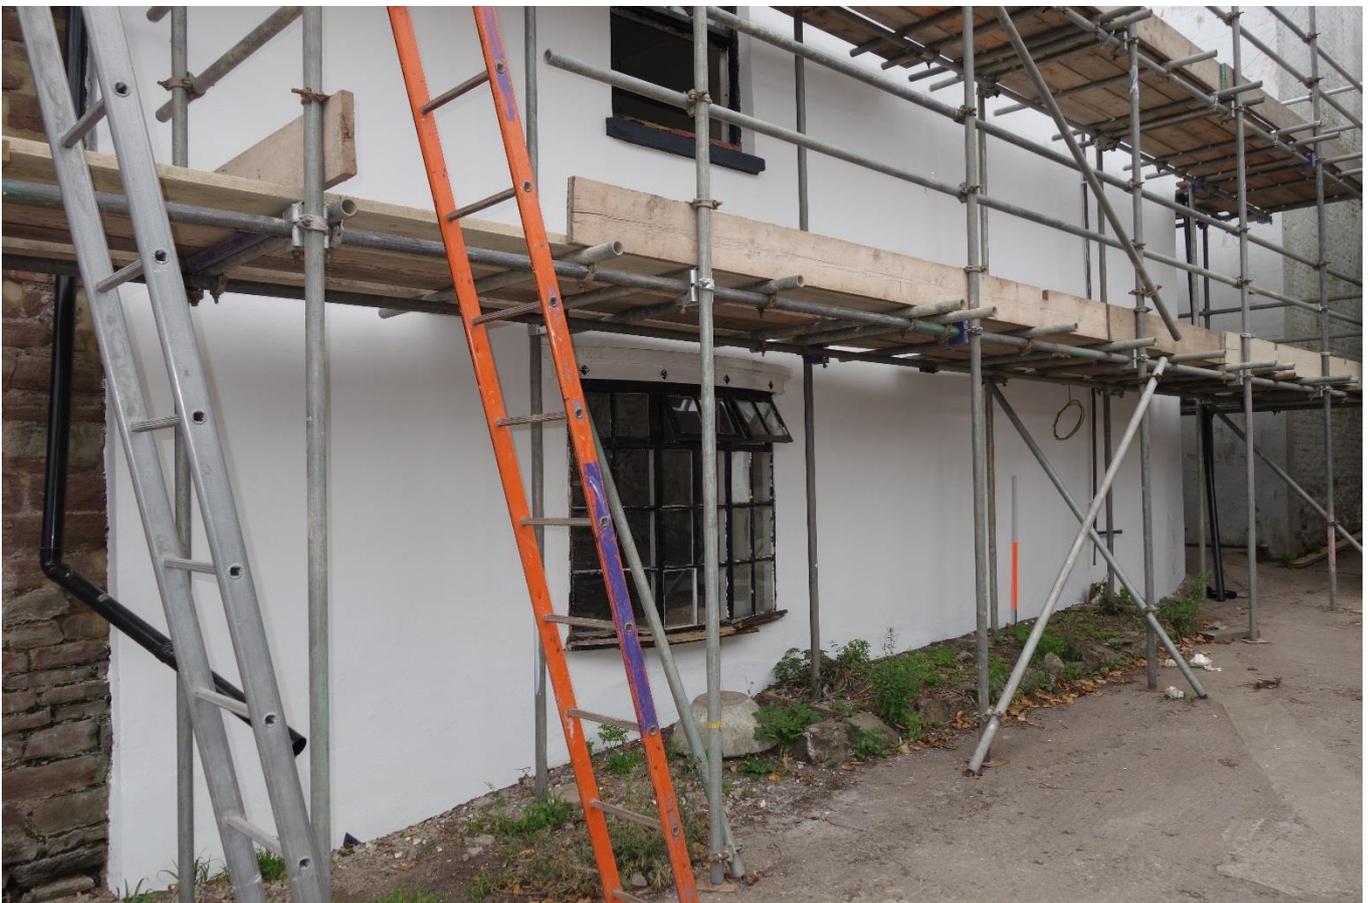
The detached L-shaped gabled building to the rear of No. 17A appears to have been constructed at some point in the mid-late 19<sup>th</sup> century; it is first shown on the OS 1<sup>st</sup> edition 25 inch map of 1887. The building stands to a height of two storeys and is of brick construction, externally rendered with a pitched slate roof (*Plate 16*). Substantial alterations to the building were made in the late 20<sup>th</sup> century when it was converted into accommodation for the owner of the hotel. All the extant window and door openings appear to be of late 20<sup>th</sup> century date, including a bow window with a leaded casement in the N-facing wall. Evidence of an external stairway was noted against the W elevation of the building, possibly associated with a lean to structure in this location which is marked on the OS 1<sup>st</sup> edition map.

*Plate 16: View looking WSW showing N-facing elevation of detached building to the rear of No. 17A High Street with a modern bow window inserted*

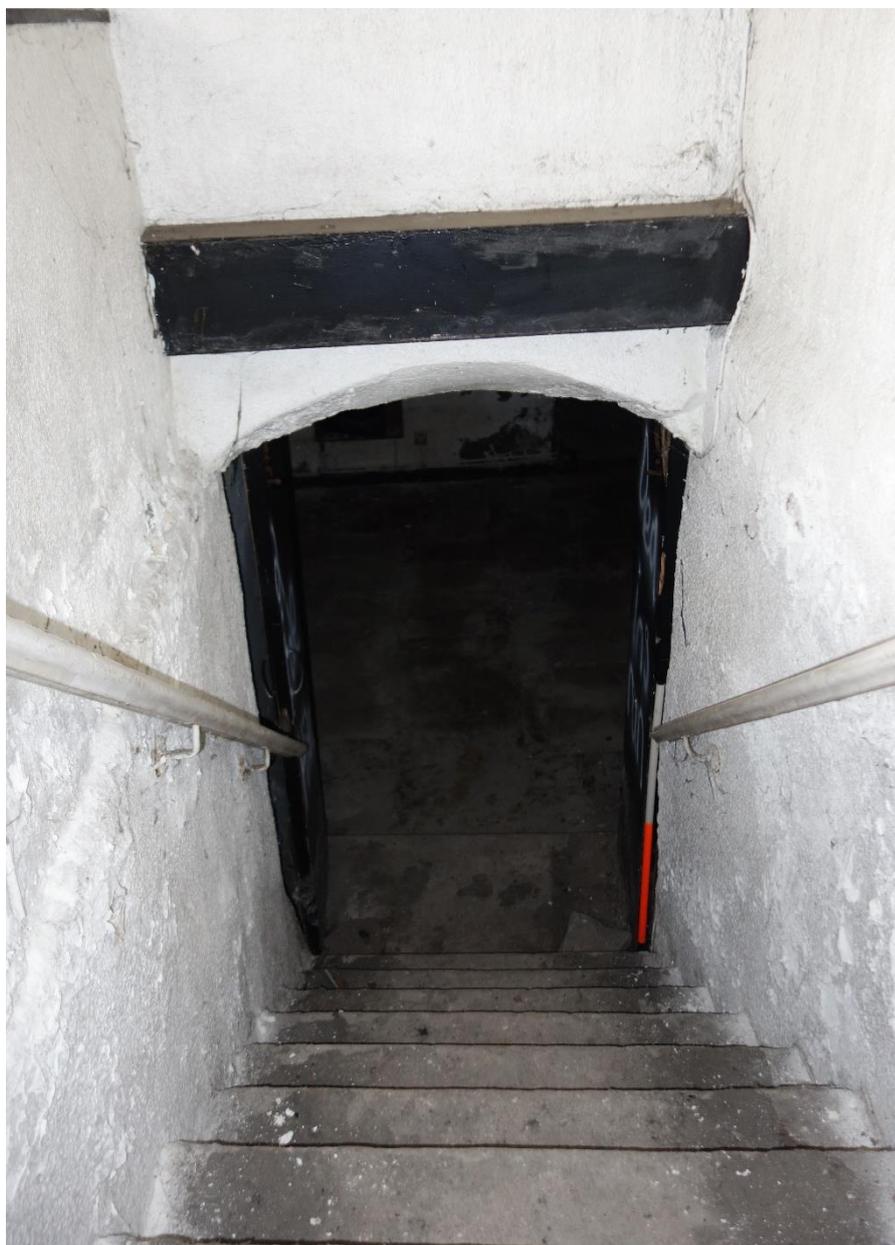
*Plate 17: Internal view looking W showing steps leading down to brick vaulted cellarage*

The cellarage is accessed by a flight of stone steps (which appear to have been renewed) leading down from the modern outbuilding to the rear of the main house to the cellar entrance, which consists of a roughly hewn low archway (*Plate 17*). The archway leads into a roughly square cellar with a low brick barrel vault which appears likely to be of 18<sup>th</sup> century in date.

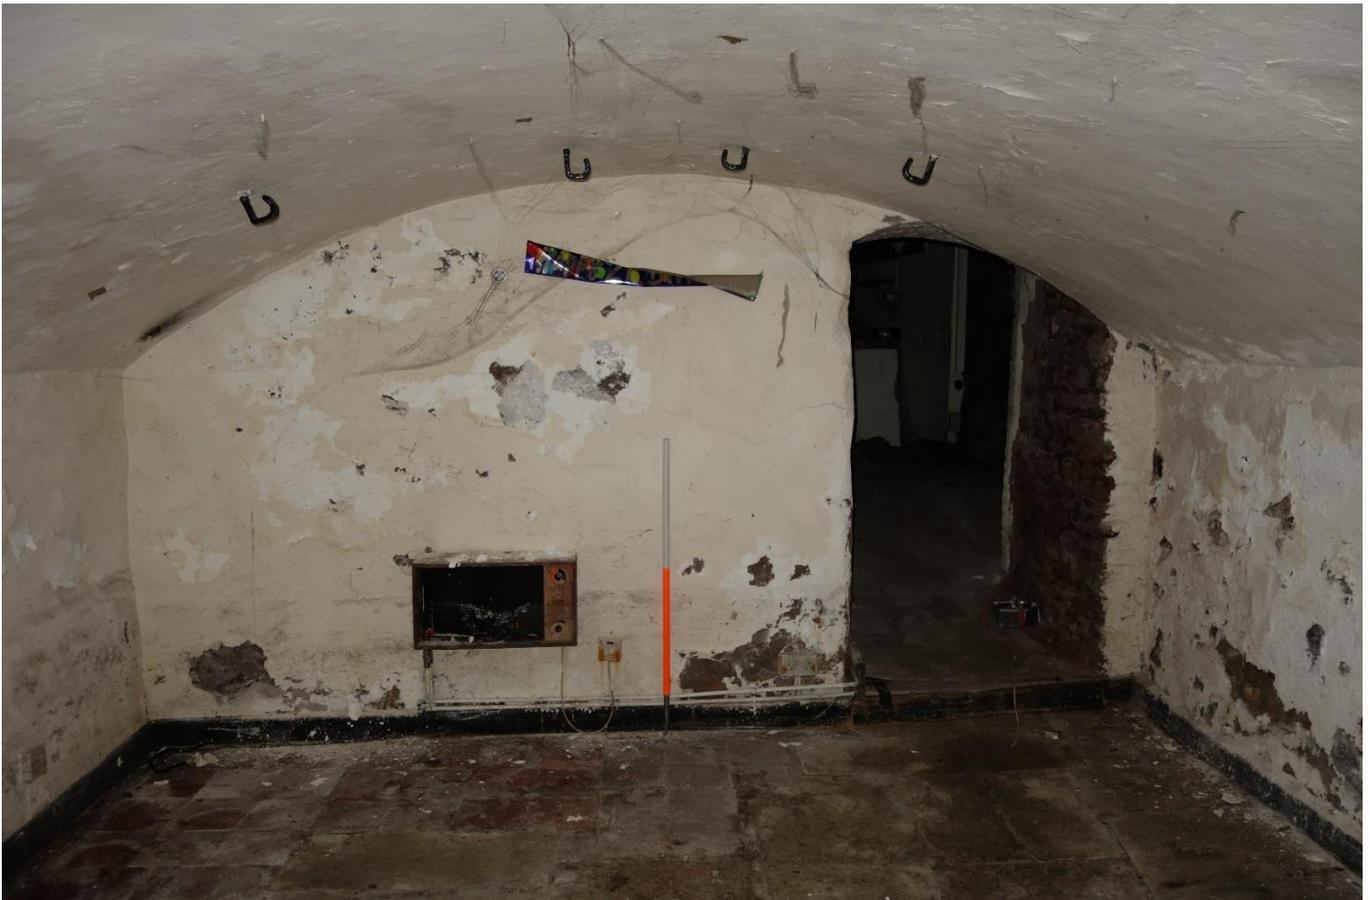
*Plate 18: Internal view looking E showing brick barrel vaulted cellarage (with hooks inserted in the vaulted ceiling) and stone flagged floor*

The walls of the cellar (of rubble sandstone masonry) and the brick vaulted roof are all coated in thick whitewash. Two rows of four cast-iron hooks have been inserted in the vaulted ceiling of the cellar, probably for hanging carcasses (*Plate 18*). The flooring of the compartment mostly consists of rectangular stone flags although some of the flagstones have been replaced by modern red ceramic tiles in the vicinity of a modern gas heater attached to the W wall of the cellar,

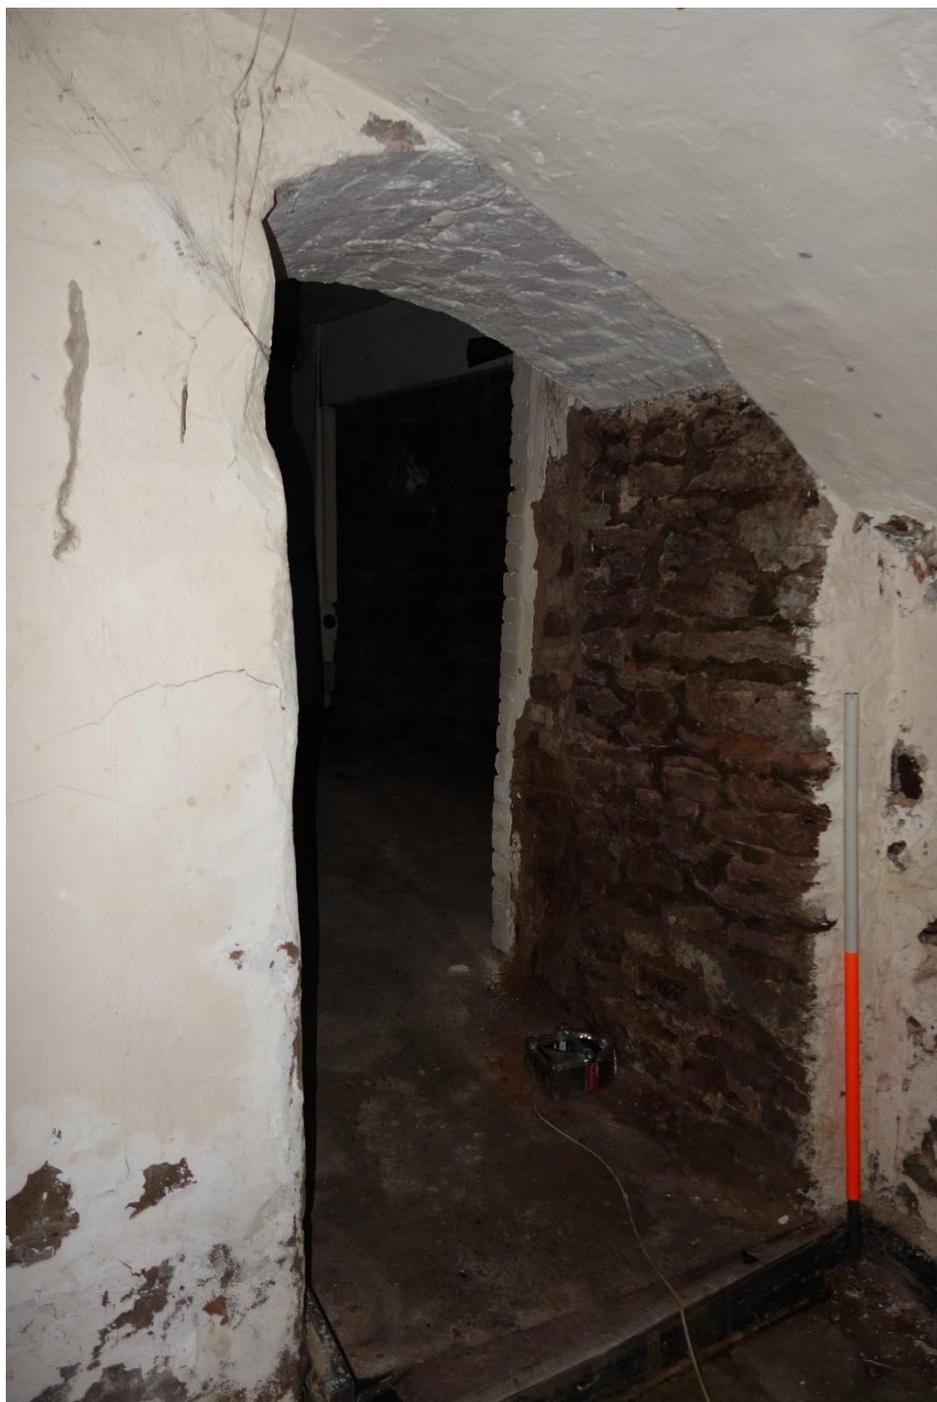
*Plate 19: Internal view looking NW showing archway to earlier part of cellar, constructed of roughly coursed rubble masonry walls and partly obscured by later brick vault*

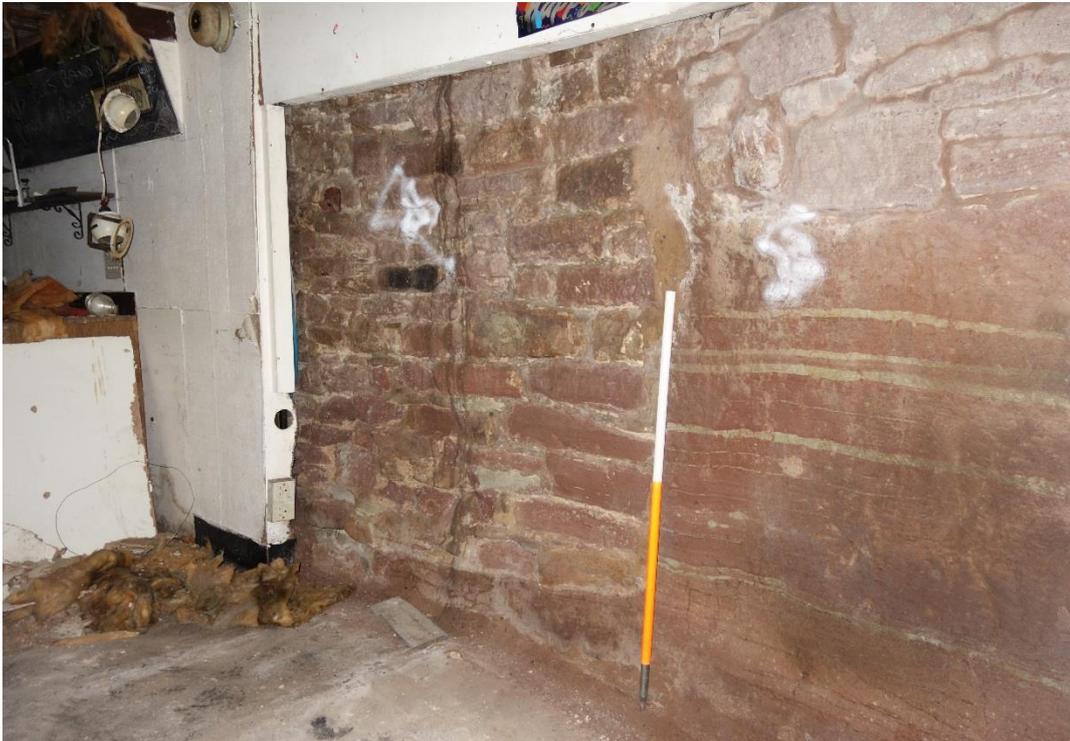
*Plate 20: Internal view looking NW showing N wall of earlier cellarage, constructed of roughly coursed sandstone masonry and cut from the natural bedrock*

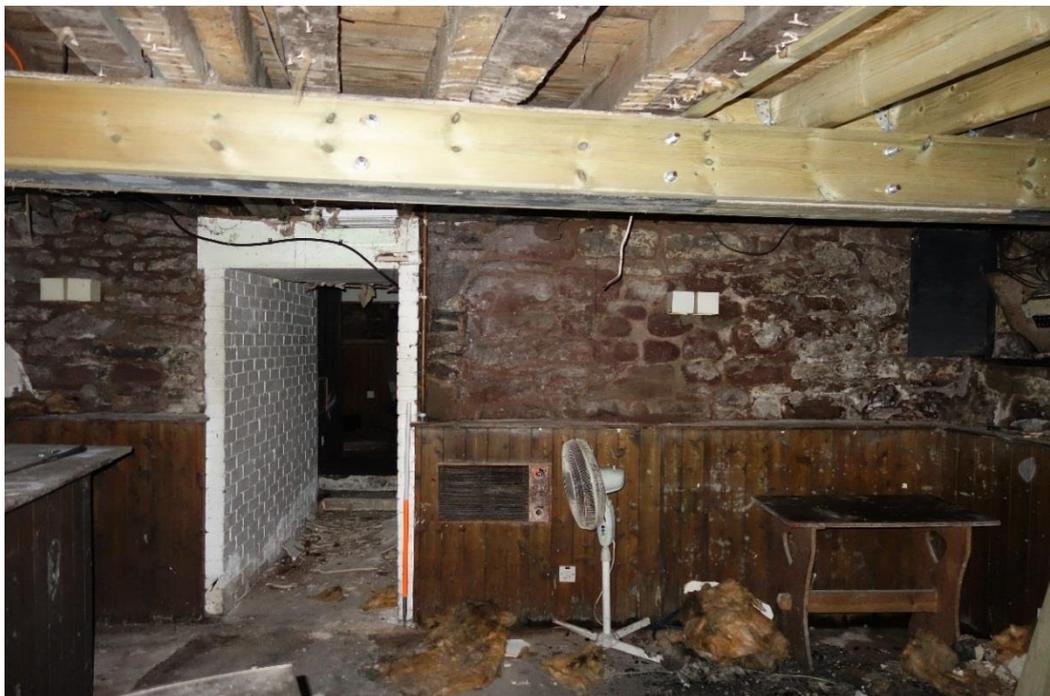
*Plate 21: Internal view looking S showing cellarage beneath the frontage of No. 17 High Street and modern brick passage leading to No. 17A*

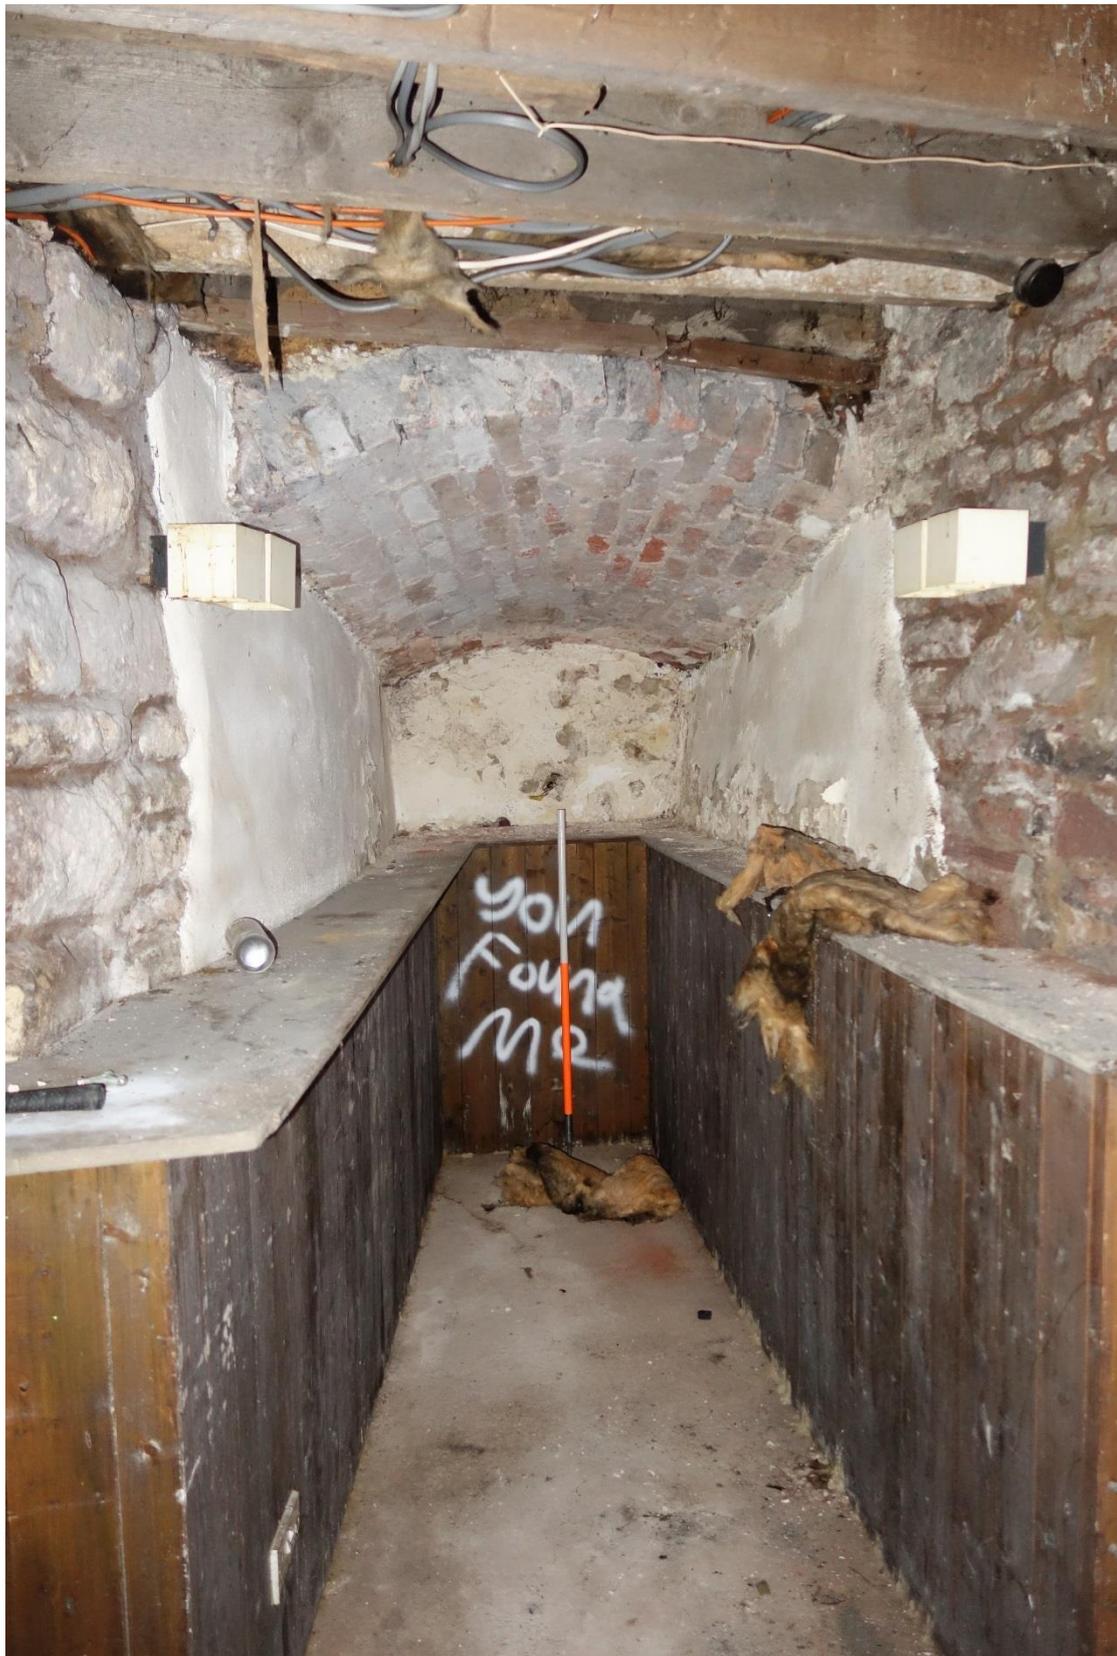
Plate 22: Internal view looking E showing brick vaulted passage in E wall of cellarage beneath No. 17

No architectural detailing was noted which could help to precisely establish the date of construction, although it is worth noting that this part of the cellar appears to lie beneath the front portion of the building which appears to have been reconstructed in brick during the 18<sup>th</sup> century. Located in the SE corner of the cellar is a deep recessed passageway, blocked at the E end, with a low brick barrel vault of probable modern date (*Plate 22*).

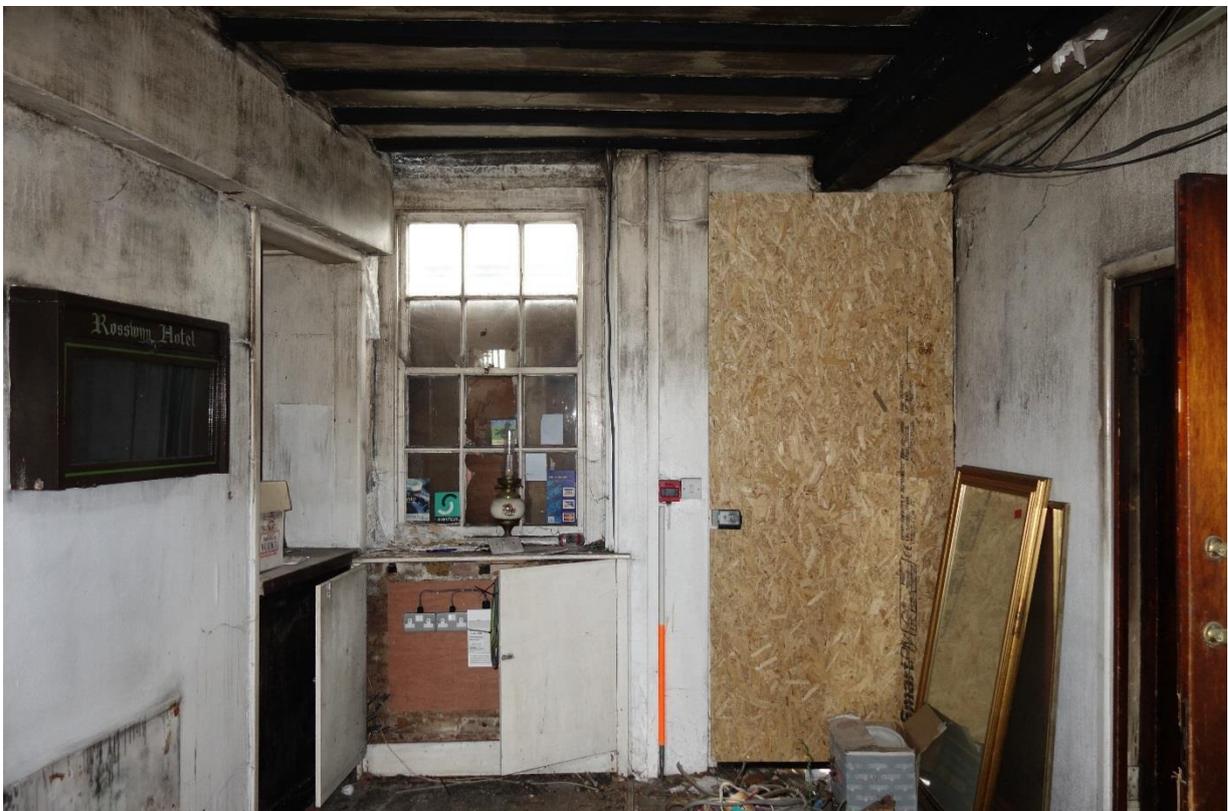
The front entrance to the house from the High Street leads into a hallway with a timber joisted ceiling and a planked floor, the walls have all been heavily rendered.

Plate 23: Internal view looking W showing the ground floor hallway of No. 17

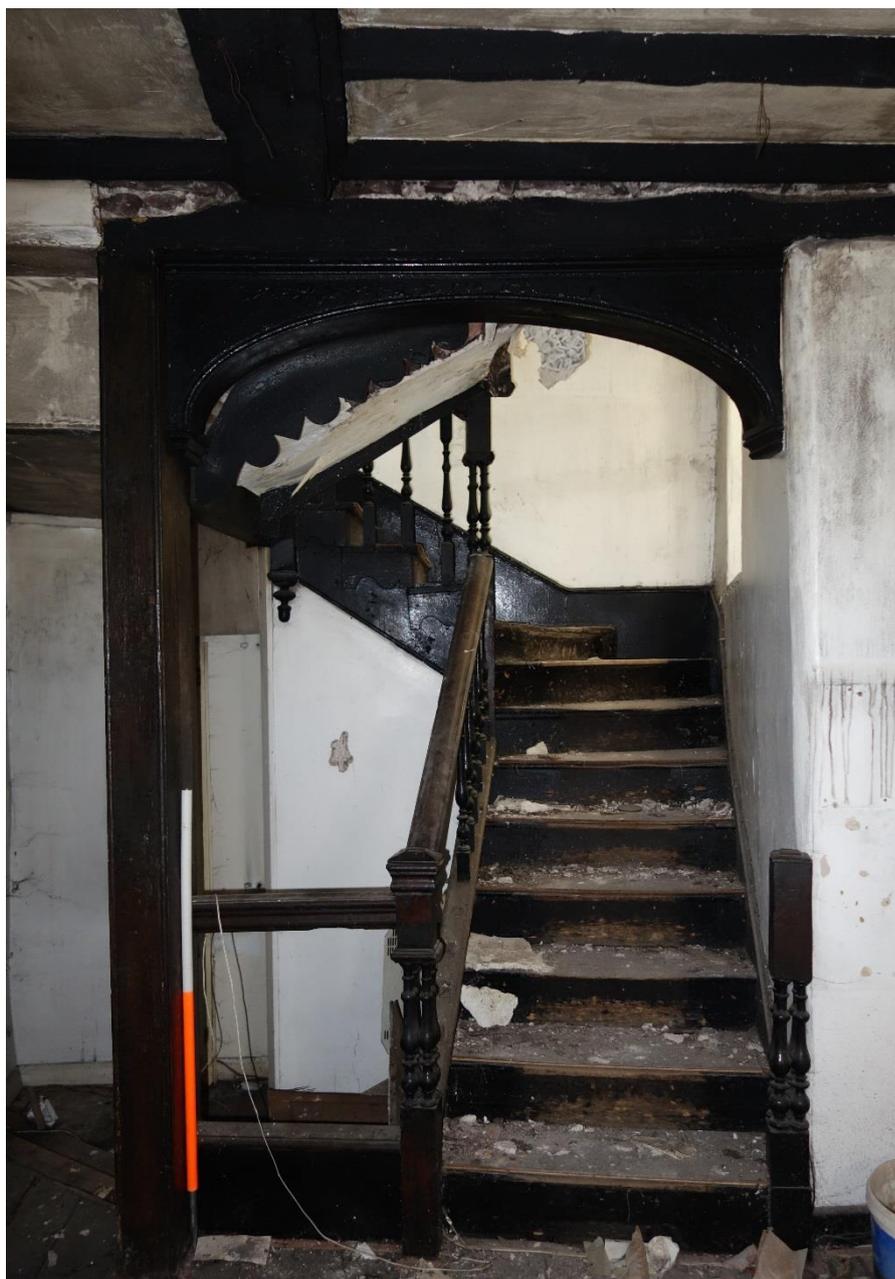
*Plate 24: Internal view looking E towards newel framed staircase at ground floor level*

Directly opposite the front entrance at the E end of the hallway is a framed newel staircase of probable late 17<sup>th</sup> or early 18<sup>th</sup> century date (*Plate 24*). The staircase, which extends from ground to second floor level, is of open string type with moulded brackets supporting the treads, some of the treads have evidently been replaced as some are moulded whereas others are not (*Plate 25 & 26*). The stair also has a moulded handrail with turned and moulded balusters and square newel posts with acorn pendants (*Plates 26 & 27*). The RCHME survey of the house (taken in 1930) suggests that these newel pendants are reused from an earlier, mid-17<sup>th</sup> century staircase. Immediately to the left of the staircase is a short flight of steps leading to a passage beneath the stairs, which is currently used for storage but also leads to a doorway in the S wall of the building (*Plate 28*).

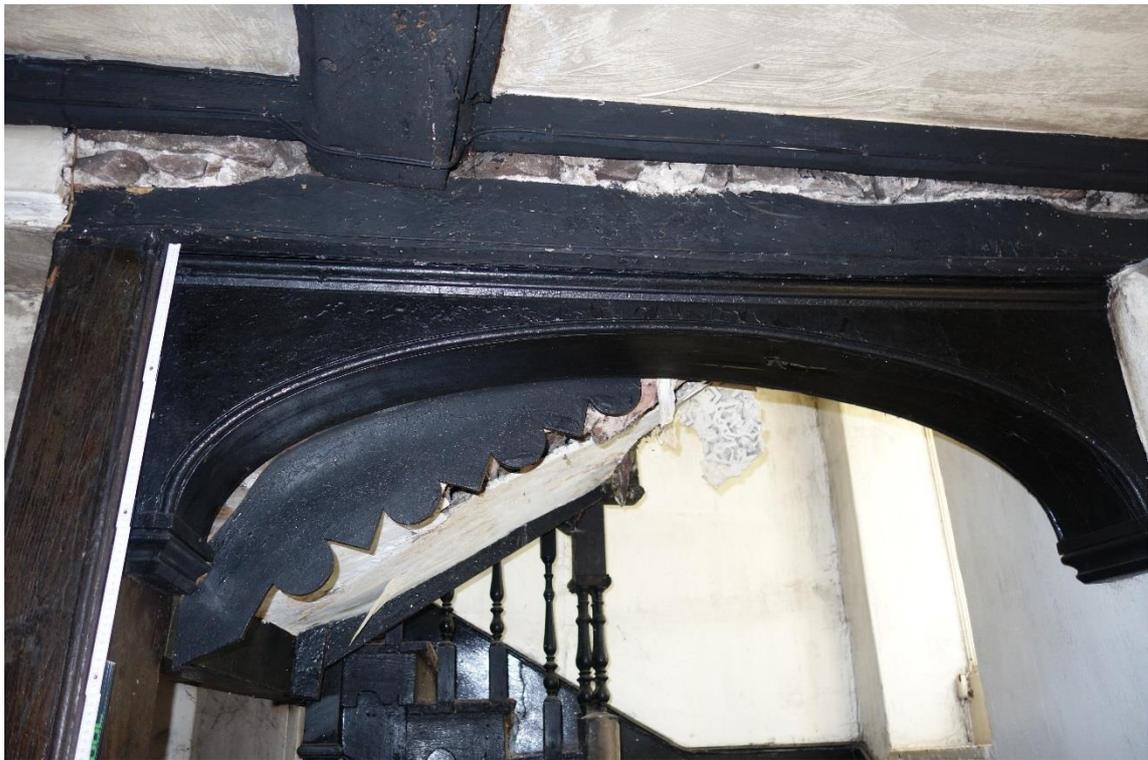
*Plate 25: View looking E showing detail of broad elliptical moulded arch above staircase*

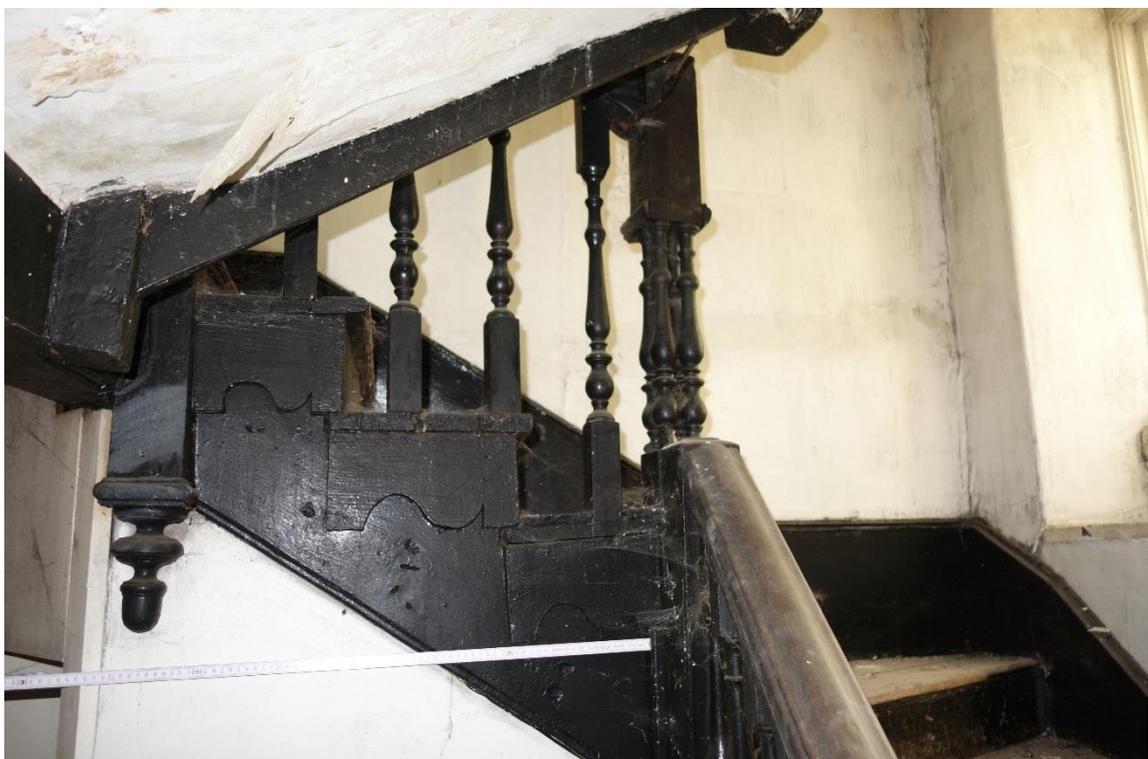
*Plate 26: Internal view looking E showing detail of floor treads and acorn pendants on newel staircase between ground and first floor*

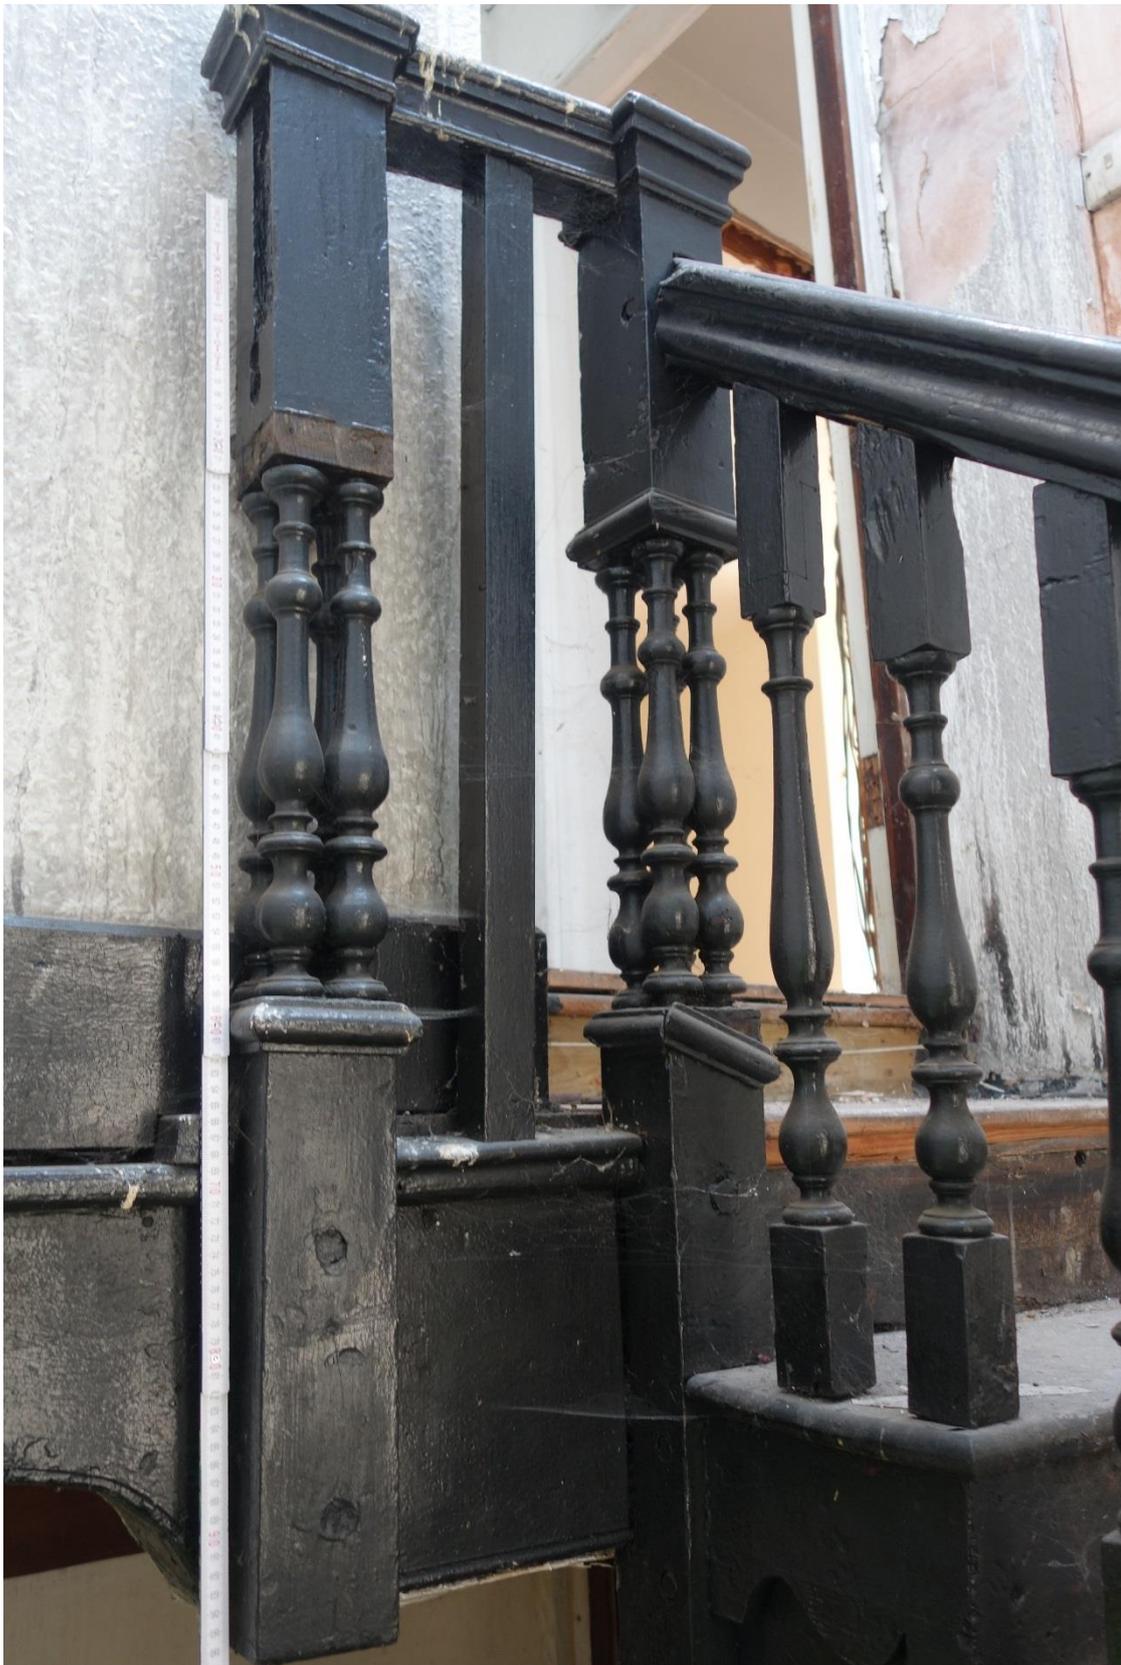
*Plate 27: Internal view showing detail of moulded handrail and twisted balusters of newel staircase*

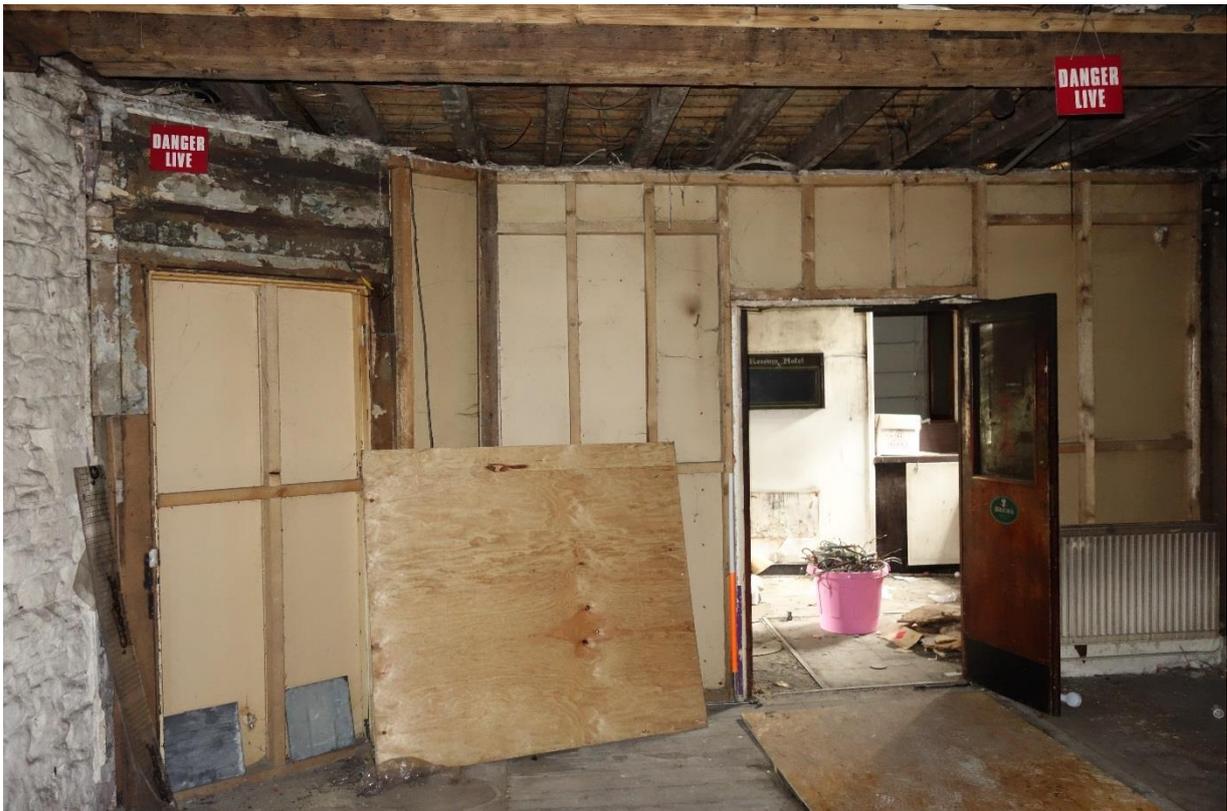
*Plate 29: Internal view looking S showing interior of public bar with earlier doorway to left of modern glazed door*

The hallway is separated from the public bar by a thin partition wall which tapers slightly to the NE to meet a substantial rubble masonry wall, forming the back end of a large central chimneystack. A partition wall is marked on the RCHME survey plan of 1930, indicating that it was in existence prior to the conversion of the dwelling into a hotel, however the existing partition wall, of thin studded timber framing with plasterboard infill, is evidently a modern replacement. The partition wall is completely plastered on the side facing the hallway and a pair of glazed doors leading to the bar is clearly a modern insertion. This modern glazed door appears to have replaced an earlier flat headed doorway located at the E end of the partition wall facing the staircase. This blocked doorway is not visible from the hallway but the opening can be seen from within the front bar (*Plate 29*).

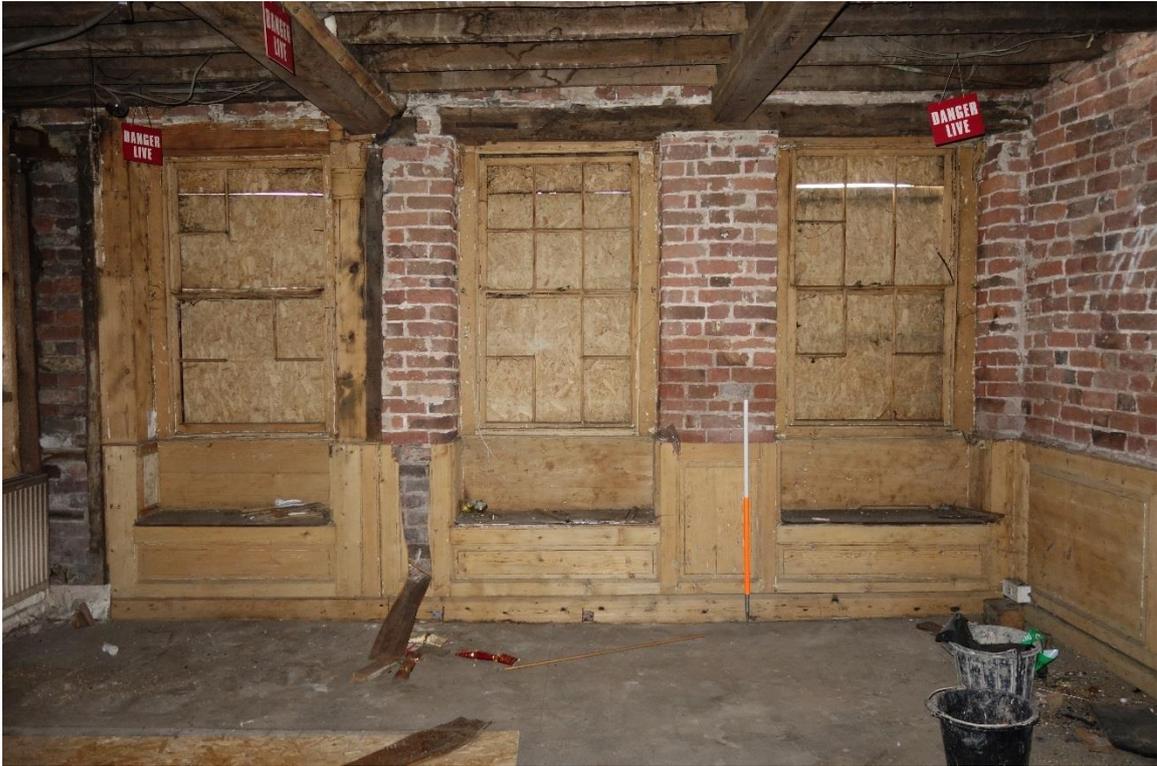
*Plate 30: Internal view looking W showing blocked windows in W wall of public bar (with sashes largely removed)*

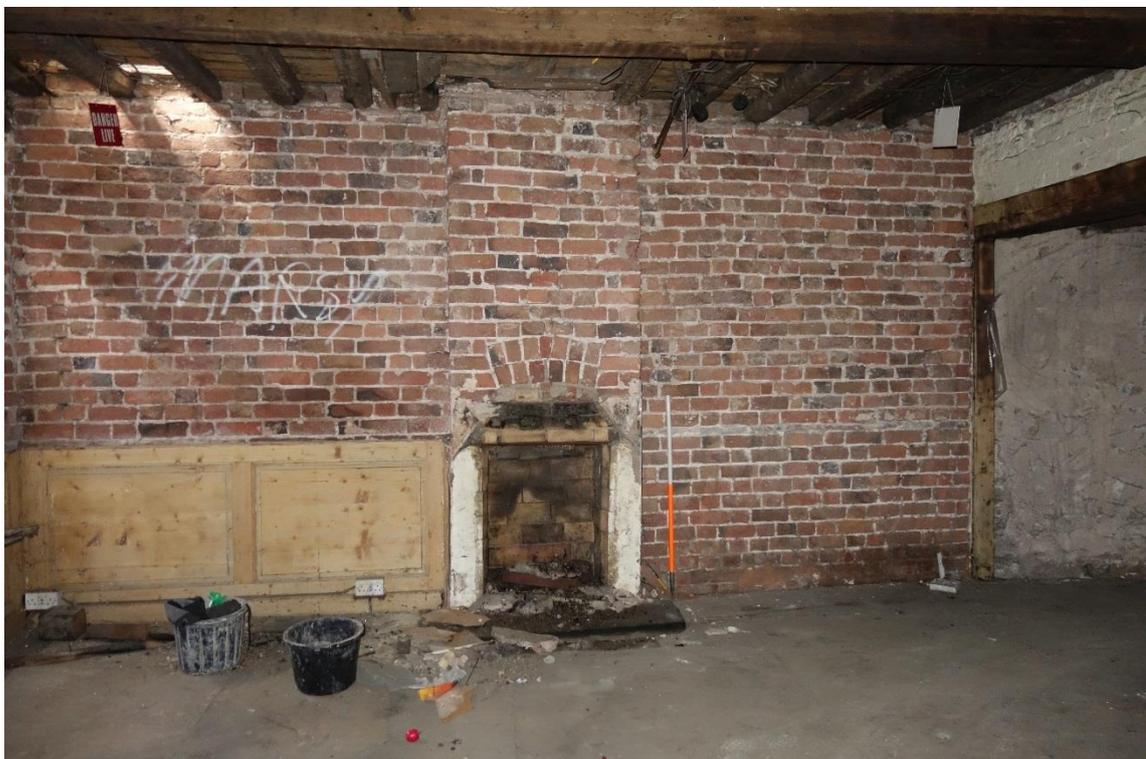
The public bar area has been stripped of most of its fixtures and fittings associated with its former usage as a hostelry, with the exception of some modern timber panelling along the lower portions of the W and N walls. The ceiling of the bar, which has evidently been much renewed, is of chamfered beam and joist construction. The W and N walls of the public bar are of brick construction, laid in Flemish bond and appear to be of 18<sup>th</sup> or possibly early 19<sup>th</sup> century date (*Plate 30*). The removal of the interior panelling along the N wall has clearly exposed the vertical construction break demarcating this later brickwork from the earlier rubble masonry of the section of wall extending to the rear of the building (*Plate 31*). Located against the N wall is a projecting brick chimney flue with a small segmental arched brick fireplace. The fireplace surround and grate have been removed.

*Plate 31: View looking N showing N wall of public bar with segmental arched fireplace*
