## Standing Building Recording Survey

**BGD Property Ltd**

Former Rosswyn Hotel  
16-19 High Street  
Ross-on-Wye  
Herefordshire HR9 5BZ

**October 2016**

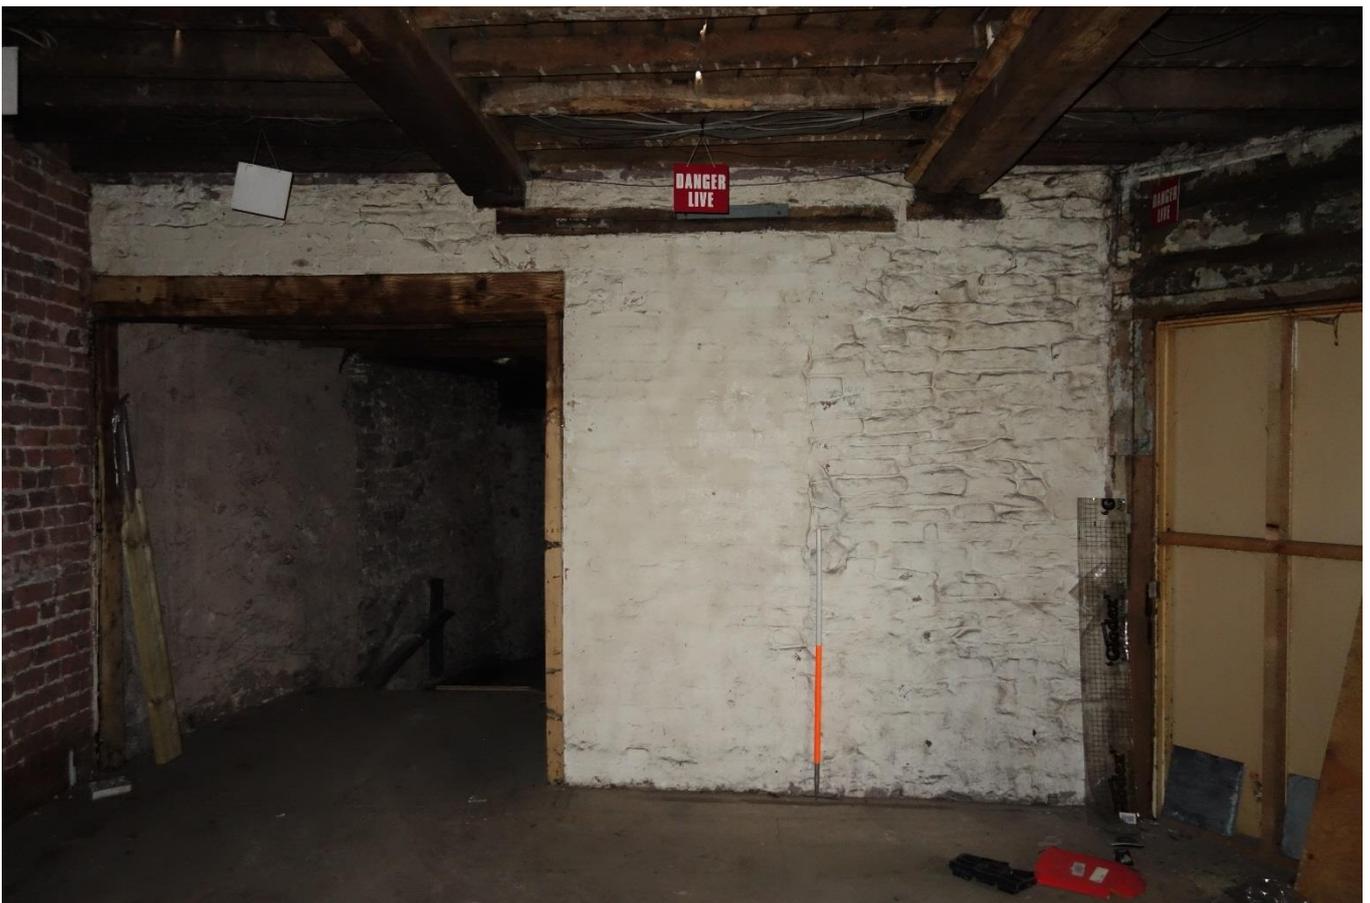
The E wall of the public bar is of brick and coursed rubble masonry construction and forms part of a substantial central chimneystack around which the house originally appears to have been built. It appears to have been extensively altered since the RCHME survey of 1930. The RCHME survey marks a fireplace against the E wall which appears roughly to correspond to the location of the existing larger fireplace on the opposite side of the chimneystack. However, this fireplace appears to have been removed and the wall partially rebuilt in brick; the construction break between the brick masonry and the earlier stone masonry is clearly discernible in spite of the thick white plaster coating (*Plate 32*).

*Plate 32: View looking E showing E wall of public bar with vertical construction break indicated between coursed rubble masonry and modern brickwork, with modern flat arched opening inserted to left of picture*

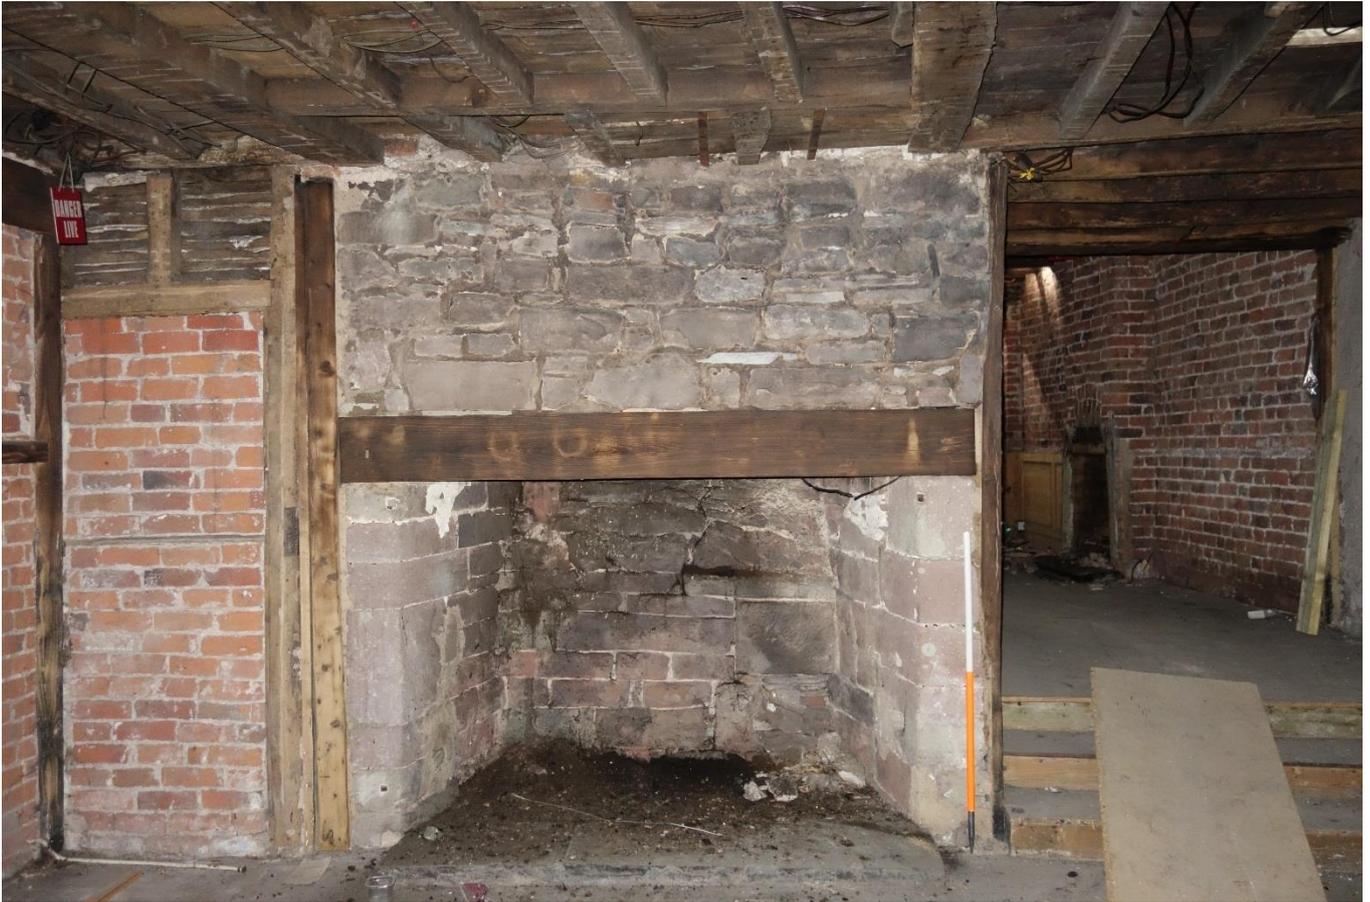
*Plate 33: Internal view looking W showing deep recessed fireplace on E (rear) side of central chimneystack*

The room on the E side of the central chimneystack is at a slightly lower level compared to its western counterpart; it is a large rectangular room with a partially tiled floor and appears originally to have been used as a kitchen, as evidenced by the broad, deep recessed fireplace in the W wall (*Plate 33; Fig. 15*). Apparently this fireplace was exposed during extensive renovations made in the early 1970s, hidden behind seven other fireplaces and a brick wall. The beam over the fireplace is evidently a modern replacement. The wall on the opposite side of the room, facing the fireplace is of coursed rubble masonry construction with evidence of brick infill. This wall is pierced with two door openings, but only the left hand opening is marked on the RCHME survey plan of 1930; the doorway on the right (leading directly to the modern lavatory block) appears to have been inserted in the place of a former window marked on the 1930 survey plan (*Plate 34*).

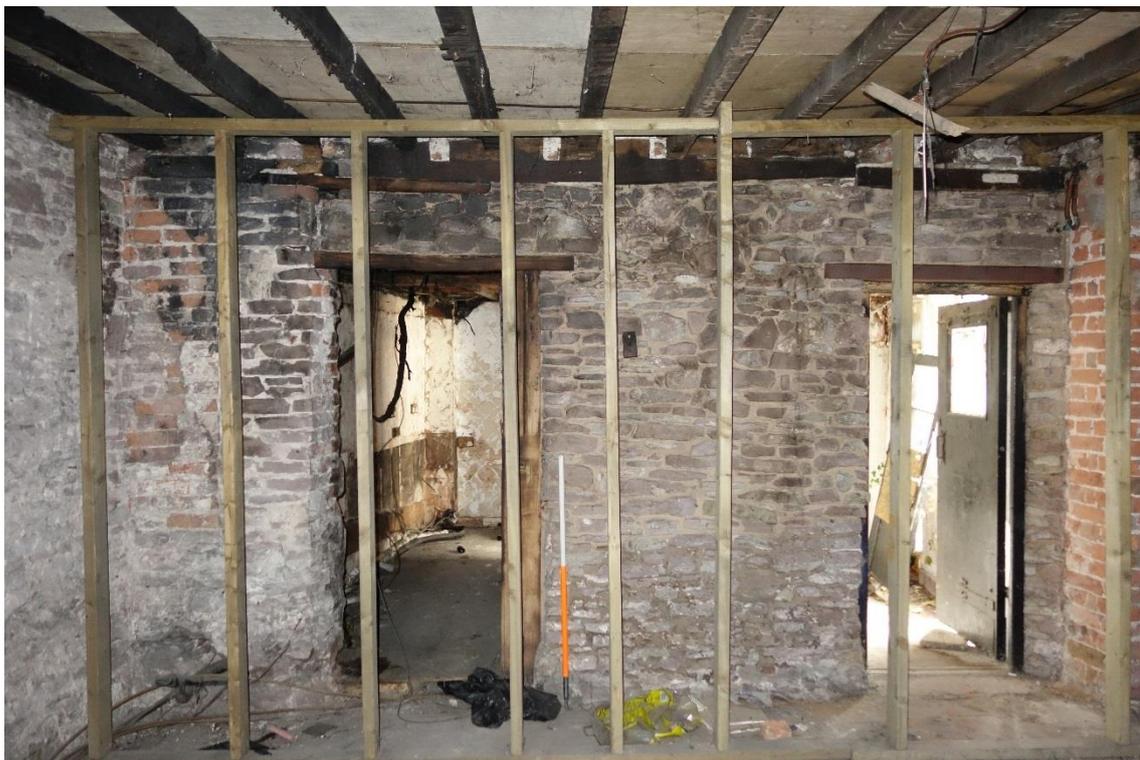
*Plate 34: View looking E showing masonry wall to E of central chimneystack, of coursed sandstone rubble construction with brick infill, pierced with two door openings*

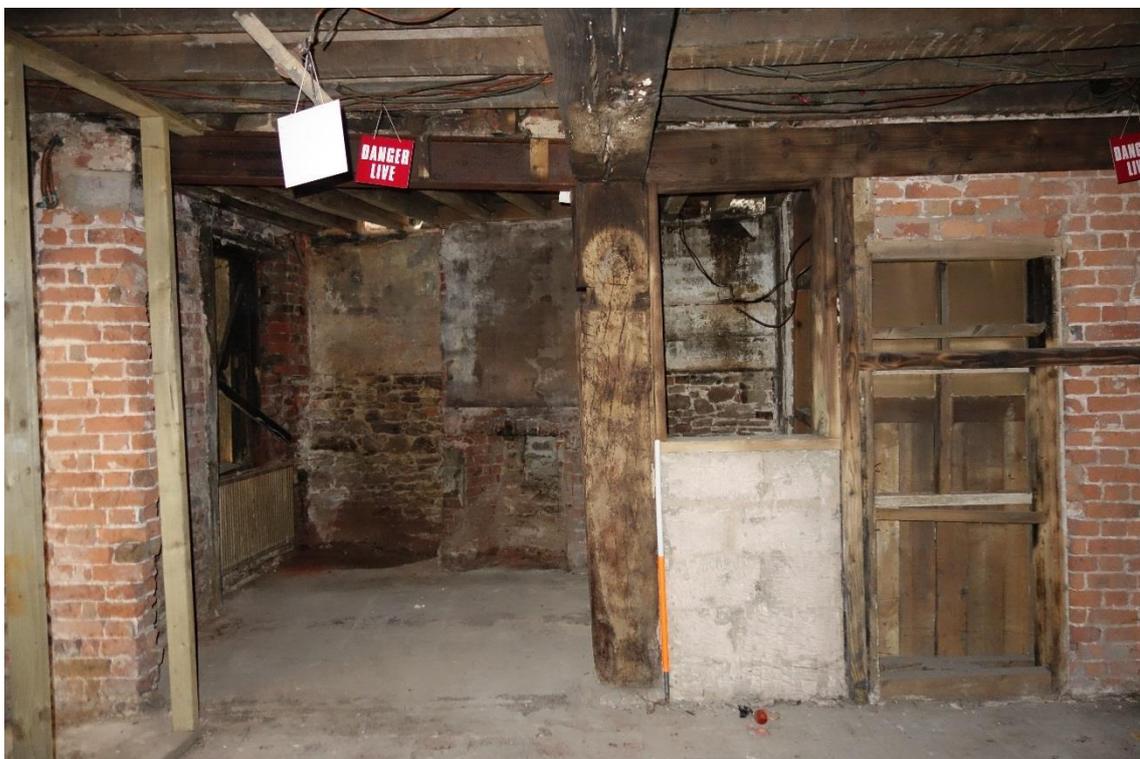
*Plate 35: View looking S showing room to SE of central chimneystack with timber framed partition wall and doorway to right*

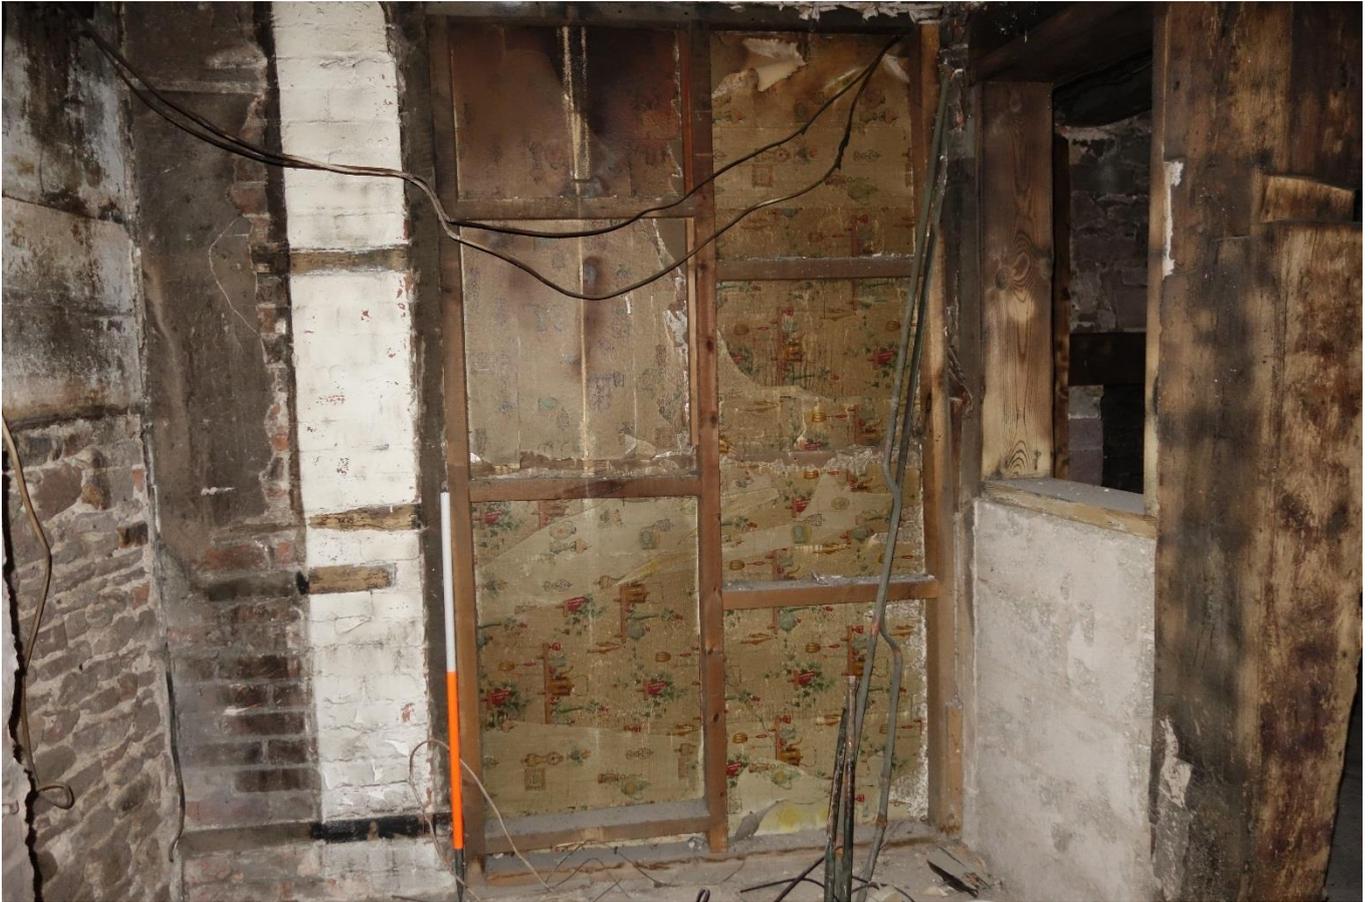
A flat headed doorway inserted on the right hand side of the partition led directly S from the former kitchen to the side entrance, giving access to the passageway which originally separated No. 17 from the adjacent house to the S (No. 17A). This doorway is marked on the RCHME survey of 1930, indicating that, at the very least, it predates the substantial alterations made in the early 1970s. The W wall of the room exhibits evidence of thin studded timber framing with brick infill. The RCHME survey marks a doorway in this wall which directly accessed the vestibule leading to the side entrance in the S wall; however the doorway and an adjoining section of the wall appears to have been removed and replaced with a modern timber framed partition with plasterboard infill (Plate 36).

*Plate 36: Internal view looking W showing partition wall in W wall of room to SE of central chimneystack*

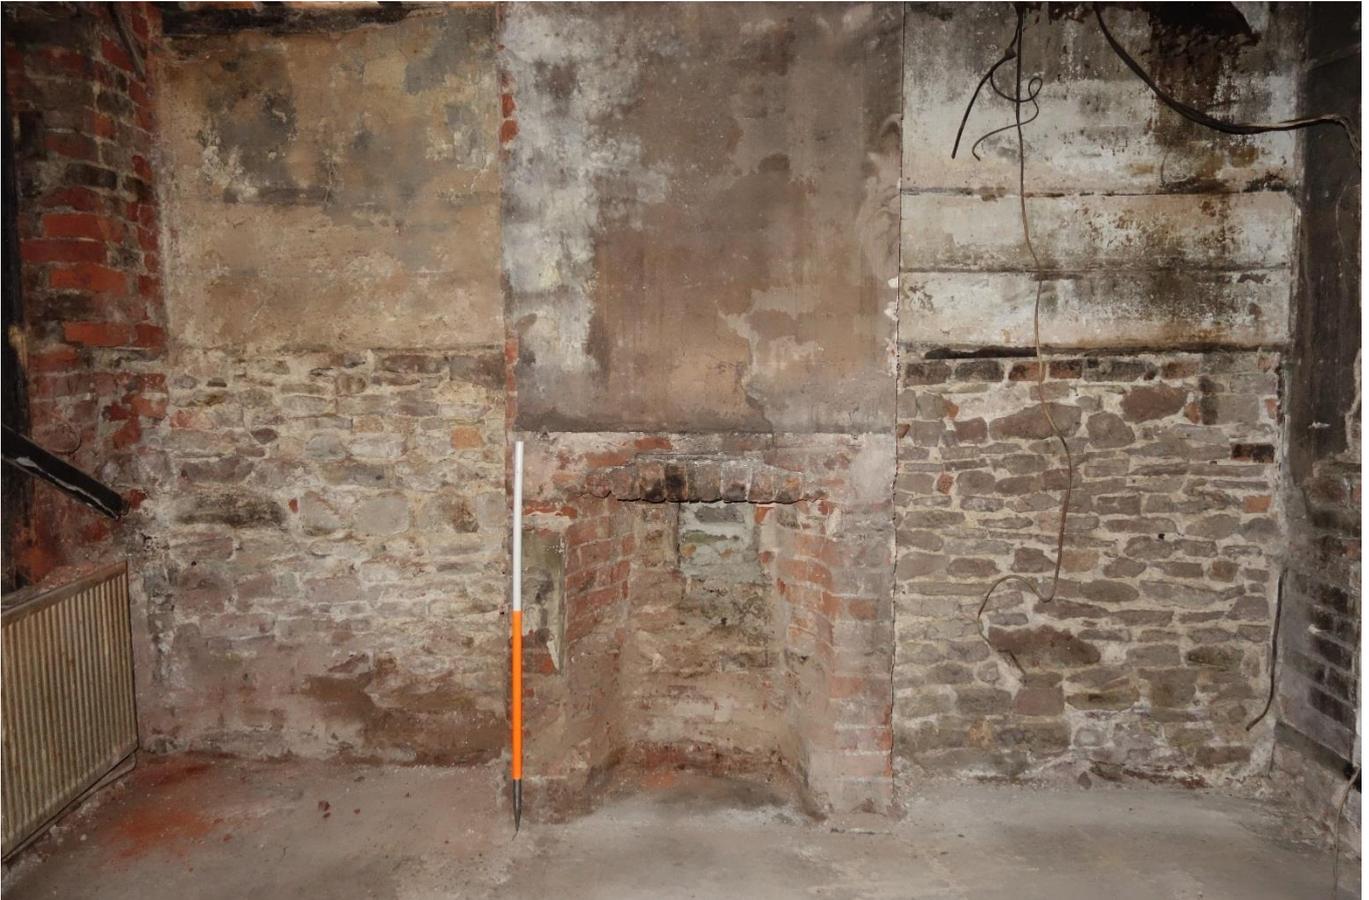
The S wall of the compartment is of coursed rubble masonry construction, the upper portions covered in thick plaster. Projecting from the S wall is a brick segmental arched fireplace; the grate and surround have been removed (*Plate 37*). Until the fire of November 2004, this room appears to have contained a considerable quantity of carved panelling dated by the RCHME to the early 17<sup>th</sup> century, comprising an elaborate carved frieze over the fireplace in the S wall with five caryatid pilasters (both male and female, with finely detailed drapery) and two 'green man' masks with foliage beneath, as well as a carved overmantel and two flanking wall cupboards with further carved decoration. This woodwork was not *in-situ* and appears to have been installed by no later than the early 20<sup>th</sup> century, when this room was used as a study.

*Plate 37: Internal view looking S showing S wall of room to SE of central chimneystack with projecting brick fireplace and heavily plastered walls above*

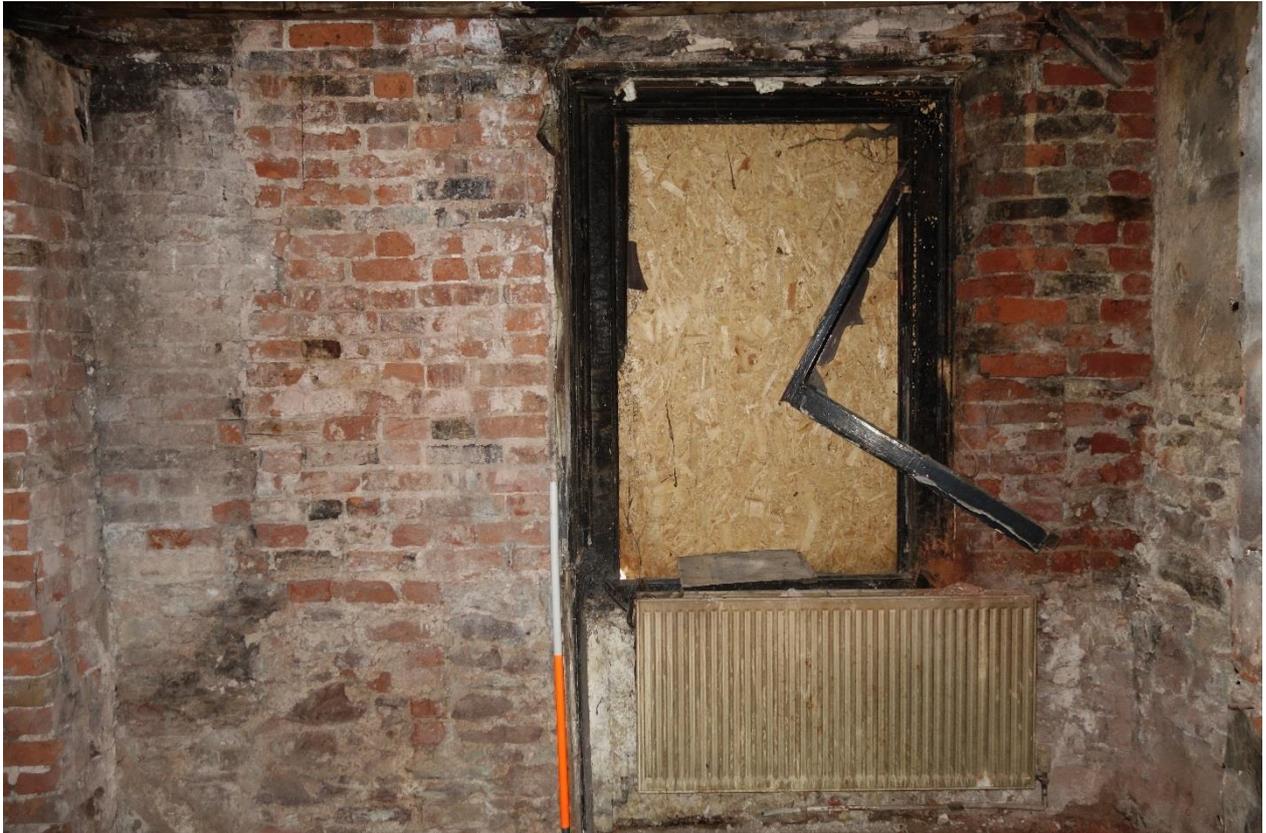
*Plate 38: Internal view looking E showing E wall of room to SE of central chimneystack, of brick and rubble masonry construction, with the remains of a moulded sash framed window with thick glazing bars*

The E wall of the room exhibits evidence of two phases of construction, the lower courses being of coursed rubble masonry while the upper stages are constructed of red brick laid in Flemish bond (*Plate 38*). Contemporary with the brickwork is a flat headed window with a moulded wooden surround; unfortunately, the glass and glazing bars have almost been entirely removed, but part of a thick sash frame (possibly of 18<sup>th</sup> century date) was noted.

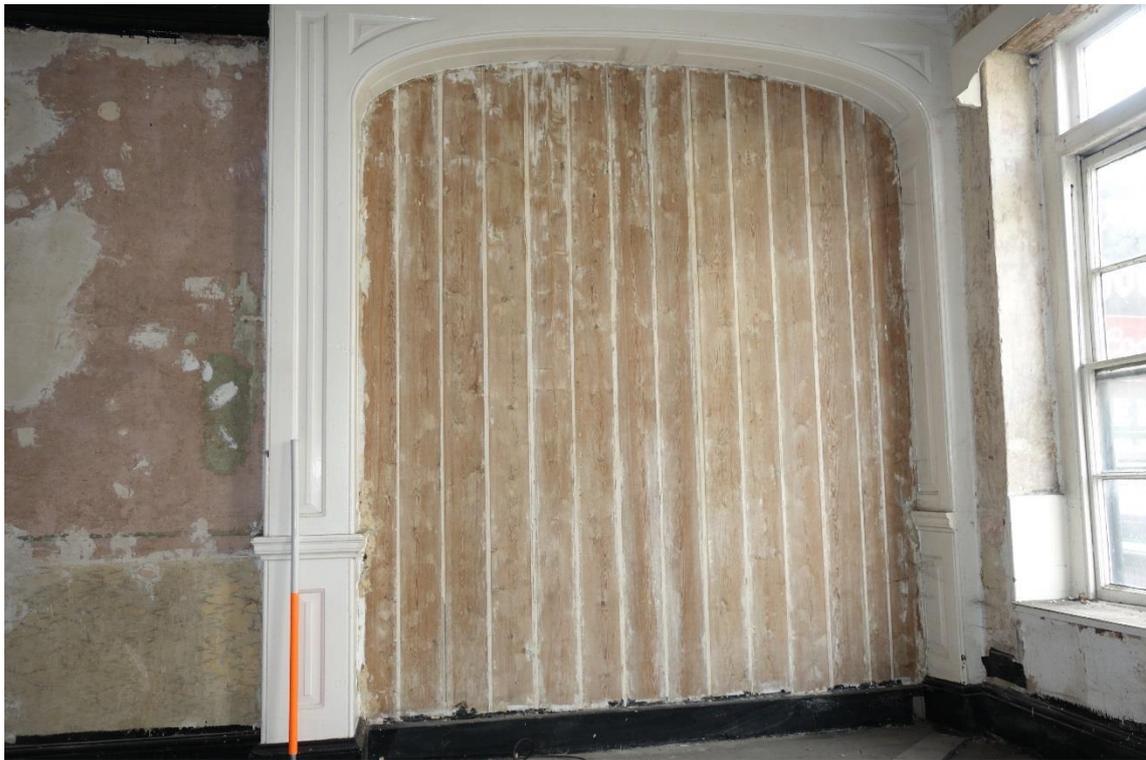
*Plate 39: Internal view looking S showing large elliptical archway in NW room at first floor level*

The first floor is accessed from the square framed newel staircase, which leads onto a wide floorboarded landing located immediately S of the central chimneystack. The RCHME survey of 1930 refers to several panelled doors of late 17<sup>th</sup> century date on the first floor but unfortunately these appear to have removed, together with their surrounds. At the front of the building, accessed from the landing by a short flight of stairs, are two large rooms which were formerly linked by a broad elliptical archway with flanking plain moulded pilasters and spandrels which appears to have been inserted in the mid-19<sup>th</sup> century and was subsequently blocked up in the mid-late 20<sup>th</sup> century (*Plate 39*).

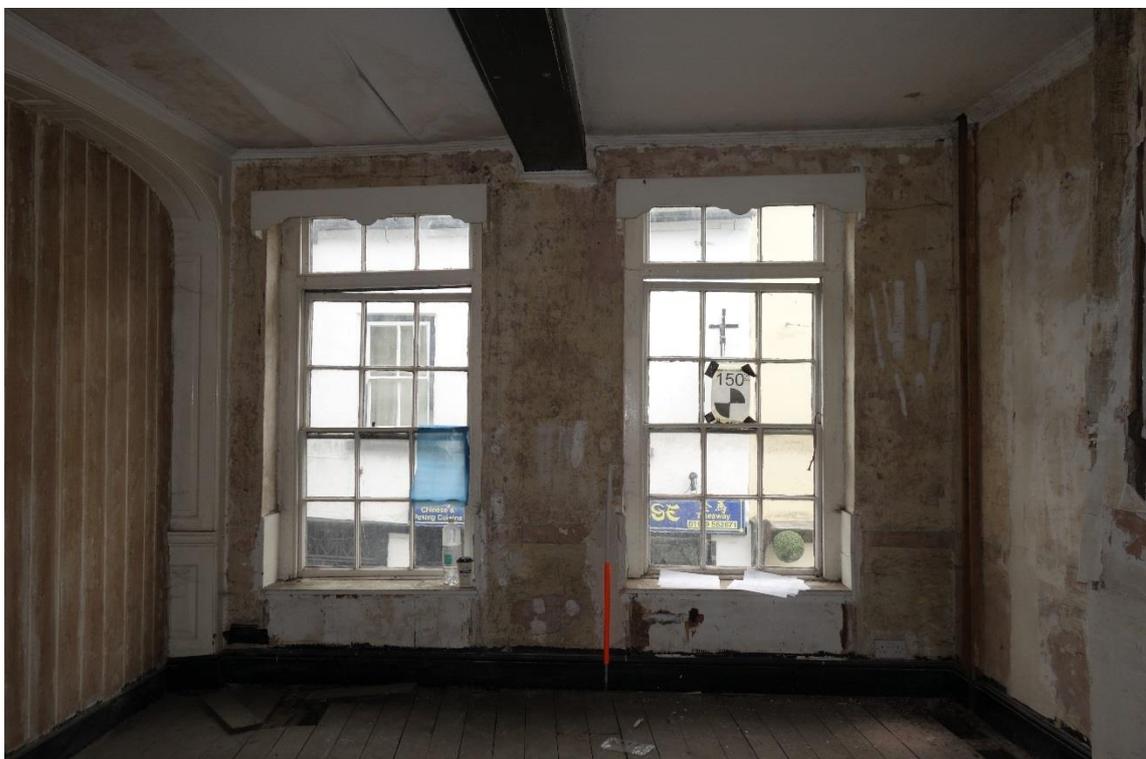
*Plate 40: Internal view looking W showing sash windows with 3-light transoms in NW room at first floor level*

The larger, NW room is lit by two sash windows both of which were altered in the mid-19<sup>th</sup> century with the addition of a three-light transom (*Plate 40*). There is a moulded cornice and skirting board, both of which appear to be modern in date. Projecting from the centre of the N wall is a brick segmental arched fireplace which has been concealed by modern wallpaper, plasterboard and skirting board (*Plate 41*). A cupboard alcove has been inserted in the thickness of the W wall which appears to be of modern date. The ceiling is plastered but there are two large exposed beams oriented E-W across the centre of the ceiling and N-S along the E-wall, which appear to have been heavily renewed in recent years (*Plate 42*).

This phase of construction, which may be dated to the mid to late 19<sup>th</sup> century, appears to be represented externally by the alterations made to the sash windows in the principal W-facing elevation at first floor level, with the insertion of three light transoms in the two left hand windows and the replacement of the original sashes with thinner glazing bars.

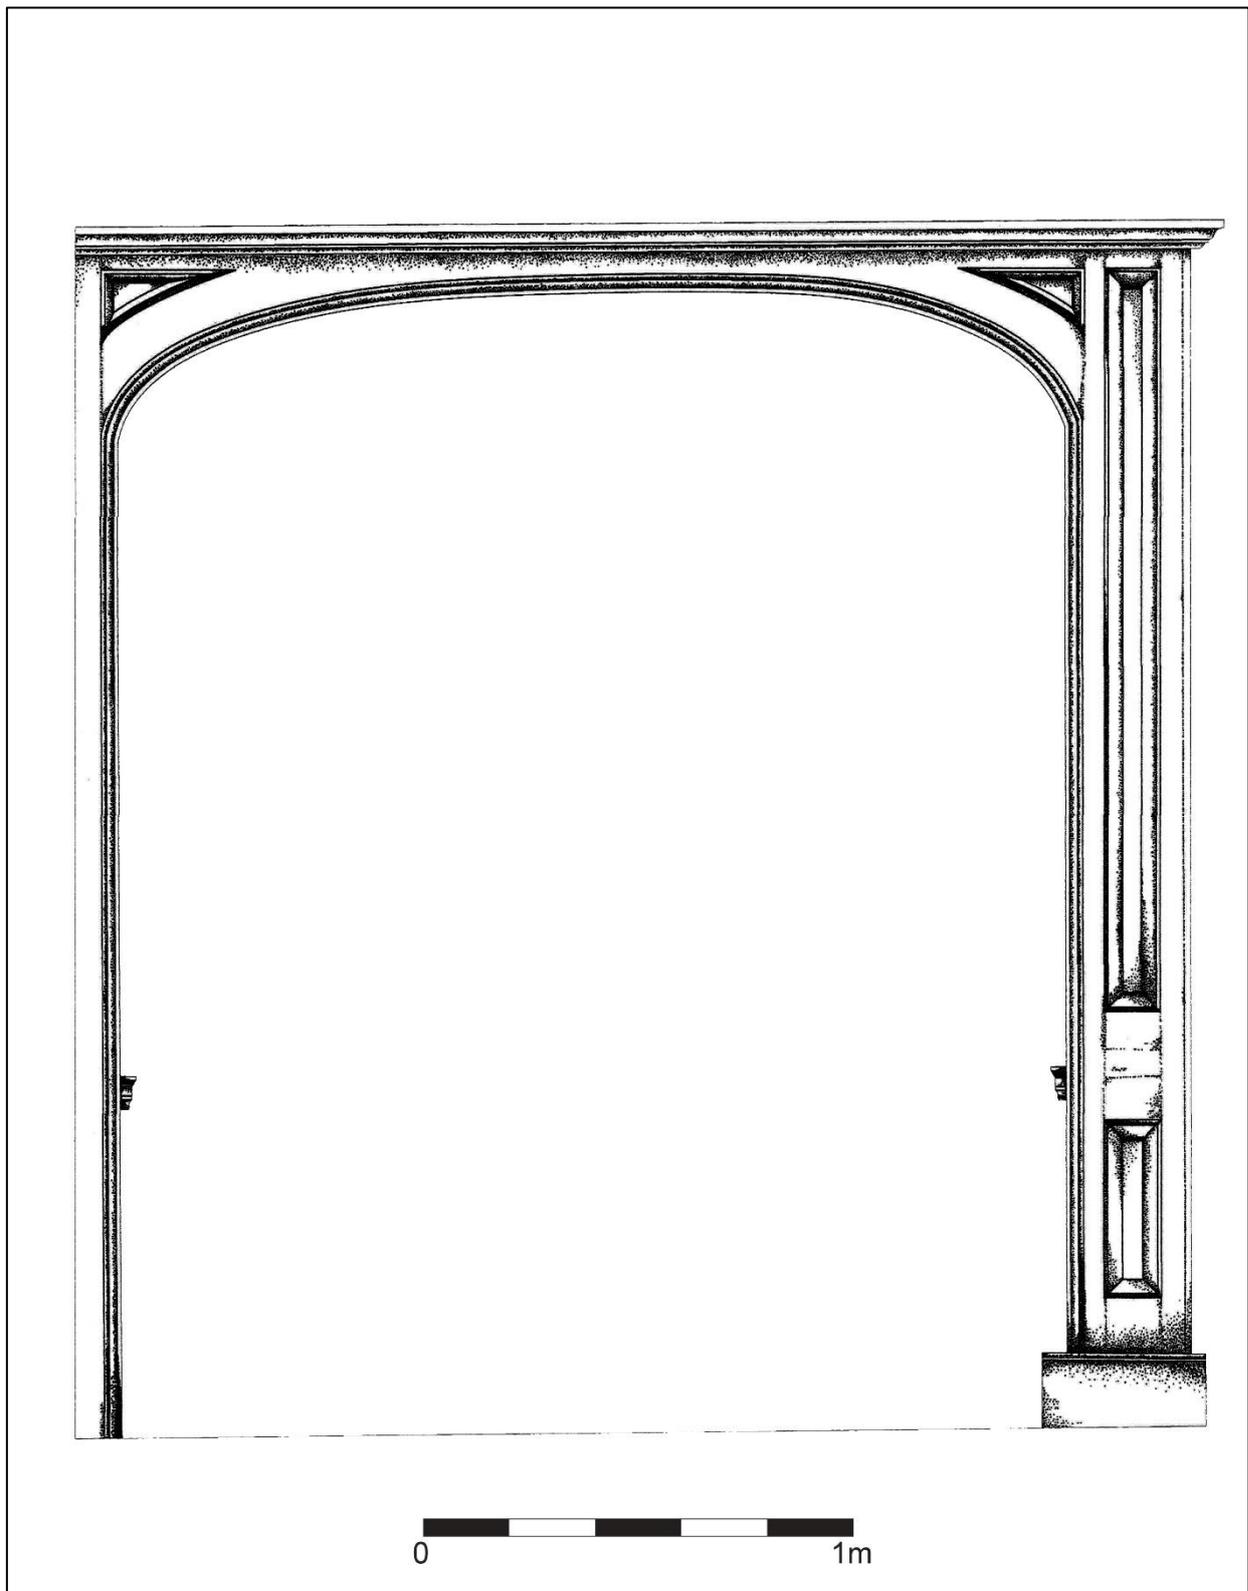
*Fig. 16: Drawing of elliptical archway in SW room at first floor level*

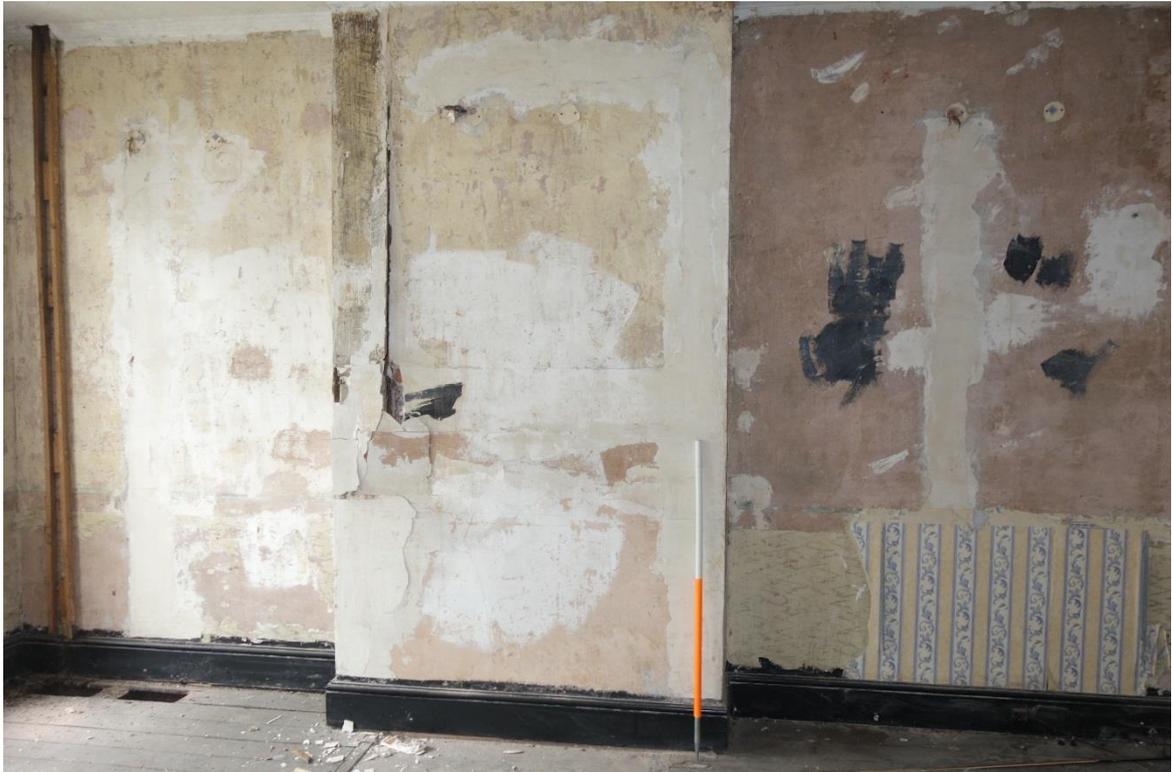
*Plate 41: Internal view looking N showing blocked up fireplace in NW room at first floor level*

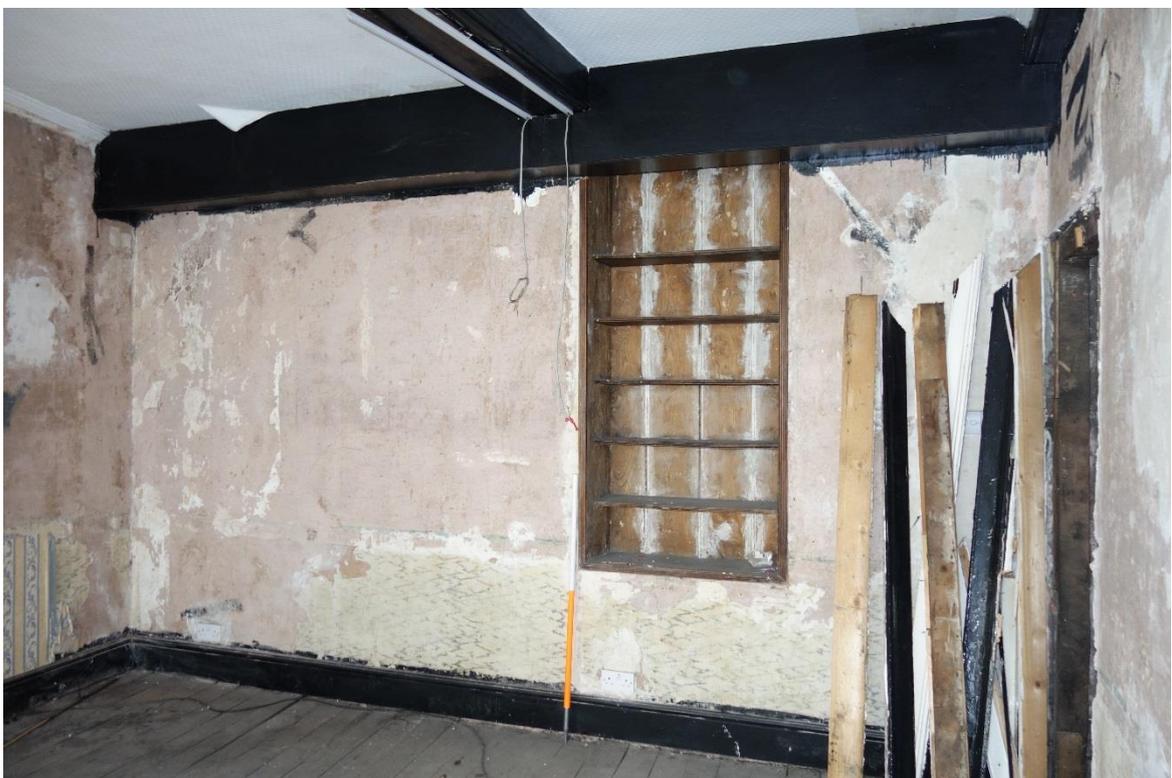
*Plate 42: Internal view looking E showing exposed ceiling beams and cupboard alcove in E wall of NW room at first floor level*

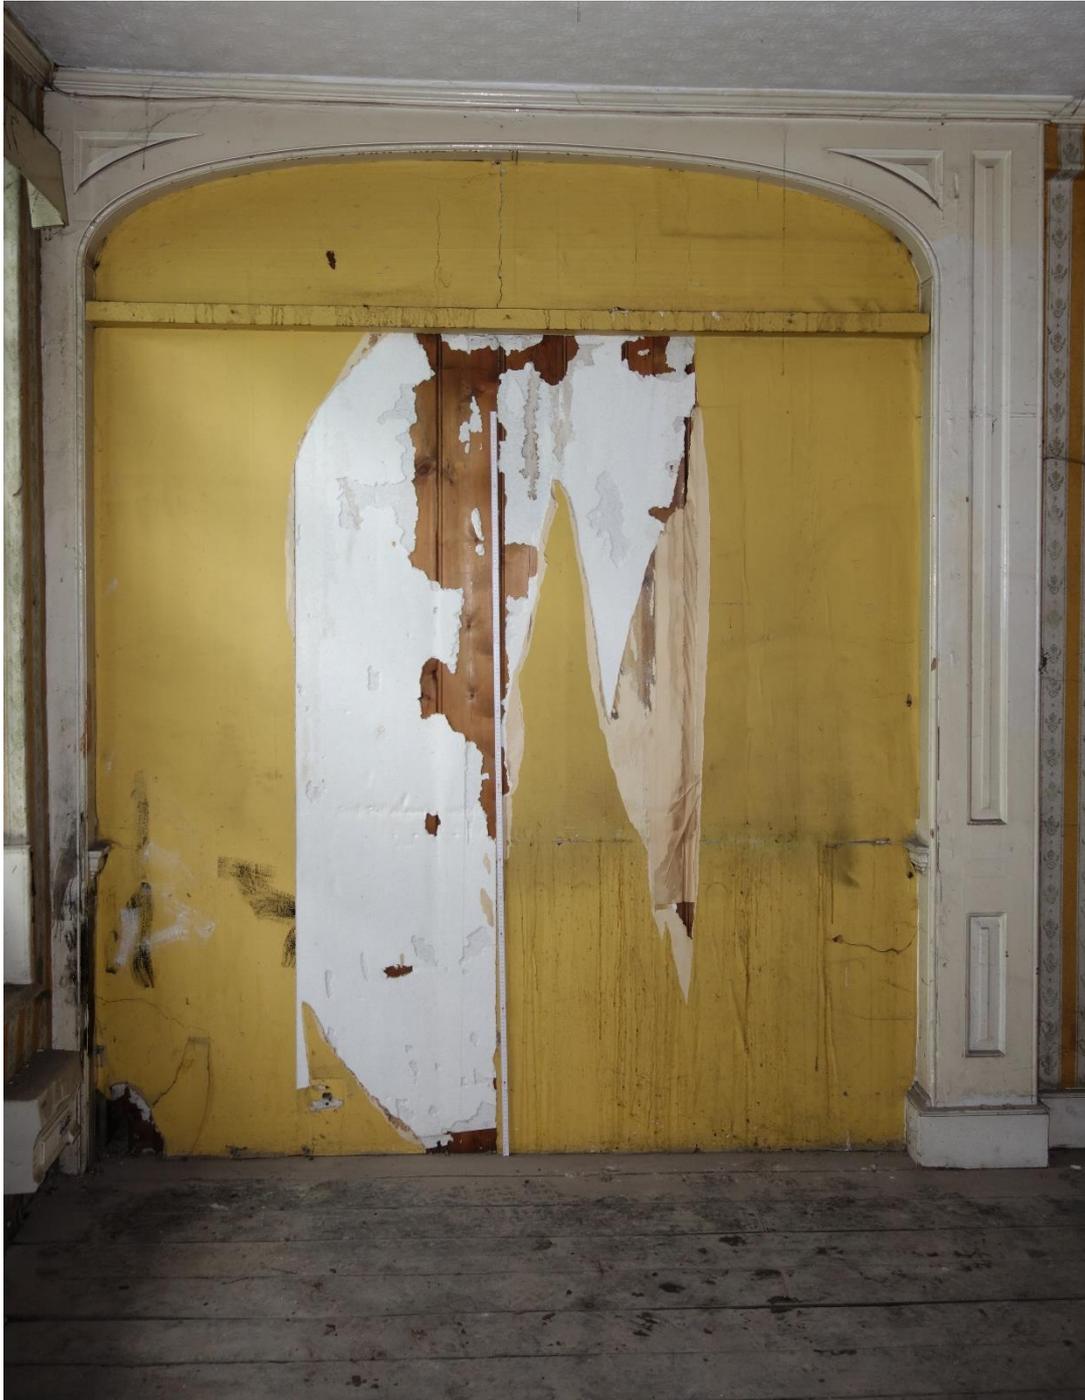
*Plate 43: Internal view looking N showing elliptical archway in SW room at first floor level*

As with the NW room, the ceiling is plastered with a plain moulded cornice and an exposed ceiling beam oriented E-W, however there is no fireplace, while the moulded skirting also appears to have been removed. Compared to its NW counterpart, the sash windows are also smaller, without the addition of the three light transom, and the moulding of the elliptical archway is slightly less elaborate (*fig. 16; Plates 43 & 44*).

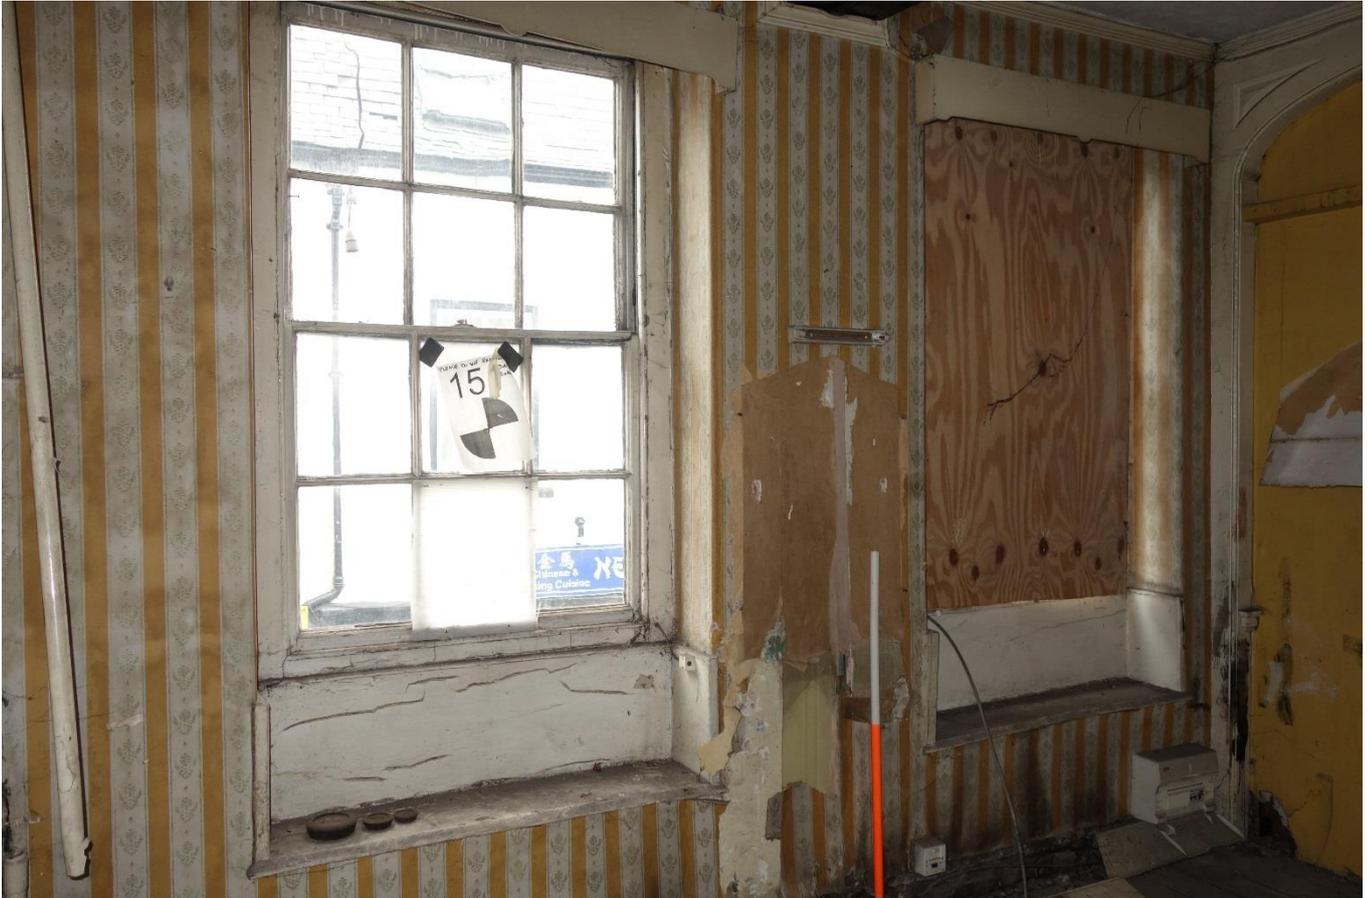
*Plate 44: Internal view looking WNW showing sash windows in SW room at first floor level*

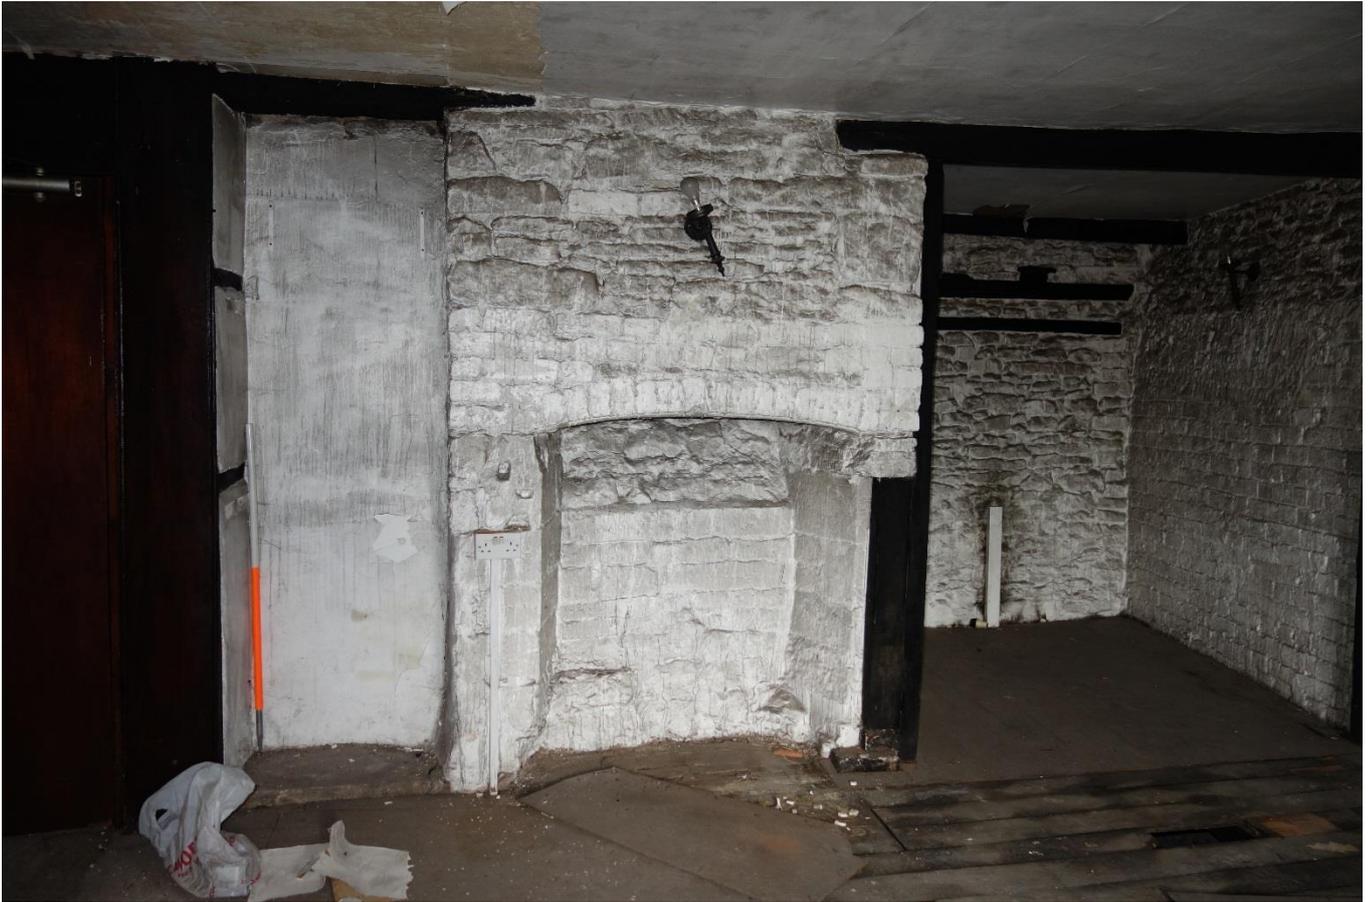
*Plate 45: Internal view looking W showing fireplace in NE room at first floor level, partially reconstructed in brick*

A doorway leads E from the landing to a large room in the NE corner of the first floor which was converted to use as a restaurant in the early 1970s. In contrast to the NW room, where the chimneystack and walls are concealed by wallpaper and plasterboard, the chimneystack and masonry walls are exposed and coated in whitewash. The floorboards have decayed in several places. Projecting from the E wall of the room is a deep recessed fireplace, the arch of the fireplace appears to have been reconstructed in brick with a low segmental brick arch, presumably replacing an earlier timber lintel. The right hand jamb of the fireplace, originally of stone construction, has been replaced with a vertical timber post (*Plate 45*).

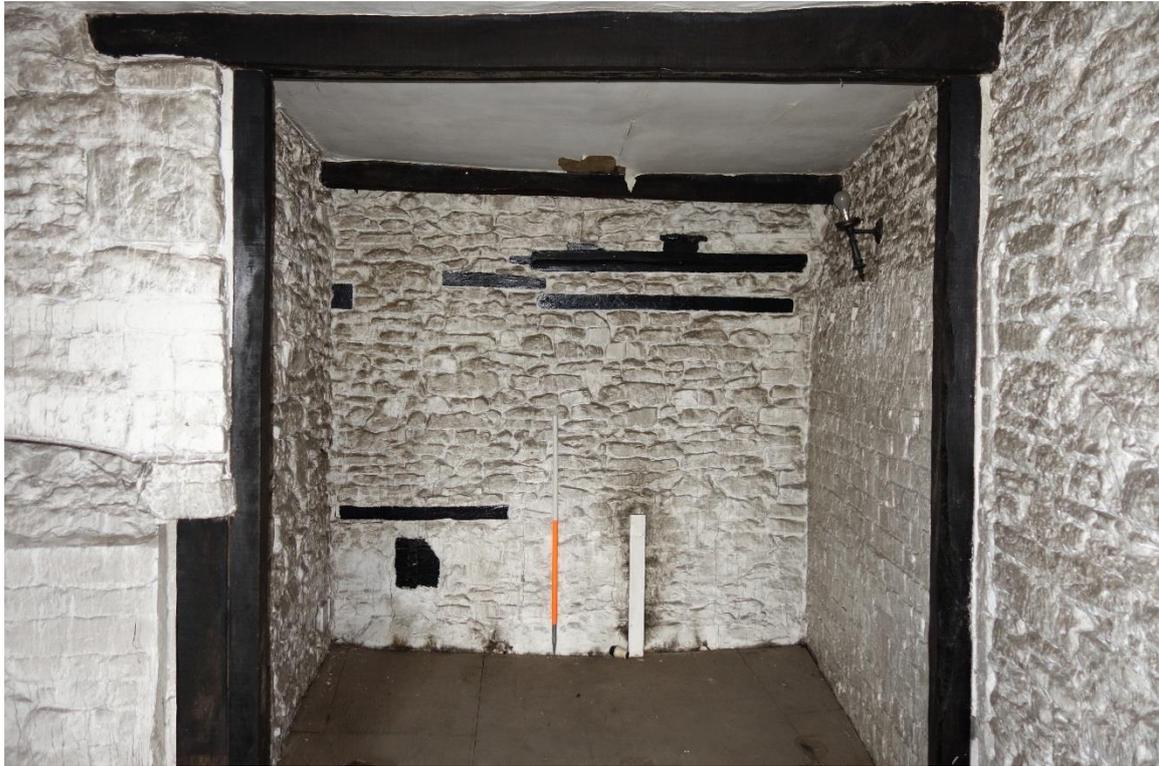
*Plate 46: Internal view looking W showing W wall of inglenook to right of fireplace in NE room at first floor level with exposed timbers*

To the right of the fireplace is a deep recess or inglenook with several exposed horizontal and longitudinal chamfered timbers (known as bond timbers) worked into the thickness of the wall to provide reinforcement (*Plate 46*). It is not clear when these were inserted, it is possible that they were introduced when the street frontage of the house was reconstructed in brick (during the 18<sup>th</sup> century), although it is possible that they predate this rebuilding. It is noteworthy that part of the N wall within the inglenook has been rebuilt in brick, contrasting with the remainder of the N wall which is of coursed rubble masonry construction.

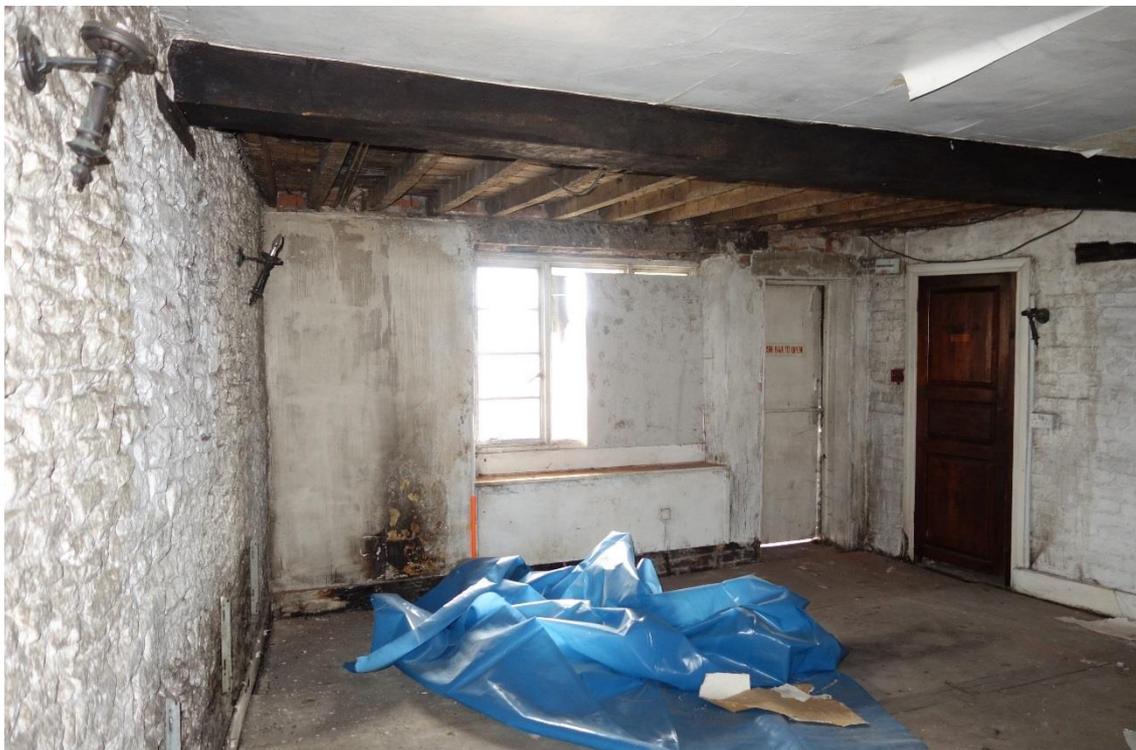
*Plate 47: Internal view looking E showing NE room at first floor level with modern casement window in E wall*

The E wall is of brick construction with a 12-paned mullioned casement window with thin metal glazing bars which appears in its present form to be a modern insertion, replacing a broader mullioned and transomed window shown on a photograph of the rear of the Rosswyn Hotel taken in about 1960 (*Plate 47*). Above the window is a wooden lintel which appears to have been reused from an earlier window. The narrow flat-headed fire escape door to the right of this window is clearly of modern date and appears to have been inserted as part of the extensive alterations to the house made in the early 1970s; it is not shown on the 1960 photograph of the Rosswyn Hotel. It appears that the original window opening was broader and was partially blocked up as a result of the construction of the fire escape door.
