## Standing Building Recording Survey

**BGD Property Ltd**

Former Rosswyn Hotel  
16-19 High Street  
Ross-on-Wye  
Herefordshire HR9 5BZ

**October 2016**

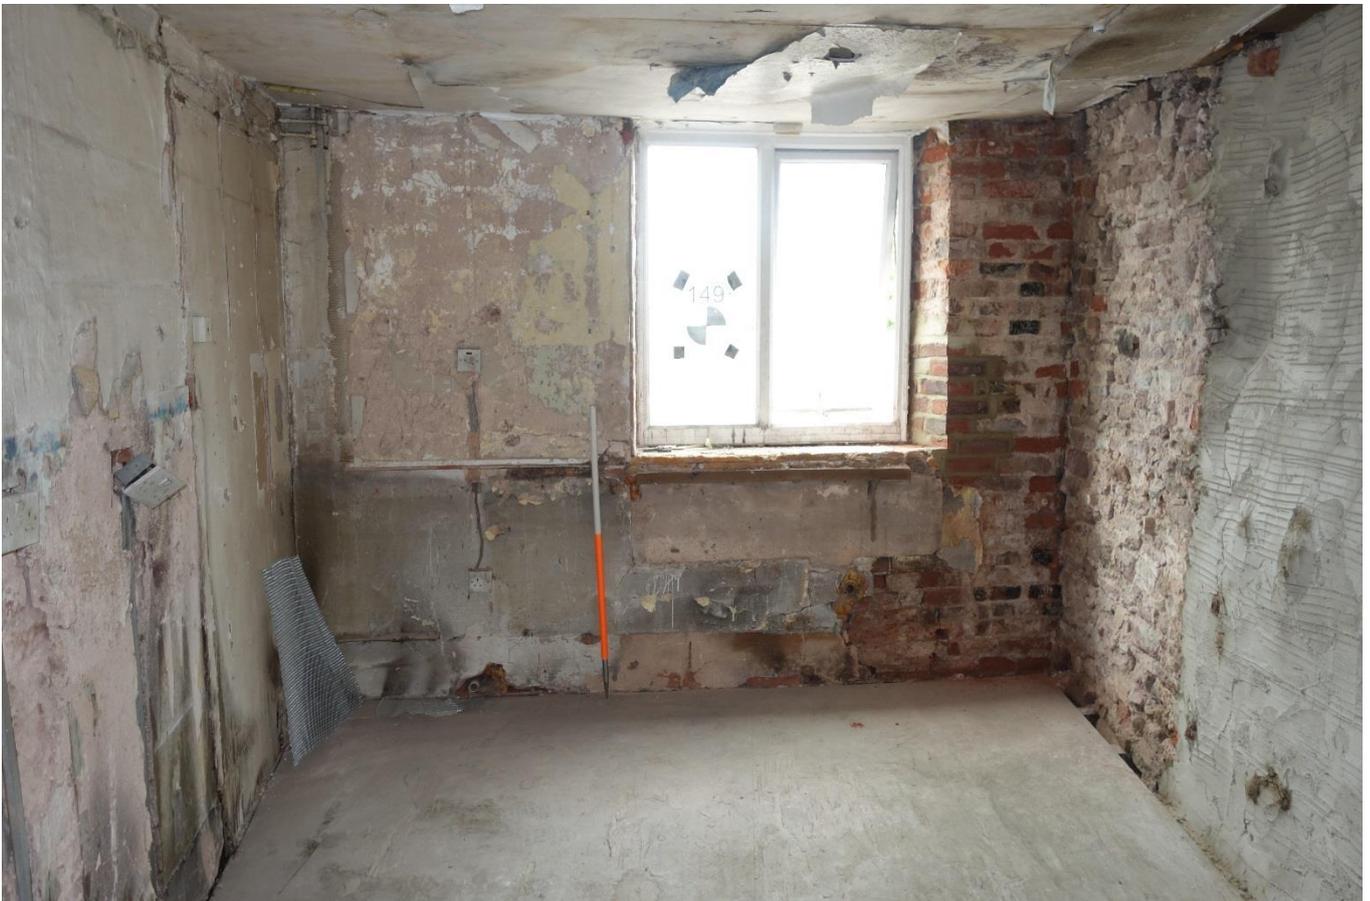
*Plate 48: Internal view looking E showing interior of SE room at first floor level with a two light casement window inserted in the E wall in place of an earlier mullioned window*

The two light PVC framed window in the E wall is clearly of modern date and replaced a much broader window (probably a four-light mullioned window) which has been partially blocked up although the original window opening is still visible (*Plate 48*). The plaster of the S and E walls have been removed, revealing the construction break between the earlier coursed rubble masonry of the S wall and the brickwork of the rear (E-facing) wall which was probably added in the 18<sup>th</sup> century. The W wall is again largely concealed by plasterwork but appears to be of timber framed construction with lath and plaster infill.

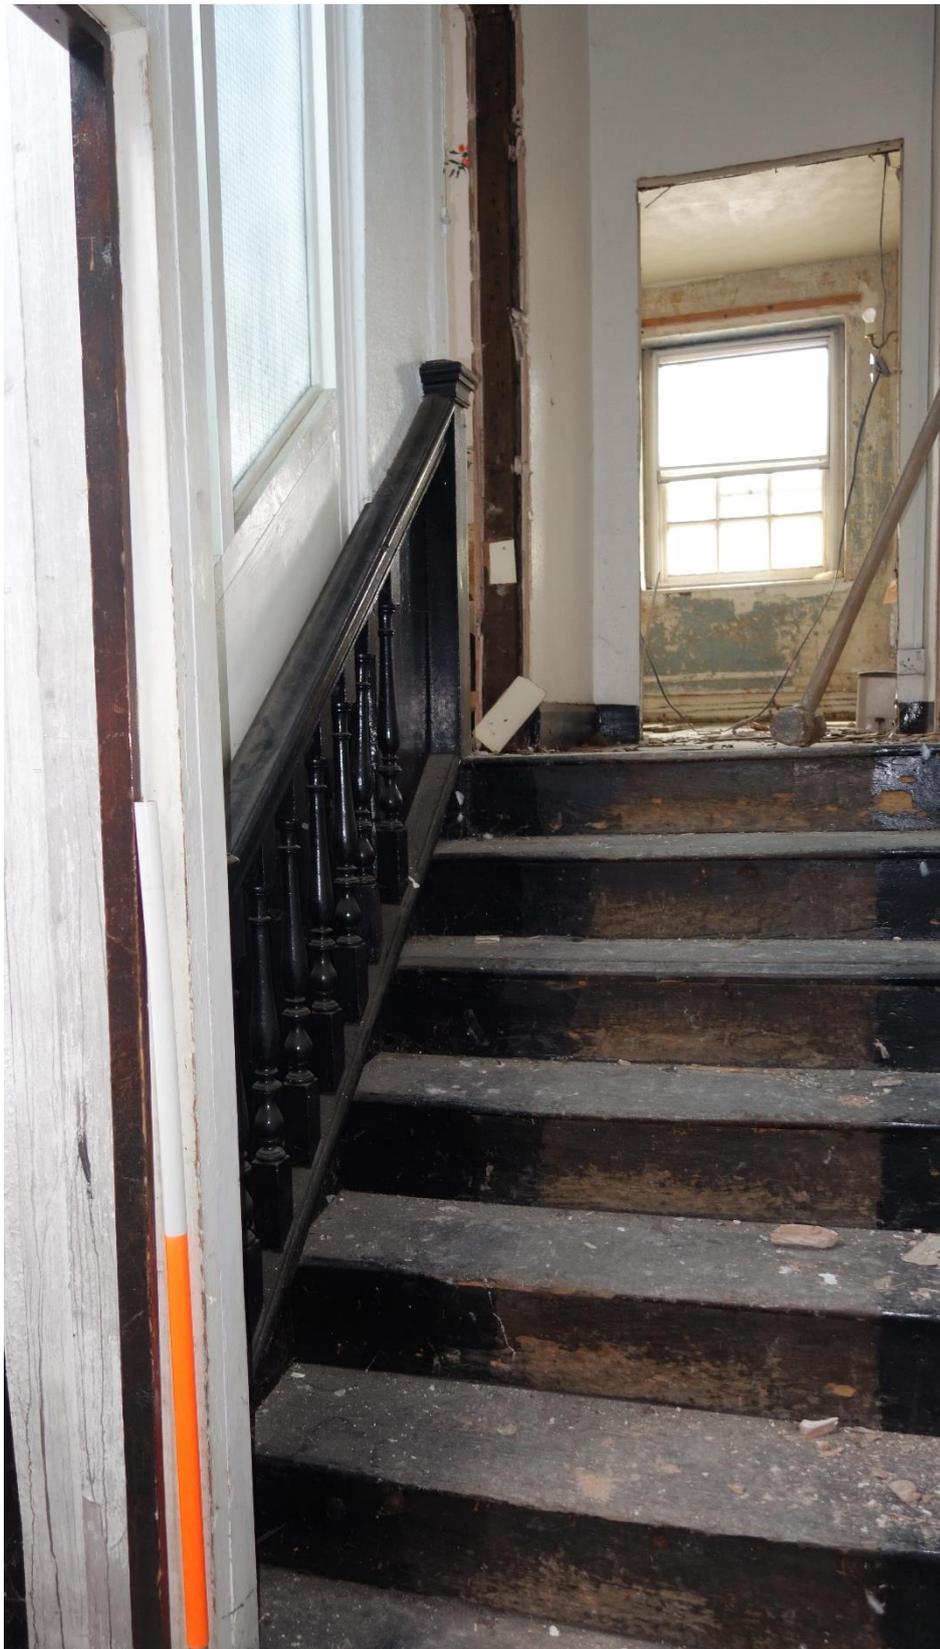
*Plate 49: Internal view looking W showing section of balustrading associated with stairs leading to second floor landing*

The section of the newel staircase leading from the first floor to the second floor exhibits some evidence of reconstruction, in particular the section of balustrading associated with the flight of stairs immediately leading up to the second floor landing appears to have been relocated from its original position, most likely when the existing partition wall with frosted glass windows associated with this flight of stairs was inserted in the early 1970s (*Plate 49*). The second floor has been subject to extensive alterations associated with its conversion into a hotel during the mid-late 20<sup>th</sup> century, which have resulted in earlier fabric either being concealed or removed altogether and the insertion of several new partition walls significantly altering the internal layout of this particular floor.

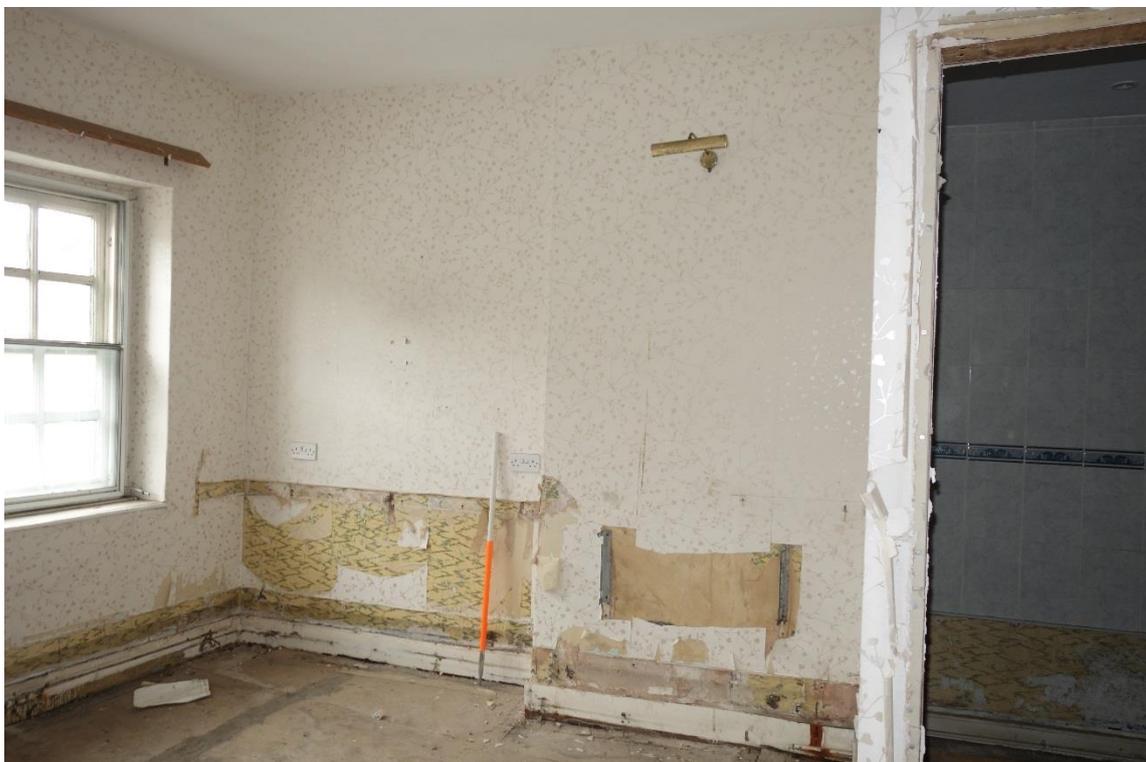
*Plate 50: Internal view looking NW showing blocked fireplace (concealed by wallpaper and plasterboard) in N wall of NW room at second floor level*

The newel staircase gives access to a wide floorboarded landing with doorways leading to two rooms to the NW and SW (overlooking the High Street) which have been subject to considerable modern alteration. The larger NW room has been heavily altered with the insertion of a bathroom and W.C. cubicle in the NE corner and a recessed wardrobe in the E wall (*Plate 50*). The walls are wallpapered while the floors are covered with linoleum although some floorboards have been exposed. The skirting appears to be entirely of modern date. A square hatchway in the ceiling in the NE corner of the room leads to the roofspace. A projecting section of the N wall almost certainly represents the location of a fireplace; however, it is completely concealed by modern wallpaper and skirting and appears partially to have been truncated by the insertion of the modern cubicle housing the bathroom and W.C.

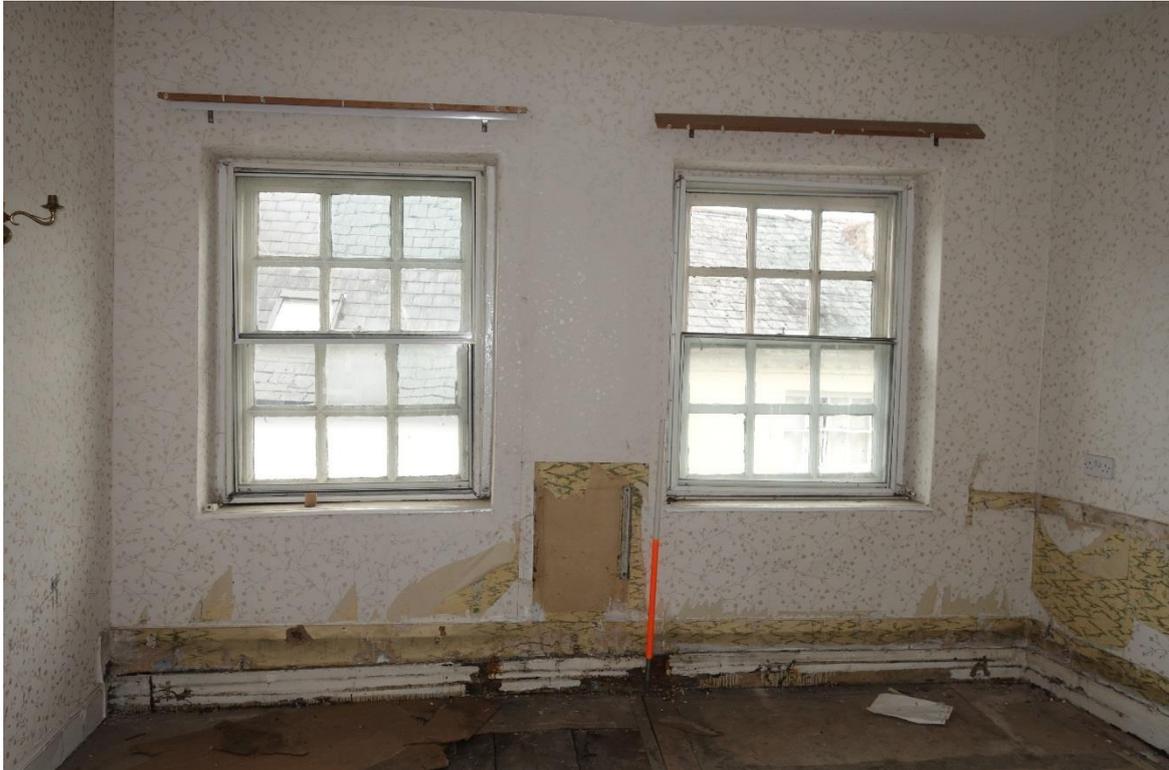
*Plate 51: Internal view looking W showing sash windows with thick glazing bars in NW room at second floor level*

The only surviving original features appear to be the pair of 12-paned flat headed sash windows in the W wall (overlooking the street) which have moulded architraves and thick moulded glazing bars suggestive of an 18<sup>th</sup> century date (*Plate 51*). Modern double glazing has been inserted over the sash windows although the original sash frames appear to have survived intact.

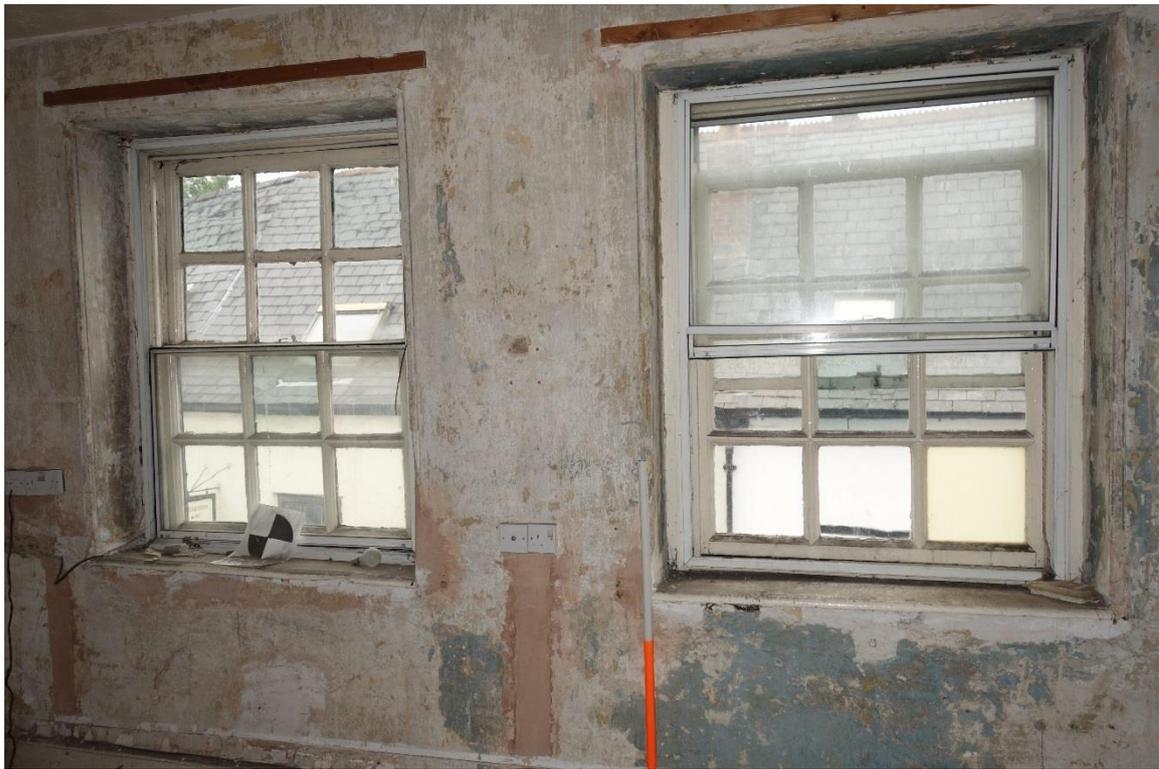
*Plate 52: Internal view looking WSW showing sash windows with thick glazing bars in SW room at second floor level*

The smaller SW room appears to have been reduced in size when a modern partition wall was inserted to create a corridor leading from the second floor landing across to No. 17A. In contrast to its NW counterpart, the wallpaper appears to have been largely removed exposing the rough plasterwork beneath. The skirting boards are modern although the floorboards (which are heavily decayed in places) could be of an earlier date. The most noteworthy features are the pair of 12-paned sash windows with thick moulded glazing bars identical to those in the NW room (*Plate 52*).

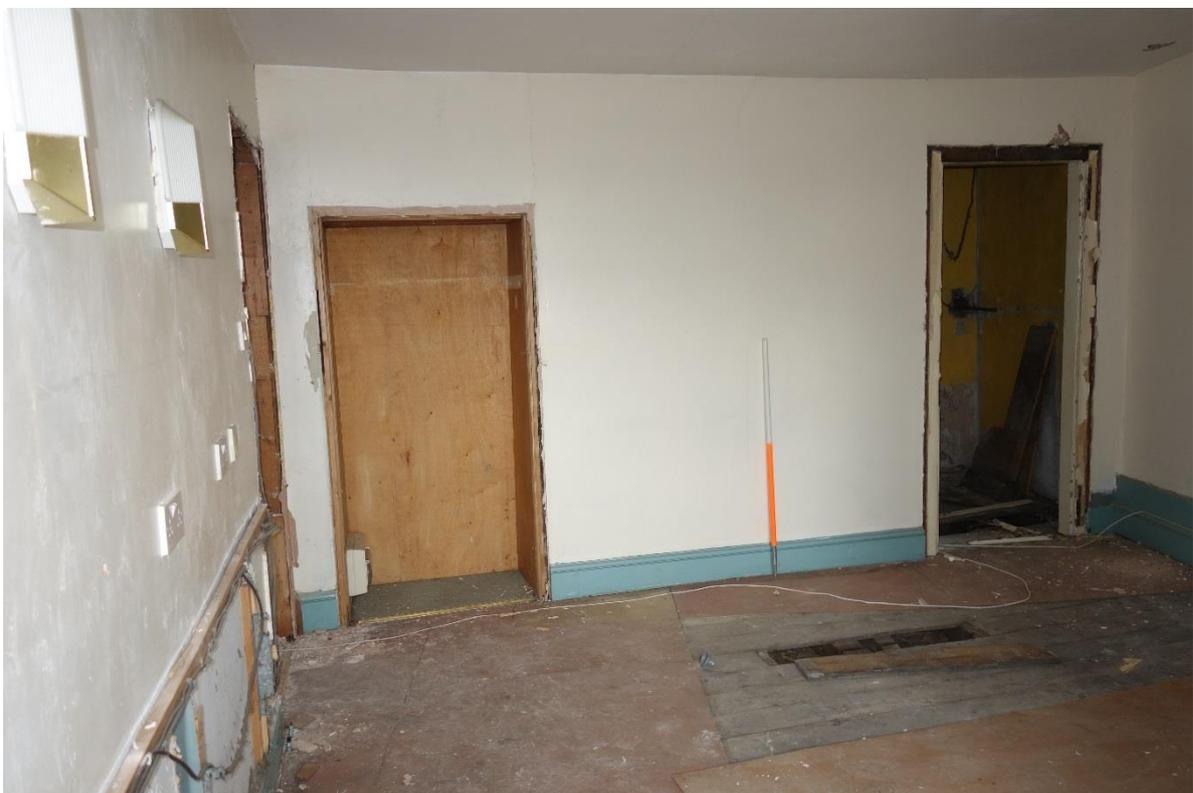
*Plate 53: Internal view looking W showing E wall of NE room at second floor level*

Located against the W wall is a projecting section of wall which corresponds to the location of the central chimneystack at ground and first floor level (Plate 53). There is no visible evidence for a fireplace against the W wall, however there is a deep recessed cupboard in the NW corner of the room which extends to the side of and beneath the chimney flue. A large longitudinal roof truss oriented E-W is visible adjacent to the chimney flue, as well as a section of lath and plaster panelling concealed beneath later plasterwork (Plate 54).

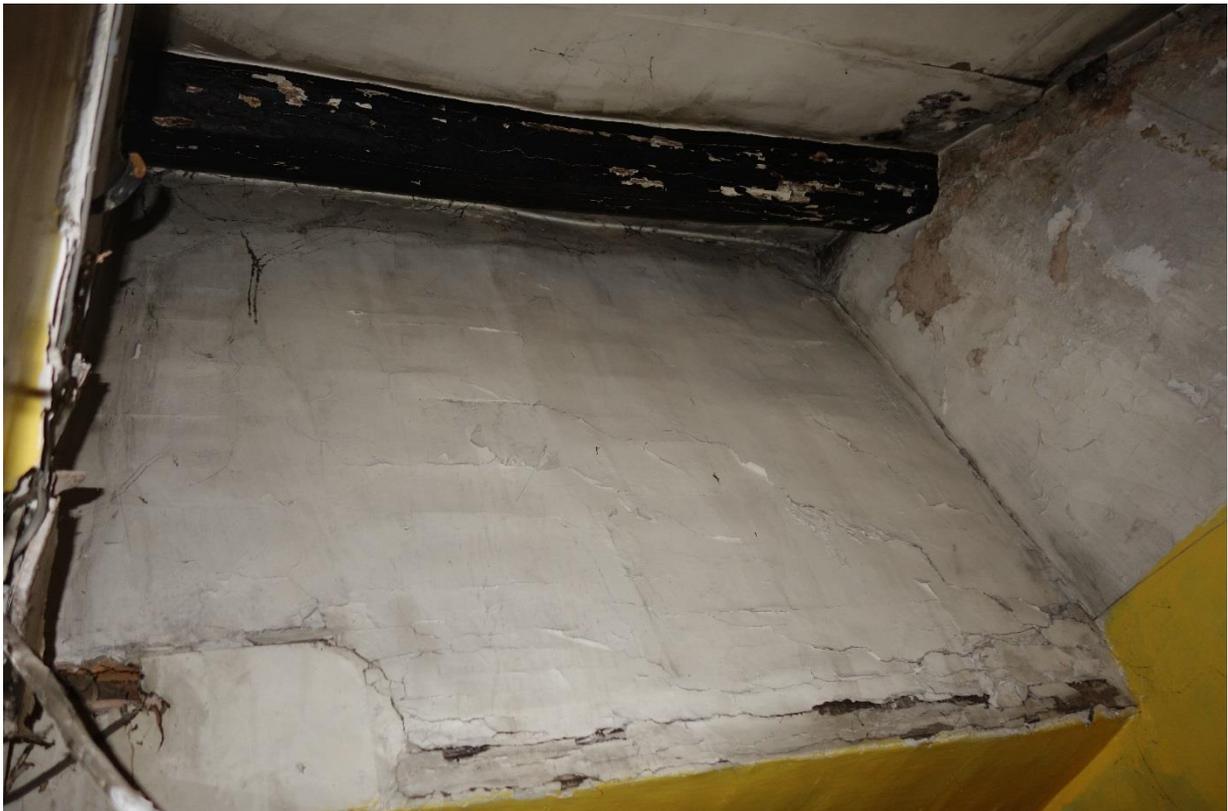
*Plate 54: Internal view showing detail of chimneystack and exposed truss revealed in cupboard within NE room at second floor level*

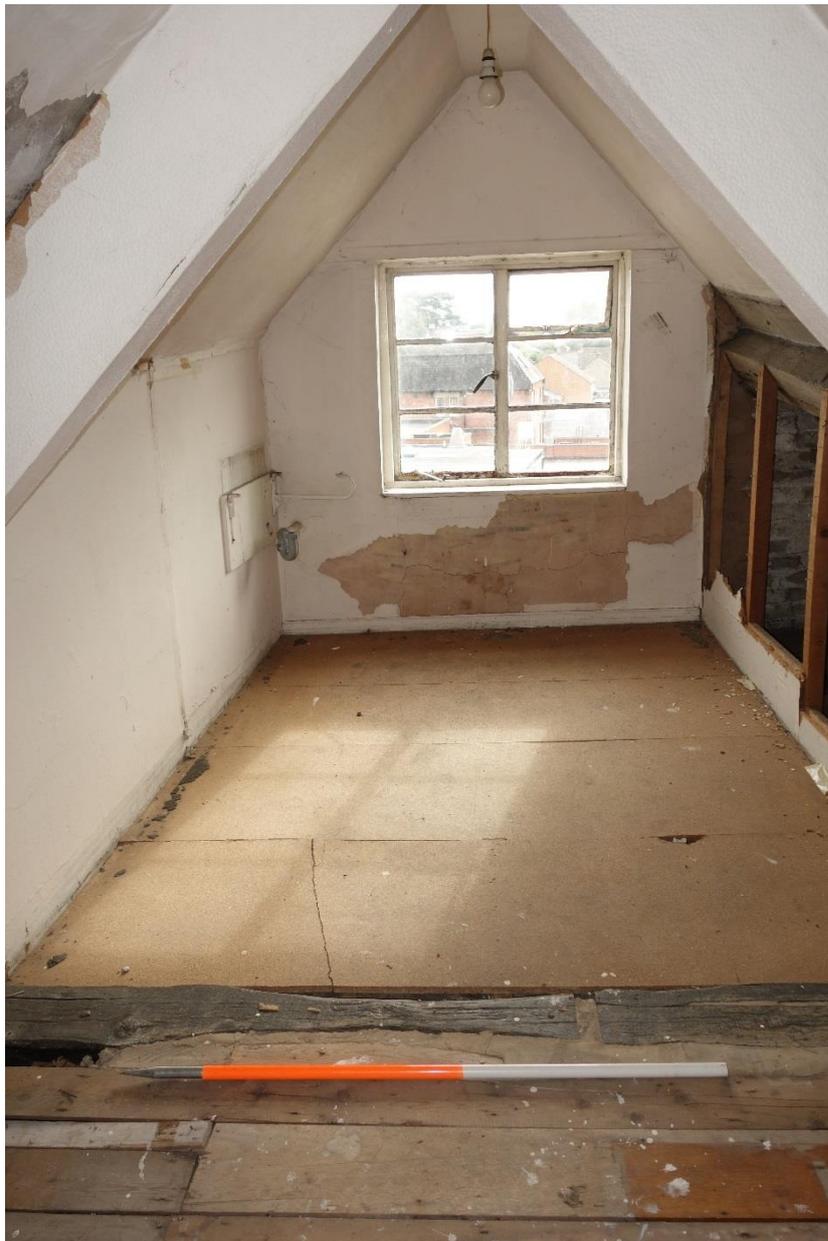
*Plate 55: Internal view looking E showing main compartment of attic with section of exposed brick gable wall to right of picture*

roof space and the brickwork of the E gable end wall (*Plate 55*). The room is lit by a 6-paned metal casement window which appears to be a mid-20<sup>th</sup> century insertion (it appears to have been in place by 1960).

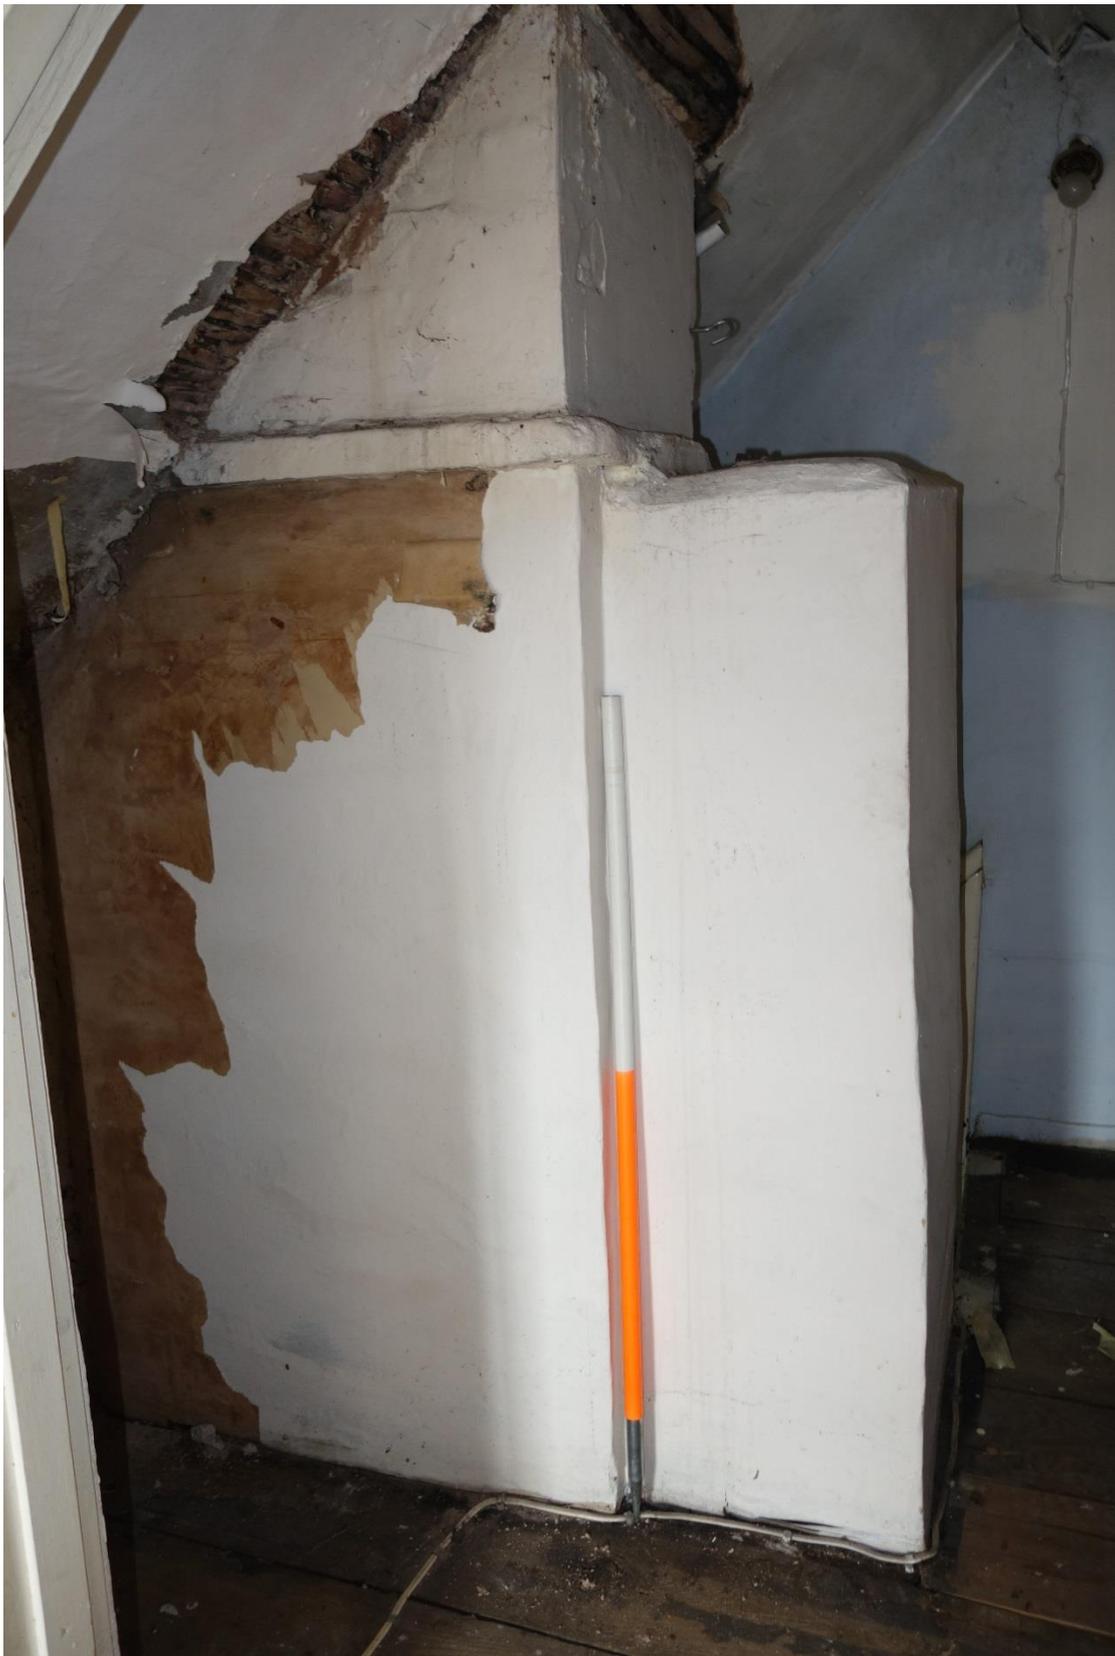
*Plate 56: Internal view showing upper stages of central chimneystack in attic space of No. 17*

Inspection of the visible roof space revealed it to be of open truss construction with the principal rafters connected to the horizontal tie beam and a linked by a single set of trenched purlins (*Plate 56*). The RCHME survey of 1930 suggests that some of the roof timbers may have originated from an earlier building but no definite evidence of reuse was noted. It was not possible to access the roofspace within the front portion of the building due to health and safety constraints.

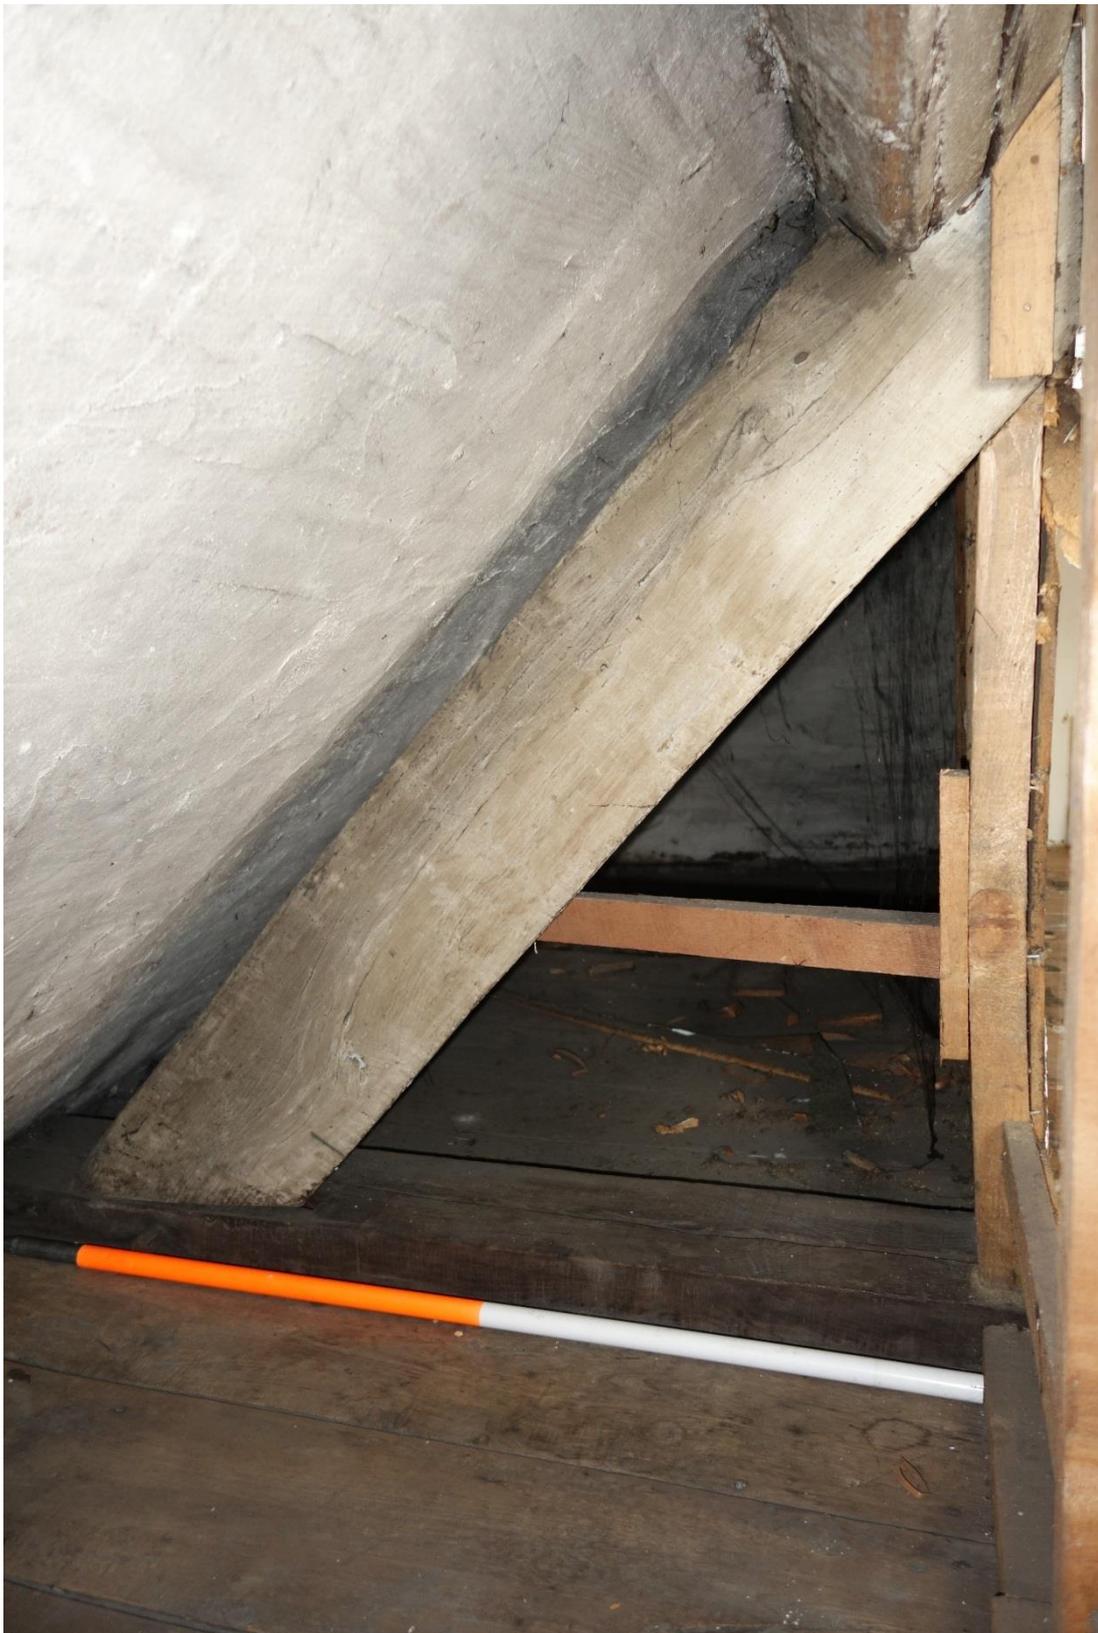
*Plate 57: Internal view looking W showing detail of roof truss in attic space of No. 17*

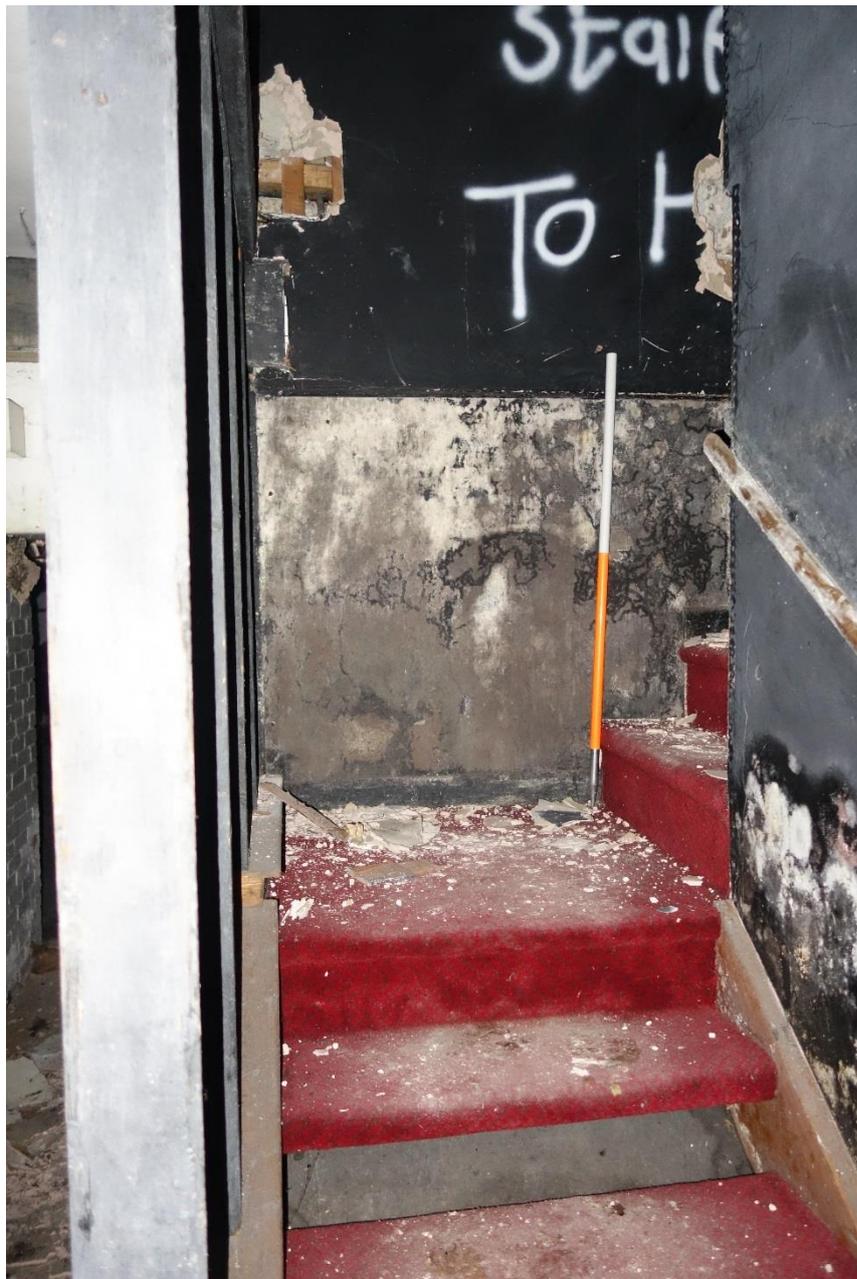
*Plate 58: Internal view looking up the dog-leg staircase leading from the basement to the ground floor of No. 17A*

The basement of No. 17A can be accessed either from a dog-leg staircase leading down from the central staircase of No. 17A or from a brick vaulted passageway leading S from the cellar of No. 17. Both the staircase and brick passageway appear, in their present form, to be of modern date (*Plate 58*).

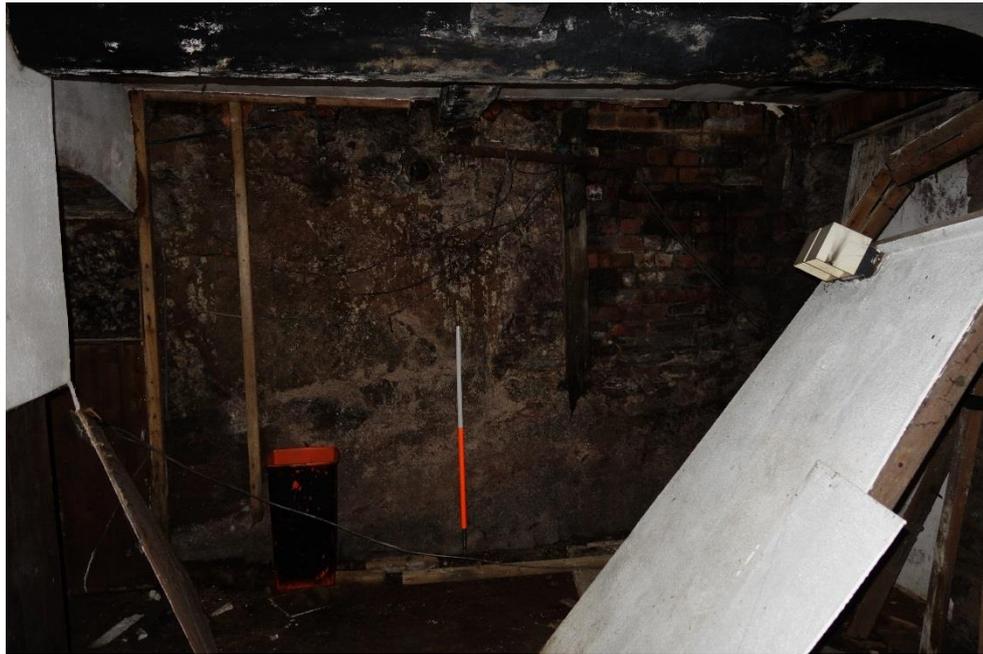
*Plate 59: Internal view looking W showing partially reconstructed W wall of cellarage beneath No. 17A*

As was the case with No. 17, the cellarage appears to extend only beneath the front of the building. The walls are mostly clad with white plaster and modern timber panelling, associated with its usage as a cellar bar in the late 20<sup>th</sup> century. However, exposed sections of the cellar walls show them to be chiefly of coursed rubble masonry construction apart from the W-wall which has been partially rebuilt in brick (Plate 59). The ceiling is of beam and joist construction with evidence of re-used, heavily smoke blackened beams. A small arched recess with a low brick barrel vault has been inserted in the SW corner of the cellar (Plate 60).

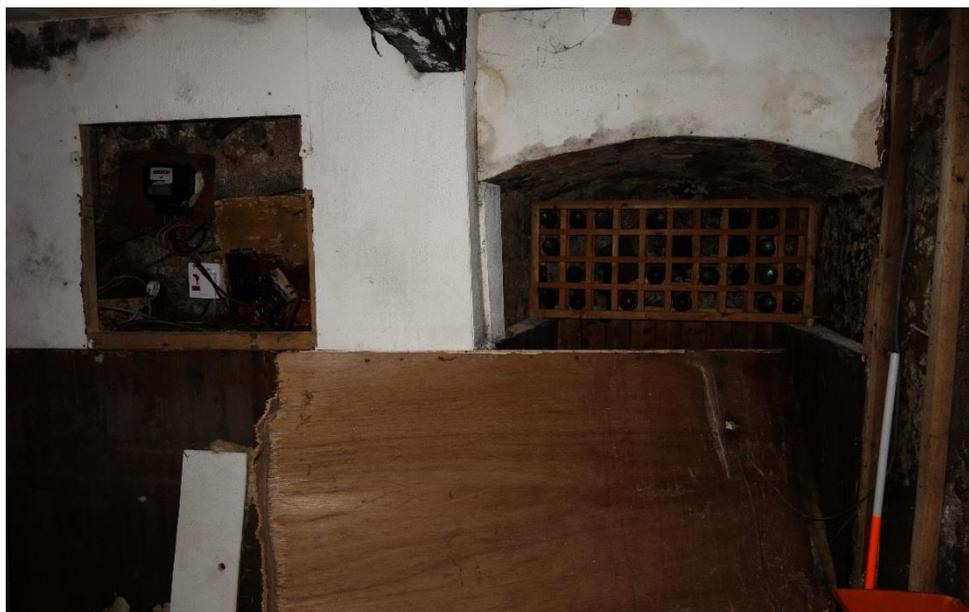
*Plate 60: Internal view looking S showing arched recess with brick barrel vault in SW corner of cellarage beneath No. 17A*

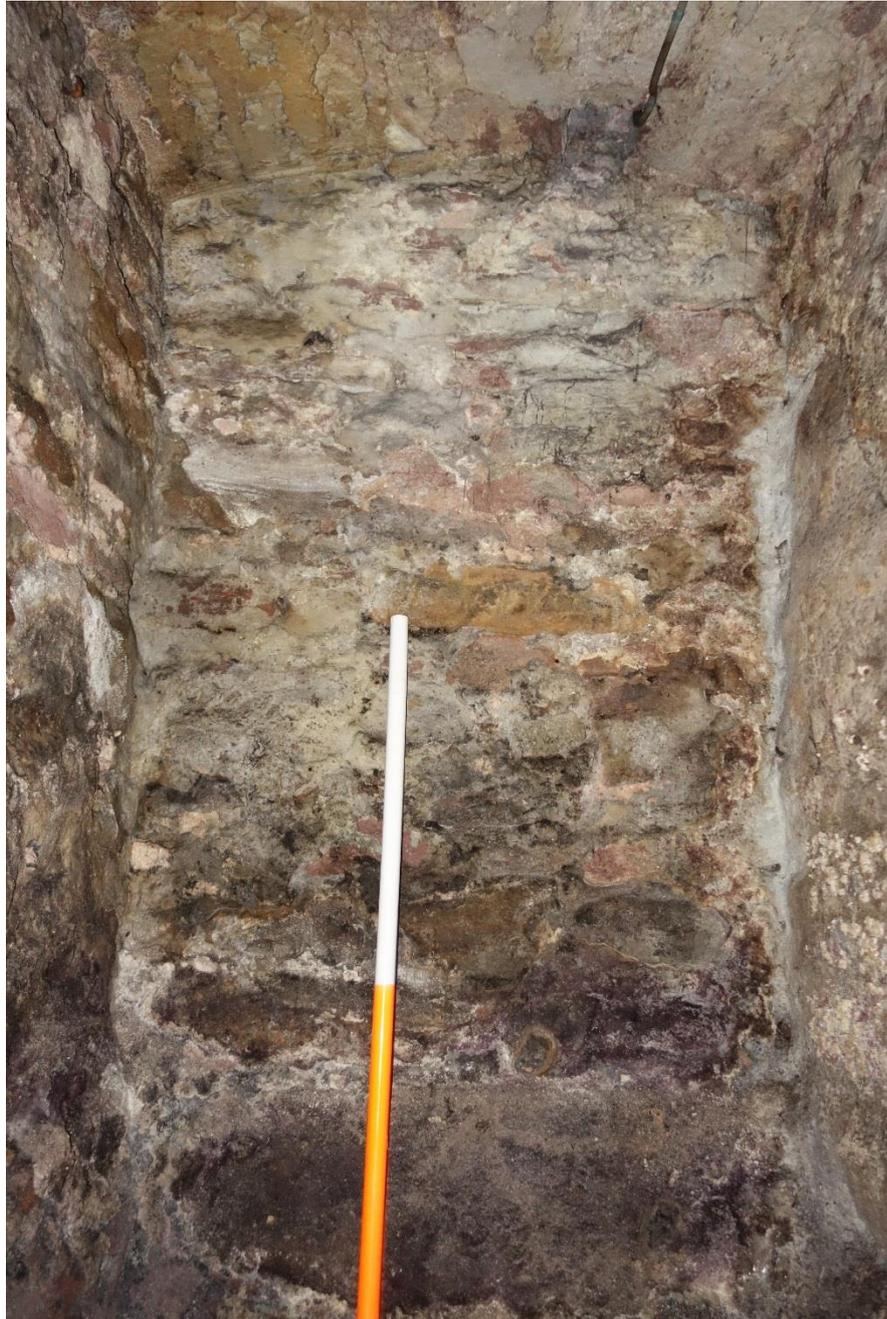
*Plate 61: Internal view looking E showing detail of stone vaulted chamber located beneath the cellar staircase at No. 17A*

Beneath the modern staircase is a narrow passage which leads to a small oblong single-celled chamber, oriented E-W with a low stone vault (Plate 61). The function of this single-celled compartment is uncertain, it does not appear to lead to any other parts of the cellarge; it is possible that this may represent the so-called 'priest hole' which was reputedly identified during works on the hotel during the early 1970s.

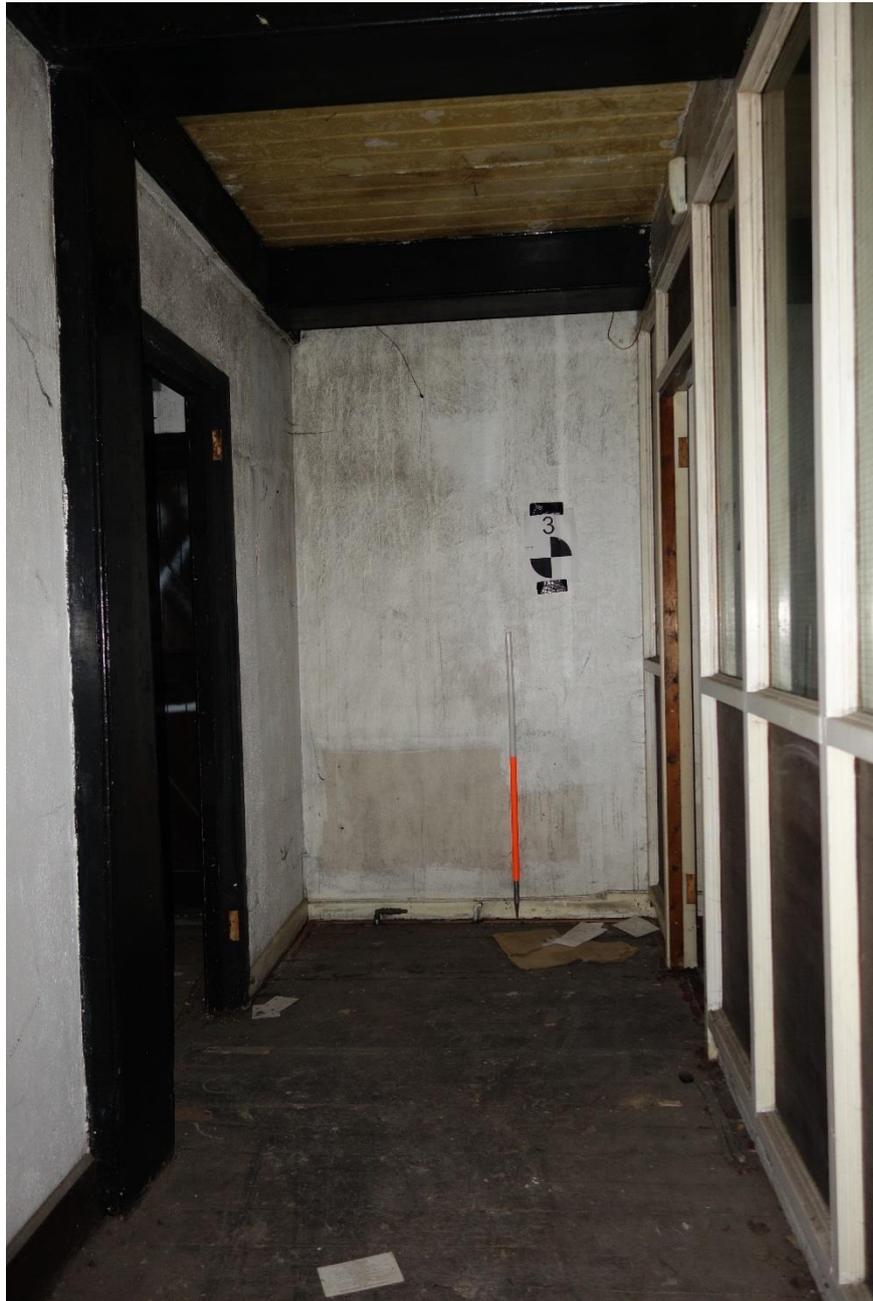
*Plate 62: Internal view looking S along modern corridor at ground floor level within No. 17A*

The ground floor of No. 17A can be accessed from two locations, to the N from the hallway of the Rosswyn Hotel (which incorporates the former passageway leading between Nos. 17 & 17A) and to the S from the covered passageway running between No. 17A and Nos. 18 & 19, where the intact doorway leads directly onto the lobby and central staircase. From the hallway of the Rosswyn Hotel, a doorway leads S into a cross-axial corridor extending N-S through the ground floor (*Plate 62*). The ceiling appears to have been much renewed and is of beam and joist construction.

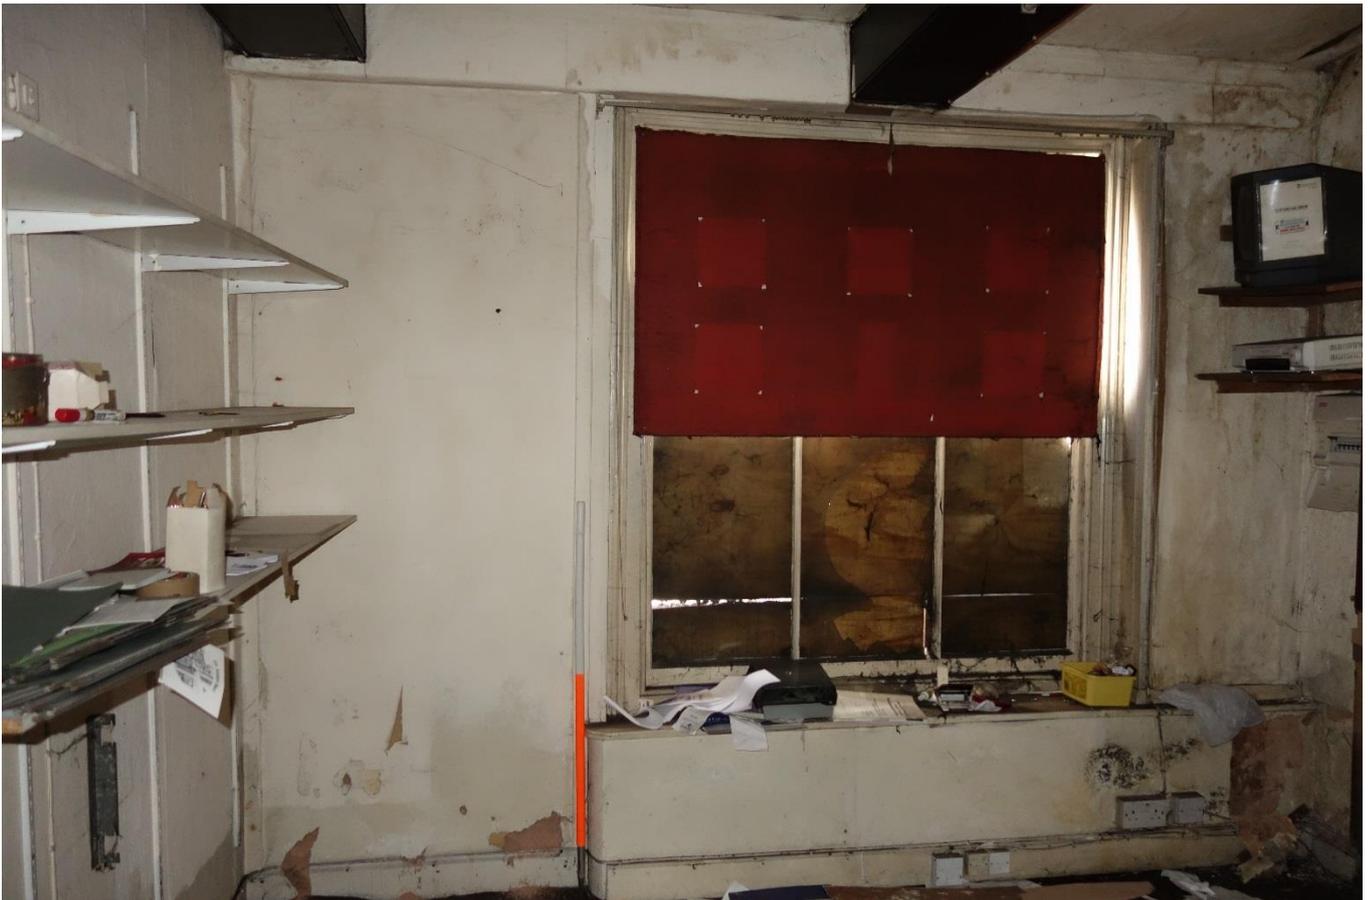
*Plate 63: Internal view looking W showing reception room on W side of corridor within No. 17A, with partially intact sash window with thin glazing bars*

On the W side of this corridor is a tall glazed partition wall which is evidently a modern insertion, demarcating a room formerly used as the hotel reception office, as evidenced by a hatchway inserted in the thickness of the N wall. Few features of architectural interest were noted, the exceptions being a partially intact sash window with thin glazing bars of probable mid-19<sup>th</sup> century date (only the upper part of the sash frame has survived intact) and two exposed ceiling beams aligned E-W (*Plate 63*).

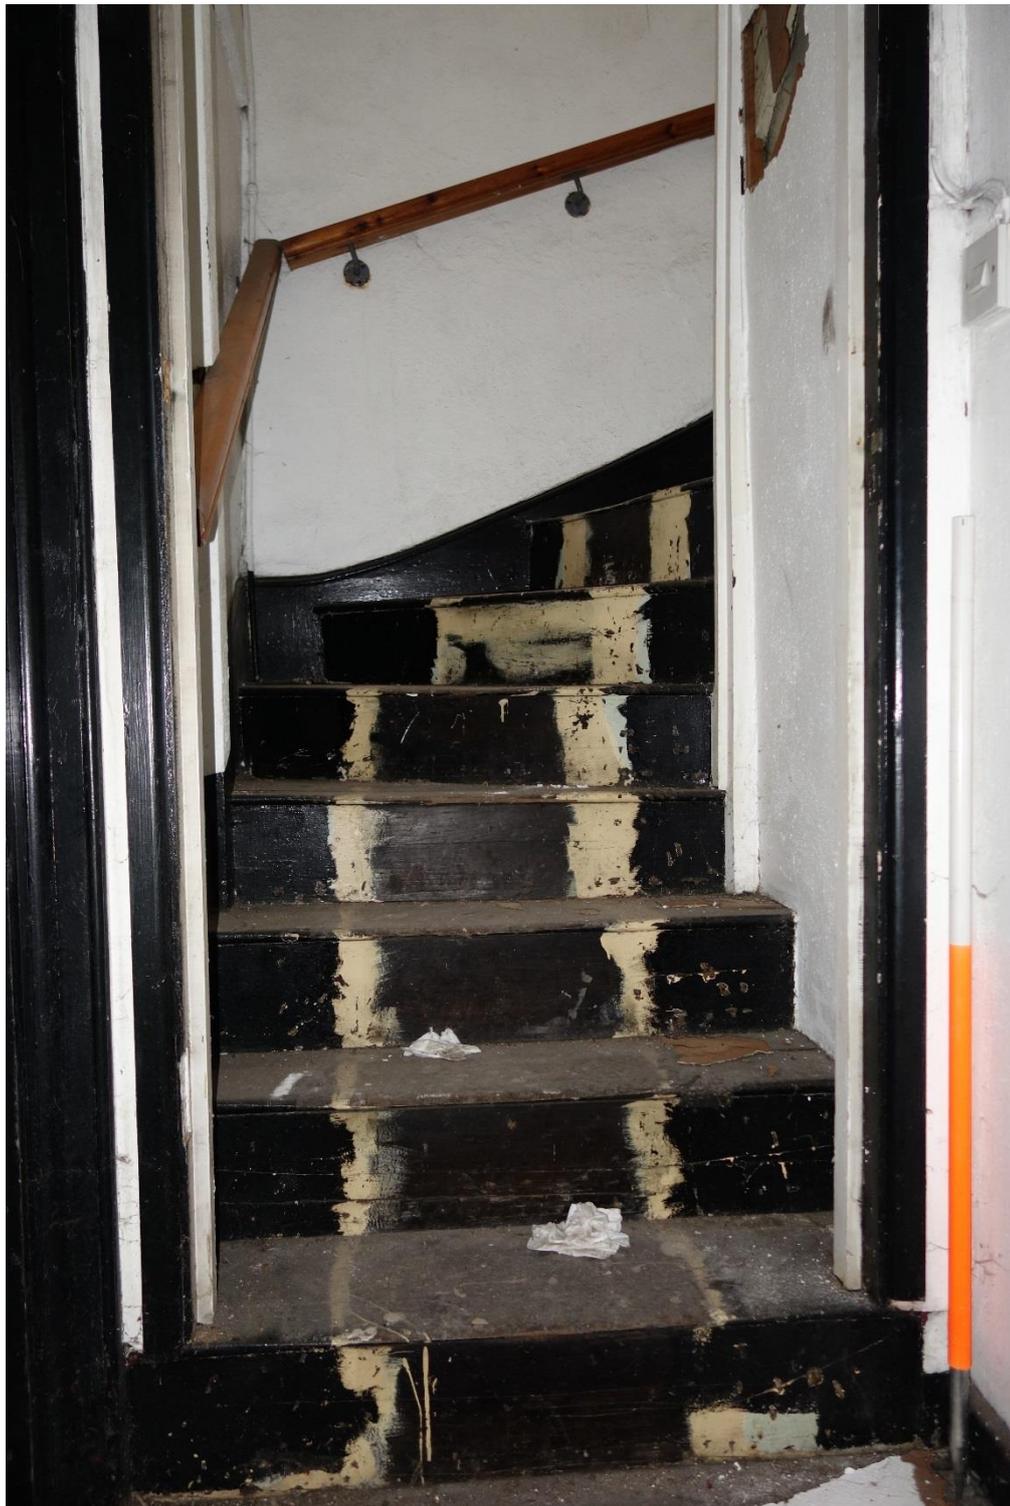
*Plate 64: Internal view showing dog-leg staircase at ground floor level within No .17A*

To the E of the corridor is a doorway leading into a narrow entrance lobby, again devoid of architectural detailing. Immediately to the left of the doorway is a timber dog-leg staircase with a moulded open string and a modern hand rail providing access to the first and second floors (*Plate 64*), with an adjoining flight of steps leading down to the cellarage. Immediately facing the staircase is a flat headed plank and batten door in the S wall which directly leads to the passageway between No. 17 A and Nos. 18 & 19.
