## Standing Building Recording Survey

**BGD Property Ltd**

Former Rosswyn Hotel  
16-19 High Street  
Ross-on-Wye  
Herefordshire HR9 5BZ

**October 2016**

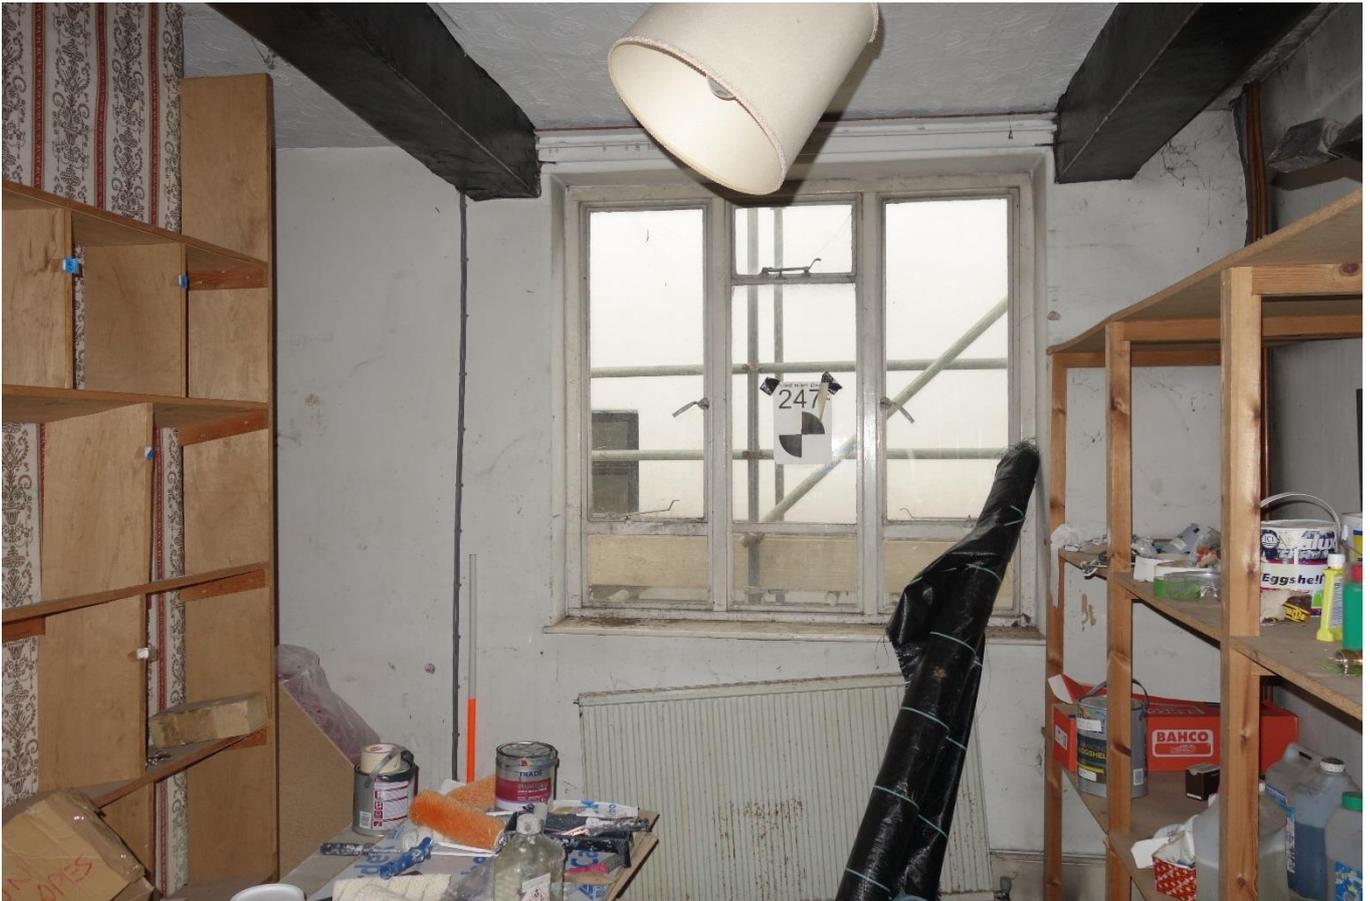
*Plate 65: Internal view looking S showing ground floor room at E end of No. 17A with exposed ceiling beams*

To the E of the lobby is a rectangular compartment currently used for storage, lit by a single 3-light casement window of mid-late 20<sup>th</sup> century date (*Plate 65*). The ceiling is plastered with moulded foliage decoration that appears to be of modern date and has two substantial exposed E-W aligned ceiling beams that appear to be heavily renewed. A projecting section of the N-wall probably represents a fireplace, however it was completely concealed by modern plasterboard and further hidden by beds and shelving stored in the room and could not therefore be investigated further.

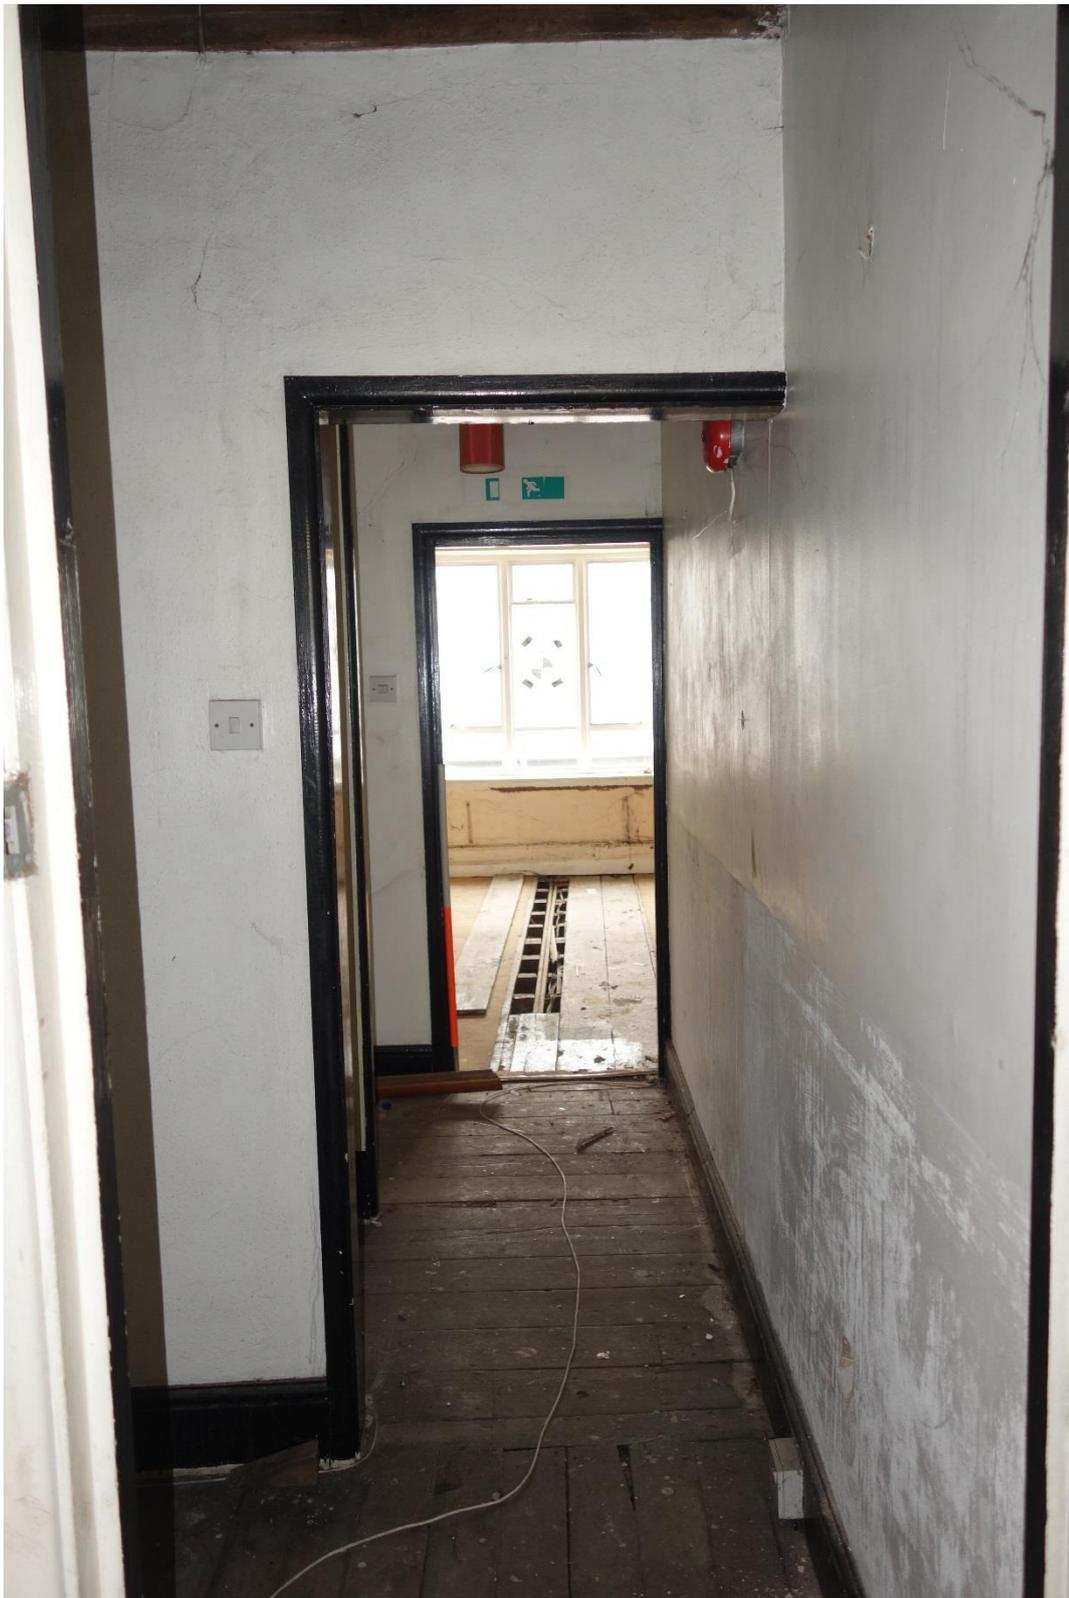
*Plate 66: Internal view looking E showing broad floorboarded landing at first floor level within No. 17A*

The staircase continues up to the first floor landing, lit by a small single light window in the thickness of the stairwell which is partially hidden by the stair treads. Immediately to the W of the stairway, a corridor provides access from the first floor landing to the adjacent house to the N (No. 17). The landing has moulded skirting and plain moulded doorways (the doors having been removed) leading to bedrooms situated to the E and W (*Plate 66*); no other architectural detailing of note was identified.

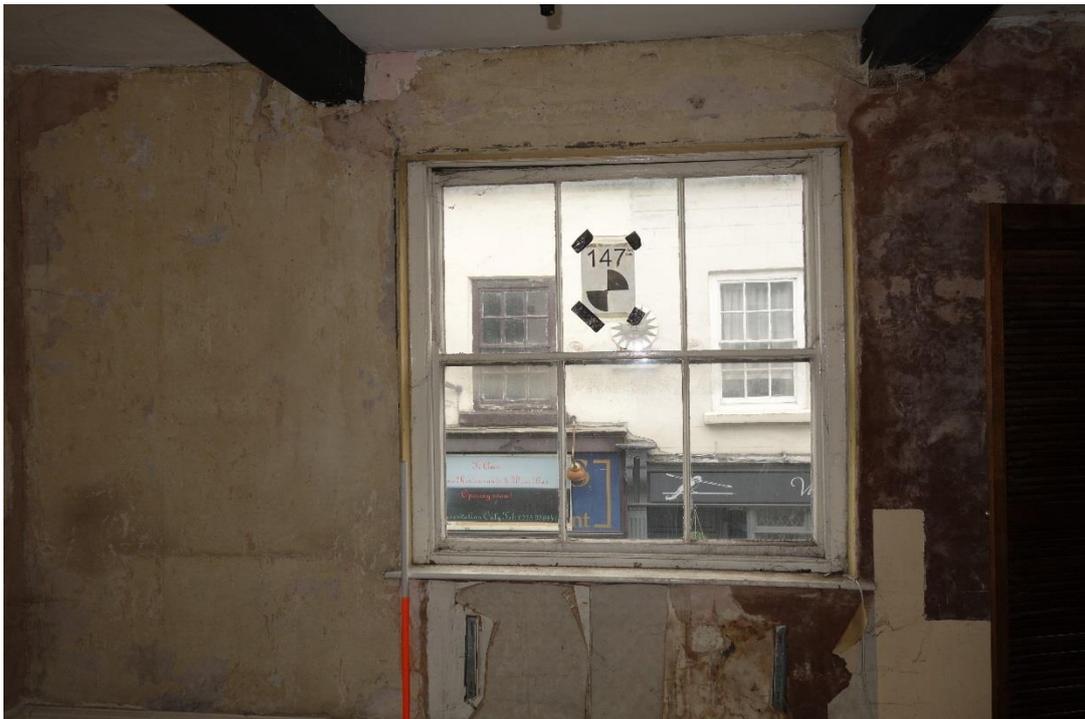
Leading off to the E and W of the first floor landing are two large bedrooms which have been subject to extensive late 20<sup>th</sup> century alterations; which appear either to have largely concealed or removed any internal features, fixtures or fittings of architectural interest. Within the front (W) bedroom, the most notable surviving features are the single 6-paned sash window with thin glazing bars, of probable early to mid-19<sup>th</sup> century date, the floorboarding and two exposed ceiling beams oriented E-W, which appear to have been heavily renewed (*Plate 67*). Against the N-wall is the site of a former fireplace which has been blocked up and concealed by modern plasterboard and skirting, immediately to the left of which is a recess for a modern wardrobe (*Plate 68*). A modern cubicle for a bathroom has been inserted in the SE corner of the bedroom.

*Plate 67: Internal view looking W showing 6-pane sash window and exposed ceiling beams in first floor W bedroom*

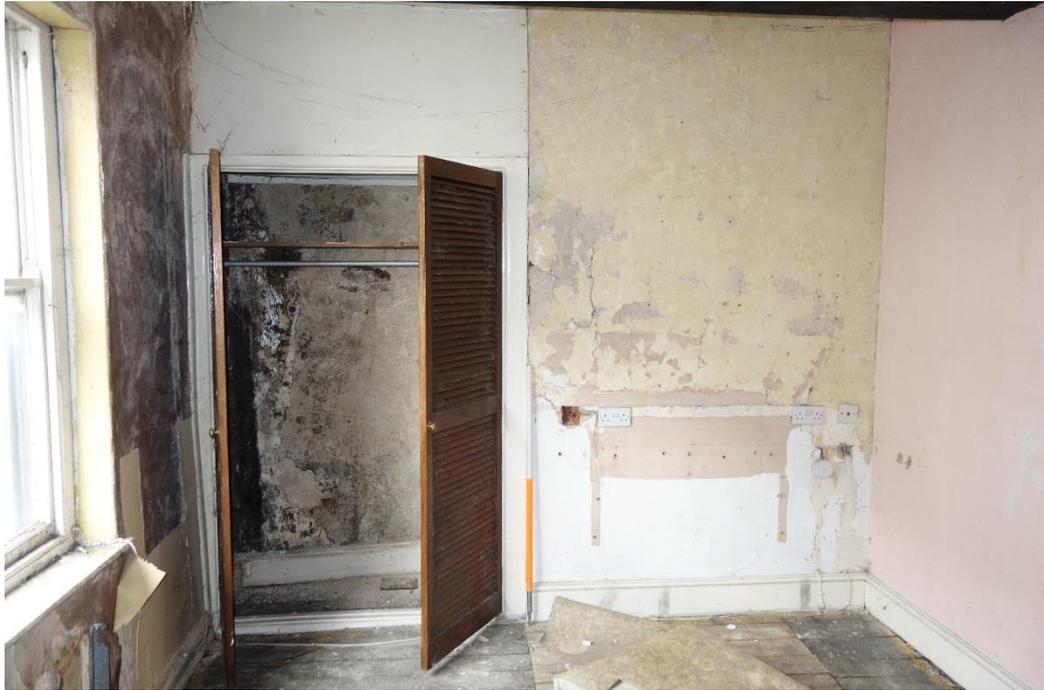
*Plate 68: Internal view looking N showing blocked fireplace to right of modern wardrobe in first floor W bedroom*

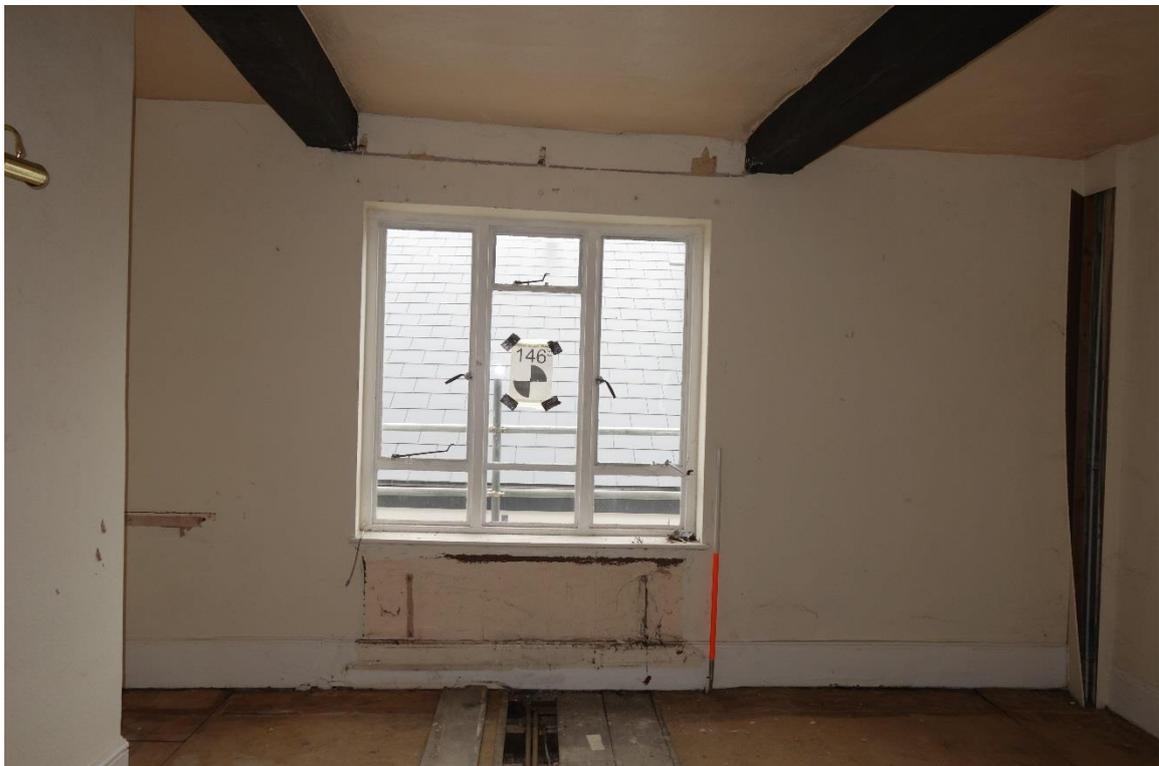
The rear bedroom to the E of the first floor landing has been even more systematically stripped of any original architectural features, fixtures and fittings (*Plate 69*). It is lit by a 6-paned metal casement window which is evidently a modern replacement. The walls are clad in modern plasterboard while the skirting also appears to be of modern date. Two exposed ceiling beams aligned E-W are visible, which appear to be continuations of the same ceiling beams visible in the front bedroom. A projecting section of the N wall with cupboard recesses on either side may represent a blocked fireplace and chimney flue but the actual fireplace appears to have been removed and concealed by modern plasterboard and wallpaper. A doorway in the SW corner of the room provides access to a modern bathroom and WC compartment which extends to the S of the first floor landing.

*Plate 69: Internal view looking E showing exposed ceiling beams in first floor E bedroom*

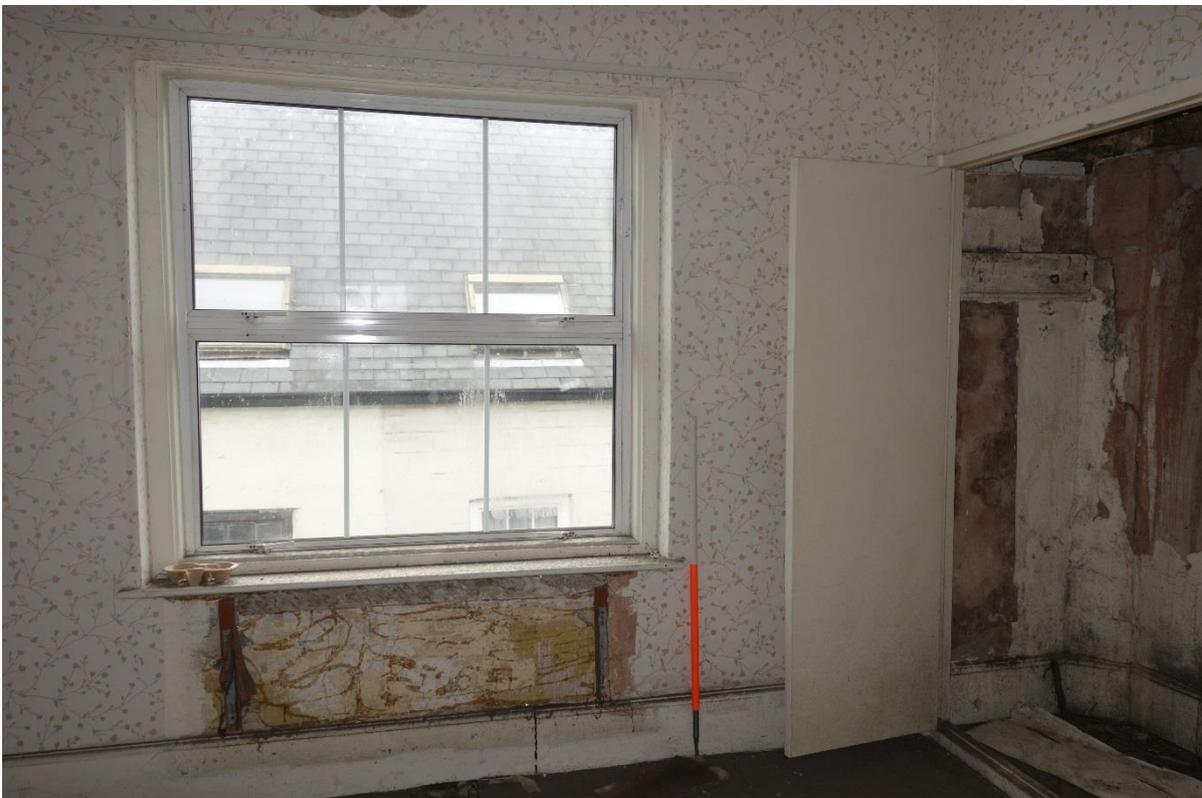
*Plate 70: Internal view looking W showing interior of front bedroom to W of the second floor landing*

The front bedroom to the W of the second floor landing has been extensively altered and clad in modern plasterboard and wallpaper. The skirting appears entirely to be of modern date. It is lit by a modern 6-paned PVC casement window which superseded an earlier 6-paned sash window of probable 19<sup>th</sup> century date (Plate 70). A deep recessed wardrobe in the N wall contains some earlier wallpaper of possible late 19<sup>th</sup>-early 20<sup>th</sup> century date. To the right of this wardrobe is the site of a former fireplace and chimney flue which has been completely concealed by modern plasterboard and wallpaper. A modern bathroom cubicle has been inserted in the SE corner of the bedroom.

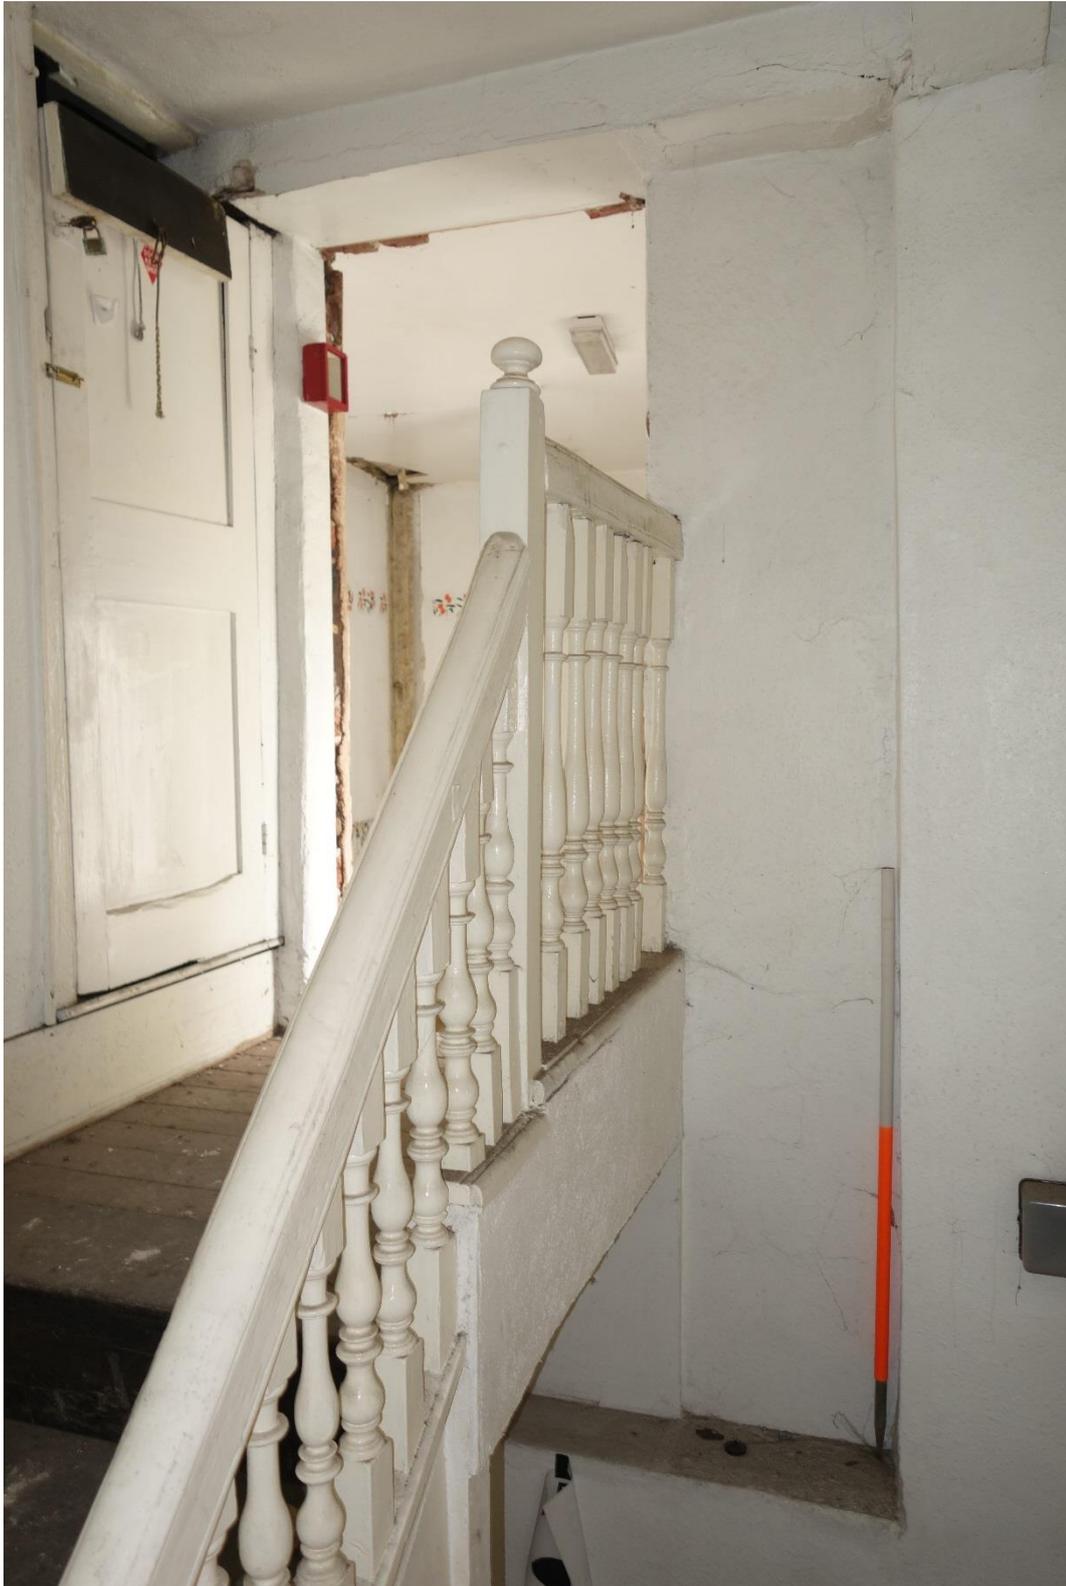
A flight of wooden stairs with a moulded handrail and twisted balusters extends up from the second floor landing to a narrow half-landing, which leads to a doorway connecting No. 17A with the adjacent house at No. 17 (*Plate 72*). The handrail and balusters associated with this flight of stairs does not appear to be in-situ and suggests that the stairway and the doorway leading to No. 17, in their present form, are probably of modern date and were inserted to provide fire escape access between the two properties. Above this doorway is a substantial transverse beam carried on a vertical jowelled post; it is possible that this represents part of an external timber framed wall although no evidence of lath and plaster infill was observed (*Plate 73*).

*Plate 72: View looking N showing flight of stairs leading to half-landing between Nos. 17 & 17A, with moulded hand rail and balusters*

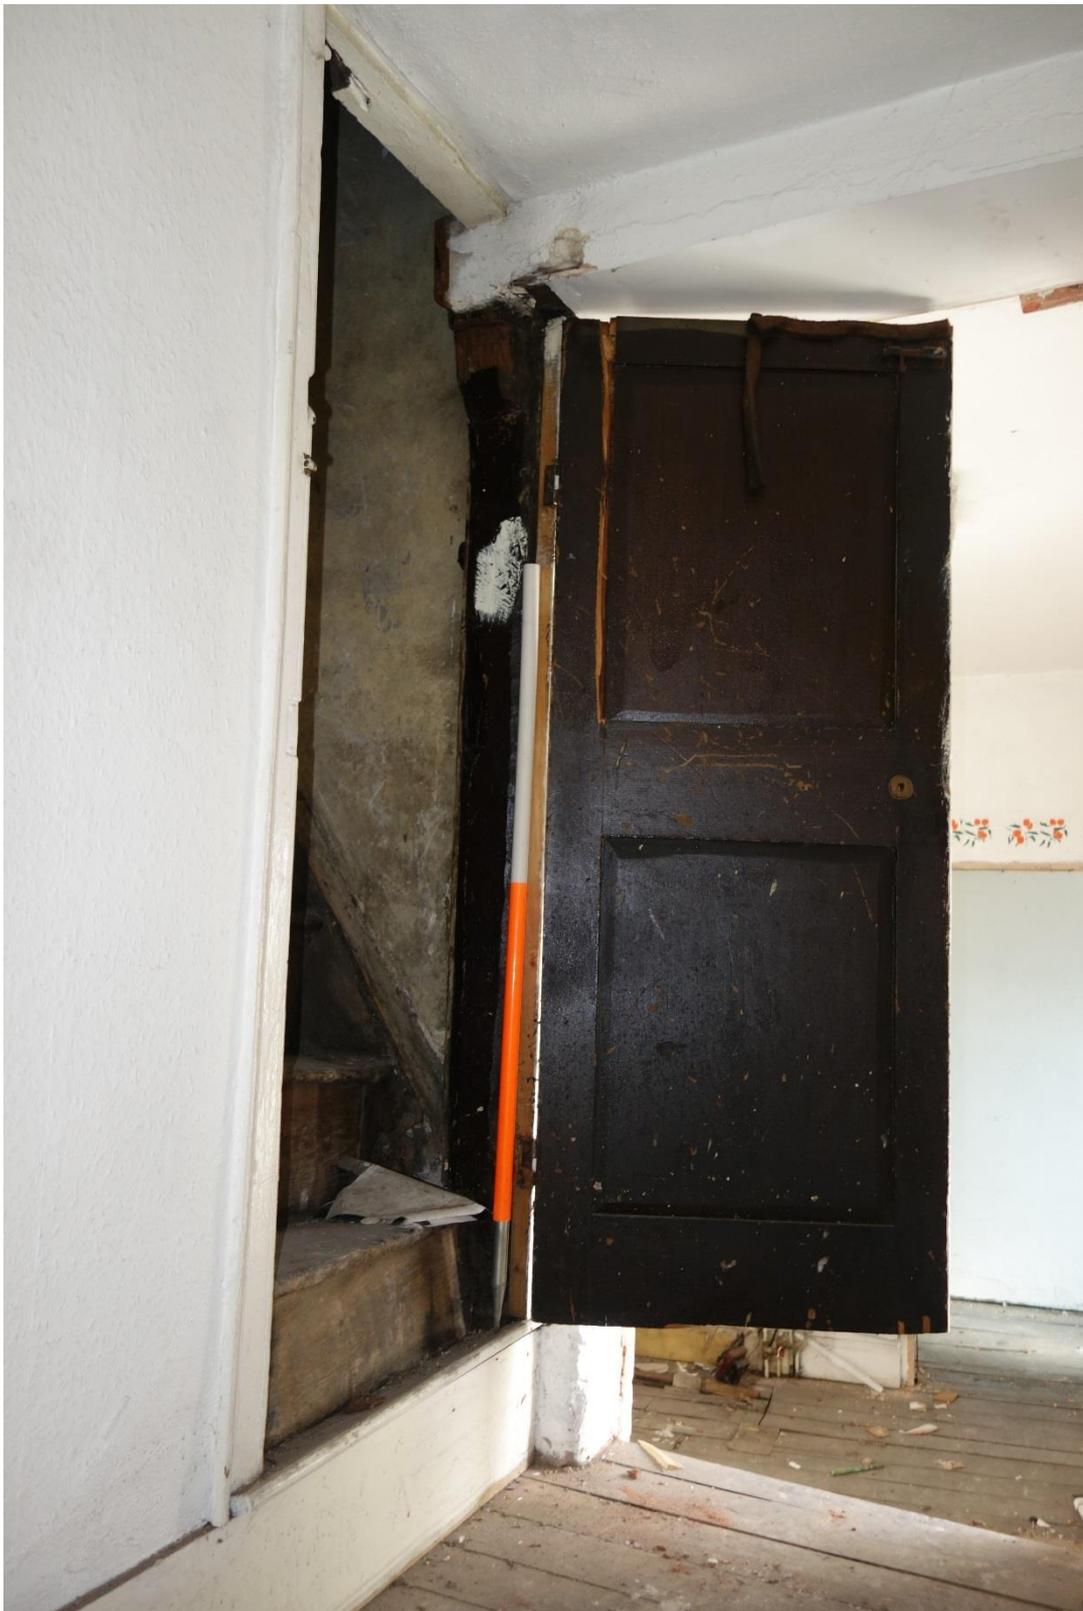
*Plate 73: Internal view looking N showing jowelled post carrying a transverse beam located above the doorway leading from No. 17A to No. 17, to the left of which is a flight of stairs leading to the attic space of No. 17A*

Leading off to the W of the half-landing is a steeply pitched flight of steps with winding treads climbing up to the attic space of No. 17A, accessed via a 3-panelled doorway positioned somewhat awkwardly against the N wall of the building (*Plate 73*). In contrast to the attic space of No. 17, where the roof timbers and floorboards have been significantly renewed and obscured by modern cladding, this attic has not been as heavily altered during the late 20<sup>th</sup> century and as a consequence, much more of the original roof structure and floorboarding, probably datable to the 18<sup>th</sup> century, has survived intact.

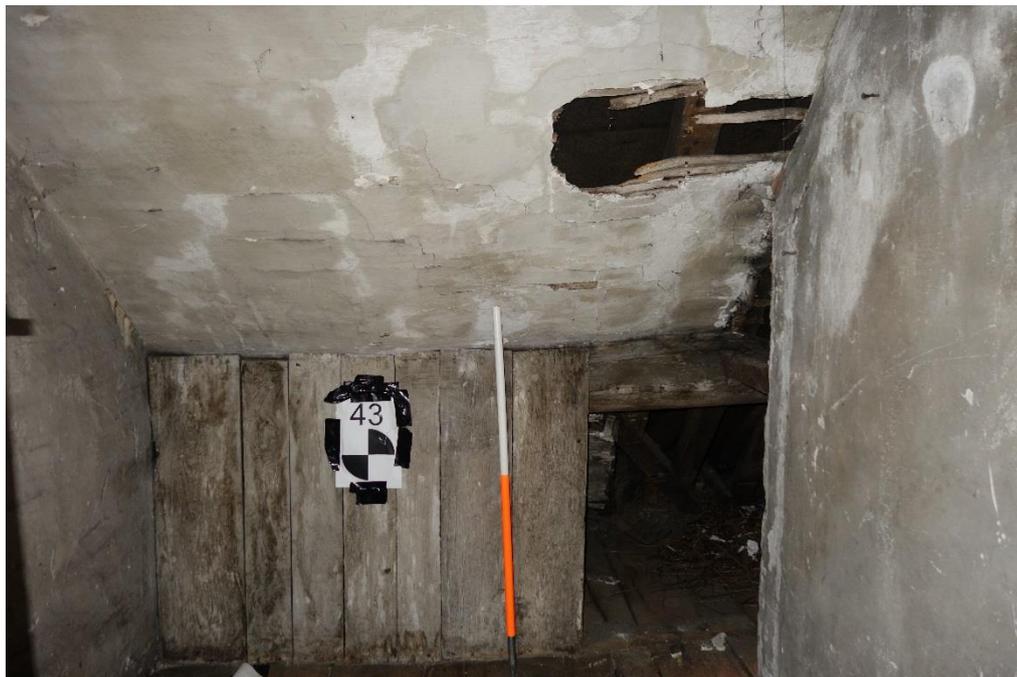
*Plate 74: Internal view looking S showing partition wall and lath and plaster ceiling to right of chimney flue*

The attic space is divided into three compartments. The landing has a steeply pitched ceiling with walls of lath and plaster and a pair of exposed purlins oriented N-S. Immediately E of the flight of stairs, against the N wall of the compartment is the upper portion of the chimney flue, the brick masonry of which is completely concealed by a thick greyish white plaster. At right angles to the chimney flue is a partition wall constructed of timber planking, above which is a pitched lath and plaster ceiling (*Plate 74*). Evidence of the roof structure was noted behind this partition wall; however, it was not possible to investigate more closely due to health and safety constraints.

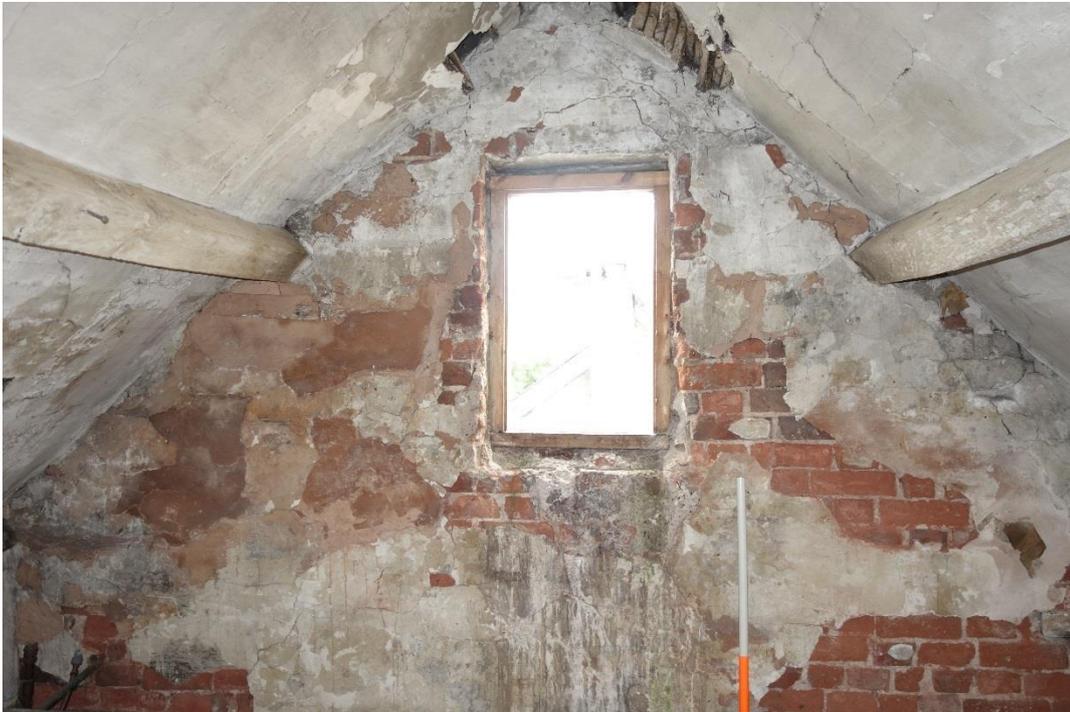
To the S of the landing is a partition wall of lath and plaster (oriented E-W) with a centrally placed doorway with plank and batten door leading to a small oblong room. This compartment has side walls and a pitched ceiling of lath and plaster with a pair of roof purlins exposed. The floorboarding has been exposed in this room and may well represent original fabric. The S-facing gable end of the room is constructed of brick (laid in Flemish bond) with a single flat headed window of probable 18<sup>th</sup> century date (*Plate 75*). The wooden framing of the window

*Plate 75: View looking S showing S gable wall of compartment in first floor attic*

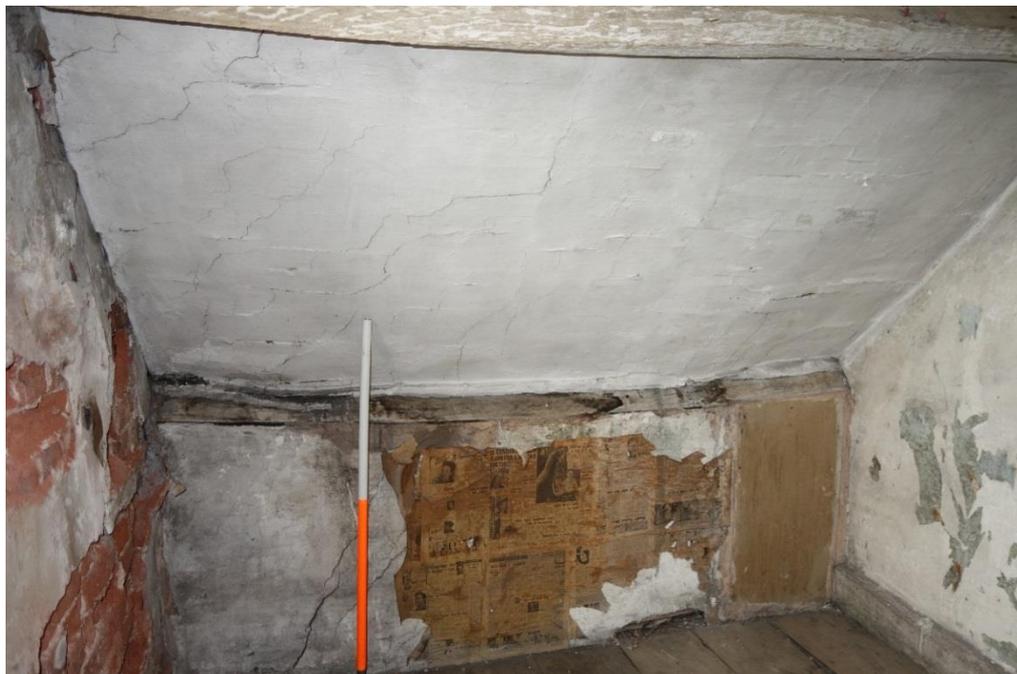
has remained intact although the glazing bars have been removed. Attached to the W wall of the compartment is a series of newspaper cuttings from the 'Sunday Pictorial' newspaper dated 1947.

*Plate 76: View looking W showing W wall of compartment within first floor attic with late 1940s newspaper cuttings attached to walls*

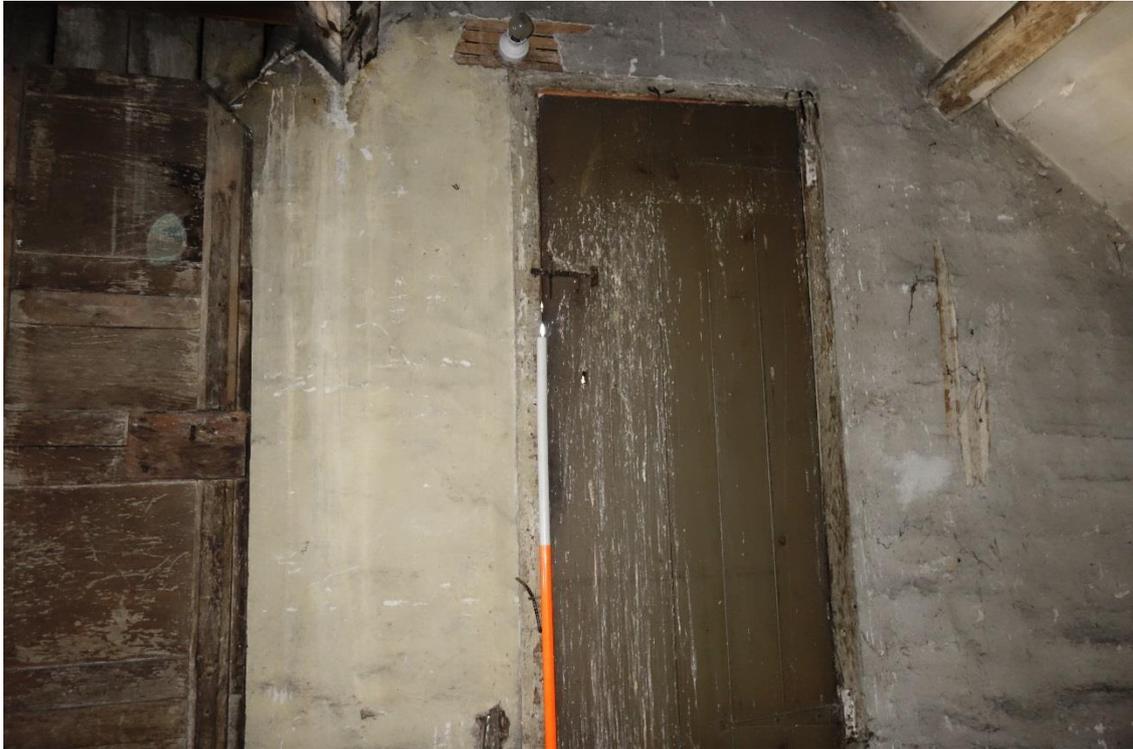
The main compartment, situated to the E of the landing, is accessed via a flat headed doorway (with 3-panelled door) set centrally within a timber framed partition wall with lath and plaster infill (*Plate 77*). Evidence of close studded timber framing is visible on the E-facing side of this partition wall. (*Plate 78*)

*Plate 77: View looking E showing plank and batten doorway set within lath and plaster partition wall, leading to main compartment within first floor attic*

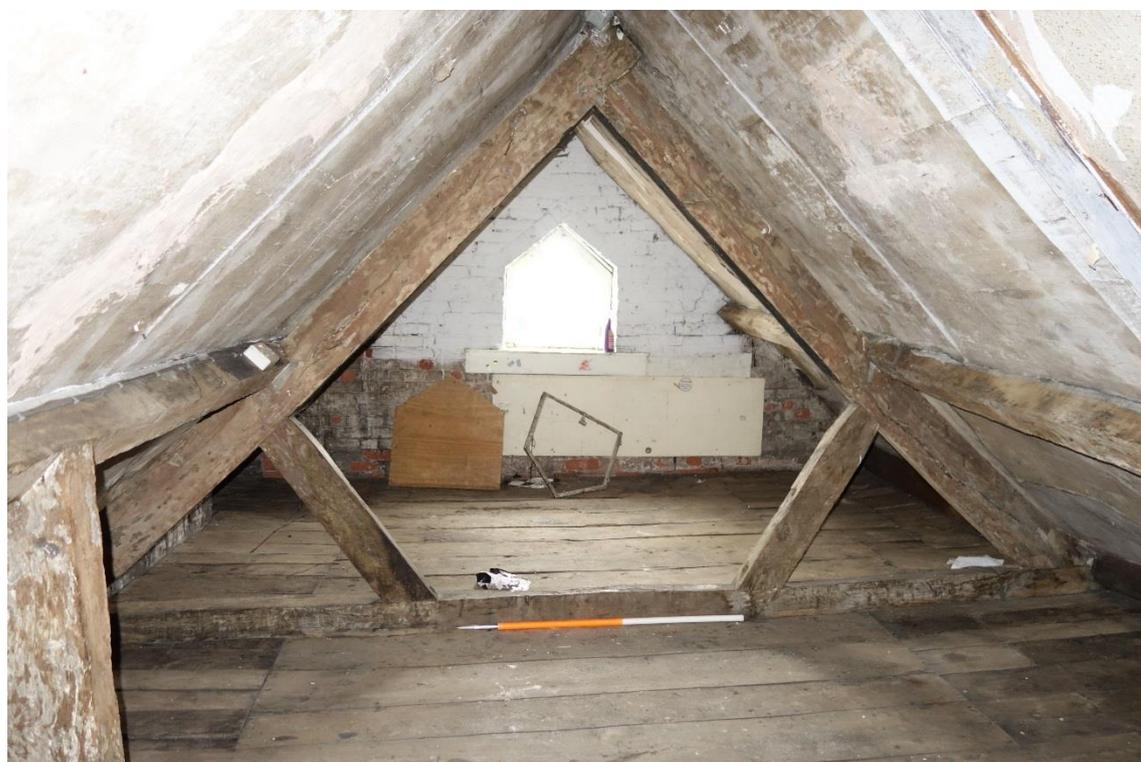
Within this compartment, the roof structure is fully exposed and is 3 bays in length (oriented E-W) with angled struts connecting the tie beam to the principal rafters (*Plate 79*). It is noticeable that the floorboards within the central and easternmost bays are oriented N-S while those within the westernmost bay are oriented E-W, it is possible that this change in direction may represent a construction break. The E gable wall is of brick construction, laid in Flemish Bond, and partially whitewashed. Inserted centrally in the wall is a pentagonal window opening, the wooden framing of which has been removed

*Plate 79: View looking W showing detail of roof trusses within compartment of first floor attic*

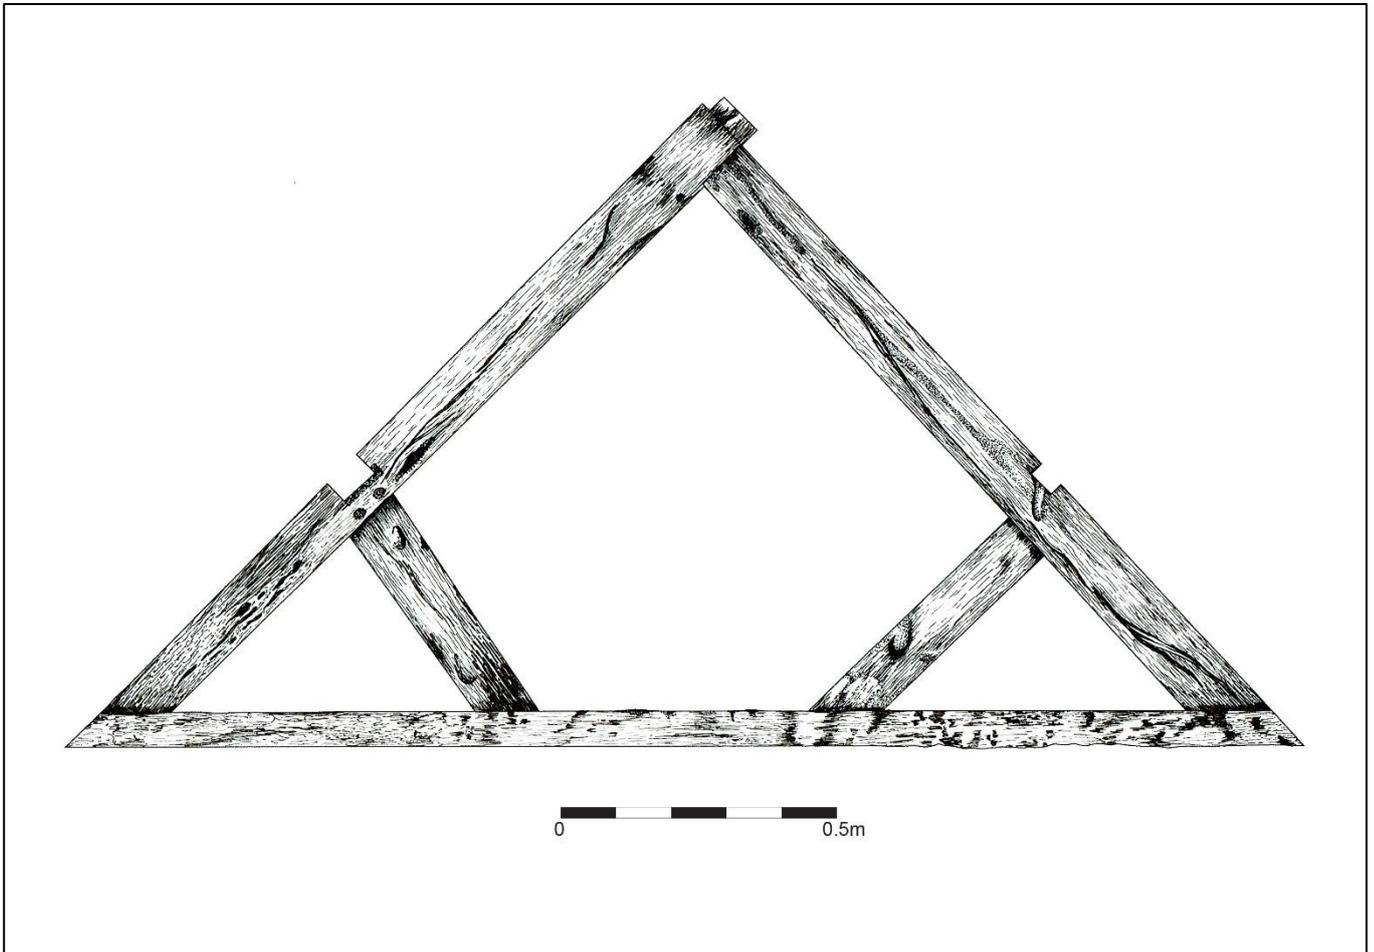
*Fig. 17: Detail of roof truss in attic space of No. 17*

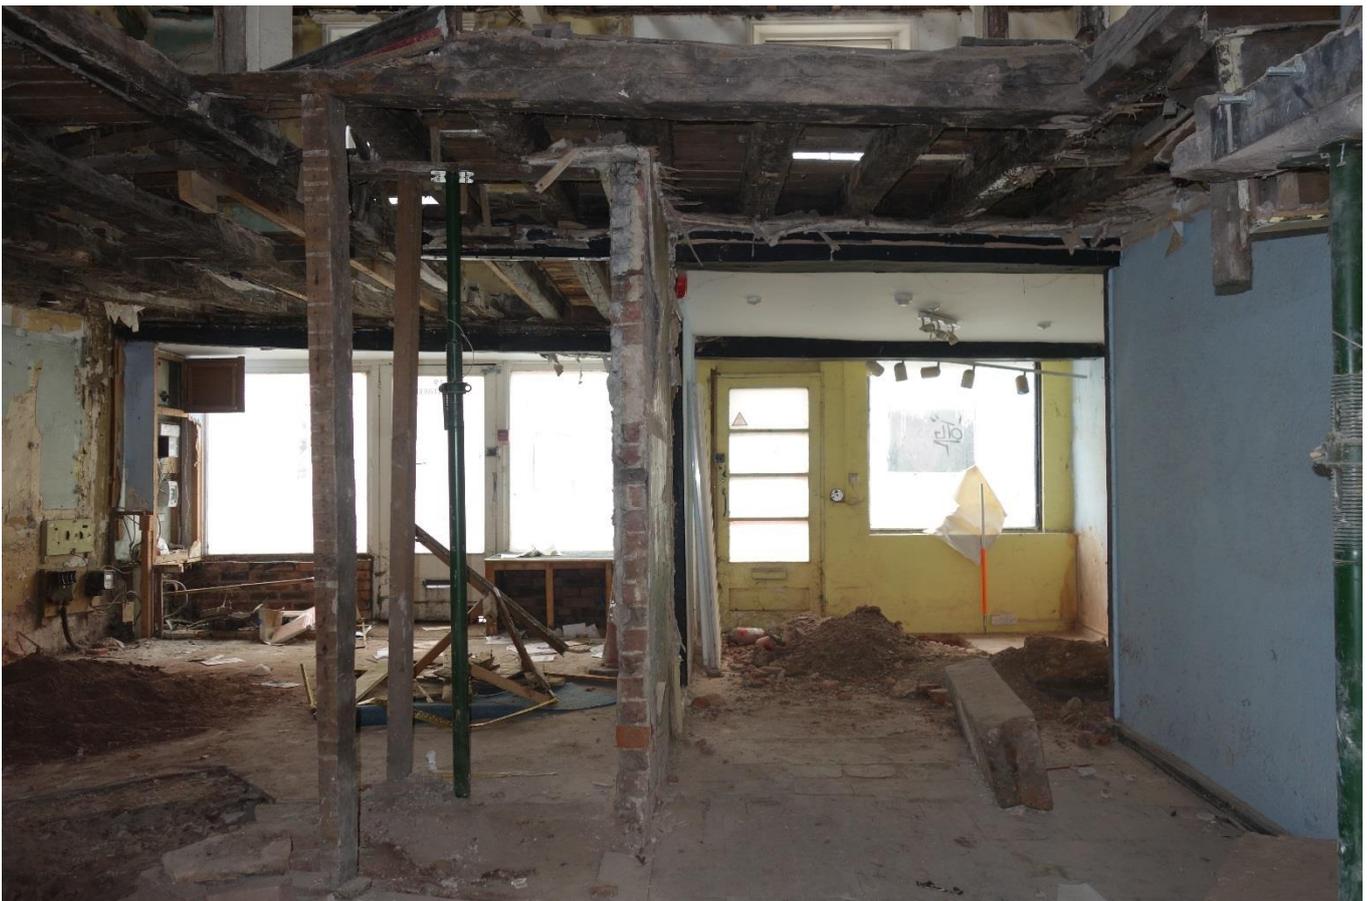
*Plate 80: Internal view looking W showing timber framed partitions with brick infill marking the division between Nos. 18 & 19 High Street*

The layout of the building is of two-unit type with a thin studded timber framed partition wall running E-W through the front portion of the building. Some vestiges of lath and plaster infill was noted, however most of it appeared to have been replaced by brick infill (*Plate 80*).

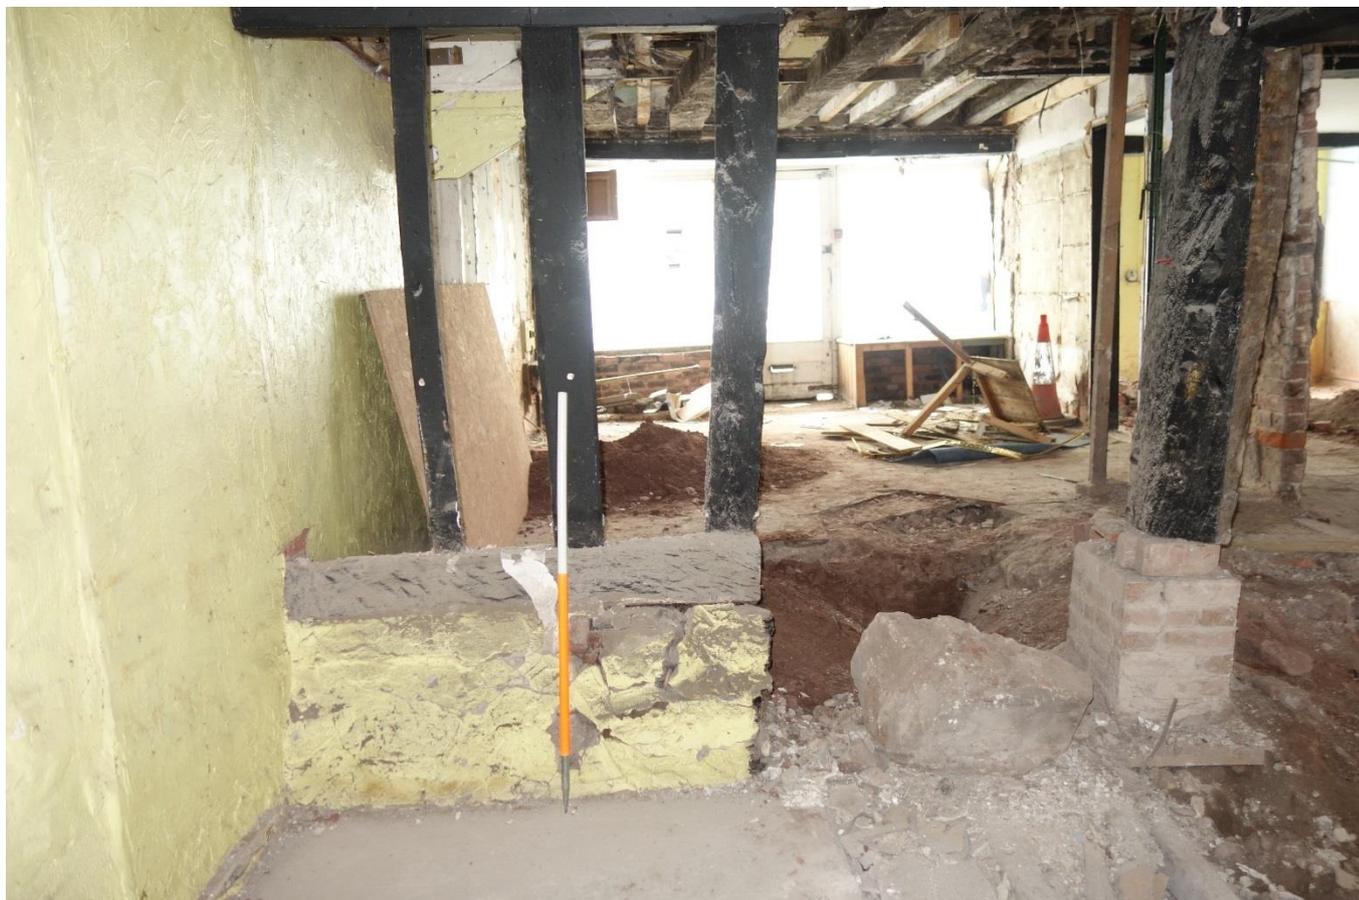
Located towards the E end of the building is a short section of close studded timber framing attached to a timber sill plate, which in turn is carried upon a N-S aligned, roughly coursed dwarf stone wall which appears to have been heavily truncated (*Plate 81*).

*Plate 81: View looking W showing remains of close studded timber framed partition resting on dwarf stone wall*

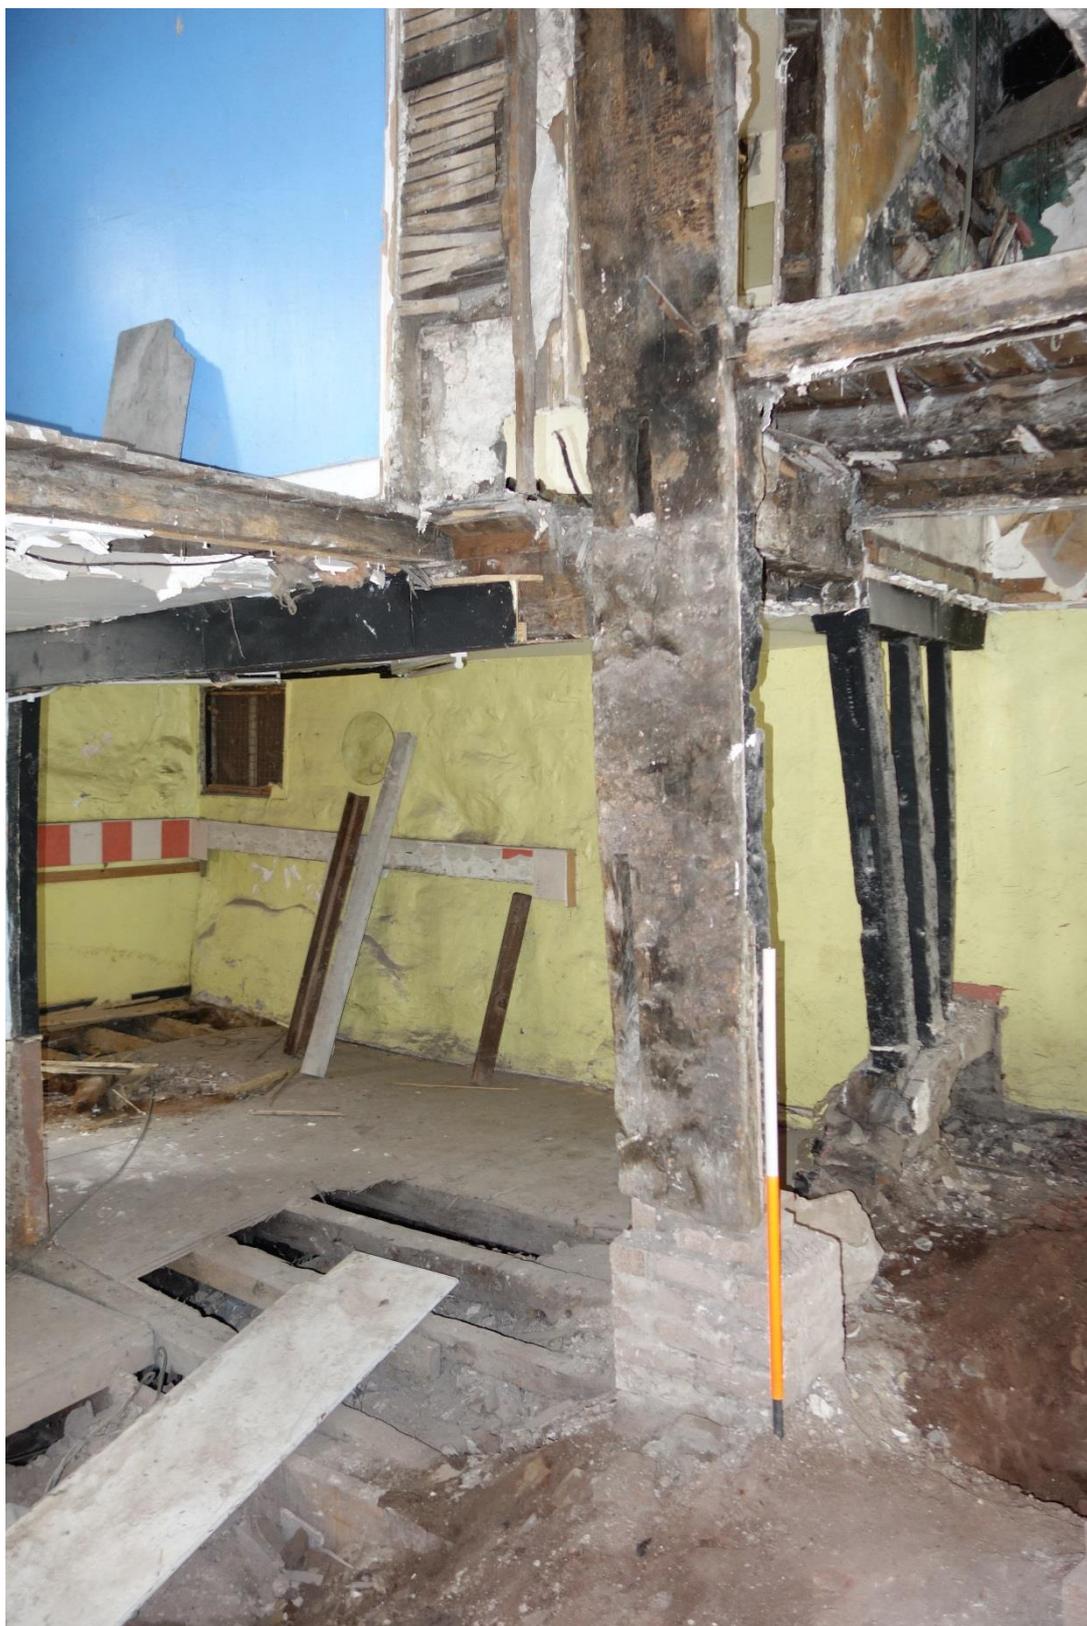
Located immediately N of this dwarf stone wall is a substantial square timber post which extends the full height of the building, with slots for vertical and horizontal members, and is carried upon a square brick plinth of modern date (*Plate 82*). It is possible that this section of timber framing represents the original rear (E-facing) wall of the building, which is further suggested by a vertical construction break in the S wall, in line with the timber framing.

*Plate 82: View looking SE showing large vertical timber post to N of dwarf stone wall*

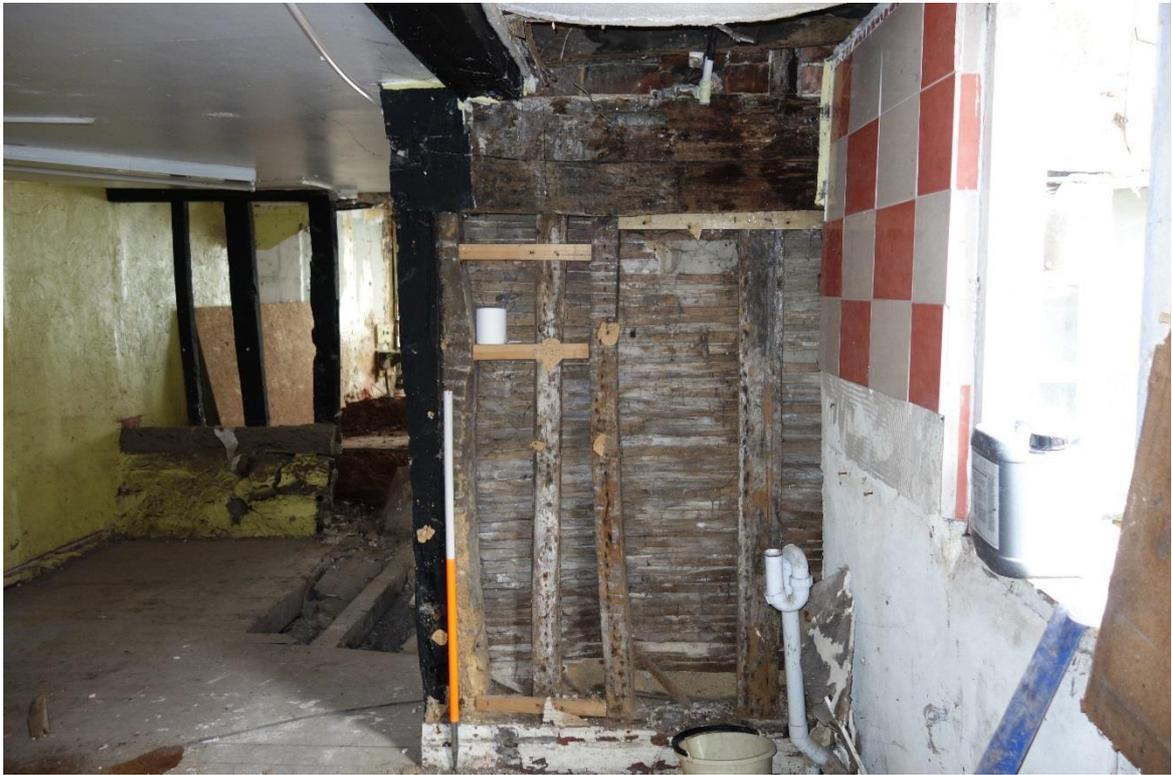
The existing E wall of the building is heavily clad in plaster but at its S end is an exposed section of close studded timber framing with lath and plaster infill with a substantial jowelled corner post which could be of 17<sup>th</sup> or 18<sup>th</sup> century date (*Plate 83 & 84*).

*Plate 83: Internal view looking W showing jowelled post and section of timber framing with lath and plaster infill*
