## Standing Building Recording Survey

**BGD Property Ltd**

Former Rosswyn Hotel  
16-19 High Street  
Ross-on-Wye  
Herefordshire HR9 5BZ

**October 2016**

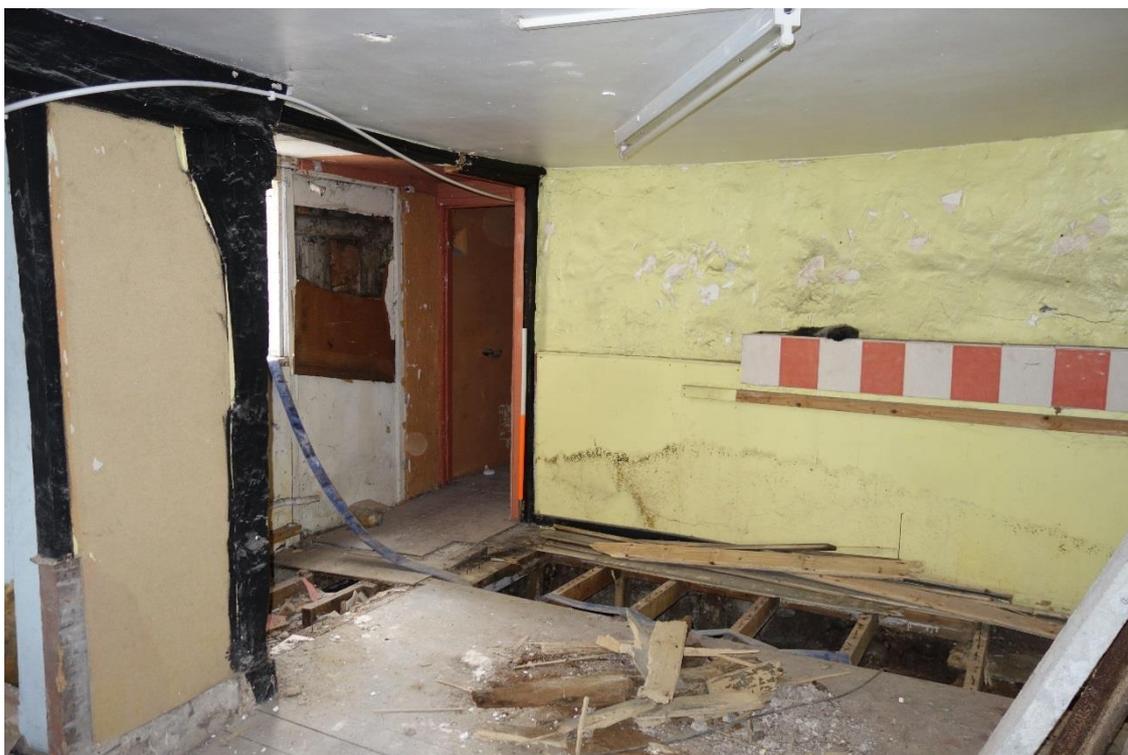
Located in the SE corner of the building, projecting beyond the E wall, is a gabled annexe with roughly coursed rubble masonry walls on its S and E sides at ground floor level (*Plate 84*), the upper storeys appear partially to be of brick construction. Inspection of the exterior shows a chimneystack in this location, against the E gable wall, however no evidence of a fireplace was visible at ground level and has presumably been removed.

*Plate 84: Internal view looking ENE showing interior of annexe in SE corner of No. 19 with masonry walls concealed beneath thick plaster, with a section of timber framing with jowelled corner post visible to left of picture*

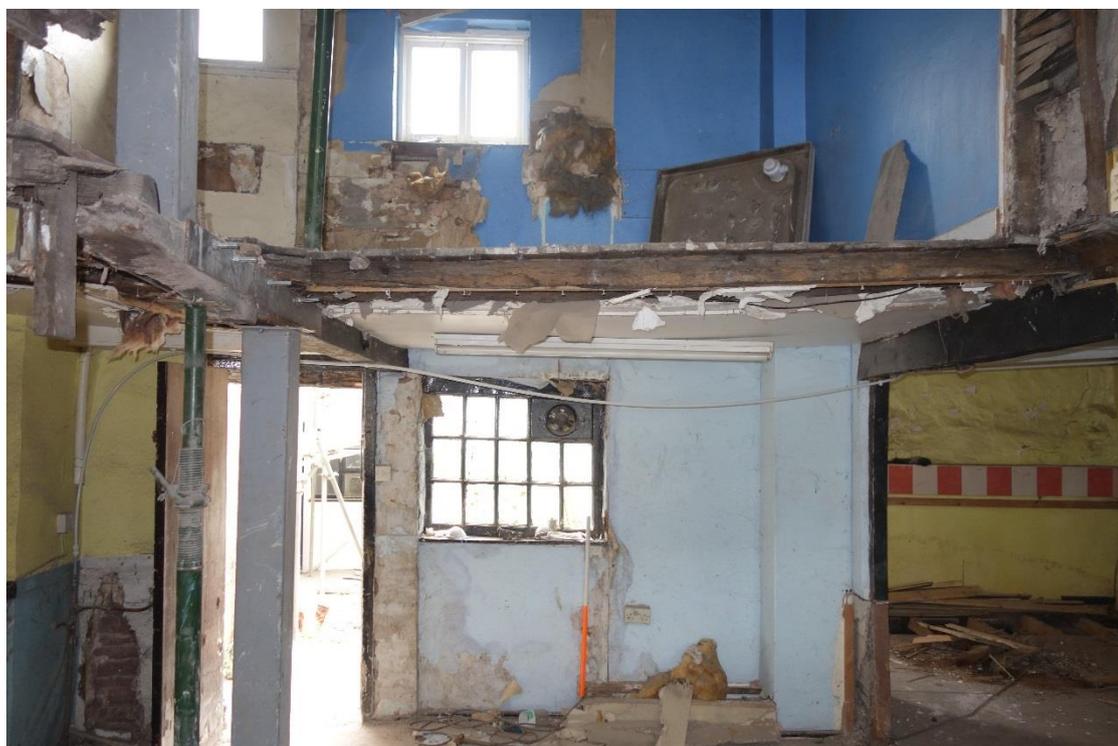
The rooms on the first and second floors could not be accessed and were therefore only viewed from ground floor level. Evidence of partially intact lath and plaster partition walls was observed on both the first and second floors (*Plate 85*).

*Plate 85: Internal view looking E showing ground and upper floor of Nos. 18 & 19 with evidence of lath and plaster partitions*

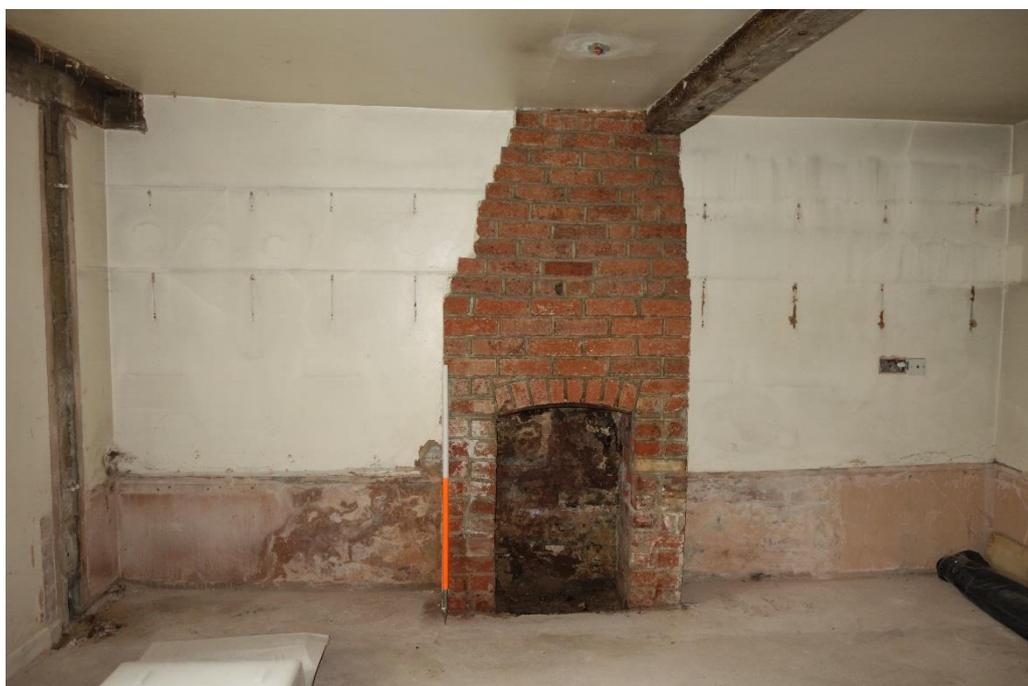
The detached building to the rear of No. 17A appears to be of late 19<sup>th</sup> century origin (it is first shown on the OS 1<sup>st</sup> edition map of 1887) but was converted in the late 1970s into accommodation for the hotel owner. Internally, the original internal arrangements of the building have been extensively altered and subdivided to form a three bedroomed house. Little evidence of original architectural detailing has survived; all the doors and skirting appear to be of late 20<sup>th</sup> century date. A brick segmental fireplace set in the E wall of the ground floor living room and a fireplace with cast iron oven set into the E wall of the ground floor lobby may be of late 19<sup>th</sup> century date (*Plate 87*)

*Plate 87: View looking E showing brick fireplace in E wall of ground floor living room of detached building to rear of No. 17A*

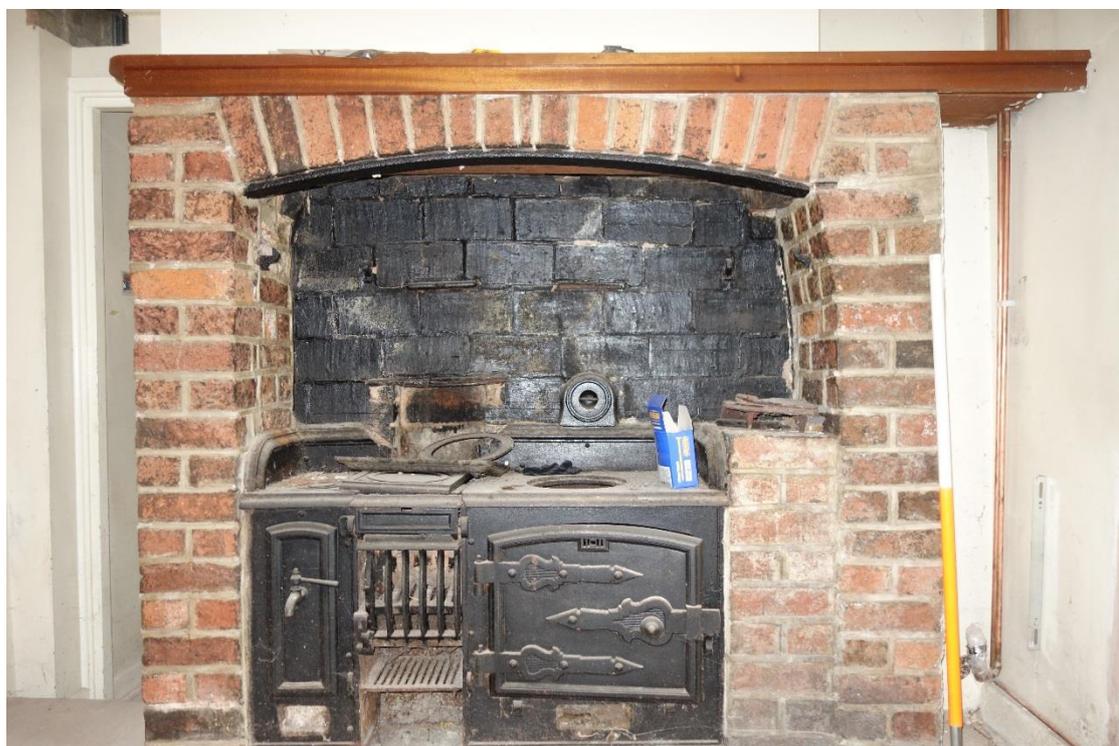
*Plate 88: Internal view looking E showing fireplace in ground floor lobby with cast iron oven of late 19<sup>th</sup> century date*

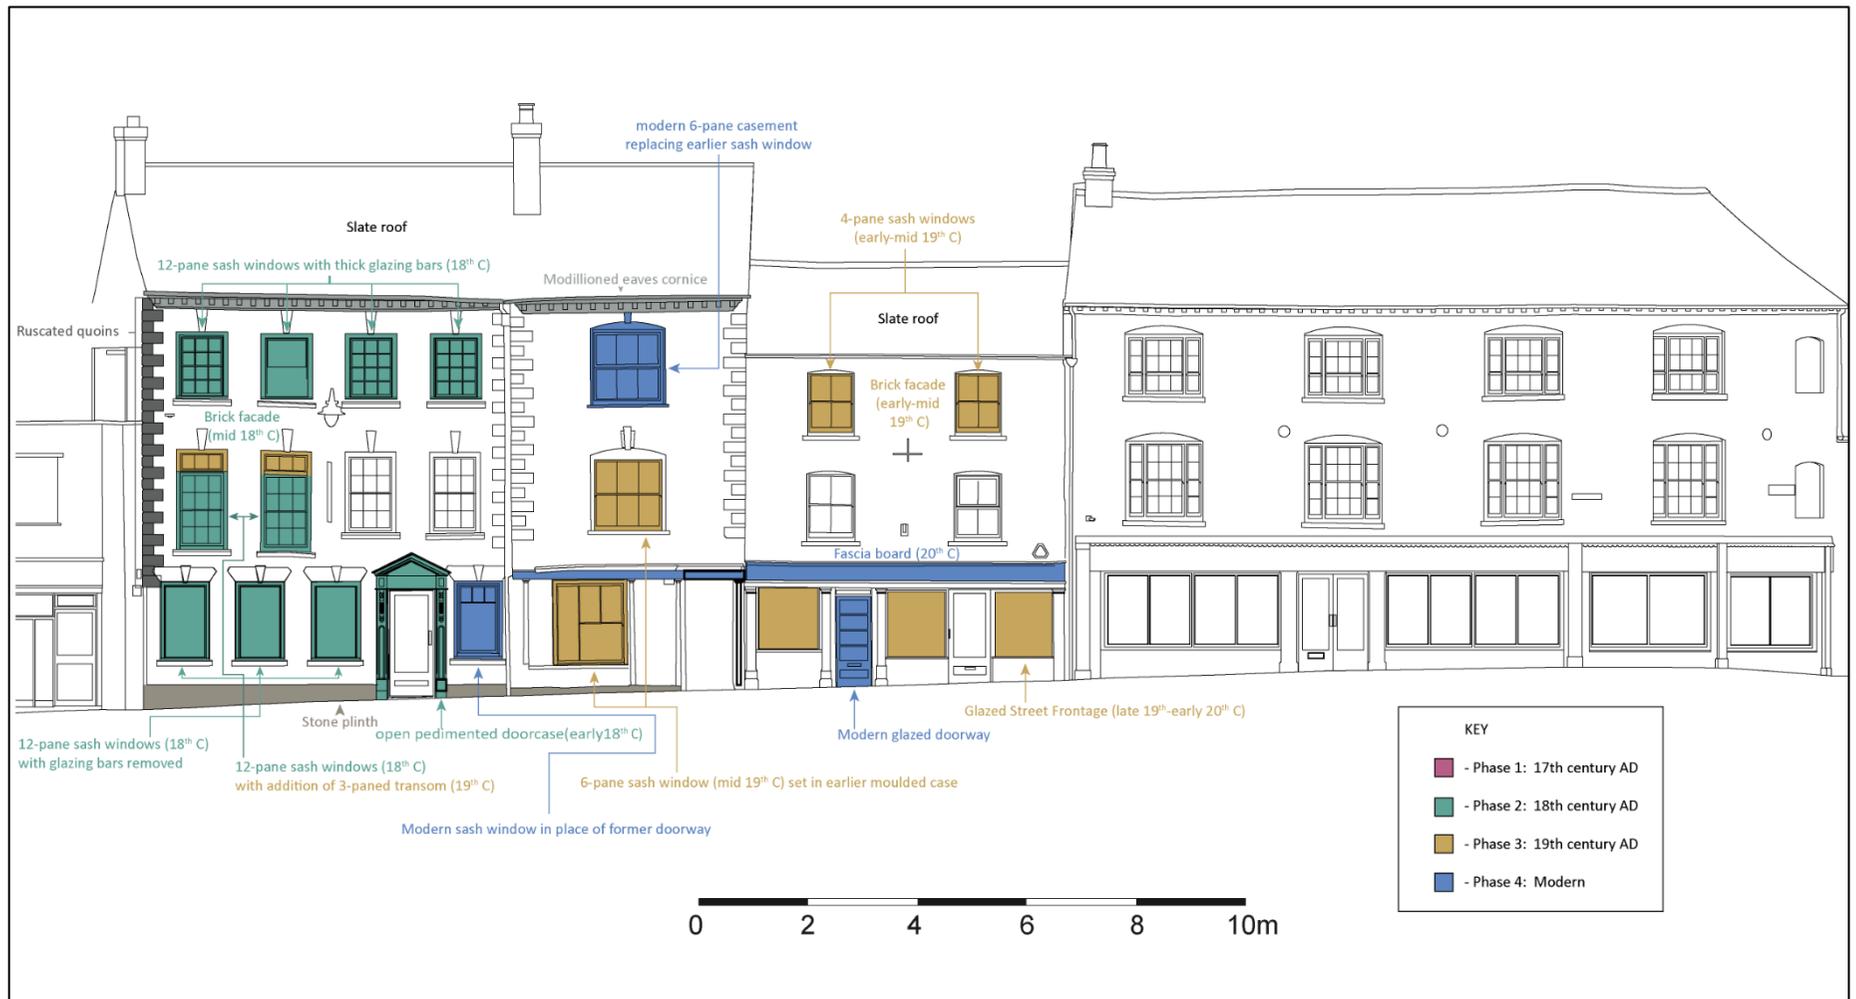
Fig. 18: Phased Front Elevation of Nos. 17-19 High Street

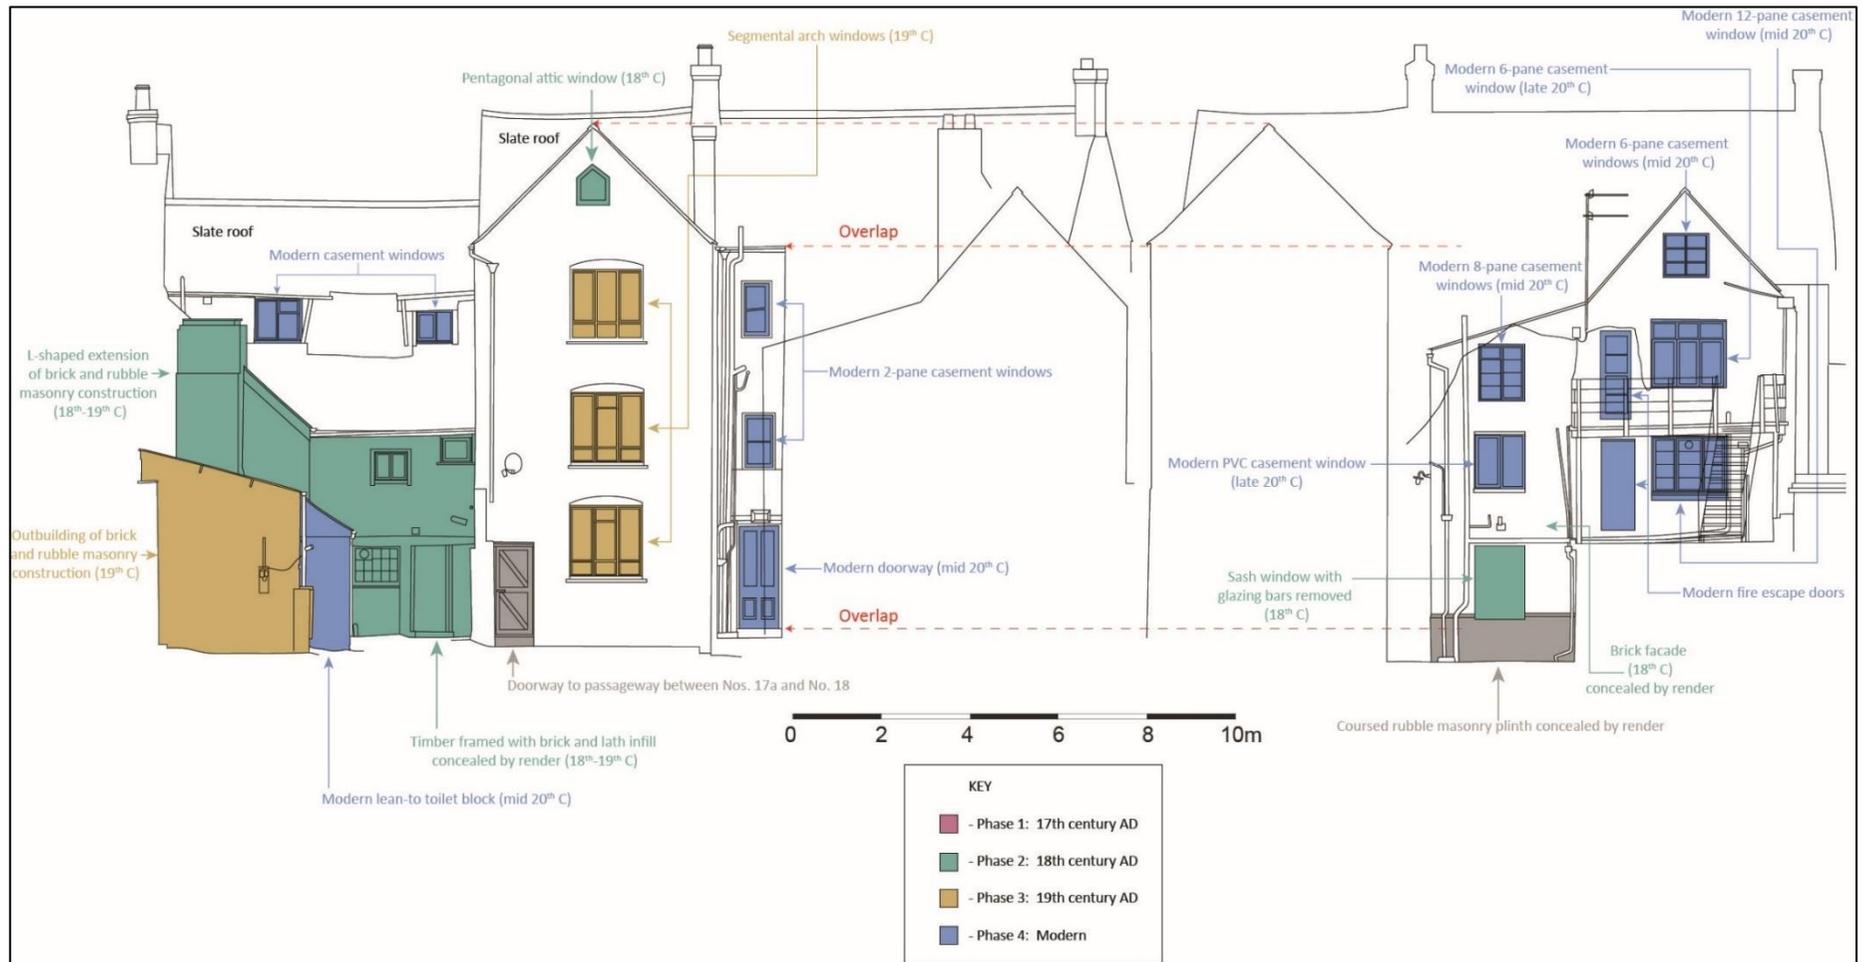
Fig. 19: Phased rear elevation of Nos. 17-19 High Street

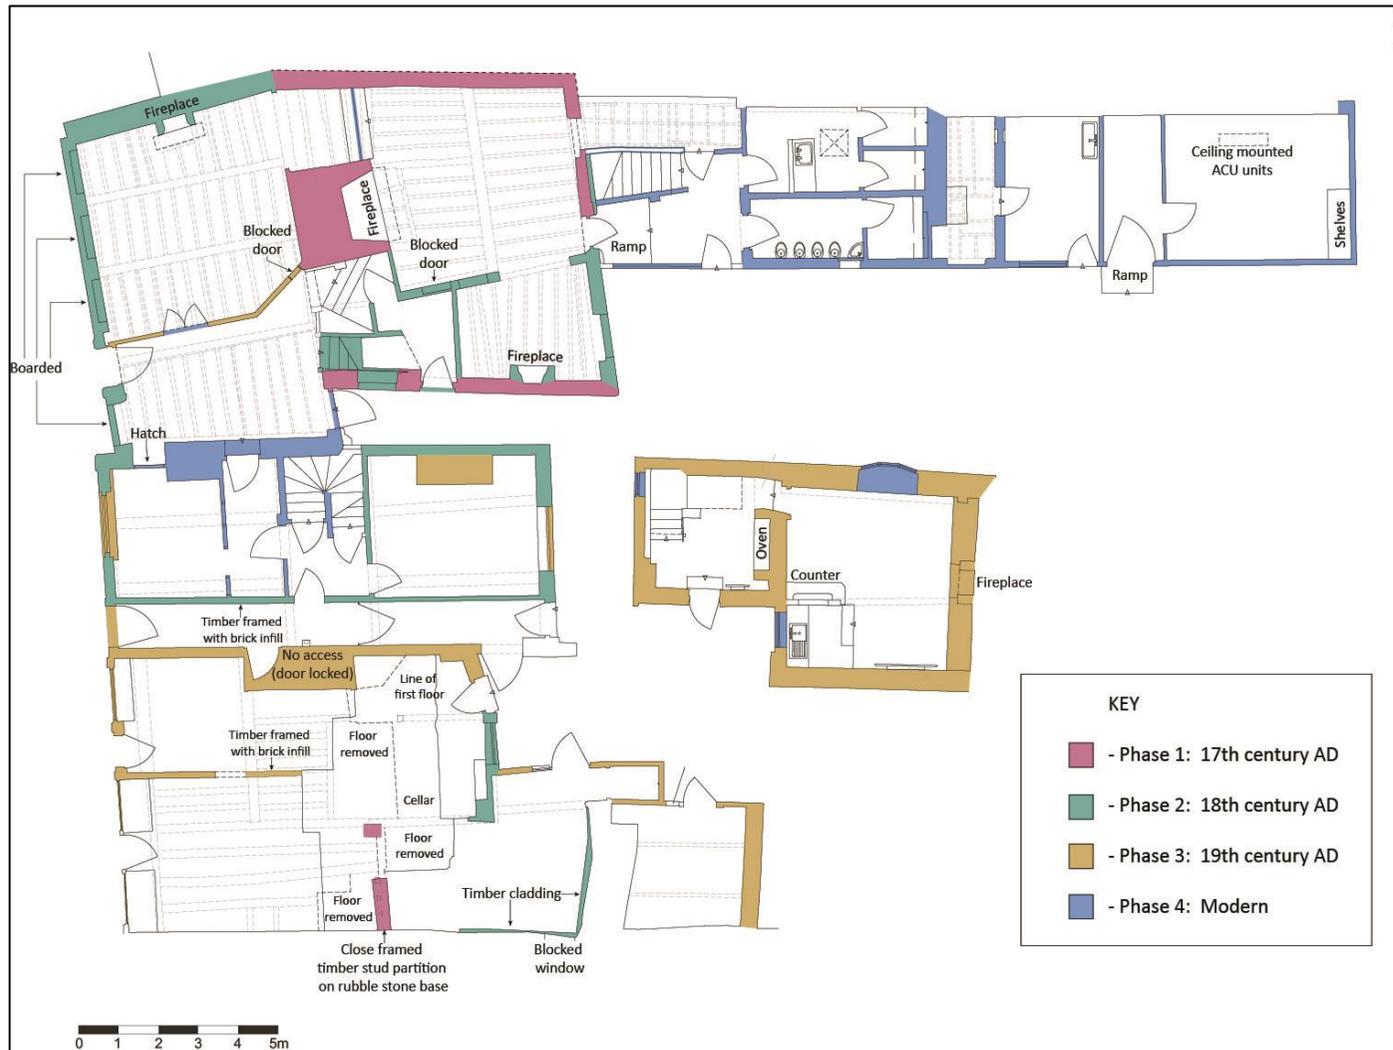
Fig. 20: Phased ground floor plan of Nos. 17-19 High Street

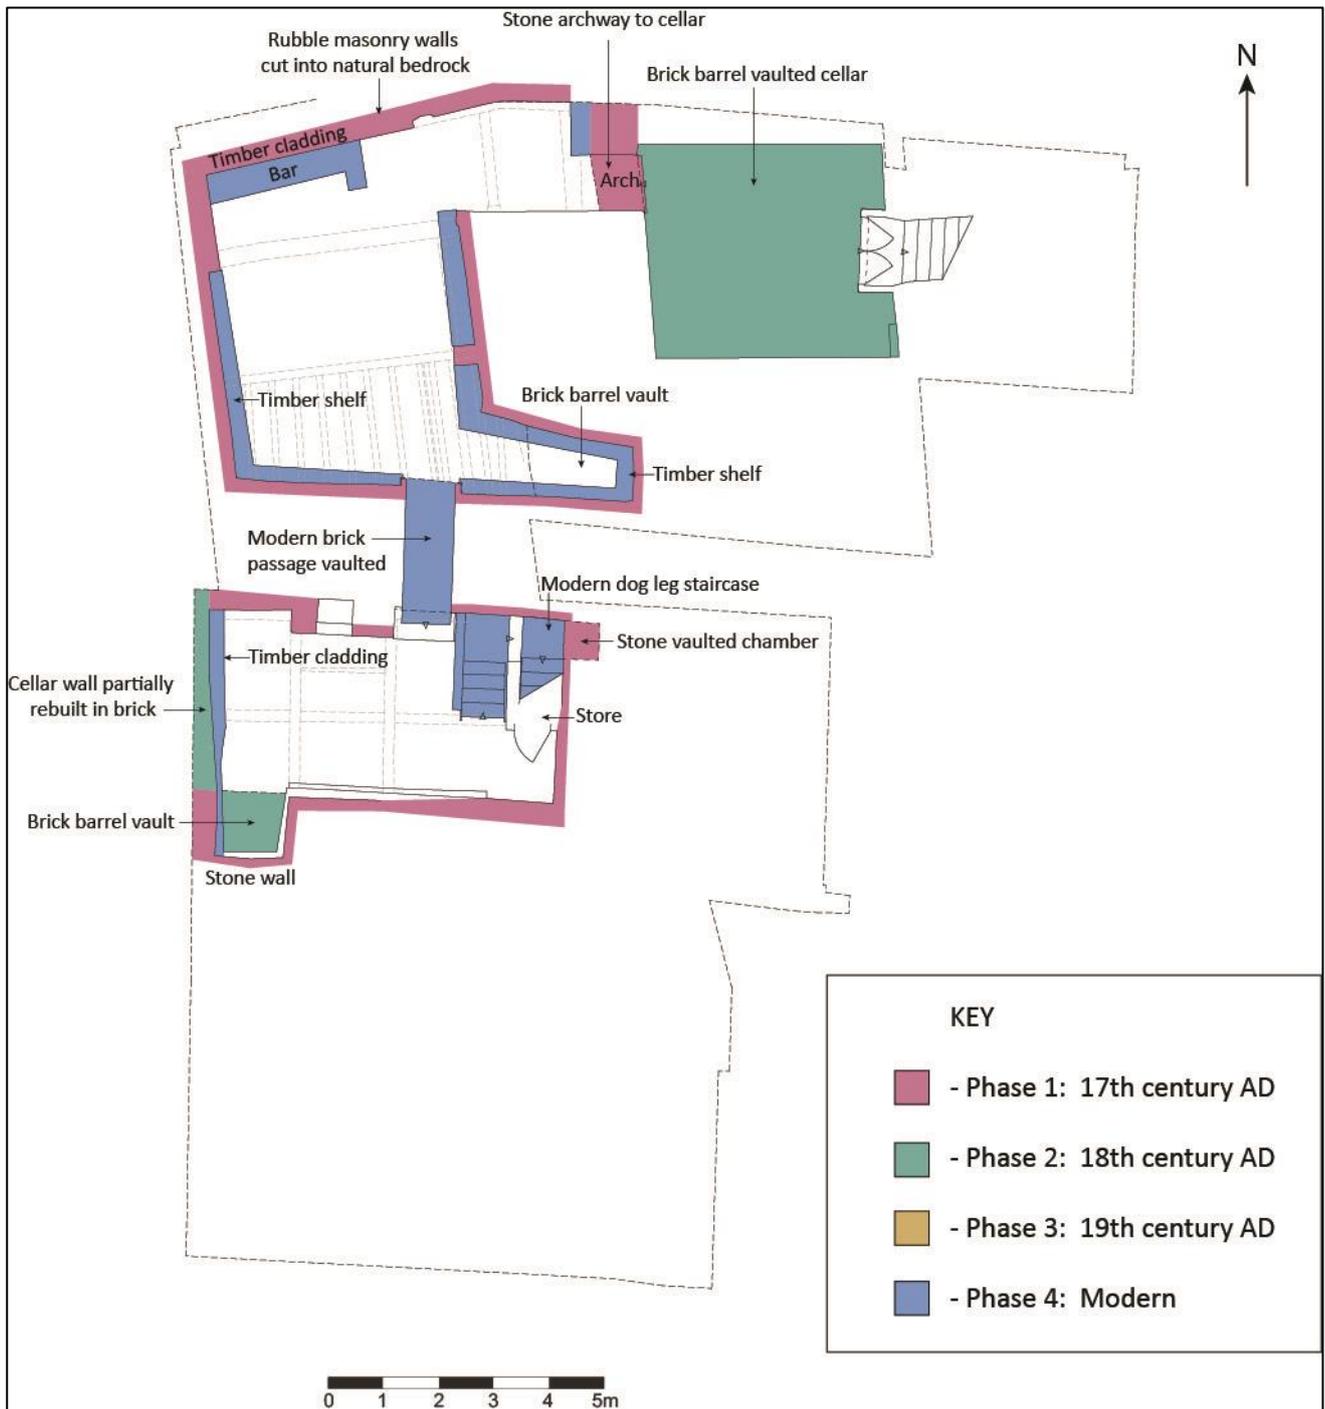
Fig. 22: Phased basement plan of Nos. 17 & 17A High Street
