Archaeological Observation

Visitor Car Park Extension

**Croome Court
High Green
Worcestershire
WR8 9DW**

September 2017

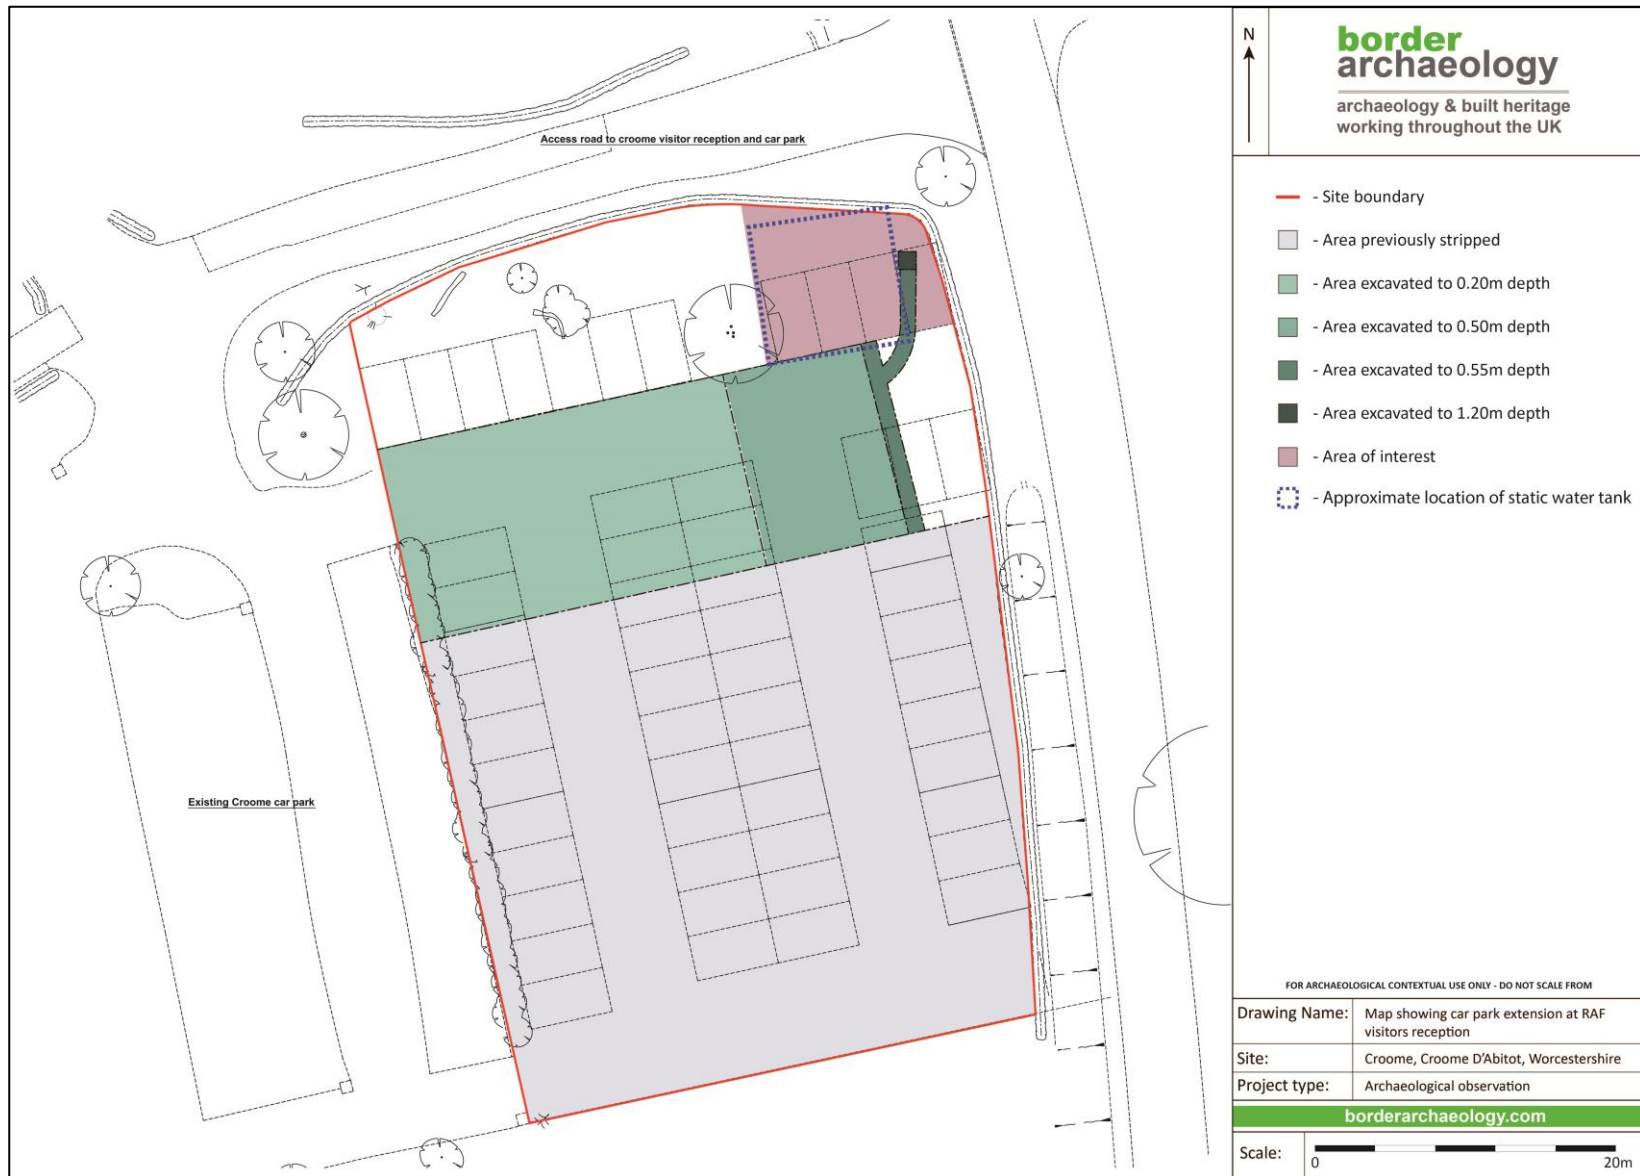
Fig. 2: Plan showing location of groundworks and approximate location of the RAF Defford Static Water Tank.

included Sergeants' and Orderlies' Quarters, an Ambulance Garage, Mortuary and Air Raid shelter (*fig. 3*). Of specific relevance to the current programme of work are the sites of a Static Water Tank and Picket Post (MNA181828) (NGR: SO88804 45249) (*figs. 2 & 3*), neither of which survives in the form of above-ground structural remains. A number of the remaining buildings have been restored by the Trust.

A small rectangular structure located adjacent to the existing entrance to this part of the site and possibly representing the remains of the Picket Post were recorded during a watching brief undertaken during Visitor Centre car park extension works. The Static Water Tank appears to have been located immediately S of this, directly within the present groundworks area (*figs. 2 & 3*).

The area observed measured 35m (ENE/WSW) × 13m (NNE/SSW), with a gully measuring 13m × 0.45m × 0.5m terminating at a pit (drain inspection chamber) measuring 1.2m². The gully (NGR: SO88818 45237 to NGR: SO88821 245215) extended towards the NE corner of the car park, identified as the approximate location of the former water tank (*fig. 2*).

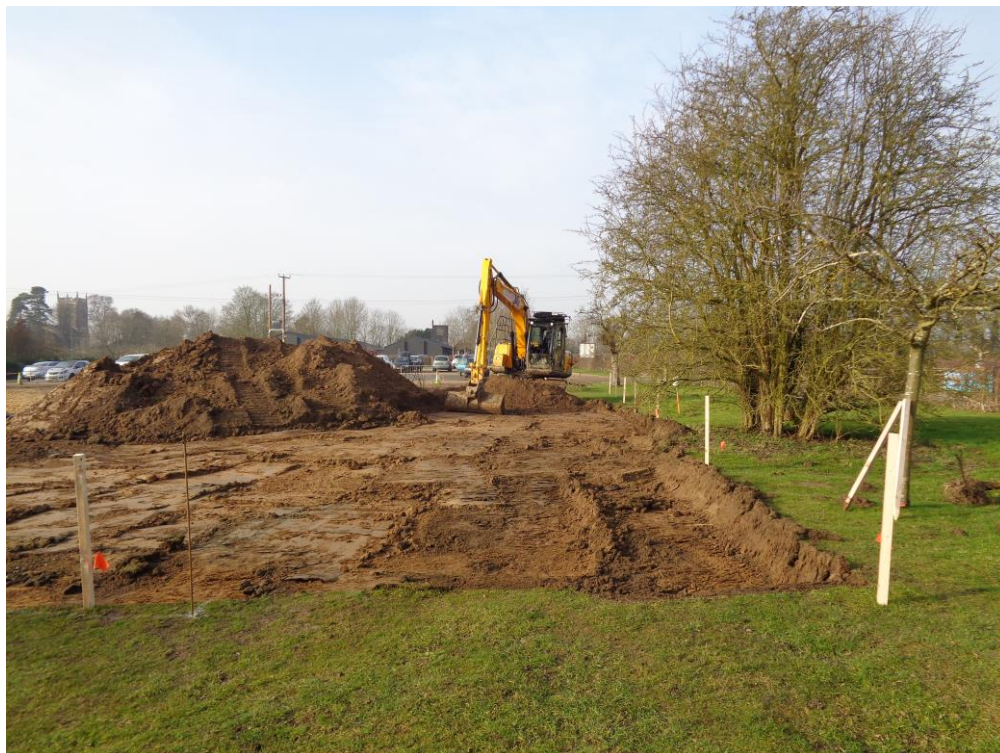
Plate 1. View W of open area.

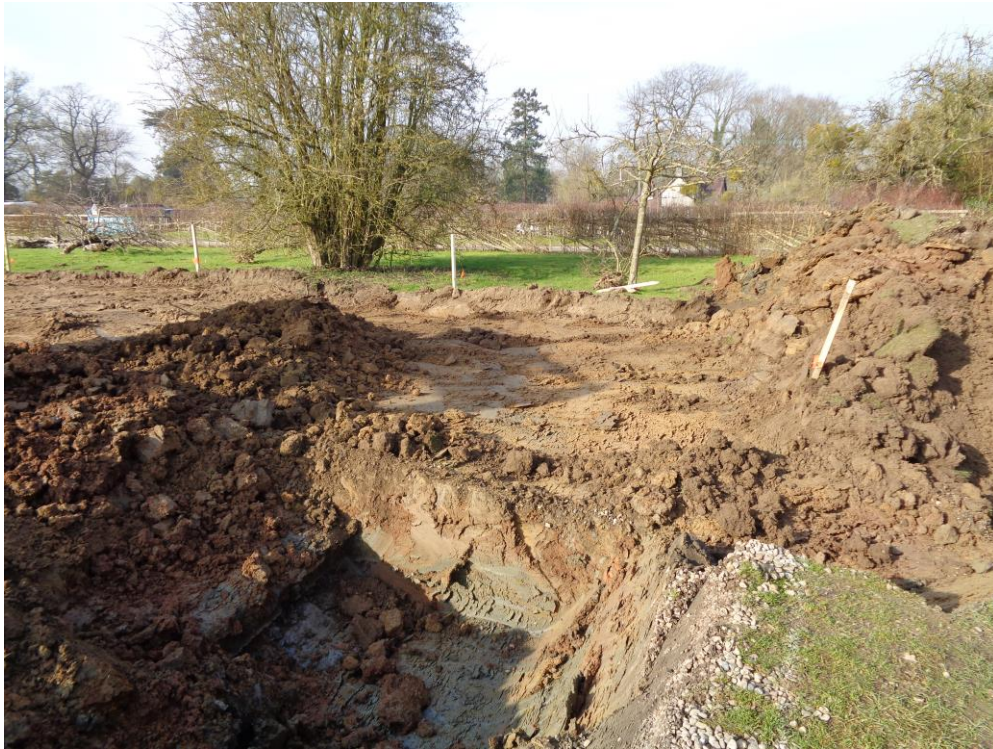
Plate 2. View NW showing position of gully and northern extent of site.

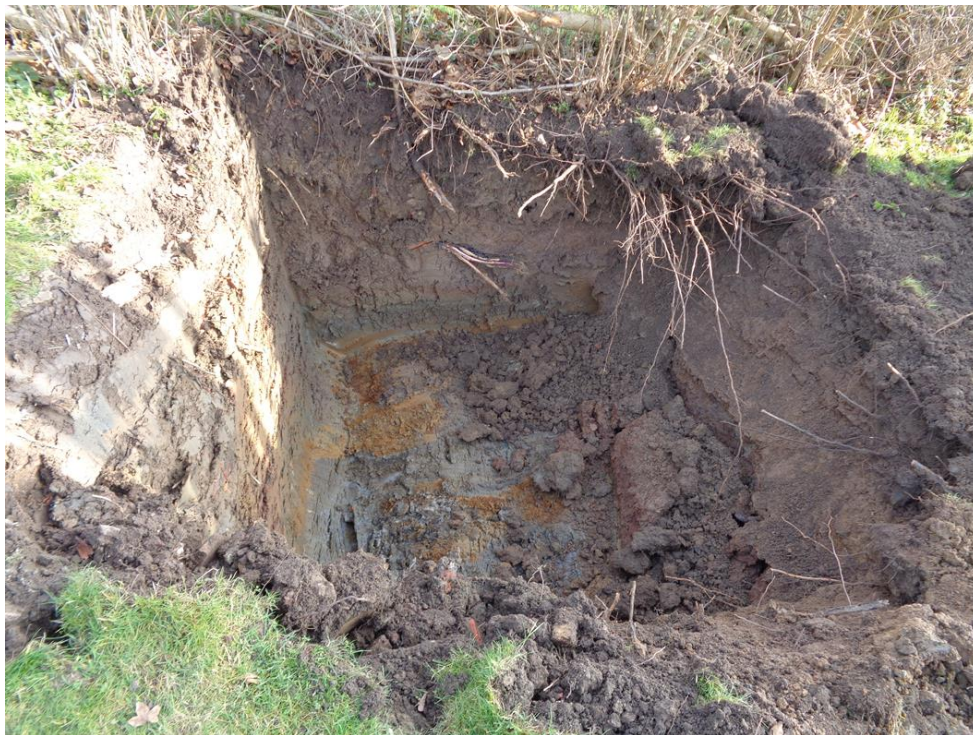
Whilst no structural remains were encountered, the pit in the NE corner of the site (NGR: SO88818 45237), which was excavated to a depth of 1.2m for drainage purposes, revealed evidence of disturbance and possible demolition activity, with disused cabling and brick fragments found at a depth of 0.4m within the subsoil (302) (*Plate 3*). Whilst this disturbance cannot be conclusively associated with the demolition of the water tank, its very close proximity to the tank's presumed location strongly suggests an association.

Plate 3: View E of drainage pit containing disused cabling and modern brick inclusions.
