**Programme of Archaeological Field
Evaluation & Archaeological
Standing Building Recording**

**The Former Interbrew Site
(Access Park)
Eastern Avenue
Gloucester
GL4 6SW**

April 2018

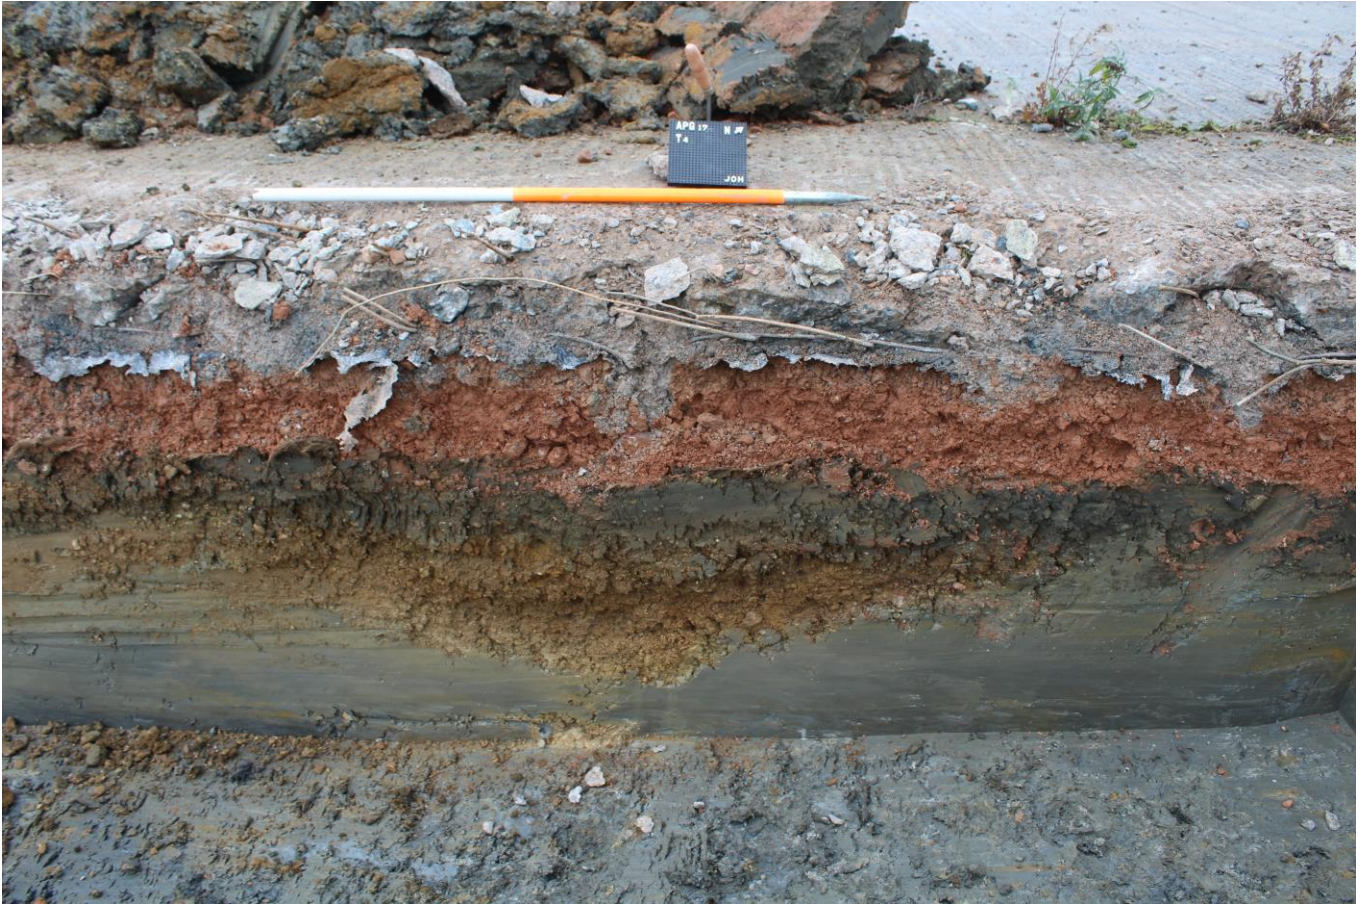
Plate A: View NW of SE-facing section of Trench 4. Absence of topsoil and subsoils representative across site.

A single land-drain ran diagonally N-S across Trench 4. Natural deposits were very similar to those encountered in Trench 3, although the orange sandy natural was less prevalent, and topsoil and subsoil were again absent (*Plate A*). No archaeological finds or features were encountered.

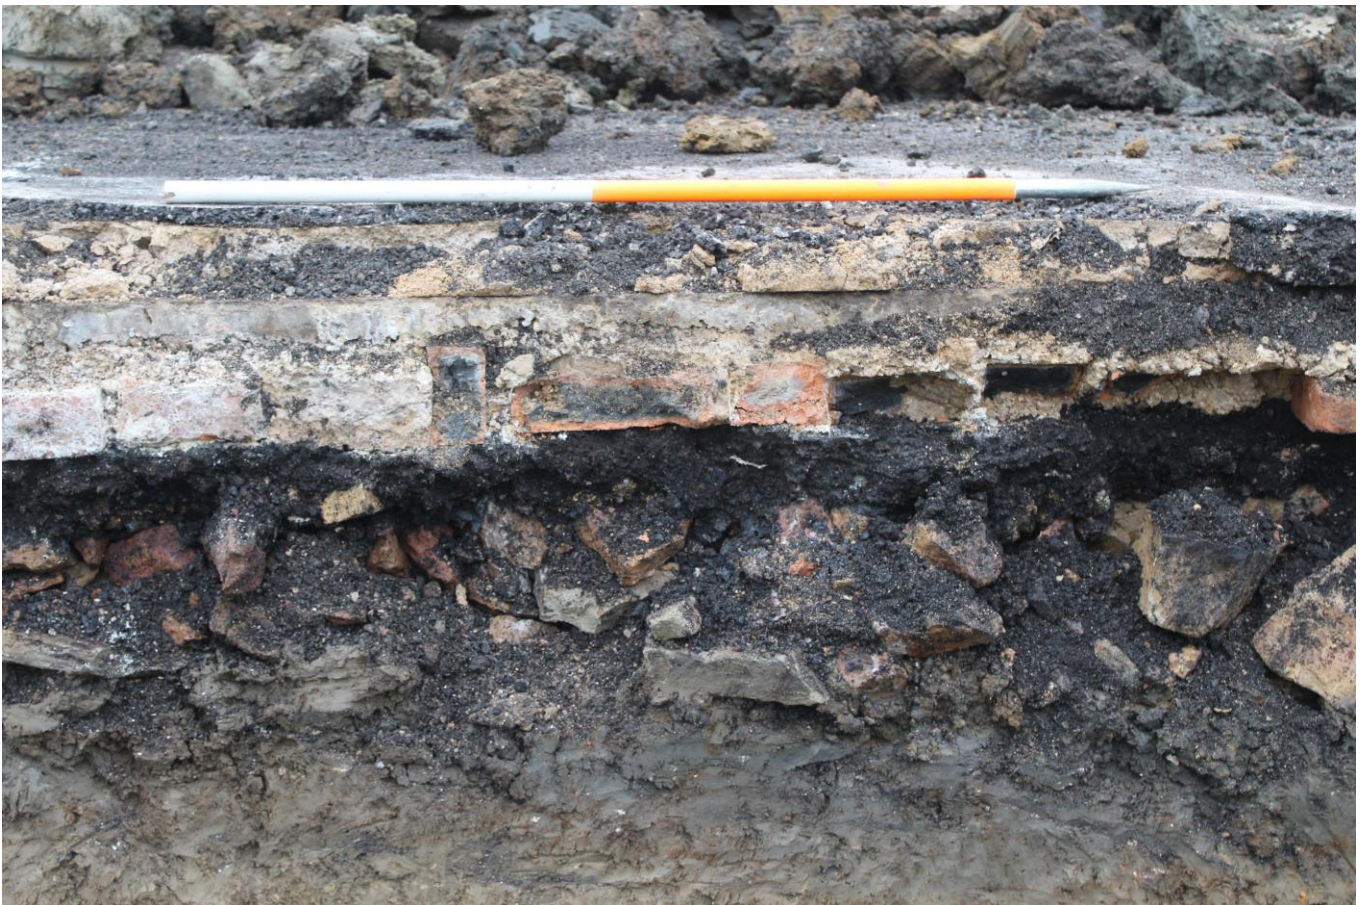
Plate B: View SW of NE-facing section of Trench 7 showing brick layer (7007) above demolition layer (7004).

Below the tarmac layer (7001) were concrete surfaces (7002), (7003), a thick demolition deposit (7004) and a brick surface (7007). The demolition material (7004) consisted of a dense mixture of assorted building debris, including red/yellow brick (white glazed and standard) and unworked sandstone, which appears likely to represent former RAF structures. A single residual sherd of 19th-20th century Bristol type stoneware was found amongst the rubble.

The lime-mortar (7008) bonded brick surface (7007) did not extend over the entire trench, measuring 10.60m (length). Its location adjacent to one of the demolished RAF buildings suggests a likely association.

Trench 7, at the southernmost extent of the site lay within a fenced area adjacent to a single-storey structure (which was subject to a separate programme of Standing Building Recording) formerly used by the RAF. A tarmac skim provided the surface in this area, with no concrete present, this probably being due to the use of this area as a carpark following the demolition of two former RAF buildings in 1999 (*Plate B*).

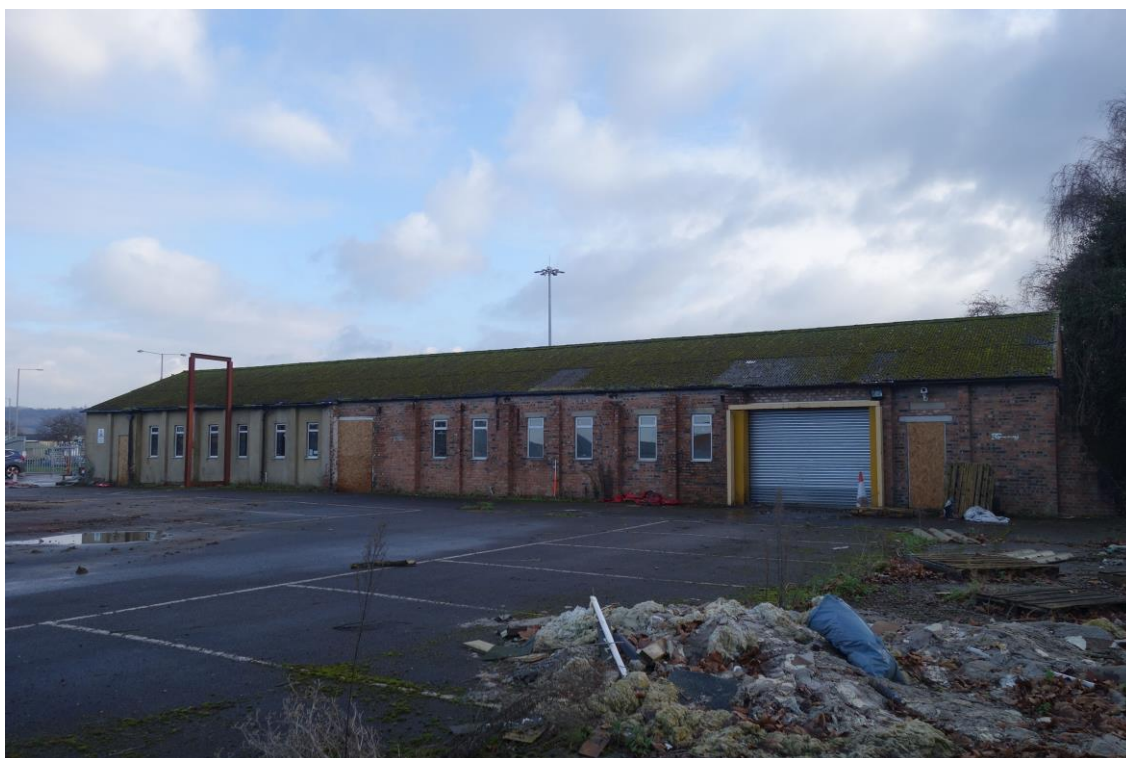
The NW elevation has 12 window-openings and four doors, including a roller-shutter door at the NE end. Although the surviving window-openings retain their original dimensions and proportions, the frames have been replaced with uPVC double-glazed units. The eight bays at the NE end of the building are pebble-dashed but cast concrete lintels have been exposed above the windows at its SW extent where the render has fallen away. All window apertures were of similar dimensions. A blocked window and concrete lintel are visible above the later door at the SW end of the building. This suggests substantial alteration affecting the SW end of the building following redevelopment of the site after 1951 and conversion of the building to other uses. There is no evidence for a window in the SW bay. Contrasting brickwork above the roller-shutter door at the SW end of the building confirms that this was almost certainly inserted at a later date.

Plate 1: View SE showing NW elevation of former RAF building; cast concrete lintels are visible above the windows at the NE end of the building

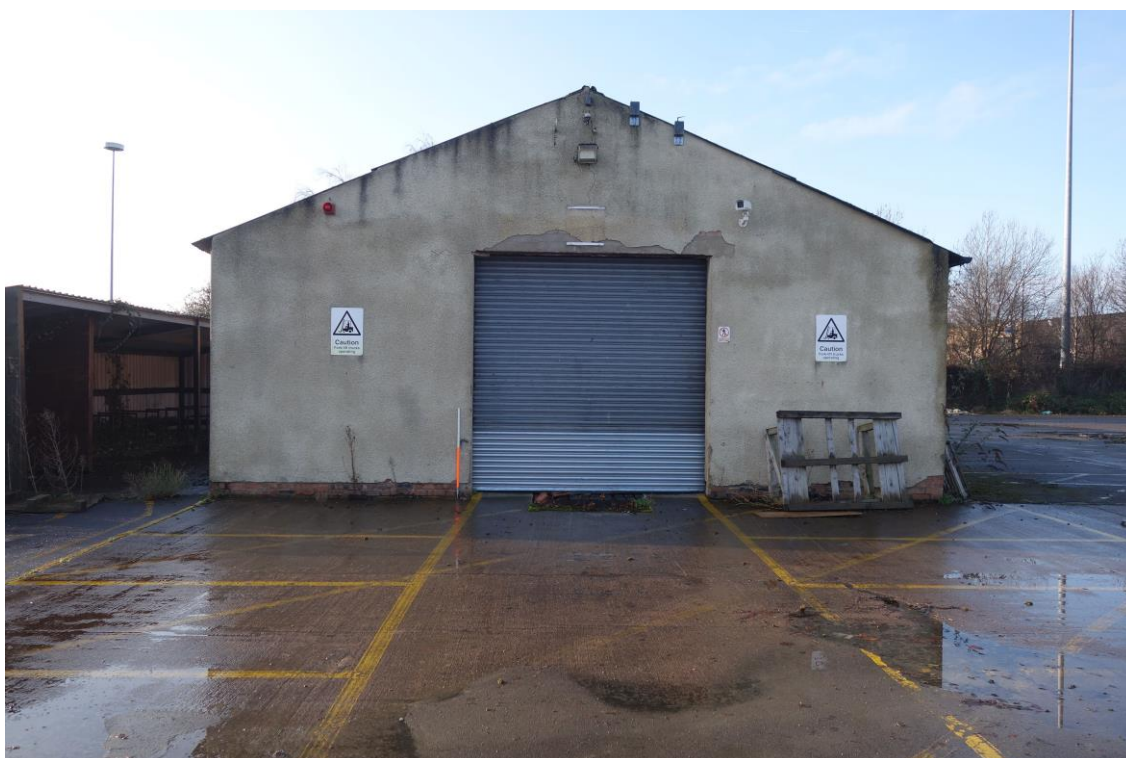
Plate 2: View SW showing pebble dashed gable end showing inserted roller shutter in the SW elevation.

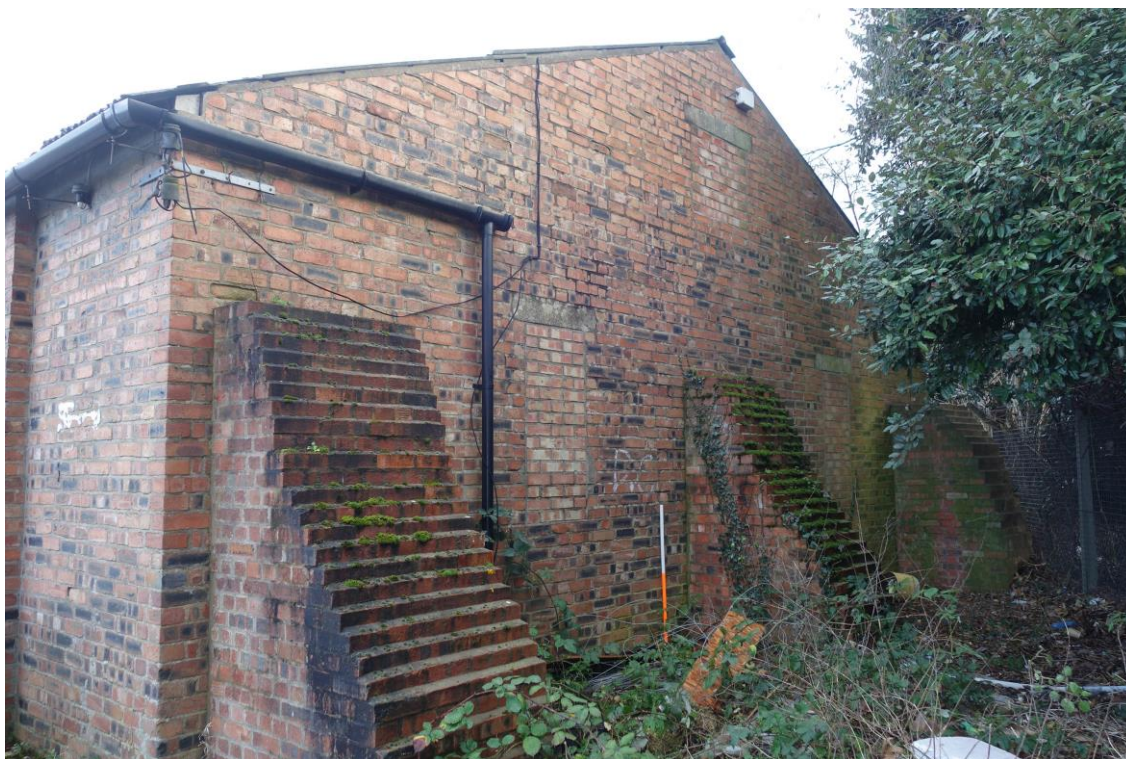
The building overall is in poor condition with substantial cracks apparent at the SW end. The buttressing at this point is a later addition as it abuts the original wall rather than being tied-into it, although structural instability appears to have developed fairly rapidly following initial construction as the materials of both the walls and the buttresses is similar. There is extensive evidence of subsequent alteration, much of this work being of poor quality.

Plate 3: View E showing stepped buttresses at SW end of building.

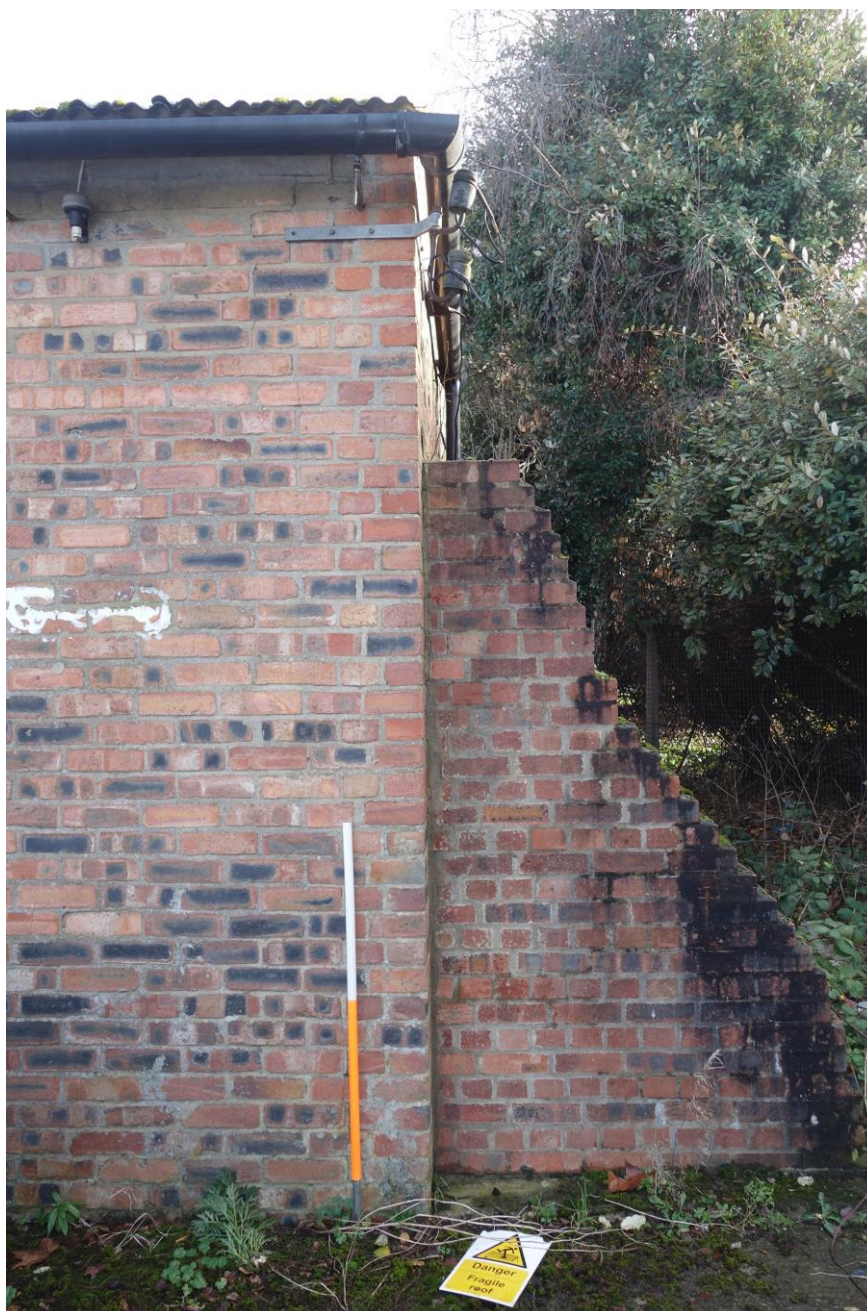
Plate 4: Original cabling and insulation at SW end of building; view SE

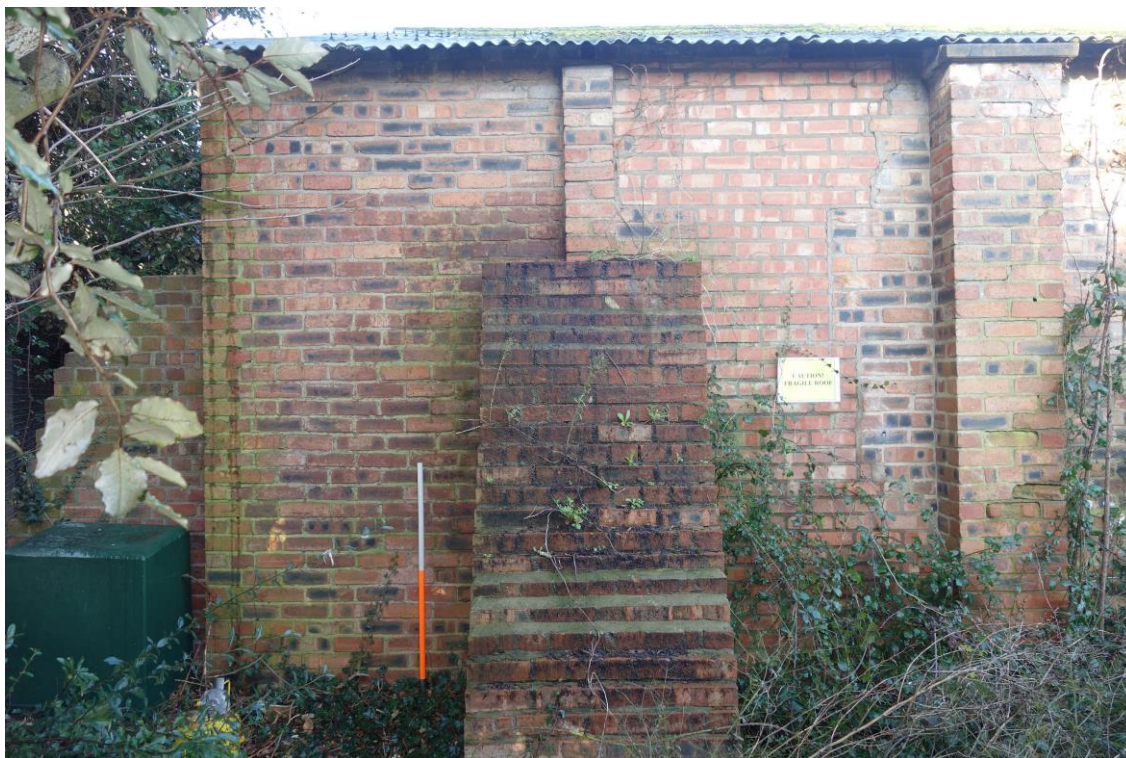
Plate 5 Brick buttress and blocked entrance on SE elevation; view NW

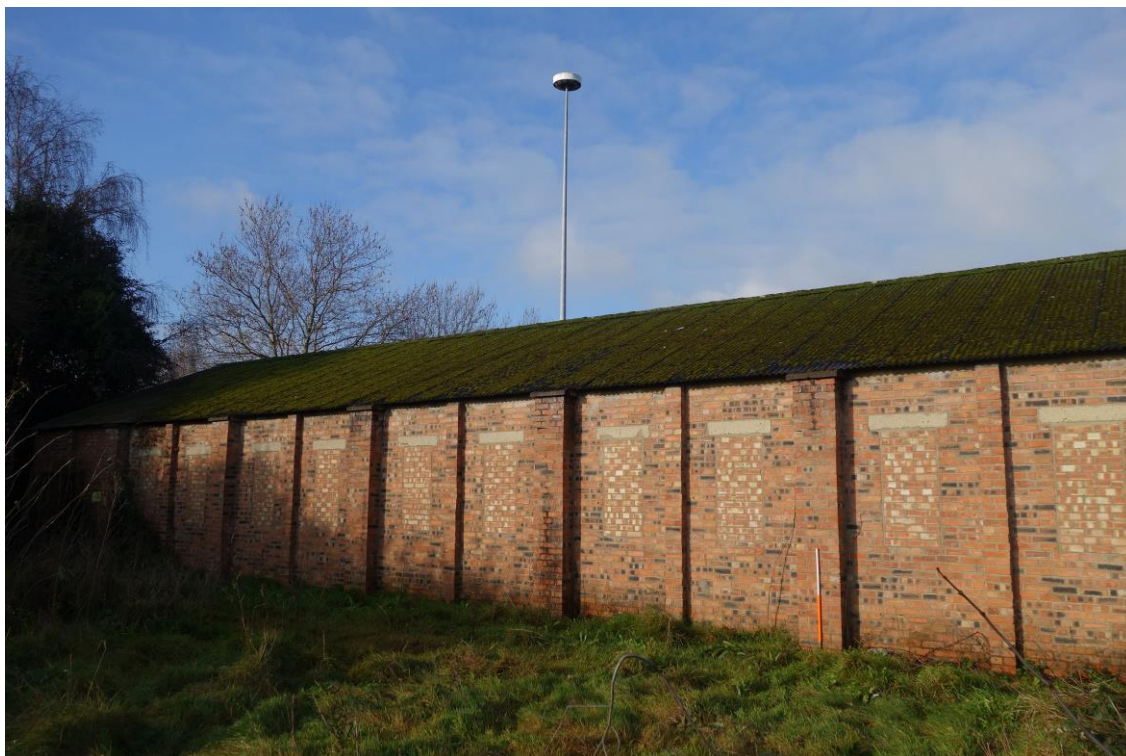
Alternate wide/narrow pilasters occur at regular intervals along the SE elevation. Window-blocking appears to have taken place some considerable time after the building was erected as the brick used differs from that of the original fabric. A substantial brick buttress abutting the SW end of this elevation (*Plate 5*) suggests a structural weakness at this point, which is further attested by a crack running almost the full height of the wall possibly suggesting subsidence.

Plate 6: View W of SE elevation showing blocked windows with cast concrete lintels and alternating small and large buttresses

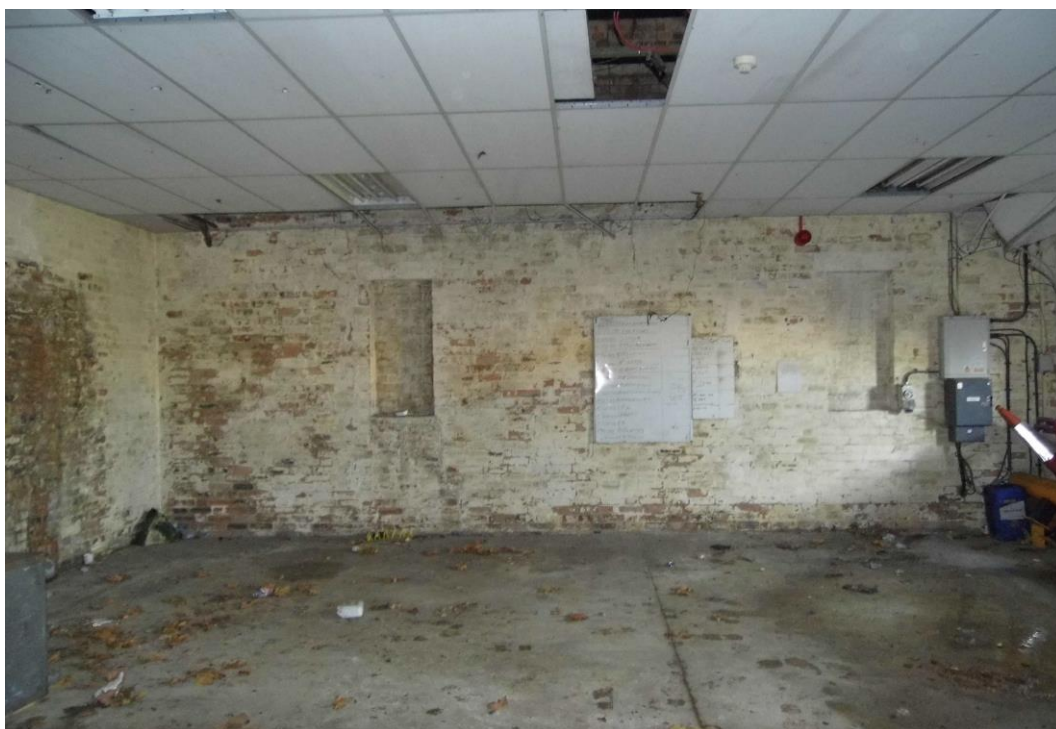
Plate 7: Internal SW elevation; view SW showing whitewashed walls and blocked windows and suspended ceiling. It is possible to see the brick construction of the SW end of the building through the missing ceiling panel.

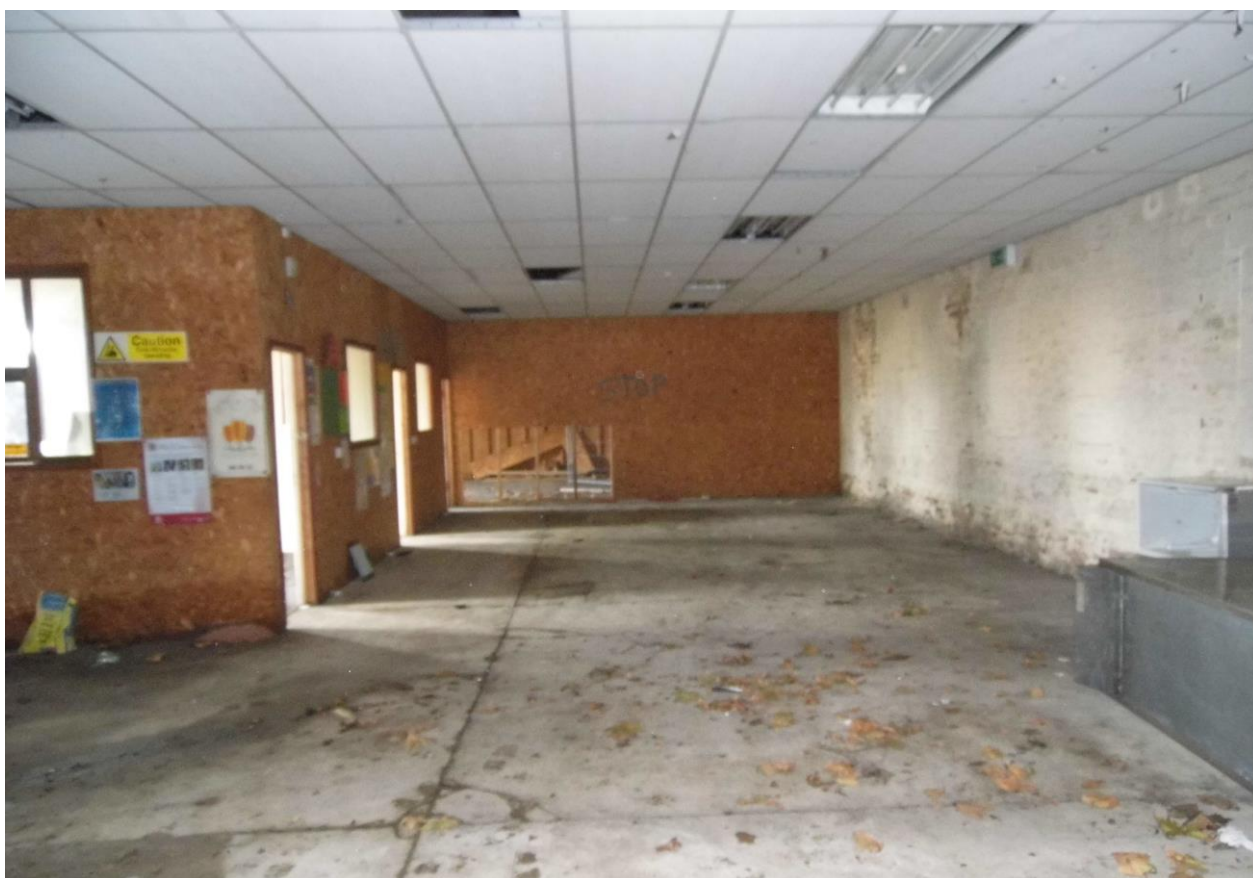
Plate 9: View NE showing inserted stud walls; Rooms 2, 3 and WC cubicle to left of picture. Brick blocked windows in whitewashed wall to right

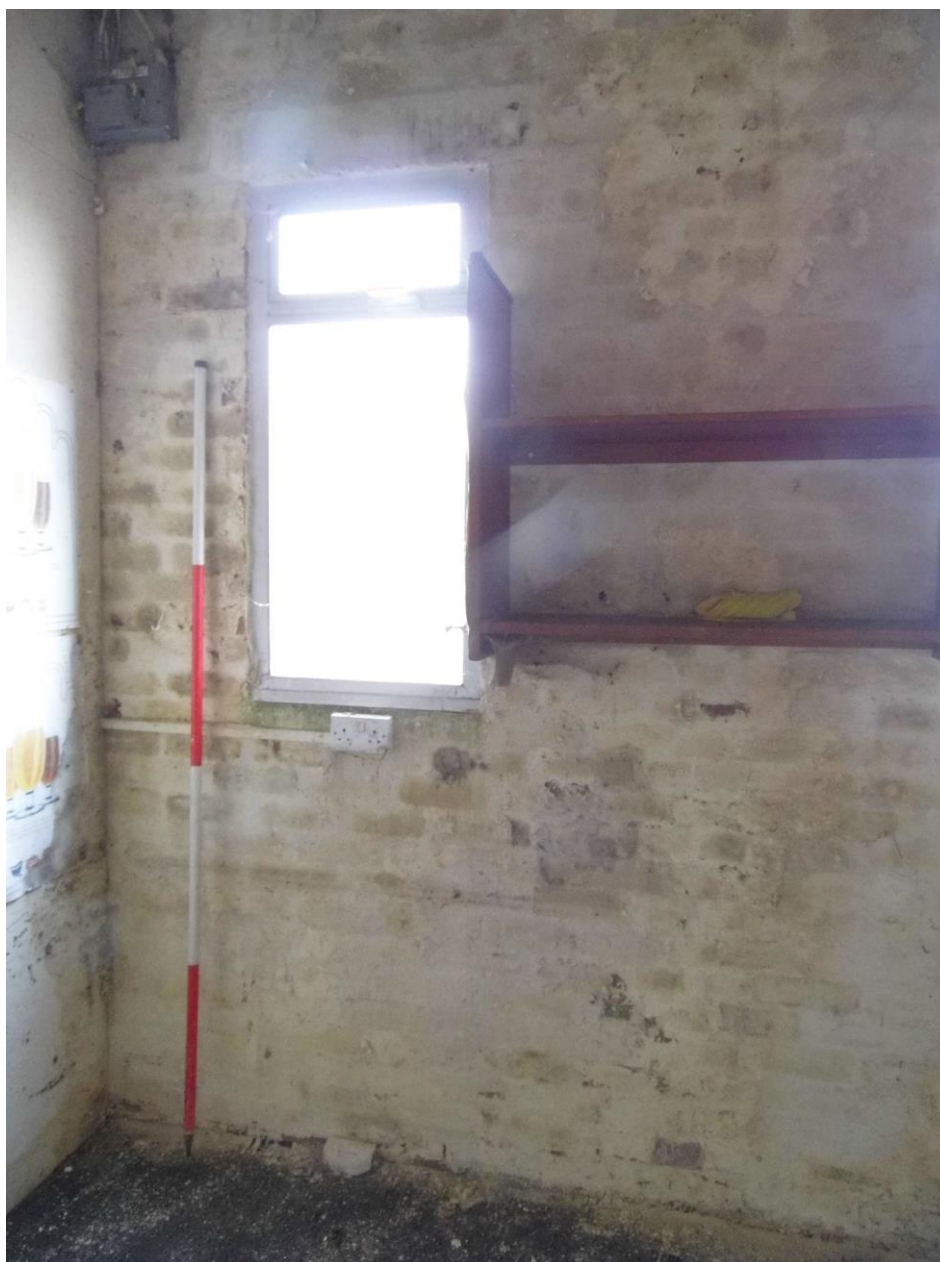
The small cubicle (Room 2) (*Plate 10*) measuring 3.8m × 2.81m was inserted on the NW side of the building. The stud-walls clad in heavy duty plywood with modern cable ducting attached are unpainted on the exterior. A service-hatch (*Plate 11*) is present on the NE side. Although the original window-openings are retained, original frames have been replaced with uPVC double-glazed units.

Plate 10: uPVC window inserted into original window space Room 2. The concrete lintel above the window can be seen beneath the whitewash. View W

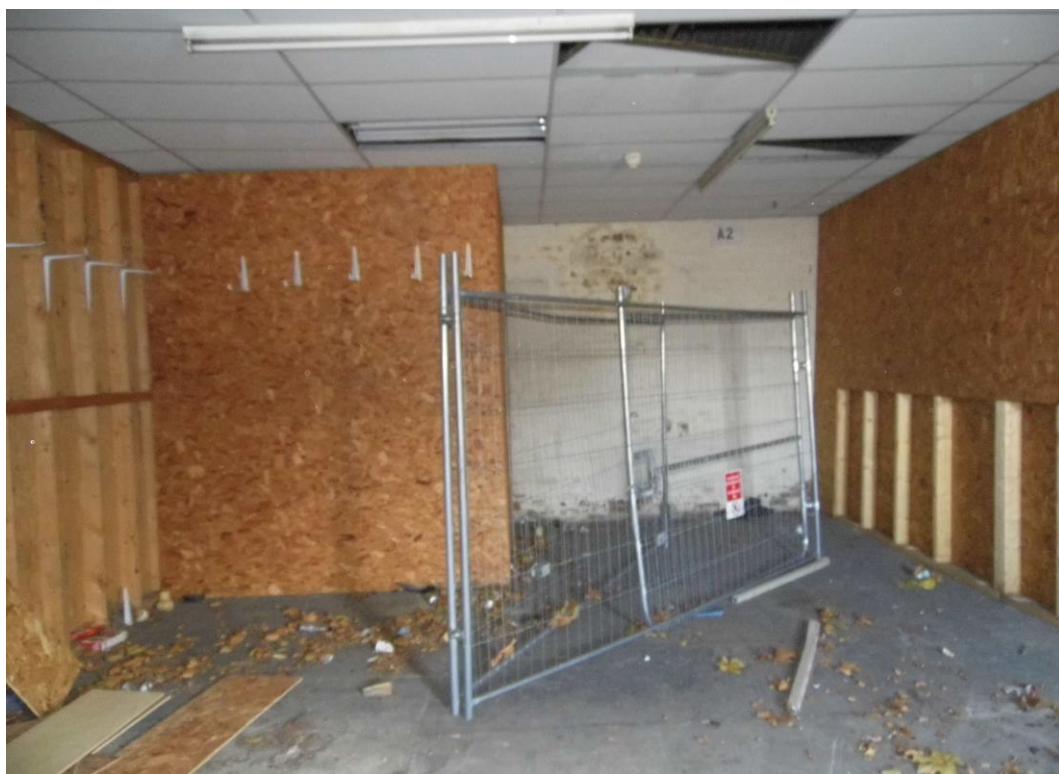
Plate 14 Room 4 view SE; inserted stud walls and suspended ceiling

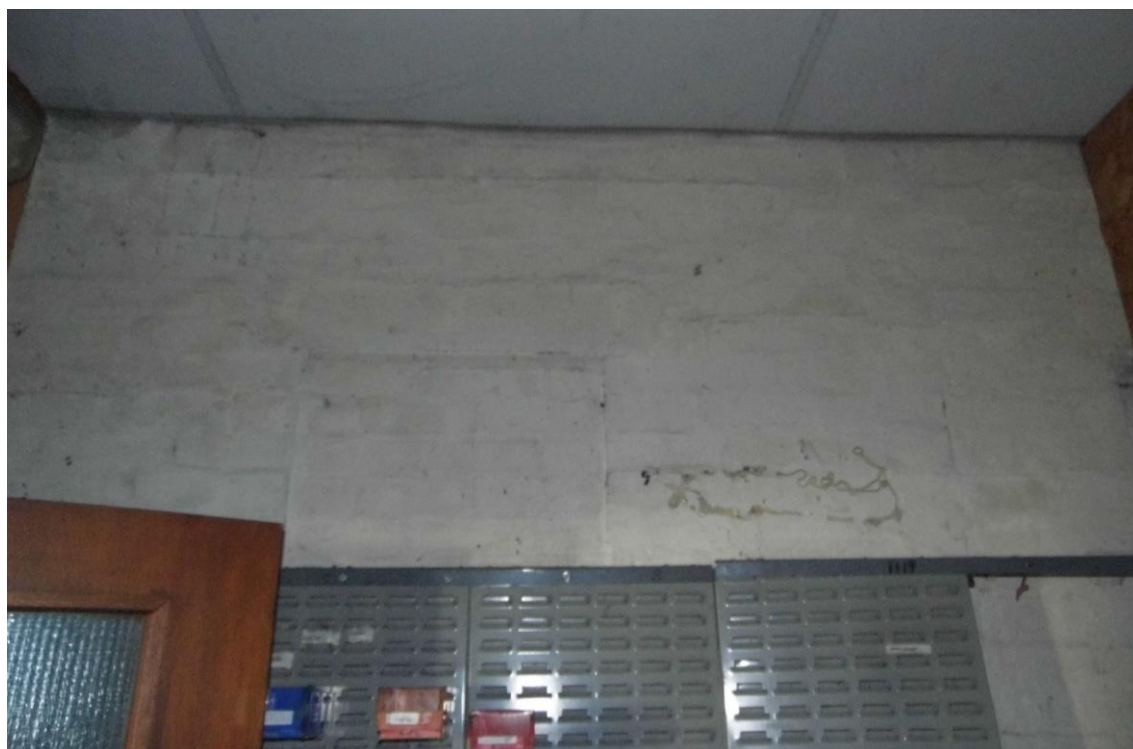
Plate 16 Room 6 view SE: Blocked windows in SE elevation are the only part of the original structure visible in Room 6

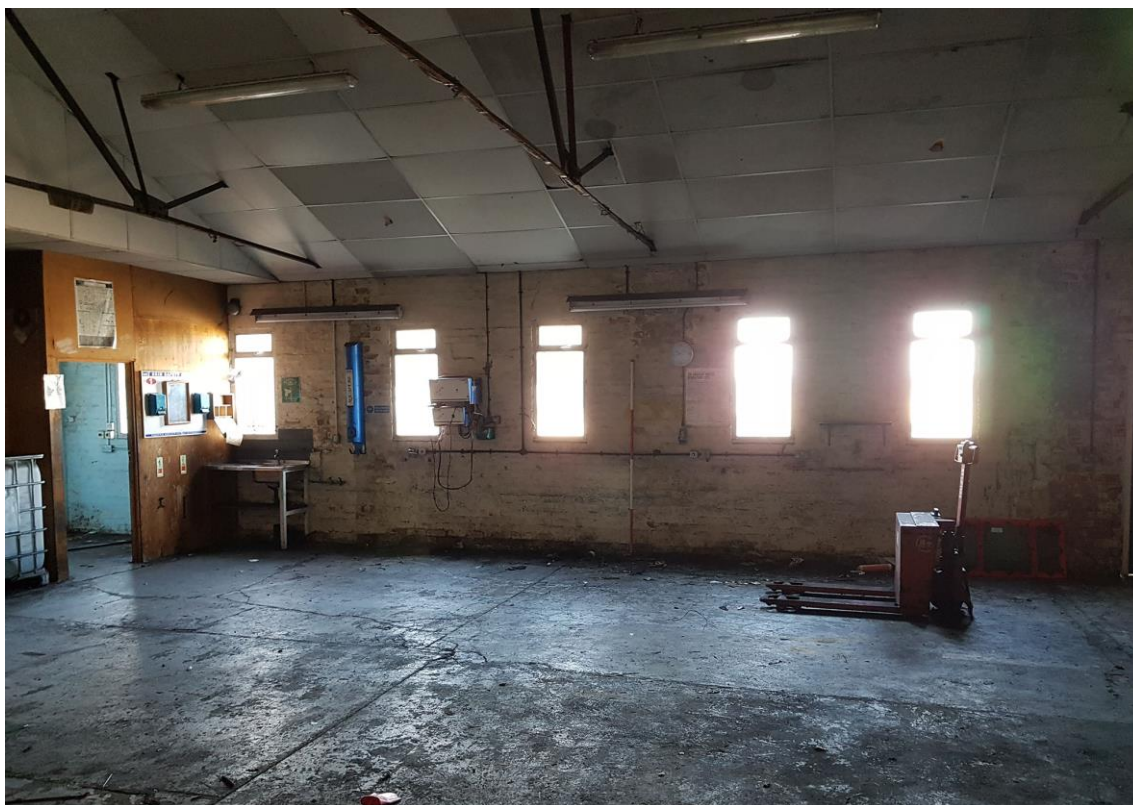
Plate 17: View W Room 5– internal NW elevation. Room 7 to L of picture.

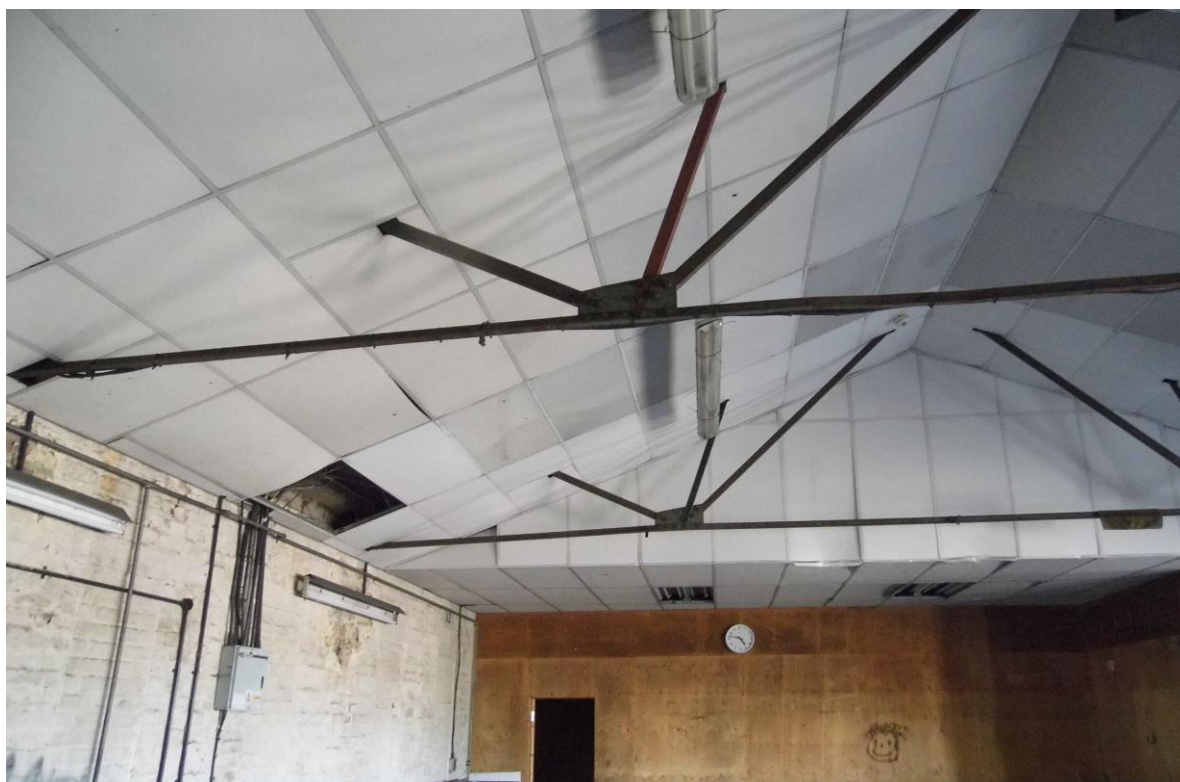
The roof structure comprising corrugated asbestos cement sheeting over angled iron trusses is almost certainly original, although much of this structure is concealed behind a suspended ceiling, with the exception of the NE end of Room 5, where the panels appear to be fixed to the original roof (*Plates 14 & 16*). Whilst the large doorway in the NE elevation is likely to form part of the original structure, at least two of the doors are almost certainly later insertions. A blocked opening on the SE side of the building (Room 1) (*Plate 8*) may have been the original entrance at this end of the building.

Plate 18: View SW - Room 5 towards Room 4 - showing detail of angled iron roof supports.
