## Programme of Archaeological Work

**Land at Pinsley Mill  
Leominster  
Herefordshire**

September 2017

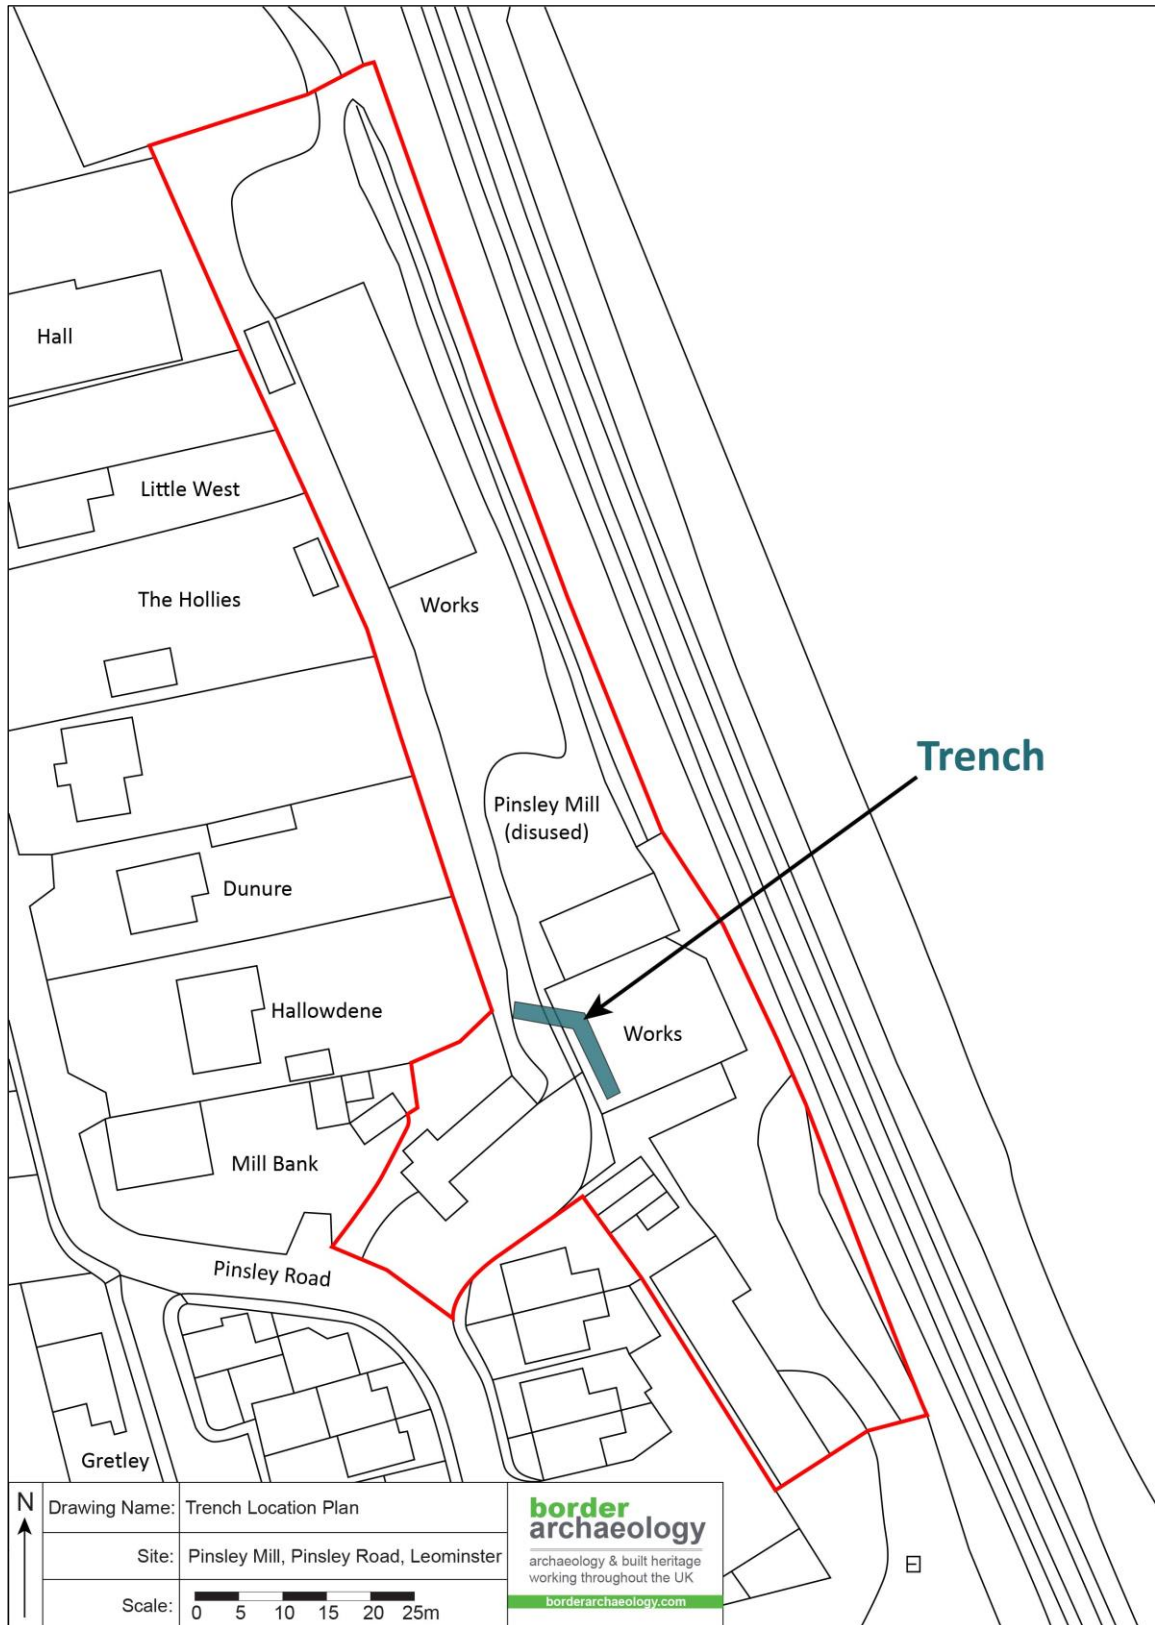
Fig. 2: Plan showing location of evaluation trench.

Prior to the commencement of development, a number of Test Pits (TPs) were opened under AO) A single 'L'-shaped evaluation trench was subsequently opened in the approximate location of the mill structure (fig. 2).

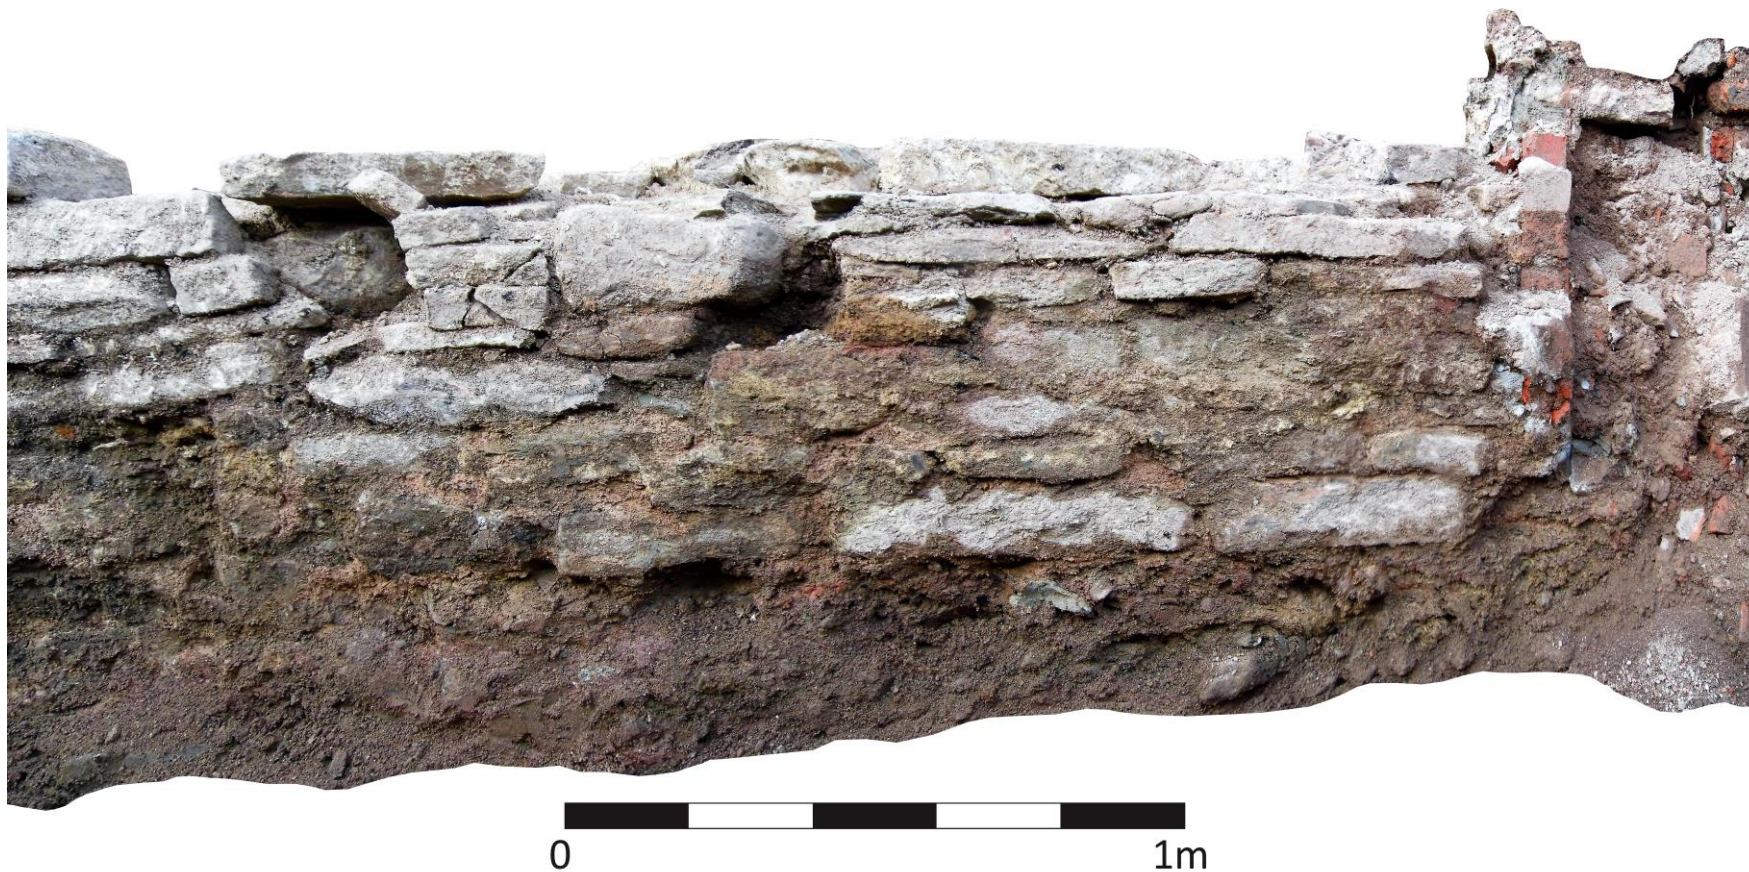
*Plate 1: E Elevation showing insertion of chute (111) into wall (107).*

A chute (111) had been inserted [116] into wall (107). The chute lay just to the N of the alignment of wall (110), implying that it may have remained in use following alteration of the cellar to form basement room (113) or even that (110) was positioned so that the chute was included in the new layout. The cut into wall (107) measured 0.8m (height) × 0.8m (width). It was very irregular, confirming that the chute was not an original part of the structure. The capping was of stone, which appeared to have been inserted rather than being part of the original structure, although it is possible that they were reused. The brick lining was bonded with a grey cement mortar, similar to that used in Phase 4, and the bricks were of similar size (100mm × 75mm × 220mm) to those used in the construction of wall (110). It cannot, therefore, be ruled out that the chute was inserted at the same time as the cellaring was otherwise altered (Phase 4). The opening of the chute measured 0.53m (height) × 0.4m (width).

Wall (107) (*Plate 1*) was thought to be the earliest masonry present on site. It was constructed of roughly-squared sandstone of varying size, bonded with a pale brownish-pink lime mortar with flecks of lime and charcoal. The recorded section of the wall measured >10.6m × 0.8m × 0.6m, continuing outside the trench to the SE. The N end had been faced with brick and rendered in concrete (Phase 4). There was no evidence for similar treatment to the S and it may be that this part of the original basement had gone out of use prior to demolition. An earlier chute or doorway appeared to have been blocked (*Plate 1* - left). This would further suggest that the S end of the basement went out use and chute (111) was inserted in place of an original structure to the N of new partition wall (109).

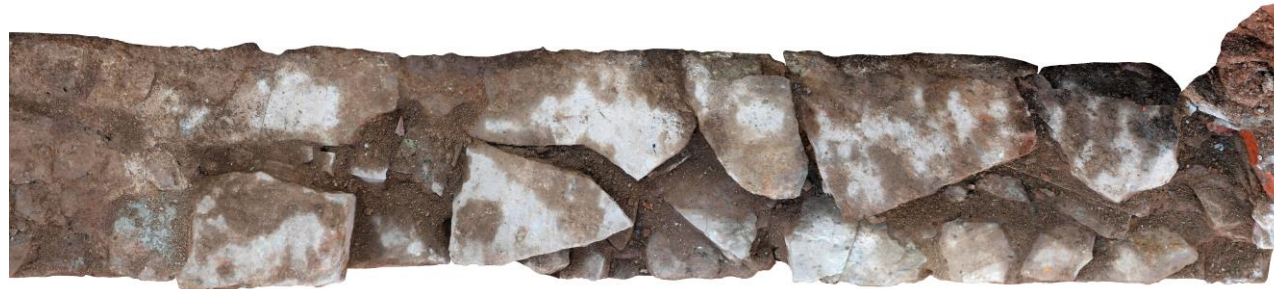
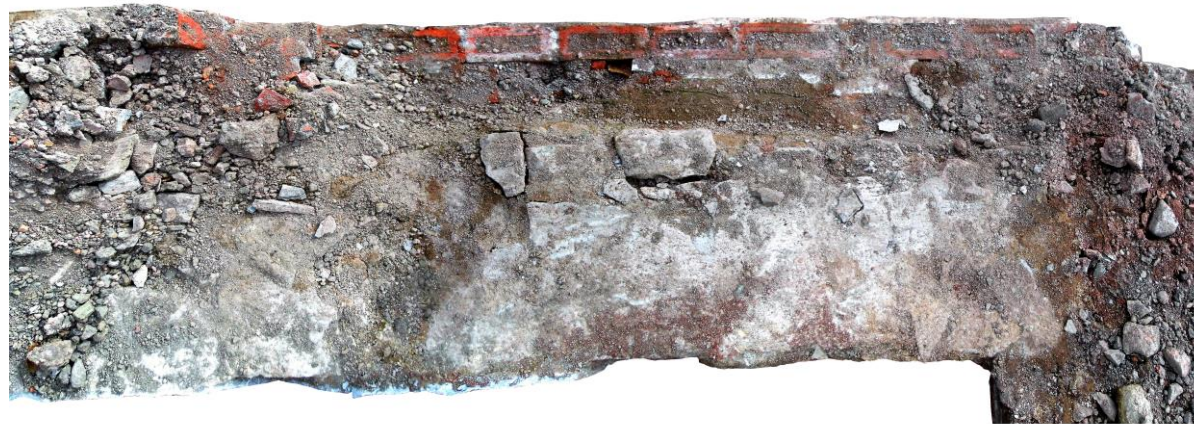
Plate 2: Above: Plan view of wall (107) S end of trench. Below: Facing (114) at N end of trench.

The existing surface consisted of a layer of tarmac on a sub-base of aggregate (101). Similar aggregate had also been used to level the surface of the site and filled a substantial hollow (*Plate 2*). At the NNW end of the longer trench, aggregate (101) overlay (109), a loose deposit consisting almost entirely of building rubble and presumably deriving from demolition works in 2014. The rubble sealed a number of earlier deposits and features, including walls (110) and (107), and filled the Phase 4 basement associated with floor (113).

The latest construction phase identified comprised basement alterations. Concrete screed flooring (113) had been laid concurrent with the concrete rendering of the walls. The addition of partition wall (110) and brick-facing (114) on wall (107) may relate to this phase or slightly earlier. It is also possible that these two alterations took place at different times, as the bricks used in (114) were of different dimensions (100mm × 75mm × 220mm) to those in (110) (120mm × 80mm × 240mm), although both walls contained a similar grey cement mortar. Facing (114) appeared to be constructed in running bond, although the concrete facing made this difficult to confirm. Wall (110) survived to a height of some 1.2m and measured 0.25m wide; it appeared to be of poor quality and was comparatively flimsy. There was no evidence for the continuation of this structure on the WSW side of the trench and this was presumably lost during demolition. It is thought unlikely that a door had been present, as it seems probable that deposit (117) was in place to the SSE at the time the cellar was in use. The construction cut [115] for (110) measured 1.2m (depth) × 0.55m (width) and was clearly visible cutting Phase 3 clay (117). On the SSE side only, a fill of rubble (119) may have served to retain clay (117), taking the weight of that deposit from the wall.

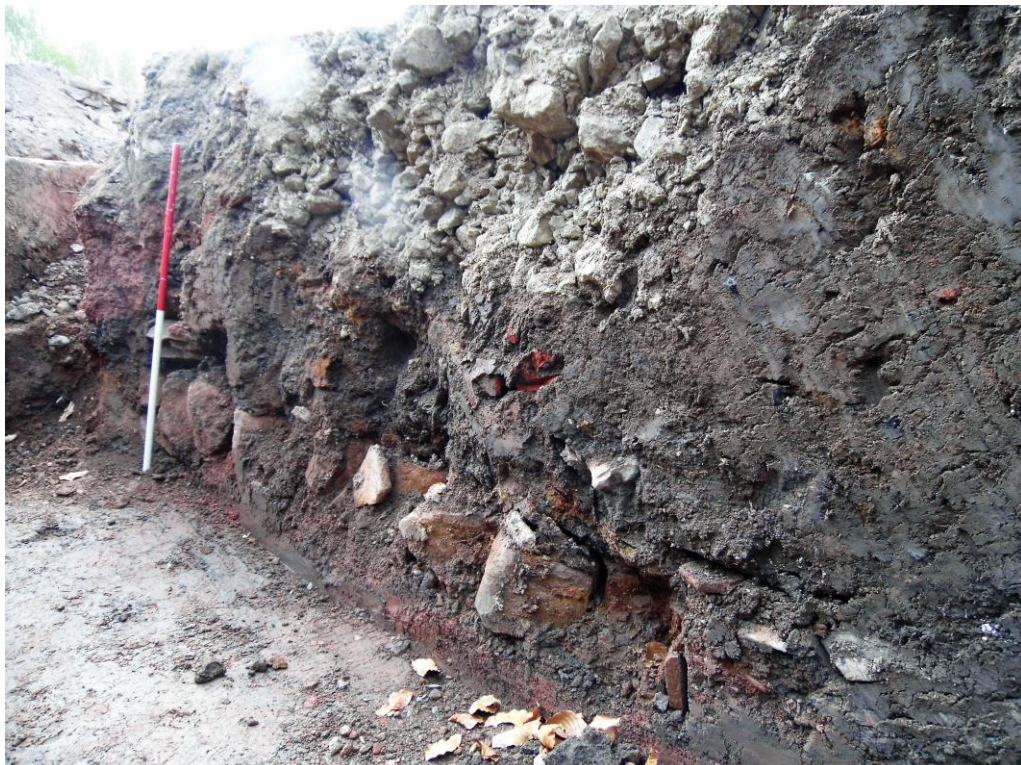
Plate 3: Stones (108) in clay (105) with natural (106) in base of trench: wall (107) back left; view SW.

In the NW arm of the trench, a layer of stones (108) set in greyish-pink clay (105) measured c.0.3m thick and appeared to have been deliberately placed. Individual stones had been roughly squared to form blocks some 200mm square. The deliberate placing of the stones indicates that they did not derive from demolition and, since the deposit was present in both trench sections, it was at least 1.6m wide and therefore unlikely to be a wall. No dating evidence was recovered and (108)/(105) lay immediately beneath possible 18<sup>th</sup> century demolition deposits and above the natural (106). It abutted wall (107) and may have been a stone surface contemporary with wall (107).
