ARCHAEOLOGICAL EXCAVATION

**DAVIES & NELSON ENGINEERING
WORKS**

**POST OFFICE LANE
TEWKESBURY
GLOUCESTERSHIRE**

Report No. BA0313POL2

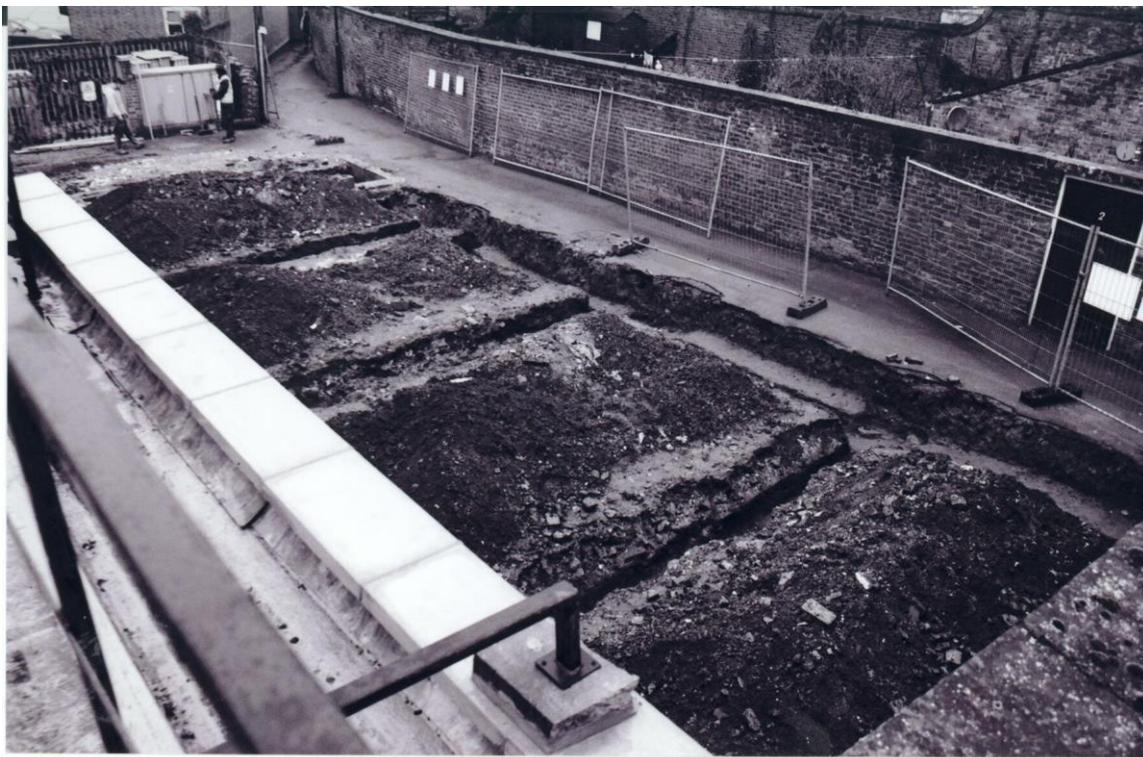
Plate 1 Overview of site, looking north
