Archaeological Observation

BGD Property Ltd

**The Former Rosswyn Hotel
Nos. 16-19 High Street
Ross-on-Wye
Herefordshire**

September 2017

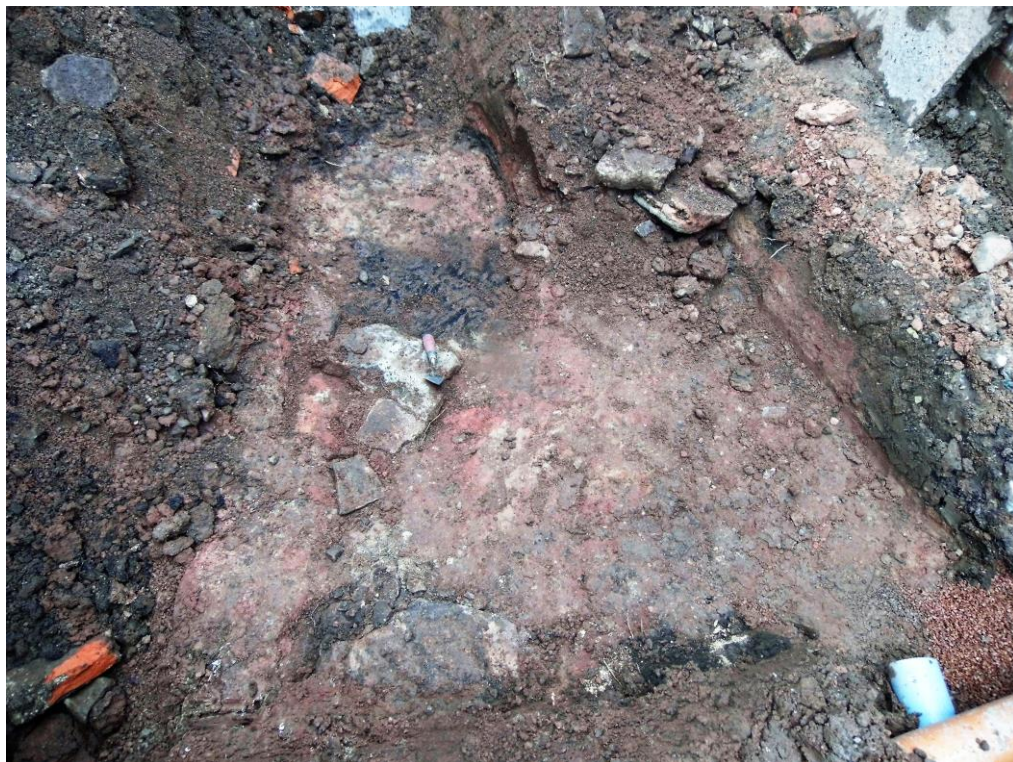
Possible surface (102) (*Plate 1*) may have been a path or a yard. It comprised flat stones lying directly above a deposit of disturbed natural clay (103) and bedrock (104), with both stones and underlying natural deposits displaying evidence of burning. This did not appear to be of sufficient intensity to indicate a hearth and the late date more plausibly suggests the site of a bonfire or similar, possibly associated with site clearance activity. Evidence recovered from (103) included a small sherd of shell-edged pearlware, suggesting a later 18th -or early 19th -century date. This late date, and the position of the stones immediately above the natural clay, would appear to confirm that the surface was laid following the clearance of earlier deposits. A number of phases of alteration to the house have taken place, including in the middle to late 19th century (BA 2016, 1) when the detached L-shaped building at the rear was constructed. Surface (102) lay adjacent to this building and may have been a yard or path associated with it.

Plate 1: View W of possible surface (102) above natural deposits (103) (104).

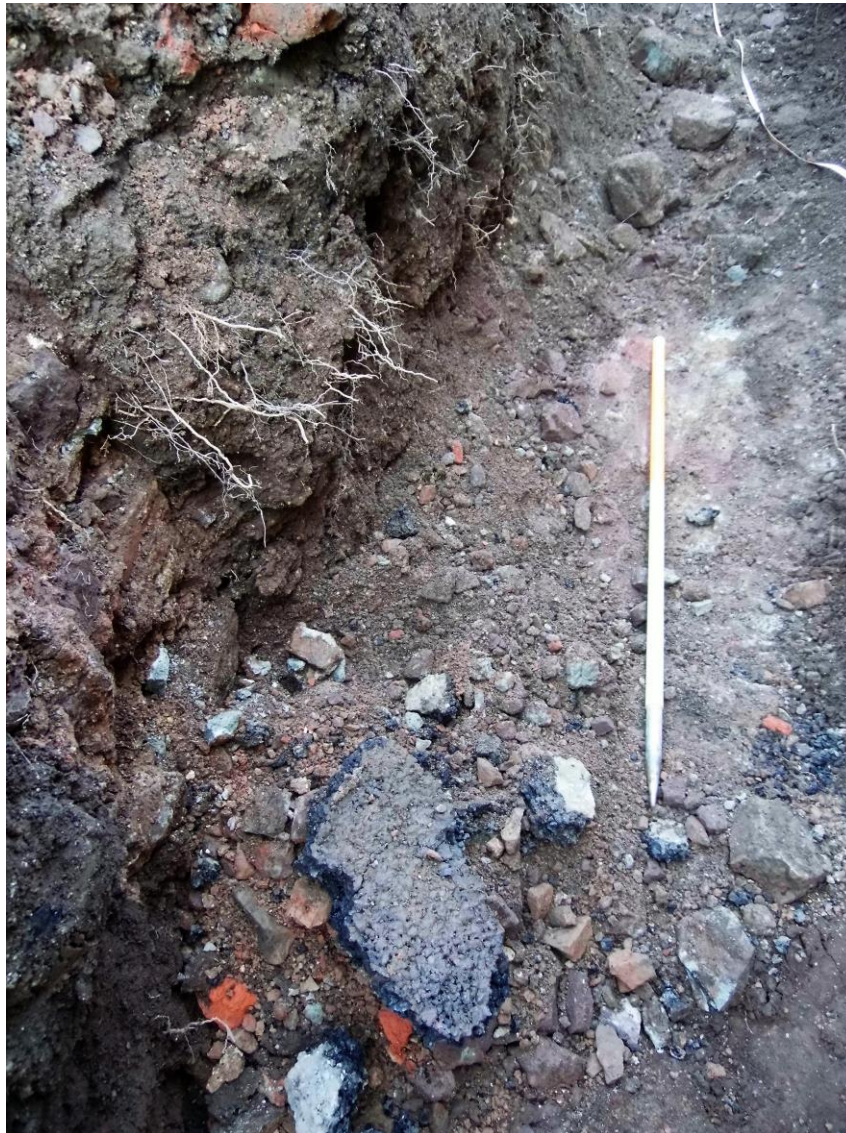
The service trench across George Place revealed disturbance to its full depth. Two brick walls on sandstone footings were present at the W end of the trench. It seems likely that these were the remains of structures shown on the 19th and 20th century Ordnance Survey maps, which appear to have been cleared in the mid-20th century.

Plate 2: View S of disturbance to full depth of trench, showing post-medieval footing (208) in base

Maps from 1888 onwards show a number of seemingly ephemeral phases of outbuildings and minor structures (BA 2016). Groundworks associated with their construction and subsequent demolition would also have caused considerable disturbance. Additionally, installation and alteration of drainage, probably during conversion of Nos. 17 and 17a to a hotel, had clearly caused considerable disturbance close to the building (*Plate 2*).
