Report Ref:

BA1539CCPR

Cover: View northeast showing culvert (1012)

Report Title		Report Ref	
Archaeological Excavation for LPG tanks on the North Lawn Croome Court High Green Severn Stoke Worcestershire		BA1539CCPR	
Report written by	Katherine Crooks BA		
Reported edited by	George Children MA MCIfA		
Issue No.	Status	Date	Approved for issue
1	Final	December 2015	Neil Shurety Dip. M G M Inst. M

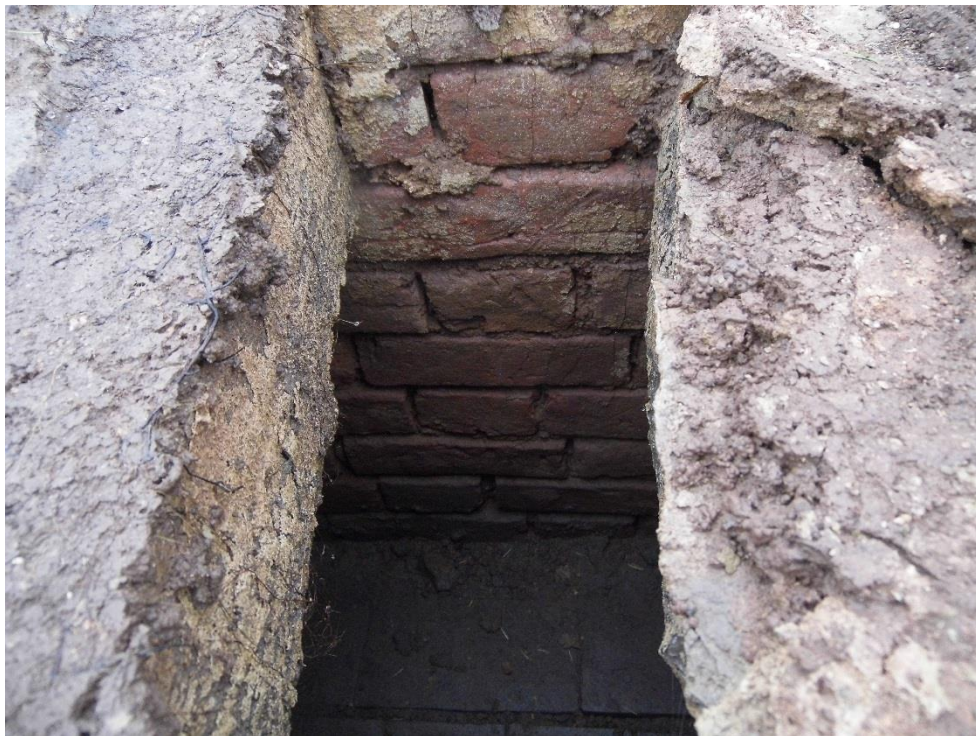
Plate 1: View inside inspection chamber (1009)

Set into the culvert was a square structure (1009) measuring about 1.95m square and probably representing an inspection chamber. It appeared to have been built as part of the original culvert as there was no evidence that it had been inserted into the culvert at a later date

The work took place in two stages and involved the excavation of two 6m square trenches. The first of these revealed a substantial culvert (Plates 1 & 2, figs. 2 & 3) crossing the trench diagonally and probably forming part of the drainage system for the landscape parkland begun in 1751 by Lancelot 'Capability' Brown. The culvert was fully recorded and the area backfilled to avoid any potential damage to this feature.

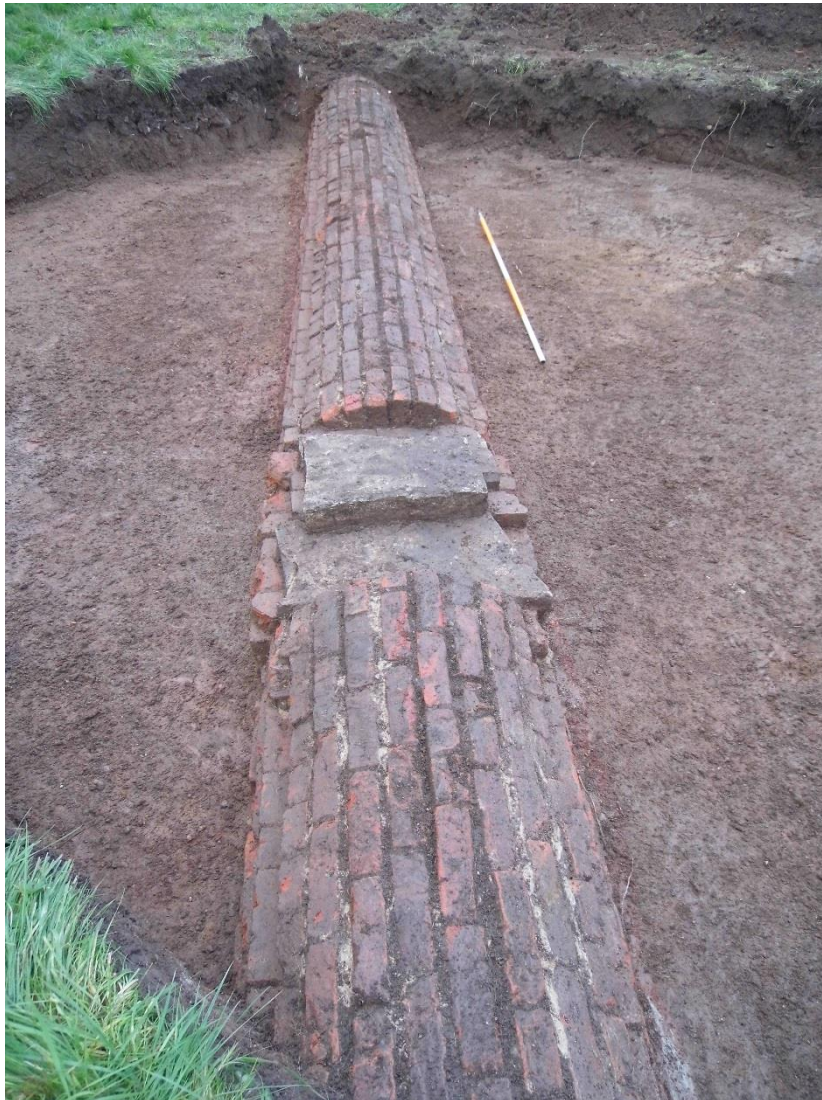
Plate 2: View SE of culvert (1012)

Its walls, (1005) and (1011), were both three brick courses thick at the base, stepping in to two, with a single course at the top of the structure. The segmental arched roof (1008) was of brick construction, with an angled springer course. Eight brick courses were present: brick size was 130mm × 60mm × 230mm and the bricks were unfrosted; their rather coarse appearance suggests they may either have been reused (although this was not obvious) or that these were poorer quality bricks intended for engineering use rather than for display. The materials themselves

were presumably manufactured within the grounds; a reference in a contract book for 1714 to a large number of bricks manufactured at ‘Seggy Meer’ (the site of the present lake) has previously been noted (Kay 2012, 95). The brickwork was bonded using a cream mortar with white flecks of lime and was laid in running bond. Bedding joints were up to 40mm wide where affected by the curvature of the arch. The culvert ran slightly downslope to the NW, levels taken from the top of the structure being 21.40m AOD at the SE end and 21.27m AOD at the NW, creating a slope of some 0.13m in a length of c.7m. The brick roof (1008) of the culvert lay immediately beneath the topsoil (1001) at the NW end and beneath a layer of rubble and rubbish (1002) to the SE. Pottery from layer (1002) suggested a date in the 19th or 20th century.

culvert, suggesting either that it was still a functioning drainage channel or that a blockage had occurred elsewhere along its length. No water was seen in it at the time of excavation. The two brick side walls of the culvert (1005) (NE) and (1011) (SW) were seven courses deep, representing a height of 0.66m.

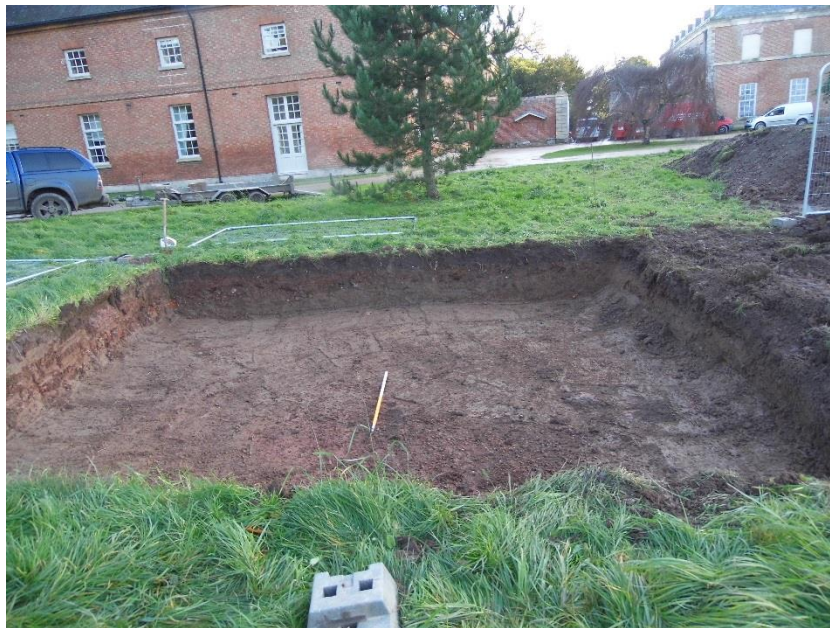
Plate 3: Trench 2 view S, showing layer of rubble (2002) beneath topsoil

The trench (*Plate 3*) was approximately 6m square and lay 2m to the E of Trench 1. A total of five contexts were encountered in the trench, one of which [1005] was allocated for the cut for a modern alkathene water main in the NW corner of the trench.

No deposits of archaeological significance were observed in this trench, with the topsoil (2001), subsoil (2003) and natural (2005) similar to deposits encountered in Trench 1. Immediately beneath the topsoil, layer (2002) consisted of loose stone rubble and rubbish. It was stratigraphically similar to (1002) in Trench 1 and it is likely that it was part of the same deposit. As with (1002), it contained angular and sub-angular stones but there was no clear evidence that it consisted of building debris. However, (2002), unlike (1002), exhibited a red clay matrix. The fact that the material was probably part of the same deposit was confirmed, however, by the presence of modern (19th or 20th -century) pottery.
