Archaeological Observation

**Harley Lodge
St John Street
Hereford
HR1 2NB**

November 2018

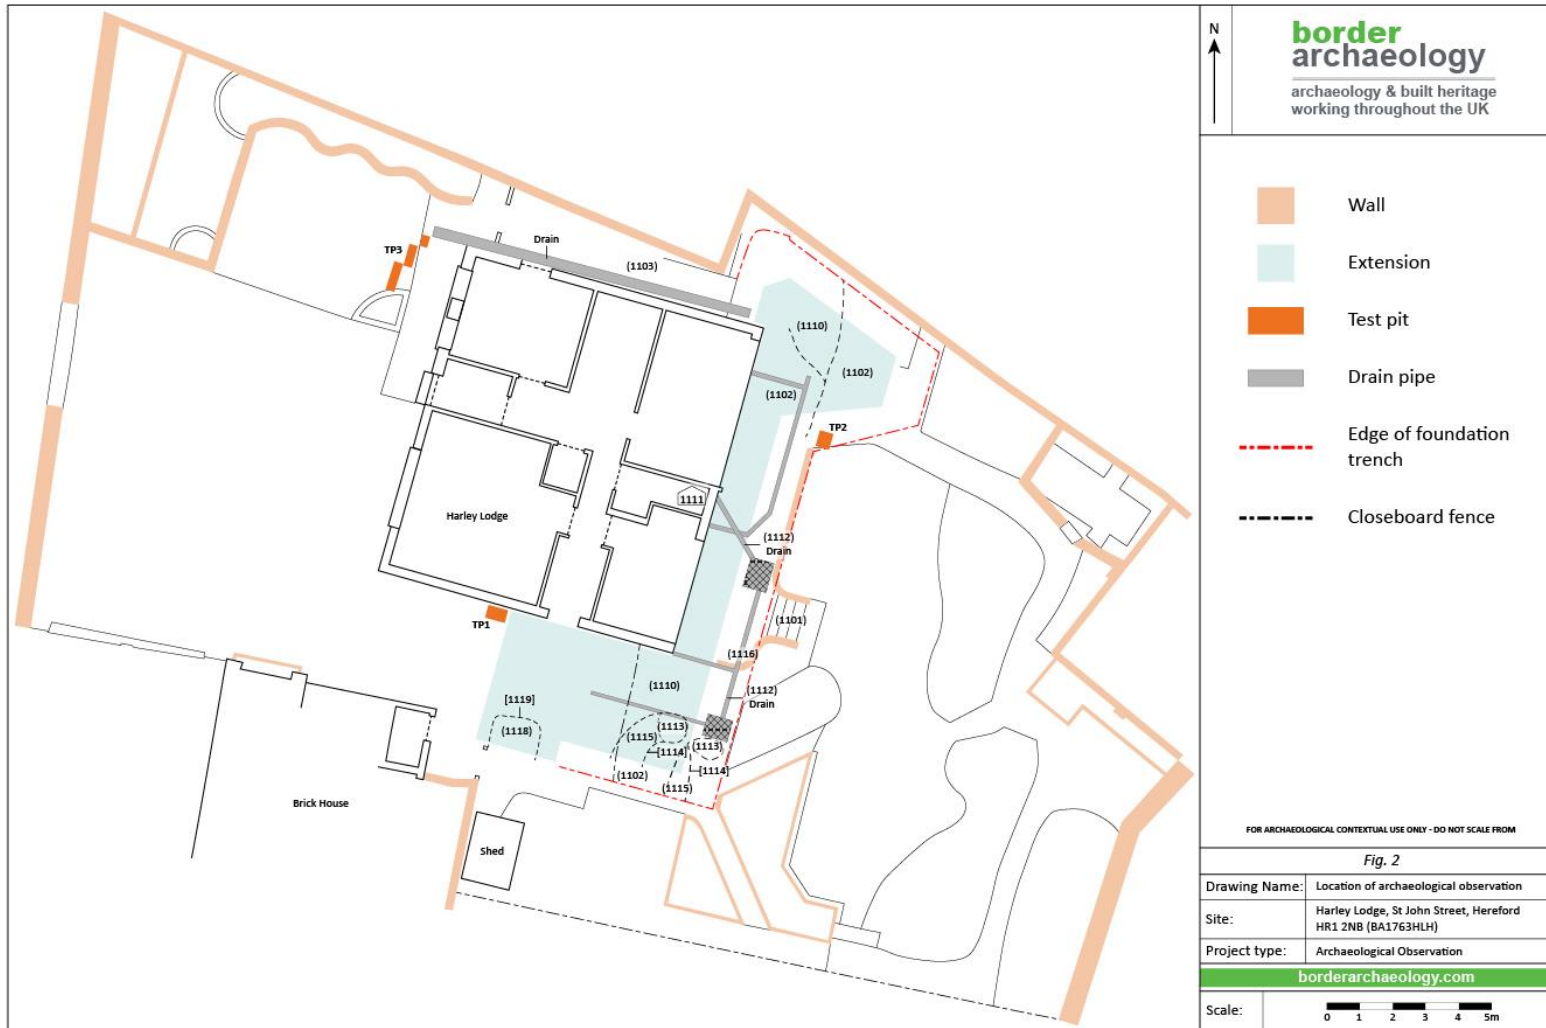
Two TPs were opened on 17th October 2017 to investigate the existing foundation arrangement and thus to establish a possible raft foundation for the extension, with a third opened on 17th July 2018 (*fig. 2*).

TP 1: Carport area - Concrete - 0.9m × 0.5m × 0.8m.

TP 2: Garden - Lawn – 0.55m × 0.5m × 0.8m.

TP3: NW corner of house – 2.0m × 0.50m.

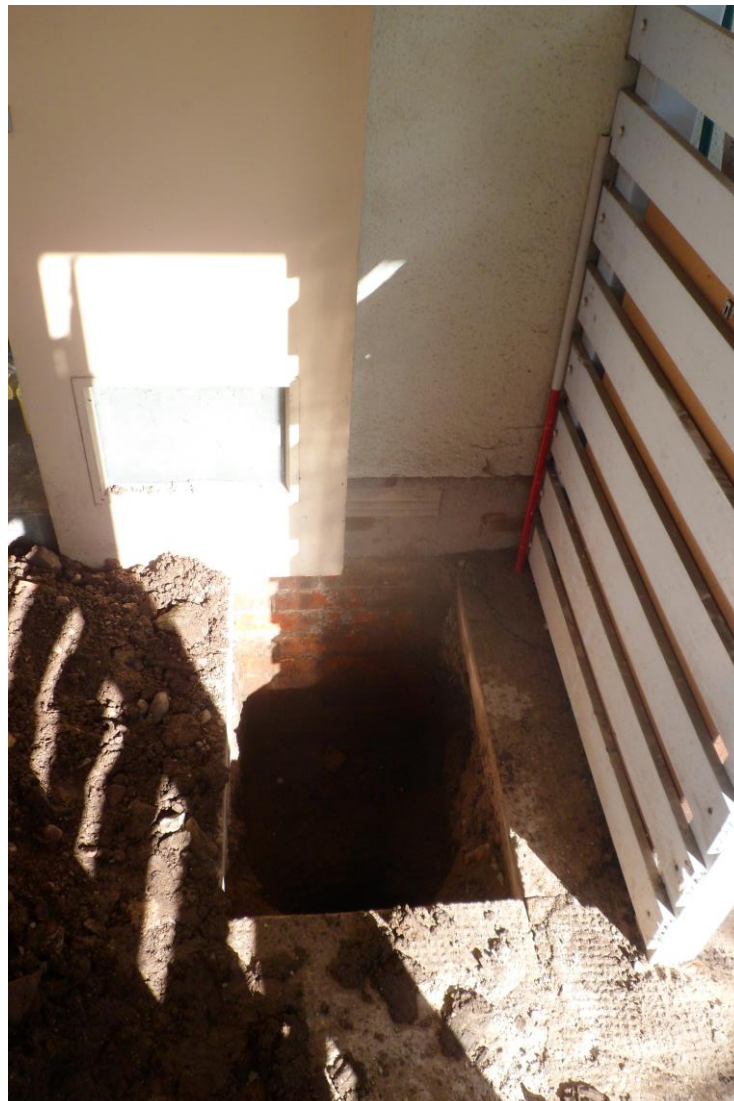
Plate 1: TP1 against SW elevation in carport

TP1 (*Plate 1; fig. 2*) against the SE elevation of a carport adjacent to the property revealed no archaeological features or deposits, the concrete surface being underlain by gravel above subsoil. TP1 extended to 0.8m below existing ground level into natural deposits (104), these consisting of friable mid-pinkish-brown sandy clay.

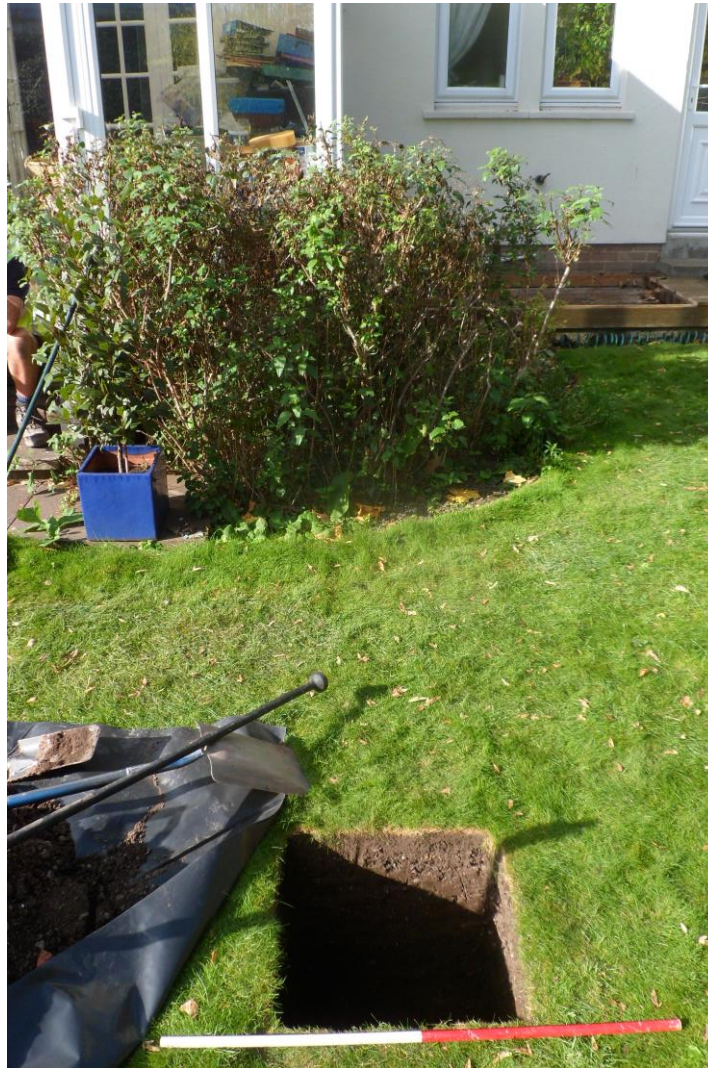
Plate 2: TP2 in the lawn at the rear of the property

TP 2 (*Plate 2; fig. 2*) was opened in the lawn area to the rear of the property, again to a depth of 0.8m, down to a friable dark brown silty gravel (206). At its base was what appeared to be the top of a cut, only very limited investigation of which was possible due to the small size of the pit. No dating evidence was recovered.

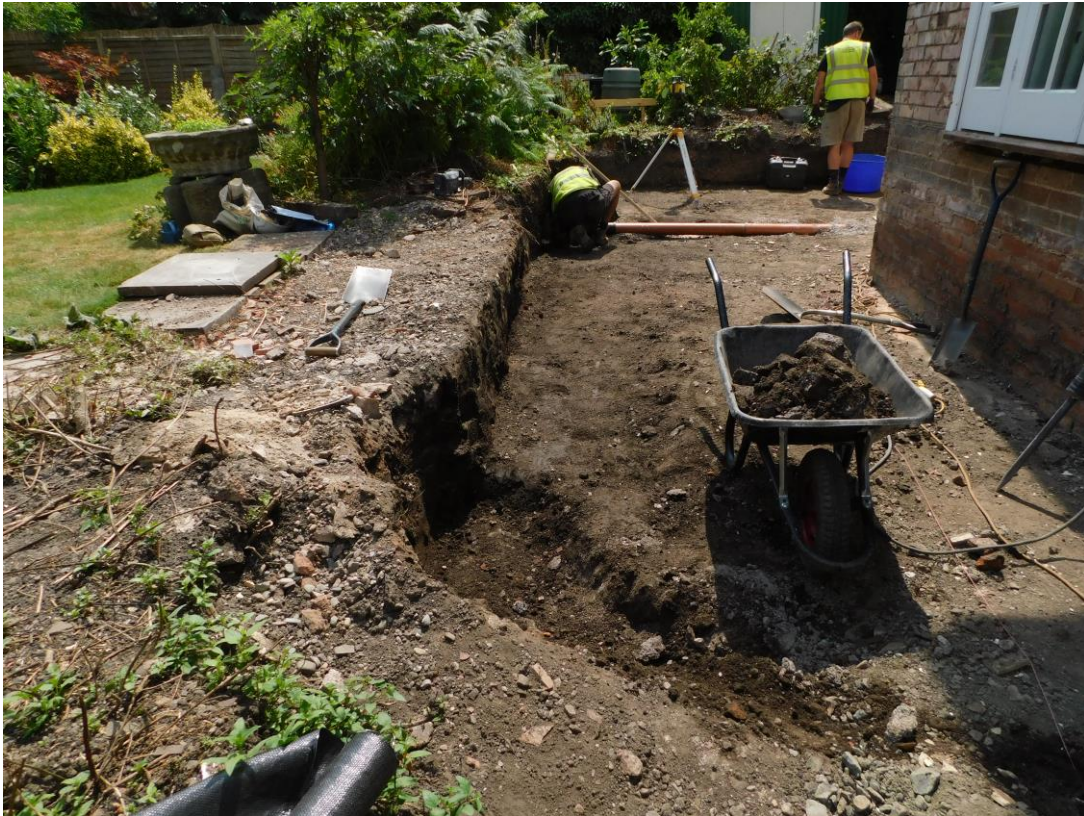
Plate 3: View SW showing foundation excavations

The only features identified during excavation of the foundations (*Plate 3; fig. 2*) dated to the very end of the 18th or early 19th Century. A substantial dump of pottery recovered from the fill (1113) of a soakaway [1114] comprised a mixture of kitchen and table wares. A rubbish pit [1119] containing pottery of similar date, together with clay tobacco pipe, was identified close by. It is thought probable that the 18th and 19th Century pottery may have been

rubbish from Harley House, buried in pits dug in the garden (with Harley Lodge itself not having been built until the late 1960s).
