## Archaeological Observation

**Water Main Renewal  
Frodesley to Acton Burnell  
Shropshire**

February 2018

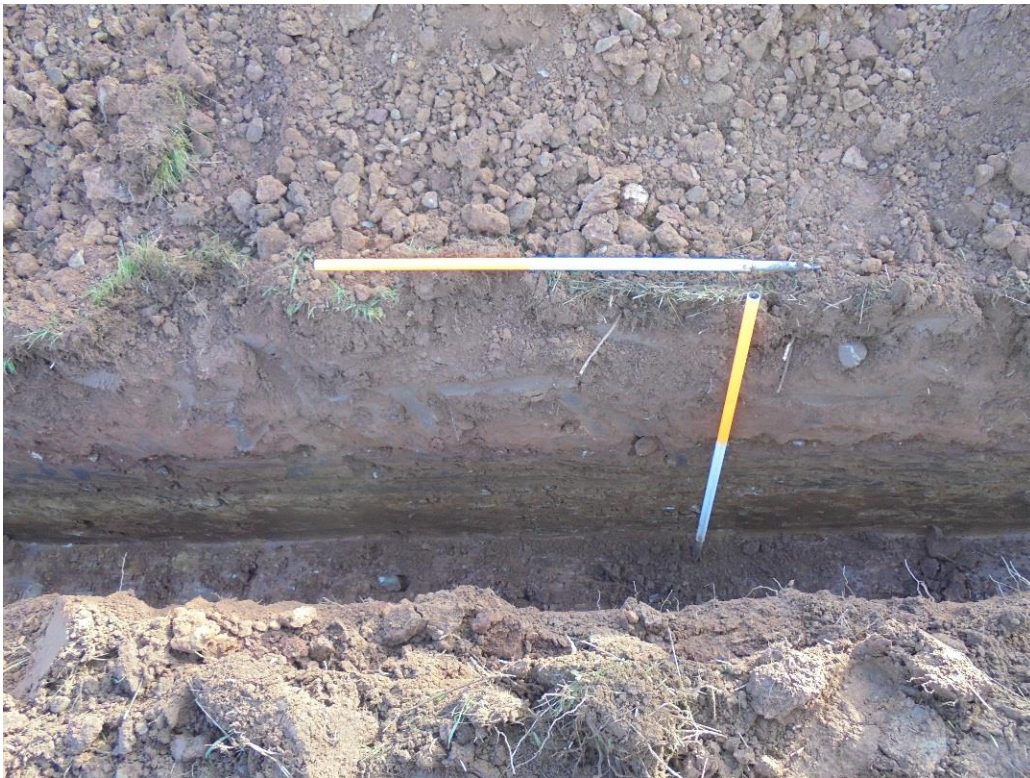
The groundworks N of the road revealed a very firm dark reddish-brown (rapidly oxidising to greyish-brown) sandy clayey silt topsoil (1001) of 0.38m thickness overlying very firm dark reddish-brown (rapidly oxidising to dark grey) silty clayey sand subsoil (1002). The natural substratum (1003) was encountered at a depth between 0.54m and 0.59m (*Plate 1*). No features or deposits of archaeological significance were encountered.

*Plate 1: NW-facing trench profile (Section 1)*

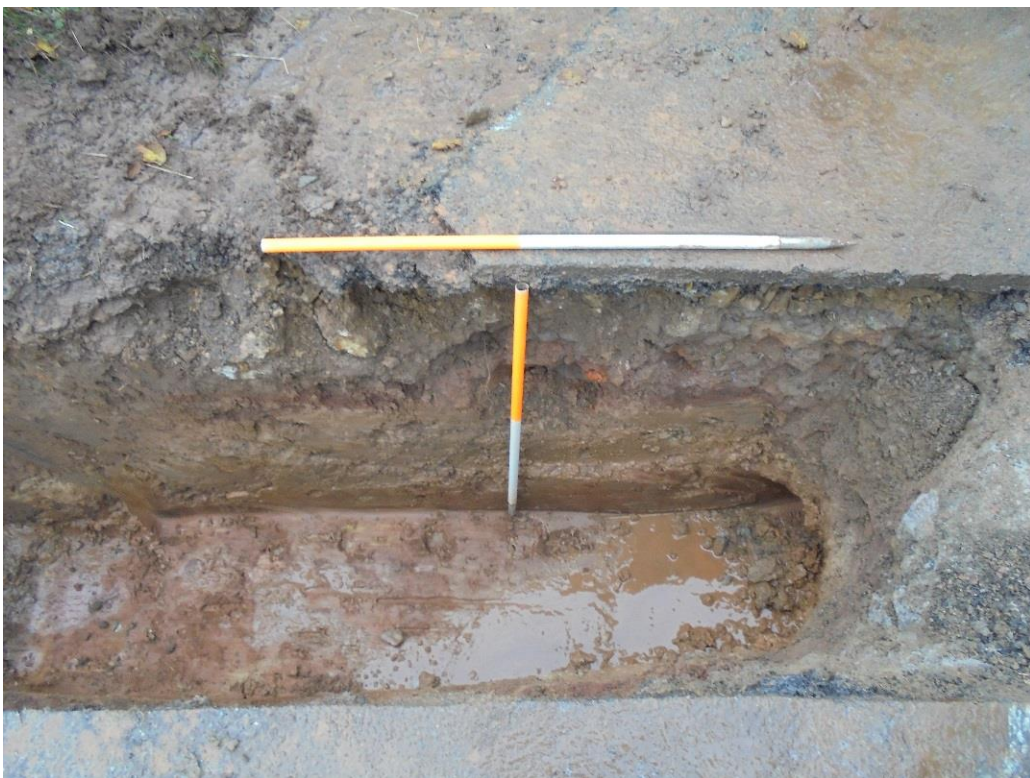
The road crossing revealed two earlier surfaces beneath modern tarmac (1004), the earliest (1006) consisting of stony sandy clayey silt from which was recovered a single horseshoe and post-medieval brick (*Appendix 1*). This deposit was sealed by road surface (1005), which was of a more consolidated limestone rubble construction within a clayey silty sand matrix.

The 'subsoil' (1002) was seen to continue beneath the earliest road surface (1006) at a depth of 0.49m, with the natural substratum encountered at a depth of 0.98m (*Plate 2*). This increase in depth of approximately 0.25-0.5m to which the subsoil is encountered suggests the road may have originally have been sunken or formed a hollow way in the landscape. The present road surface is up to 1m below the level of the fields to the N and S (*Plate 3*).

*Plate 2: SW-facing profile of road-crossing (Section 1)*

It is, however, possible that, whilst the artefactual evidence provides an 18<sup>th</sup> -19<sup>th</sup> century date, these road surfaces may relate to the extant Roman road surface through Frodesley and Longnor Green identified by Margary (1973) as being narrow but exhibiting a well-preserved alignment and surface. It is thus possible that the CBM and horseshoe are associated with later road-maintenance.

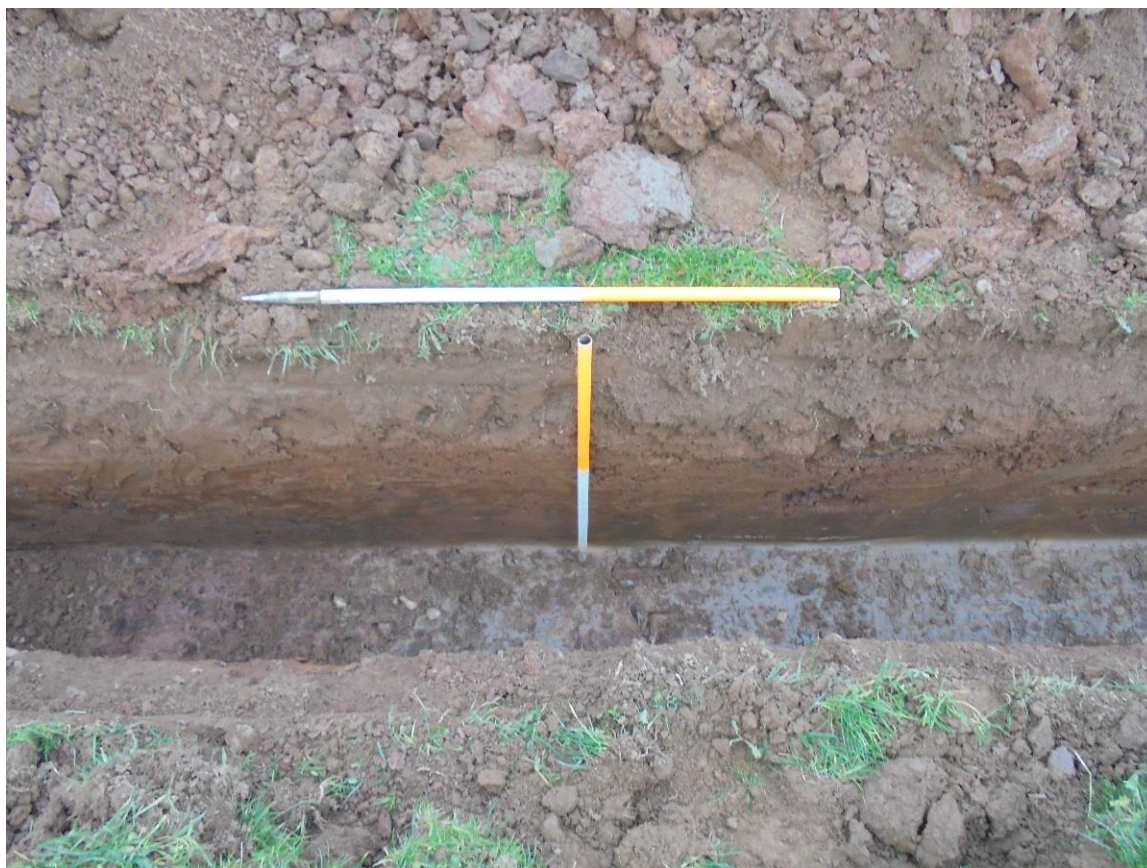
A firm-to-friable light reddish-brown silty (rapidly oxidising to greyish-brown) clayey sand topsoil (2001) of 0.39m depth overlay a very firm light reddish-brown silty sandy clay subsoil (2002). The natural substratum (2003) occurred at a depth of 0.48-0.82m (*Plate 4*).

No archaeological features or deposits were encountered.

*Plate 4: SE-facing trench profile (Section 2)*

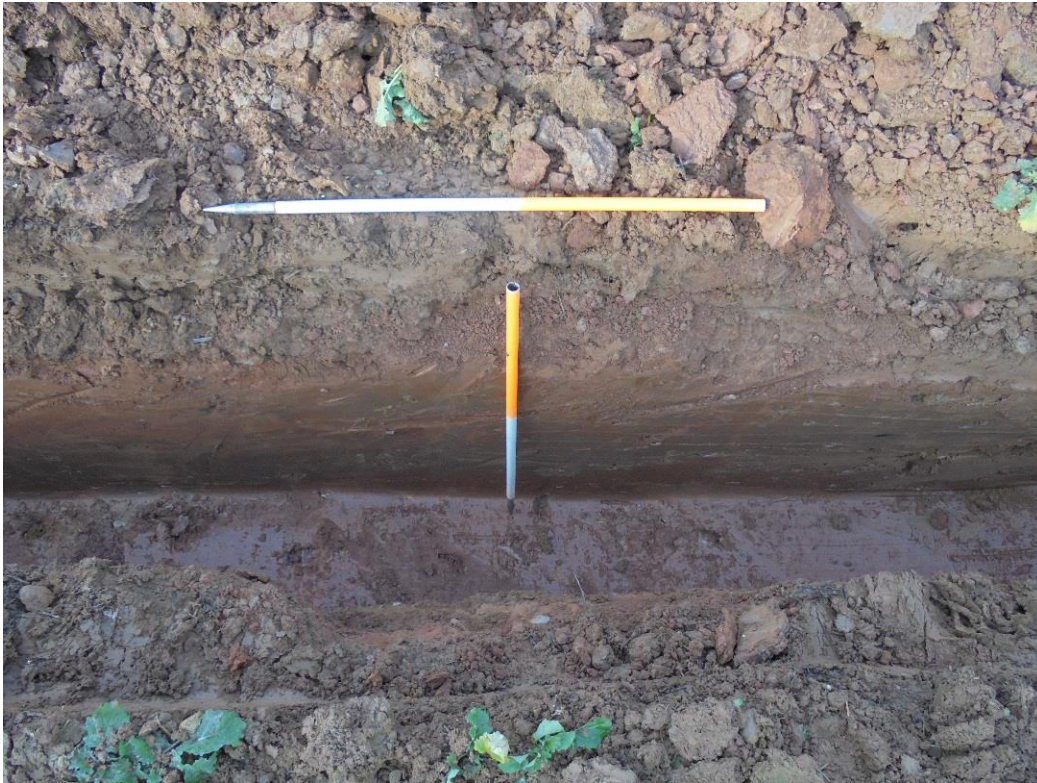
The groundworks revealed a dark friable brownish-grey silty clayey sand topsoil (3001), c. 0.38m in depth, overlying a firm greyish-brown sandy clay subsoil (3002). The natural (3003) was encountered at a depth of 0.52-0.71m (*Plate 5*).

No archaeological features or deposits were encountered.

*Plate 5: SE-facing trench profile (Section 3)*

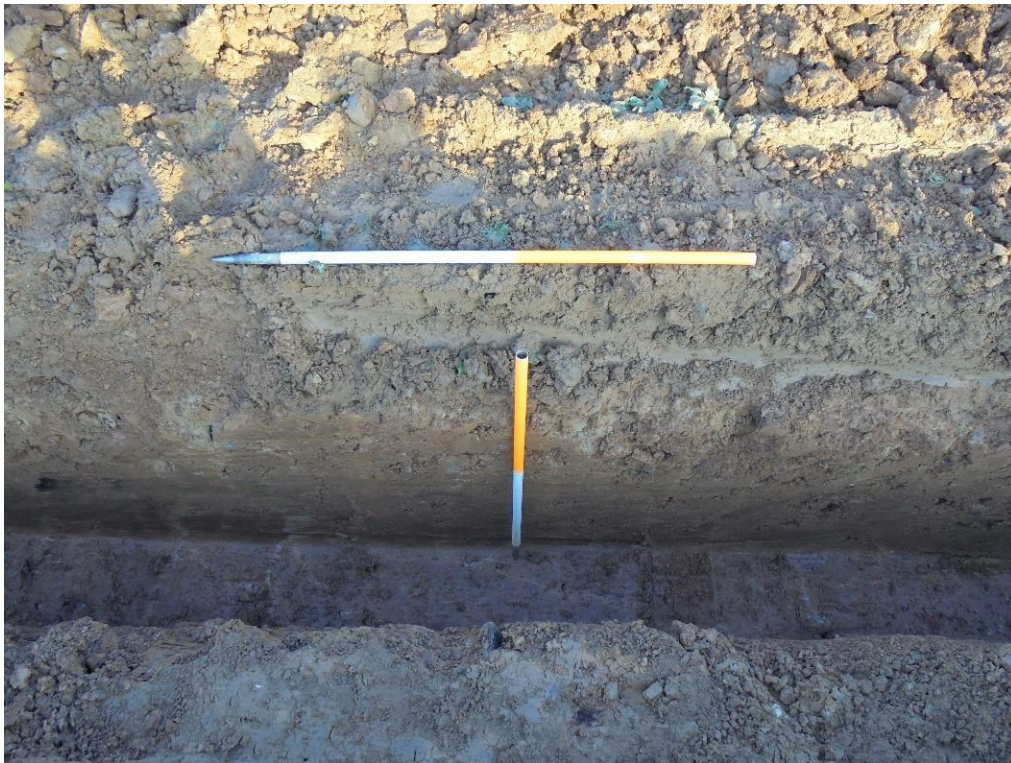
The groundworks revealed a firm dark brownish-grey silty sandy clay topsoil (4001), c. 0.51m in depth, overlying mid-greyish-brown sandy clay subsoil (4002). The natural substratum (4003) was encountered at a depth of 0.47-1.09m (*Plate 6*).

*Plate 6: S-facing profile (Section 4)*

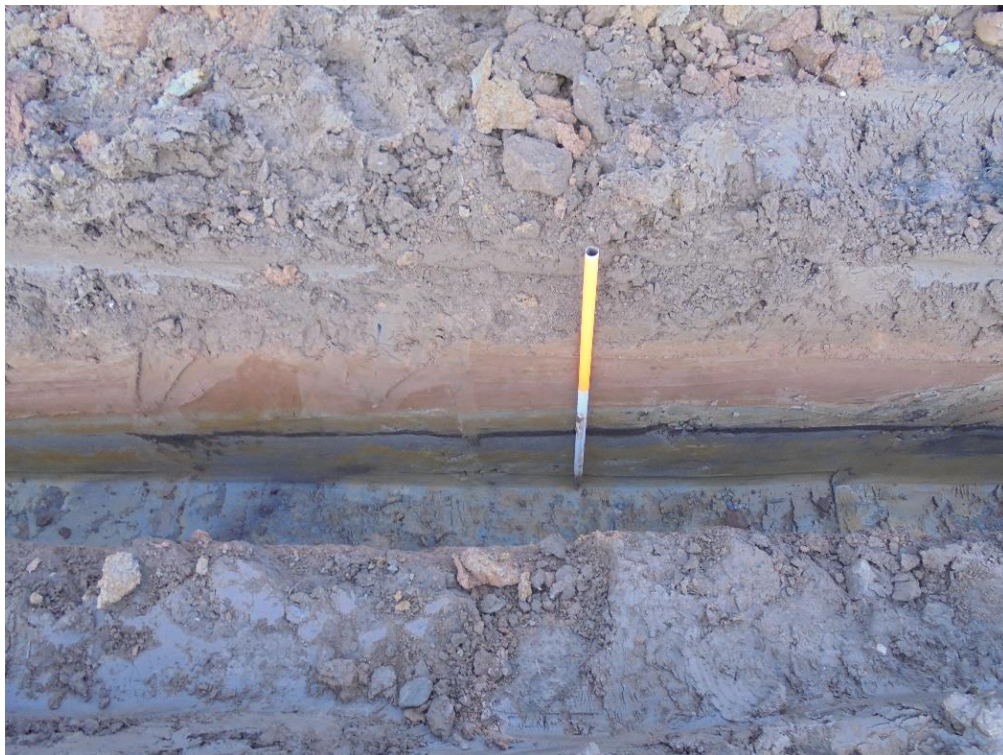
Approximately 500m E from the start of this section of trenching was a potential wetland deposit (4004) sealed by subsoil (4002). This was composed of light greyish-blue fluvial sandy clay with dark peaty lenses, occasional rooting and amorphous organic remains (*Plate 7*). The deposit was seen to extend roughly 172m along the trench, centered upon a natural depression in the field. No associated finds were recovered. Unfortunately, due to trench instability, it was not possible to recover any samples from this, or a similar deposit, (4005), encountered towards the ENE extent of the trench.

*Plate 7: N-facing profile (Section 4), showing wetland deposit (4004)*

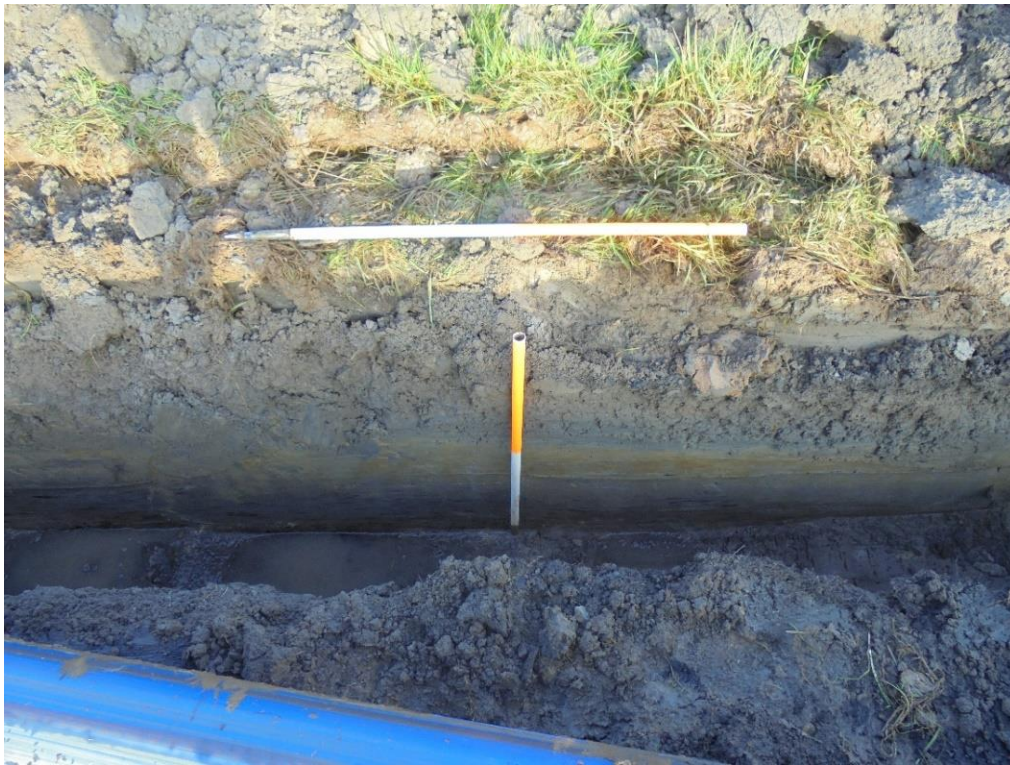
Deposit (4005) itself (*Plates 8 & 9*) was possibly associated with an earlier watercourse [4006] running across the field into Acton Burnell.

*Plate 8: S-facing profile showing, in part, palaeochannel [4006] and fill (4005)*

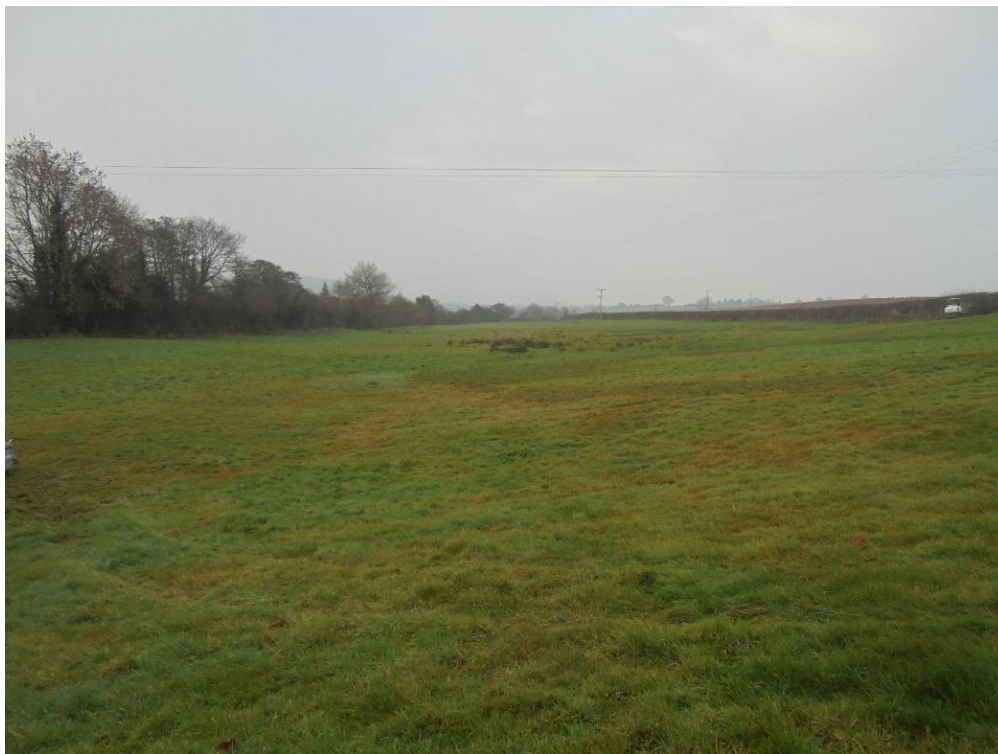
*Plate 9: Eastern extent of Section 4, showing the potential original course of the waterway*

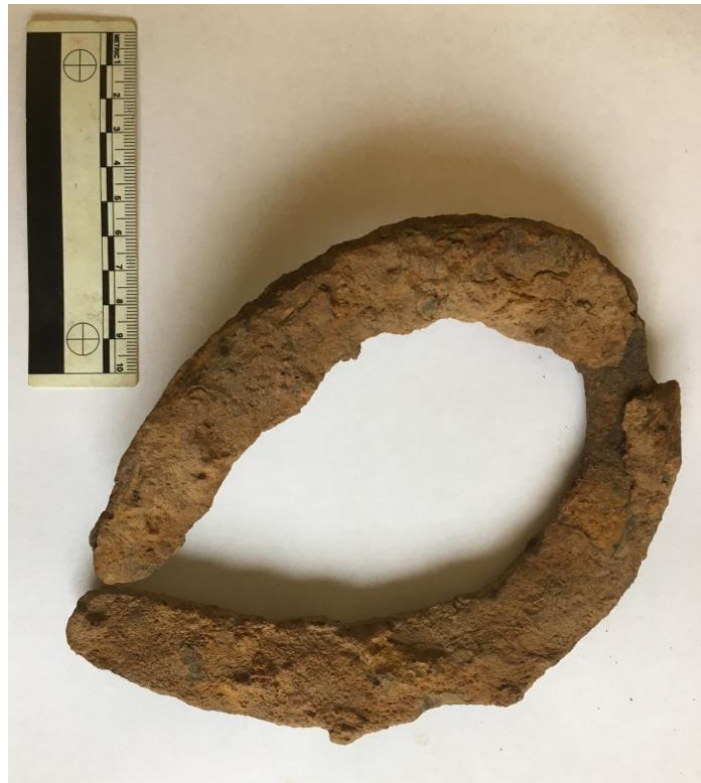
A single post-medieval horseshoe (*Plate 10*) was recovered from a stony sandy clayey silt (1006), the earliest of two former road surfaces underlying modern tarmac and sub-base material.

*Plate 10: Post-medieval horseshoe from (1006).*

Large wrought iron horseshoe of c. 18<sup>th</sup>/19<sup>th</sup> century date.

Pronounced toe-clip. U-shaped in plan, nail-holes obscured by corrosion.

Slight thinning of section at Caulkin (Heel) due to wear.

Branch width approximately 25mm wide × 7mm thick. Horseshoe misshapen.

Overall width c.130mm × 165mm in length. 610g

No further work is required.
