Archaeological Observation

Water Main Replacement Works

**North Street, Back Lane & High
Street**

Winchcombe

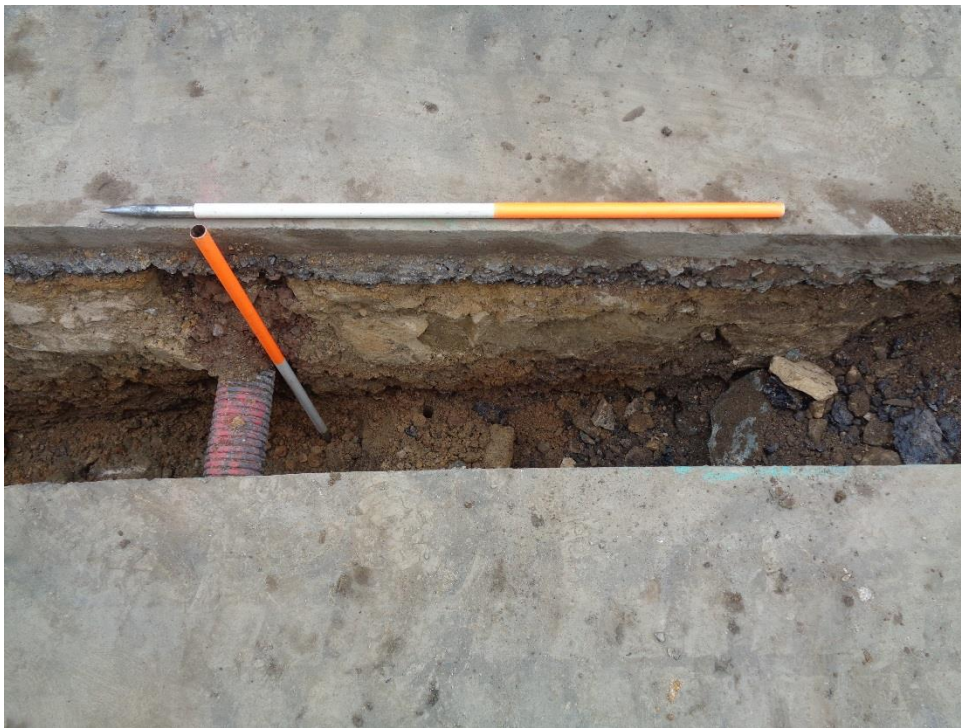
The service trenching [0004] cut through to the geological horizon, (0005), (0012), and truncated an earlier masonry culvert, (0011)/[0013], which, in turn, truncated made-ground deposit (0006) (*Plate 1*).

Plate 1: NW-facing trench section showing stone-lined culvert (0011)/[0013], sealing made ground (0006).

Cutting made-ground deposit (0006) was a potential stone-lined culvert [0013]/(0011), formed of roughly dressed limestone slabs. Unfortunately, only one stone face was seen in section, which appeared to be truncated by later services [0004].

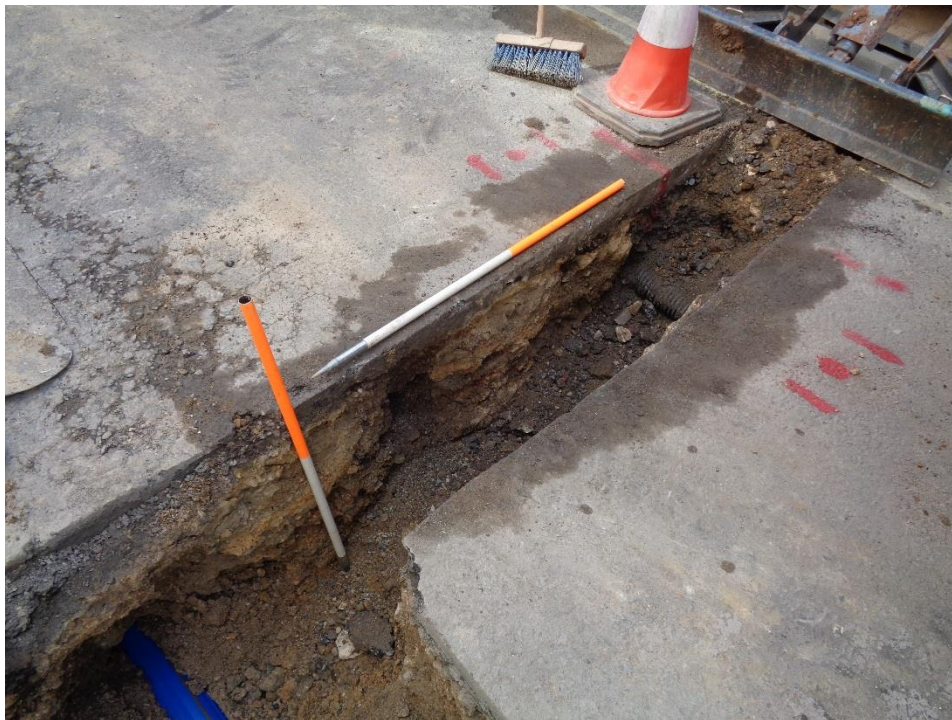
Elsewhere, the road surface (0001) sealed earlier stone road-surfacing (0014), which sealed made-ground deposit (0015) (*Plate 2*), which contained 18th century Staffordshire slip ware (*Appendix 1*). The modern pavement (of similar tarmac construction to the road (0001)) sealed a series of deposits - (0007), (0008), (0009) and (0010) - which appeared to comprise made-ground dating to the 19th century (*Plate 3*).

Plate 2: NW-facing section showing stone surface (0014), sealing made-ground (0015).

North Street likewise only revealed deposits associated with post-medieval development. An earlier sandstone and limestone rubble road surface (0014) was sealed by the existing tarmac surface (0001), beneath which was a redeposited stony silty sand deposit (0015) containing a single piece of 18th -century Staffordshire slipware (*Appendix 1*).

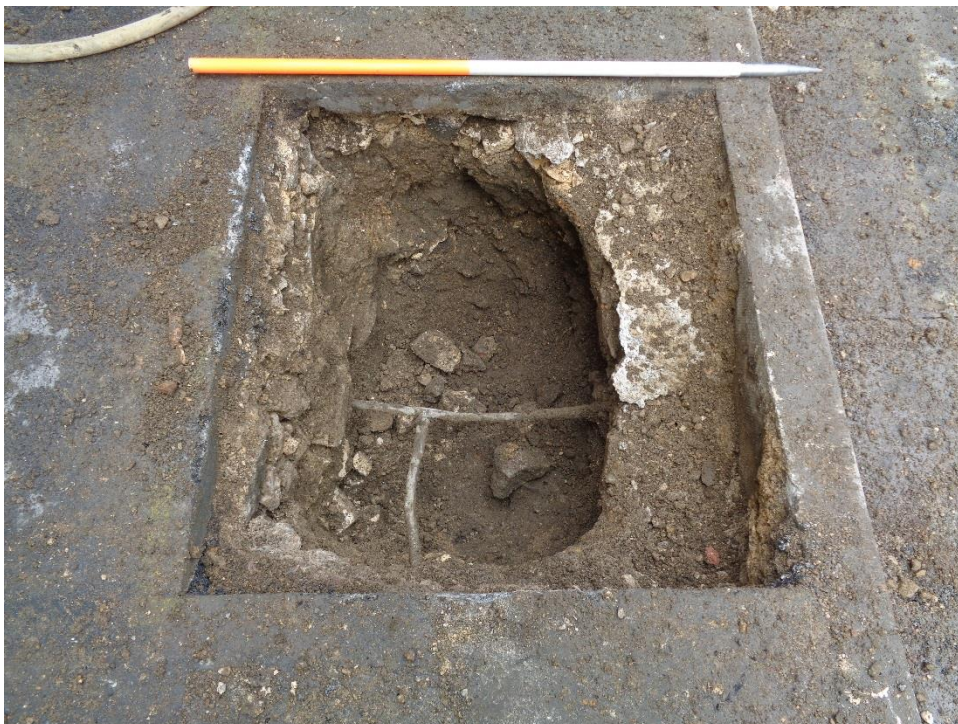
Plate 3: View NE showing deposits (0007), (0008), (0009) and (0010,) which appeared to represent made-ground deposits of 19th -century date.

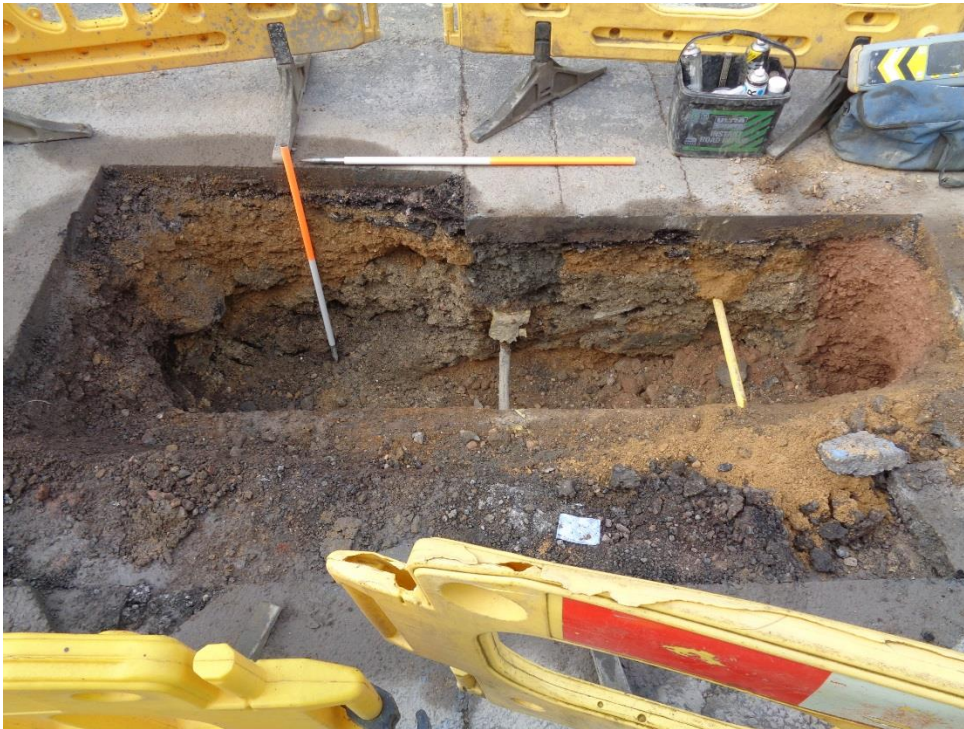
The modern road surface (1001) sealed a series of modern services, grouped together as [1003]/(1002), and were seen to cut through to the geological horizon (1004) (*Plate 4*). Along North Street these services were seen to heavily truncate earlier stone pavement (1005) (*Plate 5*) and a possible rubble road surface (1006) (*Plate 6*), both of which appear to seal the geological horizon (1004).

Plate 4: North Street: Extent of modern services [1003] running parallel and perpendicular to trench and pits. NE-facing section.

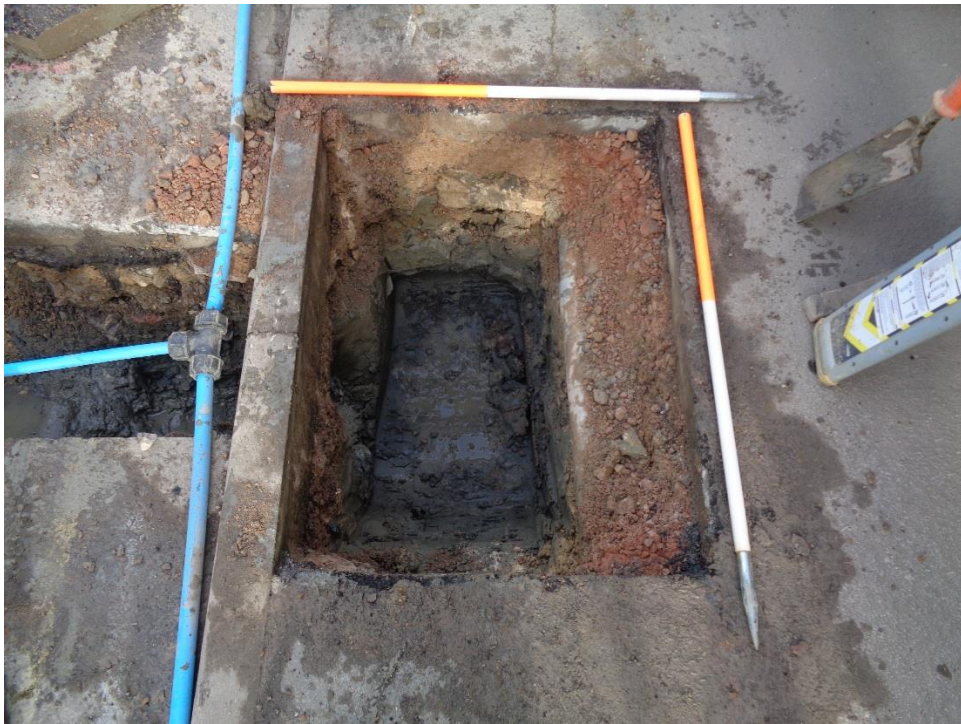
Plate 5: North Street: Earlier stone pavement (1005) sealing geological horizon (1004). SE-facing section.

Much like Area A, evidence for an earlier (18th/19th century) stone pavement (1005) (*Plate 5*) and a rubble road surface (1006) (*Plate 6*) were partially observed, as was a masonry culvert system, these features being indicative of continued and intensive post-medieval development activity.

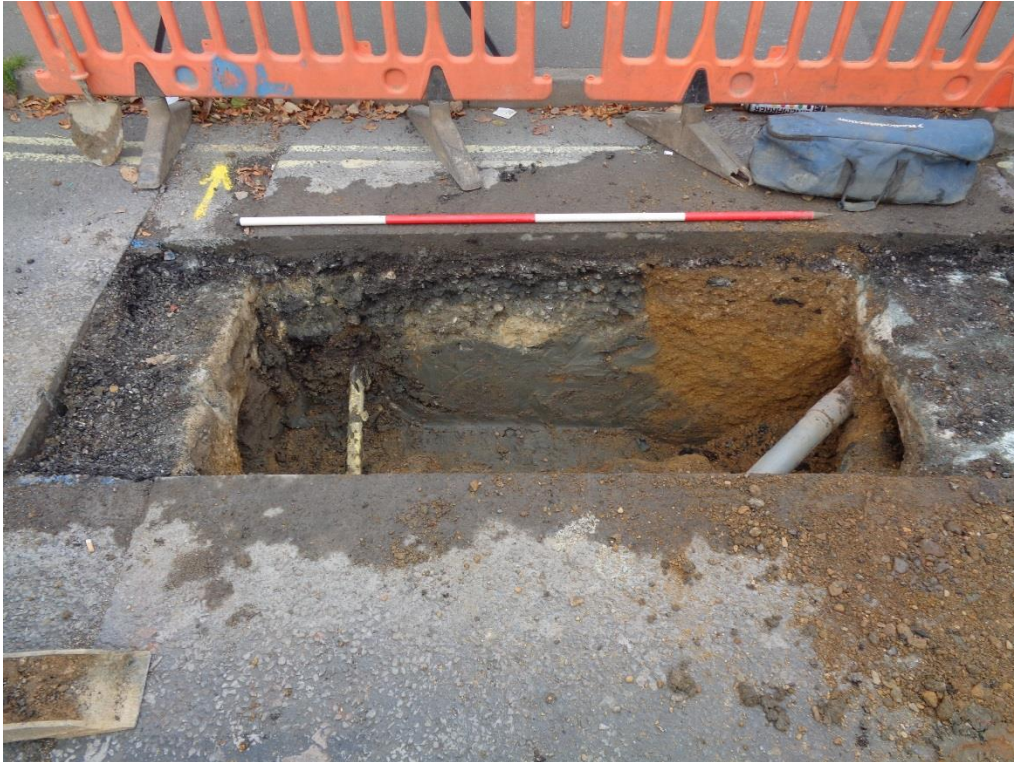
Plate 6: North Street: Possible rubble road surface (1006) sealing geological horizon (1004). SW-facing section.

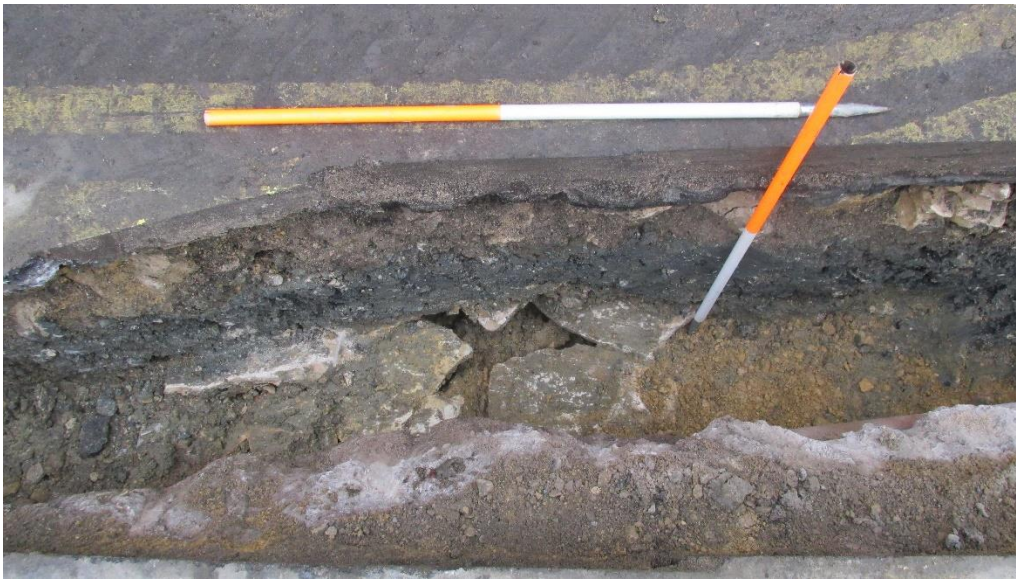
Excavations along Back Lane revealed the capping stones of an 18th/ 19th -century masonry culvert (1008) and its sealing deposit (1007) consisting of redeposited natural and containing 18th -century ceramics (*Plate 7*; *Appendix 1*). This was seen to be sealed by the road surface [1001] and heavily truncated by modern services [1003].

Plate 7: Back Lane: capping stones of 18th/ 19th century masonry culvert (1008) and sealing deposit (1007). NW-facing section.

Along Back Lane, the capping stones of an 18th or 19th -century masonry culvert (1008) were revealed at the very base of the pipe-trench, consisting of roughly dressed sandstone slabs sealed by a mixed deposit (1007) of redeposited natural and occasional 18th or 19th -century debris (CBM and pottery) (*Plate 7*).

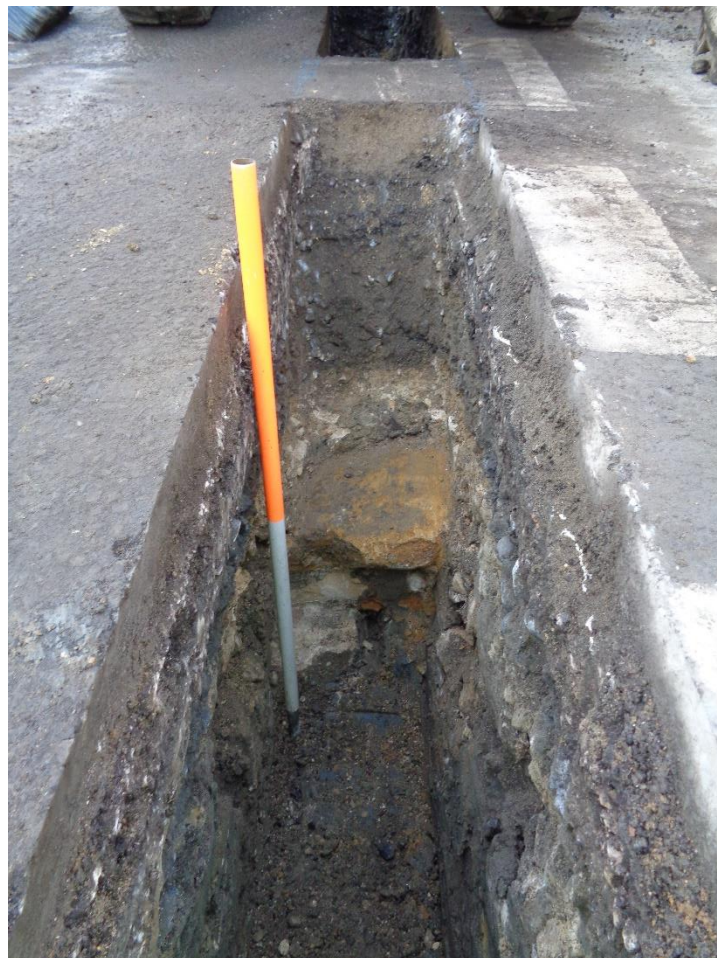
Within the main junction between the roads, another stone culvert (1009) of an unknown date was revealed, and seen to be heavily truncated by modern services [1003] (*Plate 8*).

Plate 8: Road junction, masonry culvert (1009) of unknown date. View NW.

Within the main junction between the roads, another masonry culvert (1009), of unknown date, was revealed and seen to be heavily truncated by the modern services [1003] (*Plate 9*).
