Heritage Statement

**Gannah Farm
Bolstone
Herefordshire**

February 2017

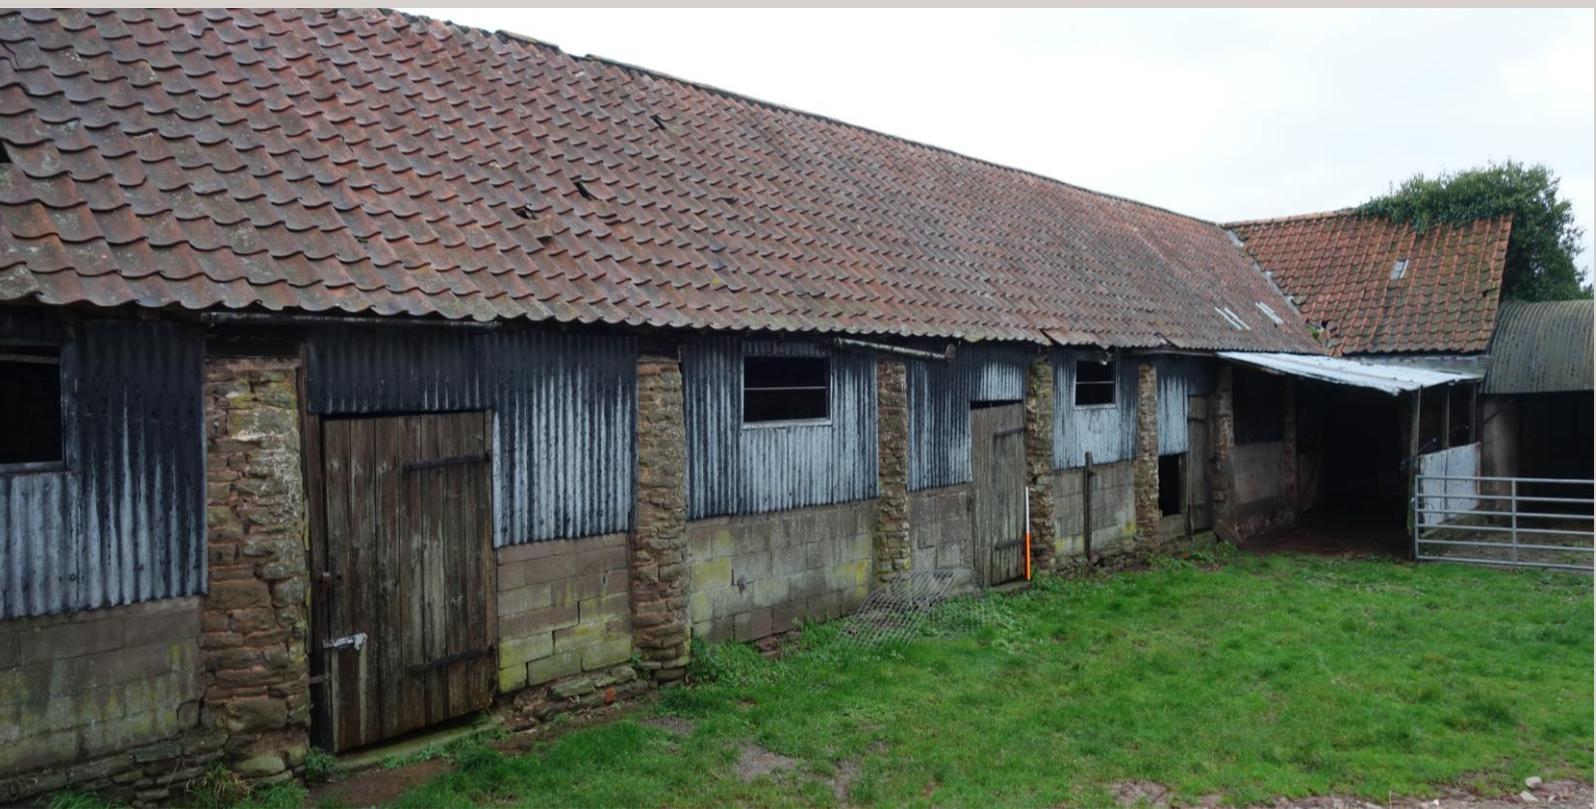
Cover: View looking N showing stone masonry piers in SE-facing elevation of cowshelter range and lean-to structure with corrugated metal roof at NE end

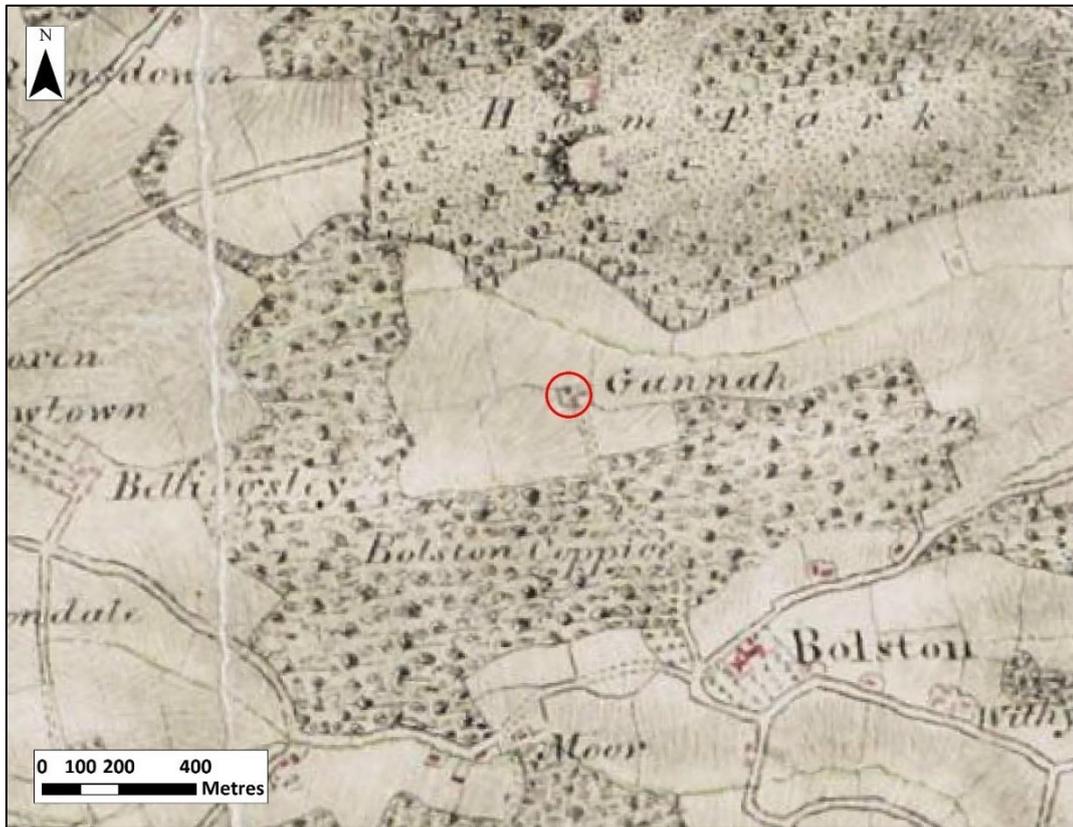
Fig. 3: Extract from Thomas Budgen's 1815 OS Surveyor's Drawing of Hereford. Gannah Farm circled in red (Reproduced by courtesy of the British Library)

An Ordnance Survey drawing of Hereford and district by Thomas Budgen dated 1815 (*fig. 3*) depicts the farmstead complex at Gannah Farm but the buildings are not shown in great detail. It appears to show the farmhouse situated towards the S end of the site with two separate outbuilding ranges located to the N and NE.

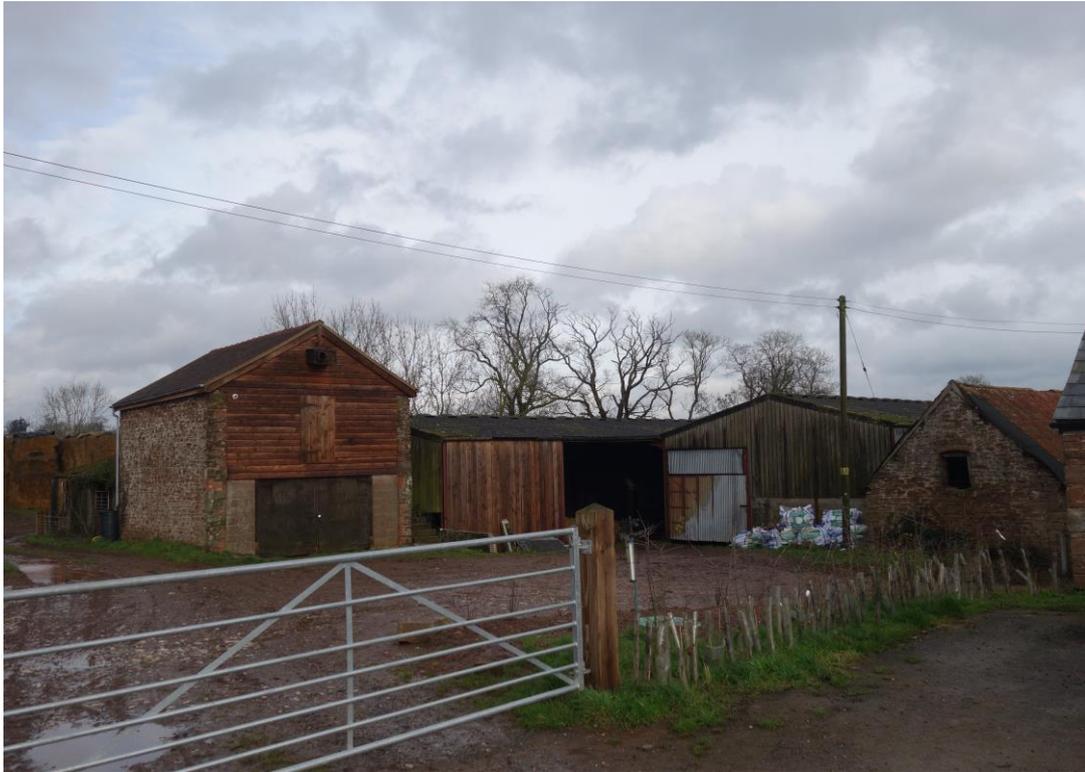
Plate 1: View looking N from the farmhouse towards the complex of farm outbuildings at Gannah Farm

The complex of farm outbuildings located to the N of the farmhouse at Gannah Farm comprises a series of traditional farm buildings (of 18th and 19th century date) and modern structures (*Plates 1 & 2*).

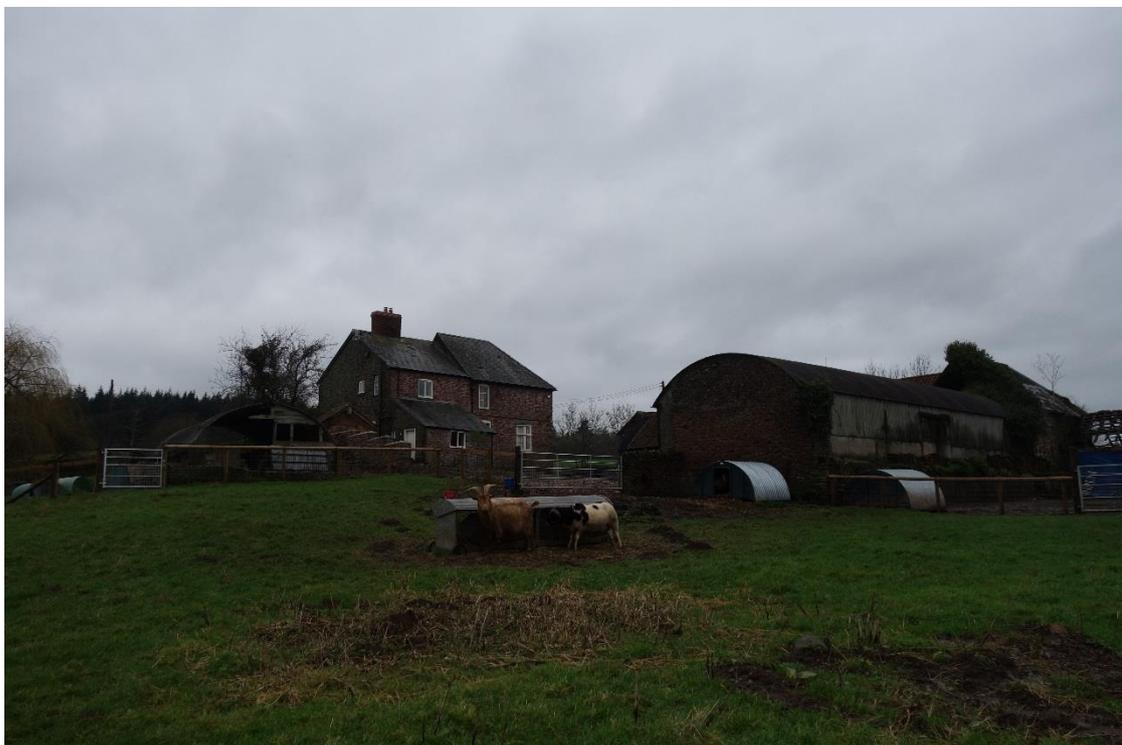
Plate 2: View looking NW towards Gannah Farmhouse and the adjacent complex of outbuildings

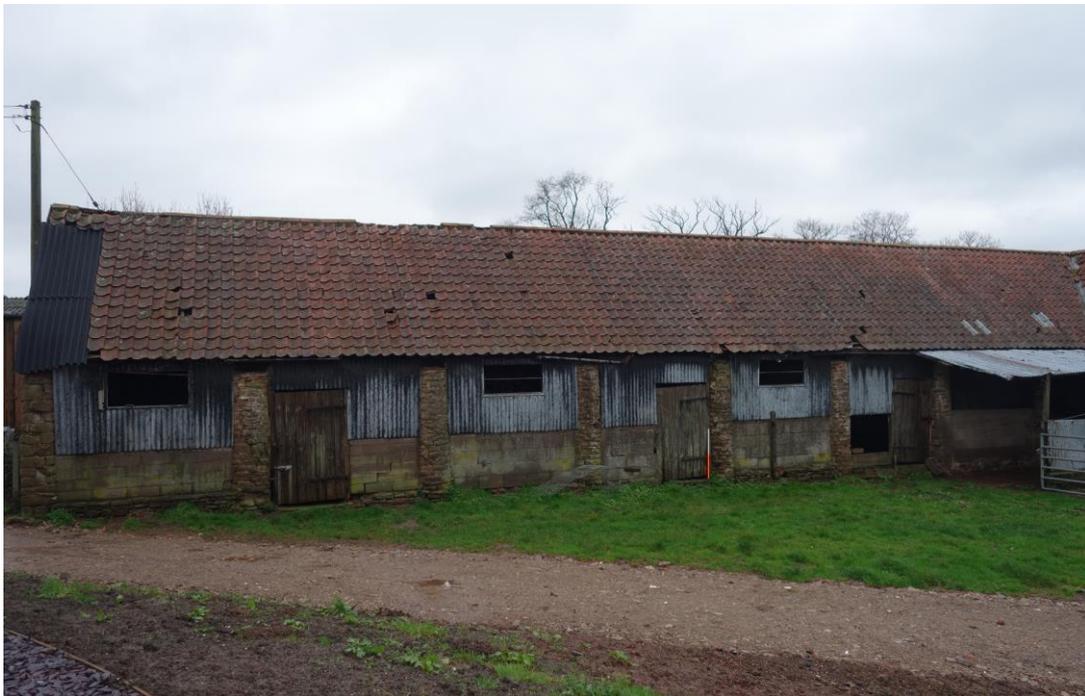
The principal SE facing elevation is sub-divided by six round piers of roughly coursed sandstone rubble masonry; the intervening spaces are infilled by low concrete breeze block walls, above which are corrugated iron sheets extending up to eaves level (*Plate 3*). It is likely that these concrete walls replaced earlier walls, possibly timber framed and infilled with brick. It is possible that the shelter would originally have been open-fronted; however it appears more likely that it was walled, certainly by the early 20th century as the OS 2nd edition map of 1904 clearly distinguishes between the open-fronted shelter/cart-shed ranges to the NE of the Building A (as indicated by a dotted line) and the walled SE-facing elevation of Building A. Two ledged doorways are inserted roughly midway along the SE facing elevation and towards the SW end. At the NE end of the range is a gabled return oriented NW-SE with a lean-to structure with corrugated iron roof which covers a gauged brick arched doorway leading to the cowshelter (*Plate 4*).

Plate 3: View looking NW across yard towards SE-facing elevation of Building A

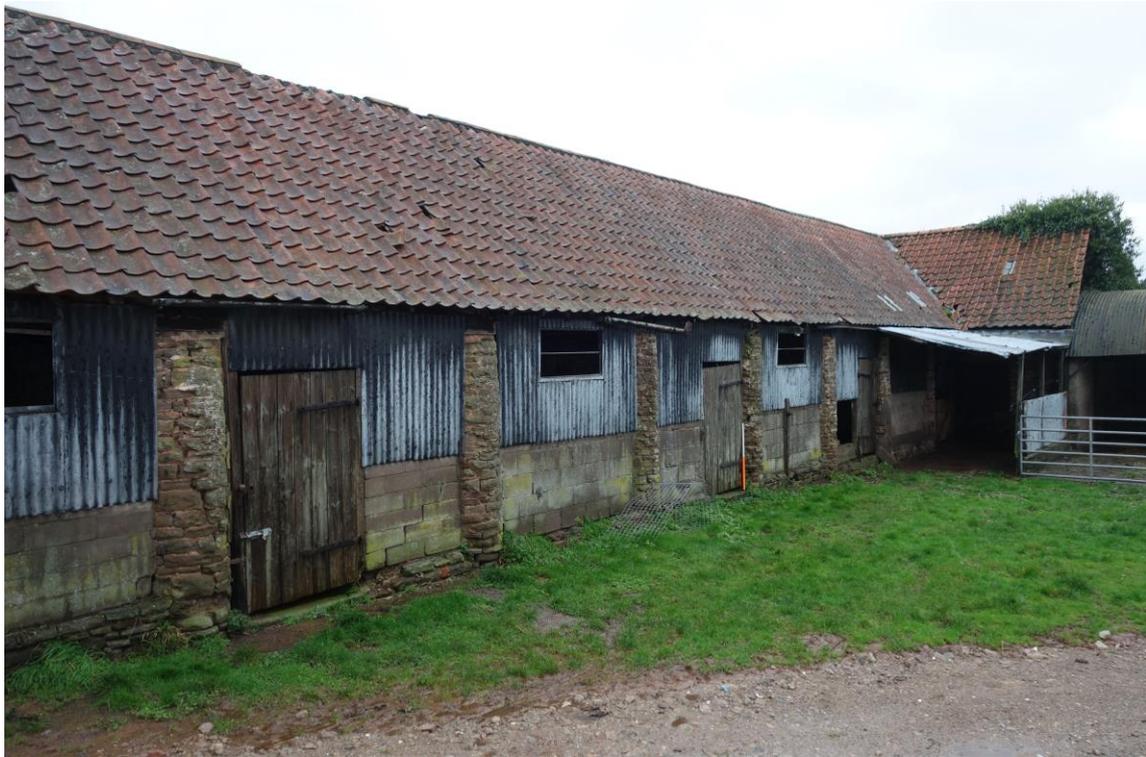
Plate 4: View looking N showing stone masonry piers in SE-facing elevation of Building A and lean-to structure with corrugated metal roof at NE end

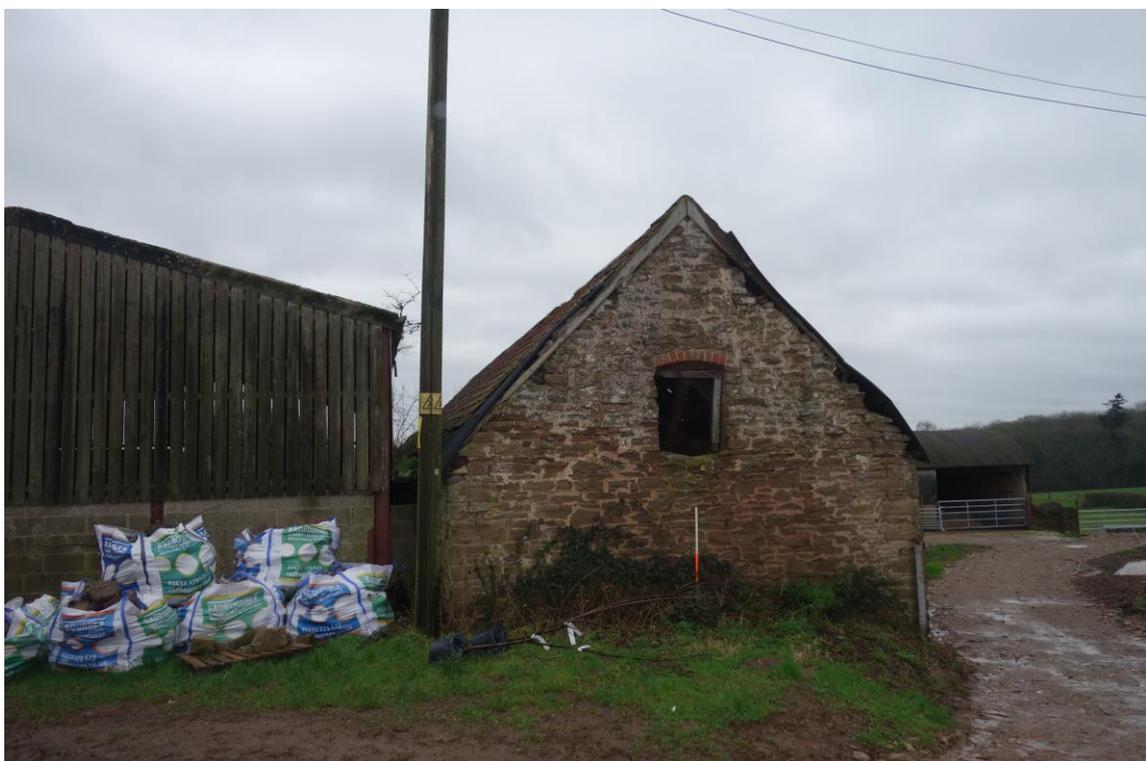
The SW-facing gable elevation has a segmental gauged brick arched single light window in the apex of the gable, which would have provided access to a hayloft at upper storey level (*Plate 5*). The NW-facing elevation is largely concealed by the large modern steel-framed agricultural shed attached

Plate 5: View looking NE showing SW-facing gable of Building A with hayloft window in apex of gable

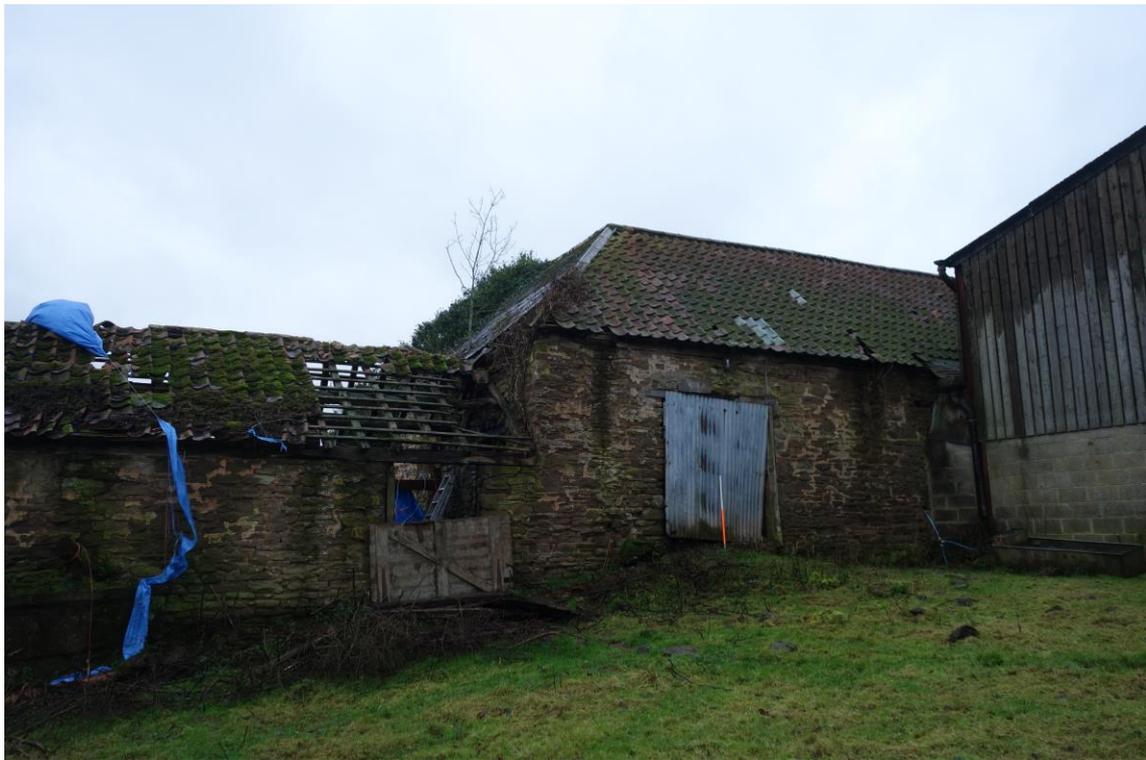
Plate 6: View looking S towards doorway at NE end of rear (NW-facing) elevation of Building A

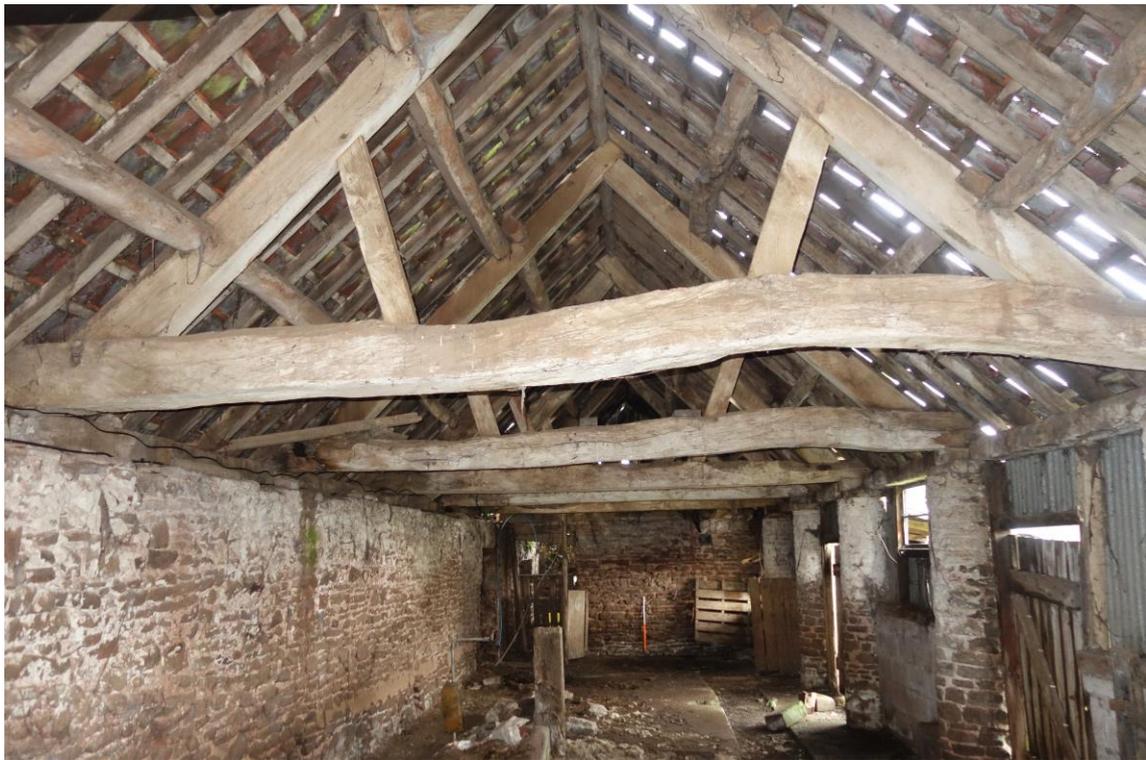
Plate 7: Internal view of cowshelter (Building A) looking NE showing open truss roof with angled struts connecting the tiebeams to the principal rafters

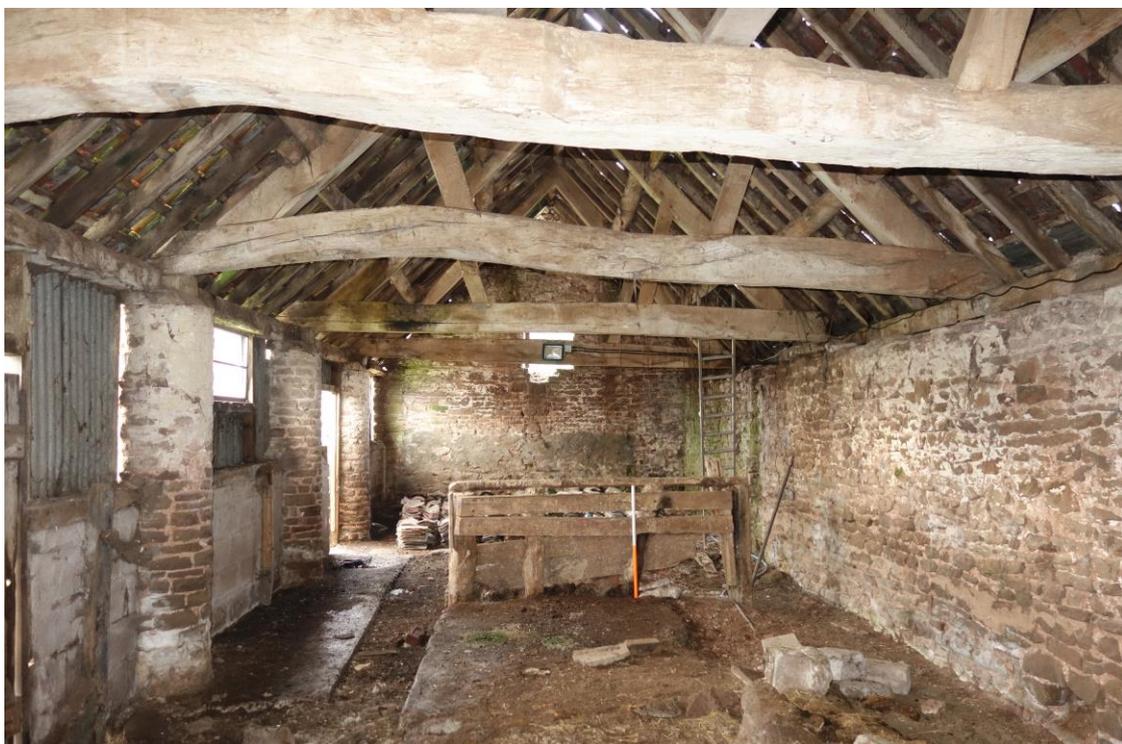
Plate 8: Internal view of cowshelter (Building A) looking SW showing feeding passage and remains of wooden stalls

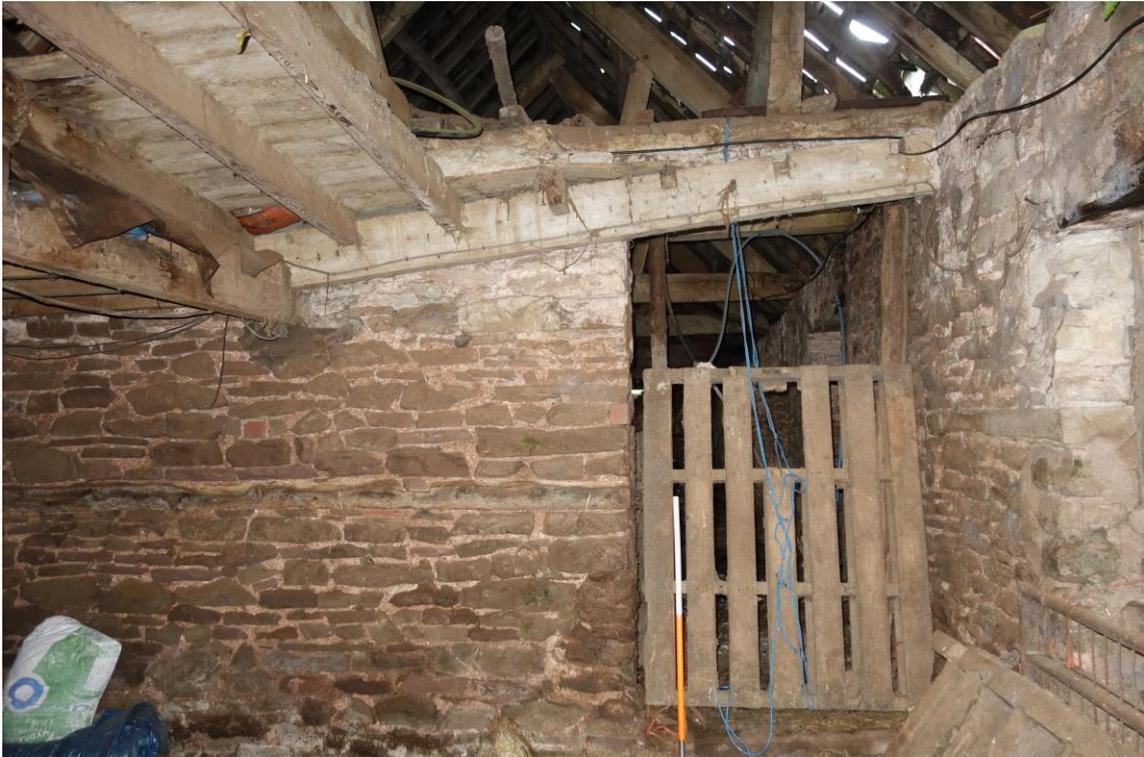
Plate 9: Internal view looking SW showing stone partition wall within compartment at NE end of Building A

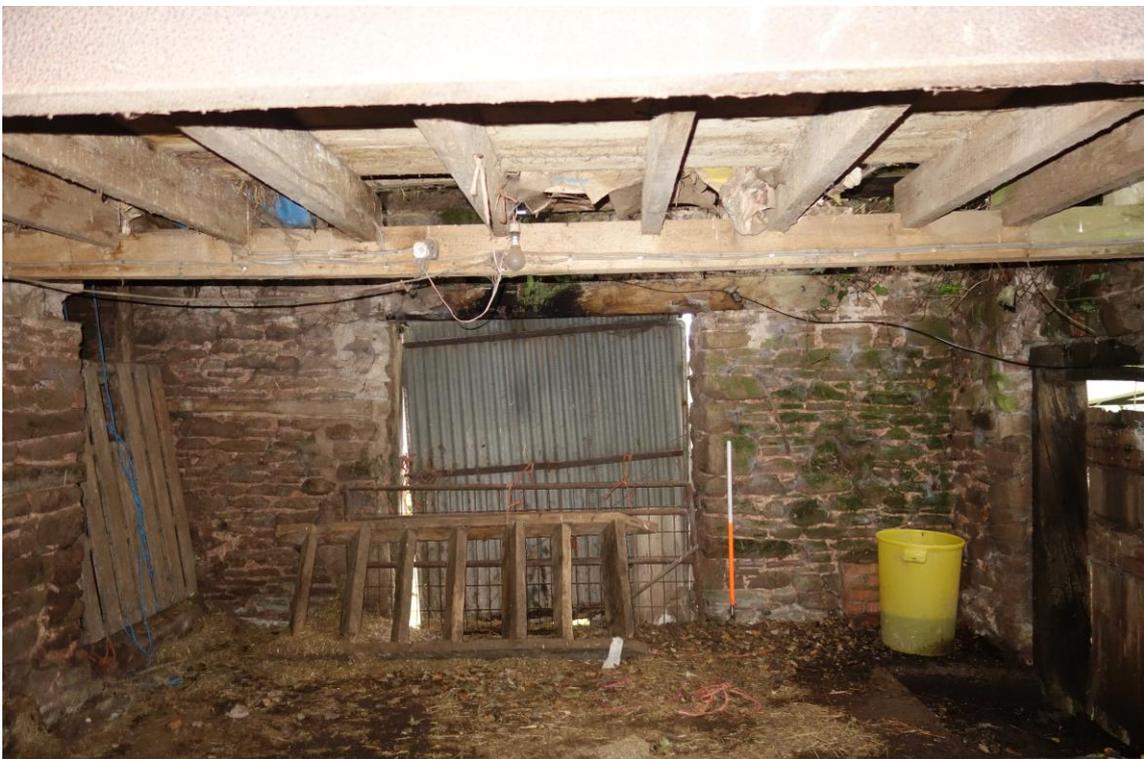
Plate 10: Internal view looking NW showing compartment with hayloft above at NE end of Building A

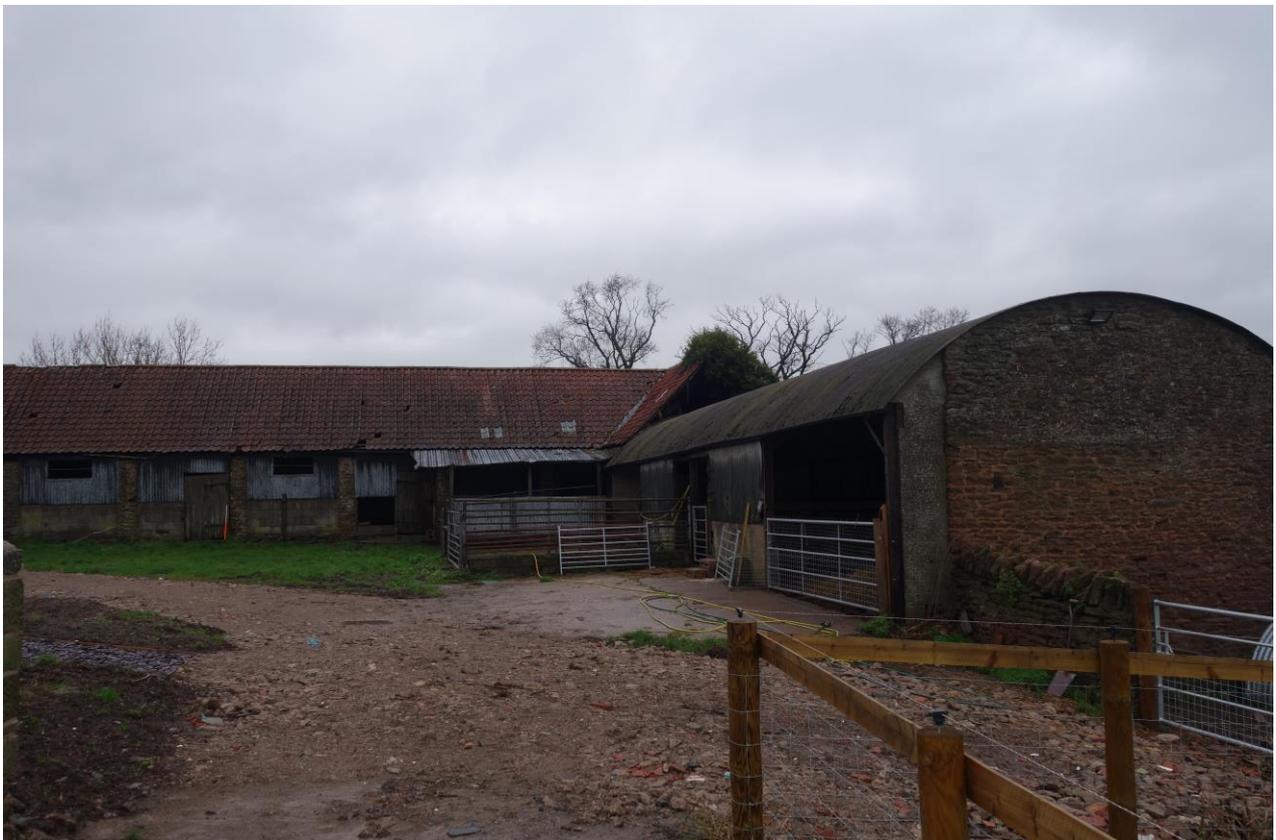
Plate 11: View looking N showing cowshelter (Building A) and the SW elevation of the lambing shed (Building B)

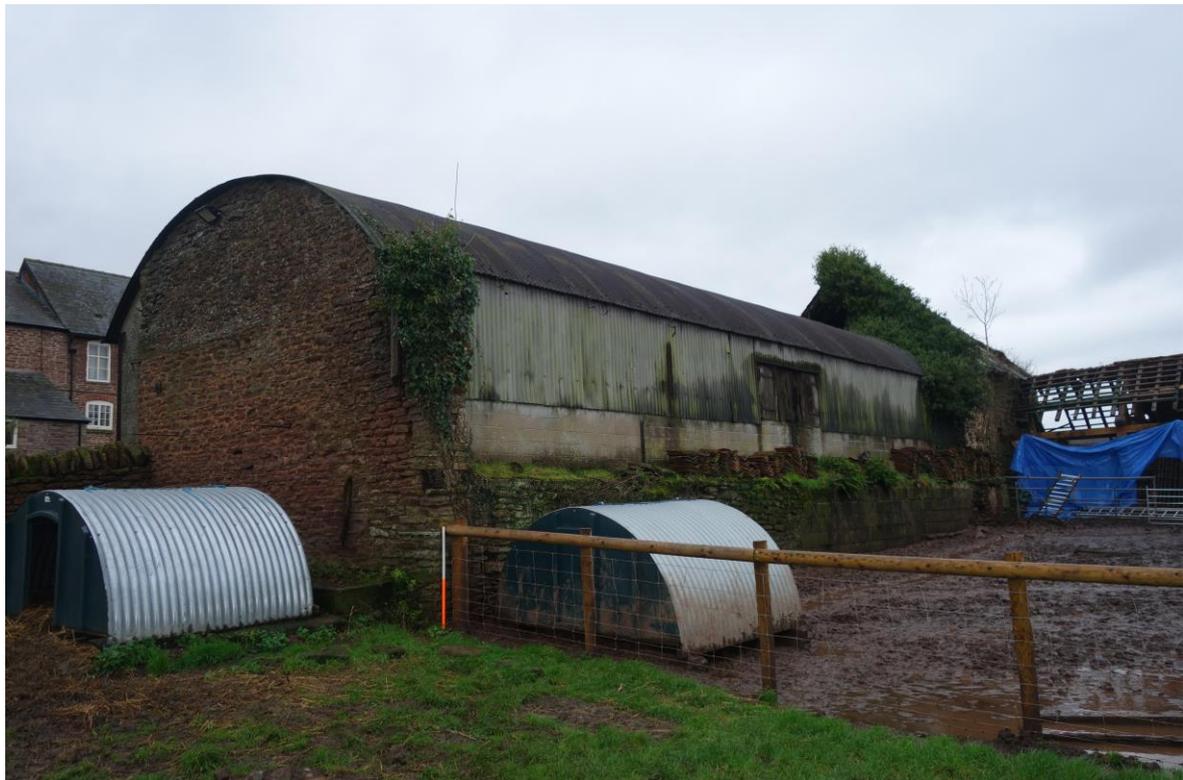
The barrel-vaulted corrugated iron roof is clearly of modern date and much of the structure has been substantially replaced with a steel framed structure with concrete breezeblock walls and corrugated metal cladding (*Plates 11 & 12*). The only surviving elements of the original barn are the SE-facing gable wall and the lower stages of the wall of the NE-facing elevation. Few external features of architectural interest were noted.

Plate 12: View looking NW showing substantially reconstructed gable end and NE-facing elevation of Building B

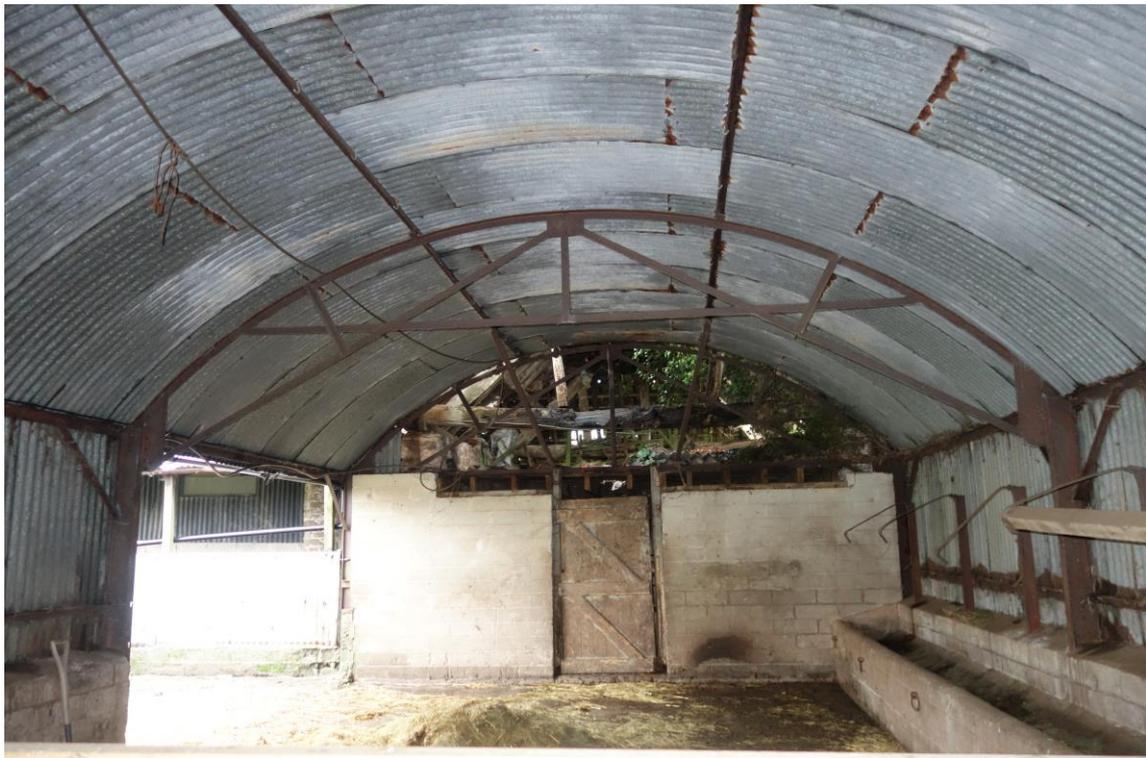
The original roof of the building has been completely replaced by a barrel-vaulted roof structure with angled steel-framed trusses (probably of mid-20th century date) and covered by corrugated iron sheeting (*Plate 13*). At the NW end of the building is a modern concrete breezeblock wall while the SE gable wall, built of sandstone rubble masonry, remains partially intact although it has been truncated and reconstructed with concrete breezeblocks (*Plate 14*). Several horizontal timbers were noted as having been inserted in the thickness of the gable wall; it is possible that these represent bonding timbers inserted to provide structural support.

Plate 13: Internal view of Building B looking NW showing modern concrete wall and steel framed roof trusses

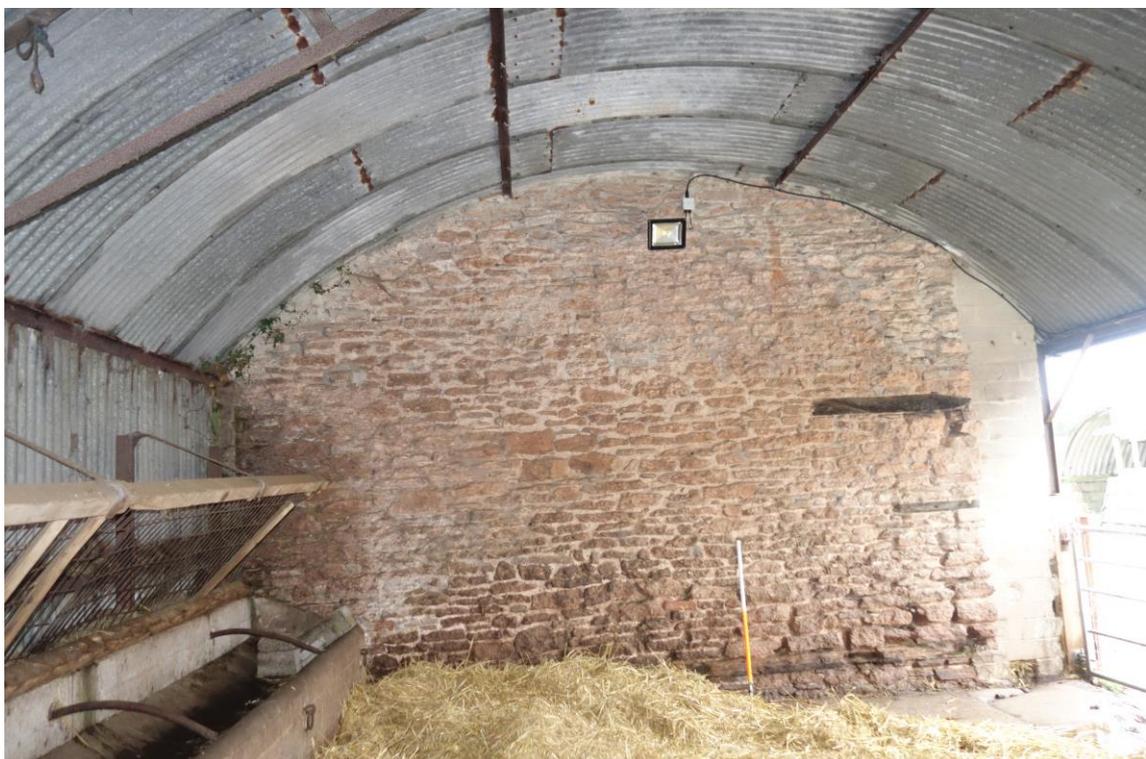
A modern concrete feeding trough with a metal wire hayrack has been built against the NE wall of the barn; however no other fixtures or fittings of interest were noted.

Plate 14: Internal view of Building B looking SE showing surviving rubble masonry wall of barn with modern concrete trough and hayrack to left of picture

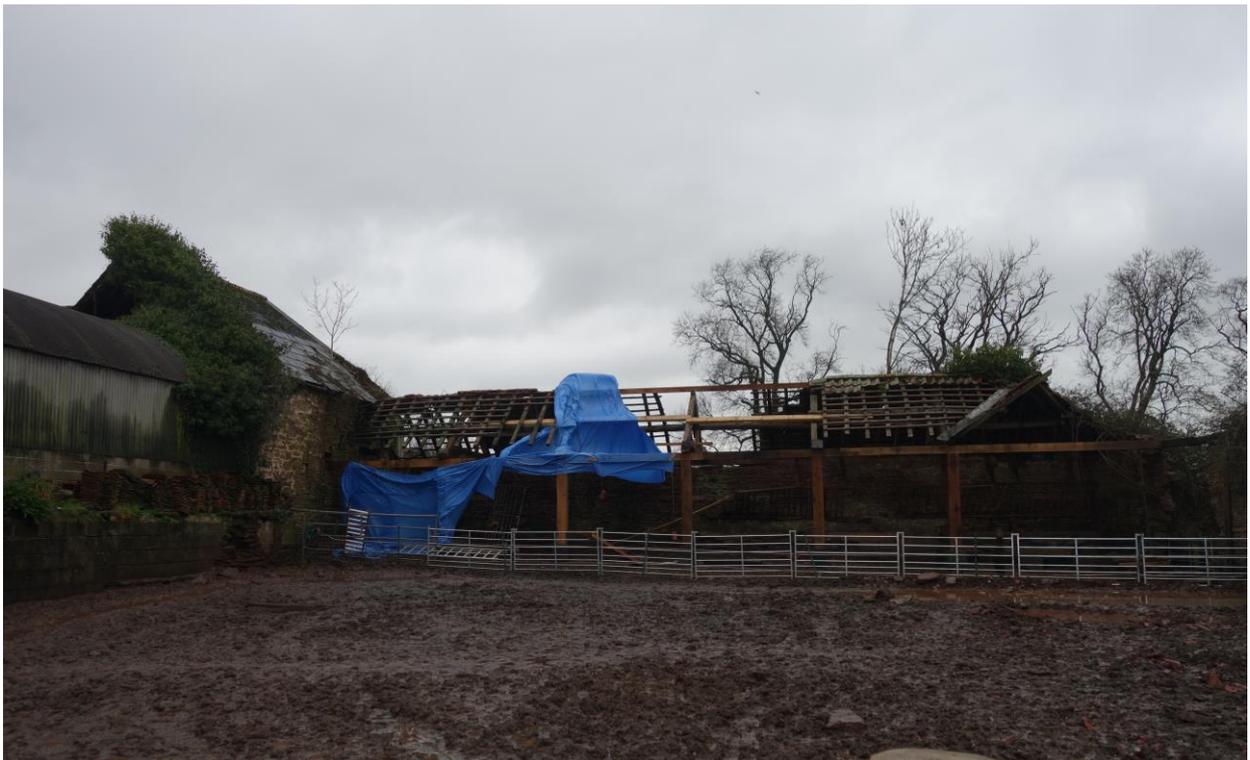
Plate 15: View NW looking across paddock towards SE-facing elevation of open-fronted shelter/cart-shed (Building C)

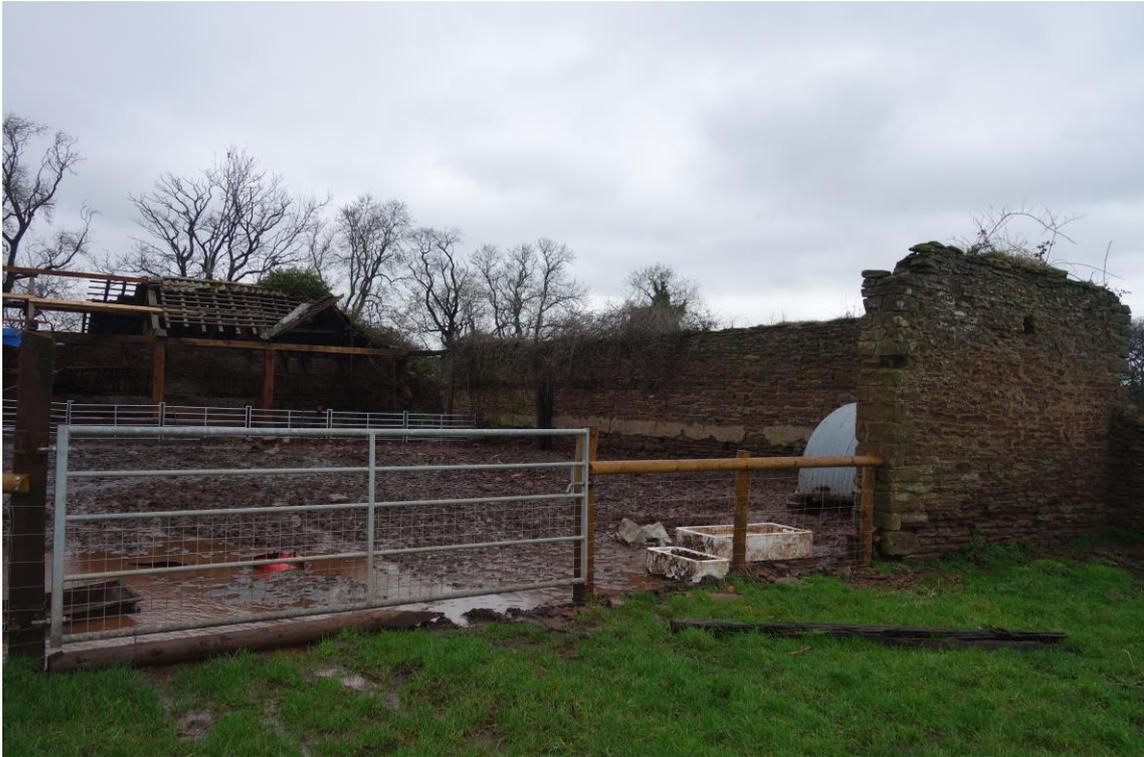
Plate 16: View looking N showing masonry wall of former open fronted shelter range extending SE of Building C

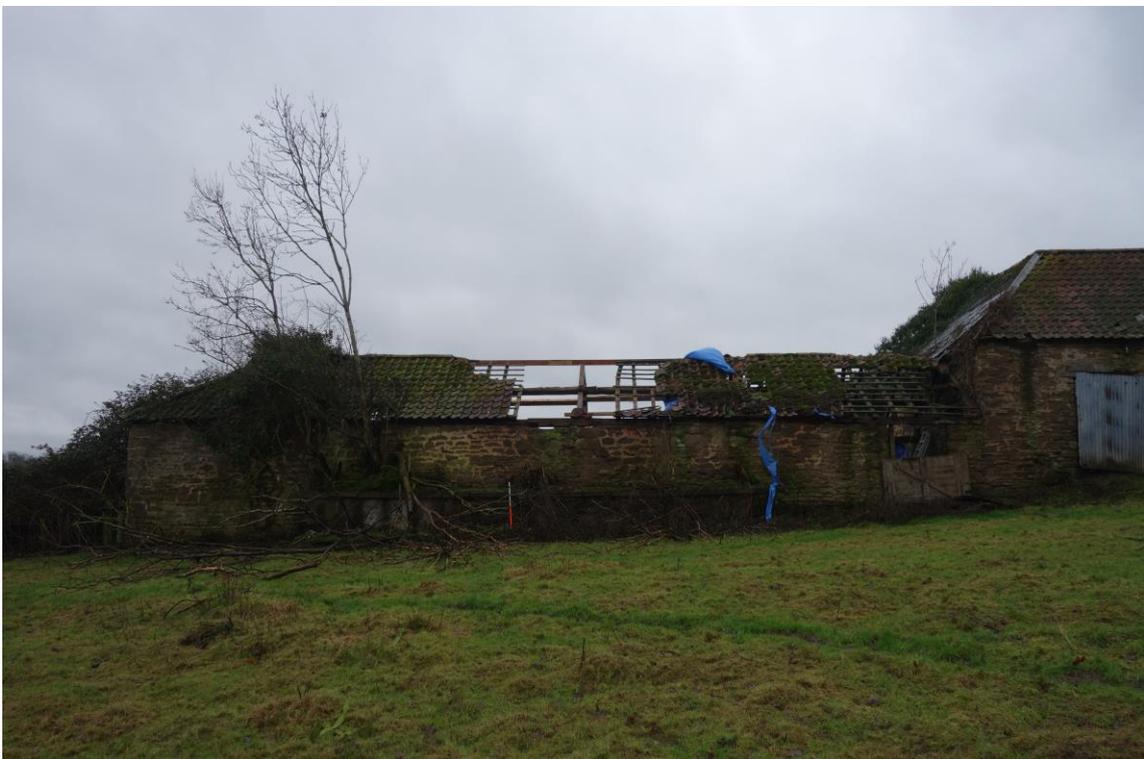
The rear NW-facing wall of Building C is constructed of roughly coursed sandstone rubble masonry. The only visible opening is a flat arched doorway inserted towards the SW end of the NW-facing elevation (*Plate 17*). No evidence of a vertical construction break was noted between Building C and the adjoining cowshelter to the SW (Building A), suggesting that they probably form part of the same phase of building activity.

Plate 17: View looking SE showing rear (NW-facing) elevation of open fronted shelter/cart-shed (Building C)

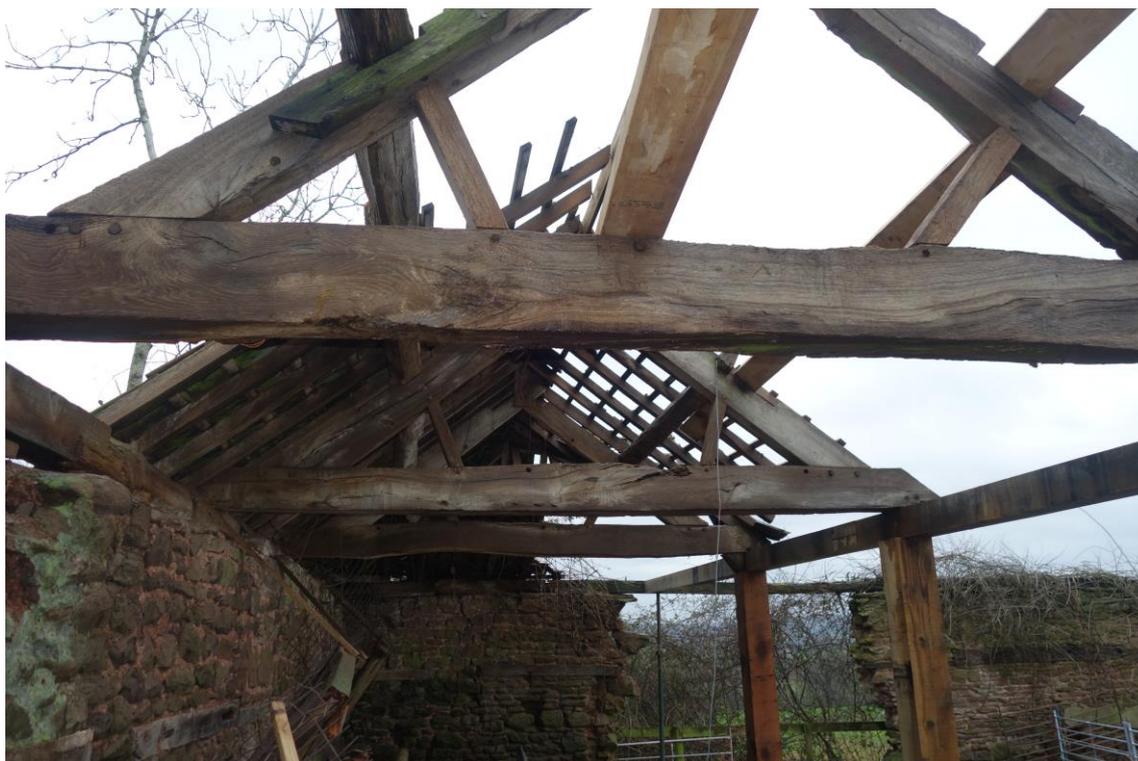
The open shelter/cart shed is largely unroofed and is arranged in six bays. The roof structure, which exhibits some evidence of having been renewed recently, is of open truss type with angled struts connecting the tiebeams to the principal rafters, which are linked by a single set of trenched purlins (*Plate 18*). The tiebeams are supported by five wooden arcade posts which in turn are carried on low splayed concrete plinths; both the existing wooden posts and the concrete plinths appear to be modern additions.

Plate 18: View looking NE showing detail of open truss roof structure within open fronted shelter/cart-shed (Building C)

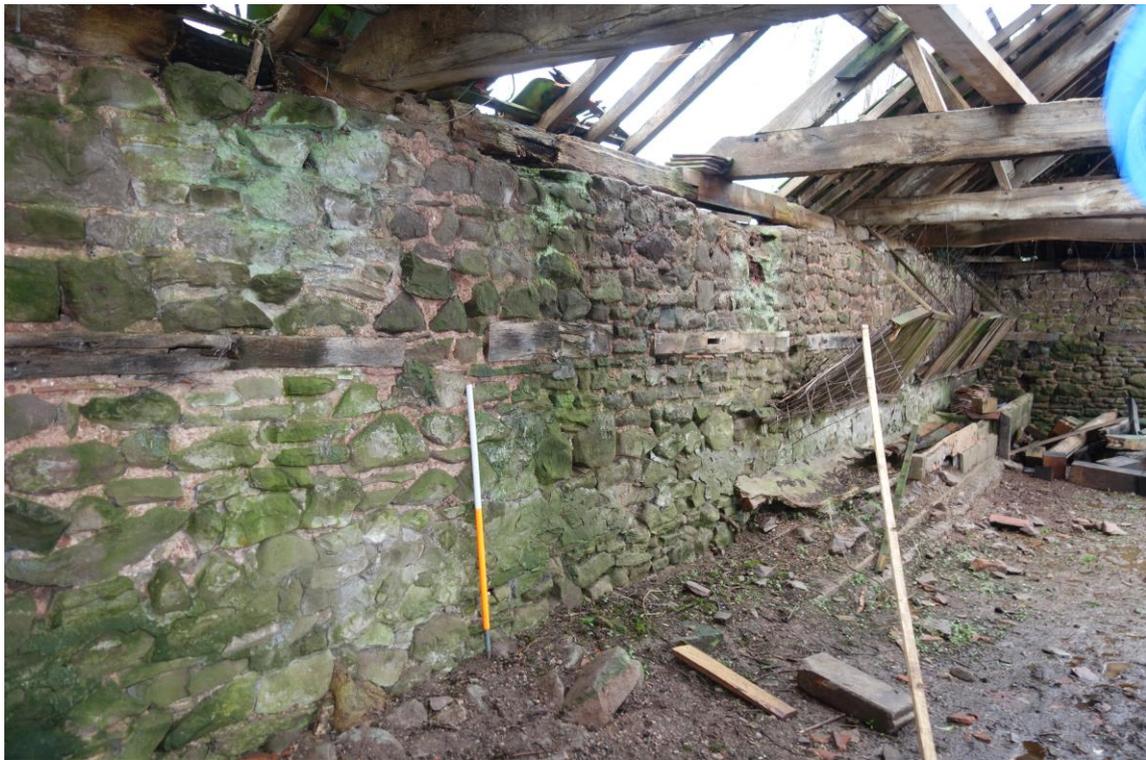
Few internal fixtures and fittings have survived intact, the only noteworthy survival being the partial remains of the wooden hayrack and feeding trough fixed against the rear wall of the shelter/cart-shed (*Plate 19*).

Plate 19: Internal view of Building C looking NNE showing remains of wooden hayrack and trough against wall of shelter/cart-shed

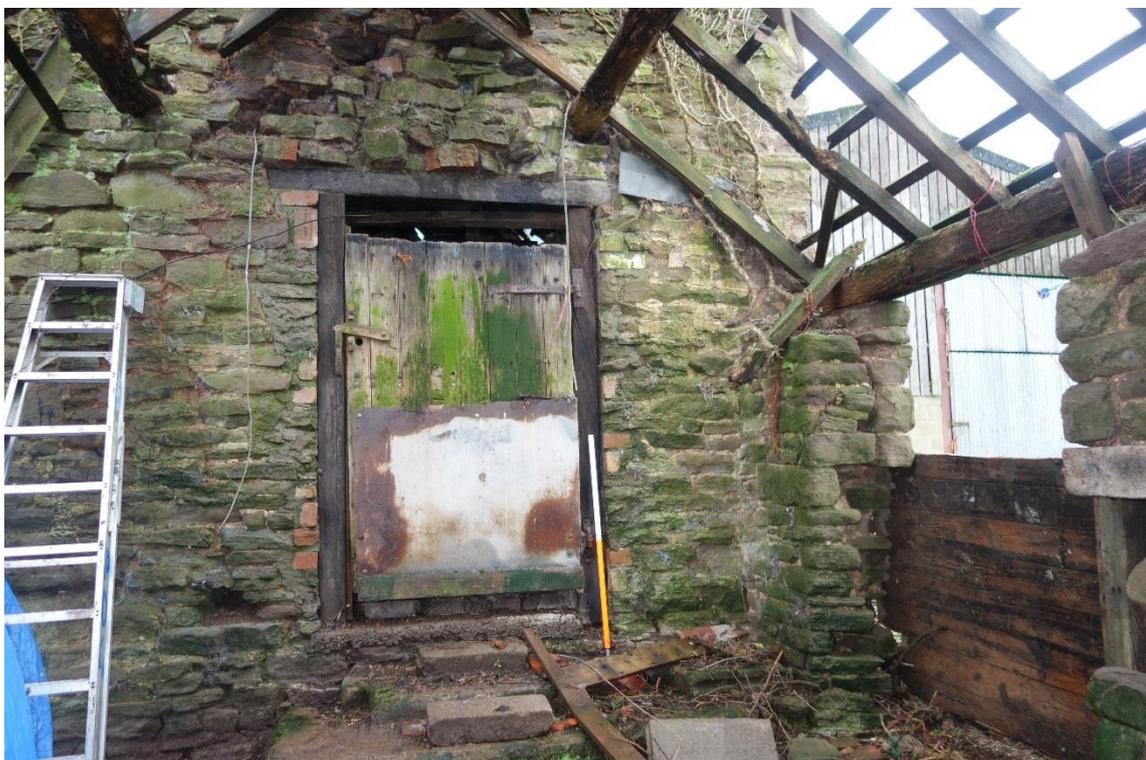
Plate 20: Internal view looking SW showing SW end of Building C with doorway leading to main cowshelter range

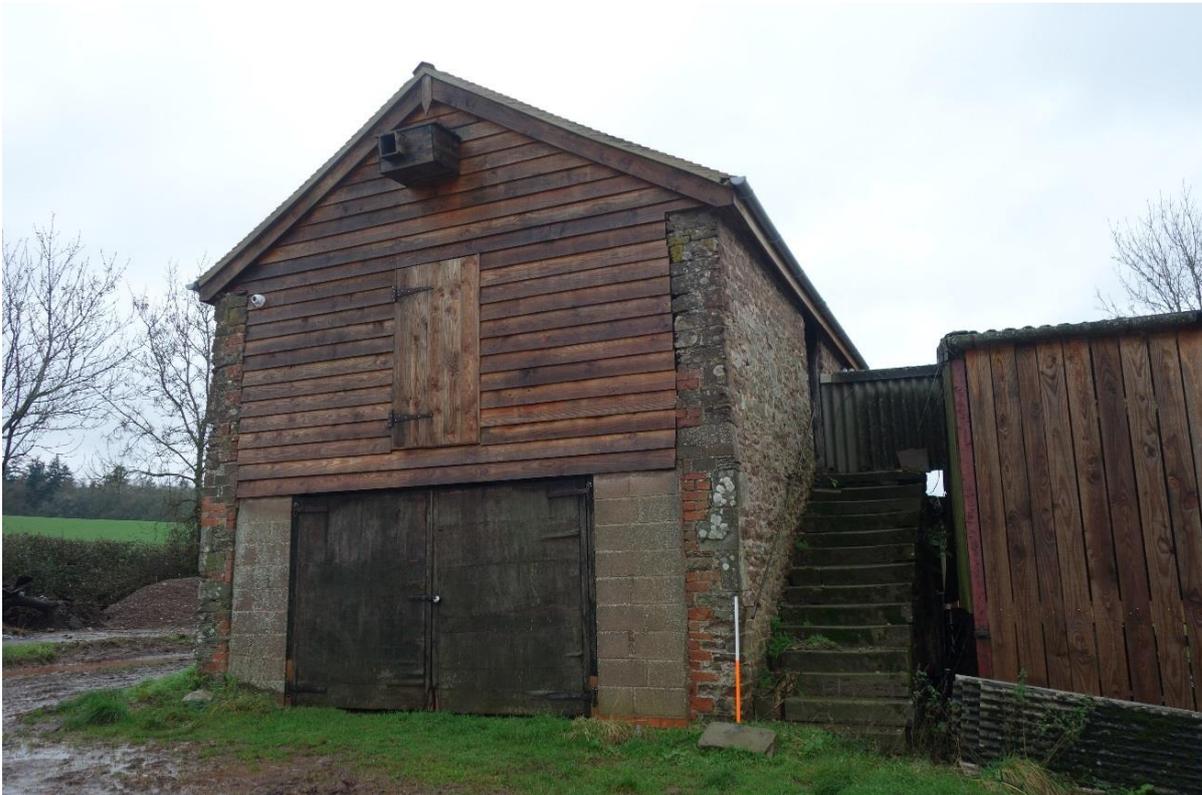
The principal SE-facing elevation has been partially reconstructed (presumably when the building was converted into a garage) with the insertion of concrete breezeblock walls flanking a pair of double doors. The upper storey of the SE-facing elevation is clad in weatherboarding which appears to be modern in date, although the centrally placed loading bay door may represent an original feature (*Plate 21*).

Plate 21: View looking NW showing SE-facing principal elevation of former granary (Building C)
