Heritage Statement

**Gannah Farm
Bolstone
Herefordshire**

February 2017

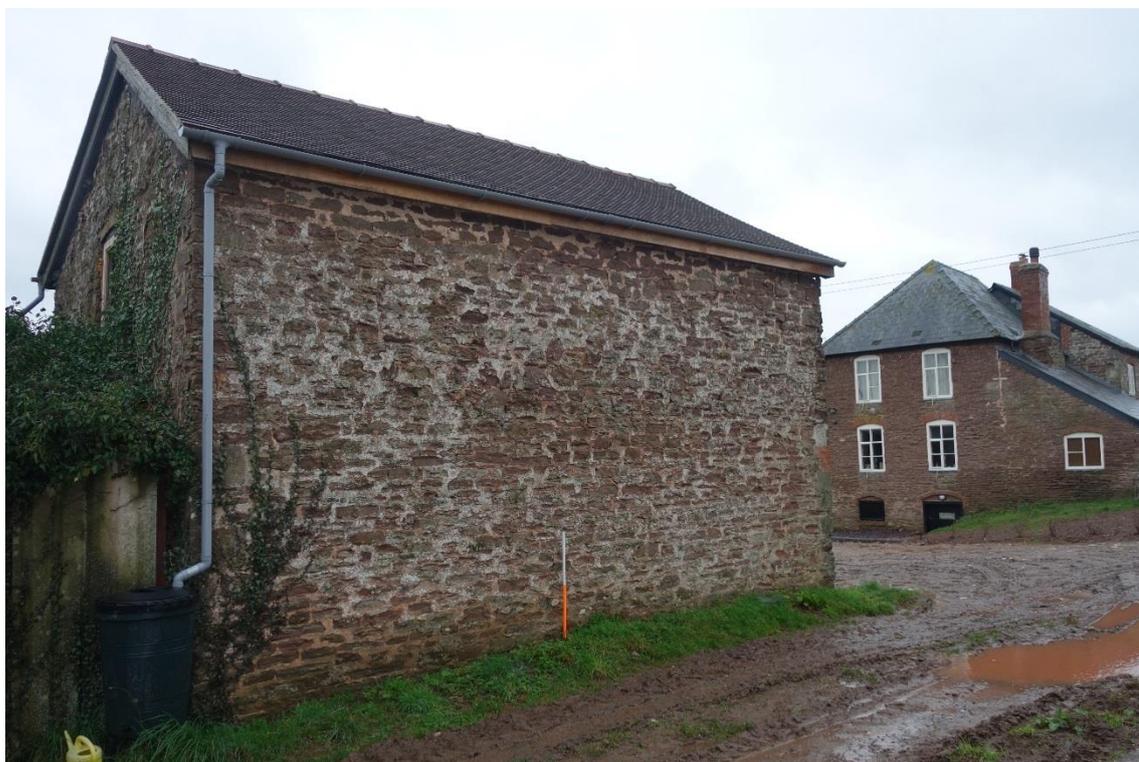
The SW-facing elevation is devoid of fenestration while the NW gable end has a single flat-arched window with a plank and batten shutter at ground floor level and a low segmental gauged brick arch window inserted in the upper storey (*Plate 22*).

Plate 22: View looking SSE showing NW gable and SW-facing elevation of granary (Building C) with farmhouse in background

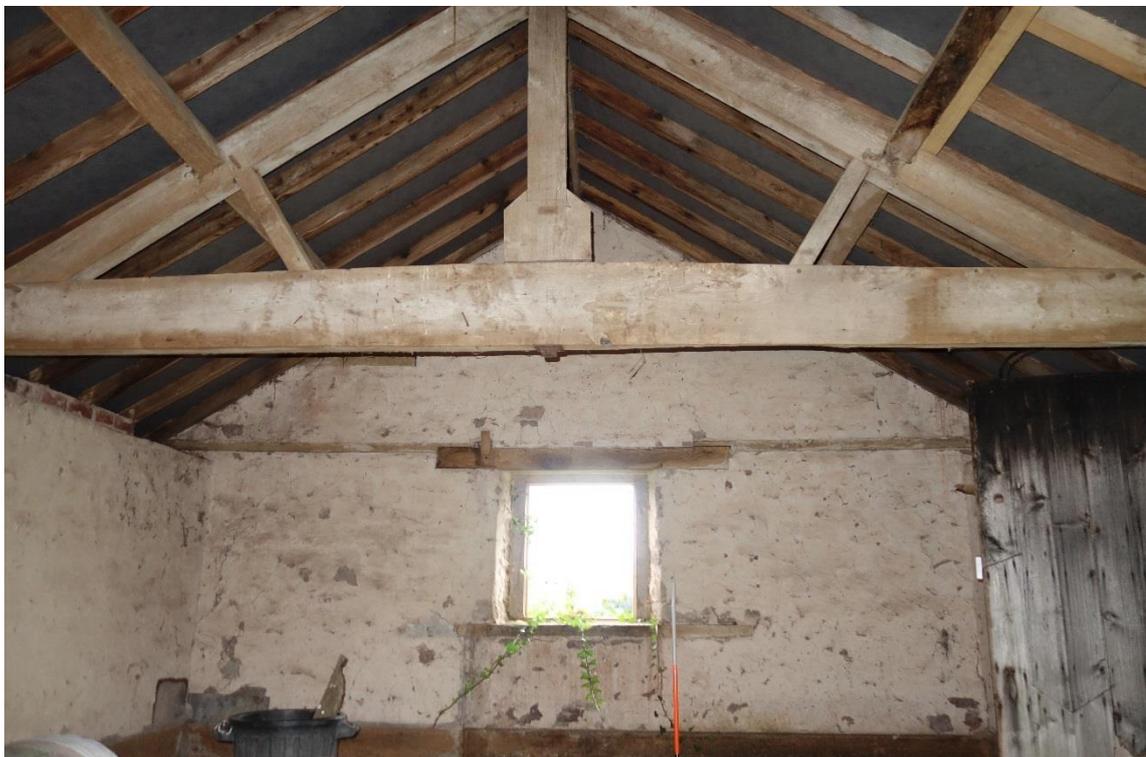
A flight of stone steps leads up to the granary at upper storey level; the interior of which has again been coated in whitewash and is currently used for storage. The most notable feature is the well-preserved kingpost roof with angled struts connecting the tiebeam to the principal rafters (*Plate 24*). The SE end of the granary has been substantially reconstructed with modern timber framing and weatherboarding, while the single unglazed window at the NW end has a wooden surround and timber lintel and sill. The planked floor of the granary may well be original and there is a small rectangular chute through which grain would have been poured into sacks below.

Plate 24: View NW showing interior of upper floor of granary (Building D) with kingpost roof with angled struts

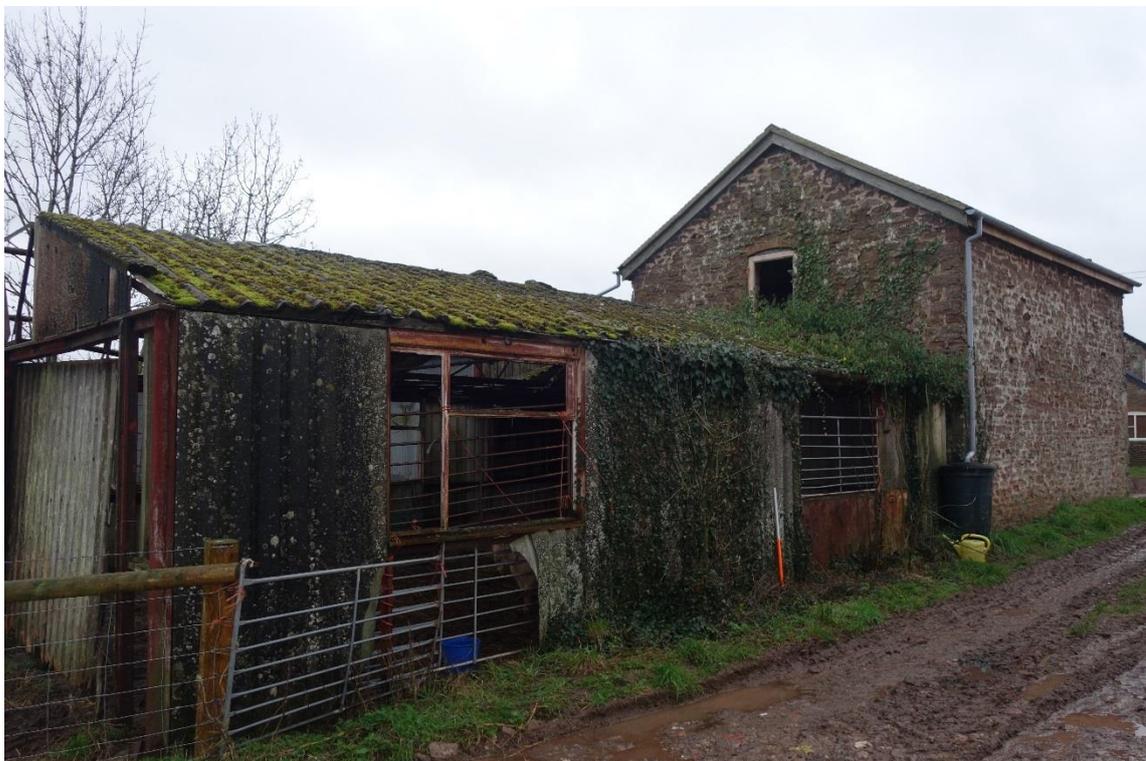
Building E, attached to the NW gable end of the granary, comprises a modern prefabricated steel framed shed used for livestock accommodation (*Plate 25*). It is constructed on a concrete base; the walls and the low-pitched roof are clad in corrugated asbestos sheeting. Attached to the NW gable end is a lean-to canopy with a corrugated metal roof (*Plate 26*).

Plate 25: View looking SE showing modern steel-framed shed clad and roofed with corrugated asbestos sheeting (Building E) attached to NW end of granary (Building D)

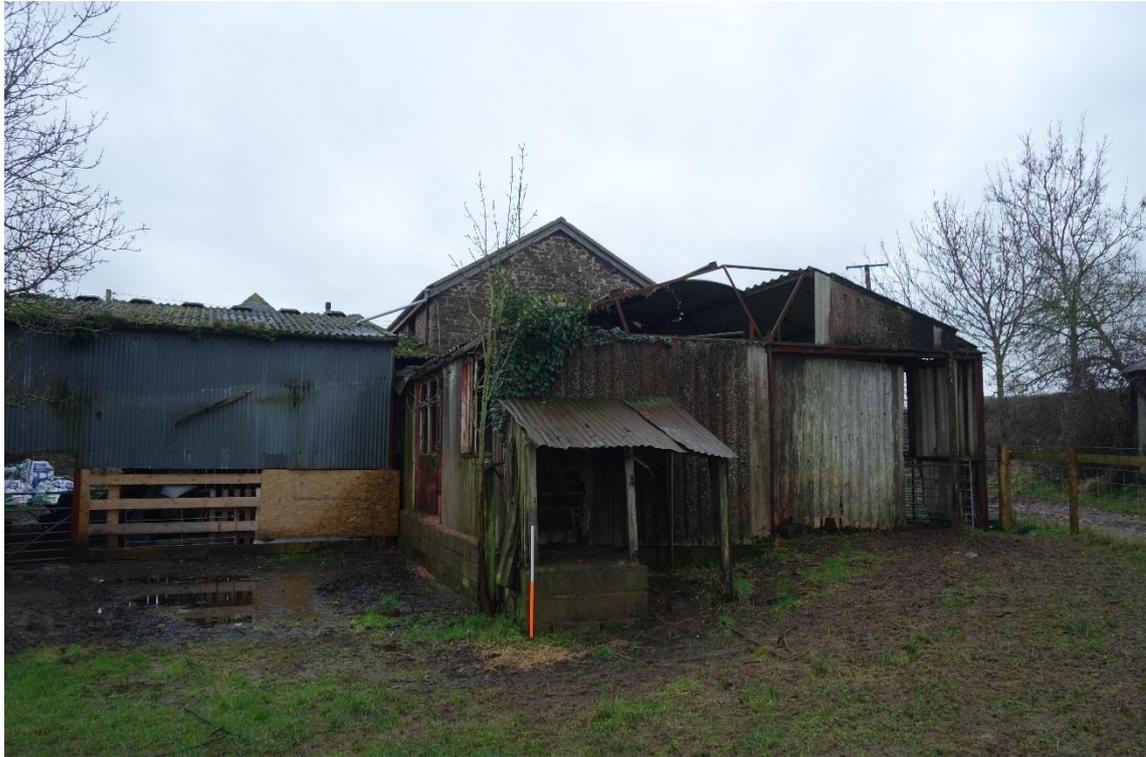
Plate 26: View looking SE showing NW gable end of modern prefabricated shed (Building E)

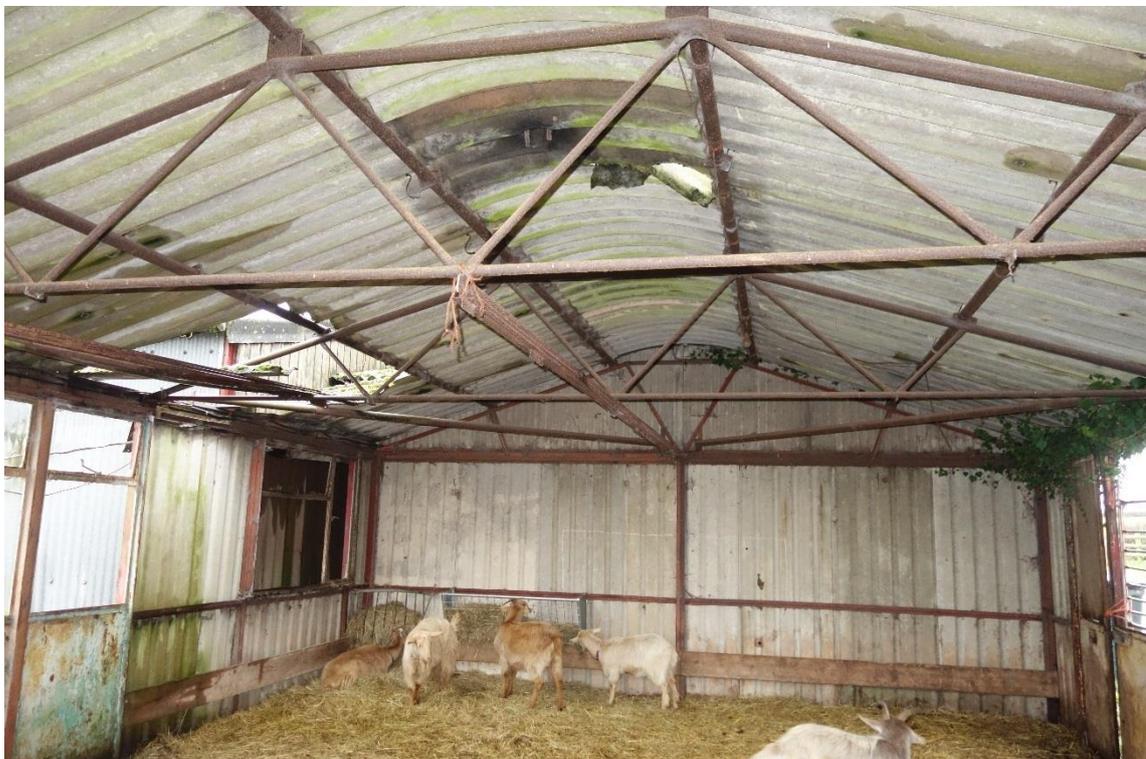
The interior of the prefabricated shed displayed few features or fittings of interest, the only noteworthy feature being the steel-framed cantilever roof trusses (*Plate 27*).

Plate 27: Internal view of Building E looking SE showing detail of roof construction with steel framed cantilever roof trusses

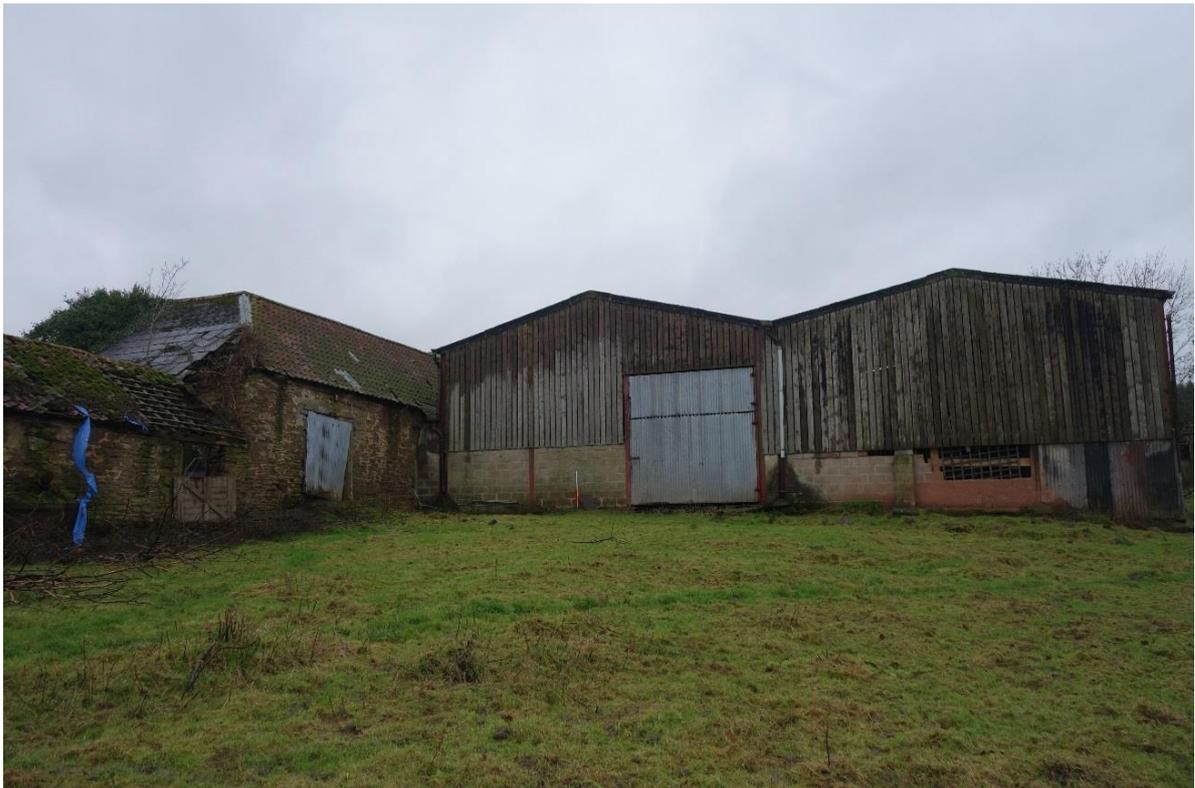
Two large modern agricultural sheds (Buildings F & G) of mid to late-20th century date are located between the main cowshelter range (Building A) and the granary (Building D). The sheds are of steel framed construction with low-pitched corrugated metal roofs; the NE and SW facing elevations have low concrete block walls with weatherboarding above (*Plates 28 & 29*) while the NW-facing elevation is clad entirely in corrugated iron sheeting.

Plate 28: View SW towards the pair of modern steel framed agricultural sheds NW of cowshelter range (Building A)

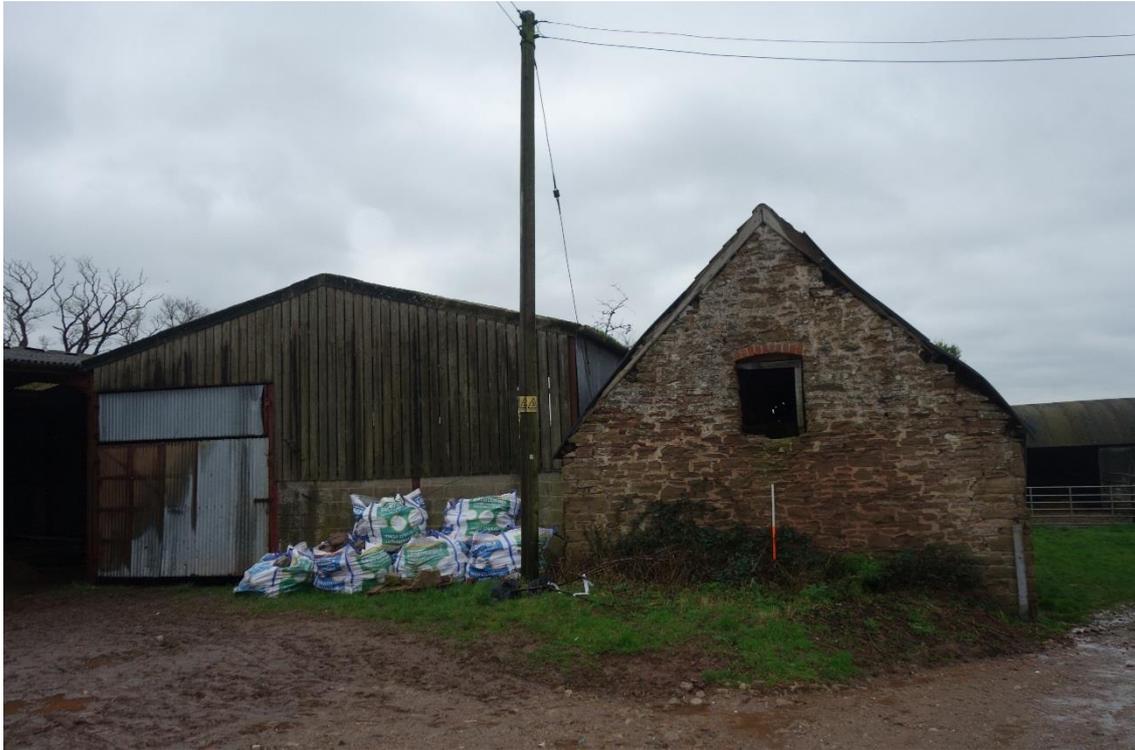
Plate 29: View NE showing modern agricultural shed situated immediately adjacent to earlier cowshelter range (Building A)

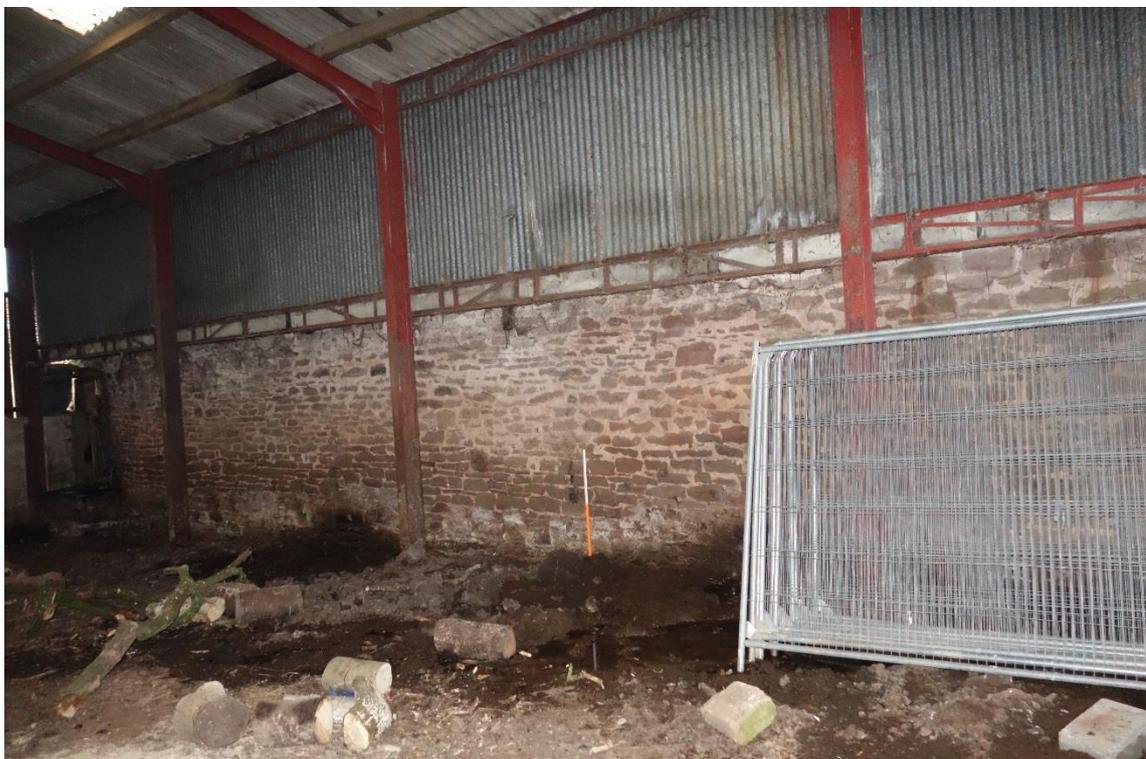
Plate 30: View looking SE showing NW elevation of cowshelter range (Building A) concealed by modern steel framed agricultural shed

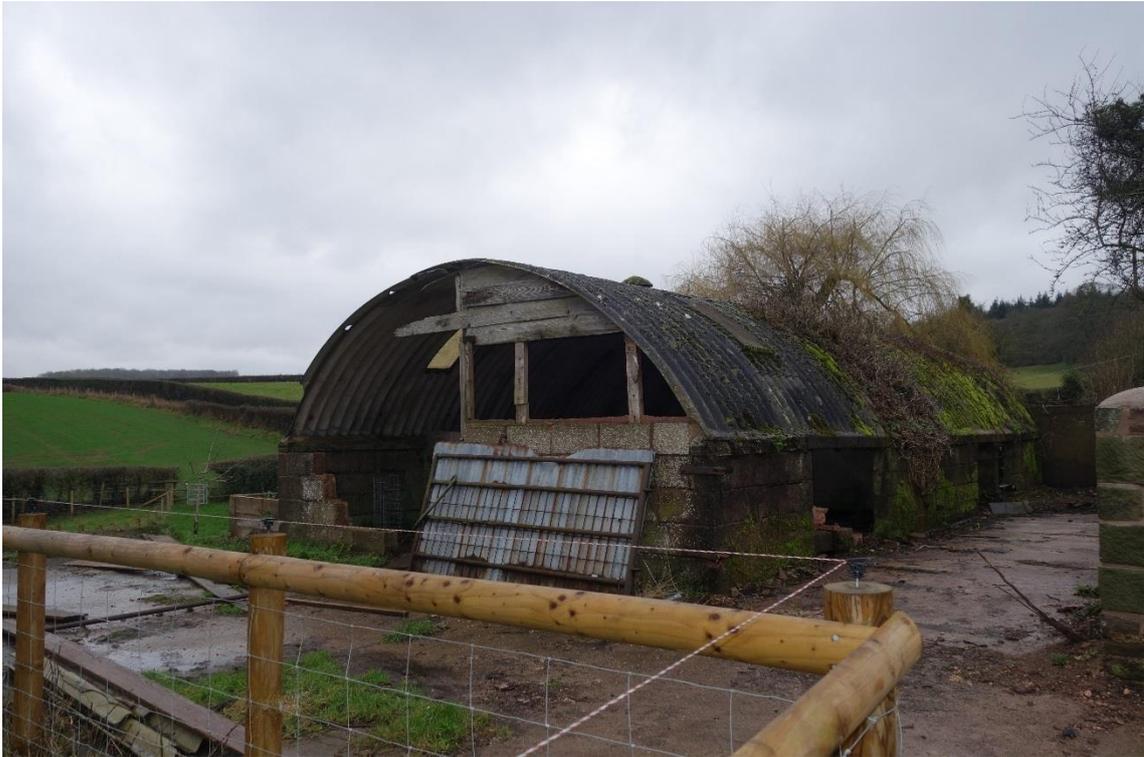
Located to the SE of the farmhouse are two small detached outbuildings of mid-late 20th century date (Building H) comprising a low rectangular pig arch of concrete breezeblock construction, oriented NE-SW and a small rectangular shed constructed of brick and concrete rubble masonry on the same orientation (*Plates 31 & 32*). No fixtures or fittings of interest were noted.

Plate 31: View looking S showing modern concrete pig arch with corrugated metal roof

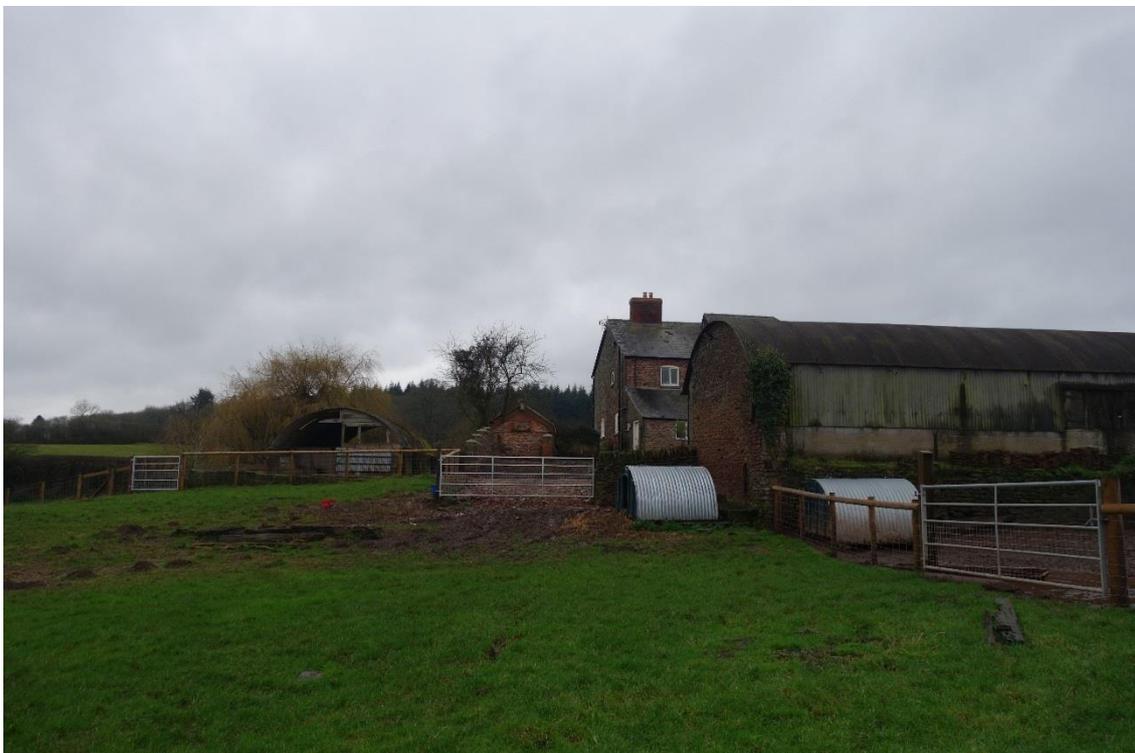
Plate 32: View SW showing pig arch and shed to SE of farmhouse

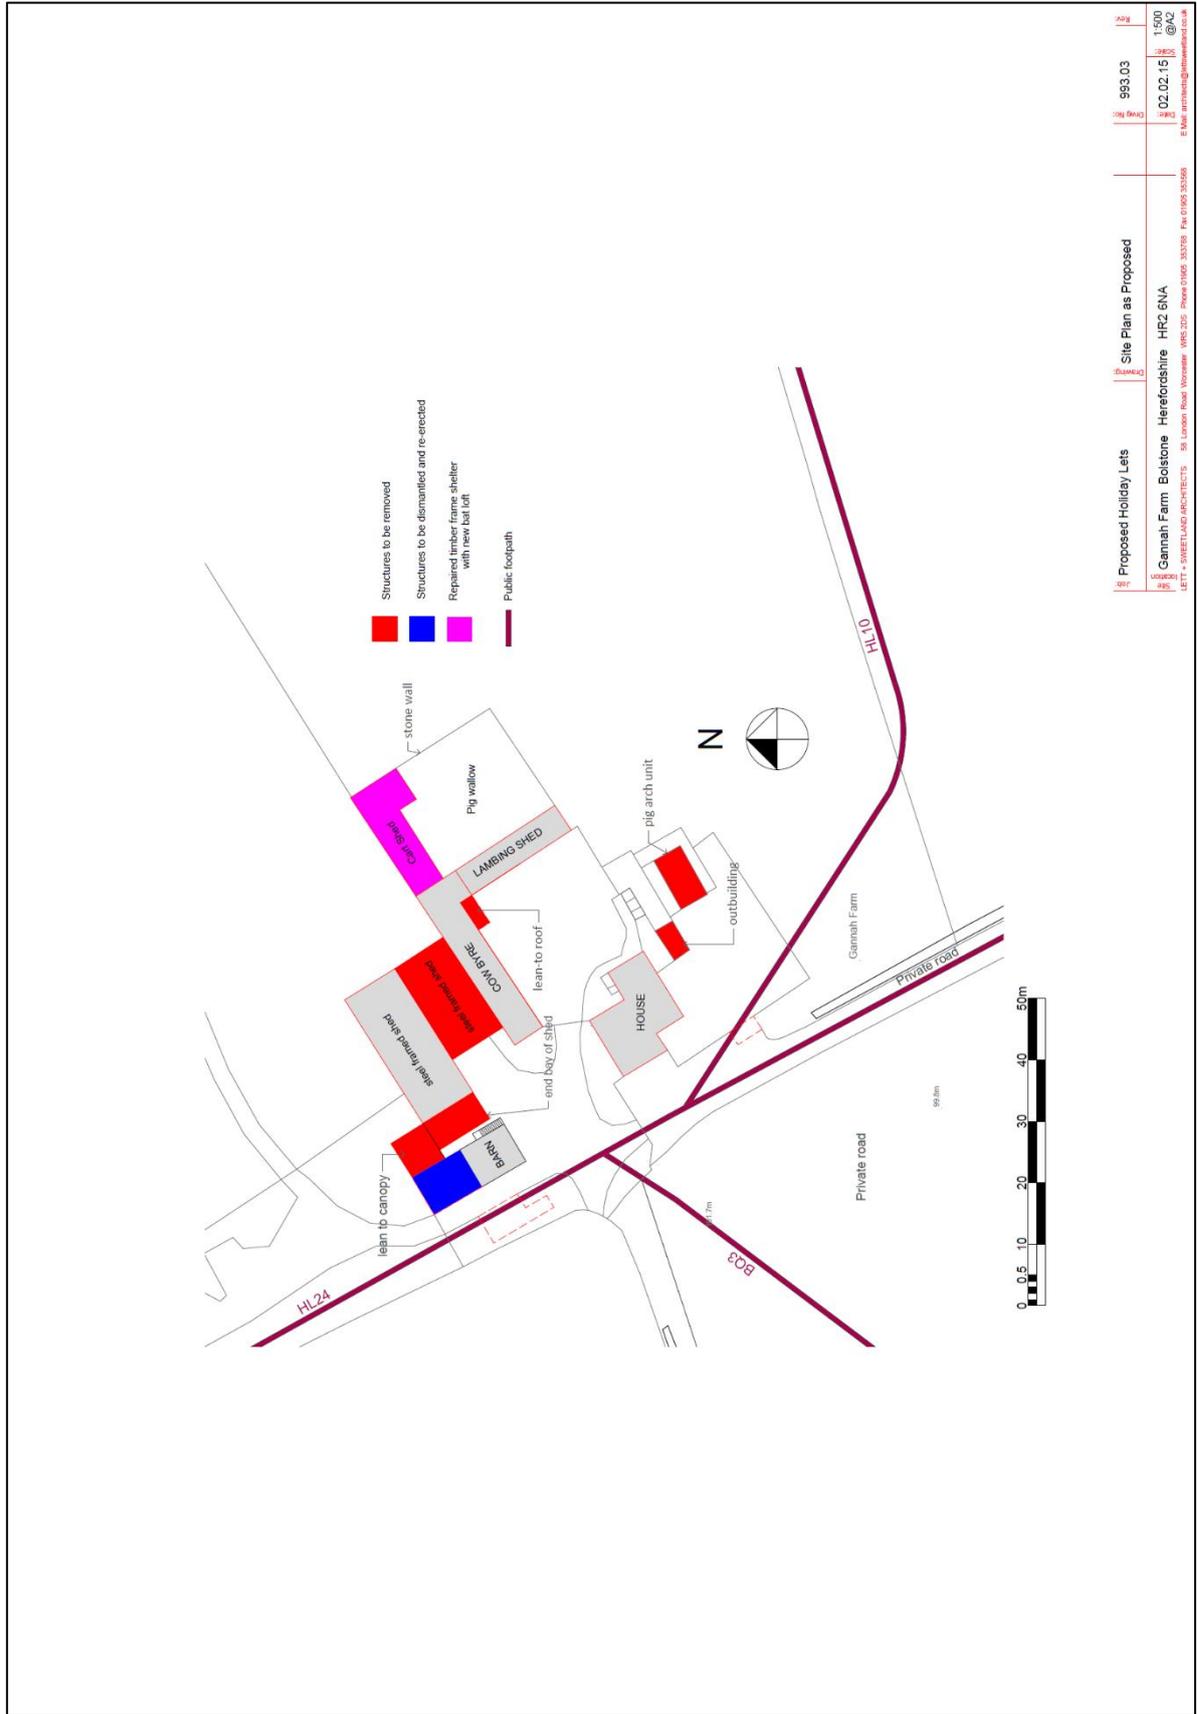
Detailed drawings of the proposed development are not yet available and consequently this assessment is based on the outline proposed site plan as supplied (Drawing Ref. 993.03). The proposed development, in broad terms, entails 1/ the conversion of the traditional farm buildings, namely the cowshelter and the detached two storey granary building into holiday accommodation and the repair of the open-fronted cart shed to the NE of the cowshelter with the provision of a new bat loft and 2/ the demolition of several modern steel-framed outbuildings adjoining the traditional farm buildings and immediately SE of the farmhouse.

Fig. 11: Outline plan showing proposals for conversion of farm outbuildings at Gannah Farm

In the case of the cowshelter and its attached ranges, it is considered that the proposed conversion will have a beneficial effect in terms of preserving the original fabric of the building, which is in a state of some disrepair, and removing unsightly modern accretions, such as the low concrete breezeblock walls and corrugated metal cladding. The repair of the open fronted shelter/cart shed range NE of the cowshelter, which is currently unroofed and in a somewhat dilapidated condition, can also be assessed as beneficial in terms of preserving the fabric of a listed building.

In the case of the detached granary, it may be argued that the proposed conversion will again have a beneficial effect in terms of preserving the fabric of the existing building and removing several modern steel-framed agricultural sheds which are in a poor state of repair and detract from the overall aesthetic appeal and coherence of the farmstead complex.
