Archaeological Observation

Reinstatement & Restoration of

'Parish Ditch'

Brackenwood

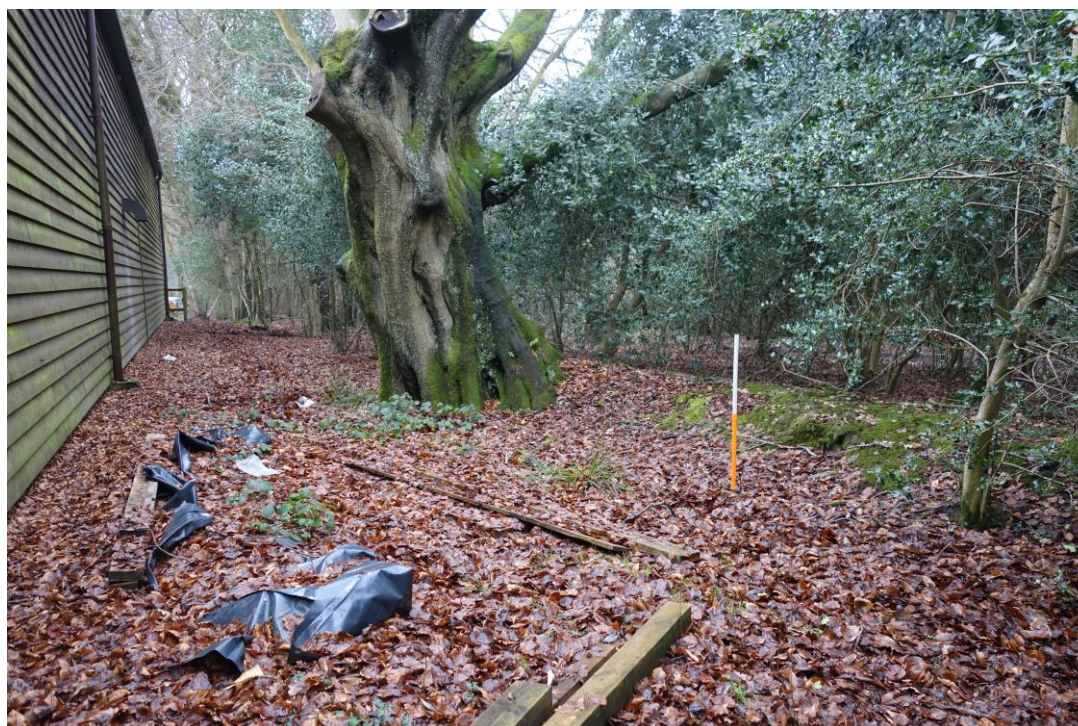
A site-visit previously carried out by BA to inspect the ditch prior to reinstatement works found it to be heavily covered with leaf mulch (*Plates 1 & 2*). The approximate maximum width of the ditch measured 3.5m and clearly tapered towards the bottom (there was evidently a void beneath the leaf mulch and spoil filling the exposed section of the ditch and some stones from the revetment wall had collapsed into it).

Plate 1: View looking roughly SE along the infilled section of the ditch immediately behind the new barn (note outer bank of ditch to right of picture)

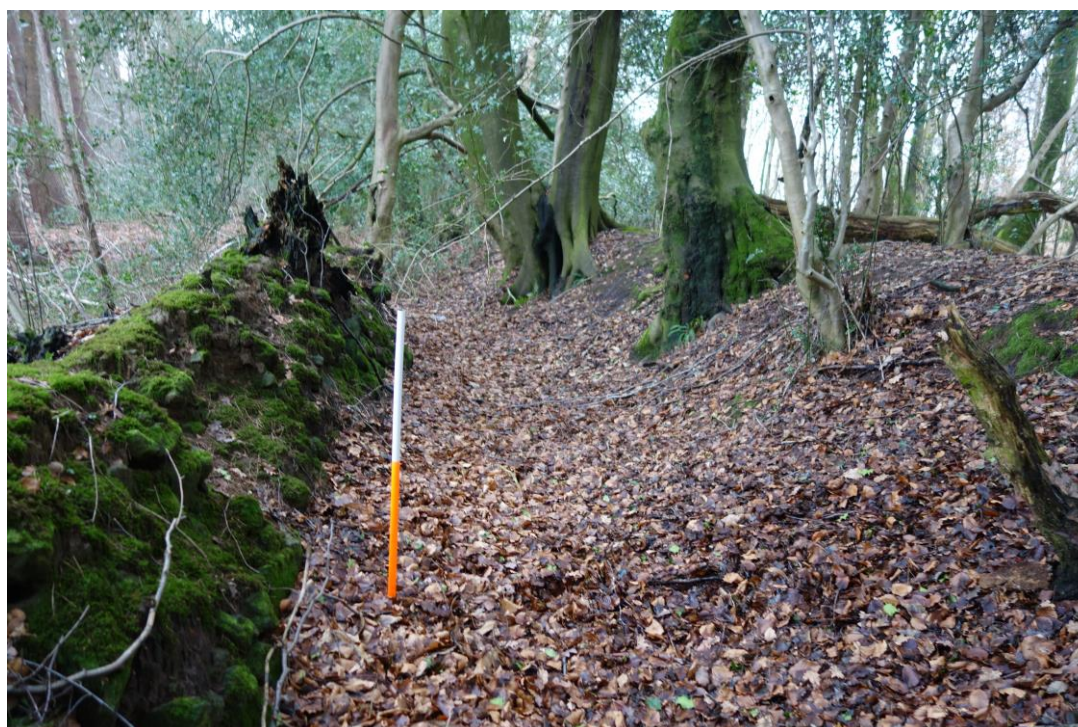
Plate 2: View SE along well-preserved section of revetment wall and ditch located about 200m SE of the site

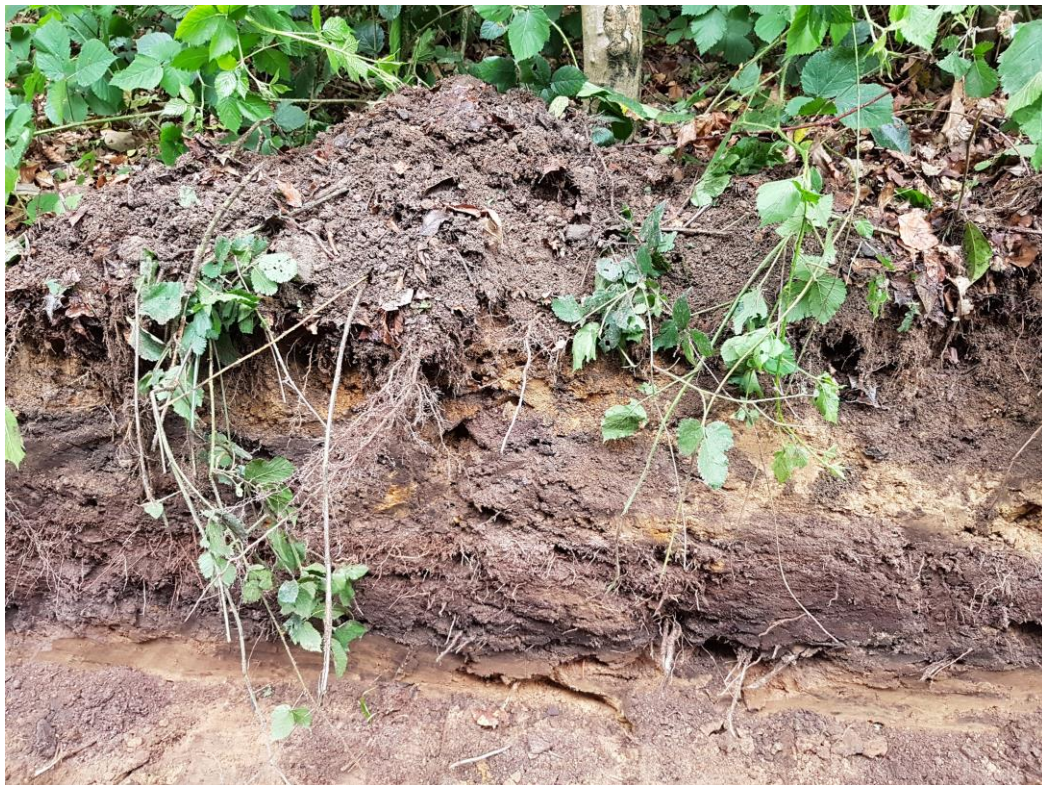
The profile revealed an original humic ditch fill overlying natural. The humic layer, at this point, was c.0.2-0.4m thick and was overlaid by modern infill material to a depth of approximately 0.5m. A modern food wrapper of probable 1990s date found on the horizon of the humic layer provided the only piece of dating evidence identified during the course of the excavations, with no other 'finds' noted apart from a scattering of roofing screws and wooden boards (relating to construction of the barn) lying on the ground surface.

Plate 3: NW/SE longitudinal profile, looking SW

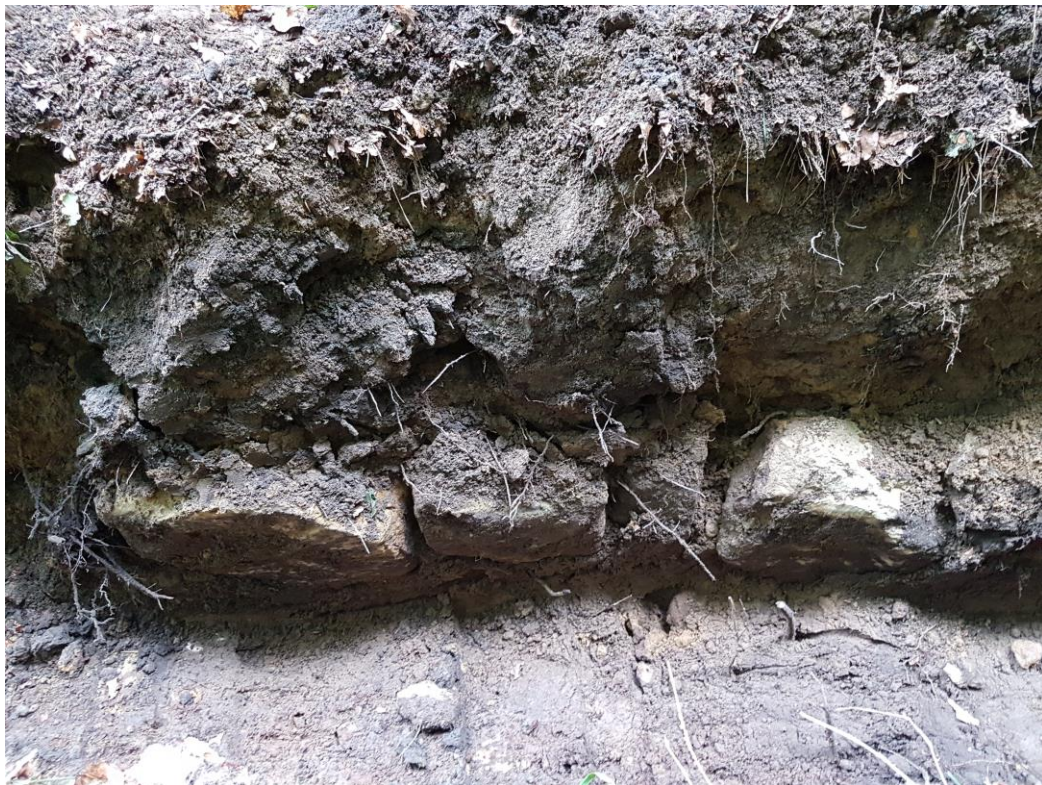
A short length of masonry revealed on the NE side of the ditch, close to the large beech tree previously noted (*Plate 5*), represented an isolated section of revetment wall, reflecting the discontinuous nature of this feature along the length of the ditch. It was also noted that the ditch was likely to have been somewhat overgrown prior to backfilling, as suggested by the presence of a holly (*Ilex aquifolium*) growing in the middle of the ditch, the callus wood on its lower trunk suggesting it predates the barn construction activity.

Plate 4: View looking SE showing remains of revetment feature, as revealed

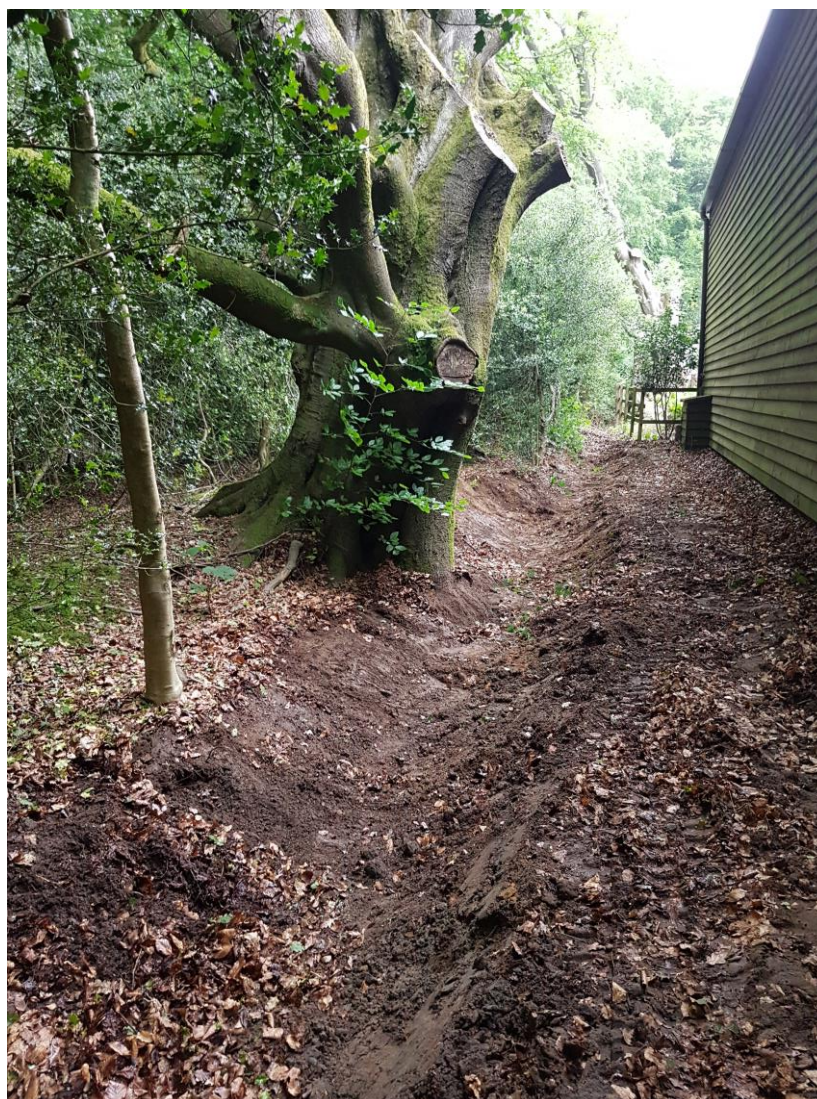
In the process of tracing the route of the ditch, a significant deviation of c.0.5m from linear alignment was noted and this was followed/respected in the reinstatement works. The deviation was especially apparent in the mid-section of the area behind the barn, where it narrowed/deviated towards the SW. There is a possibility that this deviation/narrowing may represent a section of ditch that has been less subject to the effects of slumping/weathering over the centuries since construction. It is possible that the ditch was originally fairly irregular along much of its length and that the more regular alignment noted elsewhere can be attributed to a combination of slumping/weathering activity and the 'softening' effect of vegetation.

Plate 5: View NW showing reinstated ditch and its somewhat irregular alignment. The large beech tree referred to in the text is also shown.

Work commenced from the NW end of the infilled ditch section, immediately NW of a large, established beech (*Fagus sylvatica*) (Plate 5), and progressed in a SE direction. An absence of obstructions in the form of trees and associated rooting at this point enabled the profile of the ditch to be determined. This revealed that the ditch lay closer to the bank and was narrower than both ground surface indications and comparison with other sections of the extant ditch would suggest. Root intrusion was considerable in the area around the beech tree.
