Limited Standing Building Recording & Archaeological Observation

**The White Rooms
Nos 23-25 Milford Street
Salisbury
Wiltshire**

March 2019

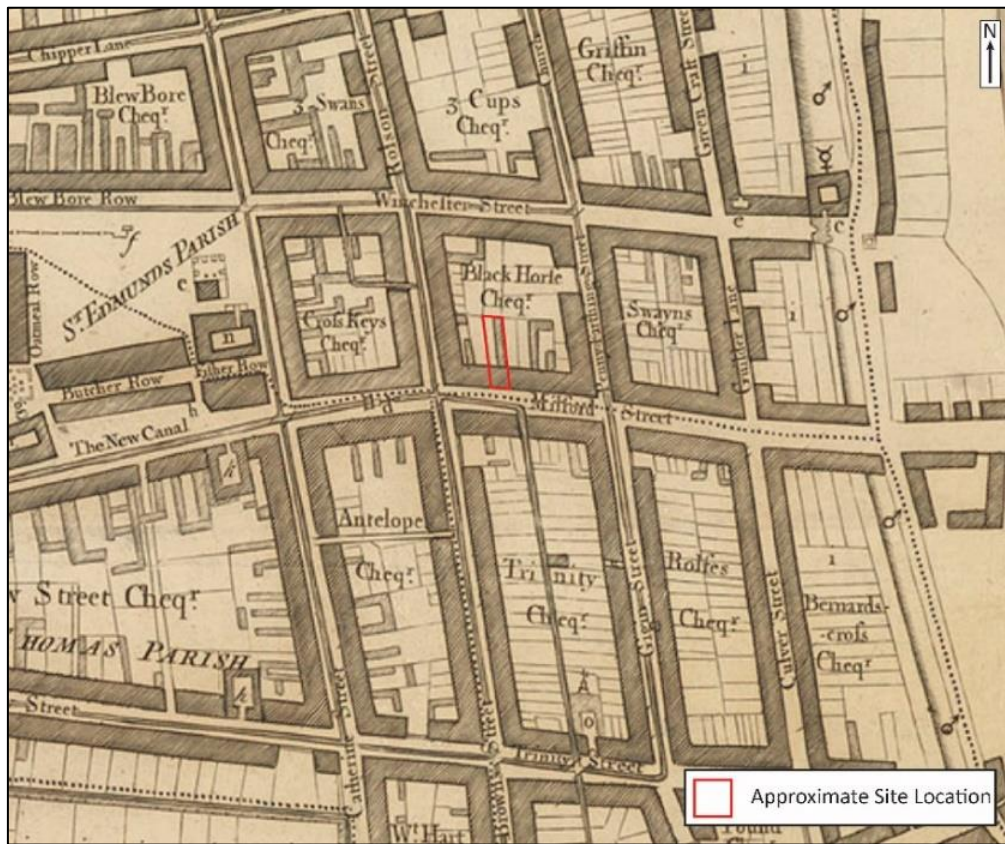
Fig. 2: Extract from Naish's Map of Salisbury (1716)
(Reproduced courtesy of the Wiltshire and Swindon History Centre)

The subsequent history of the tenement at Nos. 23-25 Milford Street during the 16th-18th Century is poorly documented. Naish's plan of Salisbury 1716 (*fig. 2*) depicts an extension to the rear of the property that may well correspond to the existing N wing to the rear of No. 25, which appears to be partially of 16th Century origin.

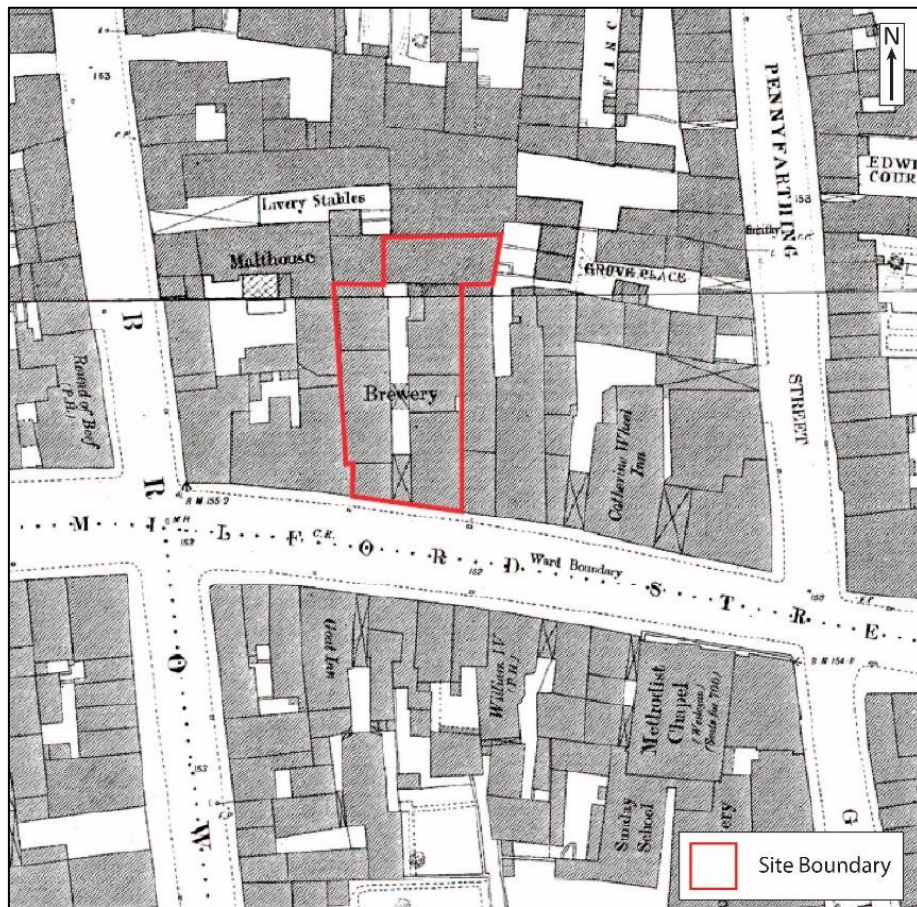
Fig. 3: Extract from the OS 1st edition 1:500 map (1880)
(Reproduced courtesy of the Wiltshire and Swindon History Centre)

By c.1832, Nos. 23-35 Milford Street were owned by a brewer, corn dealer and maltster named Thomas Maton. Newspaper records from the early 1830s refer to a substantial hop and malt brewery on the premises owned by Thomas Maton and it is possible that Maton was responsible for the construction of several of the outbuildings to the rear of the premises. This may have included the three-storey range on the W side of the courtyard and the two-storey brick and weatherboard range on the N side, the latter being dated by the RCHME to the first half of the 19th Century.

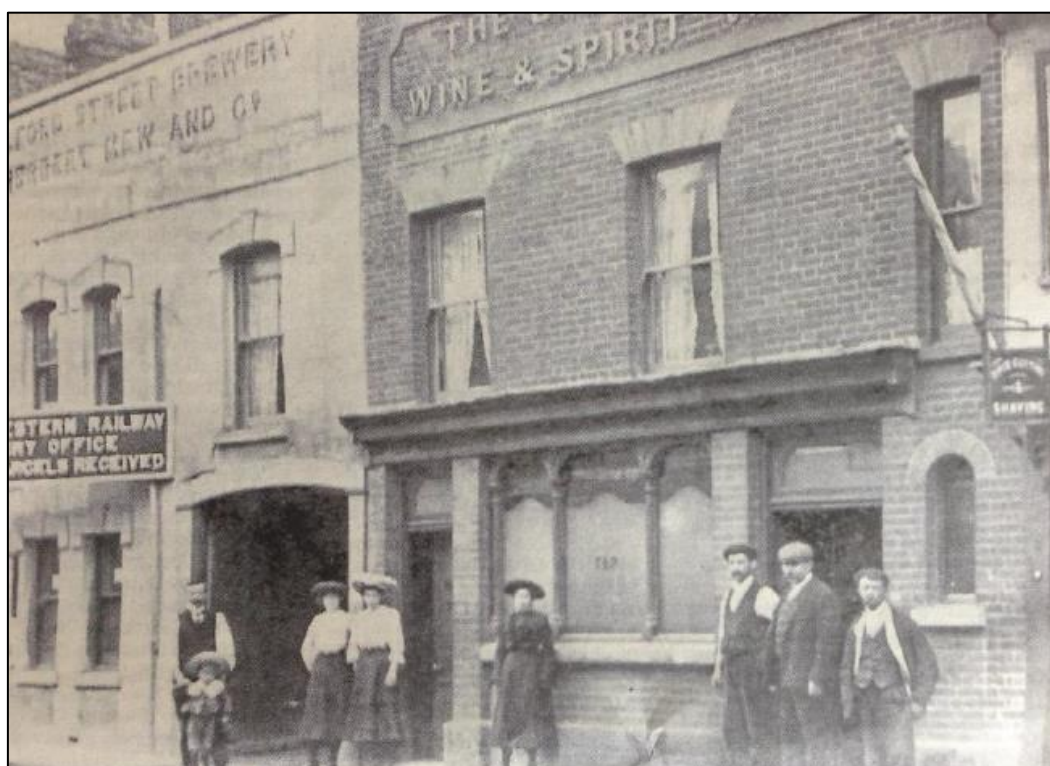
*Fig. 4: Extract from a photograph dated c.1906 showing Nos. 23-25 Milford Street
(Reproduced courtesy of the Wiltshire and Swindon History Centre)*

A photograph of Nos. 23-25 Milford Street taken in approximately 1906 shows the frontage of the buildings as being noticeably different compared to their current appearance (*fig. 4*). The westernmost three bays were clad in stucco with a low, broad segmental archway providing access to the rear, with two flat-arched sash windows to the left of the archway, while at first-floor level there were three depressed arched windows with keystones. Evidence of a vertical construction break is visible between the western half of the building and the three bays to the right (then occupied by the Brewery Tap public house), which comprised a glazed late 19th Century pub frontage at ground level flanked by two doors at either end and surmounted by a moulded fascia board. The first floor displays exposed brickwork with three sash windows, with gauged brick *voussoirs* above, which appear to be of early 19th Century date.

The fenestration at first-floor level consists of six windows (the easternmost window being roughly half the size of the other five) set within moulded architraves painted black. Compared to the windows as shown in the photograph of 1906 (*fig. 4*), it is clear that the westernmost three windows were smaller and set within depressed-arched openings with keystones (probably of mid-19th Century date) and thus these windows in their present form are modern replacements. The easternmost three windows as shown on the 1906 photograph are of similar size to their modern counterparts but are set beneath gauged brick *voussoirs* with no moulded architraves. Above these windows is a simple block cornice, surmounted by a tall parapet raised at either end with coping which conceals a pitched tiled roof.

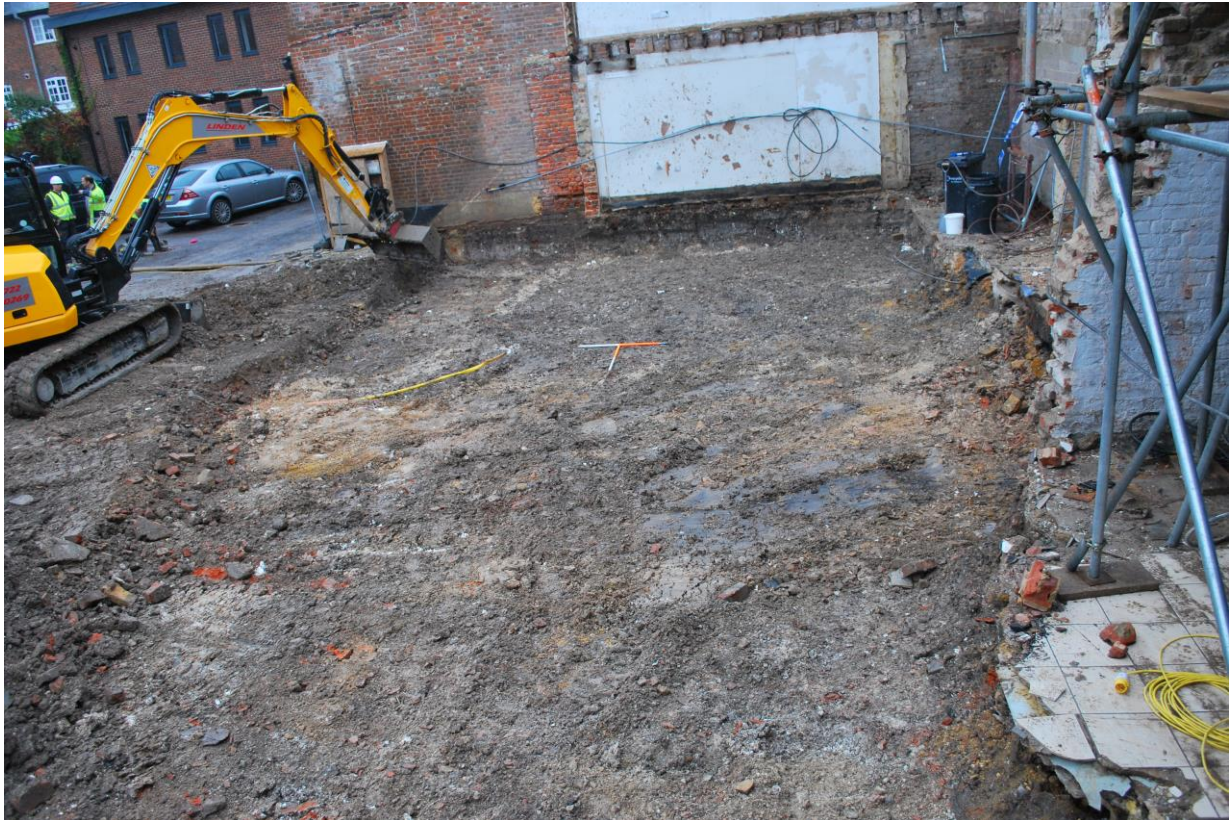
Plate A: View E showing S extent of Area 001

This area observed was levelled to remove demolition material and layers and establish a more solid foundation for the scheduled works (Plates A & B).

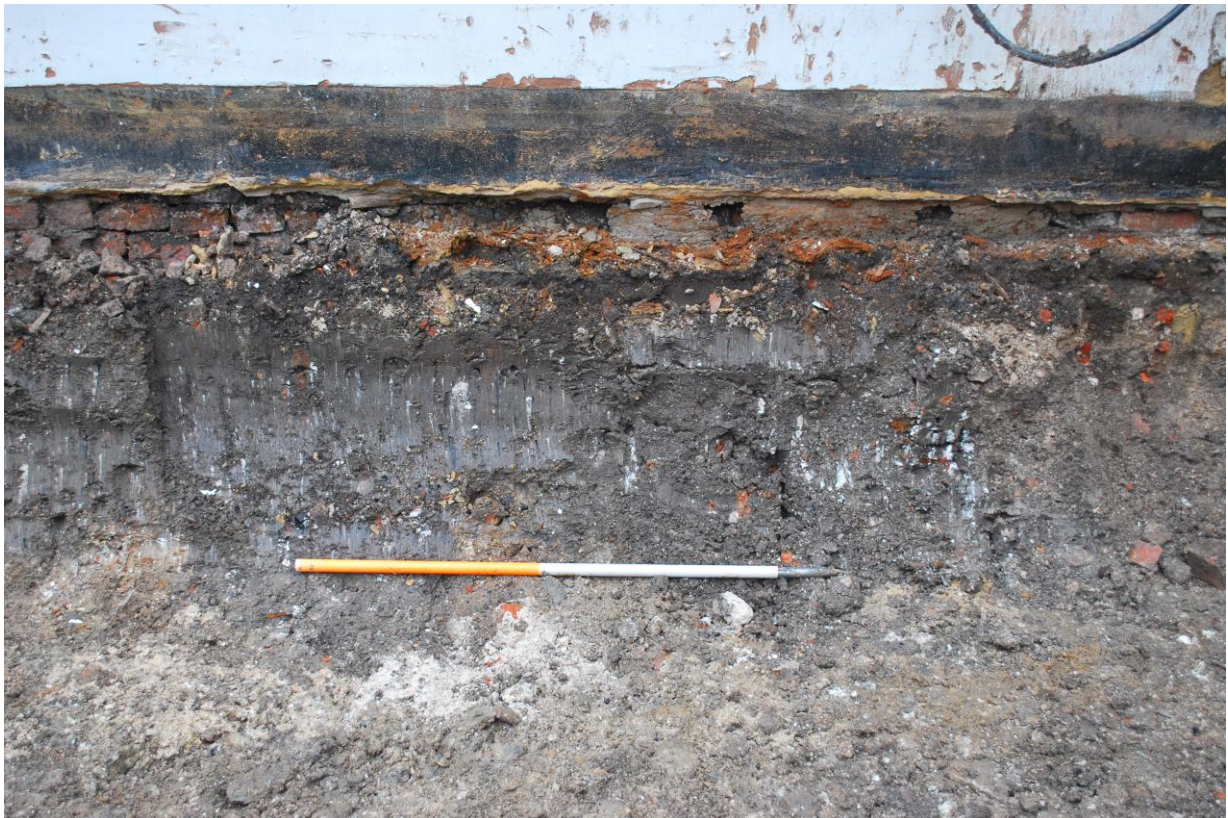
Plate D: W-facing section of Area 001

Topsoil (001001) consisted of a moderately compacted dark grey sandy silt, 0.44m thick, containing fragmentary brick and tile. The mid grey sandy silt subsoil (001002) was 0.31m thick and contained frequent brick and tile. Beneath this was a rubble demolition deposit (001003), 0.40m thick, again with frequent brick and tile. A soft loose light greyish-white lime deposit (001010) some 0.15m thick was revealed beneath (001001) on the N side of Area 001, possibly the remains of a foundation deposit beneath the northernmost building.

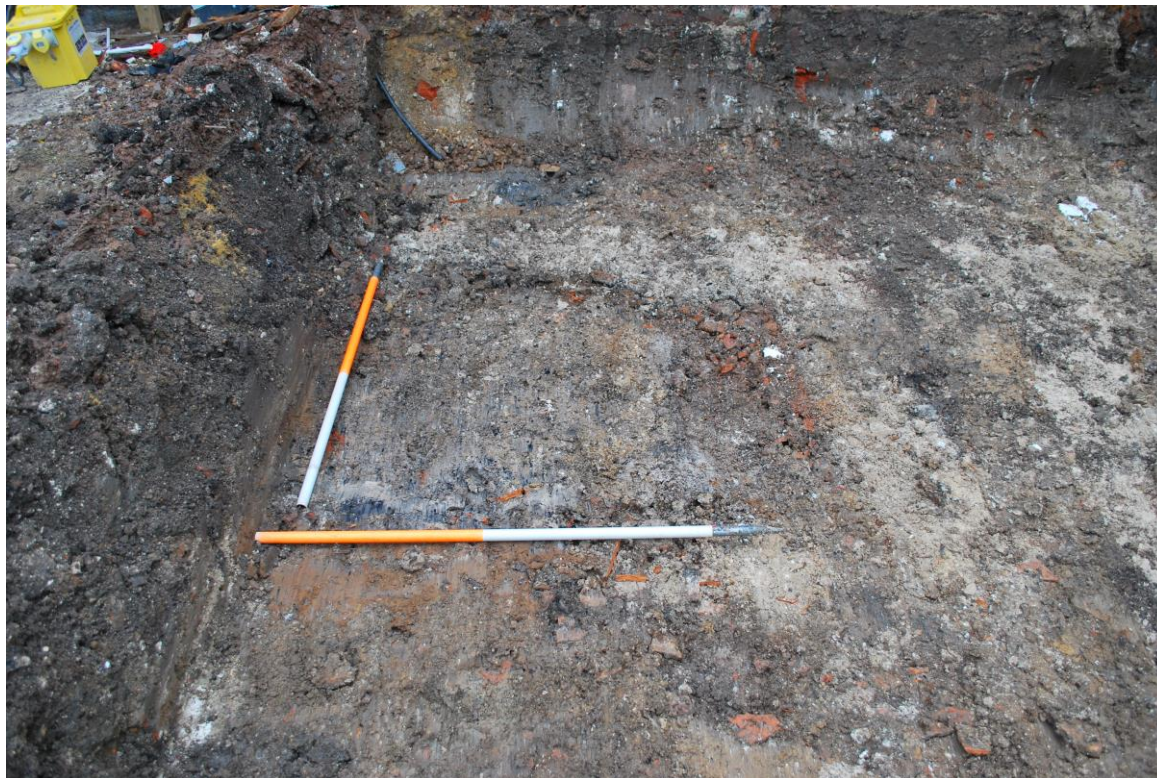
Plate F: View E of [001013] pre-excavation

A possible rectangular rubbish- or cesspit [001013] measuring 2m × 1.6m × 0.53m, of which only partial remains were evident, was located on the E side of Area 001 (Plates F-H). The feature incorporated the base of a walled construction, 001009, of chalk and mortar with moderate pebble inclusions. Excavation of the internal part of the structure revealed several deposits.

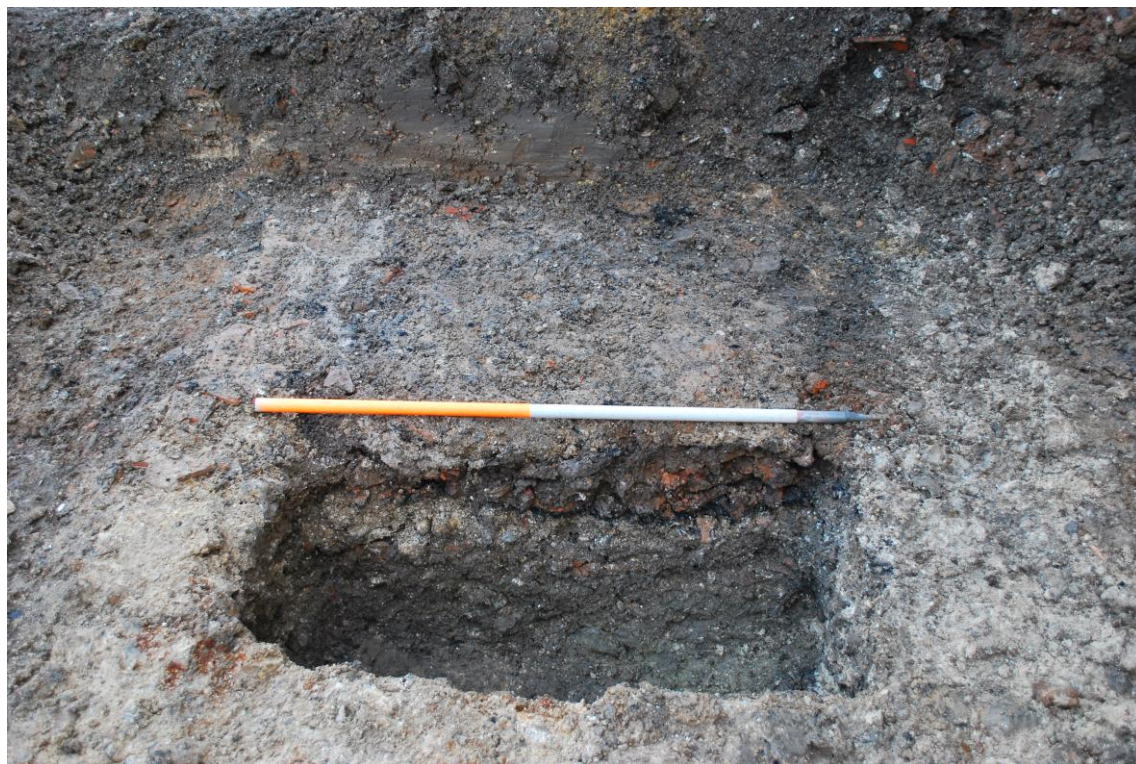
Plate G: S-facing section of [001013]/001009

The uppermost deposit (001004) was a soft mid-yellowish-grey clay silt, 0.06m thick, containing large quantities of ash and occasional pieces of charcoal. Fill samples noted it was composed of residual materials. It contained rubbly waste in the form of frequent CBM and mortar, moderate worked stone and occasional pottery, Cu alloy, slag fragments and flake hammerscale suggesting the importation of waste. It also contained frequent charcoal, moderate unburnt mammal bone, occasional unburnt small mammal and fish bone occasional burnt mammal bone (Putland 2009, see *Appendix 5*).

Underlying (001004) was a soft mid-orange-grey clay silt, 0.15m thick, containing frequent roof tile and brick (001005). Fill samples also revealed a rubbly waste composition similar to that of (001004). Small quantities of burnt and unburnt mammal bone were present, together with frequent charcoal. A mixed assemblage of medieval (including two sherds of Laverstock) and post-medieval (products of the nearby Verwood industry) pottery was recovered (Crooks 2019, see *Appendix 4*), together with bone and ferrous material. A single gunflint (SF001) of standard British form was also recovered, this probably being made locally for use in a musket (Devaney 2019, see *Appendix 3*).

Beneath (001005) was a soft charcoal-rich deposit (001006), 0.04m thick, which was, as observed in the other fills, of a rubbly composition. A probable charred seed of the poppy family also present, together with

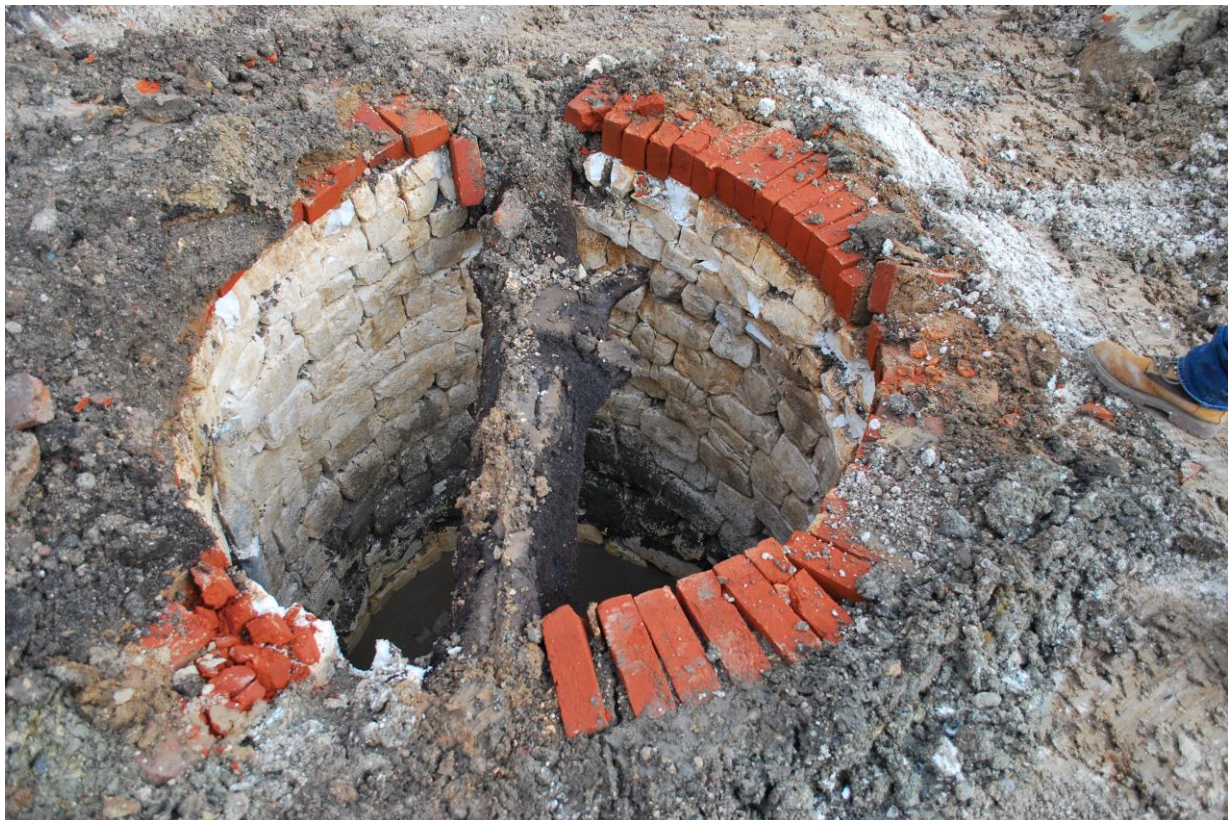
Plate I: View NW showing interior of well [001012]

A well [001012] was uncovered in the NW corner of Area 001 comprising a circular stone-lined construction (001011) of 1.35m (diameter) × 2.6m (depth). The masonry lining consisted of un-mortared regular chalk blocks with modern red-brick coping suggesting multi-period use (*Plate I*). A substantial irregular timber of no discernible function lay across the top of the well which may simply represent a makeshift support for some kind of cover (*Plates I & J*).

The date of this structure is uncertain, although the masonry lining suggests a late medieval or early post-medieval date. No well is shown in this location on the OS 1st edition 1:500 map (*fig. 3*) published in 1880, prior to the closure of the brewery in 1898, suggesting it had been decommissioned and built-over by this time. However, the brewery's need for a readily accessible source of fresh water suggests the well may have remained in use and housed within one of the brewery buildings.

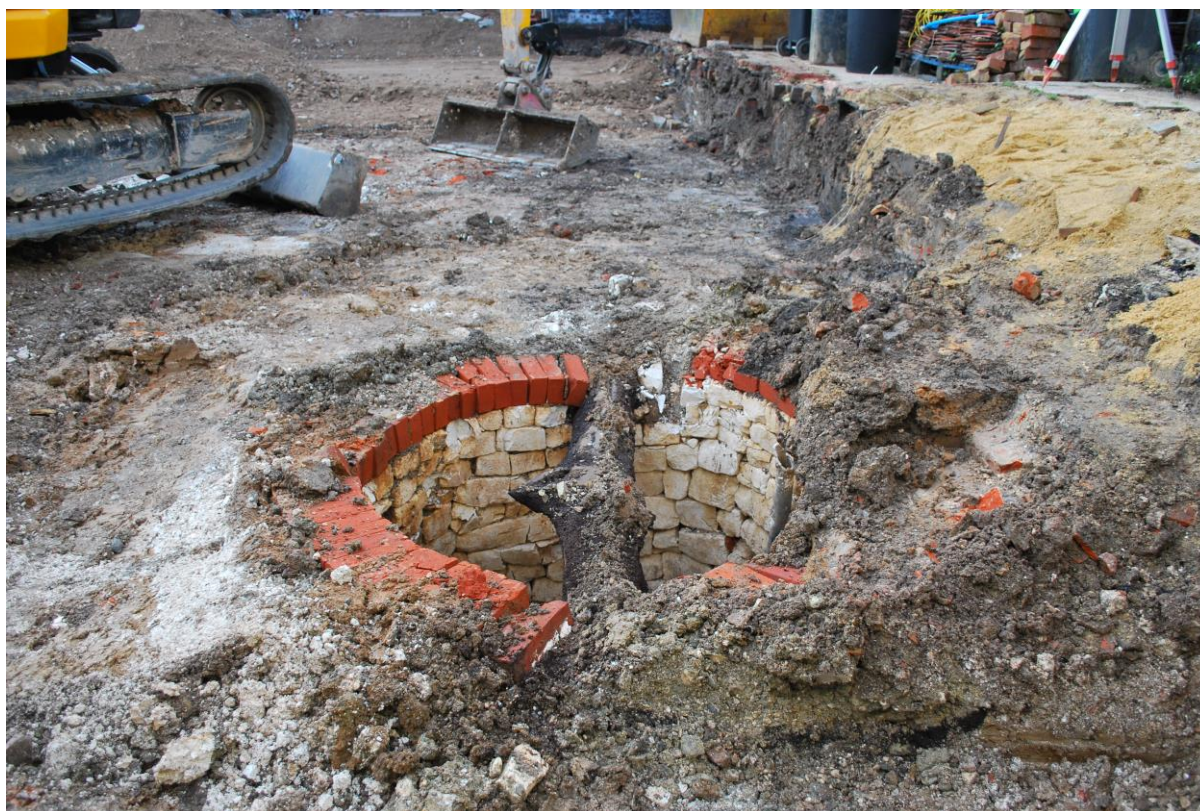
Plate J: View S showing location of well [001012] within the NW corner of Area 001

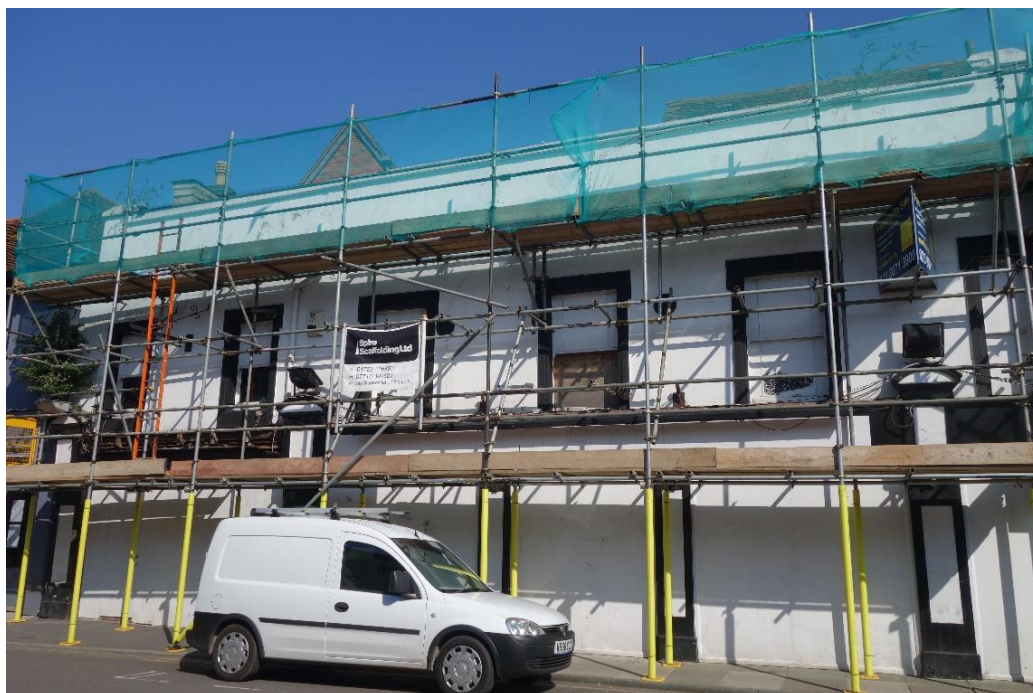
Plate 1: View looking NNW showing principal façade of 23-25 Milford Street, largely remodeled in the mid-20th Century

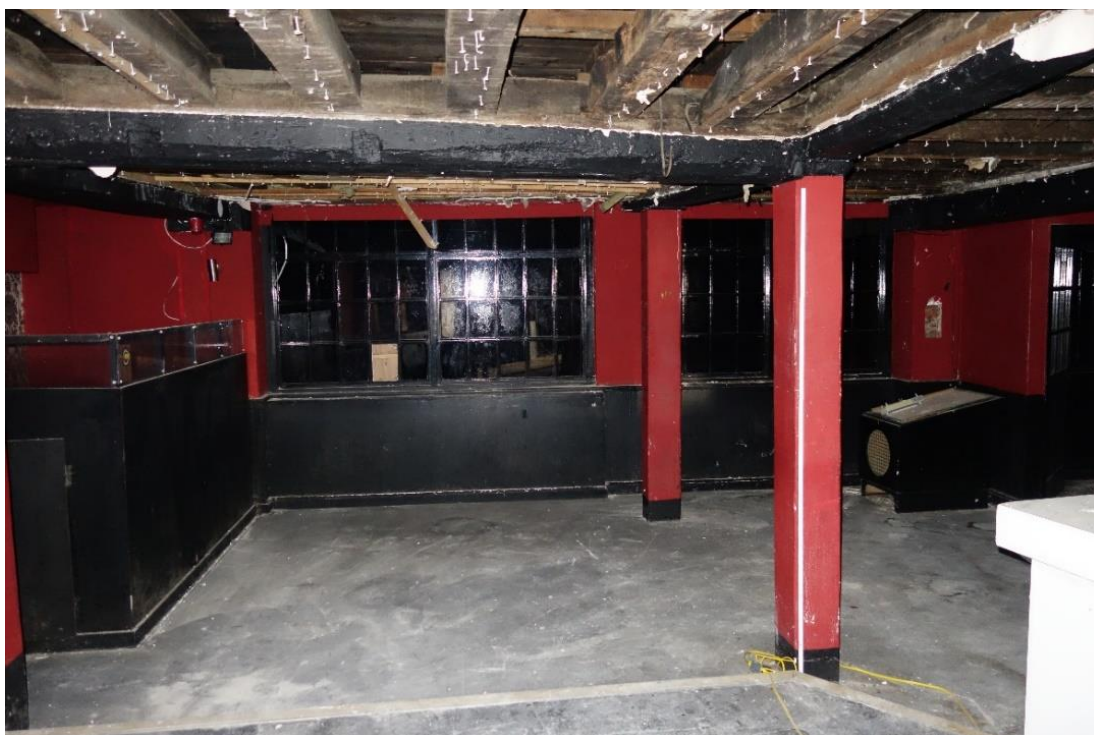
Plate 3: Internal view within ground floor of Block A showing exposed ceiling beams and joists and modern latticed glazing

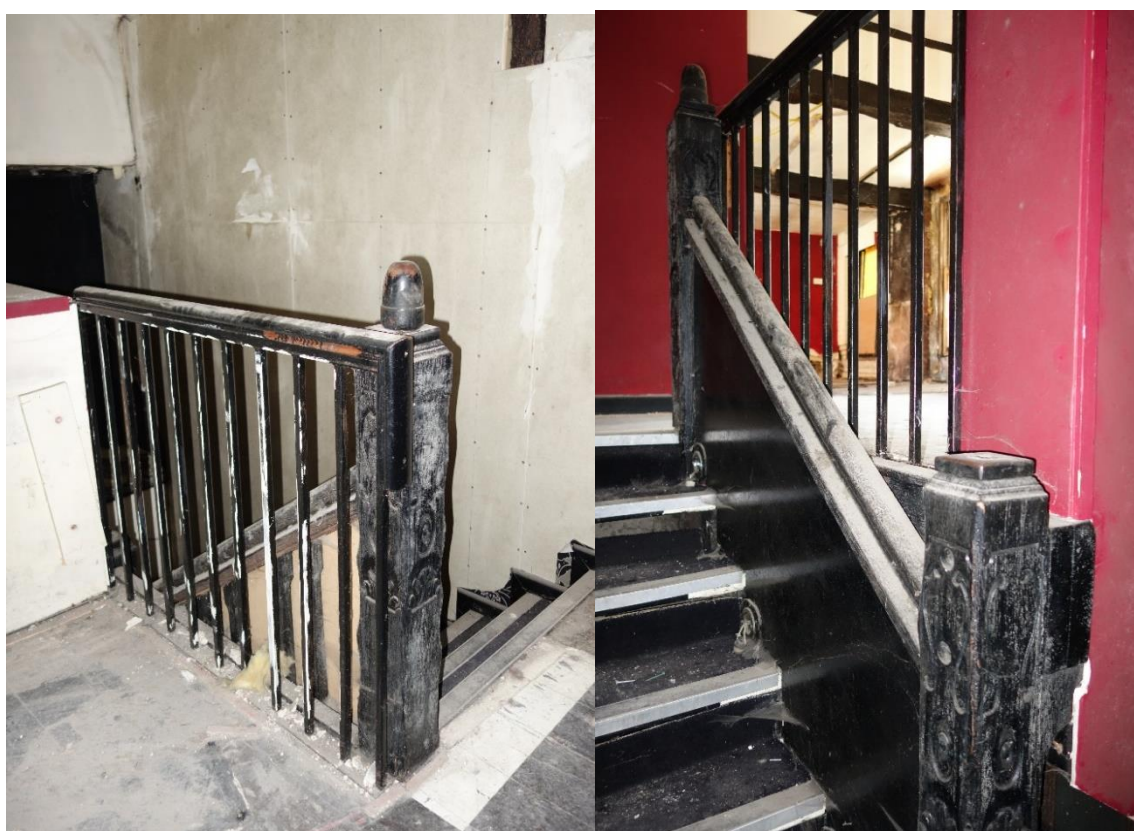
Plate 4: Internal view NW from first-floor landing in Block A showing newel post with ball finial and later balustrade with stick balusters

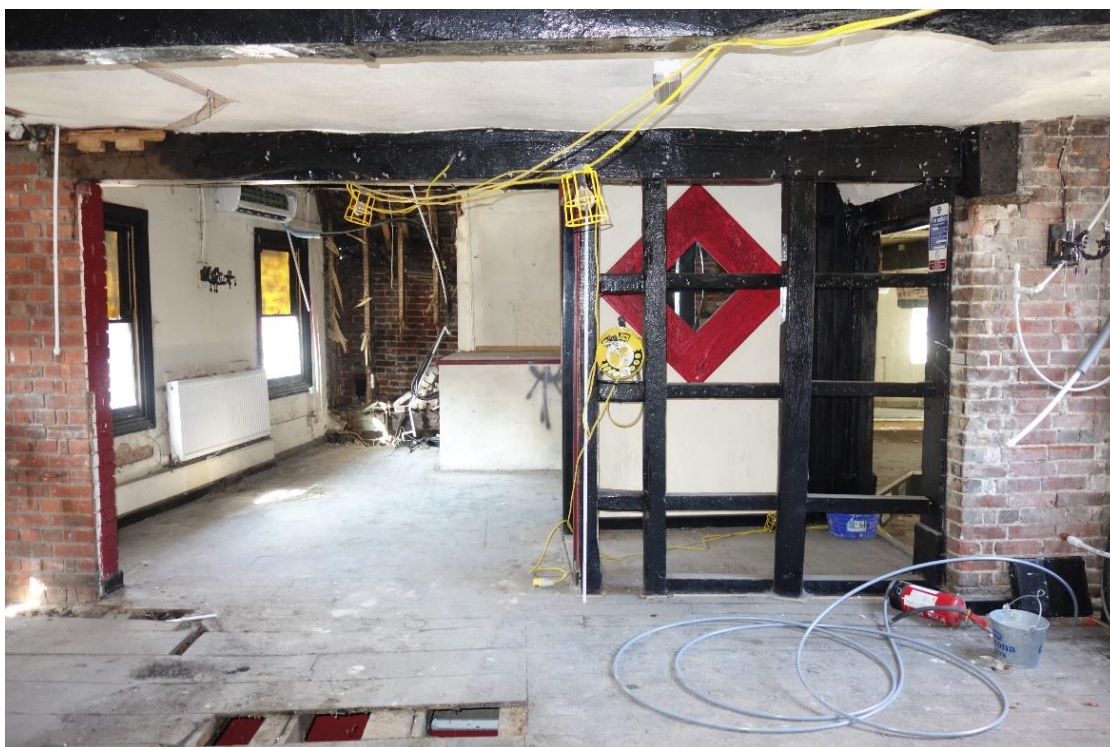
Plate 6: Internal view looking W within first floor of Block A showing modern timber-studded partition with beam above supported by brick wall-stubs

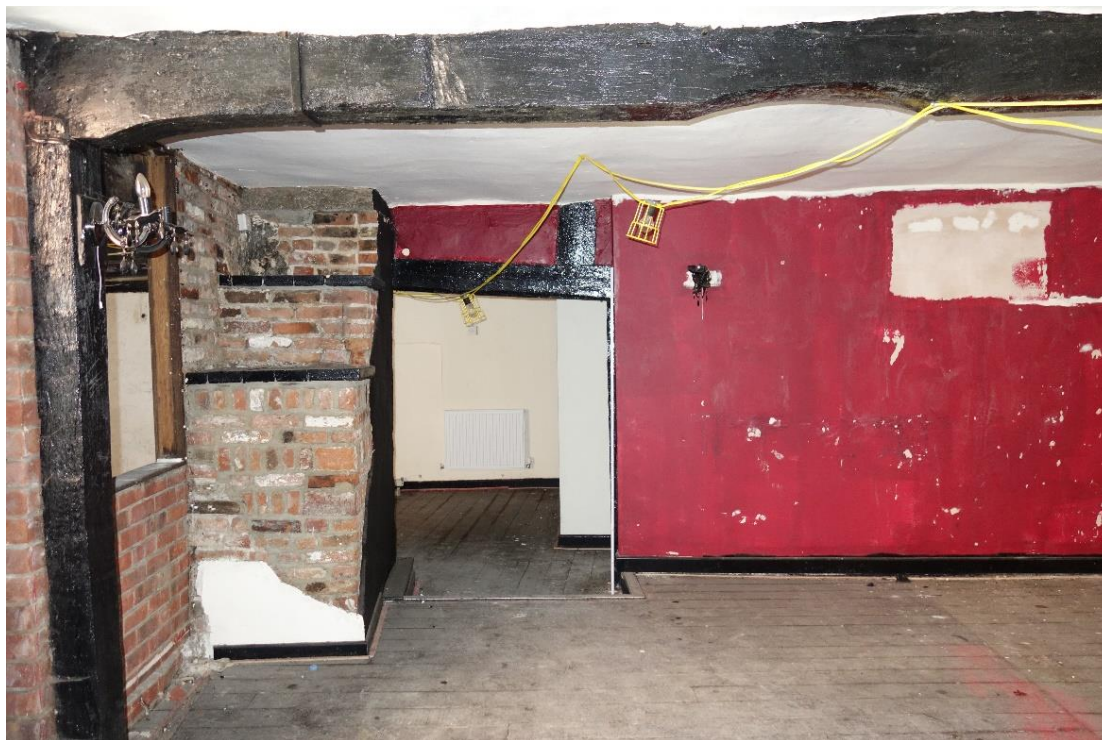
Plate 7: Internal view looking E showing partition wall between fourth and fifth bays within first floor of Block A, with exposed chamfered beam

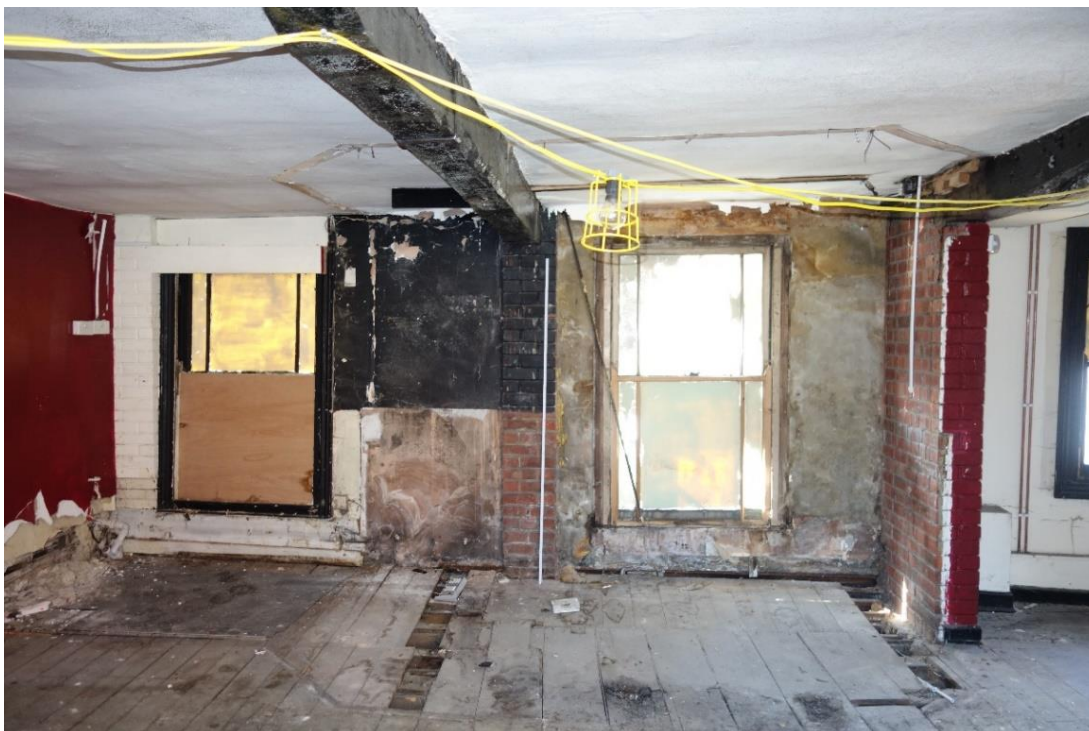
Plate 8: Internal view looking S within first floor of Block A showing brick pilaster marking construction break

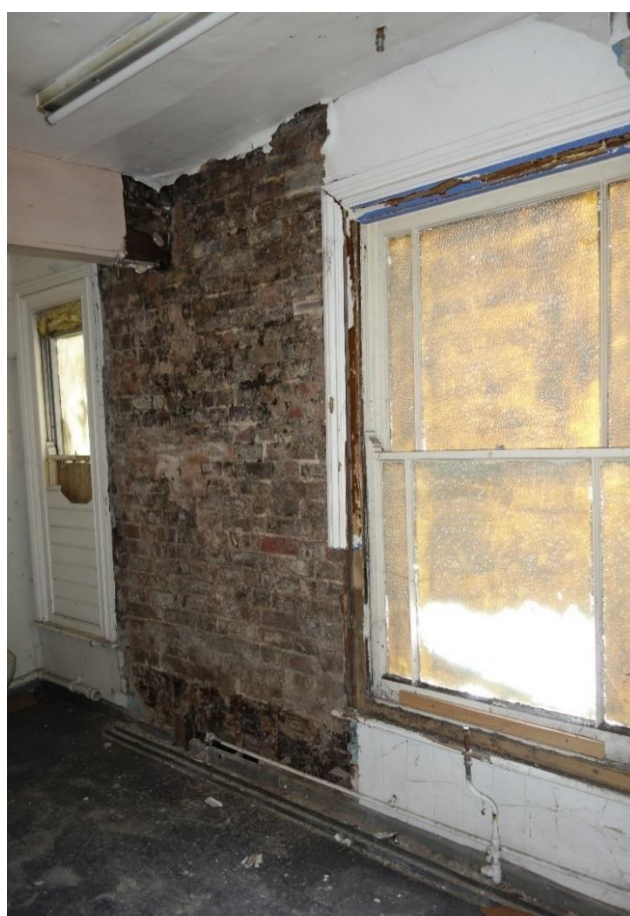
Plate 9: Internal view looking SE showing S wall within easternmost two bays of Block A with exposed brickwork

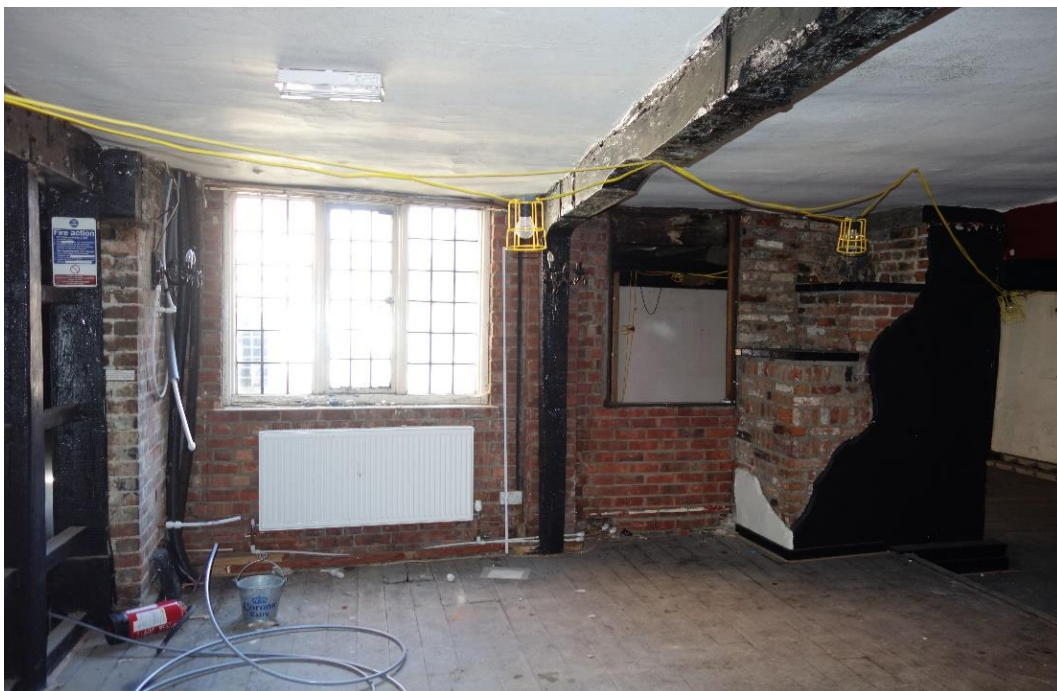
Plate 10: Internal view looking N within first floor of Block A showing modern brick wall with mullioned window, with remains of brick chimneystack visible to right of picture

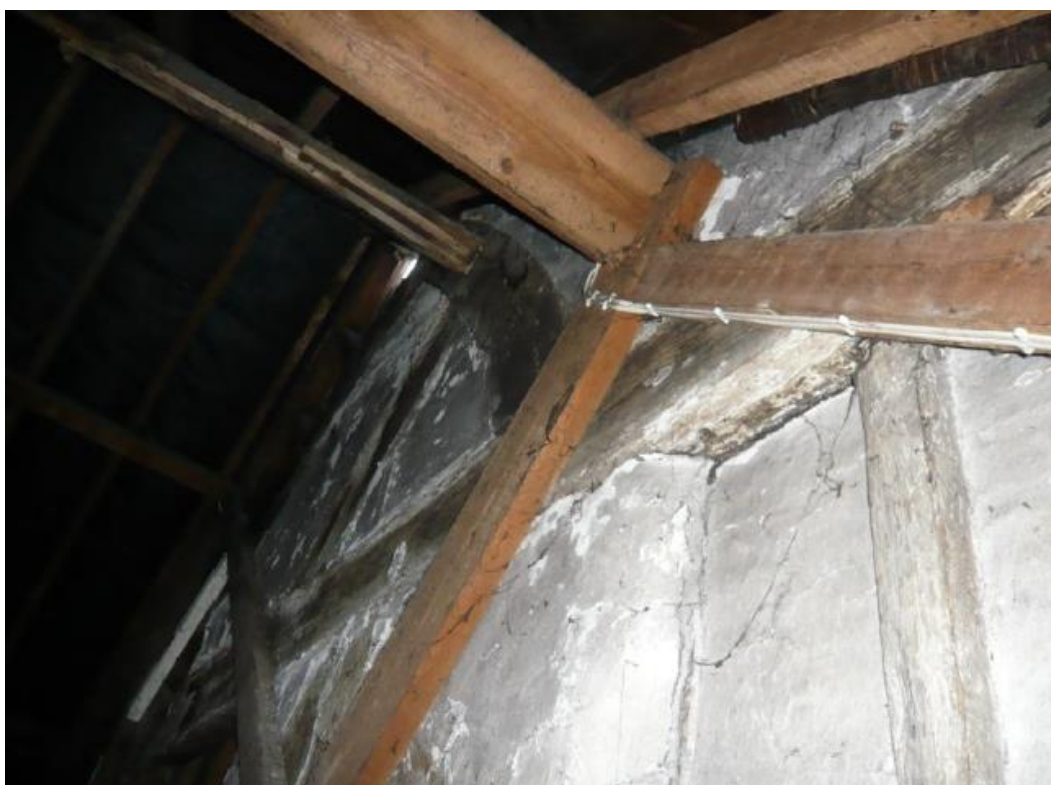
Plate 11: View within roof-space of Block A showing original timber-framing with scissor-braces above partition between fourth and fifth bays

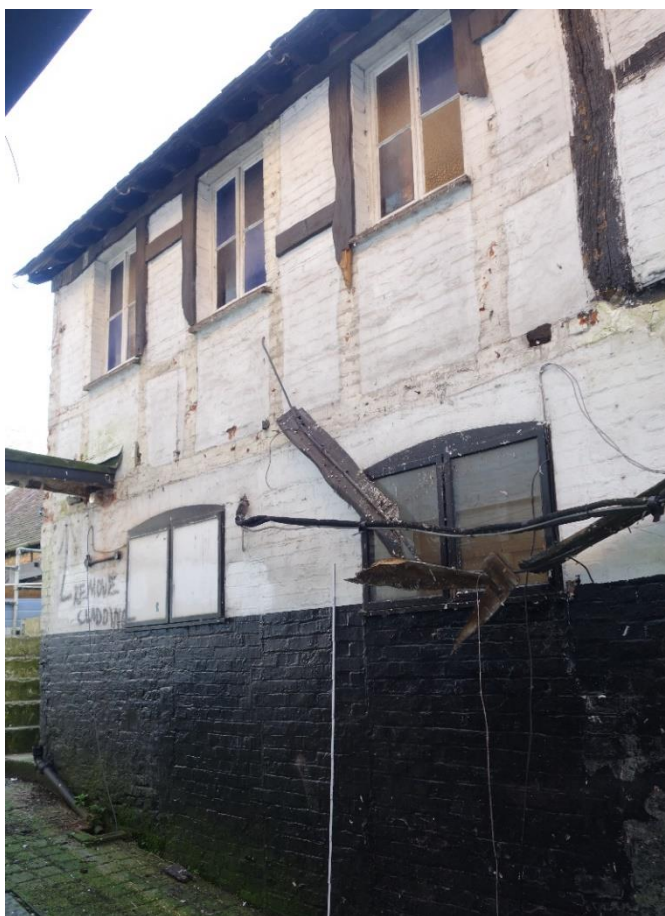
Plate 12: View looking NE showing W-facing elevation of Block B with segmental-arched windows at ground level and upper storey with false timber-framing

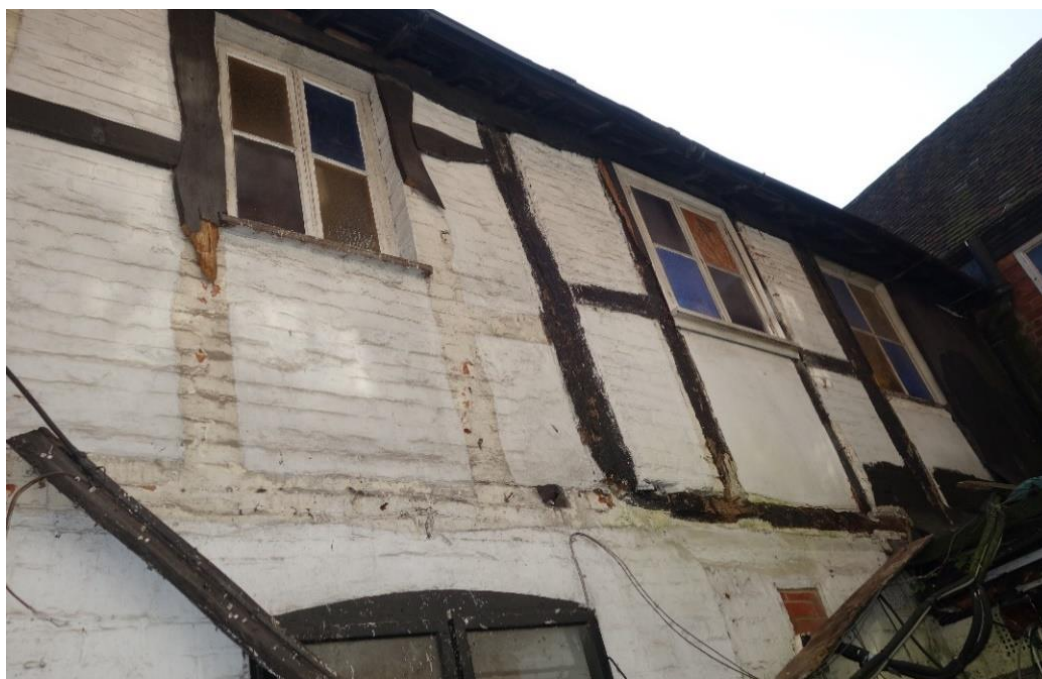
Plate 13: View looking SE showing upper storey of Block B with original timber-framing in southernmost two bays

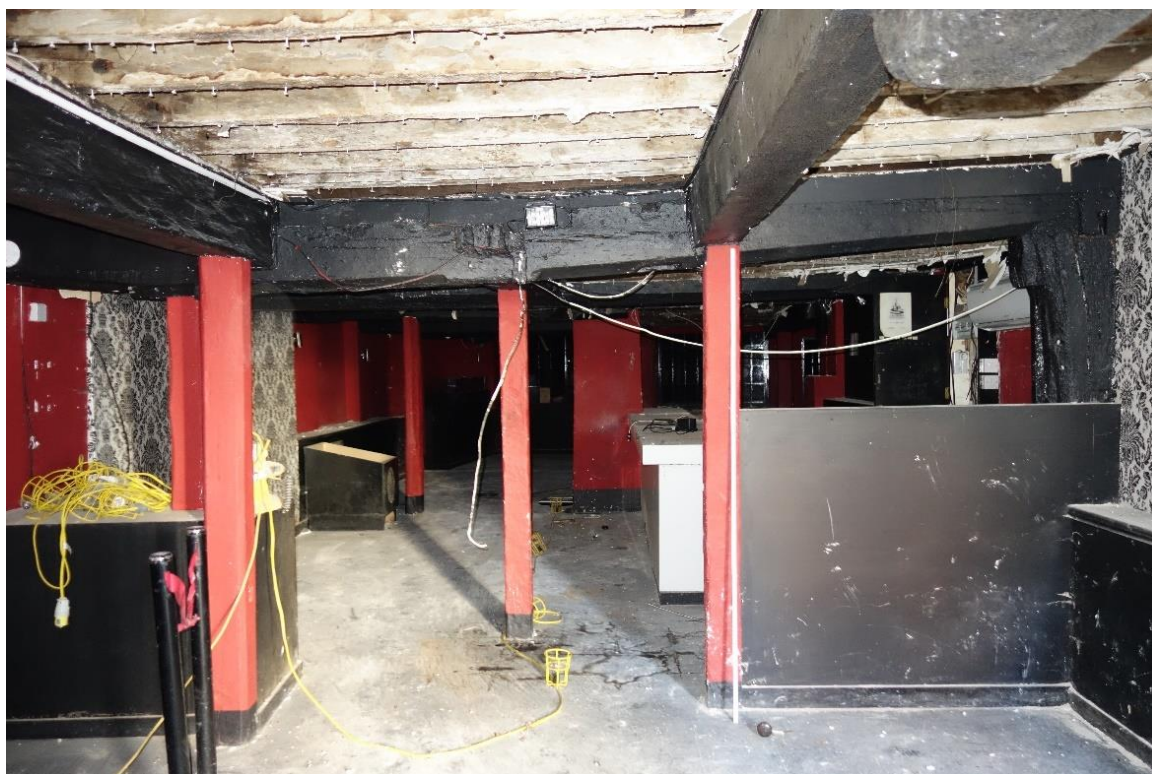
Plate 14: Internal view showing ground floor of Block B with exposed ceiling beams and joists

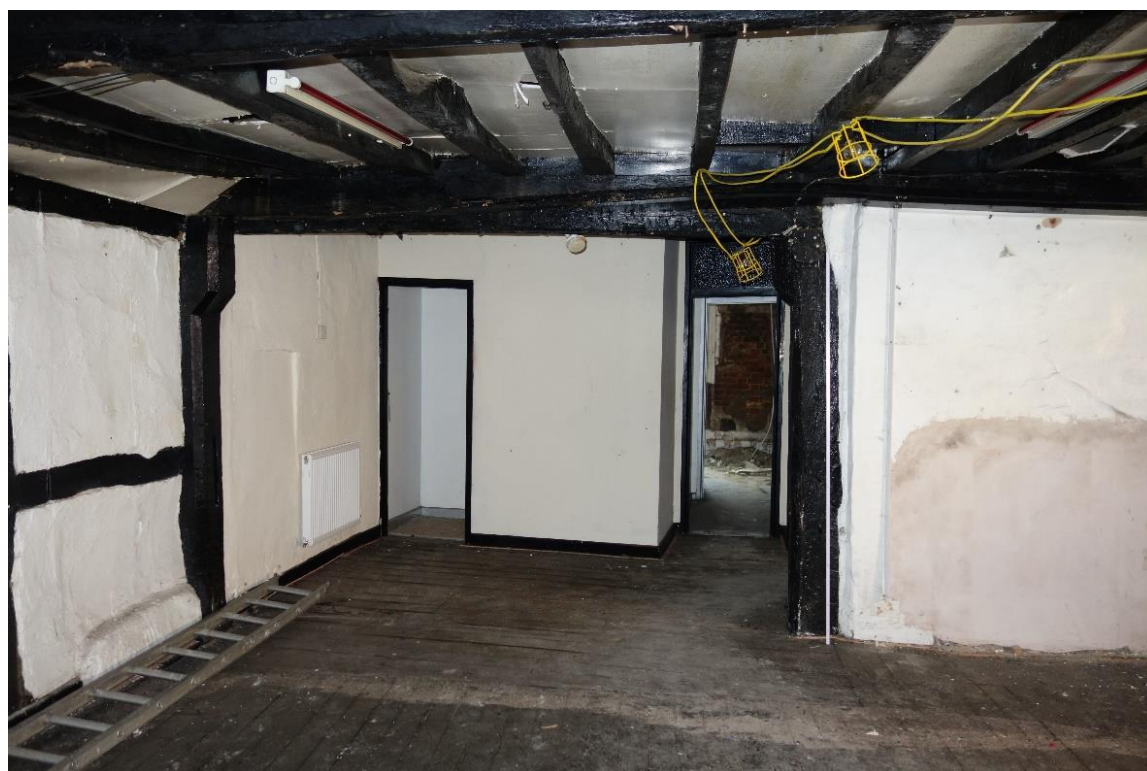
Plate 15: Internal view looking S showing southernmost bays of first floor within Block B with jowelled wall-posts and square-framed panels with lath-and-plaster infill

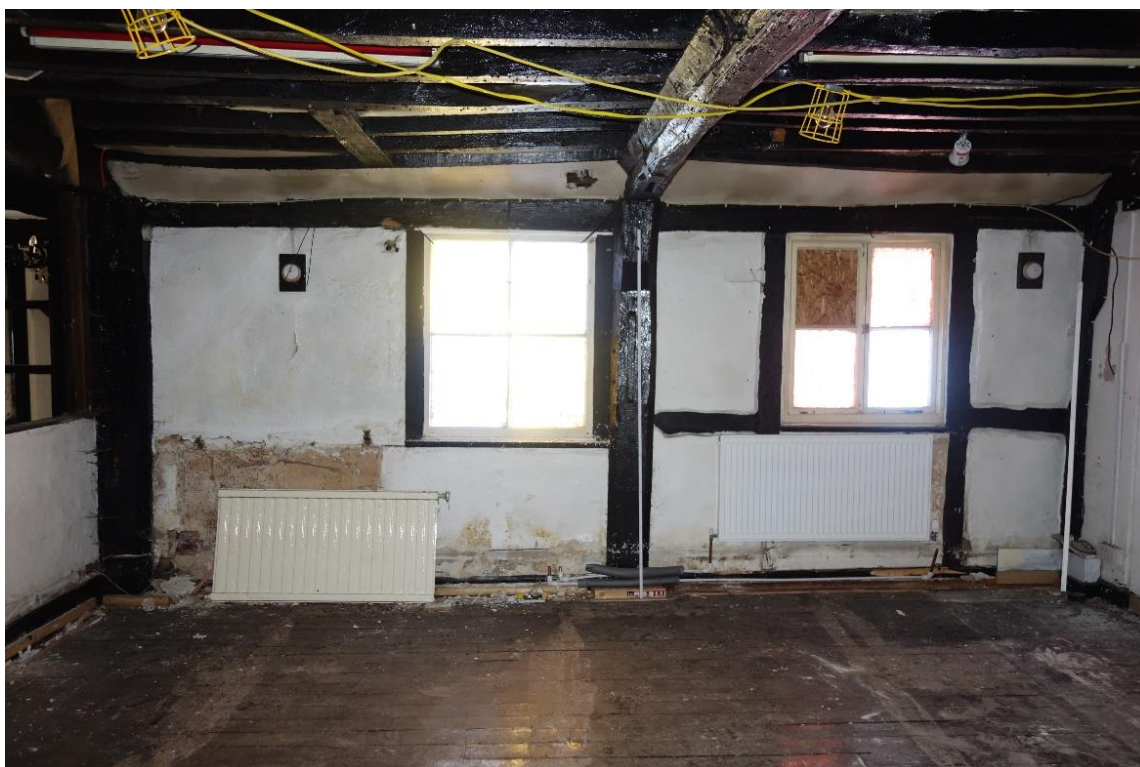
Plate 16: Internal view looking W within southernmost two bays of Block B showing W wall with timber-framed panels with brick and lath-and-plaster infill and modern casement windows, as well as exposed ceiling beams and wall-posts

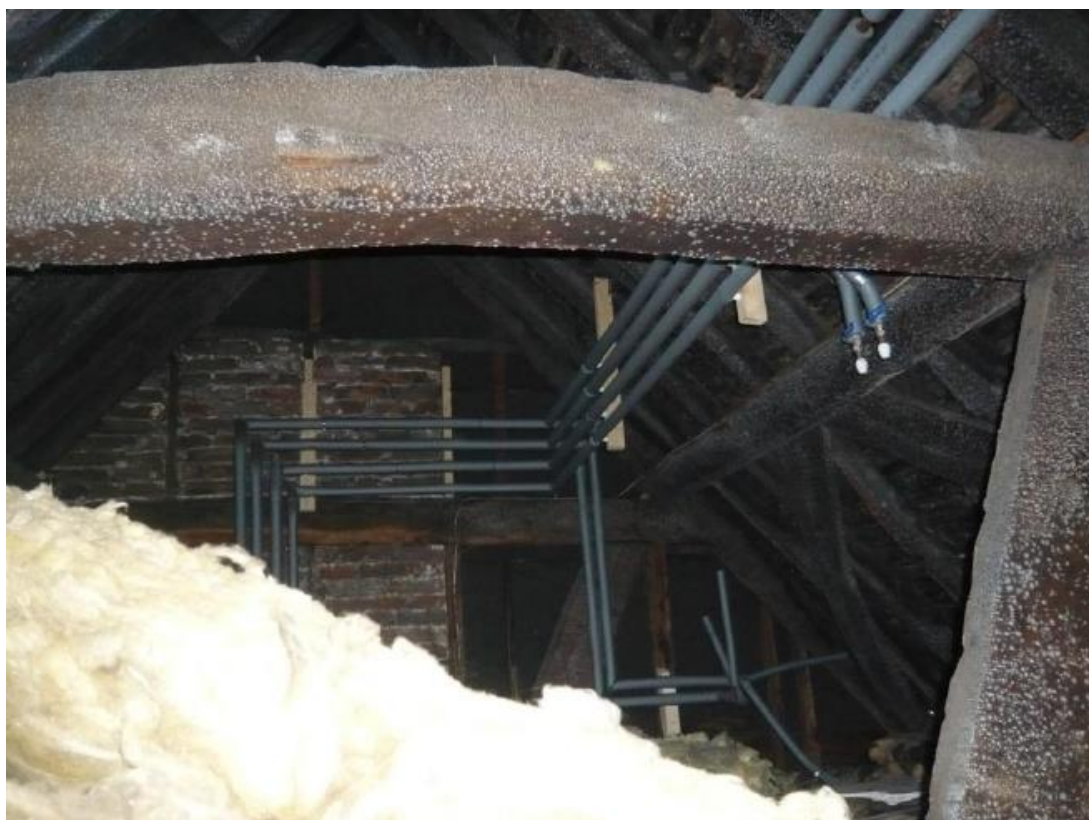
Plate 17: Internal view showing roof-space within southernmost two bays of Block B, with collar and tie-beam trusses of 16th Century date

Within the southernmost two bays, however, significant evidence of historic fabric was noted that can probably be assigned a 16th Century date. Surviving features include substantial jowelled wall-posts marking the partition between Block B and the earlier S range (*Plate 15*), evidence of timber-framed panels with lath-and-plaster infill in the E and W walls and chamfered tie-beams carried on moulded wall-posts with exposed ceiling joists (*Plate 16*). The narrow floorboards appeared to be of 19th Century date. The roof trusses visible within the southernmost two bays of Block B were of substantial collar and tie-beam construction, with clasped purlins, curved struts and curved wind braces, suggestive of a 16th Century date (*Plate 17*).
