Limited Standing Building Recording & Archaeological Observation

**The White Rooms
Nos 23-25 Milford Street
Salisbury
Wiltshire**

March 2019

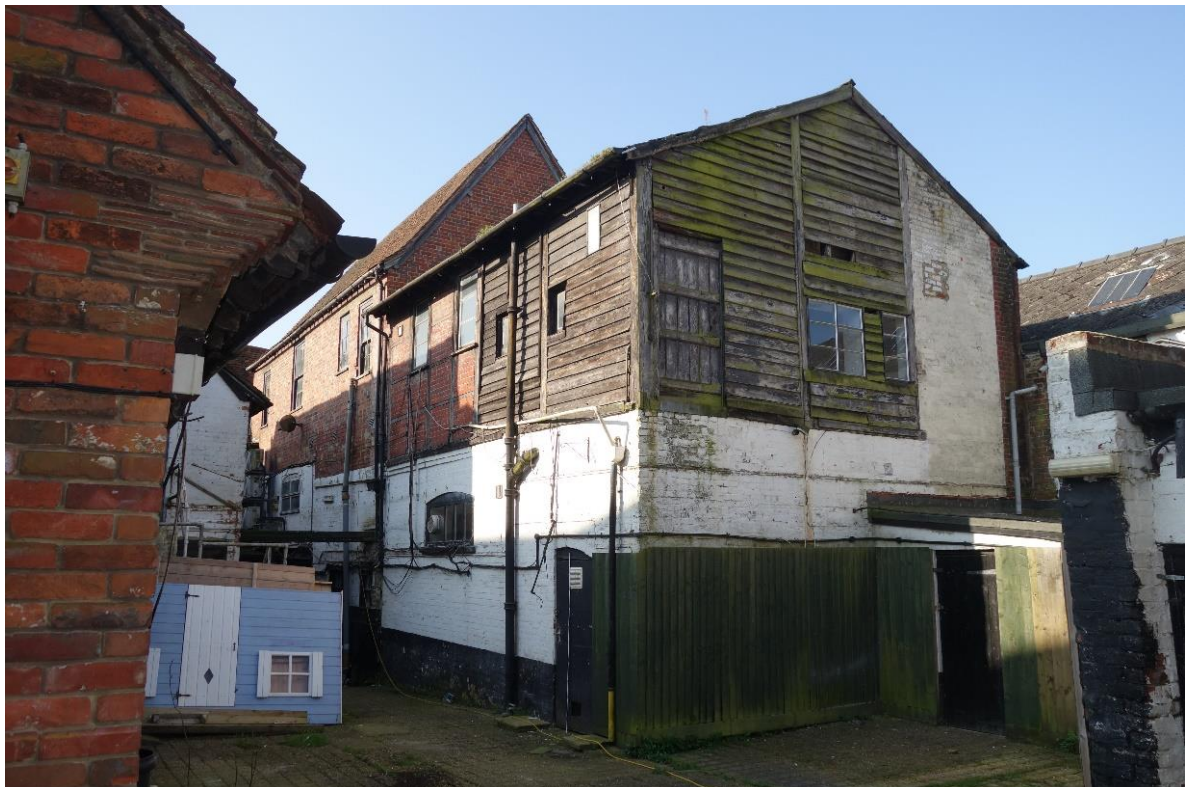
Plate 18: View SW showing three storey gabled range of early to mid-19th Century date (Block C) with two-storey range (Block D) in foreground

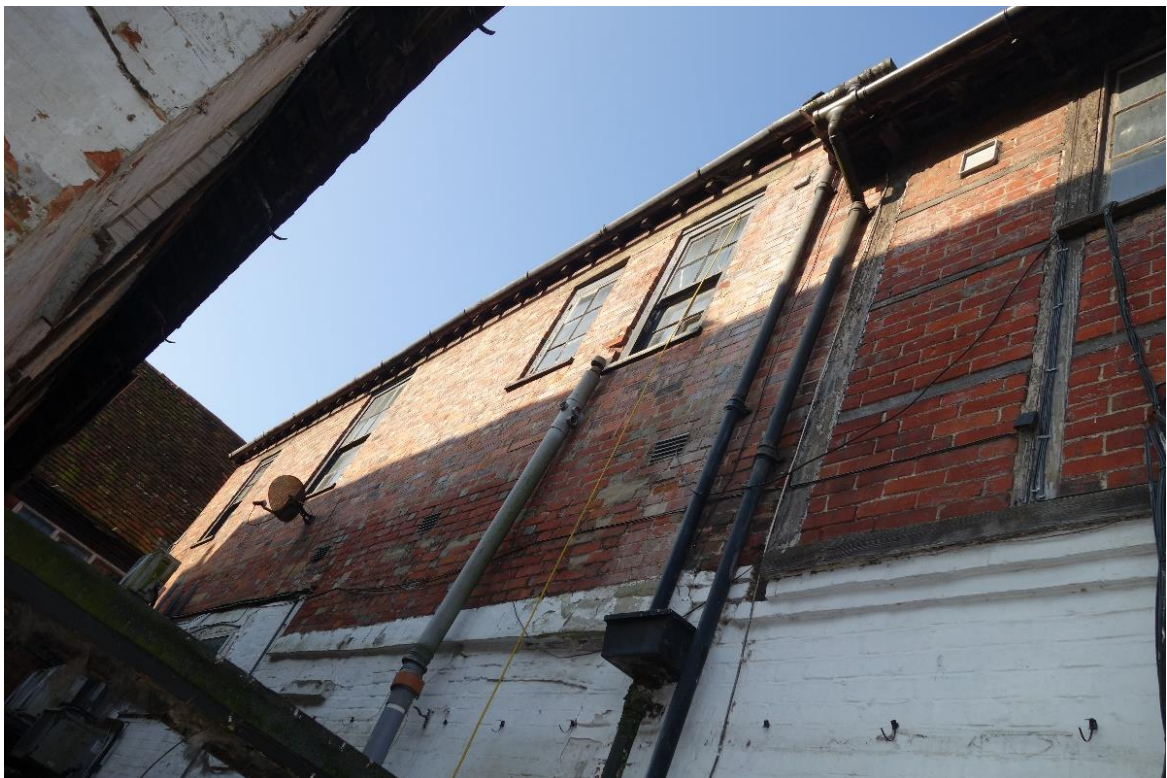
Plate 19: View showing detail of fenestration of three-storey brick range (Block C)

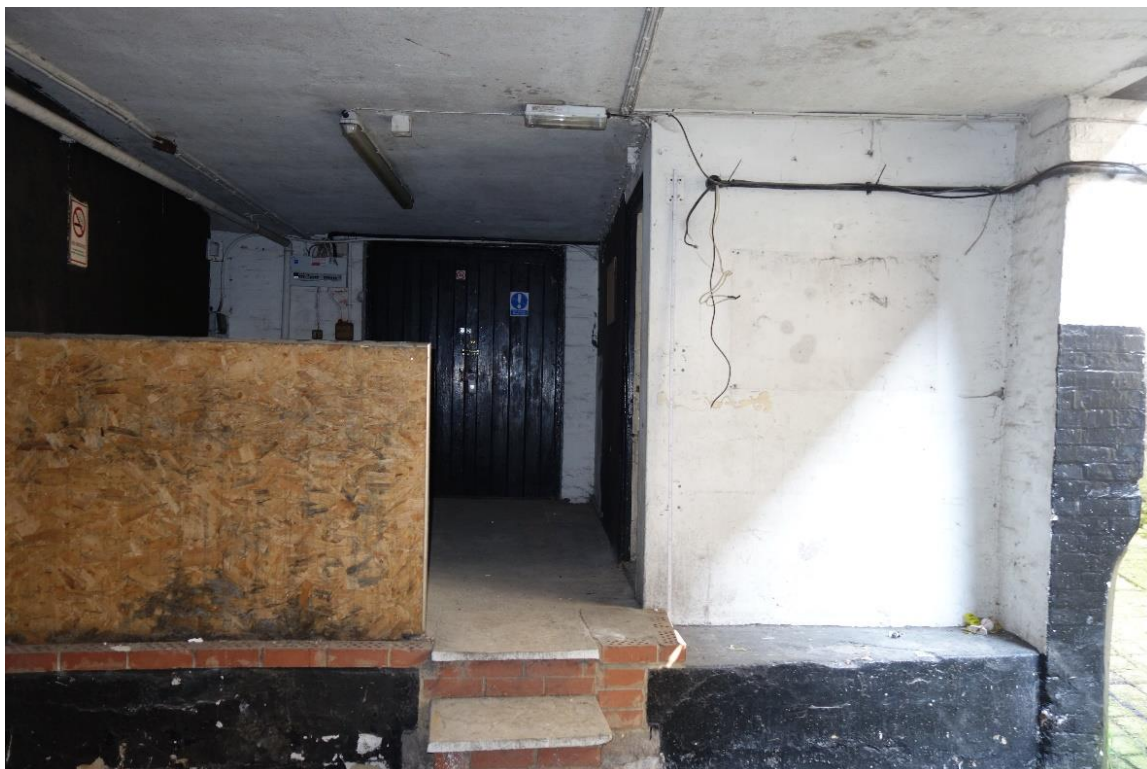
Plate 20: View looking N showing ground floor of Block C, gutted to create a loading bay

Internally, Block C was substantially altered in the late 20th Century and few original fixtures and fittings are visible. The ground floor of this range has been completely gutted to create a loading bay and storage area and, apart from the two casement windows in the E wall, no other features of interest were noted (*Plate 20*).

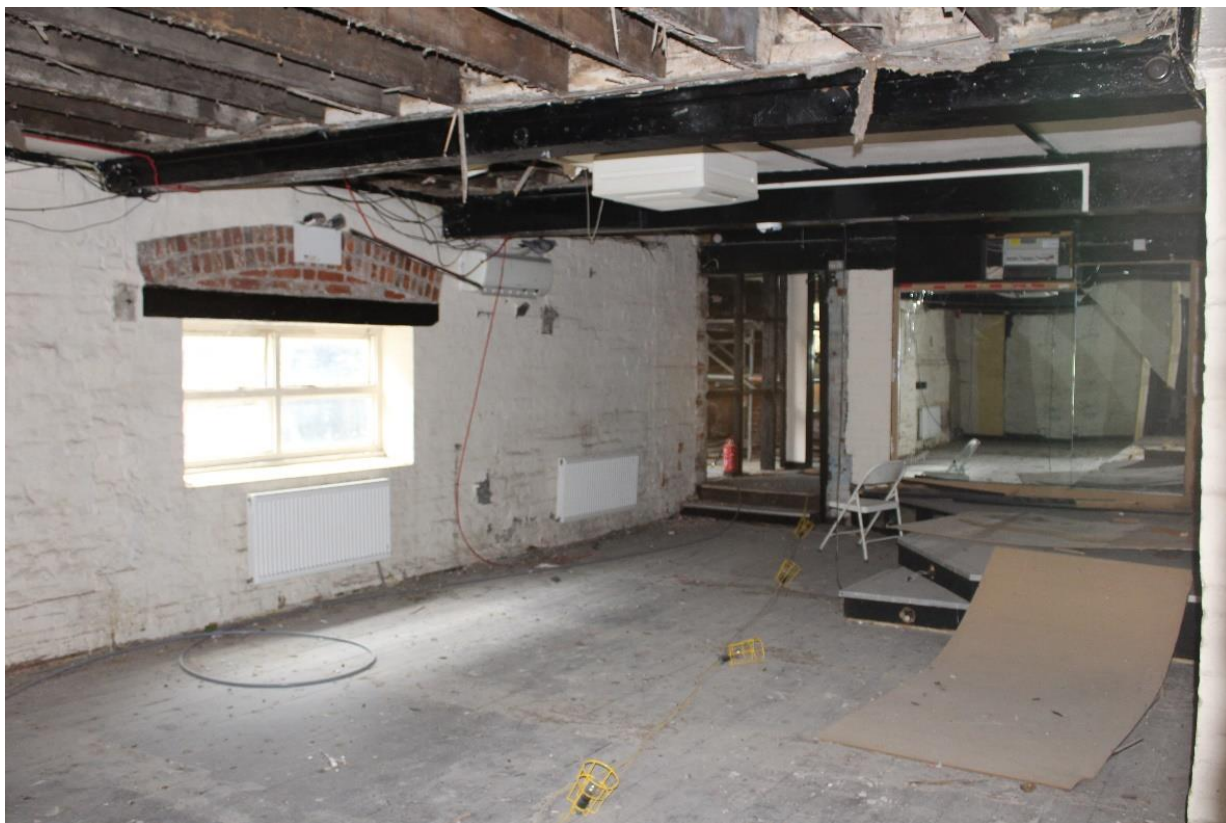
Plate 22: Internal view looking SE showing first floor of Block C lit by broad segmental-arched window

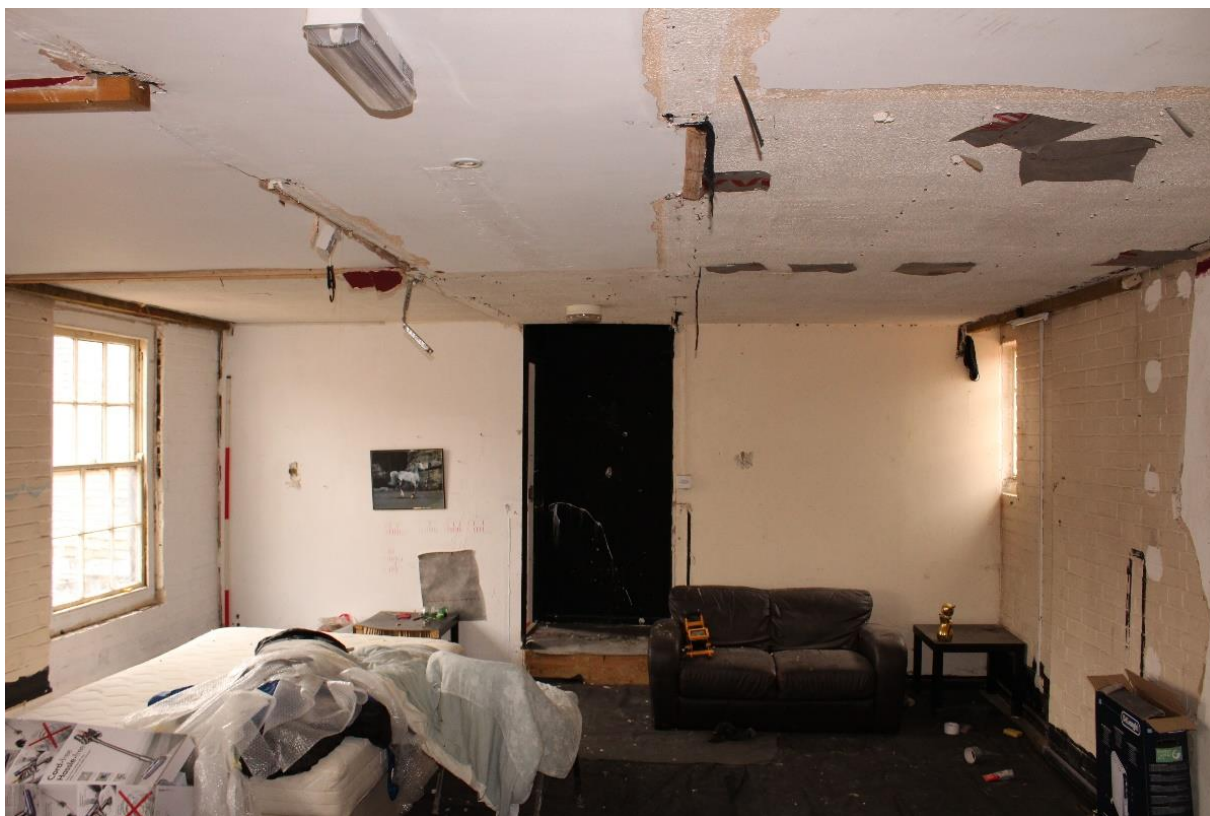
Plate 23: Internal view looking S showing second floor of Block C with modern partition

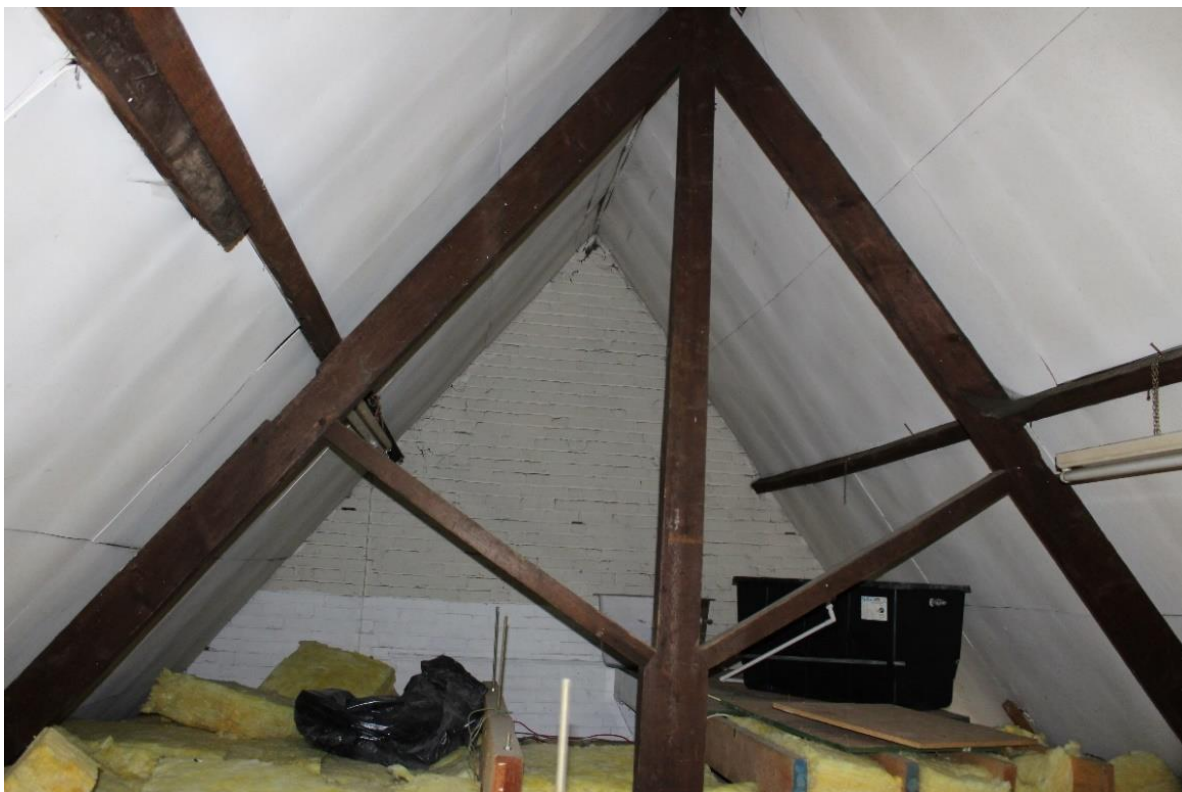
Plate 24: View showing kingpost roof-trusses within roof-space of Block C

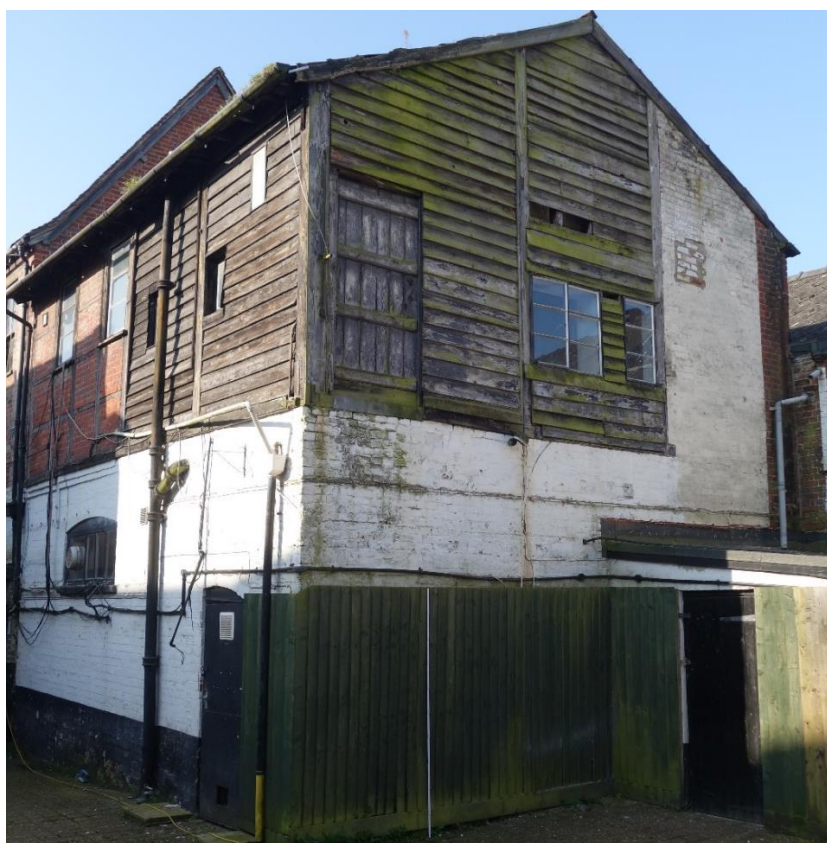
Plate 25: View looking SW showing two-storey range of brick and weatherboard construction (Block D) with weatherboard cladding in northernmost two bays

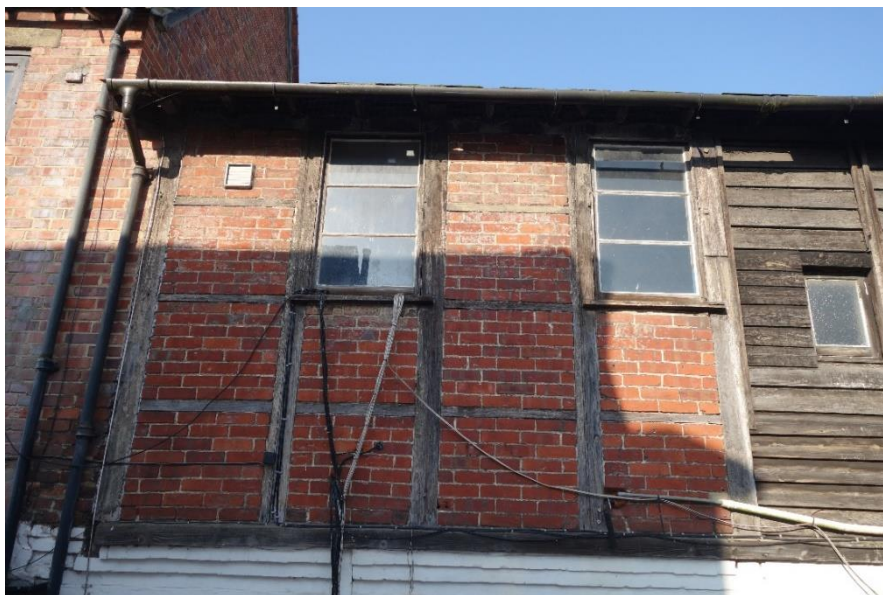
Plate 26: View looking W showing timber-framing with brick infill and casement windows in upper storey of Block D, with weatherboard cladding to right of picture

The upper storey of Block D appears to have been subject to a significant degree of alteration, probably during the second half of the 20th Century (*Plate 26*). The southernmost two bays are of timber-framed construction with brick infill (laid in Stretcher Bond); however, the northernmost two bays are clad in weatherboarding, which appears to be a relatively modern alteration; it is noticeable that in the N-facing gable, the weatherboarding appears to have been inserted in replacement of earlier brickwork. The fenestration of the E-facing elevation is somewhat irregular, consisting (from S-N) of two 3-paned casement windows and two single light windows. The N-facing gable elevation comprises a centrally-placed modern 6-paned casement window, to the left of which is a plank-and-batten door that appears to be a hayloft or loading-bay door, while to the right is a 3-paned casement window.

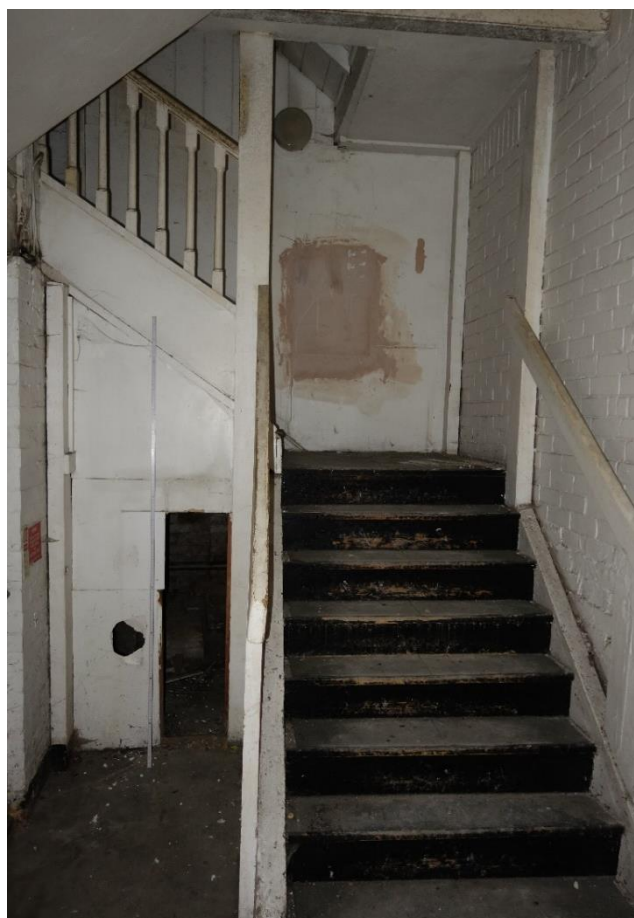
Plate 27: Internal view looking W showing dog-leg staircase with closed string, moulded handrail and stick balusters provides leading from ground floor to first floor within Block D

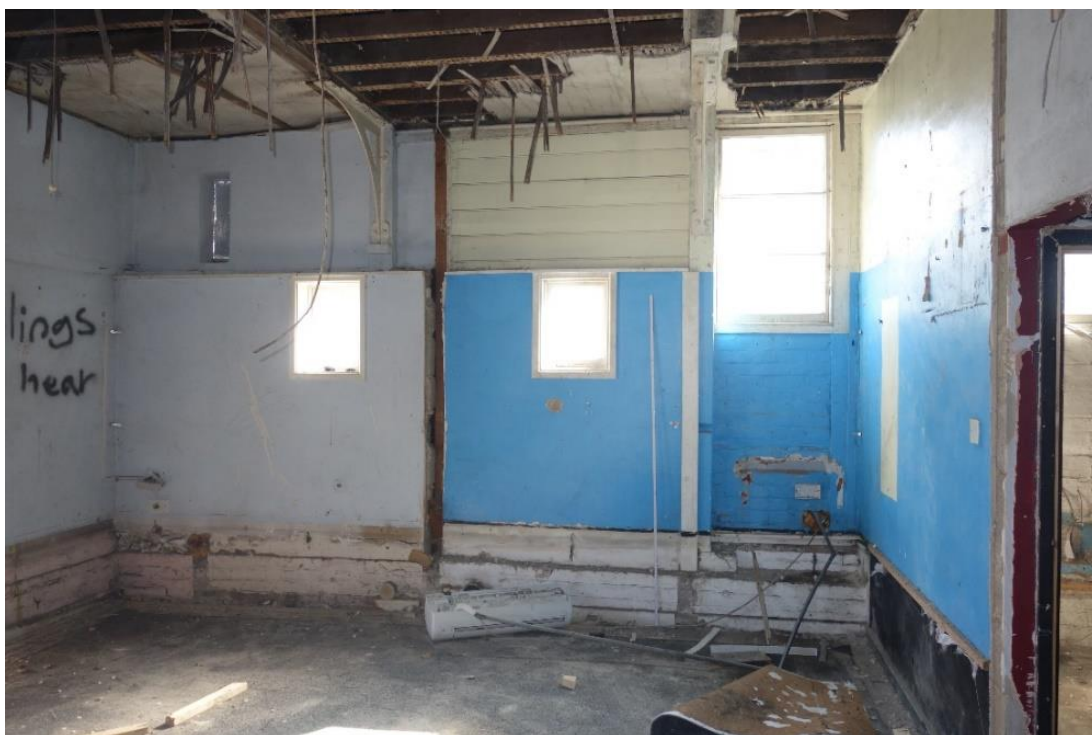
Plate 28: Internal view looking E within first floor of Block D showing ceiling beams supported by arched steel braces

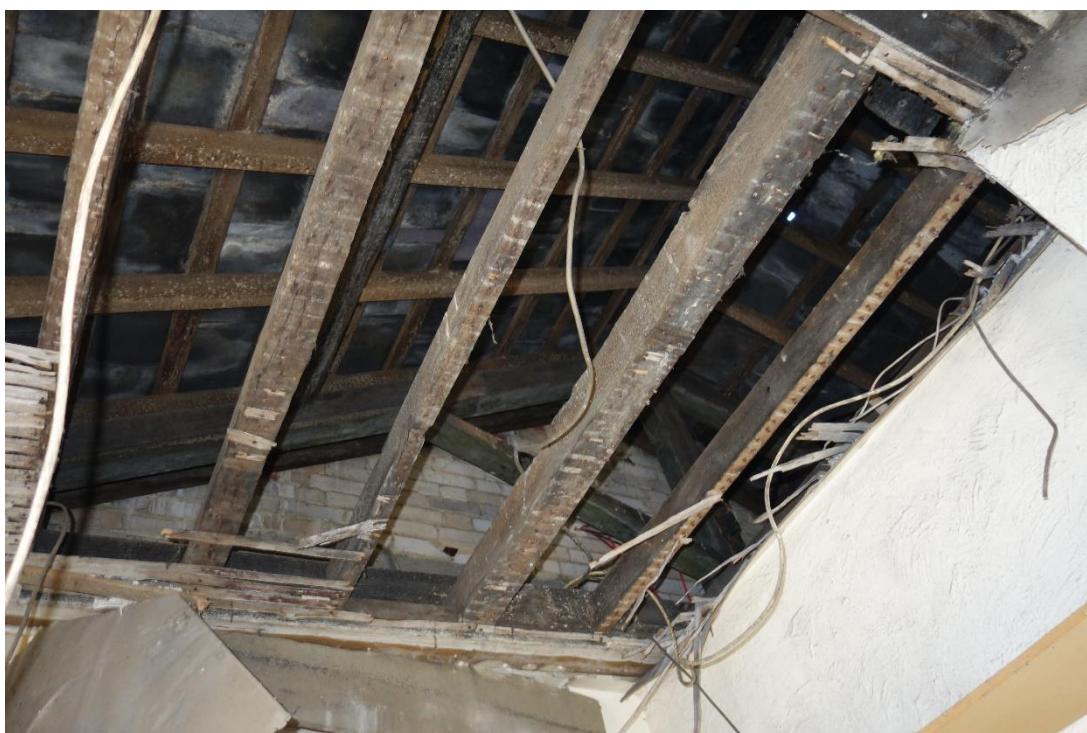
Plate 29: Internal view showing kingpost roof-truss within Block D

The ground floor has been subdivided into several compartments, used as bathrooms and WCs, by several modern lattice-glazed partitions; no features or fixtures of interest were noted. A dogleg staircase with closed string, moulded handrail and stick balusters provides access to the upper floor (*Plate 27*), which has been subdivided into two unequal-sized compartments with the insertion of a modern partition wall (*Plate 28*). The roof structure appears to be of kingpost construction, roughly similar to that within Block C, except that, in this case, the tie-beams are supported by arched steel braces (*Plate 29*).

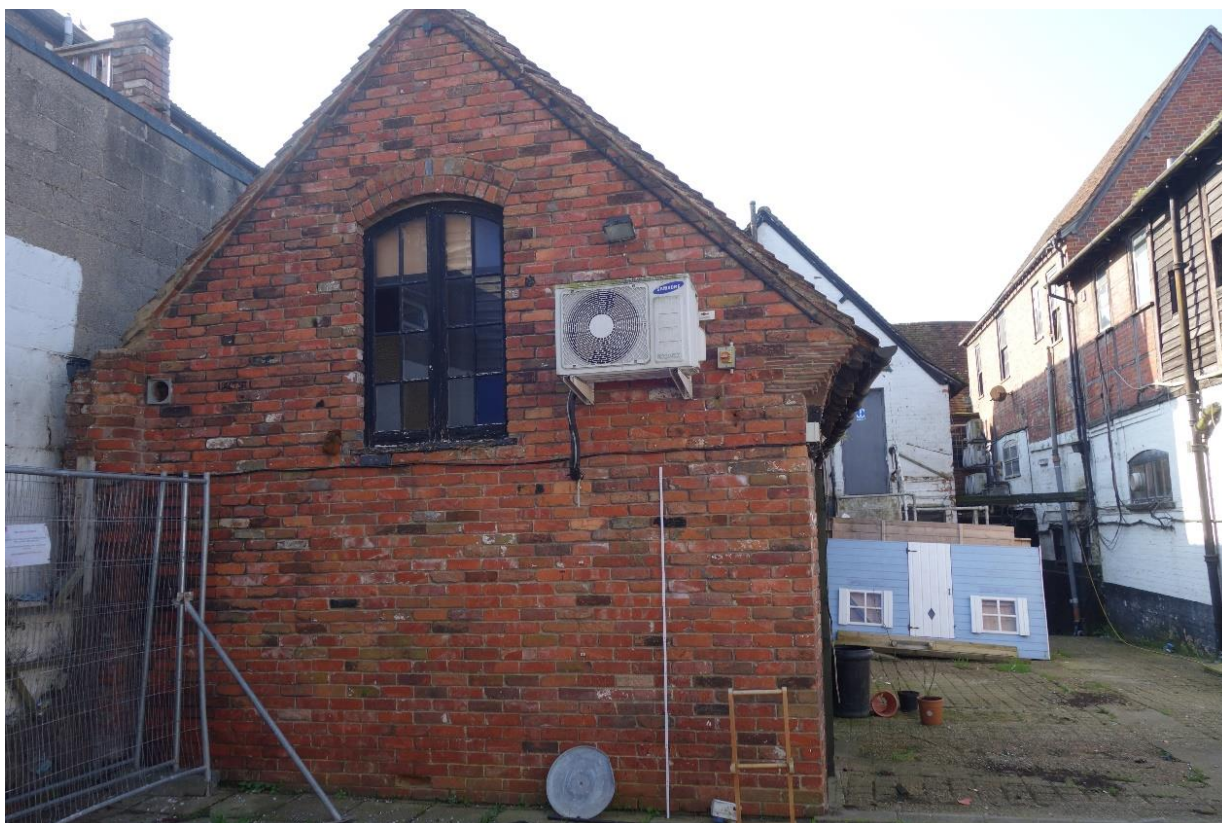
Plate 30: View looking S showing N-facing gable elevation of single-storey brick range (Block E) with segmental-arched casement window

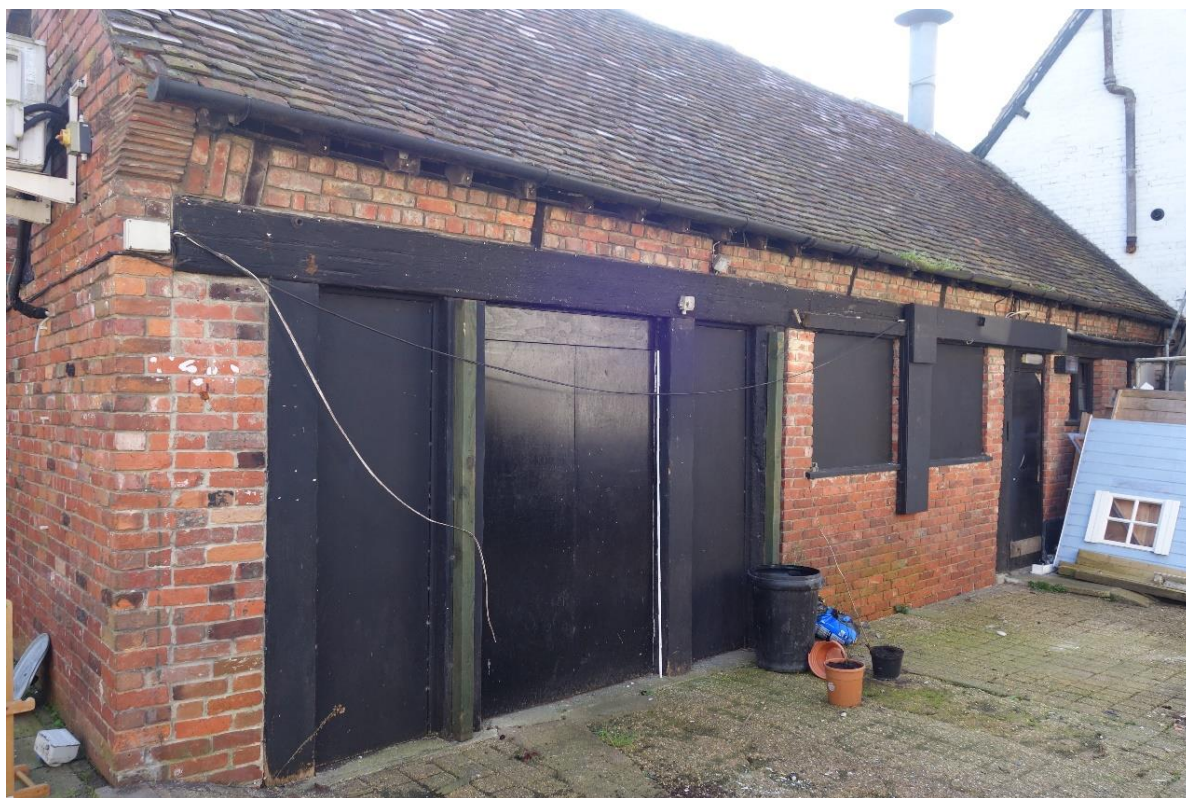
Plate 31: View looking SE showing W-facing elevation of single-storey brick range (Block E)

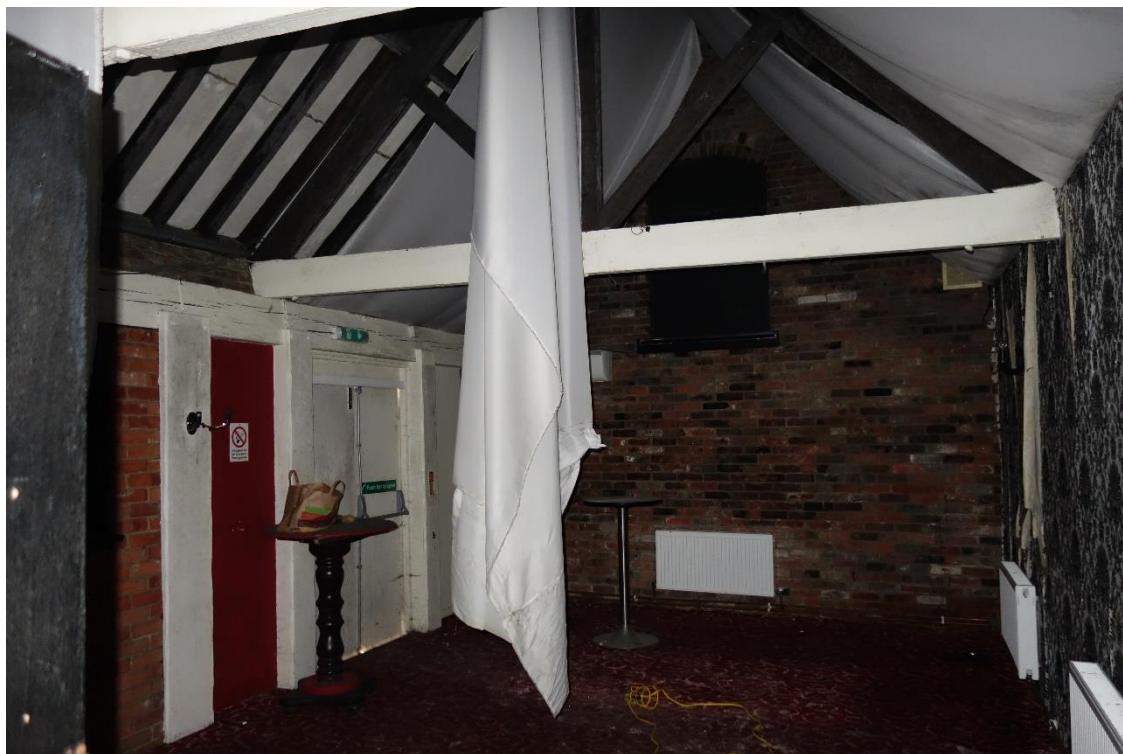
Plate 32: Internal view looking N showing kingpost roof-truss within single-storey range (Block E)

The interior of the building has been converted for use as a function room and few original fixtures or fittings are visible. The only feature of interest noted was the kingpost roof structure, although the roof-trusses appear to have been extensively renewed (*Plate 32*)

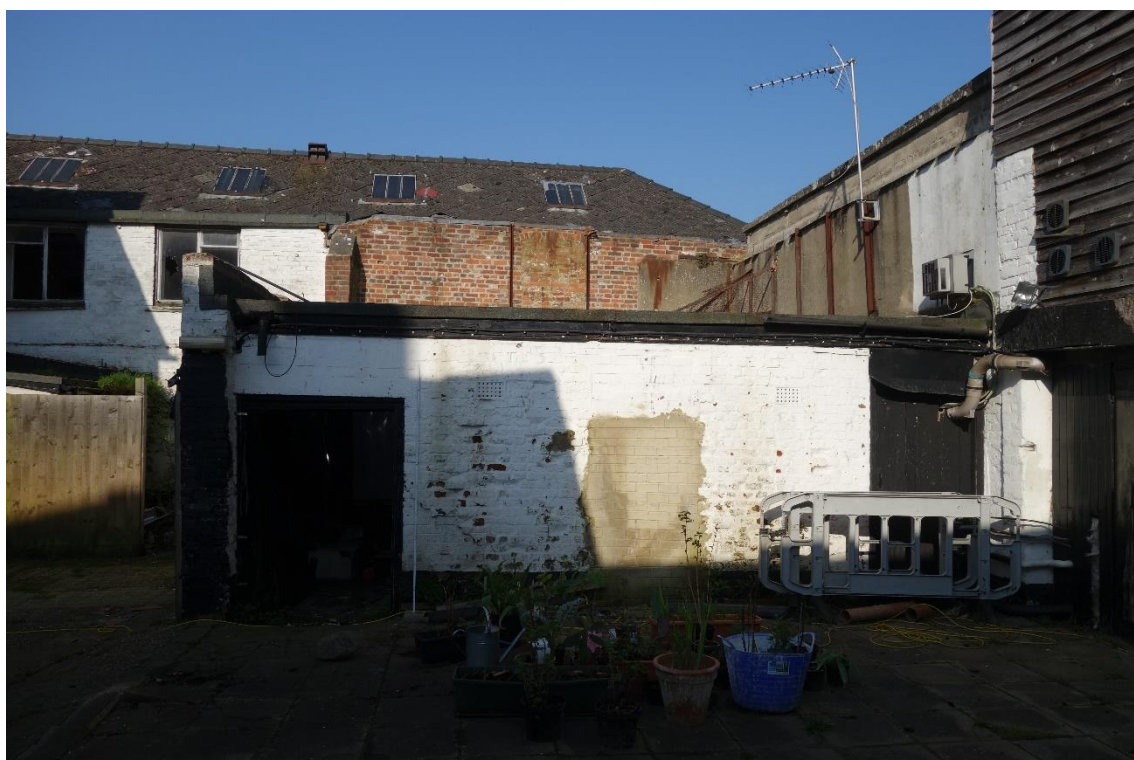
Plate 33: View looking W showing exterior of modern single-storey utilitarian range (Block F)

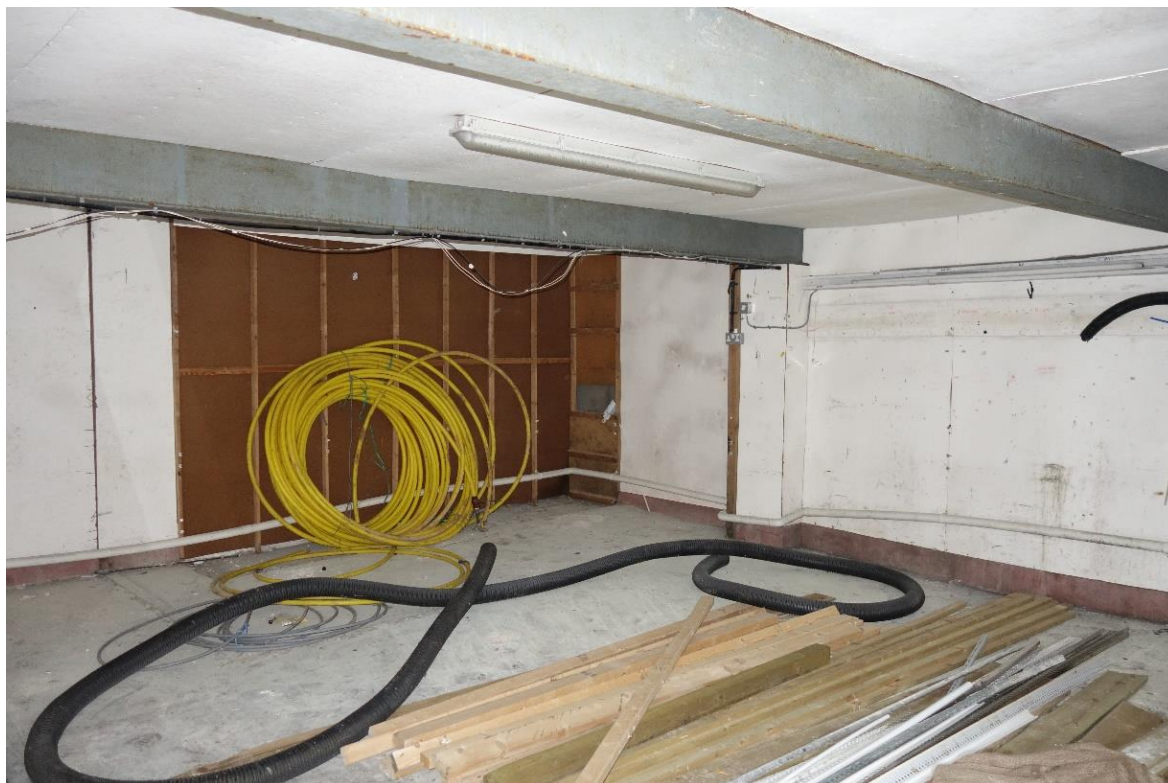
Plate 34: View looking NW showing interior of Block F with exposed steel girders

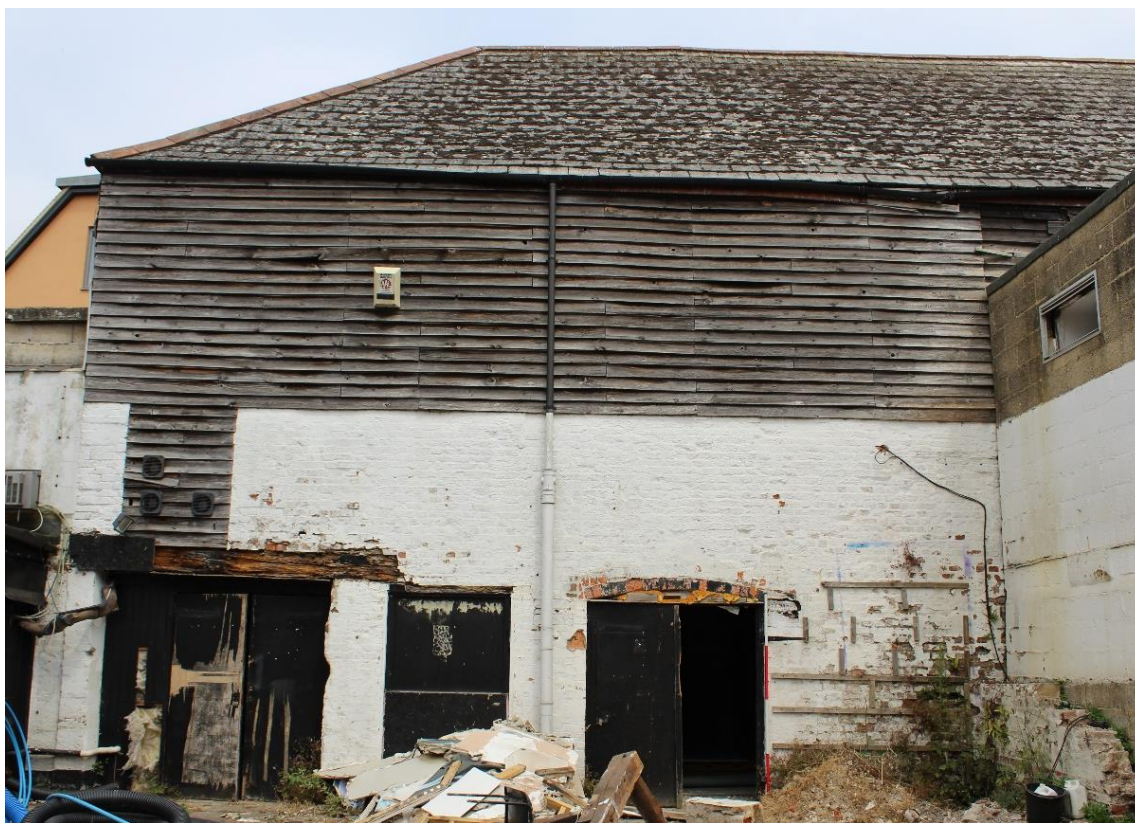
Plate 35: View looking N showing S-facing elevation of Block G, of brick and weatherboard construction

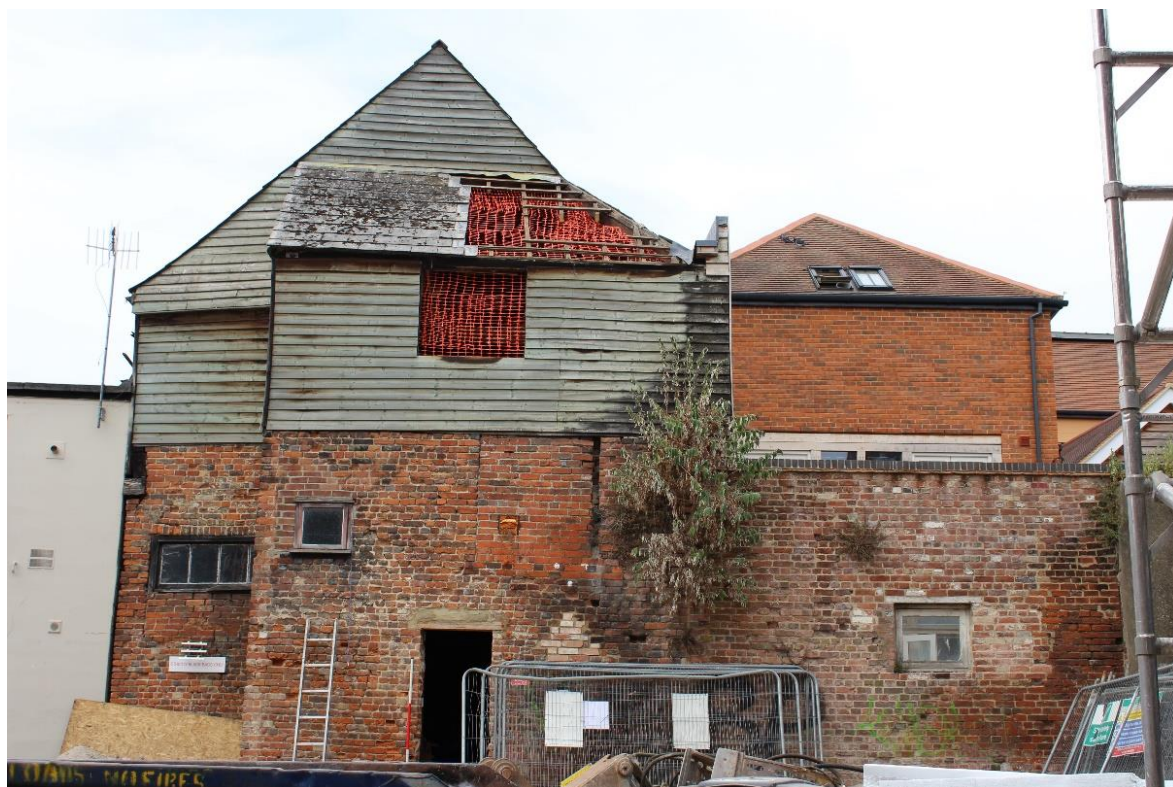
Plate 36: View looking W showing E gable end of Block G with eastern extension with catslide roof

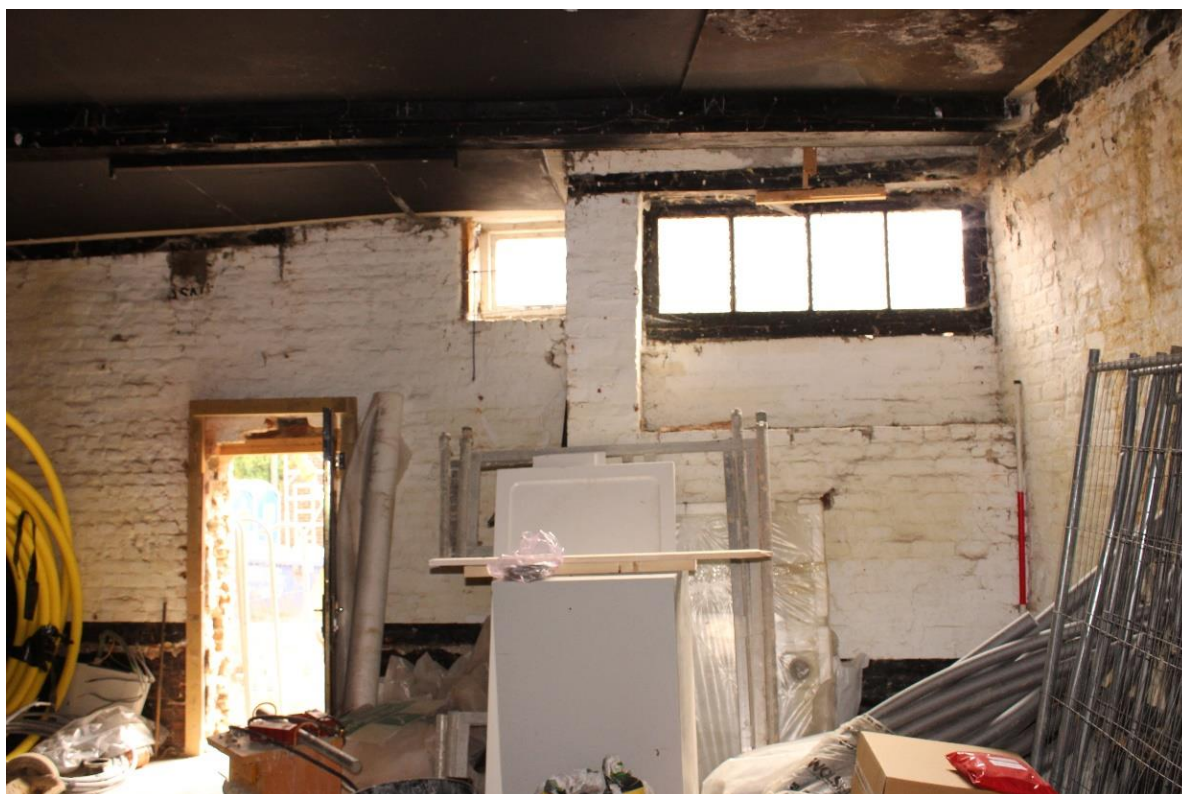
Plate 37: Internal view of ground floor of Block G looking E showing doorway to E extension with modern horizontal four-light window above and to right

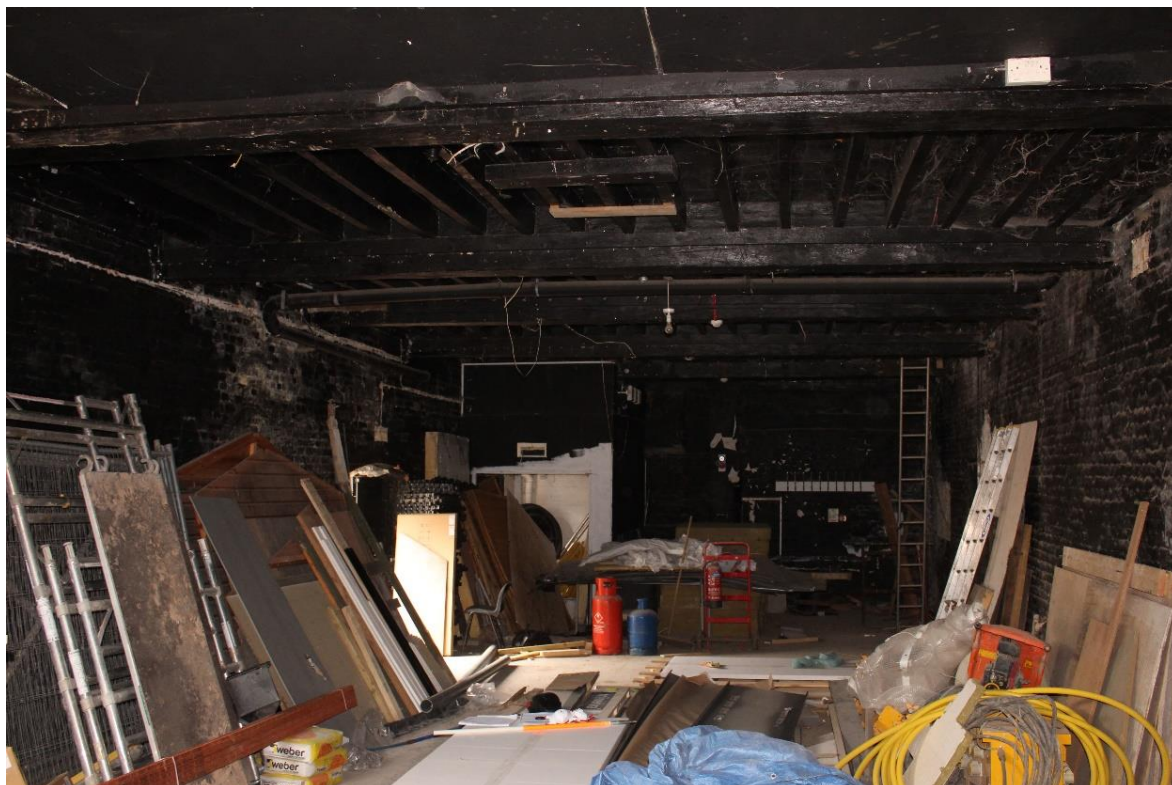
Plate 38: Internal view of ground floor of Block G looking W, showing exposed ceiling beams and joists with ladder to hatchway in NW corner

The interior of the range at ground-floor level is currently used for general storage; the brickwork has been coated in black paint and whitewash and has been largely stripped of any original fixtures or fittings. At the E end is blocked doorway providing access to the eastern extension, above which is a rectangular four-light window that appears to be a modern insertion (*Plate 37*). No evidence for internal partitions was noted at ground level, although a series of exposed ceiling beams and joists were visible (*Plate 38*).

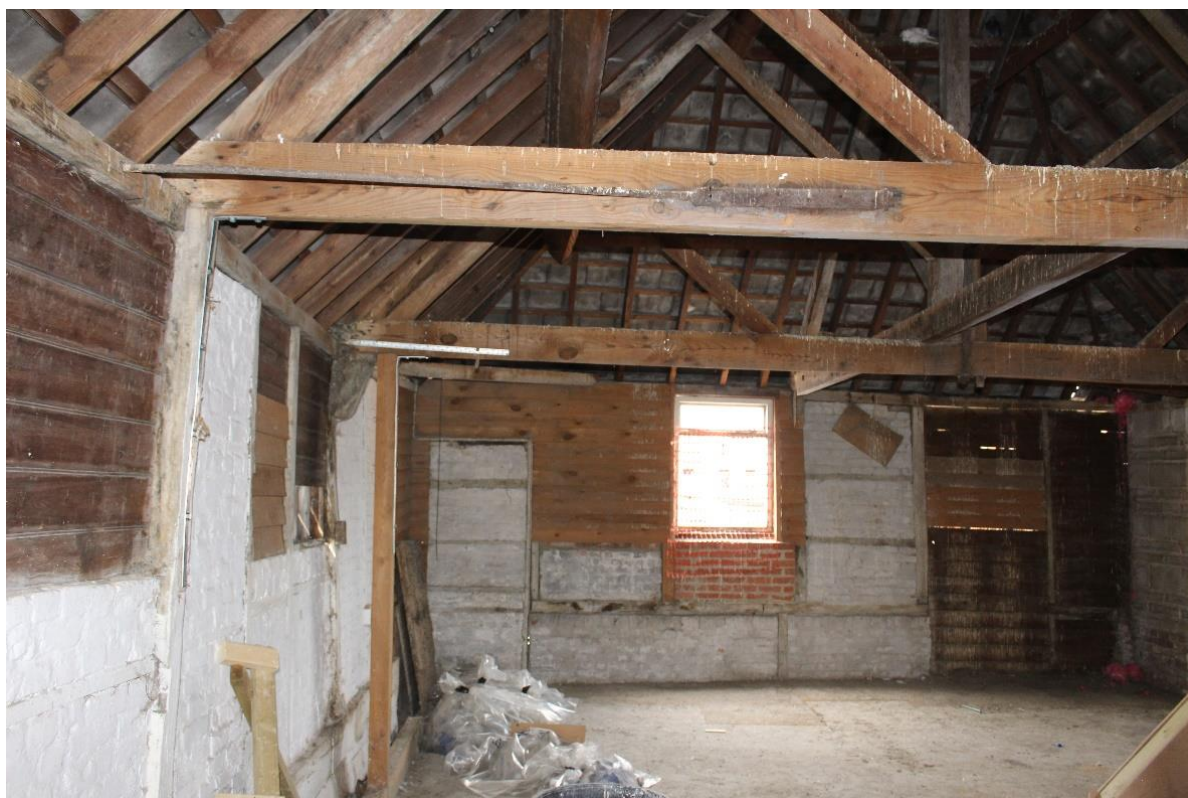
Plate 39: Internal view looking W showing upper floor of Block G with window openings in S wall (blocked by weatherboarding)

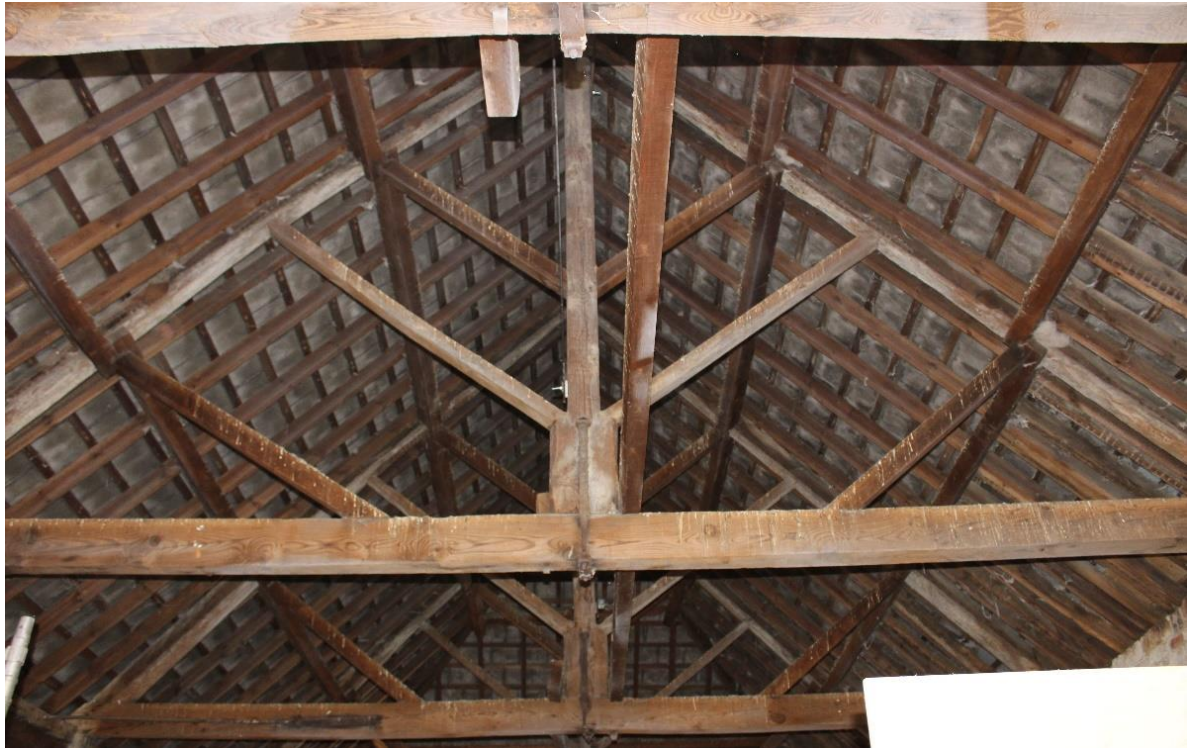
Plate 40: Internal view looking W showing kingpost roof-trusses in upper storey of Block G
