**Archaeological Standing
Building Recording**

**Osborne Quarters
Police Training Centre
Royal Victoria Country Park
Netley Abbey
Southampton
SO31 4TS**

August 2018

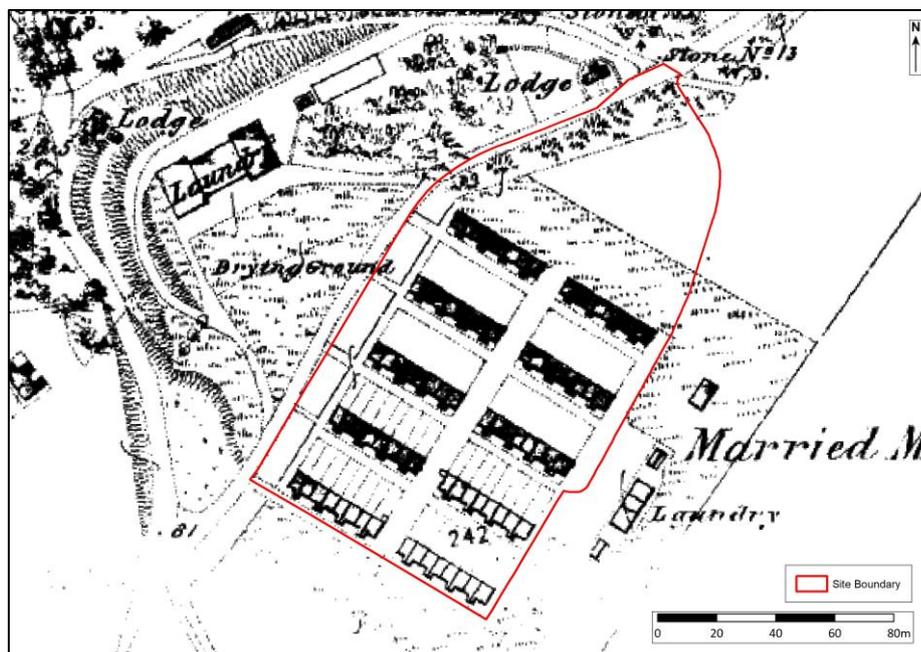
Fig. 2: Extract from the Ordnance Survey (OS) 1st edition 25-inch map of 1867
(Reproduced by courtesy of the National Archives)

The Ordnance Survey (OS) 1st edition 25-inch map of 1867 (*fig. 2*) shows the outline plan of the married quarters, labelled as 'Married Men's Quarters' and consisting of five rows of two rectangular blocks flanking either side of an axial pathway aligned NE-SW. Each block is shown as subdivided into eight compartments, with four projecting porches to the front (SW-facing) elevations and gardens to the rear. In the case of the two rows to the SW, these gardens are shown as subdivided into individual narrow plots. A laundry block and several outbuildings are marked to the SE of the Married Quarters and a gasworks to the NW.

The layout, as shown on the 1867 map, corresponds with a description of the Married Quarters dated 1883, which describes them as 'a model village, built on the most improved plan, in separate blocks, each designated by a letter of the alphabet from A to J, each comprising four houses or a total of forty neatly constructed cottages, with all the accommodation for an average of two hundred inhabitants' (*Hampshire Chronicle* 1883). The position of the Married Quarters, set well apart from the main hospital buildings, may well reflect views expressed by the leading social and medical reformer Florence Nightingale (a vocal critic of the original design of the hospital), who advised in a letter of October 1862 that at least eighty married quarters would be required and that accommodation for soldiers' wives and children should be separate from that of the nurses (McDonald 2011, 360).

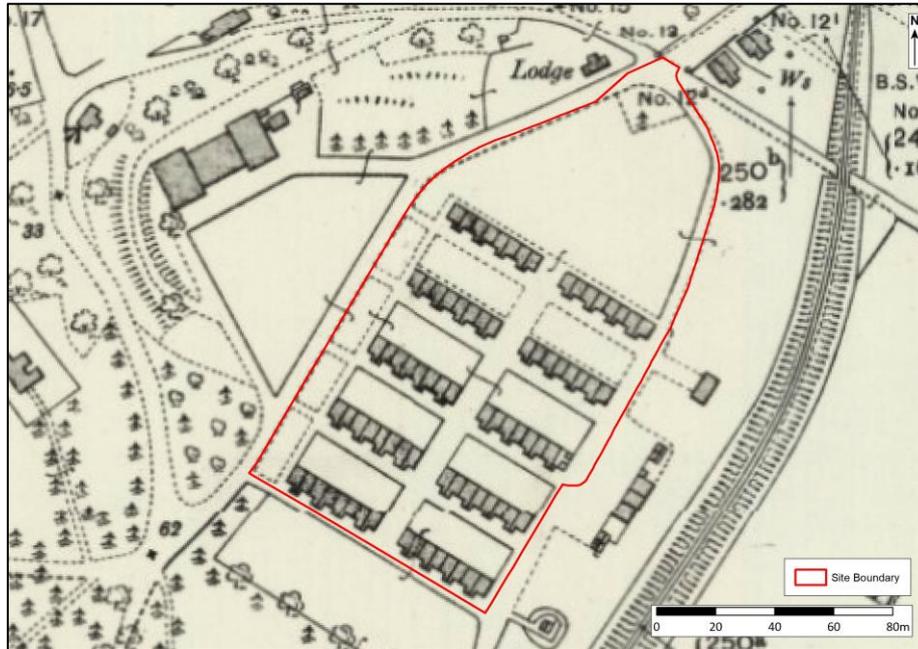
Fig. 3: Extract from the OS 3rd edition map of 1909 showing the Married Quarters at Netley Hospital
(Reproduced by courtesy of the National Archives)

Little change to the layout of the Married Quarters is indicated on the OS 2nd and 3rd edition maps dated 1897 and 1909, respectively (*fig. 3*). However, by 1900, it appears that the existing quarters were increasingly unable to accommodate the large numbers of soldiers returning from across the Empire and the facilities were clearly in need of being updated (Hoare 2007, 74). In 1914, it was reported that 'at Netley the married quarters have been improved and brought up to date by the addition of sanitary annexes and sculleries' (Commonwealth Shipping Committee Vol. 52). These 'sanitary annexes and sculleries' are represented by two rectangular extensions marked to the rear of each block, which are first depicted on the OS 4th edition map of 1932 (*fig. 4*) and are shown on photographs taken in August 1933 and 1944 (*fig. 5*).

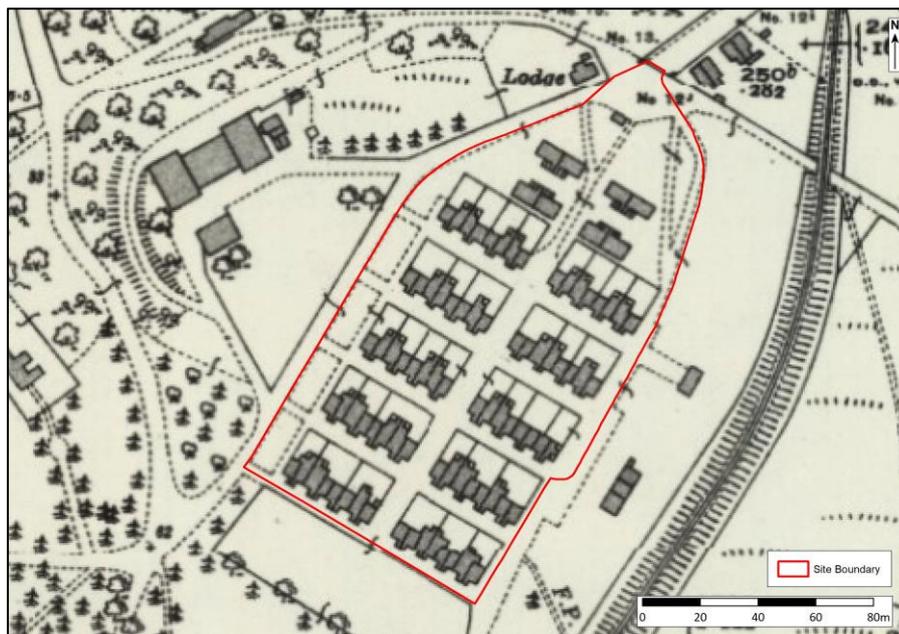
Fig. 4: Extract from the OS 4th edition map of 1932 showing the Married Quarters at Netley Hospital
(Reproduced by courtesy of the National Archives)

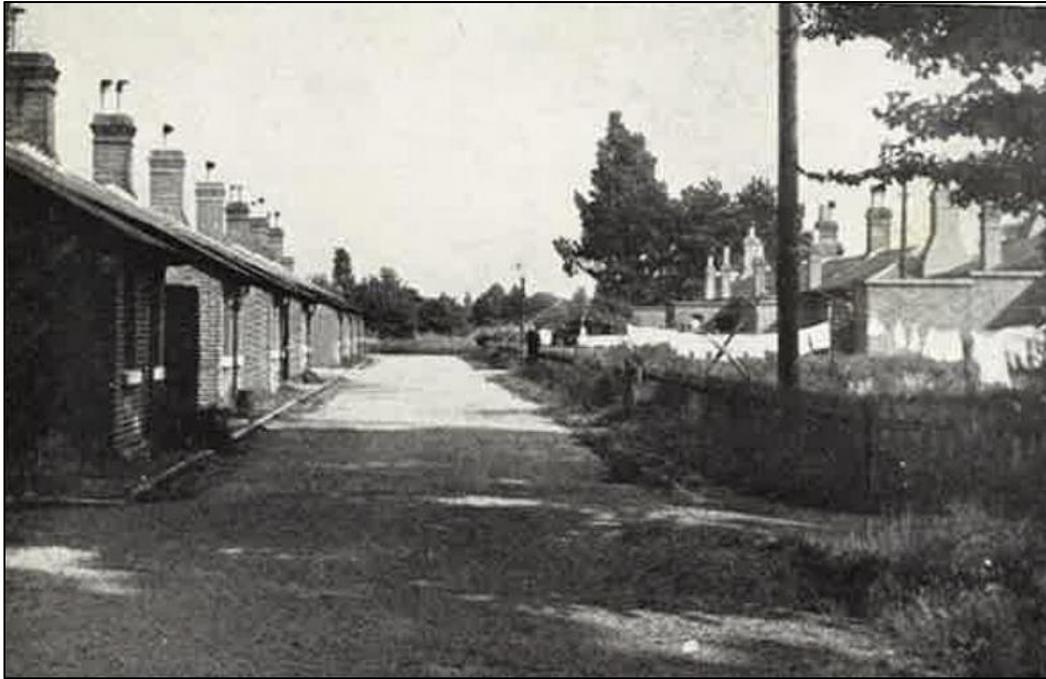
Fig. 5: Photograph taken c.1944 looking NW along the rows of Married Quarters at Netley showing the rear extensions
(Reproduced by courtesy of the National Archives)

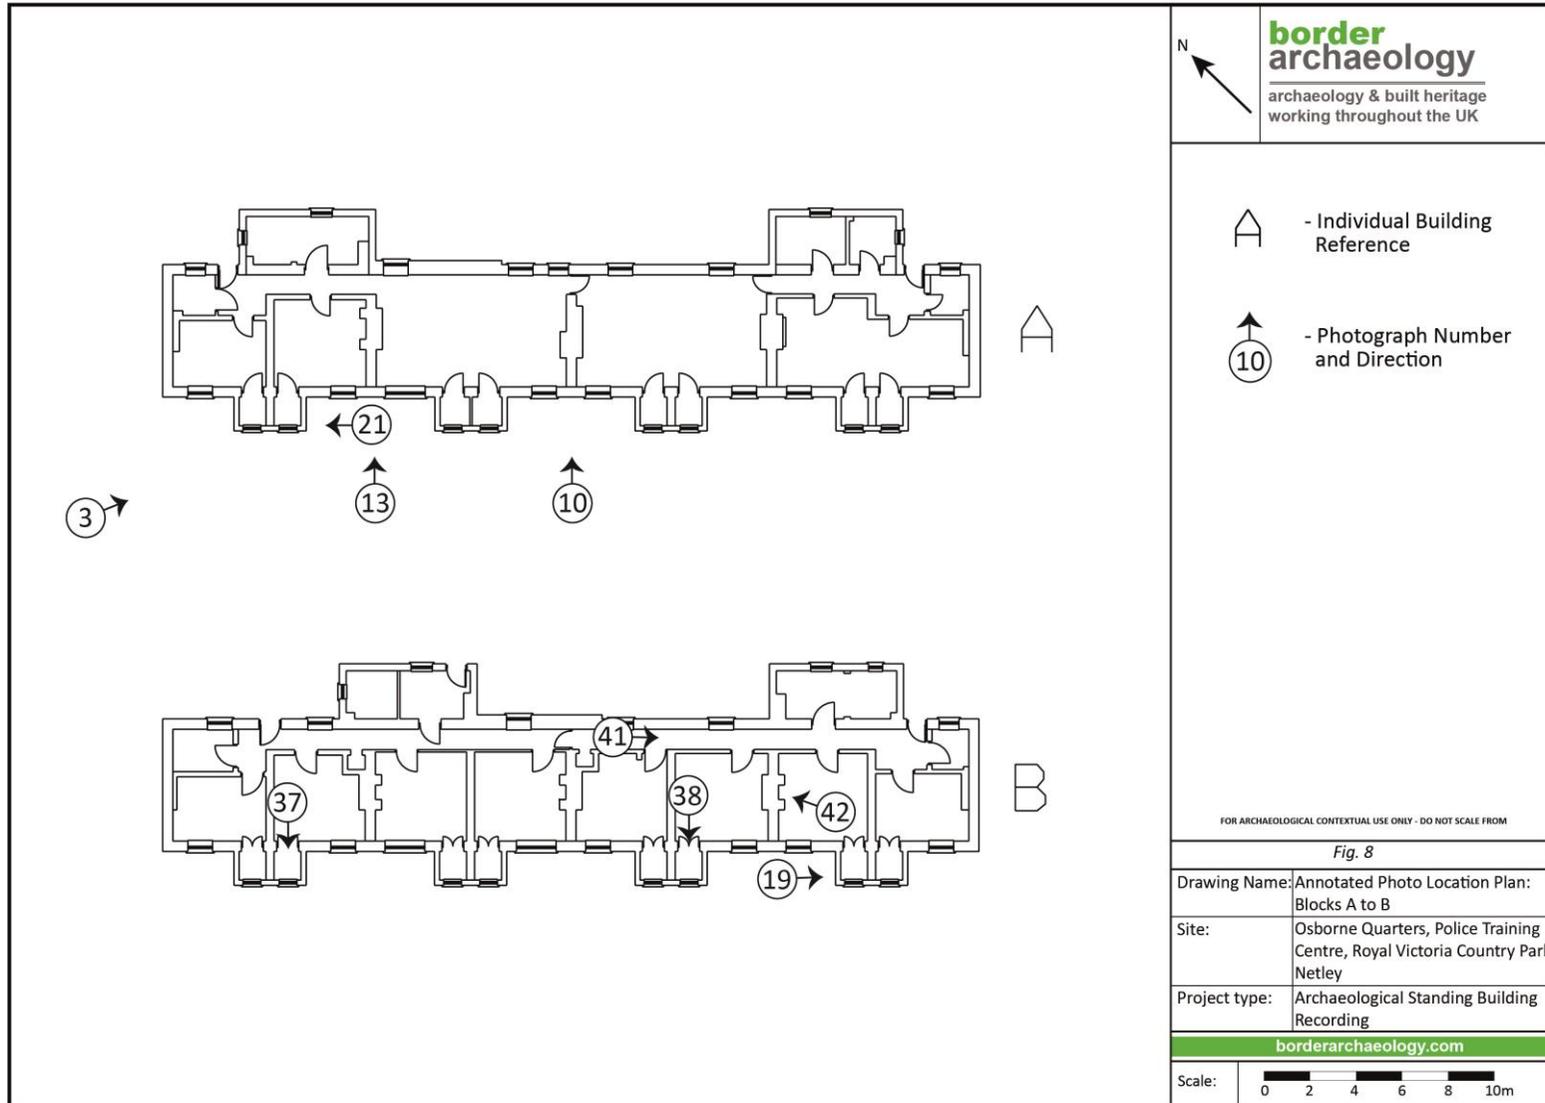
Fig. 8

Drawing Name:	Annotated Photo Location Plan: Blocks A to B
Site:	Osborne Quarters, Police Training Centre, Royal Victoria Country Park, Netley
Project type:	Archaeological Standing Building Recording
borderarchaeology.com	
Scale:	0 2 4 6 8 10m

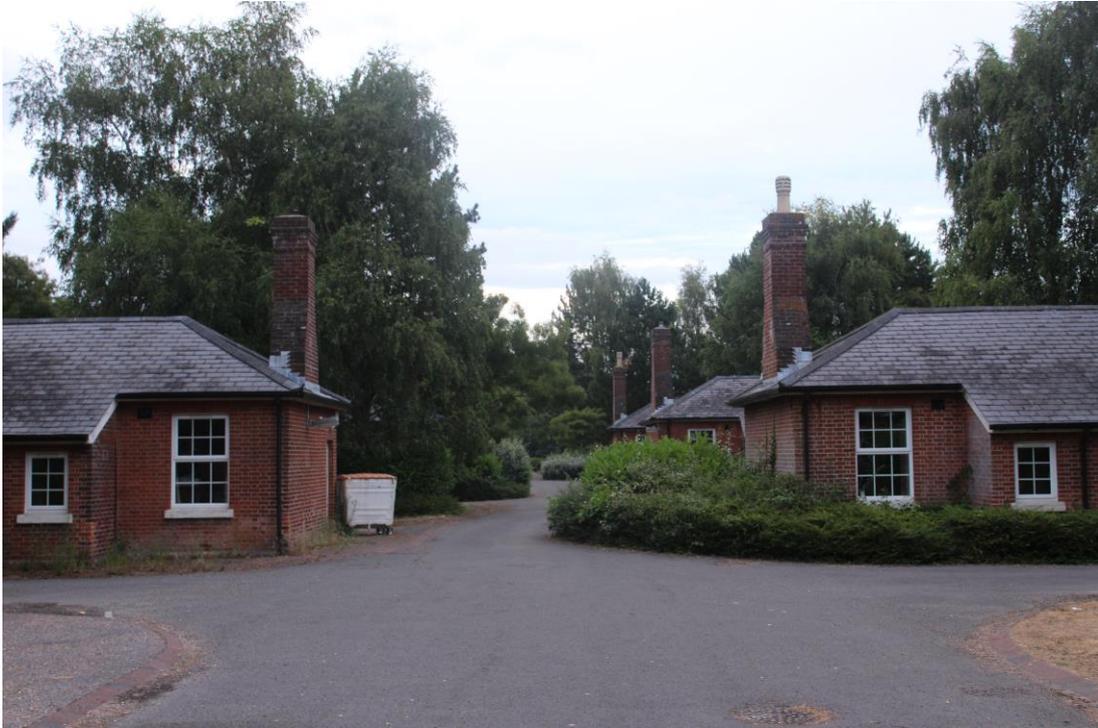
Plate 1: View looking NE from SW boundary of site along axial roadway running between the five rows of former Married Quarters

The former Married Quarters (labelled as Blocks A–K) consist of two rows of five single-storey ranges (measuring c. 35.5m NW–SE × 5.70m SW–NE) flanking an axial pathway (*Plate 1*), set within heavily landscaped grounds which were clearly intended to create a distinct sense of seclusion and separation between these buildings and the main hospital range to the SE and the Officers' Quarters to the SW (*Plate 2*). The buildings are designed in a modest, Victorian Picturesque Cottage style with minimal architectural detailing.

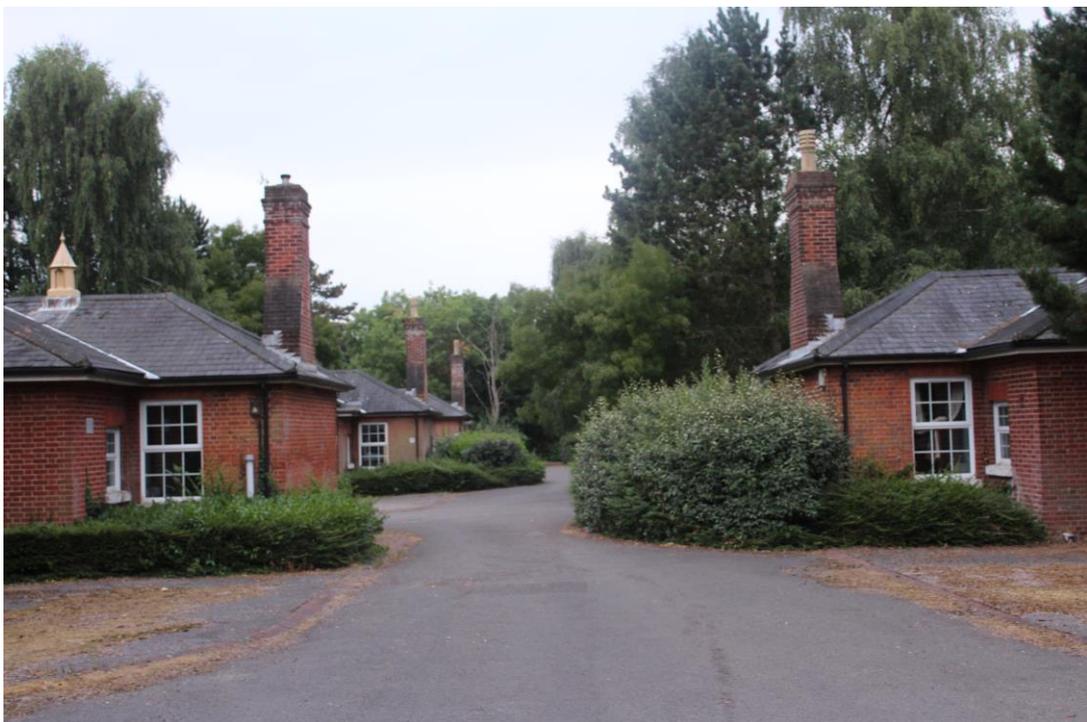
Plate 2: View looking SW towards Block E (to right) and Block F (to left) flanking the axial roadway running through the site, set within landscaped grounds

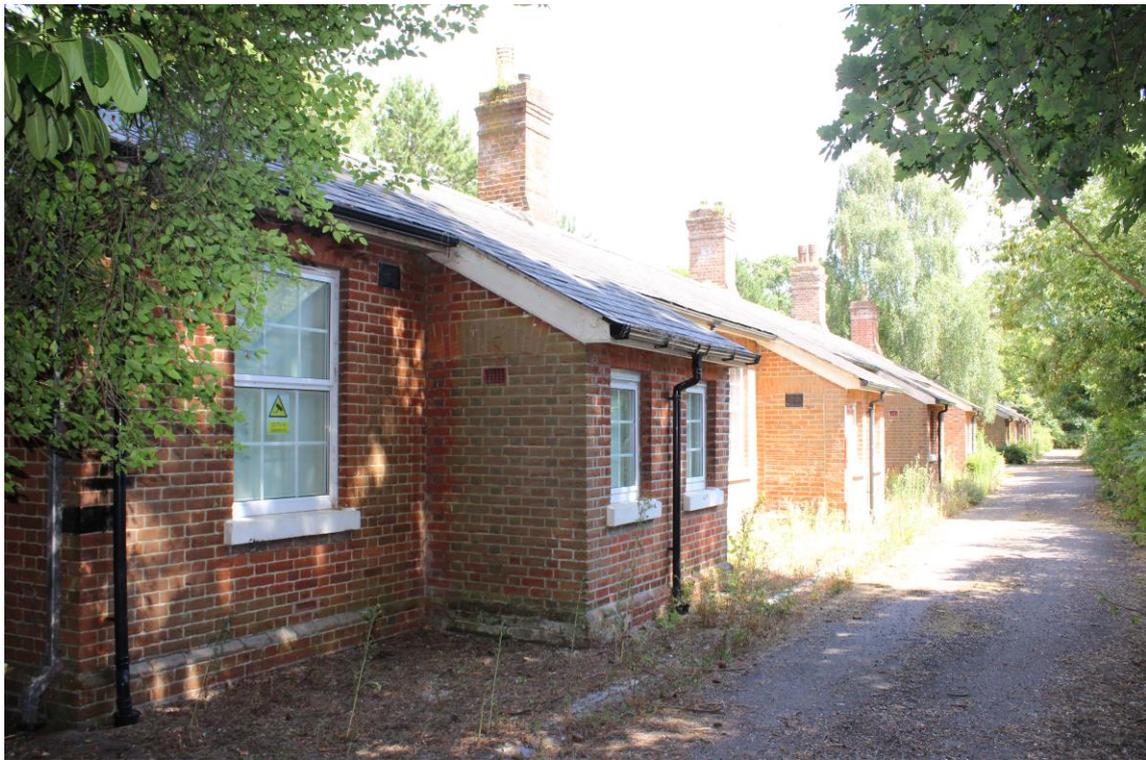
Plate 3: View looking ESE along SW-facing front elevation of Block A showing projecting entrance porches with blocked doorways

The buildings are roughly rectangular in form, eight bays long and constructed in red brick laid in Flemish bond (*Plates 3-6*). The walls terminate at ground level in a wall base brick plinth of at least three courses in height, with the upper course consisting of chamfered moulded bricks (*Plate 7*). The roofs, which are slated with broad eaves, are low-pitched and hipped at either end, with scrolled hip-irons at the bottom corners of the hipped sections. Each block is surmounted by either four or five substantial splayed brick chimneystacks, extending above the ridgeline of the roof with decorative stringcourses towards the top (*Plate 8*). It would appear the roofs were substantially renewed in the late 20th century and that several of the end stacks were presumably removed at this date; the existing guttering, drainpipes and fascia boards also date from this modern refurbishment.

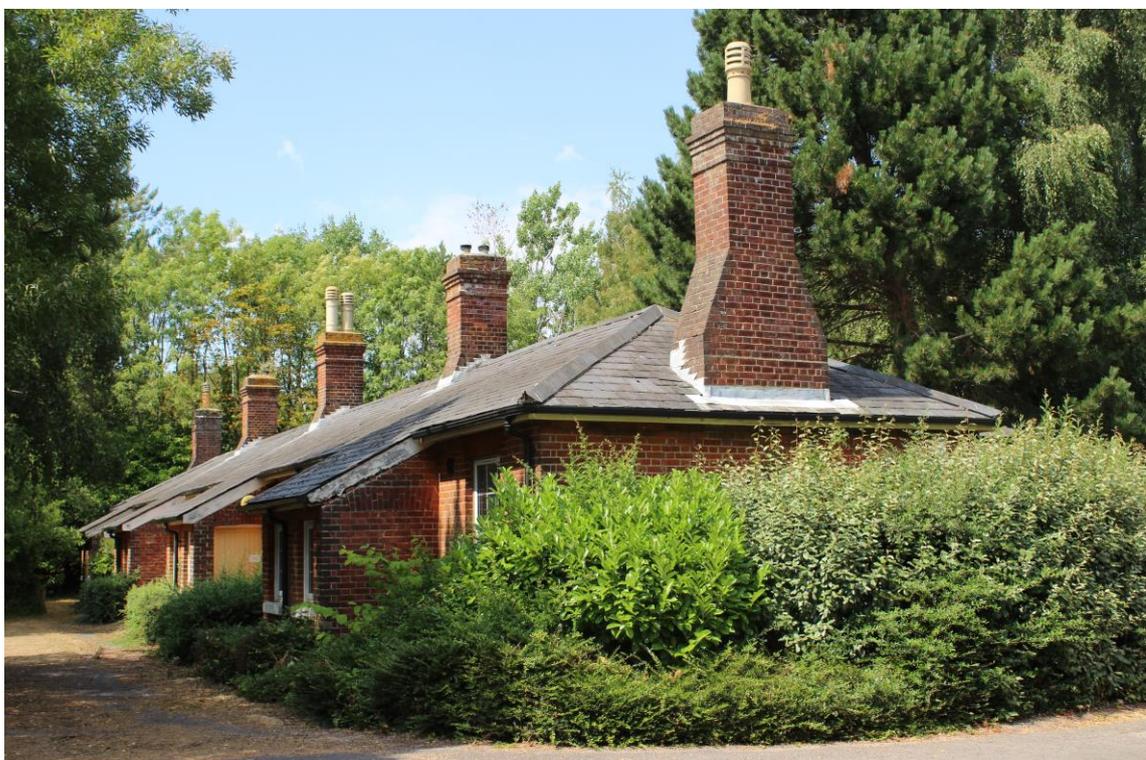
Plate 4: View looking NW along front elevation of Block E showing entrance porches with some intact doorways

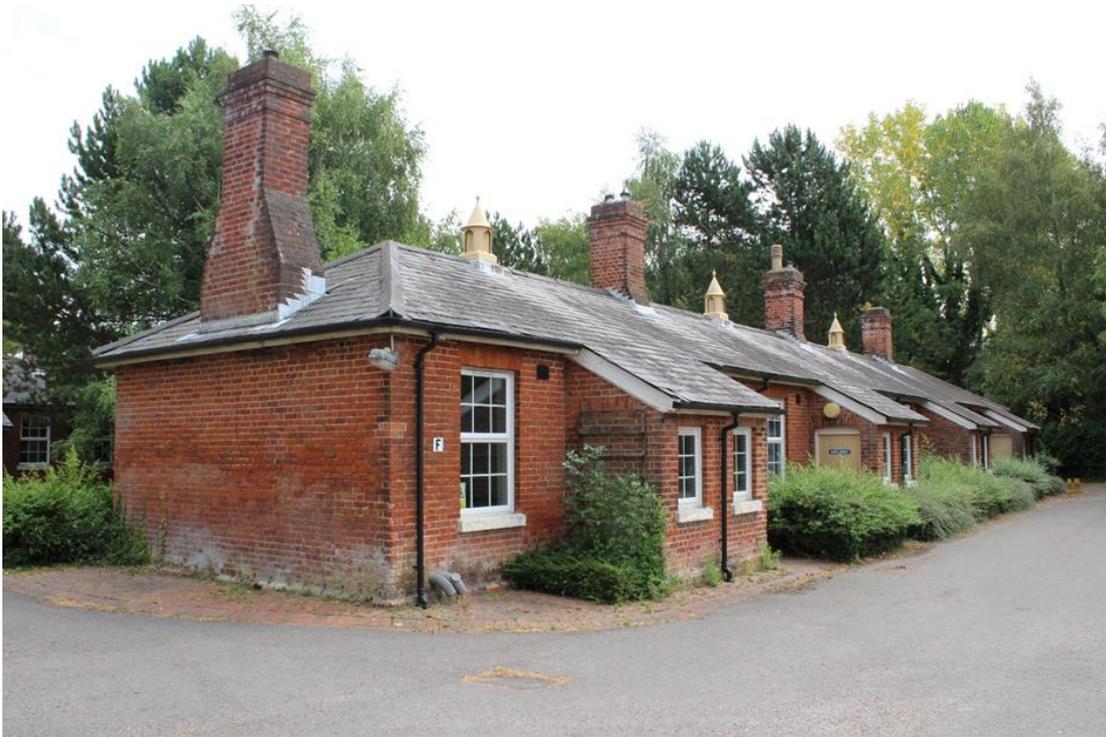
Plate 5: View looking ESE along front (SW-facing) elevation of Block F, with hipped roof surmounted by chimneystacks and copper turrets

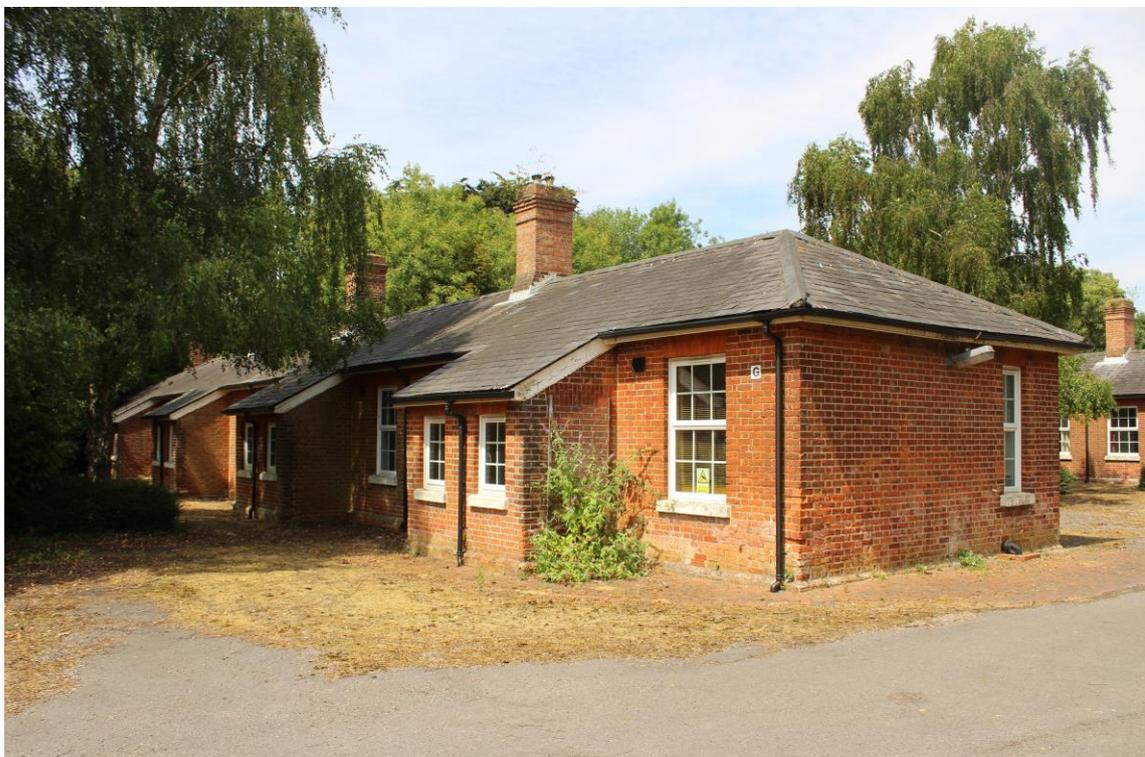
Plate 6: View looking NW along front (SW-facing) elevation of Block G, showing blocked up entrances

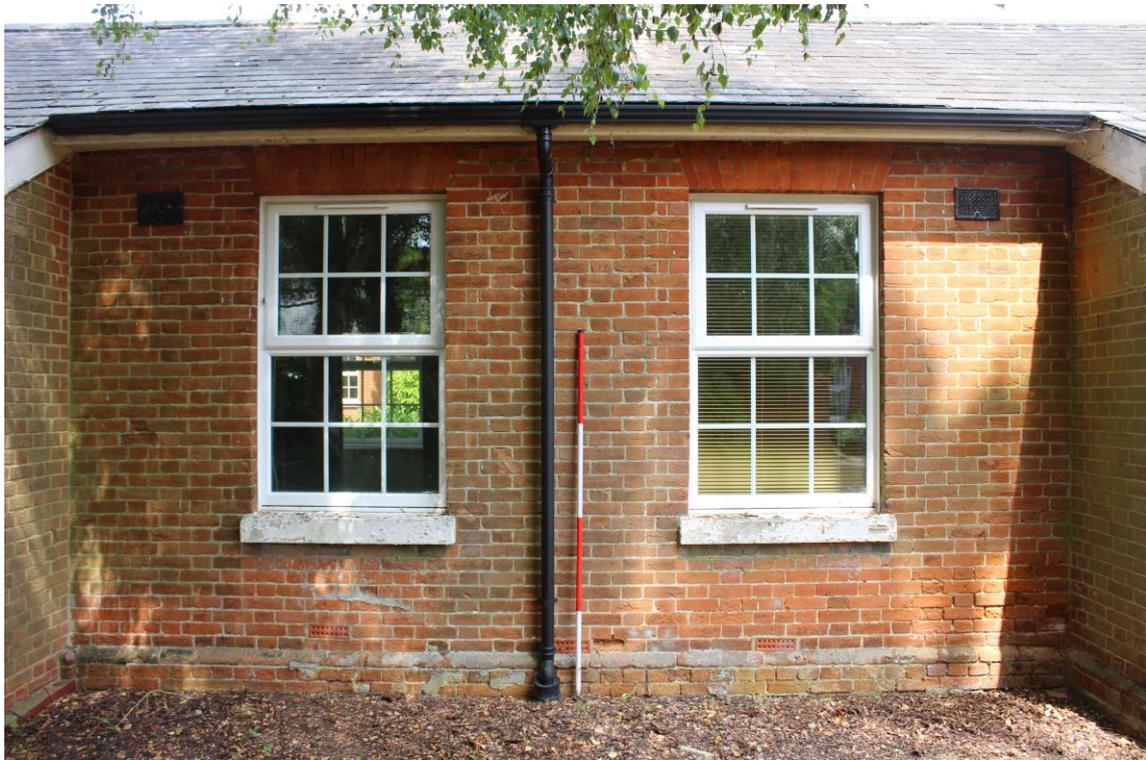
Plate 7: View looking NE showing detail of wall construction (with chamfered brick plinth) and windows in SW-facing elevation of Block G

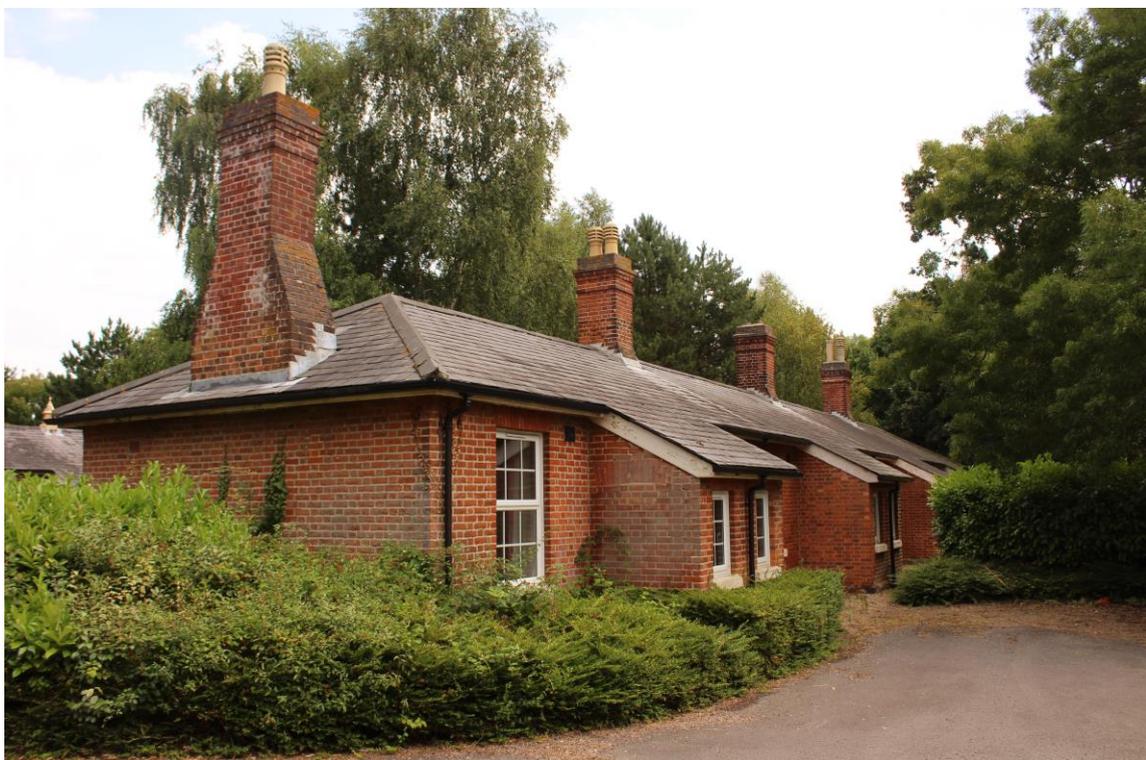
Plate 8: View looking ESE showing splayed brick chimneystacks atop roof of Block D

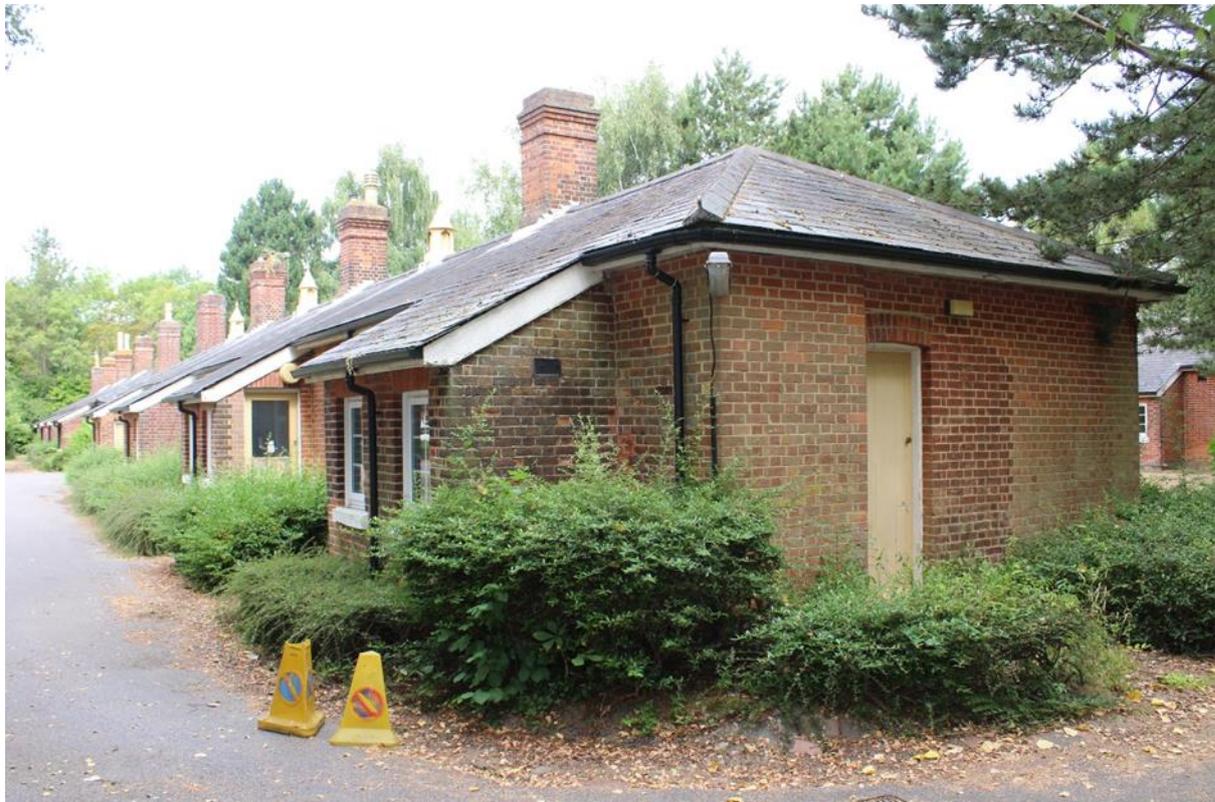
Plate 9: View looking NW showing Block F with roof surmounted by copper turret vents

In the case of Block F, there are also circular turreted vents located along its ridge line, between the chimneystacks (*Plate 9*). Similar copper vents of a late 19th century date, can be found on buildings that had Victorian heating or boiler systems installed in their roof spaces in the latter part of the 19th century, although these vents appear to have been renewed. There is no indication from photographs of the Married Quarters taken in 1933 or 1944 that similar turret vents were placed along the ridgelines of the other blocks.

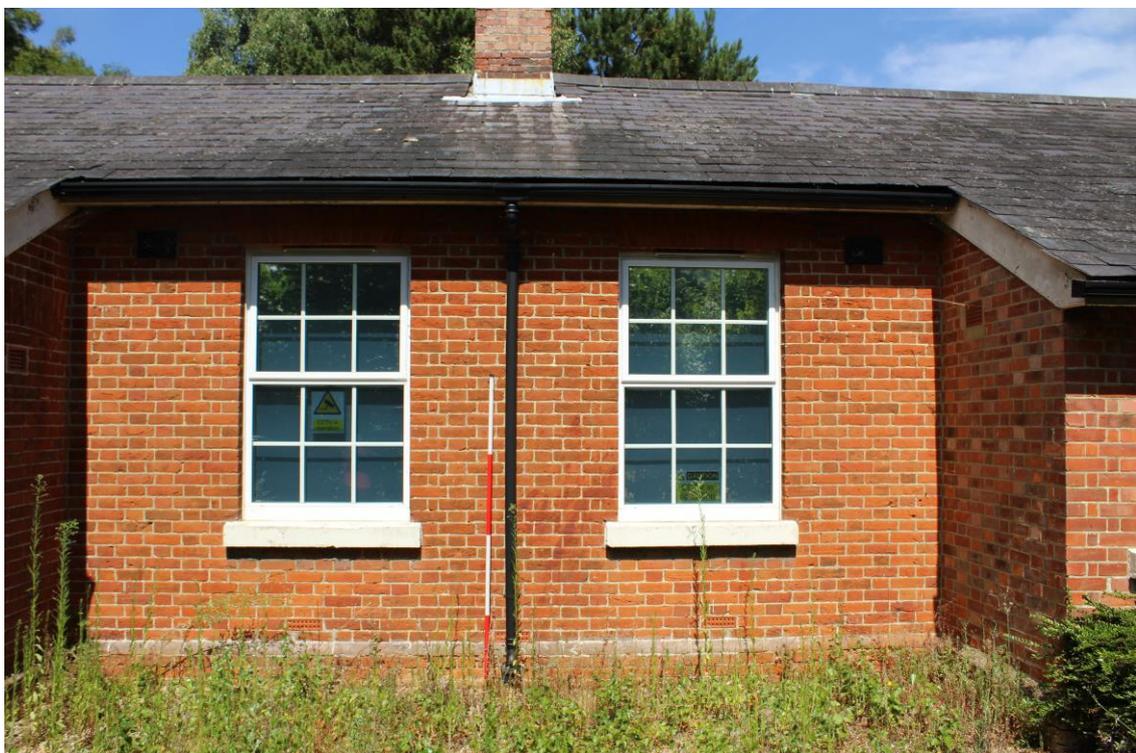
Plate 10: View looking NE showing detail of windows in central bay of SW-facing elevation of Block A

The fenestration of the front (SW-facing) elevation of each block generally consists of 12-paned casement windows set within flat-headed gauged-brick openings (which extend right up to eaves level) with plain stone sills (*Plates 10 & 11*). Located above the windows, just below eaves level are a number of cast-iron ventilation grilles that appear to be original in date (*Plate 12*). The existing PVC window frames throughout are clearly late 20th century in date and probably replaced sash windows, although the actual window openings appear to be original. Several larger 24-paned casement windows have been inserted towards the NW end of the SW-facing elevation of Blocks A to C and Block H (*Plate 13*), which probably represent later insertions.

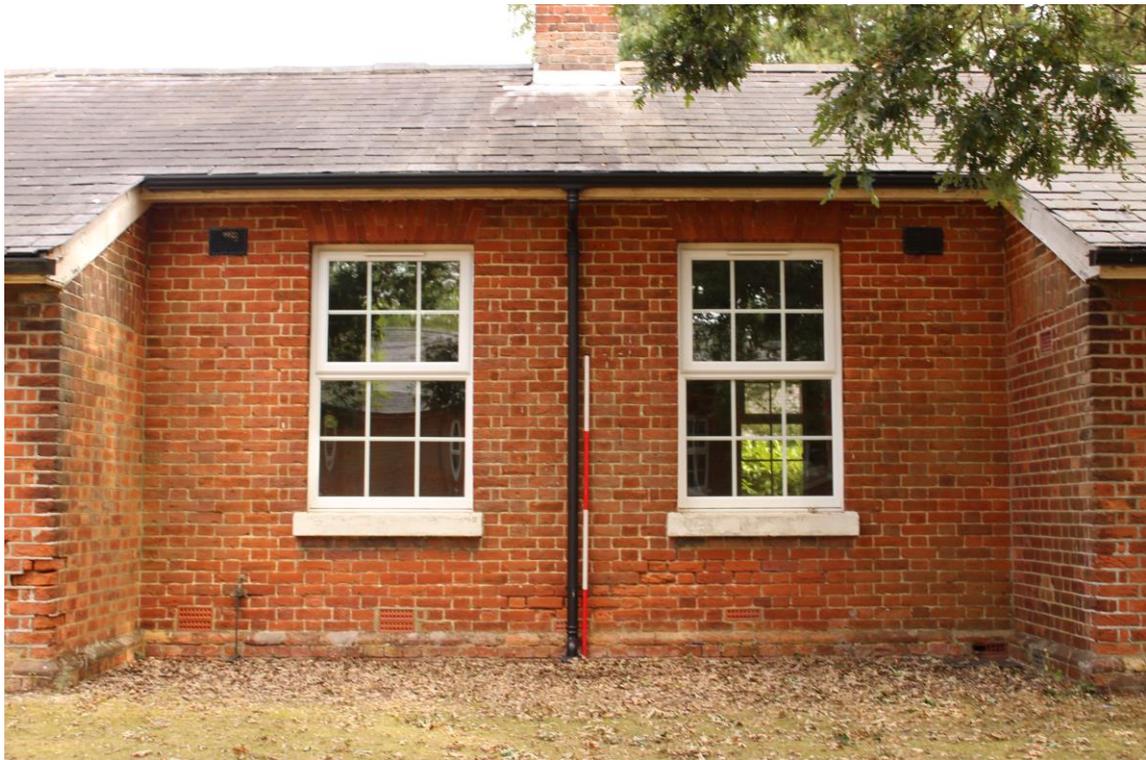
Plate 11: View looking NE showing details of windows (with flanking ventilation grilles above) at SE end of SW-facing elevation of Block D

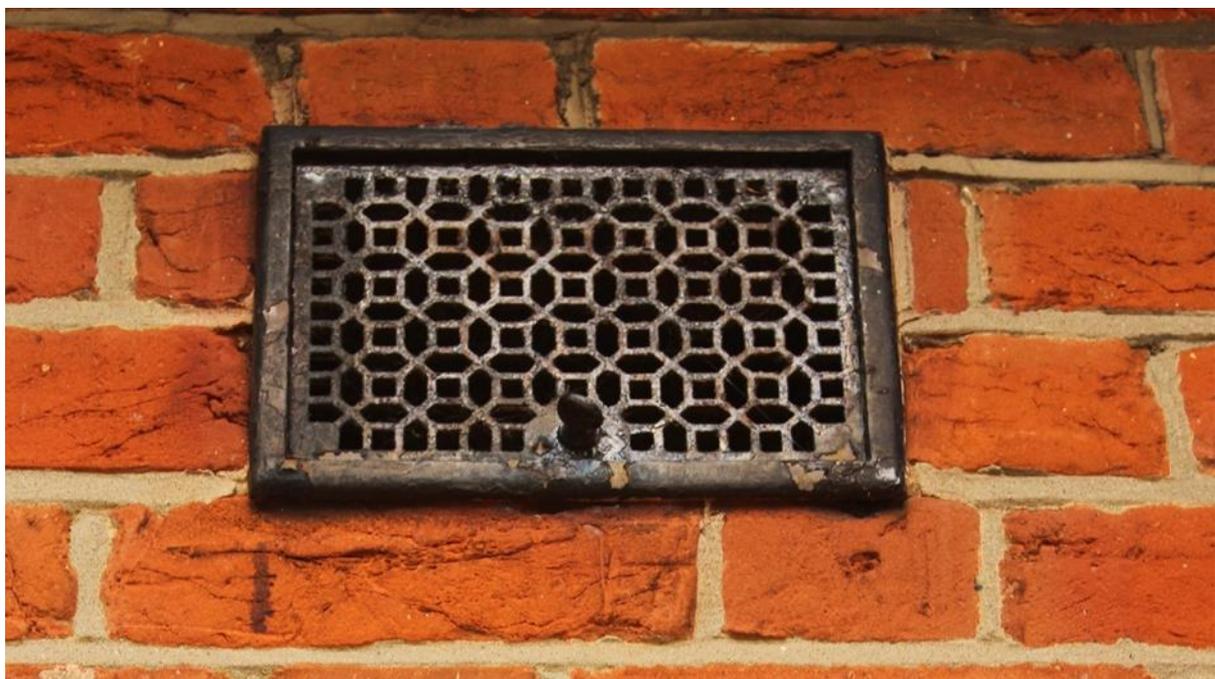
Plate 12: Detail of cast-iron exterior ventilation grille in SW-facing elevation of Block G

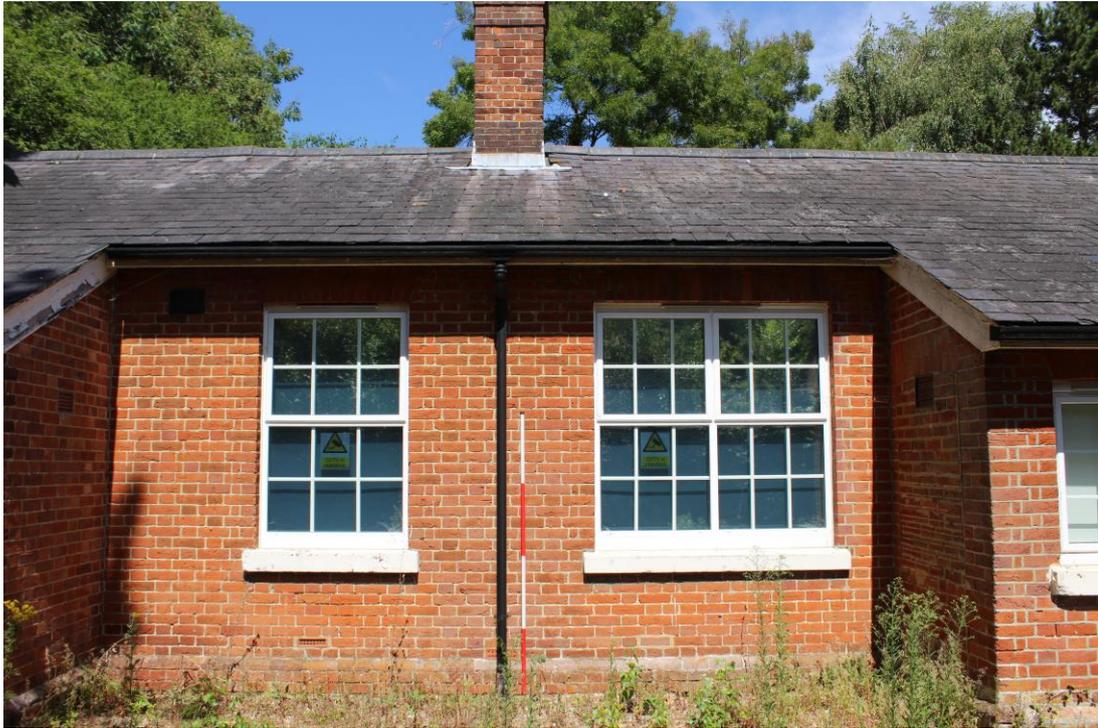
Plate 13: View looking NE showing 12-pane casement and later 24-pane casement window at NW end of front elevation of Block A

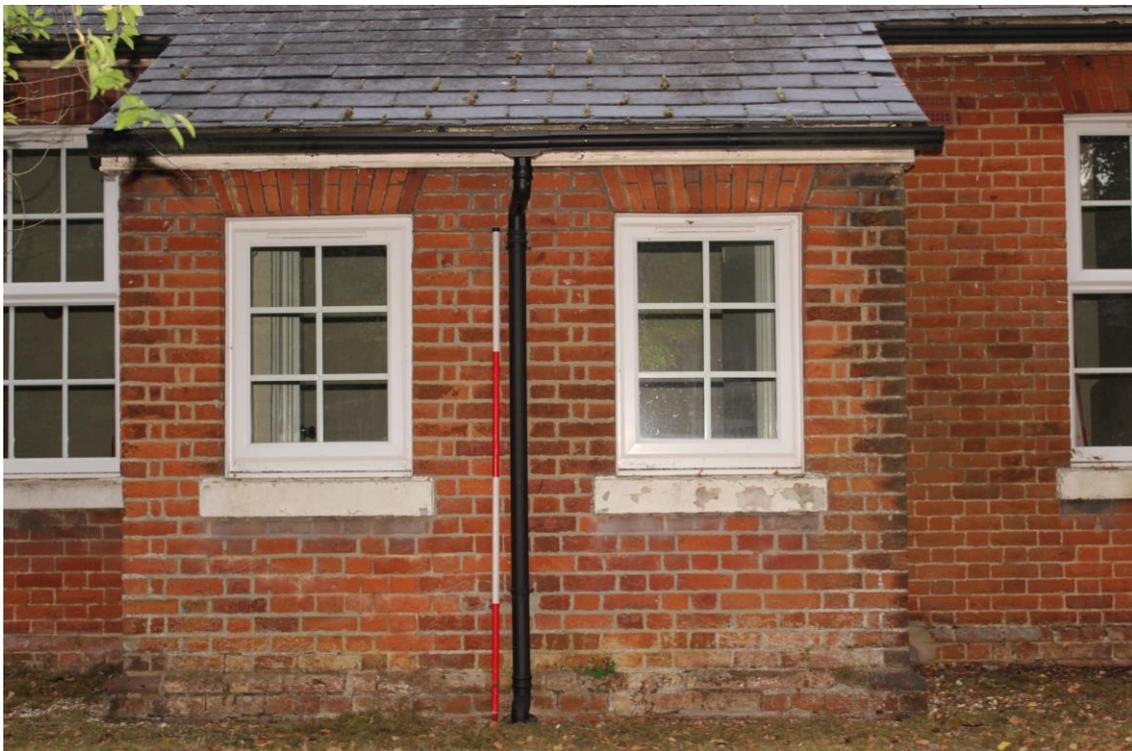
Plate 14: View looking NE showing detail of entrance porch in SW-facing elevation of Block C

Each block has four regularly spaced entrance porches on the front (SW-facing) side and rear extensions to the NE which formerly housed kitchens and washrooms/water closets. The entrance porches (*Plates 14 & 15*) are regular in form throughout with catslide roofs and opposed side entrances with segmental, gauged-brick arched doorways with chamfered jambs and stone thresholds, several of which remain intact in Blocks E (*Plates 16 & 17*) and Block F (*Plate 18*) while the remainder have been blocked up at a later date (*Plates 19 & 20*). In some cases, the porches appear to have been entirely rebuilt, removing all evidence of the former doorways (*Plate 21*). Each porch is lit by two six-paned casements set within flat-arched gauged-brick openings extending up to eaves level (*Plate 22*).

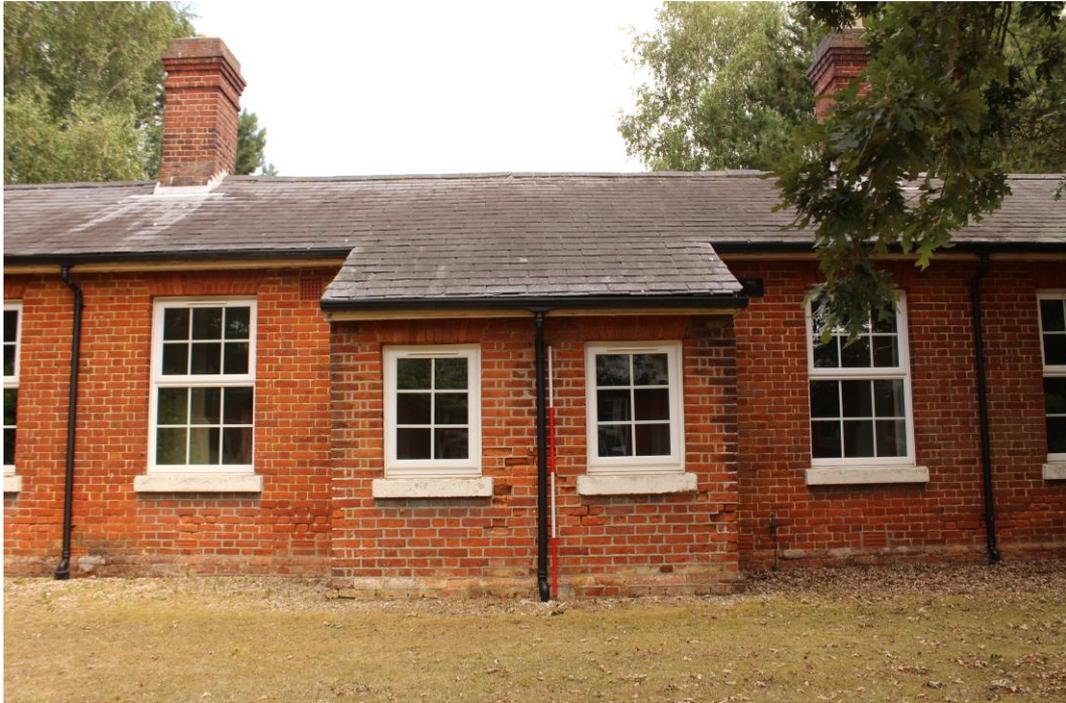
Plate 15: View looking NE showing SW-facing elevation of porch in central portion of front elevation of Block D

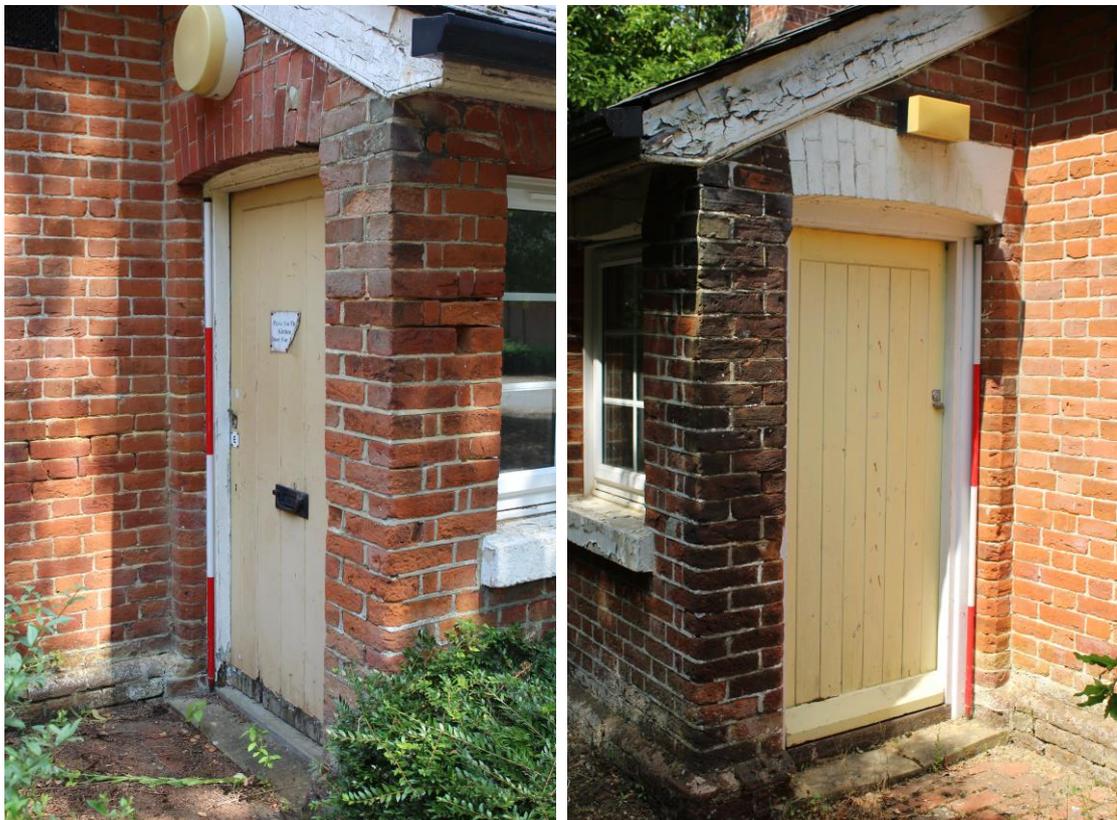
Plate 16: View looking ESE showing detail of entrance porch doorway at SE end of front elevation of Block E

Plate 17: View looking N showing detail of entrance porch doorway at NW end of front elevation of Block E

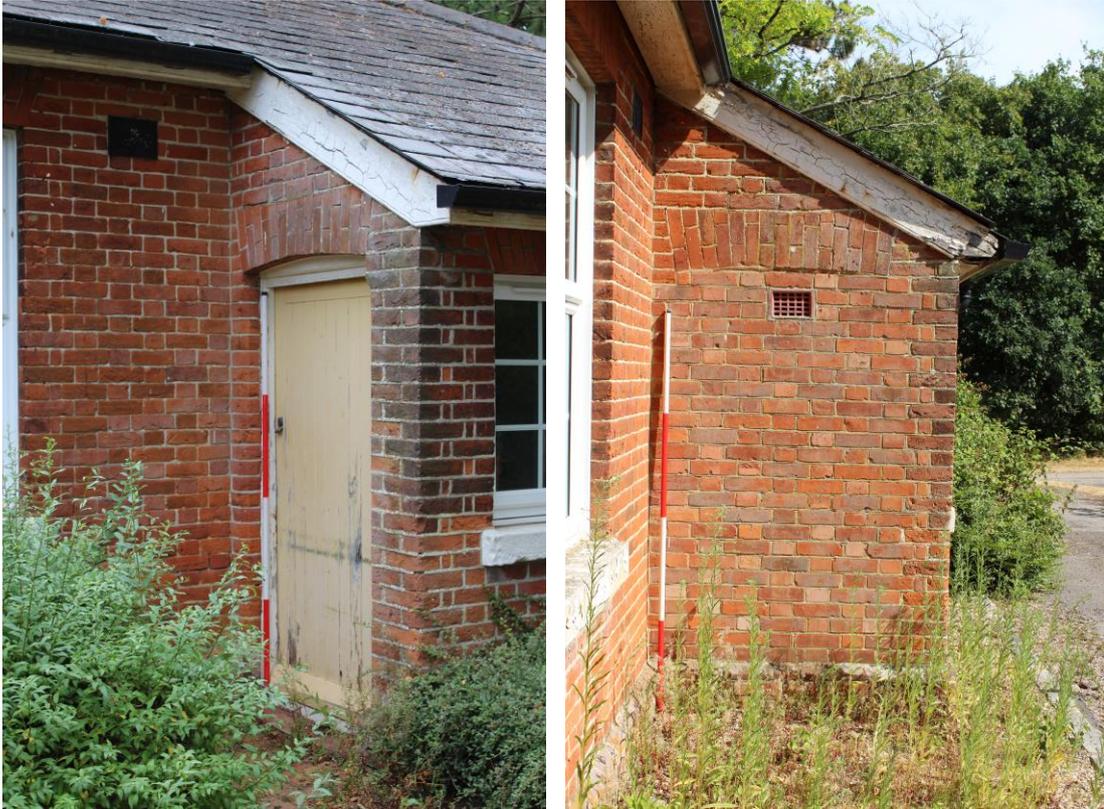
*Plate 18: View looking ESE showing detail of entrance porch and intact doorway in Block F
Plate 19: View looking SE showing blocked doorway in entrance porch at SE end of Block F*

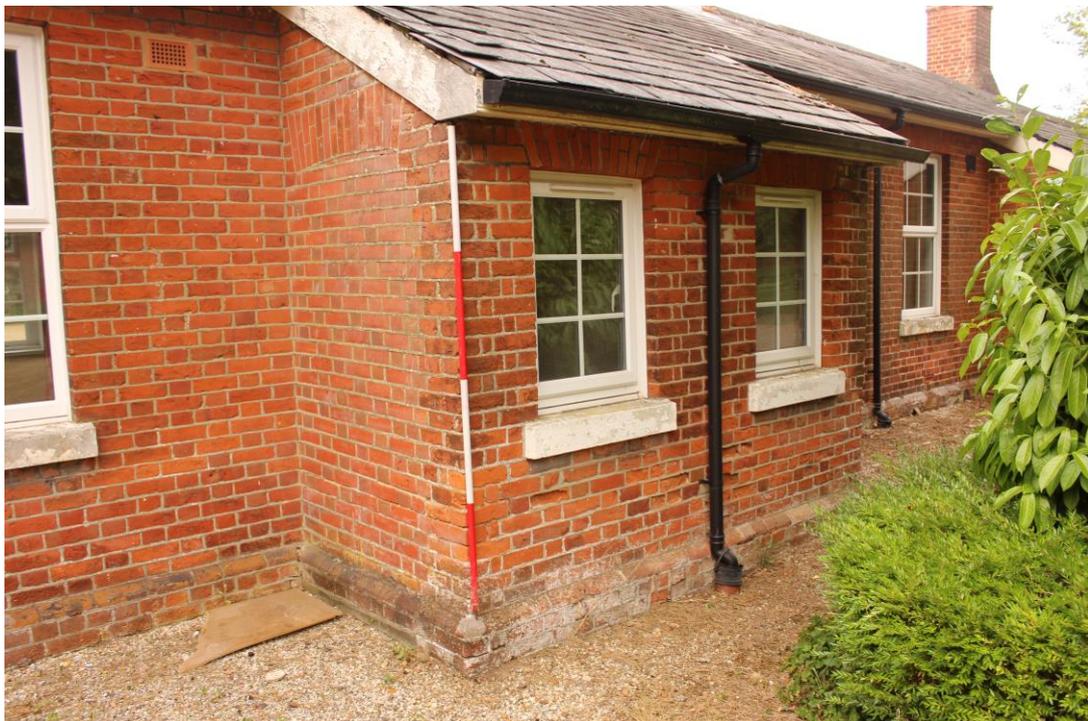
Plate 20: View looking ESE showing entrance porch with blocked doorway in Block J

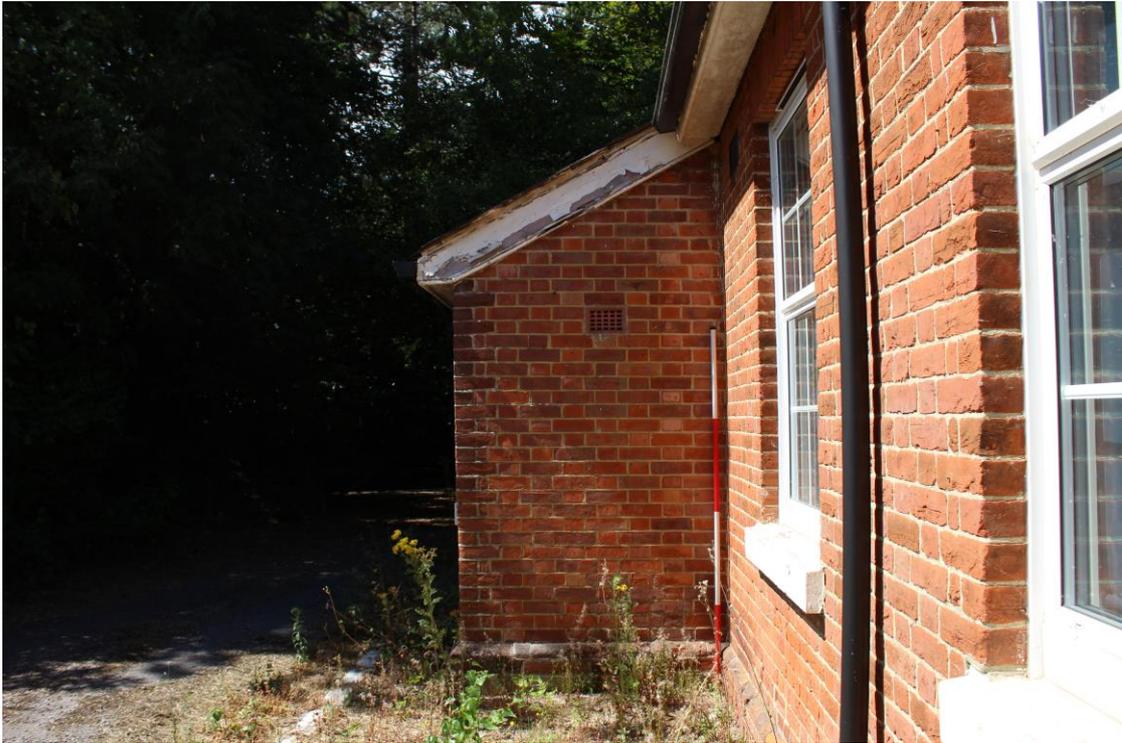
Plate 21: View looking NW showing entrance porch at NW end of Block A with side wall entirely rebuilt
