**Archaeological Standing
Building Recording**

**Osborne Quarters
Police Training Centre
Royal Victoria Country Park
Netley Abbey
Southampton
SO31 4TS**

August 2018

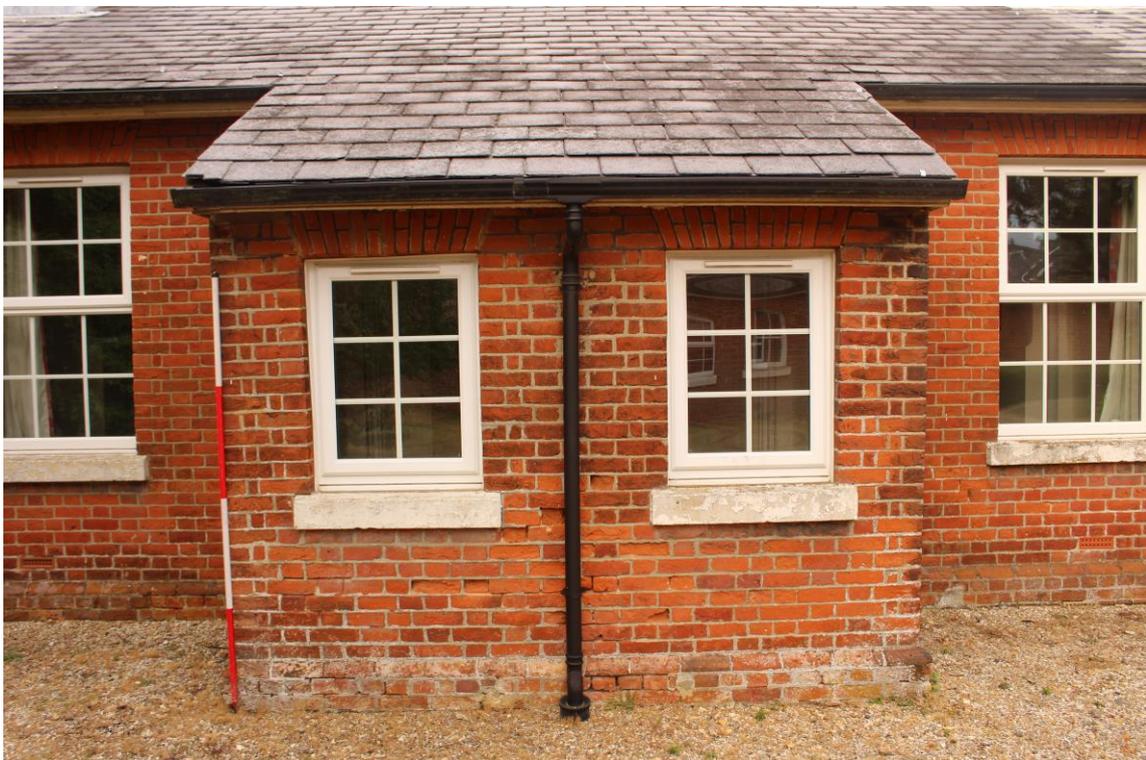
Plate 22: View looking NW showing fenestration of entrance porch in central portion of Block J

Each block has four regularly spaced entrance porches on the front (SW-facing) side and rear extensions to the NE which formerly housed kitchens and washrooms/water closets. The entrance porches (*Plates 14 & 15*) are regular in form throughout with catslide roofs and opposed side entrances with segmental, gauged-brick arched doorways with chamfered jambs and stone thresholds, several of which remain intact in Blocks E (*Plates 16 & 17*) and Block F (*Plate 18*) while the remainder have been blocked up at a later date (*Plates 19 & 20*). In some cases, the porches appear to have been entirely rebuilt, removing all evidence of the former doorways (*Plate 21*). Each porch is lit by two six-paned casements set within flat-arched gauged-brick openings extending up to eaves level (*Plate 22*).

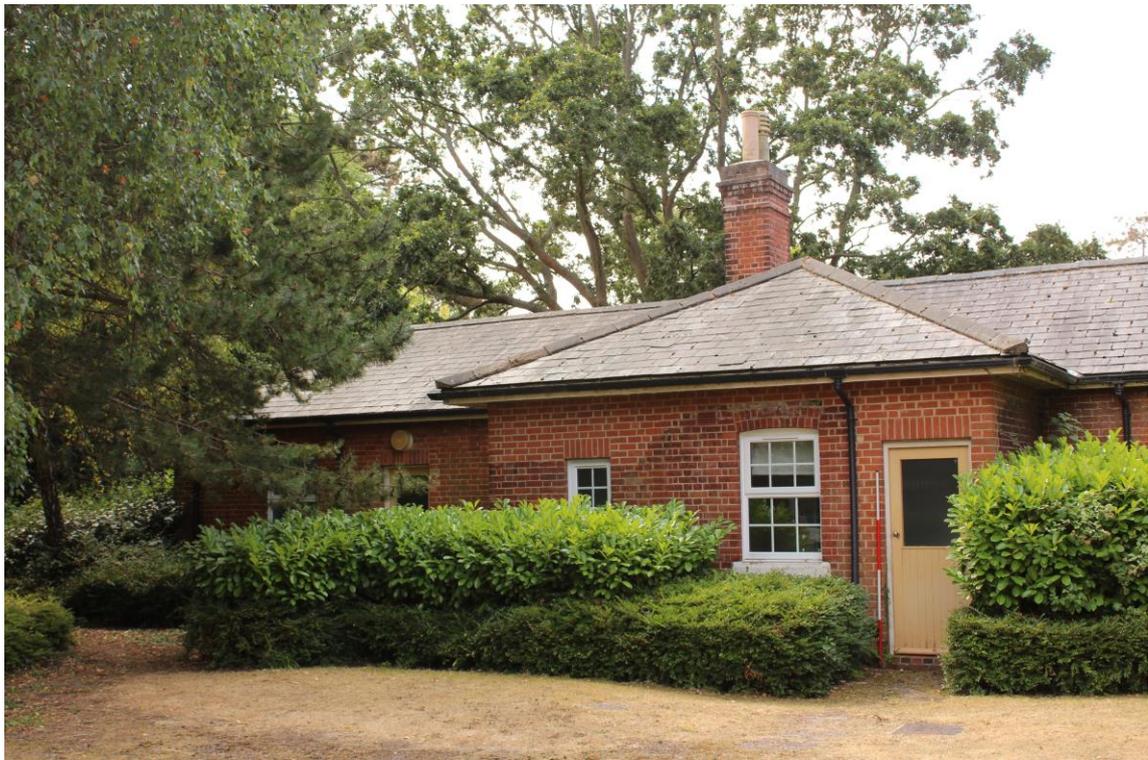
Plate 23: View looking S showing NE-facing elevation of Block D with rear extension (originally added c.1914)

Attached to the rear (NE-facing) elevations of all 10 blocks are two rectangular single-storey extensions with low pitched, hipped slate roofs, with the exception of Block F, which appears to have always had only a single extension (*Plate 23-24*). These rear extensions, which were built in 1914 to house 'sculleries and sanitary annexes [i.e. washrooms and WC's]' vary in size (between two and four bays in length) and position for no obvious functional reason. All these rear extensions were originally surmounted by chimneys, which have since been removed.

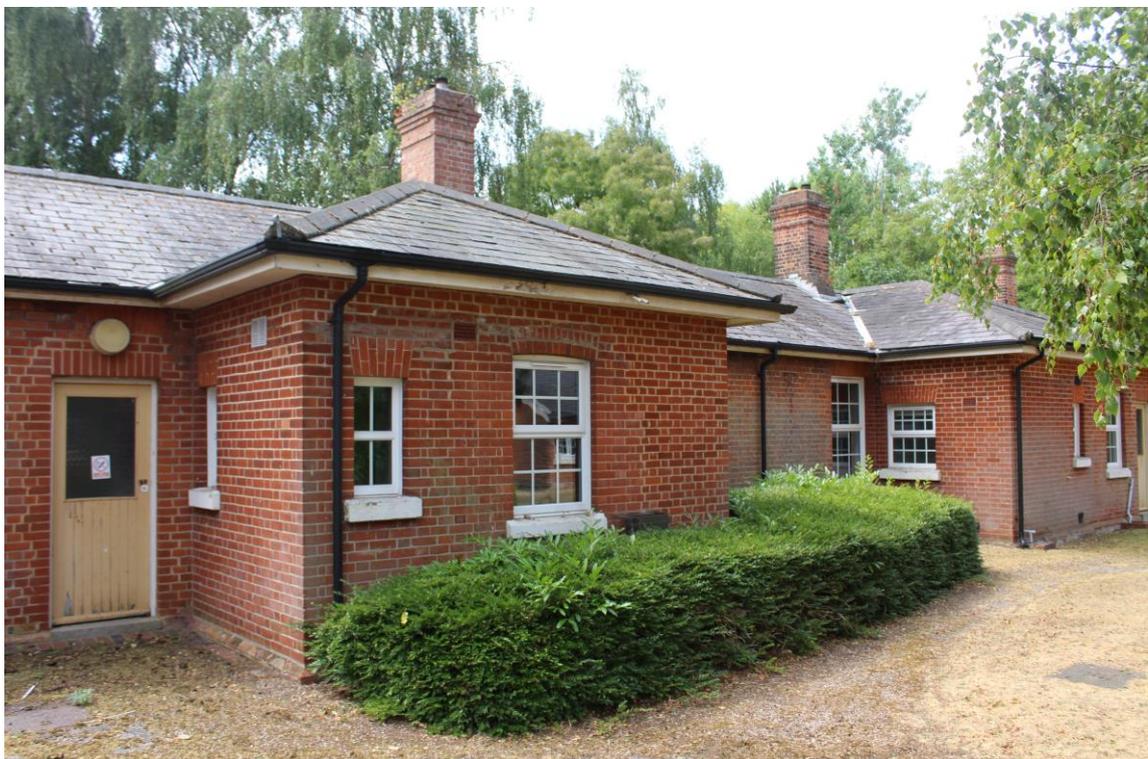
Plate 24: View looking WSW showing NE-facing rear elevation of Building G with two rear extensions originally housing kitchens and WCs

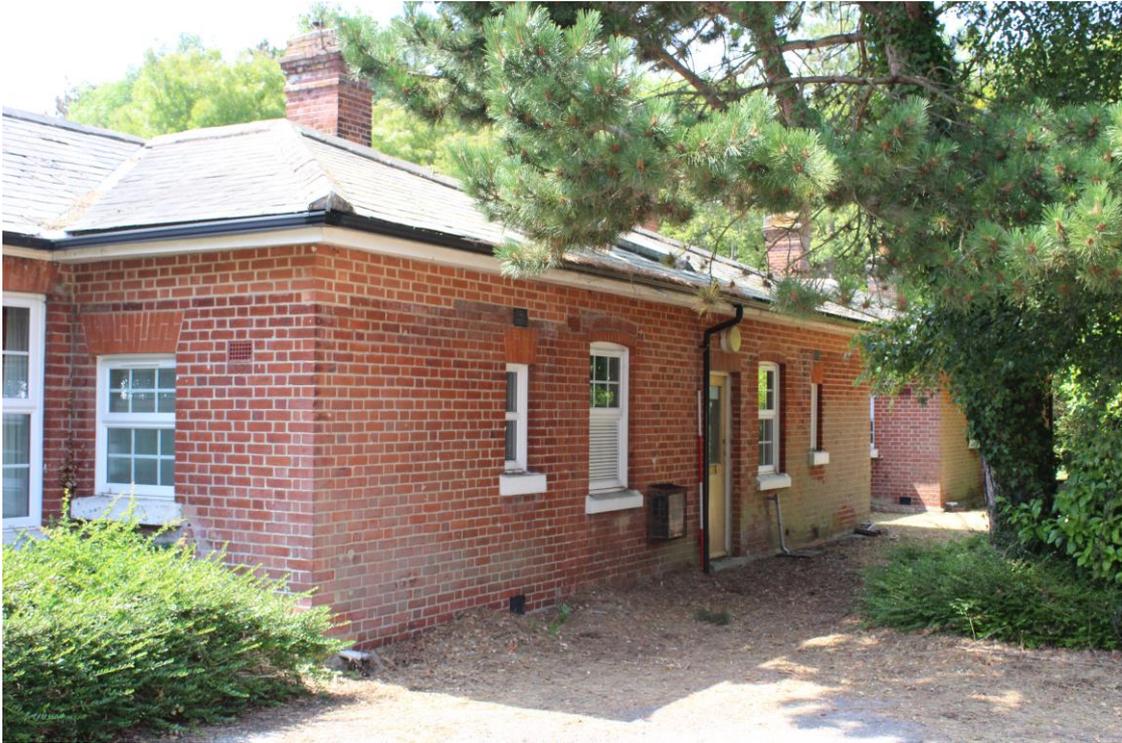
Plate 25: Oblique view looking WSW showing enlarged rear extension towards SE end of Block E with segmental arched and gauged-brick arch window openings

All of these annexes have evidently been subject to considerable alteration and enlargement during the mid-late 20th century, as attested by cartographic evidence, construction breaks and the insertion of new doorways or windows which are visible throughout. This is particularly evident in the case of the extension to the rear of Blocks E and F, both of which appears to have been widened at some time between c.1932 and 1964. In the case of Block E (*Plate 25*), the fenestration of the rear extension, consisting of a narrow gauged-brick window and a broader segmental arched window opening flanking a central doorway, has remained intact in spite of the block being widened, whereas in the case of Block F (*Plate 26*) that the doors and windows are clearly modern replacements.

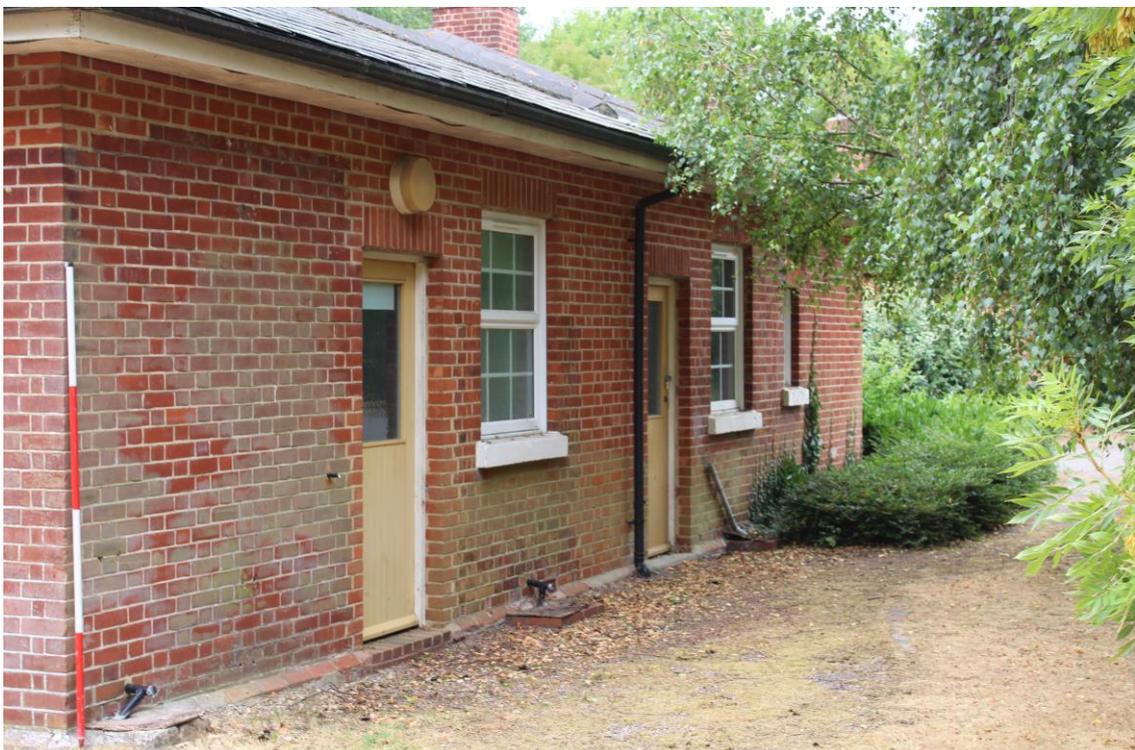
Plate 26: Oblique view looking WSW showing heavily altered and enlarged rear extension to Block F with modern flat-arched window and door openings

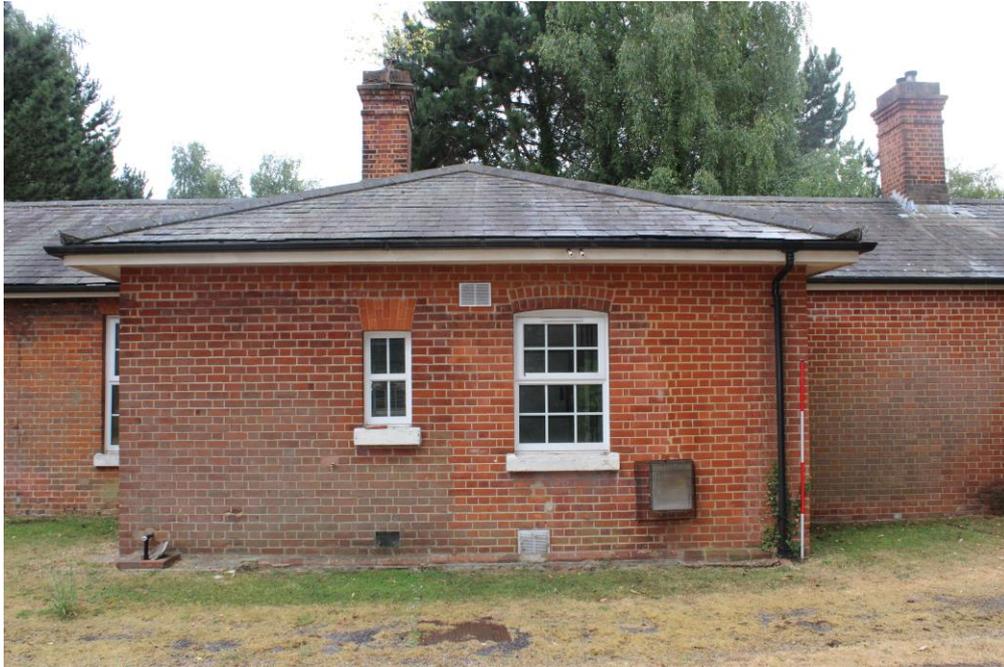
Plate 27: View looking SW showing extension to rear of Block H with evidence of heavily patched-up brickwork together with segmental arched and gauged-brick windows (possibly reset)

In the case of many of the other annexes, such as those to the rear of Block H, the original proportions appear to have remained intact but the external brickwork has been largely rebuilt and windows and doorways altered (*Plate 27*). The enlarged rear annexes are placed somewhat awkwardly at right-angles to the earlier fenestration of the main block (*Plate 28*). The addition and subsequent enlargement of the annexes must have resulted in changes to the original fenestration of the rear elevations. However, the flat-headed gauged-brick arch windows (similar to those in the front elevation) appear to be original (*Plate 29*), although the existing PVC casements are modern.

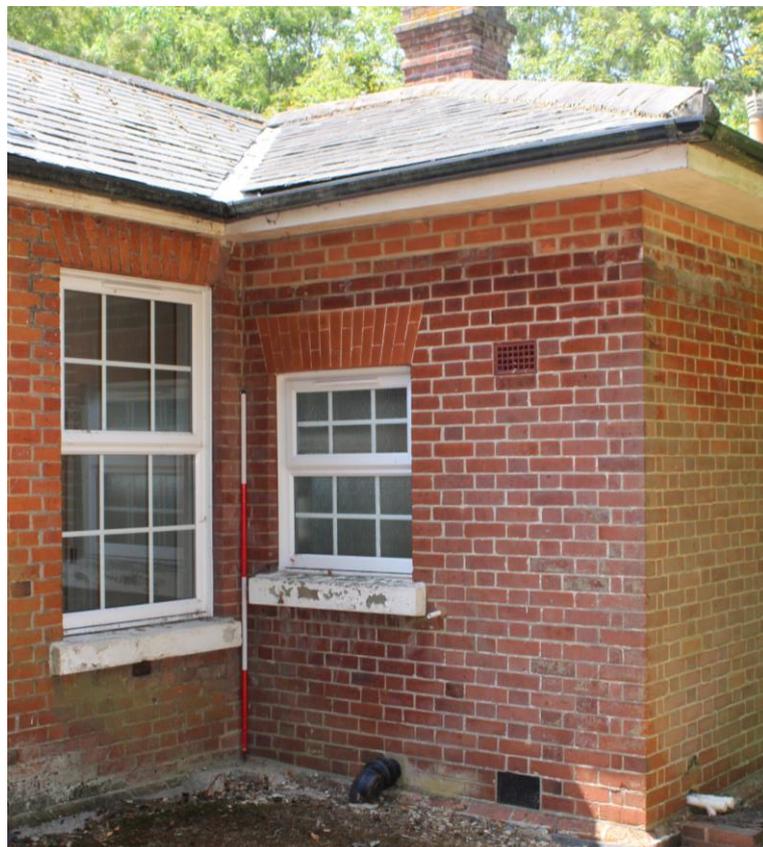
Plate 28: View looking WSW showing the enlarged extension at NW end of Block E, set at right angles to an earlier gauged-brick arch window with modern PVC casement

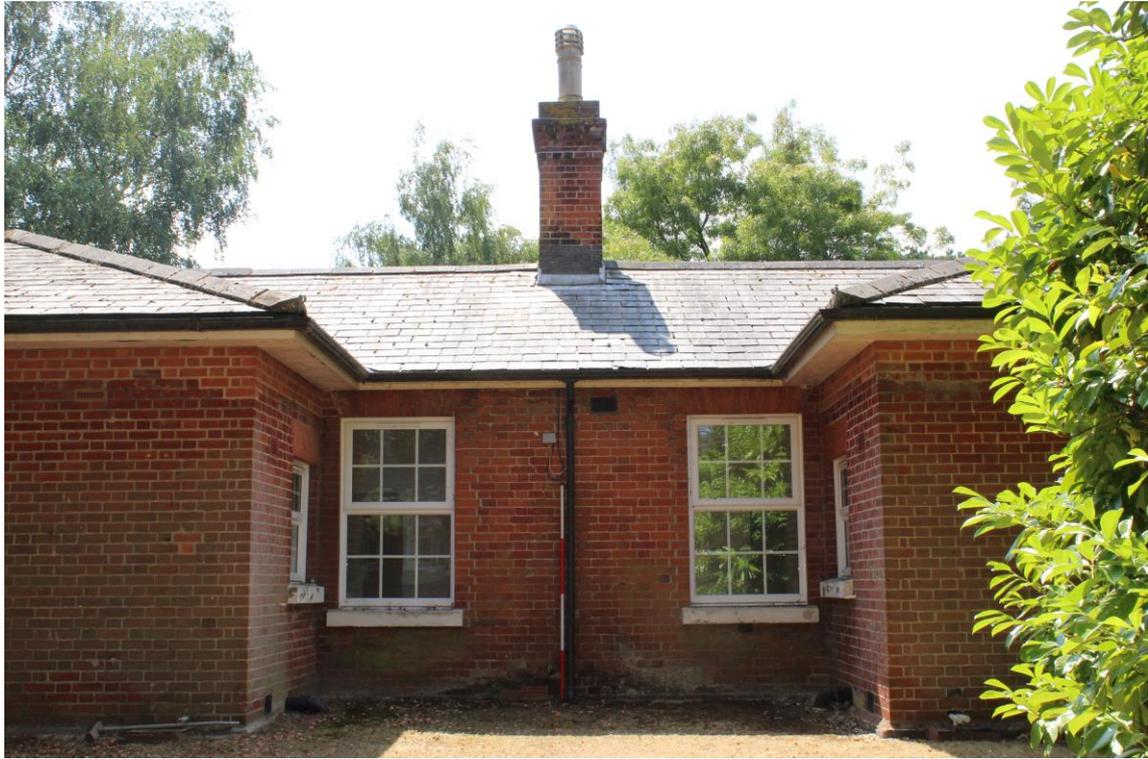
Plate 29: View looking SW showing rear (NE-facing elevation) of Block E with original gauged-brick flat arched windows set between the two enlarged rear annexes

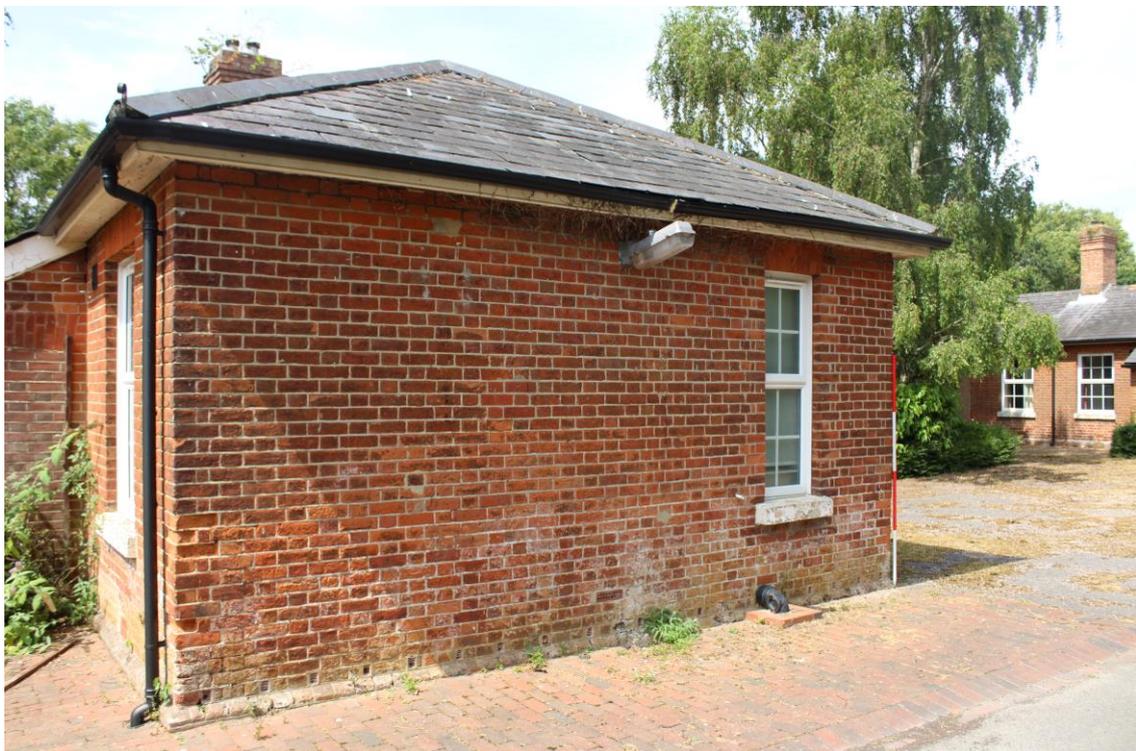
Plate 30: View looking NW showing SE end of Block G with end chimneystack removed and modern casement window inserted

The NW and SE facing ends of the blocks are, for the most part, devoid of fenestration, although modern casement windows have been inserted at either end of Blocks G and H where end stacks appear to have been removed (*Plate 30*) and two doorways have been inserted in the SE elevations of Blocks C and F. The flat-headed doorway in Block C appears to be a mid-late 20th century addition (*Plate 31*); however, the narrow segmental-arched doorway in Block F (*Plate 32*) appears to be earlier in date and appears to relate to a compartment at the end of this range which is first clearly marked on the OS 2nd edition map of 1909 and subsequent OS mapping.

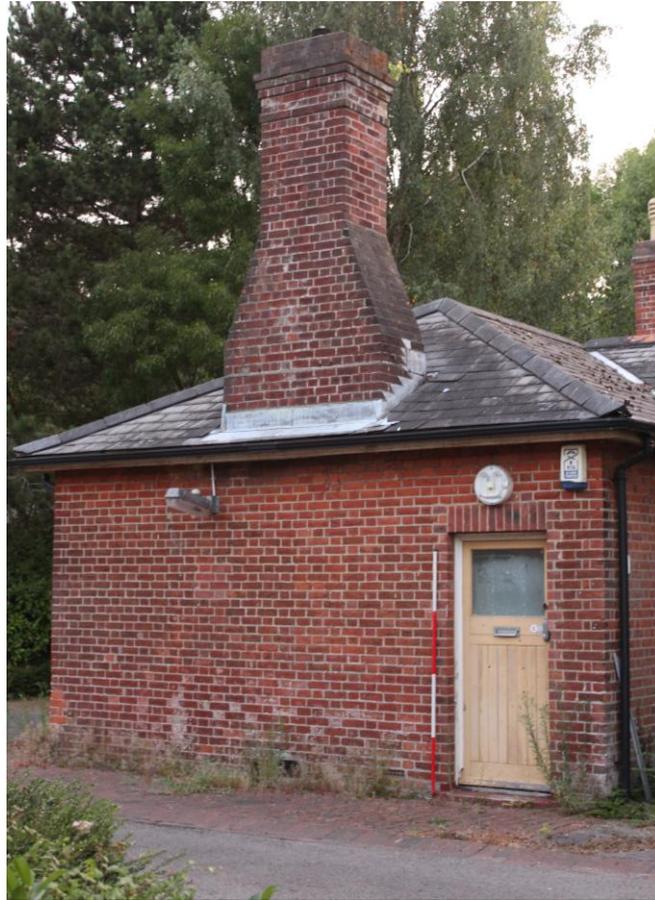
Plate 31: View looking NW showing SE end of Block C with intact end chimneystack and later doorway below

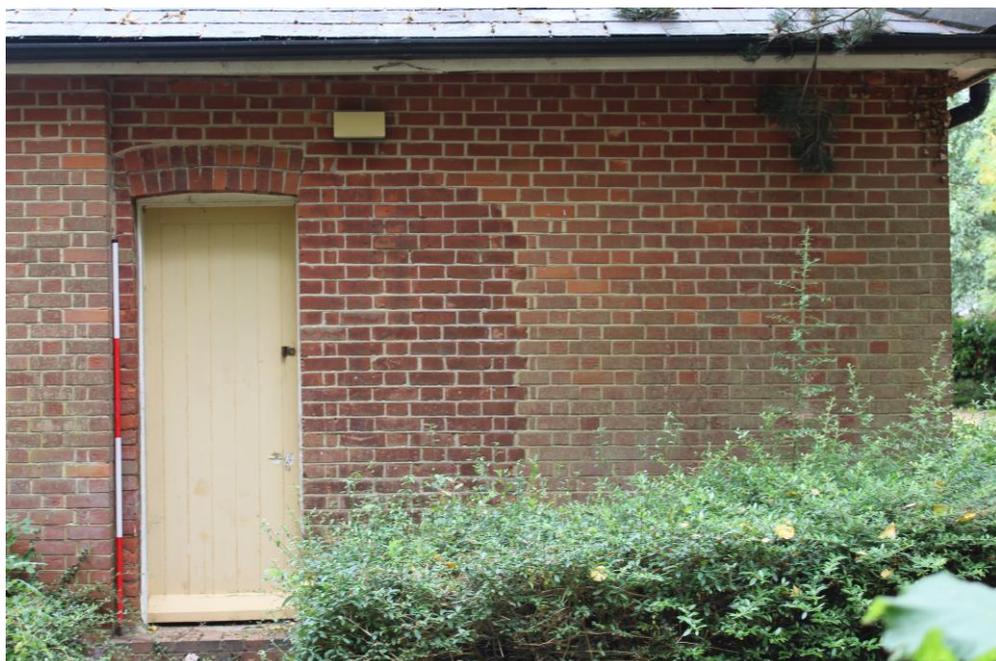
Plate 32: View looking NW showing segmental arched doorway at SE end of Block F

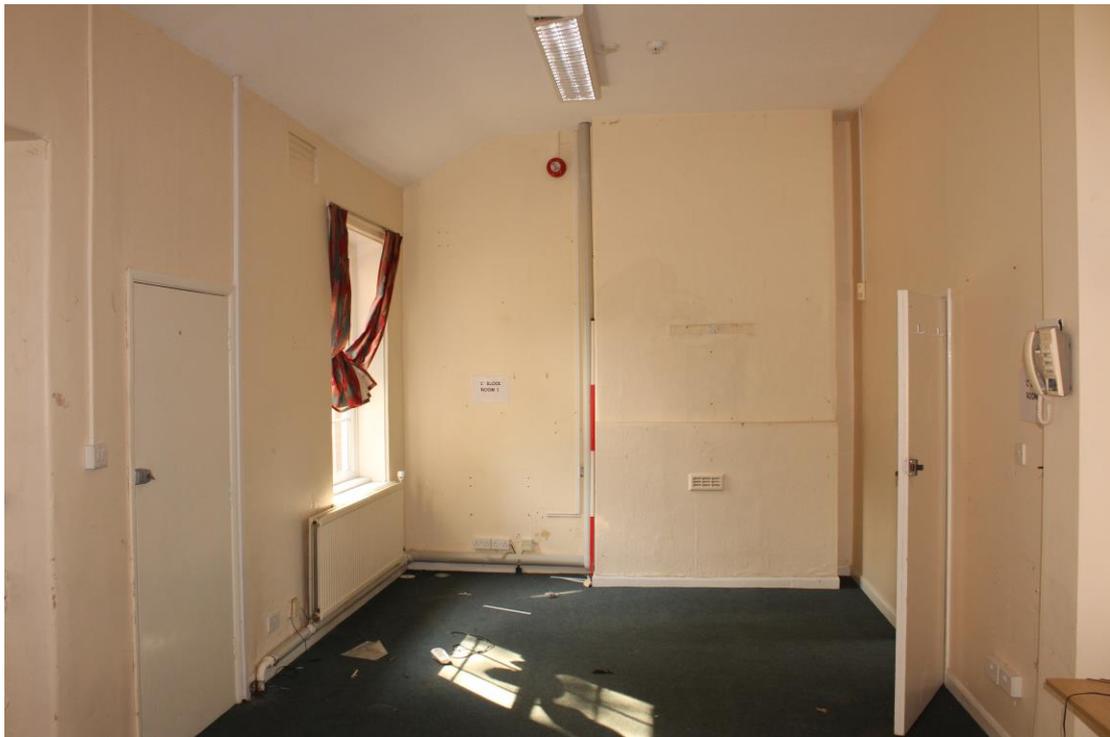
Plate 33: Internal view looking NW of central compartment in Block E with covered ceiling and fireplace at NW end, with wall stub of former partition visible to right of picture

Within the remaining blocks, the original internal subdivision into eight separate compartments of equal size is still largely intact and discernible, in spite of modern alterations. These compartments would originally have been self-contained dwellings accessed from vestibules entered via the porches in the front elevation, which in turn were separated by a dividing wall (*Plate 36*). These vestibules had interconnecting doorways which have mostly been blocked up to form cupboards or storerooms (*Plate 37 & 38*); however within Blocks E and F, where the entrance porches are still partially in use and have not been bricked up; the internal arrangements are somewhat better preserved. Although most of the doors have been renewed, several plank-and-batten doors have survived with iron strap-hinges and other door furniture which appears to be late 19th century in date (*Plates 39 & 40*).

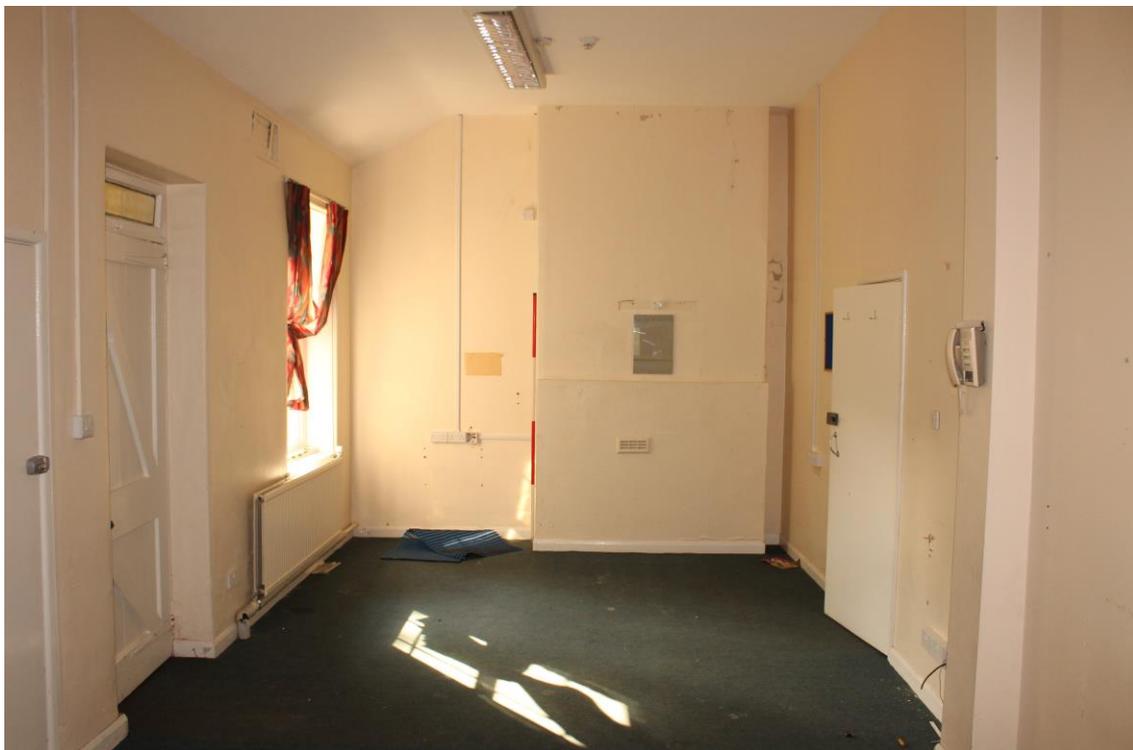
Plate 34: Internal view looking NW showing compartment at SE end of Block E showing wall stub of former partition wall visible to right, and plank and batten doorway to left of picture

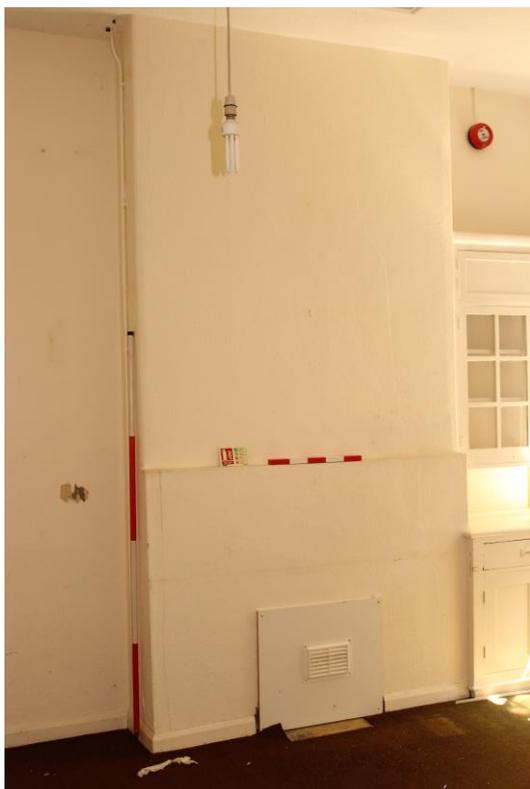
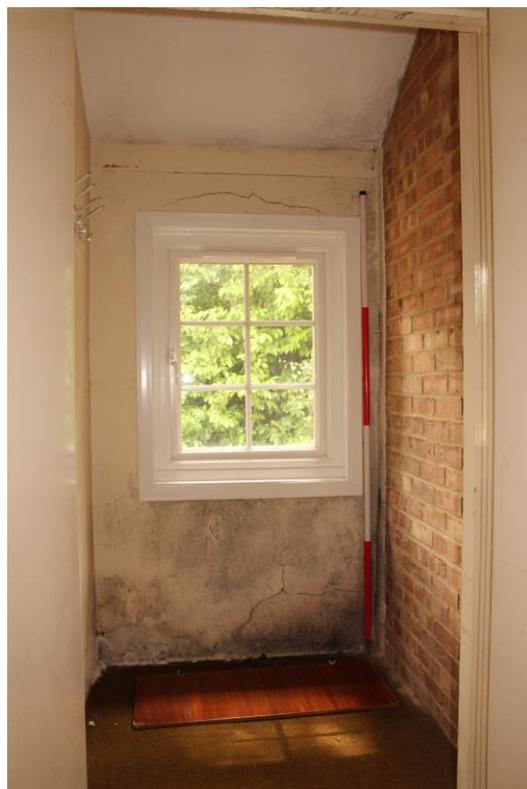
Plate 35: Internal view looking SE showing blocked fireplace to left of dresser in compartment at NW end of Block E

Plate 36: Internal view looking SW showing interior of former entrance porch and partition in central compartment of Block G

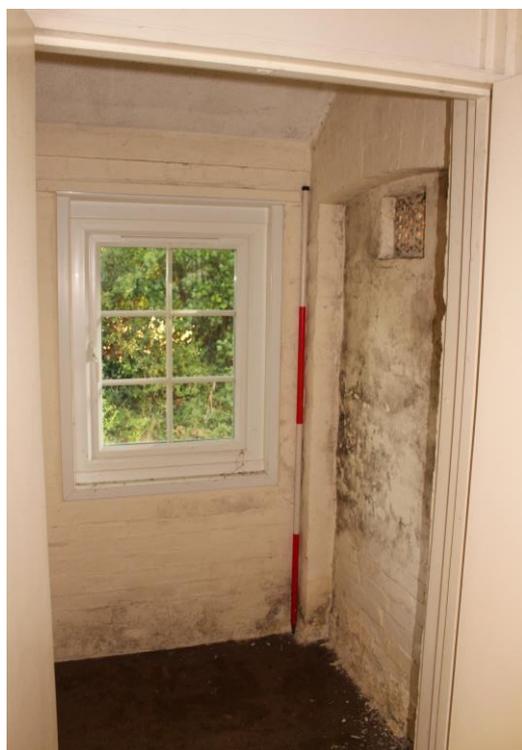
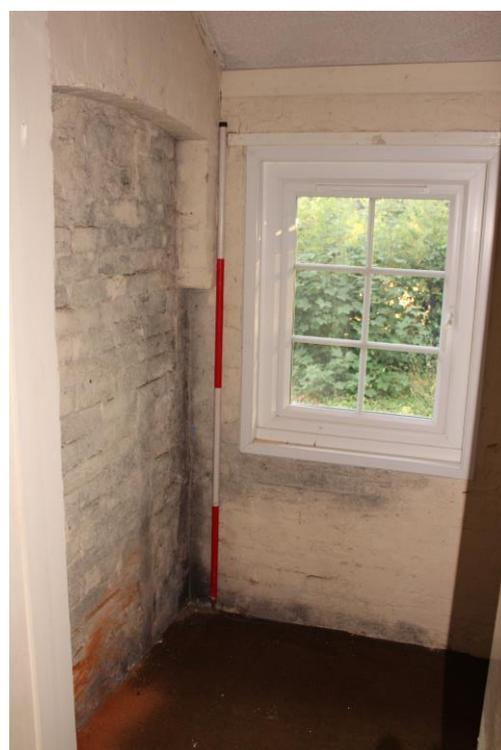
Plate 37: Internal view showing blocked door of former entrance porch in compartment at NW end of Block B

Plate 38: Internal view showing former entrance porch in central compartment of Block B (with segmental doorway to left)

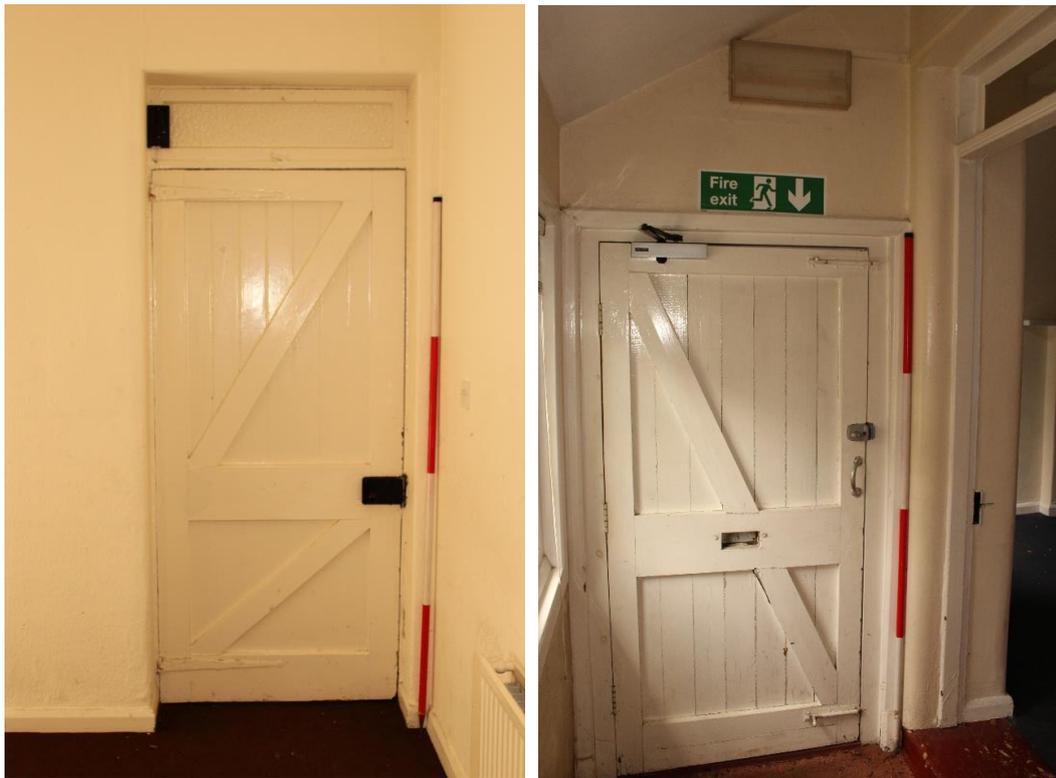
*Plate 39: Internal view SW showing plank and batten doorway leading to vestibule in compartment at NW end of Block E
Plate 40: Internal view looking NW showing detail of intact plank and batten door in entrance porch at SE end of Block F*

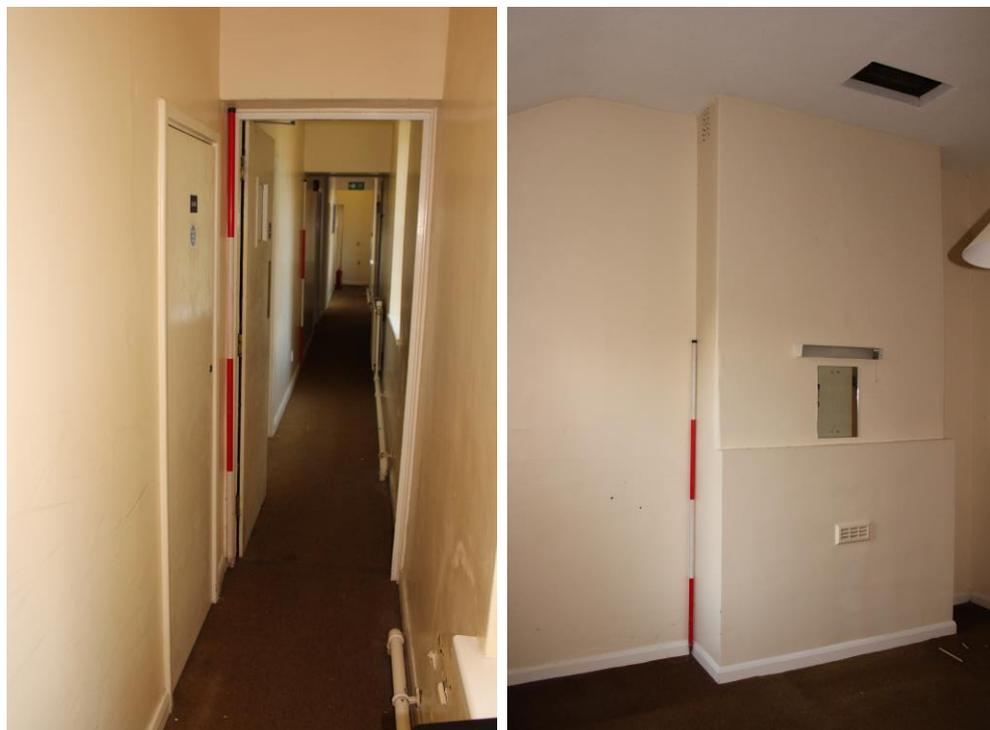
*Plate 41: View looking SE showing modern axial corridor extending within interior of Block B
Plate 42: Internal view looking NW showing blocked fireplace with covered ceiling and hatchway above within compartment at SE end of Block B*

The individual compartments have been slightly truncated as a result of the insertion of a modern axial corridor running along the entire length of each block (*Plate 41*) with the exception of Block F where no corridor had been inserted. The compartments within the main portion of Blocks B to K are generally rectangular in plan with tall coved ceilings (with hatches leading to the roof-space) and carpeted or linoleum floors (*Plates 42 & 43*). With the exception of Block F (which only has three fireplaces), all the other blocks have fireplaces distributed in similar fashion to those in Block A, consisting of two at either end of the building and three double-sided fireplaces within the thickness of the partition walls which would have served the remaining six rooms. All of these fireplaces have been blocked up and concealed by plasterboard, although their positions are clearly discernible and mantelpieces have survived over many of the fireplaces (*Plates 44 & 45*).

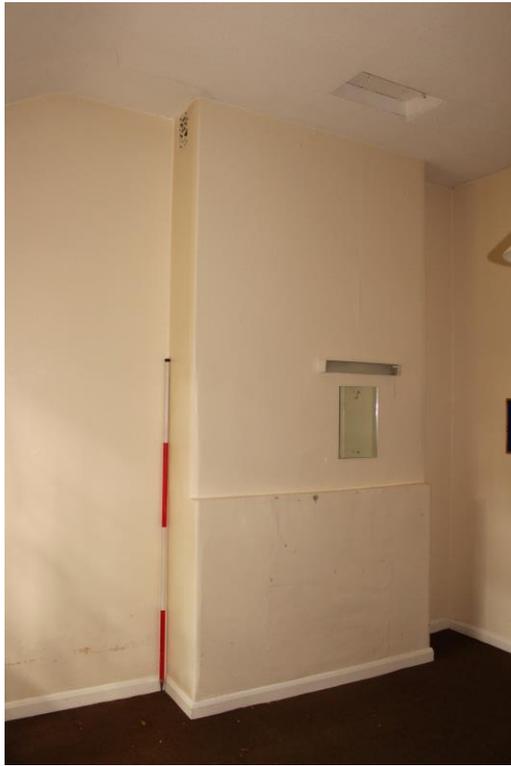
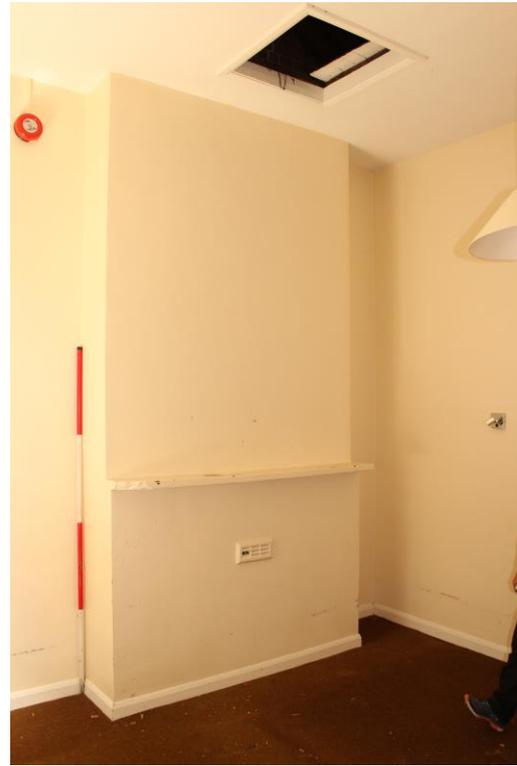
Plate 43: Internal view NW showing compartment at SE end of Block D with blocked fireplace, covered ceiling and hatchway
Plate 44: Internal view looking NW showing detail of blocked fireplace with mantelpiece within room at NW end of Block D

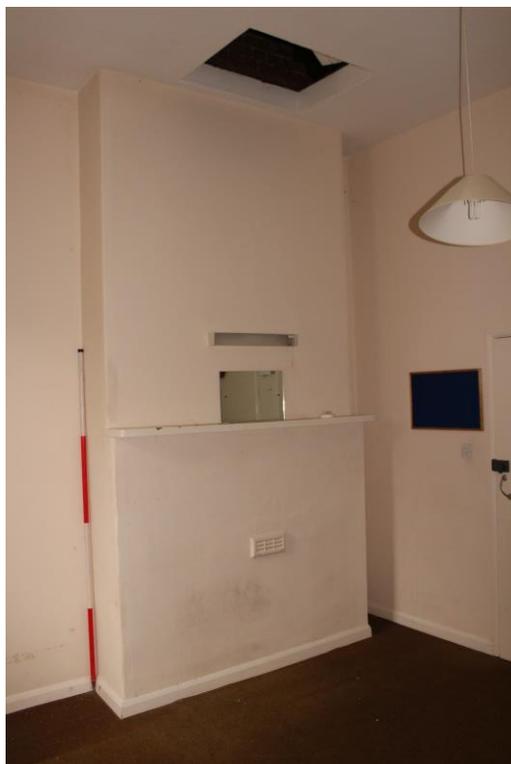
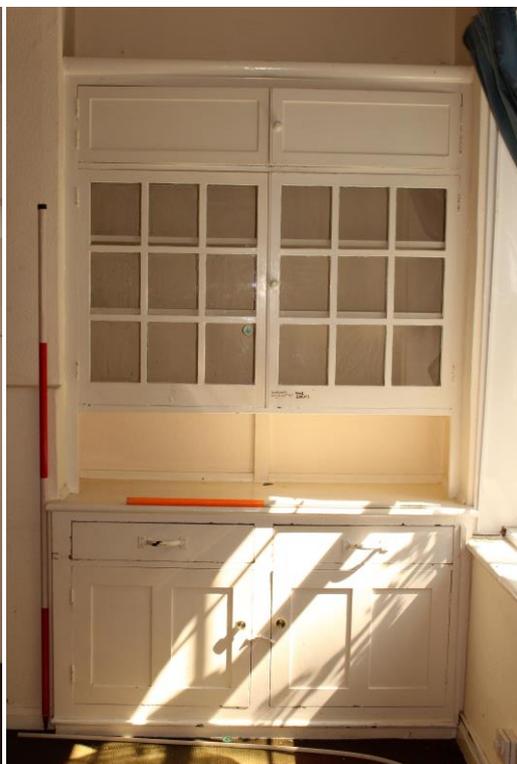
Plate 45: Internal view looking NW showing detail of fireplace with mantelpiece in central compartment of Block J
Plate 46: Internal view SE showing detail of late 19th/early 20th c. wall dresser in compartment at NW end of Block E

Relatively few fixtures or fittings of note have survived; the most notable being the tall wooden wall cupboards or dressers set within low-arched recesses adjacent to fireplaces within two of the compartments in Block E (*Plates 46 & 47*) and one of the compartments in Block F (*Plate 48*). The style of these dressers suggests a late 19th or early 20th century date, possibly associated with improvements to the married quarters that were implemented in 1914.

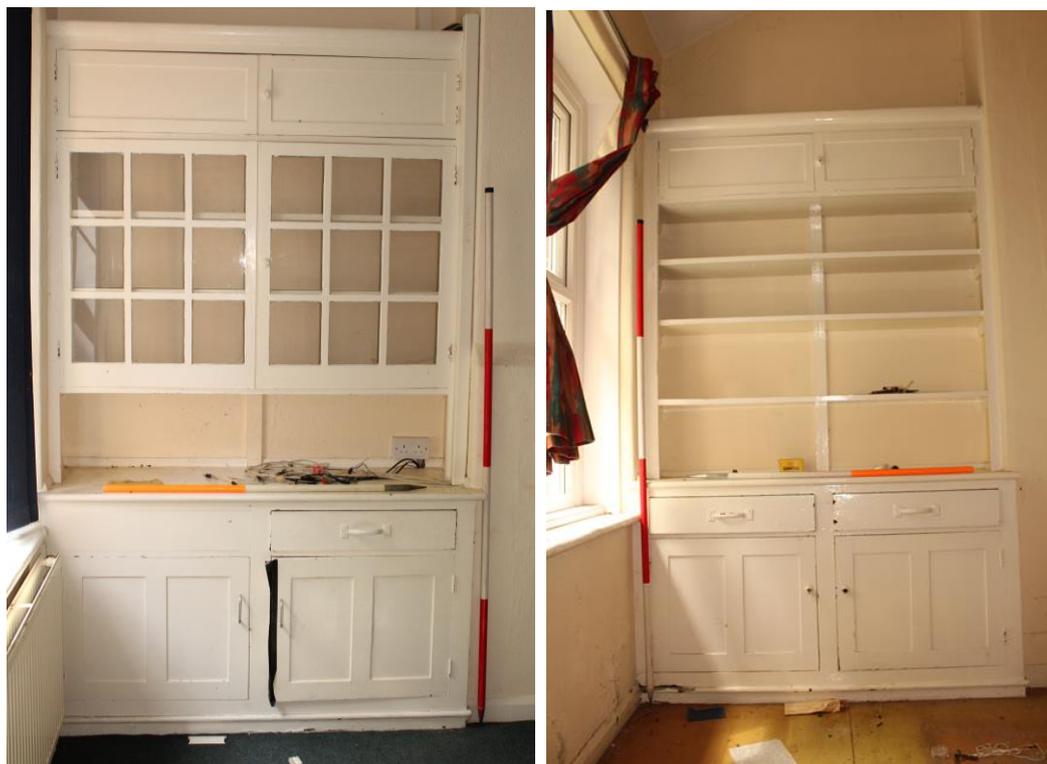
Plate 47: Internal view NW showing late 19th/early 20th c. dresser to left of fireplace within central compartment of Block E
Plate 48: Internal view looking NW showing late 19th/early 20th c. dresser within compartment at SE end of Block F

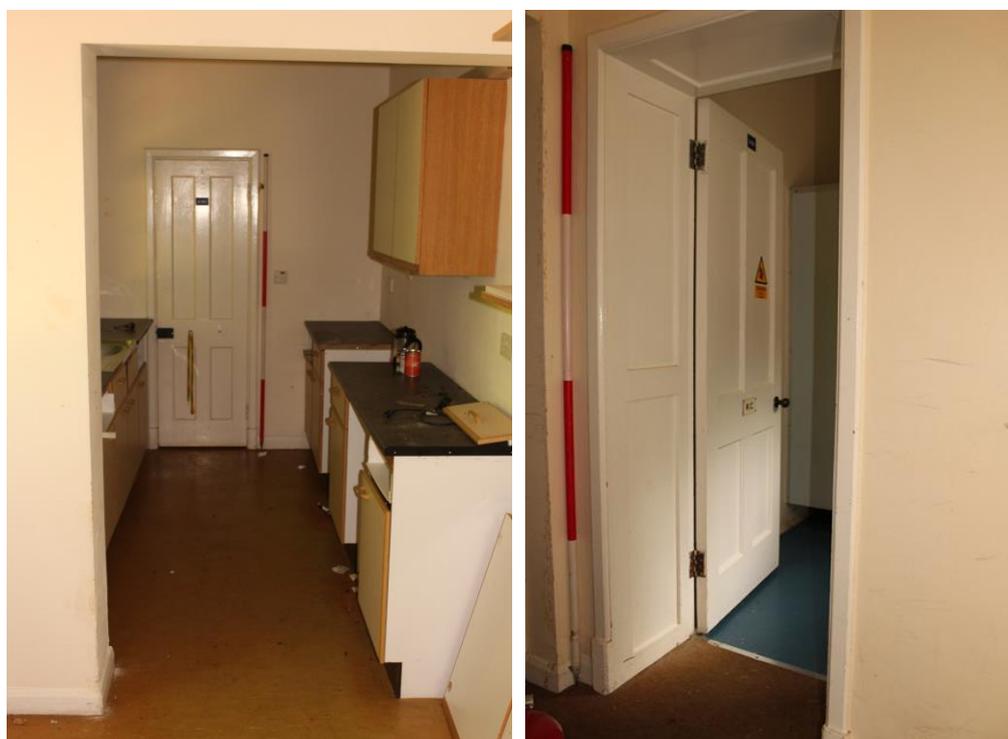
Plate 49: View looking SE showing interior of kitchen extension in Block E with four-panelled door at end of compartment
Plate 50: Internal view looking NE showing doorway to water closet in Block H with four-panelled door within recessed architrave

Within the later scullery/WC extensions, which are accessed from tall four-panelled doors leading off the main block, few fixtures and fittings of interest were noted and all have evidently been subject to extensive modern refurbishment. Some of the extensions have still been used as kitchens until recently, as in Blocks E and H (*Plate 49*), and a number of intact water closets have survived, accessed from tall 4-panelled doors set within recessed architraves (*Plate 50*). No other fixtures or fittings of note were observed within the buildings.
