Archaeological Standing Building Recording

**43-45 High Street
Leominster
Herefordshire
HR6 8LZ**

September 2018

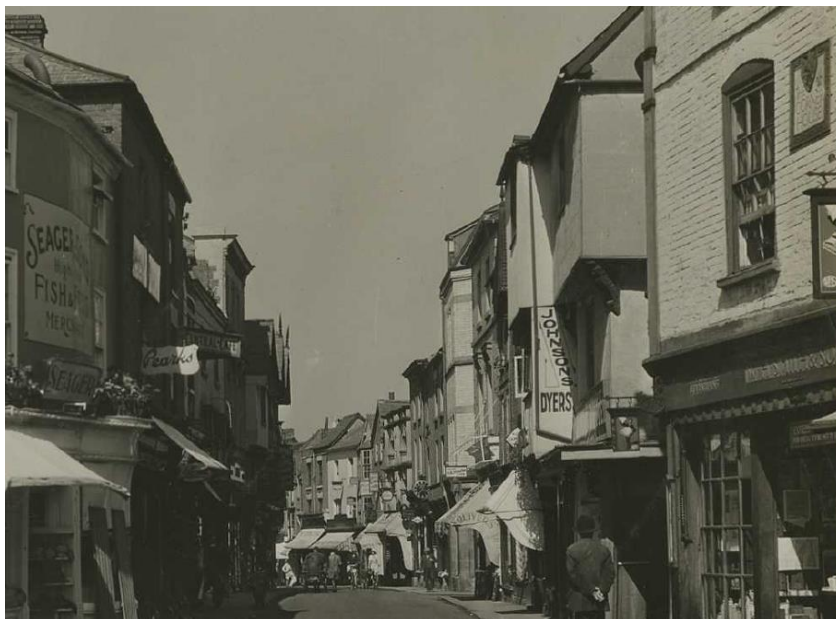
Fig. 5: Photograph dated c.1935 showing Nos. 43 and 45 High Street to right of picture at the corner with Corn Street
(Reproduced by courtesy of the National Archives)

Historic mapping shows that the form of Nos. 43 and 45 High Street has remained essentially unchanged since the early 19th century. Gallier's Map of 1832 (fig. 3) shows Nos. 43 and 45 in somewhat schematic form, without indicating the sub-division between the two properties, however the OS 1st edition 25-inch map of 1887 (fig. 4) and subsequent Ordnance Survey maps clearly show the subdivision between the two houses, with No. 43 in the NW corner fronting onto the High Street. Old photographs of Nos. 43-45 High Street show that both houses were stuccoed, with little visible timber-framing apart from the carved brackets supporting the jetties (fig. 5).

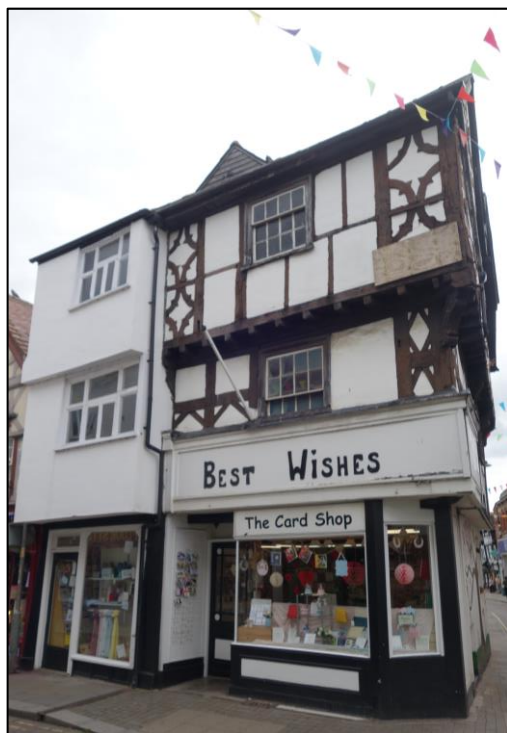
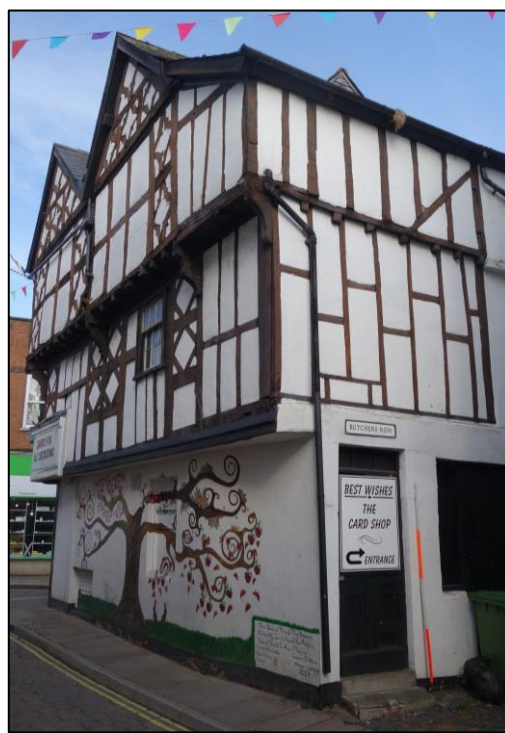
Plate 1: External view looking ENE showing W-facing elevation of Nos. 43 & 45 High Street
Plate 2: External view looking NW showing S-facing frontage of No. 45 High Street fronting onto Corn Street

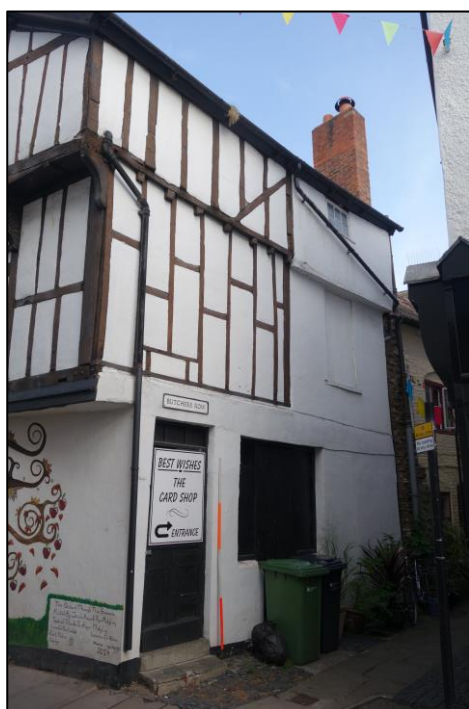
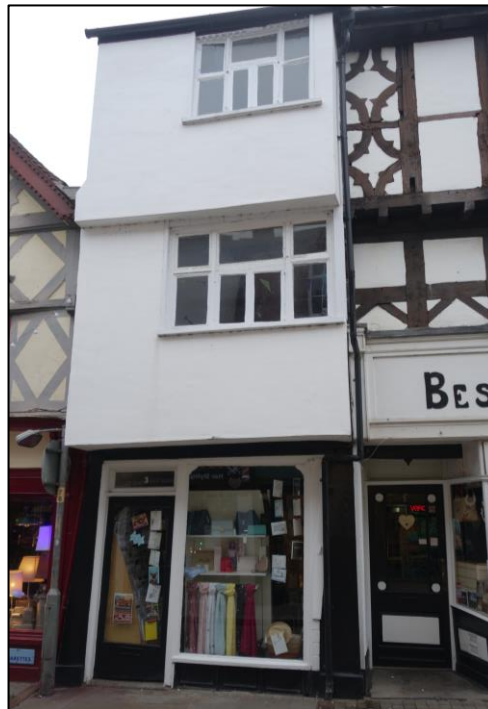
Plate 3: View looking NW showing rear elevation of No. 45 High Street with exposed thin-scantled timber framing
Plate 4: View looking E showing W-facing frontage of No. 43 High Street with jettied storeys above 19th century shop front

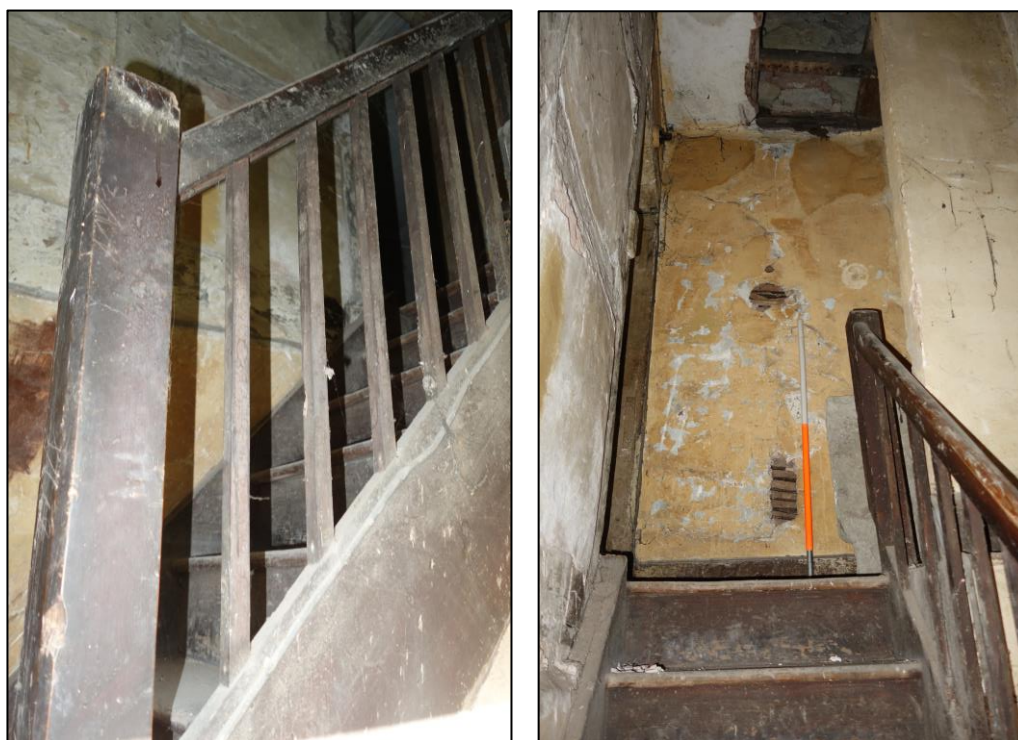
Plate 7: Internal view looking NW showing detail of ground floor staircase with newel post and stick balusters with evidence of square framed panels with thick scantling in background
Plate 8: Internal view looking N showing upper part of staircase leading to first floor landing

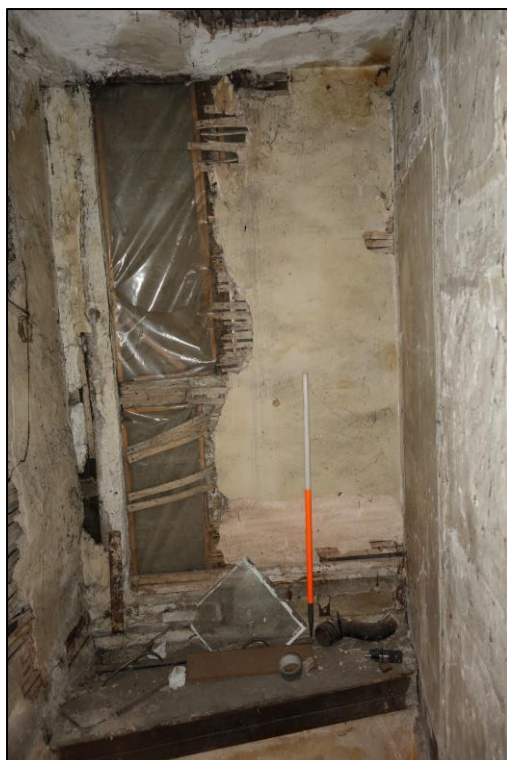
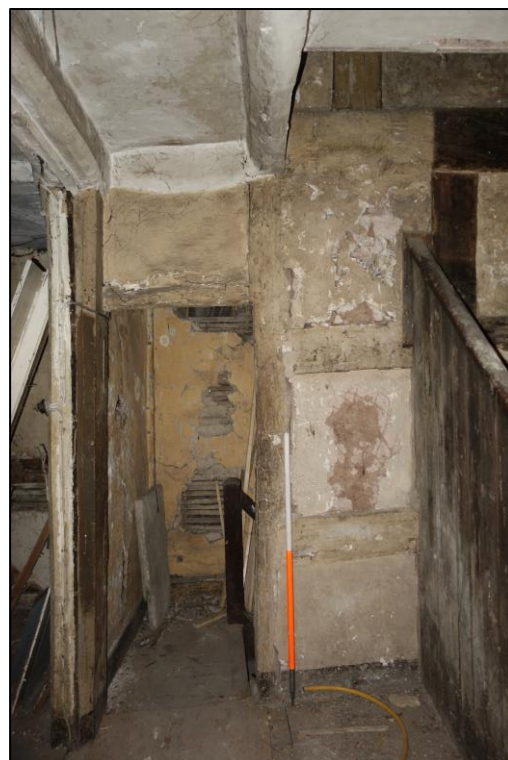
*Plate 9: Internal view S across from first floor landing (No. 45) with thick-scantled square framed panels to right of picture
Plate 10: Internal view E showing doorway inserted in timber framed wall leading from landing to first floor room (No. 45)*

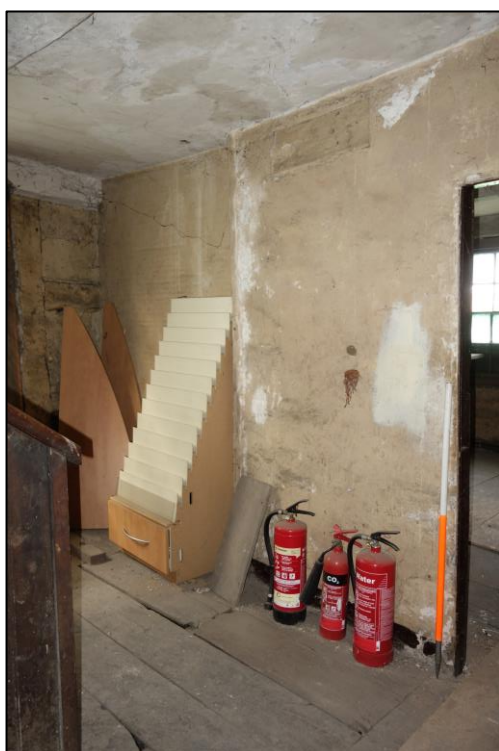
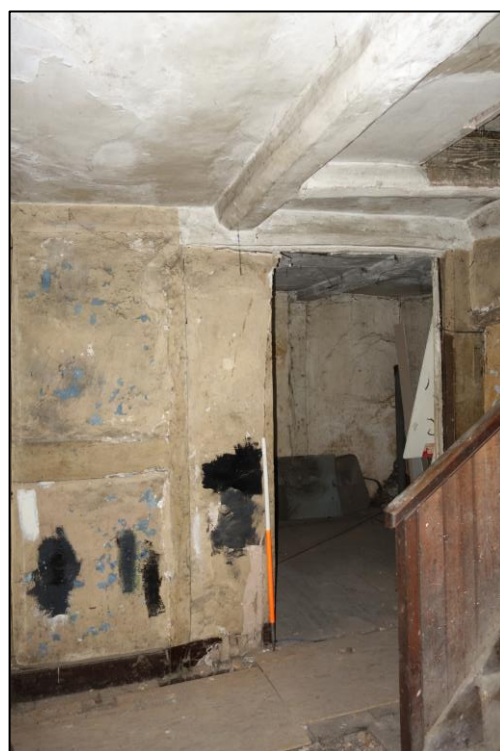
*Plate 11: Internal view SW showing staggered partition wall between SE and SW compartments on first floor (No. 45)
Plate 12: Internal view showing partition wall between SE and NE rooms on first floor (No. 45) showing square framed panels to left of picture and exposed ceiling beams*

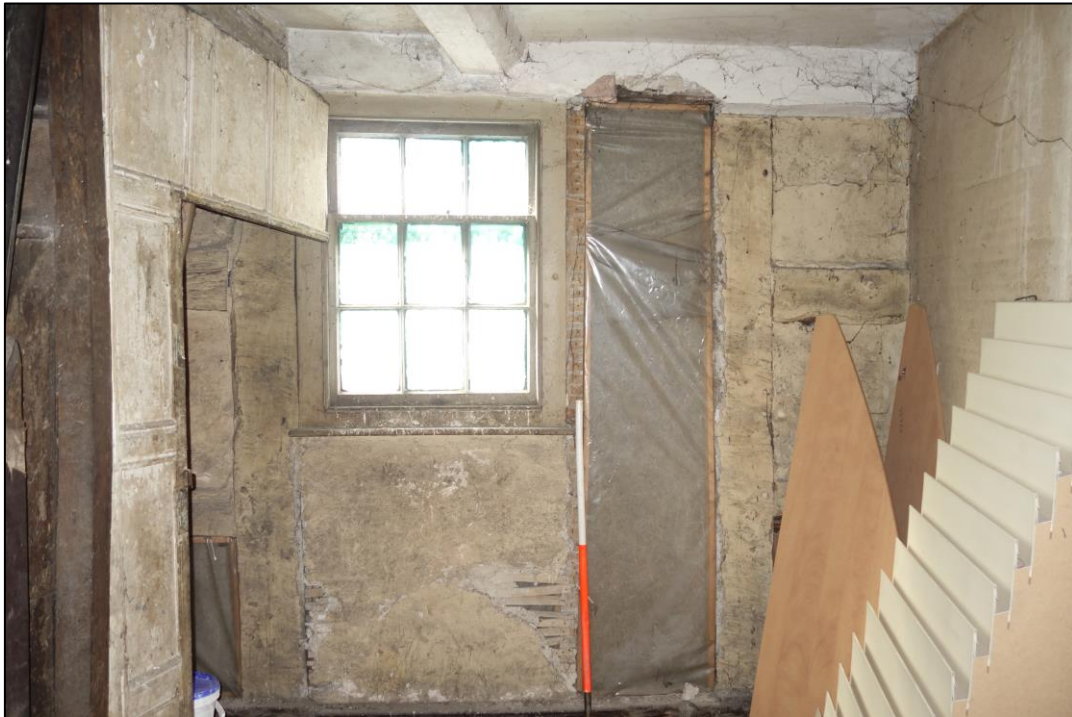
Plate 13: Internal view looking S showing SE compartment at first floor within No. 45, lit by sash window with section of oak panelling to left of picture

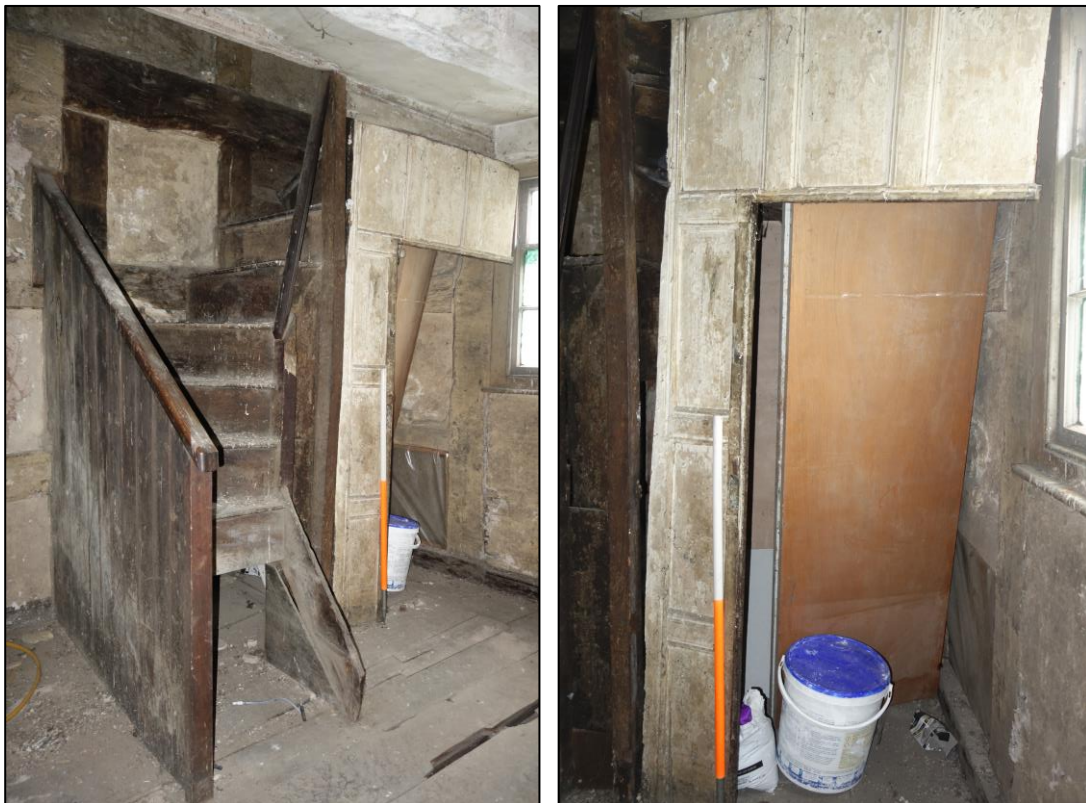
*Plate 14: Internal view SE showing oak staircase leading up to second floor (No. 45) with oak panelling to right
Plate 15: Internal view E showing section of oak panelling in SE room (No. 45) to right of staircase*

Beneath the staircase is a section of oak panelling of probable 17th century date, originally forming part of a door surround (as indicated by the hooks for hinges), which is evidently no longer *in situ* (*Plate 15*). The door surround comprises three recessed, elongated side panels and three broader rectangular recessed panels over the door opening surmounted by a moulded cornice; the right-hand panels appear to be missing. The original position of this panelled door surround is unclear: it may have stood over one of the doorways leading to the rooms to the N or W; the proportions appear to be too wide to be associated with the doorway leading to the landing and staircase to ground-floor level. The RCHME Survey (carried out in 1930) refers to a panelled door with arcaded panel in No. 45 but no visible evidence for this was noted during the present survey (RCHME 1934, 122).

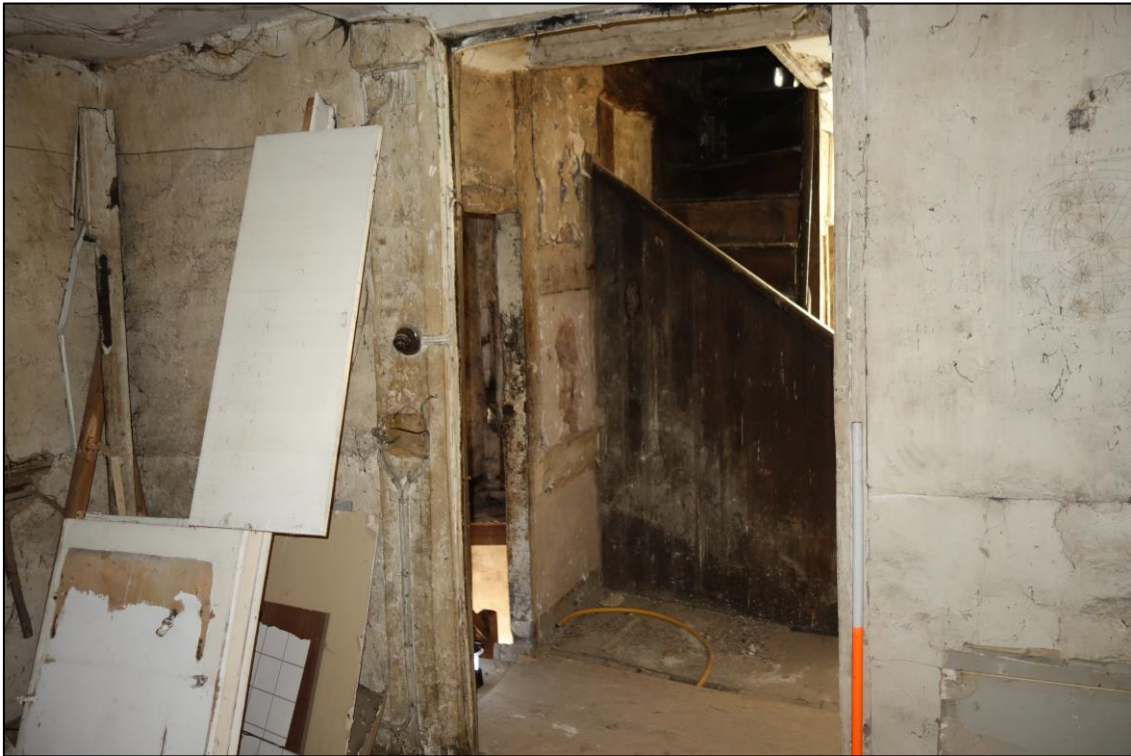
Plate 16: Internal view looking S showing doorway to NE room (with first floor landing in background) showing chamfered vertical post adjoining doorway, carrying ceiling beam

of the room, with infilled slots for horizontal rails (*Plate 16*). This vertical post and beam appear to mark the original line of the E wall, indicating that the easternmost bay was probably added at a slightly later date (*Plate 17*).

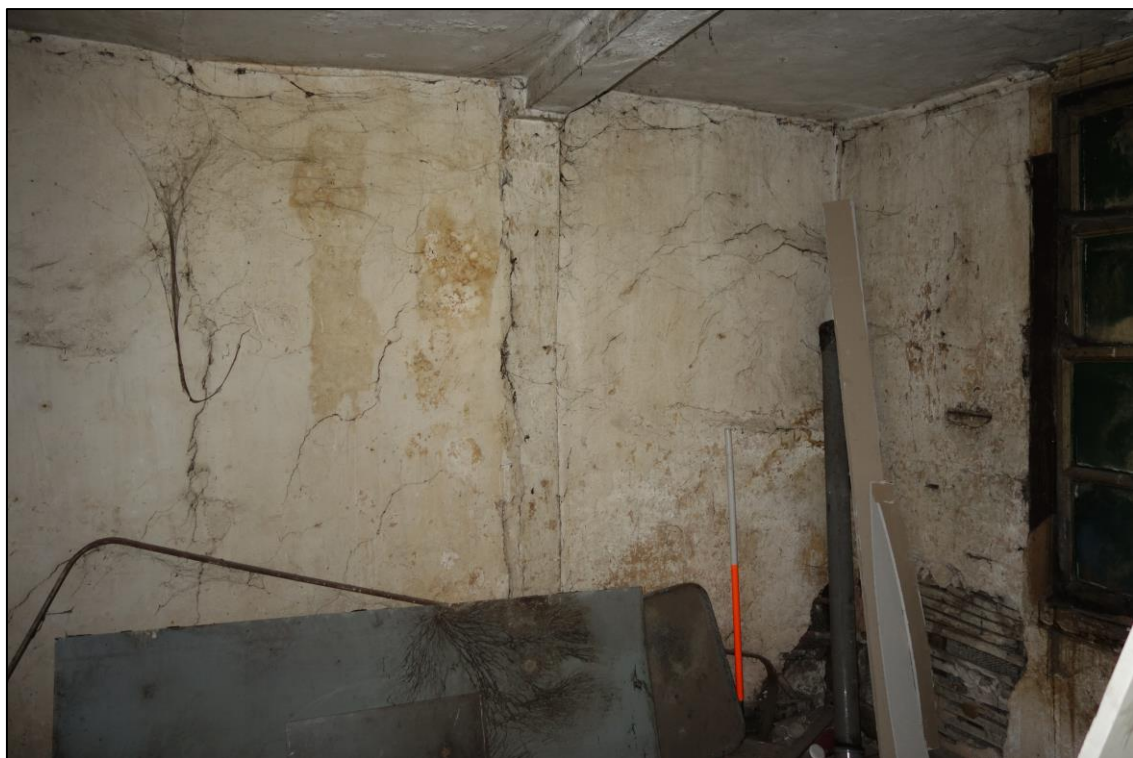
Plate 17: Internal view looking N showing vertical post and ceiling beam marking vertical construction break for easternmost bay (with 6/6 sash window to right of picture)

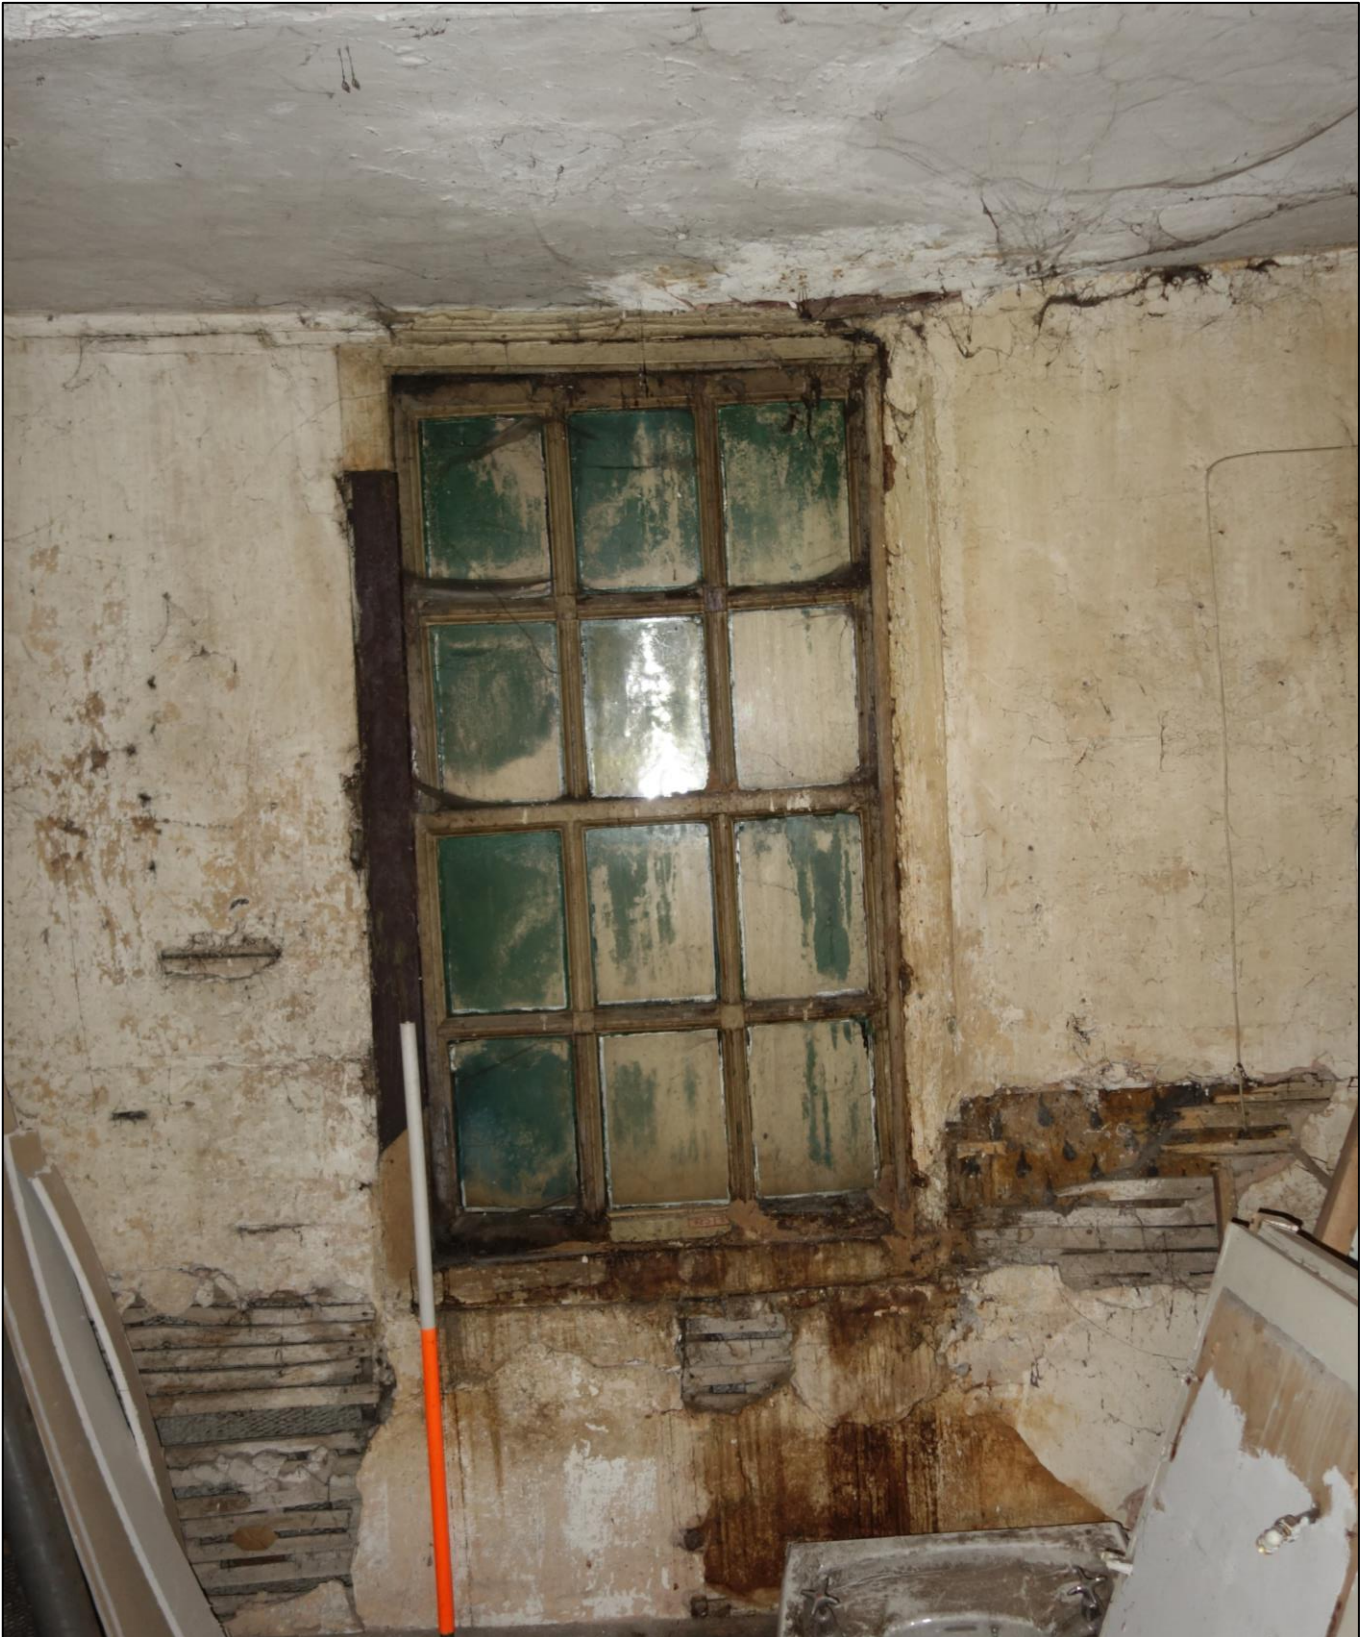
Plate 18: Internal view looking E showing 6/6 sash window in NE room on first floor (No. 45) with evidence of earlier painted wall decoration visible to right of window frame, concealed by later lath-and-plaster work

Remains of decorative painted plasterwork, bearing a repeated black droplet motif on a reddish-gold background, were noted in the wall immediately beneath and to the right of the sash window, partially truncated by the sash window frame and concealed by later lath-and-plaster work. Only a fragment of the painted decoration was revealed; however, the simple repetitive pattern is strongly suggestive of a date in the first half of the 17th century (Baird 2003; Kirkham 2010) and suggests that this room was of relatively high-status.

Within the NE room at first-floor level, evidence of painted plaster decoration (with a repetitive black droplet pattern) was noted in the wall of the easternmost bay, concealed by later lath-and-plaster work and seemingly truncated by the insertion of the 6/6 sash window, which itself appears to be of late 17th or early 18th century date.

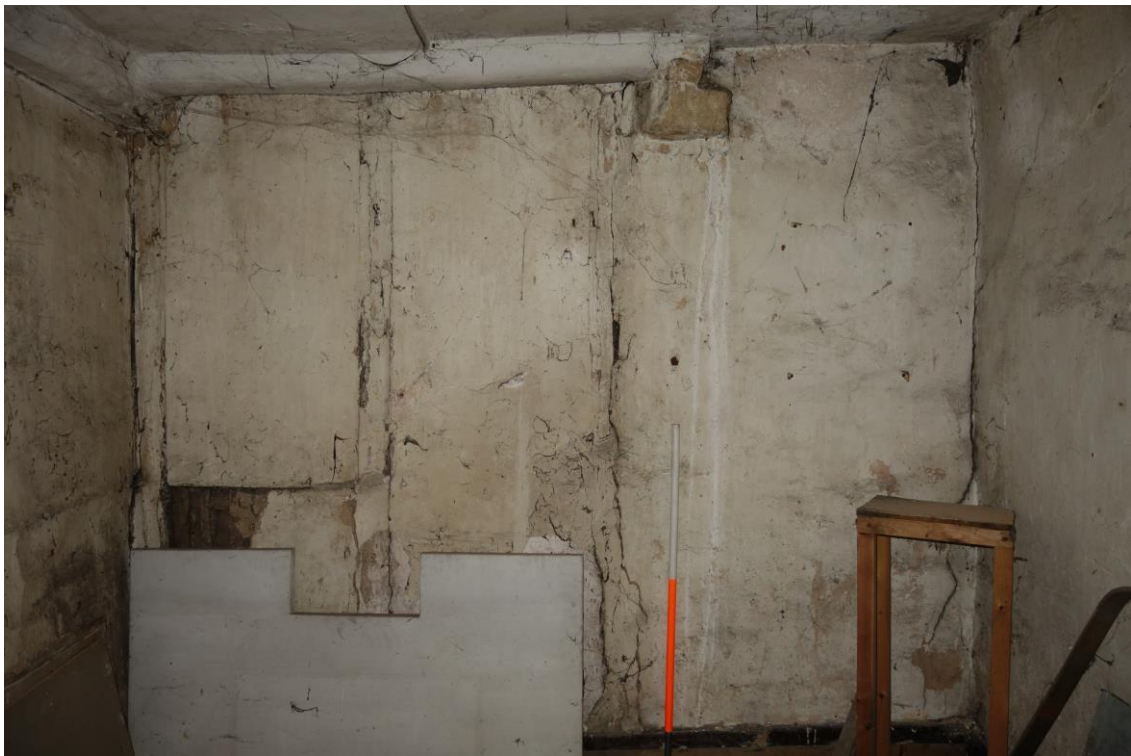
Plate 19: Internal view looking W in NE room on first floor (No. 45) showing close studded partition wall at W end of room and possible location of former fireplace in NW corner

Within the W wall of this room, evidence of close-studded timber-framing (with lath-and-plaster infill) was noted, above which was a horizontal beam carried on a substantial joist at its N end, which terminates abruptly about halfway along the wall (*Plate 19*). This may indicate the position of a former fireplace in the NW corner of this room, a hypothesis corroborated by the position of an extant brick chimneystack immediately on the other side of the wall (in No. 43) extending up to first- and second-floor level.

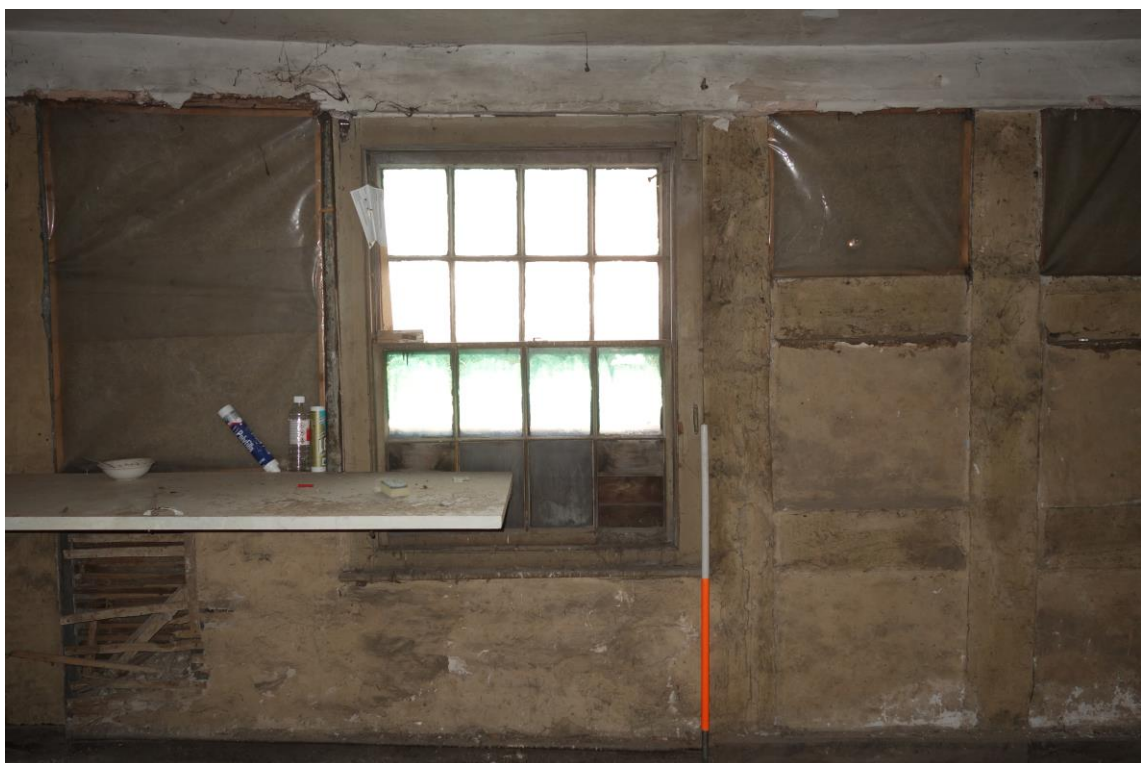
Plate 20: Internal view looking W showing 8/8 sash window in SW room on first floor (No. 45) flanked by thick-scantled square panels with lath-and-plaster infill

The room is lit by an 8/8 box-framed sash window with thin glazing bars (probably of late 18th century date) inserted into the W wall, which consists of square-framed, thick-scantled panels with lath-and-plaster infill (*Plate 20*). The lower part of the window is partially obscured by the fascia board of the early 20th century shopfront. The framing of the S wall has been exposed and appears to have been partially reconstructed at a later date, as evidenced by the insertion of thin-scantled timber framing in the centre of the elevation, flanked by thick-scantled square-framed panels characteristic of the earlier work (*Plate 21*). A series of square-framed panels with thick scantling are exposed along the S wall of the room, clearly indicating the division between No. 45 and No. 43 immediately to the N (*Plate 22*).

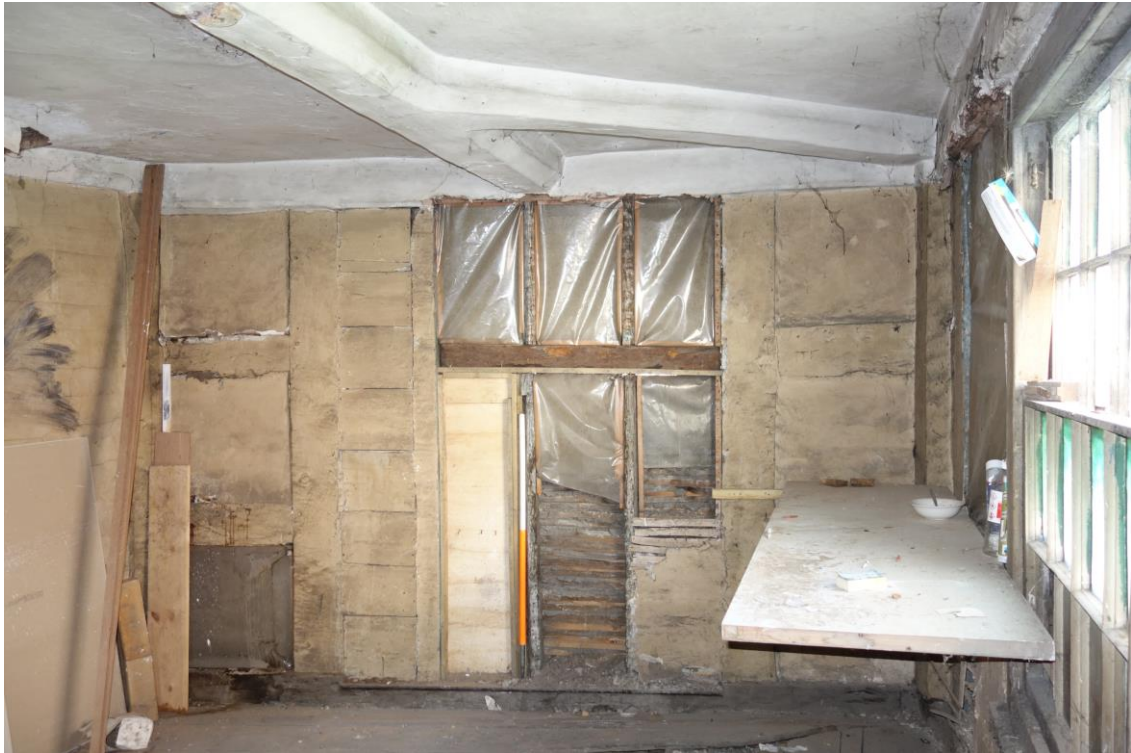
Plate 21: Internal view looking S within SW room on first floor (No. 45) showing exposed lath-and-plaster work in S wall and diagonal dragon beam in ceiling

The SW compartment of No. 45 (overlooking the High Street) is accessed from the room off the landing via a flat-headed doorway with wooden frame, the door having been removed previously. This room has planked floorboards (partially replaced with modern plasterboard) while the ceiling (which is plastered) has two exposed deep chamfered transverse beams and a diagonal beam (commonly known as a 'dragon beam'), which would have provided support to the jetty above (*Plate 21*).

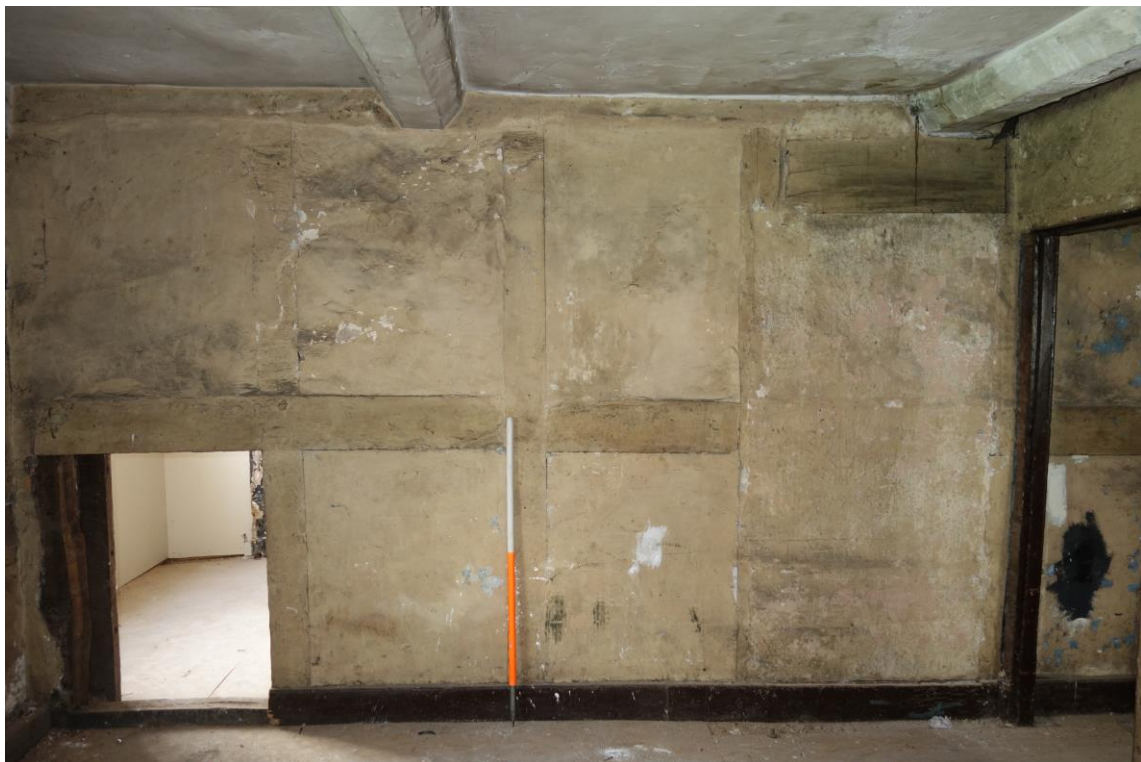
Plate 22: Internal view looking N within SW room at first floor level (No. 45) showing N wall with thick-scantled, square framed panels with lath-and-plaster infill clearly marking the division between No. 45 and No. 43 (to the N)

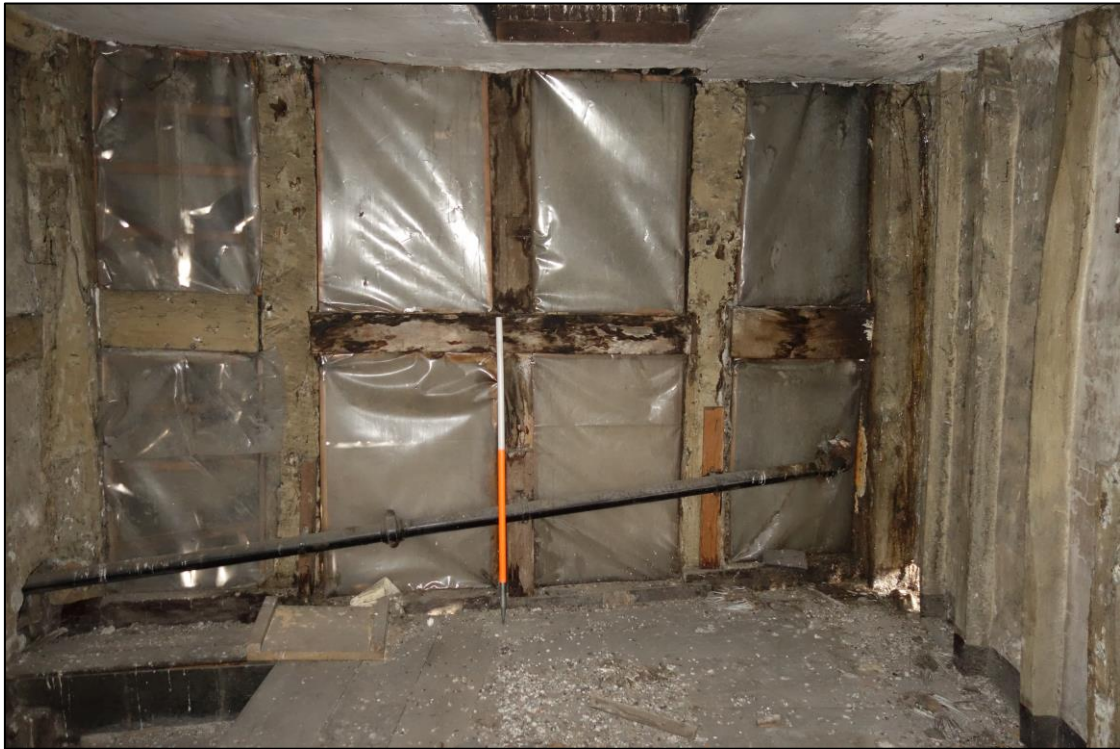
Plate 23: Internal view looking S showing SE room at second floor level (No. 45) with exposed square-framed, thick-scantled panels in the S wall and a hatchway in the ceiling leading to the roofspace

The second-floor rooms at No. 45 are accessed from the winder staircase leading up from the room immediately off the first-floor landing. The arrangement of rooms is similar to that on the first floor, consisting of two unequal sized rooms on the S side of the house, with a three-bay room to the NE and a narrow rectangular room above the staircase leading to ground-floor level. The room directly accessed by the staircase has planked floors and a plain plaster ceiling with hatch leading to the roof-space; the plaster infill within the square, thick-scantled framing of the S wall has been removed to expose the lathwork, covered by plastic sheeting (*Plate 23*). The partition wall

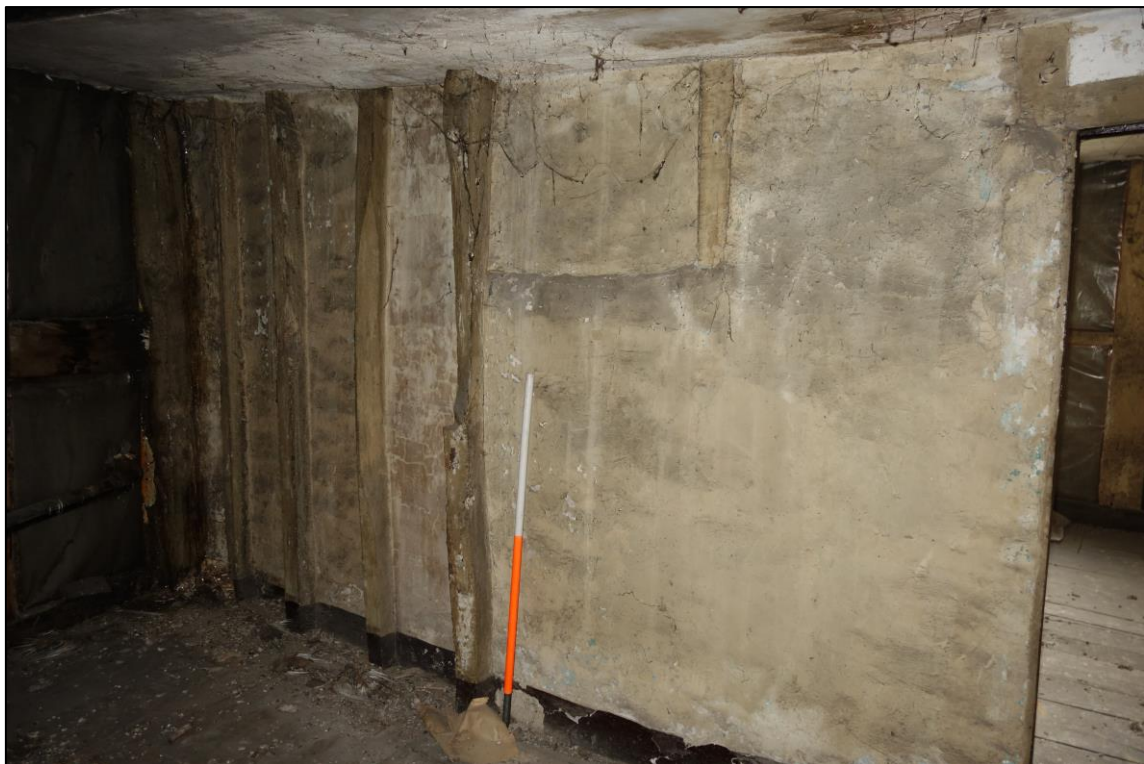
Plate 24: Internal view looking SW showing detail of close-studded wall with lath-and-plaster infill marking the division between the SE and SW rooms at second floor level (No. 45)

separating this room from the SW compartment is distinguished by its exposed slender scantling with lath-and-plaster infill (*Plate 24*).

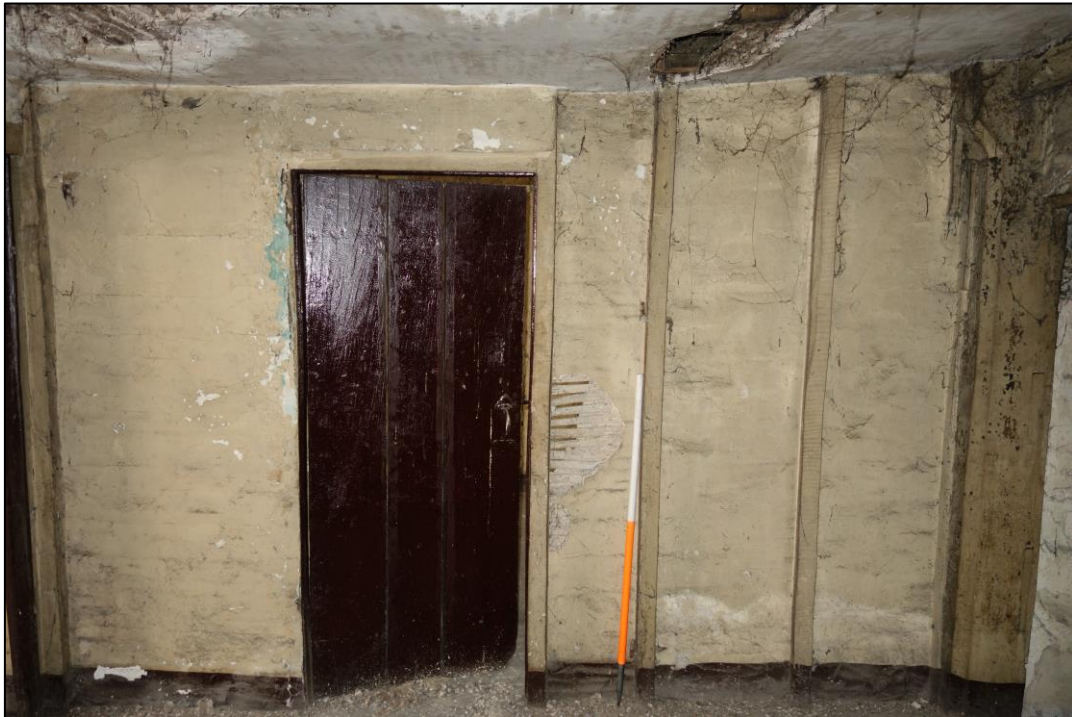
Plate 25: View looking N showing detail of N wall in SE room at second floor level (No. 45), with plank and batten doorway and close studding with lath-and-plaster infill, with jowelled vertical post at far right of picture

The lath-and-plaster partition wall demarcating the room to N the has exposed close studding with thin scantling, which is suggestive of a later repair, possibly 19th or early 20th century in date; inserted in the wall is a flat-headed doorway with an intact plank-and-batten door; the door fittings are suggestive of a late 17th or 18th century date (*Plate 25*).

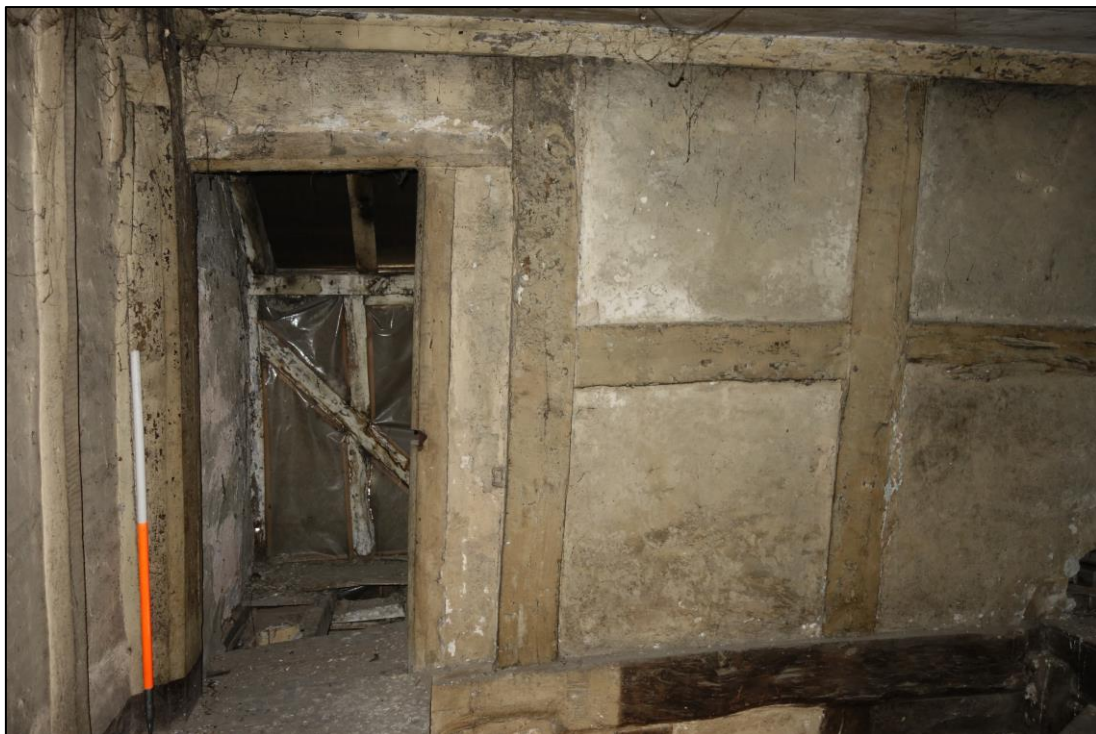
Plate 26: Internal view looking E showing detail of E wall of SE room at second floor level (No. 45), with later flat headed doorway leading to E extension, inserted within a section of thick-scantled square framed panels with jowelled chamfered post with infilled slots for horizontal rails to left of doorway

The E wall of this room consists of substantial square-framed, thick-scantled panels with lath-and-plaster infill; at the W end of this wall is a flat-headed doorway leading to the room above the landing and staircase below (*Plate 26*). This doorway is clearly a later insertion, as indicated by the fact that, at the far (left-hand) end of this partition wall is a substantial jowelled and chamfered vertical post with slots (since infilled), which would have originally carried the horizontal rails. The doorway leads to a rectangular compartment immediately above the landing and stairs to ground-floor level (*Plate 27*); the room has close-studded, thin-scantled walls with lath-and-plaster infill; there is no obvious indication that it ever had a plaster ceiling. Some of the floorboards within this compartment had been removed, so it was not possible to undertake a more detailed inspection.

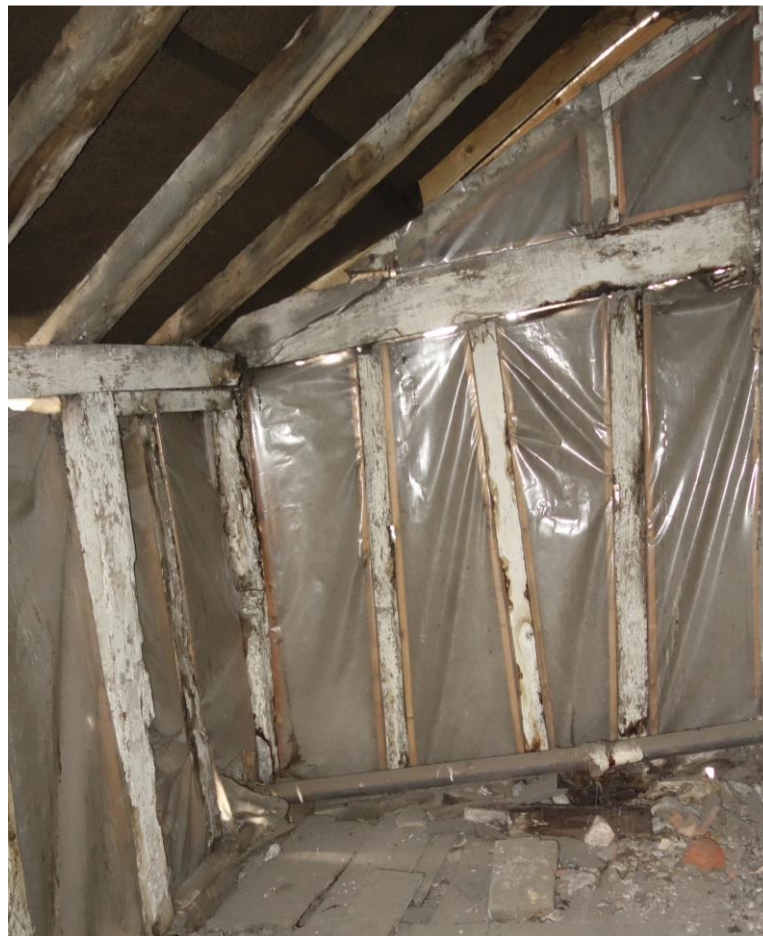
Plate 27: Internal view looking S showing detail of room in eastern extension at second floor level (No. 45) with thin-scantled timber-framing

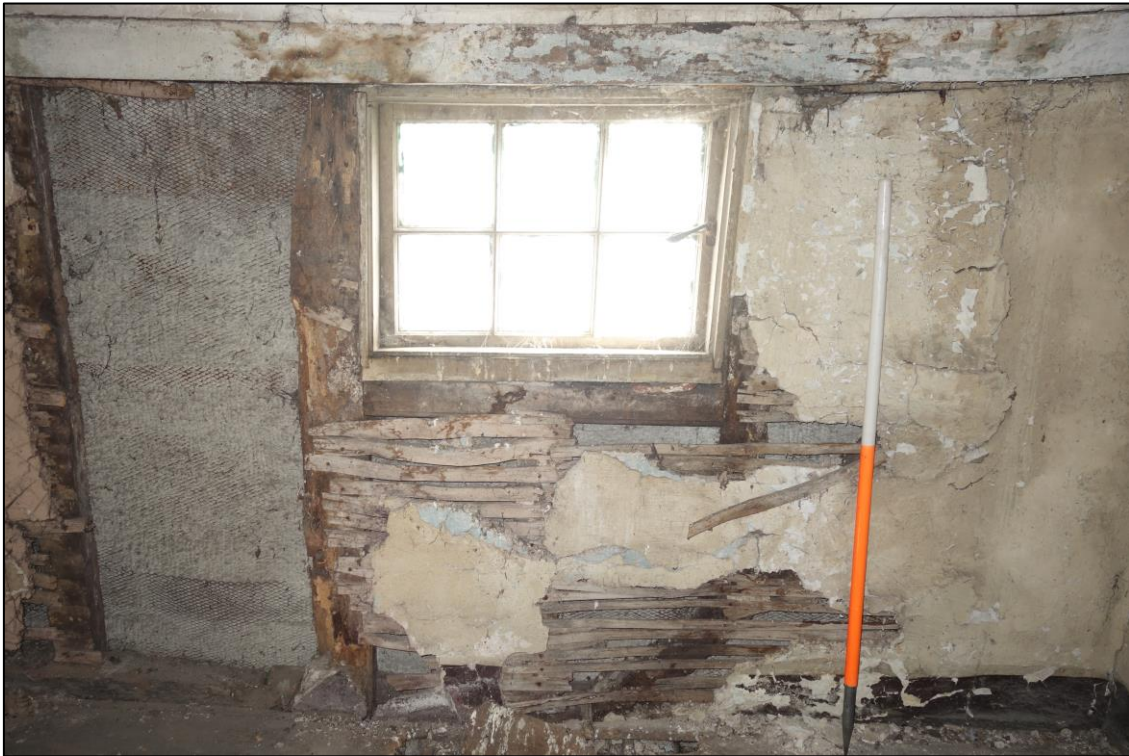
Plate 29: Internal view looking E showing 6-pane casement window in E wall of NE room at second floor level (No. 45) with exposed studding and lath-and-plaster work below

The NE room at second-floor level, like its counterpart on the first floor, is rectangular in plan, three bays long (E-W) and a single bay in width (N-S). It is lit by a small 6-pane casement window set in the E wall within a narrow rectangular wooden frame (*Plate 29*). Both the S and W walls are of studded construction with lath-and-plaster infill; much of the thin-scantled studding is exposed (*Plates 30 & 31*). No visible evidence for a fireplace was noted in the NW corner of this room.

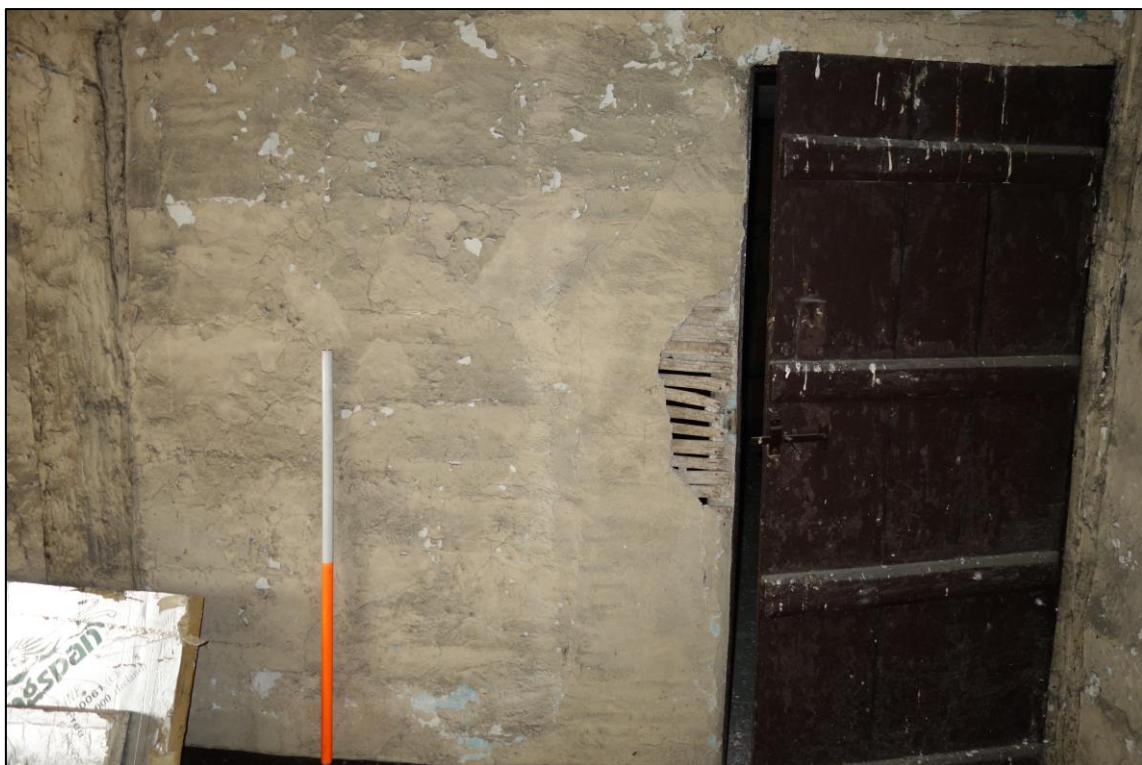
Plate 30: Internal view looking S showing S wall of NE room at second floor level (No.45) with plank and batten door and exposed lath-and-plaster work to left of picture
