Archaeological Standing Building Recording

**43-45 High Street
Leominster
Herefordshire
HR6 8LZ**

September 2018

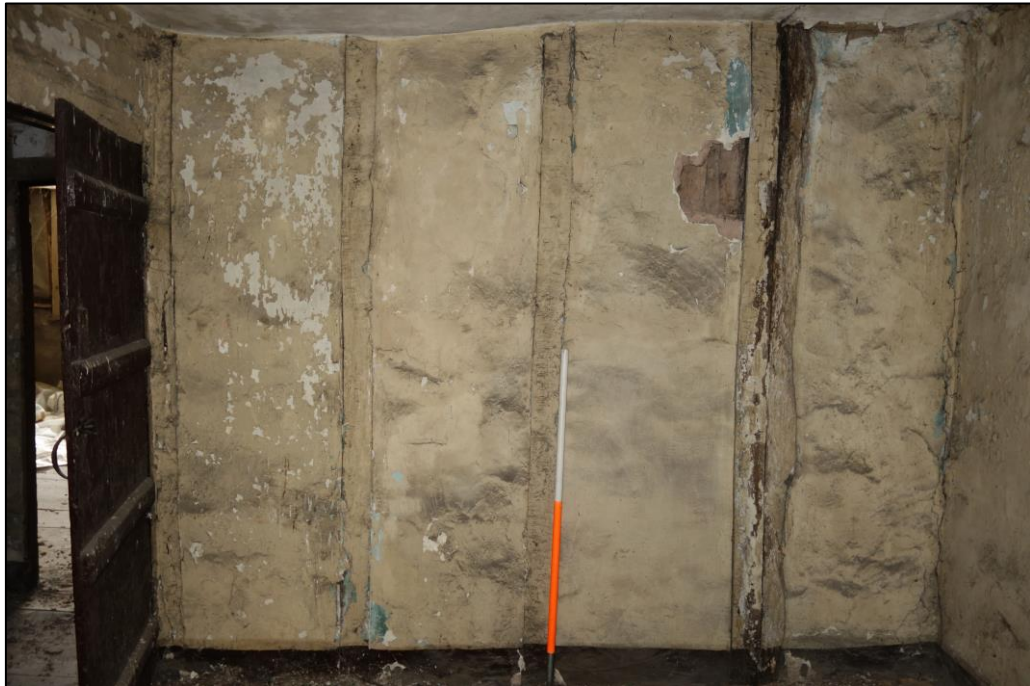
Plate 31: Internal view W showing close-studded framing in W wall of NE room at second floor level (No. 45)

The NE room at second-floor level, like its counterpart on the first floor, is rectangular in plan, three bays long (E-W) and a single bay in width (N-S). It is lit by a small 6-pane casement window set in the E wall within a narrow rectangular wooden frame (*Plate 29*). Both the S and W walls are of studded construction with lath-and-plaster infill; much of the thin-scantled studding is exposed (*Plates 30 & 31*). No visible evidence for a fireplace was noted in the NW corner of this room.

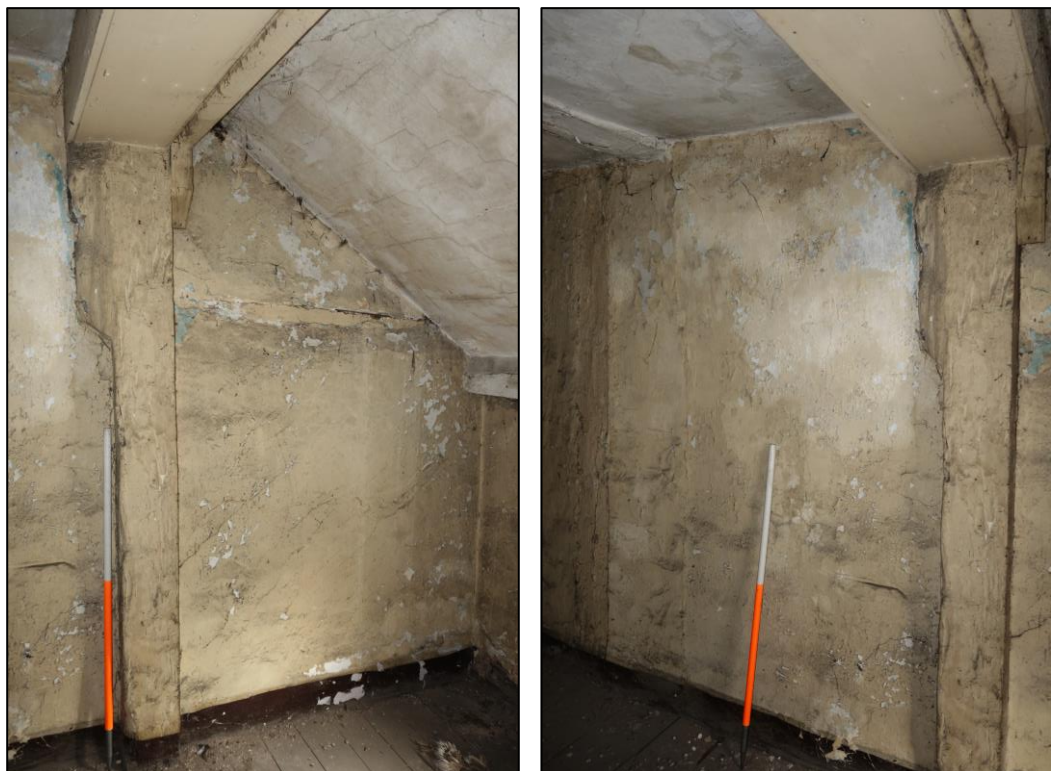
Plate 32: Internal view looking NE showing jowelled vertical post in N wall with infilled slots supporting transverse beam in easternmost bay of NE room at second floor level (No. 45)

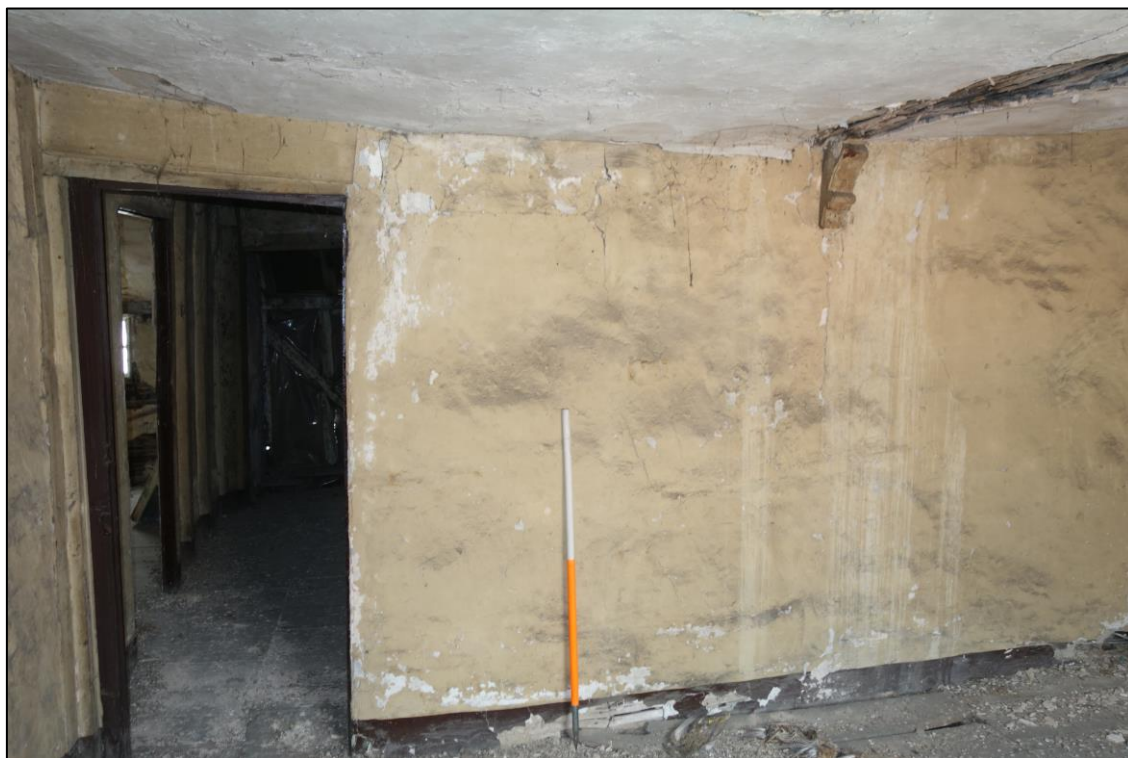
Plate 34: Internal view E showing flat headed doorway in NE corner of E wall of SW room at second floor level (No. 45) with carved wall bracket to right of picture

The room at the SW end of No. 45 is accessed via a flat-headed doorway with wooden frame and lintel above, the door itself having been removed (*Plate 34*). The room is lit by a box-framed 4/8 sash window with thin moulded glazing bars, which appears to be a later insertion of 18th century date (*Plate 35*). The W and S walls have exposed thick-scantled square-framed panels with lath-and-plaster infill (*Plate 36*), while the N wall of the compartment consists of regular thin-scantled studding with lath-and-plaster infill that appears to be later in date (*Plate 37*).

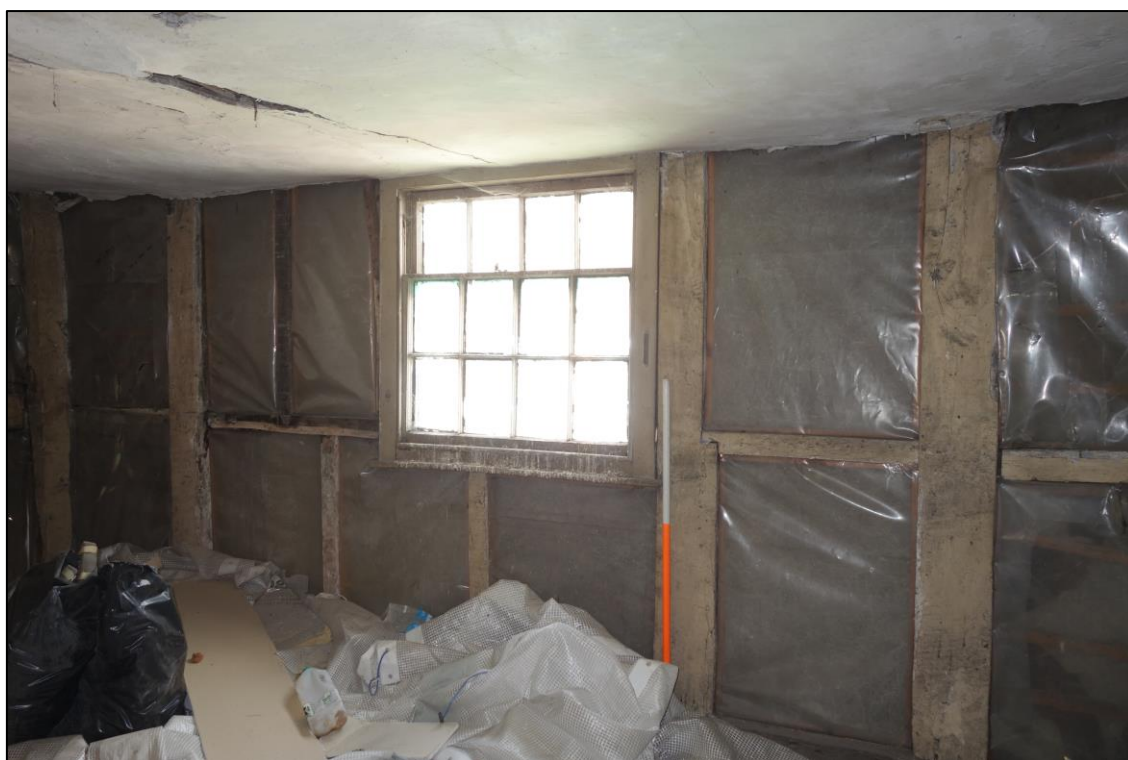
Plate 35: Internal view looking SW showing W wall of SW room at second floor level (No. 45) with later 4/8 sash window inserted, with a section of thin-scantled studding flanked by thick-scantled square panels

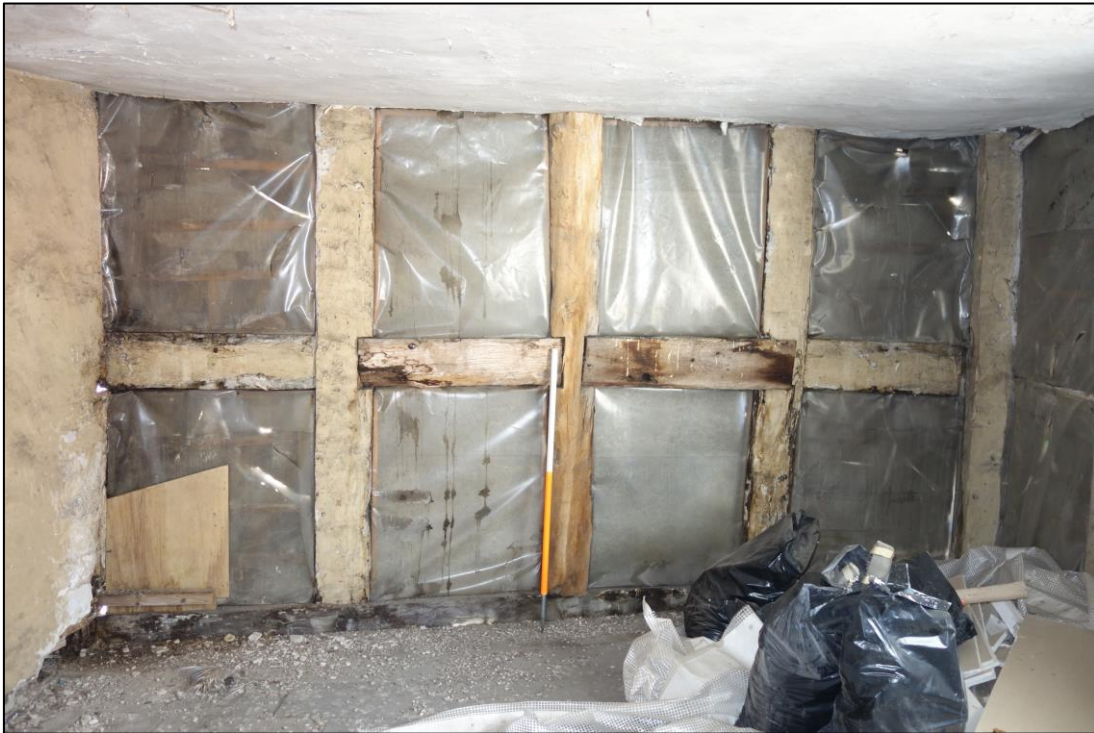
Plate 36: Internal view looking S showing square-panelled timber framing with thick scantling in S wall of SW room at second floor level (No. 45)

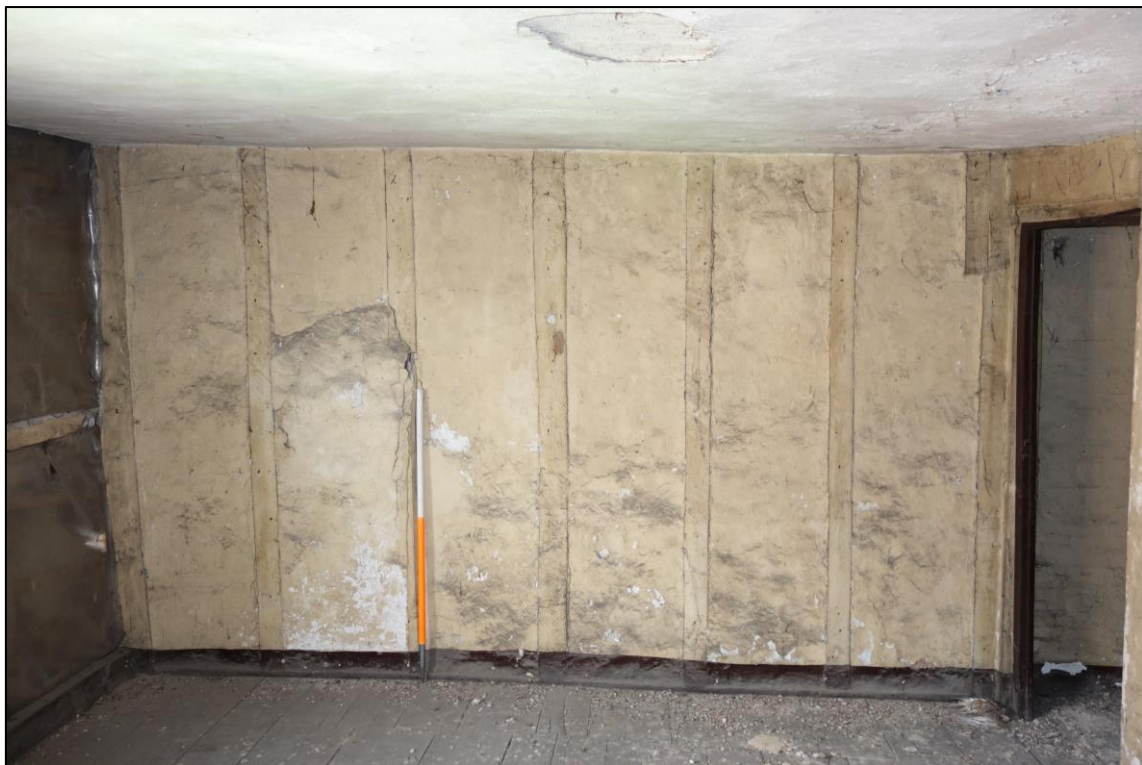
Plate 37: Internal view looking N showing N wall of SW room at second floor level (No. 45) showing close studded framing with thin scantling

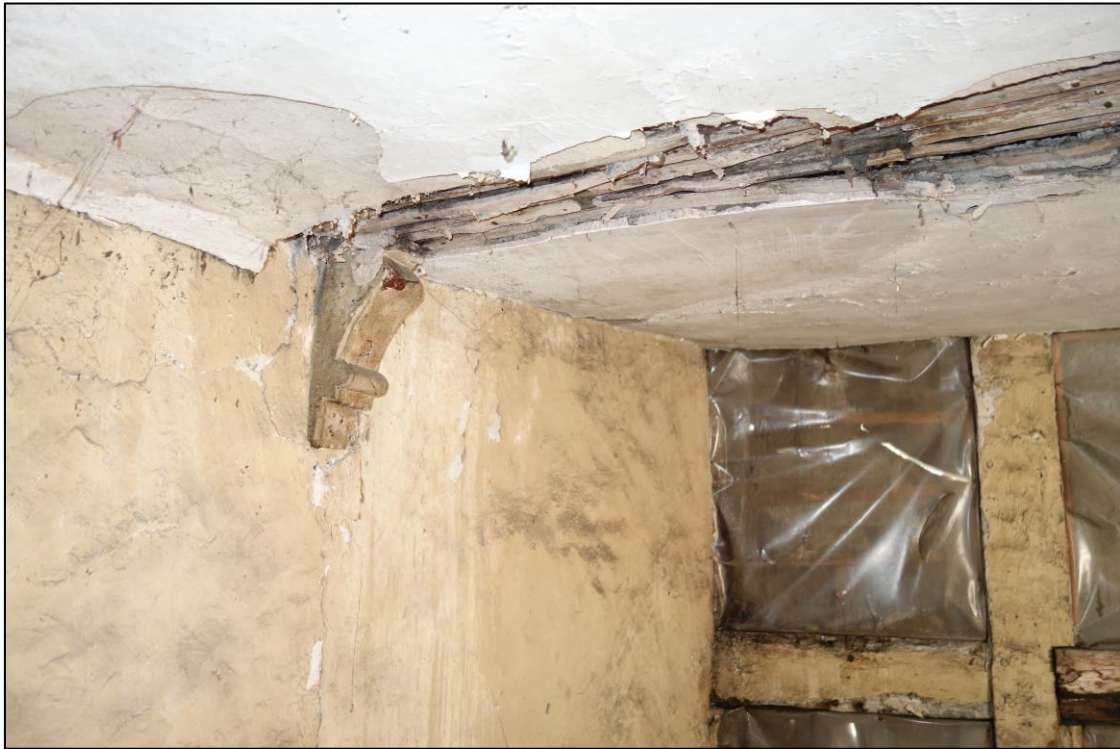
Plate 38: Internal view looking SE showing double ogee moulded bracket with traces of painted decoration on E partition wall of SW room at second floor level (No. 45)

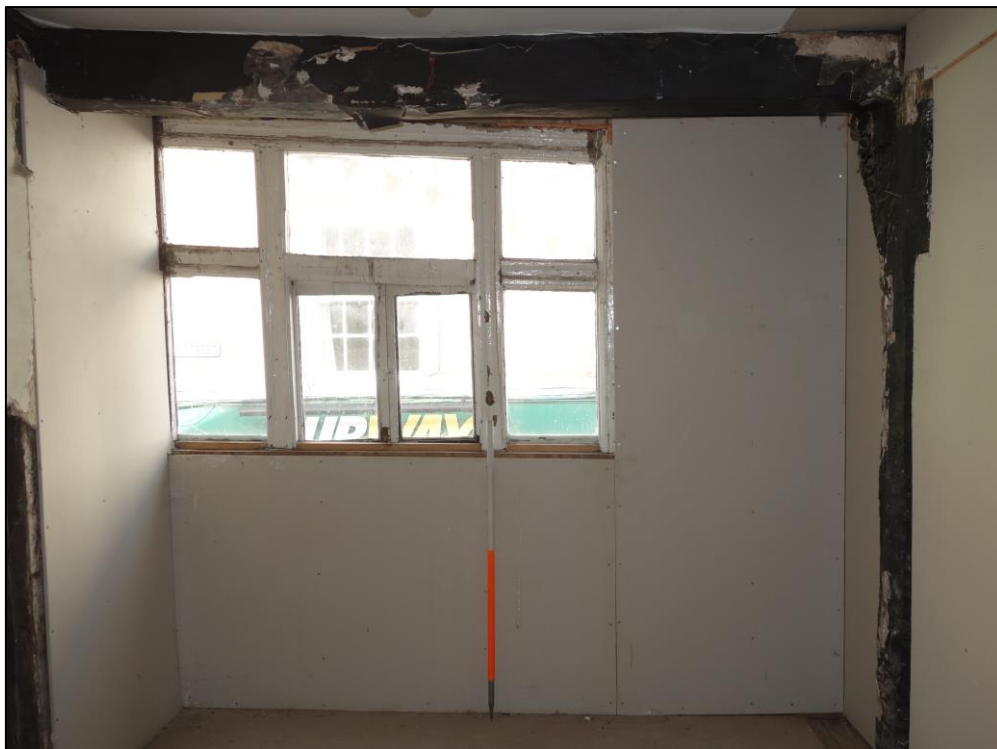
Plate 39: Internal view looking W showing westernmost bay of first floor room (No. 43) with mullioned and transomed window and exposed transverse beam carried on a jowelled vertical post (to right of picture)

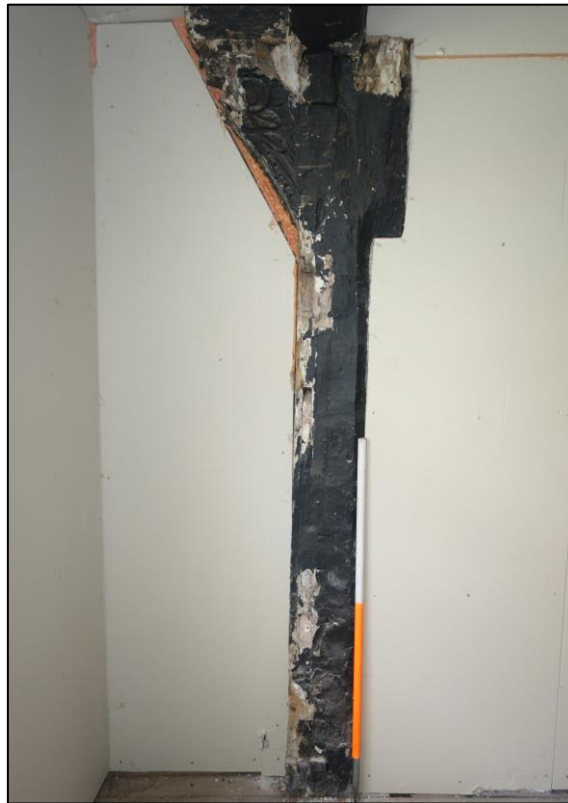
Plate 40: View looking N showing vertical jowelled post in westernmost bay of first floor room (No. 43) with enriched scrolled bracket and slots for horizontal rails, formerly denoting the W end of the house

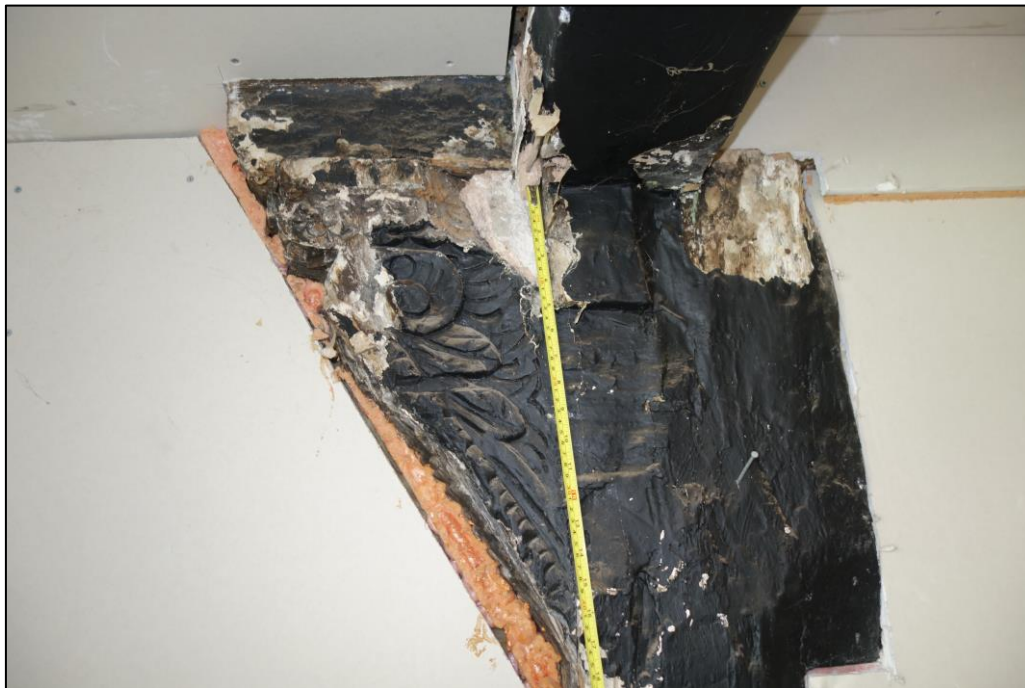
Plate 41: View showing detail of enriched scrolled bracket at top of vertical post in N wall of western bay of first floor room (No. 43)

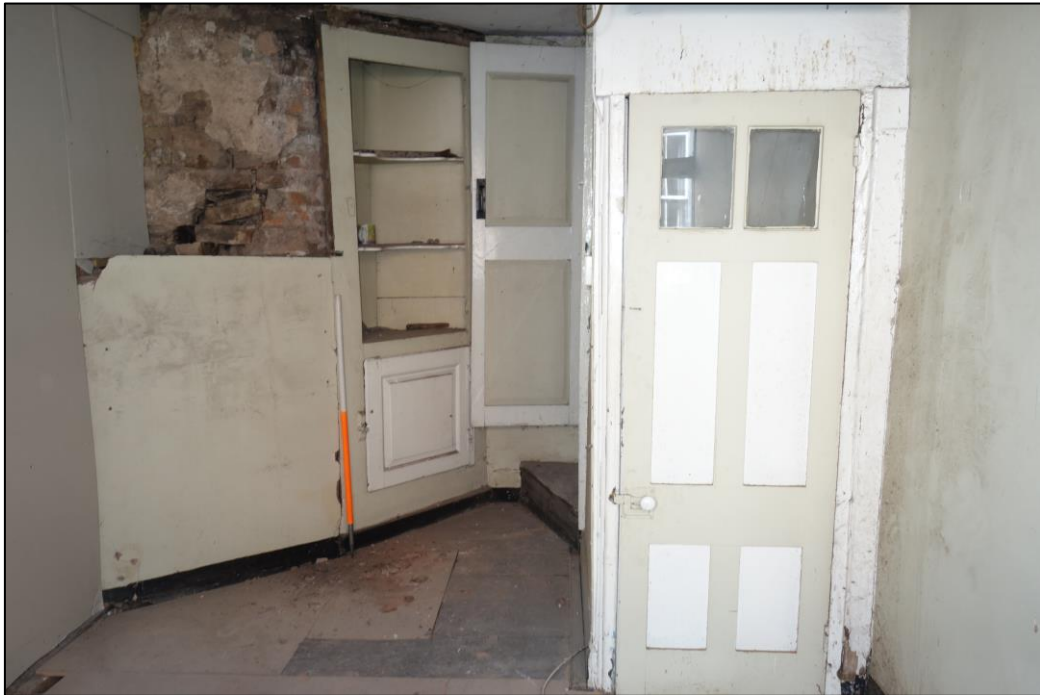
Plate 42: Internal view looking E showing E end of first floor room (No. 43) with brick chimneybreast and cupboard to left of picture and doorway formerly leading to a stairway to ground floor level (now blocked up)

The original position of the W wall is indicated by the substantial transverse chamfered beam carried on jewelled vertical posts, coated in black paint, with infilled slots for horizontal rails (*Plate 40*) and enriched scrolled brackets similar in design to those exposed brackets supporting the jetty for No. 45, which would appear to be datable to the late 16th or early 17th century (*Plate 41*). There is no access from this room to the ground floor of No. 43, although it appears that there was originally a flight of stairs to ground-floor level located within the deep recessed cupboard beneath the existing stairs to the second floor (*Plate 42*).

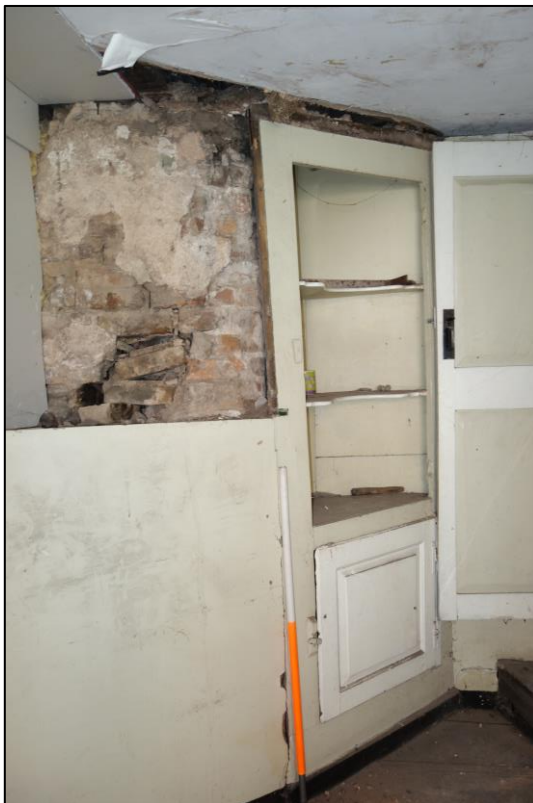
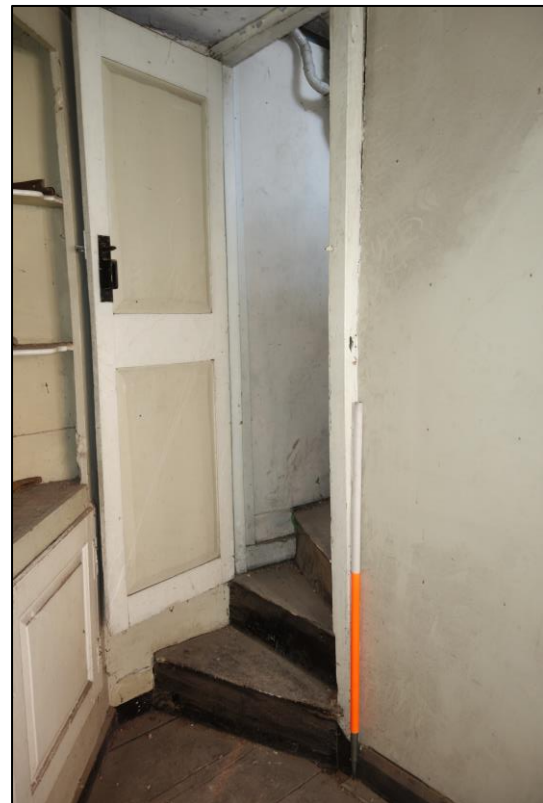
Plate 43: Internal view E showing detail of chimneybreast and recessed cupboard in NE corner of first floor room (No. 43)
Plate 44: Internal view looking SE showing panelled door leading to staircase from first to second floor (No. 43)

Towards the E end of the room is an exposed angled brick chimneybreast in the NE corner with unfrosted red bricks partially concealed by plasterwork (*Plate 43*), which has been converted to use as a recessed wall cupboard; the extant cupboard fixtures and fittings are suggestive of a late 19th century date, possibly contemporary with when No. 43 was converted wholly to commercial premises and was no longer used as a dwelling. Located in the SE corner of the room is two-panelled door providing access to a wooden dogleg staircase leading up to the second floor (*Plate 44*); the lower treads have an open string, while the uppermost section of the staircase has a closed string (*Plate 45*). The staircase in its current form appears to be of late 18th or 19th century in date.

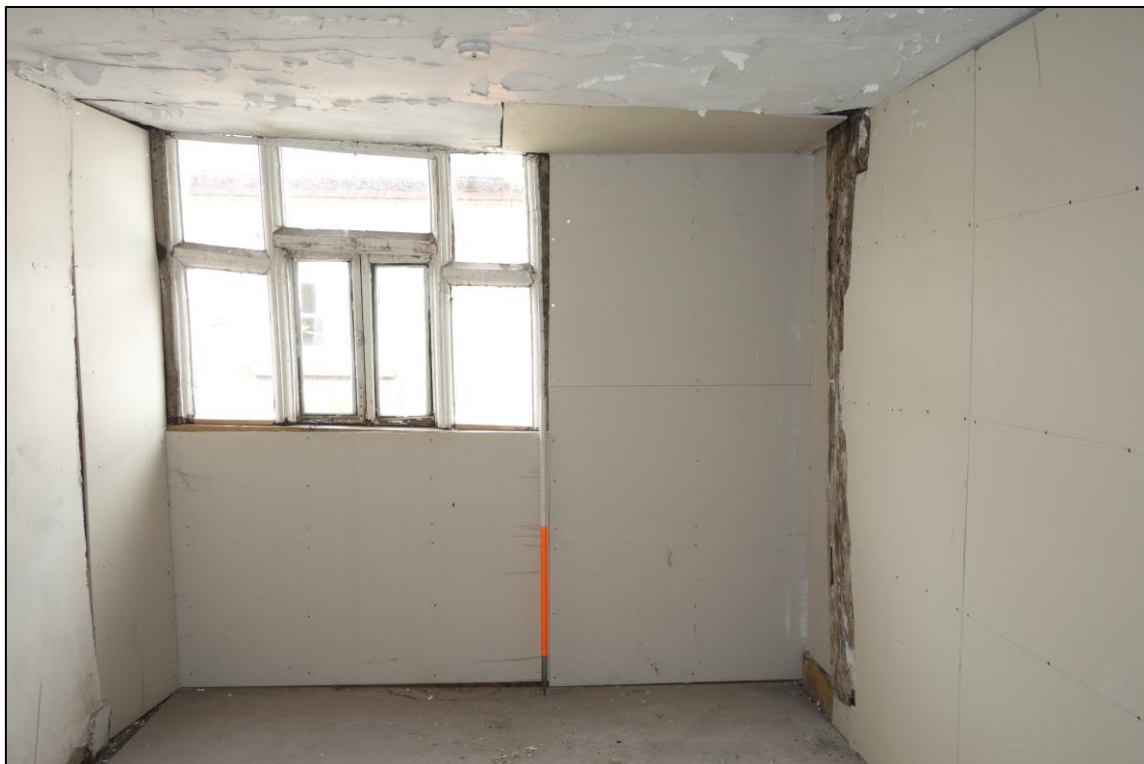
Plate 46: Internal view looking W showing westernmost bay of second floor room (No. 43) together with mullioned and transomed window with central casement

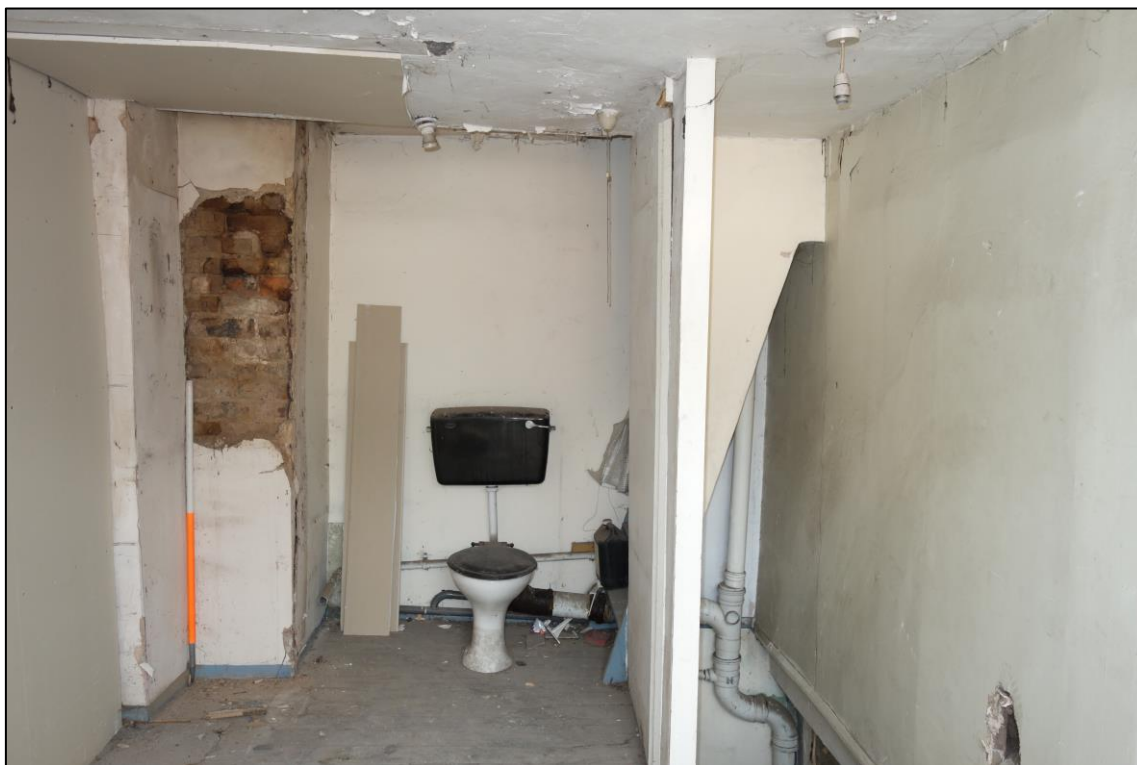
Plate 47: Internal view looking E showing eastern end of second floor room (No. 43) with chimneybreast to left of picture

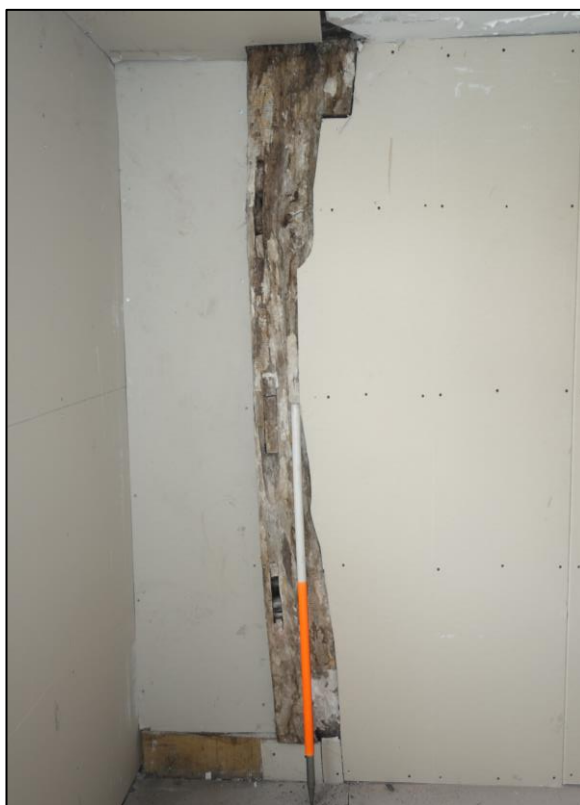
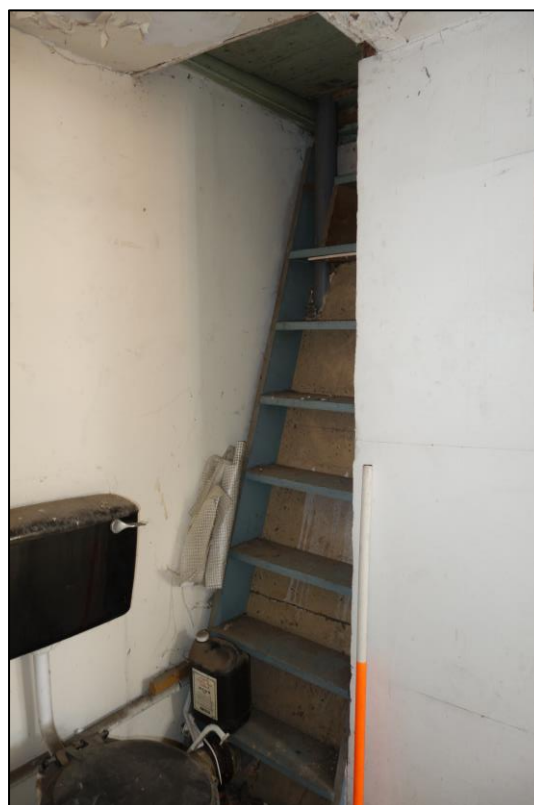
Plate 48: Internal view N showing jowelled vertical post with infilled slots within western bay of second floor room (No. 43)
Plate 49: Internal view looking SE (No. 43) showing stairs leading from second floor room to roofspace

This window appears to have been inserted when the western end of the compartment was extended (in identical manner to its first-floor counterpart), as indicated by the presence of a transverse, chamfered beam attached to a substantial jewelled and chamfered vertical post with infilled slots for horizontal rails (*Plate 48*). The room appears to have been converted to use as a bathroom in recent years, as evidenced by the modern toilet and cistern at the far E end (*Plate 47*), and few fixtures or fittings of interest were noted, except for the brick chimneybreast in the NE corner of the room and the narrow flight of stairs leading up to the roof-space above (*Plate 49*).

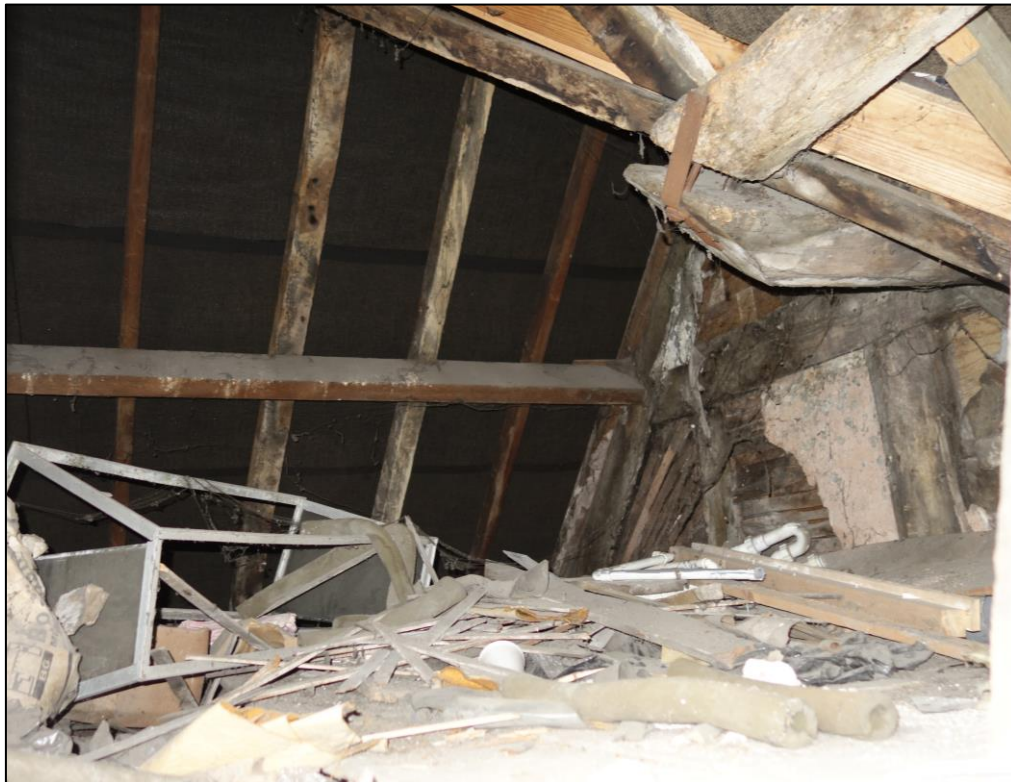
Plate 50: Internal view looking NE from hatchway showing detail of roof trusses within roofspace of No. 43

Due to health and safety concerns, it was not possible to gain full access to the roof-space; however, it appeared to be of open-truss construction with angled struts and trenched purlins similar in design to No. 45 (*Plate 50*).
