STANDING BUILDING RECORDING SURVEY

Pigeon House Farm
Eldersfield
Worcestershire
GL19 4NW

*NGR: SO 8101 3120
Job No: BA1110PHE
HER Ref. WSM 45757*

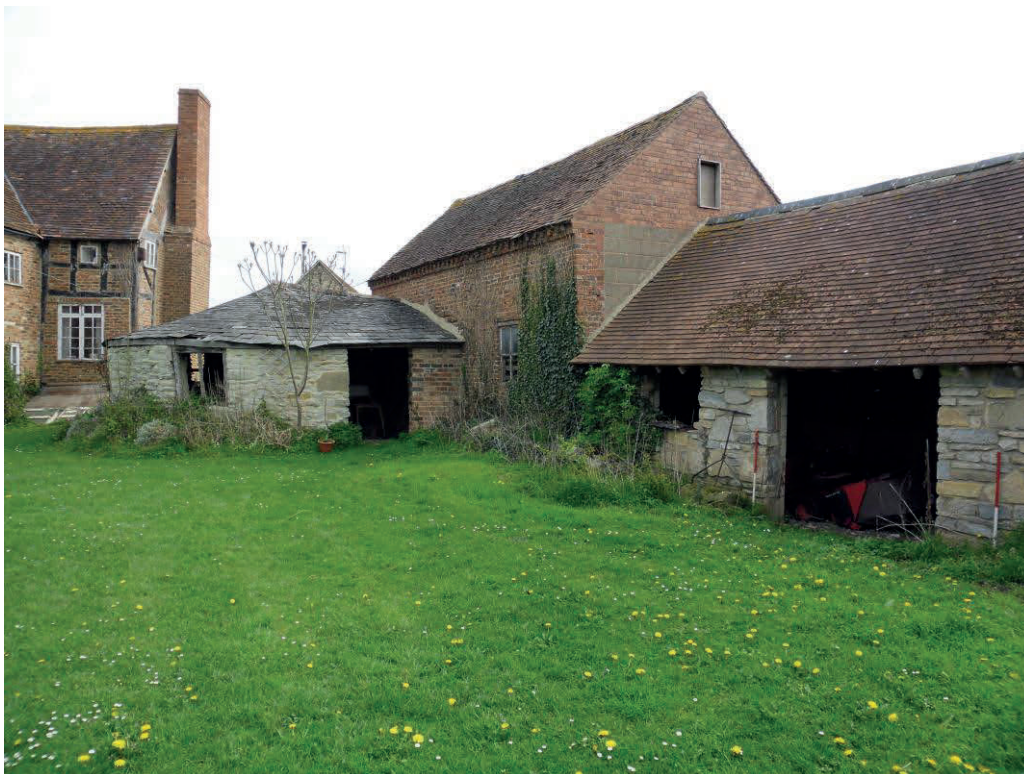
The building complex consists of a rectangular two storey barn (Barn A) with a single storey, semi circular structure (Barn B – the horse engine house) attached to the NW and a single storey, three bay barn (Barn C) attached to the SW gable end of Barn A (**Plate 1; Fig. 5**).

Plate 1: View looking ENE showing the NW facing elevation of Barn A with the attached horse engine house (Barn B) to the NW and the single storey stone barn to the SE (Barn C)

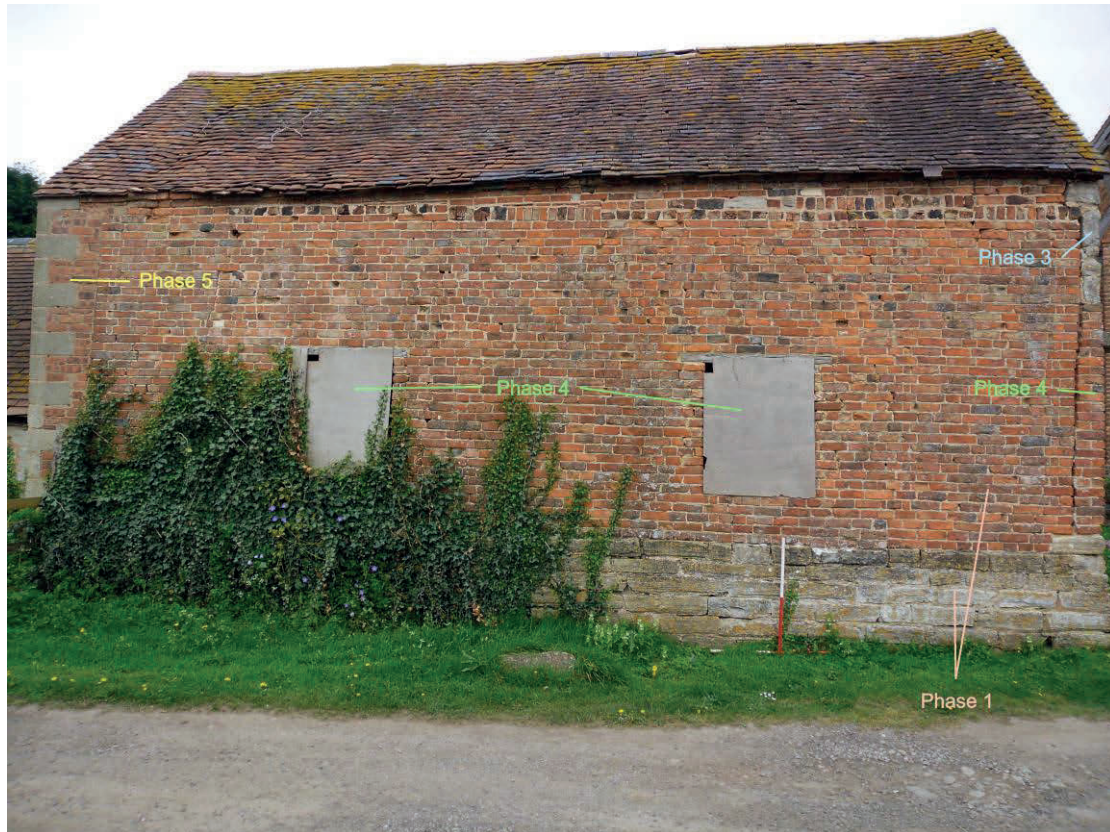
The brickwork of the SE facing elevation (overlooking the driveway leading into Pigeon House Farm) is very irregularly coursed, consisting of rows containing alternate sections of headers and stretchers with occasional rows consisting entirely of headers inserted at intervals (**Plate 2**).

The regularly coursed masonry plinth and the irregularly coursed brickwork resemble the construction of the nearby dovecote (recorded as having been erected in 1706). Two flat headed window openings with wooden lintels appear to have been inserted in the two bays flanking the centre bay of the elevation and the brickwork surrounding these windows appears to have been heavily reconstructed (**Plate 7**). Modern concrete quoins are visible at the SW end of the elevation, extending to eaves level (relating to the reconstruction of the SW gable end of the barn).

Plate 2: View looking NW showing SE facing elevation of Barn A with various phases of construction annotated

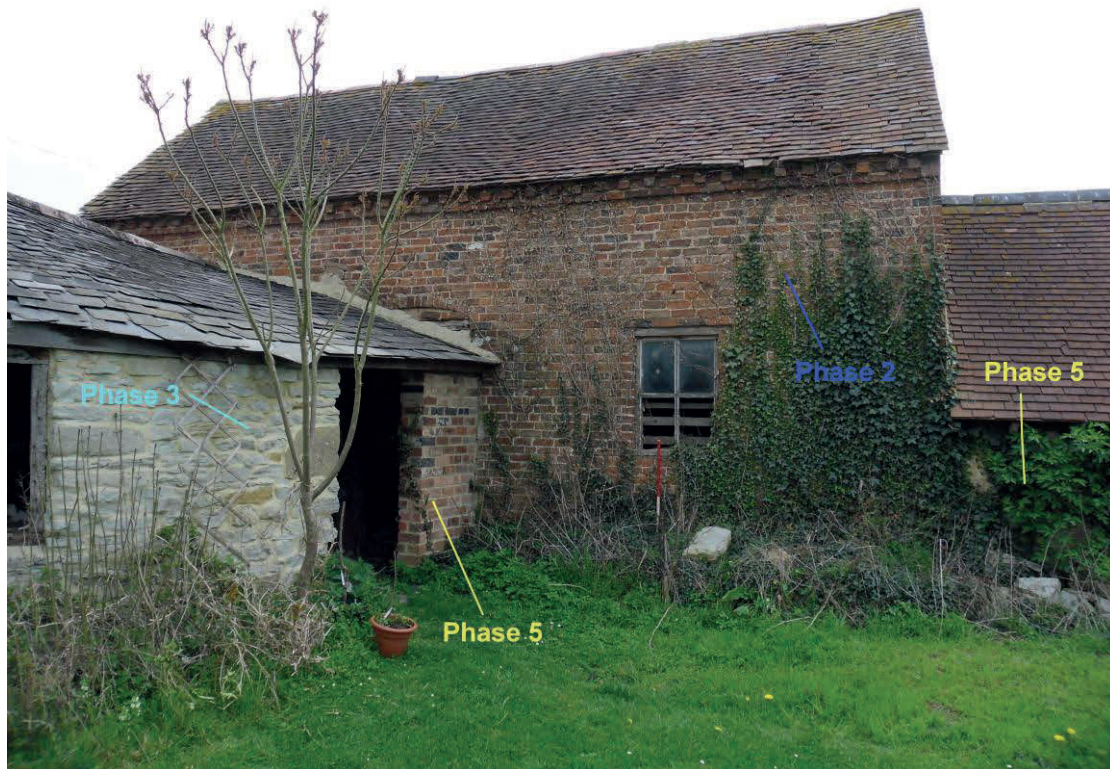
The brickwork of the NW facing elevation (overlooking the farmhouse) is more regularly coursed compared to its SE facing counterpart (**Plate 3**), consisting of between 3 to 5 rows of stretchers interrupted by a single row comprised entirely of headers, with a dentilled cornice at eaves level. The stone masonry plinth carrying the brickwork is visible internally (up to four courses) but is almost entirely obscured by dense undergrowth externally.

A segmental arched doorway, (partially obscured by the construction of the horse engine house) is located in the central bay of the elevation, with a small segmental arched window with a wooden shutter and sill to its left; the window arch had evidently been damaged by the insertion of a beam associated with the construction of the engine house and a wooden lintel had subsequently been inserted in the window to carry the weight of the beam. To the right is a flat arched casement window (with its glazing partially intact).

Plate 3: View looking SE showing NW facing elevation of Barn A with dentilled cornice at eaves level and attached horse engine house

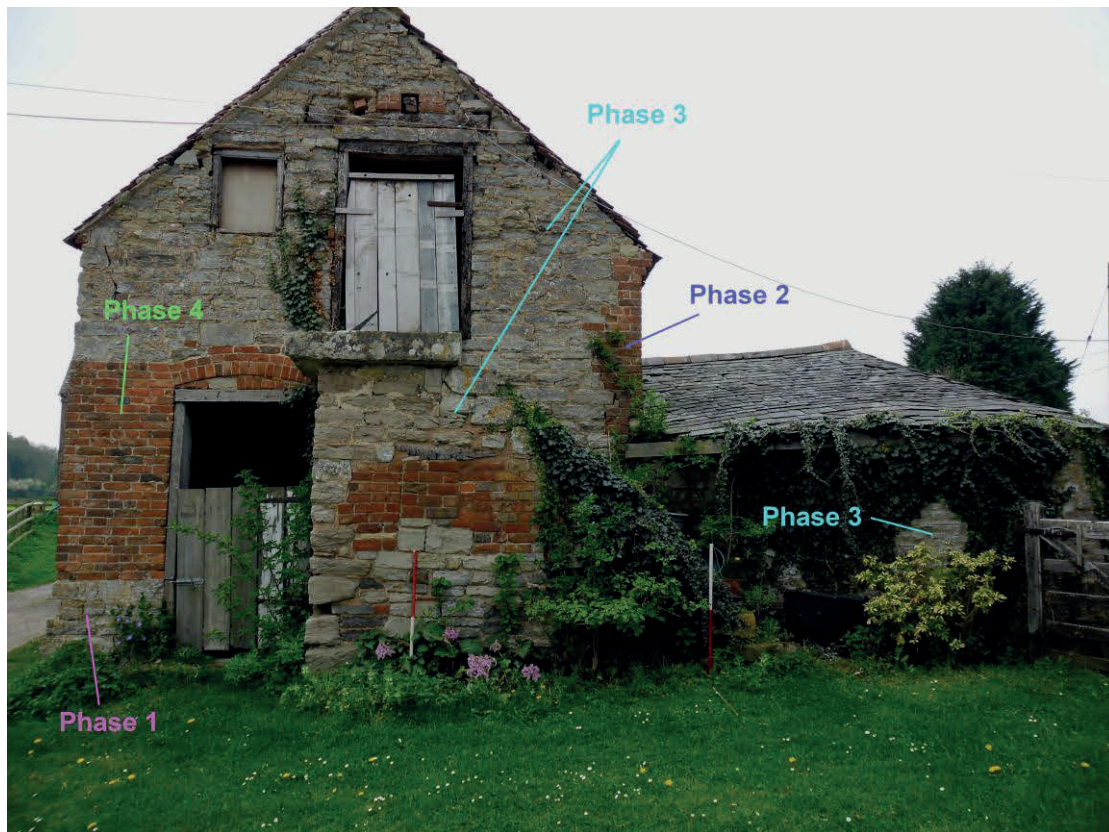
The NE facing gable elevation (**Plate 4**) is largely of stone construction, consisting of irregularly coursed rubble stone blocks of varying sizes, with a flight of stone stairs, 2.7m in height, leading to the loft at upper storey level. The stairs appear to have been partially repaired in brick and there is possible evidence for a narrow rectangular opening with a wooden lintel inserted into the thickness of the stairs.

Adjacent and to the left of the flight of stone steps is a segmental arched doorway, presumably a stable door, with a thin skin of brick work (laid in English Garden Bond) concealing the masonry work of the gable. The construction break associated with the insertion of this section of walling is clearly visible in the SE facing elevation of Barn A. At the top of the stairs is a flat arched, wooden framed doorway providing access to the loft with a small square flat arched window opening (with wooden frame) to the left of the doorway.

Plate 4: View looking SW showing NE facing gable elevation of Barn A with adjacent horse engine house (to right of picture)

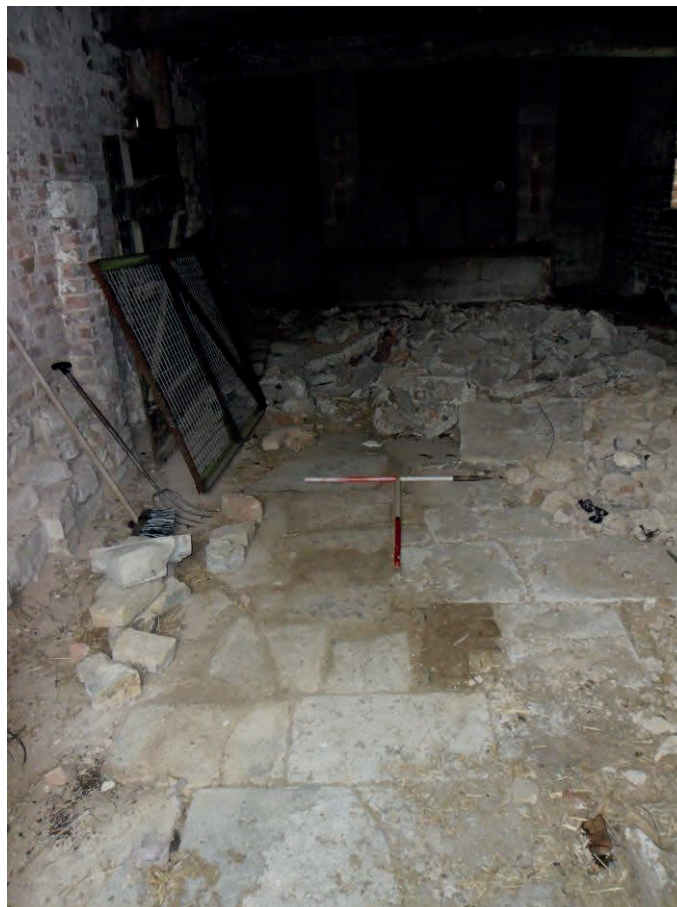
Internally, Barn A exhibited evidence of considerable alteration, mostly relating to its usage as a stable. At ground level, the partially surviving remains of an irregularly laid flagstone floor were visible (obscured by a stall in the NW corner of the barn) extending from the central bay of the barn to its NE end (**Plate 5**). Within the remaining two bays of the barn, it appeared that the flagstone floor had been removed and replaced by a modern screed concrete floor, which had also been removed at a fairly recent date. At the SW end of the barn was a modern concrete trough which presumably was contemporary with the reconstruction of the SW gable end and the laying of the concrete flooring.

Plate 5: Internal view looking SW showing flagstone floor in Barn A with a modern concrete floor and trough at the SW end of the barn

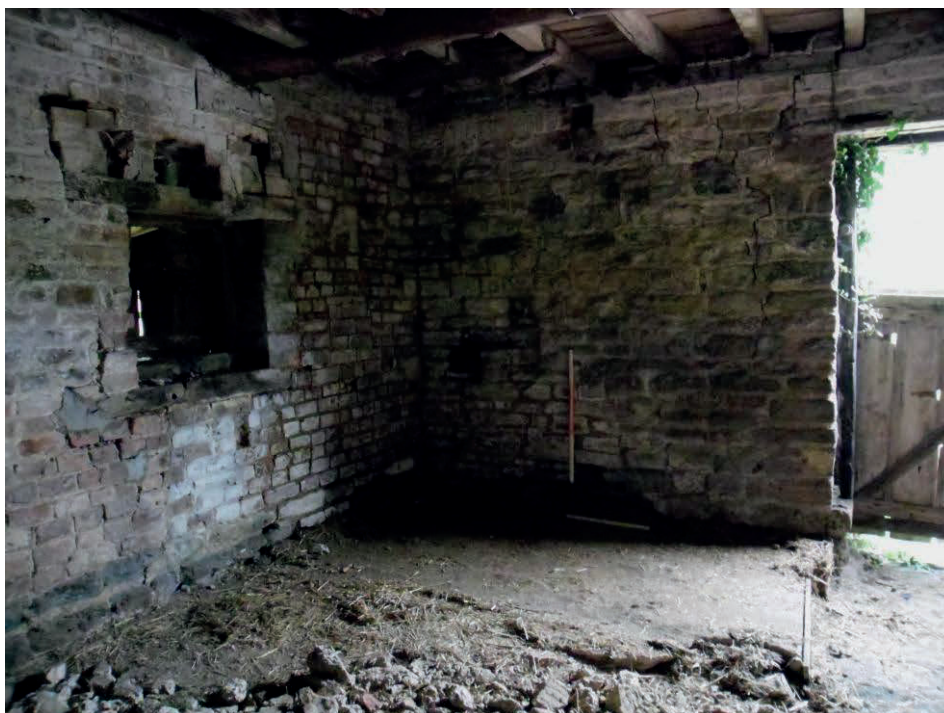
Plate 6: Internal view looking NE showing the makeshift timber lintel and slots inserted in the window of the NW elevation of Barn A

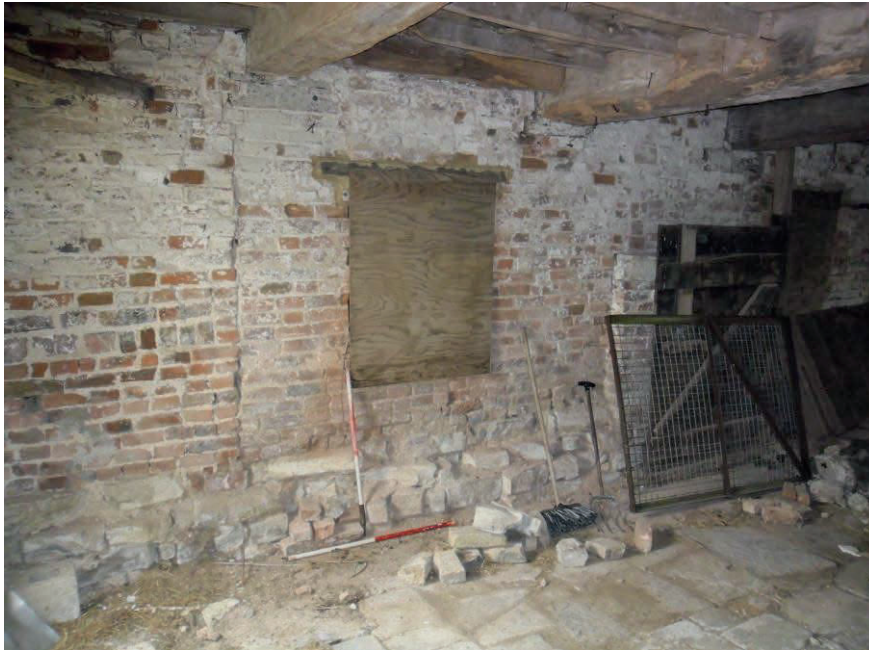
It is also noteworthy that several timber pads were inserted into the thickness of the wall close to ceiling level to support the beams carrying the rafters of the upper storey floor (**Plate 7**); a plank and batten trap door was also present in the northeasternmost bay of Barn A, which would have afforded another means of access to the upper floor.

Plate 7: Internal view of Barn A looking SE showing timber pads supporting the beams carrying the upper floor

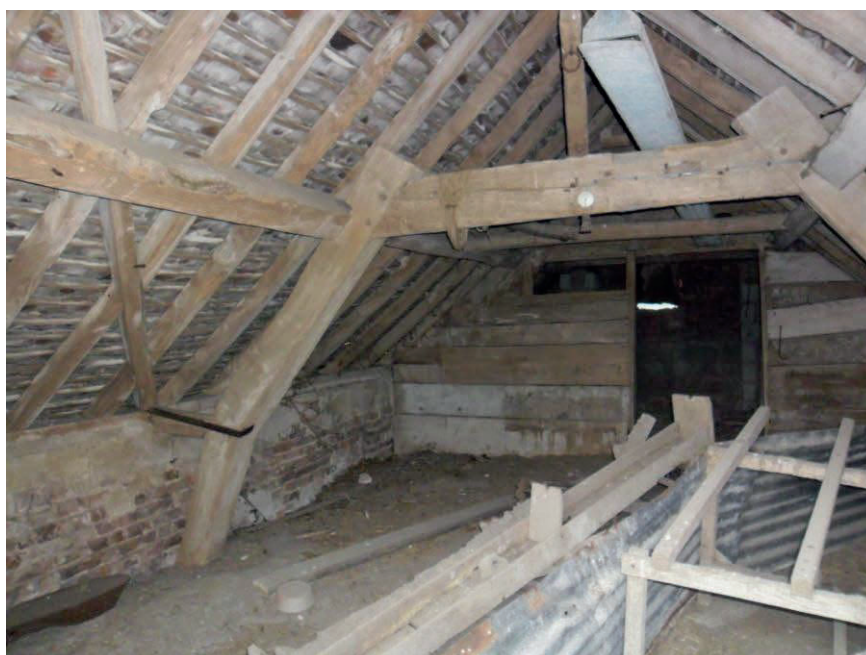
Access to the upper storey of Barn A was limited due to the unsafe nature of the floor; however the interior exhibited some evidence of remodelling. The roof construction was composite in nature, comprising a truss with a tie beam connected by two curved principals (one of which appears to have been partially replaced by iron ties) and a kingpost truss with a single row of trenched purlins, the latter truss appeared to be of 20th century date and was probably contemporary with the reconstruction of the SW end of the barn (**Plate 8**). Towards the SW end of the upper storey, a plank and batten screen appeared to demarcate a separate compartment however it was not possible, for safety reasons, to investigate further.

Plate 8: Internal view of upper storey of Barn A looking SW showing composite roof construction

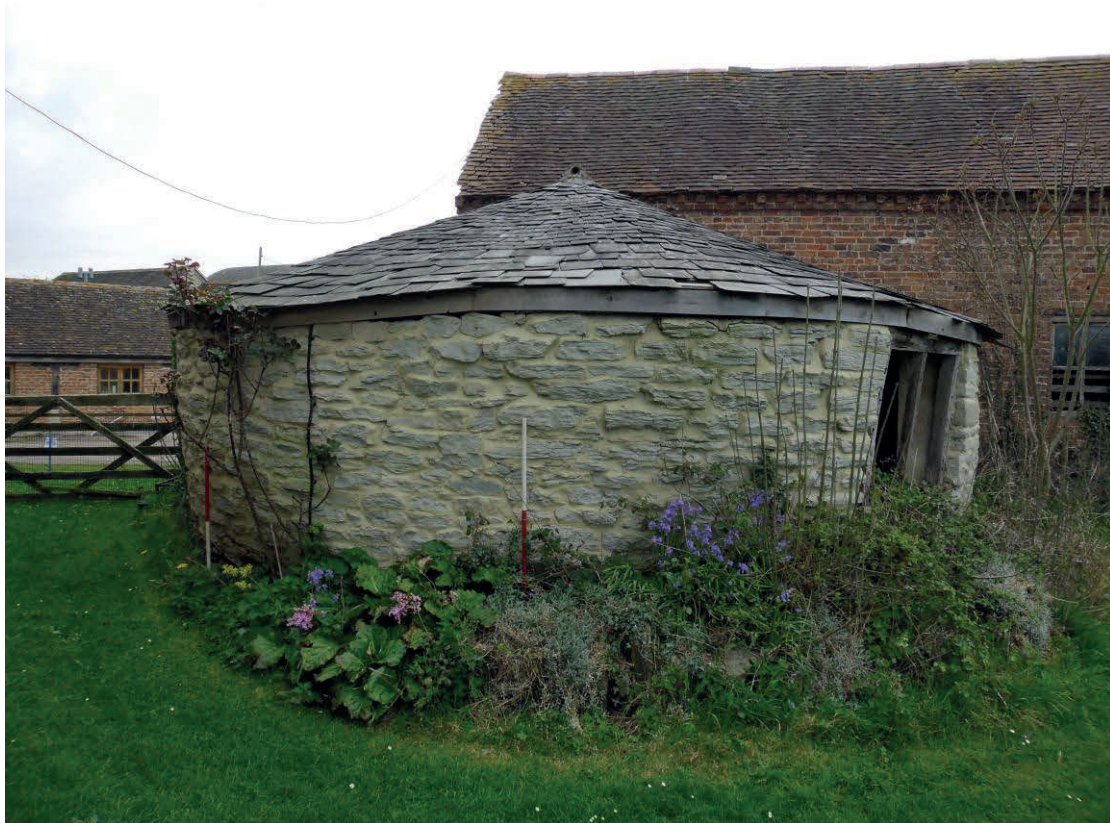
Barn B, which appears to have functioned as a horse engine house associated with a threshing or (more likely) a cider mill, is attached to NW facing elevation of Barn A. The construction of the engine house appears to have partially obscured the centrally placed, segmental arched doorway in the NW facing elevation of Barn A. It is a single storey structure, roughly semi-circular in plan (its visible dimensions measuring 6.8 NE-SW × 6.2m NW-SE) of roughly coursed rubble masonry construction with a low, conical slate roof (**Plate 9**).

The exterior walls appear to have been extensively rendered and re-pointed in cement (presumably in recent years), while the interior walls are also rendered. Two flat arched windows, with wooden frames and mullions, are visible in the N and W facing elevations while a rectangular opening in the SW corner provides access to the engine house. A section of brick walling (laid in stretcher bond) adjacent to the entrance to the engine house appears to be a modern addition.

Plate 9: View looking SE showing NW facing elevation of the horse engine house (Barn B) of roughly coursed stone with a low conical slate roof

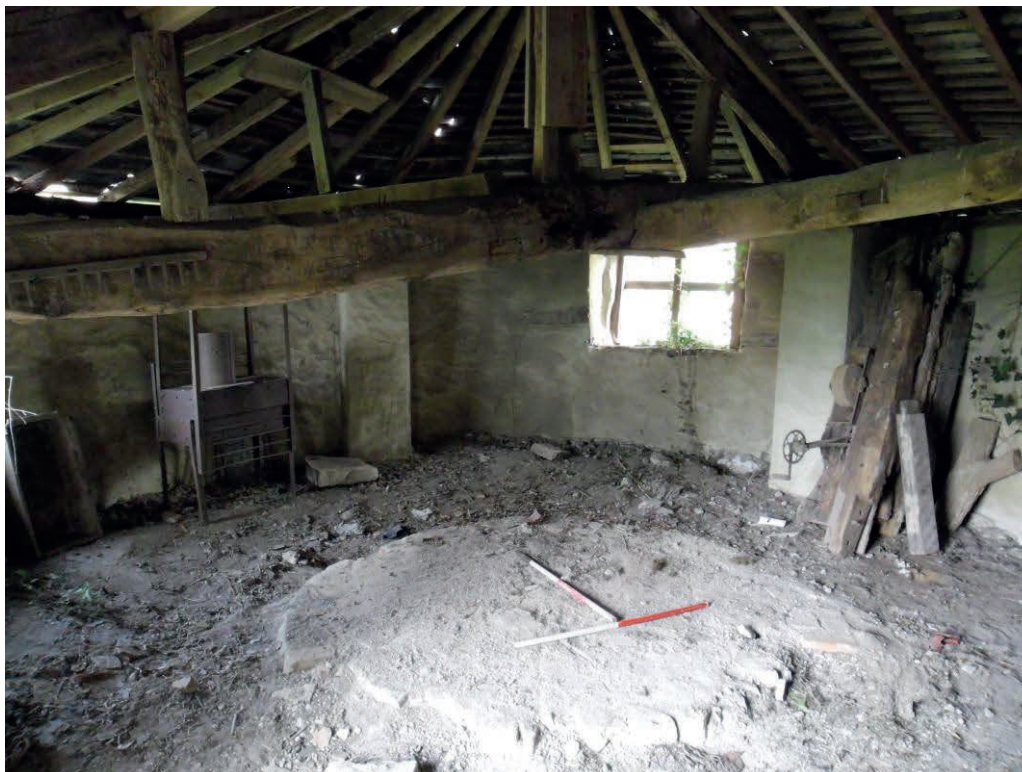
Internally, the roof construction is roughly semi-circular in plan, utilising a traditional space frame truss with one principal transverse tie beam, aligned NE-SW carrying the kingpost (connected to the tie beam with a wrought iron tie) with two subsidiary tie beams extending to the NW and the SE of the centre of the principal tie beam (**Plate 10**). Vertical struts connect the principal and the subsidiary tie beams to the rafters. The principal transverse tie beam and the NW subsidiary tie beam are carried on masonry posts projecting from thickness of the engine house wall. However the SE subsidiary tie beam has been inserted directly into the segmental arched window to the left of the doorway in the NW facing elevation of Barn A, with a makeshift wooden lintel inserted to carry the beam (**Plate 11**).

Plate 10: View looking NW showing interior of engine house and details of roof construction, with partially damaged turning circle below

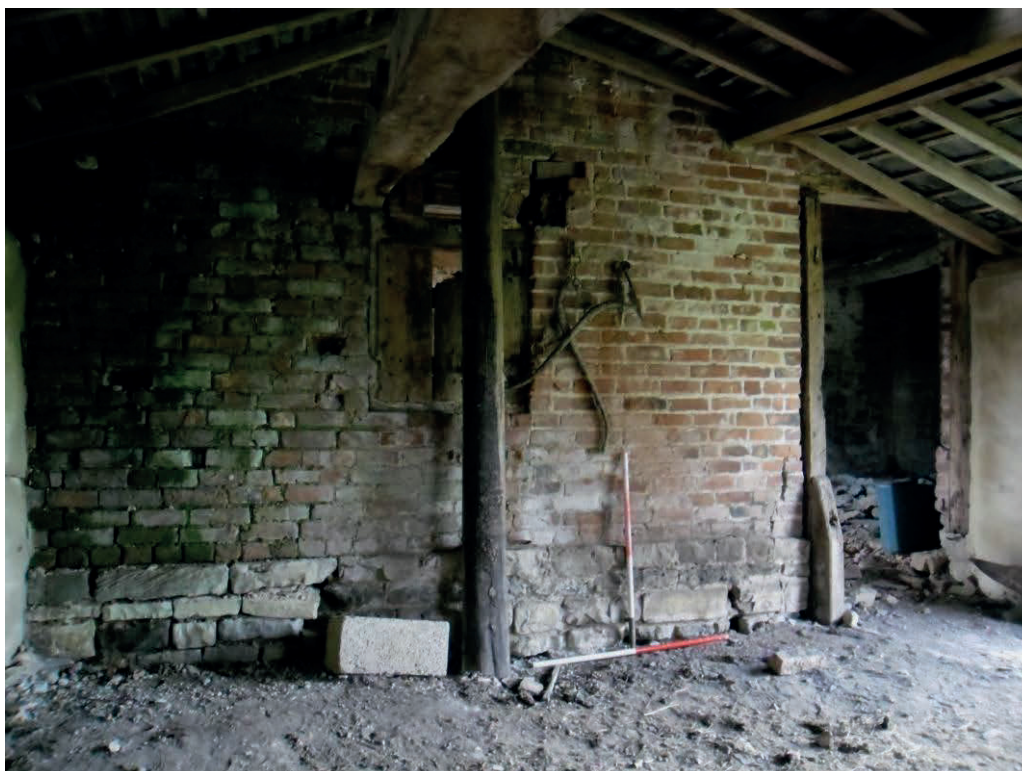
Plate 11: Internal view of horse engine house looking SE showing subsidiary tie beam inserted into segmental arched window in NW facing elevation of Barn A

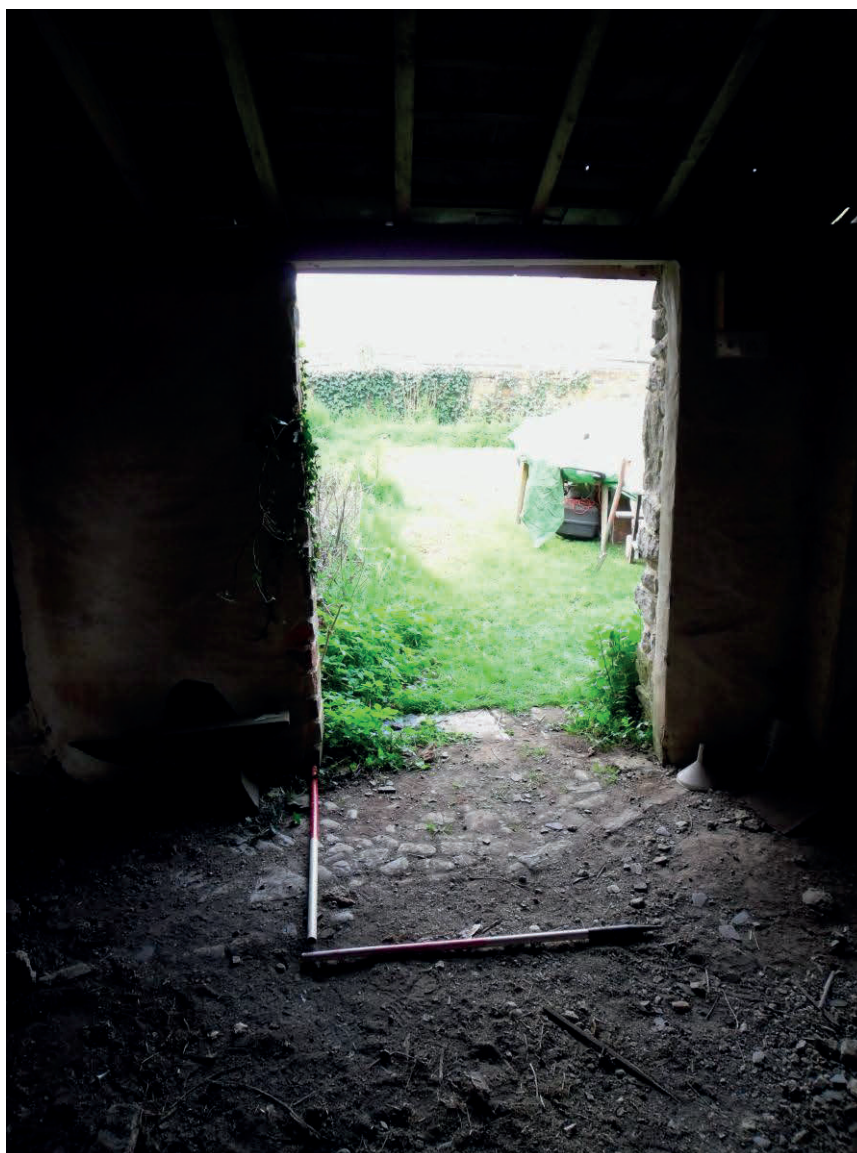
No visible evidence was identified for a centrally placed slot in the turning circle which presumably would have carried the shaft of the horse engine. A section of intact brick cobbling was noted, measuring approximately 2.25m NW-SE × 0.94m NE-SW, extending from the entrance to the engine house to the doorway in the NW facing wall of Barn A; this appeared to be distinct from the flooring within the rest of the engine house, which appeared to be an earthen floor, although it is possible that the flooring of the engine house was once entirely cobbled (**Plate 12**).

Plate 12: Internal view looking SW showing cobbled floor at entrance to horse engine house

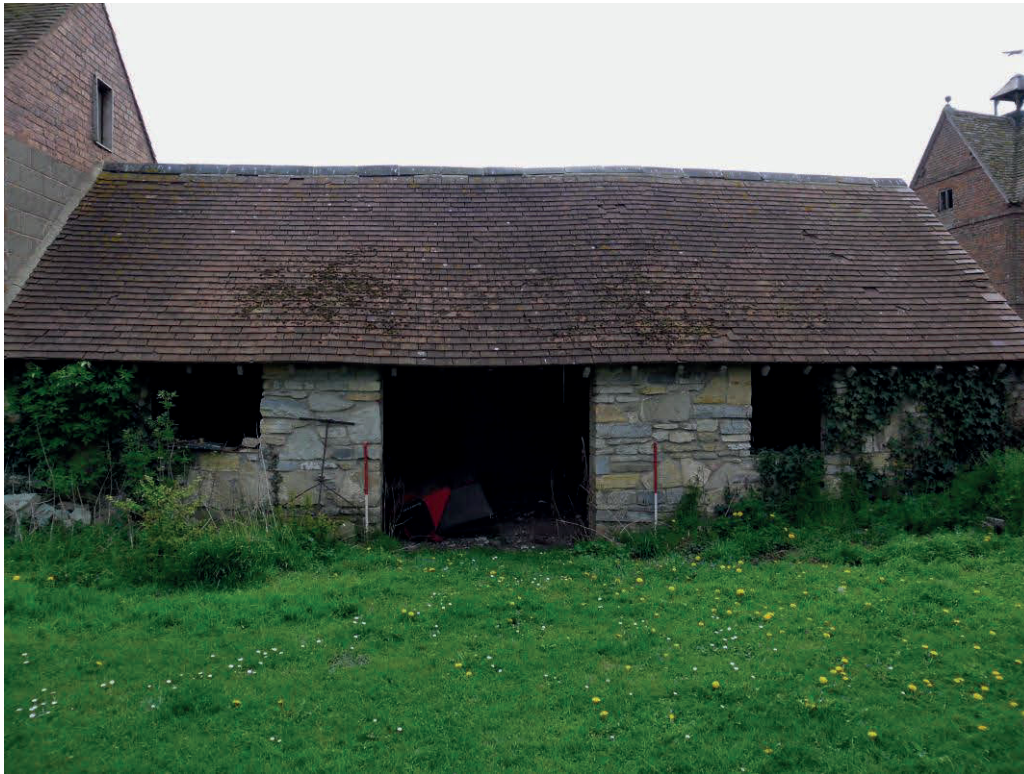
Barn C consists of a single storey rectangular structure with a gabled, tiled roof, three bays in length (10.5m NE-SW × 5m NW-SE), constructed of rubble masonry, brick and concrete breezeblocks and attached to the SW gable end of Barn A.

Plate 13: View looking SE showing reconstructed NW facing elevation of Barn C

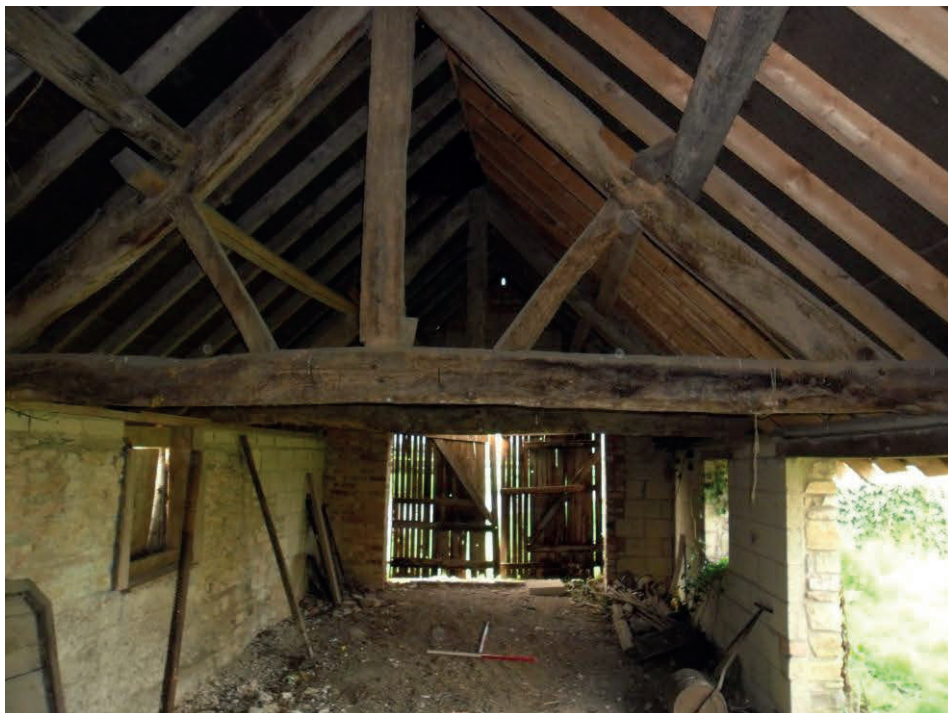
Plate 15: Internal view looking SW showing kingpost roof trusses in Barn C

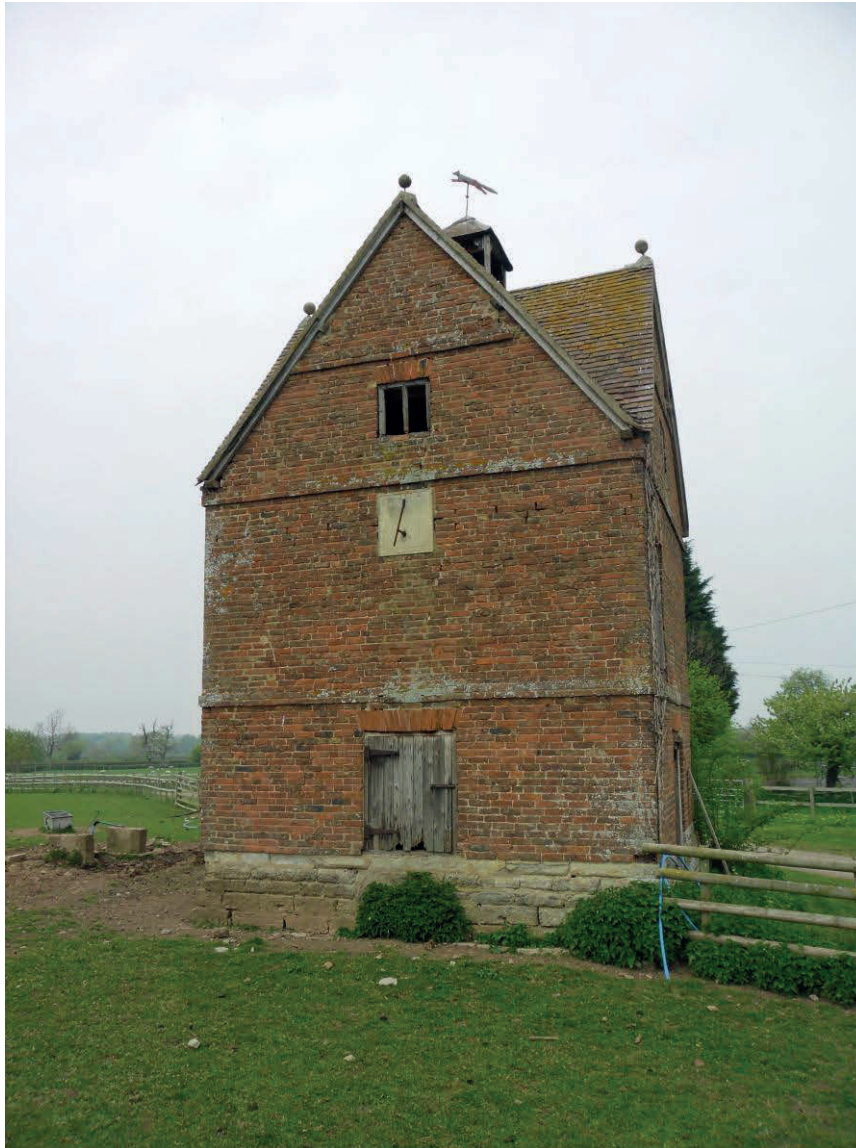
The earliest phase of building activity (Phase 1) appears to be of early 18th century date, represented by the regularly coursed masonry plinth and the irregularly coursed brick walling in the SE facing elevation of Barn A, both of which closely resemble the construction of the adjacent three storey dovecote which was built in 1706 (**Plate 16**).

Plate 16: View looking NW showing the SE elevation of the pigeon house with sundial
