Archaeological Walkover Survey

south east water

**Horne Farm to Cottage Hill
Mains Renewal Scheme
Rotherfield
East Sussex**

January 2018

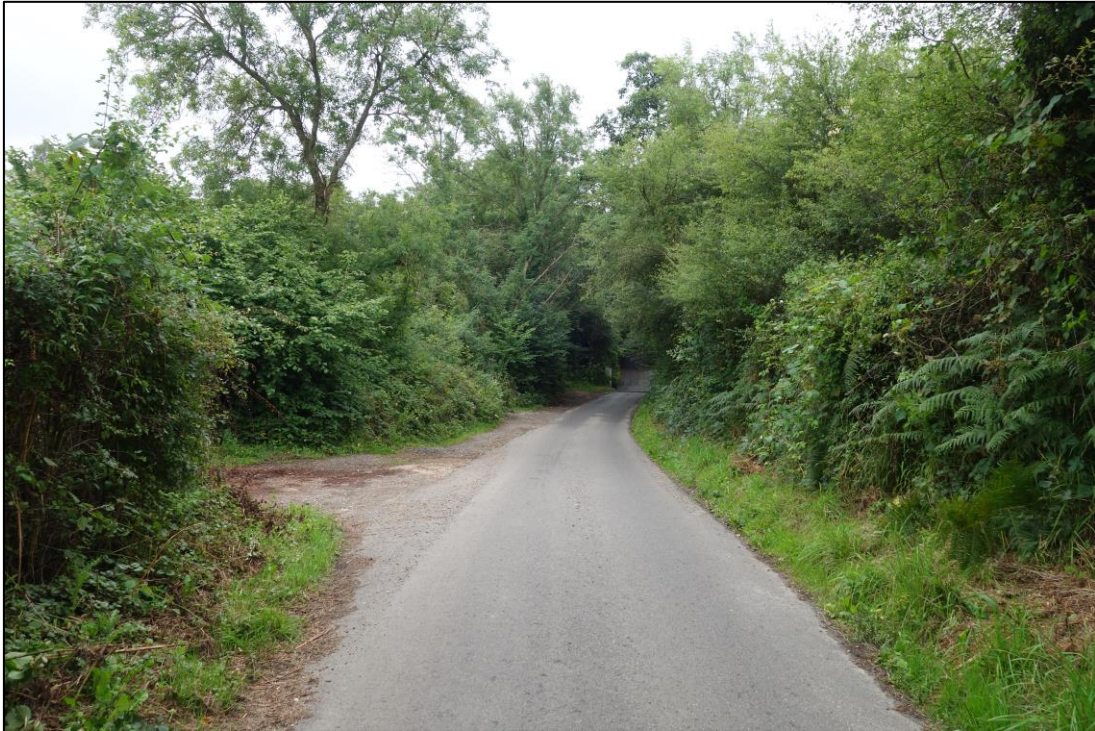
Viewpoint 1: View looking SE along Palesgate Lane towards ford, showing tree lined hedgebank on E side of Palesgate Lane

1/ The pipeline route crosses a substantial tree-lined hedge boundary immediately east of Palesgate Lane which may represent the westernmost extent of the former medieval deer park of Rotherfield.

1/ The pipeline route crosses a substantial tree-lined hedge boundary immediately east of Palesgate Lane which may represent the westernmost extent of the former medieval deer park of Rotherfield (based on documentary and cartographic evidence).

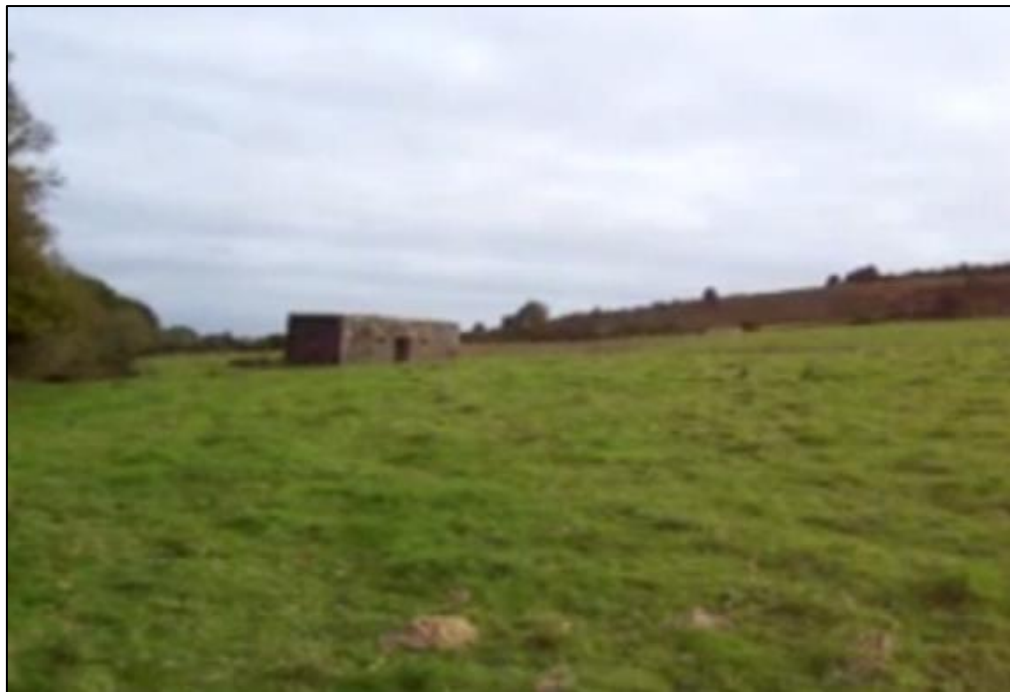
Viewpoint 4: View looking NNE towards hexagonal concrete and brick pillbox (Type 24) situated in pasture field beyond stream and woodland to E of Palesgate Lane

The pipeline continues SE across the stream and the narrow belt of woodland and then enters a large irregularly shaped pasture field (marked as Long Field on the Rotherfield tithe map of 1841) bounded to the S by the Rotherfield Road (B2100). Located approximately 50m NNE of the route, on slightly rising ground to the E of the woodland is a hexagonal concrete and brick pillbox bearing the identification number A121, constructed in 1940-41 as part of the Newhaven to Cliffe branch of the GHQ Defence Line (VP 4; NGR TQ 54181 29902). The pillbox

(which is recorded on the Defence of Britain database but does not appear to be listed in the East Sussex HER) is visible on aerial photographs dated 1944 and 1947 (US/7PH/GP/LOC165 Frame No.5061; RAF CPE/UK/1966, Frame No.2160). No trace was observed of the anti-tank ditch which is shown on the 1944 and 1947 APs as extending SW across the W half of this field, to the E of the pillbox.

2/ Evidence of Second World War fortifications was noted in the vicinity of the pipeline route, including the remains of a hexagonal pillbox (constructed in 1940-41 as part of a military defence line) located at NGR TQ 54181 29902 about 50m north of the pipeline route where it enters a pasture field immediately east of woodland adjoining Palesgate Lane. No evidence was noted for the line of an associated anti-tank ditch to the SE of the pillbox site which is shown on aerial photographs dated 1944 and 1947 and appears to be crossed by the pipeline route.

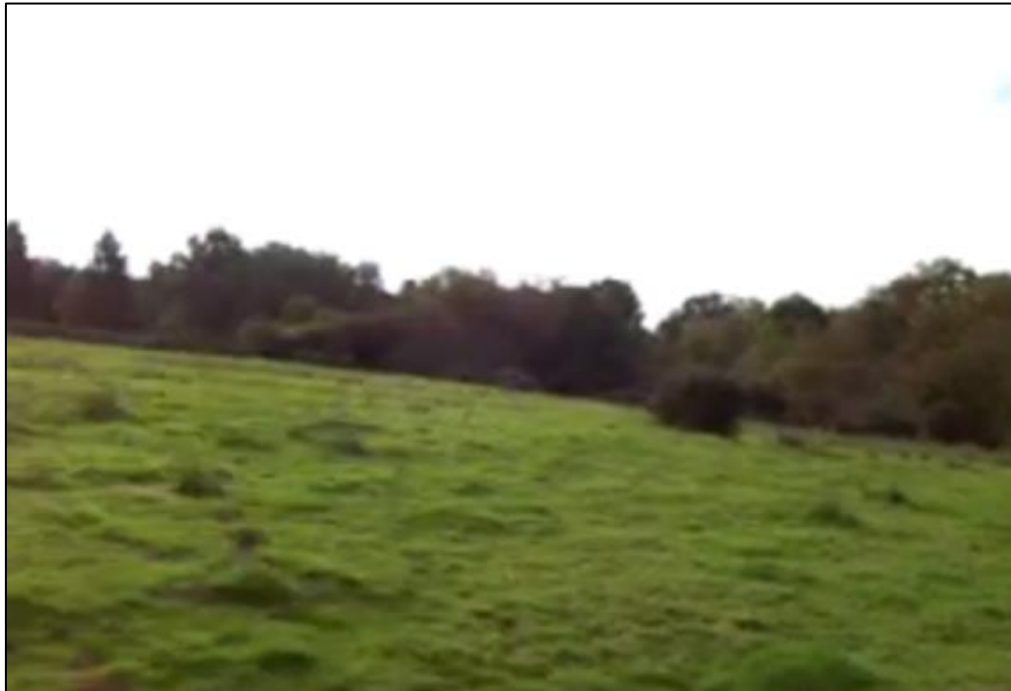
Viewpoint 5: View looking SSW across W half of steeply sloping pasture field adjoining woodland to E of Palesgate Lane, showing low amorphous depressions (drainage channels?)

Several curvilinear depressions were also noted where the pipeline route crosses the SW corner of this pasture field just to the E of the woodland (VP 5; TQ 54178 29828). These features are visible on the 1940s APs and may represent relict cultivation features or water channels associated with the nearby stream, of uncertain date. The pipeline continues on a roughly ESE alignment, climbing steeply upslope towards the SE corner of the field. A discrete area of ground disturbance was also noted within the SE corner of the field (centred on NGR TQ 54416 29818) represented by several low amorphous banks, areas of thick scrub and a possible trackway which may have been associated with the site of a demolished post-medieval outfarm which is first marked on an Ordnance Survey drawing of 1789 and was demolished by the early 1970s (VPs 6 & 7).

3/ A series of amorphous, roughly curvilinear features were noted in the southwest corner of the same field, which are visible on 1940s aerial photographs of the study area and may represent relict water channels or cultivation features of uncertain, possibly medieval or post-medieval date.

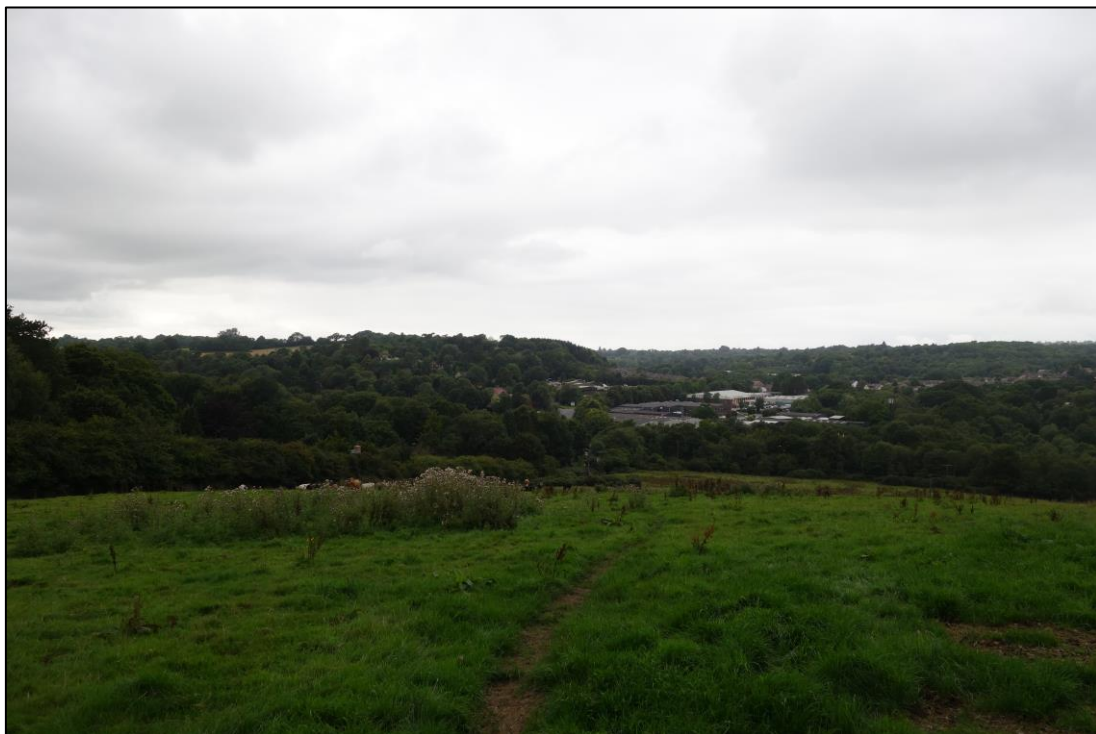
Viewpoint 6: View looking W (downslope) across upper part of pasture field beyond woodland to E of Palesgate Lane, showing areas of disturbed ground and possible trackway (in foreground) which may be associated with post-medieval outfarm

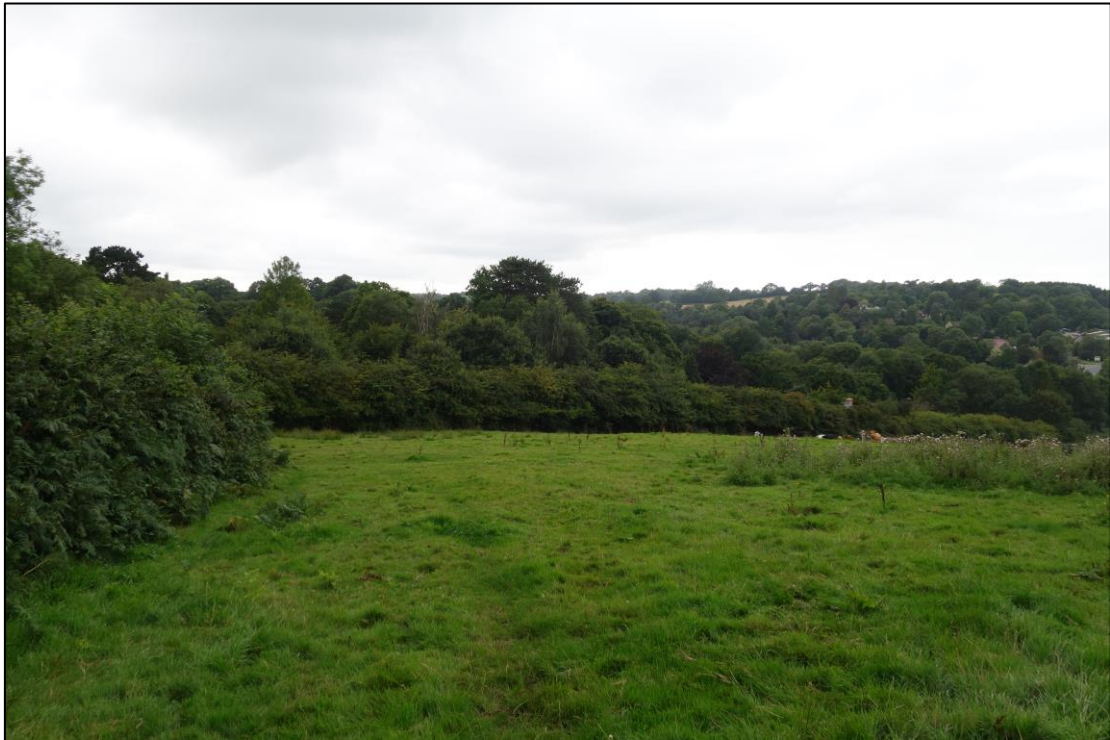
Viewpoint 7: View looking SW showing area of disturbed ground in SE corner of pasture field to W of Old Forest Lane (possibly relating to site of post-medieval outfarm)

4/ A discrete area of ground disturbance was also noted within the southeast corner of the field west of Old Forest Lane (centred on NGR TQ 54416 29818) represented by a several low amorphous banks, areas of thick scrub and a possible trackway which may have been associated with the site of a demolished outfarm of 18th-19th century date, which is first marked on an Ordnance Survey drawing of 1789 and was demolished by the early 1970s

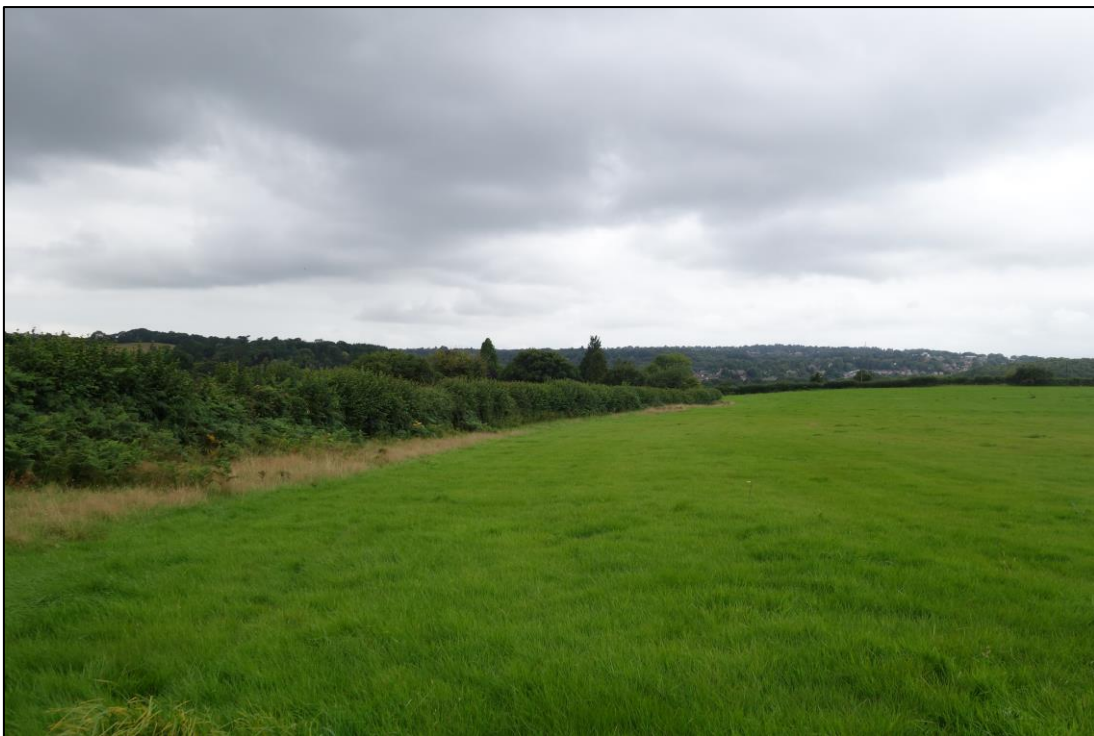
Viewpoint 10: View looking WSW showing S boundary of pasture field N of B2100, marked by substantial hedgebank (possibly representing the S extent of the medieval deer park of Rotherfield)

At NGR TQ 54444 29822 the scheme crosses 'Old Forest Lane', a long-established narrow holloway first marked on the OS surveyor's drawing of 1789 and flanked by steep tree lined hedges (VP 8) which branches off from the Rotherfield Road. The Rotherfield Road appears to have marked the southernmost extent of the medieval deer park of Rotherfield and this boundary appears to be evidenced by the substantial, tree-lined hedgebank which runs along the N side of the road (VP 10).

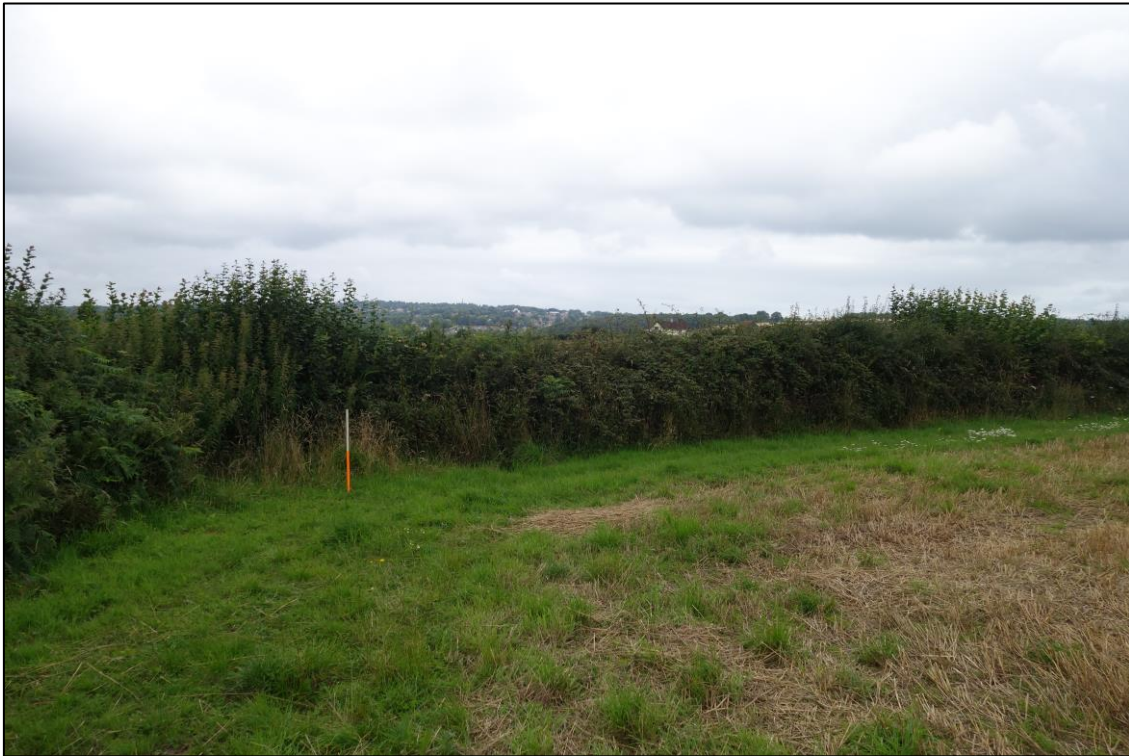
Viewpoint 11: View looking W showing substantial hedge and ditch marking W boundary of pasture field N of B2100

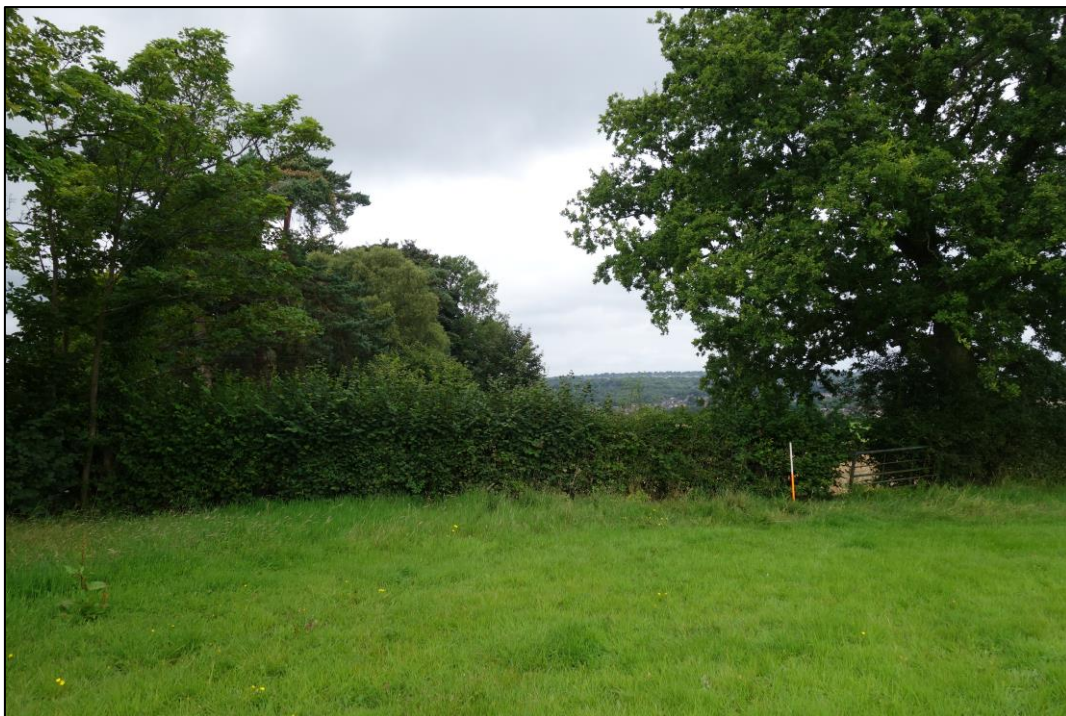
Viewpoint 12: View looking E showing tree-lined ditch marking W boundary of field to N of the B2100

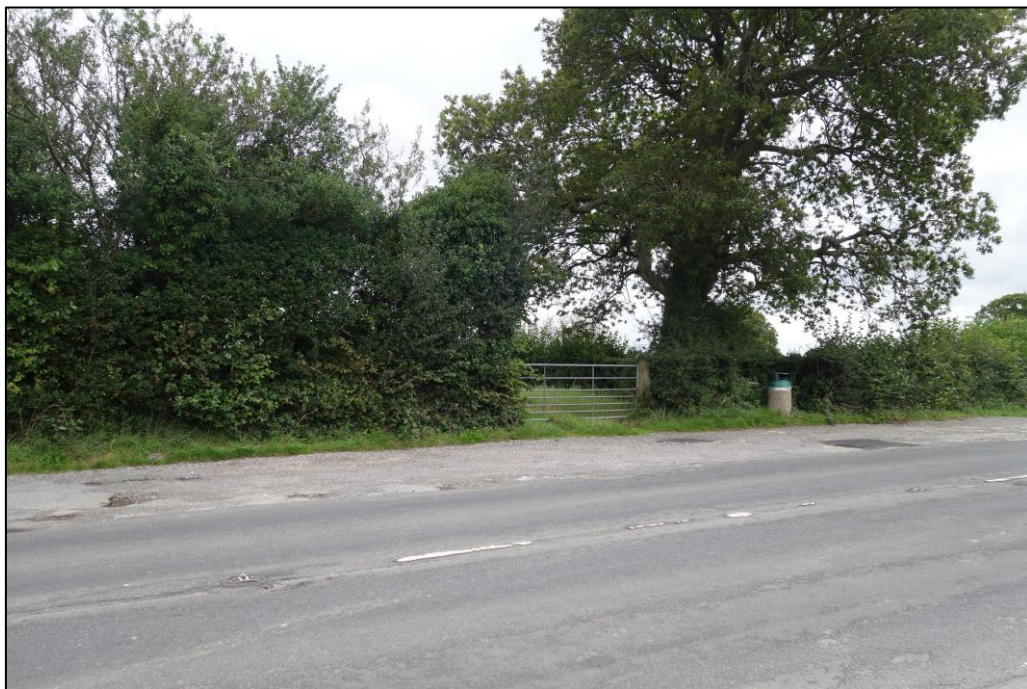
Viewpoint 14: View looking NE across B2100 (Rotherfield Road), showing tree-lined hedge boundary marking S extent of field N of Rotherfield Road, to W of Milk Lodge Farm

At NGR TQ 55104 29746, about 100m W of Milk Lodge Farm, the pipeline route turns S and crosses a tree-lined hedge boundary (VP 14) which appears to represent a continuation of the S boundary of the former medieval deer park. The pipeline traverses the Rotherfield Road and another hedge boundary on the S side of the road (VP 15 TQ 55100 29727). At this point, the pipeline route lies about 30m W of the Archaeological Notification Area relating to the historic medieval settlement of Rotherfield.

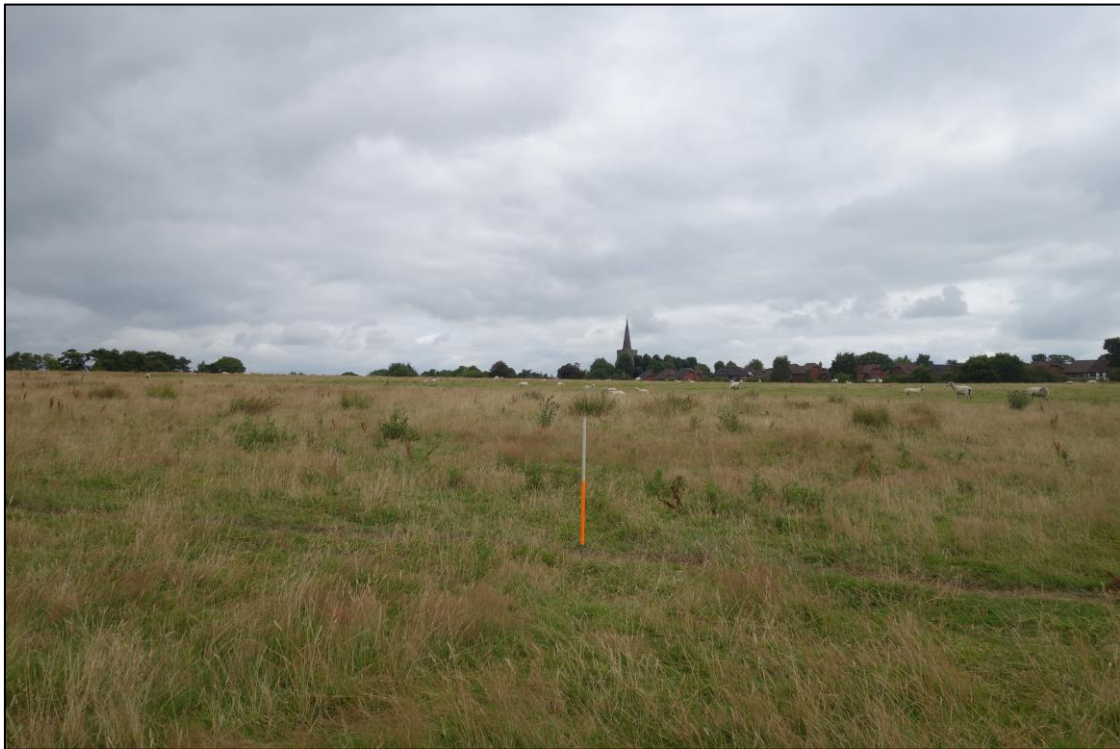
Viewpoint 16: View looking ENE towards linear depression possibly marking line of relict post-medieval field boundary in field to S of Rotherfield Road, with tower of St Denys's Church in background

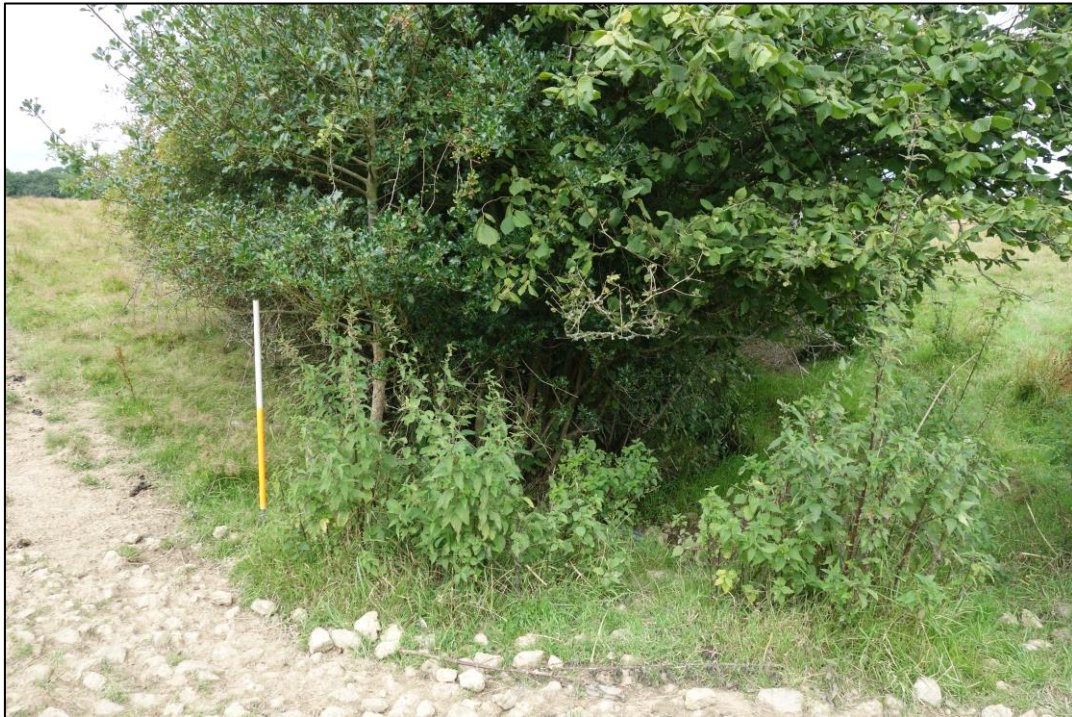
Viewpoint 17: View looking WSW showing substantial tree-lined hedge and ditch marking SE boundary of large field S of Rotherfield Road

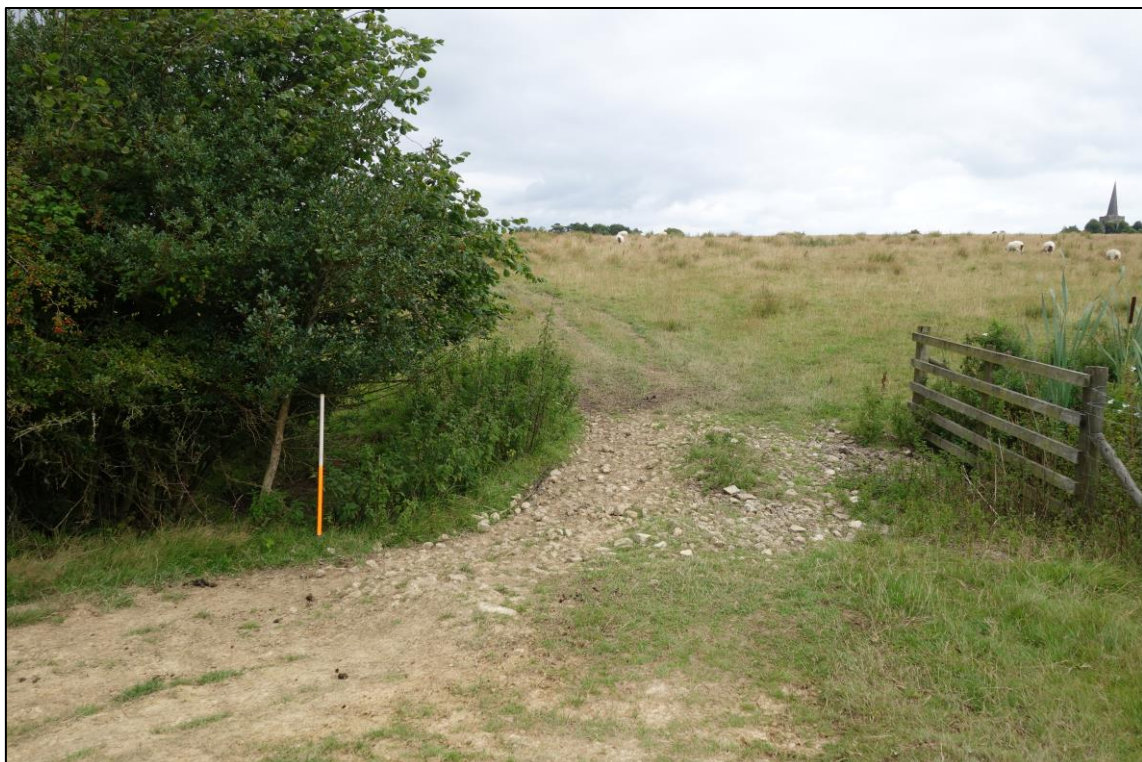
Viewpoint 18: View looking NNW showing roughly metalled trackway to SE of curvilinear field boundary

The pipeline route then continues SE through a large field enclosure which is currently under rough pasture. This field is first marked as 'Demaines' on a plan of the manor of Rotherfield dated 1597 and had been subdivided into several rectilinear enclosures by the late 18th century. A roughly NNE-SSW aligned linear depression (possibly representing a relict field boundary) was noted within the S half of this field and is crossed by the pipeline at TQ 55232 29452 (VP 16). The pipeline route crosses a substantial curvilinear drainage ditch and tree-lined hedge marking SE boundary of this field at TQ 55280 29337 (VP 17); this is clearly a long-established feature as it is marked on historic mapping dating back to 1789. Remains of a metalled trackway (possibly identifiable with the 'landway' first recorded on the tithe map of 1841) were noted running parallel and immediately SE of this field boundary (VP 18).

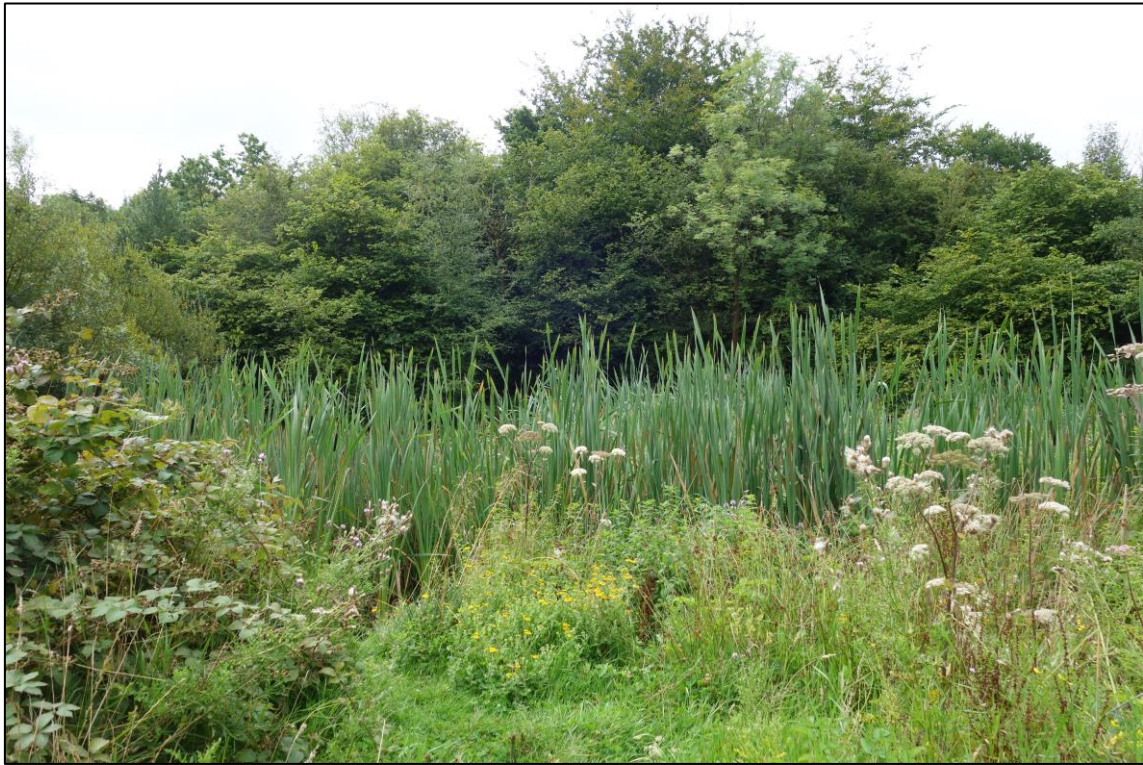
Viewpoint 19: View looking SW showing overgrown pond feature of modern date to N of Marlpit Wood

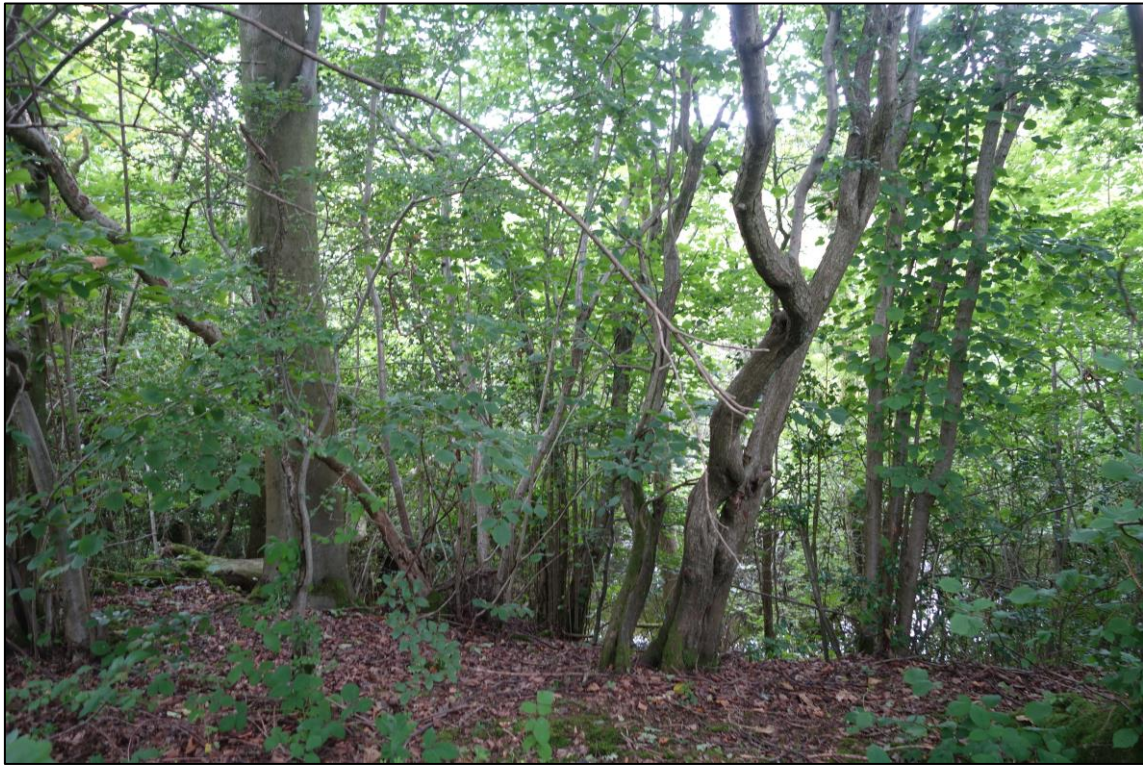
Viewpoint 21: View looking N towards disused water-filled marl pit of post-medieval date in Marlpit Wood

Located immediately SE of this curvilinear field boundary (about 10m E of the pipeline route) at NGR TQ 55297 29315 is an irregularly shaped, heavily overgrown water-filled pond which is first marked on an OS 1:2500 map of 1971 and thus appears to be a modern feature (VP 19). The pipeline route continues southwards, to the E of the pond and extends along the E boundary of a large irregularly shaped pasture field, defined by a substantial tree-lined hedge (VP 20) which is first marked on the Rotherfield tithe map of 1841. To the E of this pasture field is a woodland enclosure, which first appears as 'Marlpit Wood' on the Rotherfield tithe map. Located within this wooded enclosure, about 15m E of the pipeline route is a large water-filled former marl pit (VP 21; TQ 55284 29220), which may possibly be of early post-medieval date, based on references in 16th-17th century manorial records of Rotherfield to a marl pit 'over against Dewlands Gate' (Pullein, 1928).

5/ The eastern half of the pipeline route crosses a number of hedge boundaries which appear to be of medieval or post-medieval date, of particular interest being a substantial curvilinear ditch at NGR TQ 55280 29337. The route also runs close to the site of a disused marl pit of early post-medieval date at Marlpit Wood, north of Dewlands Manor, Rotherfield (NGR TQ 55284 29220)

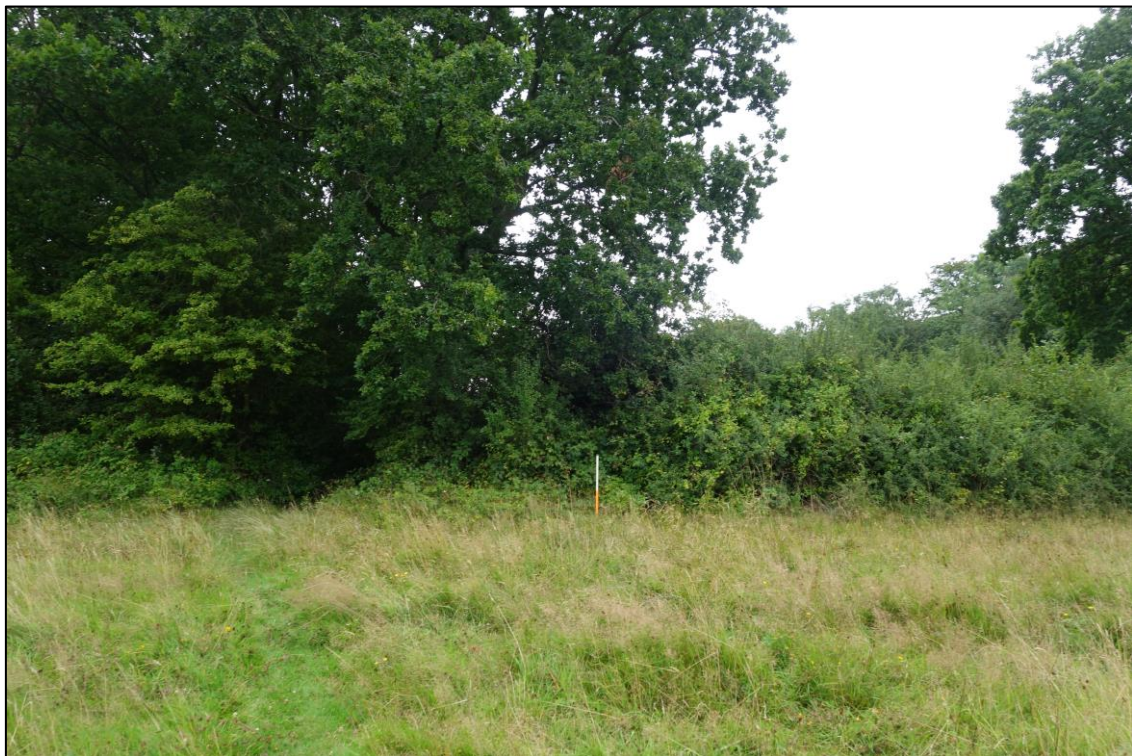
Viewpoint 22: View looking E showing tree-lined hedge marking W extent of pasture field S of Marlpit Wood (recorded as Kiln Field in the 1841 tithe award)

At NGR TQ 55262 29174, the pipeline route crosses the W boundary of a small rectangular pasture field S of Marlpit Wood, which is marked on the 1841 tithe map as forming part of a larger field called Kiln Field (VP 22). No evidence for a kiln or other features of archaeological interest was noted in this area. The pipeline runs SE across this pasture field and crosses its S boundary at TQ 55320 29126, which is defined by a linear tree-lined hedge (oriented E-W) and a low stony bank immediately to the S (VP 23). This hedge and bank also defined the N boundary of a woodland coppice called Dewlands Wood (first marked on an OS drawing of 1789) which formed part of the estate of Rotherfield Rectory (now Dewlands Manor Golf Club).

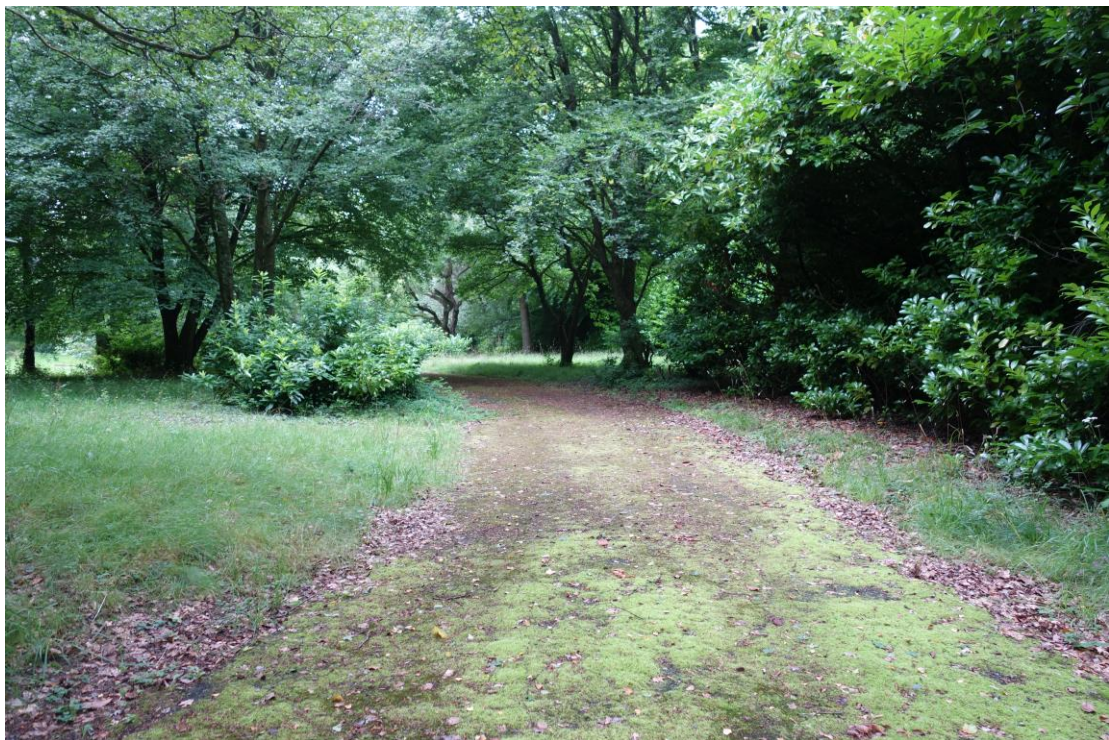
Viewpoint 24: View looking W along metalled trackway leading to Dewlands Manor (formerly the Rectory)

The pipeline crosses the woodland in an easterly direction, partly following the line of a long-established metalled trackway leading to the former Rectory which is first marked on the OS drawing of 1789 (VP 24) and then exits the Dewland Manor estate via an existing gateway flanked by rusticated stone piers which could be of late 19th or 20th century date (VP 25; TQ 55448 29067). From this point the pipeline route continues N along an existing roadway to reach the junction with the Mayfield Road (B2101) at TQ 55498 29151, adjacent to a detached house of late 19th century date first marked on the OS 1st edition map of 1878 (VP 26). From that point, the pipeline runs SE along the Mayfield Road before crossing a substantial tree-lined hedge boundary on the SW side of the road at TQ 55595 29030 (VP 27) and then continues SSW upslope across a large pasture field to reach its terminus at the modern covered reservoir at Cottage Hill (VP 28 NGR TQ 55545 28837).

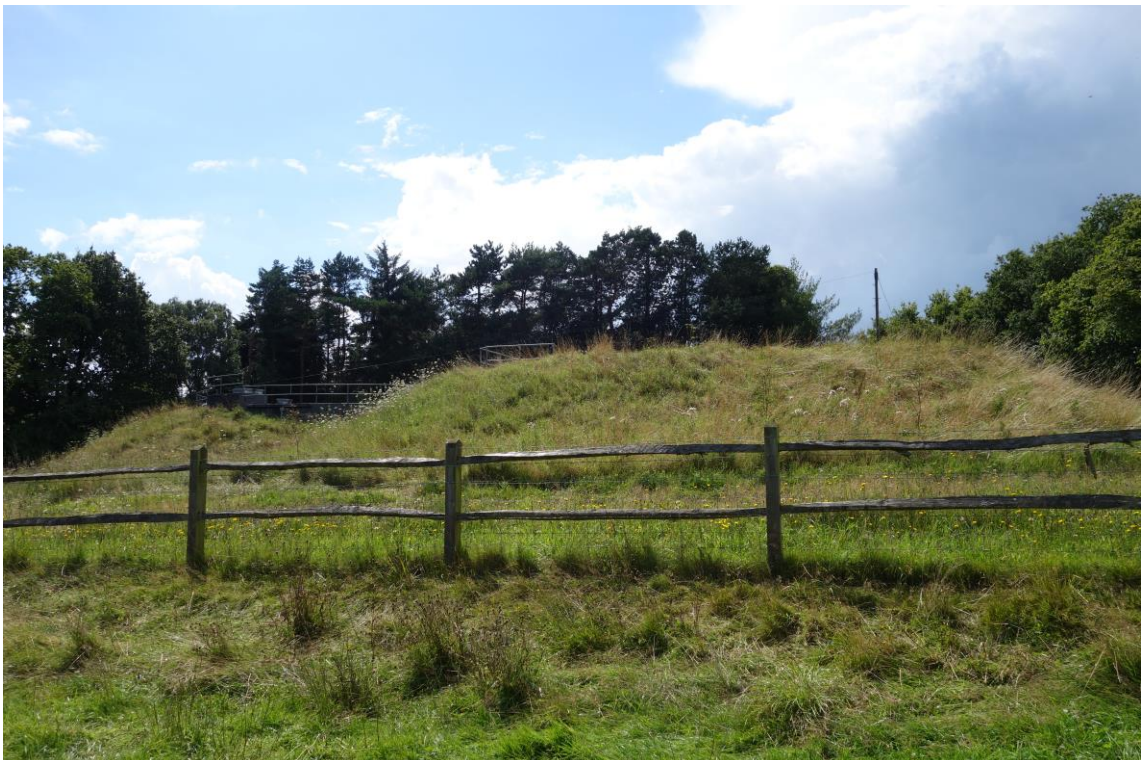
Viewpoint 28: View looking SSW towards modern covered reservoir on summit of Cottage Hill
