Archaeological Observation

Land to the rear of
No 6 Whitburn Street
Bridgnorth
Shropshire

NGR: SO 71510 93260

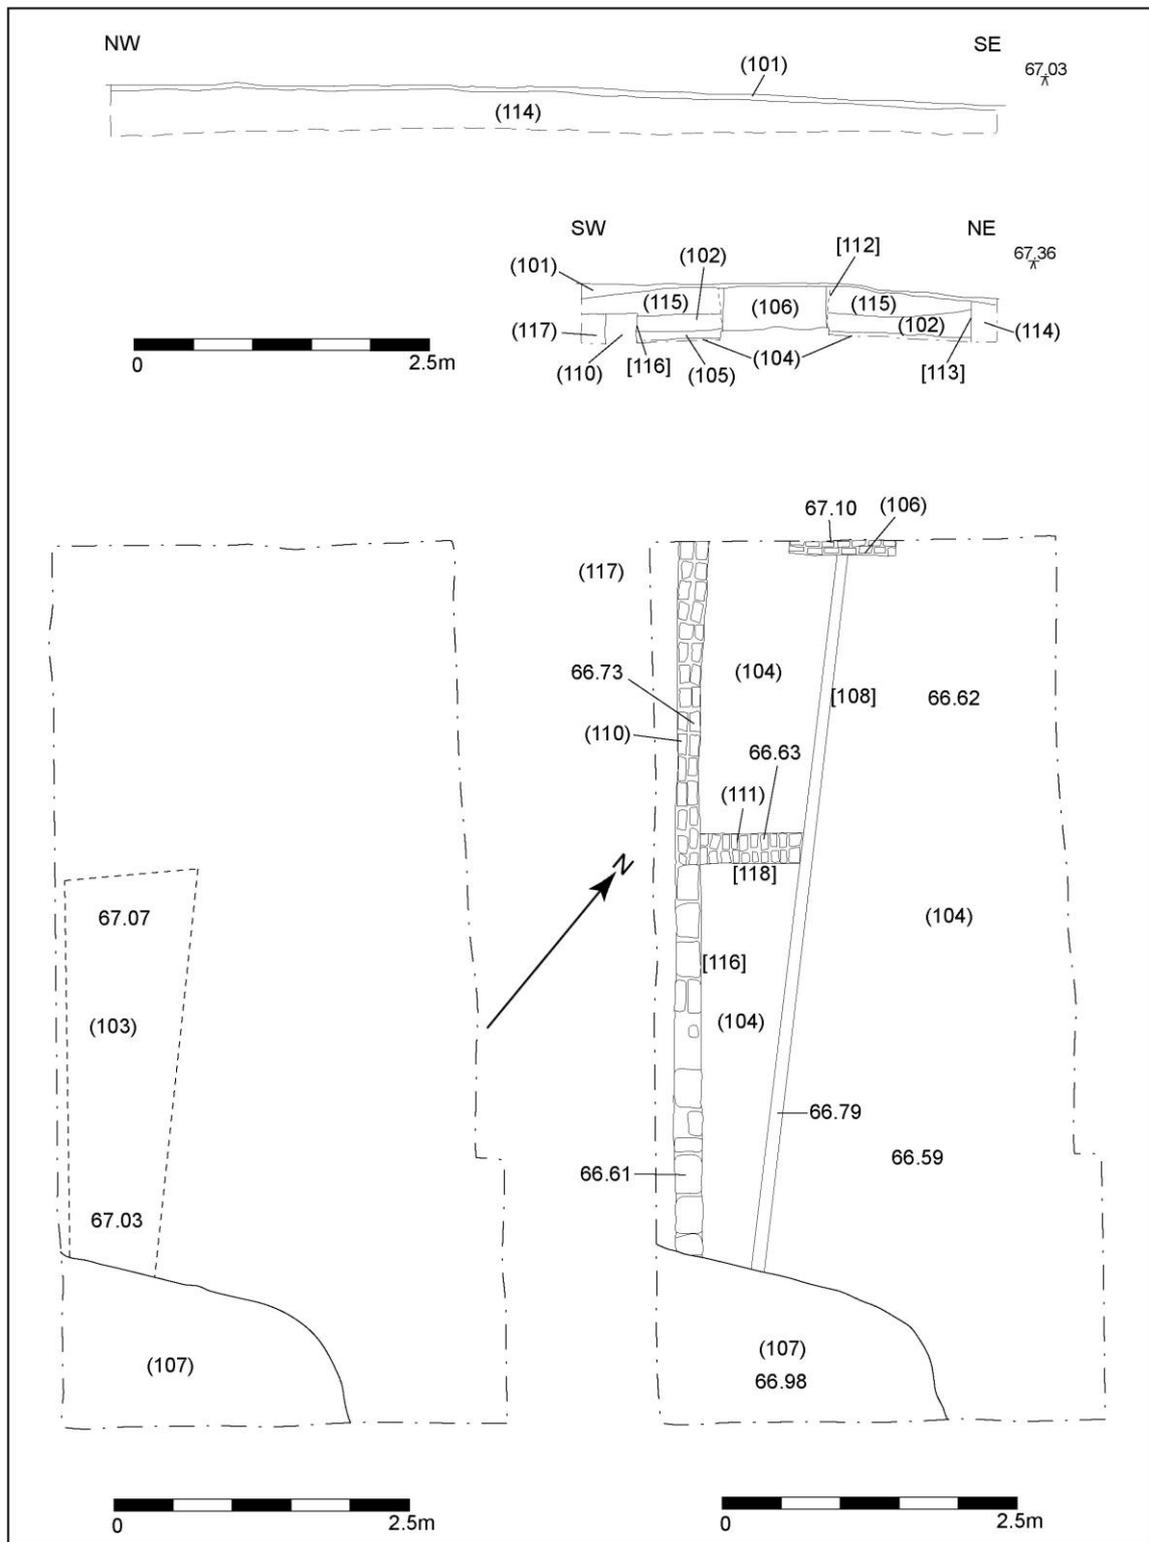
Eighteen contexts were identified during this programme of archaeological observation (**Fig. 2**). Extending across the majority of the observation area was (101), a gravel surface layer containing occasional modern plastic waste and CBM fragments, which extended 7.5m NW-SE x 3.5m NE-SW x 0.05m and formed the existing ground surface over the development area. This material abutted (107), a small, irregular area of concrete hardstanding in the extreme SW corner of the site measuring 2.45 NE-SW x 1.5m NW-SE x 0.08m.

Fig. 2: Mid-excavation & post-excavation plans and SE- and SW-facing sections showing features and deposits revealed during archaeological observation of groundworks at No. 6 Whitburn Street

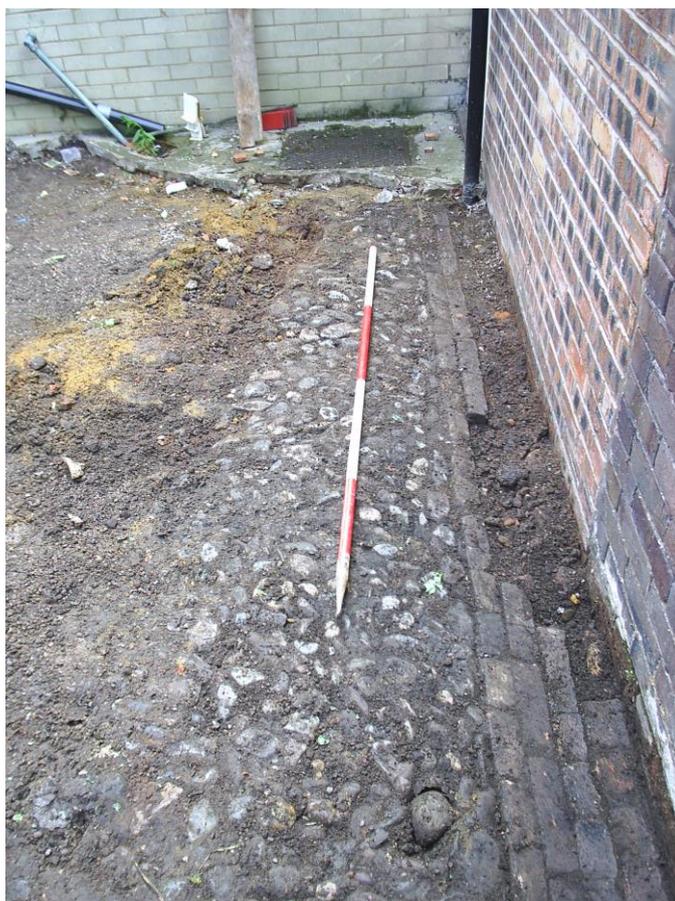
Abutting the SW boundary of the site were the disturbed remains of a narrow cobbled yard (103) consisting of a weakly cemented surface extending 3.5m NW-SE x 1m NE-SW x 0.08m (**Plate 1**). This deposit appeared to have formed a hardstanding yard surface, which was later covered by gravel deposit (101). Cutting (103) was [108], a linear drainage channel orientated NNW-SSE, its visible extent measuring >7.5m x 0.29m x 0.3m. This modern drain ran along the length of the site into an inspection chamber (106). Filling [108] was (109), a moderately compacted mid brown silty sand with frequent post-medieval CBM and mortar fragments.

Plate 1: View SSE showing cobbled yard surface (103) and adjacent wall foundation oriented NW-SE (110), both of post-medieval date, situated to rear of site

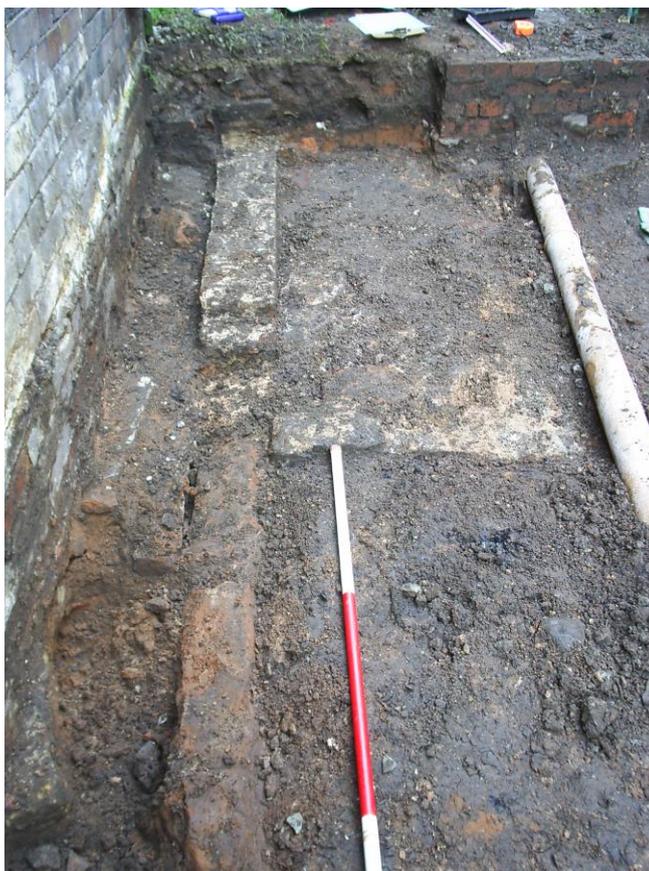
Cut [116] was linear in form measuring >6m NW-SE x 0.25m NE-SW x >0.16m, extending NW-SE parallel with the SW edge of the site. Within [116] was wall foundation (110) (**Plate 2**), which consisted of a single (visible) course of sandstone blocks overlaid at the NW end by two courses of brick, which might imply two phases of construction, with an earlier stone wall subsequently repaired in brick. It appeared that this foundation had been extensively robbed, with the brick being removed along most of its visible length.

Abutting (110) was the foundation course for a brick wall (111), oriented NE-SW (**Plate 2**). This foundation was within cut [118] and extended NE from (110) measuring 0.3m NW-SE x 0.85m NE-SW and consisted of a single (visible) course of cement-bonded brick. This foundation had been heavily truncated by drainage cut [108]. Cobbled yard surface (103) appeared to respect the NE edge of wall foundation (110) and the SE edge of brick wall (111).

Plate 2: View NW showing wall foundation (110) oriented NW-SE and abutting wall (111) aligned NE-SW
