Archaeological Observation & Photographic Survey

Mr & Mrs T. Vaughan
The Queens 113 Lower Galdeford
Ludlow Shropshire SY8 1RU

September 2014

BA1230QLG/2:

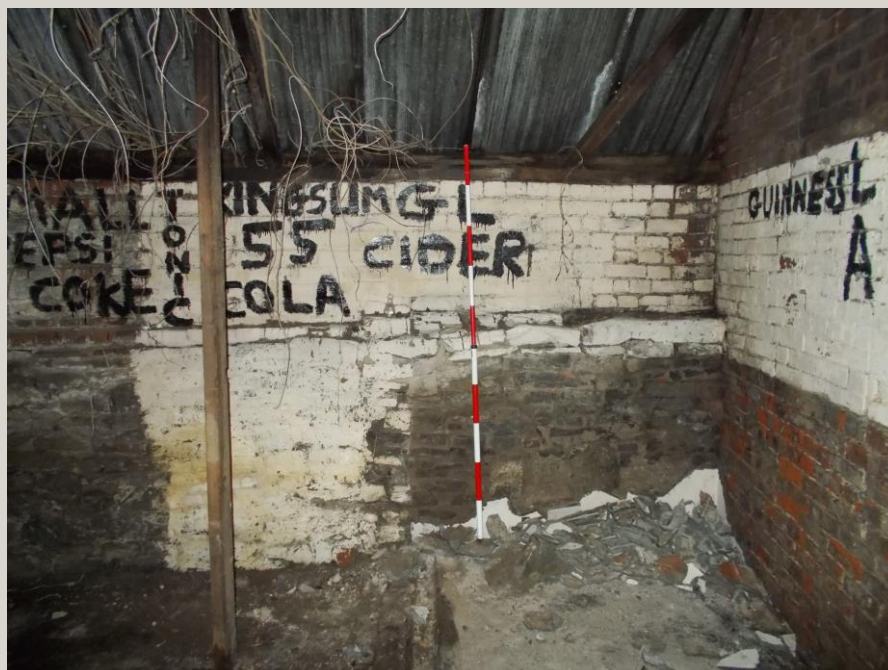
Plate 1: View W of extant boundary wall forming lower structure of western elevation of outbuilding (Area 1)

It is likely that this earlier stone building was constructed as a lean-to, utilising the existing boundary wall to the W. It was similar in width to the later brick building, which was also constructed in this manner. The southern extent of wall (105) was truncated. The northern extent ran beneath the eastern elevation of Area 2 and it was thus not possible to establish its full extent.

The S outbuilding (Area 1) was constructed as a lean-to using the W boundary wall. The stable building (Area 2) was freestanding but built up against the boundary wall.

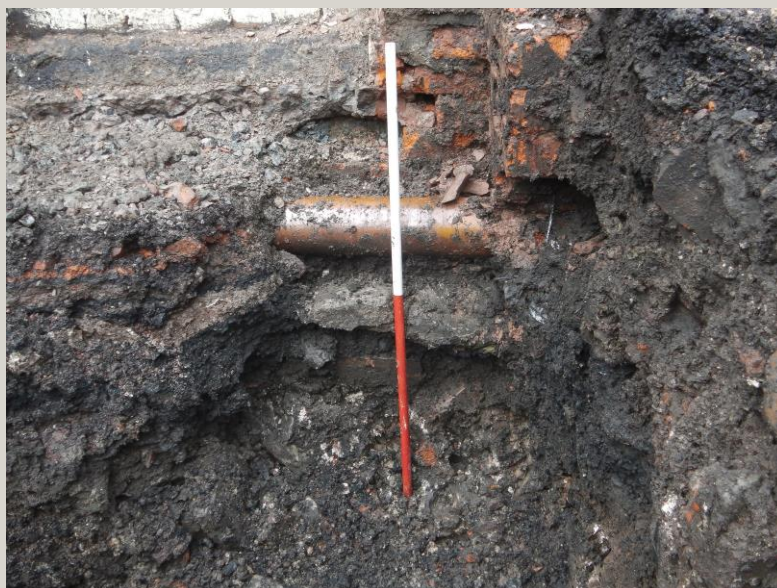
Plate 2: View N of wall course (105) in section (Area 1)

Ground works within Area 1 revealed a substantial wall course (105) oriented N-S (*Plate 2; fig. 2*). This was constructed from unworked, un-coursed, lime-mortar bonded sandstone and was located directly beneath the brick-built E elevation of the former outbuilding. It was similar in construction and material to the lower part of the extant boundary wall which formed the W elevation of the building (*Plate 1*). A lime-mortar surface (102) was revealed in the S-facing section of the E-W trenching (*Plate 3; fig. 4*); this appears to have been a continuation of the floor surface (205) encountered at this level in Area 2 (*fig. 6*).

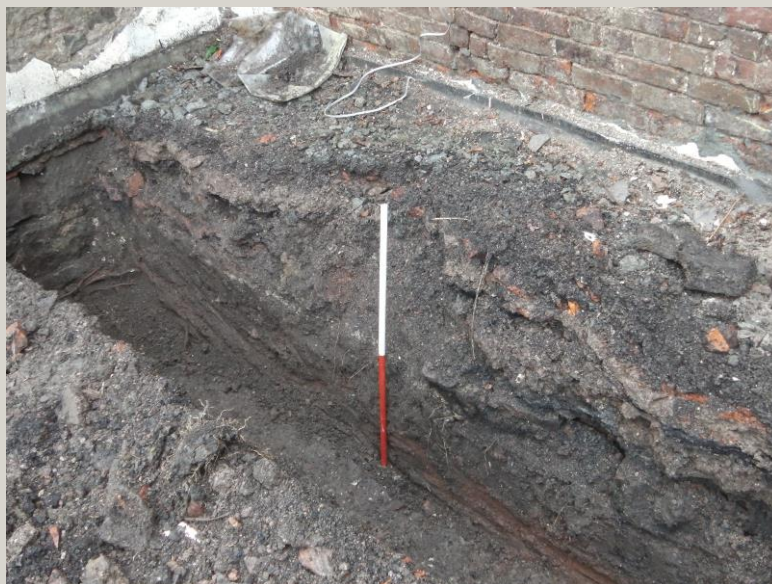
Plate 3: E-W trench at N end of Area 1, showing whitish lime-mortar surface (102) in section

Underlying (102) and (105) were two distinct layers of garden soil, (103) and (115), consistent with the historic map evidence, which suggests that the plot was formerly orchards (*Plate 3; figs. 3 & 4*).

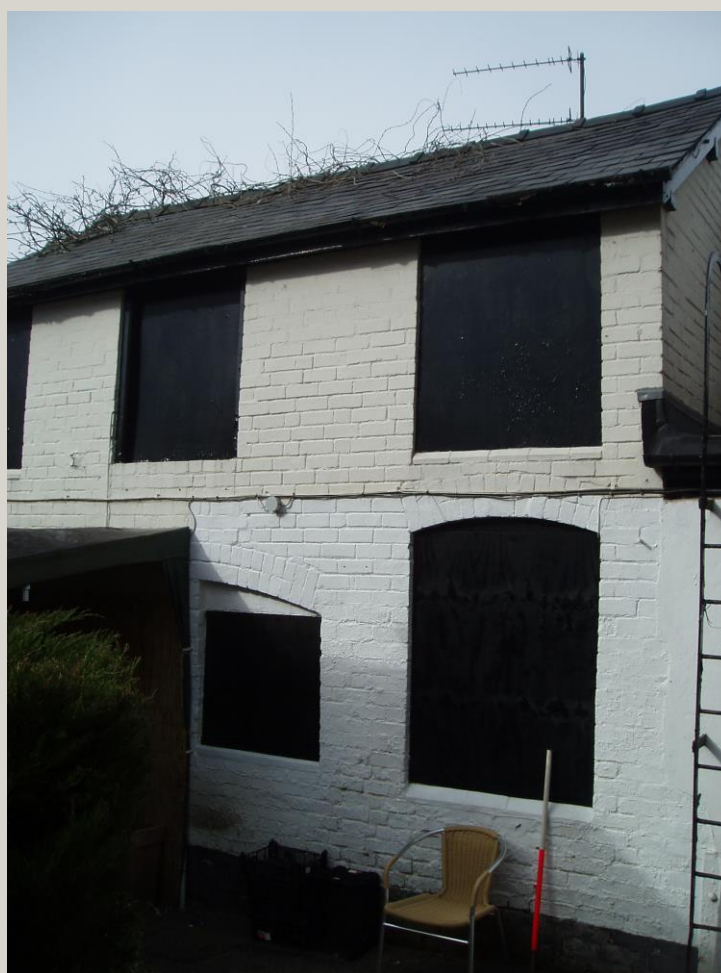
Plate 4: E elevation of Area 2 (formerly stables) showing bricked-up double-door (partially obscured by covered passageway)

The northernmost outbuilding (Area 2) had a large double-width doorway on the eastern elevation (*Plate 4*). A bricked-up entrance is discernible on the S elevation of Area 2; this was probably a pitching door for a hay loft, over the stables (*Plate 5*). Removal of the modern floor surfaces revealed the brick coursing for the W wall of the internal corridor (206), probably a later addition contemporary with the construction of the S building (Area 1) (*fig. 5*).

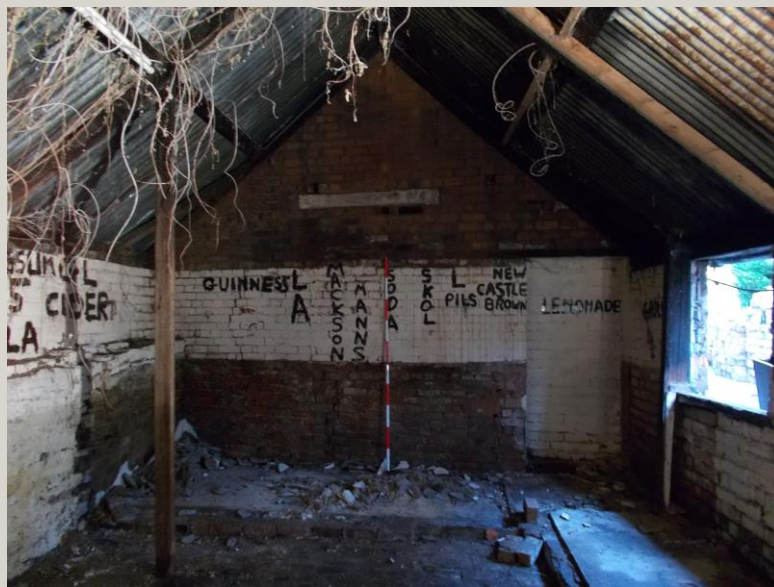
Plate 5: Internal view looking N of S elevation of Area 2, showing bricked-up doorway and corridor extending along the E side of the Area 1 building; the wooden sill for a possible pitching door is also visible in this picture

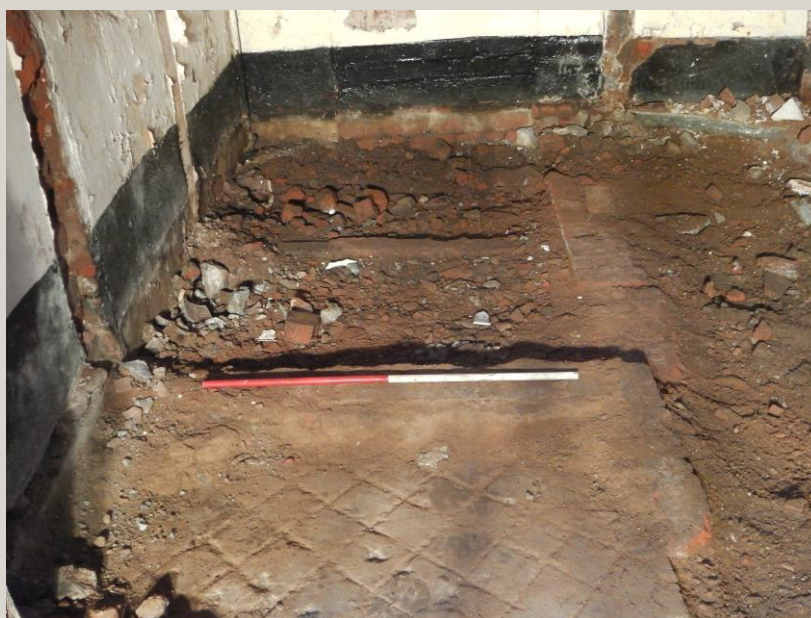
Plate 6: Internal view S of internal corridor (206) in Area 2
