# ARCHAEOLOGICAL OBSERVATION

**Pigeon House Farm**

**Eldersfield**

July 2011

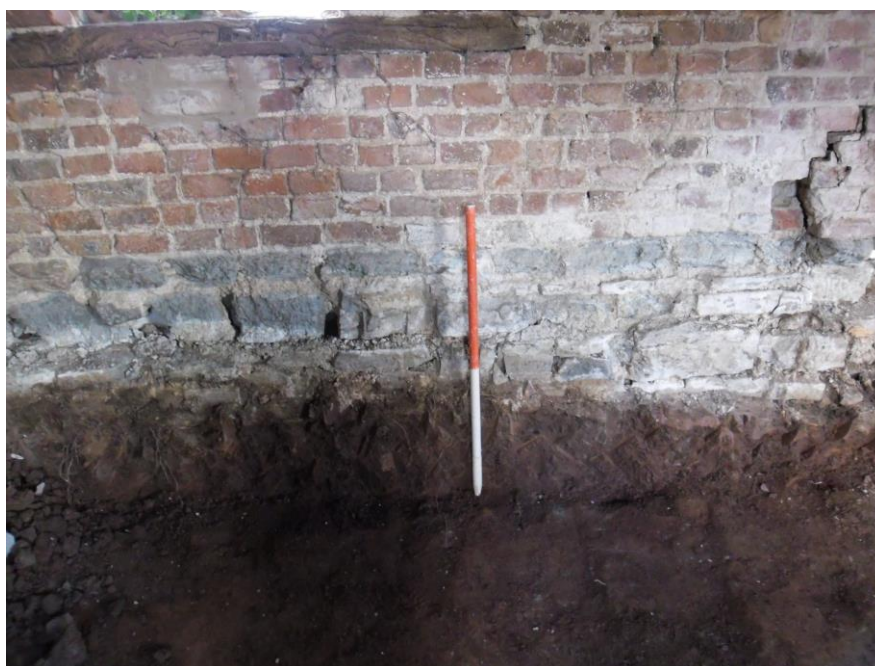
Following removal of the flagstones and the screed concrete flooring, the uppermost deposit identified was a moderately compact dark greyish-brown silty clay (003), extending to an approximate depth of 0.20m across the entire area, with moderate root action and frequent small to medium rounded and subangular stones, containing moderate quantities of bottle glass, CBM (roof tile), mortar flecking and pottery sherds (chiefly 18<sup>th</sup>-19<sup>th</sup> century blue-and-white transfer ware) and occasional animal bone. (003) was interpreted as made-up ground associated with a phase of rebuilding activity, possibly of 19<sup>th</sup> century date (*plate 1*).

*Plate 1: Internal view looking NW showing the foundation courses of the NW wall of the two-storey barn and the deposits revealed in section beneath the wall*

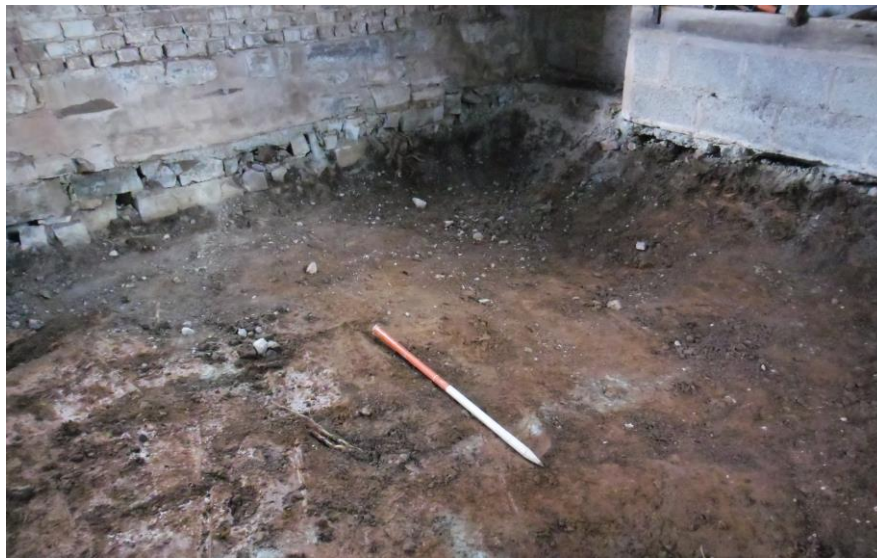
Underlying (003) and extending to a maximum visible depth of 0.20m was a firm mid reddish-brown sandy clay (004), exhibiting moderate root action, with lenses of friable bluish-grey stone visible towards the base of the deposit (*plate 2*). This deposit appeared to be devoid of pottery or CBM, although the evidence of root action suggested that it probably did not represent natural deposition.

It is possible that (004) represents a landscaping deposit associated with the formation of the low platform on which the barn stands.

Plate 2: View looking S showing mid reddish-brown sandy clay with evidence of root activity (004) following reduction of ground levels at the SW end of the two-storey barn

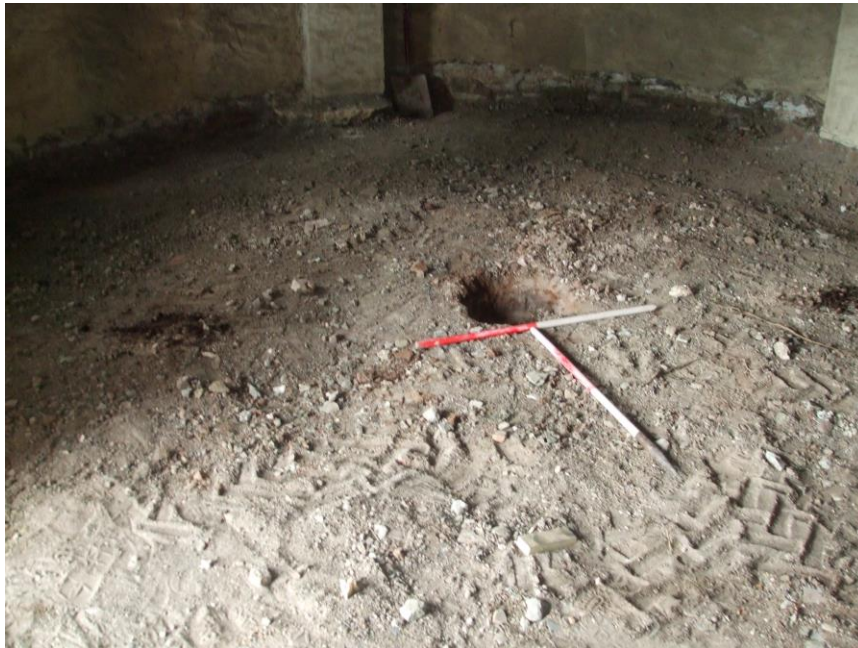
Located in the centre of the engine house and overlaid by (101) were the partially truncated remains of the turning circle for the horse engine, consisting of a low stone plinth (103), 2.45m in diameter and 0.10m high, with partially intact kerbing (106) approximately 0.25m wide around the edge of the plinth consisting of a single course of unfrogged orangey-red brick (average brick dimensions 0.25m × 0.05m × 0.10m). Within the centre of the plinth was a circular slot [104], 0.50m in diameter and 0.25m deep, which would have carried the vertical drive shaft of the horse engine (*plate 3*). Filling the slot was moderately compact, dark reddish-brown silty clay (105), 0.25m in depth, with frequent inclusions of CBM, sandy gravel and mortar flecking, interpreted as material used to backfill the slot following removal of the drive shaft. No evidence for a brick or stone paved floor surface contemporary with the turning circle was identified; an area of irregular brick and stone cobbling (107) situated just within the entrance to the engine house, measuring approximately 2.25m (NW-SE) × 0.94m (NE-SW), appears to be a later addition.

*Plate 3: View looking NW showing interior of engine house following reduction of ground levels, with circular slot for the horse engine drive shaft in the centre of the turning circle*

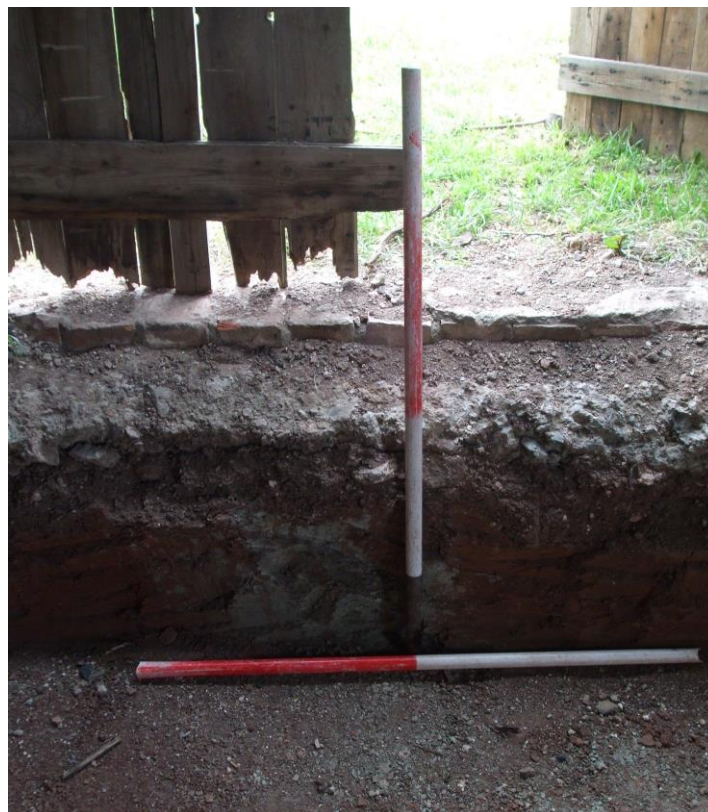
The last phase of internal groundworks comprised the reduction of ground levels to an approximate depth of 0.50m within the single-storey, stone-built barn (Barn C), attached to the southwest gable end of the two-storey barn, which was extensively rebuilt and converted into a garage in the late 20<sup>th</sup> century (*plate 4*). Within this structure, the uppermost context consisted of loose light greyish-brown sandy silt (201), 0.08m thick, with frequent inclusions of CBM, gravel and stone rubble, interpreted as a compacted layer of modern detritus. (201) in turn overlaid firm mid reddish-brown

sandy clay (202), approximately 0.40m in thickness, which appeared to represent redeposited material possibly associated with the reconstruction of the barn in the late 20<sup>th</sup> century.

*Plate 4: View looking SW showing deposits in section revealed following reduction of ground levels at the SW gable end of the single-storey barn (currently used as a garage)*

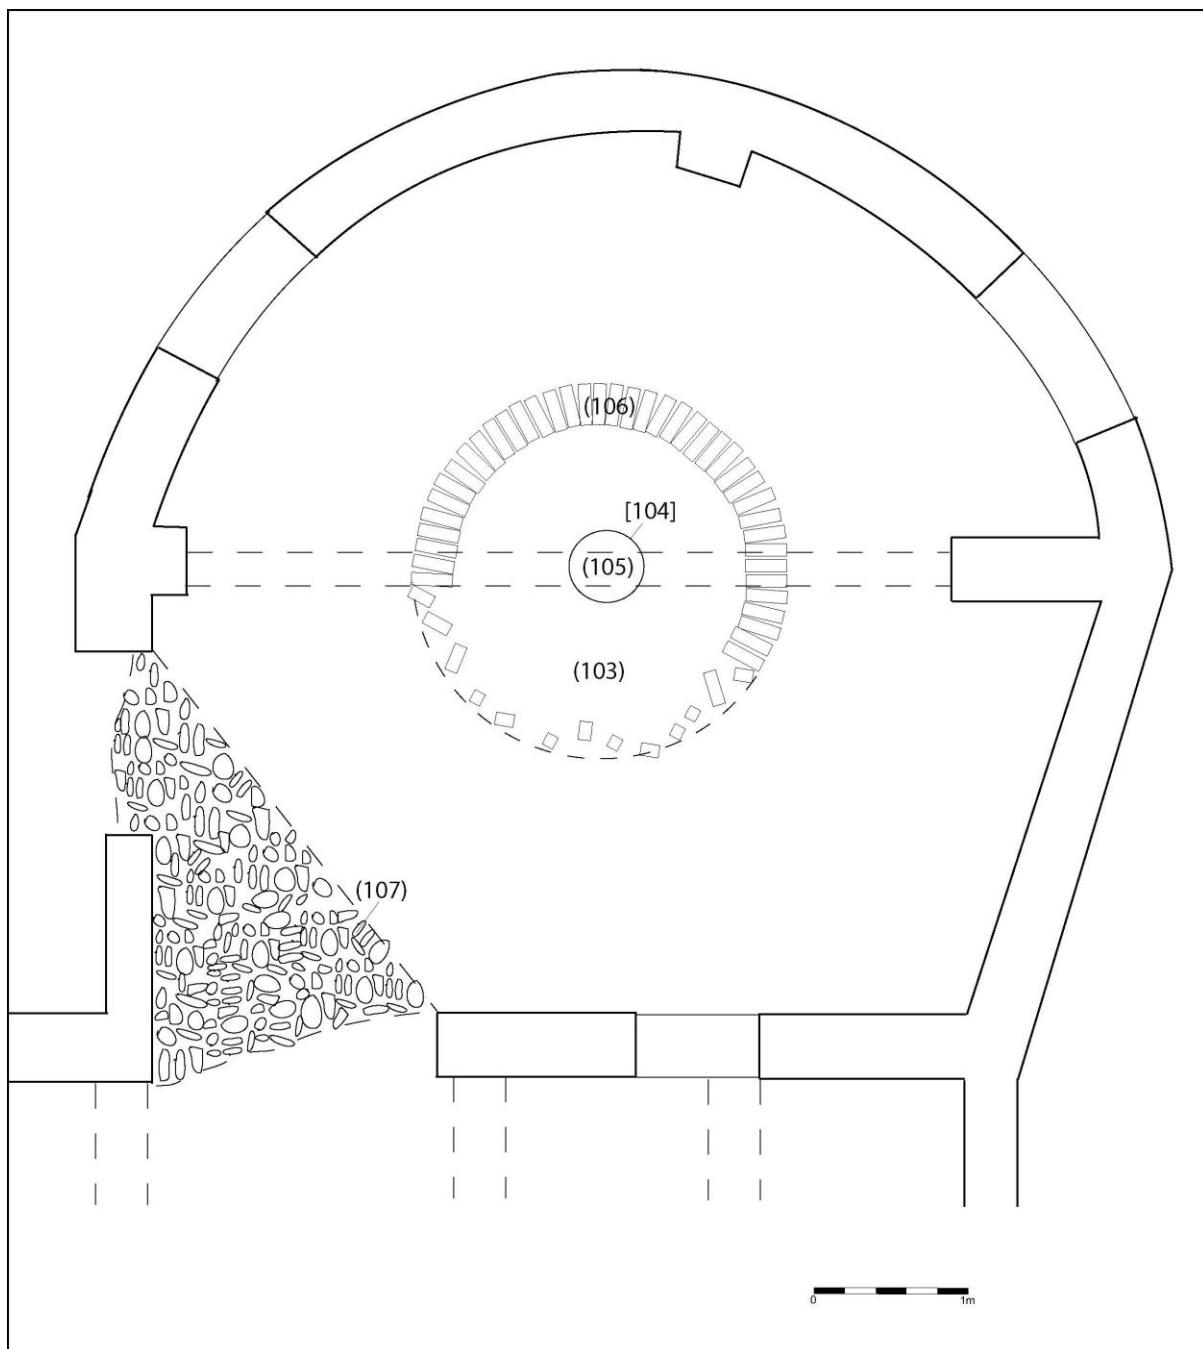
Fig. 3 Plan showing extent of groundworks and remains of turning circle within engine house (Barn B)

The next phase of groundworks consisted of the reduction of the floor-level within the former horse engine house (Barn B), a circular structure attached to the northwest of the two-storey barn, to an approximate depth of 0.25m across the entire area. A total of five contexts were identified, the uppermost being a loose light greyish-brown sandy silt (101), approximately 0.10m thick, with frequent inclusions of CBM, gravel and stone rubble, interpreted as a compacted layer of modern debris relating to the use of the engine house as a store for agricultural machinery and implements. Underlying this was a firm mid reddish-brown sandy clay (102) with small to medium subangular stones and occasional CBM and slate fragments, extending to a maximum visible depth of 0.15m.

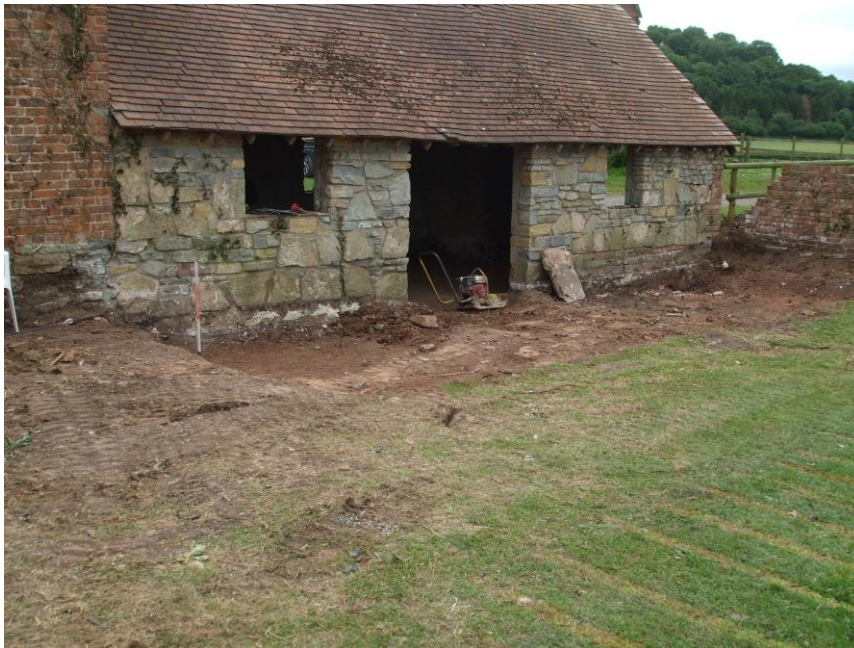
The external groundworks consisted of the reduction of ground levels to a depth of 0.30m within a rectangular strip measuring approximately 10.50m (NE-SW) × 2.00m (NW-SE), immediately in front of the NW facing elevation of the single storey barn (**Plate 5**).

The uppermost context identified consisted of a moderately compacted dark greyish brown silty clay topsoil (301), 0.26m thick, with frequent root disturbance, moderate small to medium sub angular stones and occasional 19<sup>th</sup>-20<sup>th</sup> century pottery and CBM fragments. This in turn overlaid a firm mid-reddish brown sandy clay subsoil (302) with moderate root action and small to medium sub-angular stones, 0.05m in thickness (max visible).

Plate 5: View looking SE showing reduction of ground levels immediately adjacent to the NW facing elevation of single storey barn structure (Barn C)

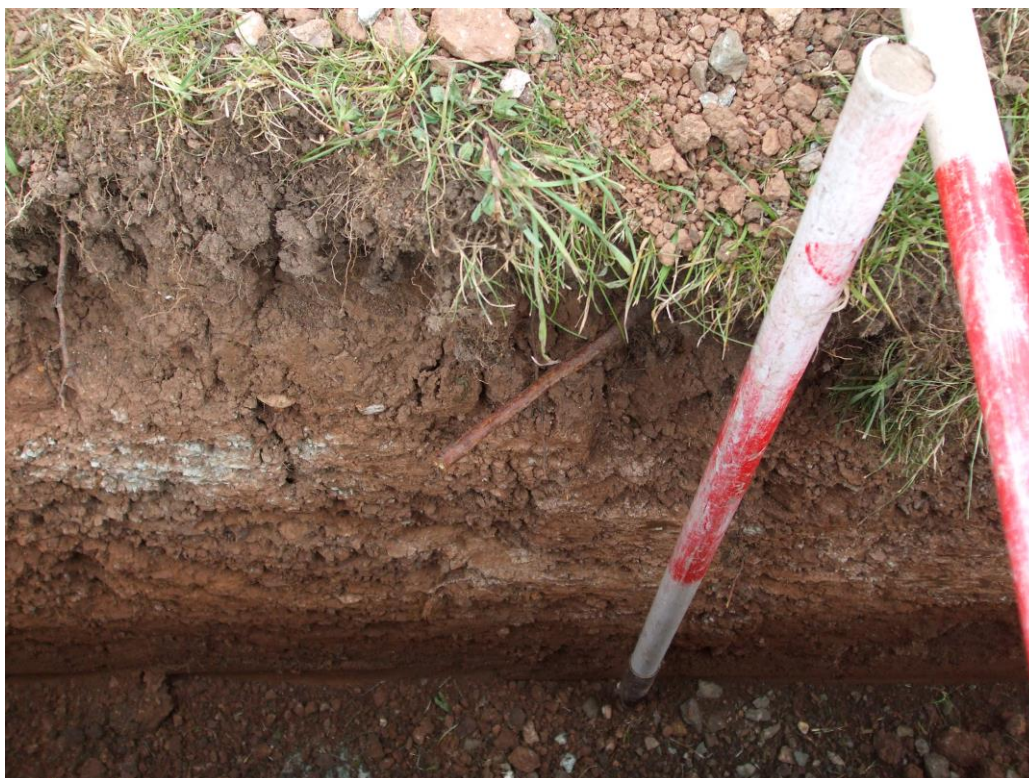
The final phase of groundworks comprised the excavation of a narrow service trench extending to the SW of the single storey barn, measuring 18m (NE-SW) × 0.30m wide × 1.20m (max depth). A total of three contexts were identified within the trench (**Plate 6**), the uppermost consisting of a loosely compacted dark greyish brown silty clay topsoil (401), 0.25-0.30m thick, underlying which was a firm mid-reddish brown sandy clay with lenses of friable, heavily degraded bluish grey stone (402) and moderate root action, 0.50m thick, which in turn overlaid a firm, dark reddish brown sandy clay (403) with frequent small to medium sub angular and rounded stones, which extended to the base of the trench (0.40m max visible thickness).

Plate 6: View looking SE showing deposits in NW facing section of service trench excavated to SW of single storey barn
