Archaeological Observation

**The Quaker Meeting House
St Mary's Lane
Ludlow
Shropshire
SY8 1DZ**

August 2019

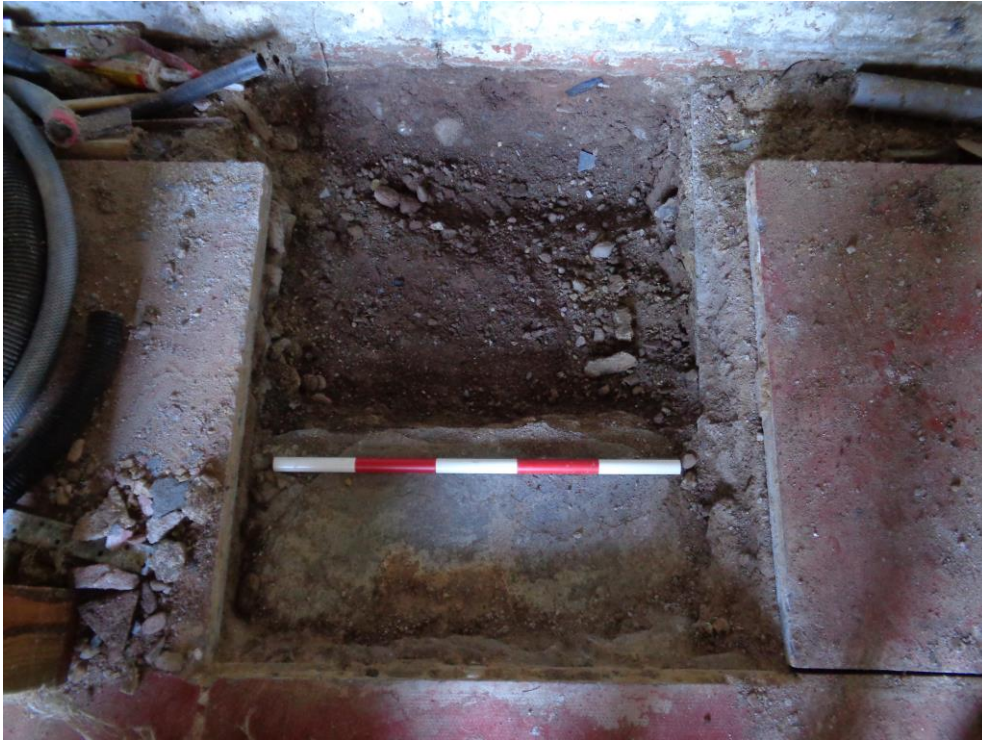
Plate 1: TH001 in Room 001

The first, internal TH001 was located in the SW corner of Room 001 (*Plate 1*). It was excavated to a depth of c.0.30m and contained modern slabs and mortar overlying slate flagstones, which were set directly onto the natural gravelly soils.

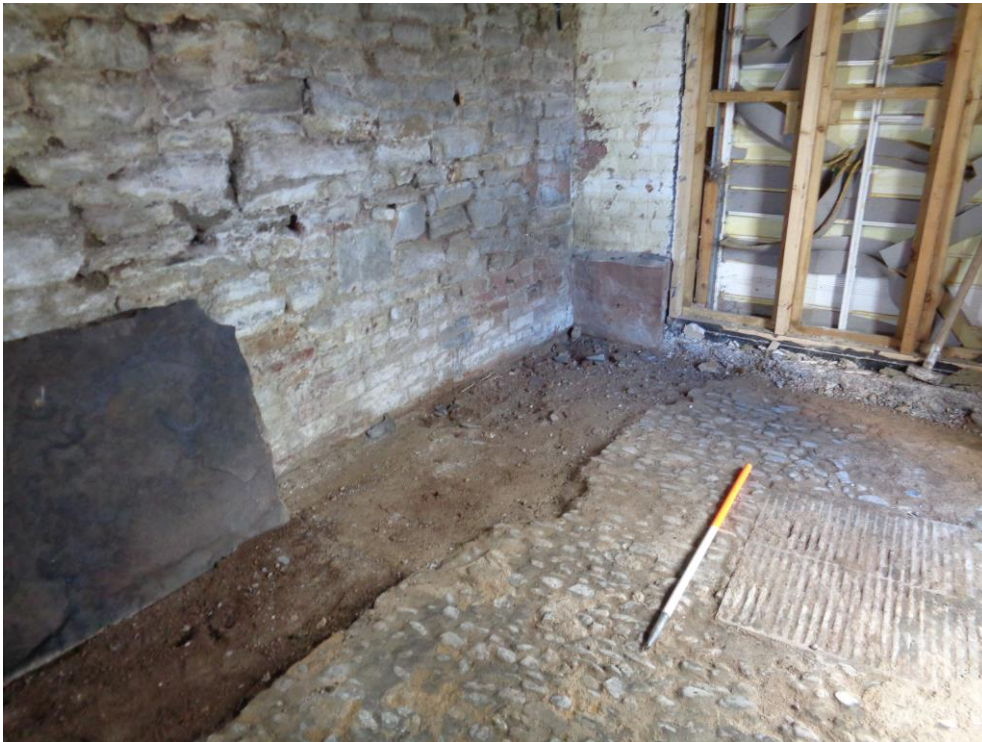
Modern concrete slabs (001001) were removed to reveal surfaces (001002) and (001003). Surface (001002) was a single course of generally rounded stones roughly 0.10m in diameter forming a cobbled floor measuring c.4.63m × c.2.09m × c.0.08m. Surface (001003) was a single course of slate flagstones measuring c.4.63m × c.0.84m × c.0.08m. The two surfaces were abutting, the flagstones probably being laid to replace areas of damaged cobbling (*Plate 2*).

Plate 2: View S of Room 001 showing cobble surface (001002) with a central drainage grate

Cobbled surface (001002) in Room 001 probably relates the remains of original 19th Century flooring; a similar surface was revealed during the evaluation carried out by BA in 2016 and dated 18th-19th Century (BA 2016).

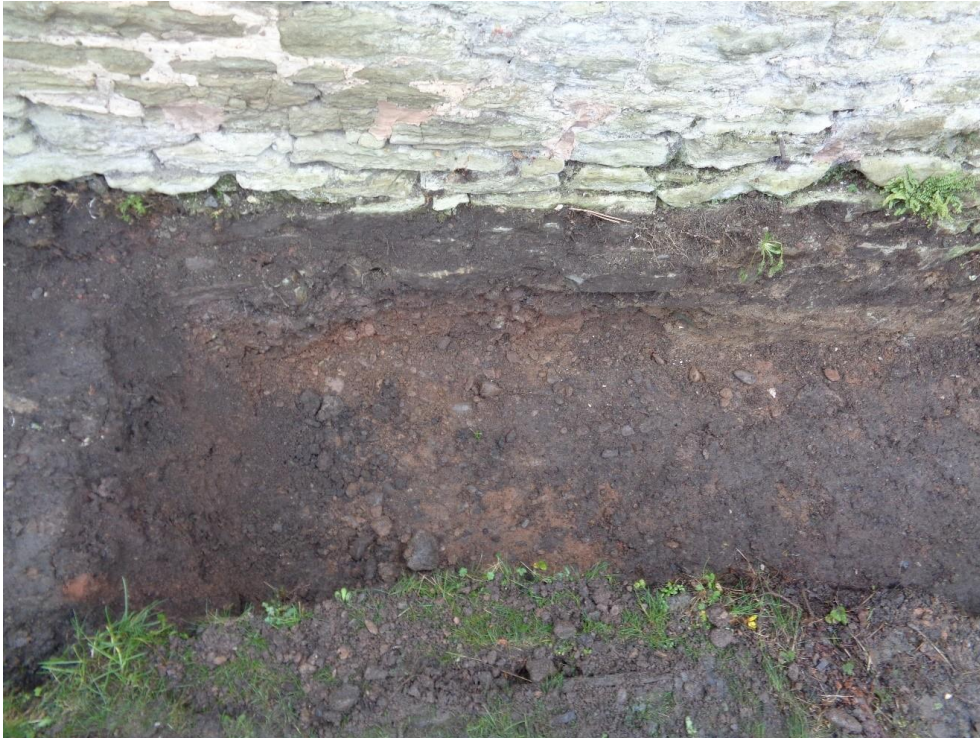
Topsoil (003001) was a c.0.20m thick, very dark brown silty clay containing frequent pebbles and directly overlying natural substrate (003002), a dark brown sandy silt gravel with very frequent pebbles (*Plate 3*). This was cut by modern drain [003003] filled by (003004) - seen within Room 002 as [002004] filled by (002005) - and running NW-SE before turning E-W.

Plate 3: Drainage Trench 001 showing masonry foundations, topsoil (03001) & natural (003002).

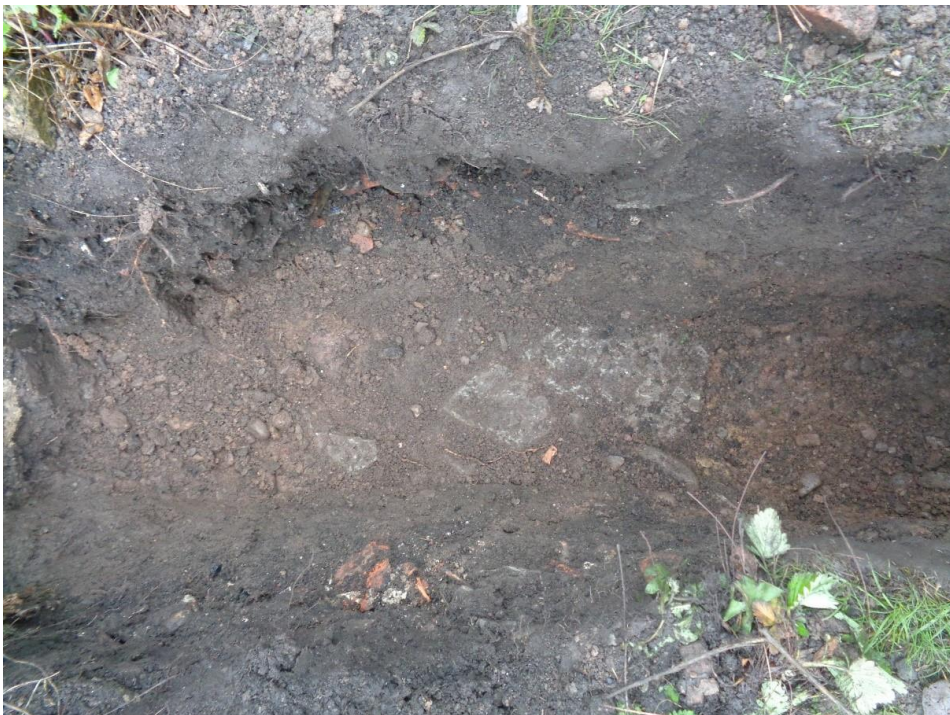
Underlying this, (004006) was a friable mid-red brown silty sand measuring c.5.50m unbroken × >0.30m × c.0.10m, which overlay a series of irregular limestone slabs (004005) extending >80m × >0.30m × >0.10m. Limited trench depth and width precluded further investigation but this did not appear to be more than a single course thick, suggesting a possible path rather than a structure (*Plate 4*). This likely had a domestic use but neither its date or function could be confirmed due to the limited extent of excavation and lack of finds from (004006).

Plate 4: View SSW of stone layer (004005), a possible pathway within Drainage Trench 002

Drainage Trench 002 revealed mainly modern garden deposits. A stone pathway (004005) was possibly of post-medieval date but due to the limited extent of excavation this could not be confirmed.

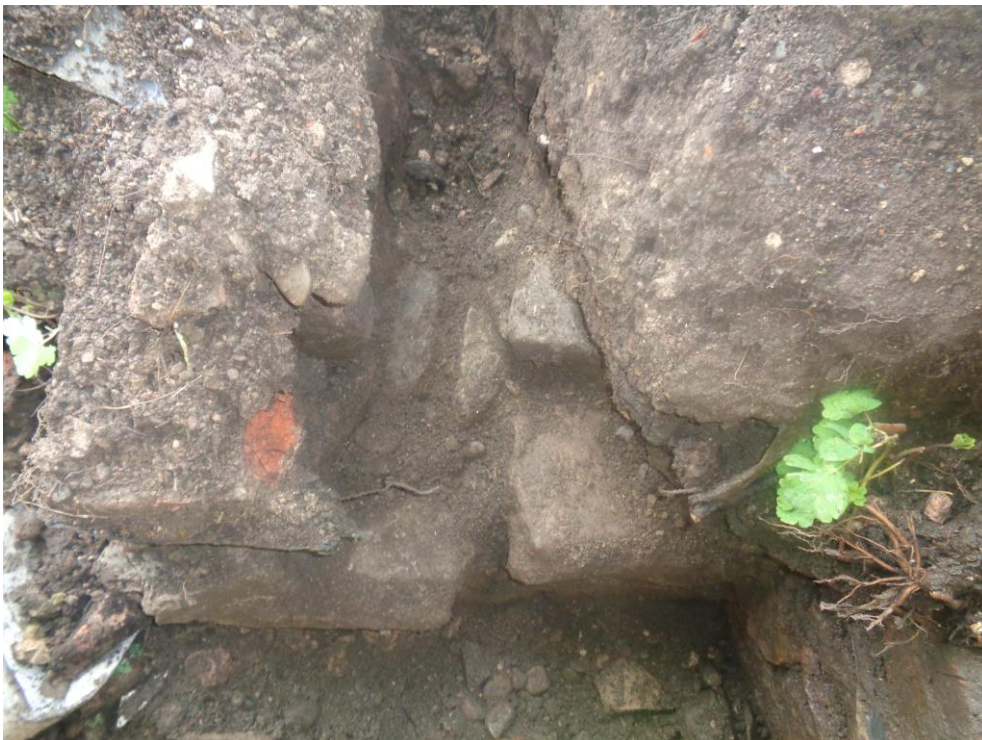
Masonry wall (004010) related to the foundations of the former barn/workshop containing Rooms 001 and 002 and was c.0.45m wide and c.0.32m-c.1m deep, with an unknown length. It consisted of three-five irregular courses of worked limestone blocks, each measuring c.0.30m × c.0.20m × c.0.20m, with stacked brickwork above (*Plate 5*). The feature was recorded within a vertically-sided cut [004015] measuring c.0.30m min × c.0.40m min × c.0.90m min. Overlying wall (004010) was a c.0.70m-thick loose mid-grey brown sandy silt (004016). However, the cut was not clearly visible in section and (004016) was very similar to (004009), which may indicate that the two made-ground deposits were built up to abut the wall and to level the ground. Given that no building is present on the OS map of the area until 1903, this can confidently be assigned a modern date.

Plate 5: View WNW of masonry wall (004010) within Drainage Trench 002

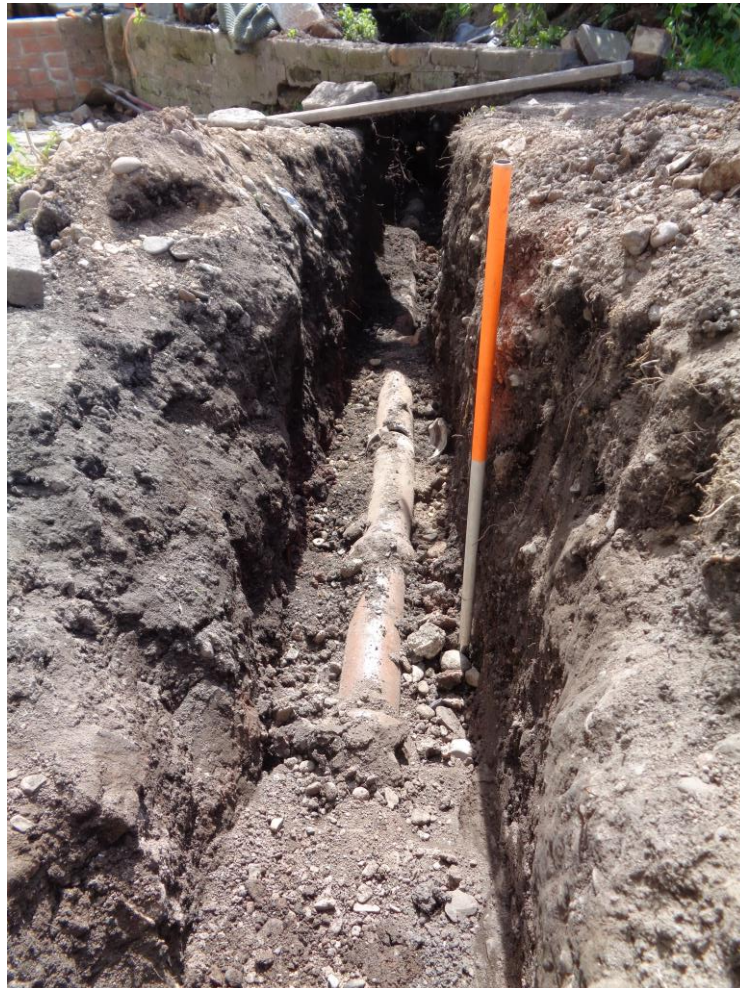
Plate 6: View SW of Drainage Trench 003, showing garden wall (005005) and drain pipe in [005003]

Turf (005001) was a moderate to firm, dark brown grey silty clay with frequent small rounded stones, occasional charcoal and CBM (not retained) measuring c.0.20m thick. The turf abutted a modern brick wall (005005) relating to a small herb garden. The wall stood to between three and six courses of running bond brickwork and ran for c.4m N-S, turning NNW-SSE (Plate 6).

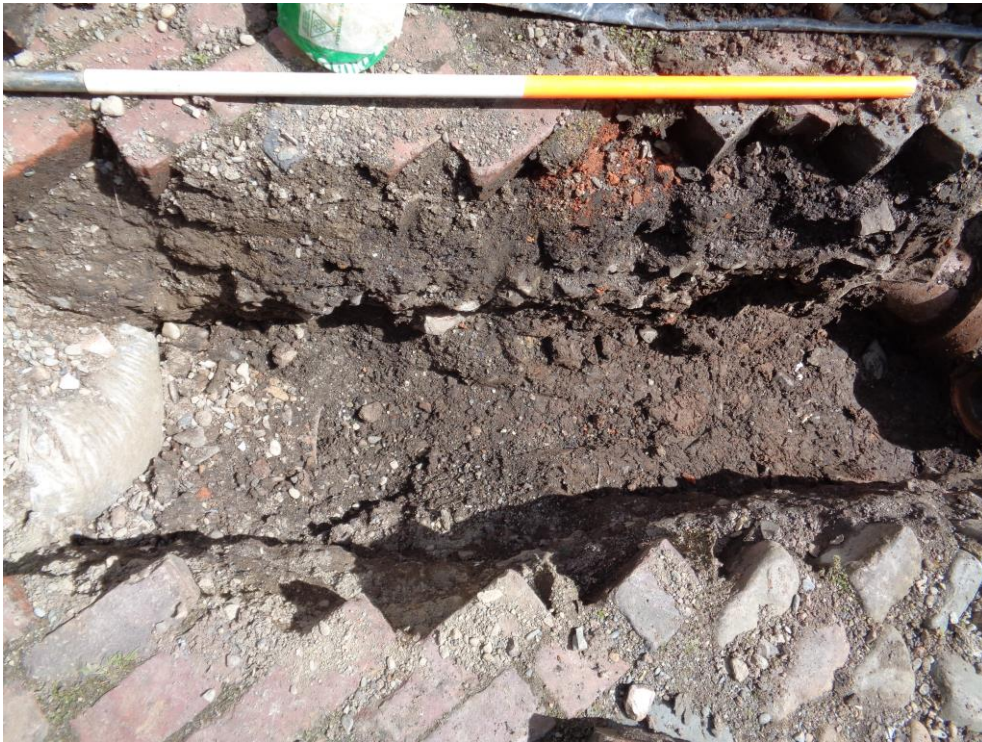
The natural substrate (006005) underlying (006003) was a soft, light brown clay sand with occasional small rounded stones encountered at a maximum depth of c.0.20m below ground level. At the boundary with the original extent of Drainage Trench 003, this was seen to be cut by [005003] (*Plate 7*).

Plate 7: NW-facing section of Drainage Trench 003 - Extension
