ARCHAEOLOGICAL OBSERVATION

UPPER HOUSE

LYONSHALL

HEREFORDSHIRE

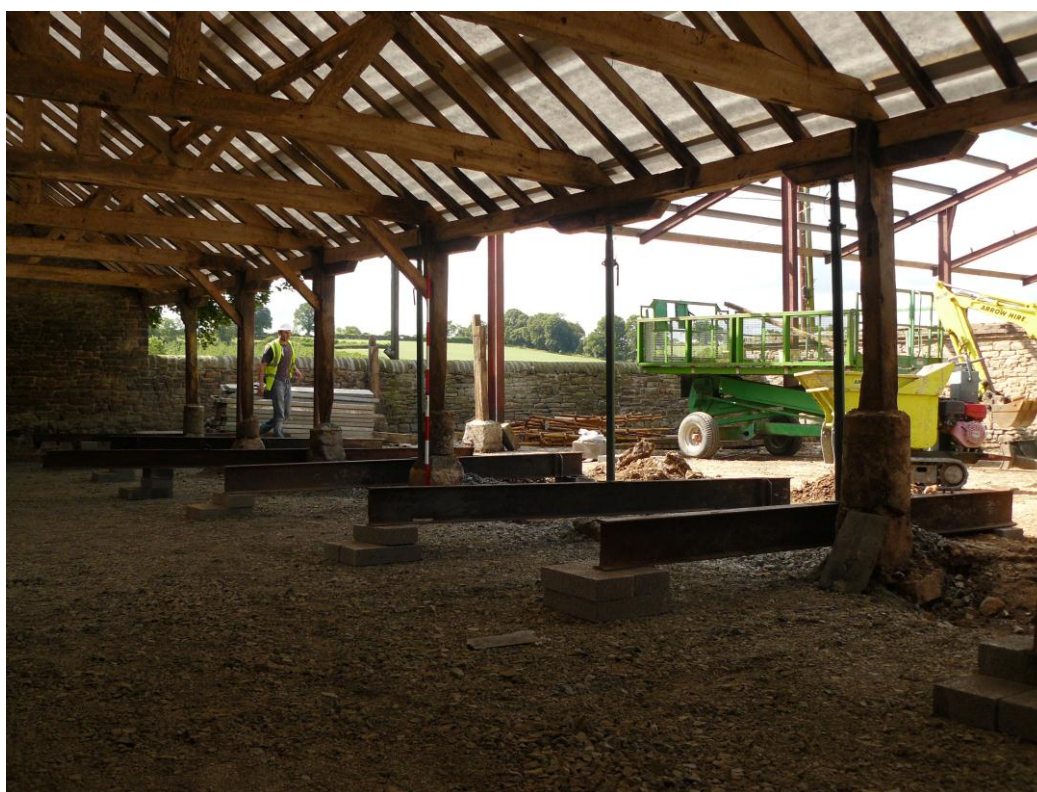
Cover: View of site, looking south

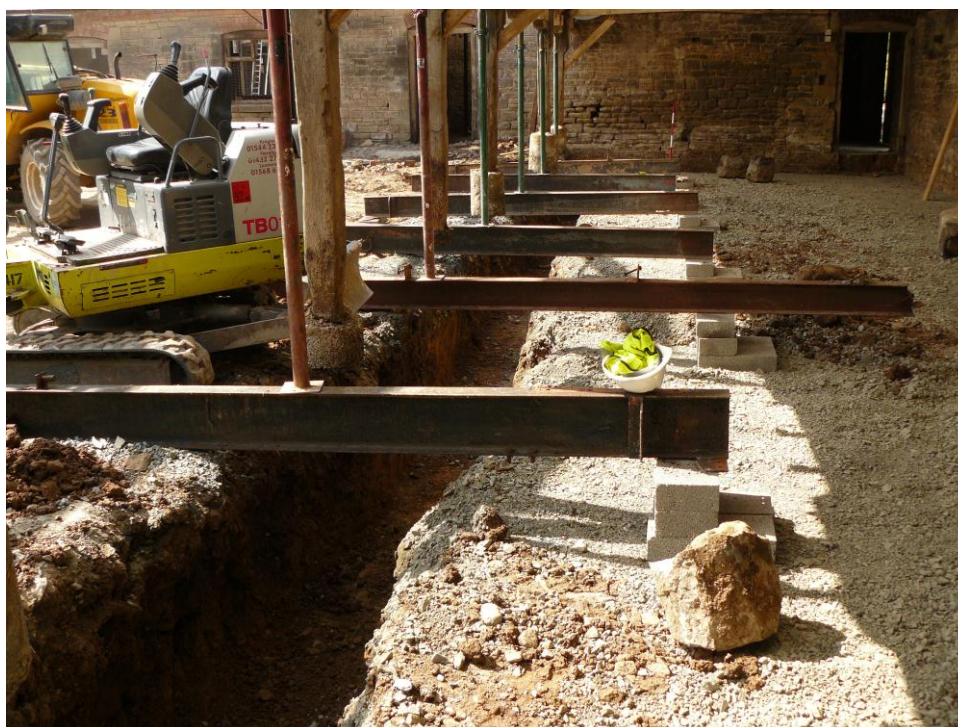
The groundworks comprised a single northwest-southeast trench measuring 18.8m × 0.8m × 1m (*plate 1; fig. 2*), the excavation of which was subject to archaeological observation and recording. Full written, graphic and photographic records of any surviving deposits, features or structures of archaeological significance were made in accordance with Border Archaeology's *Field Recording Manual*.

Plate 1: View showing northwest extent of excavation trench

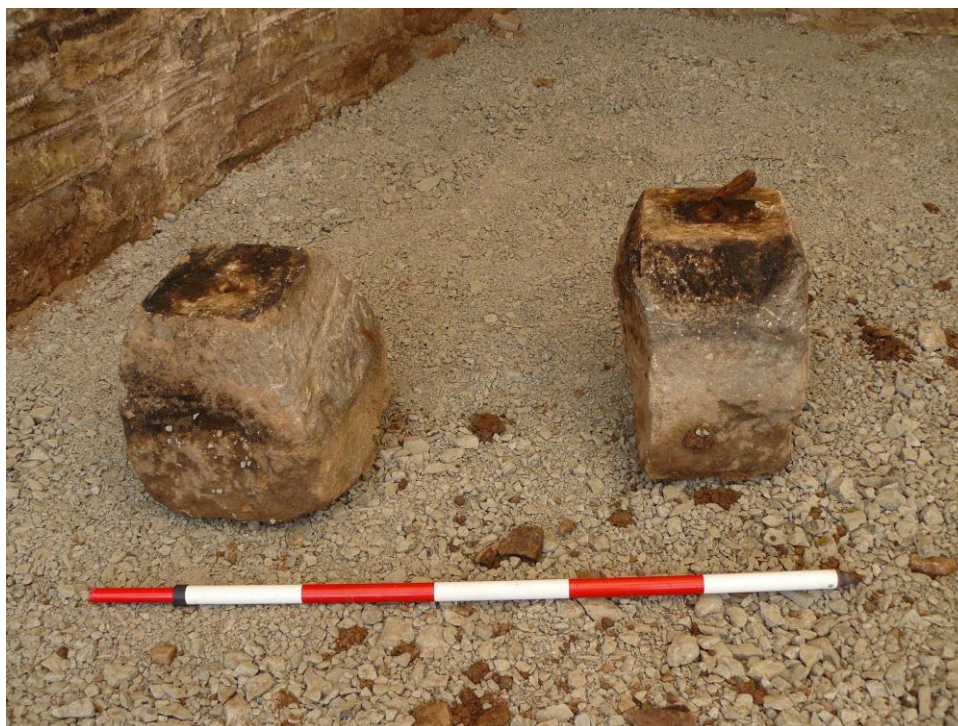
A series of tapered masonry supports, each with a pin set into its upper face (*plate 2*), were dispersed at regular 2m intervals along the western elevation of the cattle shed. These measured approximately 0.5m × 0.5m × 0.5m and were set in foundation pits cut from (007); these pits were levelled and packed with sandstone rubble.

Plate 2: Stone supports for timber uprights

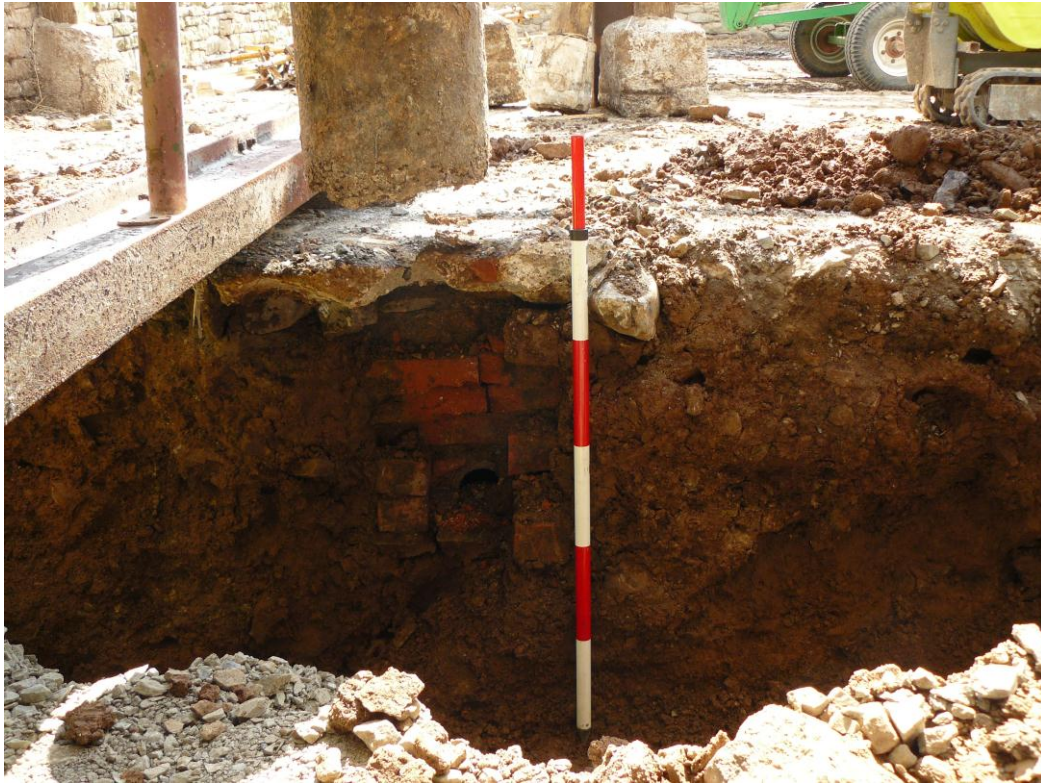
The pit at the southeast extent of the trench [028] truncated a brick drain/culvert running east northeast-west southwest (012) which comprised four courses of unfroged brick and a sandstone capstone. This was also cut from (007) but probably related to an earlier phase of construction.

Plate 3: View southwest of drain (012) and associated cut [011]

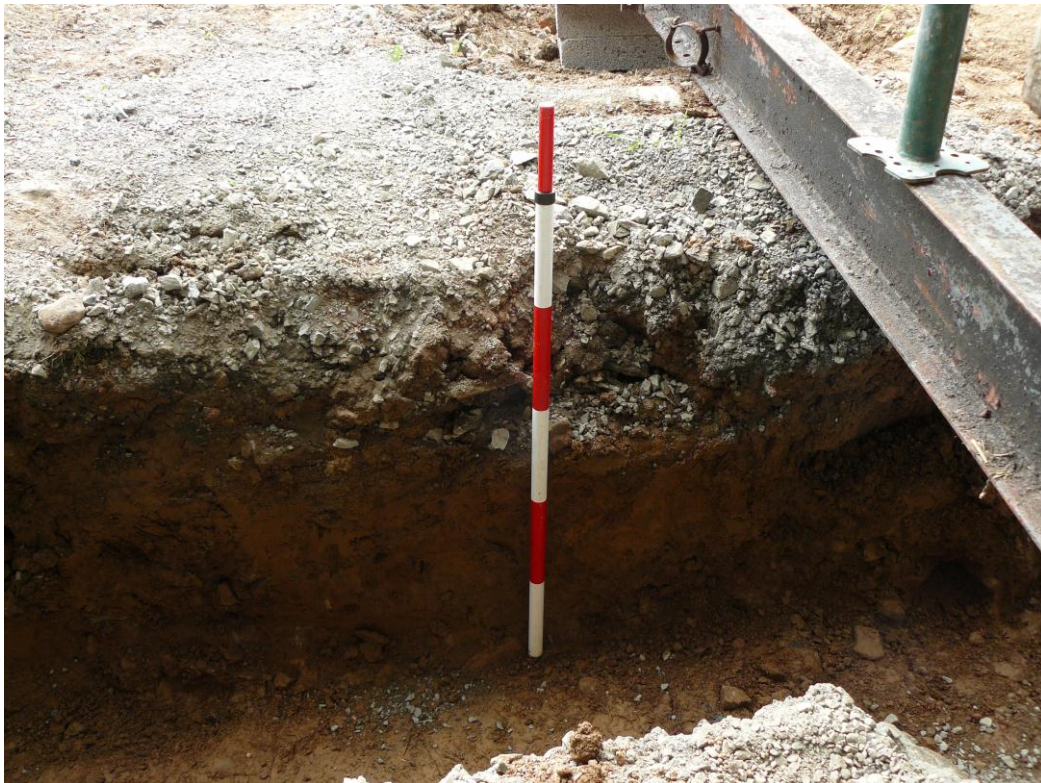
Underlying (007) was a substantial deposit of made ground (010) consisting of cohesive, dark brownish-red gritty clay, which contained frequent angular stones and CBM and measured >1.2m in thickness. Underlying (010) was (009), a firm light orangey-brown silt containing occasional large rounded and sub angular stones, extending to a thickness of >1.05m, beneath which was (008) a firm dark reddish-brown clay with moderate small and frequent large rounded stones and pebbles.

Plate 4: View southwest of centre of trench showing interface between (009) and (008)
