Standing Building Recording Survey

**Trelough Farm Barns
Whitfield Estate
Wormbridge
Herefordshire**

Report No. 2003-06-07

**Border Archaeology
PO Box 36
Leominster
Herefordshire
HR6 OYQ**

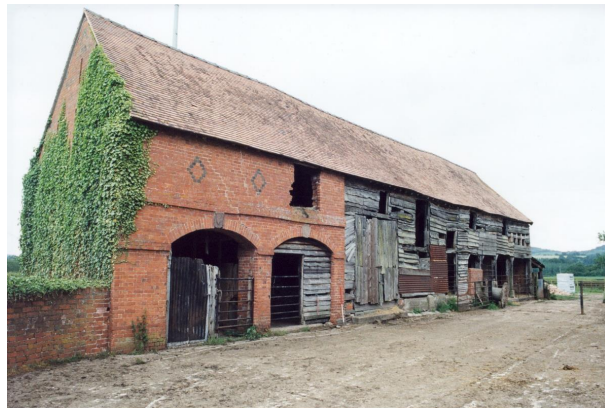
- 5.2 Barn I is a two-phase building oriented NW-SE and probably dates to the late 17th or early 18th century (**Plate 1**). The larger section of the building is a traditional timber-framed construction supporting a ceramic tile roof with straight-edged weatherboarding on the eastern and western elevations and southern gable. Abutting the northern gable end is an early-mid 19th century cattle shed and hay loft (**Plate 4**).
- 5.3 The timber framing sits on a plinth of locally quarried Old Red Sandstone, recorded along the north and south gables (**Plates 5 & 6**). In the case of the

northern gable, now incorporated into the Phase 2 construction, the plinth stands around 0.40m above the existing ground level.

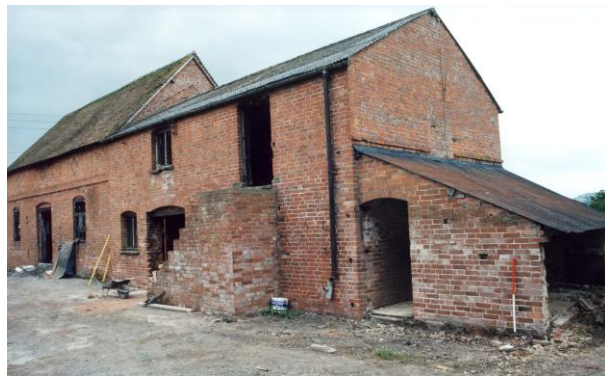
- 5.13 The interior of the building consists of open ground-floor and second-floor rooms with a king-post construction visible within the second-floor roof space. Evidence of an earlier roof line is visible on the western gable end of Phase 1.
- 5.14 Incorporated into the western gable end of Phase 2 is an unfrosted brick lean-to extension. This extension has a door opening on the northern elevation and a small rectangular window opening in the south-facing elevation. The form and use of the extension seems to have changed, with considerable alteration and re-pointing visible on the upper parts and western end of the north- and south-facing elevations. Above the extension on the western gable end of the main element of

Phase 2 is evidence of a blocked first-floor door opening either side of which is a decorative string course.

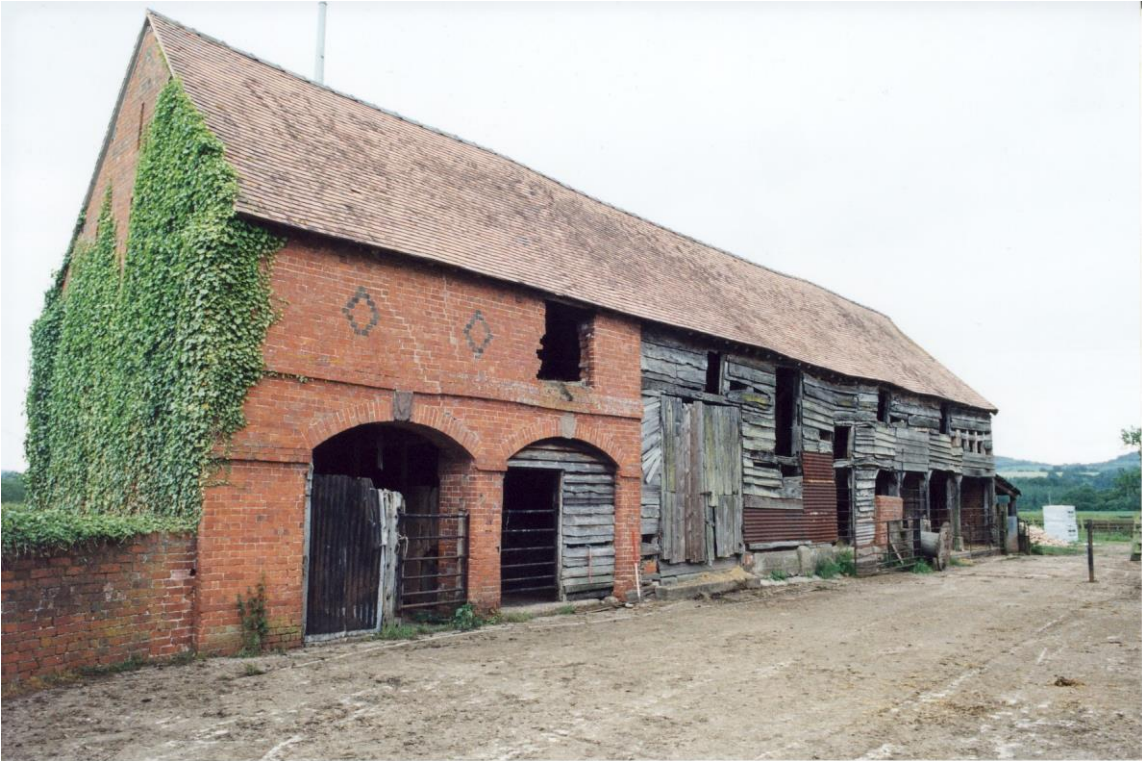
PLATE 1 BARN I LOOKING NE SHOWING CONSTRUCTION PHASES 1 & 2

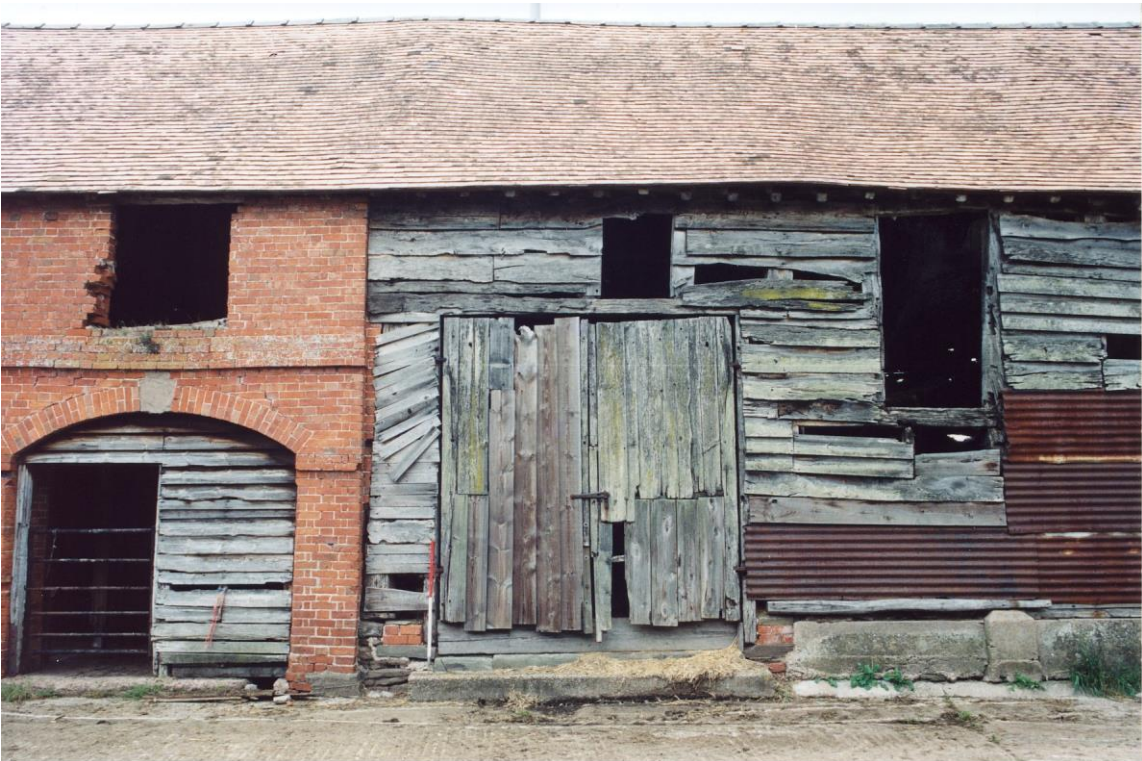
PLATE 2 BARN I SHOWING THE SOUTHERN BAYS

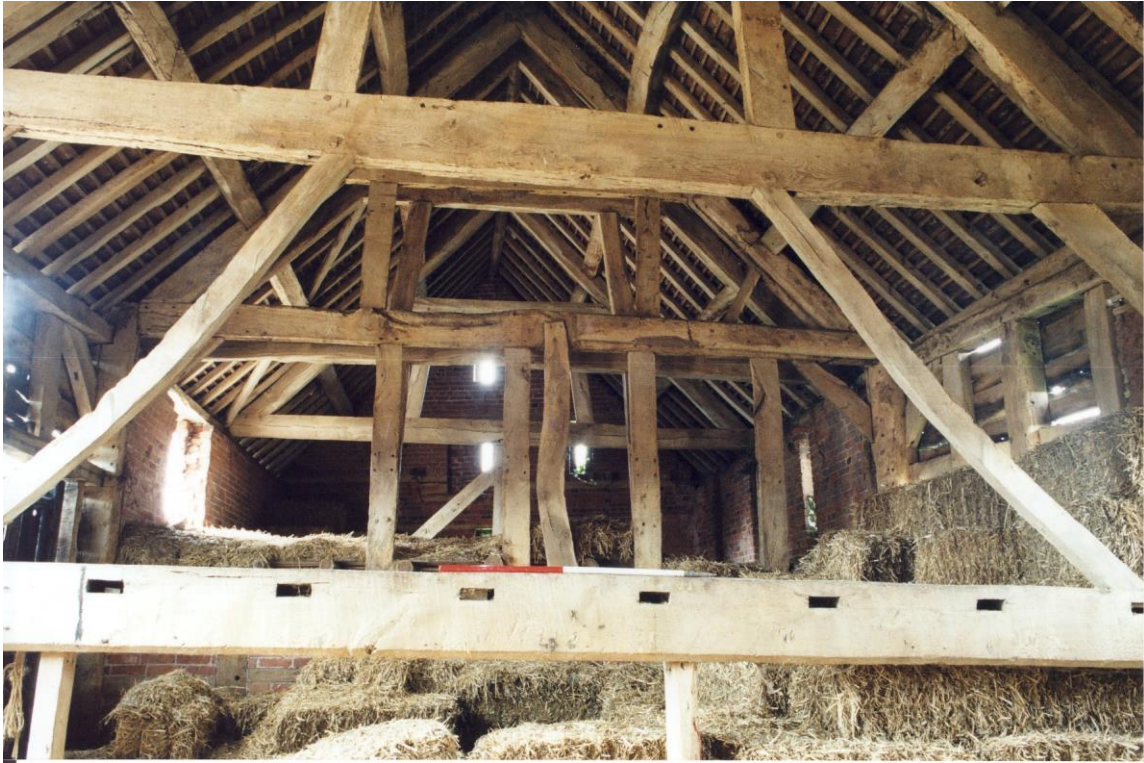
PLATE 3 BARN I SHOWING OAK TIMBER A-FRAME CONSTRUCTION WITHIN THE ROOF SPACE OF PHASE 1

- 5.6 Some of the oak and pine timbers supporting the ceramic tile roof - in particular several queen posts and purlins located within the northern section of Phase 1 - appear to be re-used. Mortises cut into some of the truss collars suggest the barn once comprised two floor levels; both were probably used for straw and grain storage (**Plate 3**). The timber construction methods are, according to Woodforde (1983), late medieval in date. However, these methods appear to continue into the post-medieval period with A-frames rather than aisled beam construction methods being used (Harris 1978:67). Furthermore, Brunskill (1981:92) suggests that the method of fixing the purlins and the common rafters onto the A-frames (or principal rafters) is used during this period. A total of six A-frames are equally spaced along the length of the building. Pine ceiling joists are used to create a two-storey building within the 19th century Phase 2 section, there being a clear change in timber-frame methodology between the two phases.

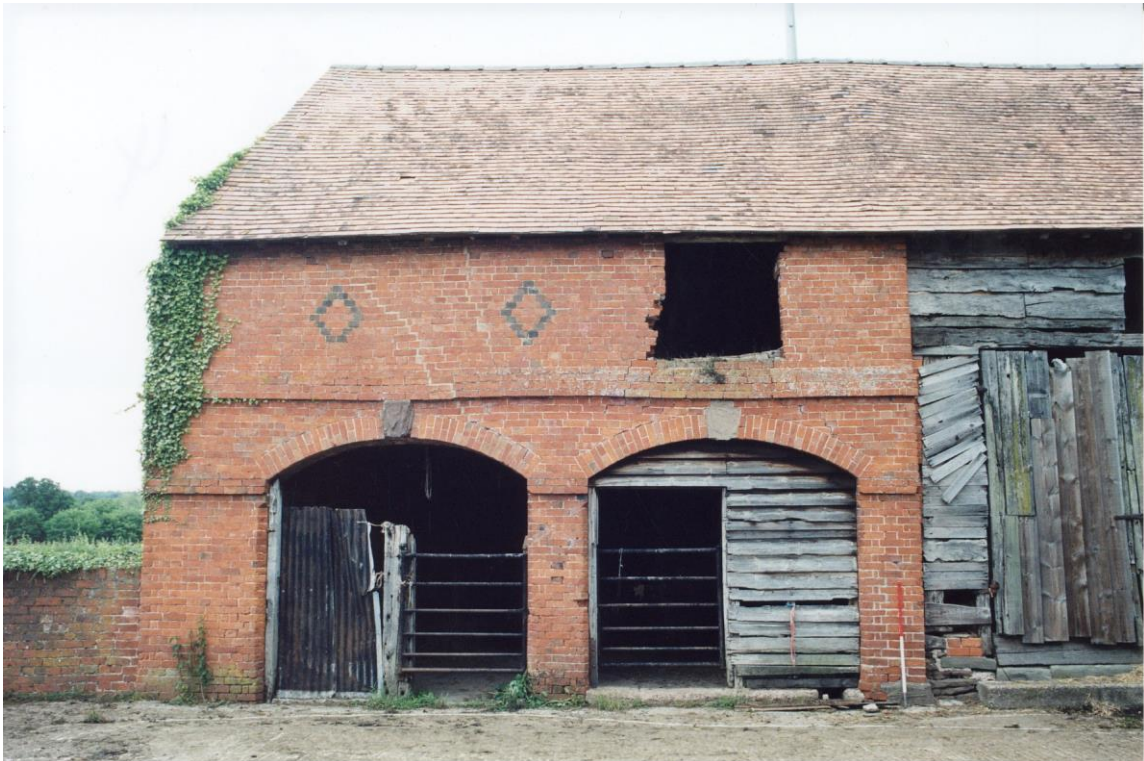
PLATE 4 BARN I SHOWING 19TH CENTURY EXTENSION

- 5.7 The early-mid 19th century extension (Barn I) is of unfrosted red brick and is similar in construction methodology to Barn II. Identical blue-brick lozenge designs appear on both buildings. This building represents Phase 2 and consists of an enclosed ground-floor room with access from the courtyard (from the west), access being through two bays with segmental arch openings. It is possible that the keystones of the arches bore a date. However, the poor quality of the stone means that any inscription has long since disappeared. The roof, supported by both Phase 1 and 2, appears to be a later element as there is no visible break within the laying of the tiles. As stated, the later phase abuts the timber-framed section of the building. Visible on the north-facing gable of the Phase 1 construction is the sandstone plinth supporting squared timber-framed panels. At some time, the panels were infilled with unfrosted brick.

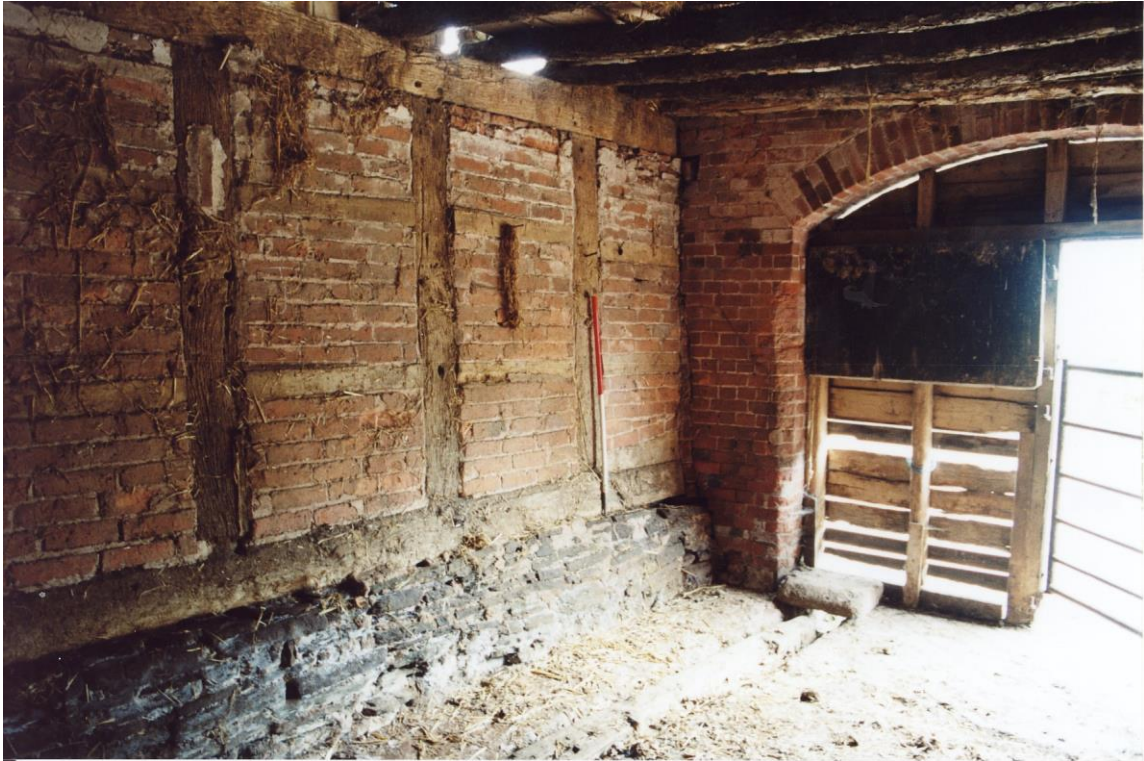
PLATE 5 BARN I SHOWING PLINTH AND TIMBER FRAMING OF PHASE 1

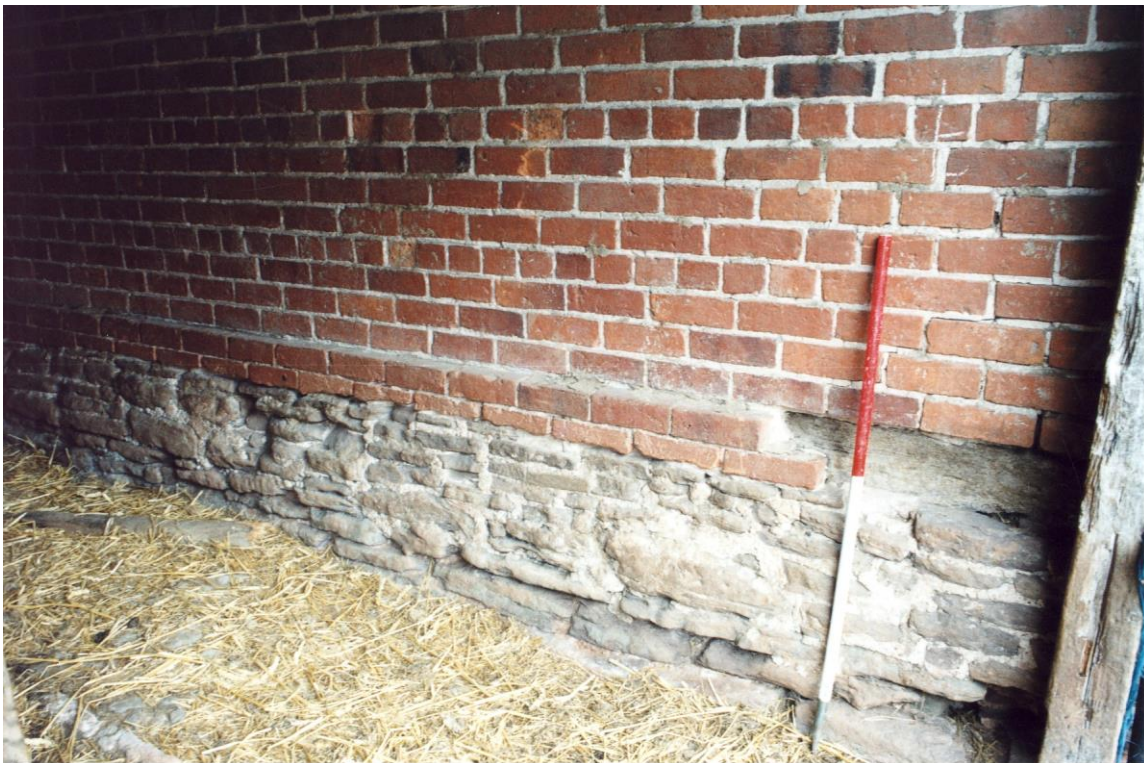
PLATE 6 BARN I SHOWING PLINTH ALONG THE SOUTHERN GABLE END

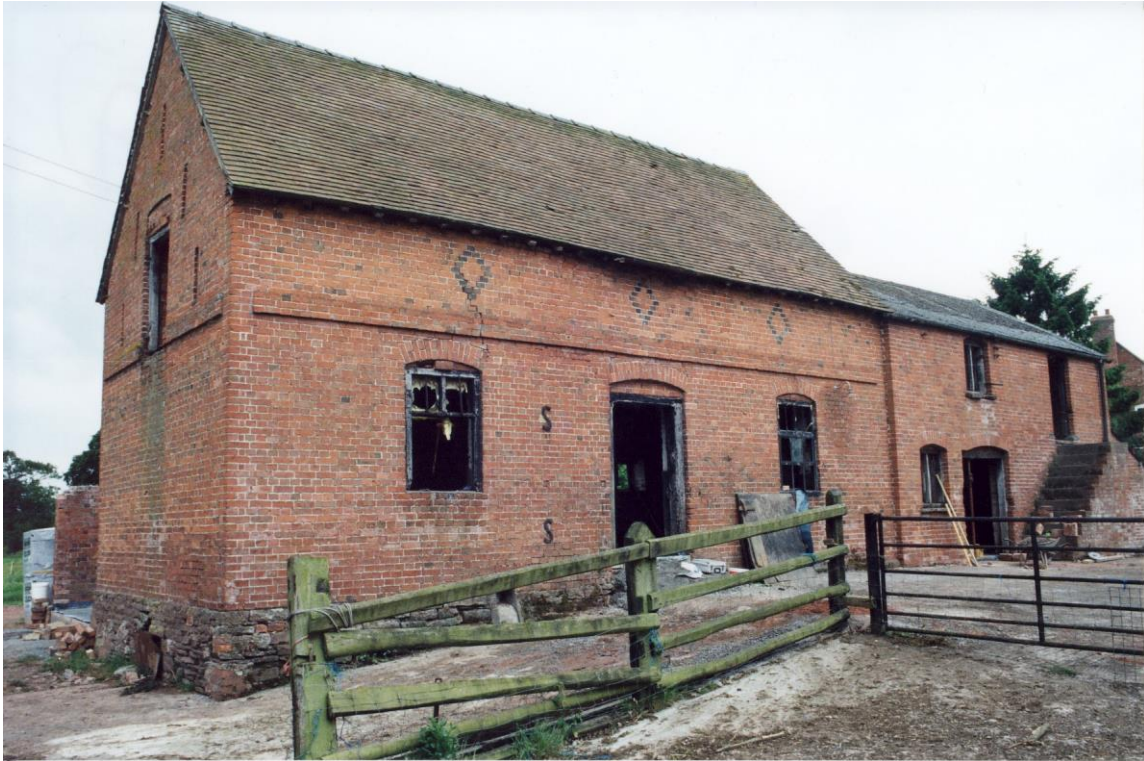
PLATE 7 BARN II SHOWING NORTHERN ELEVATION

- 5.8 Barn II is oriented approximately east-west and comprises two phases. Technically, these phases constitute a dairy and maintenance shed rather than a barn (**Plate 7**).

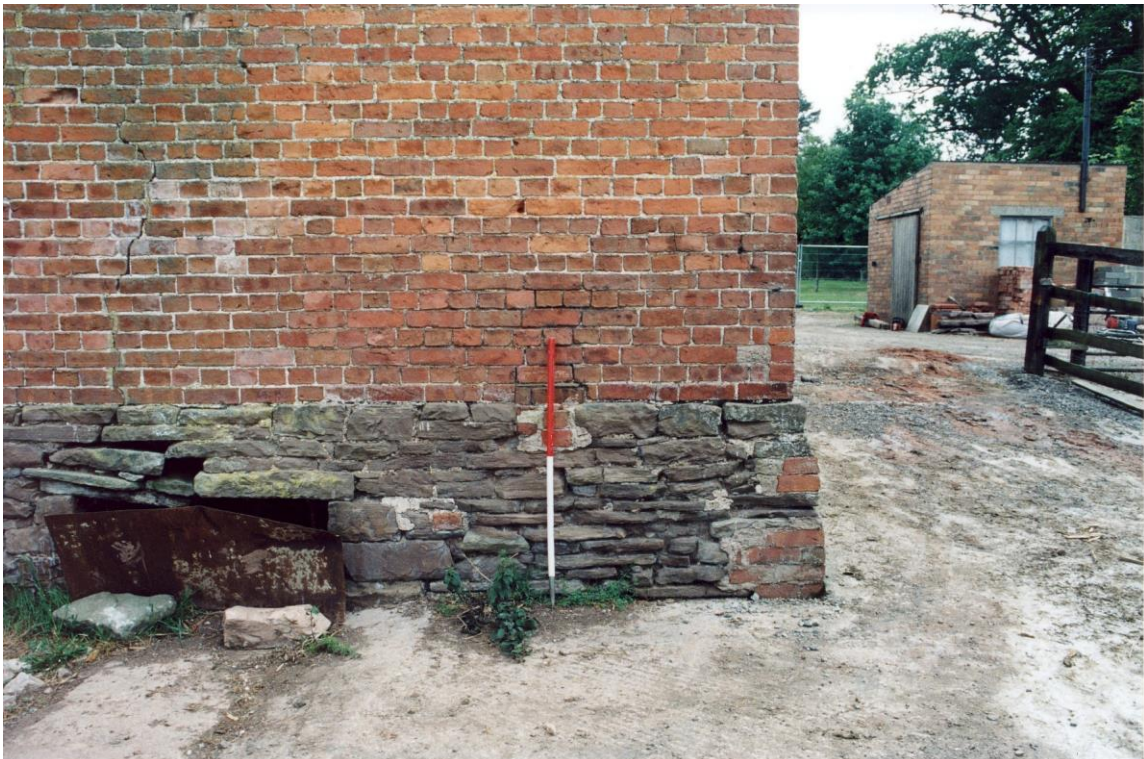
PLATE 8 BARN II SHOWING CORNER OF WESTERN GABLE AND CELLAR OPENING

- 5.10 Located within the western section of the building and underlying the ground floor is a cellar, the entrance to which lies adjacent to the western gable end (**Plate 8**). The cellar entrance appears to comprise a series of steps cut into the geology that have been infilled with concrete. A small recess cut into the sandstone plinth represents the only visible access to the room, which was probably used for cold storage or the production of butter and cheese.
- 5.11 The first floor of Phase 1 consists of an open room coterminous (in plan) with the dairy. There is at the eastern gable end a centrally placed door or window opening which is flanked by splayed slits, suggesting that the first-floor room was used for drying. The ceiling timbers are arguably robust enough to support large quantities of grain (**Plate 10**).

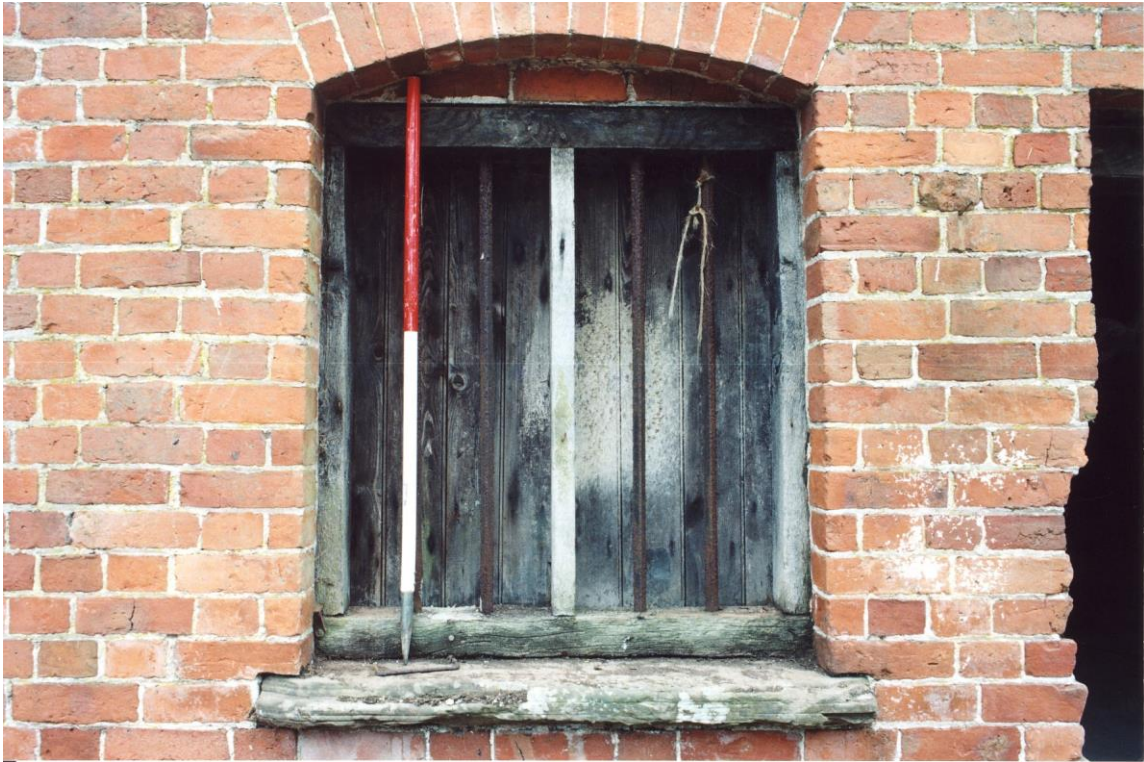
PLATE 9 BARN II SHOWING WINDOW OPENING ON THE NORTHERN ELEVATION

- 5.9 Phase 1 is the most substantial and earliest phase consisting of a two-storey building with symmetrically set central door and window openings either side. The window openings retain slatted wooden shutters and central encased mullion

(**Plate 9**). Each window opening, supported by a sandstone plinth, is firmly set into the brick surround. The building, constructed of unfrosted red brick, is elevated above the level of the courtyard and stands on a lime mortared sandstone plinth. The pitch of the roof is typically medieval in appearance.

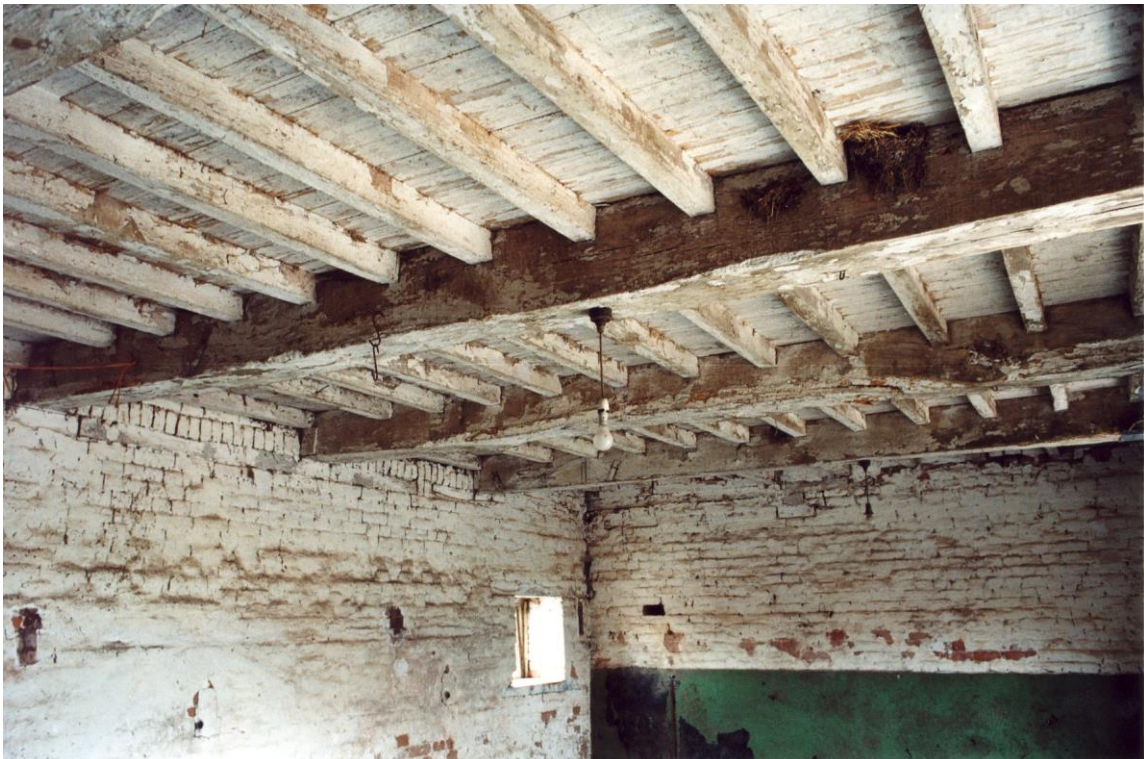
PLATE 10 BARN II SHOWING TIMBER CEILING WITHIN THE DAIRY
