Archaeological Observation

**38 South Street
Leominster
Herefordshire**

NGR SO 49595 58810

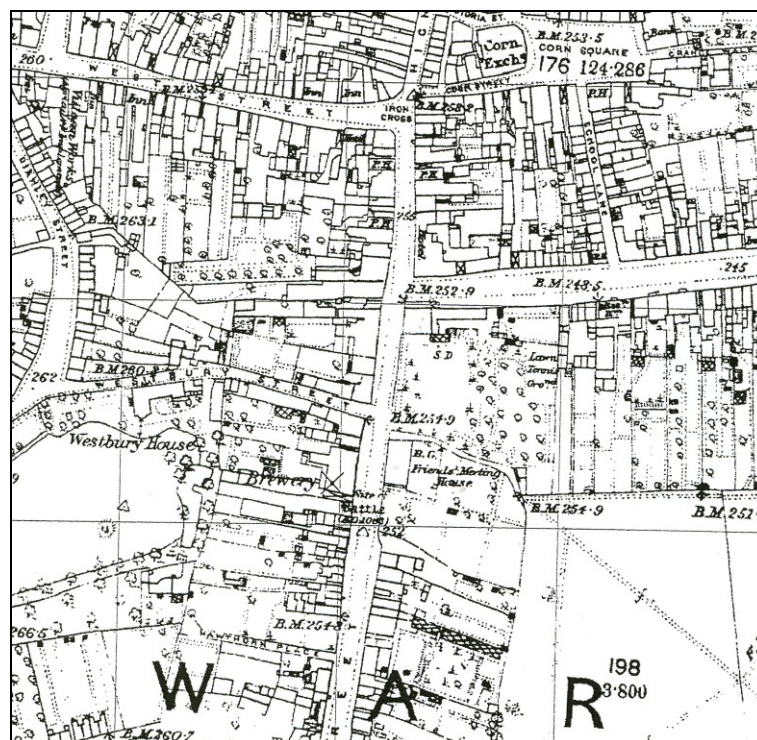
Fig. 3: Extract from OS 1st edition 25-inch map of 1887 (Herefordshire XII.15)
 (Reproduced courtesy of Herefordshire Record Office)

The OS 1st edition 25-inch map of 1887 (Herefordshire XII. 15) shows the overall layout of the site in more or less its present form (**Fig. 3**) and indicates that significant changes to the buildings on the site had evidently occurred between 1832 and 1887. The boundaries of the three narrow tenement plots delineated on Gallier's plan of 1832 had disappeared by 1887.

Immediately to the S of the main house, the 1887 map shows the carriageway leading to the rear courtyard, with the long range of outbuildings extending to the W end of the site

with a rectangular structure abutting these outbuildings to the S (marked as a brewery). The OS map of 1887 also shows a garden or orchard to the rear of the house with a rectangular structure in the SE corner and a path extending E-W down to the westernmost boundary of the property, separated by a wall from the range of outbuildings to the S. This garden appears to have largely vanished by 1904.

Brick wall (106) appears to represent the remains of a 19th century boundary wall delineating the N edge of the courtyard to the rear of No 38. The line of this boundary wall is shown on the OS 1st edition 25-inch map of 1887 (**Fig. 3**) and subsequent OS maps of the area. The evidence of the surviving brickwork indicates a 19th century date for the construction of this wall, probably contemporary with the building of the present townhouse in the early 19th century. However, it would appear to follow the alignment of an earlier burgage plot division shown on William Gallier's Map of Leominster dated 1832 (**Fig. 2**), which has been interpreted as forming part of a series of medieval tenement plots along the W side of South Street (Buteux, 1994).

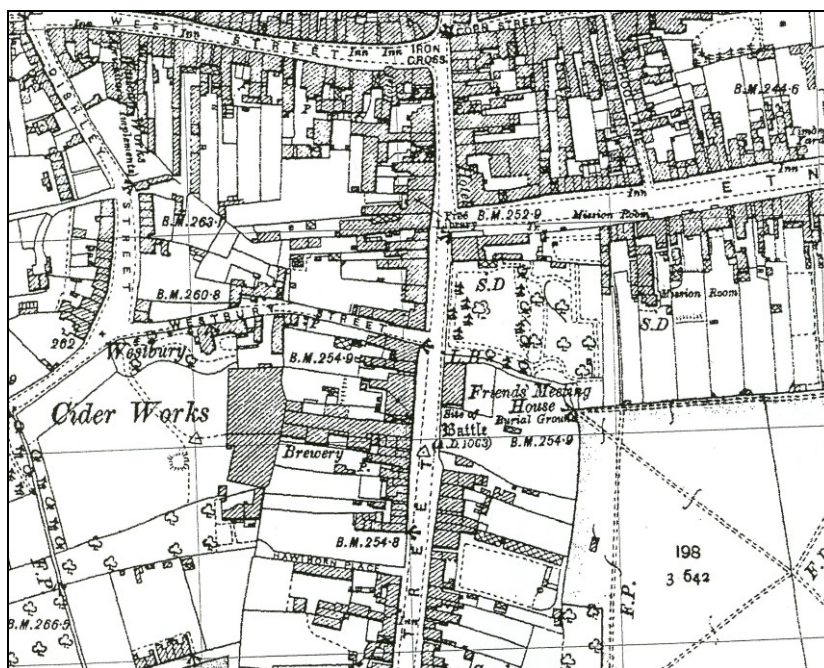
Fig. 4: Extract from OS 2nd edition 25-inch map of 1904 (Herefordshire XII.15)
(Reproduced courtesy of Herefordshire Record Office)

Comparison between the OS 1st edition 25-inch map of 1887 and the 2nd edition 25-inch map of 1904 reveals that further building work had taken place between those dates, with the construction of a rectangular structure projecting to the N of the stable range into the middle of the courtyard area (Fig. 4). A series of rectangular buildings also appears to have been erected immediately to the S of the stable range. Immediately to the W of the site, a large 'cider works' is shown as having been built on part of the landscaped gardens belonging to Westbury House.

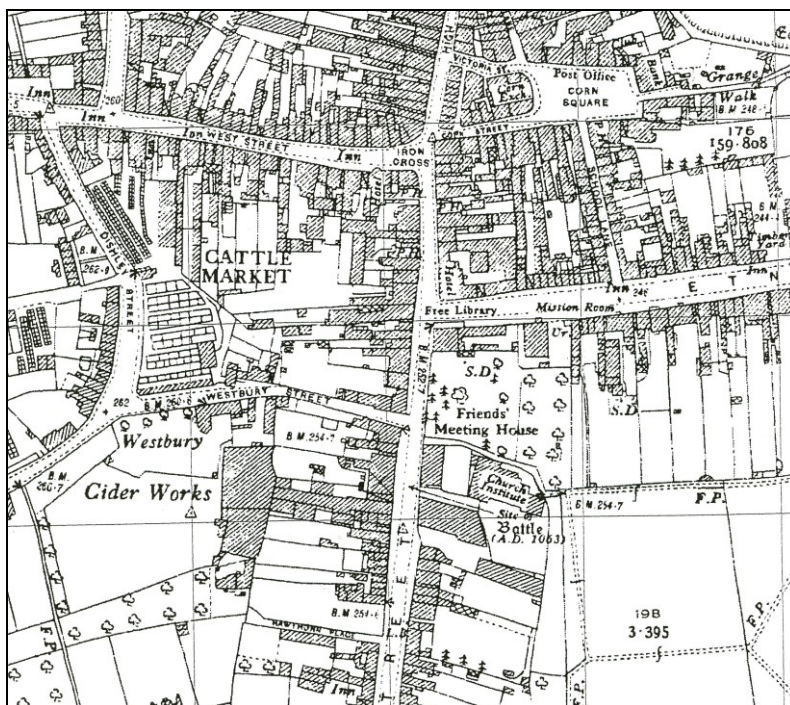
Fig. 5: Extract from the OS 3rd edition map of 1928 (Herefordshire XII. 15)
 (Reproduced courtesy of Herefordshire Record Office)

The OS 3rd edition 25-inch map of 1928 (Fig. 5) shows little change to have occurred to the layout of the buildings since 1904, although it is noteworthy that the site is no longer marked as a brewery. Relatively little change to the overall layout of the buildings at No 38 South Street appears to have occurred between 1928 and 1968, although it is worth noting that the buildings immediately to the N of the site had been demolished by the latter date (being shown only in outline) and the 'cider works' building to the W of the site had been converted into a light engineering works.

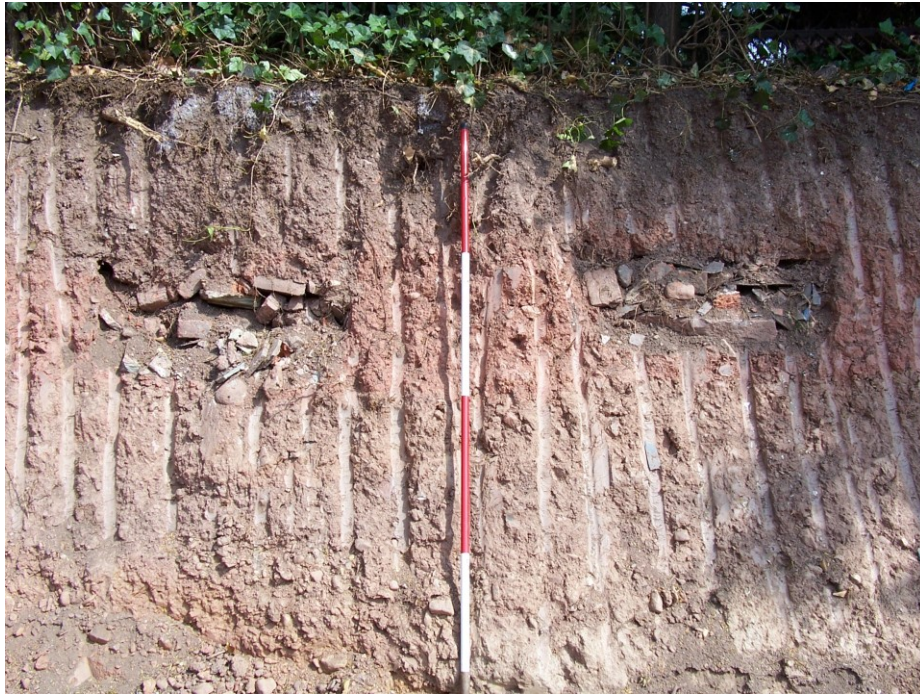
Plate 3: View N showing cuts for drainage [104] and [105] containing demolition backfill in S-facing section

A number of features were identified cutting into subsoil deposit (102). Approximately 2m E from the W end of the S-facing section, the profile of a rectilinear, U-shaped cut [104] was revealed, measuring 1m × 0.5m. [104] appeared to be the cut for a drainage channel which had subsequently been largely removed and filled with demolition backfill deposit (109), containing frequent late post-medieval ceramics (including sherds of china and white transfer ware), CBM and slate and occasional glass and wood fragments. Approximately 0.9m E of [104], a similar cut feature [105] was identified, the shape and dimensions of which were identical to [104] and which was also backfilled with demolition rubble material (110) (**Plate 3**).

Cut features [104] and [105], located to the W of brick wall (106), appear, on the basis of the stratigraphic evidence, to be roughly contemporary with the construction of this wall. If indeed they represent cuts for drainage, as seems the most likely explanation, it is possible that they may have been associated with landscaping activity within the area to the rear of No 38, which appears to have occurred during the mid to late 19th century. The evidence of the modern ceramic materials contained in backfill deposits [104] and [105] suggests that these features, together with brick wall (106), were demolished in the second half of the 20th century, possibly when the detached house to the E was built in the mid to late 1970s.

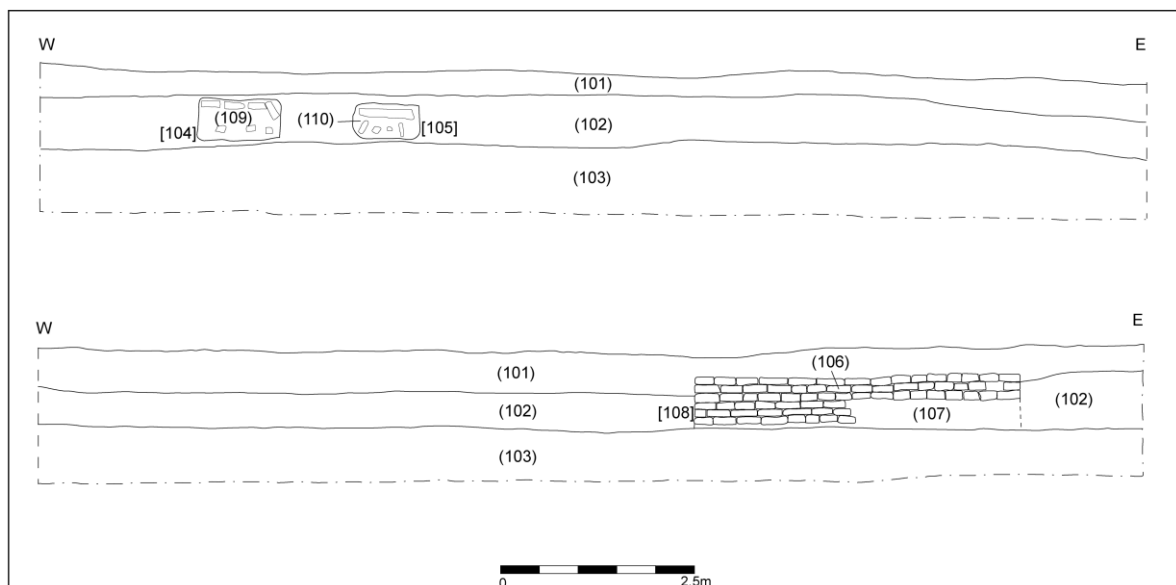
A total of 10 contexts were identified during this phase (**Fig. 4**), the uppermost of which was a friable mid to dark brown silty sand topsoil (101) with occasional charcoal flecking, post-medieval pottery sherds and CBM, which measured 0.5m thick and extended across the S- and E-facing sections.

Underlying (101) was subsoil deposit (102), comprising a firm reddish-brown sandy clay with occasional small subangular stones and charcoal flecking, measuring up to 0.65m in thickness and extending across the S- and E-facing sections of the trench. Beneath (102) was (103), a firm slightly friable mid reddish-brown silty sand with occasional small rounded stones, which was interpreted as a natural deposit extending down to a maximum depth of 1m.

Fig. 4: S-facing section showing deposits and features revealed during limited topsoil strip along the N side of the courtyard to rear of No 38

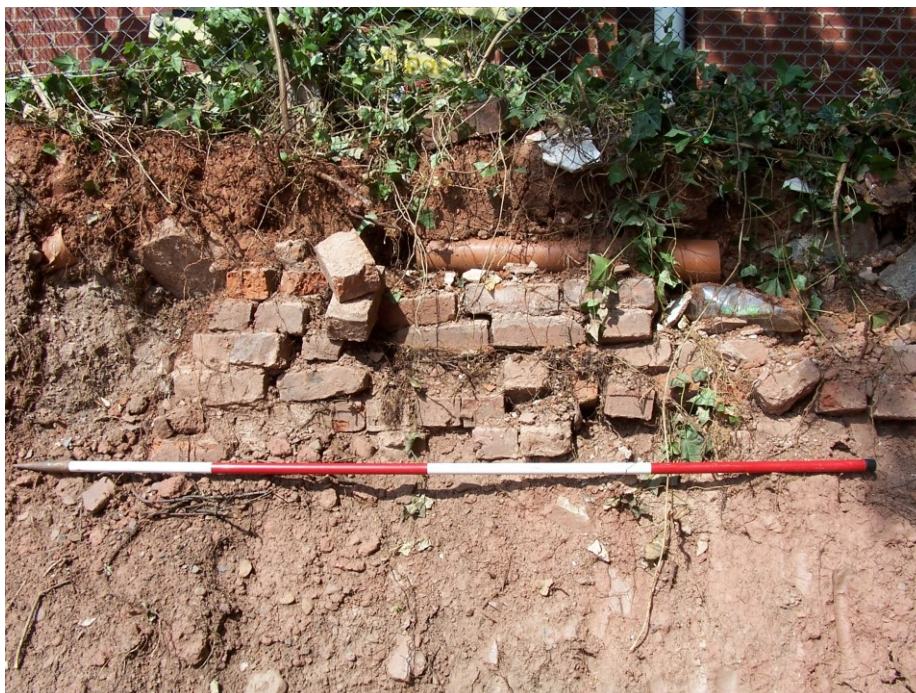
Also cutting into (102), located at the E end of the S-facing section, was the cut [108] for a heavily truncated red brick wall (106), constructed in English Garden Wall Bond using unfrosted brick and bonded with a friable greyish-brown mortar (**Plate 4**). The wall, which was only visible in section, was oriented E-W and stood up to six courses high, extending W for a distance of 4.2m from the E end of the section.

Plate 4: View looking N showing remains of heavily truncated red brick boundary wall (106) in S-facing section

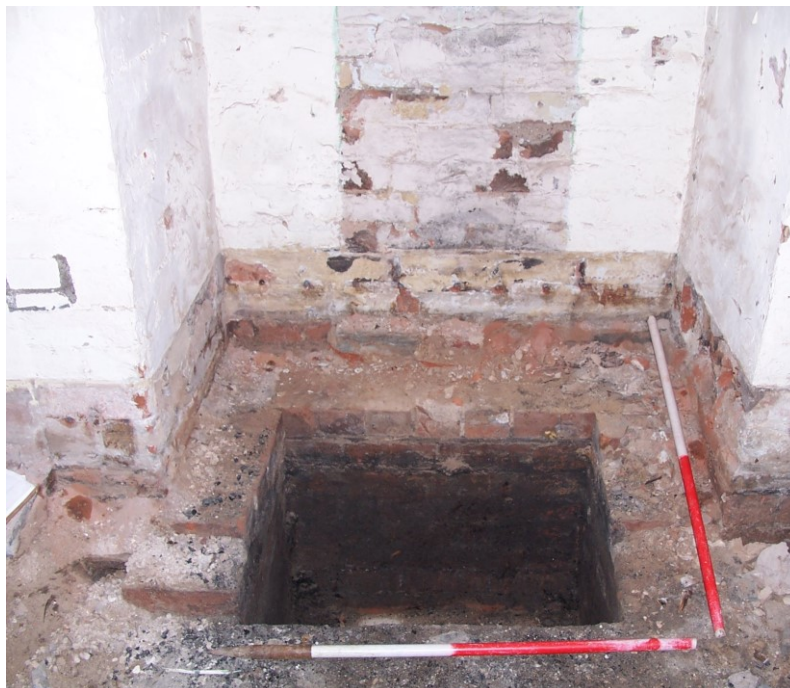
Plate 5: Internal view looking W showing rectangular brick shaft [205] at base of hearth at W end of building

Immediately in front of a broad segmental arched fireplace set into the thickness of the W wall of the room, underlying (202) and cutting into (204), was [205], the cut for a rectangular brick-lined pit (206) measuring 0.8m × 0.4m × 0.7m (**Plate 5**); eight courses of mortared red brick constructed in English Garden Wall Bond were visible. The pit appears to have been constructed to accommodate a kitchen range or stove within the fireplace hearth. At the base of the pit was a single large flagstone.

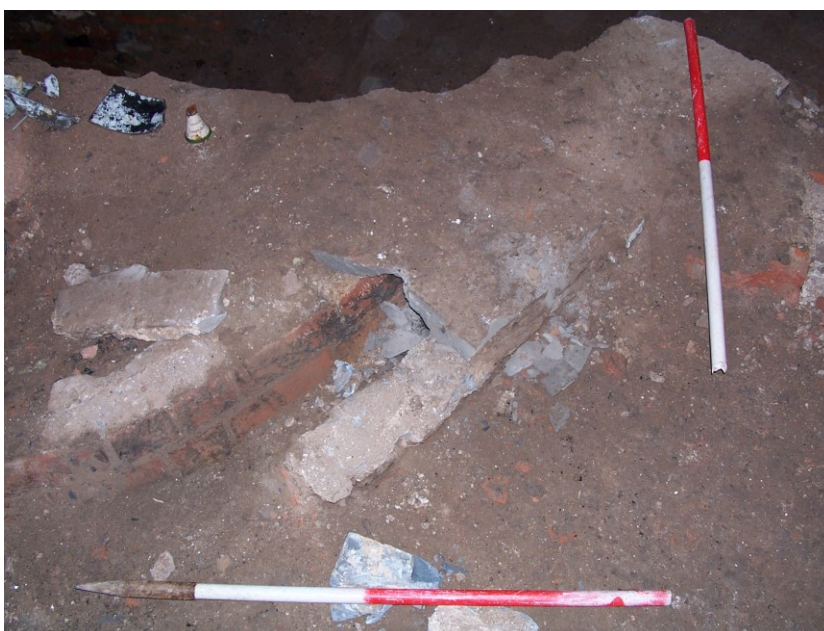
Cutting through the top of wall (207) was a curvilinear drain cut [209] (**Plate 6**), 0.3m wide, partially lined with brick and running approximately NW-SE for a visible length of 4.2m. The drain was filled by (211), a dark greyish-brown silty clay with pieces of ceramic pipe, gravel and slate, and capped with a stone lining (212), 0.1m in thickness. [209] appeared to be truncated by [213], the cut for a modern ceramic drain pipe (215), measuring 0.3m in diameter, encased in concrete and extending N-S for a visible length of 3m, probably installed as part of the extensive alterations to the interior carried out in the 1970s.

Plate 6: Internal view looking SE showing brick-lined drain [209] with remains of stone capping (212)

The curvilinear drain cut [209] through the top of wall (207) and the cuts for drains (214) and (219) also appeared to postdate the construction of the W extension in the 1870s, as did the rectangular brick-lined pit [205]. The laying of the concrete flooring (201) and sub-base (202) probably occurred in the late 20th century and may be contemporary with the construction of the former toilet and washroom (now demolished), representing a third, final phase of building activity.

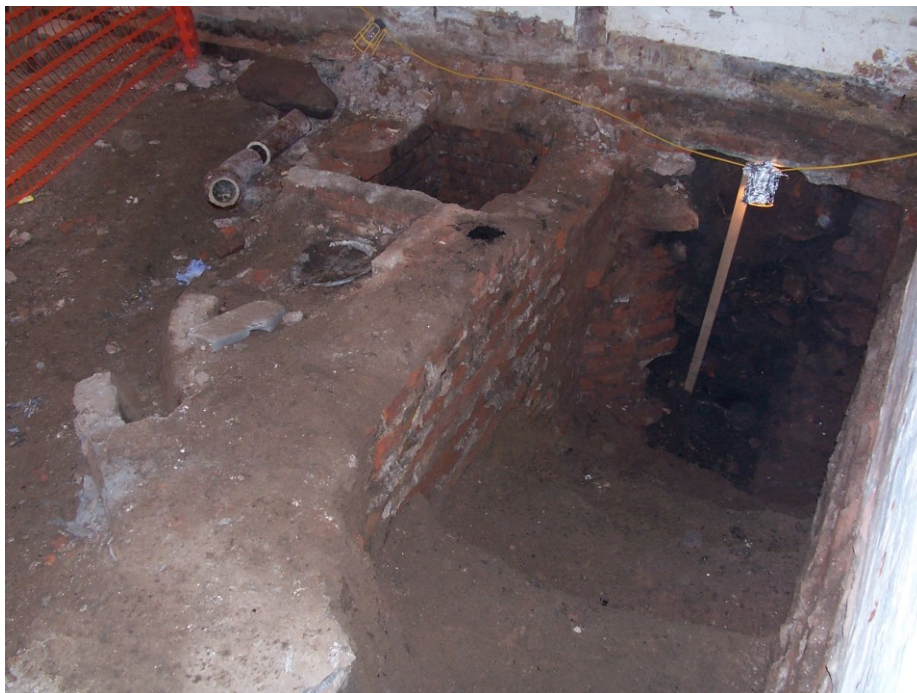
At the E end of the room, underlying (204), was a substantial brick wall (207) aligned N-S, measuring 4.6m × 0.34m and extending to a maximum visible depth of 1.26m (**Plate 7**). The wall consisted of at least 15 visible courses of regularly coursed unfrogged red

brick laid in English Garden Wall Bond and bonded with a friable whitish lime mortar. (207) was interpreted as the remains of a narrow rectangular structure which presumably abutted the external wall of the main house, represented by irregularly coursed Flemish Bond red brick wall (208), bonded with a greyish-white lime mortar, which extended N-S for 4.6m and to a maximum revealed depth of 1.4m.

Plate 7: Internal view looking N showing area of stepped excavation in NE corner of room revealing evidence of brick walling (207) and segmental archway (220) leading to cellarage

Excavation within this area revealed, at a depth of 0.4m below the pre-existing ground level, a segmental red brick archway (220) set into the N wall, which measured 0.65m × 1m (**Plate 7**). It appeared that there originally had been a flight of steps leading down to this archway, which presumably gave access to cellarage, although no structural evidence of these steps appeared to have survived. Due to safety considerations, it was not possible to obtain access to the subterranean structure but it appears to have extended to the N of the building represented by wall (207) and no evidence was found of a link between it and the existing cellarage within the main house. The void framed by a rectilinear brick-lined shaft (221) immediately adjacent to (220) appeared to represent a chute leading to the subterranean structure entered via archway (220) and was filled by (223), a probable demolition backfill deposit similar to (216).

The features identified during this phase of groundworks appeared to relate to three phases of building activity. The earliest phase was represented by wall (207), apparently relating to the footings of a narrow rectangular structure adjoining the main house. This structure presumably contained a stairway leading to (220) a segmental arched doorway that gave access to a subterranean structure, probably a cellar.

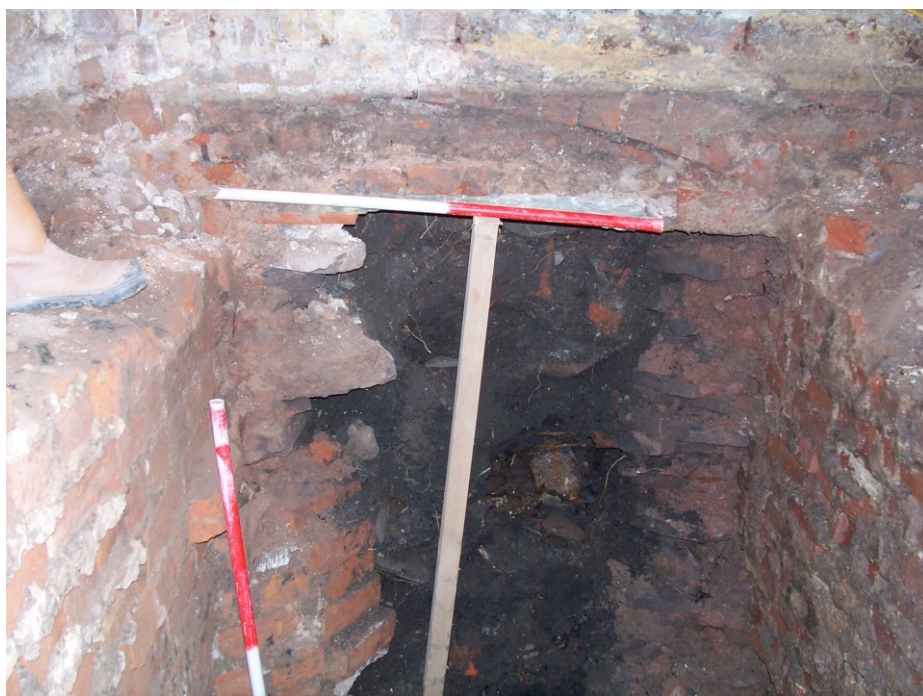
Plate 8: Internal view looking N showing segmental arched doorway (220) set into N wall of building

There was no structural evidence of any connection between this subterranean structure and the cellarage beneath the main house. The date of the building represented by wall (207) and the associated subterranean structure appears to fall between the building of the main house between c. 1835 and 1840 and the construction of the existing W extension (c.1870-76)

The rectangular structure represented by (207) subsequently appears to have been incorporated into the existing two-storey W extension, which is known from documentary evidence to have been built either in or shortly before 1876. It is likely that the subterranean structure associated with (220) and (221) was backfilled at about this time and that backfill deposit (216) represented this backfill event. The dating of the majority of the pottery recovered from this deposit would also appear to generally support a mid to late 19th century date for this event.
