Archaeological Evaluation

**169 Southgate Street
Gloucester**

NGR: SO 82849 17838
Report No: BA0432SSGMB

January 2005

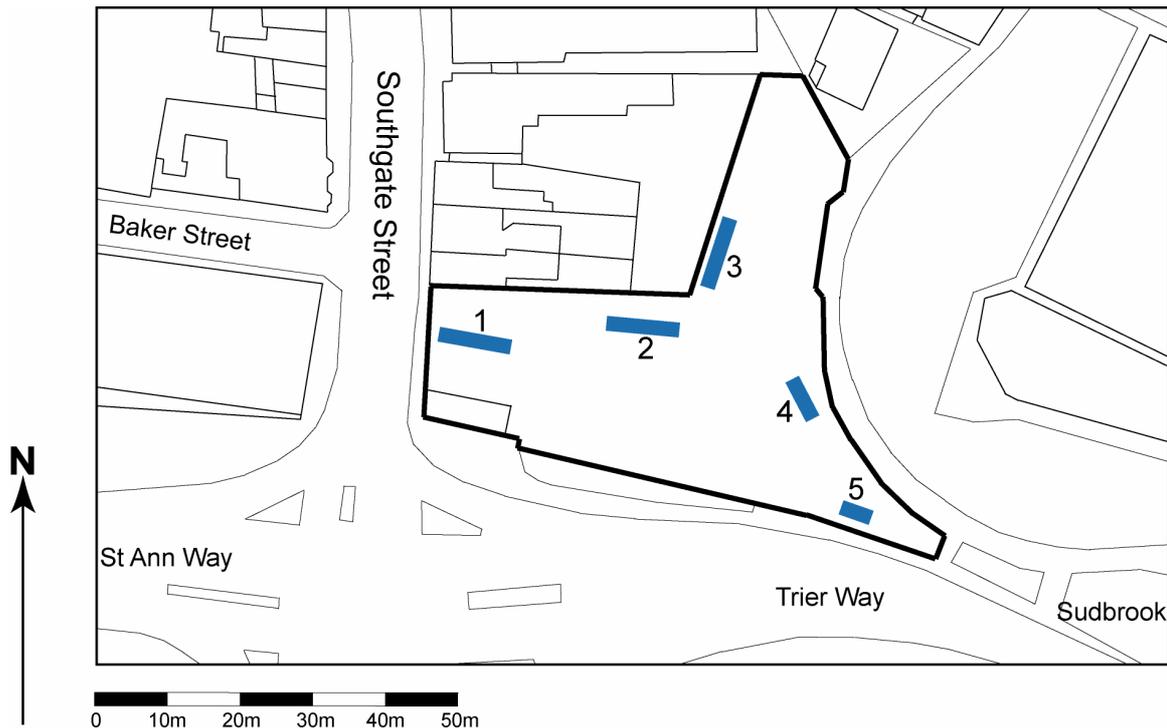
Figure 1: Location plan showing position of trenches

Five evaluation trenches were positioned in order to target specific areas of potential archaeology. Trench 1 was located on the W edge of the site along the line of the street frontage to investigate potential Roman, medieval and post-medieval archaeology. Trench 2 lay to the E of this trench immediately to the rear of the street frontage within an area unaffected by 19th century building foundations. Trench 3 was located in order to investigate the location of a detached house shown on Causton's map of Gloucester (1843) and Trench 4 to investigate an area depicted as an orchard on the 1843 map, showing possible evidence of early 19th century landscaping connected with the Spa pleasure grounds laid out in 1815. Trench 5 was located in order to investigate the area closest to the Sudbrook, an ancient watercourse shown on 18th and 19th century maps of Gloucester and its suburbs and documented in medieval records and possibly the site of Roman or medieval settlement.

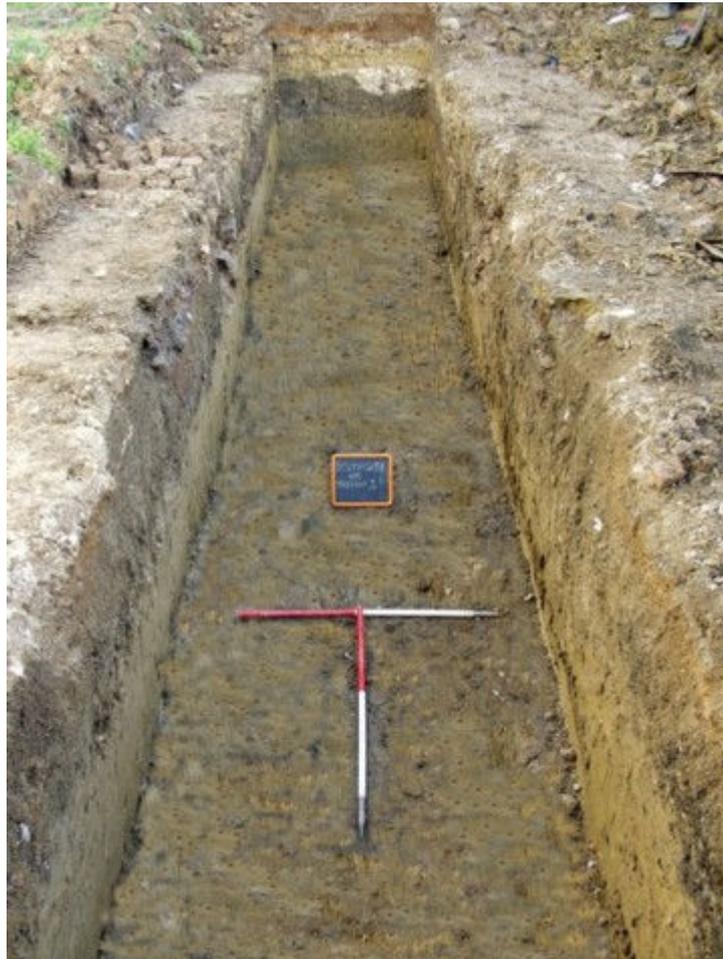
Plate 1: Trench 1 facing E

Trench 1 was located within the western area of the site and was oriented E-W, measuring 10.00m x 1.80m x 1.20m. A series of 19th and 20th century reclamation, demolition and clearance phases were revealed, with an average depth of 0.60m. Natural deposits were observed at c.0.65m below the existing ground surface (11.67m AOD).

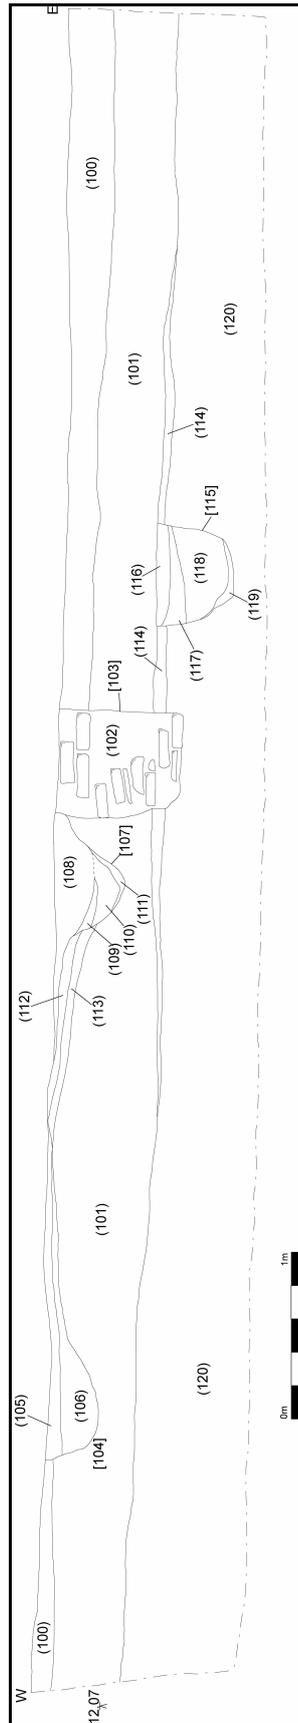
Figure 2: Trench 1 S-facing section

The uppermost layer extending over most of the trench area comprised loosely compacted dark grey clayey sand containing very frequent charcoal flecking and occasional fragmentary animal bone and 19th century pottery (100). Underlying (100) across the majority of the trench was an accumulated reclamation spread comprising dark grey clayey sand containing very frequent charcoal flecking and occasional fragmentary animal bone and post-medieval pottery (101). Cutting through (100) approximately midway along the trench was a post-medieval wall (102) within its cut [103], the wall being constructed of standard gauge 19th century brick with mortar bonding and standing to a height of eight courses. This wall was the only physical evidence of 19th century structural activity on the site and probably relates to a series of 19th century buildings fronting Southgate Street. The wall also cut through contexts

(101), (114) and into context (120). Also cutting through context (100) and into context (101) was a shallow cut [104] containing fills (105) and (106), both of which were coarse sandy clays with frequent chalk and post-medieval CBM fragments, the feature probably representing 20th century clearance and demolition. Underlying (100) within the centre of the trench was a fine lense of coarse sand and small fragmentary CBM pieces (112). Underlying (112) was another fine lense of coarse sand and small fragmentary pieces of CBM (113), both deposits probably resulting from 20th century demolition. Cutting through these two contexts was a 0.40m deep pit [107] containing coarse sandy clay lenses (108), (109), (110) and (111). Again, this feature probably relates to the 20th century demolition phase.

Underlying (101) on the eastern side of the trench was a blackish-grey clayey sand with frequent charcoal flecking and occasional oyster shell (114). Cutting through (114) and into the underlying natural soils (120) was a small pit [115] containing four fills, the uppermost of which was a mortar spread containing red brick fragments (116). Underlying (116) was a blackish-grey sandy clay with frequent charcoal inclusions (117). Underlying (117) was a mixture of re-deposited yellow brown clays (118) that overlay another blackish-grey sandy clay with charcoal inclusions. Contexts (114) to (119) represent the earliest phase of activity remaining on the site. Underlying (114) and (101) were natural soils comprising moderately to tightly compacted yellowish-brown clays (120).

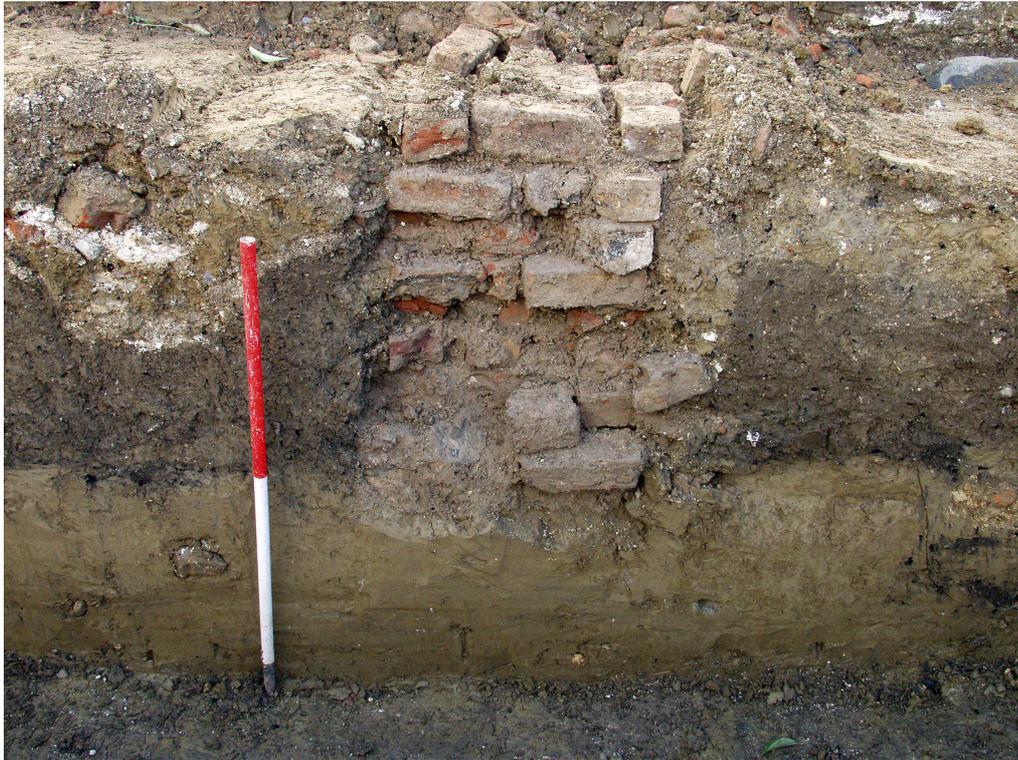
Plate 2: Trench 1 – brick foundation (102), probably of post-medieval building occupying the Southgate Street frontage

(102)	Wall orientated N–S extending across trench over a distance of greater than 1.80m. 0.70m in height and 0.50m wide. Eight courses. Constructed from standard gauge post-medieval bricks
INTERPRETATION:	Part of a foundation wall for a property fronting on Southgate Street
[103]	Cut rectilinear in plan. Dimensions - >1.80 x 0.50 x 0.70m. Break of slope top sharp. Sides vertical. Break of slope base sharp. Base flat
INTERPRETATION:	Cut of post-medieval foundation wall (102)
[104]	Cut, shape in plan not fully revealed. Width 2.00m. Thickness 0.40m. Break of slope top gentle to moderate. Sides variable, between steeply and gentle sloping. Break of slope bottom gentle. Base curving. Filled by (105) and (106)
INTERPRETATION:	Pit cut probably relating to 20 th century demolition and clearance of site

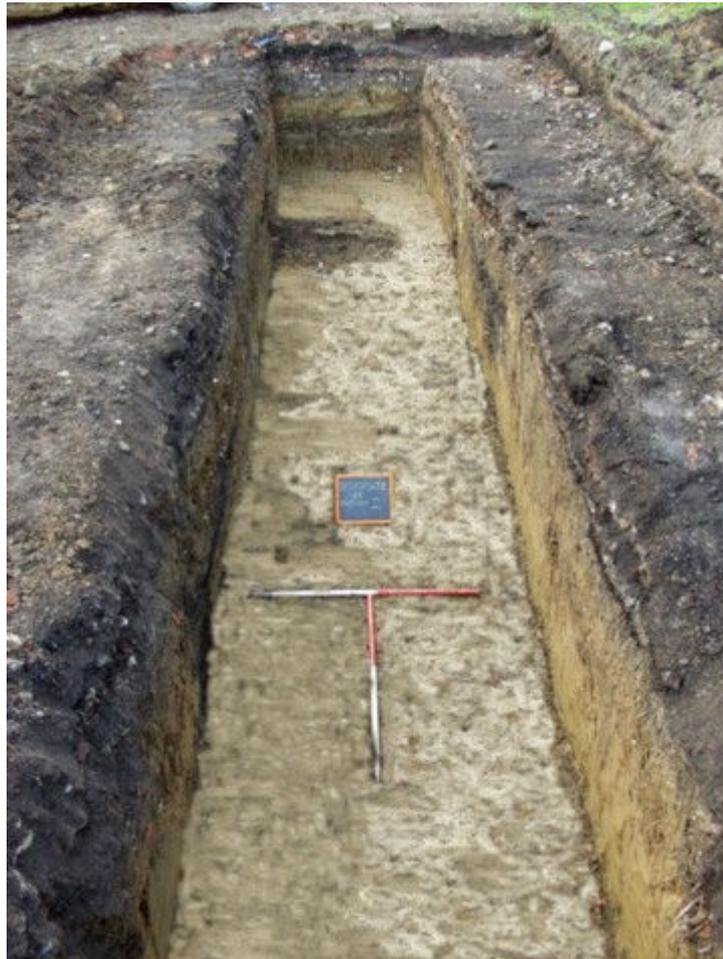
Plate 3: Trench 2 facing W

Trench 2 was located within the central area of the site, running parallel to the E-W boundary and measuring 10.00m x 1.80m x 1.27m. A series of 19th and 20th century reclamation, demolition and clearance phases comparable with those observed within Trench 1 were revealed in all trench sections, with an average depth of c.1.00m. Natural deposits were encountered at c.0.80m below the existing ground surface (c.11.66m AOD) at the W end of the trench and at c.1.00m at the E end.

The upper deposits comprised loosely compacted black tarmacadam (201) overlying moderately compacted black and orange gravel sub-base (202), these probably being the remains of a yard situated to the rear of now demolished properties. Cutting through (202), (203), (205), (213), (215) and into context (211) was a large post-medieval pit of unknown function [208], which contained a continuous fill of tightly compacted yellowish-brown clay with occasional rounded stones and charcoal flecking (209). Underlying (201) throughout most of the trench was a tightly compacted grey sandy clay containing frequent charcoal and post-medieval CBM and a block of worked carboniferous limestone with quartz inclusions measuring 0.25 x 0.16 x 0.20m (203). The stone was faced on two sides with a ridge at the top partly cut away to form a slot, probably to accommodate some sort of wooden frame. An apparent fracture surface on one side of the stone suggests that it originally formed part of a larger block that probably served as ashlar facing for a brick structure of unknown date. Cutting through (203) and (214) was a post-medieval land drain trench [219] filled by a loosely compacted medium brown silty loam with occasional charcoal flecking surrounding a ceramic land drain (220). Underlying (203) at the W end of the trench was a loosely to moderately compacted layer of coal grit with occasional post-medieval CBM (204). Underlying context (203) immediately to the E of pit [208] was a loosely compacted black coal dust layer (213) while across the majority of the E end of the trench (203) overlay a tightly compacted light brown sandy silty clay with moderate amounts of charcoal flecking (214). Underlying (204) was a moderately compacted greyish-brown sandy clay with frequent charcoal flecking, mortar fragments and post-medieval CBM (205). Underlying context

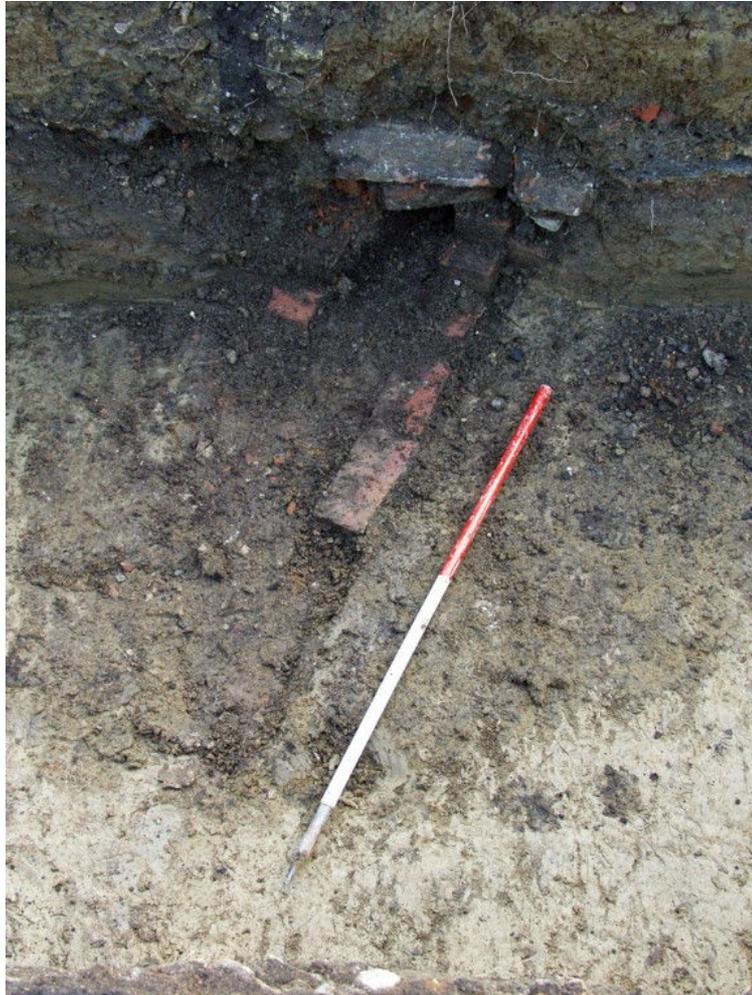
Plate 4: Brick culvert (212) within Trench 2

Cutting through this deposit, context (214) and into context (207) were drainage ditches [210] and [216]. The westernmost of these cuts [210] contained fills (206) and (211) and a brick culvert (212). Context (206) was a loosely compacted coal lense with occasional post-medieval CBM while (211), which comprised the bulk of the fill overlying the culvert, consisted of a moderately compacted medium brown silty loam with occasional mortar, charcoal and post-medieval CBM. Underlying this fill was culvert (212) comprising two courses of standard gauge red brick overlaid by a series of flat sandstones. The culvert was roughly 0.40m wide and poorly constructed.

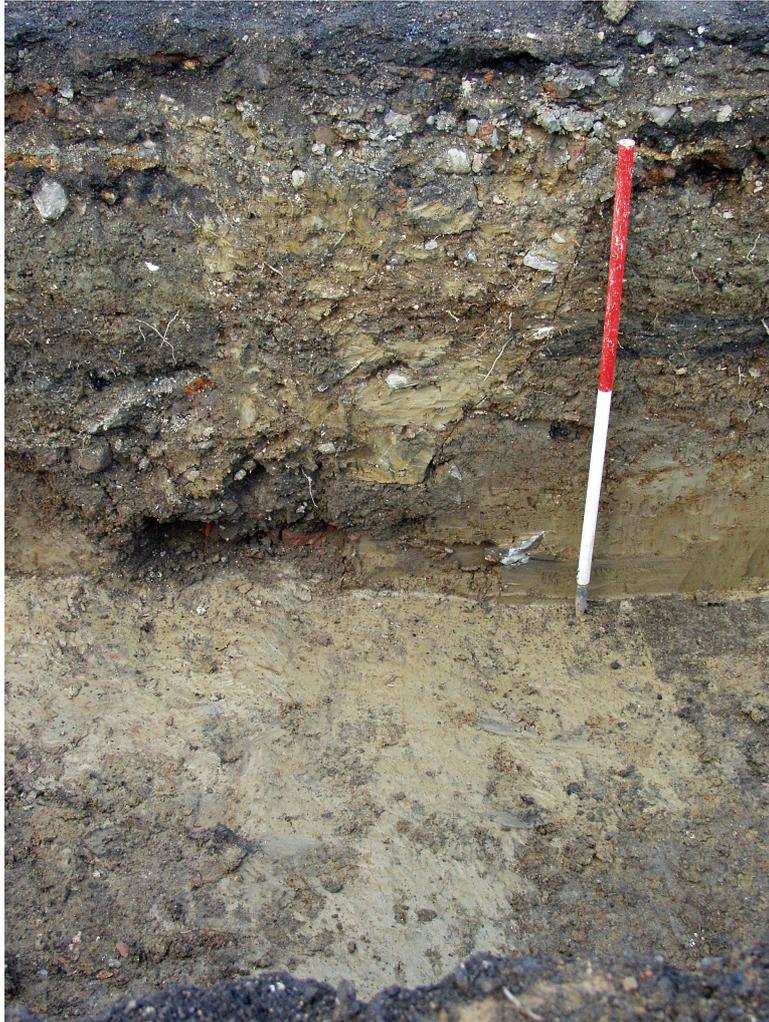
Plate 5: Re-cut pit in centre of Trench 2

The second ditch [216] was located towards the centre of the trench and contained fills (217) and (218). The uppermost of these (217) consisted of a loosely compacted greyish-brown sandy loam with occasional charcoal flecking. Underlying this was a loosely compacted grey silt containing numerous horse (*Equus*) skulls, leg bones and vertebrae. The jumbled deposition of the bones and their sheer number, together with the size of the ditch, appears to rule out any form of burial, the most probable explanation being that the ditch was used for drainage.

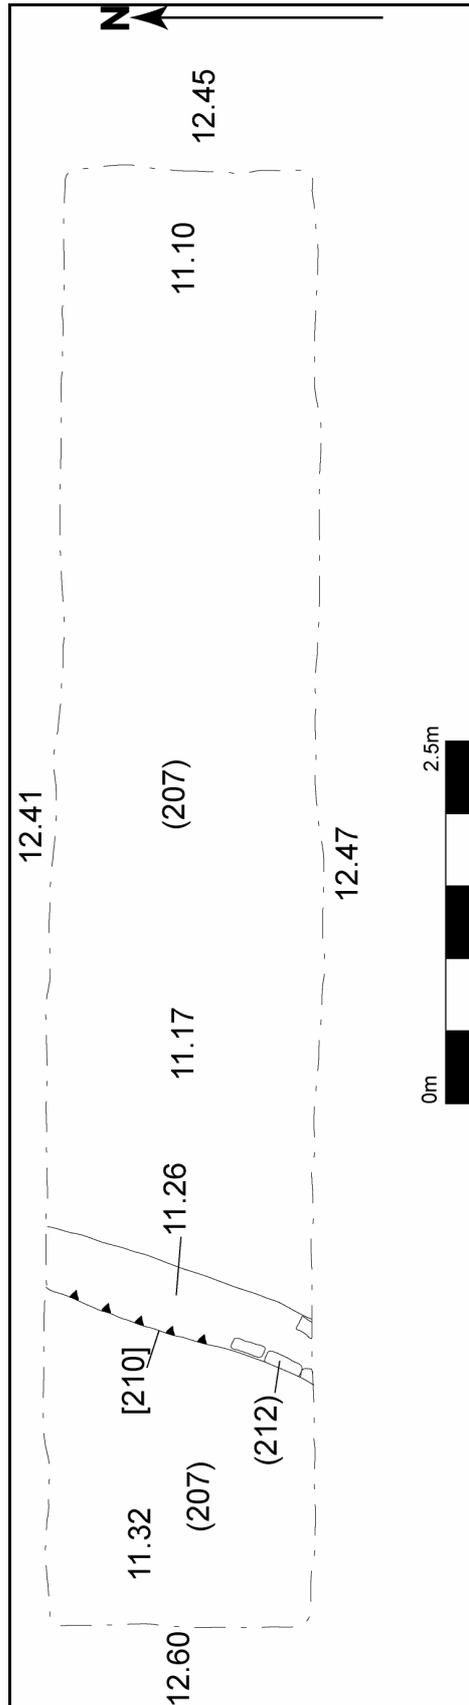
Figure 3: Plan of Trench 2

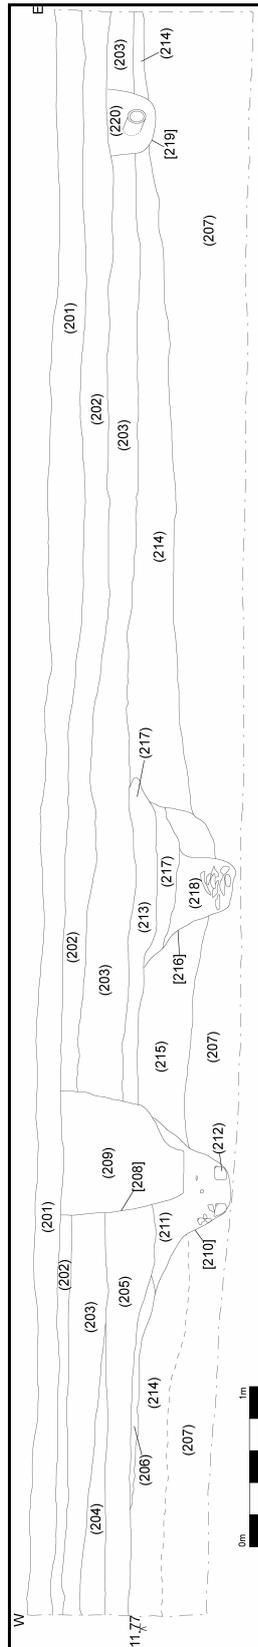
Figure 4: Trench 2 S-facing section

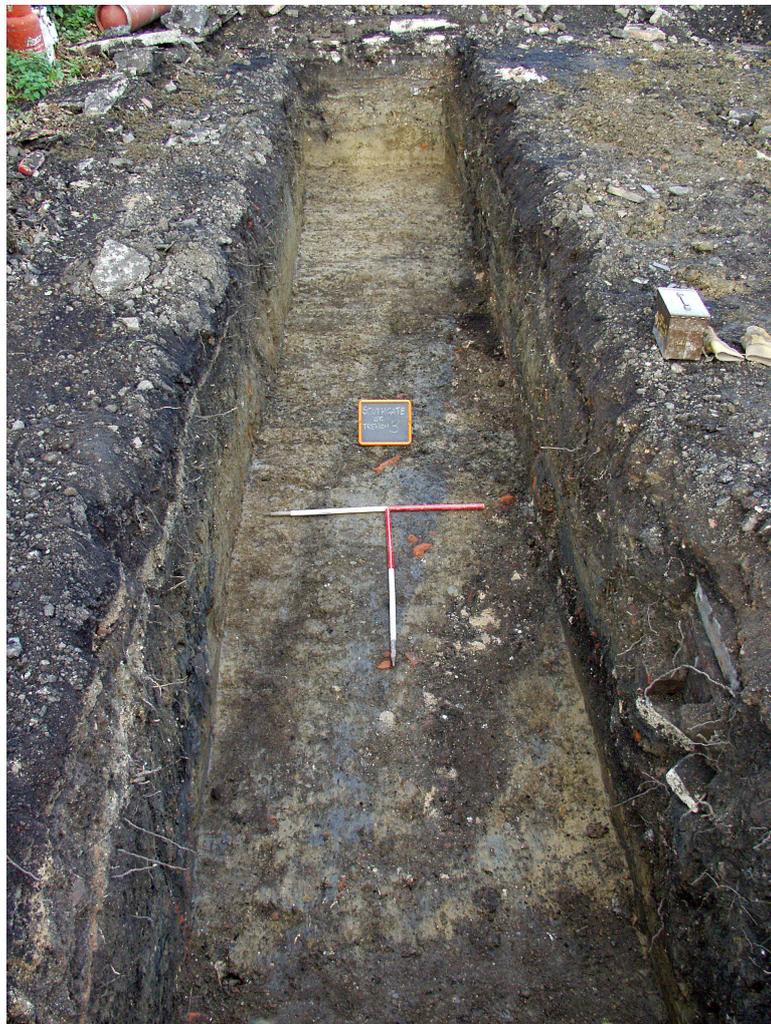
Plate 6: Trench 3 facing S

Located within the northern area of the site, Trench 3 ran parallel to the NNE-SSW boundary and measured 10.00m x 1.80m x 1.20m. Revealed in all sections were a series of 19th and 20th century reclamation, demolition and clearance phases with an average depth of c.0.75m. Natural deposits were encountered at a depth of c.0.95m below the existing ground surface (12.02m AOD) and extended throughout the trench area.

The uppermost deposit comprised loosely compacted coal waste with occasional pieces of post-medieval CBM (301). This deposit extended over most of the southern end of the trench and overlay a degraded cement layer (302) which, in turn, overlay a tightly compacted greyish-brown silty sand with moderate amounts of post-medieval CBM and charcoal (303). Underlying (303) at the southern end of the trench was a grey cement and sand layer (304) that overlay a coal waste and silty loam deposit (305), which, at the northern end of the trench, was the uppermost deposit.

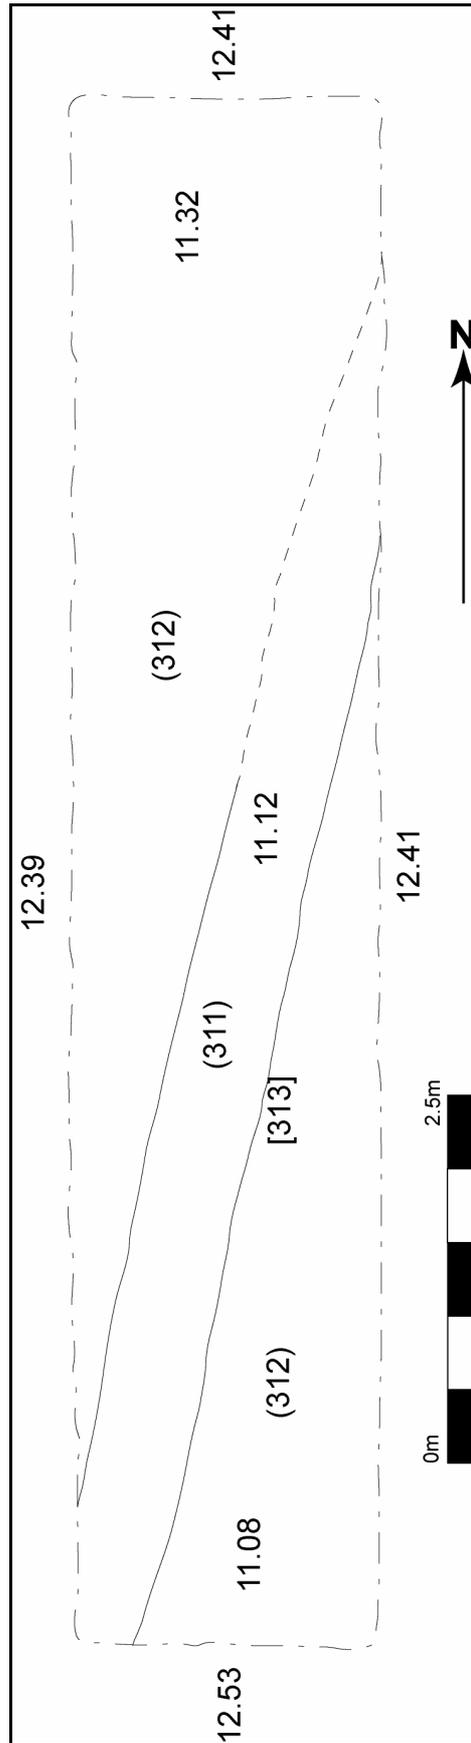
Figure 5: Plan of Trench 3

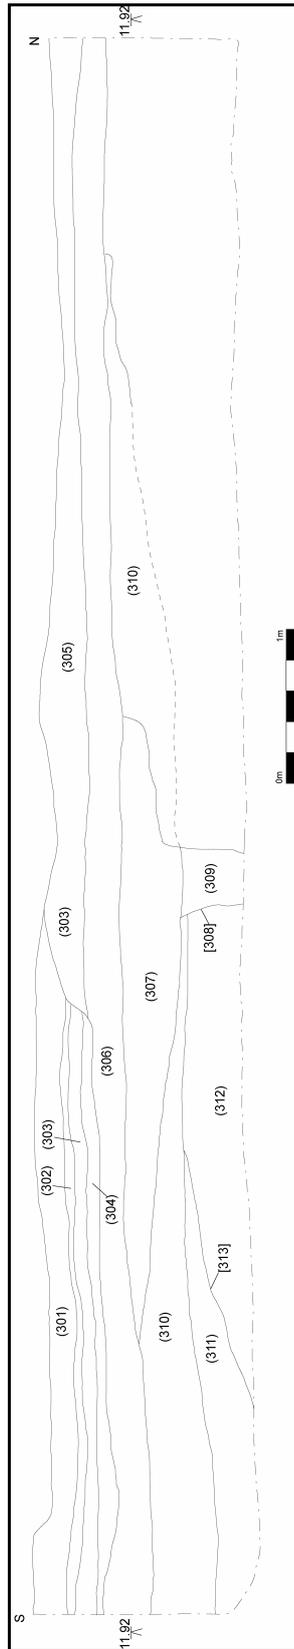
Figure 6: Trench 3 E-facing section

Underlying (304) at the southern end of the trench and (305) at the northern end was a moderately compacted medium brown silty loam with moderate amounts of charcoal flecking and post-medieval CBM (306). Context (306) overlay a mixture of medium brown silty loam and re-deposited grey and yellow clays (307). Underlying (307) was a mixture of grey and yellowy-orange sandy clays with occasional charcoal flecking (310), underlying which, across most of the trench base, was a natural soil comprising yellowish-brown sandy clay (312). Cutting through (310) and (312) was a small post-medieval pit [308] filled by a tightly compacted mixture of grey and yellowy-orange sandy clays with occasional post-medieval CBM (309). Cutting into context (312) was a linear feature [313] running from the NE end of the trench to the SE and filled by a tightly compacted grey clay with moderate amounts of post-medieval CBM and post-medieval pottery, mainly stone and white glazed wares (311).

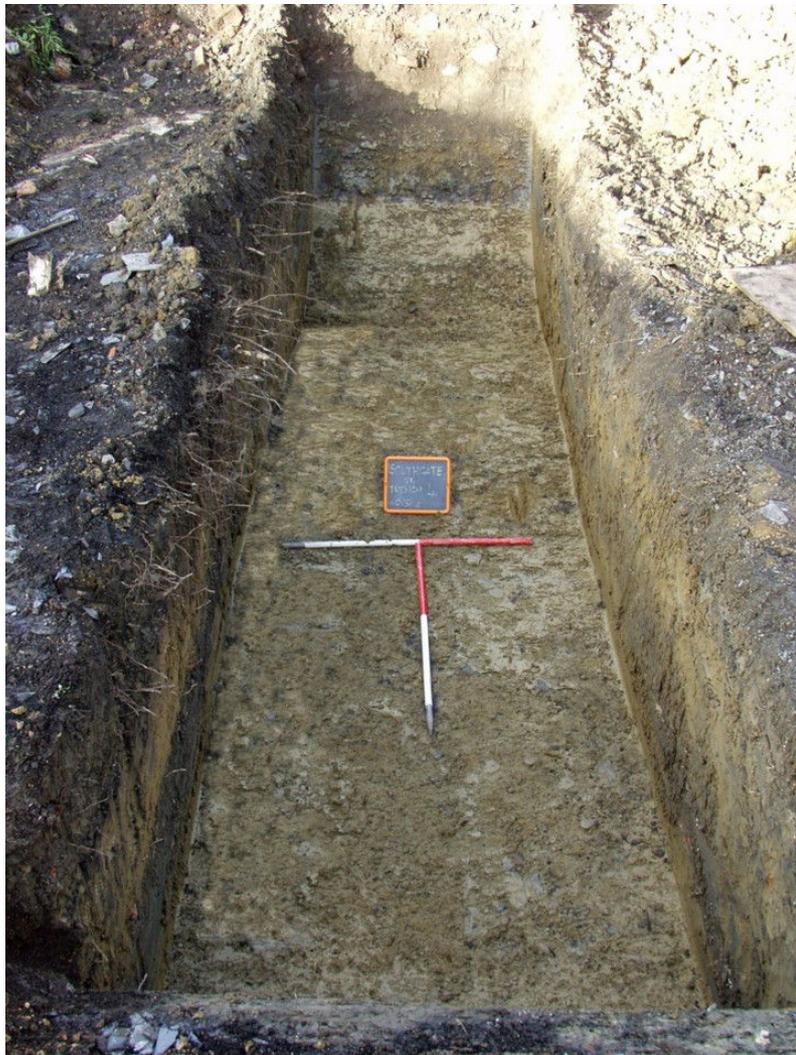
Plate 7: Trench 4 facing SW

Located within the E area of the site and oriented NW-SE, Trench 4 measured 6.00m x 1.80m x 1.18m. Exposed within all section was a series of 19th and 20th century reclamation, demolition and clearance phases with an average depth of 0.88m. Natural deposits were observed at c.0.88m (11.42m AOD) below the existing ground surface and extended throughout the trench.

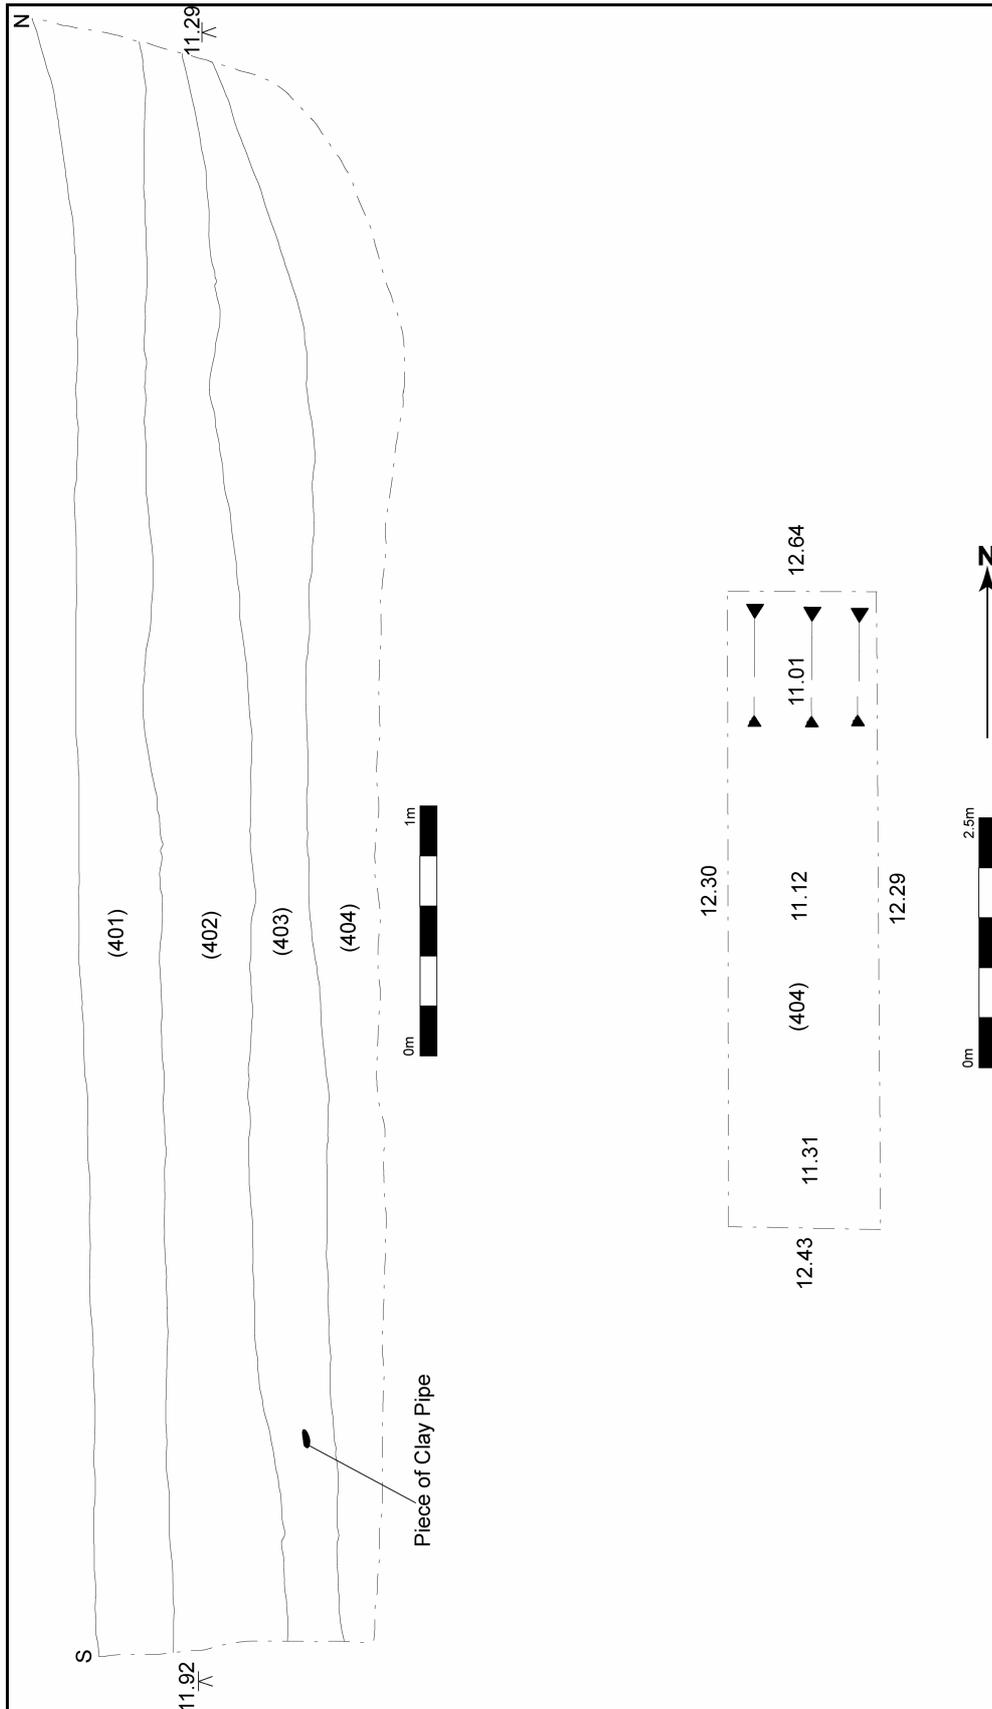
Figure 7: Trench 4 plan and E-facing section

The uppermost deposit consisted of loosely compacted dark grey gritty silty loam with frequent CBM fragments (401). This overlay a tightly compacted medium brown silty clay with moderate amounts of charcoal and occasional post-medieval CBM fragments (402), which, in turn, overlay a grey gritty silty clay containing moderate amounts of post-medieval CBM and charcoal flecking (403). At the base of the trench were natural light orangey-brown sandy clay soils (404).

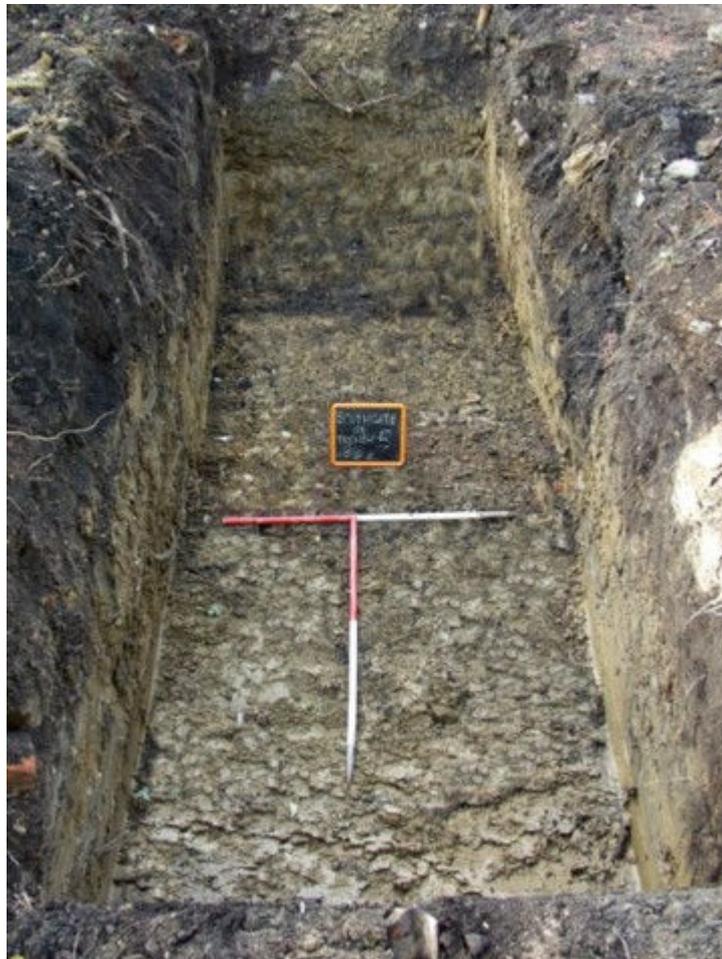
Plate 8:Trench 5 facing SE

Located within the SE area of the site and oriented NW-SE, the trench measured 5.00m x 1.80m x 1.10m and again revealed evidence of 19th and 20th century reclamation, demolition and clearance activity to an average depth of 0.80m.

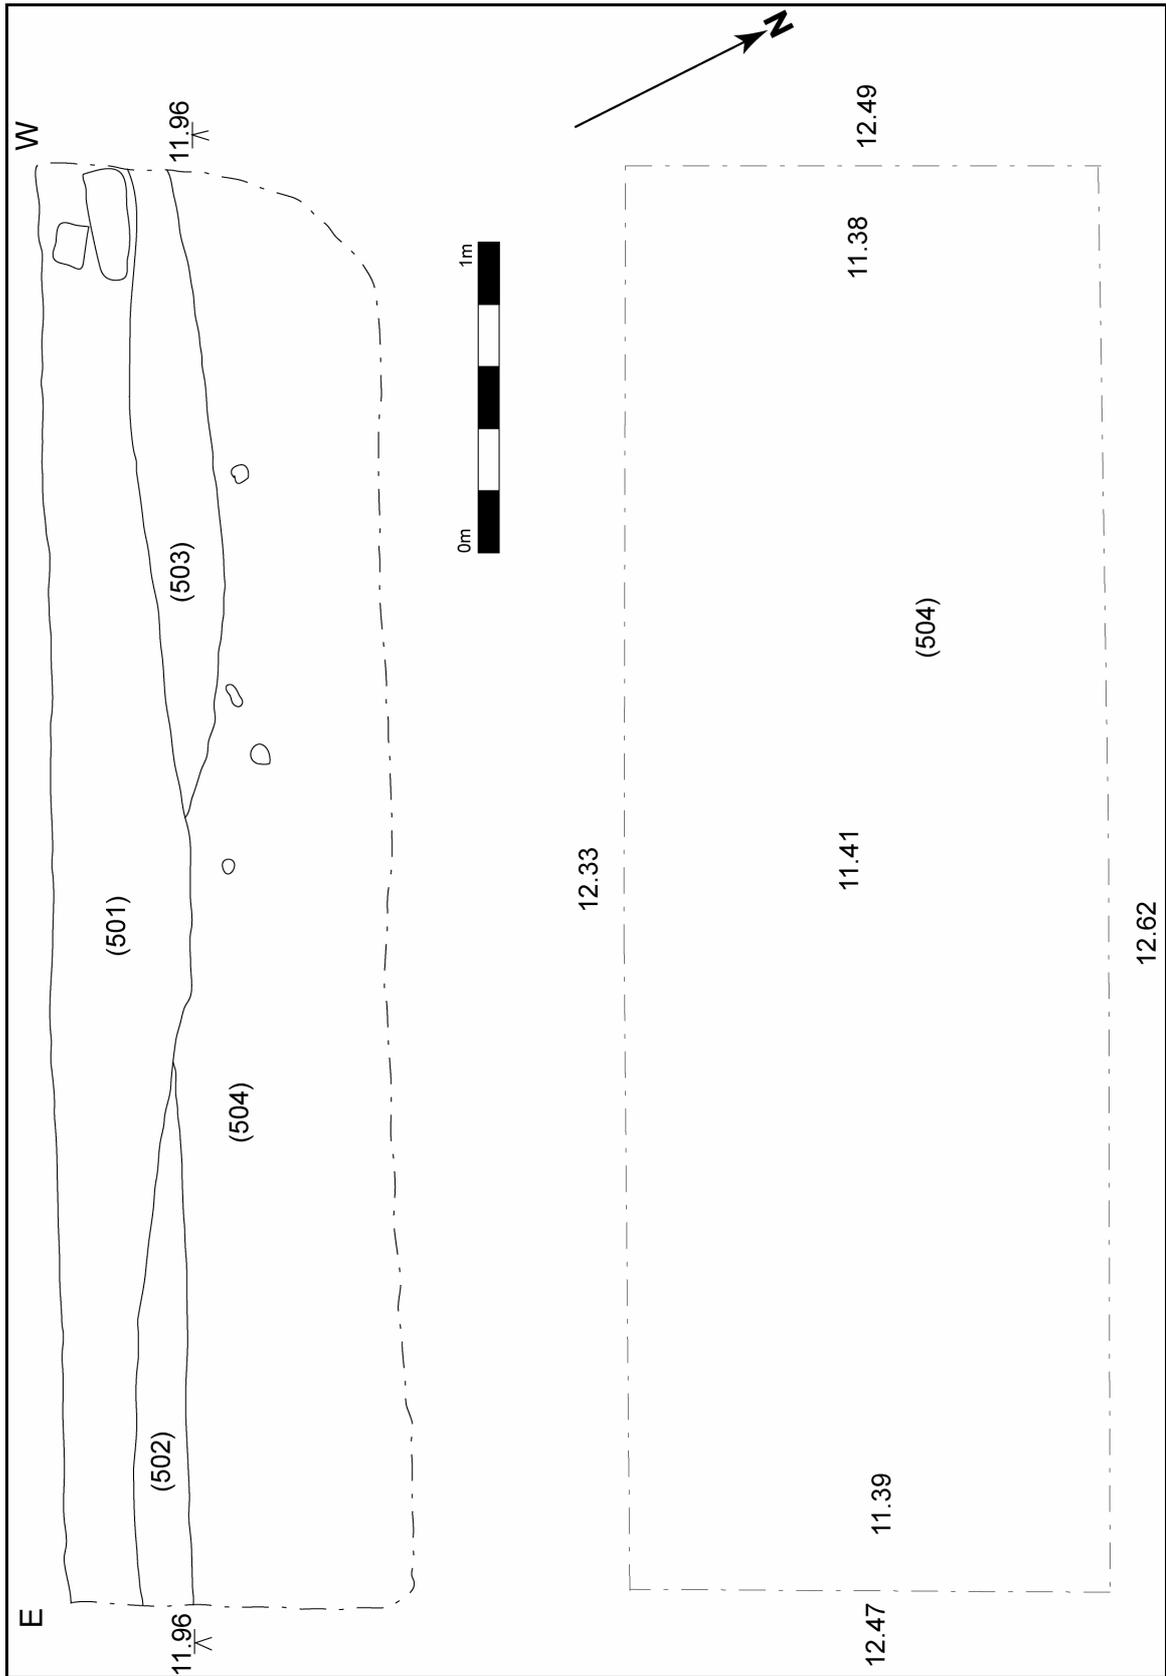
Figure 8: Trench 5 plan and N-facing section (1)

The uppermost deposit was a loosely compacted blackish-brown gritty silty loam (501) (**Fig. 8**). On the eastern side of this part of this section, (501) overlay a grey gritty silty clay with frequent post-medieval CBM (502). At the western end of the section, (501) overlay medium brown silty clay containing moderate amounts of post-medieval CBM (503). Underlying both (502) and (503) was a light orangey-brown sandy clay (504) interpreted as natural.

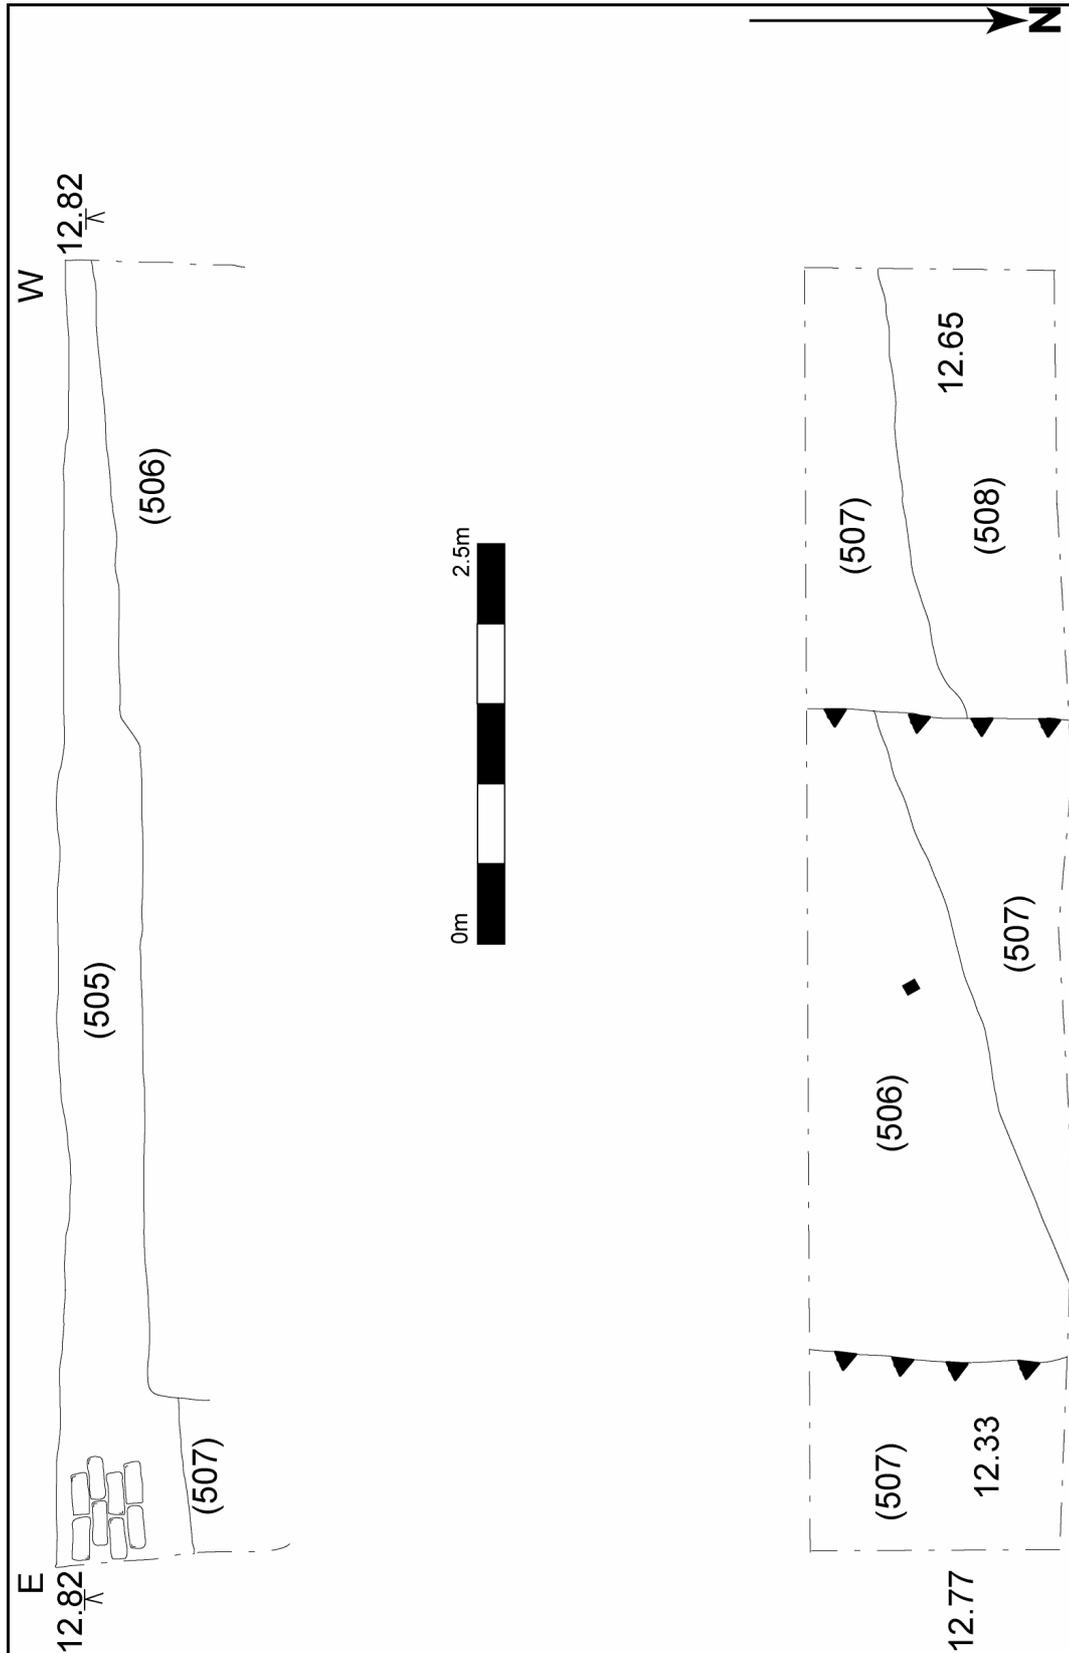
Figure 9: Trench 5 plan and N-facing section (2)

Underlying a loosely compacted blackish-brown gritty silty loam (505 - same as 501), containing a large block of brickwork, probably the result of demolition activity, were three deposits (**Fig. 9**). Contexts (506) and (508) were thick layers of concrete that filled most of the trench and appeared to form part of a foundation representing the SE extent of the factory building that previously occupied the site. It was decided that this should remain in situ and that the trench should be extended to the W (Section 1). Abutting contexts (506) and (508) was a moderately compacted greyish-brown silty clay with frequent post-medieval brick (507).
