ARCHAEOLOGICAL EVALUATION

**Bedford College
25 Cauldwell Street
Bedford
Bedfordshire**

NGR: TL 0492 4942
Report No: BA0436BC

November 2004

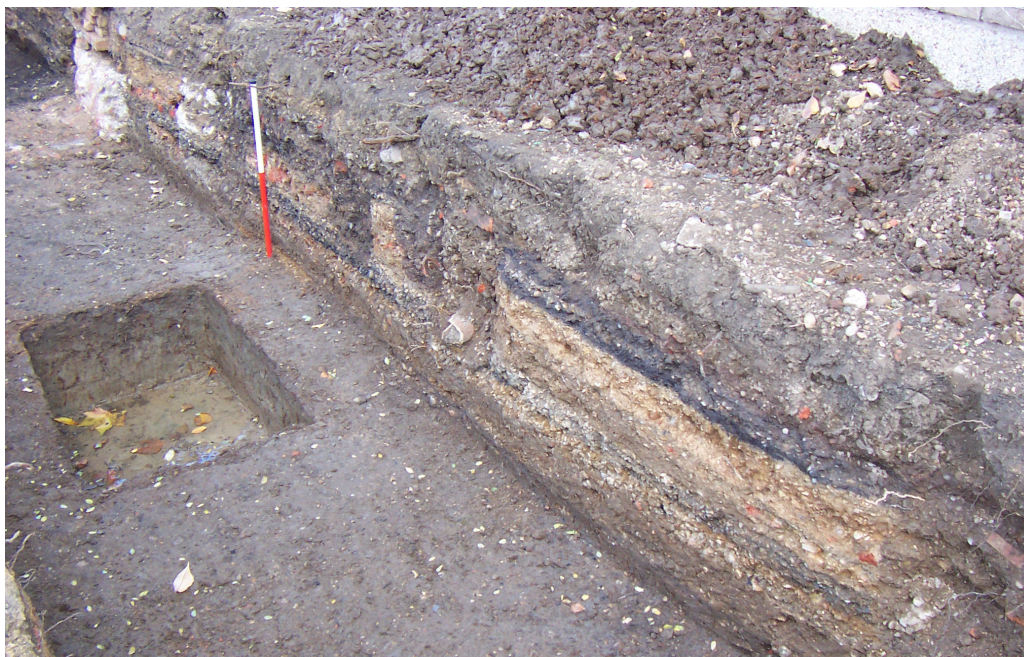
Plate 1: SW-facing section of Trench 1 including Test Pit 1

Excavation revealed a sequence of late 19th / early 20th century reclamation and post-construction / demolition layers, truncating which were numerous service trenches ([103], [108], [133], [148], [137], [139], [141] and [155]). Two sequences of building activity were also identified, the first of these taking the form of a deep-set concrete stanchion / foundation (118) truncating the above reclamation deposits and standing to a height of 25.72m OD (0.70m below existing ground level). Oriented SW-NE, (118) extended out from the SW-facing section and continued for c.1.60m before returning NW, being observed along the base and into the SE-facing section of the trench. These foundations within the NW end of the trench appear to have formed the internal part of a structure. The second phase of construction comprised the base five courses of a stretcher bonded red brick wall that appeared to follow and respect stanchion (118). Standing to a height of 0.36m, the wall probably represented a subsidiary wall that utilised (118), indicating modernisation or the addition of a standing building. It was difficult to assess the contemporaneity of the foundations due to the insertion of service cuts either side of wall (106).

Stanchion (118) appears to have formed a boundary demarcating associated activity of a probable internal area of a building and an earlier phase not associated with this structure. This was made apparent by two different types of deposit found at the base of the trench. The deposit on the internal side comprised a fairly homogenous layer (117) composed of lightly compacted ash and coke containing frequent large slag fragments. Found at 25.24m OD, it extended down for 0.28m to the base of the excavation and was observed throughout the entire base of the NW end of the trench. This may well represent an accumulative reclamation spread raising the internal surface of the building post the laying of stanchion / foundation (118).

The external deposit (153) found within the SE side of the trench was composed of tightly compacted light grey clays. Test Pit 1 was excavated within this portion of the trench to ascertain the depth and origin of the deposit, revealing a continuation of the deposit to the base of the test pit at 24.65m OD (1.72m below the existing ground surface). The emergence of groundwater at this depth prevented further excavation of the test pit. Occasional animal bone was recovered throughout the depositional profile of this deposit and frequent charcoal flecking was noted. No pottery was observed during the initial clean back of (153) or during the excavation of Test Pit 1, the deposit probably being riverine in origin, the accumulation resulting from water transgression / regression within the river zone. The inclusion of animal bone debris and charcoal within this deposit may represent an interfacial area of limited human habitation on the edge of the River Ouse. This deposit underlay a sequence of 19th / 20th century reclamation deposits comparable with those within the NE area of the trench.

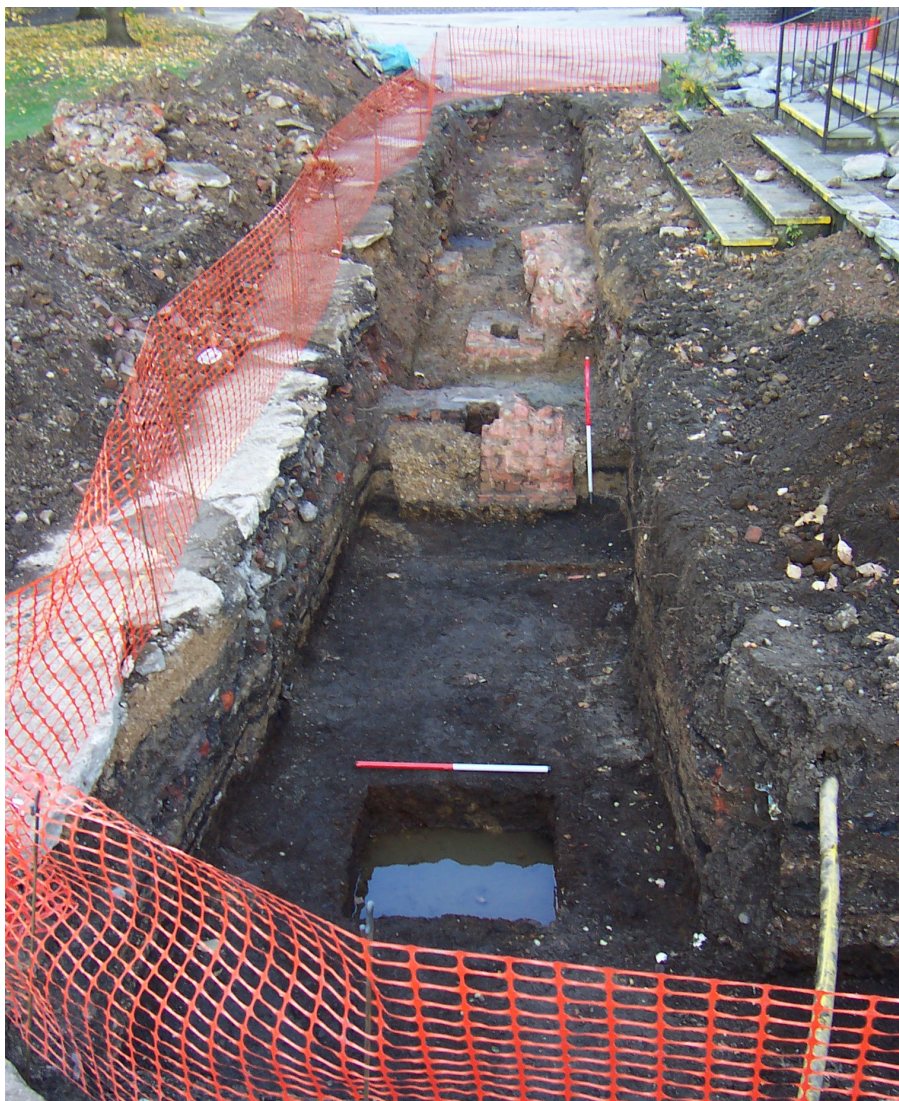
Plate 3: Trench 2 looking NE including Test Pit 2

Trench 2 was located to the NW of the existing building and was oriented NE-SW, measuring 19.00m x 2.00m x 1.20-1.30m. Test Pit 2, measuring 1.00m x 1.00m x 0.35m, was inserted within the base of the trench at the SW end.

Excavation revealed a continuation of the 19th / 20th century reclamation deposits found within Trench 1, the lowermost of these being observed within the base of the trench at a depth of 1.20m below the existing ground surface (25.21m OD). The majority of the trench also indicated extensive development during or slightly after the area had apparently been reclaimed during the 19th and 20th centuries. Evidence of this development within the central and NE areas of Trench 2 was once again represented by a sequence of concrete stanchions and foundations (222)-(226), the heights of which ranged from 25.39m OD to 25.89mOD. Test Pit 2 located at the SW end of the trench was excavated into deposit (216), which was the same as deposit (117) within Trench 1, consisting of lightly compacted ash and coke containing frequent large slag fragments. The test pit revealed a continuation of (117) found within Trench 1 within all its sections and the base, the base being measured at 24.91m OD (1.46m below the existing ground surface). No deposits comparable to the clays (153) found within Trench 1 were observed at the base or in the sections of this trench.

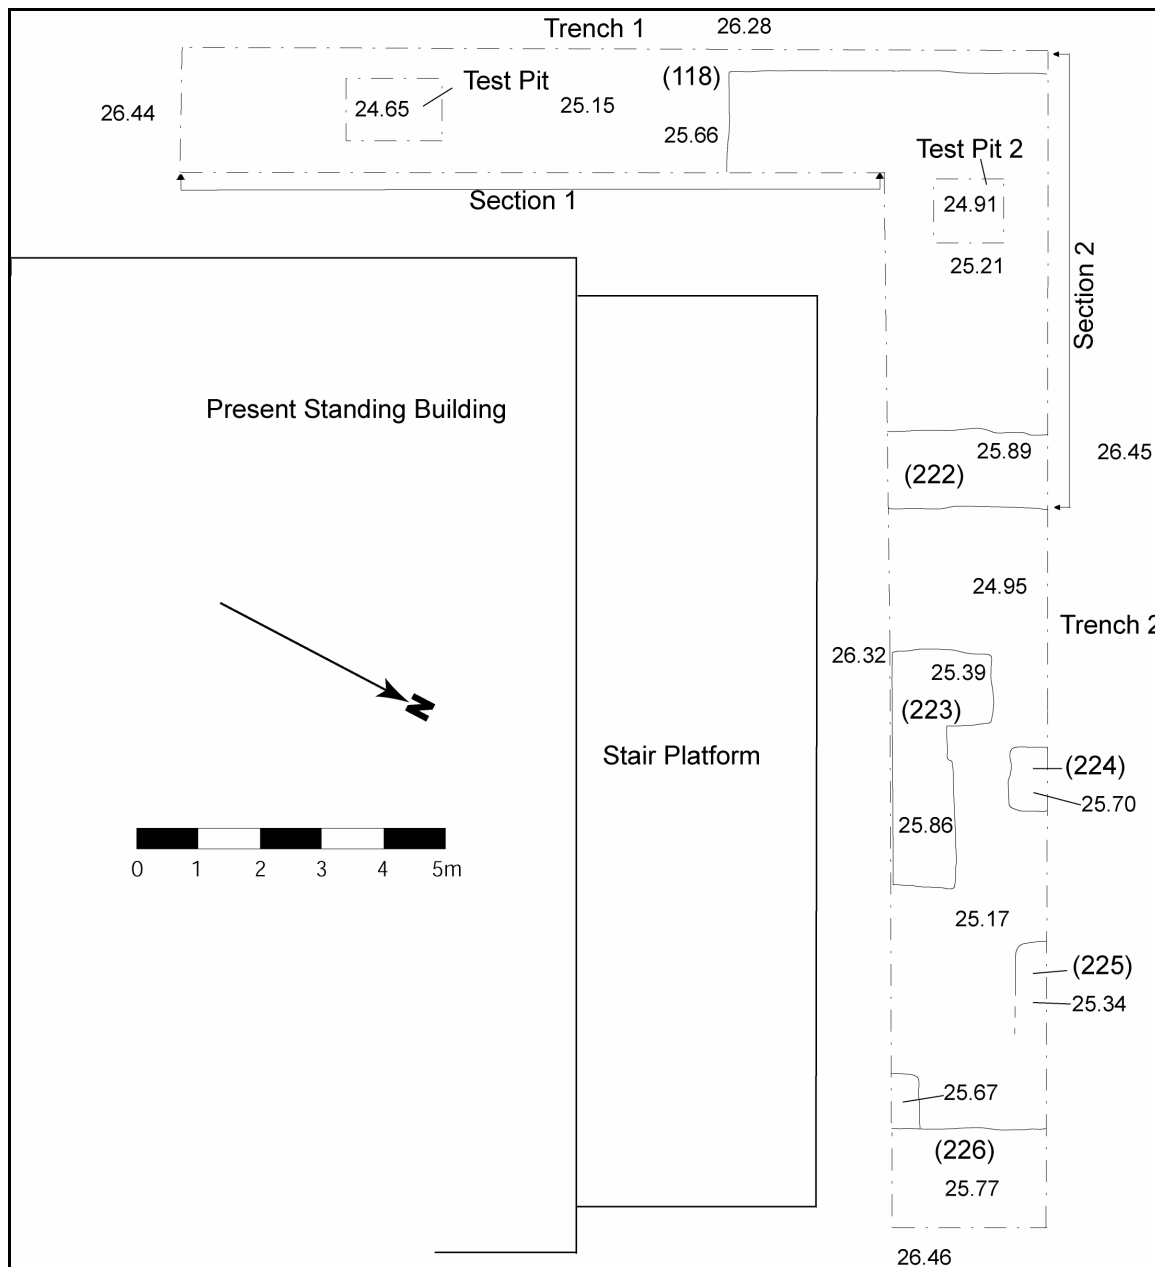
Fig. 2: Plan of trenches

Two trenches were located within the proposed development area (each being tied into architects' plans of the site as existing) to form an L-shaped arrangement respecting the ground plan of the existing college building to the S and E.

Trench 1 was located to the SW of the existing building and measured 14.10m x 2.00m. Oriented NW-SE, the trench was excavated to a depth of 1.20-1.30m, a test pit (Test Pit 1) measuring 1.00m x 1.50m x 0.50m being inserted within the base of the trench at the SE end in order to ascertain the depth of deposits.

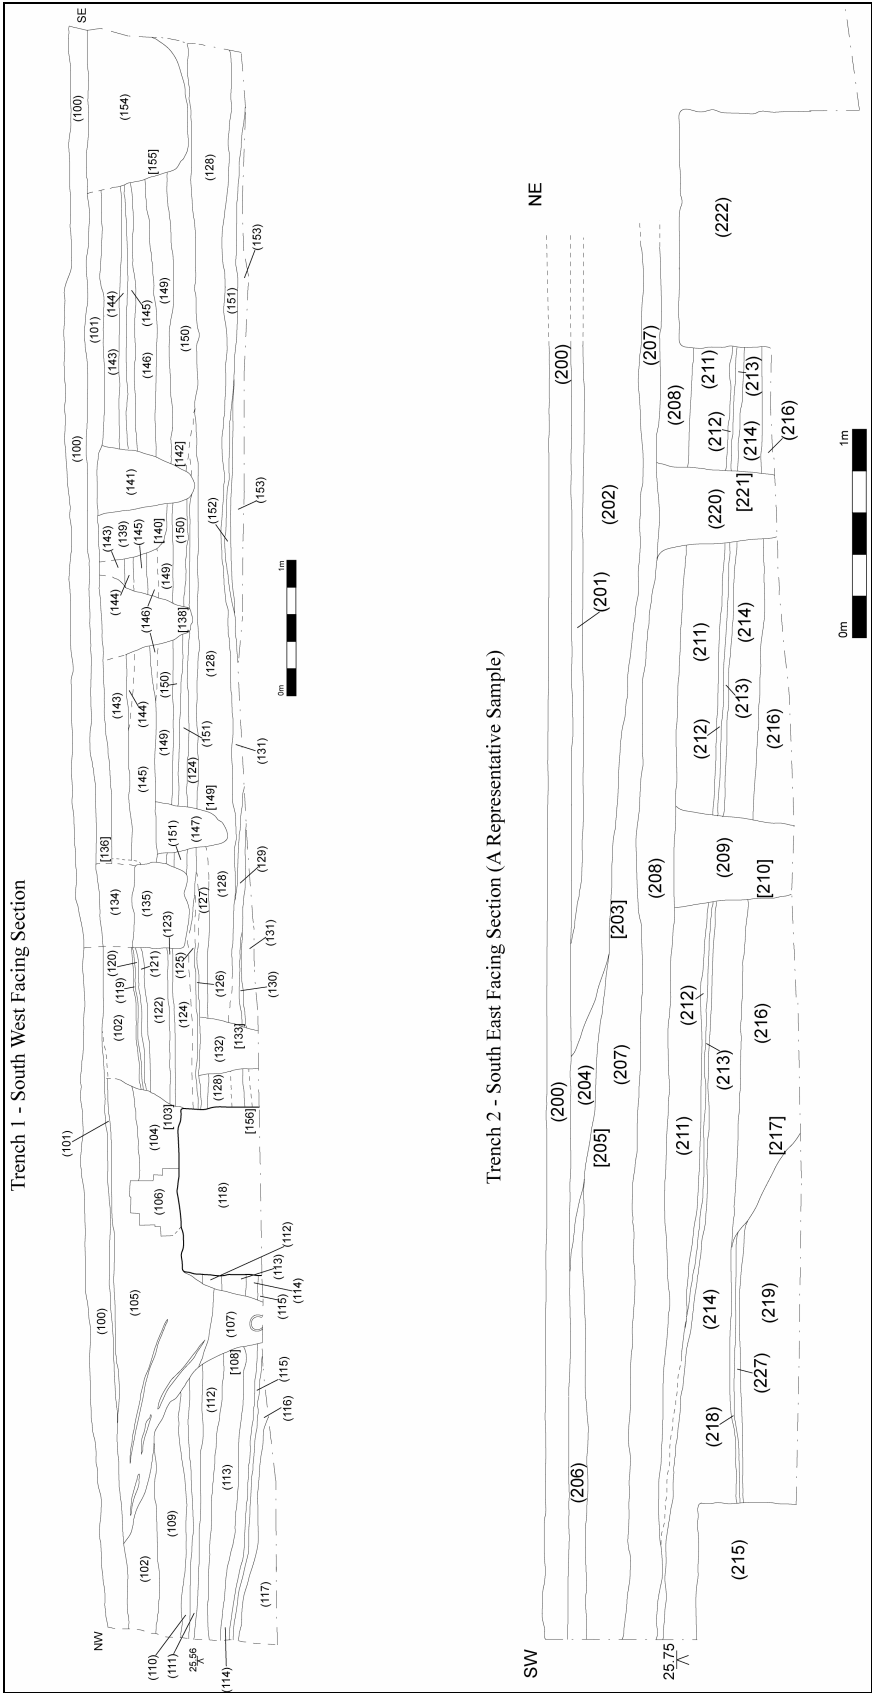
Fig. 3: Trench sections (Trenches 1 & 2)

The evaluation of each trench included a detailed stratigraphic record using a context numbering system. Due to the apparent uniform deposition of 19th and 20th century reclamation and demolition layers encountered throughout the evaluation it was deemed necessary to record only a representative sample of the trench sections.

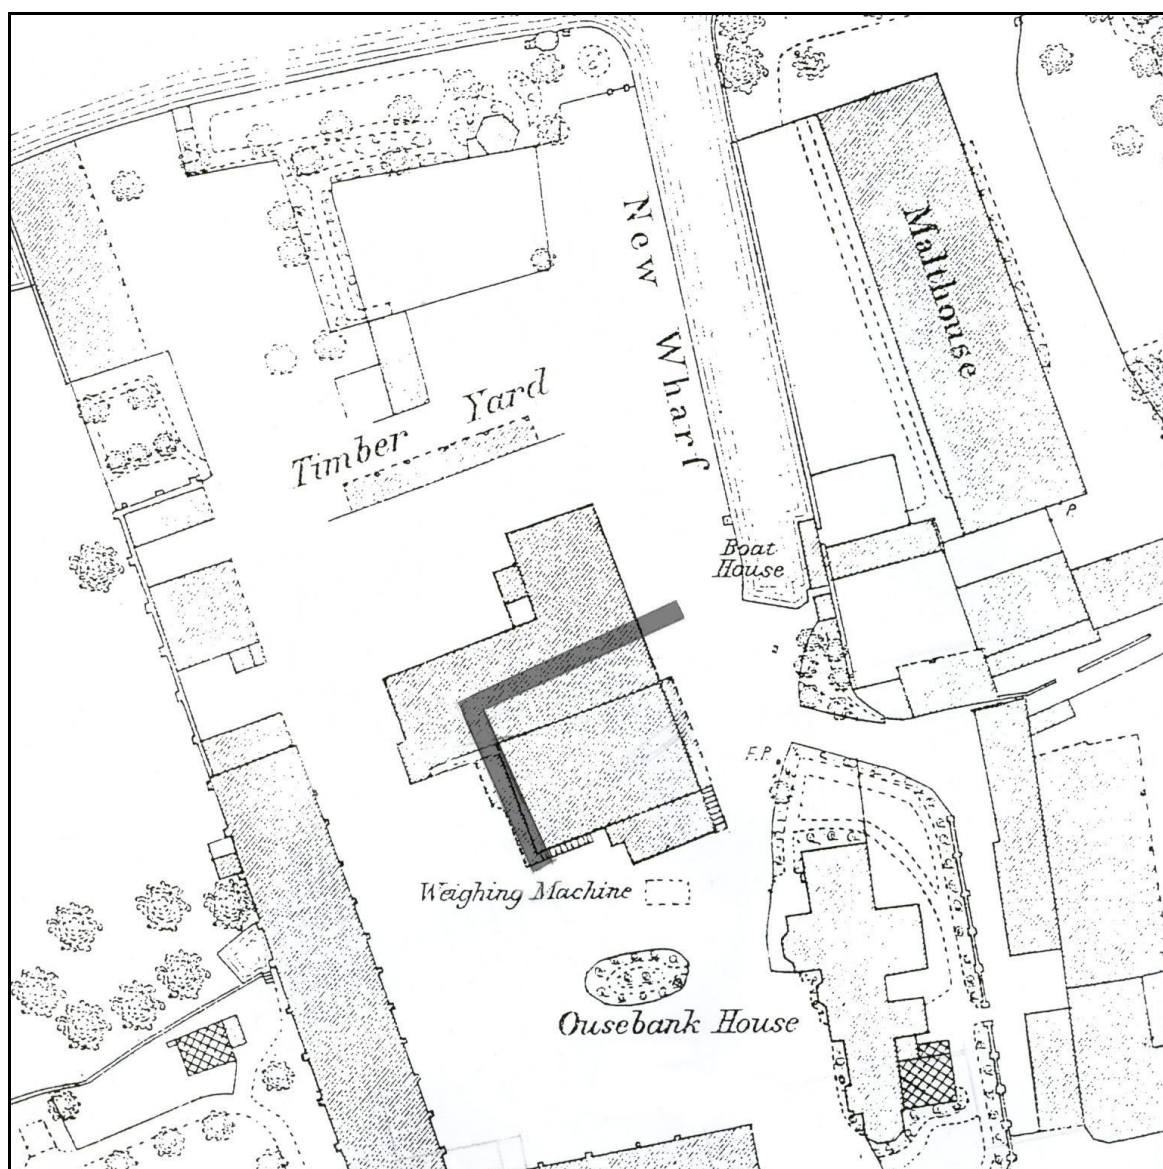
Fig. 6: Ordnance Survey 1883 25 inch 1st edition map

The trenching revealed no significant features / structures, the immediate area evidently having undergone extensive development during the second half of the 19th century and continuing well into the 20th century. The foundations observed during the evaluation probably relate to a series of adjoining buildings oriented NW-SE and best represented on the Ordnance Survey 1883 25 inch 1st edition map, which indicates structures within and to the S of a timber yard (**Fig. 6**).
