Archaeological Standing Building Recording

**Oxnalls Farm
Newnham Bridge
Tenbury Wells
Worcestershire
WR15 8LP**

June 2020

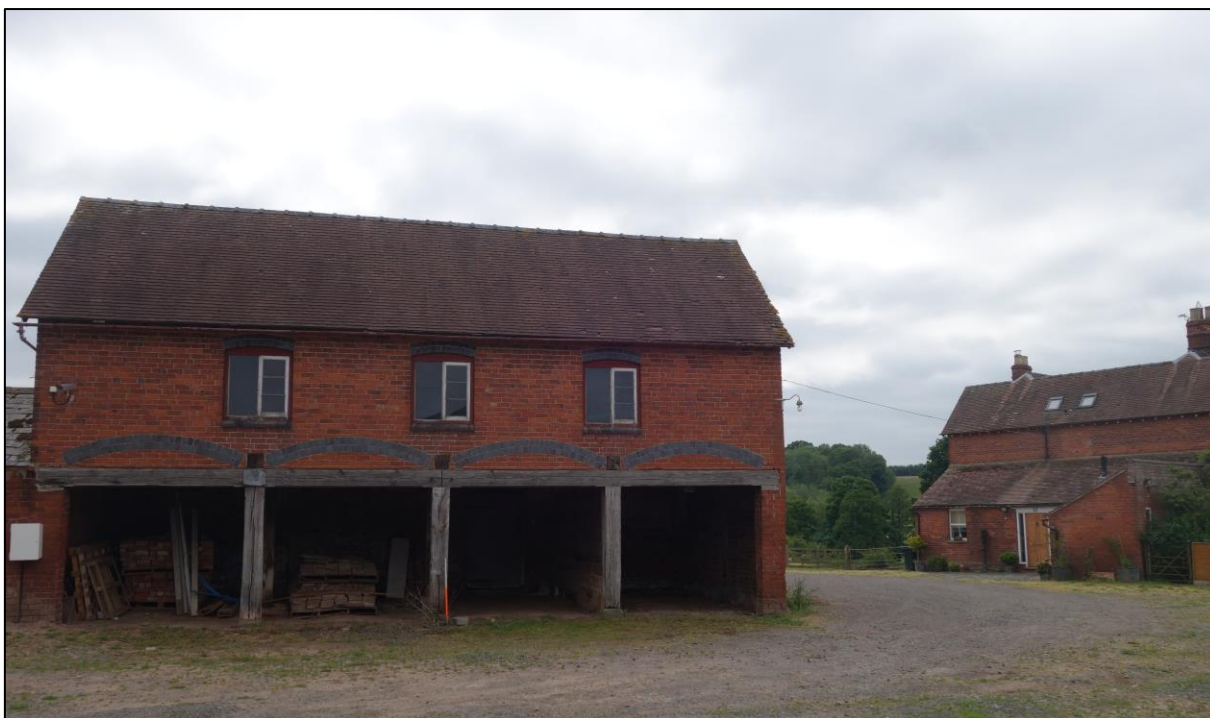
The traditional farm outbuilding forming the subject of this programme of standing building recording is located about 15m to the N of the farmhouse at Oxnalls Farm (*Plate 1*) and consists of a two-storey gabled cartshed with granary above, four bays long and oriented NE-SW, with an attached two-storey range (formerly a stable with loft above), three bays in length and aligned NW-SE, located at right angles to the cartshed/granary (*Plate 2*). The building is of red brick construction (laid in Flemish Stretcher Bond) and has a cross-gabled, tiled roof. No evidence for a construction break was noted between the cartshed/granary and the stable range, indicating that both represent a single phase of building activity.

Plate 1: View looking S towards granary/cartshed range with farmhouse to right of picture

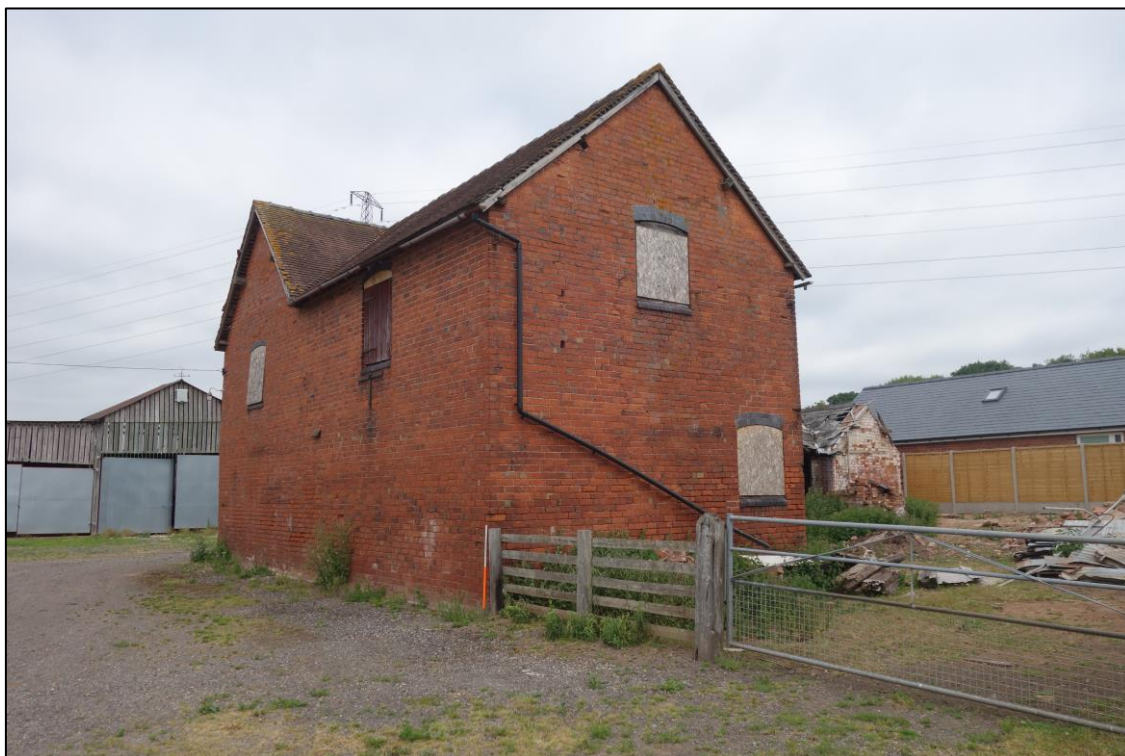
Plate 2: View looking NNW showing SE gable of two storey-stable range attached to rear of the granary/cartshed

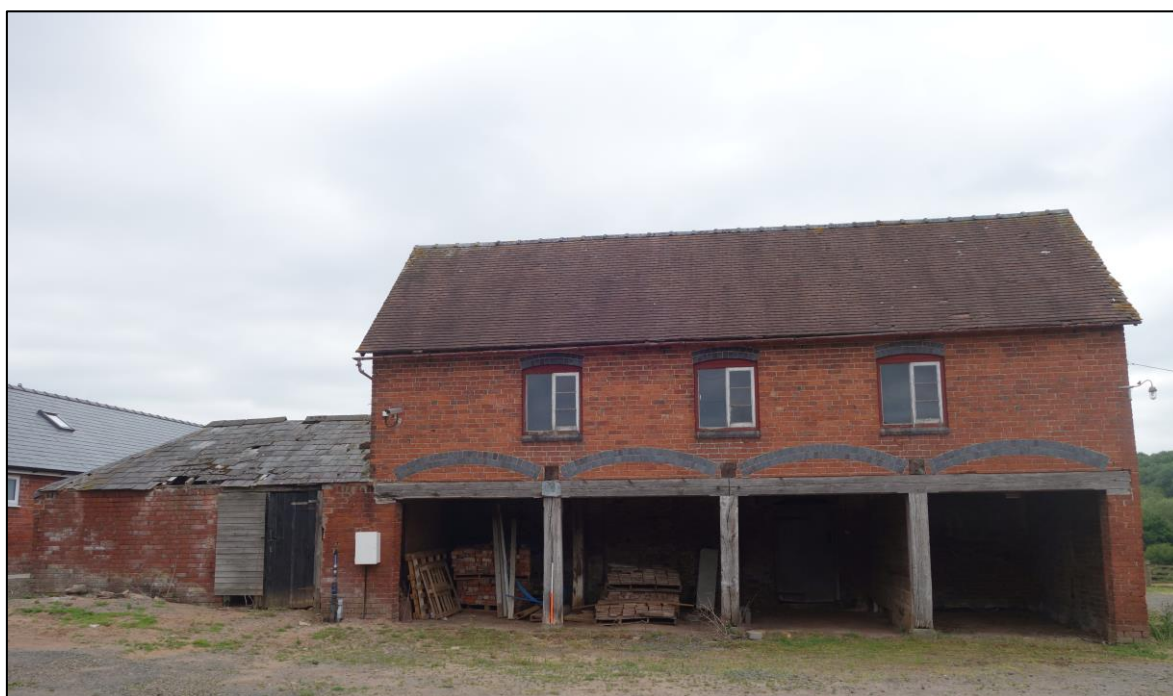
Attached to the NE end of the cartshed/granary range is a single storey structure, also of red brick construction (also laid in Flemish Stretcher Bond) with a cross-gabled slate roof which forms the remaining portion of an outbuilding range aligned NW-SE which was demolished recently and was used as accommodation for livestock (*Plate 3*).

Plate 3: View looking SE showing principal NW-facing elevation of granary/cartshed with attached single storey outbuilding to the NE

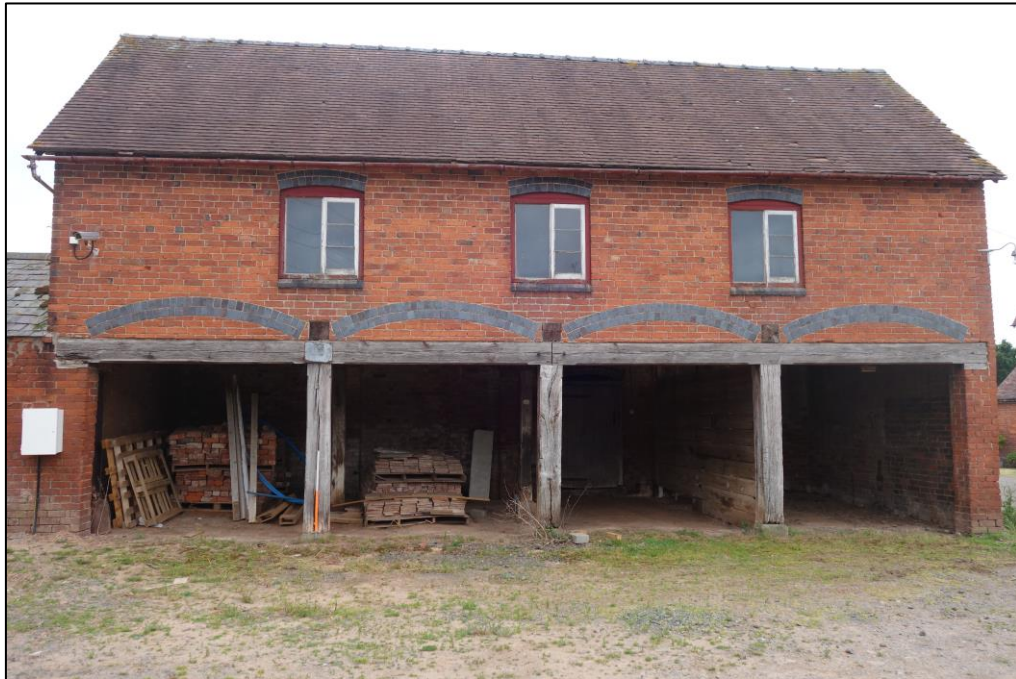
The granary/cartshed range is a rectangular gabled building with a pitched tiled roof with broad eaves and plain bargeboarded gables, of brick construction (laid in Flemish Stretcher Bond), two storeys high, four bays long (aligned NE-SW) and a single bay in width (*Plate 4*). The principal, NW-facing elevation of the cartshed at ground level has four open fronted bays subdivided by three square wooden arcade posts which have stop-chamfered heads and are carried on roughly chamfered stone bases (*Plate 5*).

Plate 4: View looking SE showing open-fronted cartshed and first floor granary with segmental-arched casement windows

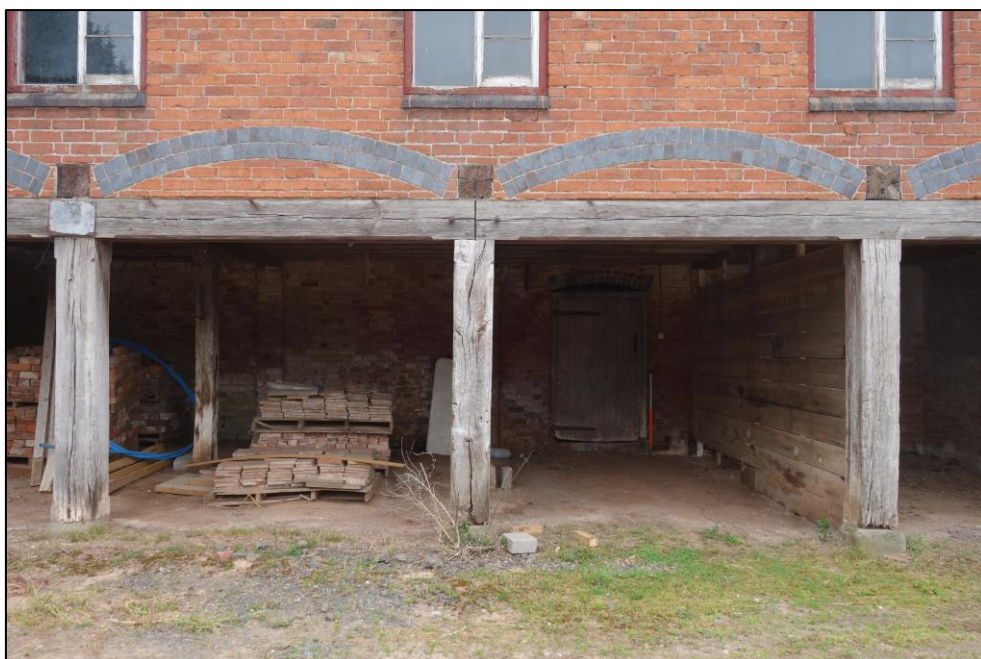
Above each bay of the cartshed is a segmental arch comprising two courses of Staffordshire blue bricks which appear to be purely decorative in purpose (*Plate 5*). The upper storey, housing the granary is lit by three two-light glazed casement windows set within segmental arched openings with Staffordshire blue brick dressings and chamfered brick lintels.

Plate 5: View looking SE showing detail of cartshed openings with stop-chamfered posts and lintel with segmental Staffordshire blue-brick arches above

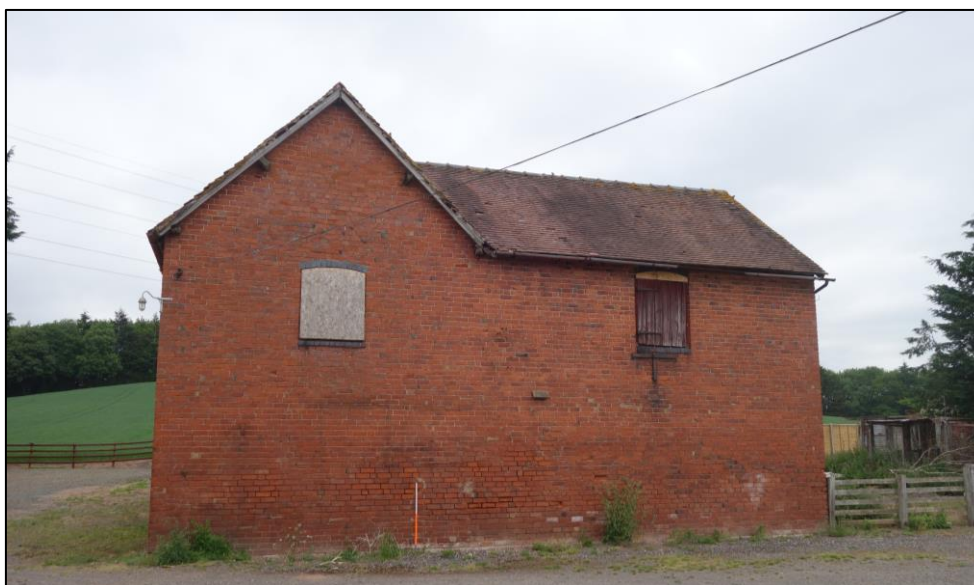
The SW-facing elevation of the granary/cartshed and attached two-storey stable range is largely devoid of architectural detailing except for the bargeboarded gable end and two openings at upper storey level, comprising a segmental arched window with blue-brick lintel and sill (now boarded up) at the SE gable end of the granary and a plank and batten loft door just below eaves level within the stable, which is also set within a segmental arched opening with a cross-tie plate located just beneath the sill (*Plate 6*). The SE-facing gable elevation of the two-storey stable block is also bargeboarded and is lit by a single window at ground level and a centrally placed window in the upper storey, both of which have been boarded up and are set within segmental arched openings with blue brick lintels and chamfered sills (*Plate 7*).

Plate 6: View looking NE showing SW-facing elevation of the granary/cartshed and attached two storey stable block

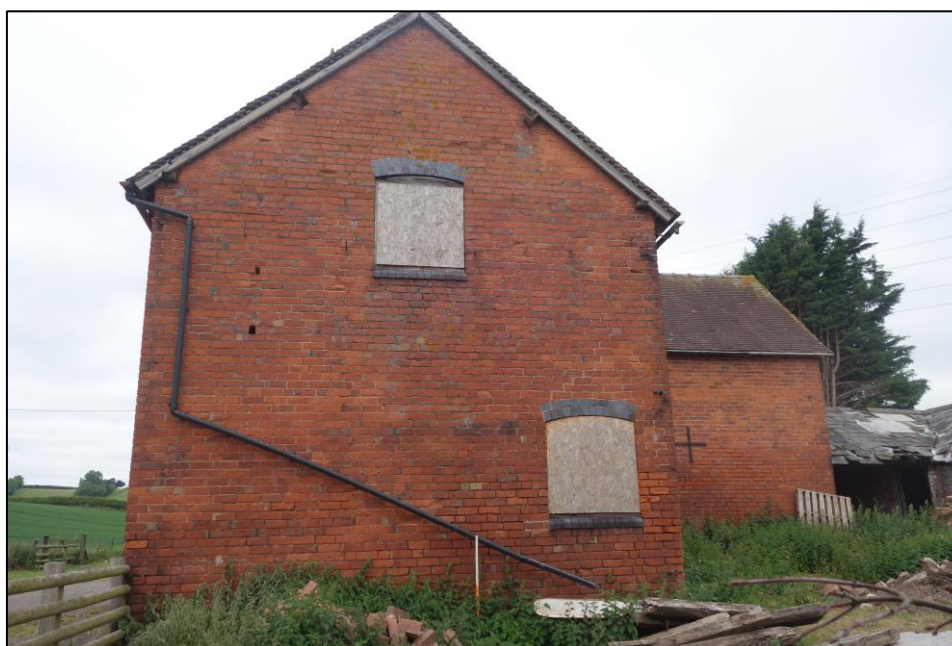
Plate 7: View looking NW showing SE-gable end of two storey stable range with bargeboarded gable

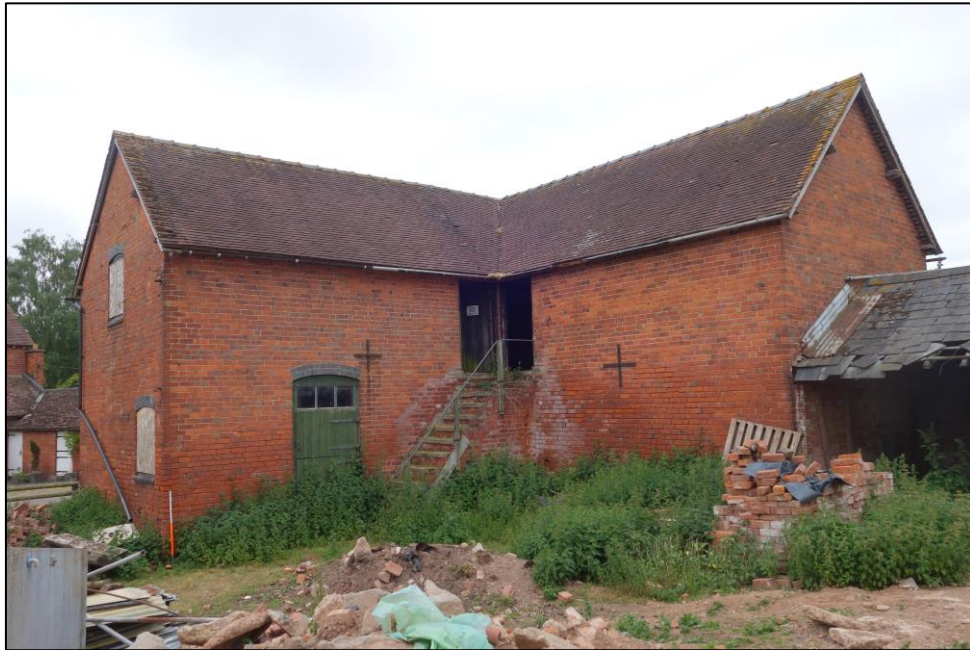
The rear elevation of the cartshed/granary and stable block overlooks a yard which is now heavily overgrown and occupied by rubble and debris associated with the recently demolished outbuilding range which bordered the NE edge of the yard (*Plate 8*). An external staircase of brick construction with stone treads located in the corner between the two ranges leads up to two flat arched doorways set at right angles to each other, respectively providing access to the granary and hayloft over the stable (*Plate 9*).

Plate 8: View looking W across former yard towards rear elevation of granary/cartshed and attached stable range with external staircase

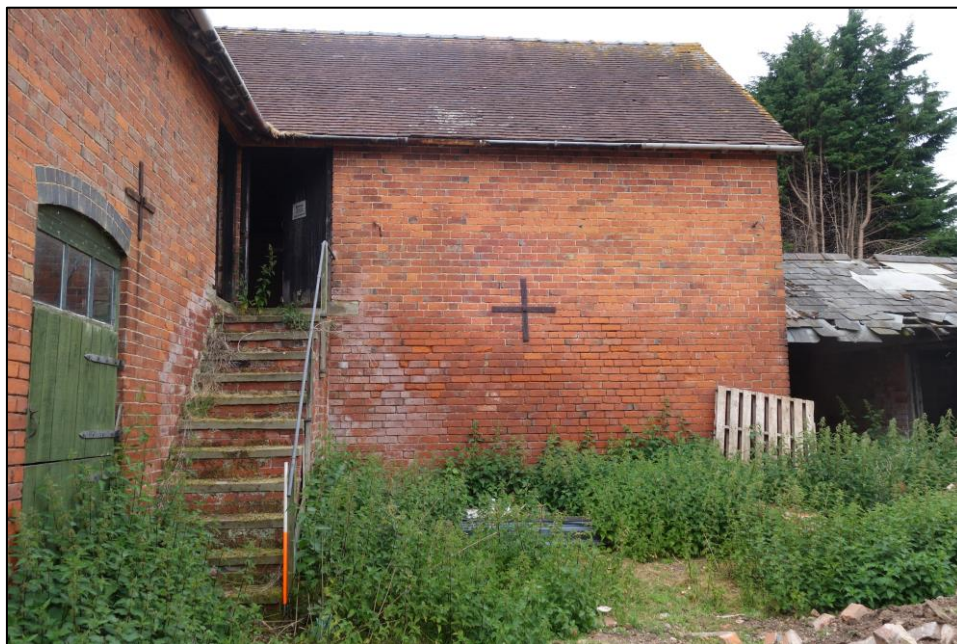
Plate 9: View looking NW showing rear elevation of granary/cartshed range and staircase leading up to granary and hayloft

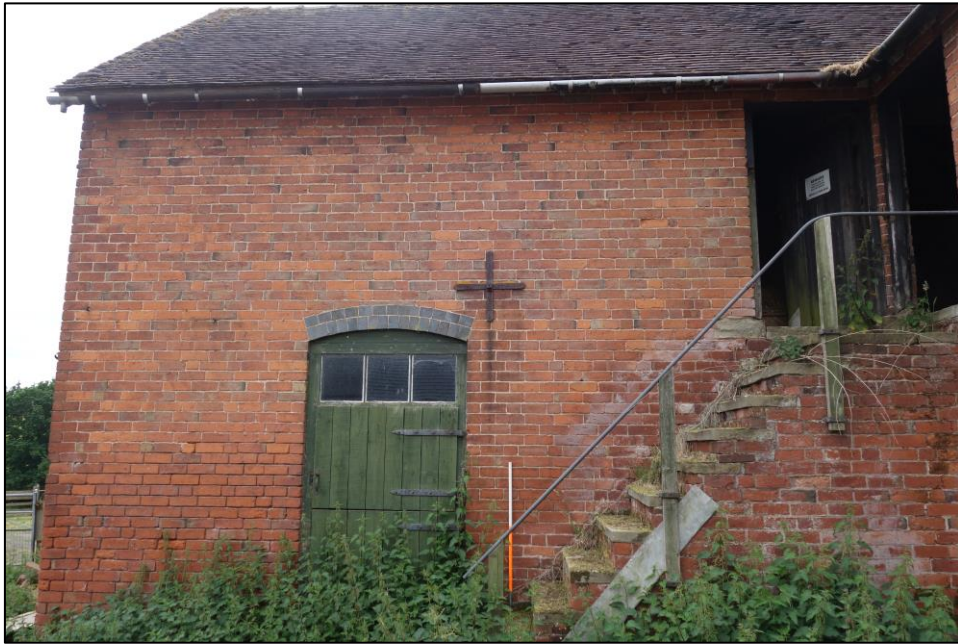
At the foot of the staircase is a plank-and-batten stable door with a glazed 3-pane overlight and strap hinges providing access to the stable range (*Plate 10*). Two cross-tie plates are set in the wall of the granary/cartshed and stable range between ground and upper storey level. The lower portion of the rear wall of the granary/cartshed range exhibits evidence of whitewash, which may be associated with a rectangular structure in this location marked on the OS 2nd edition map of 1904.

Plate 10: View looking SW showing detail of rear elevation of stable range with segmental-arched stable door

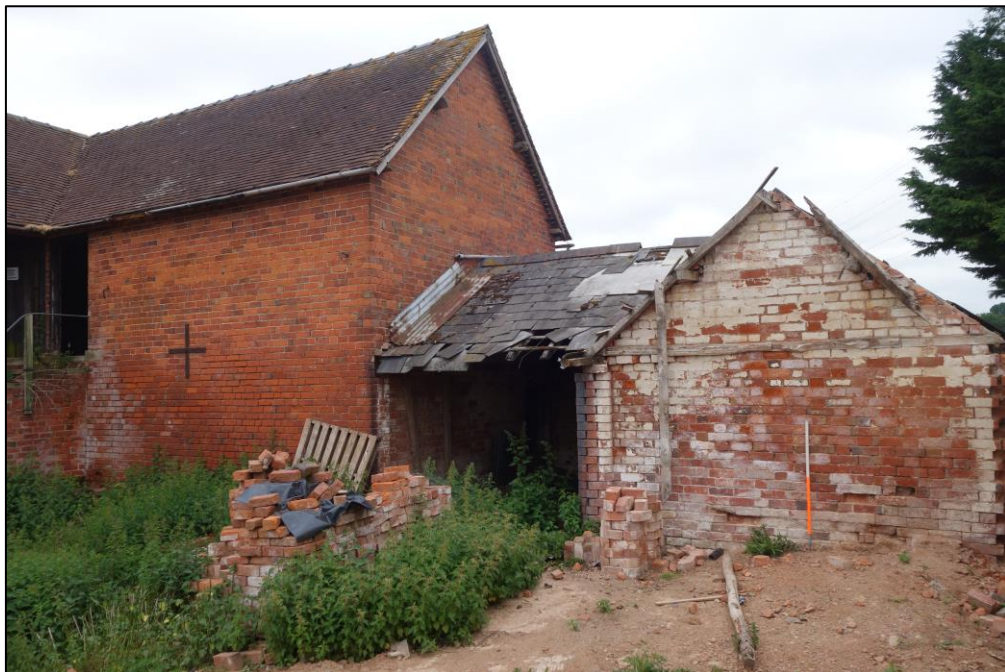
Plate 11: View looking NW showing gabled outbuilding with slate roof to NE of granary/cartshed

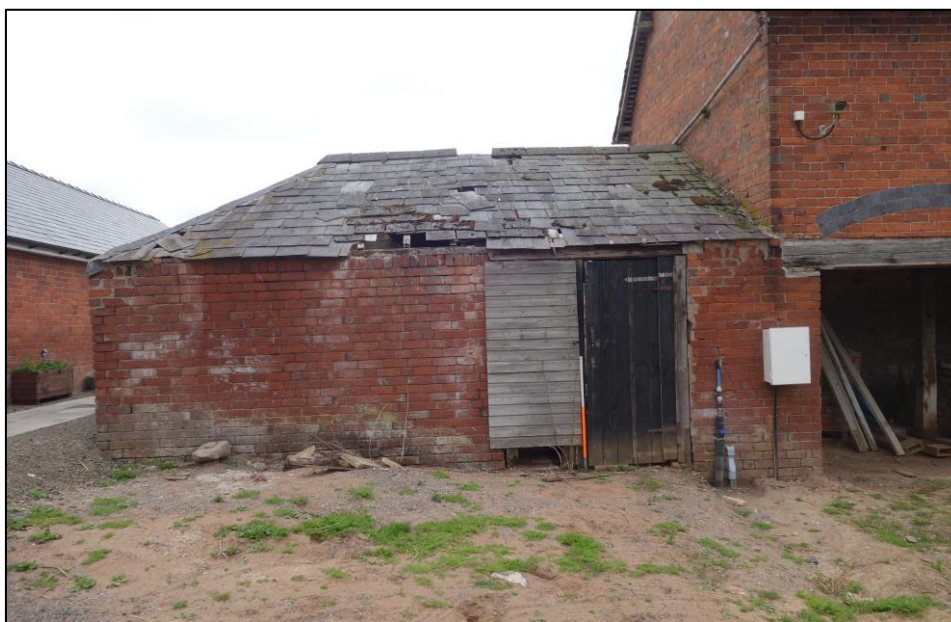
Attached to the NE gable end of the granary is a single storey L-shaped brick range with a partially denuded cross-gabled slate roof, comprising a narrow compartment or vestibule aligned NE-SW and open-fronted to the rear, linking the cartshed range to a low-gabled rectangular building, oriented NW-SE (*Plate 11*). The vestibule is accessed from an opening at the NE end of the cartshed and a plank and batten door in the front (NW-facing) elevation (*Plate 12*). The gabled rectangular structure appears to represent the remaining portion of a long rectangular single-storey range aligned NW-SE formerly used as livestock accommodation and extending along the N side of the courtyard but was clearly separated from the rest of that range by a brick wall (*Plate 13*).

Plate 12: View looking SE showing front elevation of single-storey outbuilding with slate roof attached to NE end of granary/cartshed

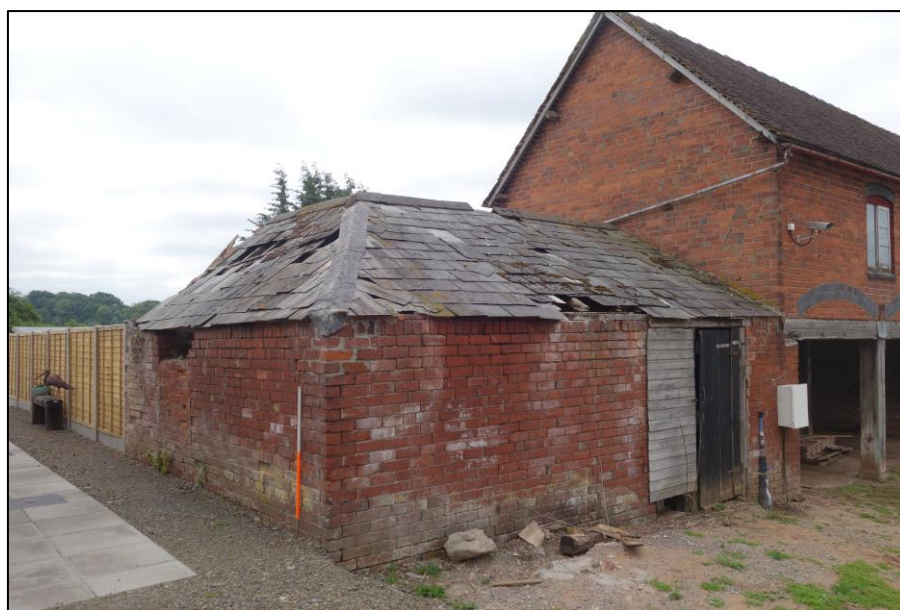
Plate 13: View looking S showing single storey outbuilding with slate roof attached to NE gable end of granary/cartshed

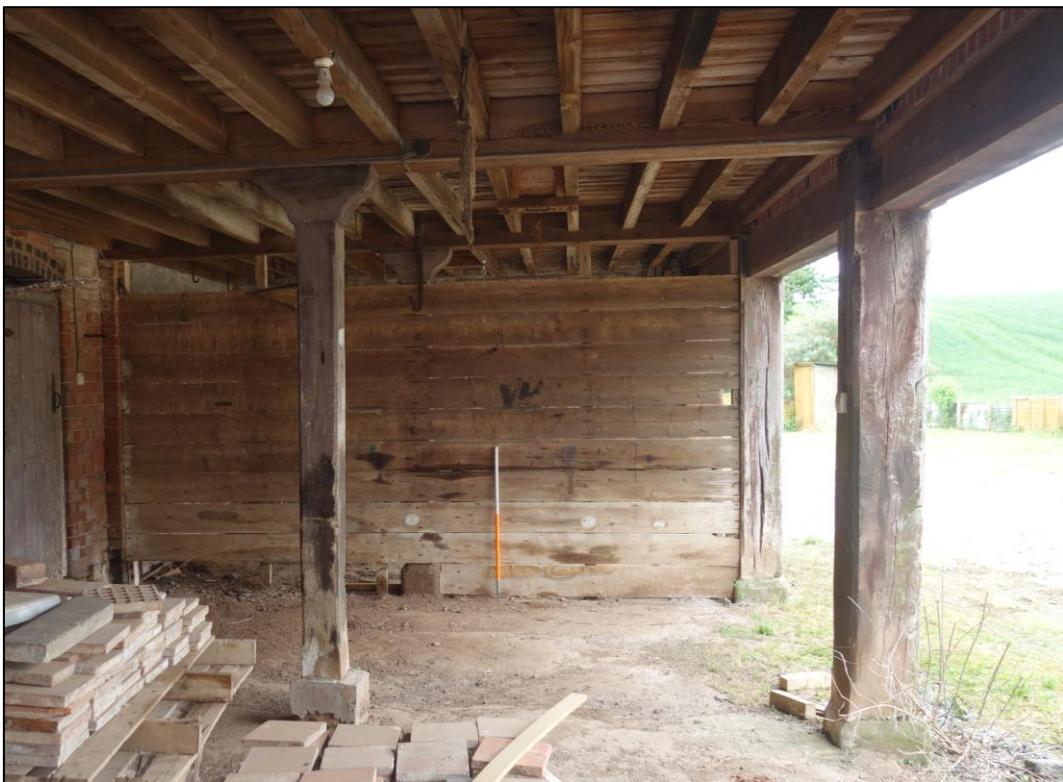
The interior of the cartshed is currently used as a garage for farm vehicles and for the storage of brick and tiles which appear to be reclaimed from a demolished outbuilding. The floor is of rammed earth with no obvious evidence for cobbling or hardstanding. The cartshed comprises four bays subdivided by transverse ceiling beams which are in turn supported by arcade posts resting on squared stone bases (*Plate 14*) with ogee-moulded wooden capitals and three shallow brick pilasters attached to the rear wall of the cartshed. A plank and batten door with strap hinges set within a segmental arched doorway in the back wall provides access to the stable range (*Plate 15*), to the left of which was a hook which may have been used for the hanging of harness associated with the carts that would have been stored in this location.

Plate 14: View looking SW showing interior of cartshed with arcade posts and a grain chute visible in the ceiling

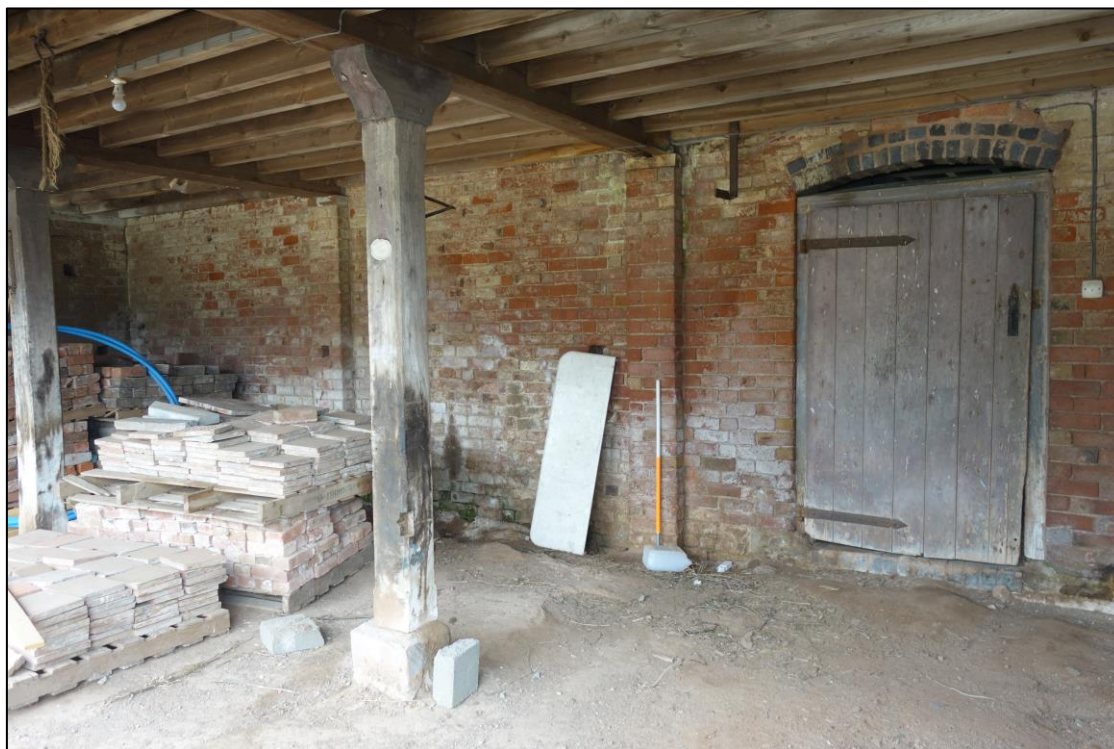
Plate 15: View E showing interior of central bays of cartshed with segmental-arched doorway in wall leading to stable range (to right of picture)

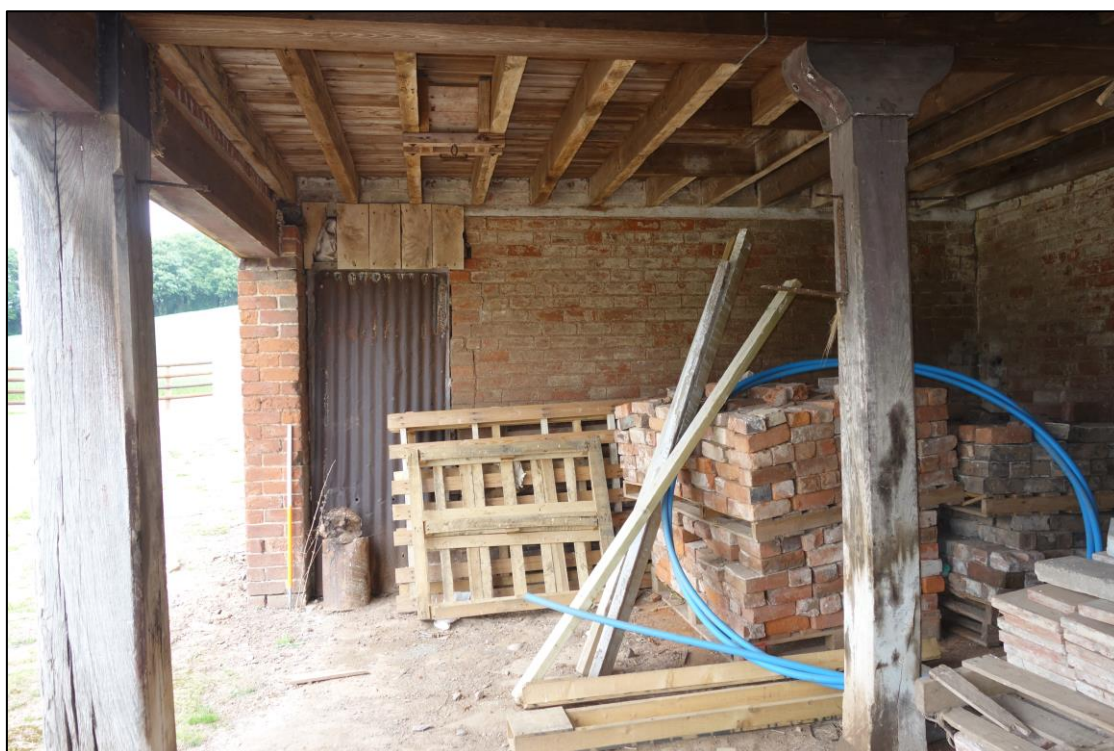
Plate 16: View looking NE showing northeasternmost bay of cartshed with grain chute and trapdoor in ceiling

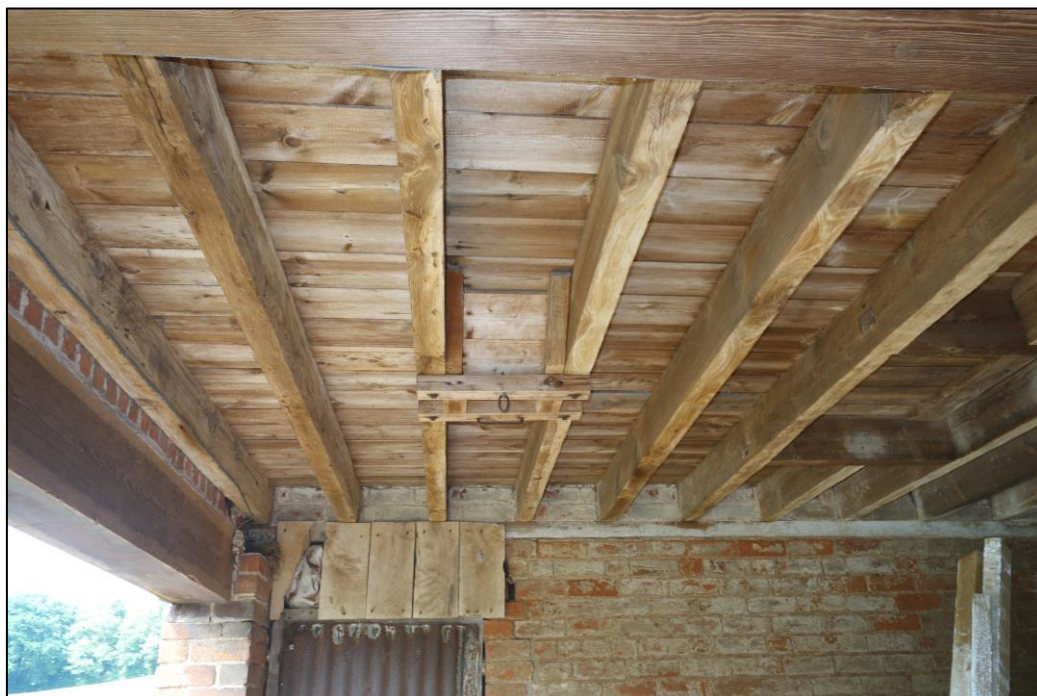
Two trap doors of plank-and-batten construction had been inserted in the ceiling within the NE and SW compartments of the cartshed, which would have been used for moving sacks of corn hoisted up directly from the carts into the granary (*Plate 16 & 20*). Two small angled wooden grain chutes with associated horizontal timbers (noggins) and attached metal handles with ropes were also noted within the exposed ceiling joists in the northeasternmost compartment of the cartshed and within the bay containing the entrance to the stable block (*Plates 17 & 18*).

Plate 17: View looking NE showing detail of grain chute in ceiling of northeasternmost bay of cartshed with trap door visible to right of picture

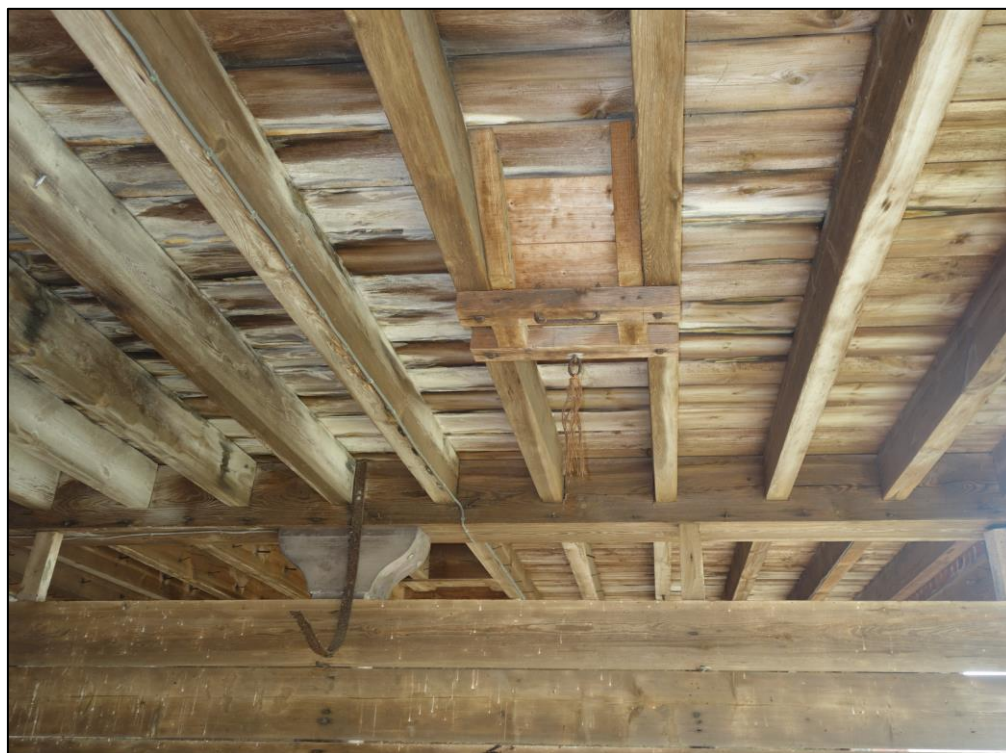
Plate 18: View looking SW showing detail of grain chute in cartshed bay opposite entrance to stable block

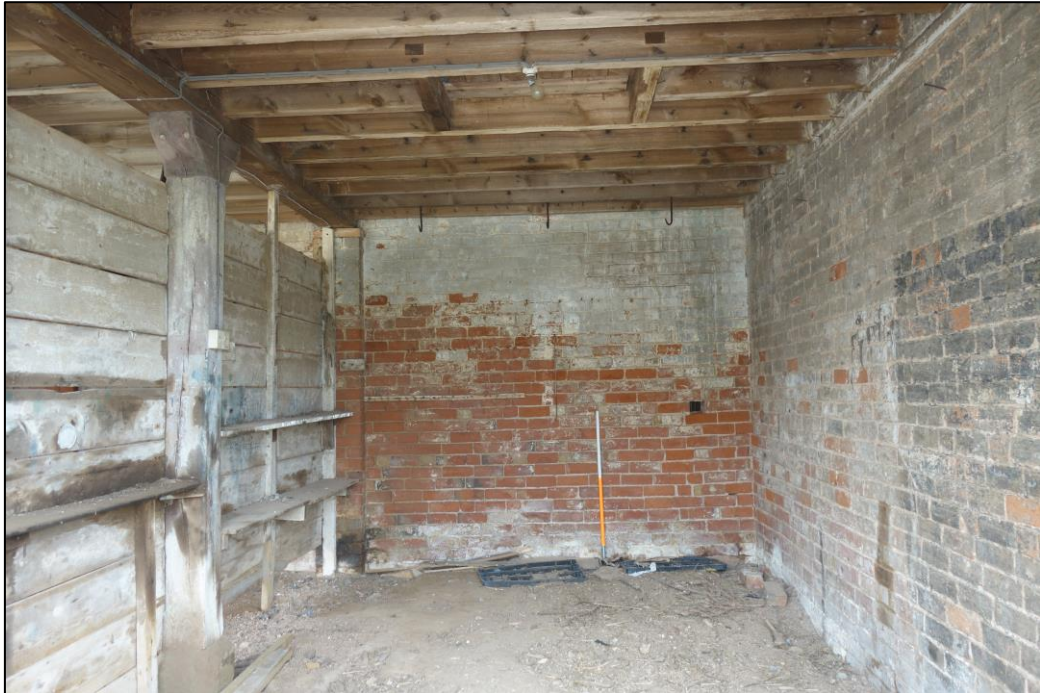
The compartment at the SW end of the cartshed has been demarcated from the other three bays by horizontal wooden slats with shelving attached, suggesting that this was used for the storage of farm implements or possibly produce that was kept intentionally separate from the other compartments (*Plate 19*). Three hooks were attached to the ceiling joists at the far end of this compartment, used for hanging equipment or harness.

Plate 19: View looking SE showing interior of compartment within southwesternmost bay of cartshed, demarcated by horizontal wooden slats with shelving (to left of picture)

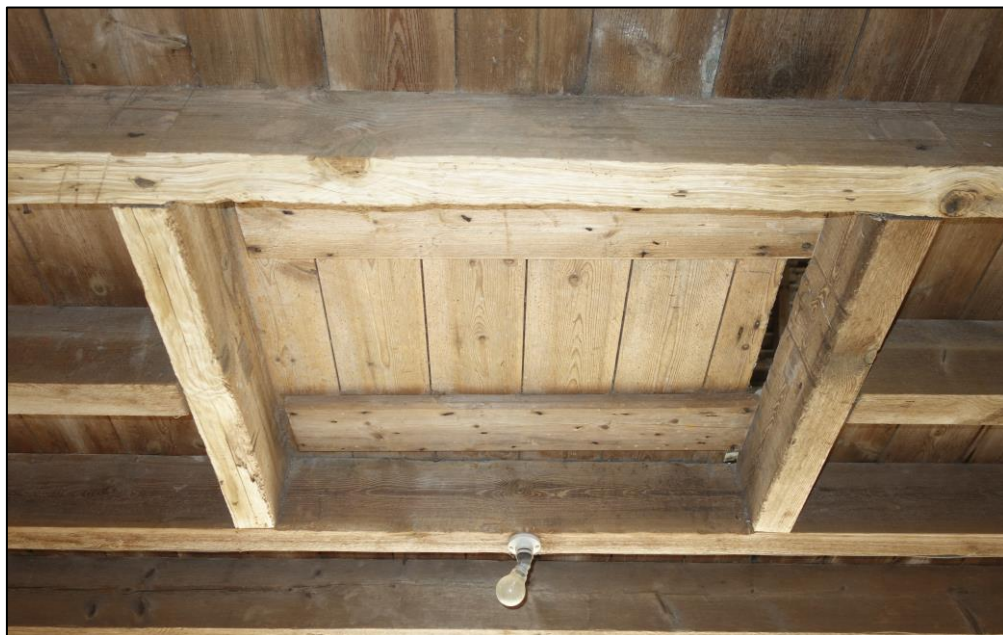
Plate 20: View looking SE showing detail of trap door in ceiling within southwesternmost bay of cartshed

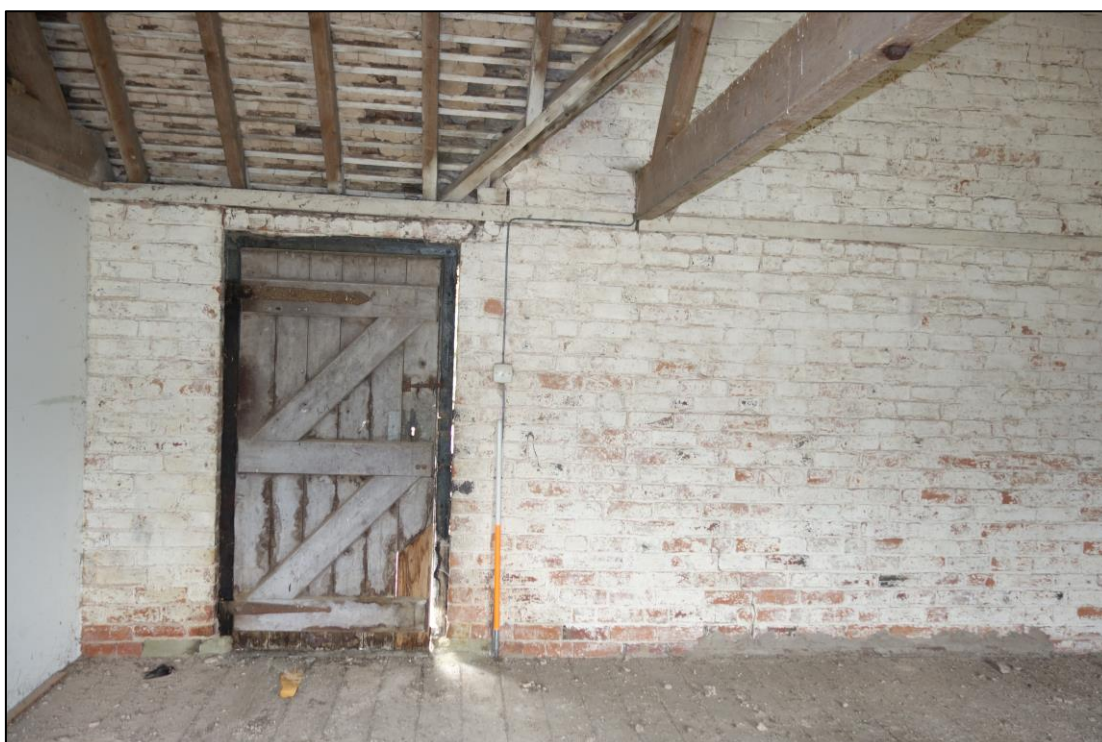
The granary above the cartshed is accessed via a flat-arched plank and batten door at the top of a staircase leading up from the rear of the building (*Plate 21*). The interior is four bays long and sub-divided into two compartments, with the NE bay separated from the remaining three bays by a plasterboard partition wall which appears to be a later insertion (*Plate 22*). The NE compartment also has a plasterboard ceiling which is evidently a modern addition.

Plate 21: Internal view SE showing plank-and-batten door in SE wall of first floor granary

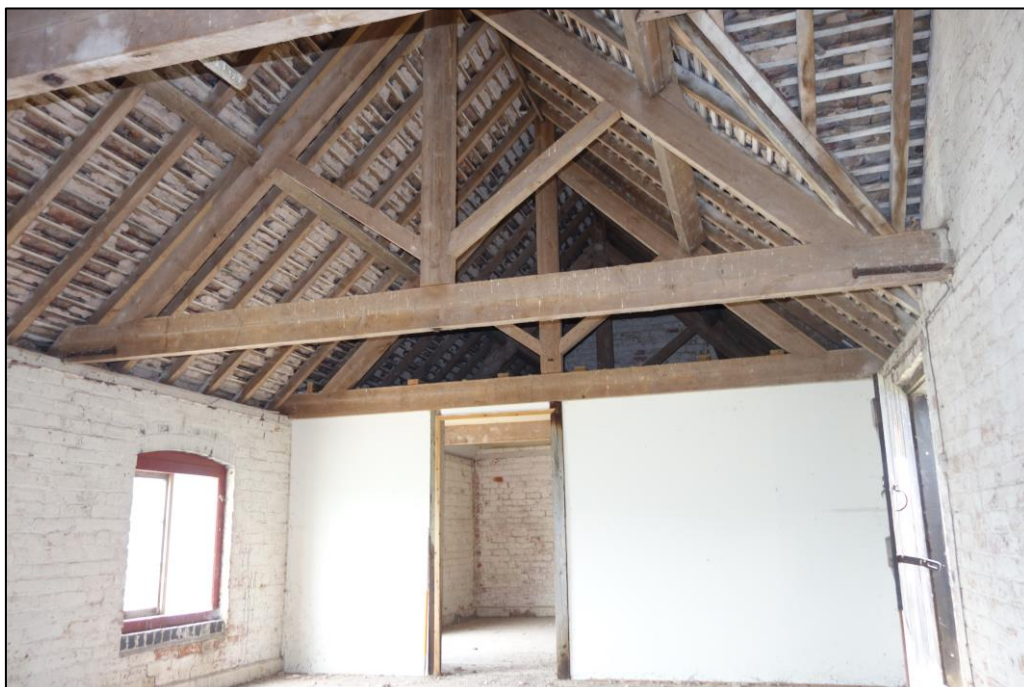
Plate 22: Internal view looking NE showing interior of granary with kingpost roof trusses and modern partition wall demarcating the NE compartment

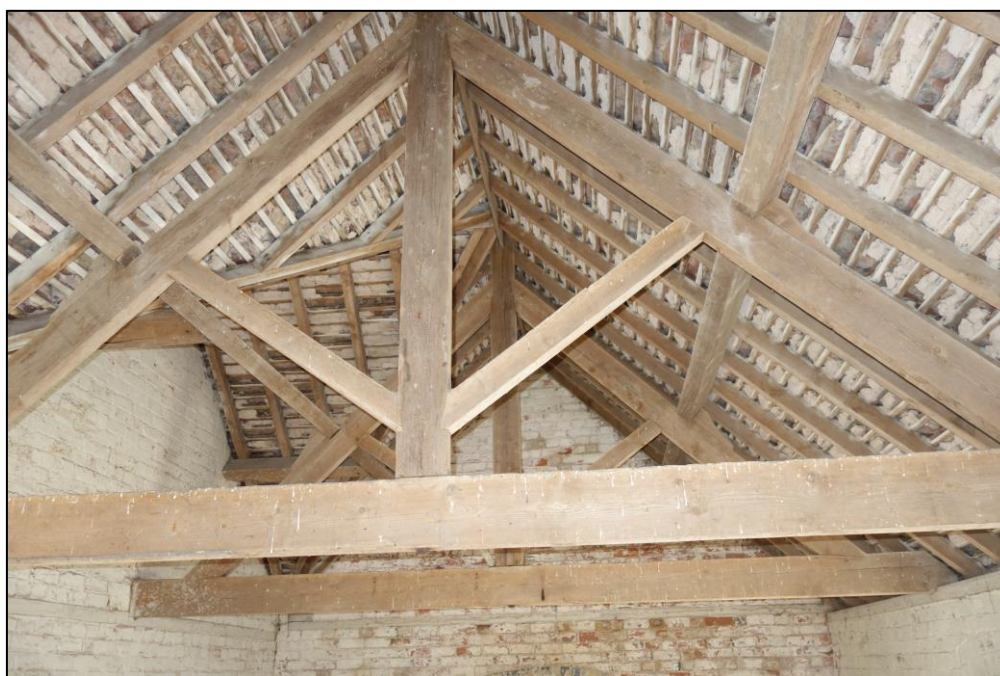
The roof structure comprises four kingpost roof trusses with angled-struts connecting the kingpost to the principal rafters which in turn are linked by a single pair of trenched purlins. Each truss has a cast iron bolt connecting the tie beam to the kingpost and strap plates linking the tiebeam to the wallplate (*Plate 23*). Within the southwesternmost bay, this roof structure intersects at right angles with the roofline of the stable block aligned NW-SE, however there was no evidence to indicate the presence of a connecting door directly linking the granary to the loft above the stable (*Plate 24*)

Plate 23: Internal view looking SW showing detail of kingpost roof trusses in granary with angled struts connecting the kingpost to the principal rafters, which are connected by a pair of trenched purlins

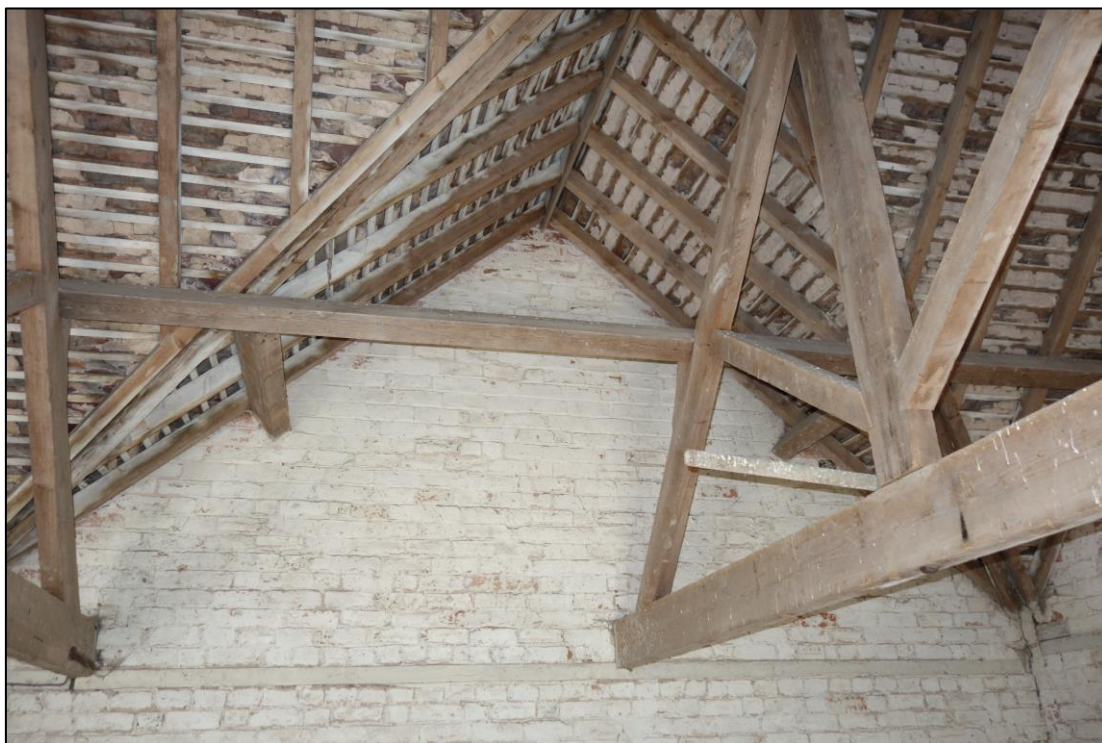
Plate 24: Internal view looking SE showing cross-gabled roof structure in SW bay of granary

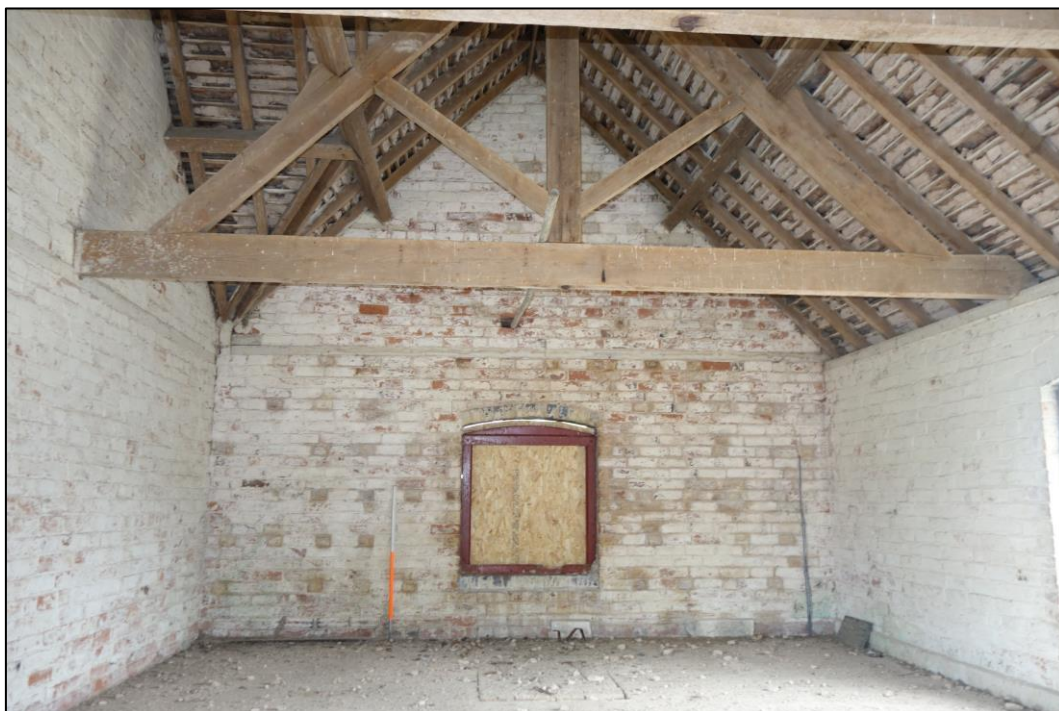
Plate 25: Internal view looking SW showing southwesternmost bay of granary with kingpost roof structure and segmental-arched window in SW wall

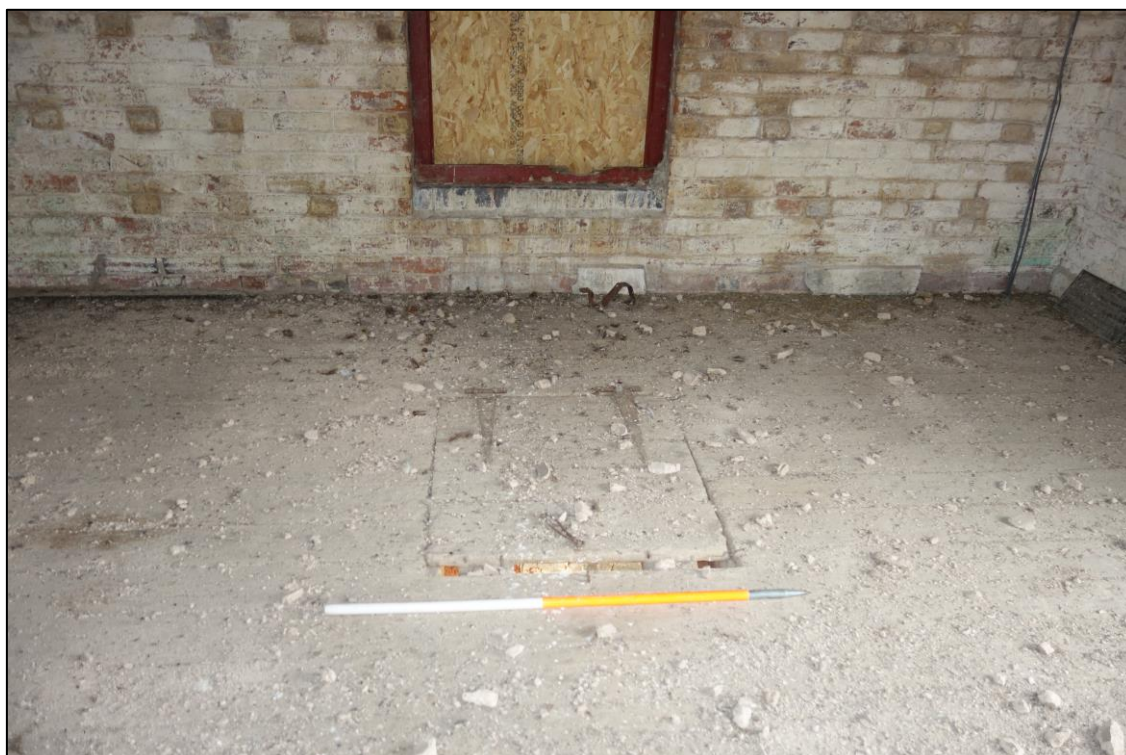
The interior of the granary is lime-washed (a common feature in buildings of this type, to keep the grain dry and reduce vermin) and lit by three windows in the NW wall and a single window in the SW gable end (*Plate 25*). The floor is laid with tight-fitted lapped floorboards (to prevent loss of grain) and has two trap doors with cast-iron strap hinges measuring 1m × 0.80m, centrally placed within the NE and SW bays of the barn (*Plates 26-28*).

Plate 26: Internal view looking SW showing detail of floorboards and trap door in SW bay of granary

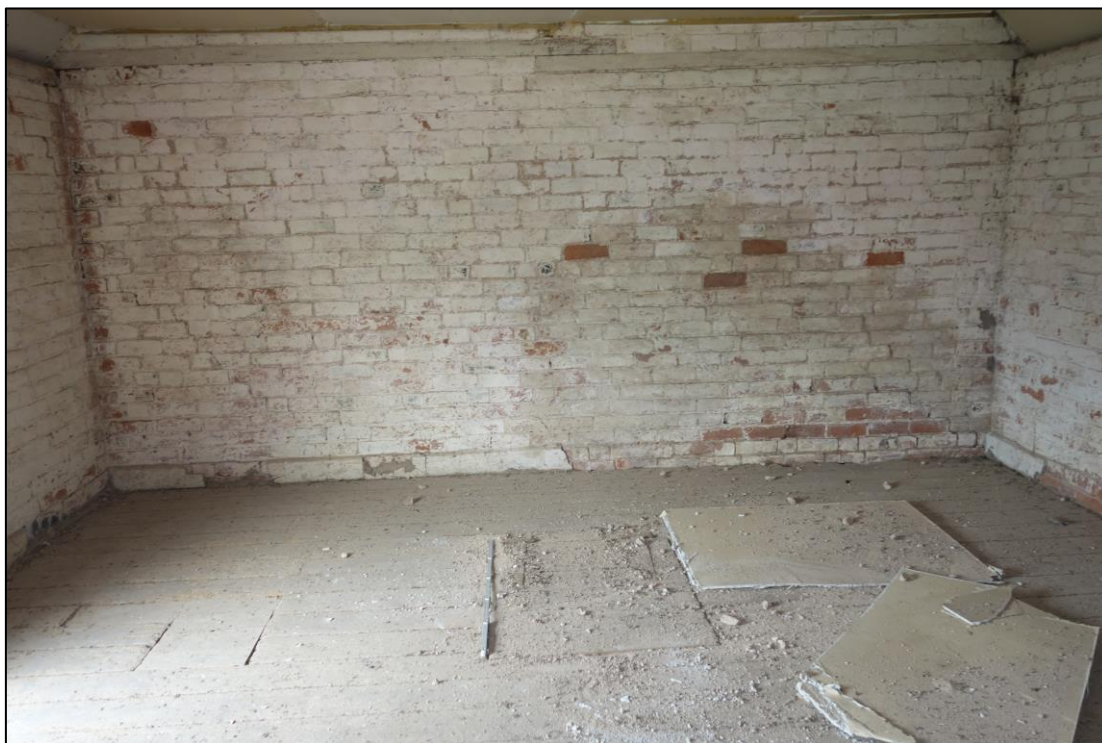
Two hatches for grain chutes were also noted in the granary floor; the hatch in the NE bay, which is L-shaped in plan (measuring 0.80m × 0.55m) is set to the left of the trap door while the hatch in the bay opposite the entrance to the granary is rectangular in shape, measuring 0.60m × 0.50m (*Plates 29 & 30*). No other fixtures or fittings of architectural interest were noted within the granary.

Plate 27: Internal view looking NE showing northeasternmost bay of granary with trap door and grain chute to left of picture
