Archaeological Standing Building Recording

**Oxnalls Farm
Newnham Bridge
Tenbury Wells
Worcestershire
WR15 8LP**

June 2020

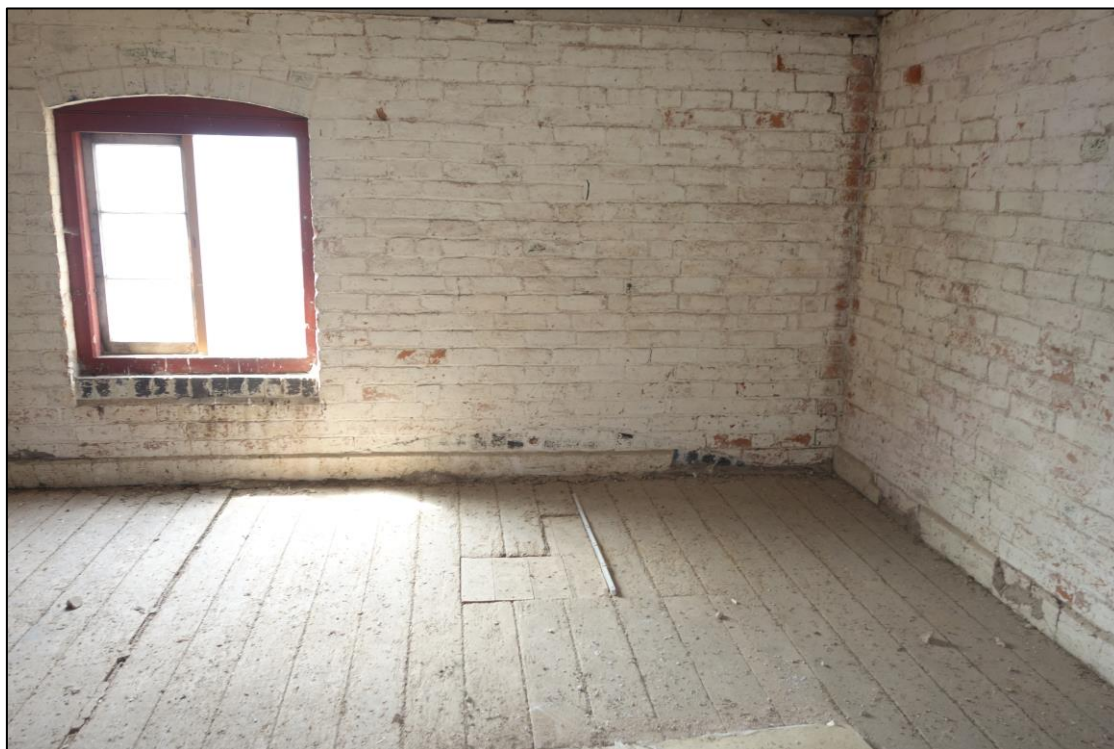
Plate 29: Internal view looking NW showing segmental-arched window and grain chute in northeasternmost bay of granary

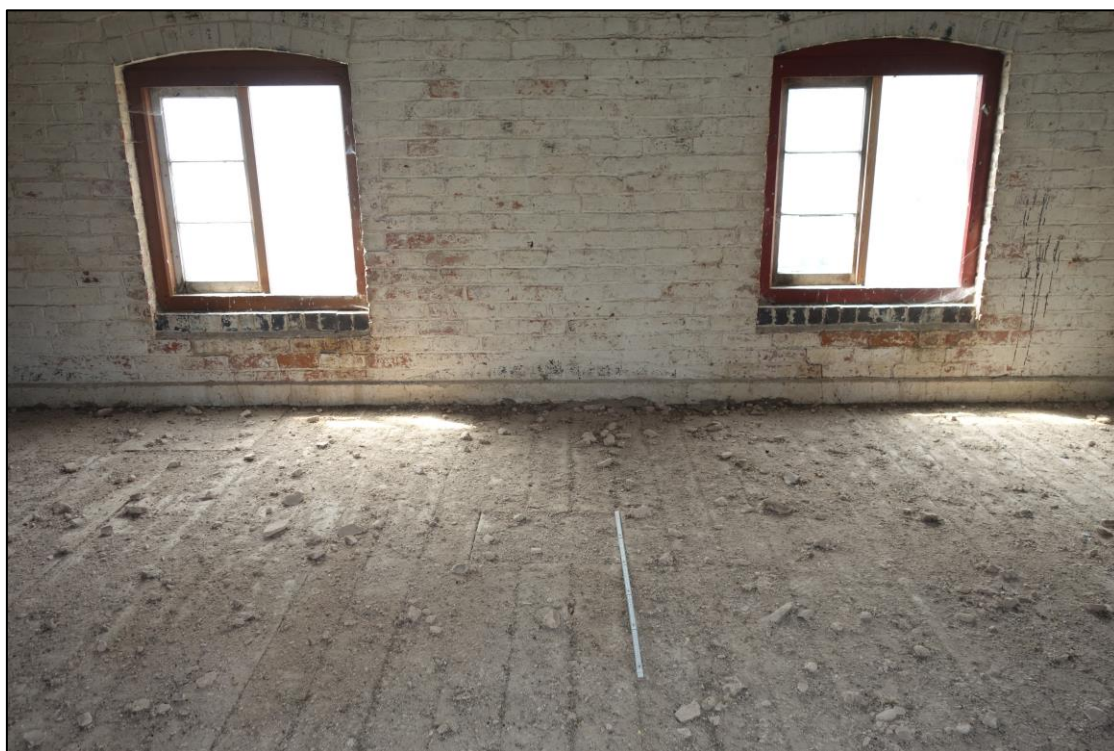
Plate 30: Internal view looking NW showing central two bays of granary lit by segmental-arched casement windows and rectangular grain chute in floor (in centre of picture)

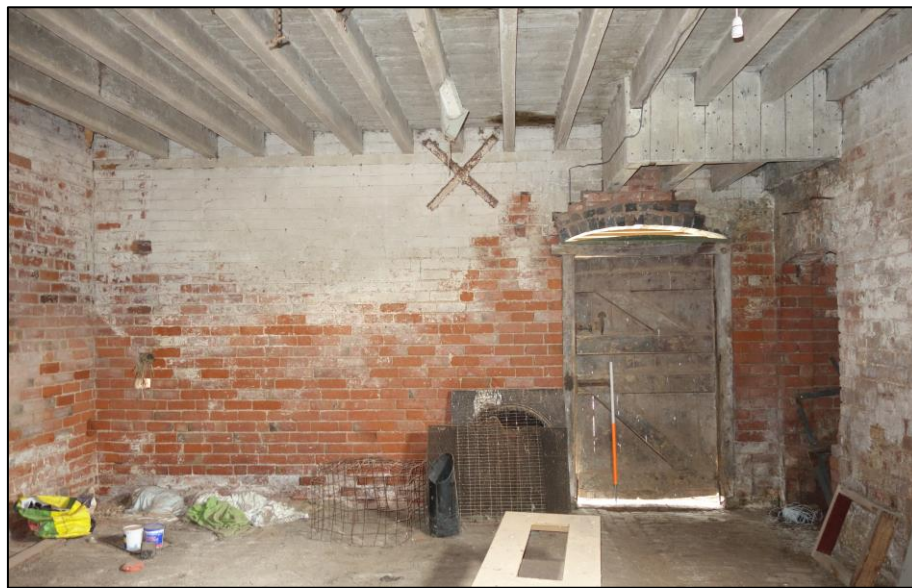
The former stable range at ground floor level is accessed from the cartshed via a plank and batten door set within the NW wall (*Plate 31*), immediately to the left of which is a narrow segmental arched opening leading to a small alcove beneath the external staircase leading to the granary and hayloft above (*Plate 32*). The function of the alcove is unclear; dog kennels were often sited beneath staircases leading up to granaries, however the alcove appears too small and no evidence for kennels was noted in this location. It seems more likely that the alcove was used for storage purposes.

Plate 31: Internal view of stable range showing exposed ceiling joists and segmental-arched door in NW wall

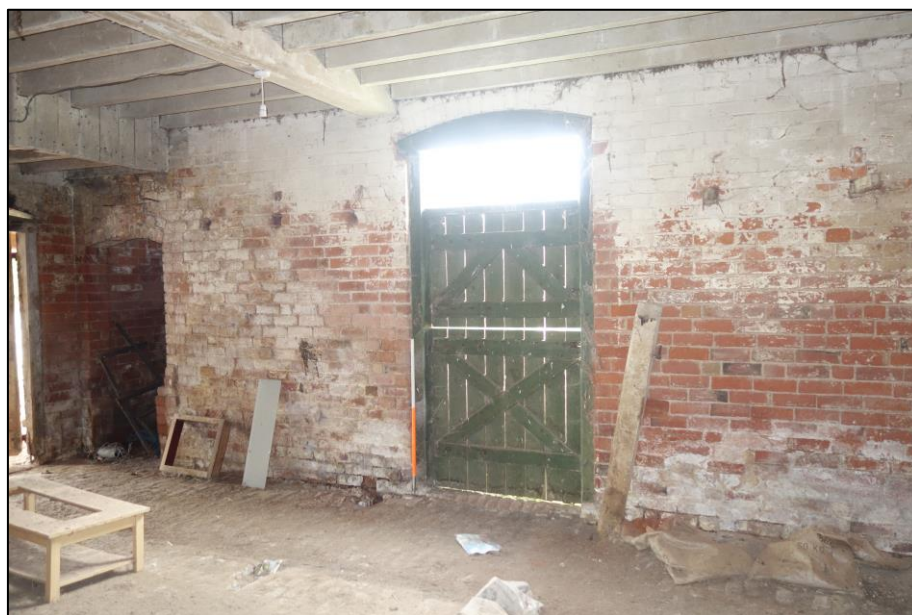
Inserted centrally within the NE wall of the range is a tall plank and batten stable door with a glazed overhead; flanking it on either side are three square indentations for horizontal harness rails, only one of which has remained intact (*Plate 33*). The room is lit by a segmental arched window with wooden frame in the SE gable end wall of the range, which has since been boarded up (*Plate 34*). Further indentations were noted at a lower level in the SE and SW walls of the range which probably relate to hay rack or mangers; however no trace of these fixtures appears to have survived. It is presumed that the range housed two loose boxes; the subdivision between the two may be represented by the vertical wooden post located roughly midway along the SW wall (*Plate 35*)

Plate 33: View looking N showing segmental-arched door with glazed overhead in NE wall of stable flanked by indentations for harness rails (with an intact harness rail to right of picture)

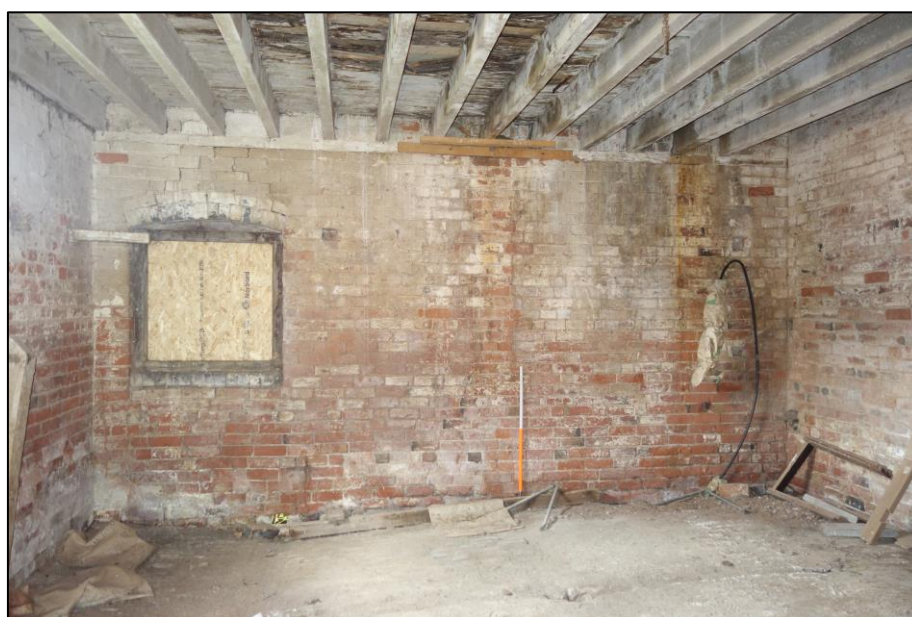
Plate 34: Internal view looking SE showing interior of granary and segmental-arched window (now boarded up)

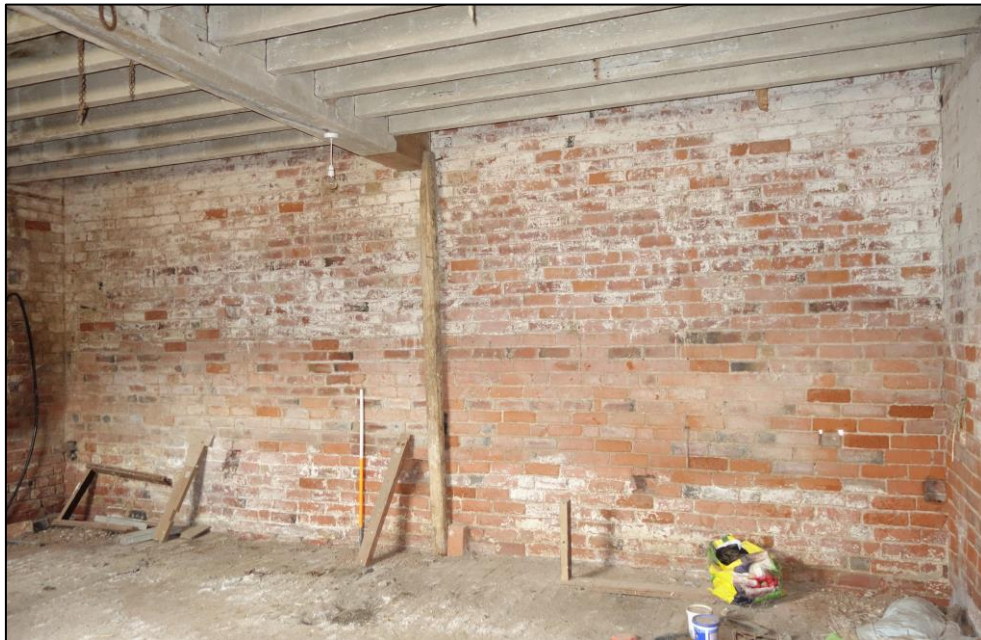
Plate 35: View looking SW showing vertical post midway along SW wall, representing a subdivision within the stable range

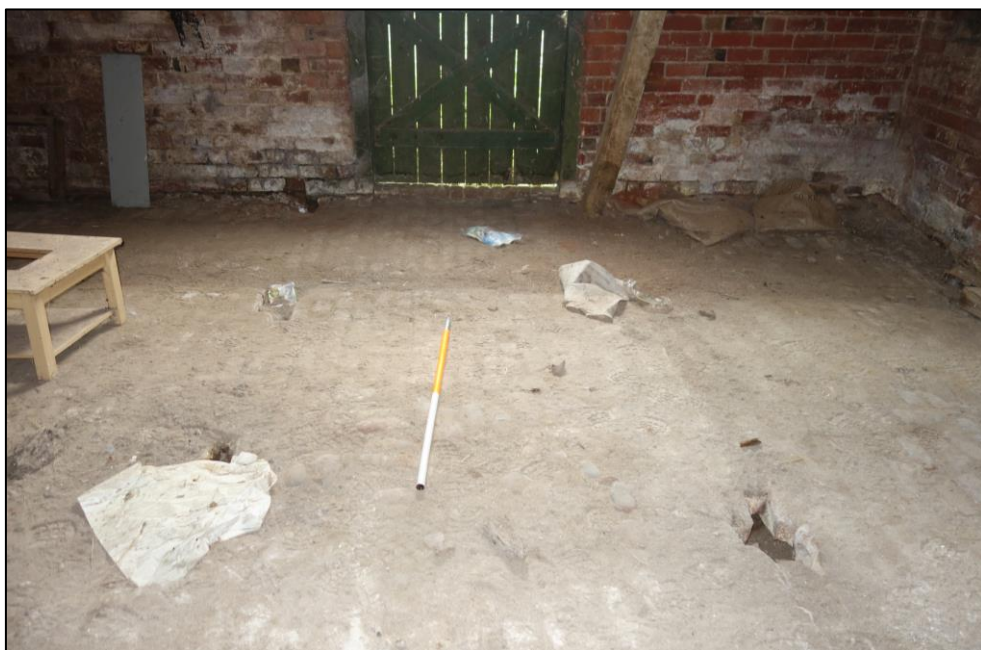
The exposed ceiling beams and joists and the walls of the range are coated with whitewash although some of the whitewash appears to have been removed and the boards carried on the joists have decayed in places. Evidence of hooks and chains attached to the ceiling beams were noted, these were presumably used for the hanging of tack. No evidence for trap doors or chutes were noted in the ceiling. Few fixtures or fittings associated with its original usage as a stable appear to have survived, however the slightly cambered brick cobbled floor has remained largely intact, with a shallow drainage channel running NW-SE parallel to the NE wall of the stable range (*Plate 36*).

Plate 36: View looking NE showing detail of cobbled floor and drainage channel within stable range

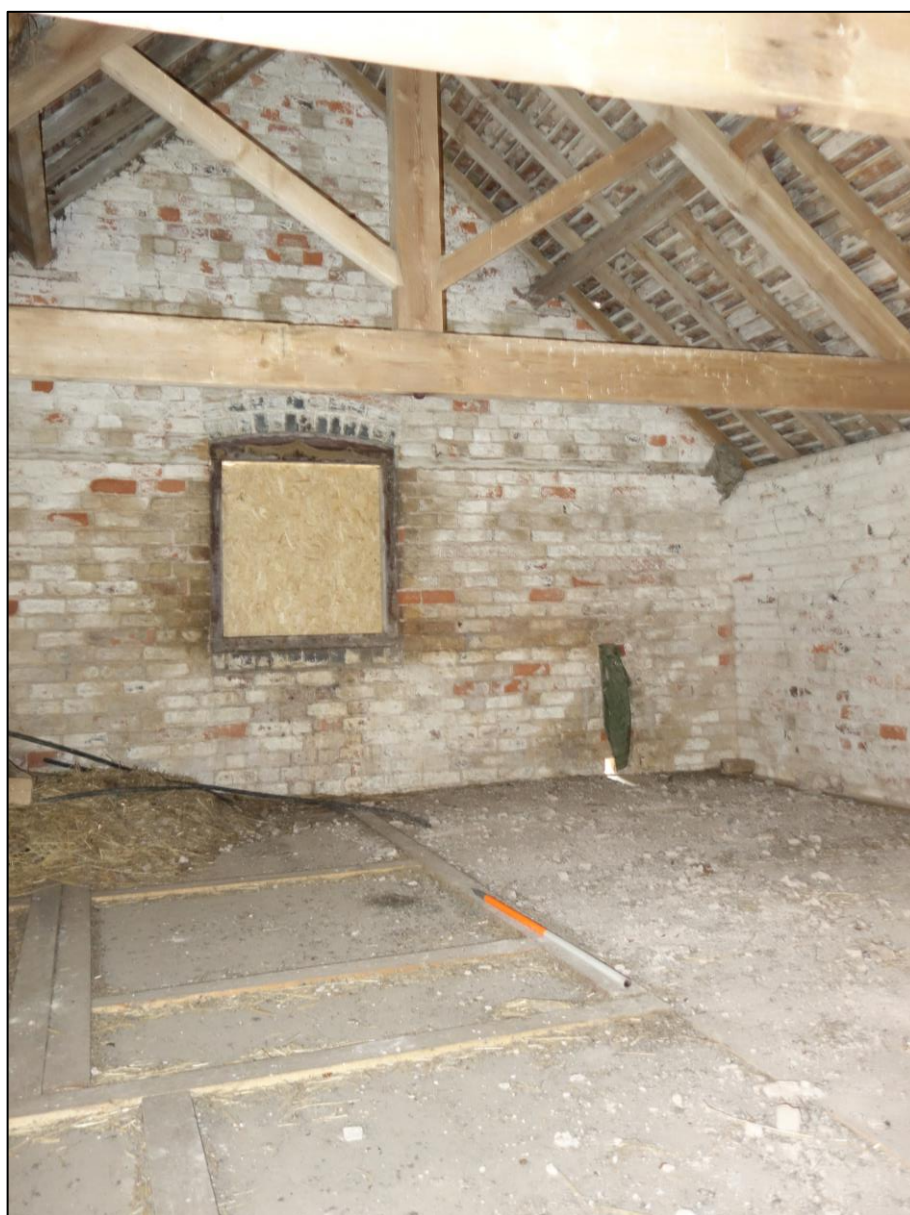
The loft above the stable range is accessed from the external staircase to the rear of the block, via a flat-arched plank and batten door. It was evidently used until recently for the storage of hay and the floor is covered throughout by hay and other detritus. Recording of the loft was limited for health and safety reasons due to holes and large damp patches in various places within the loft floor. The loft floor is raised slightly above the threshold of the doorway; a considerable portion of the original floorboards appear to have been replaced with large square boards along the NE side of the loft, which may represent a later repair due to the floorboards having decayed or an attempt to reinforce the floor for storage purposes. The loft is sub-divided into three bays and has whitewashed walls; it is lit by a single segmental arched window in the SE wall which has been boarded up (*Plate 37*).

Plate 37: View looking SE showing southeasternmost bay of hayloft with segmental-arched window in SE wall and partially denuded flooring in loft

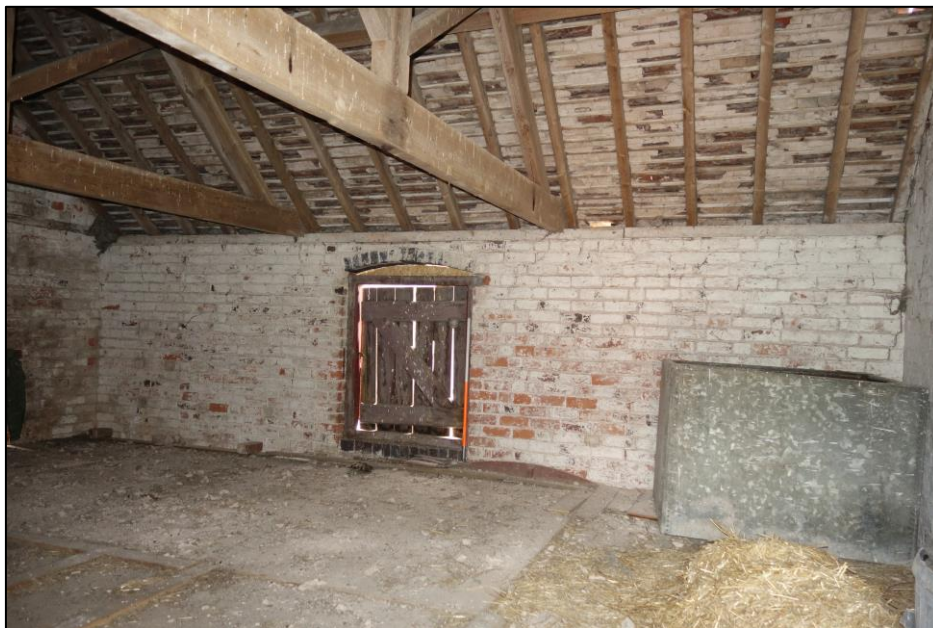
Located roughly midway along the SW wall of the stable range is a plank-and-batten loading bay door set within a segmental arched opening (*Plate 38*). To the right of the loading bay door, a large rectangular metal tub was noted in the extreme SW corner of the loft which appears to have been used as a grain bin and has evidently been moved from its original location. The roof structure is of kingpost construction with angled struts and trenched purlins identical to that found in the granary and evidently of similar date (*Plate 39*). No other fixtures or fittings of architectural or historical interest were noted within the loft.

Plate 38: View looking SW showing interior of hayloft above stable with loading bay door in SW wall and metal tub (grain bin) to right of picture

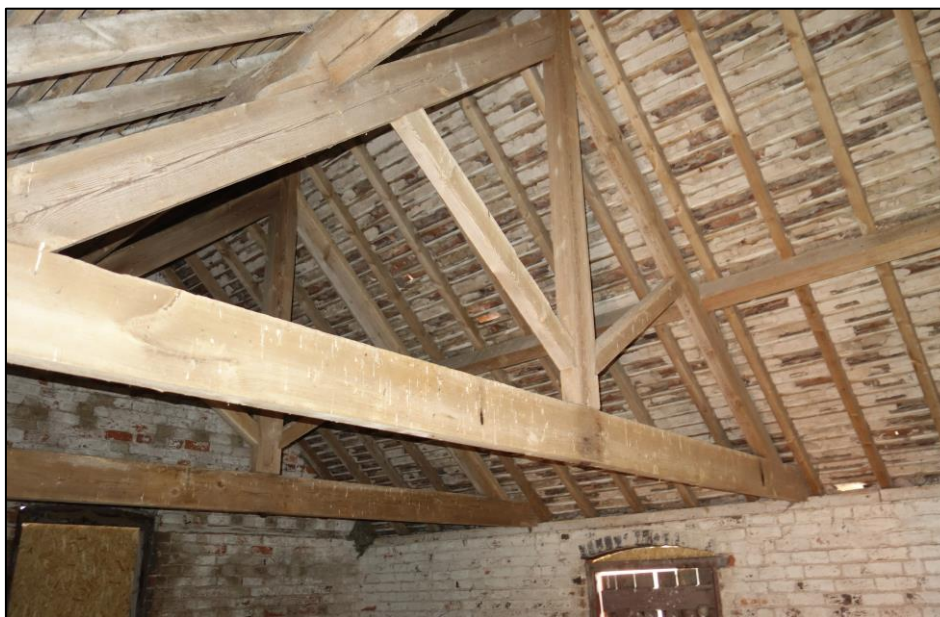
Plate 39: Internal view looking S showing detail of roof structure with central kingpost truss and angled struts in hayloft

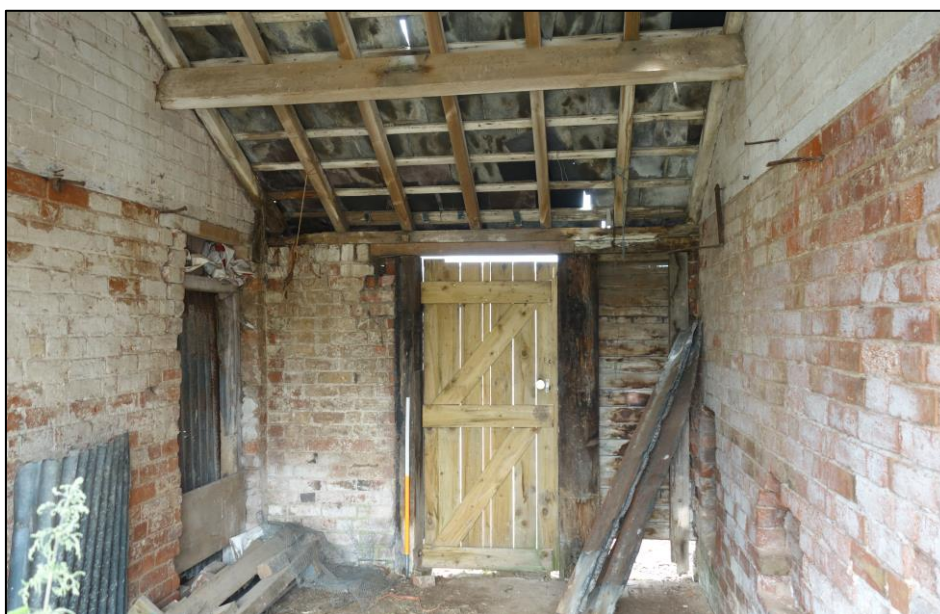
Attached to the NE end of the cartshed is an open fronted shed or vestibule, slate-roofed and open-fronted to the rear, which provides access to a single-storey rectangular gabled outbuilding oriented NW-SE with a cross-gabled slate roof (*Plates 40 & 41*). This gabled structure appears originally to have formed part of a long outbuilding range aligned NW-SE and used as livestock accommodation which appears to have been heavily rebuilt and clad with wooden slats and corrugated metal sheeting and was demolished in recent years. However, this gabled structure was separated from the rest of the range by a brick partition wall.

Plate 40: View looking NW showing interior of open-fronted shed/vestibule between cartshed and outbuilding

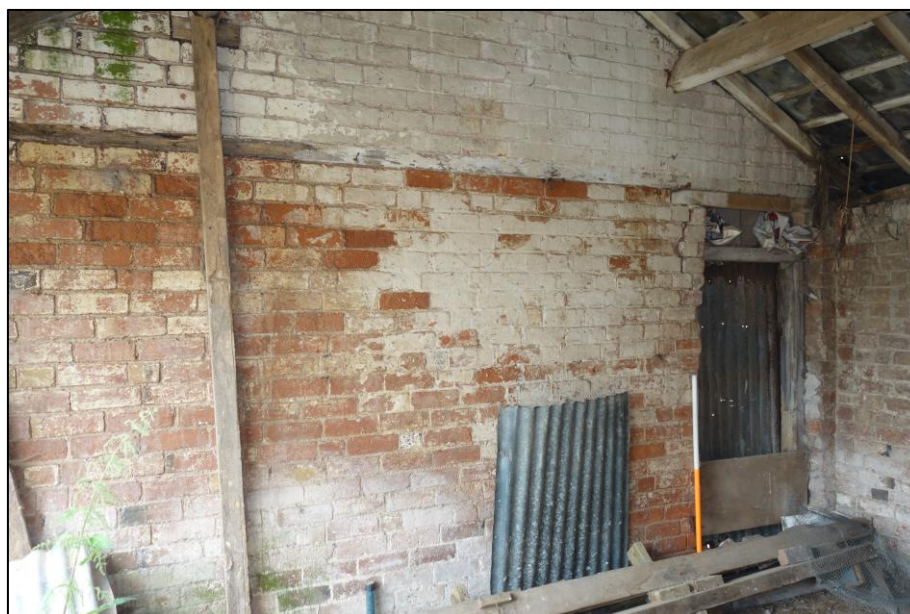
Plate 41: View looking W showing lower portion of NE wall of cartshed, partially whitewashed

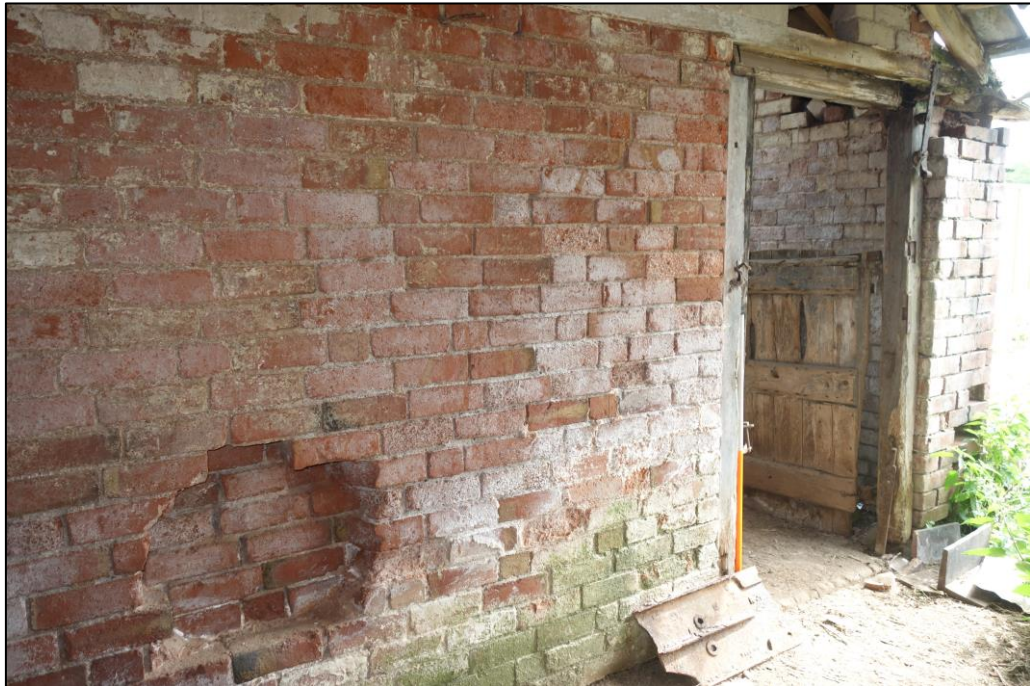
Plate 42: View looking E showing flat-arched door in SW-facing elevation of brick outbuilding to NE of cartshed

The gabled outbuilding is accessed by a plan-and batten door set in a flat-arched doorway in the SW-facing elevation (*Plate 42*). The interior consists of a single compartment which has been entirely coated with whitewash while the roof structure (which has partially collapsed in places) is of open truss type with trenched purlins (*Plate 43*). Indentations for hay racks were noted in the SE wall but no surviving historic fittings or fixtures were observed within this outbuilding, which may have been used to isolate horses (such as mares in foal) or livestock.

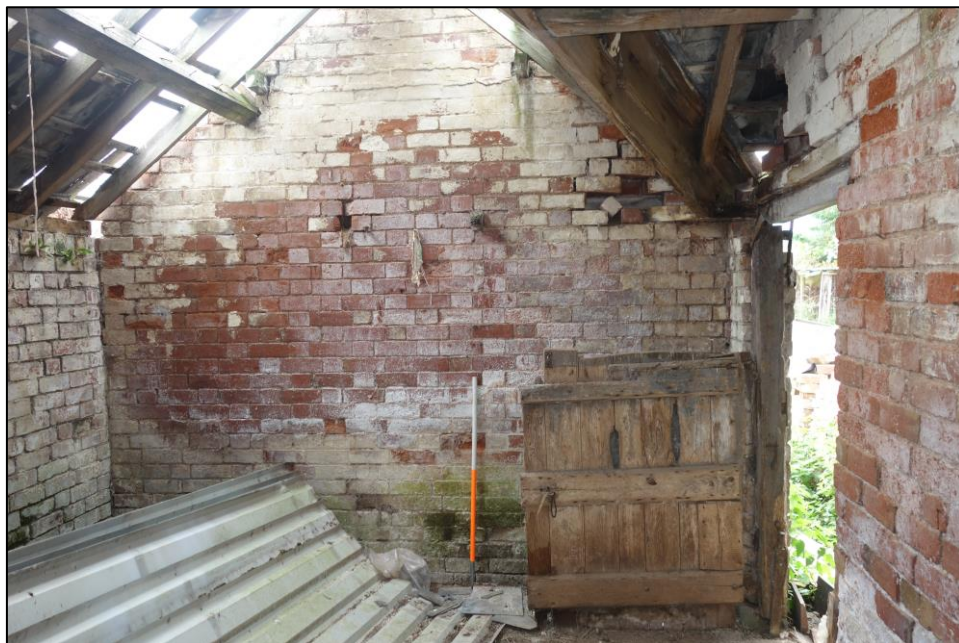
Plate 43: View looking SE showing interior of gabled outbuilding to NE of cartshed
